## **Diffusion Coatings for Corrosion-Resistant Components in Coal Gasification Systems**

Final Technical Report  
Covering the period June 1, 2003 through May 31, 2007

SRI Project P13063

DOE Contract No. DE-FC26-03NT41616

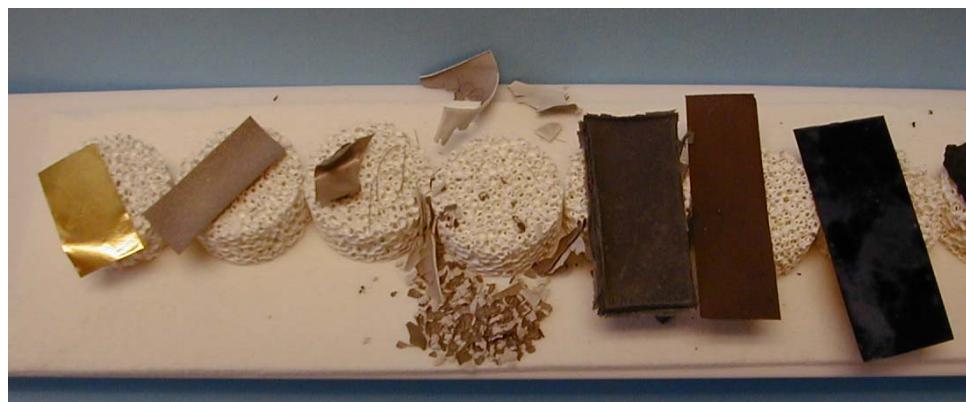
Figure 14. Samples after exposure to simulated coal gas at 900°C in Test #5.

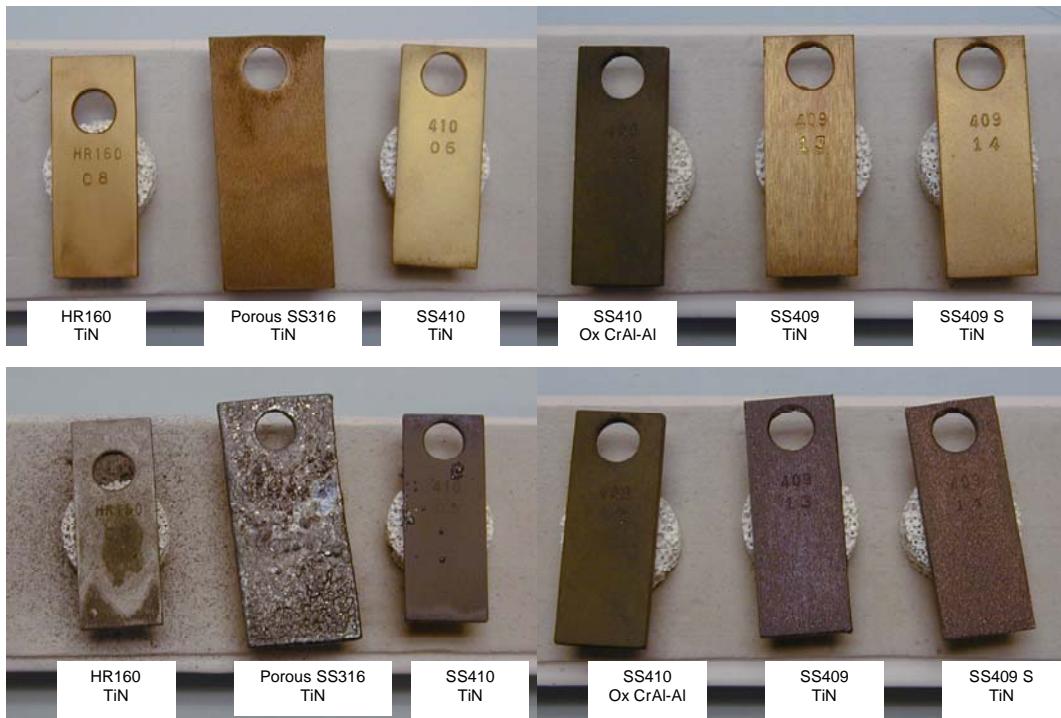
Figure 24. Samples from Test #7a before and after exposure to simulated gasifier environment for 96 h.

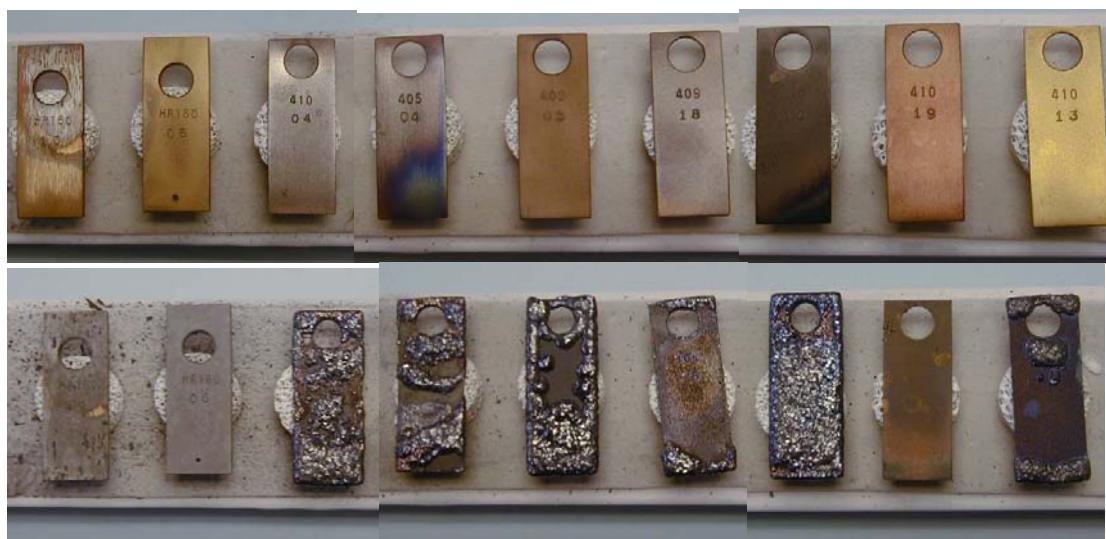
Figure 26. Samples before and after exposure for 306 h at 900°C to a simulated coal gas in Test #9a.
