Nevada
Environmental
Restoration
Project

**Post-Closure Inspection and
Monitoring Report for Corrective
Action Unit 110: Area 3 WMD
U-3ax/bl Crater,
Nevada Test Site, Nevada**

For the Period July 2005-June 2006

August 2006

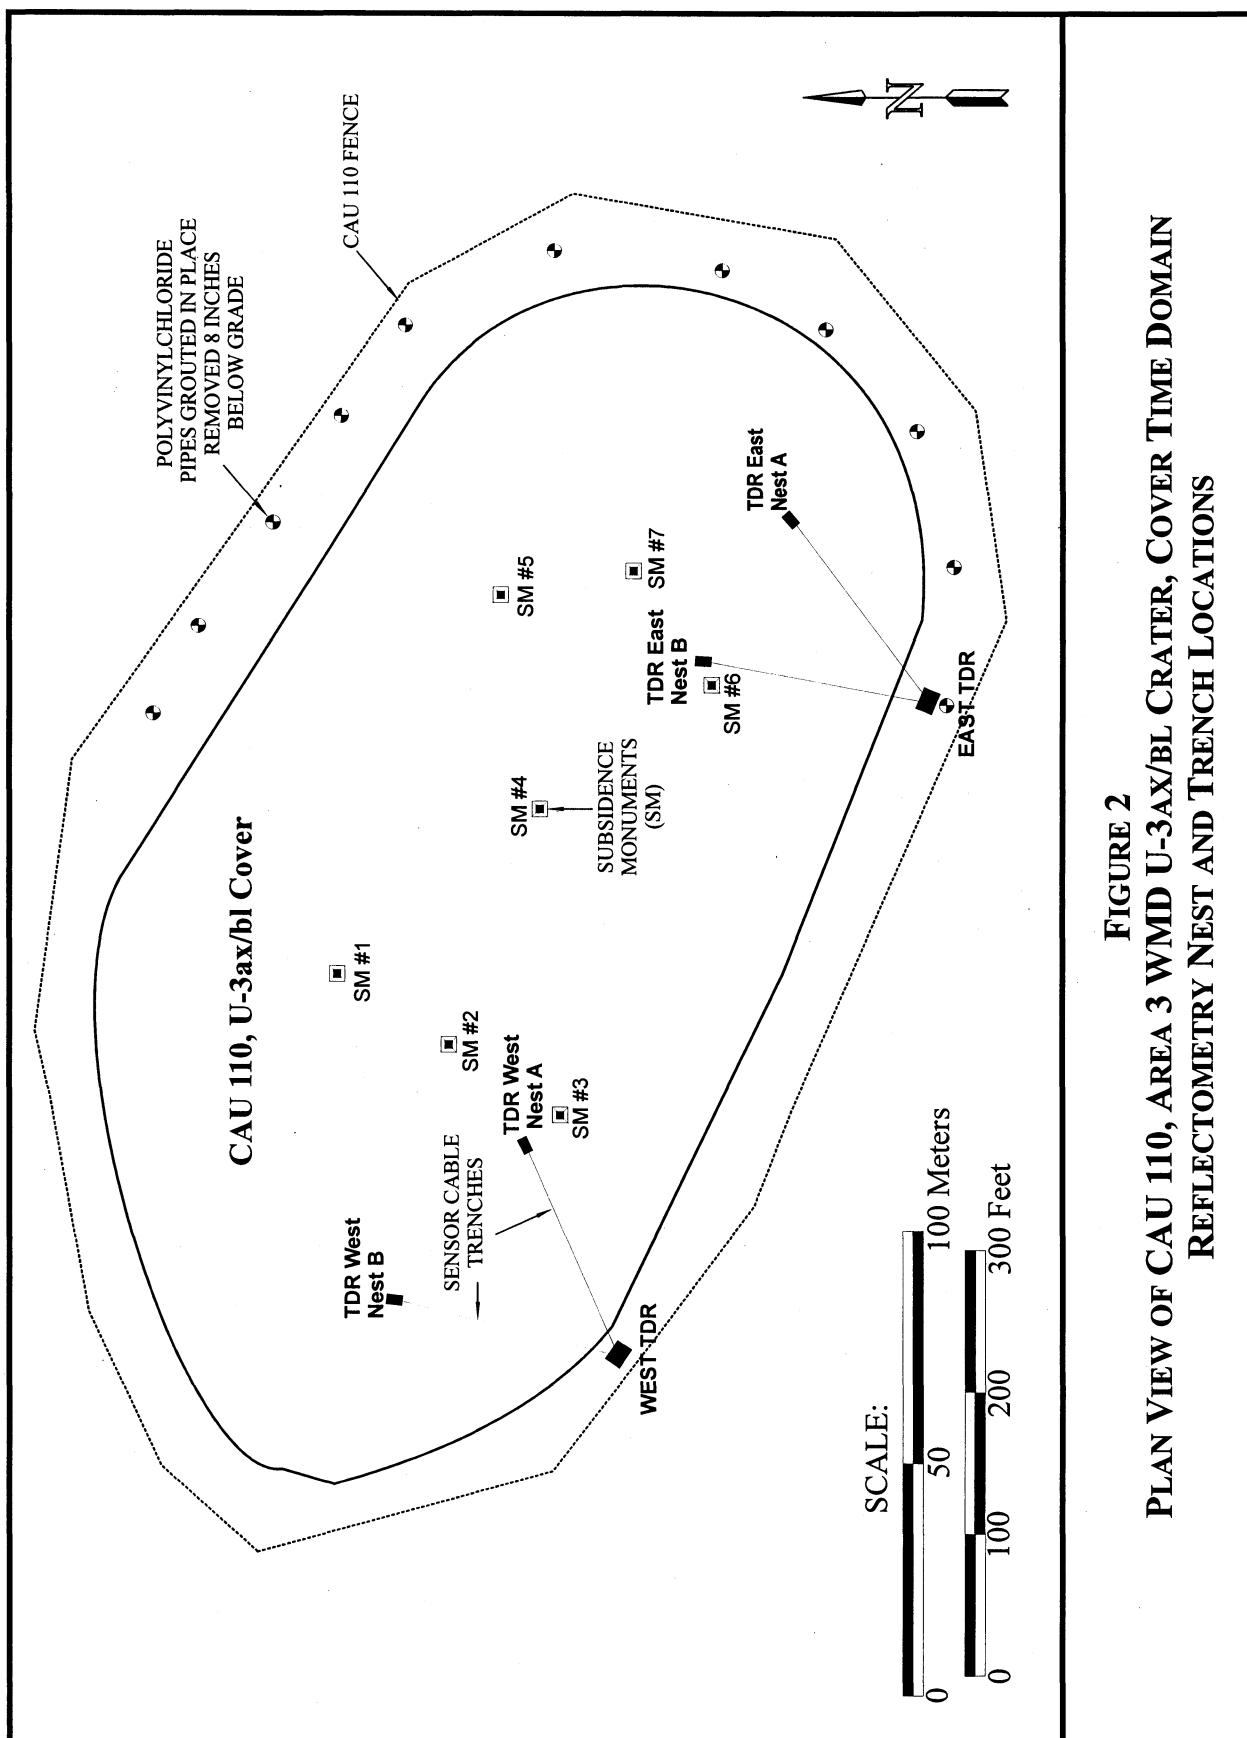
FIGURE 2
PLAN VIEW OF CAU 110, AREA 3 WMD U-3AX/BL CRATER, COVER TIME DOMAIN
REFLECTOMETRY NEST AND TRENCH LOCATIONS

The soil moisture content is obtained using two Campbell Scientific TDR-100 dataloggers housed in instrumentation shelters located along the periphery of the cover (Figure 2). TDR probes are Campbell Scientific CS610s using RG8 coaxial cable. The probes are installed at a distance of 50.3 m (165 ft) from the edge of the cover, and buried in the cover at depths of 0.3 to 2.4 m (1 to 8 ft) below the cover surface, one probe every 0.3 m (1 ft). Arrays of eight probes (a nest) are positioned at four locations across the cover (Figure 3). Soil moisture content data from the TDR moisture probes are collected once per day and stored on a datalogger. A radio link connects both the eastern and western TDR dataloggers to a telephone line at the Area 3 RWMS office, and the data are downloaded over this remote link.

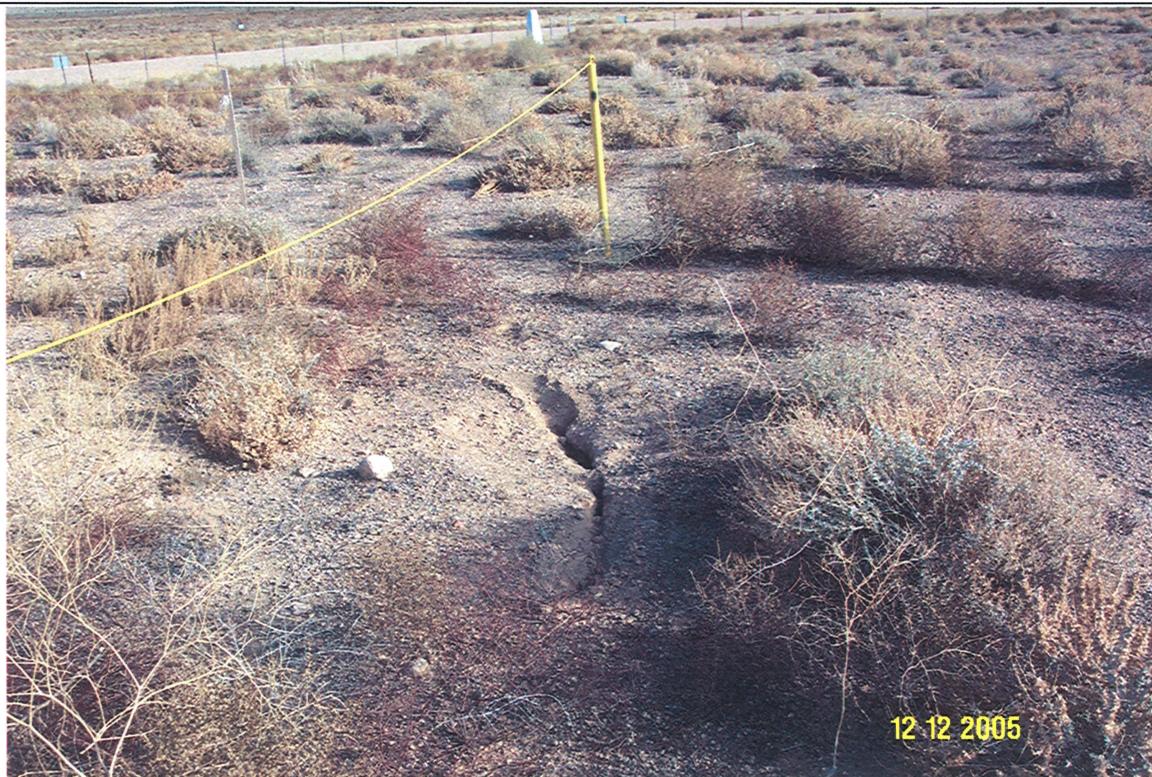
- Gate lock does not open.
- Three signs of subsidence were found. They are a 1 x 1.5 x 8-ft area found 10-ft to 12-ft north of the east TDR, a 2-in. x 18-in. x 8-ft area found on the east side where previous subsidence has been monitored, and a crack 10-ft to 12-ft long and 1-in. wide that has been previously monitored.
- The condition of warning signs and fencing was good.

12/12/2005
9. Subsidence crack along eastside of the cover.

During the December 12, 2005, inspection, three areas of settling on the cover (one area 10-ft north of the east TDR, one on the east side, and one in the northeast) exceeded the settling compliance criterion. The area along the east side of the cover had been repaired on several previous occasions. The three areas were repaired over the period of February 6-7, 2006. A portable, gas-powered tamper was used to compact the cracks in the cover. The first two areas were backfilled with clean, native soil using wheelbarrows and shovels, and then compacted using the tamper. Because the crack system on the third area was much larger and deeper than anticipated, work on the third area was ceased for the first day. After an engineer reviewed and approved proceeding with work, the third area work commenced again on the second day. This area was repaired following the same procedure as for the other cracks. Field notes for this repair are included in Appendix A.

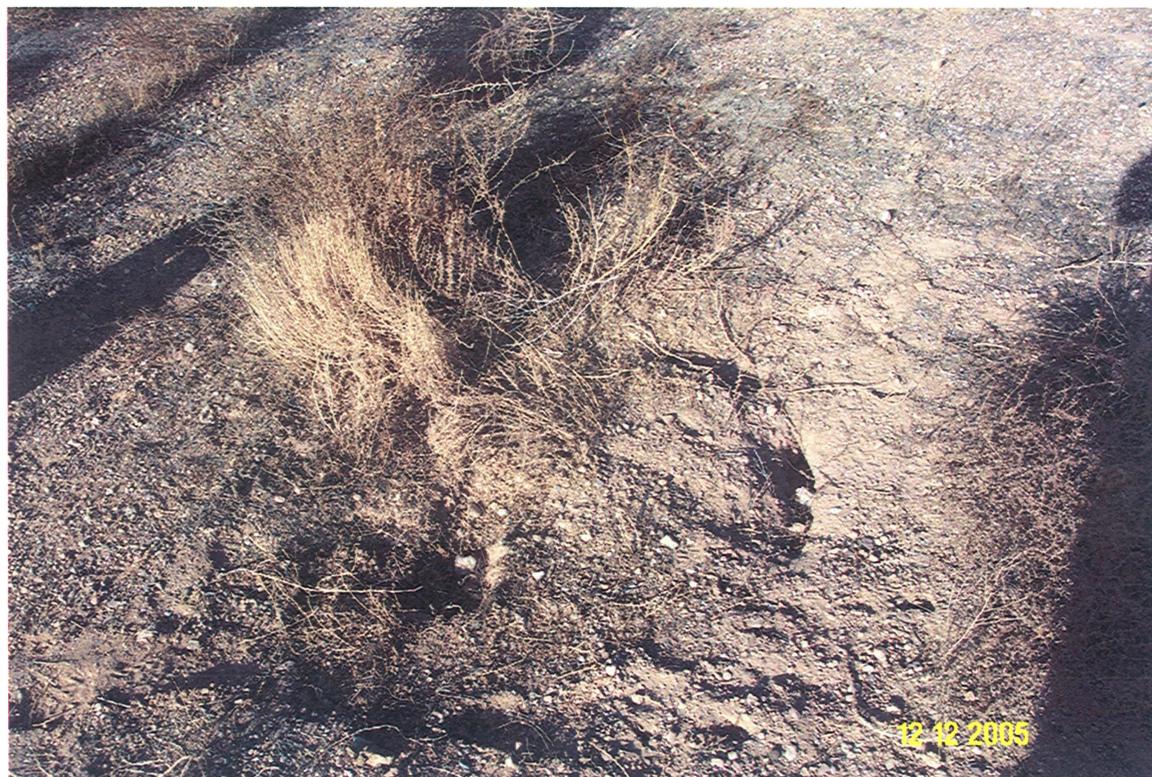
12/12/2005
10. Circular subsidence crack on the cover.

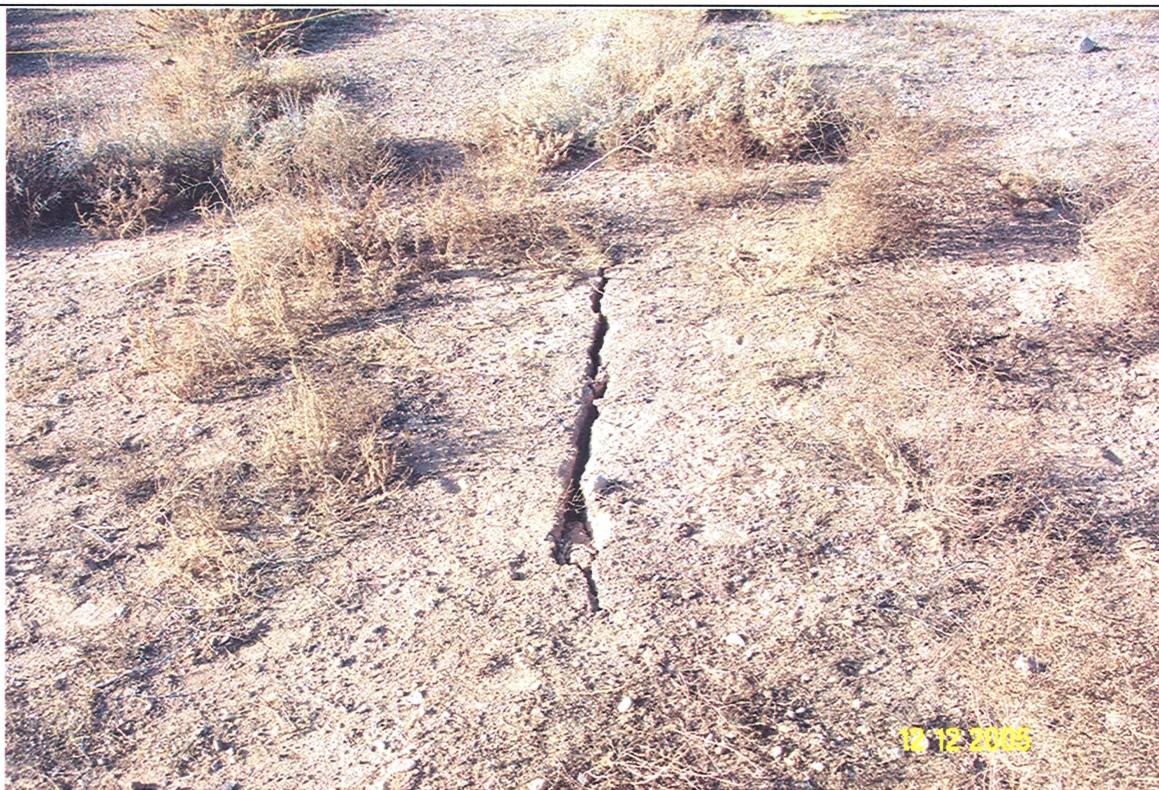
12/12/2005
11. Reoccurring subsidence crack on the cover.

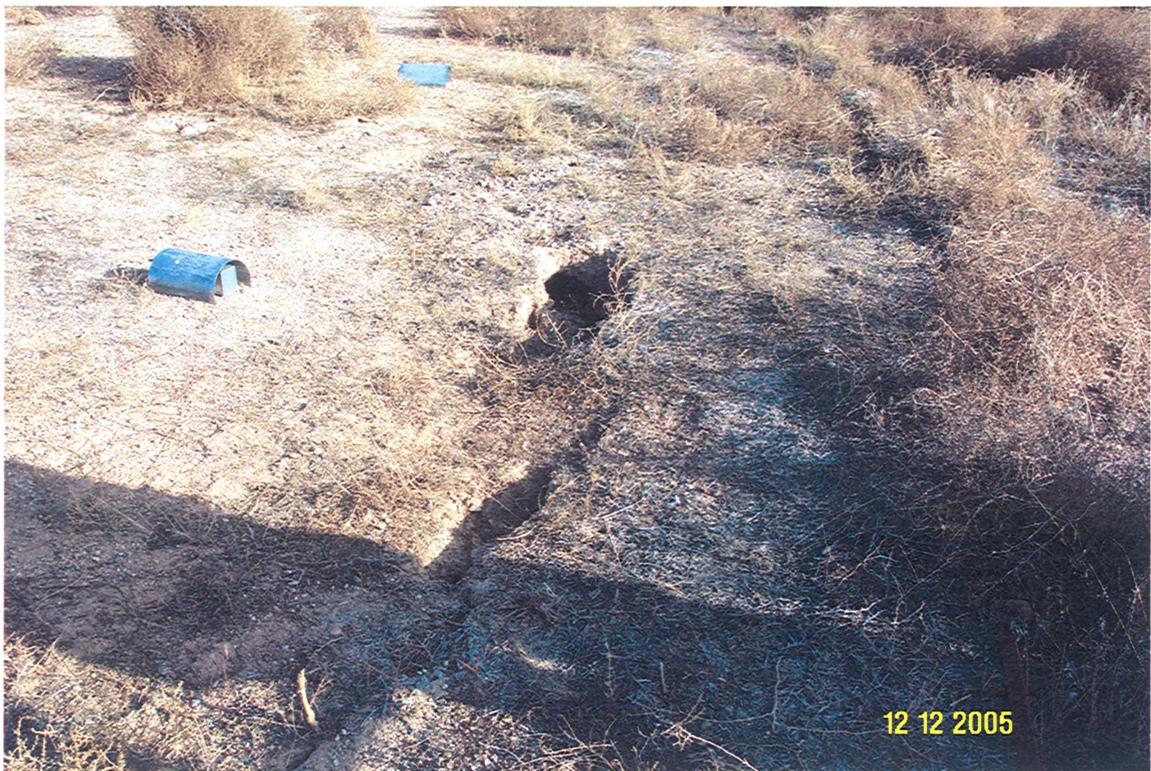
12/12/2005
12. Small animal burrow on a subsidence crack.

Because of the large number of small animal burrows found on the cover and fence line during the March 23, 2006, site inspection, trapping and relocating small mammals on the cover was undertaken. This activity began the week of April 18-20, 2006, during which a total of 160 deer mice and kangaroo rats were trapped and relocated from the cover.

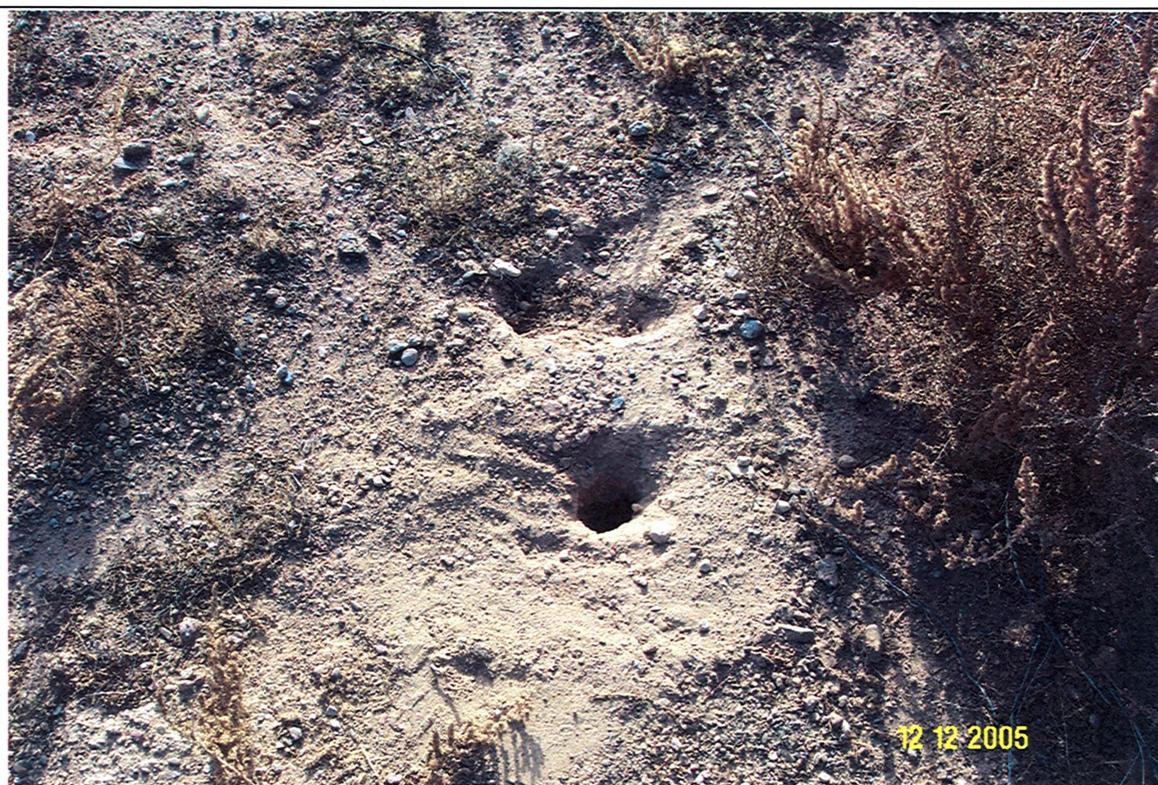
13. Small animal burrow on the cover.

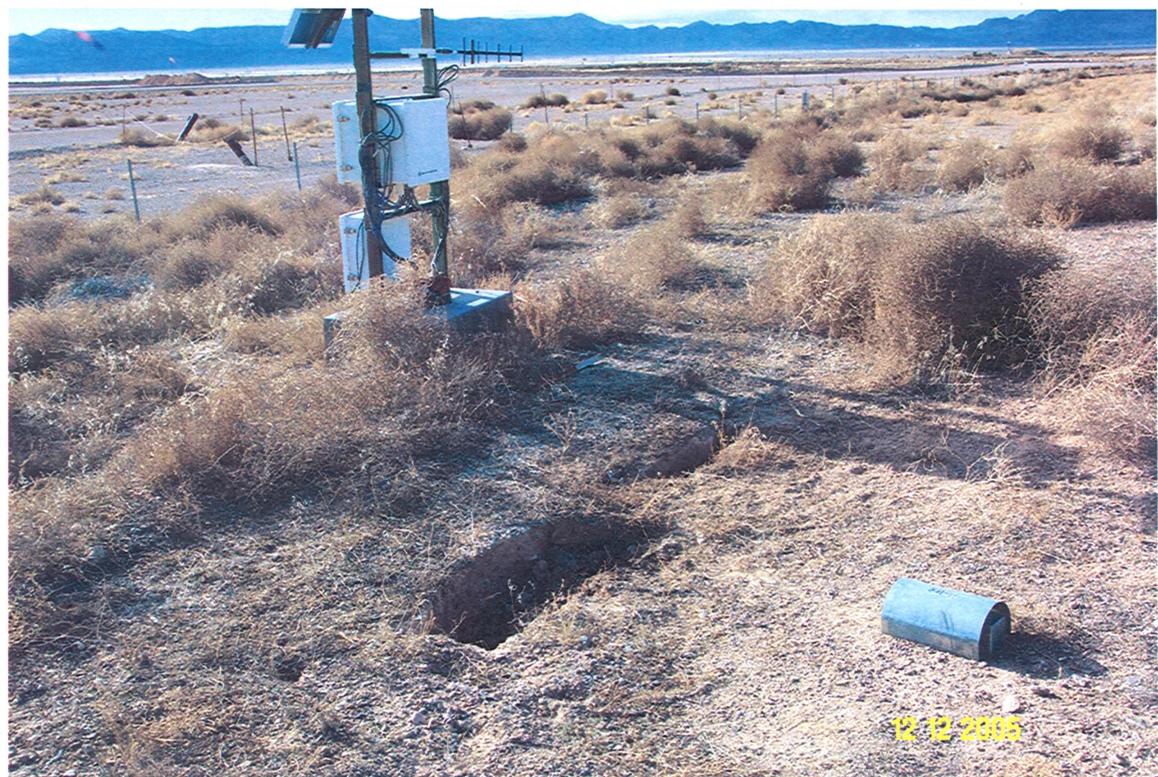
12/12/2005
14. Small animal burrow behind the west TDR.

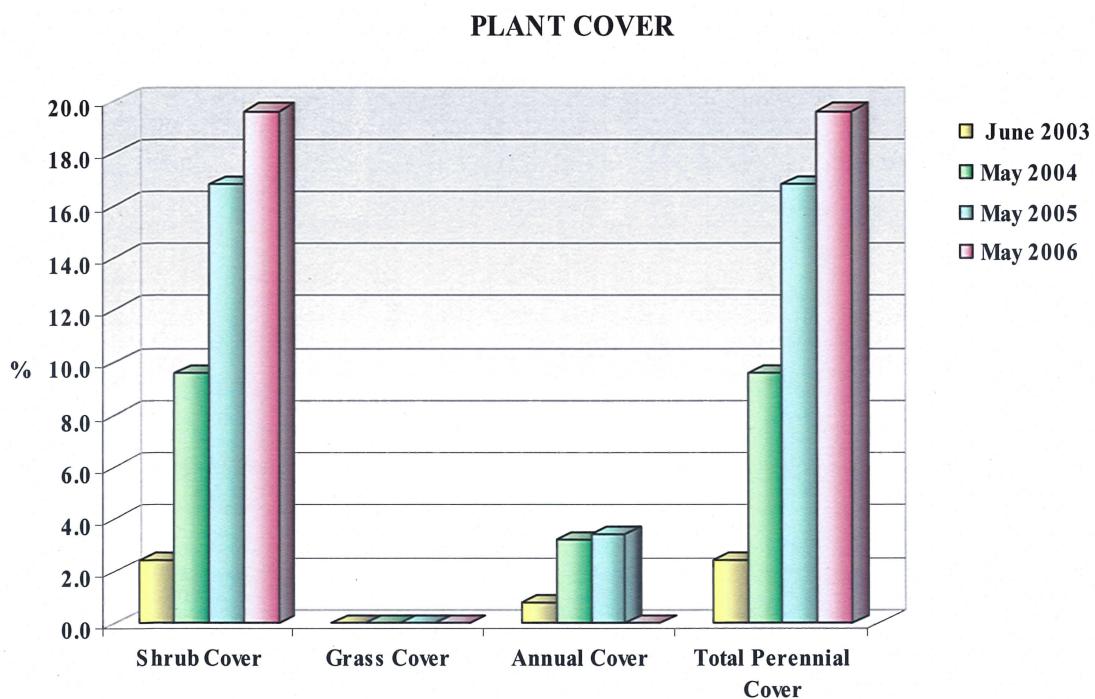
Figure 1. Changes in plant cover on the closure cover at CAU 110, U3-ax/bl over last four years.

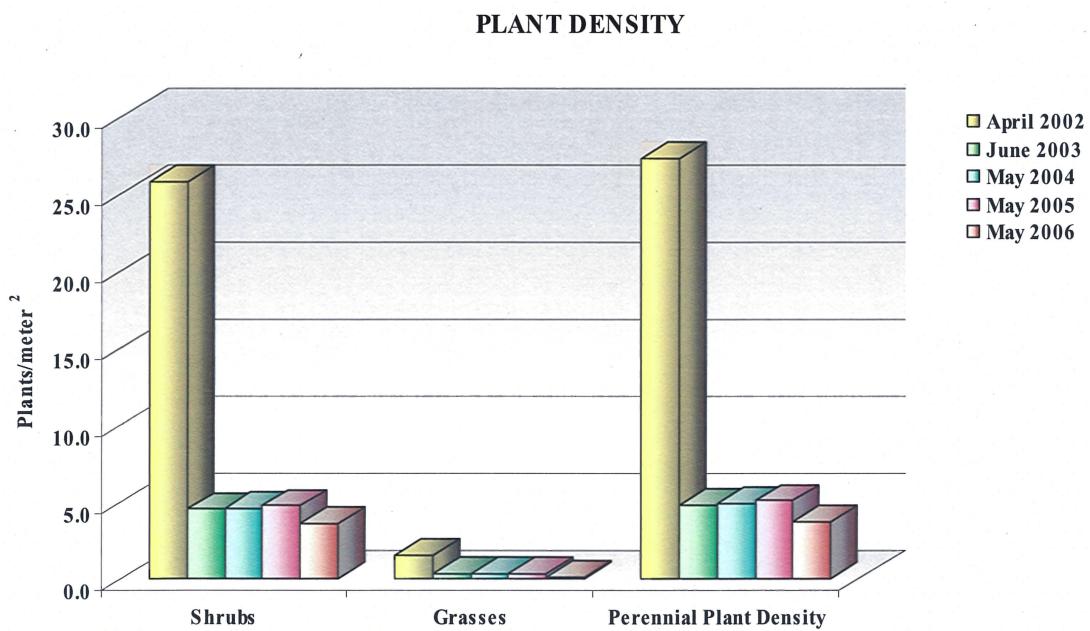
Plant Density – The 3.6 perennial plant species/m² represents the lowest density measured on the closure cover (Figure 2). The decrease cannot be attributed to a single species, rather a slight decline in all species including shadscale, Nevada ephedra, winterfat and Indian ricegrass (Table 2). Bud sagebrush and spiny hopsage were not encountered on the study plots this year. Spiny hopsage has been present on site since 2001. Spiny hopsage was observed on the closure cover, but it is uncommon. The other species of note is squirreltail. It was first observed on the closure cover in 2002 and a few individuals, mainly seedlings, were observed last year, but none were encountered this year. Several individual plants of fourwing saltbush are still present on the site although not encountered this year on the study plots. This species is not a preferred species on the closure cover because of its deep rooting system.

Figure 2. Changes in plant density on the closure cover at CAU 110, U3-ax/bl over last five years.

The density of annual plants was equally low (Table 2; Figure 2) and not different from the density of annual plants on the unseeded area. The most abundant annuals were Russian thistle and halogeton. Other annual species commonly found in previous years, were rarely encountered.
