SUBMITTAL OF THE LETTER REPORT TO ADDRESS COMMENTS ON THE CLOSURE REPORT FOR CORRECTIVE ACTION UNIT 224: DECON PAD AND SEPTIC SYSTEMS, NEVADA TEST SITE, NEVADA, REVISION 0, MARCH 2008, DOE/NV/25946--XXX

Background

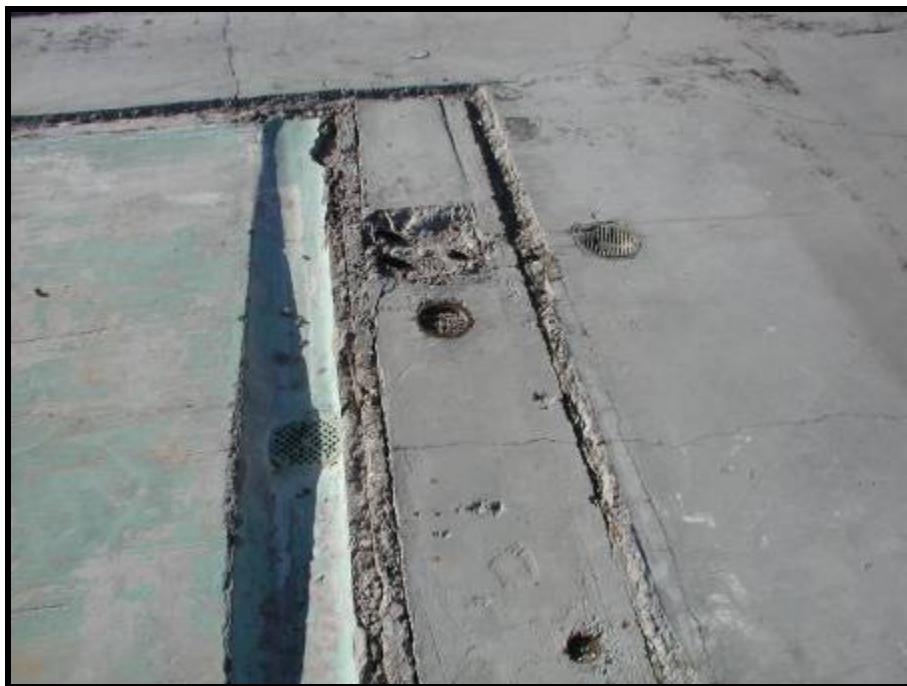
Figure 3. CP-2 Floor Drains

A field visit with construction personnel and facility owners was conducted on March 11, 2008, to verify site conditions and identify the number and location of drains and lines required to be filled with grout. 20 drains and apparent drain openings were identified on the slab of the former CP-2 location. An example of the floor drains at the CP-2 location is shown in Figure 3. Some drains have metal grate-type covers, and some openings that appear to be drain pipes did not have drain covers. A current site map of the Area 6 sewer system was reviewed, and the area of the currently active sewer line was identified in the vicinity of CAS 06-03-01. The at-grade manhole cover for the inactive closed south sewage lagoon was located and opened for inspection. Piping openings in the bottom of the manhole were verified to be accessible for filling with grout (Figure 4). A line leading into the west side of the manhole was confirmed to have been previously grouted from the adjacent active manhole. The proximity of the CAS 06-03-01 manhole and active sewer system manhole are shown in Figure 5. The north sewage lagoon manhole could not be located; however, portions of a manhole and associated debris are located on the ground surface approximately 100 yards north of the estimated location of the former manhole (Figure 6). It is speculated that the manhole was removed during construction of the currently active sewer line and that the debris was moved to its current location on the edge of Yucca Lake. Prior to conducting the additional field activities, a utility survey was conducted, and a manhole was not located.

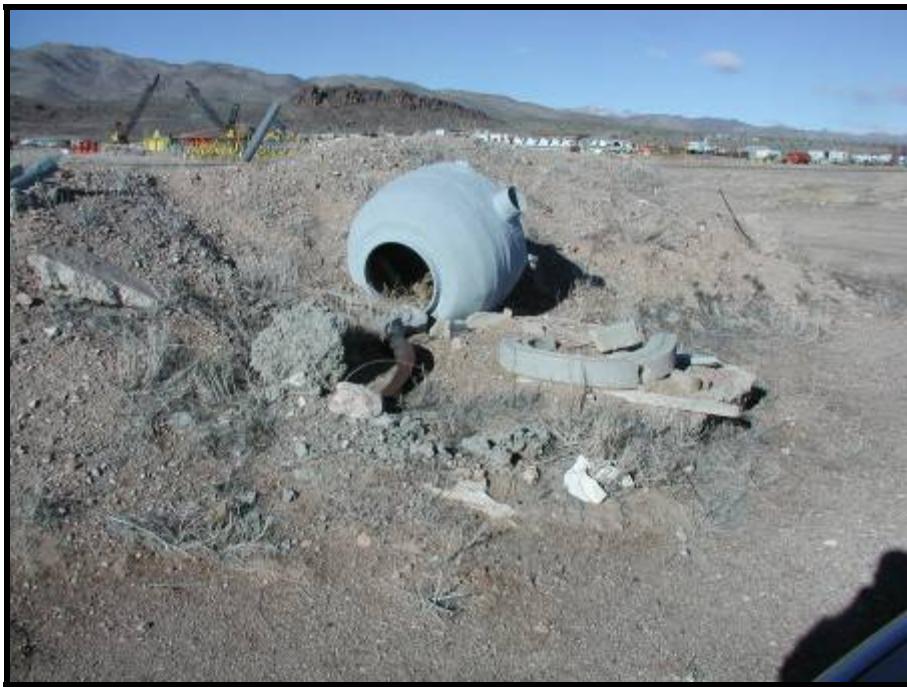
Figure 6. Suspected Location of the CAS 06-03-01 North Lagoon Manhole (removed)

A utility survey using a hand-operated magnetometer was completed in an attempt to locate the CAS 06-03-01 north sewage lagoon manhole. The survey failed to locate any buried anomalies in the area which could be an indication of a buried manhole.
