# River Corridor Closure Contract

## 300 Area D4 Project 4th Quarter Fiscal Year 2006 Building Completion Report

**Washington Closure Hanford**

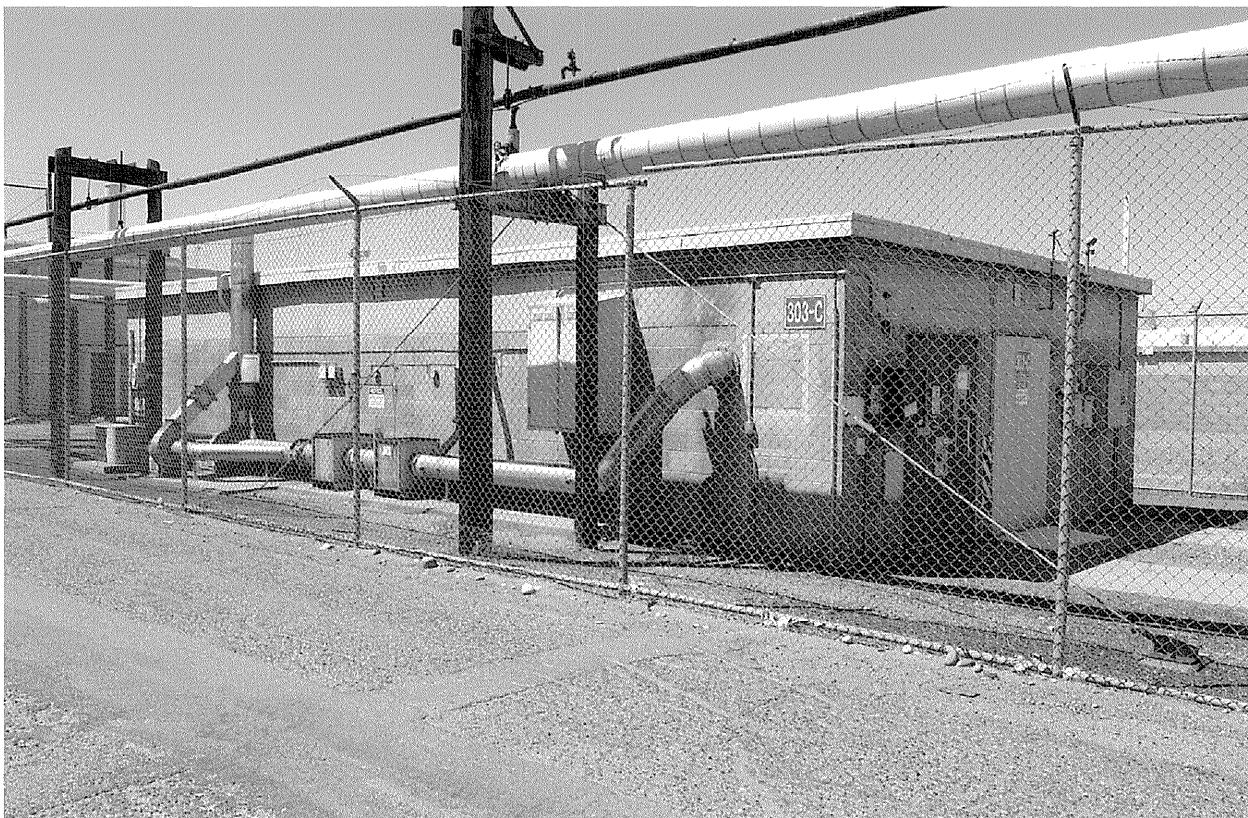
Figure 1. 303C Building.

The 303C Building was known as one of the "Fresh Metal Storage Buildings" and also as the "Special Nuclear Materials Storage Facility" (Figure 1). It was originally built and used for the storage of unirradiated uranium billets prior to them being moved to the 314 Building, where they were pressed into rods. Later, the building was used for the assembly and testing of experimental nuclear material detectors.

The original construction of the 303C Building consists of concrete block walls on a 0.13-m (5-in.) concrete slab floor with foundation and a 0.15-m (6-in.) concrete slab roof with built-up roofing material. The dimensions of the building are 14.7 m (48.2 ft) by 8.3 m (27.2 ft) by 3.1 m (10.1 ft) in height.

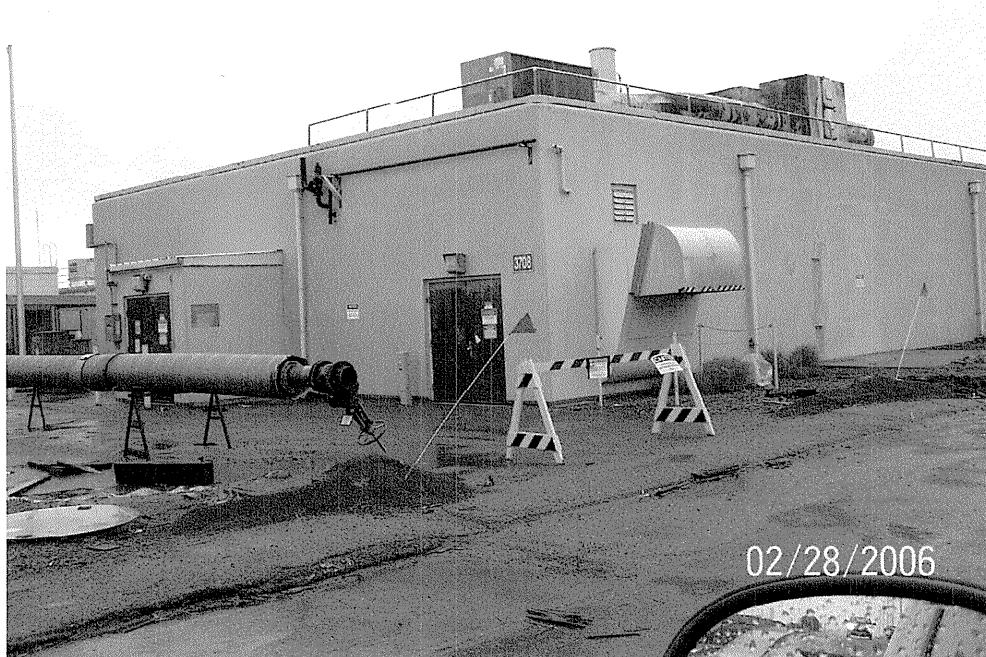
**Figure 2. 3708 Building.**

The 3708 Building was known as the “Electrical and Optical Shop,” the “Transuranium Pilot Facility”, and the “Radioanalytical Laboratory” (H-3-48773) (Figure 2). The building was constructed in approximately 1948 and consisted of a 0.15-m (6-in.) concrete slab foundation with footings and concrete block walls. The roof was a concrete slab with parapet and built-up roofing. The dimensions of the building were 22.8 m (74.7 ft) by 15.6 m (51.3 ft) by 5.02 m (16.5 ft) in height. There was a 3.25-m (10.67-ft) deep service pit in the north end of the building.

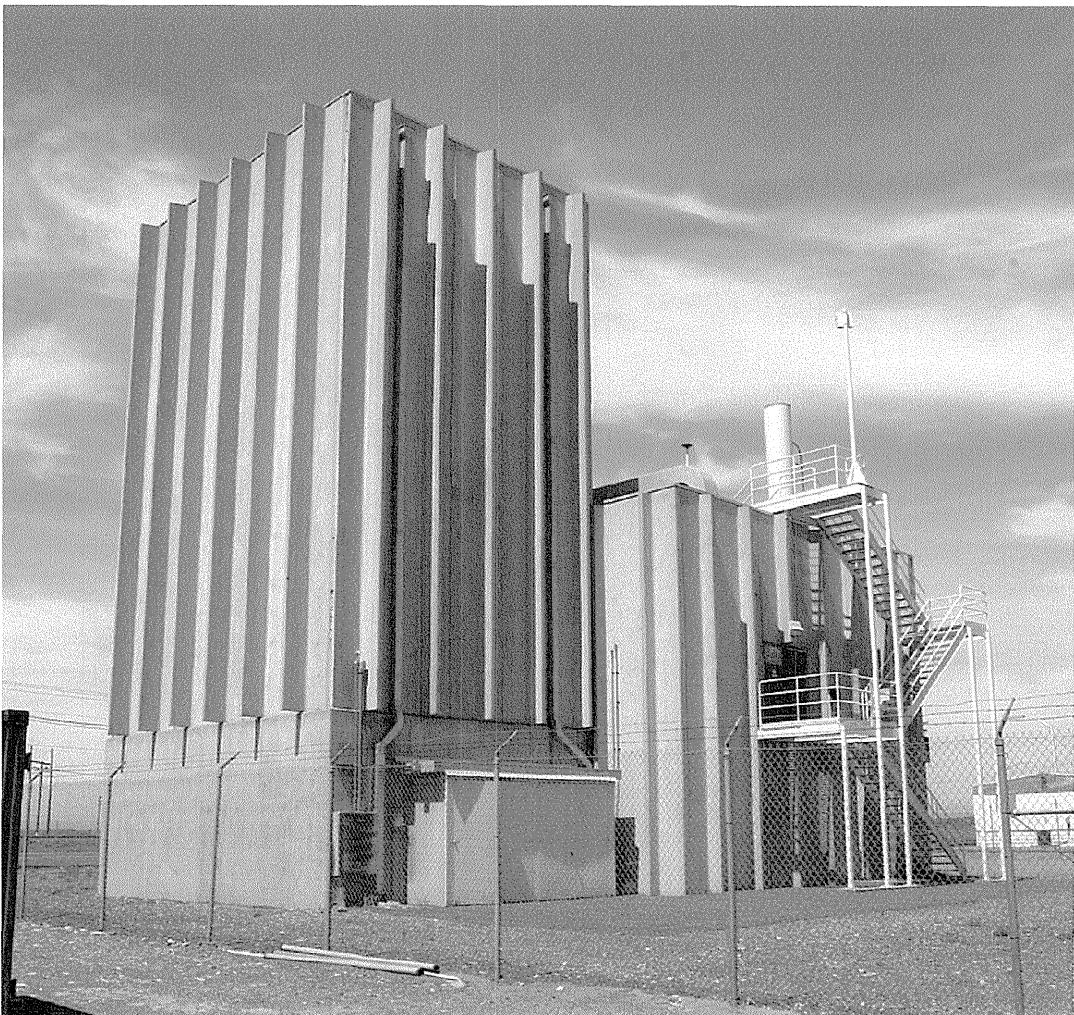
Figure 3. 377 Building.

The 377 Building was known as the Steam Generator Examination Facility and the Geotechnical Engineering Laboratory (Figure 3). The building was designed and constructed in the early 1980s as a special-use facility for Pacific Northwest Laboratory to conduct nondestructive testing, inspection, examination, and destructive testing of a steam generator from a commercial nuclear power plant. Actual steam generator examination activities took place between 1983 and 1987. Following completion of the generator activities, considerable decontamination and equipment removal took place at the facility. In 1990, the facility was transferred to Westinghouse Hanford Company. For a short period of time the building was known as the Geotechnical Engineering Laboratory and was used as a characterization laboratory for the testing of Hanford Site soil samples. All operations within the facility were discontinued in late 1995.

The 377 Building was composed of two distinct sections, north and south, with a common wall. The north section was a two-story support structure approximately 9.14 m (30 ft) in height above the finished grade and measured approximately 9.75 m by 7.72 m (32 ft by 25.3 ft). The exterior walls, elevated floors, and roof were precast concrete panels. This support wing contained an entry vestibule, change rooms, air lock, laboratory area, decontamination shower, trucklock, and a mechanical room on the second floor.

The south section was the former generator tower and was composed of four floors and a basement approximately 12.19 m by 10.82 m (40 ft by 35.4 ft) in size. The basement walls were cast-in-place reinforced concrete, extending 3.65 m (12 ft) above finished grade, and three sides with the common wall between the north and south sections extending to 9.14 m (30 ft).

The walls above the cast-in-place concrete were precast concrete panels. The elevated floors consisted of steel grating, and the roof was concrete on metal decking with a built-up asphalt cover. There were four removable roof panels (4.9 m by 4.9 m [16 ft by 16 ft] total) that were provided to allow placement and removal of the steam generator. The bottom floors of both sections were slabs on grade.

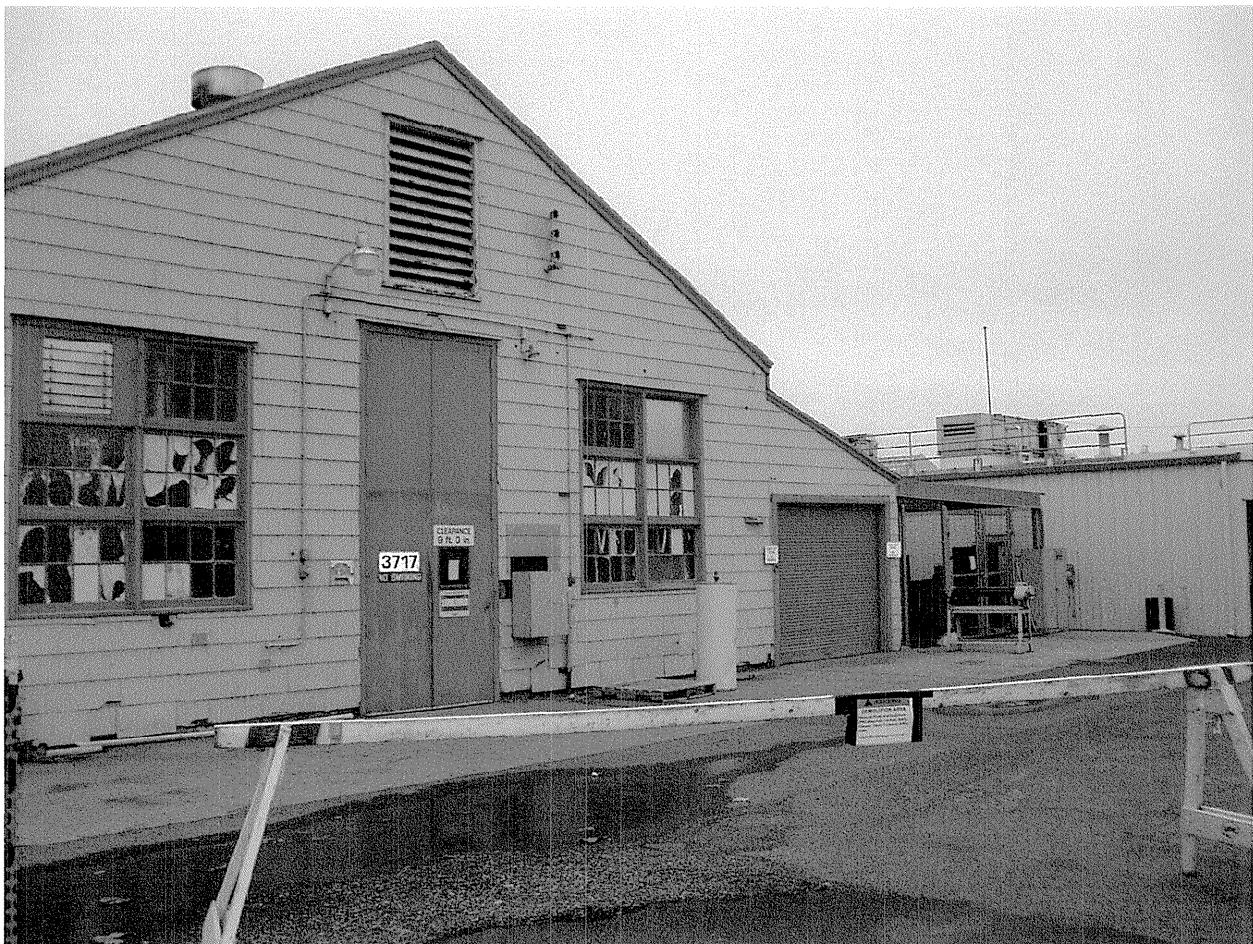
Figure 4. 3717 Building.

The 3717 Building, called both the Maintenance Sheet Metal Shop and the Sheet Metal and Engineering Building, was constructed in 1943 to support maintenance and craft construction (Figure 4). It was a one-story wood frame structure, 22.2 m by 50.3 m by 7.3 m (73 ft by 165 ft by 24 ft), built on concrete foundation with concrete slab floor. A 22.6-m by 9.8-m by 4.3-m (74-ft by 32-ft by 14-ft) addition was constructed on the north side of the building in 1954. The facility included offices, a storeroom, sanitary restrooms, and craftsman work benches. Shop floors at the east end were sloped to floor drains that were connected to the process sewer

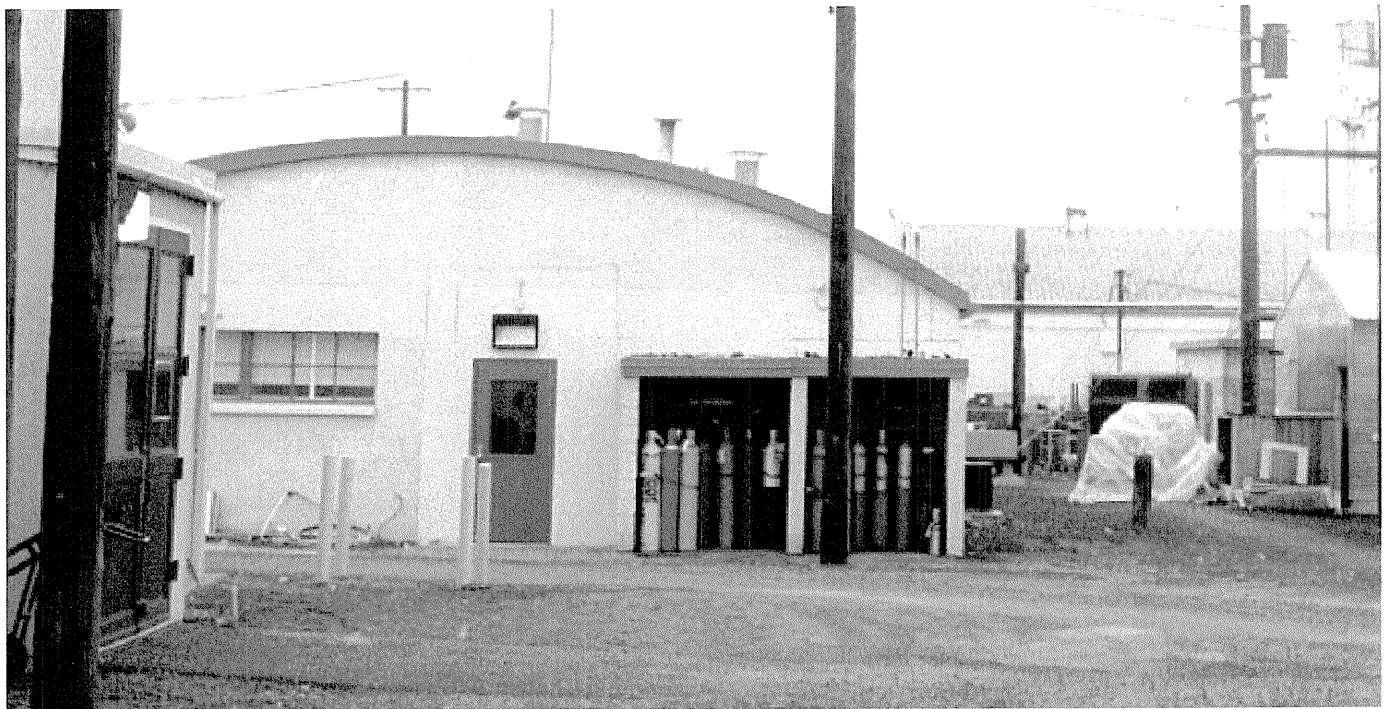
Figure 5. 3717B Building.

The 3717B Building was known as the Standards Laboratory and was built in 1950 to provide maintenance, calibration, and standards services to the 300 Area (Figure 5). The original 3717B Building was a one-story, concrete block and metal (prefab partitions) structure with a Quonset hut-type built-up roof, all built on a concrete slab with footings. The original building dimensions were 12.6 m (41.5 ft) by 51.2 m (168 ft) by 4.66 m (15.3 ft) high. In the early 1980s an addition was added to the southwest portion of the building to house the Metrology Lab, and had dimensions of 7.3 m (24 ft) by 23 m (74 ft) by approximately 3.7 m (12 ft) high. In the early 1990s an addition was added to the southeast portion of the building to house the Mass, Electrical, and Electronics Lab and had dimensions of 7.6 m (25 ft) by 24.8 m (81.3 ft) by approximately 3.7 m (12 ft) high.

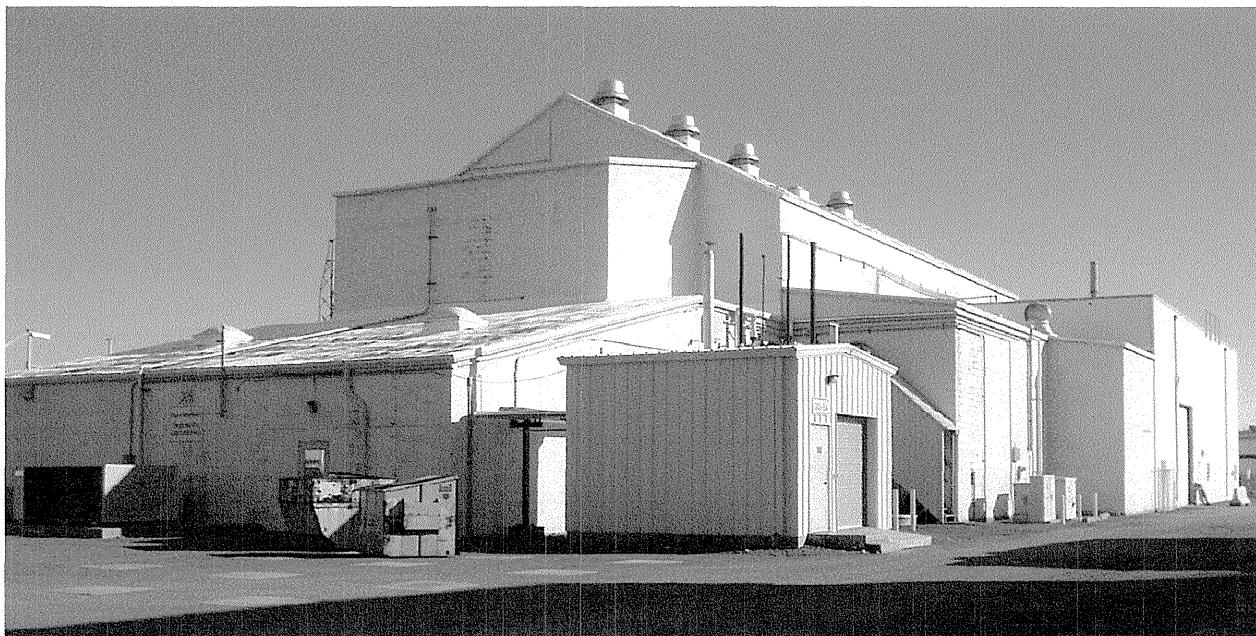
**Figure 6. 305 Building.**

The 305 Building housed the 305 Test Pile, a.k.a. Hanford Test Reactor (HTR), and later was used to support cold mechanical development including for the Hot Cell Verification Facility (Figure 6). It was a two-story and high bay steel-framed concrete structure with steel superstructure supports, concrete block and concrete tilt-up slab walls, a pre-cast concrete slab pitched roof (with asphalt composition coating), and reinforced concrete floors throughout. The 305 Building was 16 m (51 ft) high and had an overall length of 67.6 m (222 ft), an overall width of 26.5 m (87 ft), and covered a total area of 1,254 m<sup>2</sup> (13,500 ft<sup>2</sup>).

The 305 HTR, the first operating reactor at the Hanford Site, began operations in March 1944. In 1964, it was the oldest operating reactor in the world. The 305 Test Pile was used to provide real-time quality control inspection and acceptance of reactor fuel and construction materials (i.e., uranium, graphite, aluminum) for production use until 1968. It continued to support the N Fuels Program until 1973. Work to remove the HTR natural uranium core (27 tons) was performed in 1974 and 1975, and from 1979 to 1985 the 305 Building was used as the Hot Cell Verification Facility, a cold equipment testing prototype of the 427 Fuels and Materials Examination Facility near the Fast Flux Test Facility reactor area. The building continued service as a research and testing facility until 2001, supporting test programs for Waste Receiving and Processing facility waste containers, work on a flexible radiation detection system, and testing of several mechanical systems for the K-Basin Spent Fuel Storage Project.

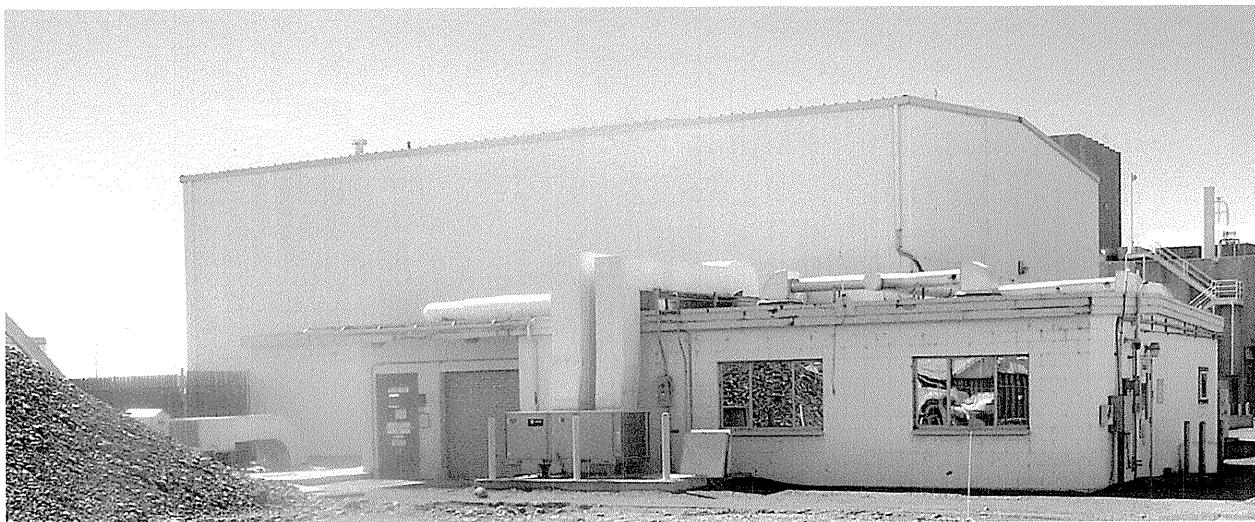
**Figure 7. 305B Building.**

The 305B Building complex was known variously as the Test Reactor Facility (TRF), the Process Engineering Laboratory, and the Hazardous Waste Storage Facility (Figure 7). The 305B Building Complex consists of three physically distinct structures, which share common walls, and were constructed at different times during the earlier years of Hanford Site operations. The facility was a *Resource Conservation and Recovery Act* (RCRA)-permitted waste treatment, storage, and disposal (TSD) unit, which operated under RCRA TSD permit WA7890008967 (Ecology 1994) until 2006.

The 305B TRF was a mostly subsurface structure built in 1954 directly south of the 305 Building. It was an underground reinforced concrete monolith, measuring 37 by 5.5 by 2.6 m high (121 by 18 by 8.5 ft high), with a flat concrete roof, and was surmounted by a small (13.6-m<sup>2</sup>) (146-ft<sup>2</sup>) entry building/bathroom. It contained test reactor cells on each end, as well as two assembly rooms and two control rooms. The east end of the facility, which housed the Physical Constants Test Reactor (PCTR), protruded above grade approximately 3 m (9.5 ft) and is adjacent to the entry building. The west end of the facility housed the Thermal Test Reactor and protruded 1.4 m (4.5 ft) above grade. A 3-m (9.5-ft)-high soil berm surrounded the entry building and PCTR cell on three sides. The underground TRF operated from about 1954 to 1978 to support the determination of physical constants for various reactor concepts.

The 305B Office Building was a single-story facility built in 1958 and overlapped about one-half of the western portion of the roof of the TRF. It had a concrete block exterior with structural steel supporting the tar and gravel-topped plywood roof, and measured 21.8 m by 12.4 m (71.5 ft by 40.5 ft). In addition to offices, the building contained a computer room, counting room, instrument room, maintenance shops, and change room. A stairway access was constructed from this building to the underground TRF.

The 305B Hazardous Waste Storage Facility (HWSF) was constructed in 1980 directly west of, and sharing a common wall with, the office building. It also overlapped the last one-quarter of the underground TRF, and a portion of the TRF's roof was removed to provide direct access from the HWSF. It was a high-bay facility measuring 23 m by 18 m by 8.5 m high (75 ft by 60 ft by 28 ft high). It contained an individually exhausted fume hood and environmental chamber, four walled storage cells, and a network of spill curbing and trenches. The HWSF operated until early 2006.

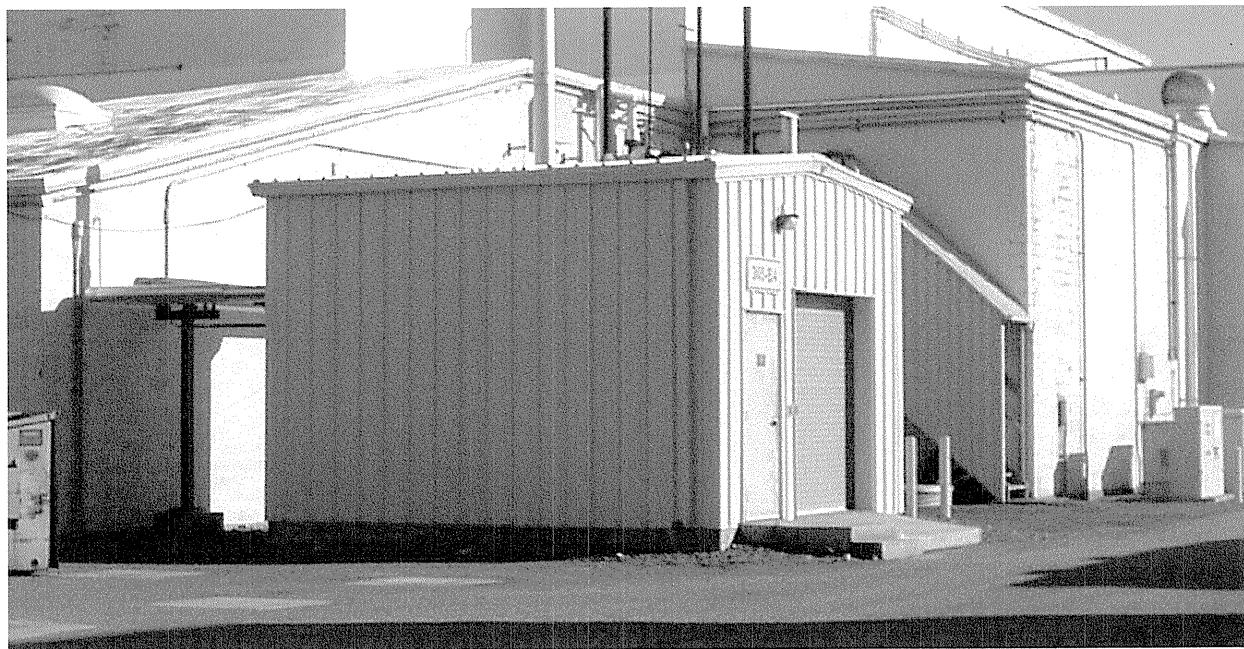
**Figure 8. 305BA Building.**

The 305BA Boiler Annex Building was a small steel frame building constructed in the 1990's to replace the steam heat provided by the deactivated 384 Building. It had corrugated metal roof and walls, and a concrete slab floor.

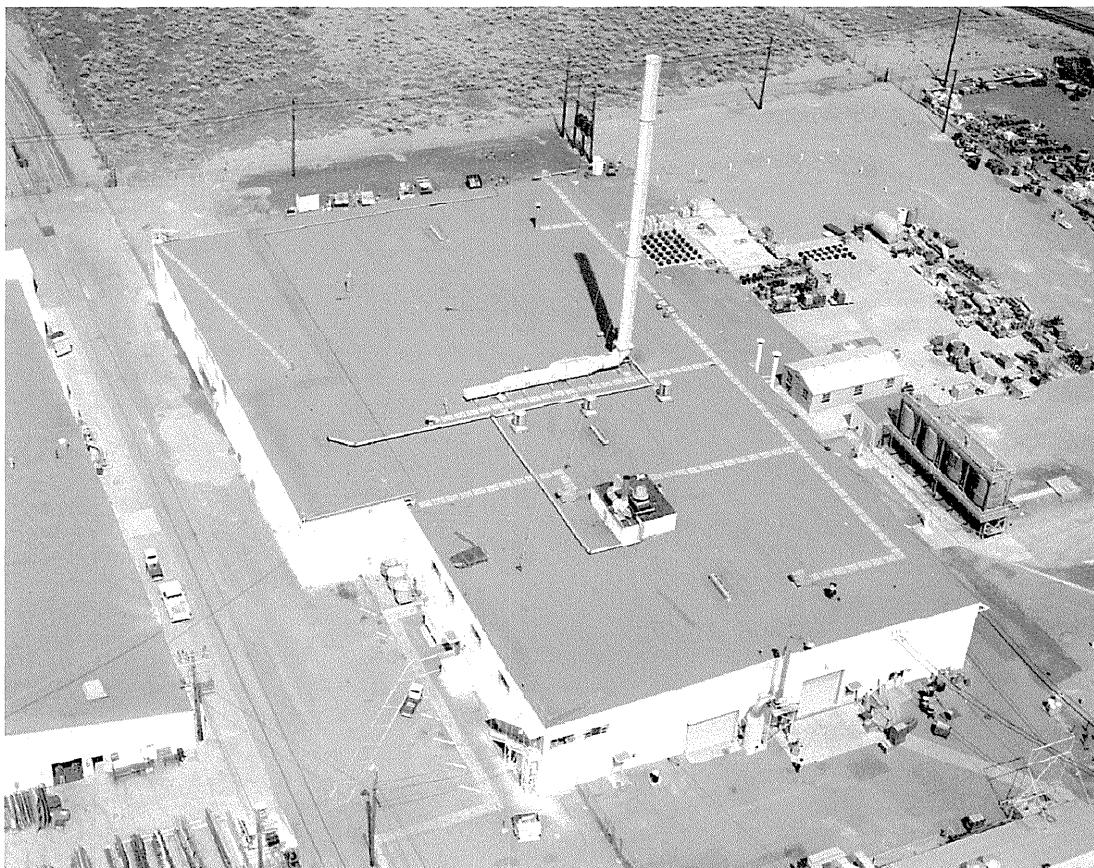
Figure 9. 333 Building (Aerial View, circa 1982).

The 333 Building was a large steel frame structure with double metal insulated panel exterior walls and concrete foundation and floors (Figure 8). The roof covering consisted of metal insulated foam board covered with four-ply graveled asphalt roofing. A high bay ran through the length of the building. The original construction included a mezzanine on the east side for offices, a second floor chemical mezzanine in the center of the building, and an electrical mezzanine in the center of the east side. A second floor office, lunchroom, shop, and ventilation area was added to the west side of the building. The over-all floor plan of the building was 4321 m<sup>2</sup> (46,514 ft<sup>2</sup>.)

The 333 Building was built during 1959 and 1960 to manufacture fuel elements for the N Reactor using the co-extrusion process. The building also housed part of the 300 Area Waste Acid Treatment System.
