Date Submitted: <u>TBD</u>	WASTE SITE RECLASSIFICATION FORM Operable Unit(s): <u>100-BC-1</u>	Control Number: 2008-027
Originator: <u>J. M. Capron</u>	Waste Site Code: <u>100-B-23</u>	
Phone: <u>372-9227</u>	Type of Reclassification Action: Closed Out <input type="checkbox"/> Interim Closed Out <input checked="" type="checkbox"/> No Action <input type="checkbox"/> RCRA Postclosure <input type="checkbox"/> Rejected <input type="checkbox"/> Consolidated <input type="checkbox"/>

**REMAINING SITES VERIFICATION PACKAGE FOR THE
100-B-23, 100-B/C AREA SURFACE DEBRIS, WASTE SITE**

Attachment to Waste Site Reclassification Form 2008-027

June 2008

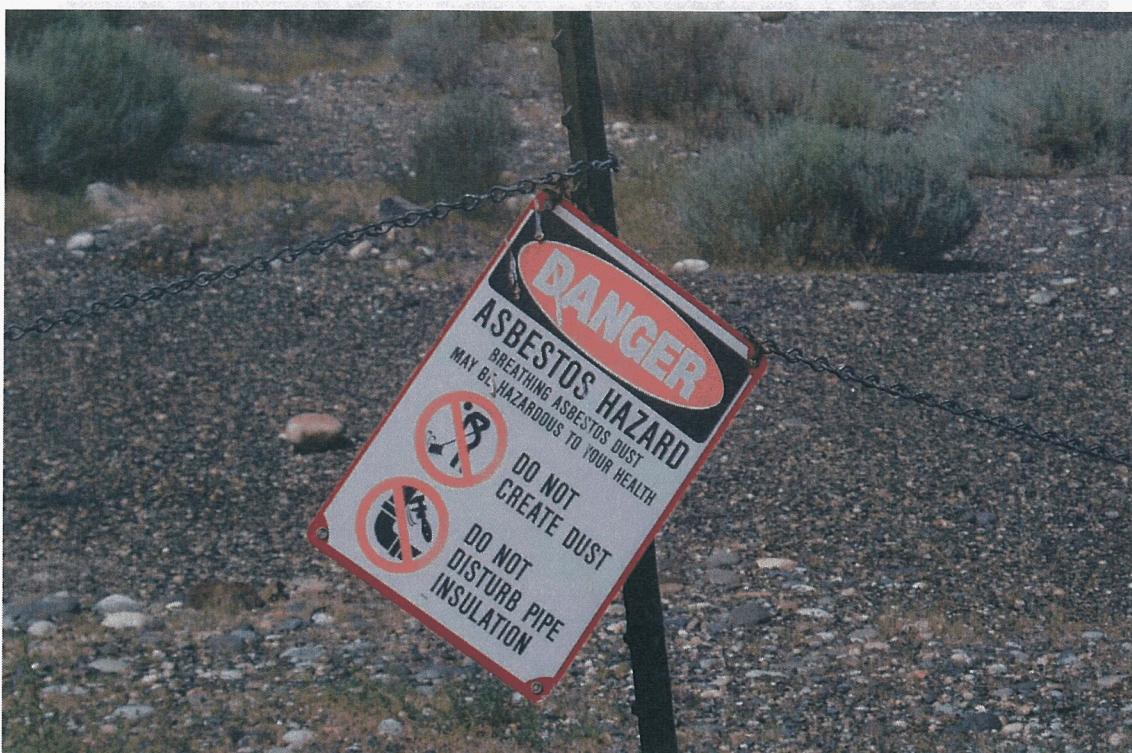
Figure A-1. Posted ACM Area Signs (ID #45). Posting Has Been Removed.

**CERTIFICATION OF VISUAL INSPECTION FOR DOWNPOSTING
OF ACM WASTE SITE (ID #45)**

In accordance with the Work Package for Asbestos Abatement, the Competent Person hereby certifies that a visual inspection of the Work Area (all surfaces including pipes, beams, ledges, walls, ceiling and floor, decontamination area, sheet plastic, etc.) has been performed and no dust, debris or asbestos residue was found.

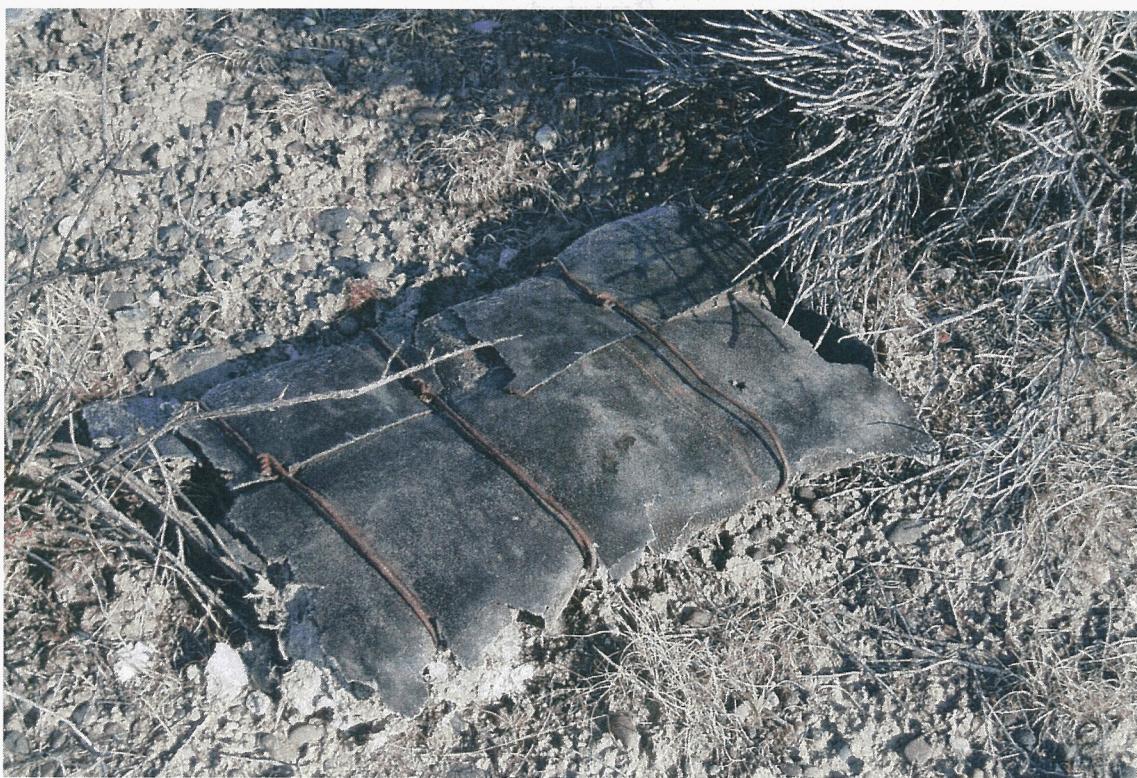
Figure A-2. Photograph of Potential Friable ACM Material (Pipe Wrapping – ID #5).

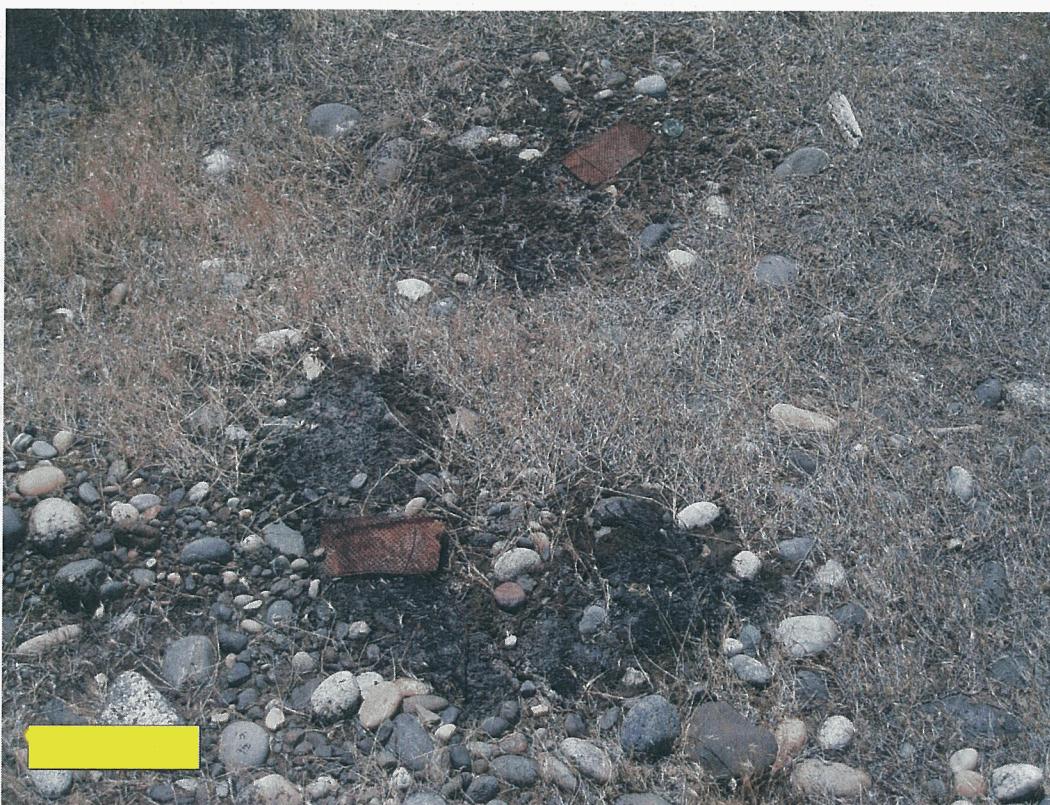
Figure A-3. Example of Oil-stained Soil and Oil Filters (ID #88).

The oil filter debris (Table 1) was removed along with any underlying stained soils. The soils were concurrently sampled for TPH to ensure that remediation was complete. Five locations exceeded the TPH screening level of 200 mg/kg. These areas were further remediated and re-sampled for TPH. All subsequent TPH samples passed. An example of the oil-stained soil and oil filters prior to remediation activities is provided in Appendix A, Figure A-3.

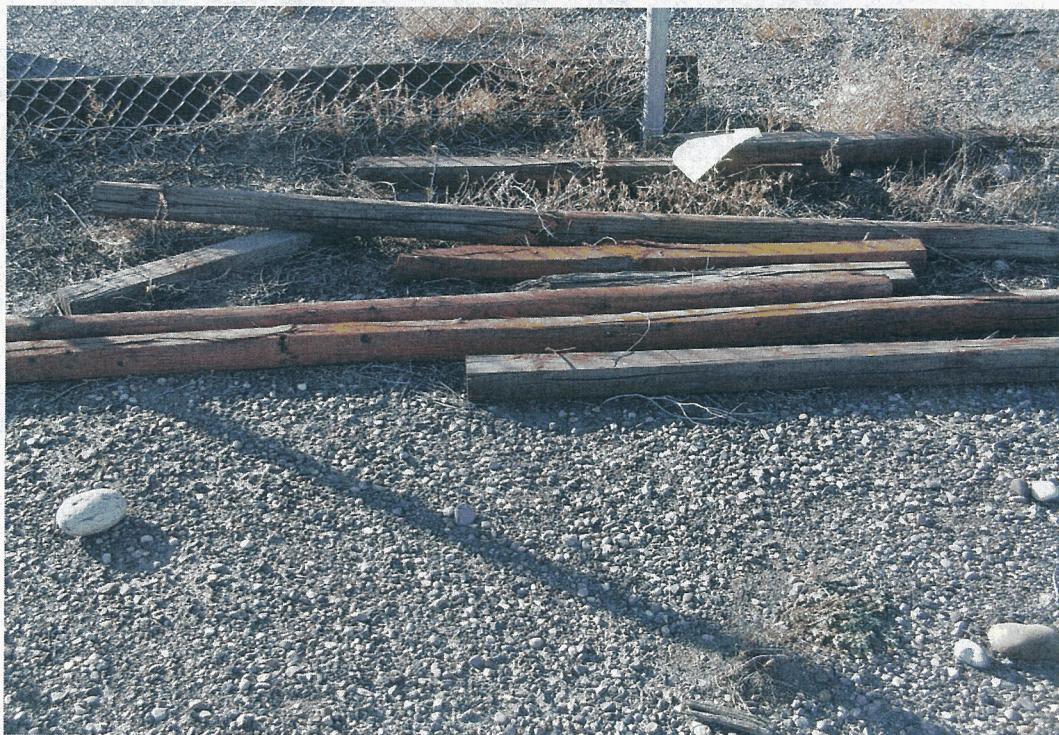
**Figure A-4. Example of Treated Wood Debris (ID #130).
Removed.**

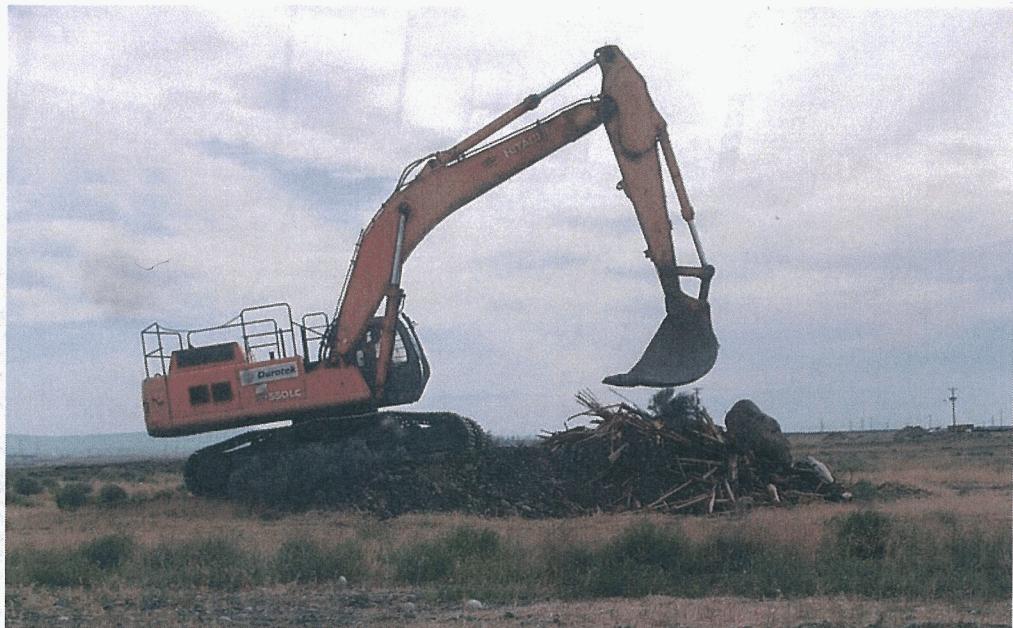
Figure A-7. Remediation of Treated Wood Debris – Loading Ramp (ID #122).

Focused verification samples were collected July 2007 of soils underlying the remediated “loading ramp.” No visual staining was observed for these soils; however, because of the larger size of the remediated area (approximately 4.5 m by 6.0 m [15 ft by 20 ft]), one sample and a duplicate were collected. The verification sample was composed of 25 aliquots, collected at equal intervals across the base of the remediation footprint. Both samples were analyzed for

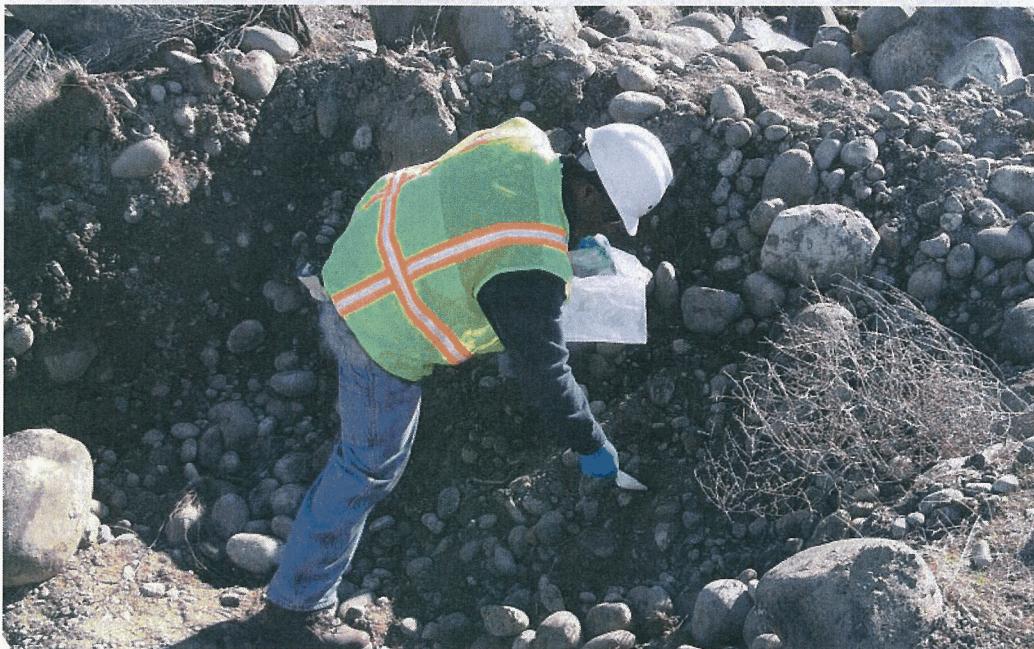
Figure A-8. Stained Soil Underlying Leaking Battery Cache (ID #85).

All lead debris items listed in Table 1 were removed and the underlying soils were field screened with x-ray fluorescence (XRF) following the debris removal. During debris removal, item #85 (Table 1) was discovered to be a cache of leaking batteries. The soils underlying the batteries had high XRF readings of lead and mercury. The leaking batteries and stained soils (less than 5 bank cubic meters [BCM]) were removed. The extent of soil removal was guided using XRF readings and visual inspection. Verification samples were collected of the remediated soils per an addendum to the original sample design (Capron 2008).

Sampling of the soils underlying the cache of leaking batteries (debris item #85) was performed in February 2008. XRF instrumentation was used to locate areas of elevated lead and/or mercury for sample collection. One grab sample and a duplicate were collected from the underlying soils and analyzed for ICP metals and mercury as instructed in Capron (2008). The primary sample and duplicate were composed of three aliquots that were taken from the areas with the highest XRF readings. As outlined in the verification sampling approach (WCH 2007e), no sampling was performed for the soils underlying the other remediated lead debris items listed in Table 1.
