Date Submitted: <u>3/6/07</u>	<b>WASTE SITE RECLASSIFICATION FORM</b>	Control Number: <u>2007-004</u>
Originator: <u>L. M. Dittmer</u>	Operable Unit(s): <u>100-BC-1</u>	
Phone: <u>372-9664</u>	Waste Site Code: <u>126-B-2, 183-B Clearwells</u>	
	Type of Reclassification Action:  Closed Out <input type="checkbox"/> Interim Closed Out <input type="checkbox"/> No Action <input checked="" type="checkbox"/> RCRA Postclosure <input type="checkbox"/> Rejected <input type="checkbox"/> Consolidated <input type="checkbox"/>

**REMAINING SITES VERIFICATION PACKAGE FOR THE  
126-B-2, 183-B Clearwells**

**Attachment to Waste Site Reclassification Form 2007-004**

**March 2007**

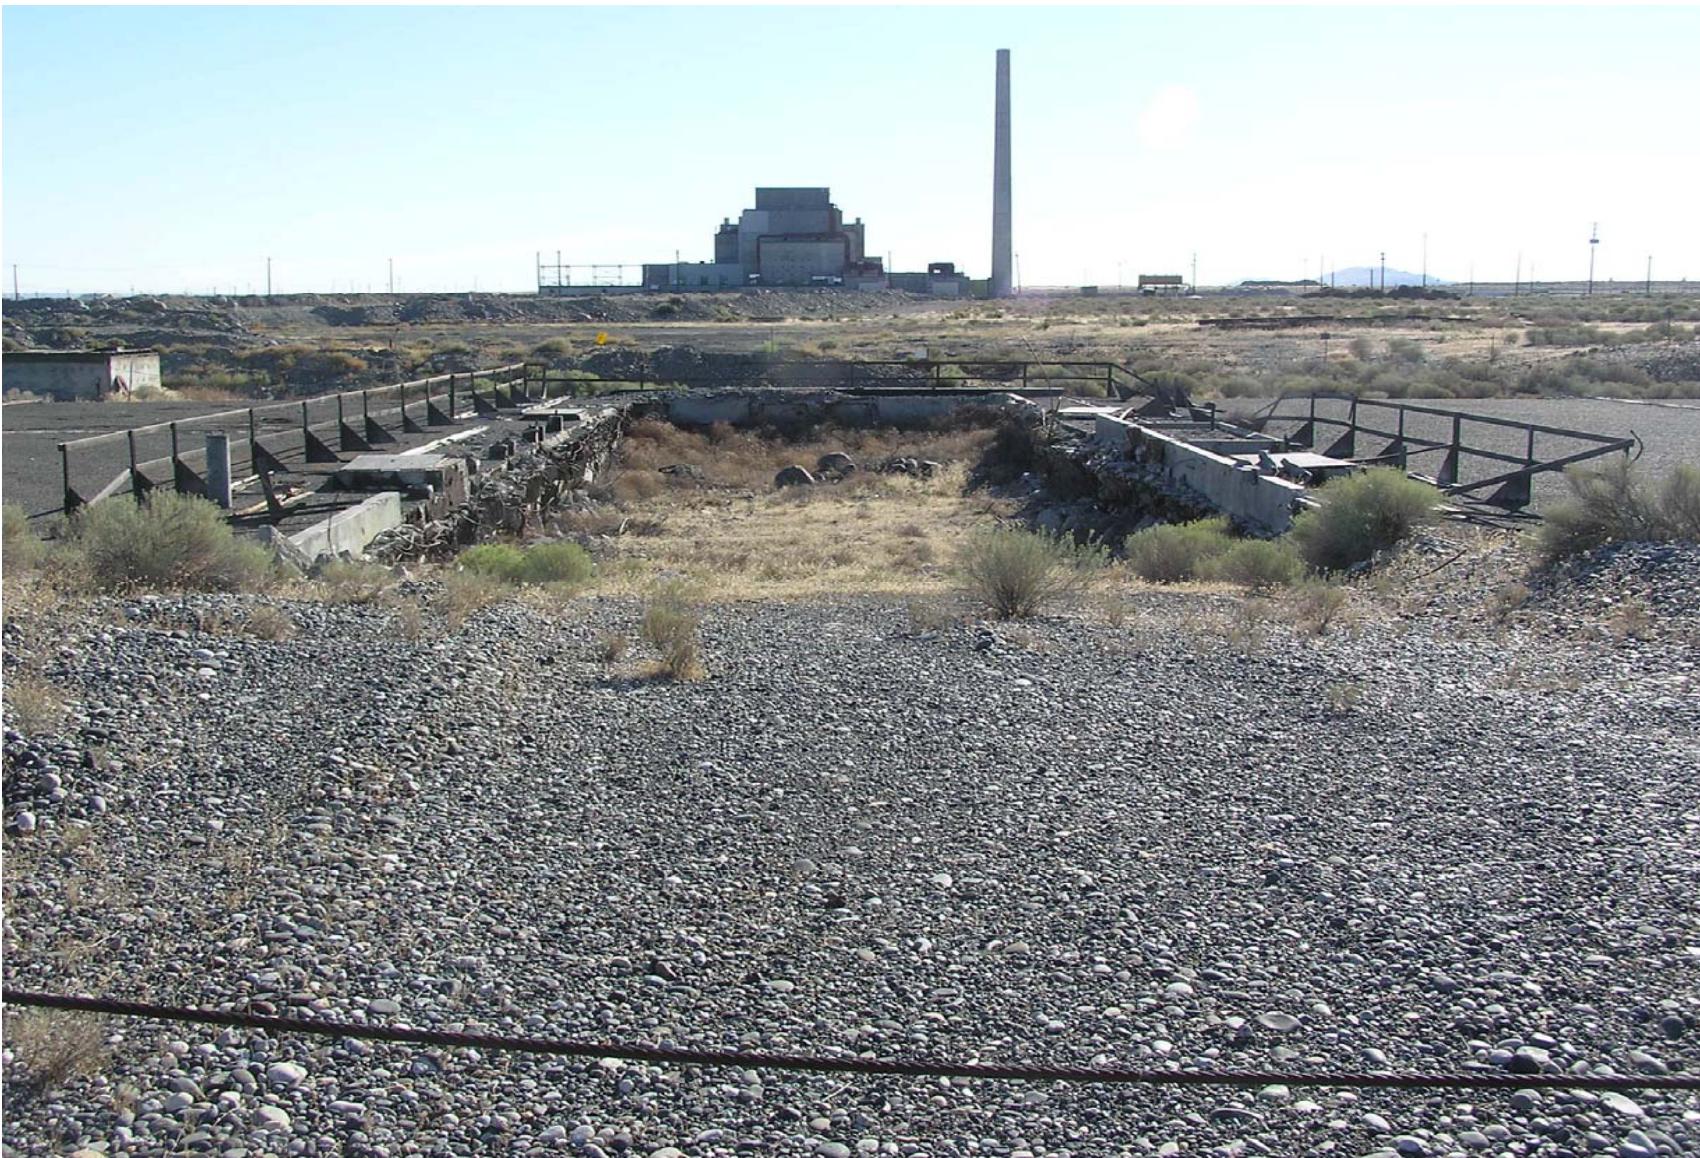
Photograph B-3. The 105-B Reactor viewed from 183-B.

**Background:** The 105-B Reactor  
**Center:** The remains of the 183-B Pumproom with the 126-B-2 Clearwells to either side.  
**Foreground:** Gravel over the demolished 183-B Filter Building.

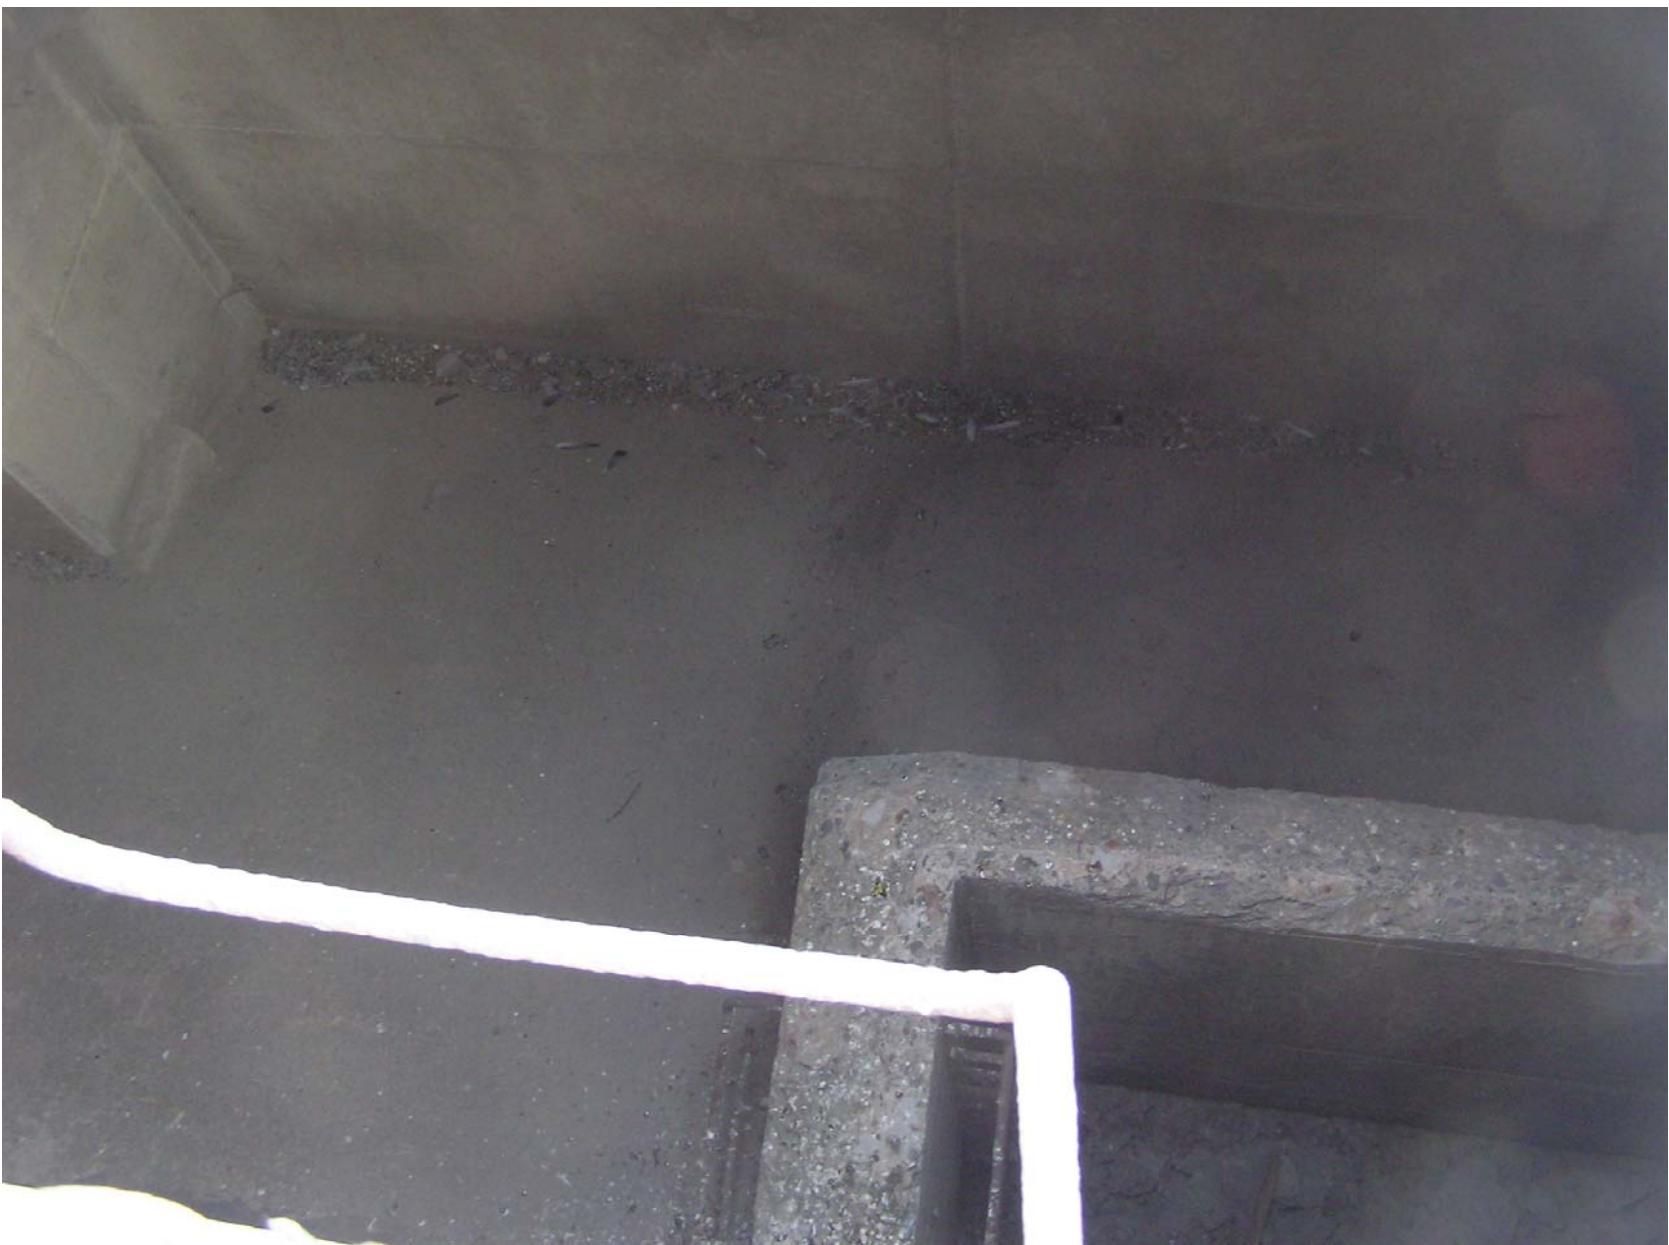
**Photograph B-4. An Access Hatch on the West Side of the Northern 126-B-2 Clearwell**

A site visit to the 126-B-2 Clearwells was conducted on November 1, 2006, to determine the current condition of the interior of the clearwells. Observational access was made at three hatches around the northern clearwell. For safety reasons, no actual physical entry was made into the clearwells. Windblown debris, sand, and evidence of bird habitation were observed inside the structure, but no liquids, chemical stains, or cracks were observed therein (Appendix B, Photographs B-4 through B-7). The structure itself appears to be in good shape, except for the central walls that were connected to the now demolished 183-B Pumproom. The access hatches on the southern clearwell were all closed, bolted, and rusted shut. It is assumed that the current interior condition of the southern clearwell is the same as the interior condition of the northern clearwell.

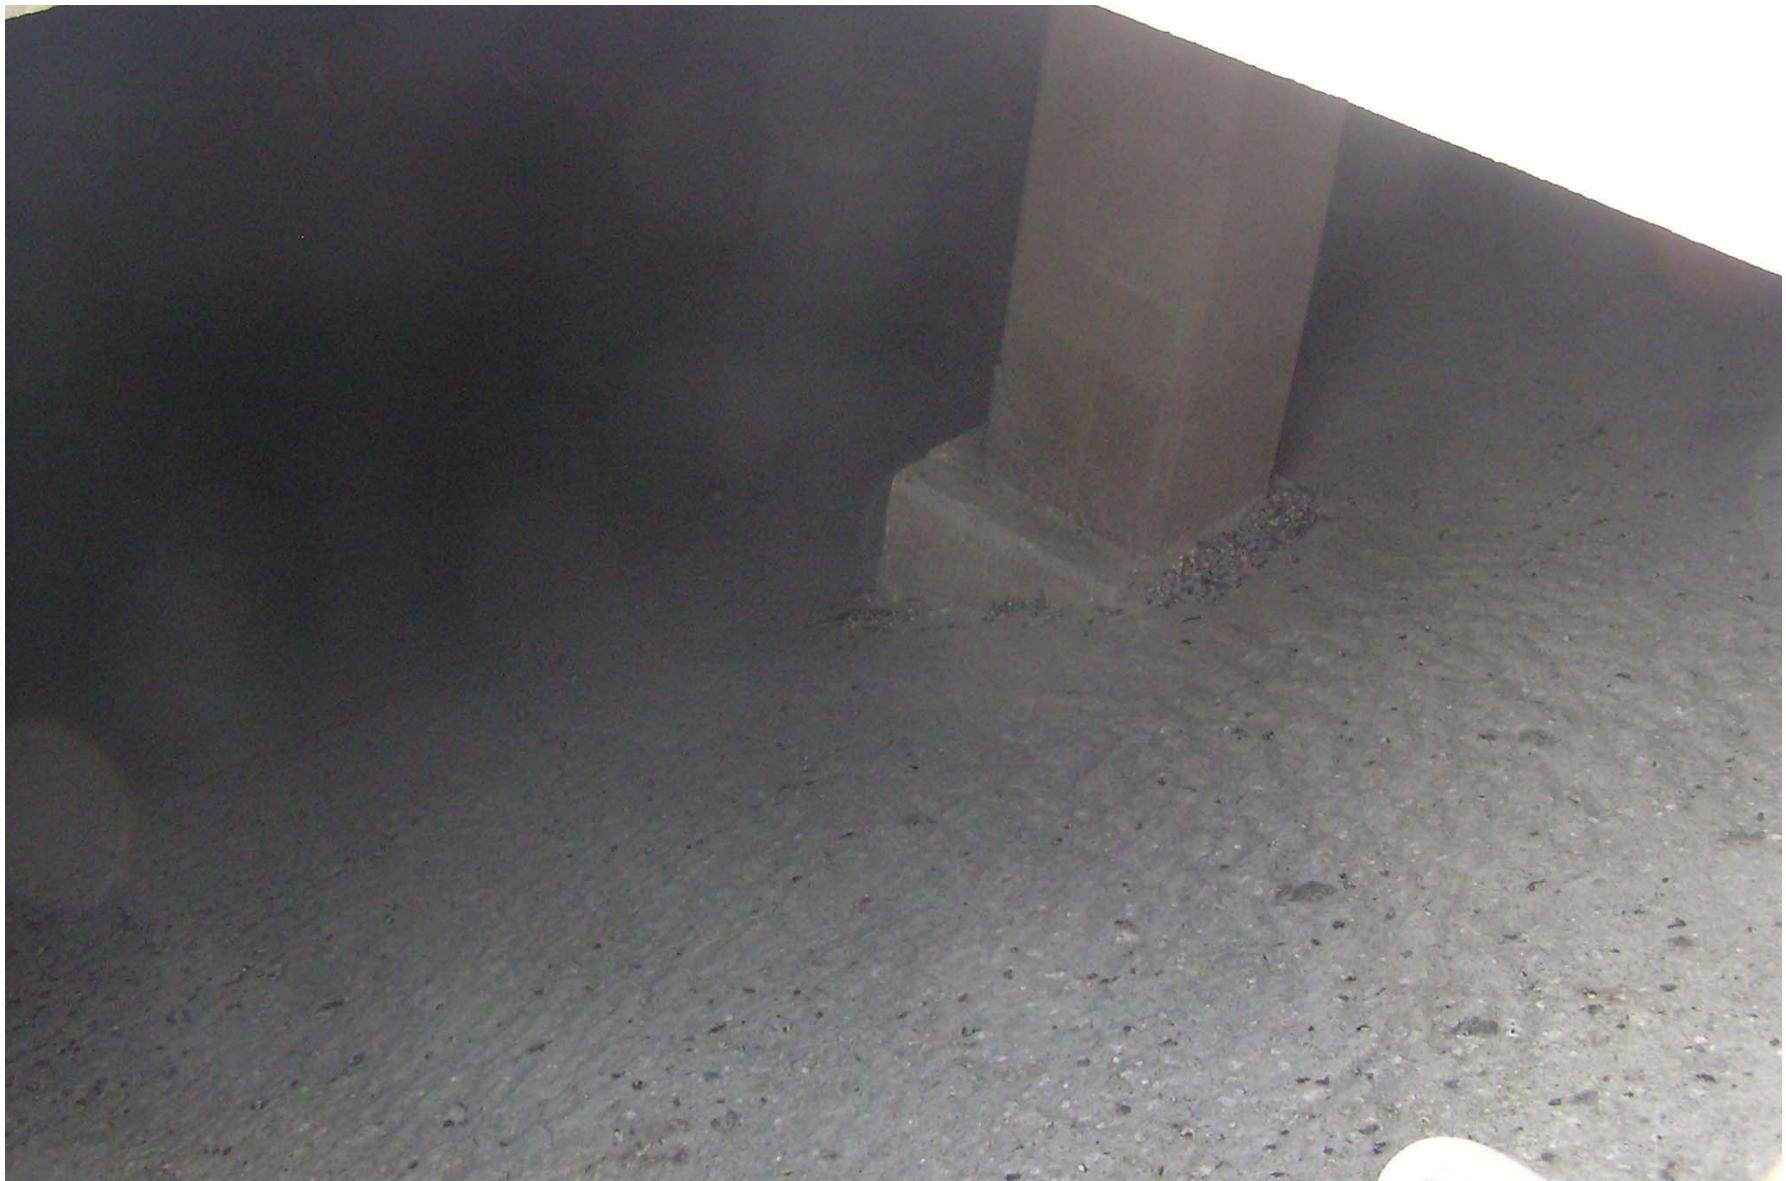
**Photograph B-7. Concrete Sidewall on the East Side of the Northern 126-B-2 Clearwell**

external visual inspection of the inside of the 126-B-2 clearwells revealed no chemical staining or structural cracks.
