# **River Corridor Closure Contract**

## **300 Area D4 Project Fiscal Year 2007 Building Completion Report**

**Washington Closure Hanford**

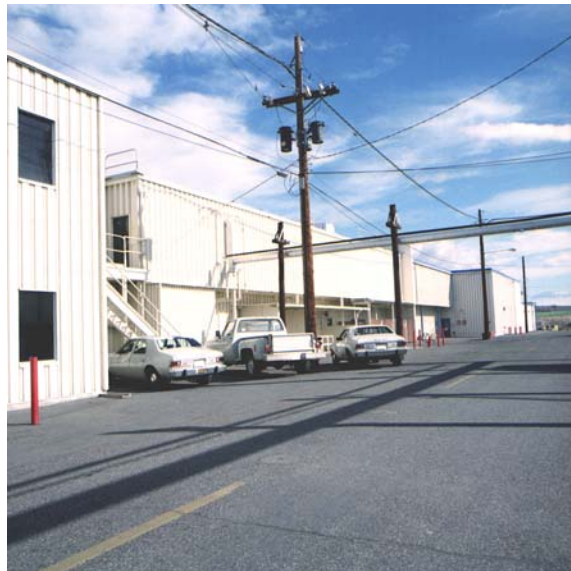
**Figure 1. 306E Building.**

The 306 Building was completed in 1956 as the Metallurgical Semi-Works. The building contained metallurgical equipment and a fuel element pilot plant (Figure 1). Its initial mission was to support 313 Building operations and to pilot process improvements in single-pass reactor fuel fabrication methods. This included the development and fabrication of experimental fuel elements. Equipment at this time included standard metal finishing and forming tools, heat treating, welding, and metallographic equipment.

The 306E Building was a two-story bolted steel frame building with no basement. It had a concrete roof, fluted steel insulated panels for exterior siding, reinforced concrete first floor slab, and second floor of steel deck topped with concrete. The overall building size was 3,393.7 m<sup>2</sup> (36,531 ft<sup>2</sup>). The west wall of 306E was a common wall with the 306W Building.

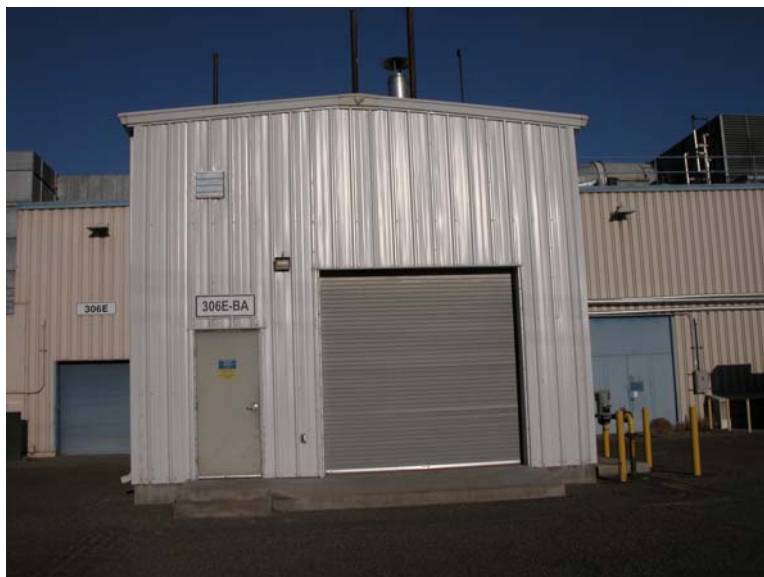
**Figure 2. 306EBA Building.**

The 306EBA (Boiler Annex) was built to supply steam to the 306 Building. All of the 300 Area boiler annexes were pre-engineered metal buildings on concrete slabs (Figure 2). The building was 7.2 m by 6.9 m by 4.3 m (23.5 ft by 22.5 ft by 14.0 ft). Each annex had 3-in. curbing around the sump and water softener. The buildings were electrically heated with one or two corner units installed in each annex.

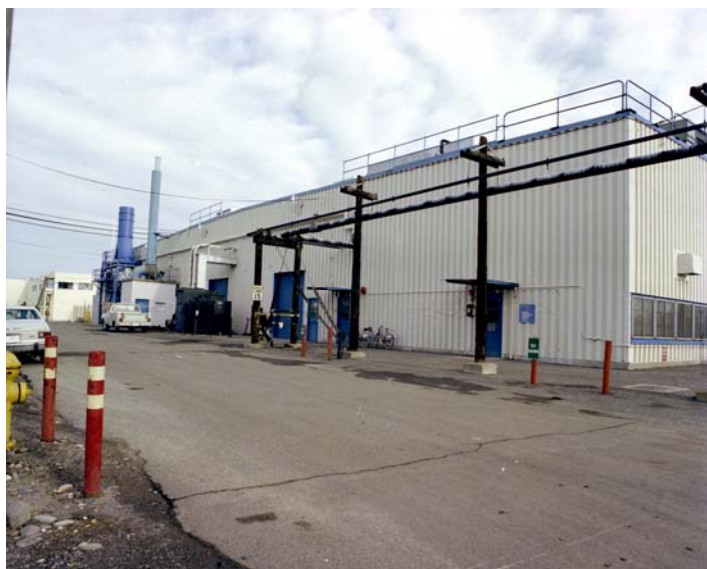
**Figure 3. 306W Building.**

The 306 Building was completed in 1956 as the Metallurgical Semi-Works. The building contained metallurgical equipment and a fuel element pilot plant (Figure 3). Its initial mission was to support 313 Building operations and to pilot process improvements in single-pass reactor fuel fabrication methods. This included the development and fabrication of experimental fuel elements. Equipment at this time included standard metal finishing and forming tools, heat treating, welding, and metallographic equipment.

The 306W Building was a two-story bolted steel frame building with no basement. It had a concrete roof, fluted steel insulated panels for exterior siding, reinforced concrete first floor slab, and second floor of steel deck topped with concrete. The overall building size was 3,393.7 m<sup>2</sup> (36,531 ft<sup>2</sup>). The east wall of 306W was a common wall with the 306E Building.

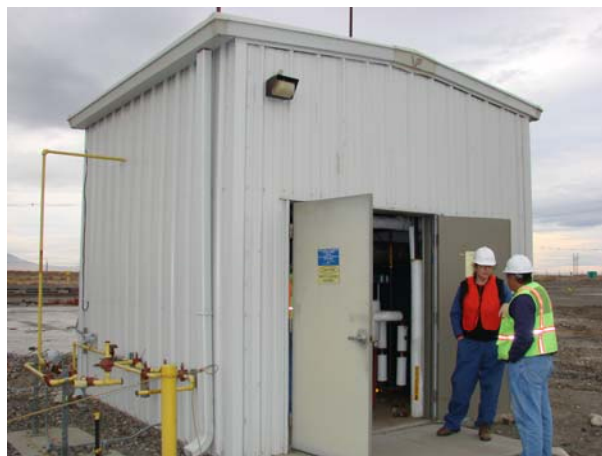
**Figure 4. 3705BA Building.**

Boiler Annex 3705BA was located immediately adjacent and to the east of the 3705 Building. The boiler annex shared natural gas and waste piping with the 3705 Building (Figure 4). The boiler annexes were pre-engineered metal buildings on concrete slabs. The building was 4.1 m by 4.1 m by 3 m (13.5 ft by 13.5 ft by 10.0 ft). Each annex had 3-in. curbing around the sump and water softener. The building was electrically heated with one or two corner units installed in each annex.

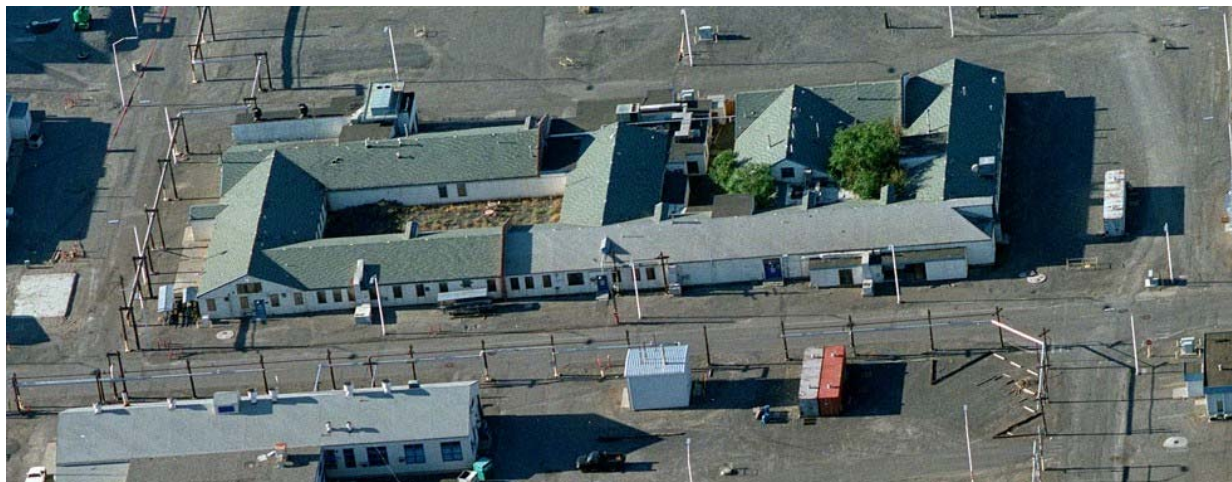
**Figure 5. 3706 Building.**

The 3706 Building, the original radiochemistry and radiometallurgy laboratory on the Hanford Site, was successively called the Technical Building (1943), the General Services Building (1964), and the Communications & Documentation Services Building (2001 [Figure 5]).

The 3706 Building was a single-story, mostly wooden rectangular building measuring approximately 100 m (327 ft) by 43 m (140 ft) including two interior courtyards. The building consisted of wood frame and concrete block with concrete floor and foundation, wood section exterior walls covered with asbestos shakes, sheetrock and cement asbestos board (CAB) interior walls, and roofing of mineral surface asphalt shingles over tar paper. Two brick fire walls divide the structure into three sections. Near the center of the building on the south side was a room with 2-ft-thick concrete walls that was used as a counting room for radiological work. The total plan area of the building was 3,480 m<sup>2</sup> (37,459 ft<sup>2</sup>).

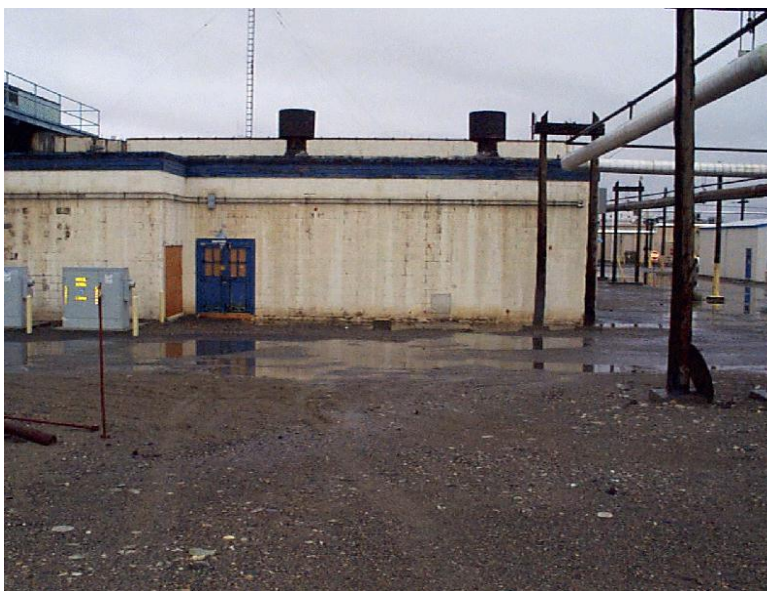
**Figure 6. 3706A Building.**

The 3706A Building was a small concrete structure that housed the heating, ventilation, and air conditioning (HVAC), vacuum system (i.e. vacuum pump and receiver tank), electrical distribution panels, and other support equipment for the 3706 Building (Figure 6).

The 3706A Building was located immediately south and parallel to the 3706 Building and was constructed of concrete block walls and a roof consisting of built-up asphalt felt supported by wooden rafters. The total plan area of the building is 139 m<sup>2</sup> (1,500 ft<sup>2</sup>).

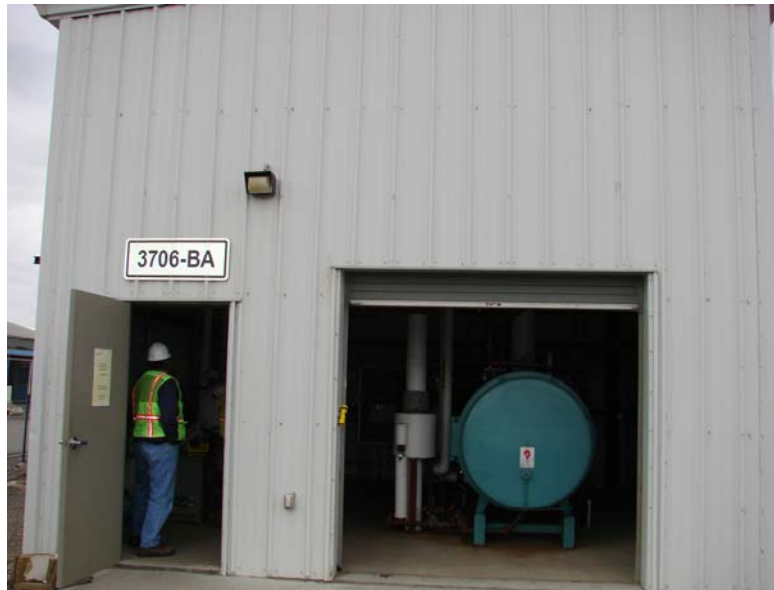
**Figure 7. 3706BA Building.**

Boiler Annex 3706BA was built to supply steam to the 3706 Building. All of the 300 Area boiler annexes were pre-engineered metal buildings on concrete slabs (Figure 7). The building was 7.2 m by 5.9 m by 3.7 m (23.5 ft by 19.5 ft by 12.0 ft). Each annex had 3-in. curbing around the sump and water softener. The buildings were electrically heated with one or two corner units installed in each annex.

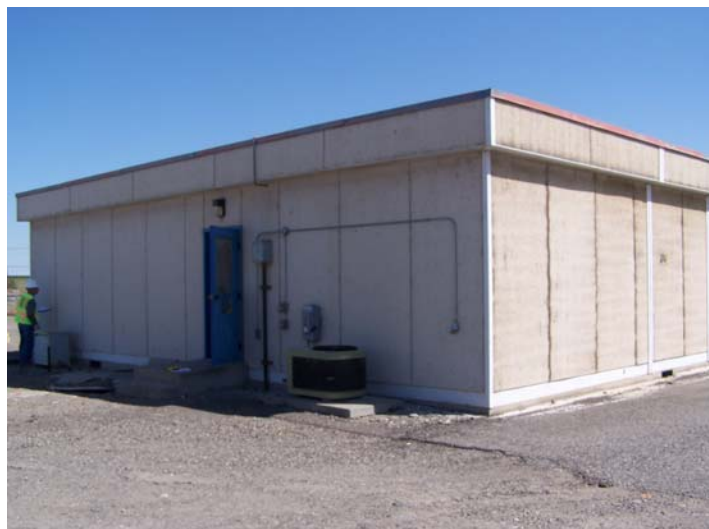
**Figure 8. 3707H Building.**

The 3707H Building was known as the Maintenance Crafts Change Room. The 3707H Building was a single-story, insulated, modular-type relocatable structure placed on a reinforced concrete wall footing (Figure 8). The exterior walls were polyurethane insulating core between reinforced pre-cast concrete. Interior walls contained acoustical material for attenuation of sound transmission. The walls of the change room were waterproof and all others were covered with hardwood veneer panels or vinyl. The floors were vermin-proof and covered with 0.125-in.-thick vinyl tile. The dimensions of the building were 12 m by 9 m (39 by 30 ft).

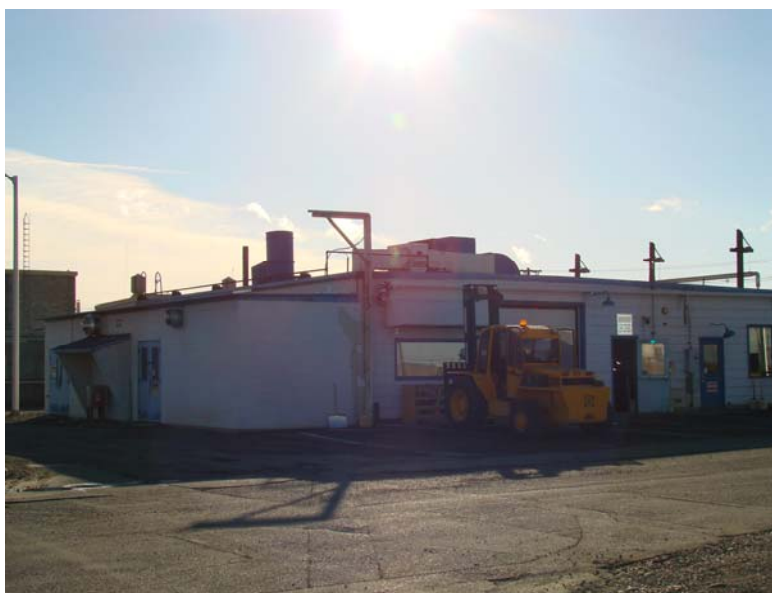
**Figure 9. 3709 Building.**

As originally constructed, the 3709 Building was a single-story, 14.3 by 11.6 m (47- by 38-ft) wood frame structure on a concrete slab (Figure 9). Centered on the south wall was a 9 m (30-ft-) high hose-drying tower. The exterior walls were asbestos shakes, and the roof was wood base with built up felt, tar, and gravel surface. Two modifications and 60 years later, the building measured 14.3 by 20 m (47 by 66 ft), the tower had been removed, portions of the walls were concrete block, and some of the roof was metal. The building contained two small offices, lunchroom, kitchen, bathroom, and heated and vented rooms that were devoted to paint and solvent storage, sign painting, spray painting, silk screening, sandblasting, and paint drying.

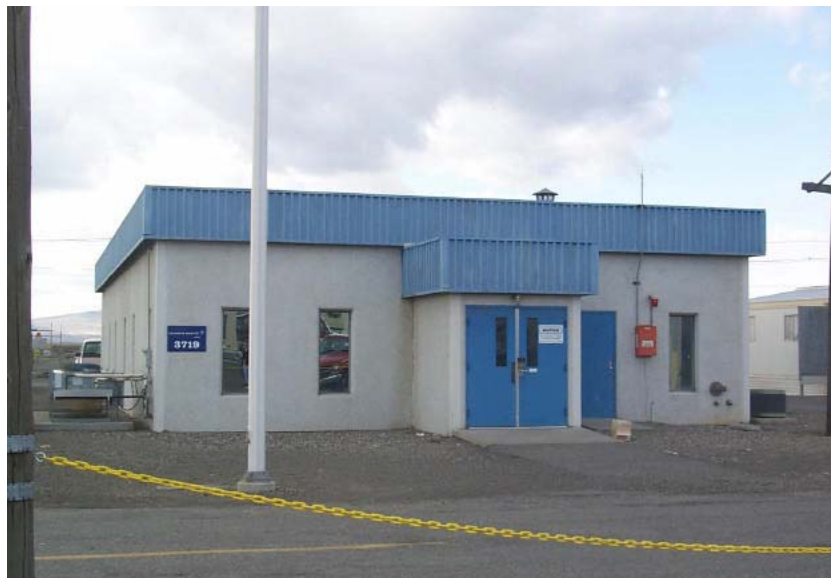
**Figure 10. 3719 Building.**

The original 3719 Building has been used as a first aid station, fire protection headquarters, janitor service building, and finally as a transportation dispatch office (Figure 10). Most recently, the 3719 Building had been used as a document storage facility and finally as a computer facility.

The original building was replaced in the 1977 to 1978 time frame, with a single-story modular construction building with poured concrete slab foundation. Exterior walls were polyurethane insulating core placed between reinforced pre-cast concrete. Interior partitions contained acoustical material for attenuation of sound transmission. The ceiling was equipped with acoustical tile constructed from noncombustible materials. The dimensions of the building were 22 m by 12 m (72 by 39 ft).

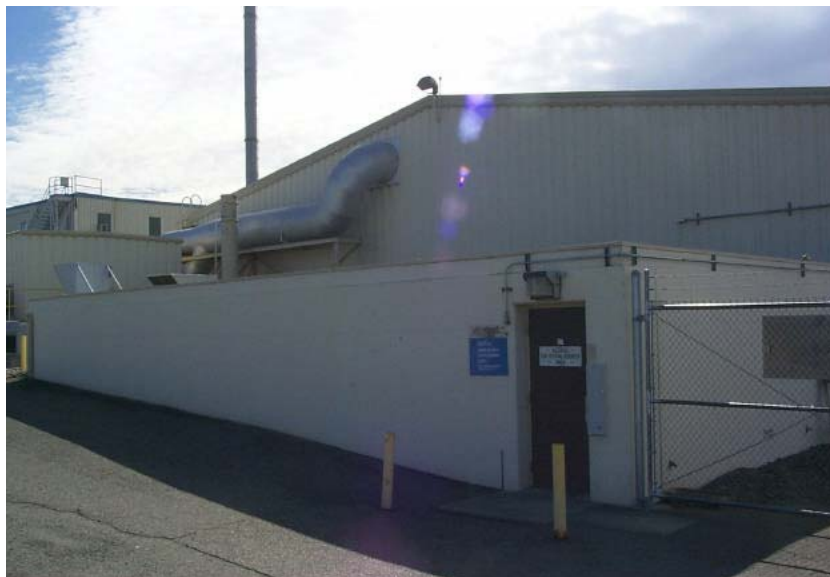
**Figure 11. 3720 Building.**

The 3720 Building was built in 1964 as the Consolidated Service Facility - Maintenance and Quality Control Laboratory. It was used by General Electric (GE), Douglas United Nuclear (DUN), and United Nuclear Industries (UNI) to provide analytical chemistry support for the fabrication of nuclear fuels for the Hanford Site reactors (Figure 11). The 3720 Building was transferred to PNNL in 1971 as the Material Sciences Laboratory.

There were 29 offices and 31 laboratories of various sizes in the building. The 3720 Building was a two-story metal frame structure on a concrete foundation and concrete slab floor. The exterior walls were steel panels with fiberglass insulation. The building had a concrete partial basement (southwest quadrant), a concrete block addition with a full basement (northwest end), and covered storage area (southwest end). The sloped gable roof had tar and gravel over a corrugated sheet metal base. The main 3720 was 73 m (240 ft) long (north-south), 30.5 m (100 ft) wide, 4.2 m (13.8 ft) high at the roof eaves (9.2 ft to top of concrete masonry unit [CMU] wall), and an overall height of 6.1 m (20 ft) to the roof peak.

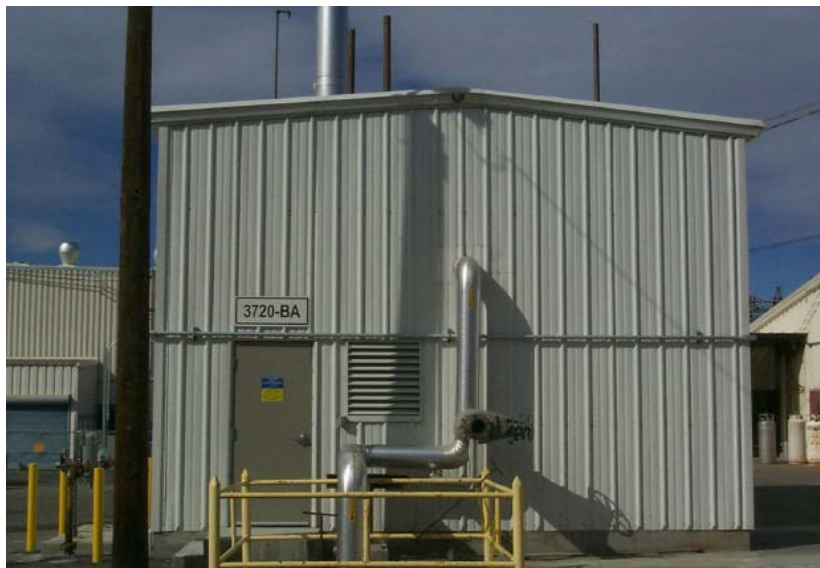
**Figure 12. 3720BA Building.**

The 3720BA Building (Boiler Annex) was located at the southwest corner of the 3720 Building to provide steam (Figure 12). The boiler annexes were pre-engineered metal buildings on concrete slabs. The building was 7.2 m by 7.2 m by 3.7 m (24 by 24 by 12 ft). Each annex had 3-in. curbing around the sump and water softener. The buildings were electrically heated with one or two corner units installed.

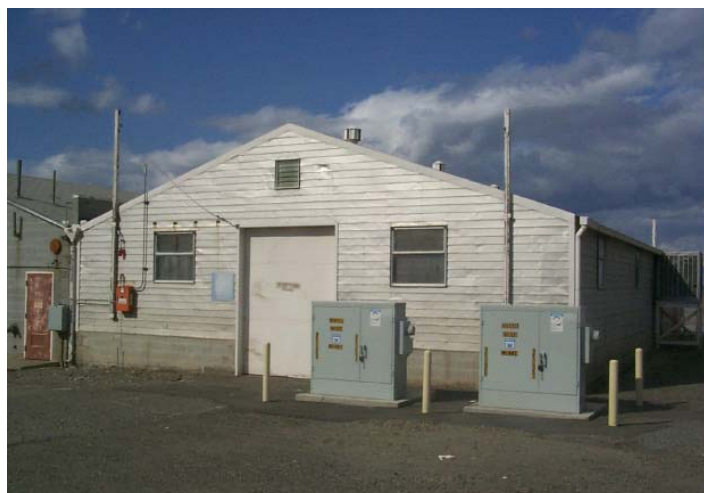
**Figure 13. 3731 Building.**

The 3731 Building was originally built as an Army mess hall. It was relocated to the 300 Area in 1961 as the 3731 Building for Hanford laboratory storage (Figure 13). Its primary use was for storing graphite materials. The north end of the 3731 Building was used for maintenance of U.S. Department of Transportation 6L (special nuclear material) shipping containers from 1968 to 1987 when it was identified as a Fissile Material Storage Facility. A criticality detection/alarm system was installed in 1968 and fire protection sprinklers were installed in 1980 for a paint spray booth to support painting shipping containers. In 1966, a new graphite shop (3731A) was constructed immediately adjacent to the west side of the 3731 Building with an adjoining wall and a fire door to the south half of 3731.

The 3731 Building was a 12.2 m (40 ft) wide by 24.3 m (80 ft) long by 5.2 m (17 ft) high all metal building with aluminum siding, frame, trusses, and roofing. The metal building sits on a 2- to 3-ft-high concrete block foundation on concrete slab floor.

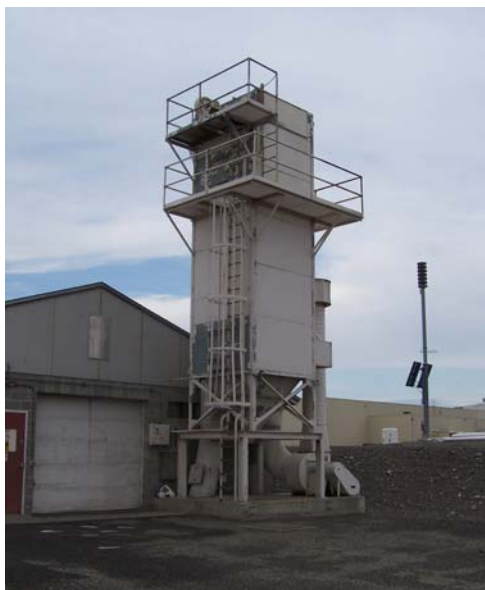
**Figure 14. 3731A Building.**

The 3731A Building was built in 1966 and operated as a “cold” graphite machine shop until 1995 when it was placed in standby condition by PNNL (Figure 14). The building included a large external vacuum dust (graphite) collection system outside the northwest corner of the building. The 3731A Building was constructed immediately adjacent to the west side of the 3731 Building with an adjoining wall and a fire door to the south half of 3731.

The 3731A Building was a 12.2 m (40 ft) wide by 24.3 m (80 ft) long by 5.2 m (17 ft) high concrete block building on a concrete slab with a 4:12 pitched wooden truss roof.

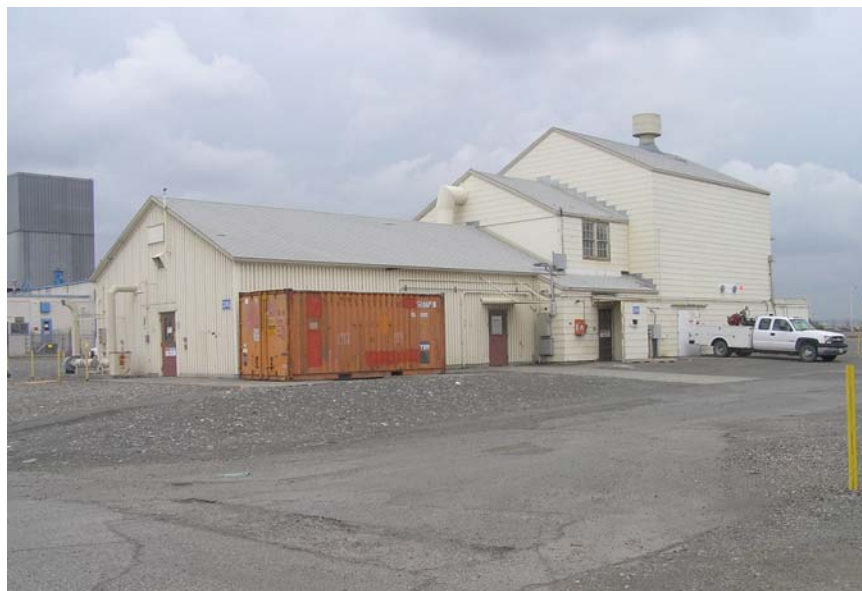
**Figure 15. 3745 Building.**

The 3745 Building was known as the “Radiological Calibrations and Standards” Building (Figure 15). The 3745 Building was built in 1944 to support the calibration of a wide range of radiation detection instruments using x-ray, alpha, gamma, and neutron sources. From the beginning, the building experienced contamination and personnel exposure problems from contaminated portable survey instruments being brought in from the field and from instruments with faulty cases or shielding. An instrument decontamination area was established in the facility in about 1945. This building received major shielding upgrades in 1956 to reduce radiation exposures to calibration personnel within the building and to reduce radiation dose rates outside the building.

The 3745 Building was a two-story wood-frame rectangular building with a multiple gable-type roof. The exterior measured 29.6 m by 11.0 m by 12.2 m high (97 ft by 36 ft by 40 ft high). Part of the roof was built-up hot mopped asphalt; the rest was asphalt shingle. There were three large ventilators on the roof. A reinforced concrete vault in the southwest corner of the building had a flat, reinforced concrete roof with tar and gravel surface. The exterior walls were asbestos shake shingles over the concrete block. The main floor was on-grade concrete and the building was supported on concrete footings. The second floor was wood framing with a wood deck and asphalt tile. The building was steam heated, first by steam provided by the 384 Power House and later by a Johnson Controls, Inc. steam boiler located inside the building.

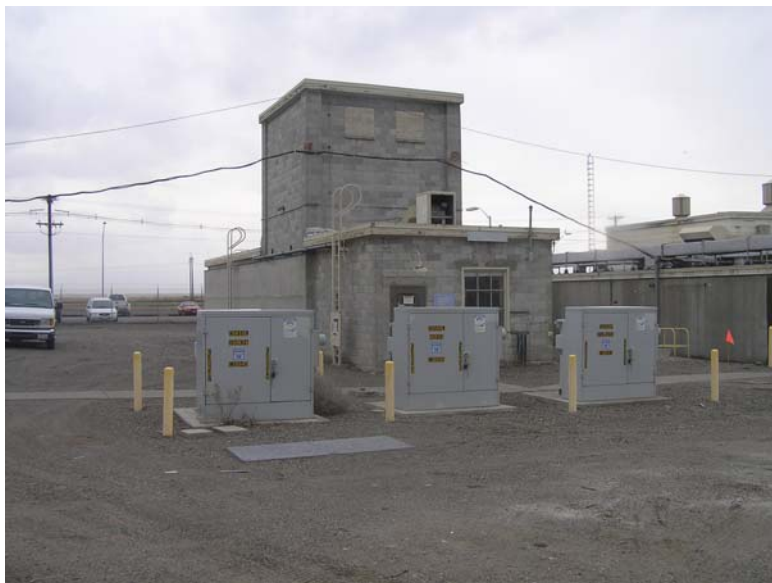
**Figure 16. 3745A Building.**

The 3745A Building was known as the “Electron Accelerator” Building (Figure 16). The 3745A Building was constructed in 1947-1948 as shielded laboratory space for health physics research involving ion bombardment in support of General Electric Hanford Company’s Radiological Physics Group. The building and equipment were later used in support of Battelle Northwest/Pacific Northwest Laboratories’ Occupation and Environmental Safety Department.

3745A was a rectangular building with concrete block walls and an at-grade concrete slab floor that measures approximately 22.3 m (73 ft) long in an east-to-west direction by approximately 5.3 m (17.5 ft) wide in a north-to-south direction. The main roof was 3 m (10 ft) high and the high bay roof was 8.8 m (28.8 ft) high. The roof was concrete with a tar and gravel finish. The center of this building consisted of a high-bay section designed to house a vertical standing accelerator. The south exterior wall is composed of concrete block that has been augmented with poured concrete for radiation shielding purposes. This poured concrete extends outward 18 in. from the building's concrete block walls. The west wall is composed of concrete block that has been similarly reinforced with poured concrete shielding. The shielding helped reduce the amount of radiation that escaped the building during accelerator operations. At the western end of the north side of the building is a reinforced concrete wall off set from the building.

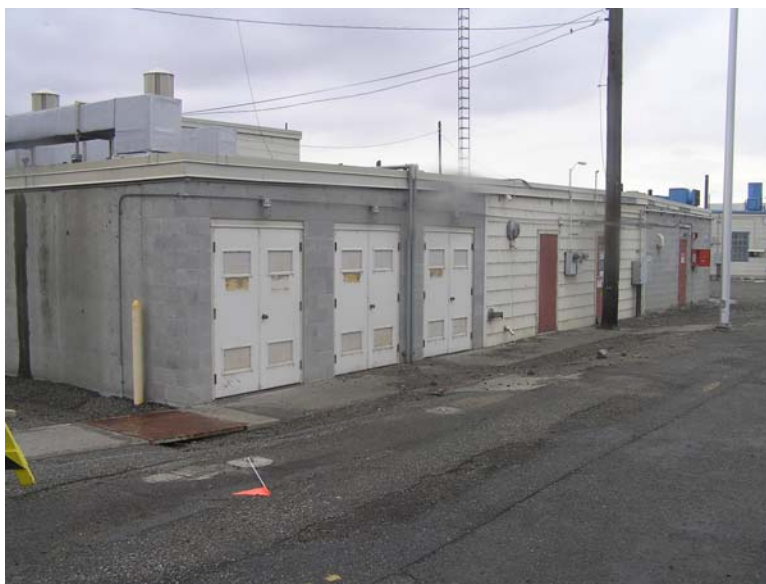
**Figure 17. 3745B Building.**

accelerator had multiple beam tubes and used a variety of gases such as hydrogen, helium, and deuterium. Targets included beryllium, carbon, and tritium. The facility underwent many structural modifications to accommodate new projects, including studies involving protons. A tandem accelerator was added to the facility. Experimental work was shut down in 1995 due to budget cuts.

3745B was a rectangular building that evolved into its pre-demolition configuration through a series of additions. Initially, the building had a concrete floor, walls, and roof at the sample target area while the remainder was constructed of wood frame covered with asbestos shake siding. Subsequent additions to the north and south sides of the building were constructed of concrete block with some concrete shielding walls. All the tar and gravel roof areas had a slight slope for water run-off. A concrete block equipment storage addition 7.9 m by 4.6 m by 10.1 m (26 ft by 15 ft by 4 in.) was added to the building in 1981. Heating and cooling was provided by steam and refrigeration, respectively.

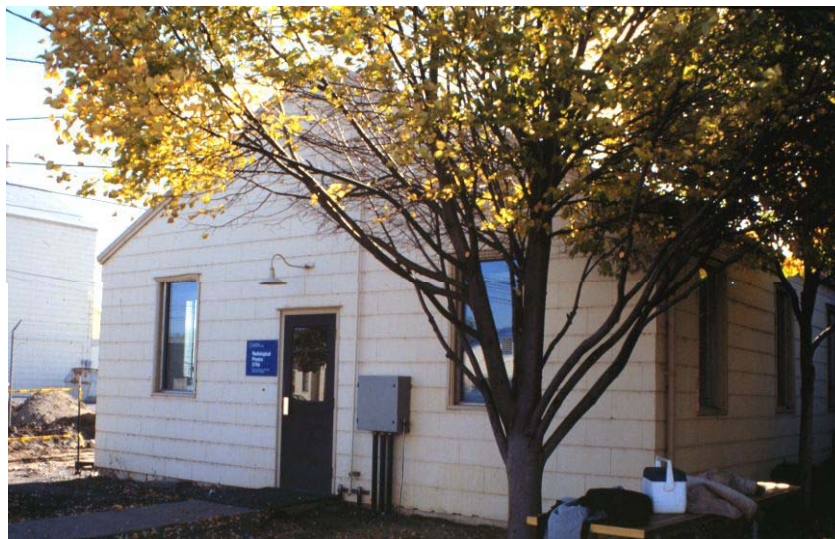
**Figure 18. 3746 Building.**

The 3746 Building has been identified with several names including the Control Building, the Irradiation Physics Building, and the Radiation Protection Administration Building. The 3746 Building provided support space such as offices, lunchroom, and restrooms (Figure 18). The building was used as office space for personnel associated with health physics and research, and development projects in the 3746-A, 3745-A, and 3745-B Buildings. The function of the building was to perform tests and verify that the composition of various process substances were within specifications. The building was also used to calibrate thermoluminescent dosimeters, which were first used at the Hanford Site in the 1970s.

The 3746 Building was built in 1945 and was a 205 m<sup>2</sup> (2,211-ft<sup>2</sup>) gable roofed, one-story wooden building that contained 10 rooms. A 10.1 cm (4-in.) reinforced concrete slab floor was supported by reinforced foundation walls and well-tamped earth. The walls were of drop siding over building paper and 2 cm (7/8-in.) sheathing. The gable roof was a built-up felt roof supported by wooden rafters. Wooden louvers are located at either end of the building for attic ventilation. The rooms consisted of a small electronics laboratory, shop, dark room, storage room, two restrooms, four offices, and a corridor that runs from one end of the building to the other along a center axis. The overall dimensions of the 3746 Building were 22.1 m (72.5 ft) long (north-to-south), 9.3 m (30.5 ft) wide (east-to-west), and 6.5 m (21.5 ft) in height. Cooling was by evaporation and heating was by steam.

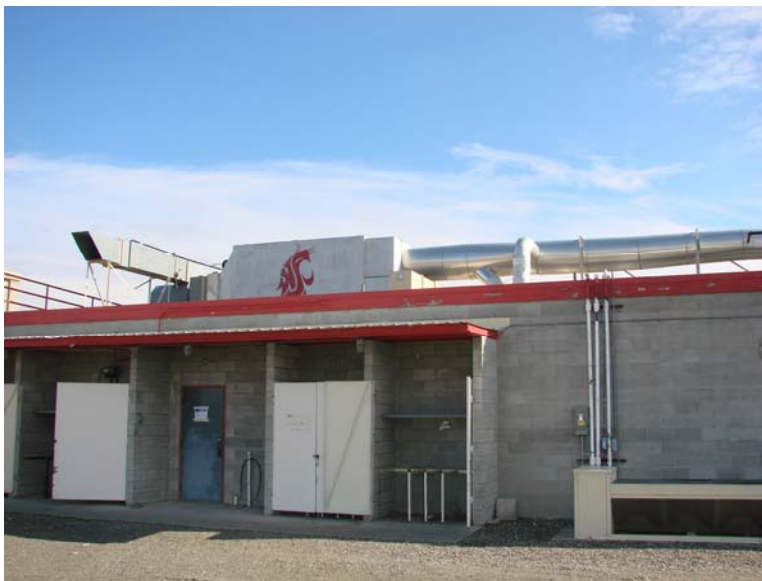
**Figure 19. 3746A Building.**

The 3746A Building (Radiological Physics Laboratory) provided laboratory and office space for PNNL's Radiological Science Department (Figure 19). Records are poor and the history of the operations that took place at the building is not documented. Based on drawings, available information, and lack of hazardous identification postings, the activities that occurred within the

The 3746A Building was originally constructed in 1948 on a concrete foundation with an on-grade concrete floor slab. The one-story building originally contained a total of four offices, seven laboratories and support rooms, a water purification room, and a mechanical room of various sizes. The seven laboratory and support rooms were identified as the cell biology laboratory, tissue culture laboratory, instrumentation development and microdosimetry room, x-ray room, two radiation and biochemistry laboratory rooms, and a micro-spectrofluorimetry room. The outside walls and internal bearing walls were constructed of concrete block. All internal partitions were constructed of gypsum board on steel studs. The roof was constructed of wood planking with built-up roofing and insulation supported on glue-laminated wood beams. Laboratory floor covering consisted of sheet vinyl, and the office/corridor floor covering was vinyl asbestos tile.

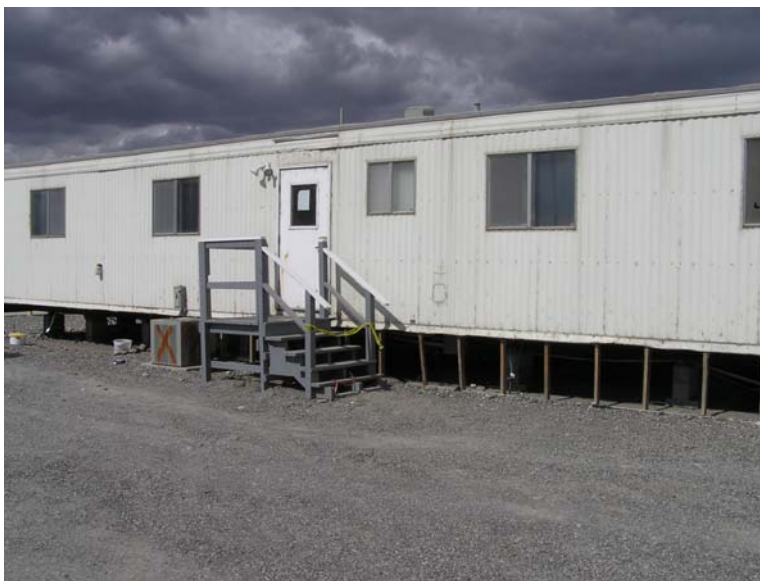
**Figure 20. MO-905 Building.**

The MO-905 temporary mobile office trailer was used by Field Remediation Radiological Controls group as a temporary office space, meeting room, and lunch area (Figure 20). One room of the trailer was also used for counting radiological air samples and smears, and performing source checks. The building was a double-wide 24- by 60-ft transportable metal clad building on a steel frame located in the north-central region of the 300 Area.
