FINAL TECHNICAL REPORT

Project title: Multifunctional Metallic and Refractory Materials for Energy Efficient Handling of Molten Metals

Award No: DE-FC36-04GO14038

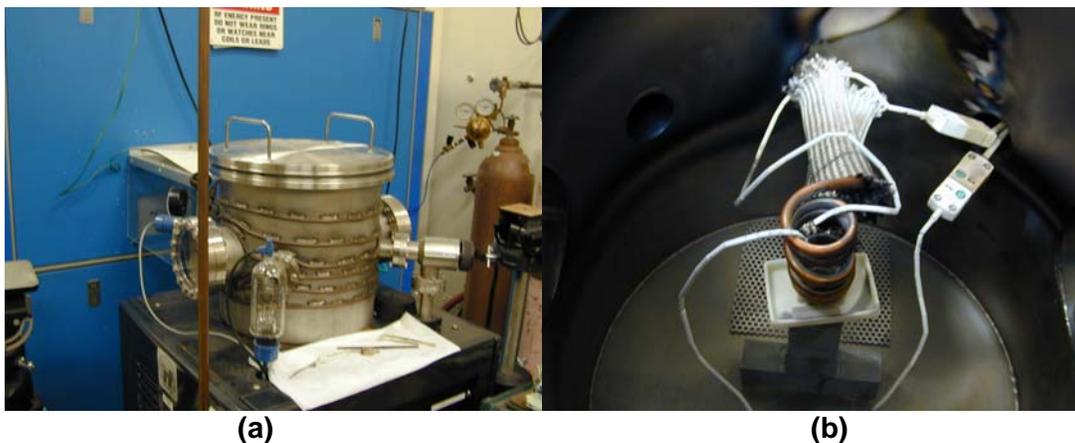
**Figure 2 : Apparatus of the static sessile drop unit
(a) test unit; (b) induction heating coil and thermocouples**

A solid cube of Zn or Al alloy was placed on the solid substrate prior to heating. The apparatus used for the static sessile drop experiments is shown in Figure 2, and its corresponding schematic drawing is illustrated in Figure 3. It consisted of an induction furnace (Figure 2b), using an evacuating system with a rotary pump. In the inductive furnace chamber, the sample substrate was placed on a ceramic support rod, which sat in a ceramic catch pan for protection, in case the molten metal dropped off the base and contaminated the furnace. The metal cube was located in the center of the induction heating coil for evenly distributed heating (Figure 3). The front window, made from quartz was installed in the inductive furnace, allowing a color CCD camera to continuously monitor the experiments. The resolution of the camera is 640 by 480. Three Type-S thermocouples (with ceramic sheath) were inserted into the furnace chamber (Figure 2b) by the feed-through for monitoring the refractory substrate temperature, molten metal drop temperature, and the reaction temperatures, respectively.

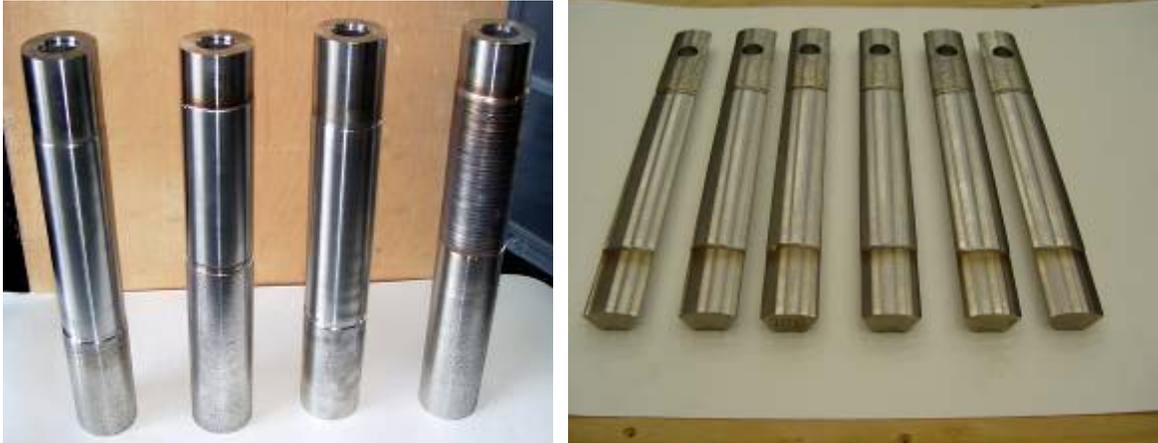
Static corrosion tests were carried out in the continuous galvanizing baths at our industrial partners for up to 150 days. Two different kinds of overlay samples were employed in the tests. One kind consisted of 4-in.-OD by 1-in.-wall tubes with 2020 weld overlay. The tube sections were 24-in. long with weld overlay section varying from 8- to 12-in. long. These tubes are shown in Figure 6 (a). Another type of samples, 2-in.-wide sections, are shown in Figure 6 (b).

Figure 6: CF3M (316L) tubes weld overlaid with 2020 for in-plant testing. (a) tubes; (b) 2-in-wide samples

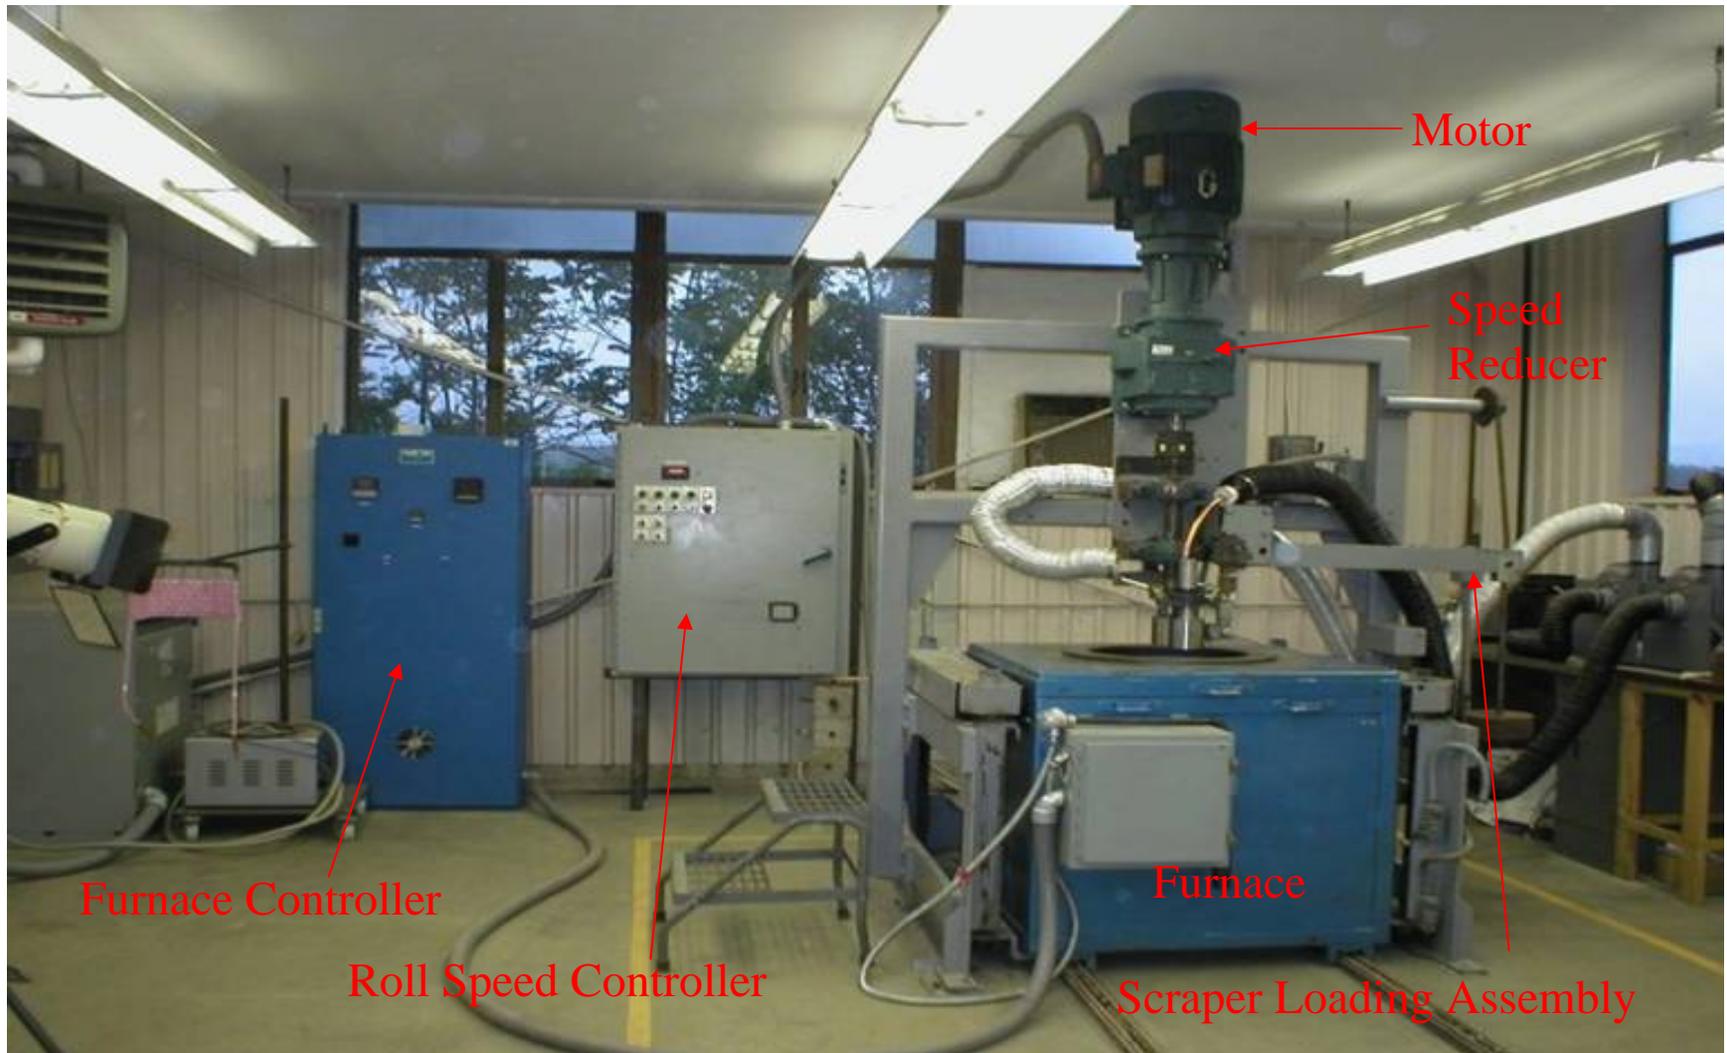
15 Hp Motor: A three phase 15Hp motor is used to rotate the shaft which was submerged in the molten bath and rotated at a constant speed. The rotating of shaft needed a high torque motor to overcome the initial friction due to the density of the molten bath. But high torque motors have high RPM, in order to reduce the speed a DODGE speed reducer was attached in between the shaft and the motor as shown in the Figure 7.

Figure 7: Dynamic Scrapper Wear Test Set-Up

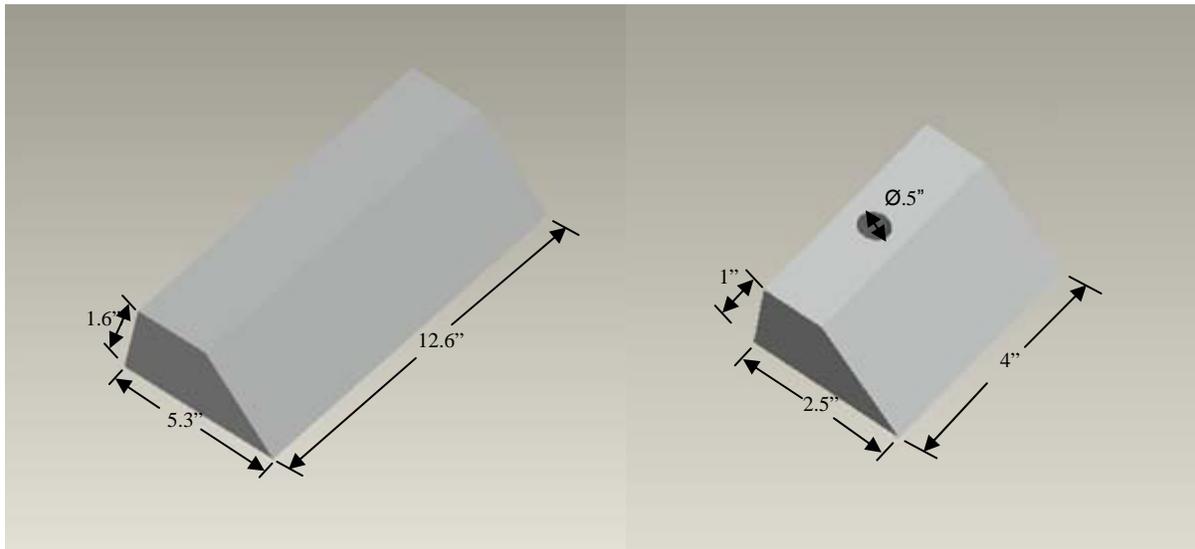
Scraper Set-up: In CGL, the scrapers used are 320mm X 135mm X 40mm (12.6"x5.3"x1.6") which are spot welded to the scraper arm. First the scraper was scaled down corresponding to the roll diameter and the space available in the bath, so that the scraper would come back to the rest position when the scraping action was completed, without damaging the crucible walls. Based on this consideration, the scraper was scaled down to 4"x 2.5"X 1" with an Ø0.5" hole on the top face as shown in Figure 8, so that they can be fastened and removed from the loading arm. The scraper is supported by two rectangular arms on either side with a spacer in the middle, so that the load applied is always on the tip of the scraper.

Figure 8: Actual and Scaled down Scraper Dimensions

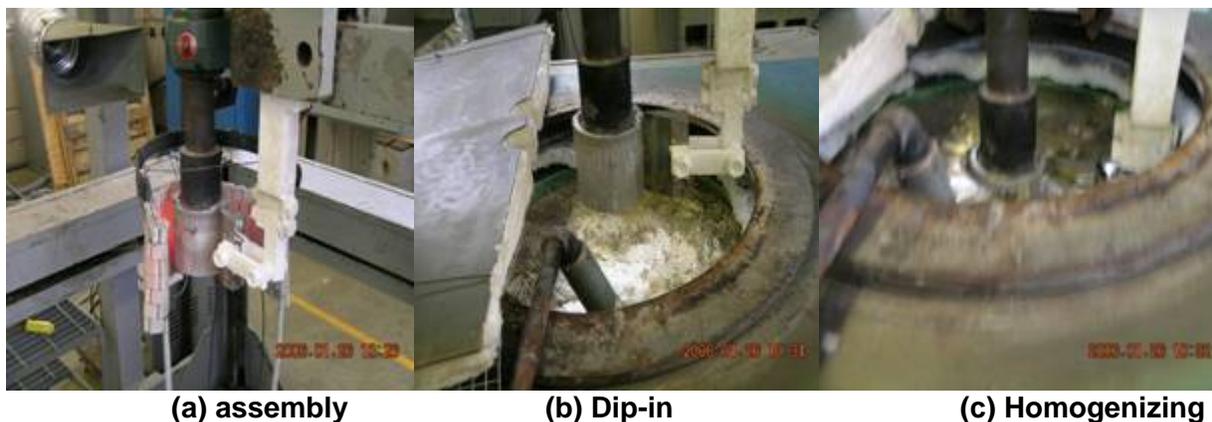
Figure 9: Various Steps followed Prior Testing

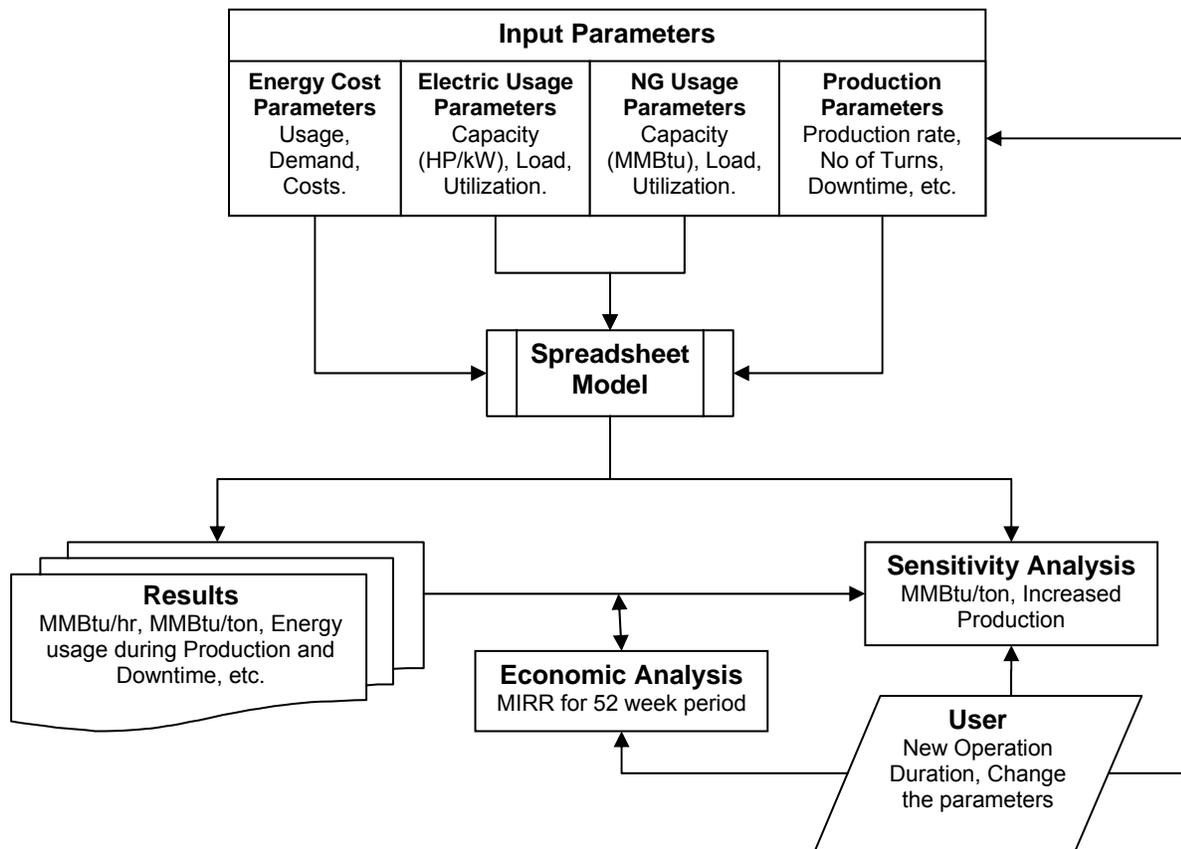
Initial visits were conducted to leading galvanizing facilities. The entire process and the basics of the continuous galvanizing process were studied thoroughly. A list of all the common equipment was documented. The energy intensive equipment and energy consumption points were noted. The systems development was completed and the details of the systems diagram are shown in Figure 10.

Figure 10: System Diagram

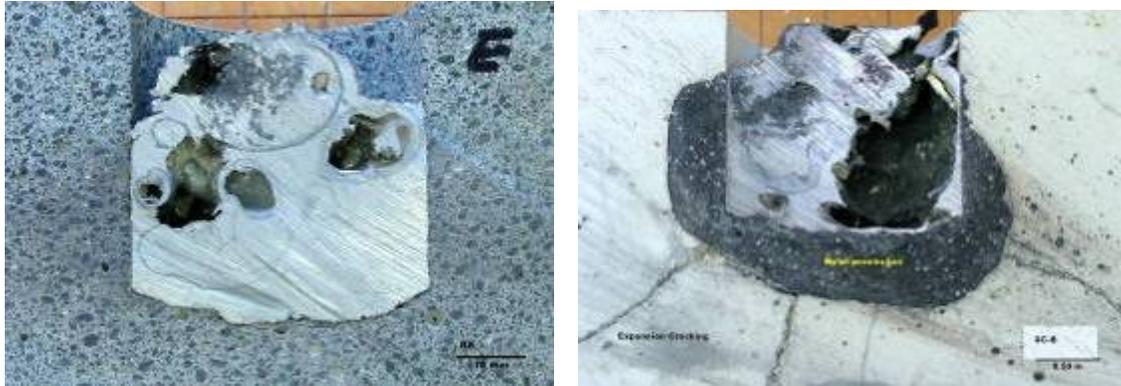
Upon completion of static cup testing, the cups were cut along the cross section to study penetration. Based on visual observation of the penetration and its effects, tested materials were then ranked in order of resistance to penetration. See Figure 14 below.

Figure 14: Cross Section after cup testing. Left – Good Material; Right – Weak Material

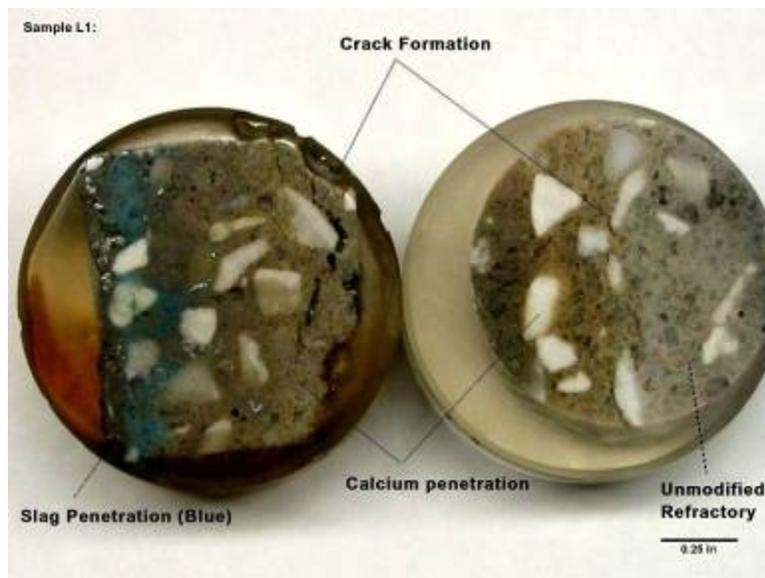
Figure 15: Typical Microscopy sample ready for analysis

A piece of the refractory was then selected for microscopy and cored out of this cross-section. It was then mounted in epoxy and prepared for microscopy after multiple stages of grinding and polishing. A typical microscopy sample is seen in Figure 15. It includes all the phenomena occurring in the sample during cup testing such that the material can be completely analyzed during one microscopy event.

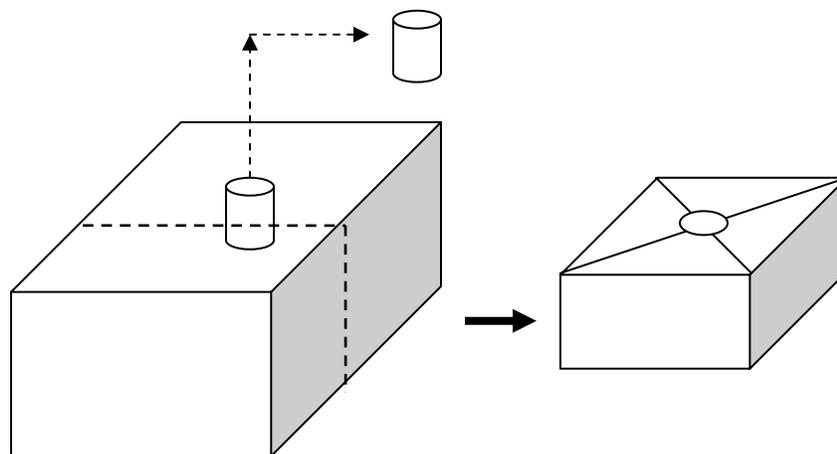
Sample preparation is shown schematically in Figure 16. All materials received from in-kind partners were made into standard 9-in straight bricks (9" x 4.5" x 2.5"). These bricks were then machined into cup test specimens as shown in Figure 16. Each brick was cut into half and each section was machined to accommodate an aluminum alloy plug for the static cup tests. For this purpose, a 1.5" diameter hole was cored into the sectioned brick piece to a depth of 1.5".

Figure 16: Machining Process to Prepare Refractory Sample for Static Cup Testing

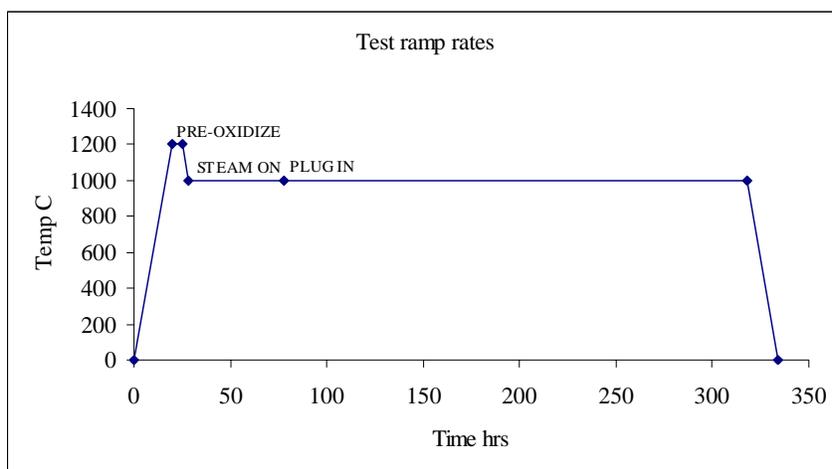
- Heat and to 1200°C and pre-oxidize sample for 5 hours
- Cool to 1000°C
- Cold Al 5083 plug introduced at 1000°C
- Hold at 1000°C for 10 days (240 hours)
- Steam atmosphere maintained during entire test.
- Cool to room temperature

Figure 17: Test Ramp Rates for 10 Day Static Cup Test

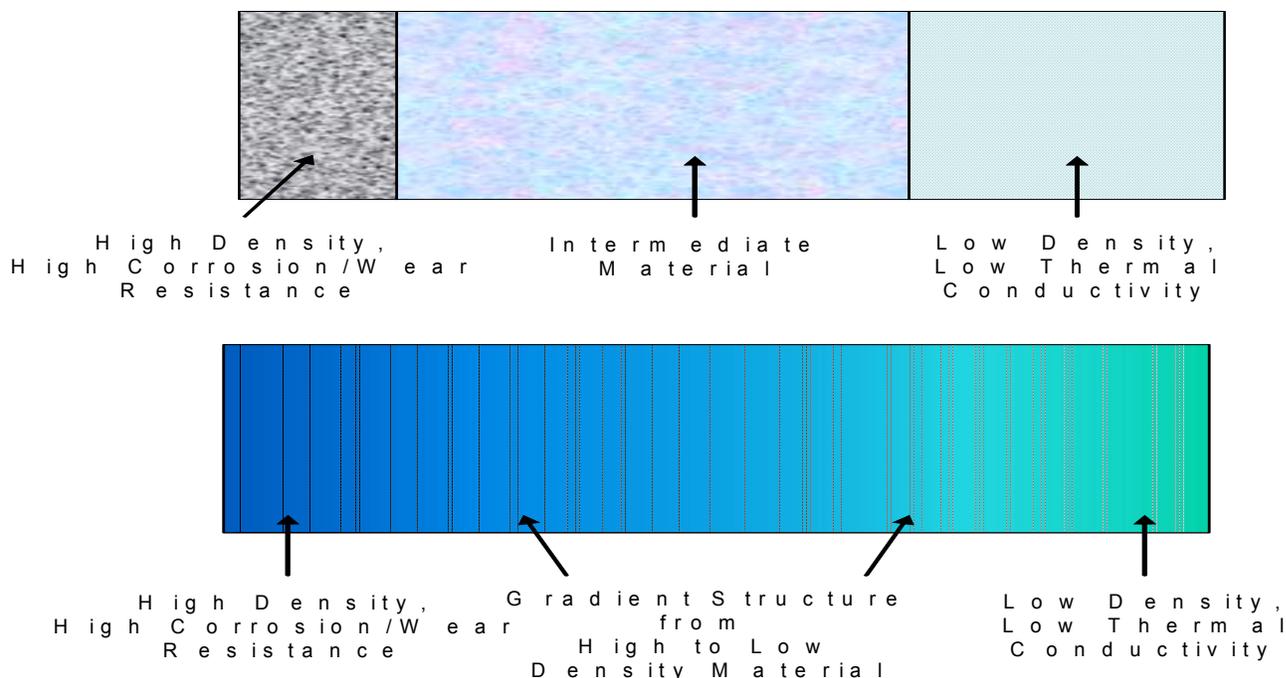
Based on the understanding of corrosion damage mechanisms and ThermoCalc™ modeling, new material systems were identified as a base. The base system was then further modified for its multi-functionality through the concept shown in Figure 21. The new refractory systems were then designed and prepared into coupons for corrosion, wetting testing, and thermal conductivity measurement.

Figure 21: Various Composite Lining Systems Found

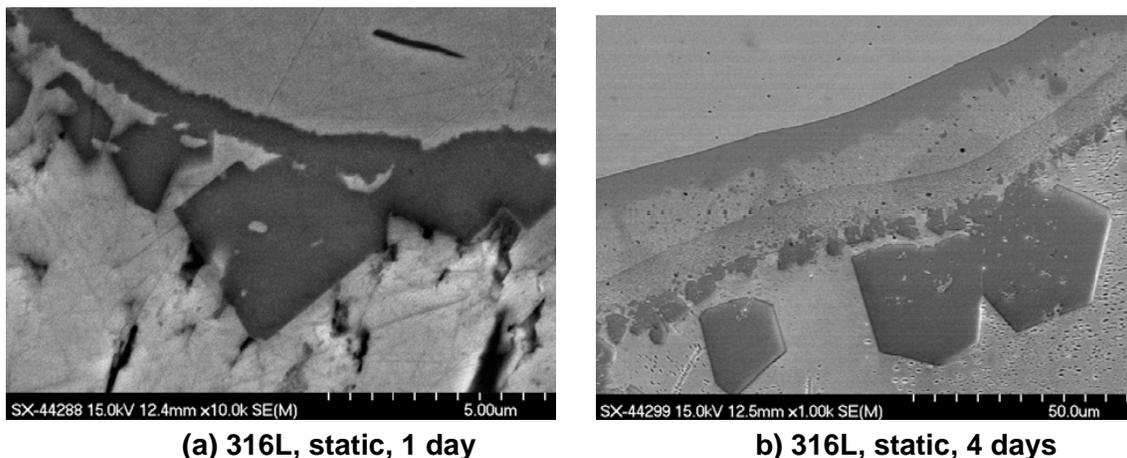
Figures 26 (a) and (b) show that after a four-day dipping, the thickness of the reaction layer increased to about 30 microns and there were several sub-layers formed. On the top of the reaction layer, there were two dross layers formed. The one next to the reaction layer is a semi-continuous dross layer with an average dross size of five microns, and on the top of this layer, there are several large dross particles with an average size of 30 microns. It is believed that these big dross particles are from the bath.

Figure 26: SEM micrographs of 316L stainless steel after lab-scale static dipping test in Zn-0.22% Al for various times

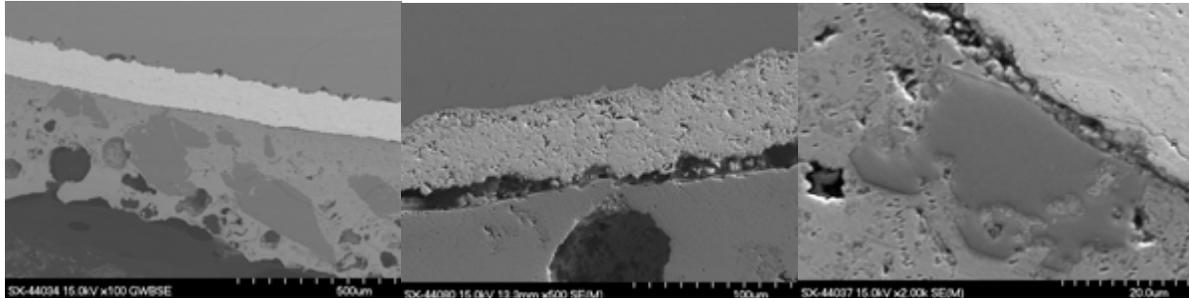
Figure 27 shows the WC-Co coating after dipping in GI (Zn-0.22Al%Al) for 15 days. The coating was supplied by industrial partner, Praxair Surface Technologies, and the substrate was 316L stainless steel. The top layer in both pictures is the steel substrate, the middle layer is the coating, and the bottom layer is frozen Zn bath. It is indicated in the pictures that the coating shows almost no-wetting with the Zn bath, and there is a crack between the bath and the coating. However, there are more pores in the coating after the 15-day dipping than in the virgin coating, which shows the degradation of the coating. In addition, there are few dross particles attached to the coating surface after a 15-day dipping test.

Figure 27: WC-Co coating after dipping in lab-scale Zn-0.22%Al bath for 15 days

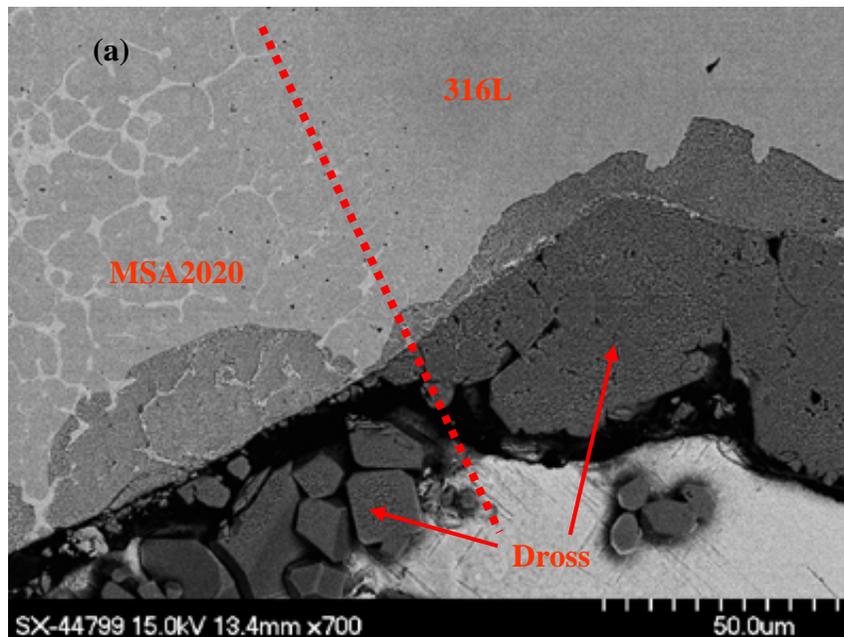
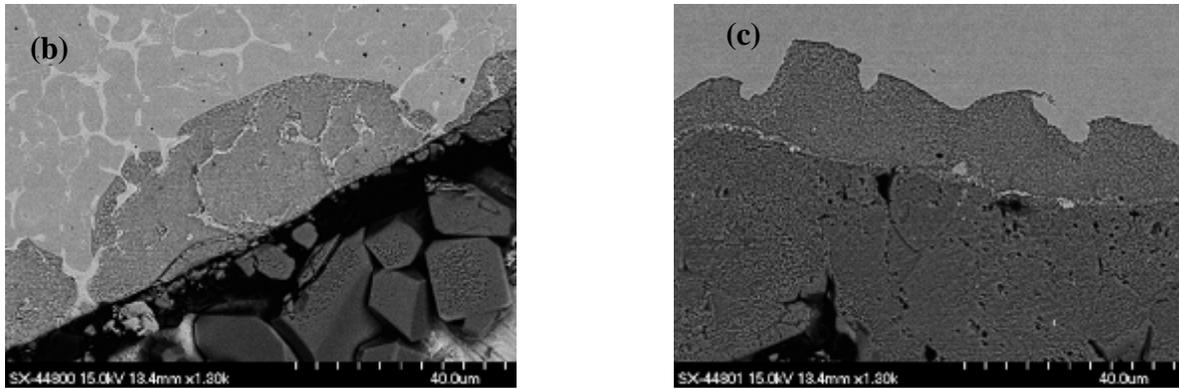
Figure 28 (a) is the back-scattered electron image (BSI) of the interfacial dross layers formed by the immersion of the 316L specimen, partially coated by Alloy 2020 weld overlay, in the galvanizing bath (Zn-0.22%Al) at 465°C for 30 days. As seen in Figure 28 (a), the bright area on the left of the micrograph is the Alloy 2020 weld overlay (also shown as Figure 28 (b)) while the dark area on the right side is 316L stainless (also shown as Figure 28 (c)). To the right of the substrate, a relatively thick dross layer was observed attaching on the 316L surface, but no continuous dross layer was built up on Alloy 2020 except where scattered small dross particles were detected. Both 316L and Alloy 2020 had a uniform, continuous interfacial reaction layer formed on the side of the base materials. More details are shown in close-up images in Figures 29 (a) and 29 (b) comparing the wettability of the base materials by dross. The conclusion was drawn that Alloy 2020 weld overlay had better non-wetting performance than 316L stainless [24].

Figure 28: Static molten metal corrosion and dross buildup test in GI bath at 870°F for 30 days on materials (a) Alloy 2020 weld overlay (b) 316L stainless

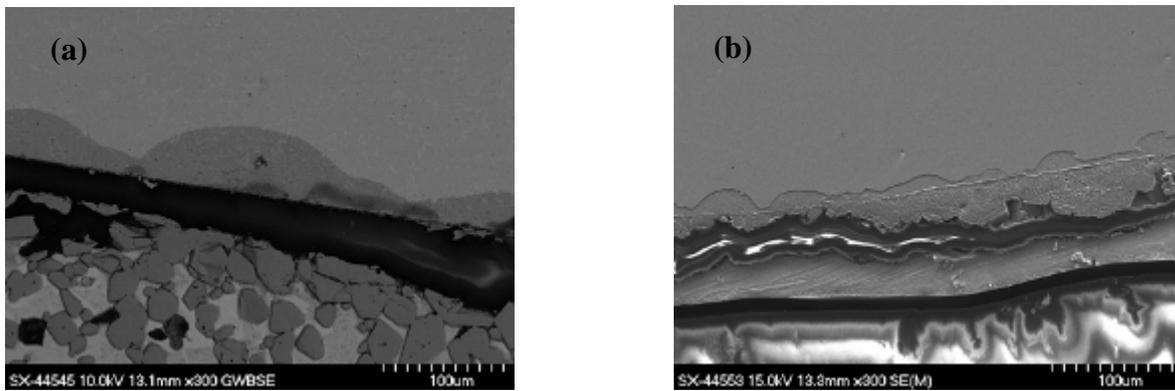
Figure 29: Static Molten Metal Corrosion and Dross Buildup Test at 870°F for 81 days in GI bath at Nucor Steel's Crawfordsville, Indiana plant (a) Alloy 2020 Weld Overlay (b) 316L stainless

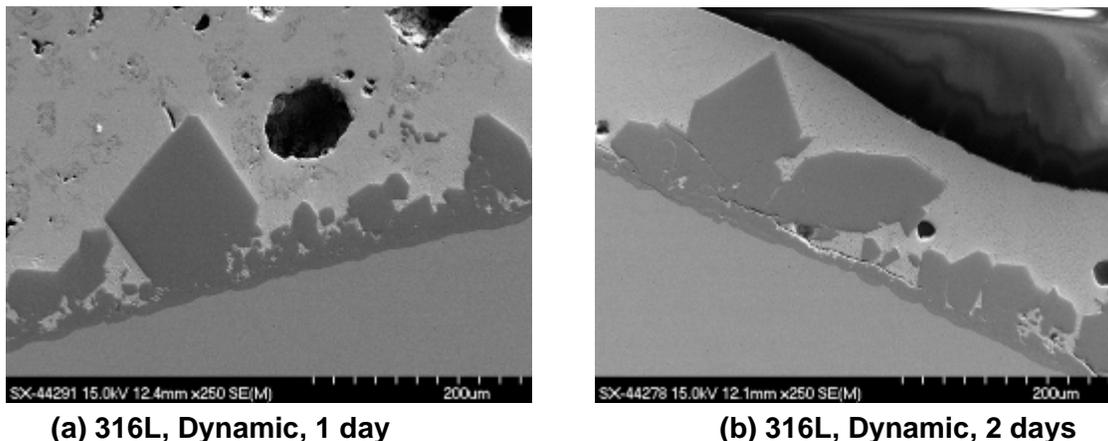
316L stainless steel: A series of dynamic corrosion/dross-buildup tests on current roll materials – 316L stainless steel in GI bath were carried out. The testing temperature was 460°C and the rotation speed was 60 rpm. The testing times were one day, two days, four days, and five days. The Zn, provided by Wheeling-Nisshin, was saturated with Fe, and had 0.22%wt aluminum content. After the tests were conducted, samples were analyzed by SEM/EDAX and microprobe.

Figure 30: 316L stainless steel bars after lab-scale dynamic test in Zn-0.22%Al bath

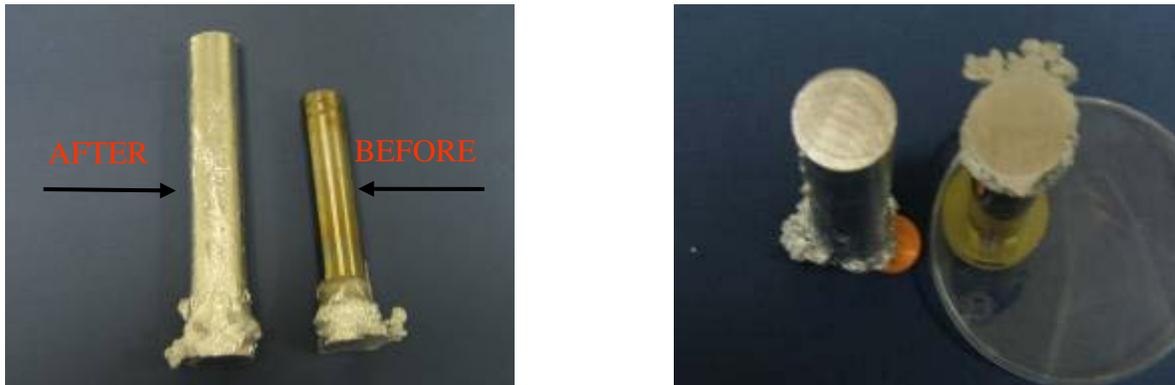
Figure 31: Alloy 2020 weld overlay attacked by GI bath after 30 days at 870°F

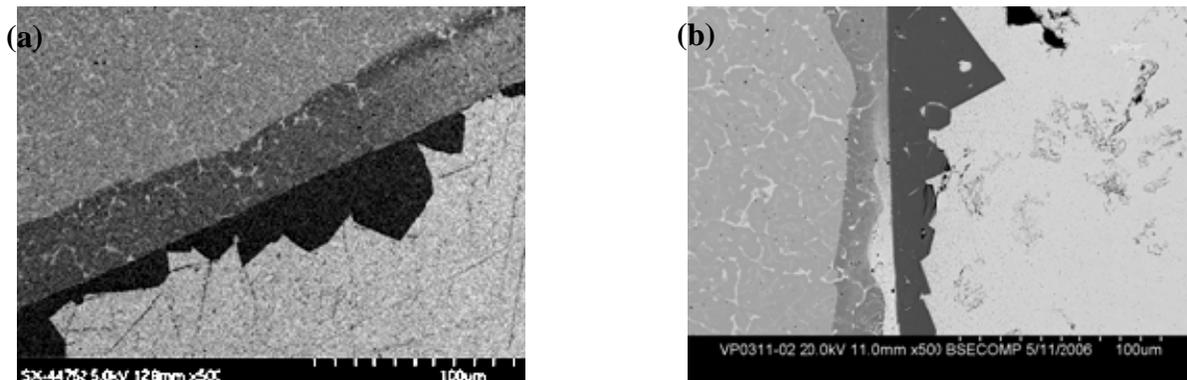
By comparing Alloy 2020 overlay dynamic tests for 15 days and 30 days, no obvious difference was found on the thickness of either dross buildup or reactive layer formation after extending dynamic testing duration from 15 days to 30 days, as shown in Figure 32.

Figure 32: Dynamic molten metal corrosion and dross buildup test on Alloy 2020 weld overlay in GI bath at 870°F (a) 15 days (b) 30 days

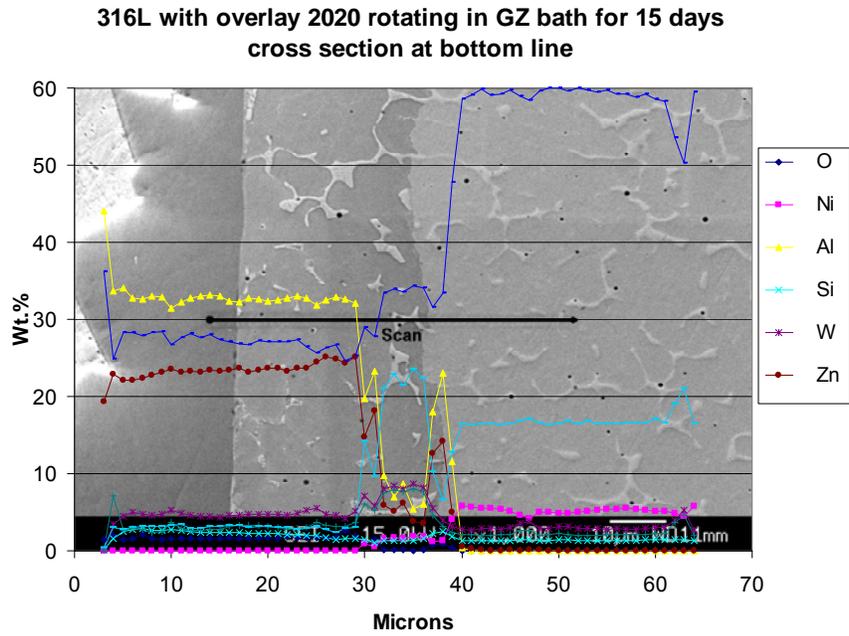
Figure 33: Cross section line scan of dynamic molten metal corrosion and dross buildup tests Alloy 2020 overlay in GI bath at 870°F after 15 days rotation (rotating rate 60 rpm)

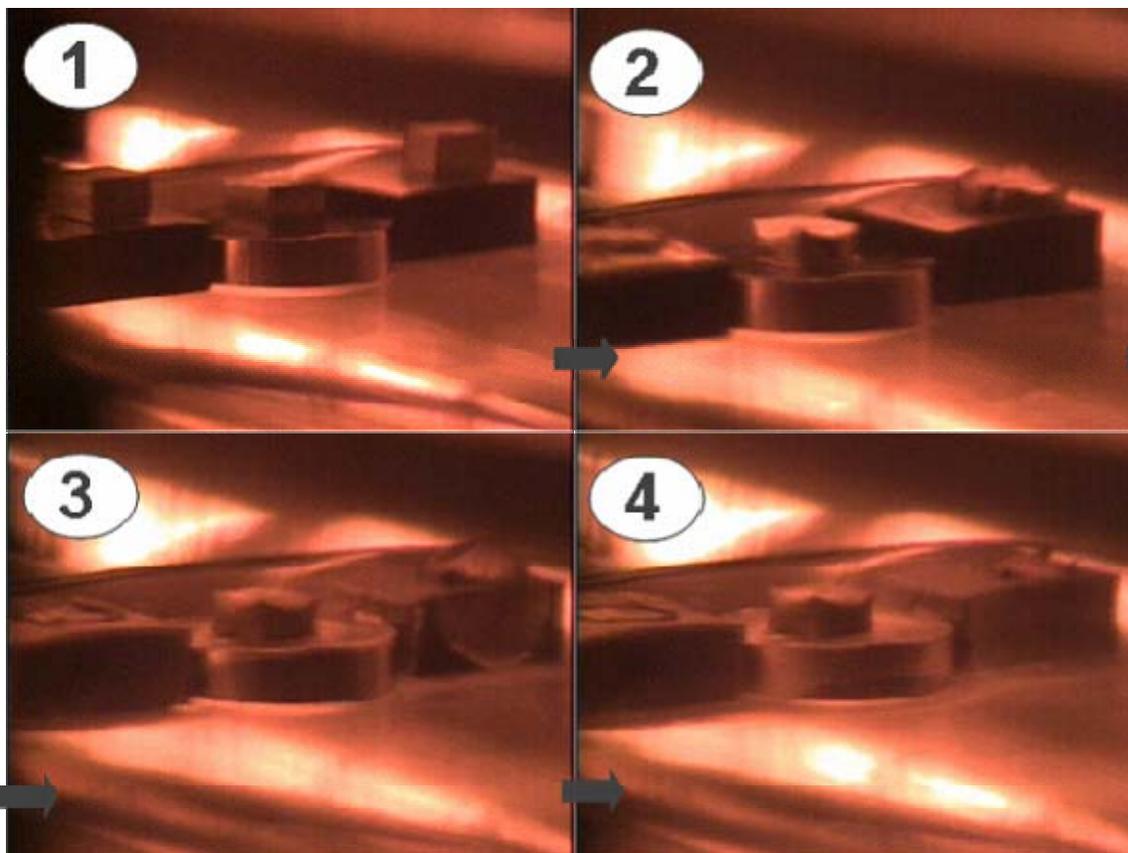
In this task, performed by WVU personnel at ORNL, sessile drop tests for newly developed Alloy 2020 coating were performed and compared to 316L stainless steel and cast-Alloy 2020. Primary results are presented in Figure 36 [25].

Figure 36: Static sessile drop wetting test results

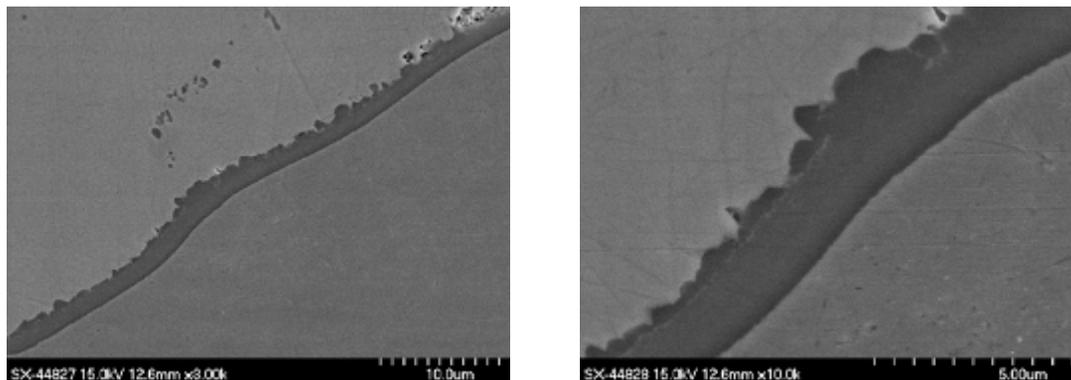
A number of 316L stainless steel coated samples were tested in California Steel Industries'(CSI) GI bath for various times, and the samples were analyzed by means of optical microscopy, SEM/EDAX and microprobe.

(a) 316L, 1-day in CSI, low magnification; (b) 316L, 1-day in CSI, high magnification

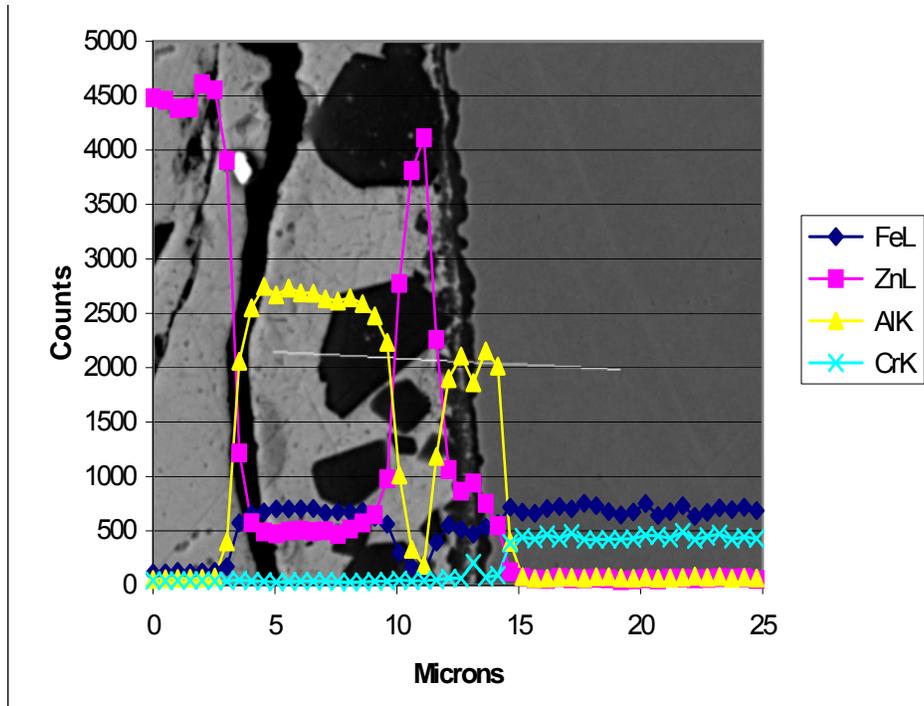
Figure 38 shows the distribution of Fe, Zn, Al, and Cr in the vicinity of the reaction layer. It is indicated in the figure that there are at least three sub-layers in the reaction layer: the "internal corrosion" sub-layer next to the steel substrate, the continuous sub-layer formed by tiny-dross particles, and the frozen bath sub-layer between these two sub-layers. The figure shows that the Al content in the reaction area was lower than that of the big dross particles.

Figure 38: Line-scan of the 316L sample after 1-day test in CSI bath

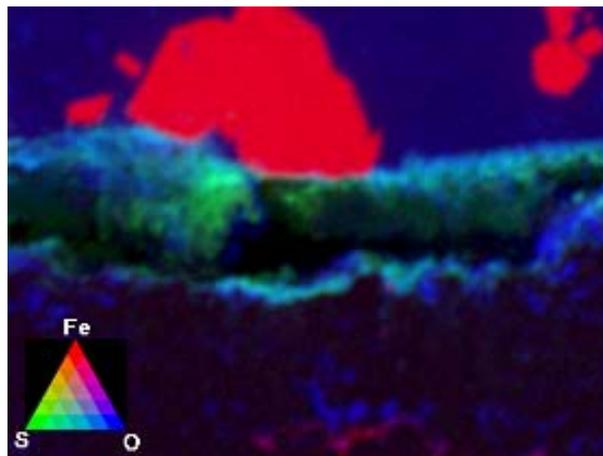
Figure 39: Microprobe Fe-S-O mapping of the WC-Co coating after 3-day dipping test in California Steel Industries

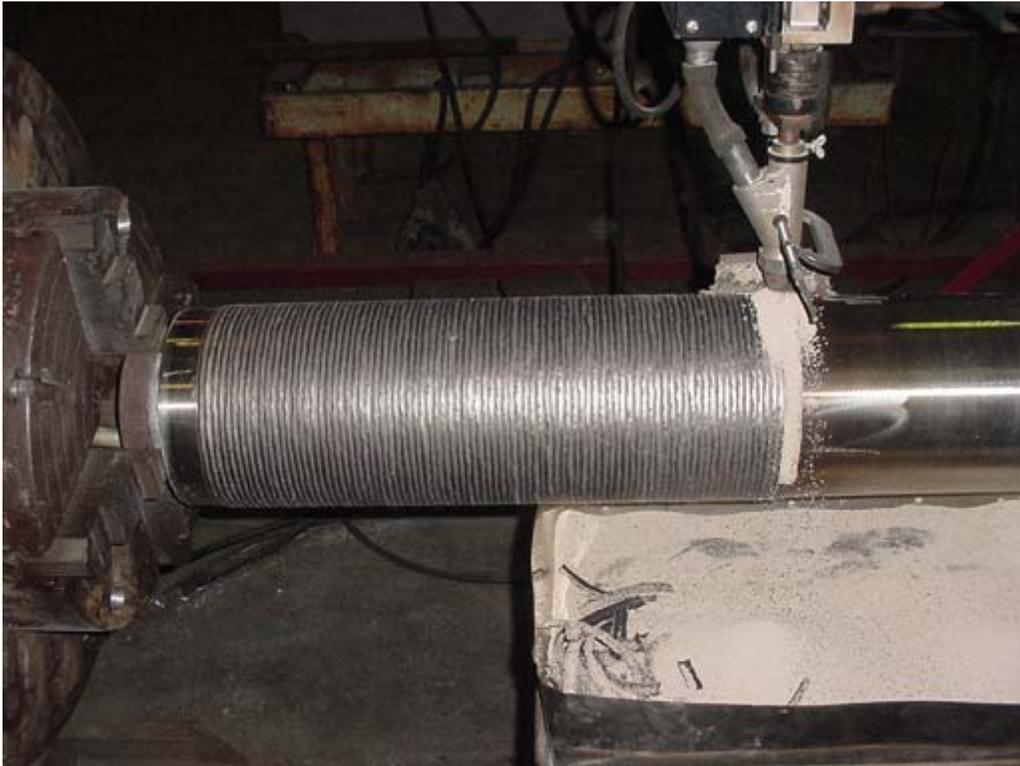
Figure 43: Nearly half of weld overlay of 2020 completed on 316L casting for stabilized roll application at Nucor in Indiana

The stabilizer rolls for in-plant tests were donated by Nucor Steel Co. and the coatings were deposited and post-coating processes were conducted by ORNL and WVU, in collaboration with industrial partners (Metallics, Duraloy, Specialty Welding, and Stoodly Company). For the test at Nucor Steel – Crawfordsville, an 8-in.-OD roll of type 316L was weld overlaid with 2020 wire. Figures 43-45 show the progressive steps of the weld overlaying and Figure 44 shows the completed roll. The welding was carried out at Specialty Welding & Machining, Inc. The welded roll was shipped to Duraloy Technologies, Inc. for putting the ends on and machining the weld overlaid surface to achieve the desired surface finish. Figure 45 shows the partially machined roll. During machining, it was realized that there may be areas of the roll that would not clean up without needing some weld repair.

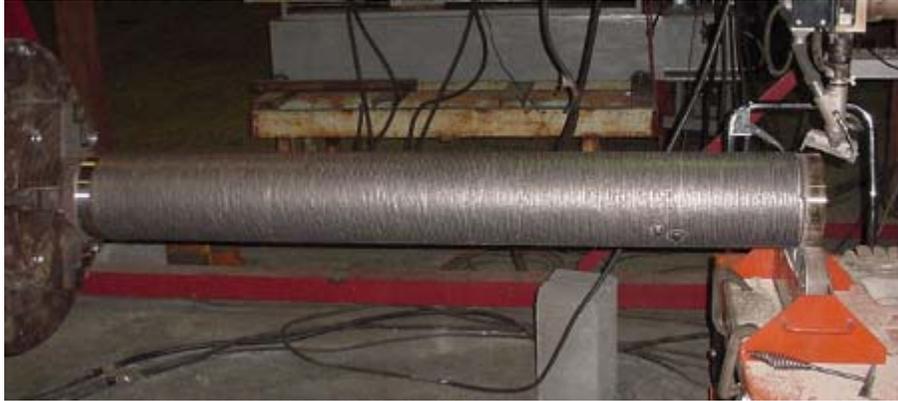
Figure 44: Completed stabilizer roll with 2020 weld overlaid on 316L casting

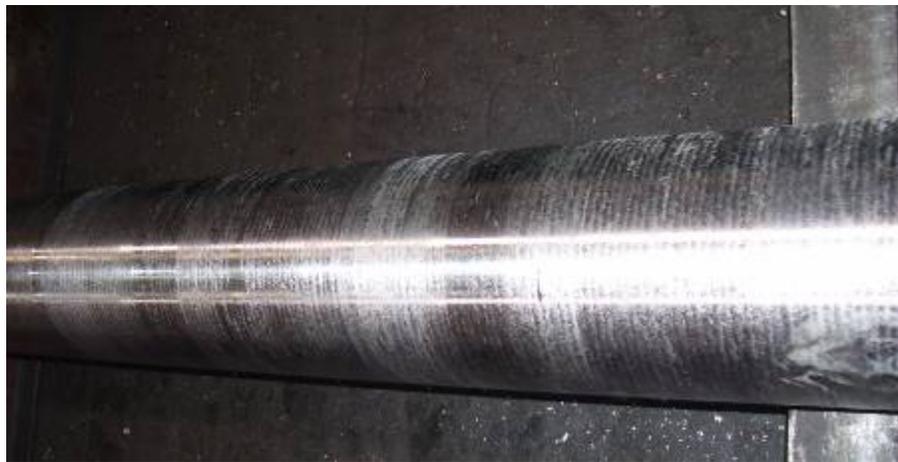
Figure 45: Partially machined roll surface of 316L/2020 weld overlay

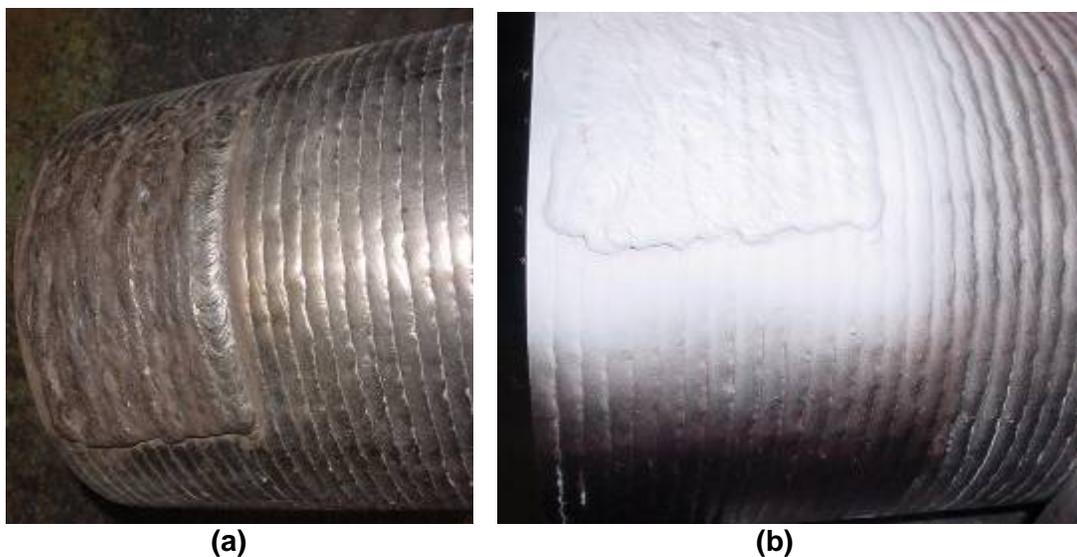
The second layer of 2020 deposited with newly designed electrodes is shown in Figure 46. This figure shows the as-deposited second layer and the same layer after dye check. The dye check showed no defects in the second layer produced from the electrodes. This is a very significant accomplishment in light of always needing some weld repair while welding a large surface.

Figure 46: Second layer of 2020 deposited with the newly developed electrode: (a) as-welded and (b) after dye check. No cracks were noted.

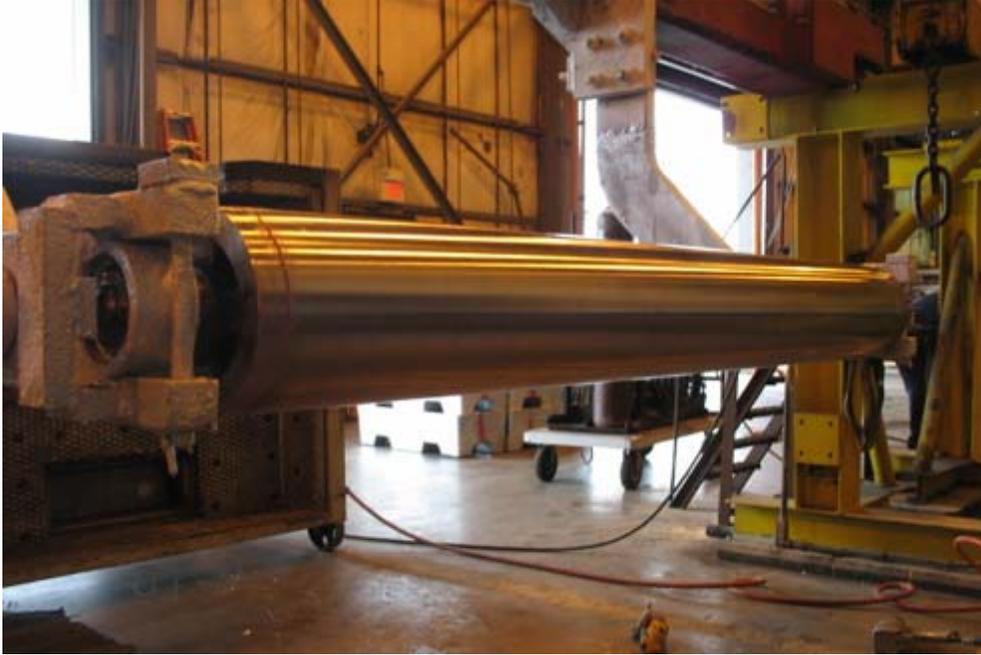
Figure 47: The 316L/2020 roll in maintenance stand prior to installation for in-line trial at Nucor's Crawfordsville, IN Plant

The roll, prior to going for in-line trial, is shown in Figure 47. Details of this roll's in-line trial are given below.

- 316L/2020 Weld Overlay
 - Installed on May 6, 2007
 - Removed on May 14, 2007, due to operation problem discussed below
 - Total number of days in-line: 7
 - Total feet of sheet production run on the new roll: 2,615,029
- Comparable 316L Removed from Service after Sheet Production Run of 5,773,911 ft

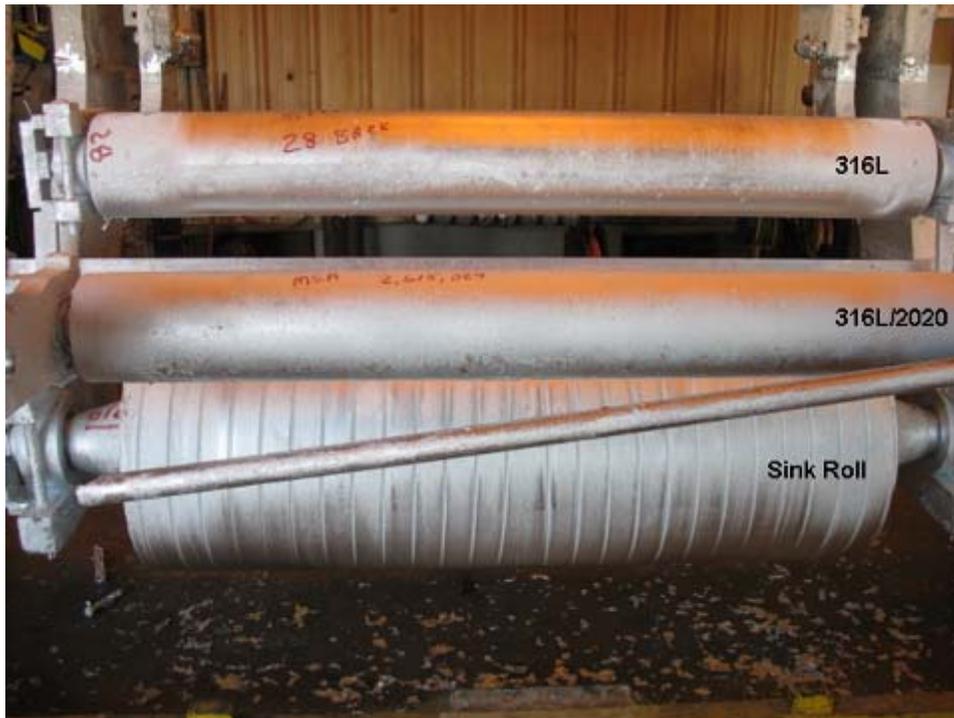
Figure 48: Rolls removed from service at Nucor's Crawfordsville, IN Plant: 316L/2020 (Alloy 2020) roll had a one-week in-line service with 2,615,029 ft of material processed

Rolls removed from the in-line trial are shown in Figure 48. This figure shows the sink roll and stabilizer rolls of 316L and 316L/2020 weld overlay. Close-up of stabilizer rolls of 316L and 316L/2020 removed from in-line trial are shown in Figure 49.

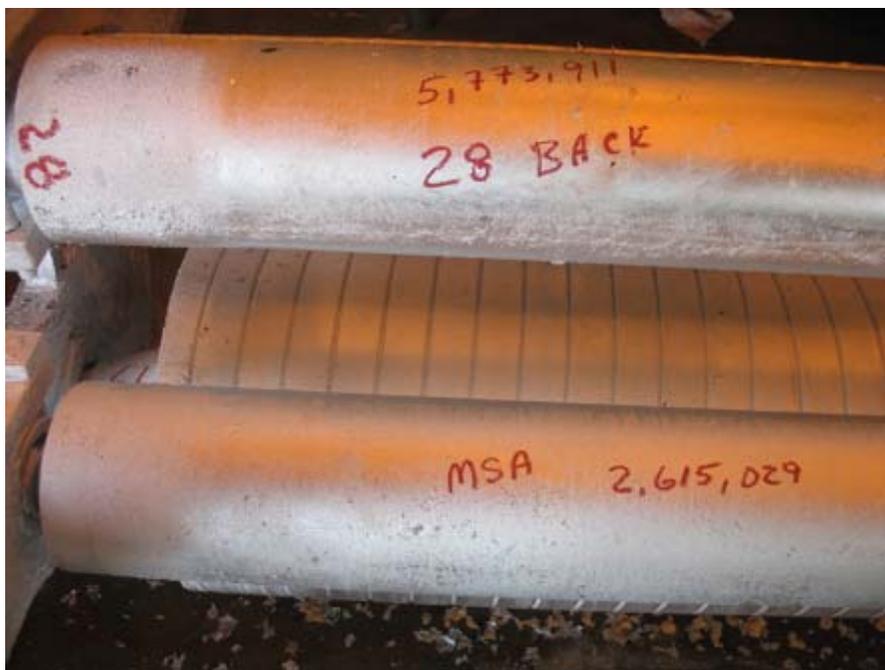
Figure 49: Close-up of 316L (28) and 316L/2020 (Alloy 2020) rolls: Alloy 2020 roll has approximately half the in-line time as compared to the 316L roll

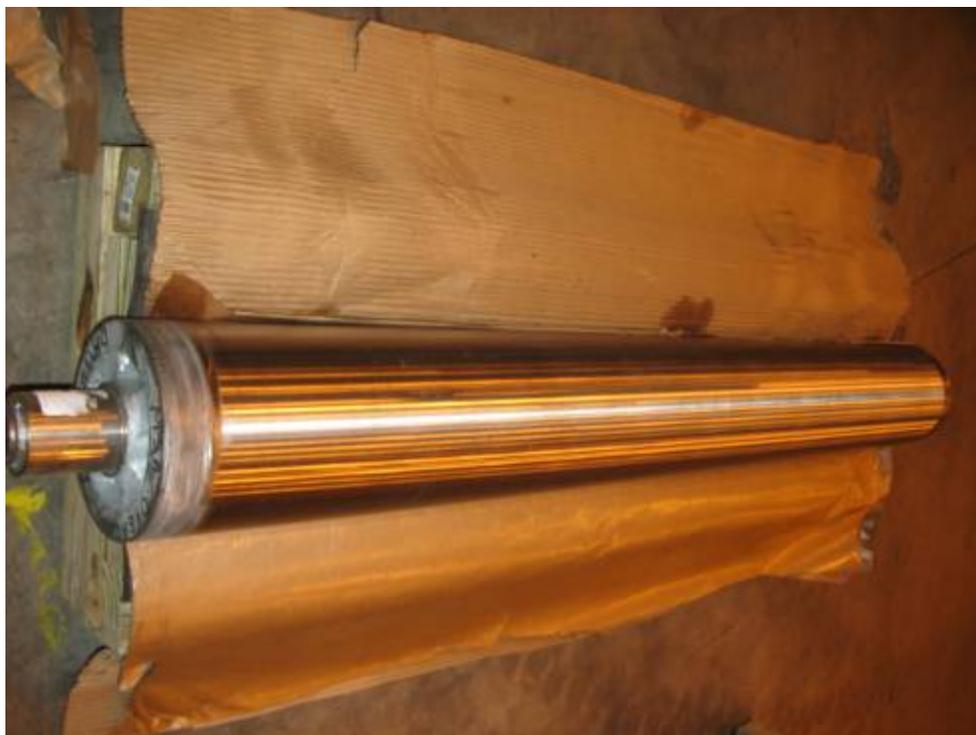
Figure 50: Machined roll surface after first cycle of in-line trial at Nucor's Crawfordsville, Indiana plant

After the first trial cycle, a roll was finally machined by surface grinding. The machined roll surface was 7.975 in. and a surface finish of Ra60. With a starting roll diameter of 8.0 in., only 0.0125 in. of the weld overlay was removed at this stage. The as-machined roll after the first cycle is shown in Figure 50.
