FINAL TECHNICAL REPORT

Project title: Multifunctional Metallic and Refractory Materials for Energy Efficient Handling of Molten Metals

Award No: DE-FC36-04GO14038

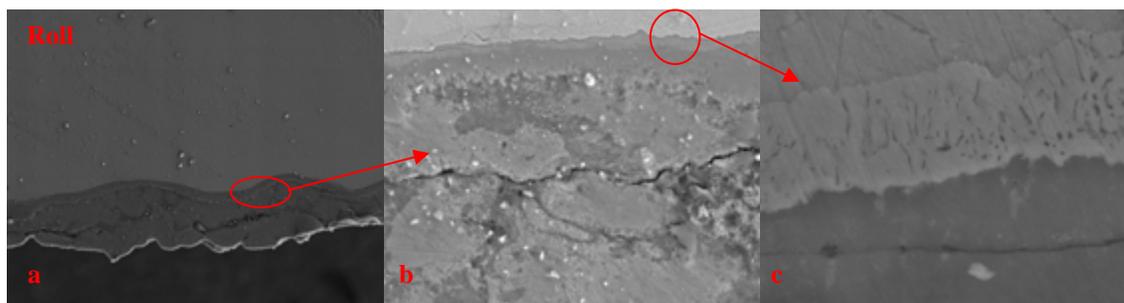
Figure 51: Micrographs of the roll-bath interface (surface of the roll) (a) 250X magnification, (b) 1000X magnification, (c) 8000X magnification

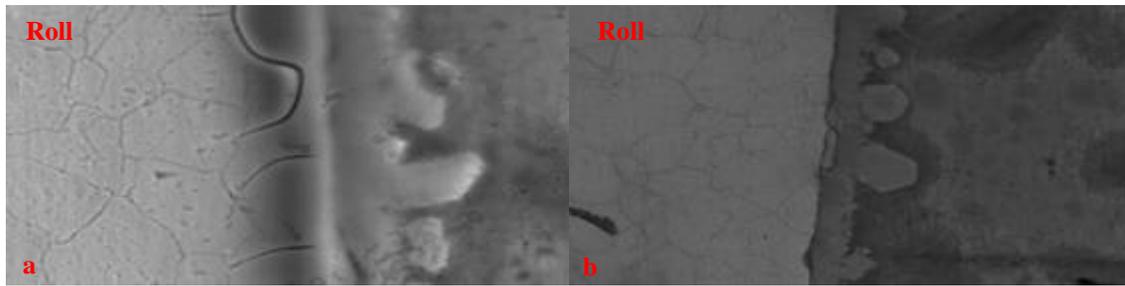
Figure 53: Sample roll-bath interface after 40 minutes (a) Microcracks on the roll-bath interface (2000X magnification), (b) Small dross particles (~12 μ m) (1000X magnification)

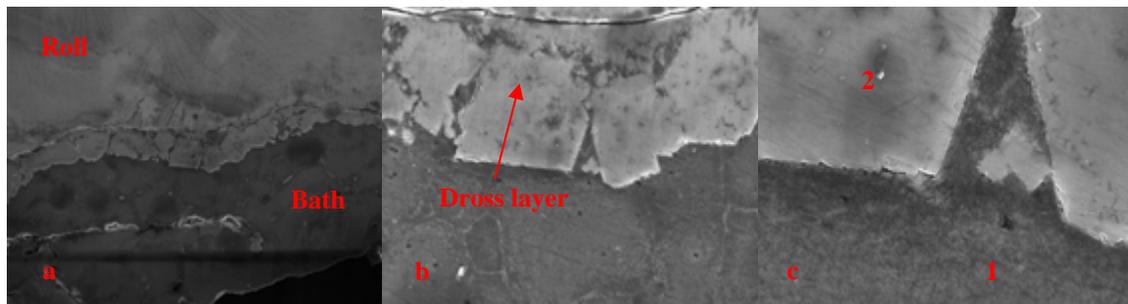
Figure 54: Sample-Bath interface after 60 minutes (a) structure of the dross layer formed at the interface (250 X), (b) 1000X magnification, (c) agglomeration of small dross particles on the continuous layer (4000X)

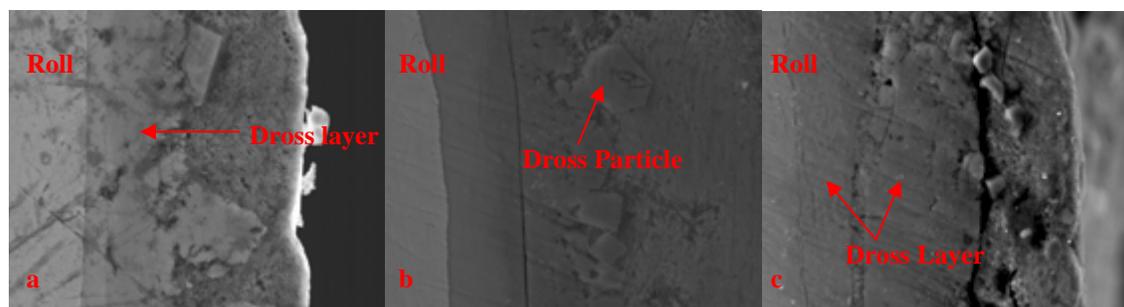
Figure 57: Sample Roll-Bath interface after (a) 100 minutes (1500X), (b) 120 minutes (1500X), (c) 140 minutes (1500X)

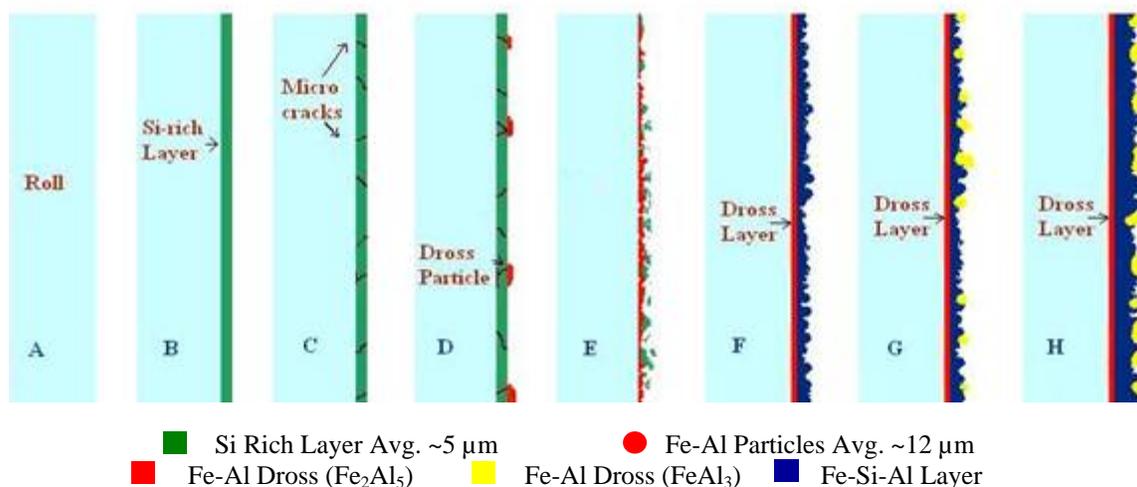
Figure 58: Schematic representation of dross formation on roll surface in galvalume bath

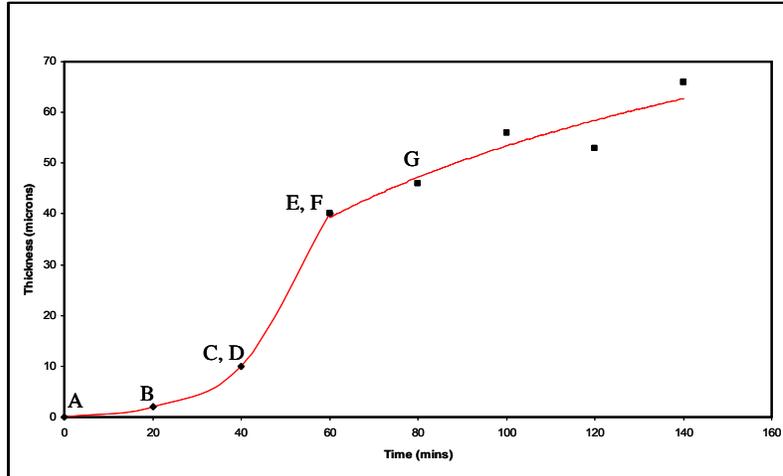
Figure 59: Dross layer growth pattern

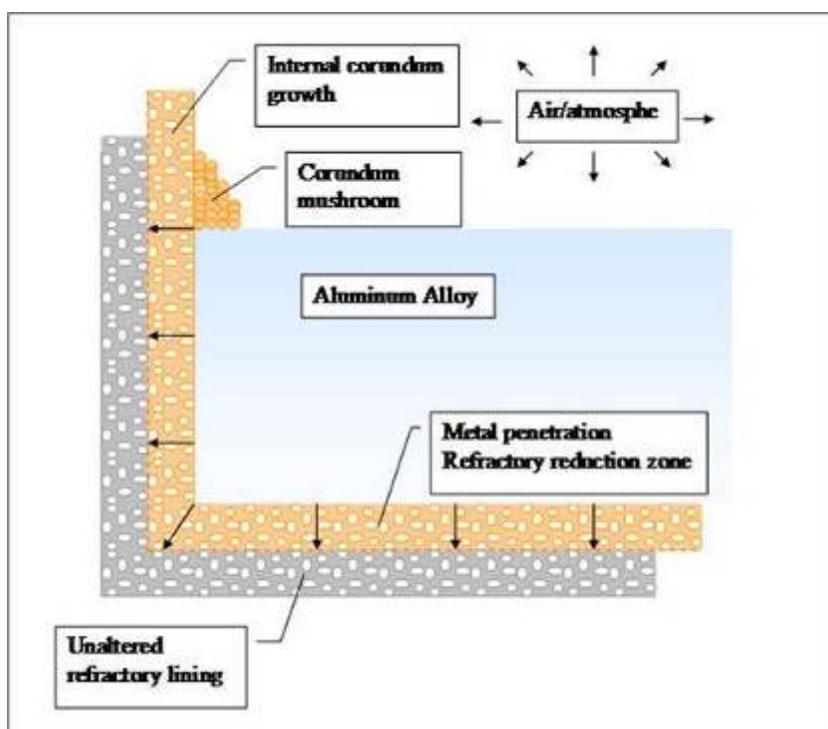
Figure 63: Degradation Mechanisms Identified in the Refractory (both above and below the melt line)

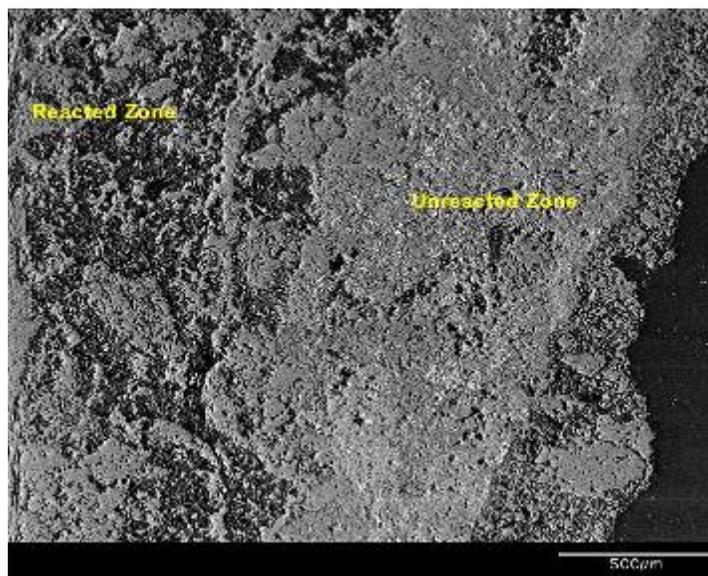
Figure 64: SEM image of penetration interface in sample SC-B

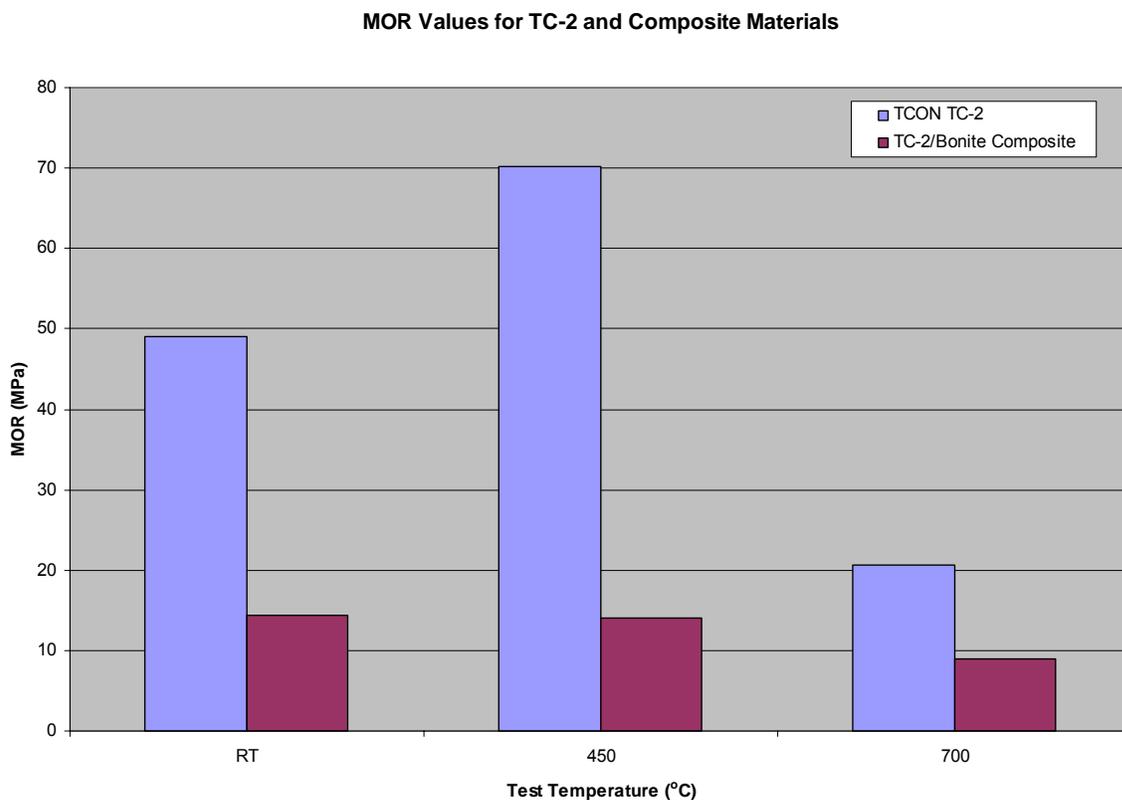
Figure 68: Results of MOR Testing Performed at Room Temperature

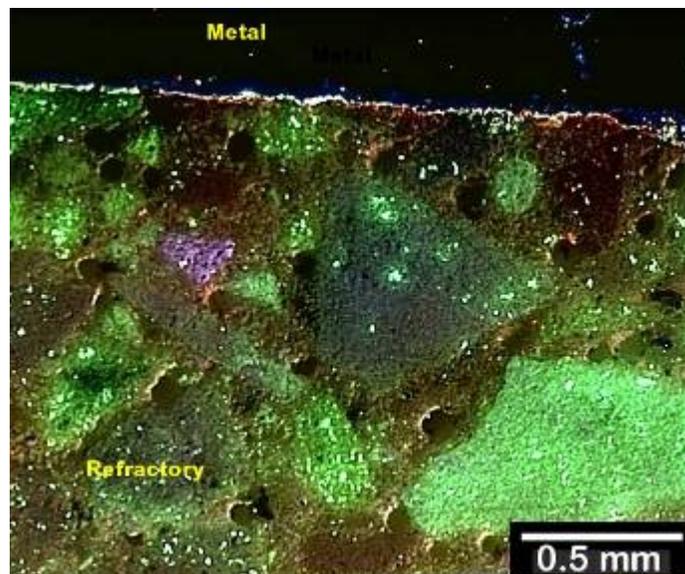
Figure 70: CLM Image of Penetration Interface after Static Cup Testing

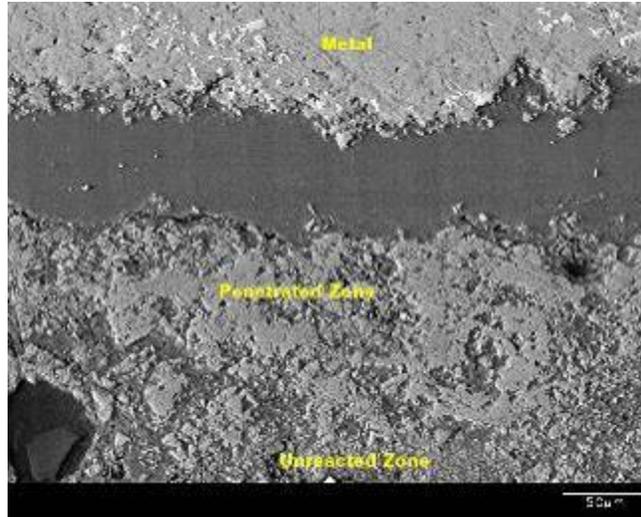
Figure 71: SEM Image of Penetrated Zone after Static Cup Testing

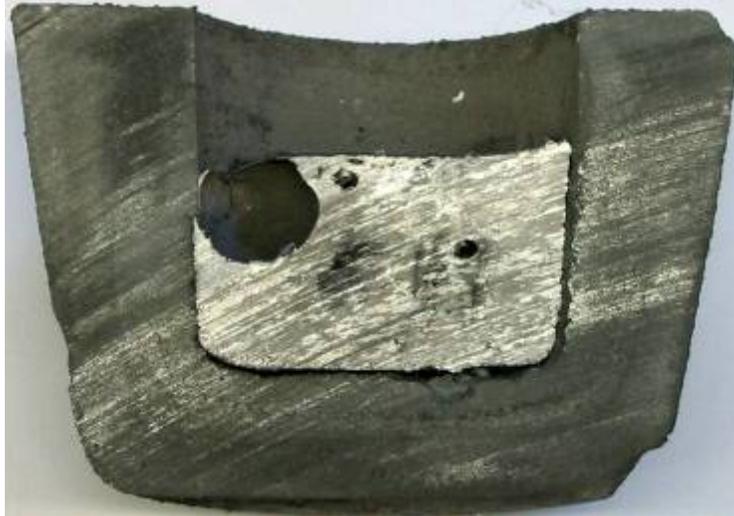
Figure 73: Material EH after static cup testing

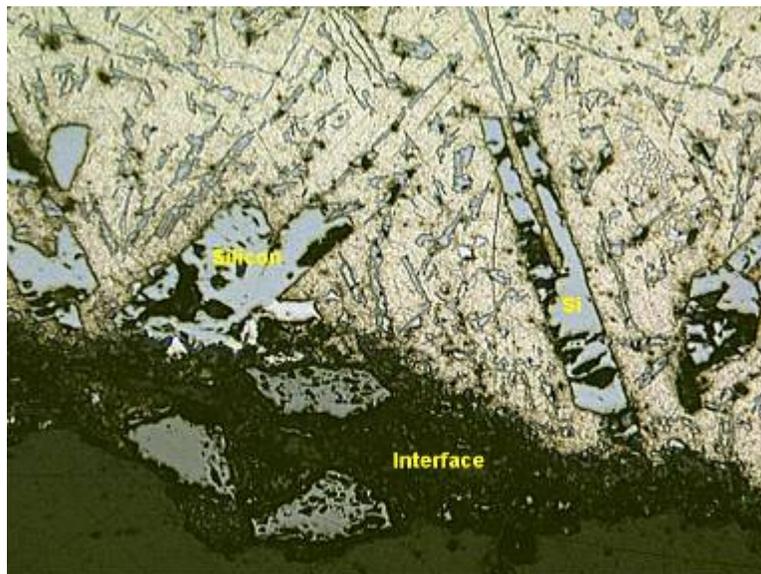
Figure 74: Eutectic Silicon Dendrites in Molten Alloy after Testing

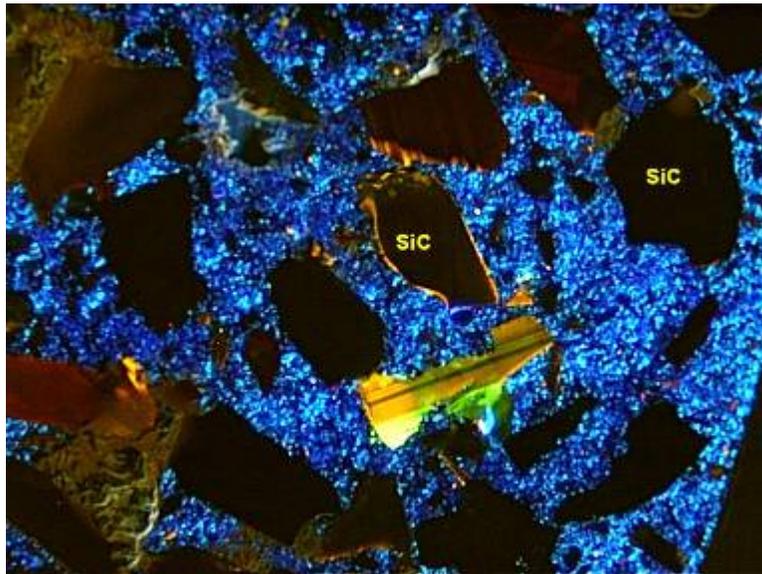
Figure 75: CLM Image of Virgin Material EH

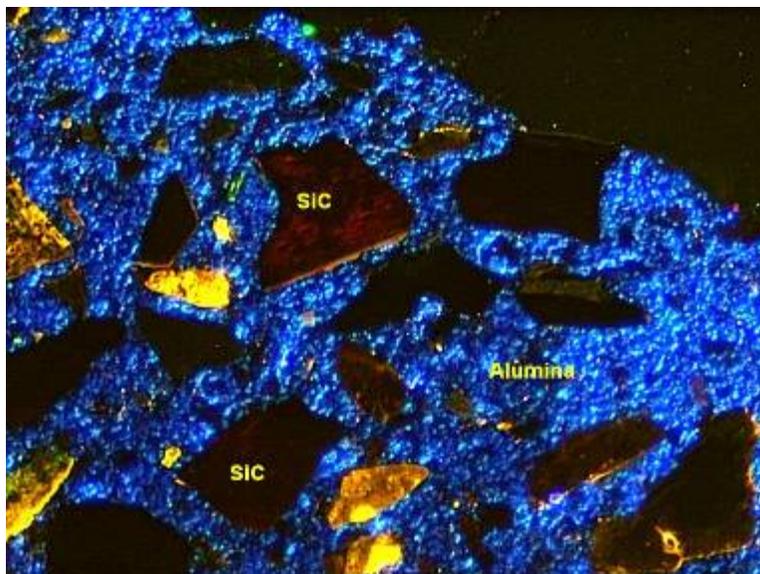
Figure 76: CLM Image Of Contact Area of Material EH After Testing

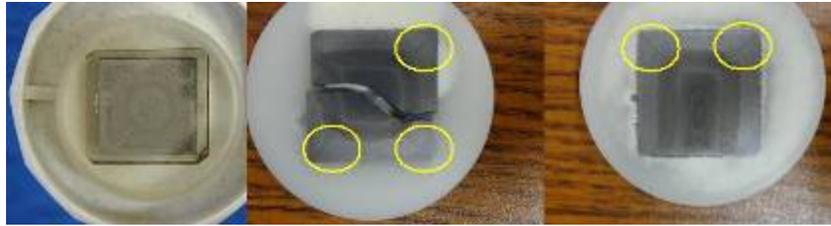
Figure 77: Cross-sectional mounts of TCON[®] materials subjected to corrosion testing in molten aluminum showing sharp edges of samples maintained, significant non-wetting behavior, and cracking indicating thermal shock

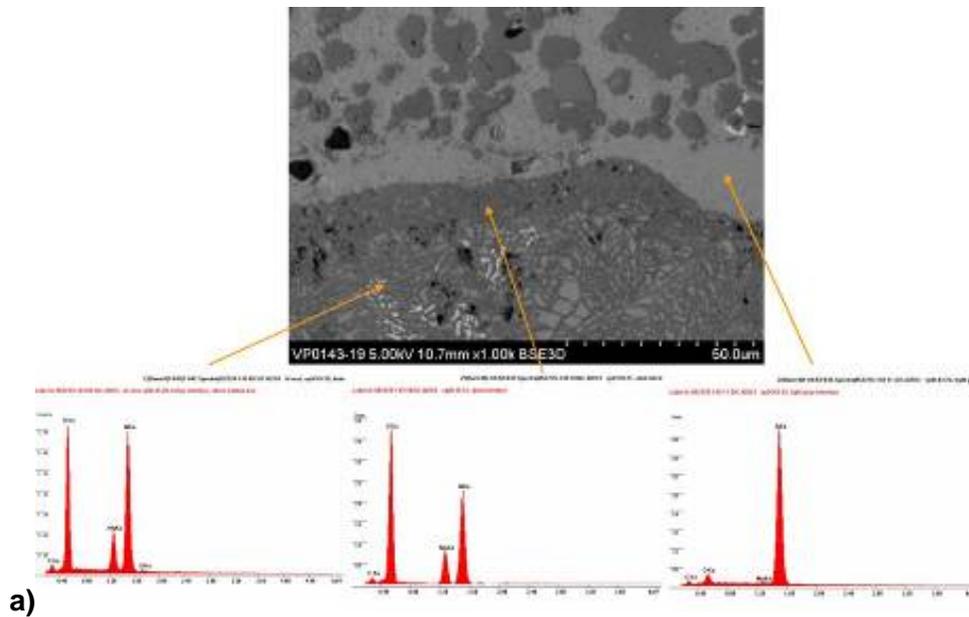
Figure 78a: Microstructural and X-ray analysis results for early TCON[®] version (MC) sample after 100 hour exposure in molten aluminum for edge region

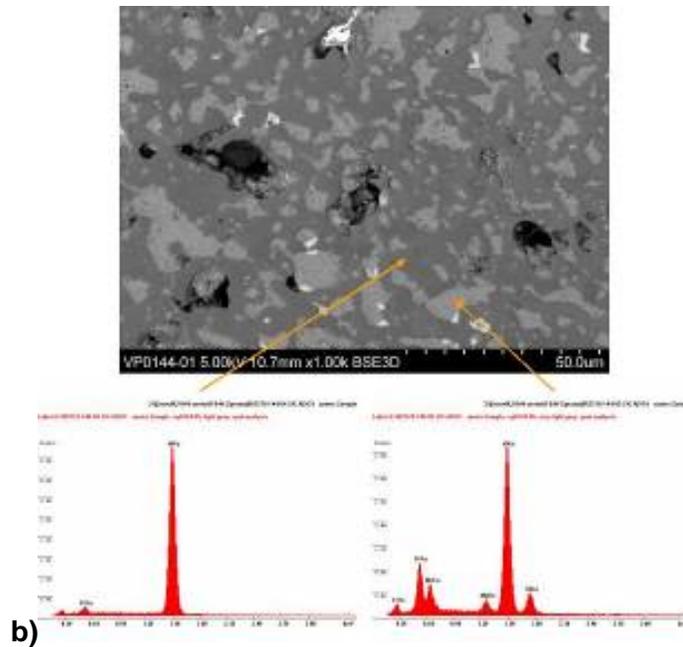
Figure 78b: Microstructural and X-ray analysis results for early TCON[®] version (MC) sample after 100 hour exposure in molten aluminum for edge region (a) and center region (b)

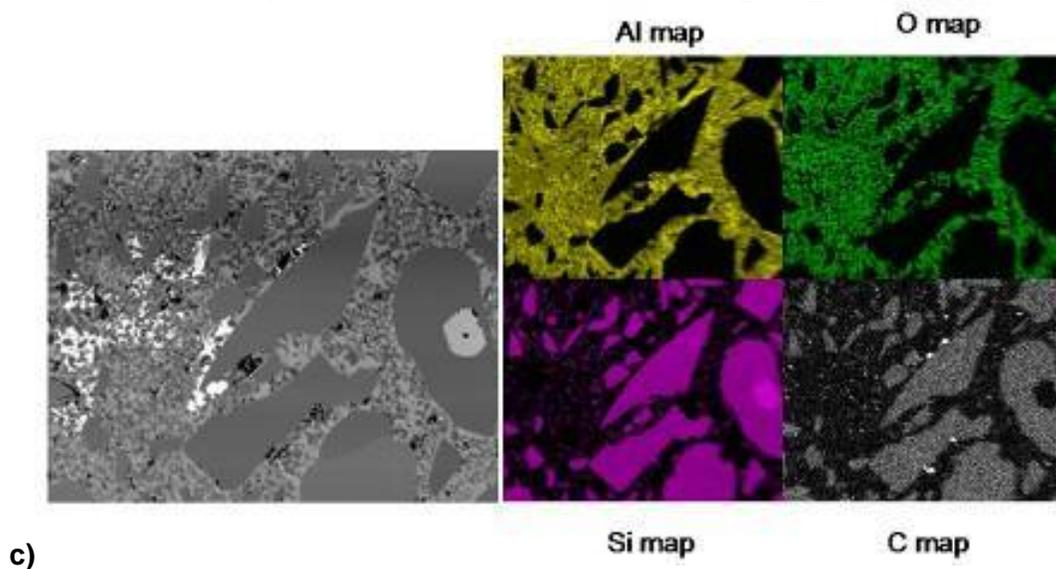
Figure 78c: Microstructural and chemical analysis results for later TCON[®] version (TC) sample after 100 hour exposure

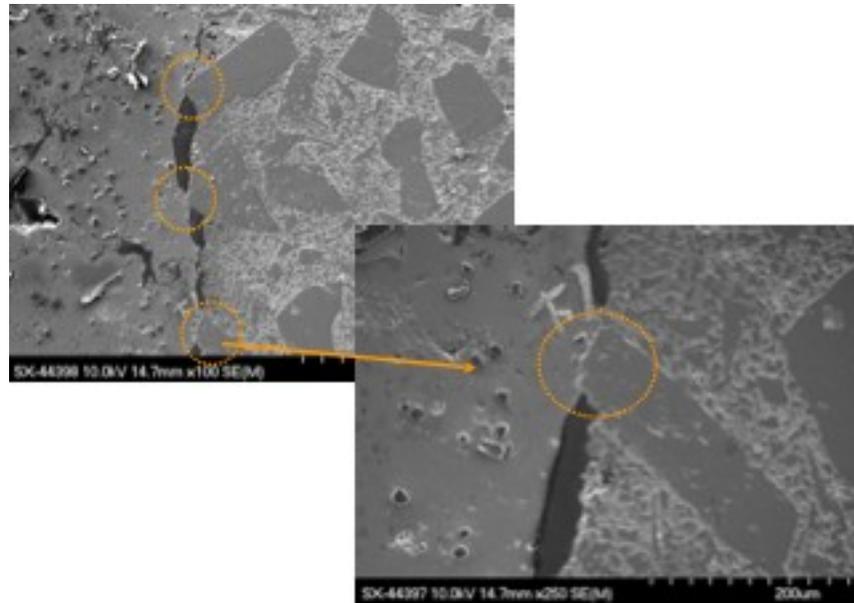
Figure 79: Wetting of SiC particles in TCON[®] refractory material by 5083 aluminum (circled regions) - Gaps seen between alumina refractory matrix and 5083 aluminum

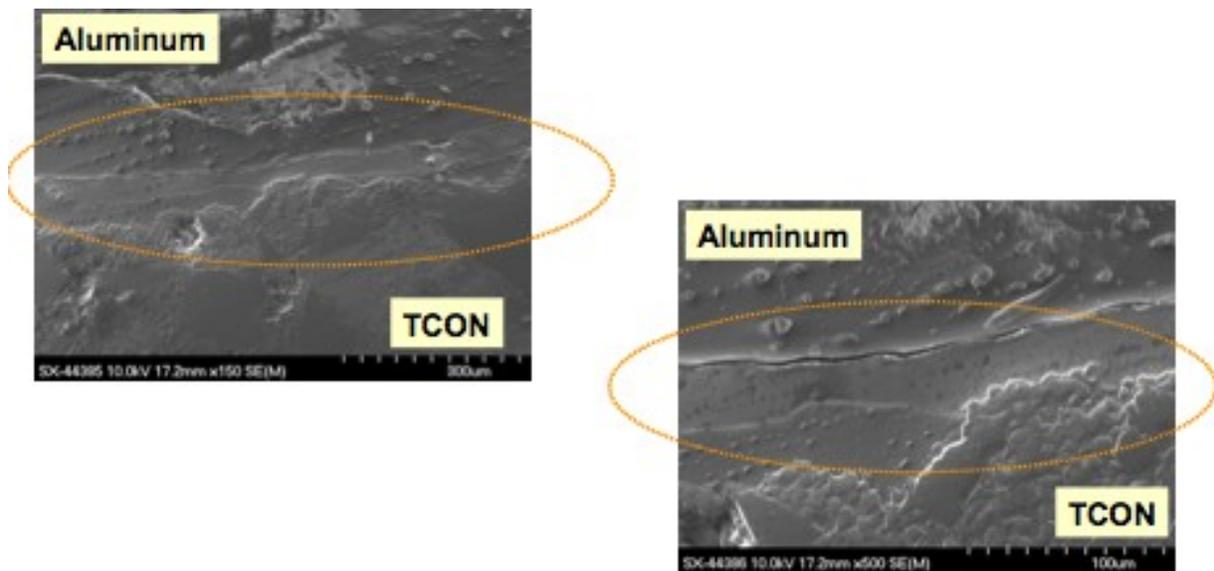
Figure 80: Presence of reaction layer between TCON[®] refractory material and 5083 aluminum

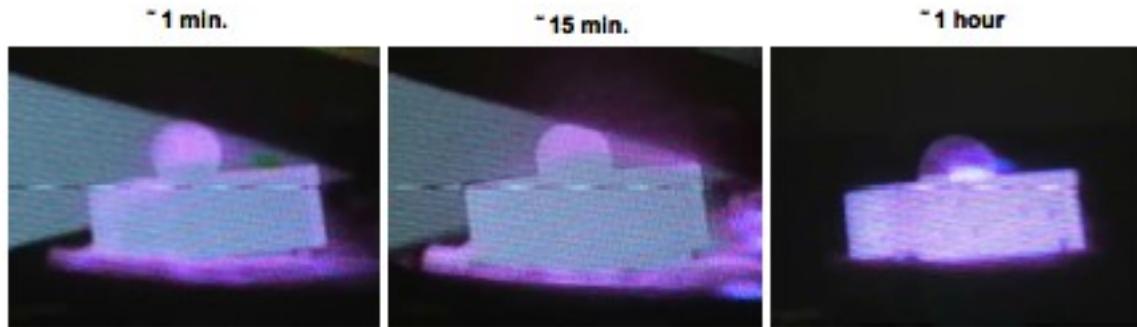
Figure 81: Static sessile drop testing of TCON[®] TC refractory with 50835 aluminum

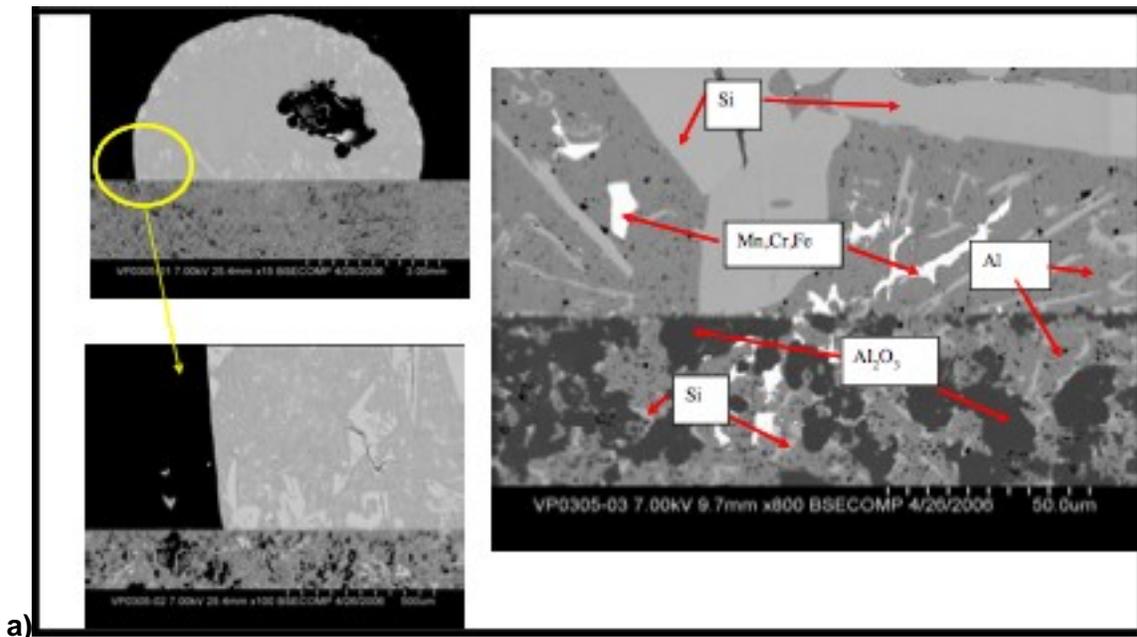
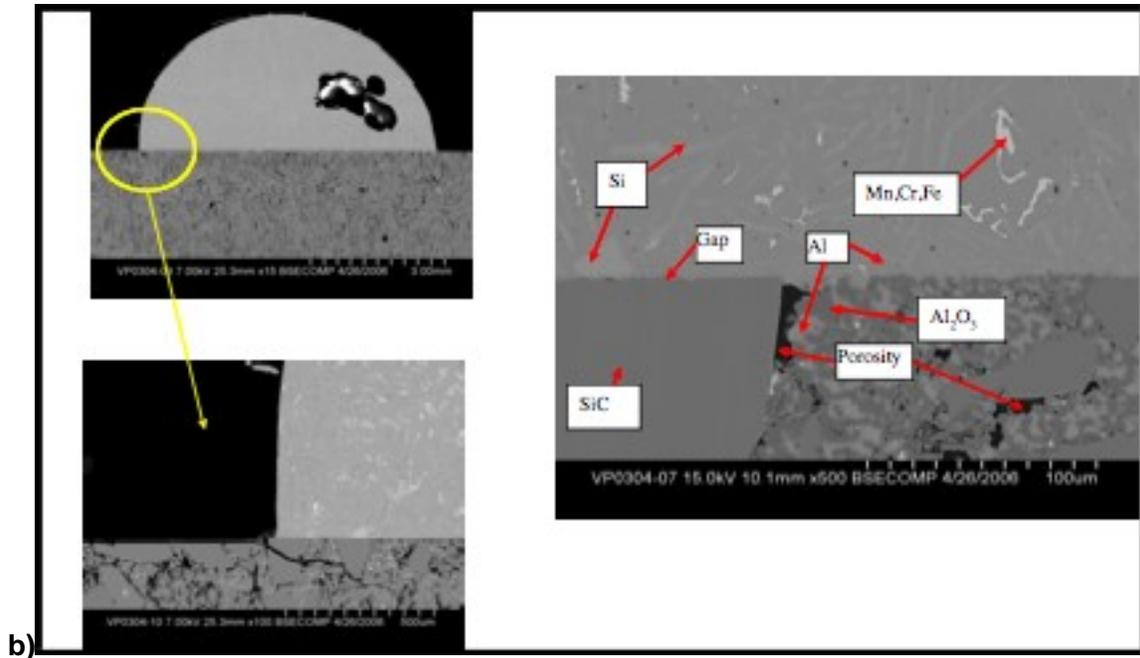
Figure 82: Micrographs of TCON[®] TC refractory static sessile drop specimens with aluminum alloy

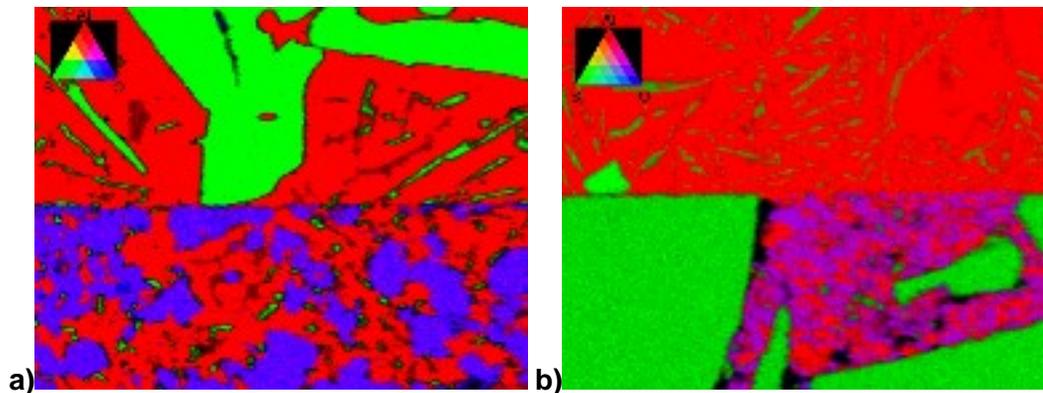
Figure 83: Microprobe images of TCON[®] TC refractory static sessile drop specimens with aluminum alloy

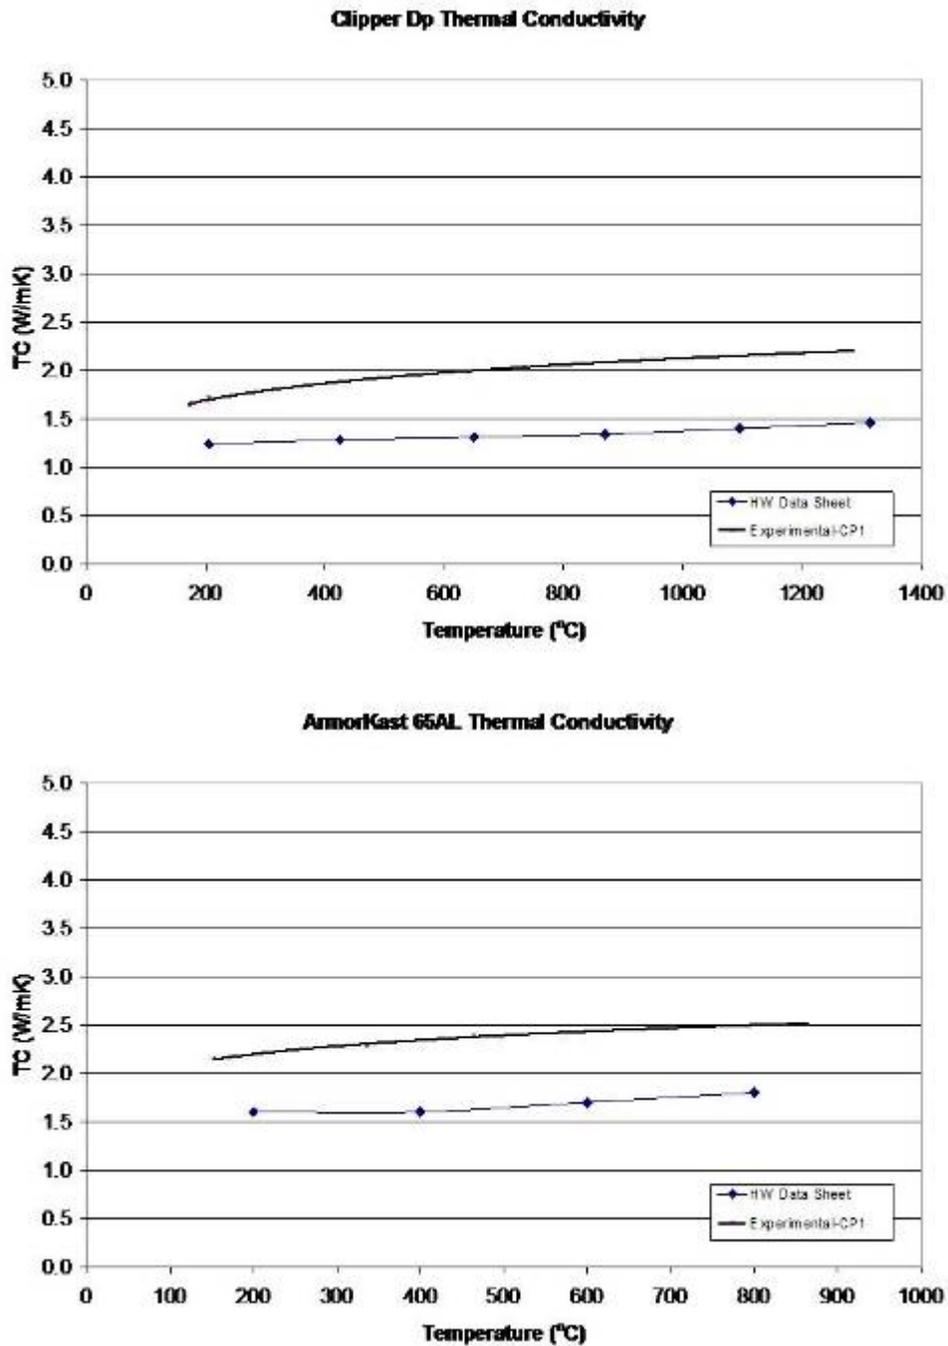
Figure 86: Experimental and Published Thermal Conductivity Values for Clipper DP and ArmorKast 65AL Refractory Materials

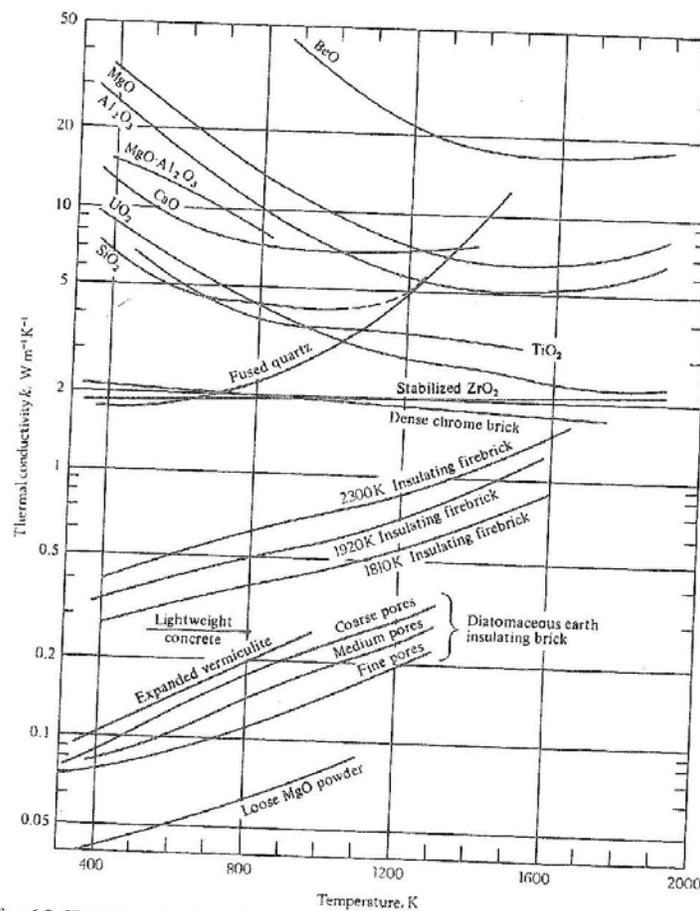
Fig. 6.3 Thermal conductivity of oxides and various insulating materials. (From A. Schack, *Industrial Heat Transfer*, Wiley, New York, NY, 1965, page 189.)

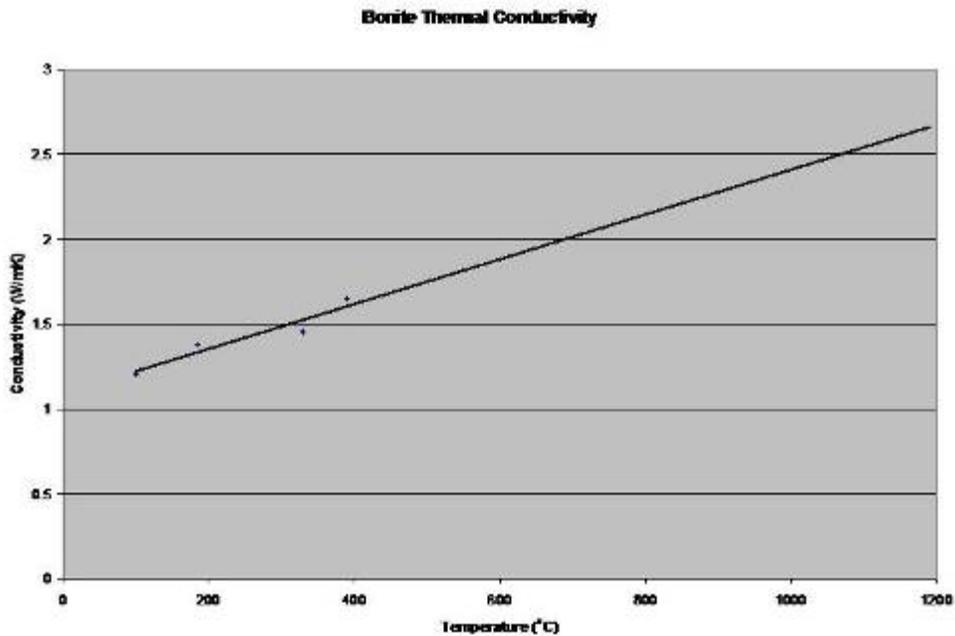
Figure 90: Results of Bonite Thermal Conductivity Testing with Projected Trend in Data

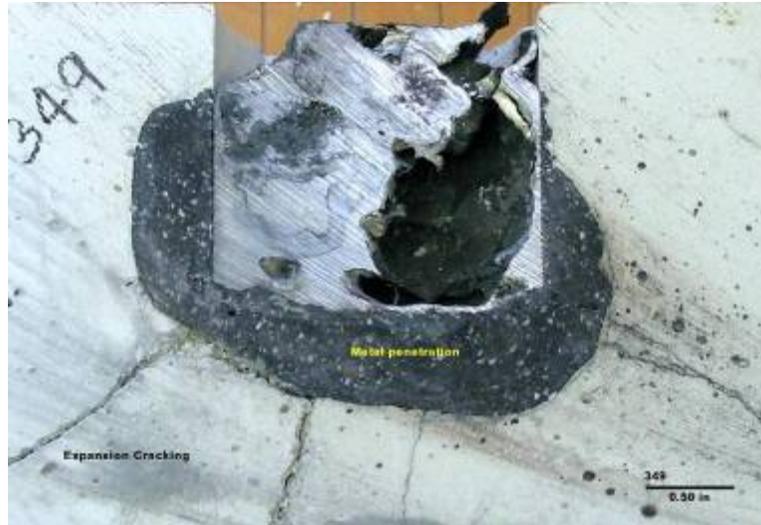
Figure 91: Expansion cracking in aluminosilicate castable after aluminum penetration

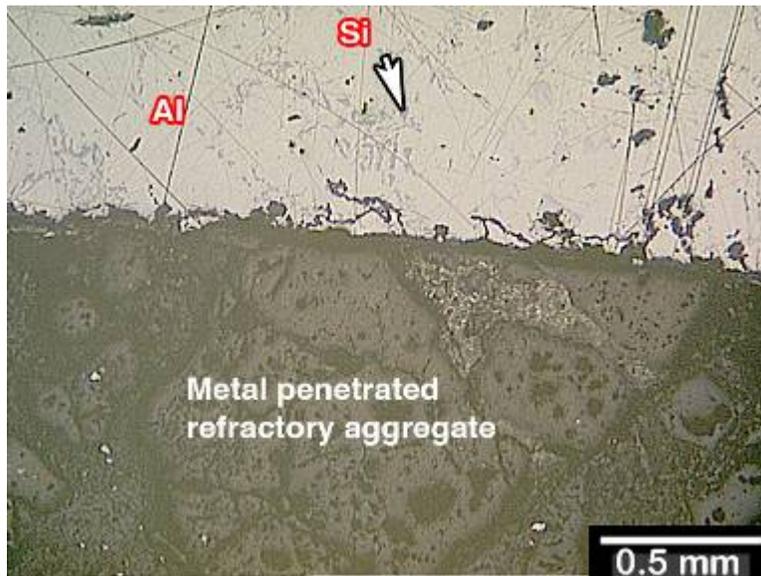
Figure 92: “Silicon Pickup” in aluminum after testing with aluminosilicate refractory

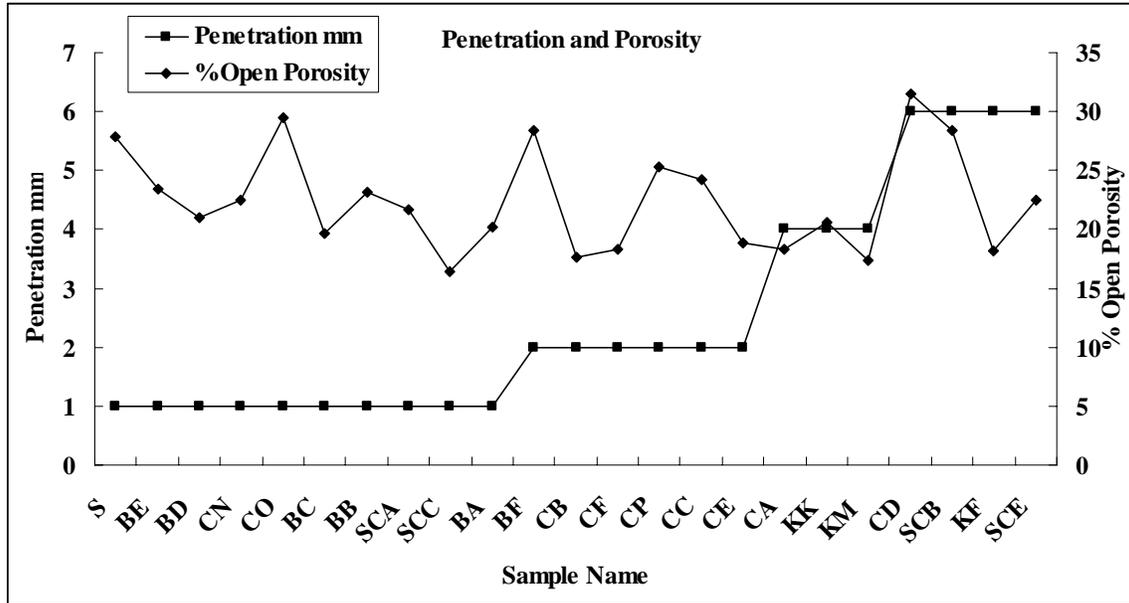
Figure 93: Graphical comparison of Penetration with Porosity

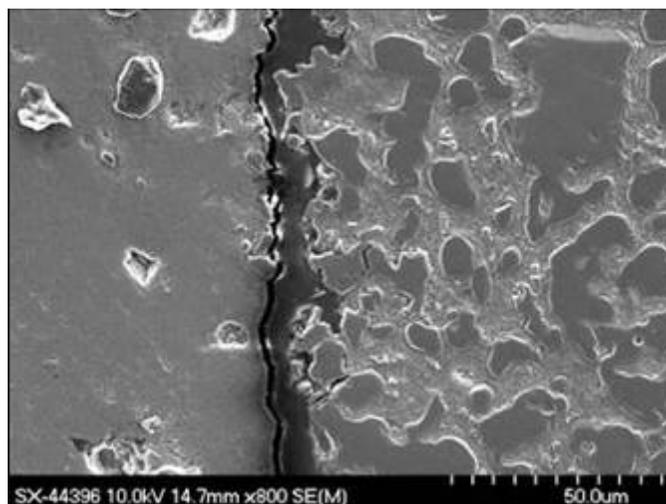
Figure 98: SEM Micrograph of TCON[®] Refractory after 2,000 hours of use showing no wetting or penetration
(note aluminum alloy on left of micrograph and TCON[®] on right)

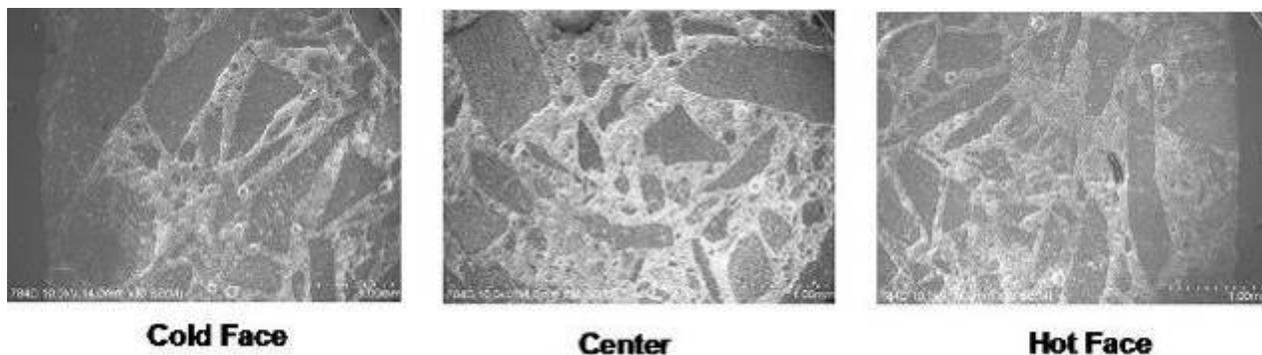
Figure 99: SEM Micrographs of the Castable Bonite Refractory after 2,000 hours of use

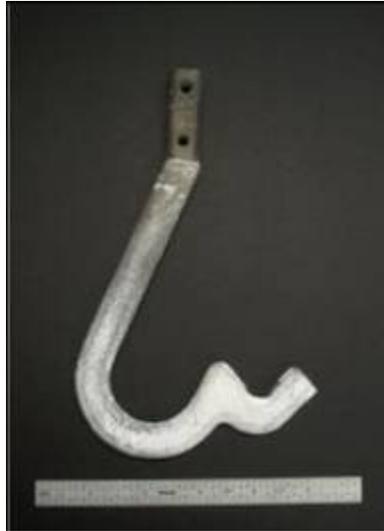
Figure 100: Examples of the TCON® Hooks

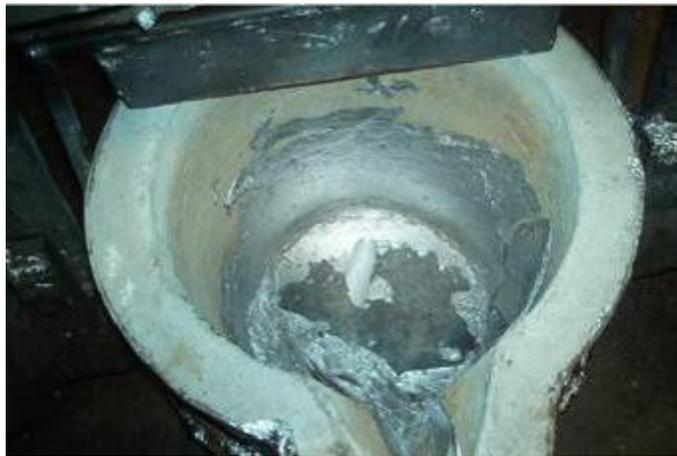
Figure 101: Reduce Erosion of the Refractory in the Ladle Bottom using TCON®
