Final Report

Natural Gas Vehicle Cylinder Safety, Training and Inspection Project

Cooperative Agreement: DE-FC26-05NT42608

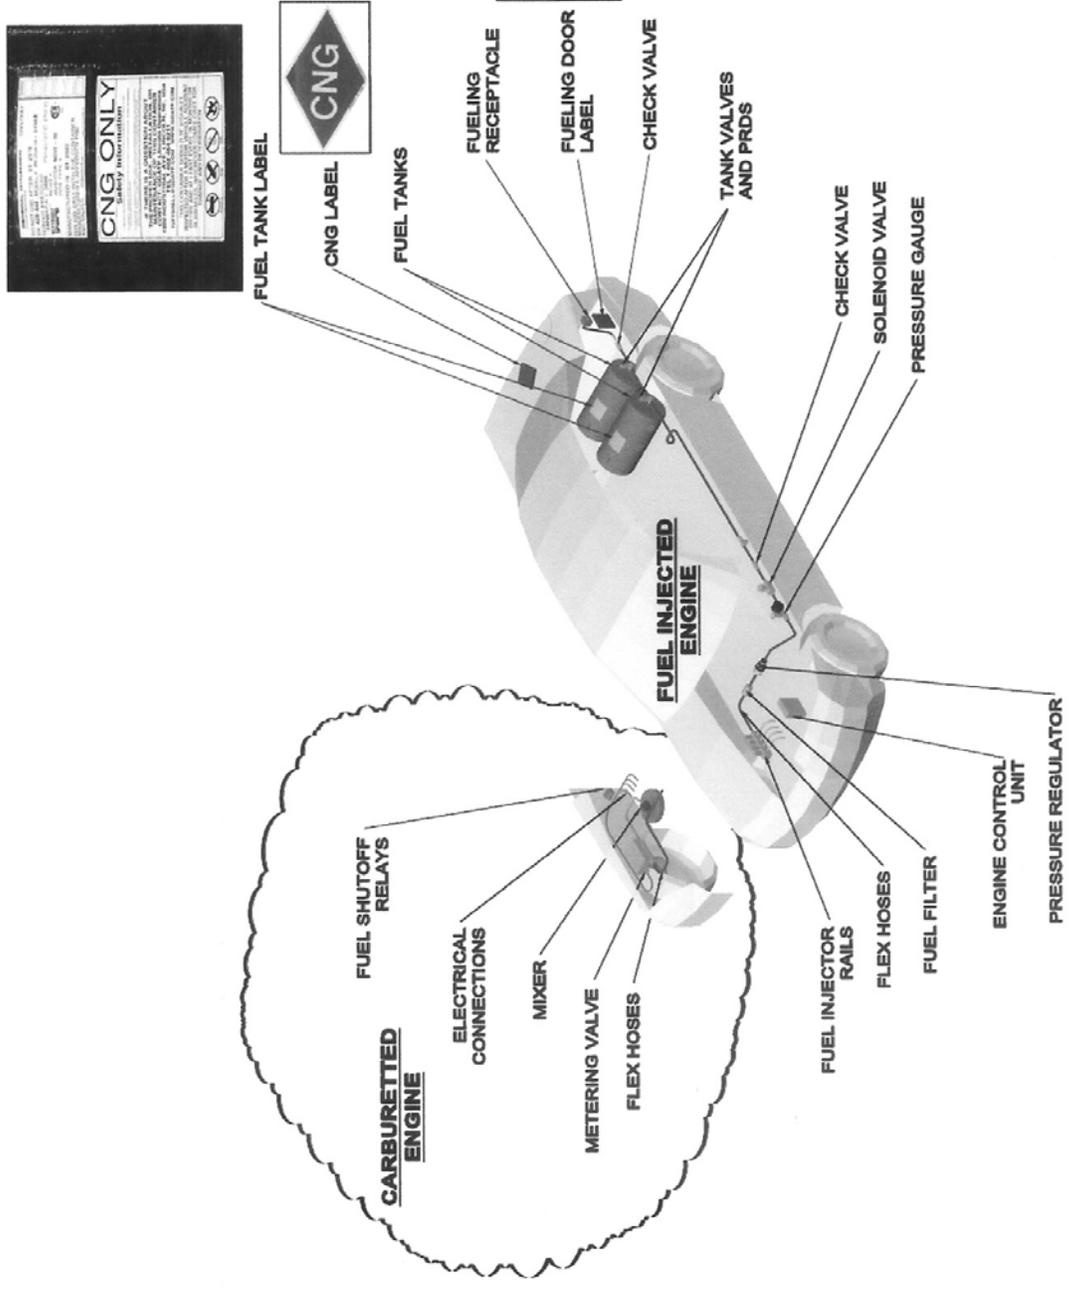
Sample Compressed Natural Gas Vehicle Schematic

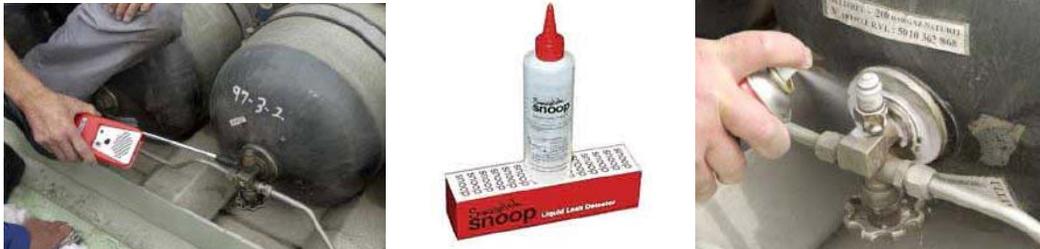
Figure 1.1 Leak Testing

In the rare event that there would be an urgent safety concern, the inspector should immediately decide on the appropriate action. If leaks are found or more serious levels of damage are suspected, stop and determine how to resolve the issue. This can be something as simple as turning off a cylinder or fuel line shut off valve to recommending CNG defueling and contacting emergency responders, before any further inspection is considered.

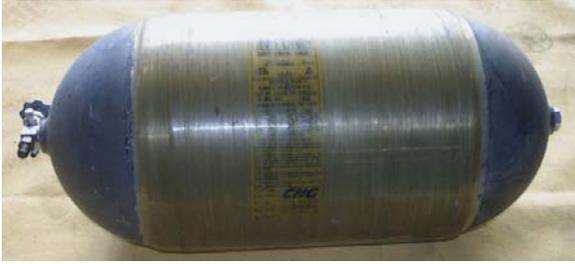
Figure 2.2 Type 2 Hoop Wrapped

In Type 1 all of the internal force is contained by the metal. In Type 2 and 3, the metal and composite share the pressures. The difference between the two is the coverage of the fiberglass overwrap. Type 2 covers the center of the cylinder only, while Type 3 wraps the entire cylinder. Type 3 will have a significant decrease in the metal liner thickness.

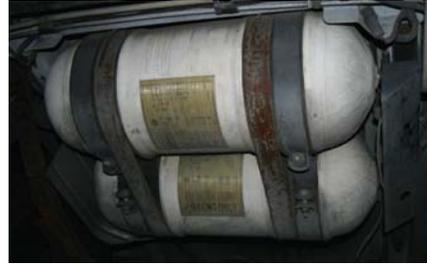
Figure 2.3 Type 3 Fully Wrapped

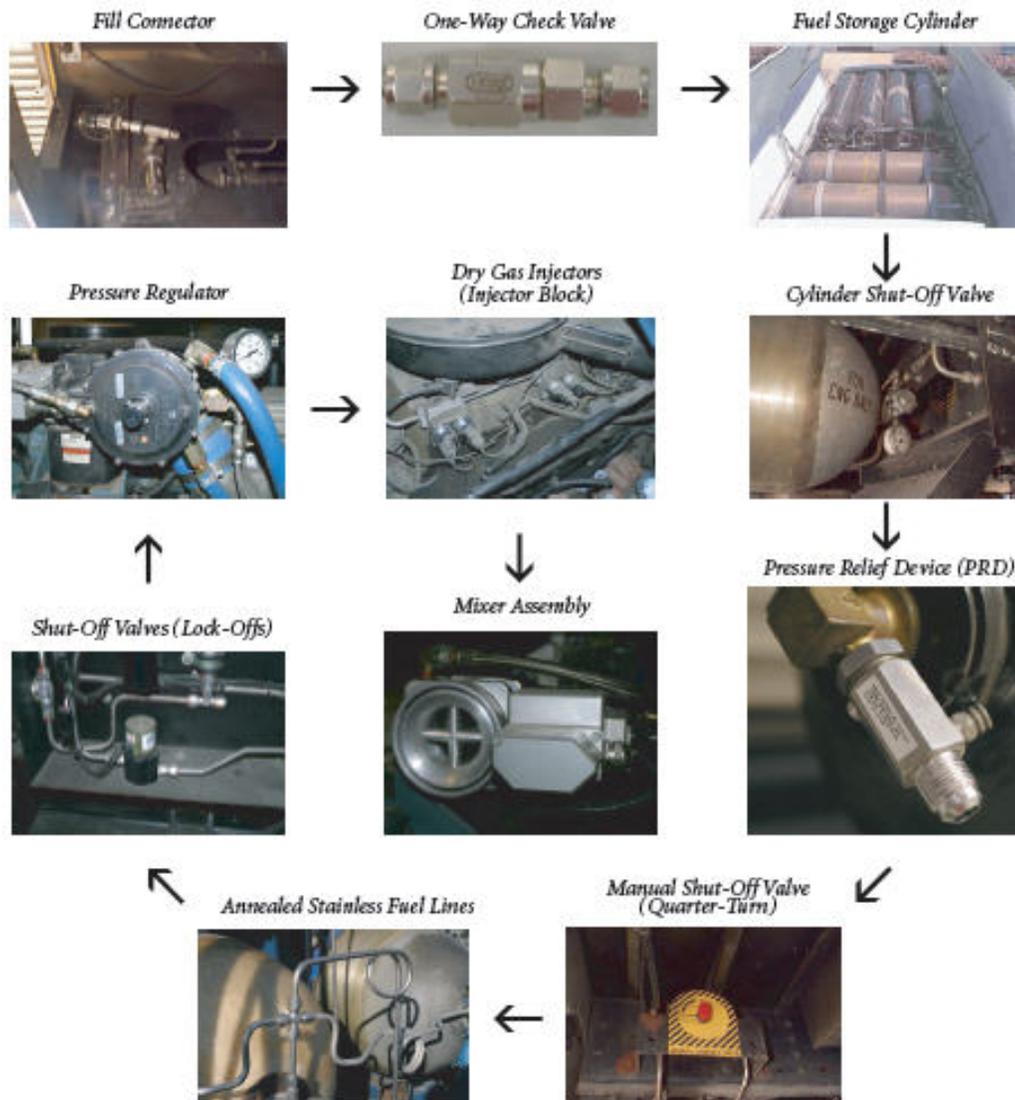
Figure 2.5 Typical Fuel System Components (Courtesy LBCC)

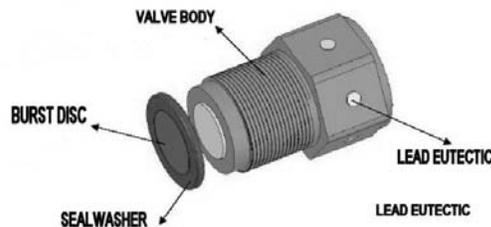
This type has a thin steel 'rupture' or 'burst disc' designed to burst at a predetermined pressure backed by a lead eutectic as a plug or thru a series of channels within a brass body. It requires excessive pressure and temperature to cause it to operate. It cannot prevent an improperly filled (overfilled) cylinder from rupturing due to hydrostatic pressure at room temperature, or any temperature below the melting point of the fusible material. Both the burst pressure and temperature are generally stamped on the PRD body.

Figure 3.3 Series PRD

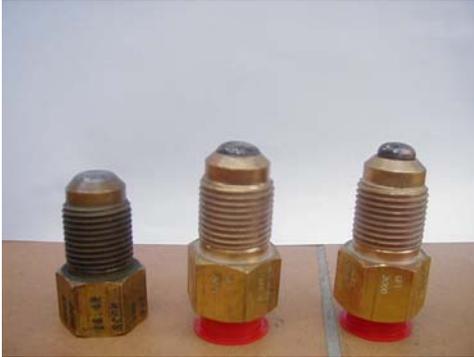
By the same token, evaluating an extruded eutectic can be difficult. Consider these three Pressure Relief Devices. It would appear that the lead plug on the right has begun to extrude but the center and right PRD's are both new! So the difference between a manufacturing anomaly and an actual extruded eutectic might not be obvious. You must see evidence of damage or leaking of the fusible material before condemning it.

Figure 3.4 PRD

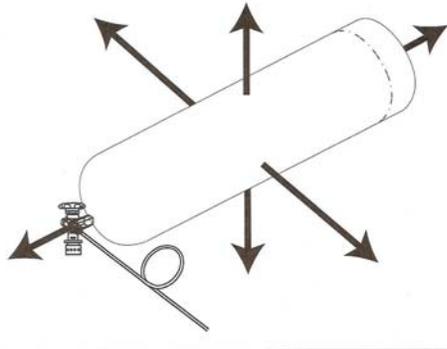
Figure 4.1 Six principle directions

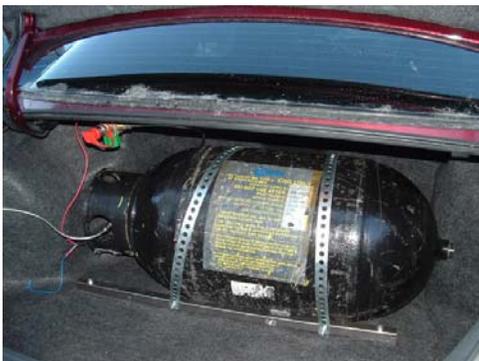
Figure 4.2a Bad Mounting

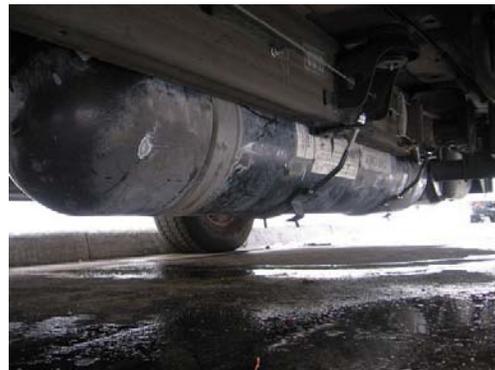
Figure 4.2b No Shielding

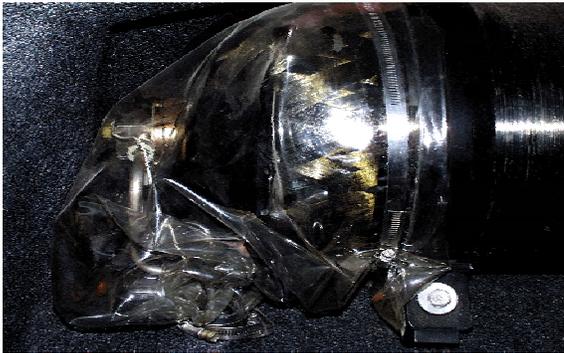
Figure 4.3 Polyethylene vent bag (L. DaShiell)

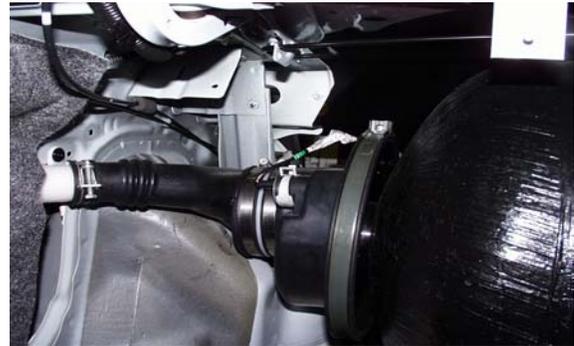
Figure 4.4 Formed vent cover (L. DaShiell)

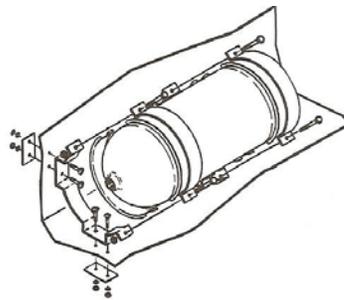
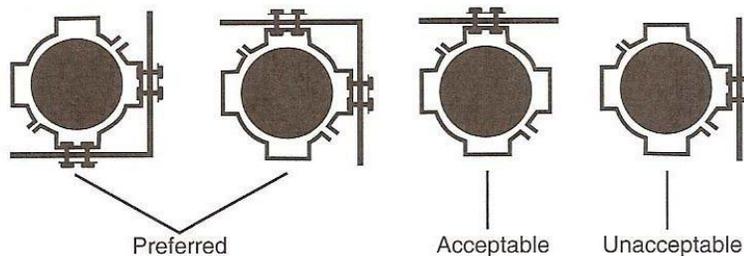
Figure 4.5 Proper and improper cylinder mounting procedures (Courtesy CNG Cylinder Company)

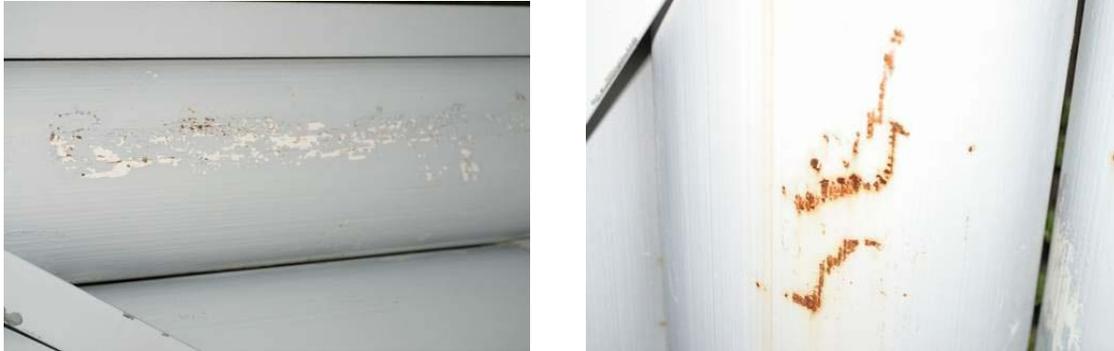
This is most prominent on Type 1 and 2 cylinders due to exposed metals. Many newer cylinders have epoxy painted coatings to help prevent this damage. Corrosion should be cleaned off, evaluated, and resealed to prevent further damage. Corrosion or pitting over .030 inch in depth can be Level 3 damage if it covers considerable surface areas of the cylinder (see §7.6.1.4 of CGA C-6.4). Type 1 cylinders must be evaluated for loss of wall thickness. This will require specifics on the original cylinder. CGA C-6 provides additional guidance and lists wall thicknesses for certain steel cylinders.

Figure 5.1 Corrosion

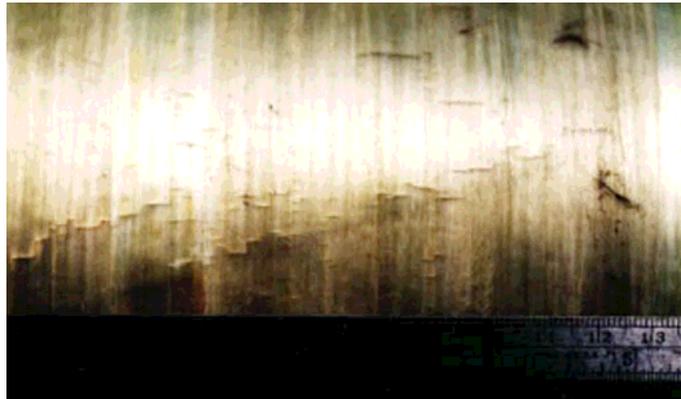
This occurs when the cylinder is cycled repeatedly causing expansion and contraction of the cylinder, which is usually a sign of age or over pressurization. The fiber wrap cracks longitudinally causing loss of the cylinder pressure safety factor. Any identified stress or fatigue cracking is Level 3 damage. A contributing factor can be chemical attack e.g., battery acid.

Figure 5.2 Stress Corrosion Cracking (SCC)

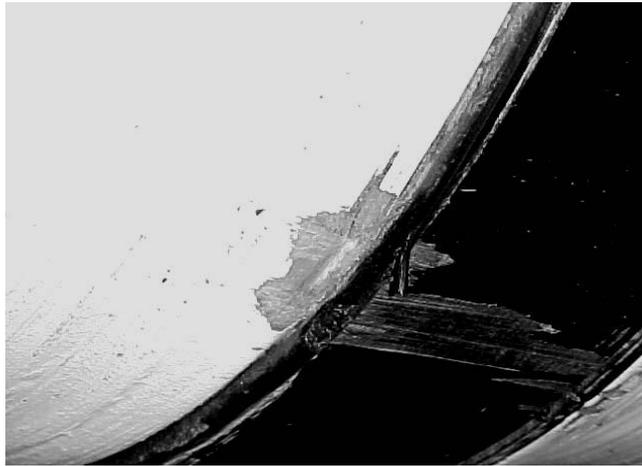
This is very common on cylinders that are mounted underneath the vehicle, if shielding is inadequate or the cylinder is exposed. Type 2, 3, and 4 cylinders with less than 0 .010 in have Level 1 damage.

Figure 5.3 Abrasion Damage

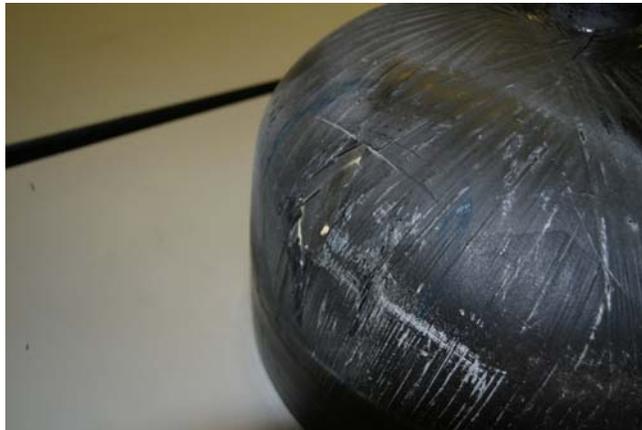
These are caused by a foreign object coming in contact with the cylinder. Brackets and other items rubbing against the cylinder can also cause this damage. Cuts or gouges less than 0.010 in. deep are defined as Level 1 damage regardless of length, number or direction. Cuts or scratches greater than or equal to 0.010 in deep are defined as Level 2 or Level 3 damage and may require the use of manufacturer's guidelines (see §7.5.2 of C-6.4).

Figure 5.4 Cuts

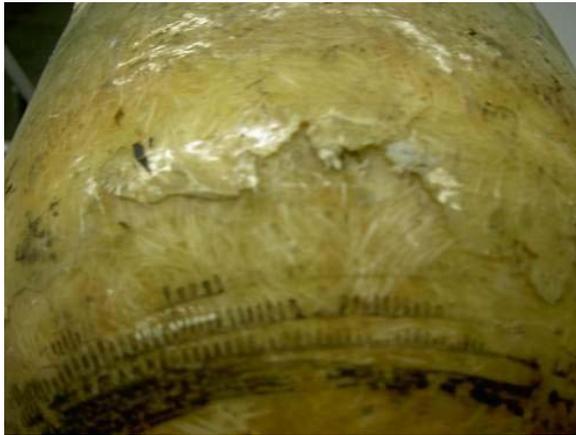
Minor dents up to 1/16" inch and greater than 2 in. diameter on Type 1 cylinders can be tolerated. However, blunt impact damage on Type 2, 3, and 4 cylinders is very hard to evaluate and can be dangerous, especially on Type 4 cylinders. Extreme care must be taken to determine if any deformation of the cylinder is present indicating fiber damage. This is a sign that the cylinder may not be structurally sound and is considered Level 2 or 3 damage.

Figure 5.5 Impact damage

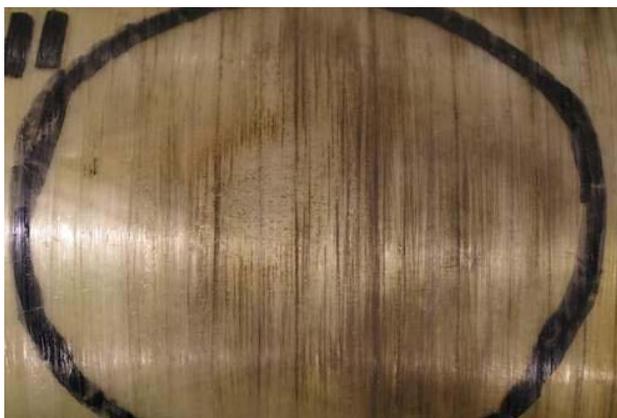
Acids and other chemicals can severely damage the cylinder wrap and possibly the metal itself. Extreme care should be taken to identify and neutralize any chemicals spilled on the cylinder. Only minor discoloration is allowed after neutralization and a very careful inspection should be performed to make sure the chemical did not get between the wrap and the cylinder where unseen damage could progress. Chemical attack can also lead to Stress Corrosion Cracking (see No.2 above). Comdyne cylinders suspected of being exposed to acid should be depressurized as soon as possible to prevent rupture. The cylinders should then be removed from service, rendered unusable, and disposed of. Any other CNG cylinder that has been exposed to acid should be examined in accordance with either the vehicle or cylinder manufacturer's recommendations. Ref. CVEF Safety Advisory.

Figure 5.7 Chemical damage

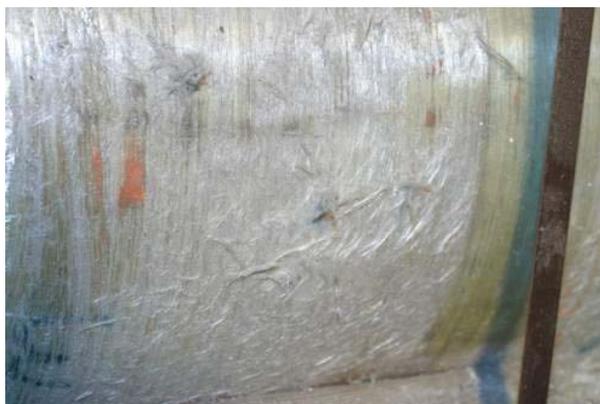
Ultraviolet light can cause damage to the wrap which must be addressed. In most cases the manufacturers have coatings on the cylinder to prevent this damage. Excessive weathering results in Level 3 damage, as the fibers are damaged.

Figure 5.8 UV damage

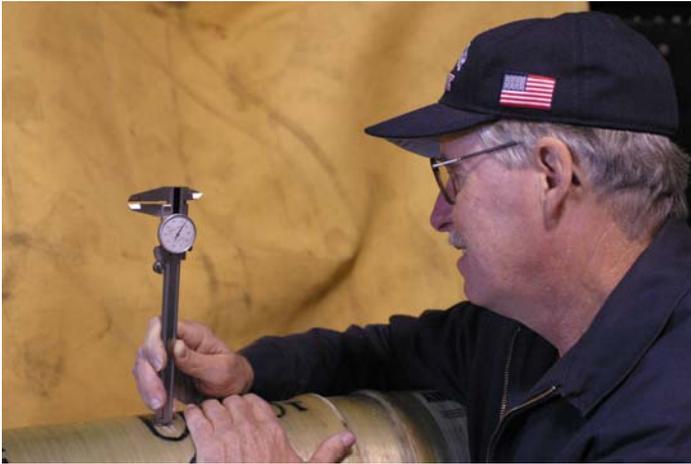
Figure 5.10

Sometimes, it is necessary to use a straight edge across a gouge to seek a level from which to measure. With this method you must subtract the thickness of the straight edge from your reading.

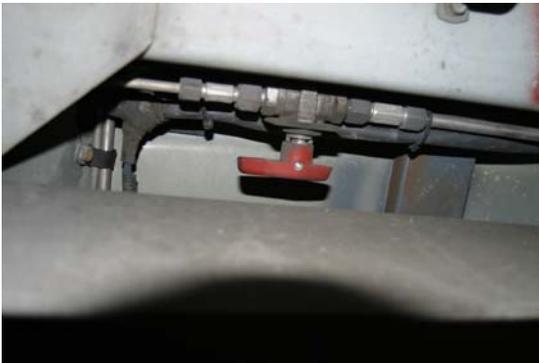
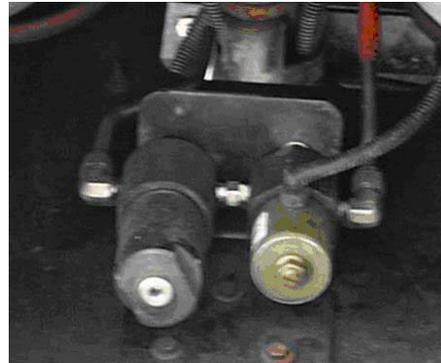
Figure 6.1 Manual and Electric Shut off Valves

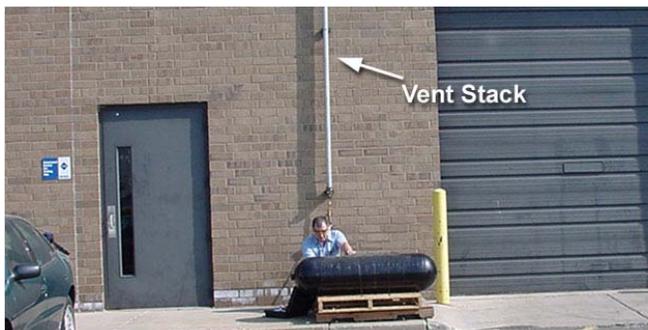
The use of atmospheric venting must be done with care. A static electrical charge can build up when releasing gas that can cause a spontaneous ignition. There are several documents that cover the necessary precautions to prevent this including CGA C-6.4 Appendix C; NFPA 52 Section 6.14 (2006) and the GTI Cylinder Care and Maintenance Handbook. All indicate that this should be done only by trained personnel. Atmospheric defueling should only be done with approval of local authorities, as natural gas (methane) is a potent greenhouse gas.

Figure 7.1 Intended defueling

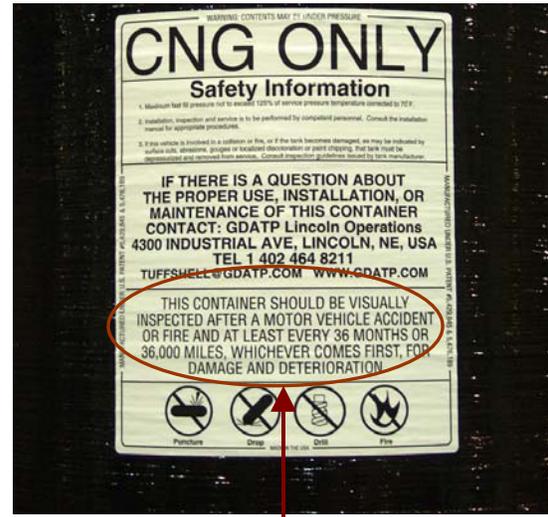
Figure 6: CNG cylinder label with inspection requirements (11)

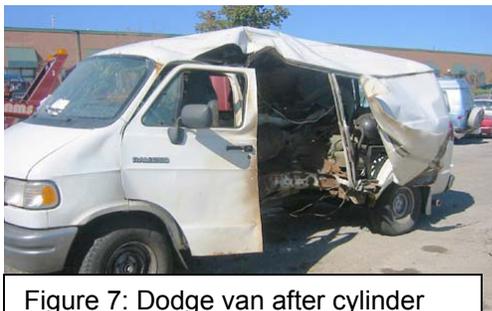
CYLINDERS/FUEL SYSTEMS NEED INSPECTION – In September 2003, in Scarborough, Ontario (a suburb of Toronto) a cylinder ruptured during fueling of a Dodge Ram van which had been converted to CNG in 1994. “Apparently the cylinder failed during fueling at substantially under its rated 3000 psi (200 Bar). The driver said he had smelled gas for a long time but hadn’t gotten around to checking the source. It was reported that there was massive external corrosion on the tank and there was no evidence of it having been inspected.” (16)

Figure 7: Dodge van after cylinder rupture (17)

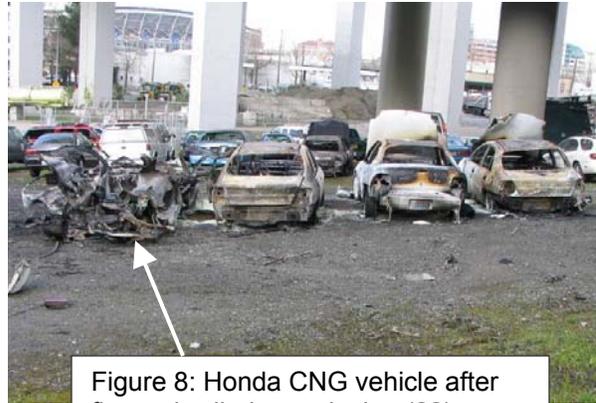
On March 26, 2007, an arsonist torched 12 vehicles in a Seattle, WA city government holding lot. All the vehicles were damaged or destroyed including a CNG Honda GX, whose fuel tank exploded in the fire. The tank was apparently compromised by fire moving from the back seat area onto the center of the cylinder, which was protected by a PRD at one end.

Figure 8: Honda CNG vehicle after fire and cylinder explosion (22)

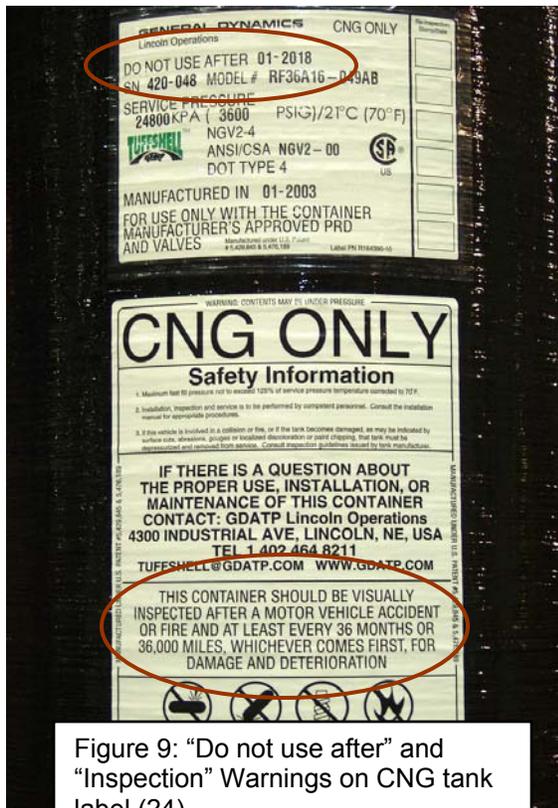
Figure 9: “Do not use after” and “Inspection” Warnings on CNG tank label (24)
