## Lightning Arrestor Connectors Production Readiness

**KCP-613-8510**

Final Report on 706500, 703010, 703044

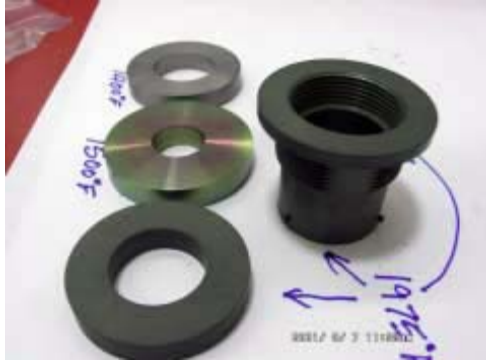
**Figure 1: Connector Shell Assembly D-Flat**

The connectors involved were originally designed to include 304L stainless steel circular bodies with EG2164-type sealing glass and Alloy 52-type contacts. A d-flat (shown in Figure 1) in the shell body makes orientation and assembly in next assembly more convenient. However, this d-flat creates high unsymmetrical stresses, especially at the center of this d-flat. The change in shape produced a lack of contact in areas between the stainless steel shell sealing surface and the glass. Removing the steel from the glass also revealed no residual glass adherence to the steel, even though the steel shells were pre-oxidized before sealing. Pre-oxidation is known to aid in providing a seal<sup>1</sup>.

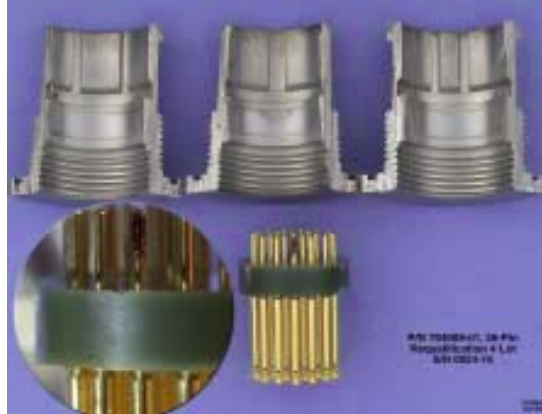
**Figure 2a: Stain in D-Flat**

This lack of contact resulted in an inability to exceed the  $1 \times 10^{-8}$  cc/sec He stp. Typical failures were in the  $2 \times 10^{-8}$  up to  $1 \times 10^{-6}$  cc/second range. Sectioning of the connectors revealed a 'typical v-shaped stain' on the inside surface of the d-flat, as shown in Figure 2a. Soaking the failed connectors in dye penetrant and then reviewing them under a black light usually revealed one or more potential leak paths as shown in Figure 2b. While the parts require temperature cycling, some even failed before temperature cycling. The project objective was, therefore to develop improved pre-oxidation and to obtain residual glass on the steel of a connector when sectioned.

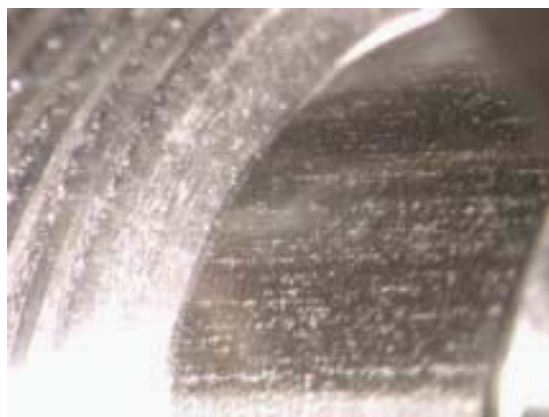
**Figure 3: White Spots from Passivation**

***Surface effect from passivation.*** As indicated earlier, the 304L stainless steel shells were being passivated using a room temperature nitric acid bath. Heat of approximately 125°F was added to the nitric bath. Heated passivation significantly affected the appearance of the stainless steel surface. Little whitish spots were enlarged to approximately four times those at room temperature, as shown in Figure 3. There is some speculation that this change roughens the surface, increasing the leak path distance and providing more sealing surface area for the molten glass to bond.

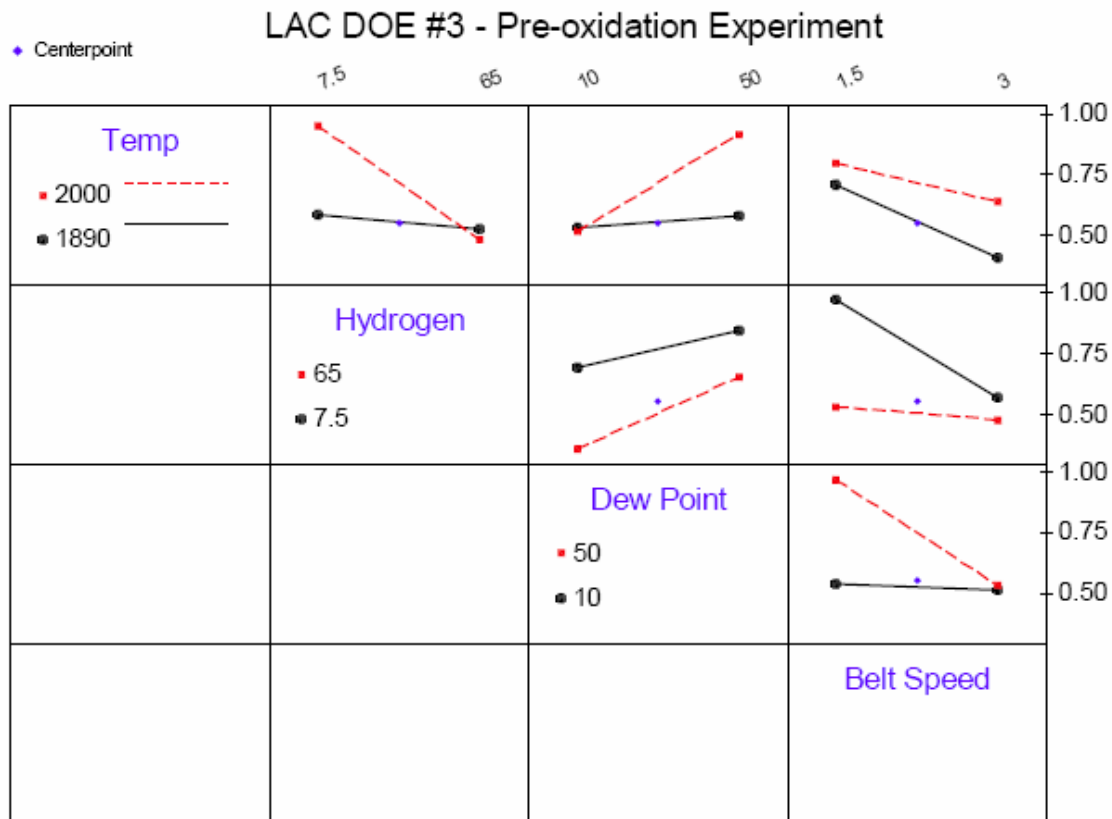
**Figure 4a: Pre-oxidation Interaction Plot**

Type. The experts on the team recommended obtaining a chrome oxide, which is green. This was accomplished by varying furnace parameters. The response variable was color. The color could best be judged at the exit end of the furnace, which happened to have a good white light.

Thickness. Some literature indicates that too much oxide can produce a weak seal. The challenge was in obtaining enough oxidation. This was accomplished by slowing the belt speed, which kept the shells in the hot zone longer. A design of experiment with the furnace system being used allowed us to obtain a green chrome oxide. The belt speed in the furnace was somewhat challenged to be in the hot zone long enough to obtain the desired oxidation. The following was a first-cut at providing predictors for oxide thickness based upon data obtained in the recent DOE. The Interaction Plots shown in Figure 4a and Surface Plots in Figure 4b are examples of some of the analyses performed.

Some of the conclusions drawn from pre-oxidation and surface plots were

- High Temperature - High Dew Point
- High Temperature - Low Hydrogen
- High Temperature - Low Belt Speed
- Low Hydrogen - Low Belt Speed
- High Dew Point - Low Belt Speed

From this, one might use High Temperature, High Dew Point, Low Hydrogen and Low Belt Speed. Then, assuming a 0.8 micron minimum oxide thickness is desired, it was estimated that the team should use 1975°F or higher, 24°F or greater dew point, 2 ipm or slower belt speed and 20% or less hydrogen.

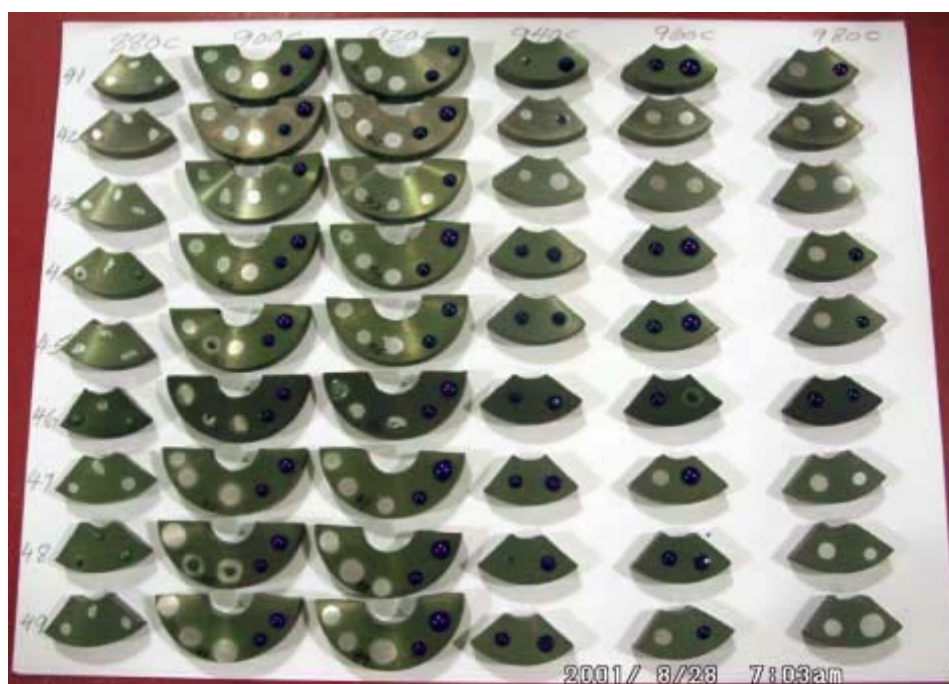
**Figure 6: Sessile Drop Tests**

**Sealing.** The team also evaluated the sealing process using sessile drop tests, Figure 6, and design of experiments to optimize parameters. Glass from different sources, including EG2164 and S8061 were evaluated and in all cases, the S8061 glass performed best. The coupons sections with light spots indicate non-adherence tests. Those with dark spots indicate adherence. Rows 41 through 49 represent various oxidation parameters. Columns represent sealing temperatures. Row 46, which used oxidation parameters and sealing temperatures 940°C and 960°C, indicate the best potential parameters.

A Box Plot of the oxide thickness measurements is shown in Figure 7<sup>2</sup>. Note that coupon segments #46 had the greatest oxide thickness and also appeared darkest in Figure 6.

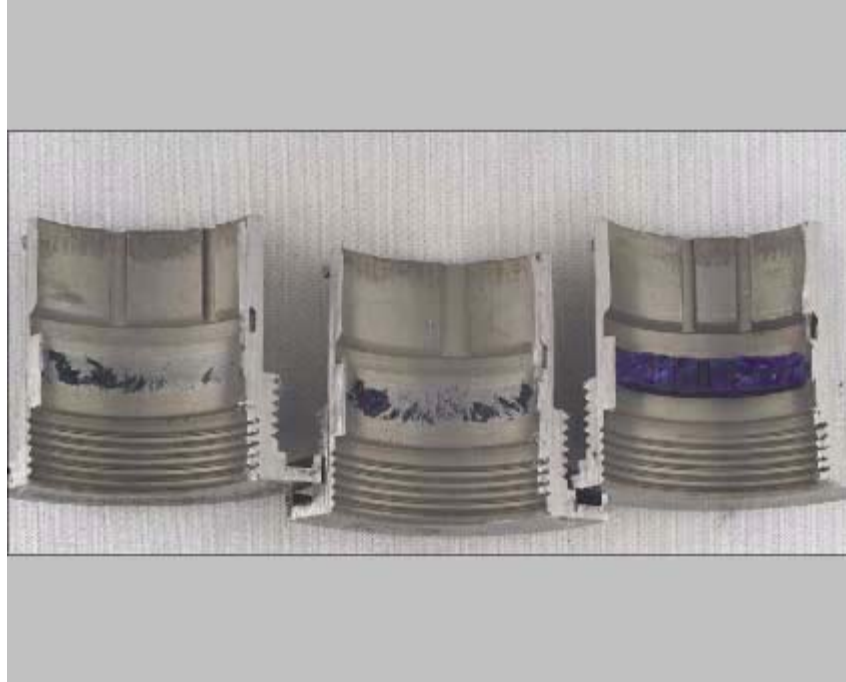
**Figure 8: Residual Glass Adherence**

**Shell Body to Glass Adherence.** The end result was that the S8061 glass adhered better. In fact, it has been consistent enough that the team agreed to an adherence specification in which test

connectors are sectioned and checked for a 'no stain' condition, and the presence of residual glass is verified, as shown in Figure 8. Glass now has to be 'sprung' out of the section with the major keyway so that the section can be checked for the 'no stain' condition. The team also performed overtesting on a small group of parts to determine robustness.

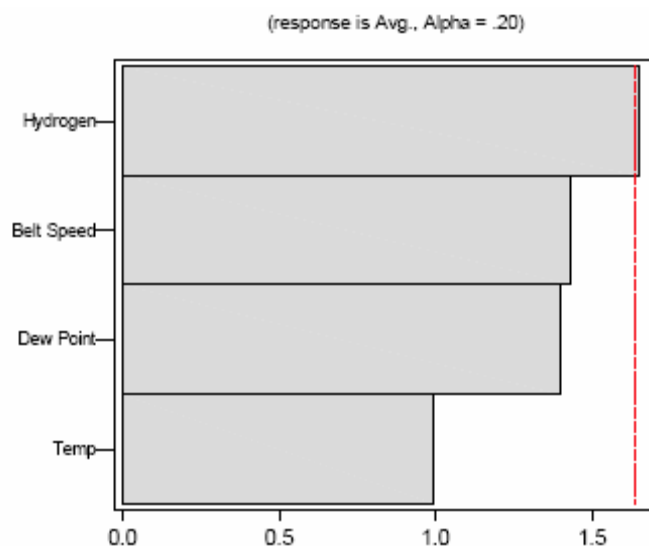
**Figure 9: Pareto Chart of the Standardized Effects**

Figure 9 is a Pareto Chart of the average effects due to hydrogen, belt speed, dew point and temperature during preoxidation<sup>2</sup>. The Pareto chart indicates hydrogen has the greatest effect, even though it may not be significant (does not extend beyond the plotted reference line).

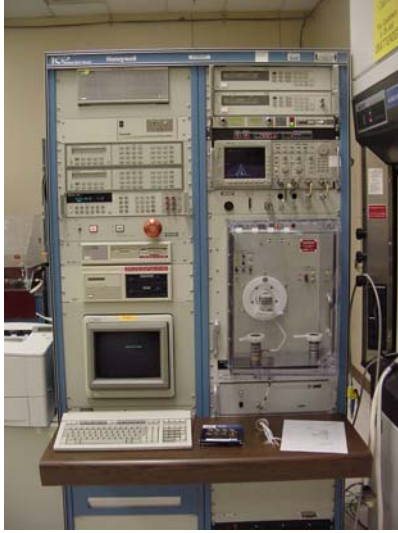
**Figure 16: PT3665, FRB Tester**

- Performed failure analysis that lead to a specification change. The LAC had been tested at a voltage of 500 volts. A PPI failure investigation revealed the test voltage can approach the designed breakdown voltage (FRB) of the LAC. Working with the design agency product engineer and systems, the specification was changed to a test voltage of 400 volts. No further failures have occurred.

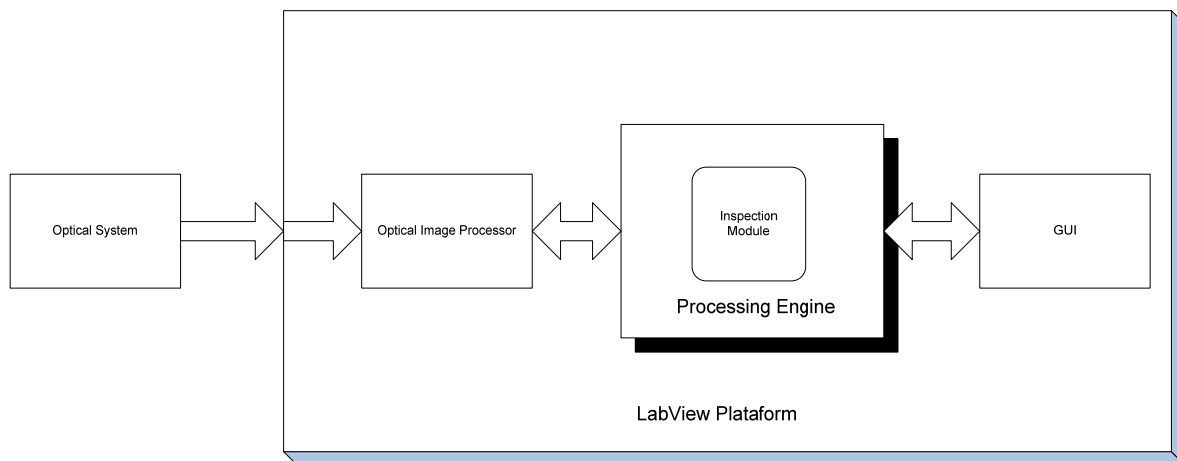
**Figure 21: System simplified block diagram**

The application software was developed in LabView 8.2. It consists of a Graphical User Interface (GUI), inspection module and processing engine (*see* Figure 21). The inspection module resides inside the processing engine and contains the specific inspection program for a particular part. A set of rules govern the data input and output format for this module. The Processing Engine provides the necessary information for the Inspection Module to perform the verification of a particular part. The way the Inspection Module process this data is transparent to the processing engine, for as long the data input and output format are followed. This configuration allows the inspection process to be as elaborate and complex as desired and at the same time provides the capability of adding new parts without any main program modification. The verifications can be written by expert personnel and then incorporated to the program to be used by non-expert users.

The GUI provides the input and output interface for the user to select what parts to verify and observe the verification results. It also provides the necessary controls for calibration and adjustments, as well as data recording and retrieval.

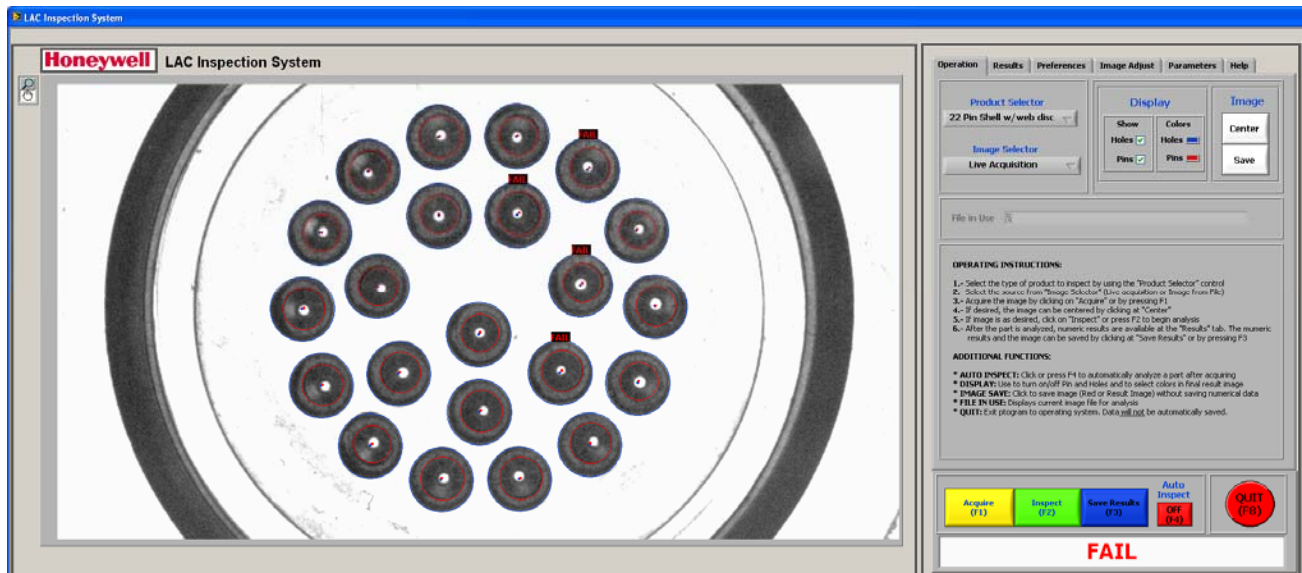
**Figure 24: Shell assembly**

Figure 24 demonstrates the results obtained when analyzing a 25 pin shell assembly.
