Evaluation of MerCAP™ for Power Plant Mercury Control

Final Project Report

**Cooperative Agreement Number
DE-FC26-03NT41993**

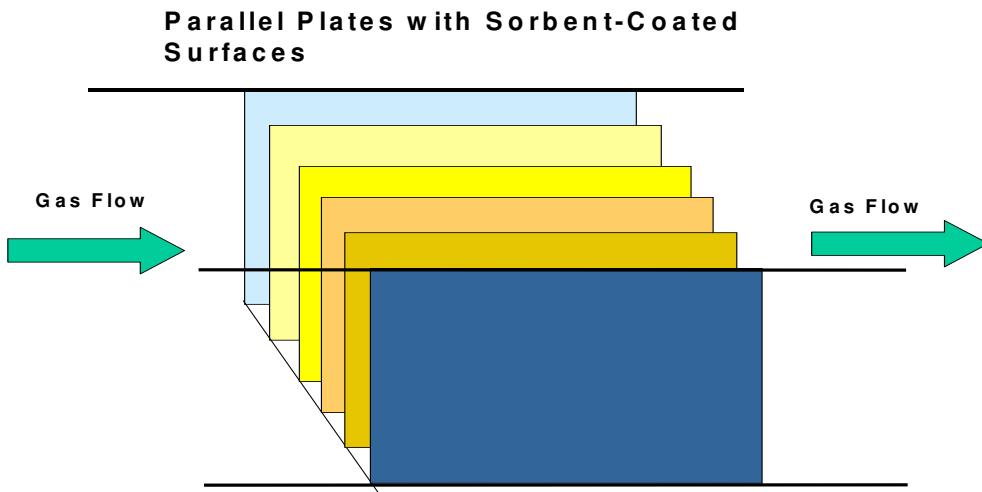
Figure 1-1. Parallel Plate Configuration of a Fixed Sorbent

The MerCAP™ concept has been tested in actual flue gas since 1999, starting with evaluations of small gold-coated coupons and evolving to long-term tests of probes containing 10-ft substrates. These tests have shown that high mercury removals (>80%) can be achieved at various operating parameters and in different flue gas types. Tests have also indicated that gold-coated substrates can be thermally regenerated without degradation of the initial adsorption capacity. Tests conducted with an in-duct probe in North Dakota Lignite (NDL)-derived flue gas downstream of a spray dryer-baghouse configuration showed >80% mercury removal with a substrate configuration of 10-ft long gold-coated plates spaced 0.5 inches apart at a gas velocity of 40 ft/s. These results were consistent with mass transfer model predictions. Results with a 140-acfm probe showed mercury removals of >70% for six months of continuous flue gas exposure in NDL-derived flue gas.

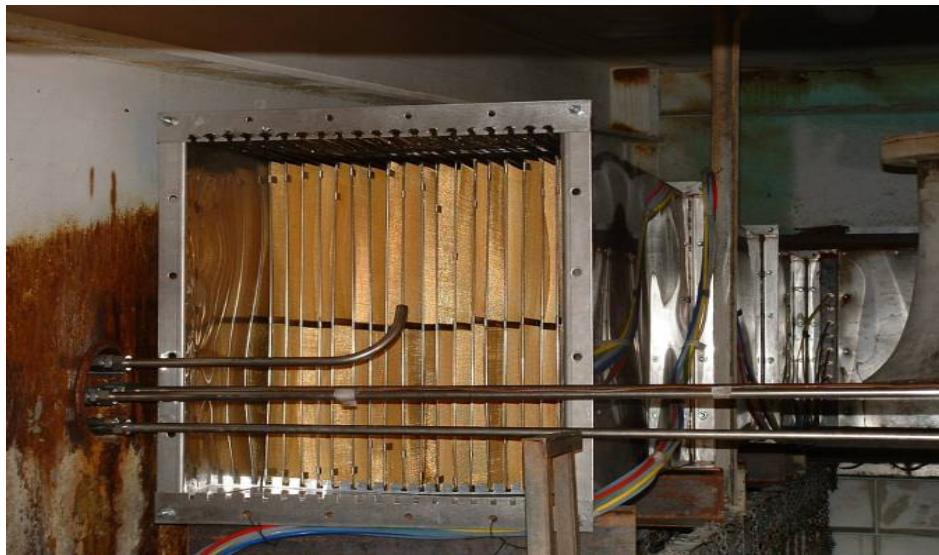
Figure 3-3. MerCAP™ Array Duct Section 1 Stanton Unit 10 Baghouse Compartment

Figure 3-3 shows the gold MerCAP™ substrates installed in the duct section at 1-inch plate spacing. For ease of handling the plates were built into 2-foot cubic containers that slid into the duct sections. Later in the course of the program, this allowed for testing of varied active length in a quick, convenient manner. Also shown in the foreground of Figure 3-3 is the inlet mercury sampling systems for each duct section. The colored lines running back along the outer edge of the duct section were differential pressure lines to measure the flow down each duct section and the pressure drop across the array. The outlet mercury sampling array is not shown in the figure, but mimics that of the inlet array shown.

baghouse compartment (inlet duct to outlet duct). Figure 3-3 shows a photograph of the inlet of one of the four duct sections installed in the baghouse compartment.

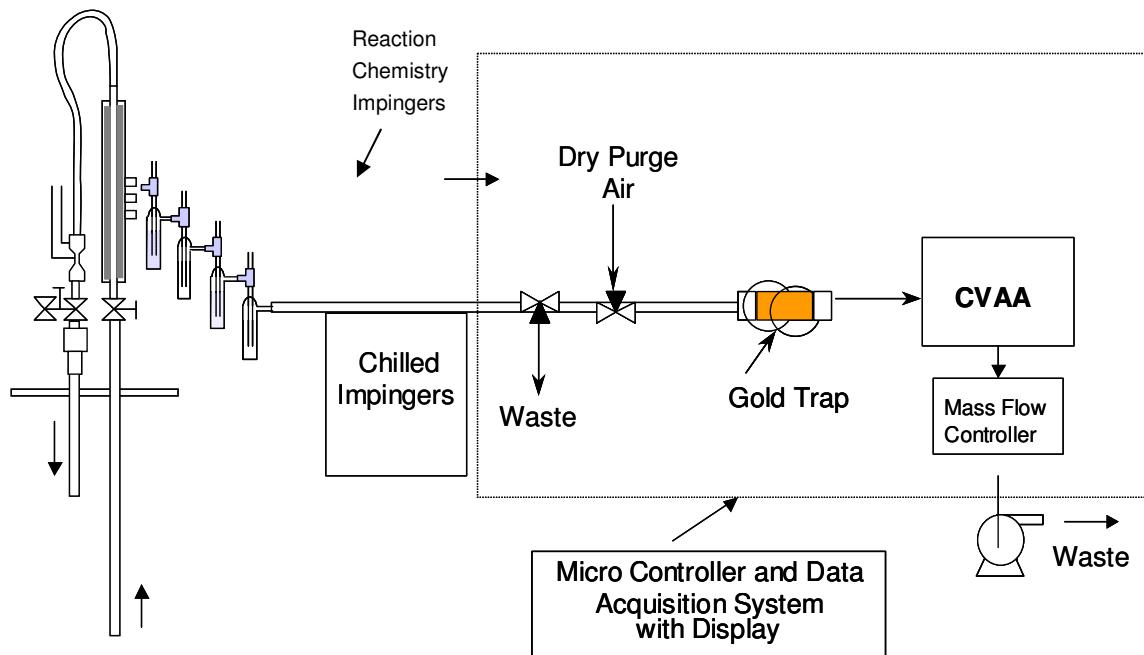
Figure 3-4. Apogee CMM Schematic.

The CMM consists of a commercially-available cold vapor atomic absorbance (CVAA) spectrometer coupled with a gold amalgamation system (Au-CVAAS). The CMM measures and controls the sample gas flow using a precision mass flow controller to record the sample gas volume for each sample cycle. Sensors built into the CMM measure vacuum and sample gas oxygen content to detect any failures in the sample transport systems as well as to standardize emission rates at varied gas compositions. (Typically mercury concentrations are corrected to 3% oxygen content to account for in leakage and dilution effects) A generic sketch of the Apogee CMM is shown in Figure 3-4 and a photograph of an Apogee CMM and sample extraction system is shown in Figure 3-5.

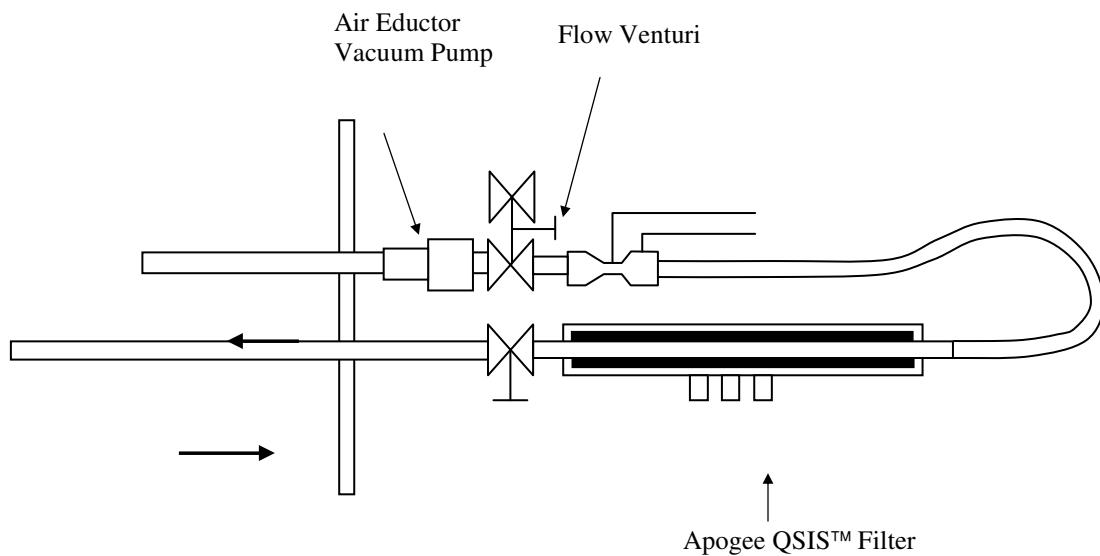
Figure 3-6. Apogee QSIS™ Probe.

Apogee QSIS™ sample extraction systems are utilized in concert with the CMM and sample conditioning systems to ensure an unbiased mercury measurement. The QSIS™ extraction system includes the Apogee QSIS™ Probe and controls. This system enables the sampling of vapor-phase mercury from combustion flue gas without introducing sampling artifacts. The Apogee QSIS™ sample extraction system is protected by a U.S. patent and has been used extensively by a number of testing groups demonstrating a proven performance track record. Figure 3-6 shows a schematic of the Apogee QSIS™ Probe. For this program the QSIS™ system was modified to be utilized with the MerCAP™ array.

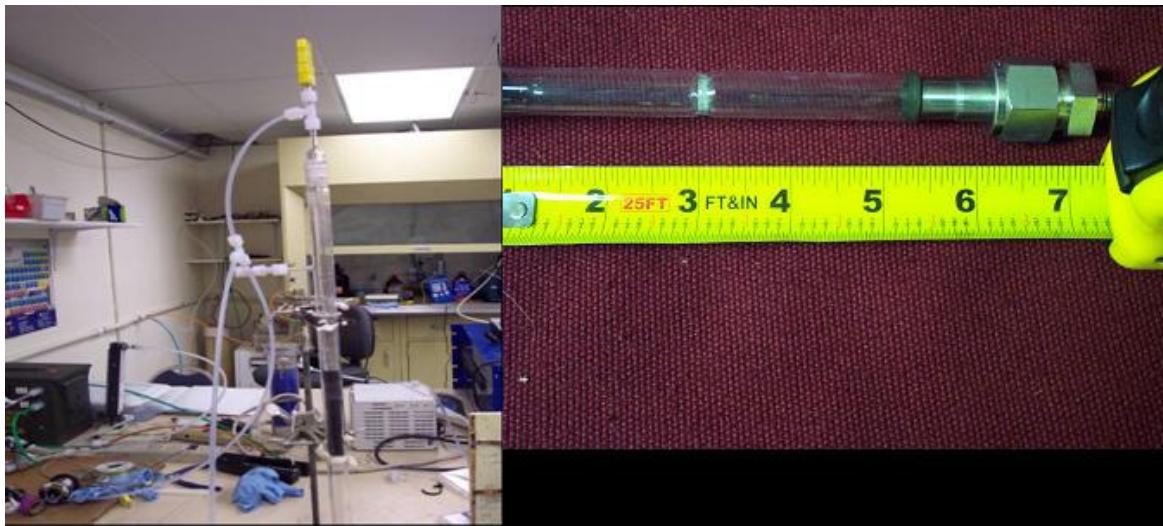
Figure 3-7. Small-Scale Test Equipment

Small-scale evaluations of alternative sorbent materials and samples taken from the full-scale sorbent structures were conducted in the Apogee laboratory facility. A CMM and field sampling equipment were used to document and quantify mercury removal performance and capture capacity of substrate samples and promising alternative sorbent materials. Specially designed quartz glass and Teflon™ equipment was used to ensure no biasing of results obtained in the small-scale evaluations. Figure 3-7 shows a photograph of the laboratory test equipment, including an apparatus for testing plate and screen material (left) and an apparatus for fixed bed and fluidized bed testing (right). Figure 3-8 is a schematic representation of the small-scale test equipment used to evaluate different sorbent substrates.

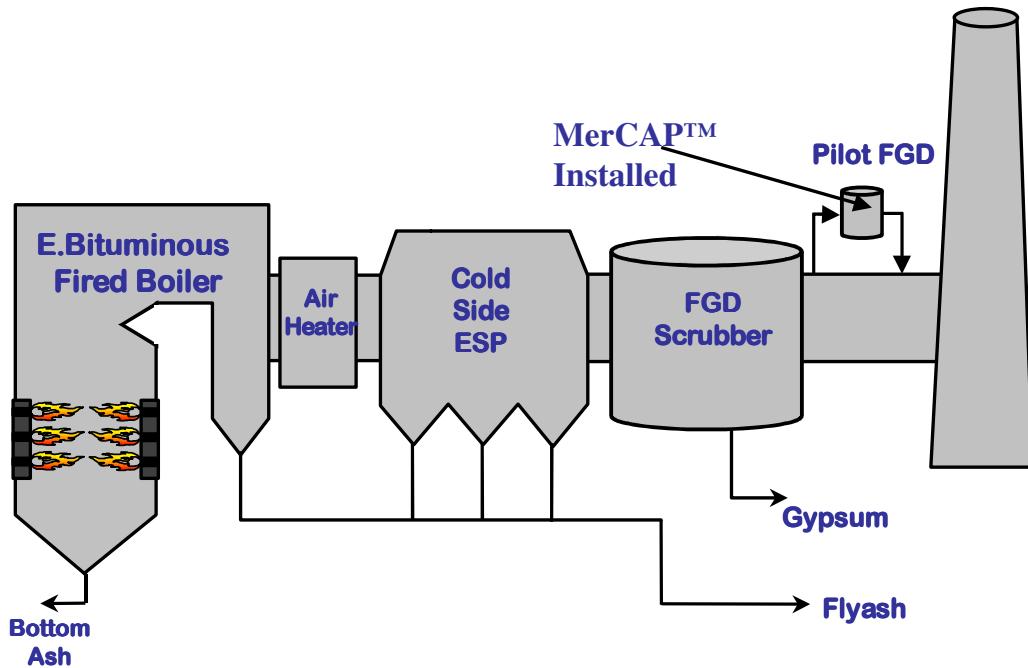
Figure 3-9. Plant Yates Unit 1 Configuration.

Yates Unit 1
Boiler	
Type	CE Tangential Fired
Nameplate (MW)	100
Coal	
Type	Eastern Bituminous
Sulfur (wt %, dry)	~1.0
Mercury (mg/kg, dry)	~0.16
Chloride (mg/kg, dry)	300-1400
ESP	
Type	Cold-Side
ESP Manufacturer	Buell (1968 and 1971 vintage, refurbished in 1997)
Specific Collection Area (ft ² /1000 acfm)	173
Plate Spacing (in.)	11
Plate Height (ft)	30
Electrical Fields	4
Mechanical Fields	4
ESP Inlet Temp. (°F)	310
ESP Design Flow Rate (ACFM)	490,000
NO_x Control	Low NO _x Burners
SO₂ Control	Chiyoda CT-121 wet scrubber (JBR)
Flue Gas Conditioning	None

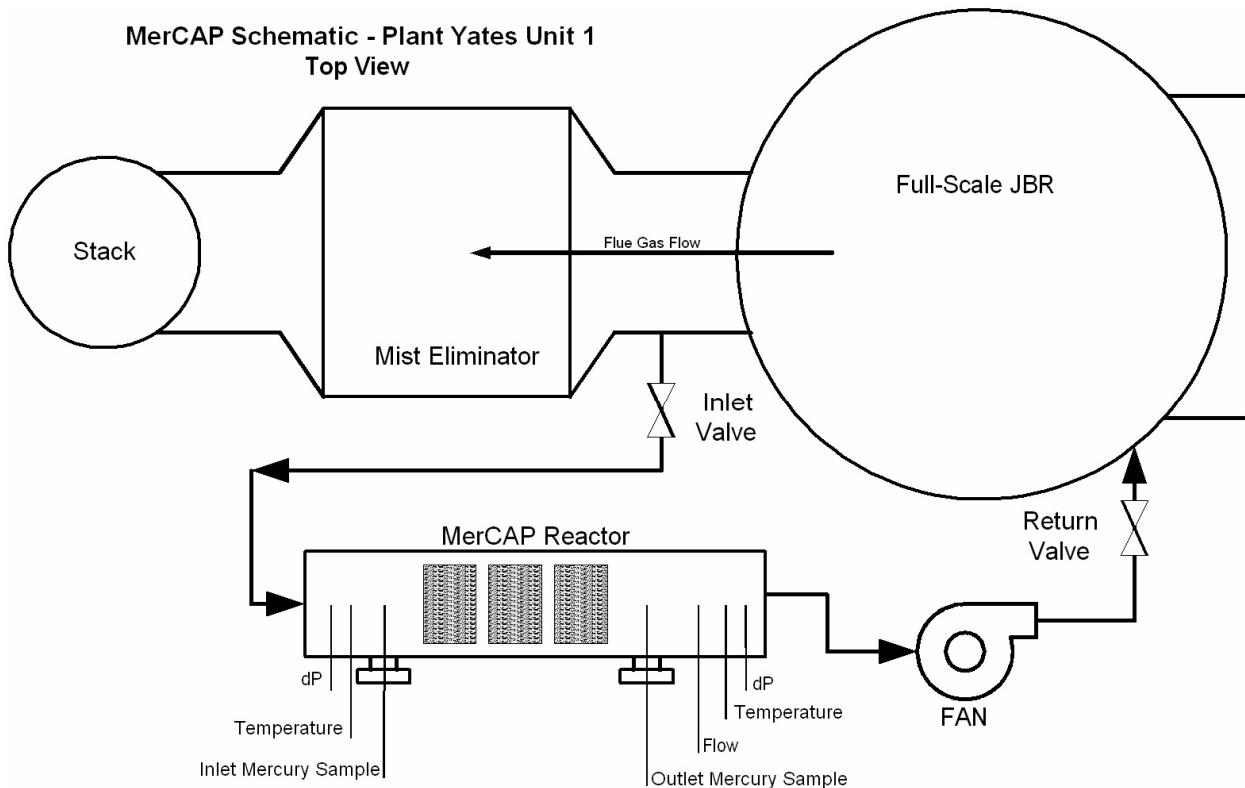
Figure 3-13. Initial MerCAP™ Installation at Plant Yates Unit 1

Figure 3-13 illustrates the configuration for the initial MerCAP™ pilot unit installed at Plant Yates. The reactor was installed in a long horizontal run of pipe that originally ran to the inlet of Southern Company's pilot FGD scrubber. This was previously identified as the best location for the installation because the MerCAP™ unit could be easily retrofitted into the existing system at this location and because the run of pipe was relatively close to the ground, thus aiding in the gold plate installation and flue gas sampling activities. The flue gas fan, located downstream of the reactor, provided the motive force for the flue gas across the MerCAP™ unit. Flue gas exiting the MerCAP™ reactor flowed back to the Unit 1 duct, re-entering just upstream of the full-scale JBR unit.

The initial pilot unit configuration was found to be insufficient for achieving the desired flue gas flow across the MerCAP™ system. This was due to a combination of limited fan power and pressure differential between the slipstream take-off and re-entry locations. This problem was alleviated by refurbishing the fan and reconfiguring the slipstream duct configuration.

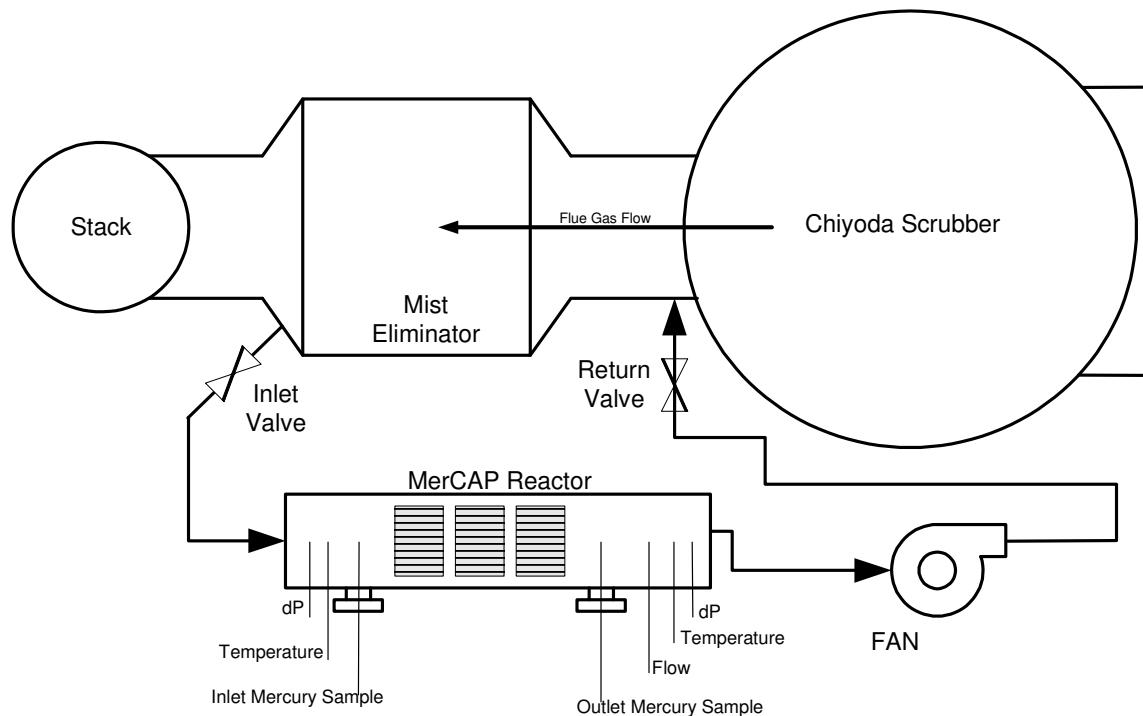
Figure 3-14. Reconfigured MerCAP™ Installation at Plant Yates Unit 1

Figure 3-14 illustrates the re-configured pilot MerCAP™ system. Here, flue gas exiting the reactor and fan was re-ducted to flow to a port downstream of the JBR absorber, as opposed to the original installation that had the flue gas return upstream of the JBR. With this new configuration the pressure drop across the entire MerCAP™ (slipstream) system was reduced from nearly 20 in. H₂O to approximately 3 in. H₂O.

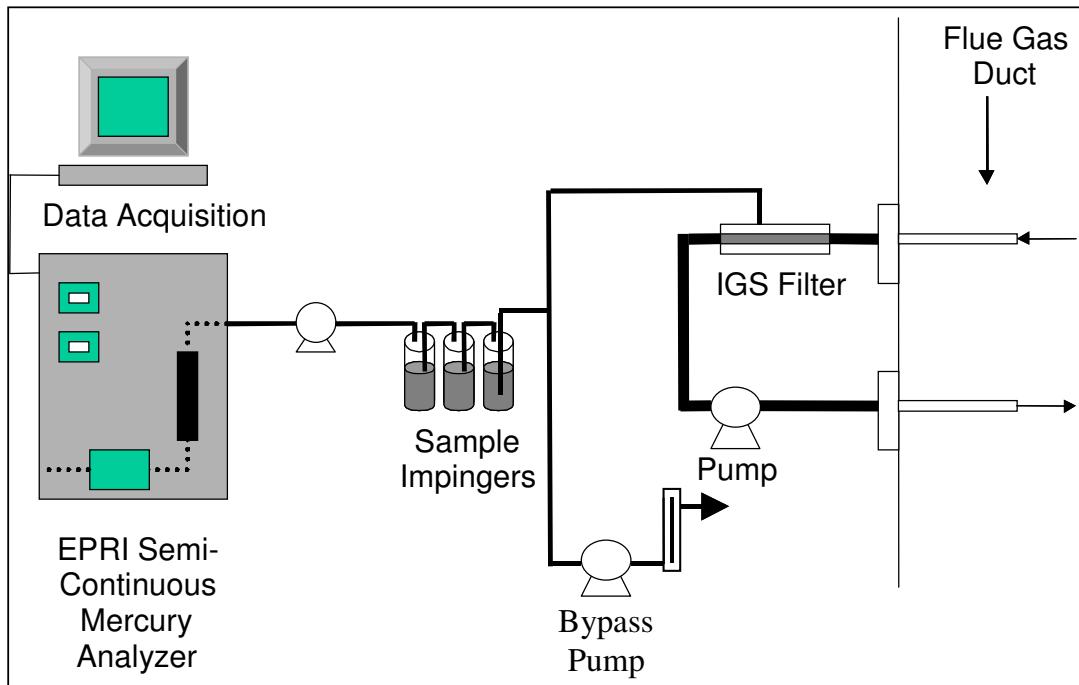
Figure 3-15. Schematic of EPRI Semi-Continuous Mercury Analyzer

to remove acidic components from the flue gas; elemental mercury is quantitatively transferred through these impingers.

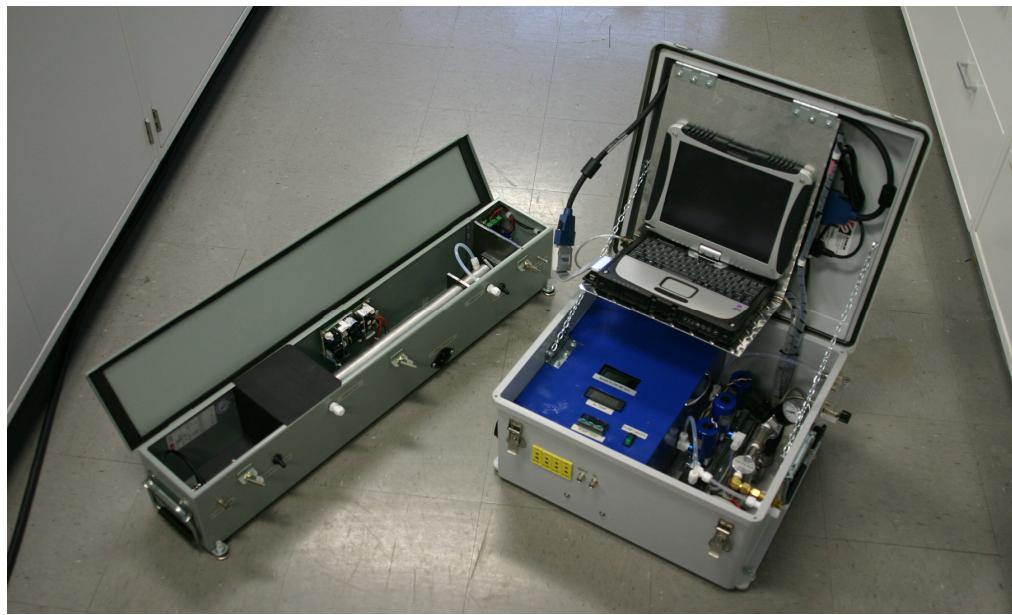
Figure 3-16. Sampling Control Module and Detector of EPRI SCEM

To measure elemental mercury only, an impinger containing either 1M potassium chloride (KCl) or 1M Tris Hydroxymethyl (aminomethane) and EDTA is placed upstream of the alkaline solution impingers to capture oxidized mercury. Oxidized forms of mercury are subsequently captured and maintained in the KCl or Tris impingers while elemental mercury passes through to the gold amalgamation system. Comparison of “total” and “elemental” mercury measurements yields the extent of mercury oxidation in the flue gas.

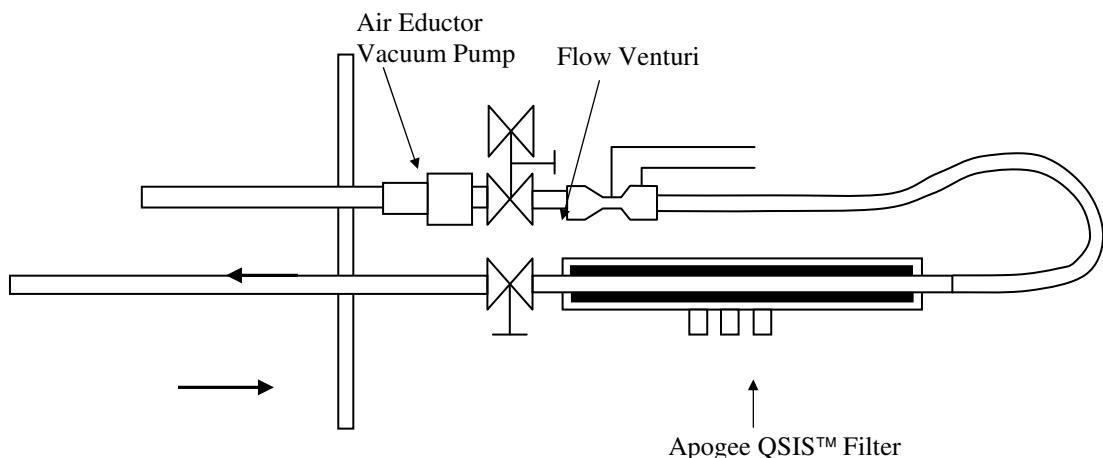
Figure 3-17. Apogee QSIS™ Probe

Apogee QSIS™ sample extraction systems are utilized in concert with the SCEM system and sample conditioning systems to ensure an unbiased mercury measurement. The QSIS™ extraction system includes the Apogee QSIS™ Probe and controls. This system enables the sampling of vapor-phase mercury from combustion flue gas without introducing sampling artifacts. Figure 3-17 shows a schematic of the Apogee QSIS™ Probe that was utilized with the MerCAP™ pilot system. This inertial gas separation filter consists of a heated stainless steel tube lined with sintered material. A secondary sample stream is pulled across the sintered metal filter and then is directed through the mercury analyzer at a rate of approximately 1-2 L/min thus providing near real-time feedback during the various measurement periods.

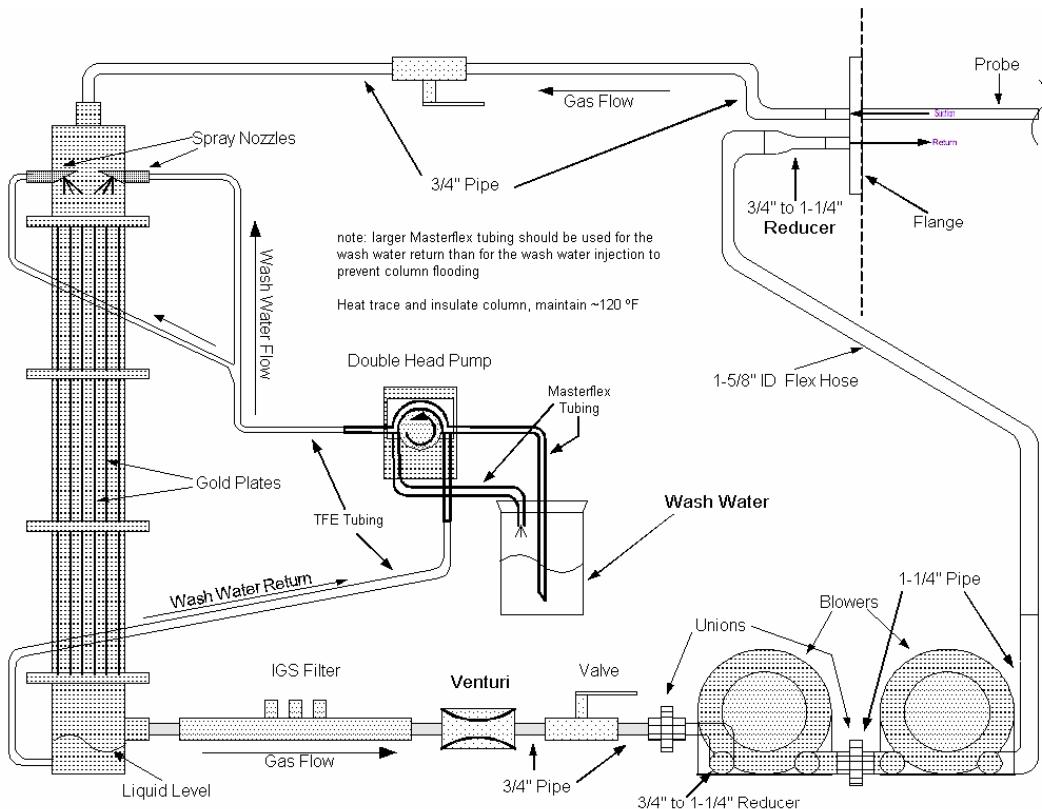
Figure 3-19. EPRI Slipstream MerCAP™ Reactor Schematic

EPRI's wet MerCAP™ slipstream test system was configured to obtain flue gas from the Unit 1 stack, just downstream of the JBR scrubber. Figure 3-19 illustrates the slipstream MerCAP™ system that consists of three 12-inch long sections of gold plated stainless steel screens. The MerCAP™ test column consisted of an array of seven gold-coated screens spaced evenly across a 1.87" x 1.87" square channel. Flue gas flowed parallel to the screens. The total length of the parallel screen reactor was 36-inches.

The slipstream system was equipped with a washing system that sprayed the screens with water at regular intervals using an electronic timer. The wash water was sprayed at the top of the wet MerCAP™ column thus rinsing the sorbent plate surfaces in a co-current manner relative to the flue gas flow. For most of the testing the screens were washed for 5 seconds out of every minute for half an hour every 2 hours. Thus, the total rinse time over each 30-minute washing period was 2.5 minutes. Deionized water, obtained from the Unit 1 FGD laboratory, was used as the washing liquid. Wash water was recycled in batch mode during each test and replaced periodically. The solution pH was routinely monitored to ensure an operating range between 4-8.

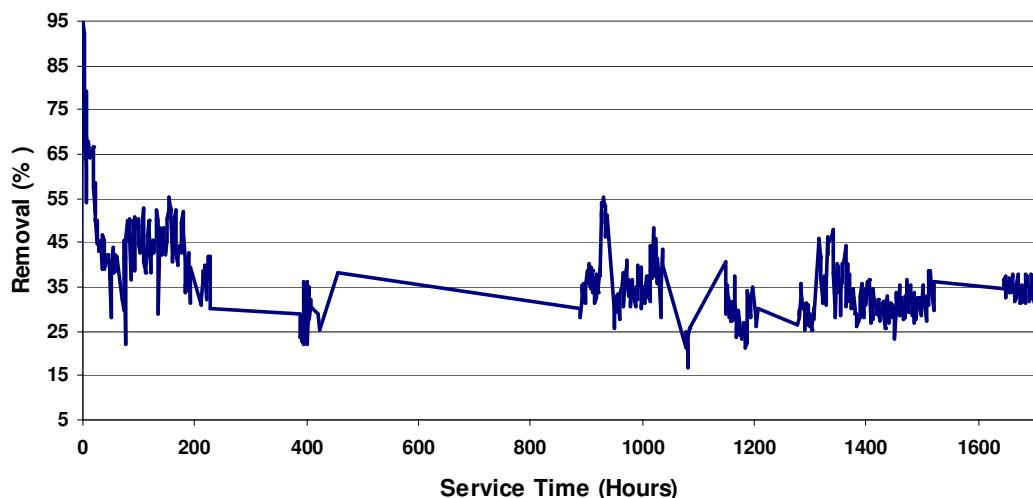
Figure 4-1. Mercury Removal Performance North Dakota Lignite

From the initial start-up of the MerCAP™ array in August 2004 through November 2004, Stanton Unit 10 burned a local North Dakota lignite coal. Only the substrates installed in duct section 1 treated flue gas derived from the lignite fuel. Figure 4-1 shows the mercury removal performance of the MerCAP™ substrates as a function of service time with the Lignite fuel being fired.

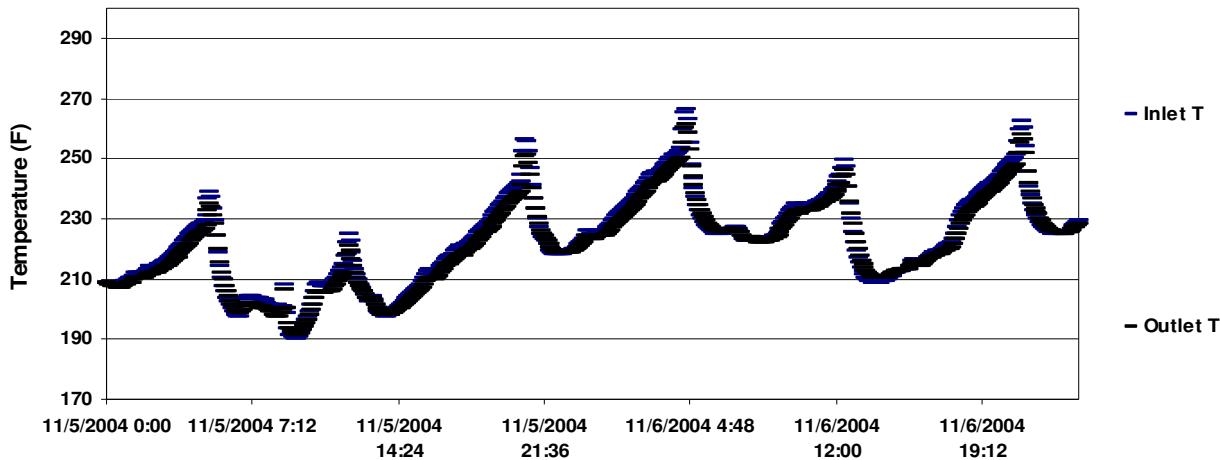
Figure 4-2. Post PRB Fuel Switch Duct Temperature

On November 3, 2004, Stanton Unit 10 switched fuels from a local North Dakota Lignite to a Powder River Basin subbituminous coal. The fuel switch was observed to cause remarkable changes in key operations parameters. Duct temperatures were, in general, significantly higher with the PRB fuel and varied significantly. Also, the lime slurry feed to the SDA was decreased due to the lower sulfur content of the PRB fuel. Figure 4-2 shows a plot of the measured duct temperature at the inlet and outlet of the MerCAP™ array over a several day period following the fuel switch.

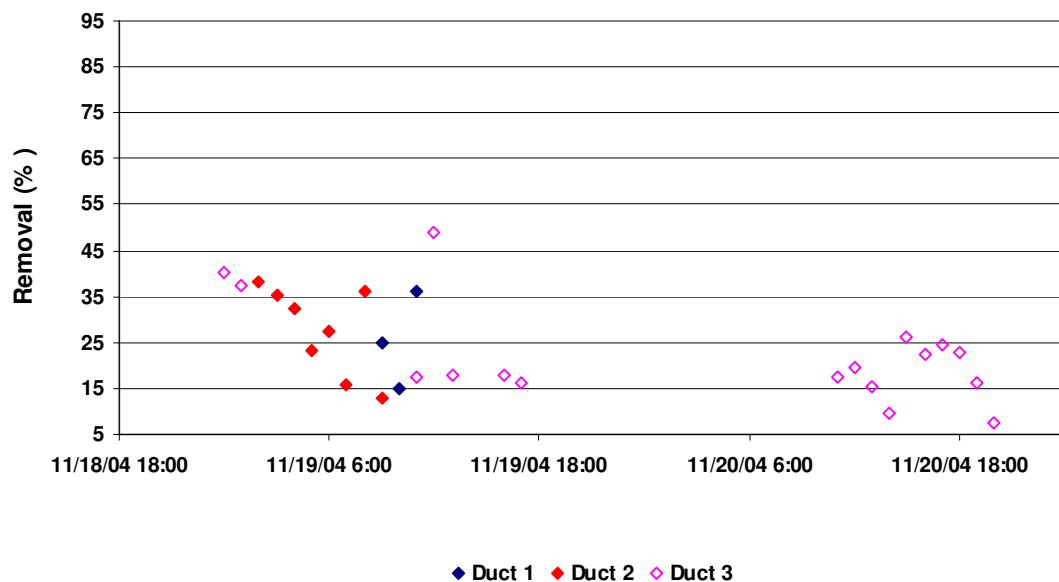
Figure 4-4. Initial Operation Substrates in Ducts 2 and 3

Shortly after the switch to PRB coal, MerCAP™ substrates were installed into duct sections 2 and 3. These substrates were not pretreated with an acid wash unlike the substrates already in service in duct section 1. The substrates installed in duct section 2 matched the configuration of those in duct section 1, with 1-inch plate spacing and 10 feet of active length. The duct 3 substrates were configured in ½-inch plate spacing and 10 feet of active length in order to investigate possible performance improvements that might be achieved by modifying the geometry of the MerCAP™ substrates. Figure 4-4 shows the initial MerCAP™ performance following installation of sorbent substrates into duct sections 2 and 3.

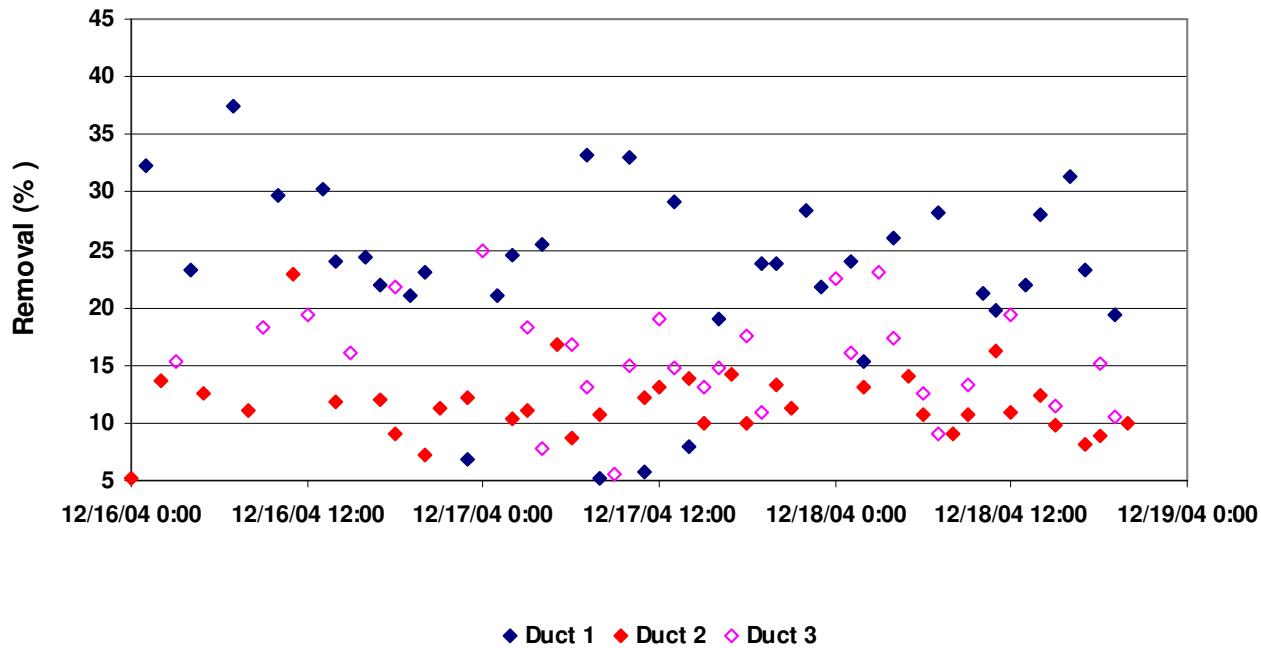
Figure 4-5. Mercury Removal Performance Prior to Ducts 2 and 3 Removal from Service for Acid Treatment

mercury removal performance just before ducts 2 and 3 were pulled from service. Figure 4-6 shows the mercury removal performance following re-installation of the substrates.

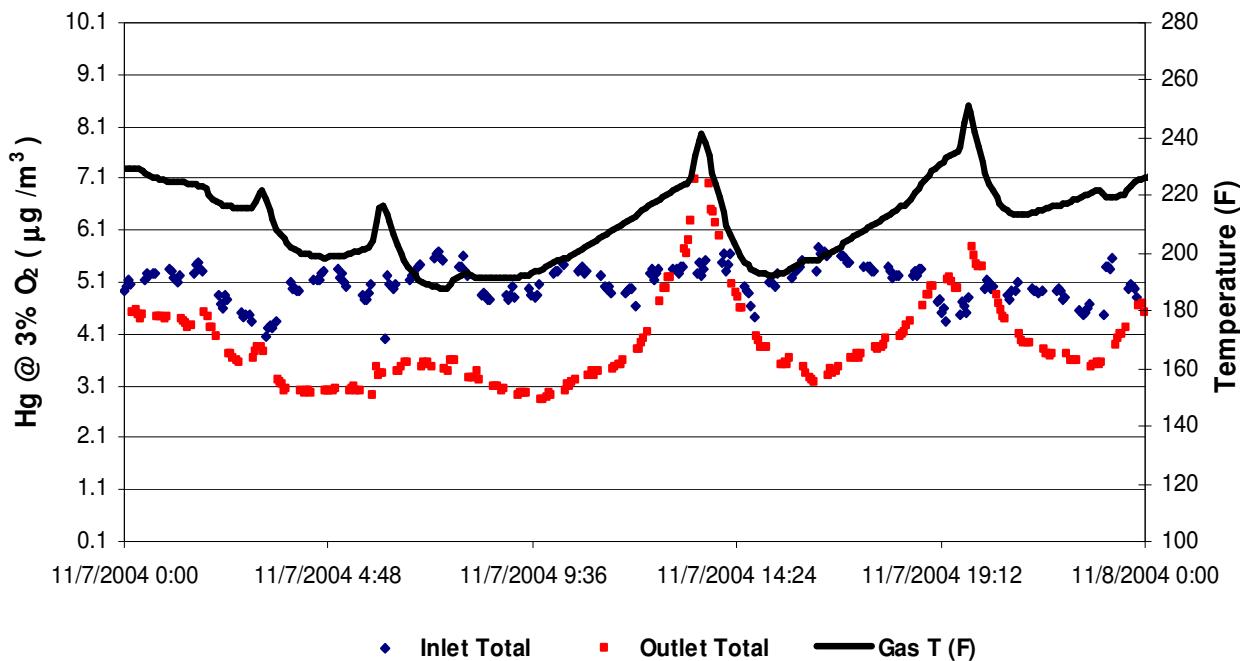
Figure 4-7. Gas Temperature Effect on MerCAP™ Mercury Removal

As has been mentioned above, the temperature of the flue gas was observed to have dramatic impacts on the mercury removal performance of the MerCAP™ substrates. The host site was able to provide some measure of control over gas temperatures for short periods of time, which enabled the collection of data to directly verify the effect. Figure 4-7 shows a plot of CMM data and gas temperatures demonstrating the impact of gas temperature on the mercury removal performance of the substrates. These results show that as the gas temperature increased so too did the outlet mercury concentration. In some cases, the outlet mercury levels actually spiked above those at the inlet, indicating that mercury was being emitted from the substrate plates. Using the observations gained from data such as that shown in Figure 4-7, a test was conducted to determine if in-situ regeneration of the substrates at relatively low temperatures was possible.

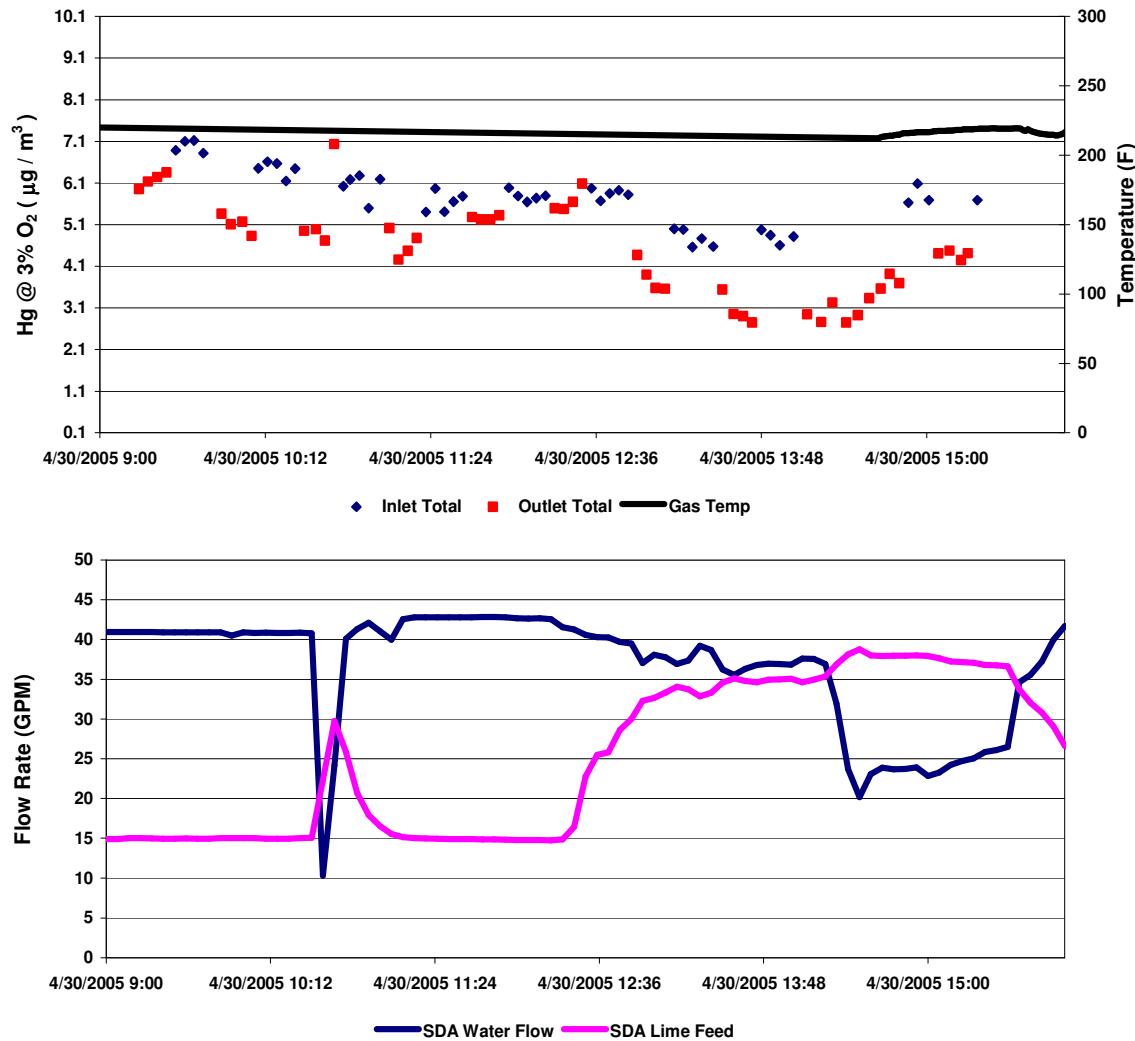
Figure 4-9. SDA Parametric Test Results

Tests conducted at Stanton Unit 10 showed that in addition to gas temperatures, changes in the water and lime slurry feed rates to the SDA affected mercury removal performance of the downstream MerCAP™ substrates. Tests were conducted to investigate and quantify this effect by changing the feed rates of lime slurry and water to the SDA. Also, a different lime feedstock, designed to increase SDA sulfur capture, was also tested. On February 30, 2005 a test was conducted where the lime slurry and water feed rates to the SDA were varied. Figure 4-9 shows the results of the test.

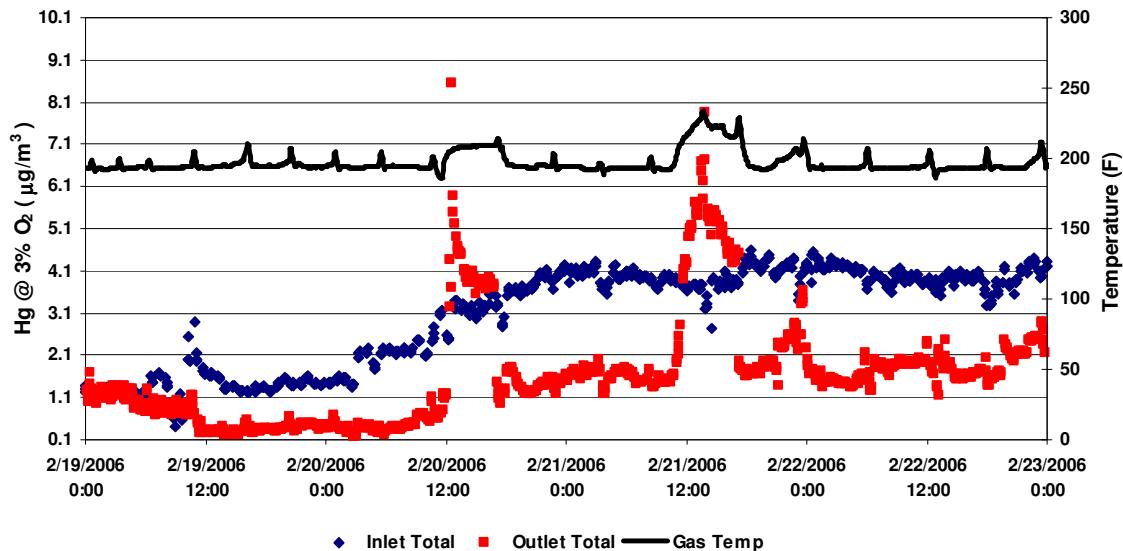
Figure 4-10. Lime Change Test Results

In addition, a high efficiency lime reagent was fed to the SDA on February 20, 2006 resulting in increased sulfur (i.e., SO_2) removal. Figure 4-10 shows the CMM data just preceding and following the change in SDA lime reagent. Table 4-3 shows a summary of the results for the MerCAP™ substrates during the high efficiency lime tests.

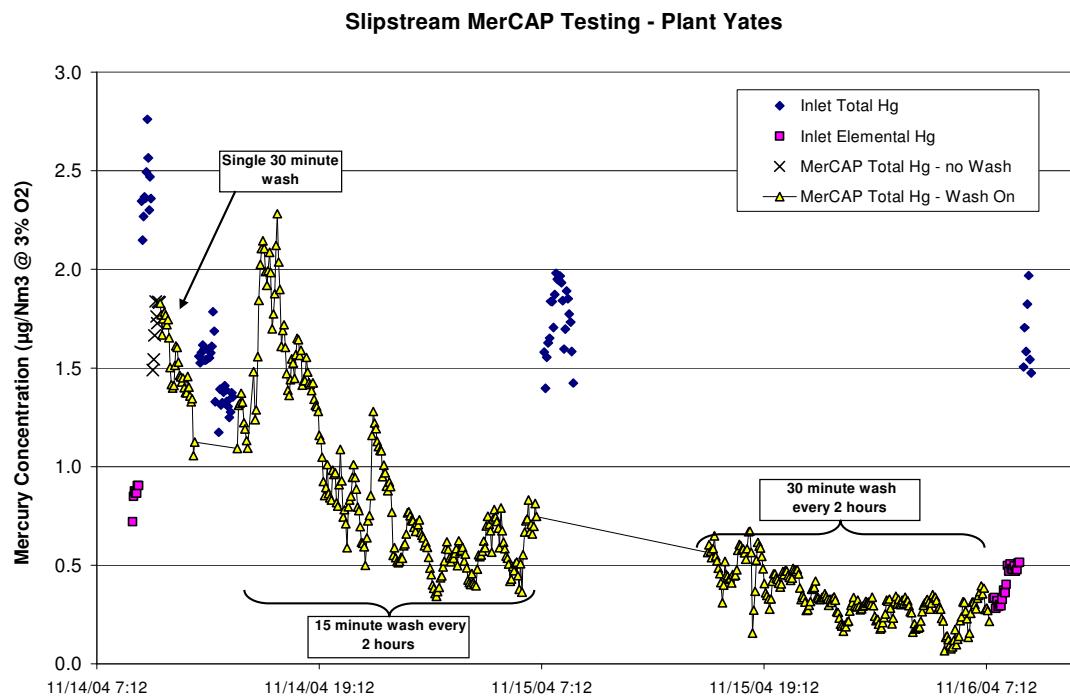
Figure 4-13. Impact of Water Wash on Slipstream MerCAP™ Reactor Performance.

improvement in performance, with an average mercury removal of 76% achieved after 4 rinsing cycles.

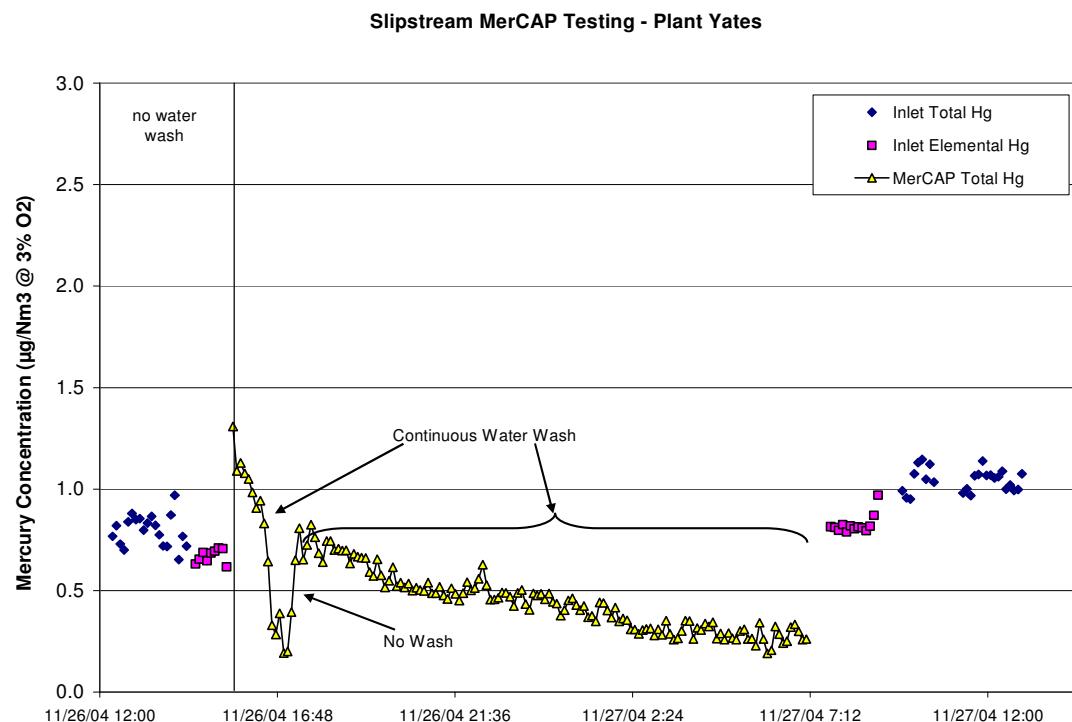
Figure 4-14. Impact of Continuous Water Wash on MerCAP™ Performance.

that factors associated with prolonged flue gas exposure may lessen or inhibit the impact of the water rinse.

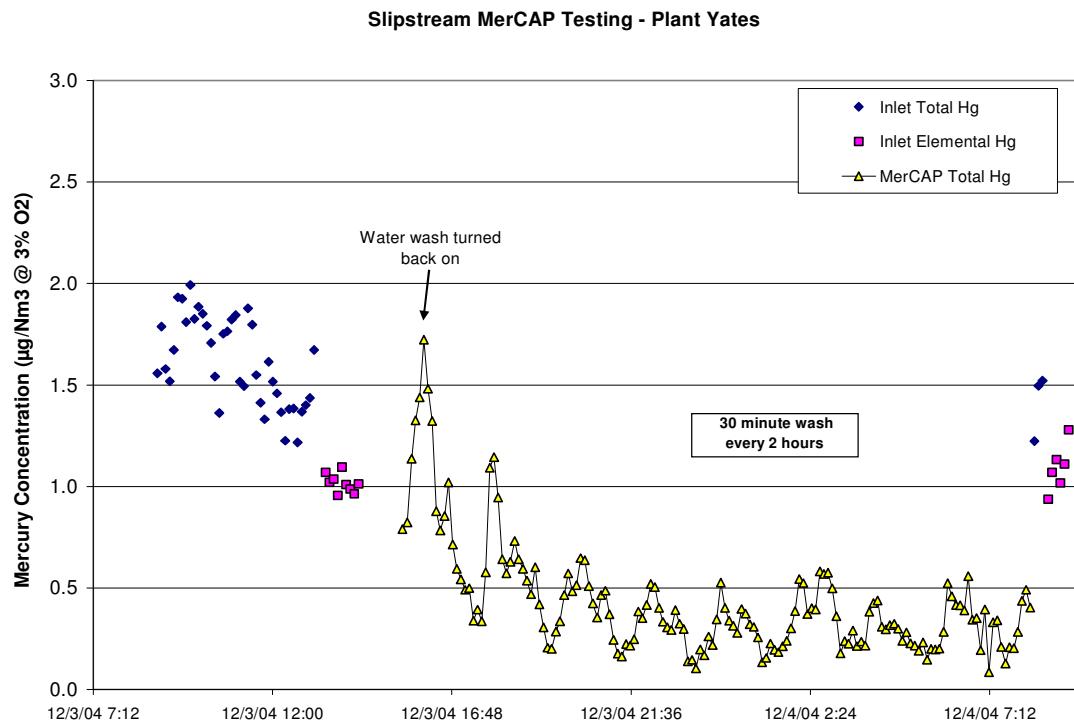
Figure 4-15. MerCAP™ Mercury Removal With Water Wash Cycling.

Based on the obtained results, it was desirable to determine possible impacts of a catastrophic failure of the water rinse system. To evaluate this, the water rinse was turned off for a period of five days while the MerCAP™ reactor continued to treat flue gas. Mercury removal decreased to just below 40% during this period. This represented less of a drop in performance than observed previously. Although the reason for this is not understood, it is possible that the extended continuous rinse conducted prior to the test may have played some role. Figure 4-15 shows results following re-implementation of the water rinse at a 30-minute interval once every 2 hours. Relatively quick recovery was observed, with over 70% removal achieved after five rinsing cycles (i.e., 10 hours). Results showed a clear correlation of increasing, then decreasing removal with each water rinsing cycle. Once stabilized, outlet mercury values consistently ranged from 0.1 – 0.6 $\mu\text{g}/\text{Nm}^3$. This level of removal was effectively maintained for over twelve hours; the system was allowed to run at these condition for several more days. These results suggest that an effective water rinsing scheme may be critical for the control of mercury emissions across a wet MerCAP™ system.

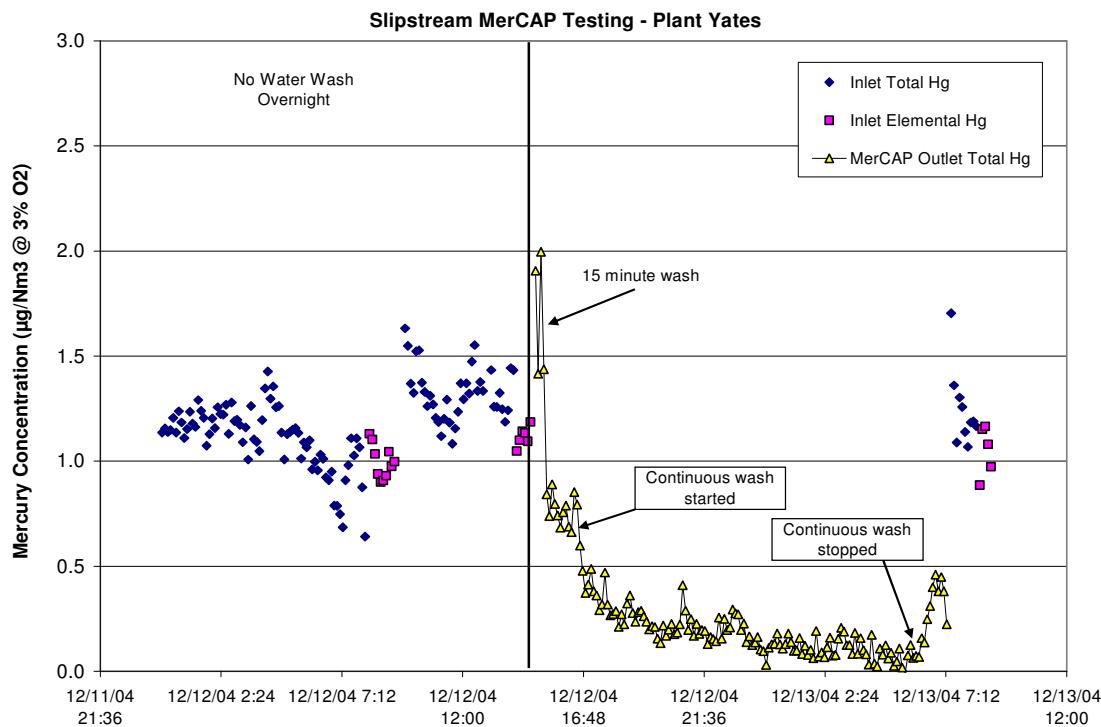
Figure 4-16. Recovery of MerCAP™ Performance after Losing Water Wash System.

Despite the consistent results observed during the first 24 hours of operation following implementation of the 30 minute/2 hour rinse, performance dropped off to approximately 40% removal over the next week of operation. It was decided to implement a longer-term continuous rinse of the sorbent arrays in an attempt to recover the ‘initial’ performance. It was also desired to determine the level of removal that could be achieved with an intensive rinsing process. Figure 4-16 shows the results from this test. After an appreciable initial improvement in performance, outlet mercury levels continued to slowly decrease with continued rinsing. Measurements showed average mercury removals of 90% and 94% after 7.5 and 13.5 hours of continual rinsing, respectively. Upon terminating the rinse, outlet mercury levels immediately started to increase; only 60% removal was observed one hour after the rinse was turned off.

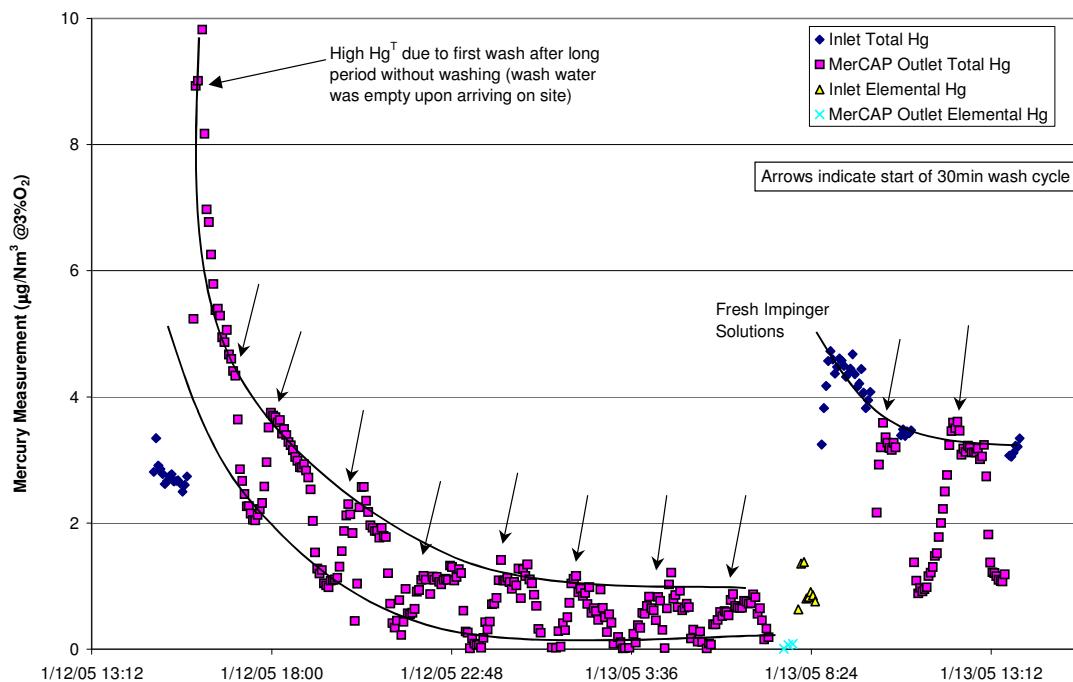
Figure 4-17. MerCAP™ Performance Cycling with Water Wash.

Upon arriving on site after approximately three weeks of continuous operation, it was determined that the wash water reservoir tank had been depleted for an undetermined amount of time; the reason for the water loss from the closed system was not determined. The tank was refilled with DI water, and allowed to wash for one hour before mercury measurements were made. Figure 4-17 contains a plot of these measurements.

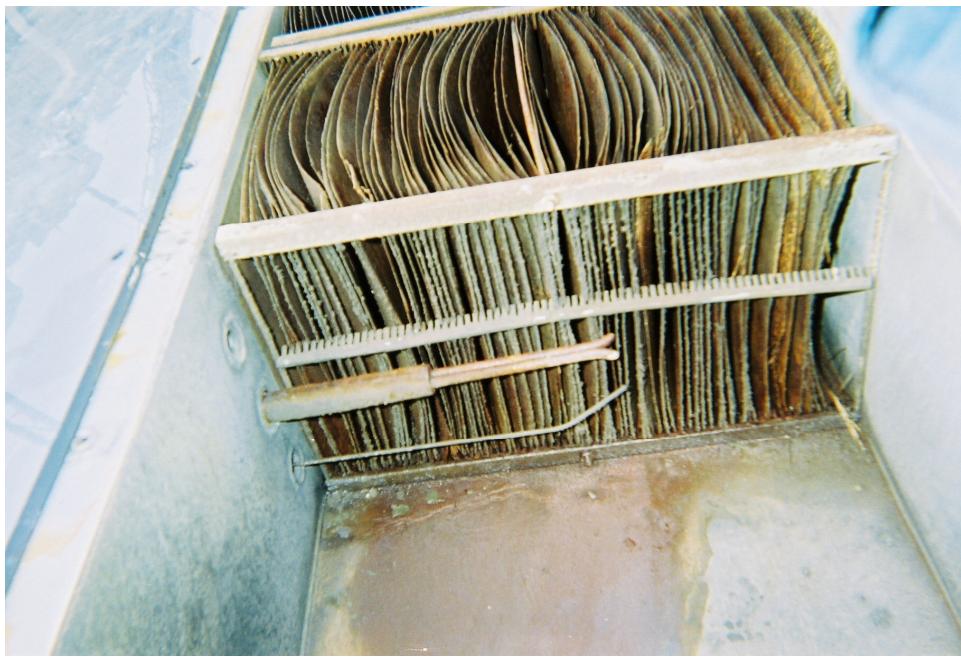
Figure 4-19. Corroded Gold Screens in the MerCAP™ Reactor Following Flue Gas Flow Reversal.

The MerCAP™ substrates were then disassembled and the reactor was cleaned. Plans were then made for preparing new sorbent arrays for the Yates pilot program. Additional plans were made to reconfigure the pilot system to decrease the overall system pressure-drop and prevent chances for exposure to untreated flue gas, as described in the next section.
