Evaluation of MerCAP™ for Power Plant Mercury Control

Final Project Report

**Cooperative Agreement Number
DE-FC26-03NT41993**

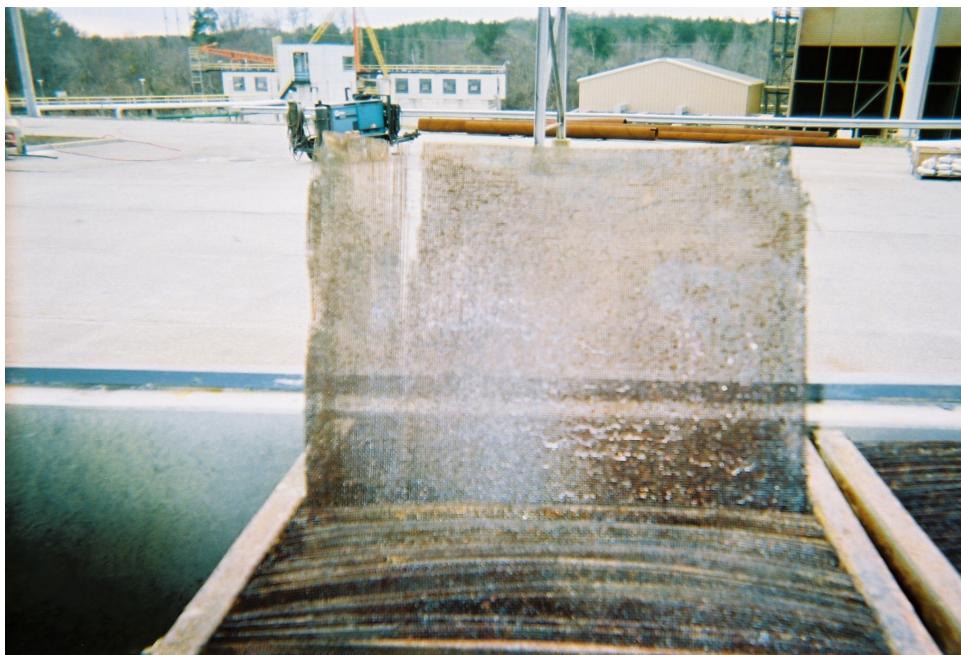
Figure 4-20. Corroded Gold Screens in the MerCAP™ Reactor

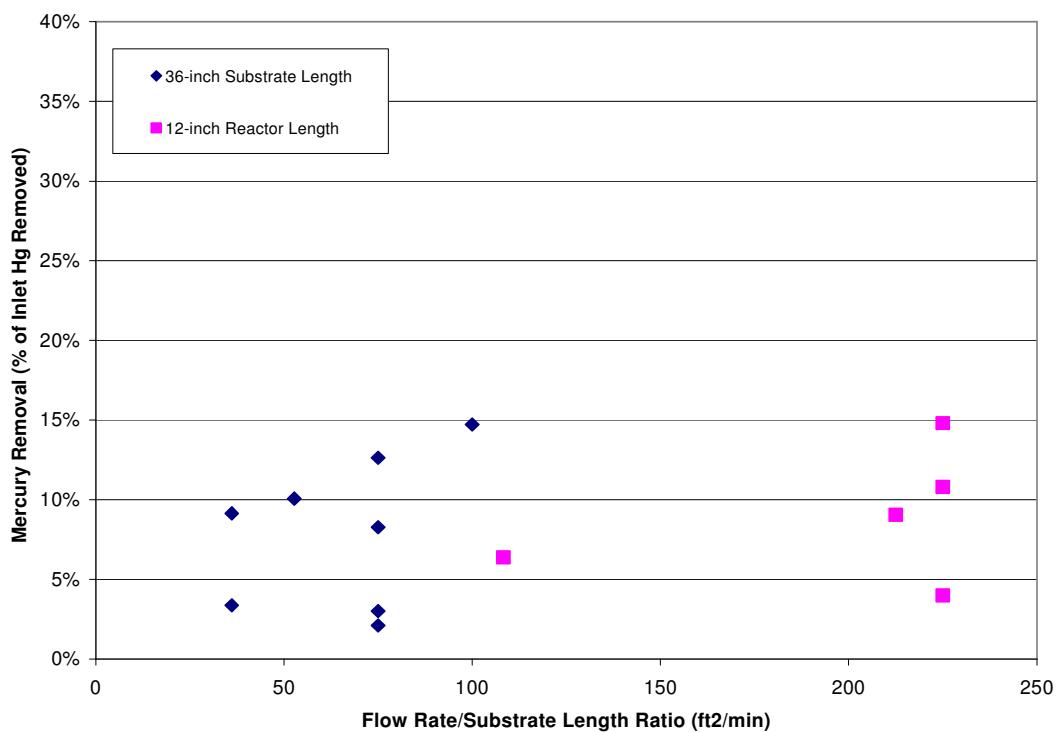
Figure 4-21. Impact of Gas Flow Rate and MerCAP™ Sorbent Array Length on Mercury Removal.

Date	Flow Rate	Gold Length	Inlet Hg	Outlet Hg	% Hg Removal
	(acfm)	(inches)	(μgNm^3 @ 3% O ₂)	(μgNm^3 @ 3% O ₂)	
7/13/2006	3600	36	3.61	3.08	15%
7/13/2006	2700	36	3.51	3.07	13%
7/14/2006	2700	36	4.23	3.88	8%
7/14/2006	1900	36	3.98	3.58	10%
7/14/2006	1300	36	3.98	3.61	9%
7/15/2006	1300	36	2.03	1.96	3%
7/15/2006	2700	36	4.23	4.11	3%
8/4/2006	2700	36	6.19	6.06	2%
8/6/2006	2700	12	4.52	3.84	15%
8/18/2006	2700	12	3.41	3.24	5%
8/18/2006	1300	12	3.53	3.30	6%
9/23/2006	2550	12	4.76	4.33	9%
9/24/2006	2700	12	2.53	2.26	11%
9/25/2006	2700	12	4.73	4.03	15%
9/25/2006	2700	12	2.12	2.04	4%

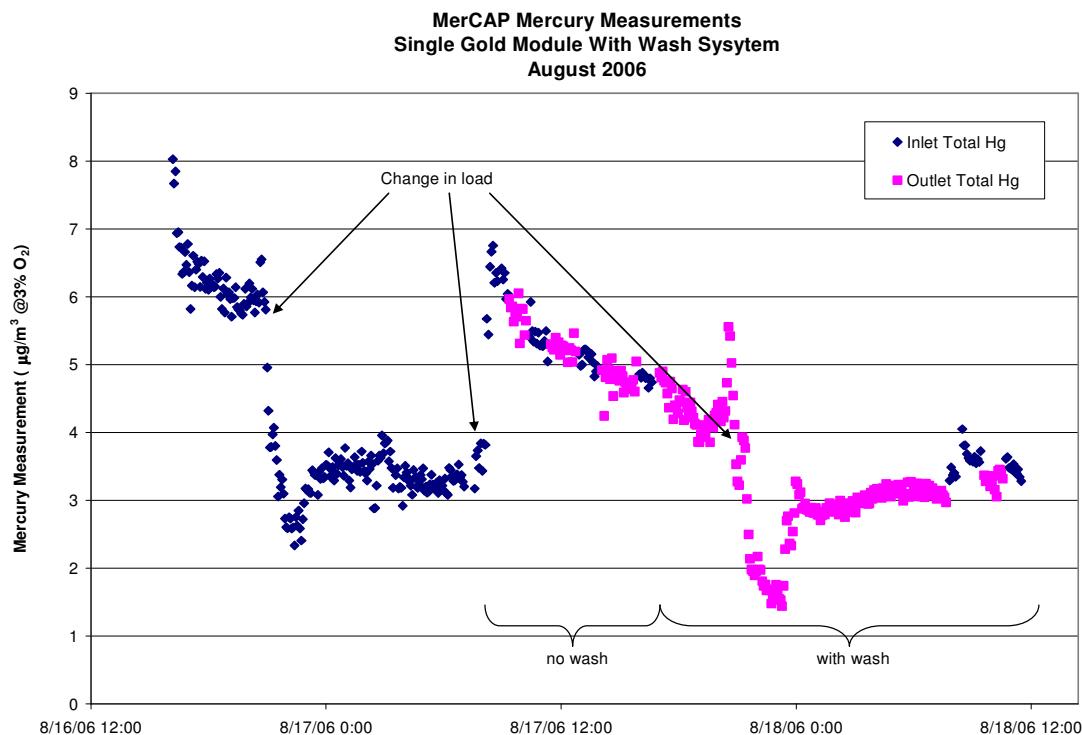
Figure 4-23. Impact of Water Rinse on Mercury Removal by Single Module MerCAP™ System.

Measurement results indicated a decrease in removal performance to approximately 5% (Table 4-13). This was considerably lower than the theoretical removal of 31% for a single sorbent module configuration (Table 3-3). No appreciable change was observed after decreasing the flue gas flow to 1300 acfm. To further evaluate the impact of rinsing the wet MerCAP™ screens, the rinse system was turned off for an eight hour period on August 17th, 2006. Results over that period, shown in Figure 4-23, showed virtually no mercury removal across the single sorbent array. Upon re-establishing the water rinse, the relatively low levels of mercury removal were again observed.

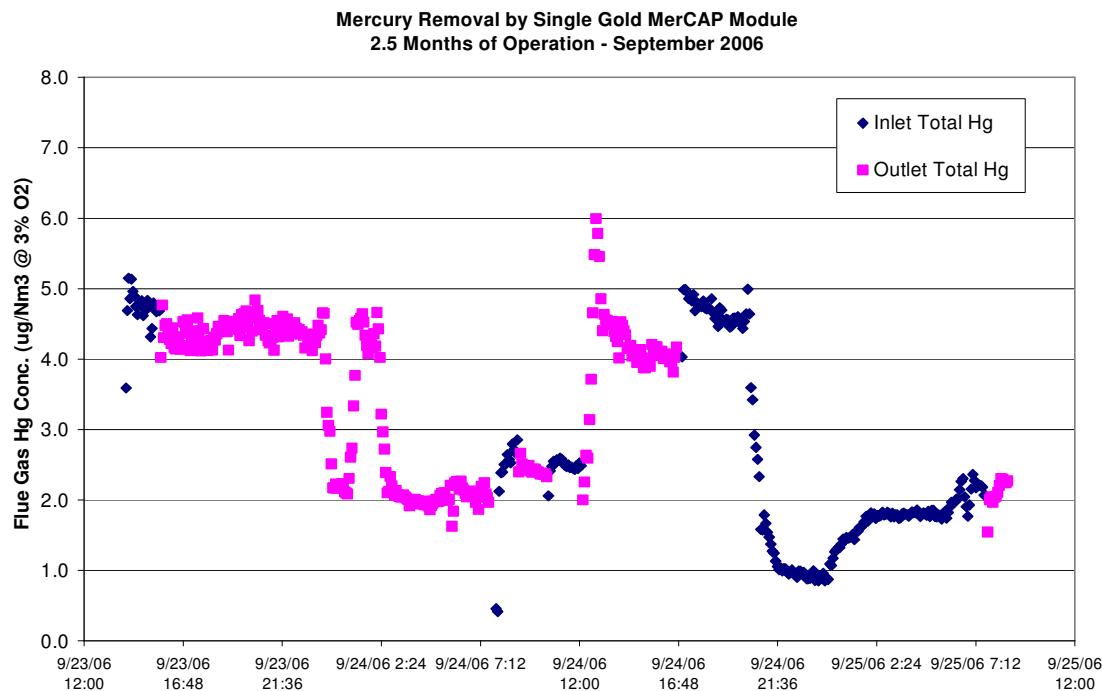
Figure 4-24. Mercury Removal by Single-Module MerCAP™ Array after 2.5 Months of Operation

as unit load changed over the period. These changes resulted in no appreciable changes to the MerCAP™ performance, with outlet emissions tracking those of the inlet with only low levels of removal observed.

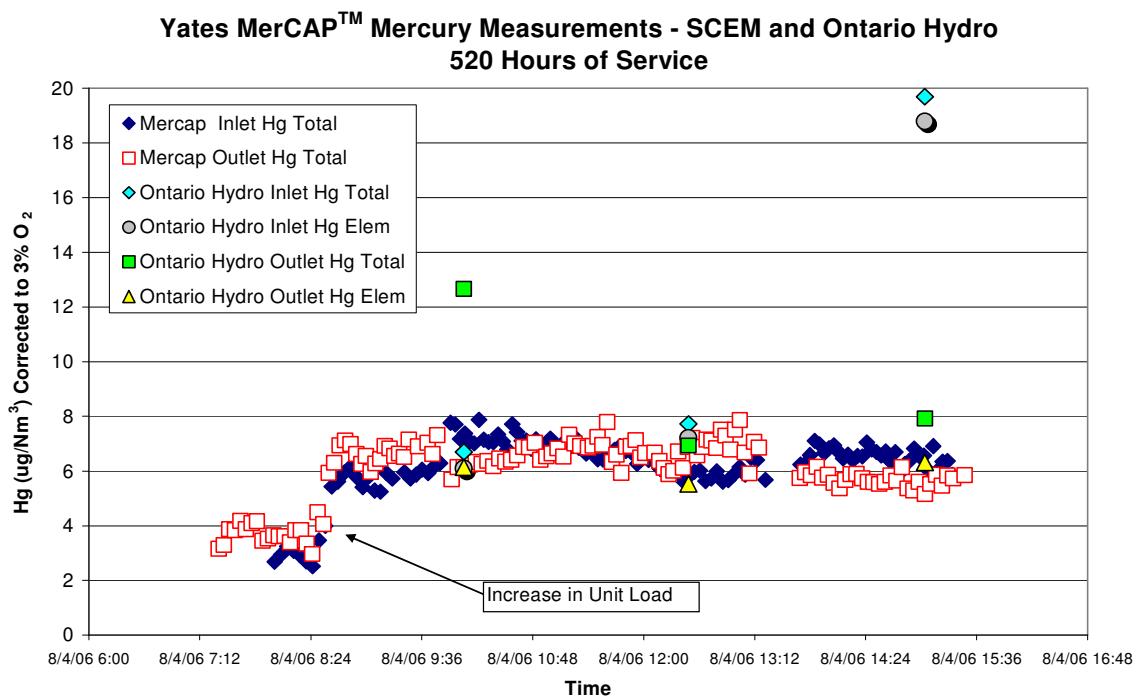
Figure 4-27. SCEM and Ontario Hydro Mercury Measurements across the MerCAP™ at Plant Yates

Increased water washing frequency had no effect on the removal efficiency of the system in May and August of 2007. Each round of Ontario Hydro measurement with the increased wash confirmed that there was minimal mercury removal across the MerCAP™ reactor.

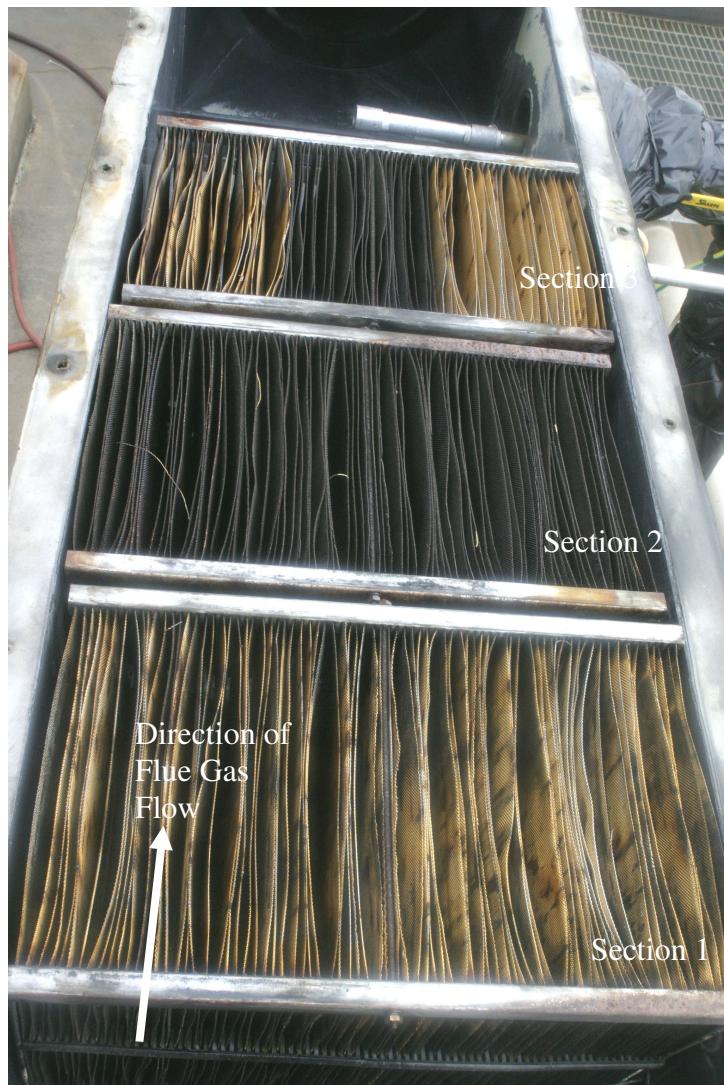
Figure 4-29. Gold Substrates after One Month of Flue Gas Service (2006 test).

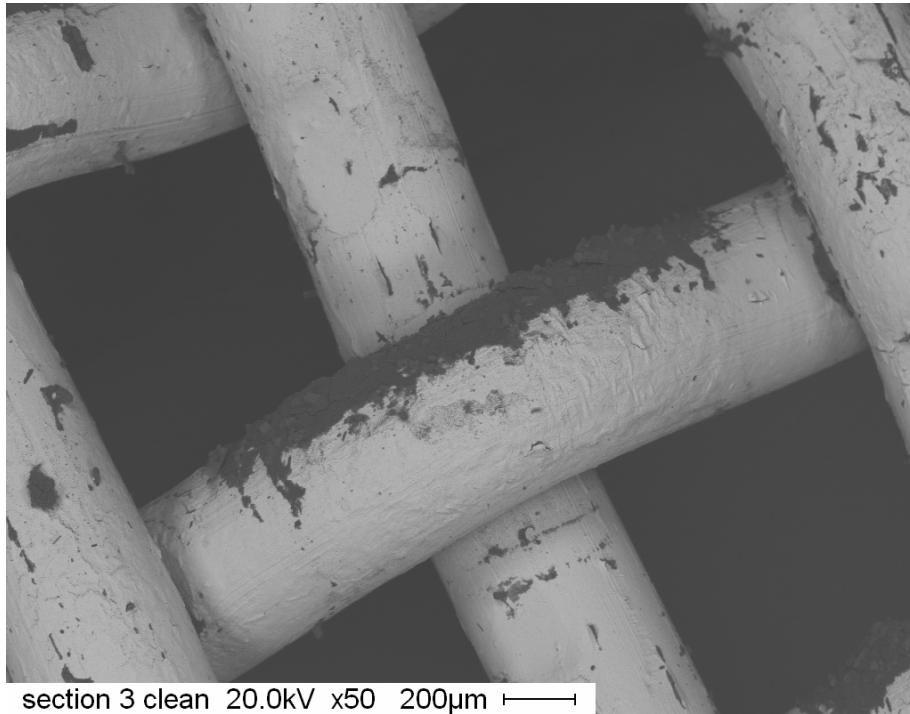
Figure 4-30. Scanning Electron Micrograph of Clean Gold Screen Surface.

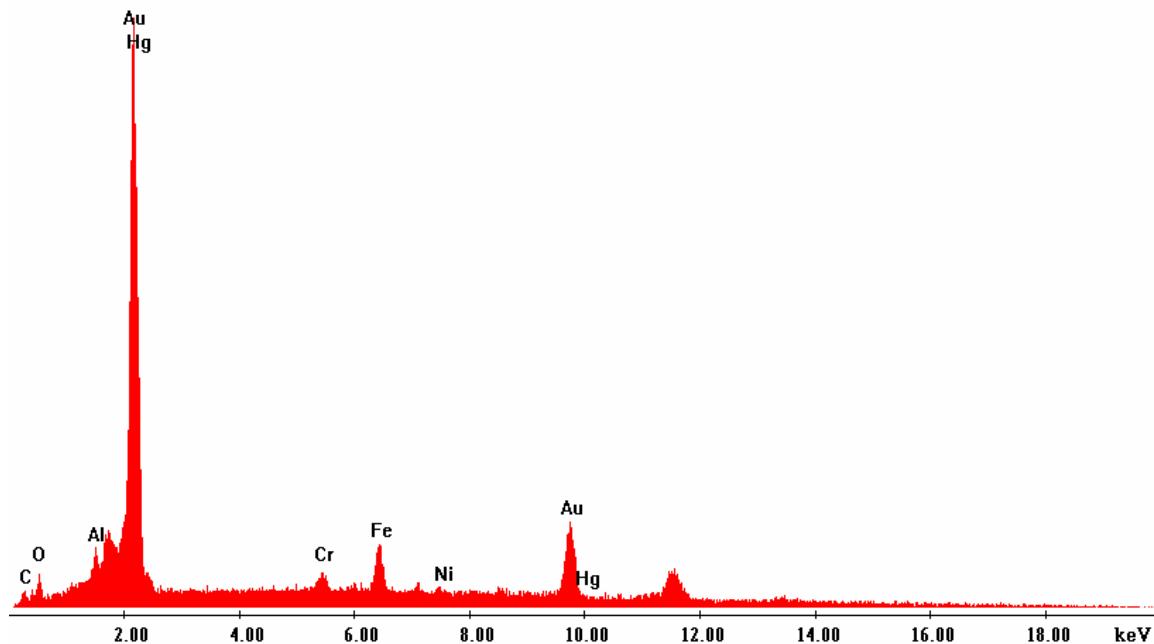
Figure 4-31. EDS Scan of Clean Gold Surface.

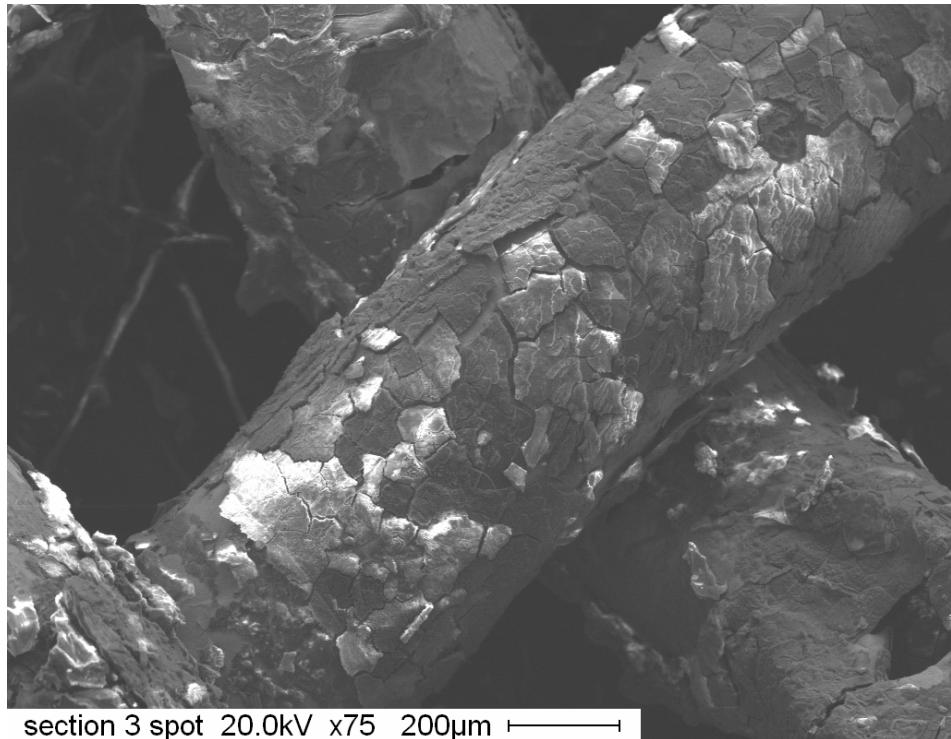
oxides at the gold surface. Fairly high levels of copper and manganese were also detected in the treated sample.

Figure 4-32. Scanning Electron Micrograph of Fouled Gold Screen Section.

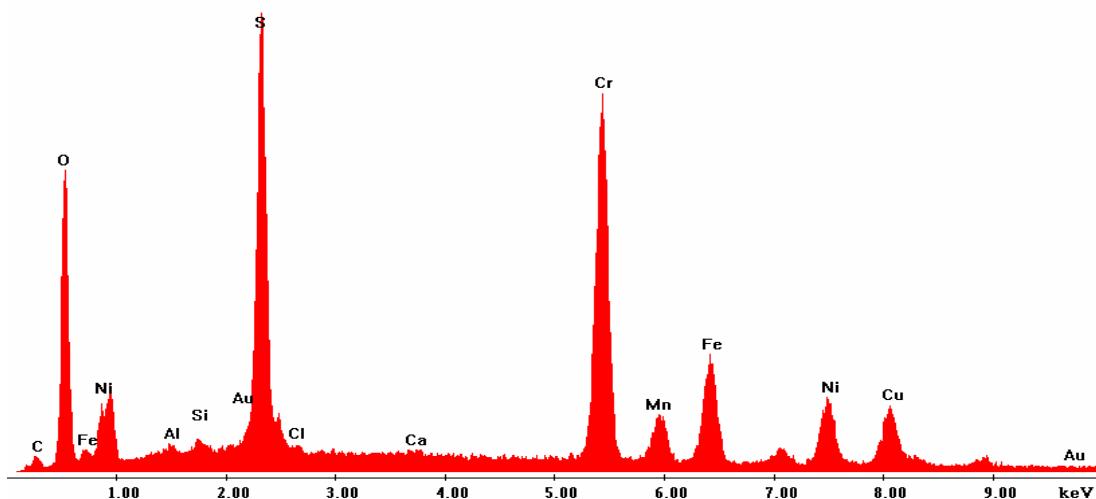
Figure 4-34. EDS Scan for Screen Pictured in Figure 4-33

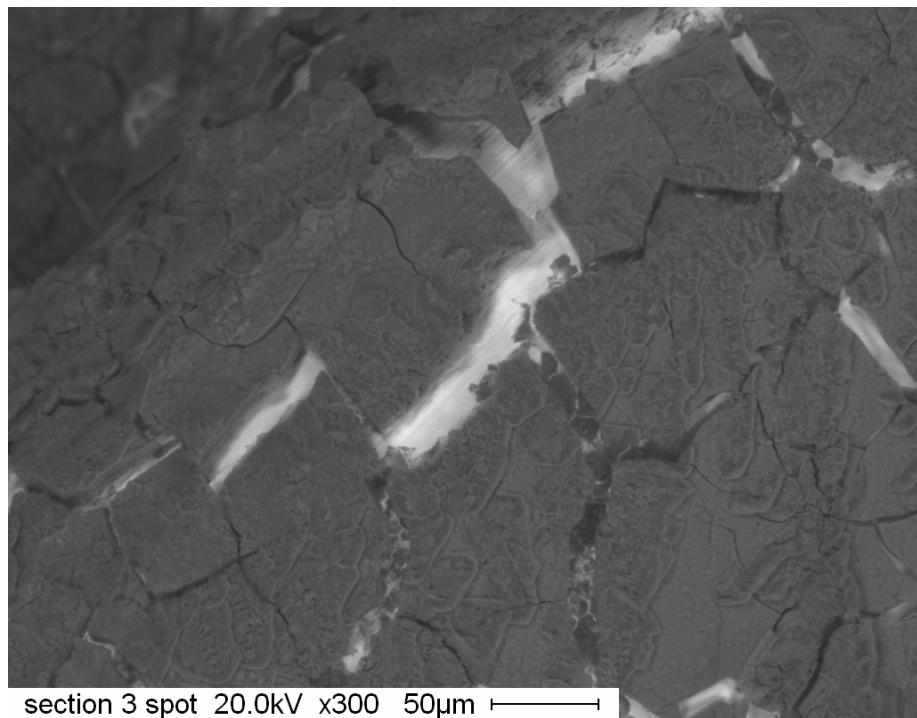
Figure 4-35. SEM Photo of a Discolored Spot on a Relatively Clean Screen

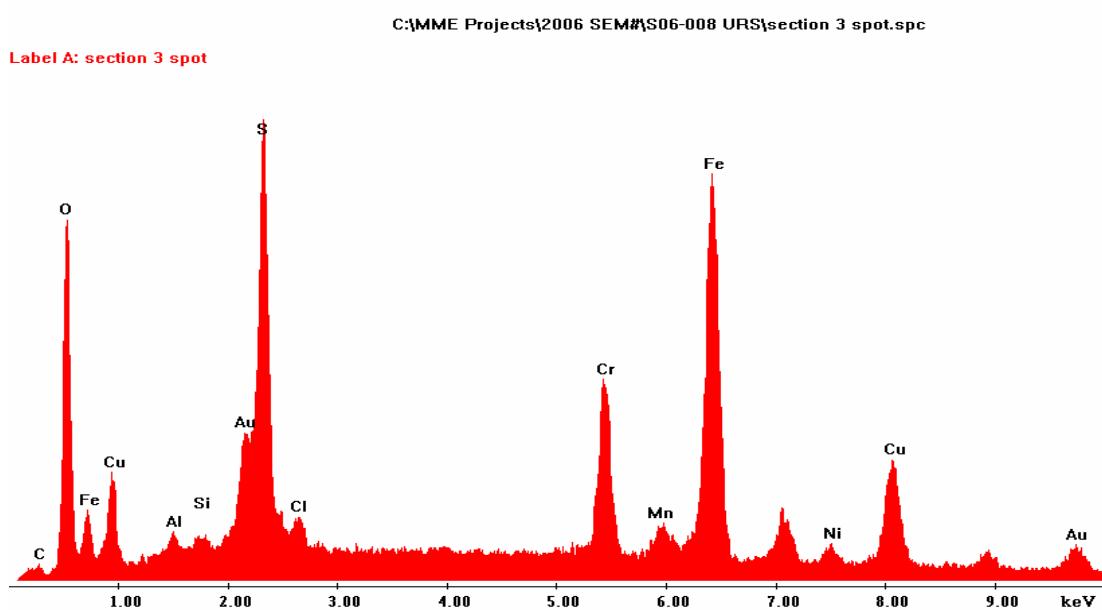
Figure 4-36. EDS Scan for Screen Pictured in Figure 4-35

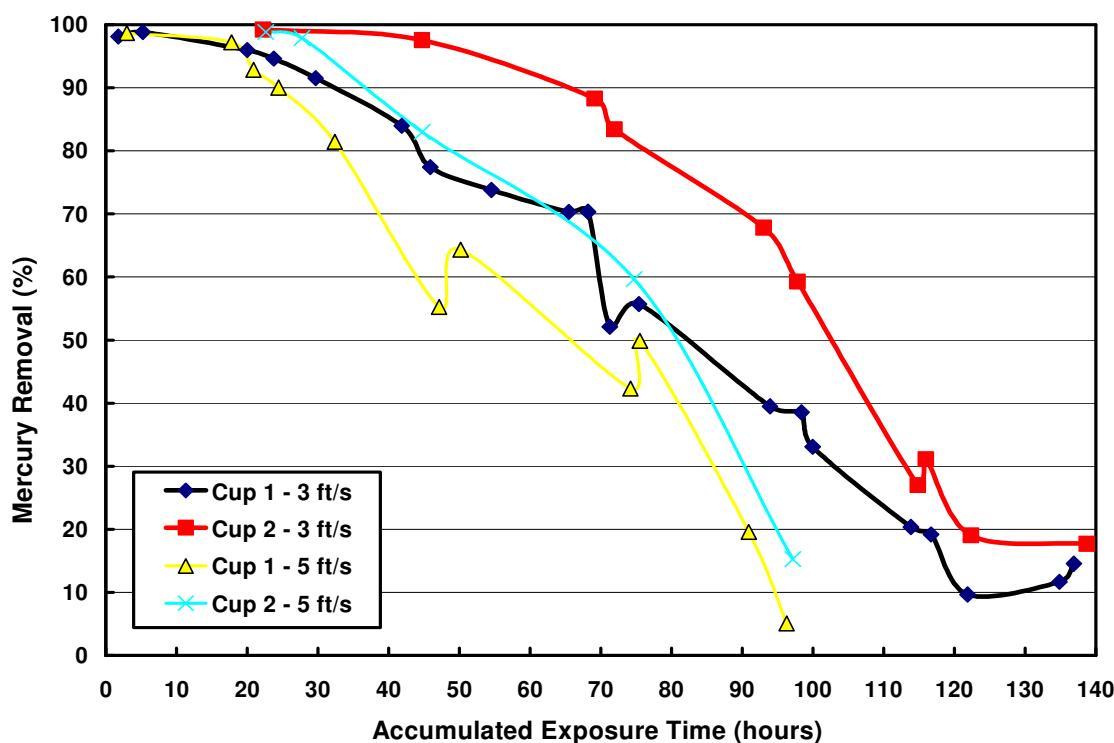
**Figure 5-2. Mercury Removal by Norit Darco Hg Granules;
Plant Yates Slipstream Tests (2-inch bed depth)**

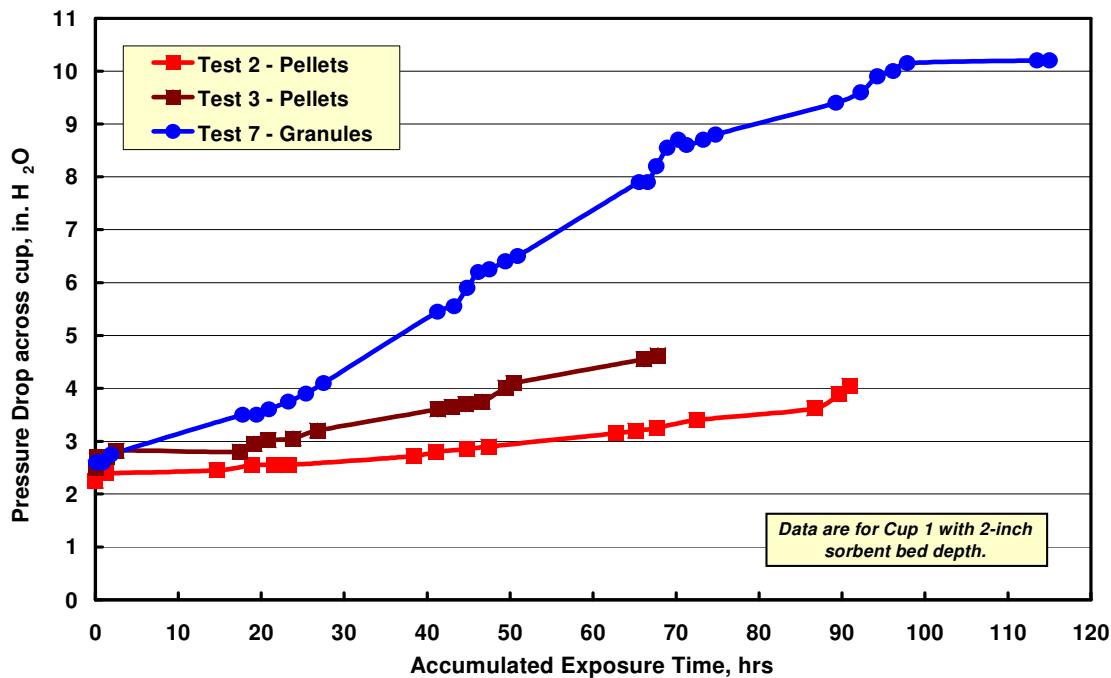
Figure 5-3. Pressure Drop Across Granular Sorbents During Mercury Removal Tests

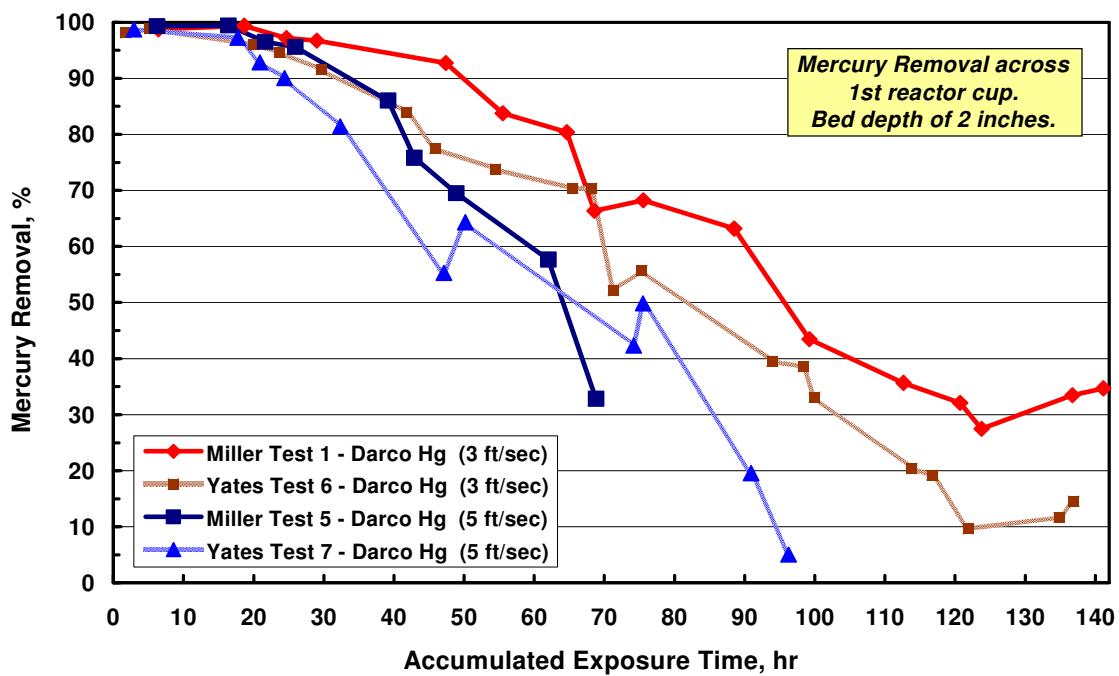
Figure 5-4. Mercury Removal by Norit Darco Hg at Plants Miller and Yates

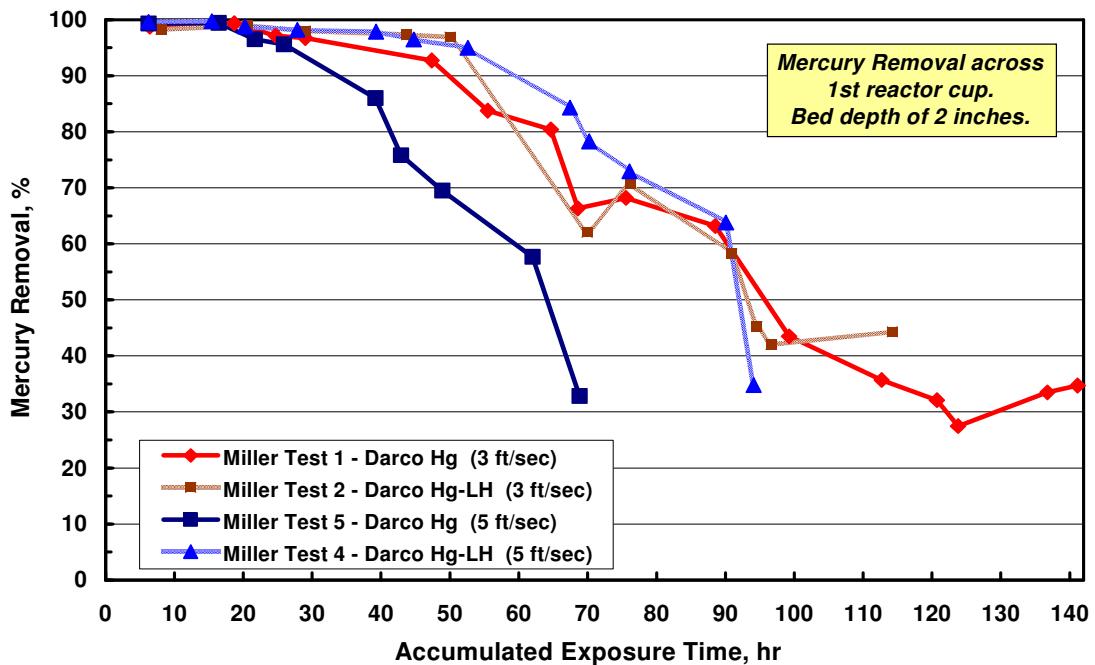
Figure 5-5. Comparison of Norit Darco Hg and Darco Hg-LH Performance at Plant Miller

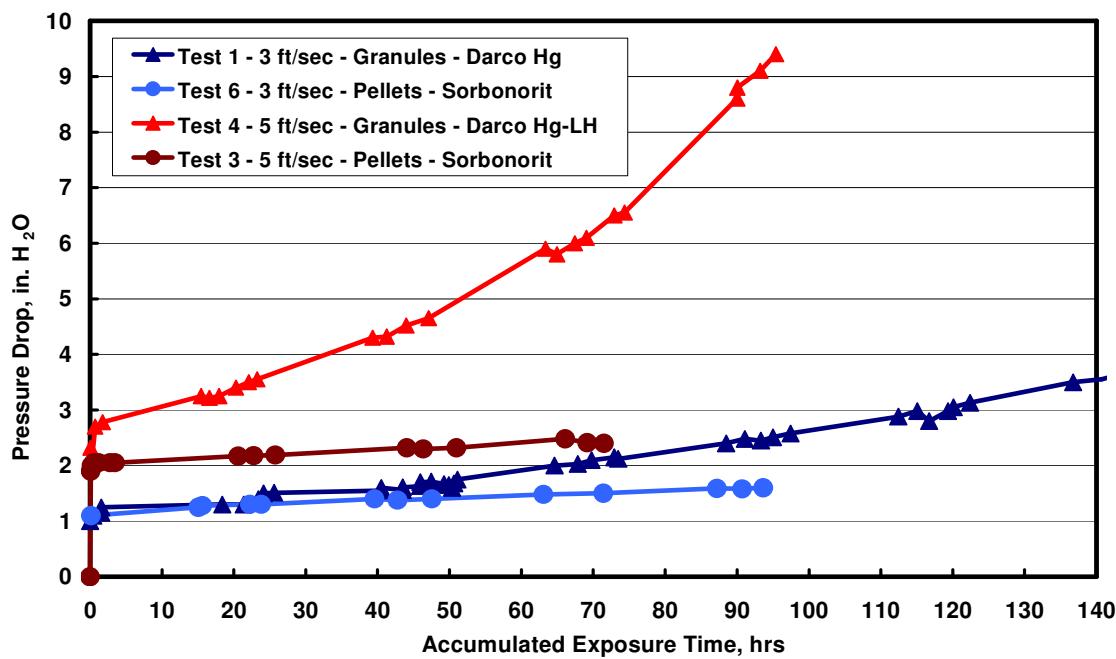
Figure 5-6. Pressure Drop across Pellets and Granules at Plant Miller (2-inch beds)

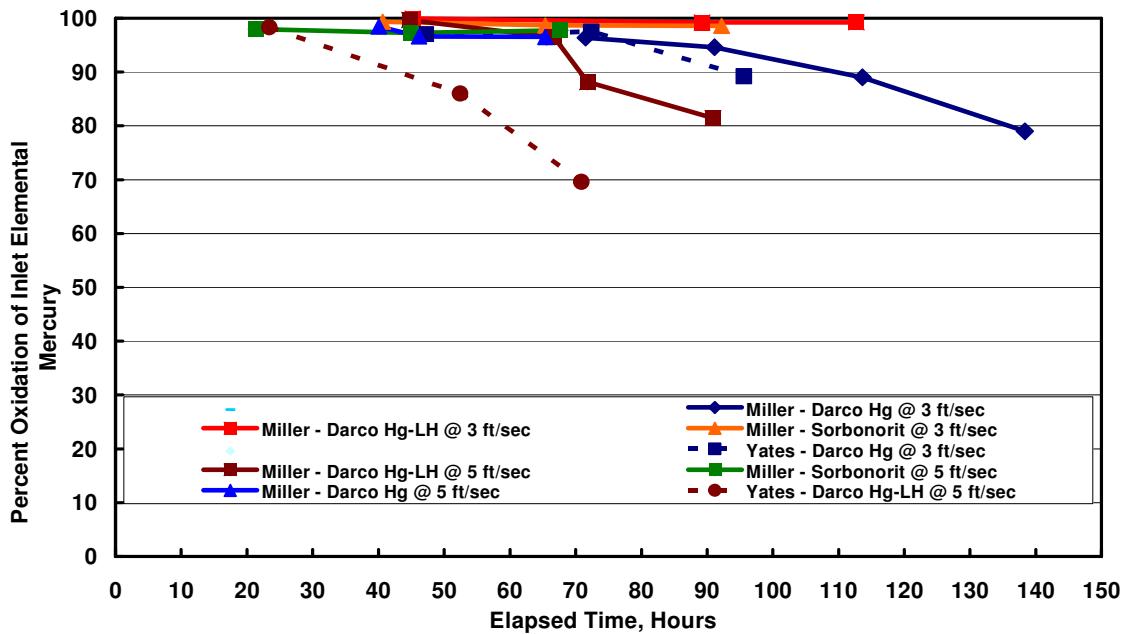
Figure 5-7. Elemental Mercury Oxidation by Mercury Sorbents at Plant Miller

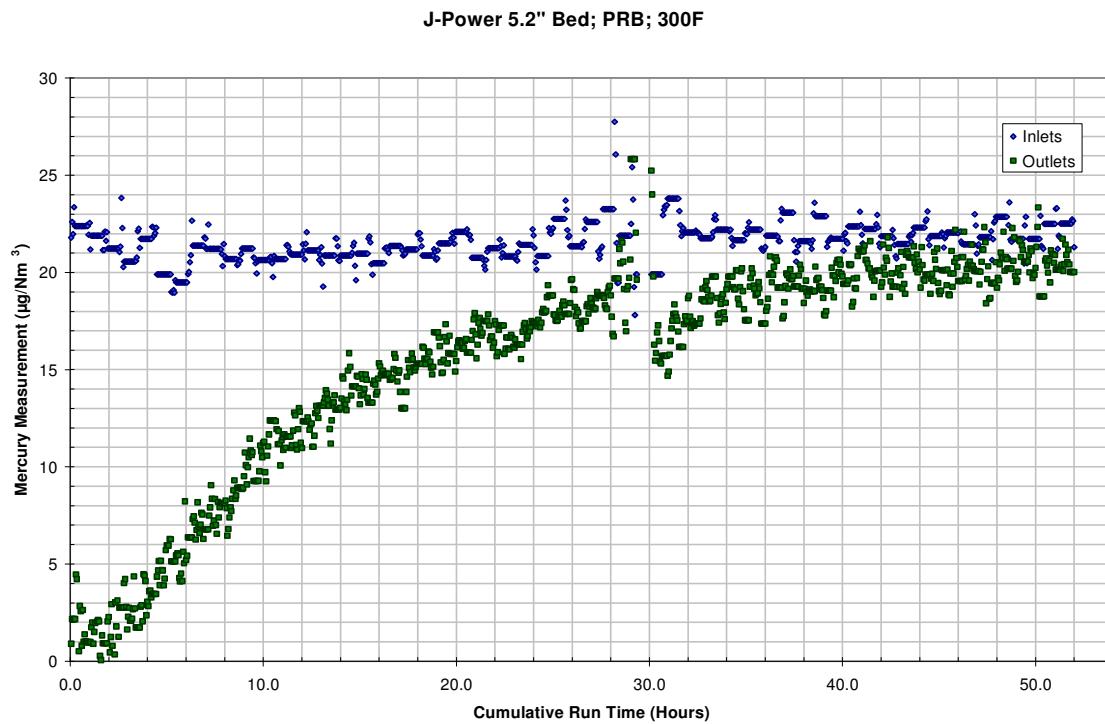
Figure 5-9. Representative Breakthrough Curve for Lab Tests – J-Power Sorbent.

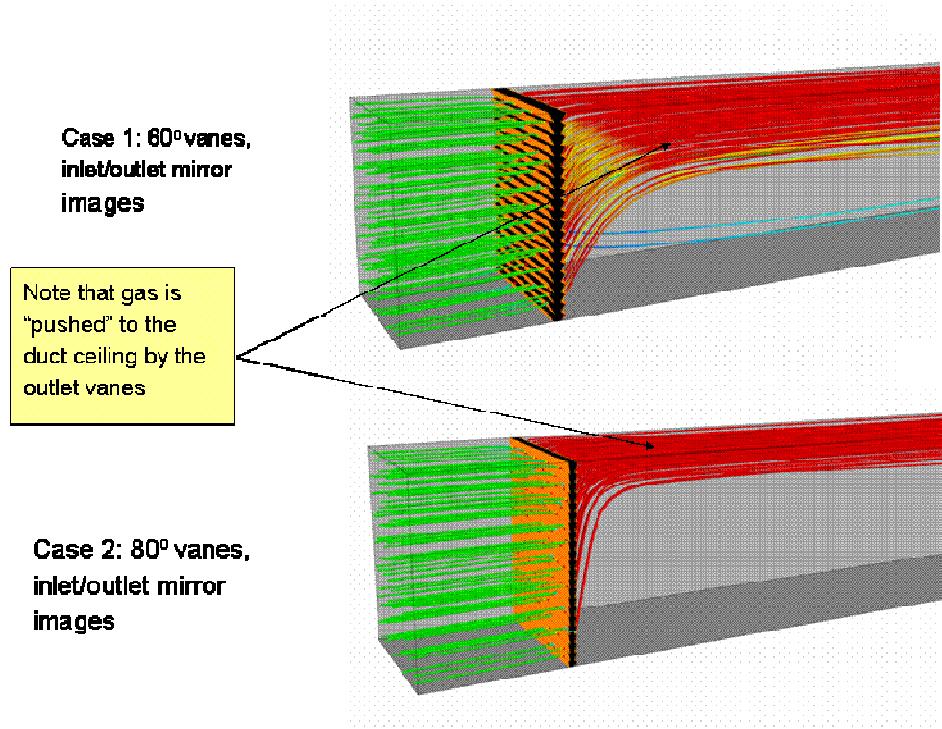
Figure 5-10. Flue Gas Streamlines, Colored by Velocity

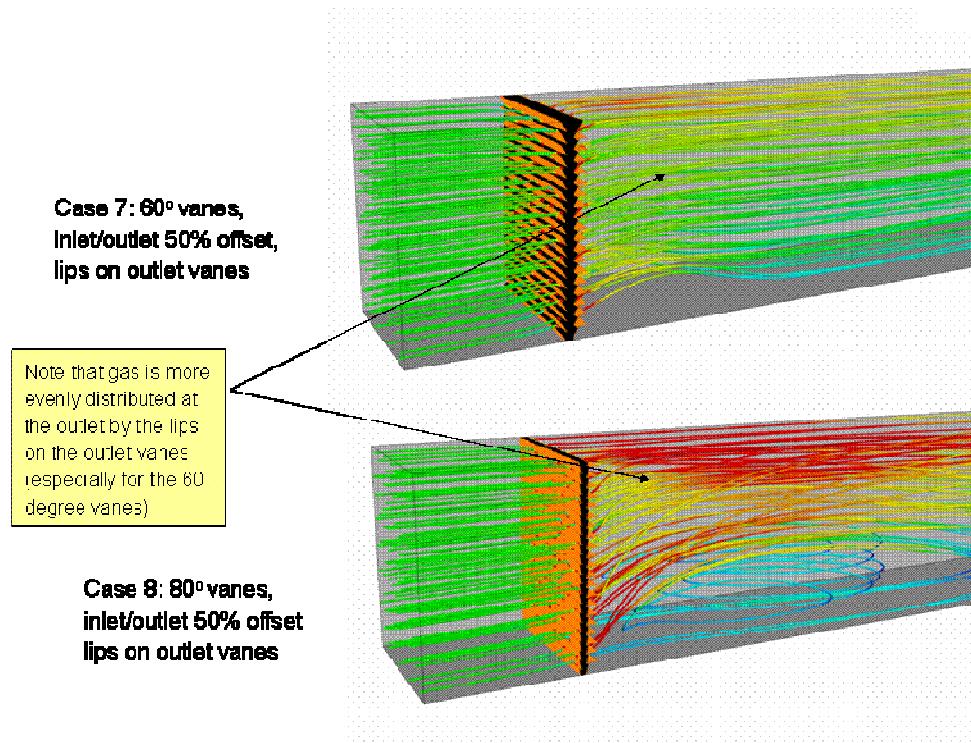
Figure 5-11. CFD Model of Louver Design with Flow Straighteners and Offset (Isometric View)

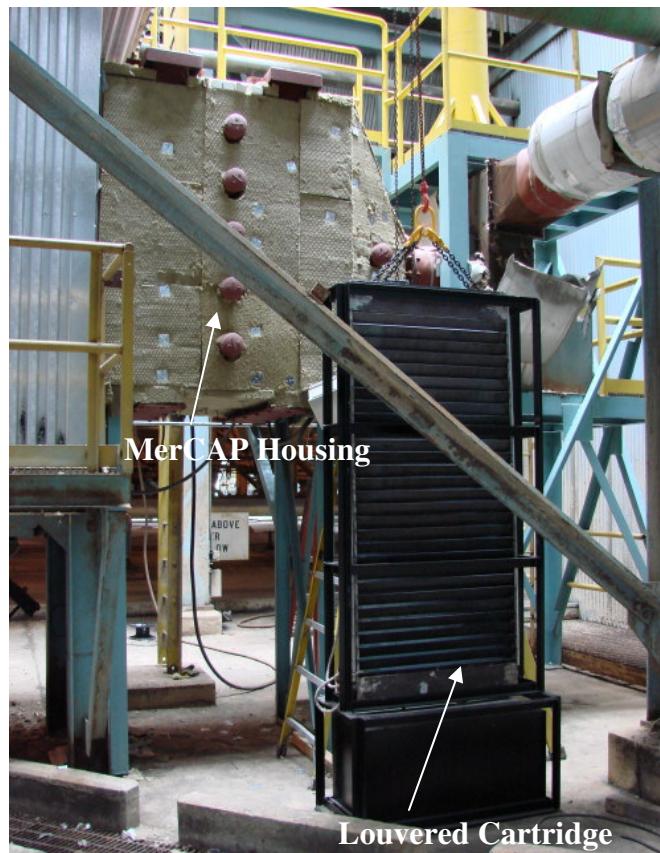
Figure 5-13. Carbon-Based MerCAP™ at Plant Miller

A pilot-scale reactor was fabricated based on results from the modeling effort. The reactor consisted of a louvered sorbent holding vessel sized to fit within the existing pilot unit located at Plant Miller. The louvered device developed by the model was welded to a frame that acts as a cartridge that can be raised and lowered into a slot on the pilot housing. The cartridge is removed from the pilot in order to change sorbent material or to inspect the fixed bed. A picture of the louvered apparatus appears in Figure 5-13. In this photo, the louvered cartridge is resting in its external holder that was used to support the cartridge while loading and unloading carbon. The cartridge is maneuvered using an overhead jib crane that was installed specifically for this purpose. The cartridge is filled with carbon at the ground level, and is then lifted over the MerCAP™ housing and then lowered into one of the two slots designed to accommodate the cartridge. Once the cartridge is in place a pair of inflatable seals are inflated that run down the entire length of both sides of the cartridge. The purpose of these seals is to prevent gas from sneaking around the cartridge without passing through the carbon bed.

Once the bed was in place and the gas tight lid secured, the pilot system was put into service by starting the COHPAC™ fan, closing the air purge valve, and opening the flue gas valve at the inlet to the COHPAC™ ESP. An Apogee QSIS extraction probe was installed in a test port on the side of the housing and was used for outlet mercury measurements. An additional QSIS probe was installed in an upstream port on the pilot

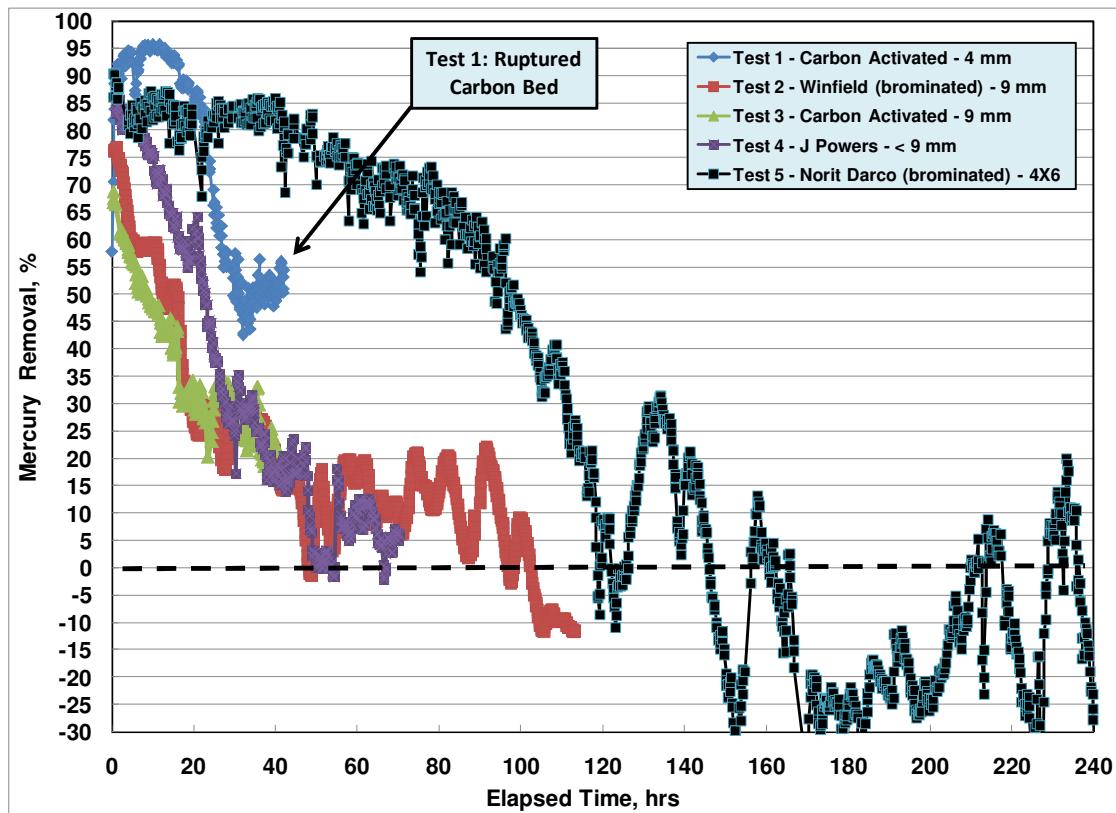
(¹ Carbon Bed Ruptured after ~25 hours, ² Following low temperature operation)

Figure 5-14. Mercury Removal over Time for Carbon-Based MerCAP™ Sorbents

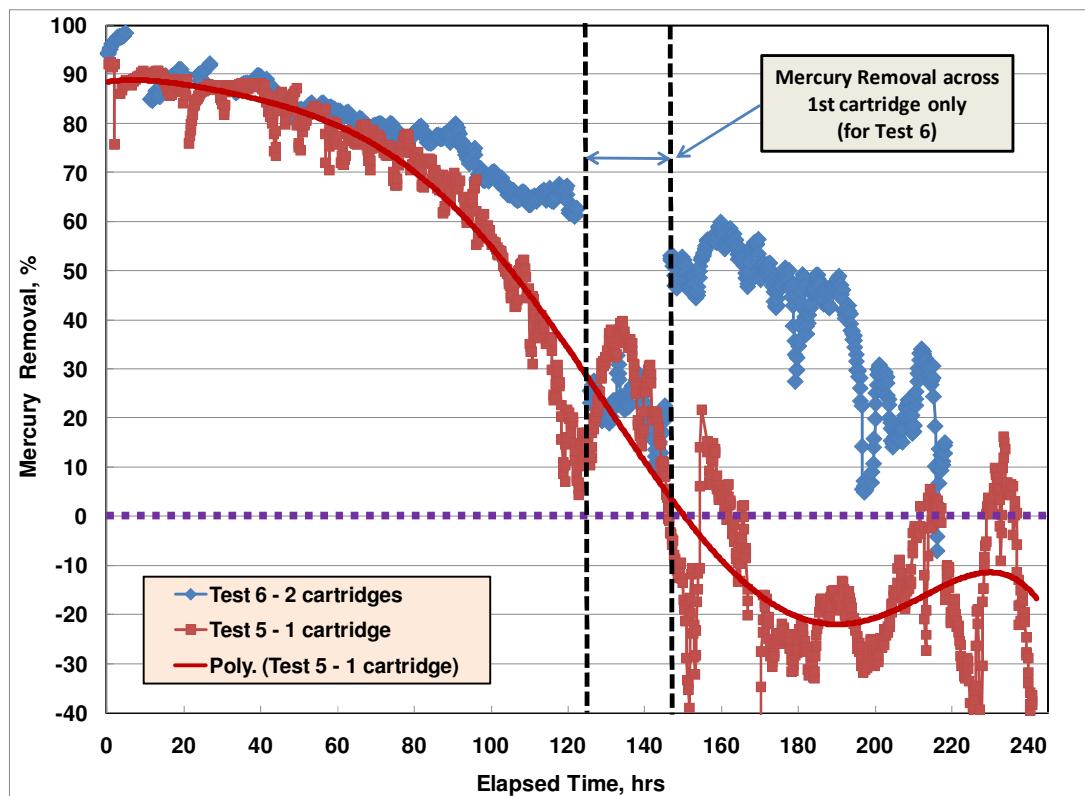
Figure 5-15. Mercury Removal across the carbon-MerCAP™ Beds for Tests 5 and 6
