ORGDP CONTAINER TEST AND DEVELOPMENT PROGRAM
FIRE TESTS OF UF_6 -FILLED CYLINDERS

Report Number: K-D-1894

Date of Issue: January 12, 1966

A. J. Mallett
Engineering Division

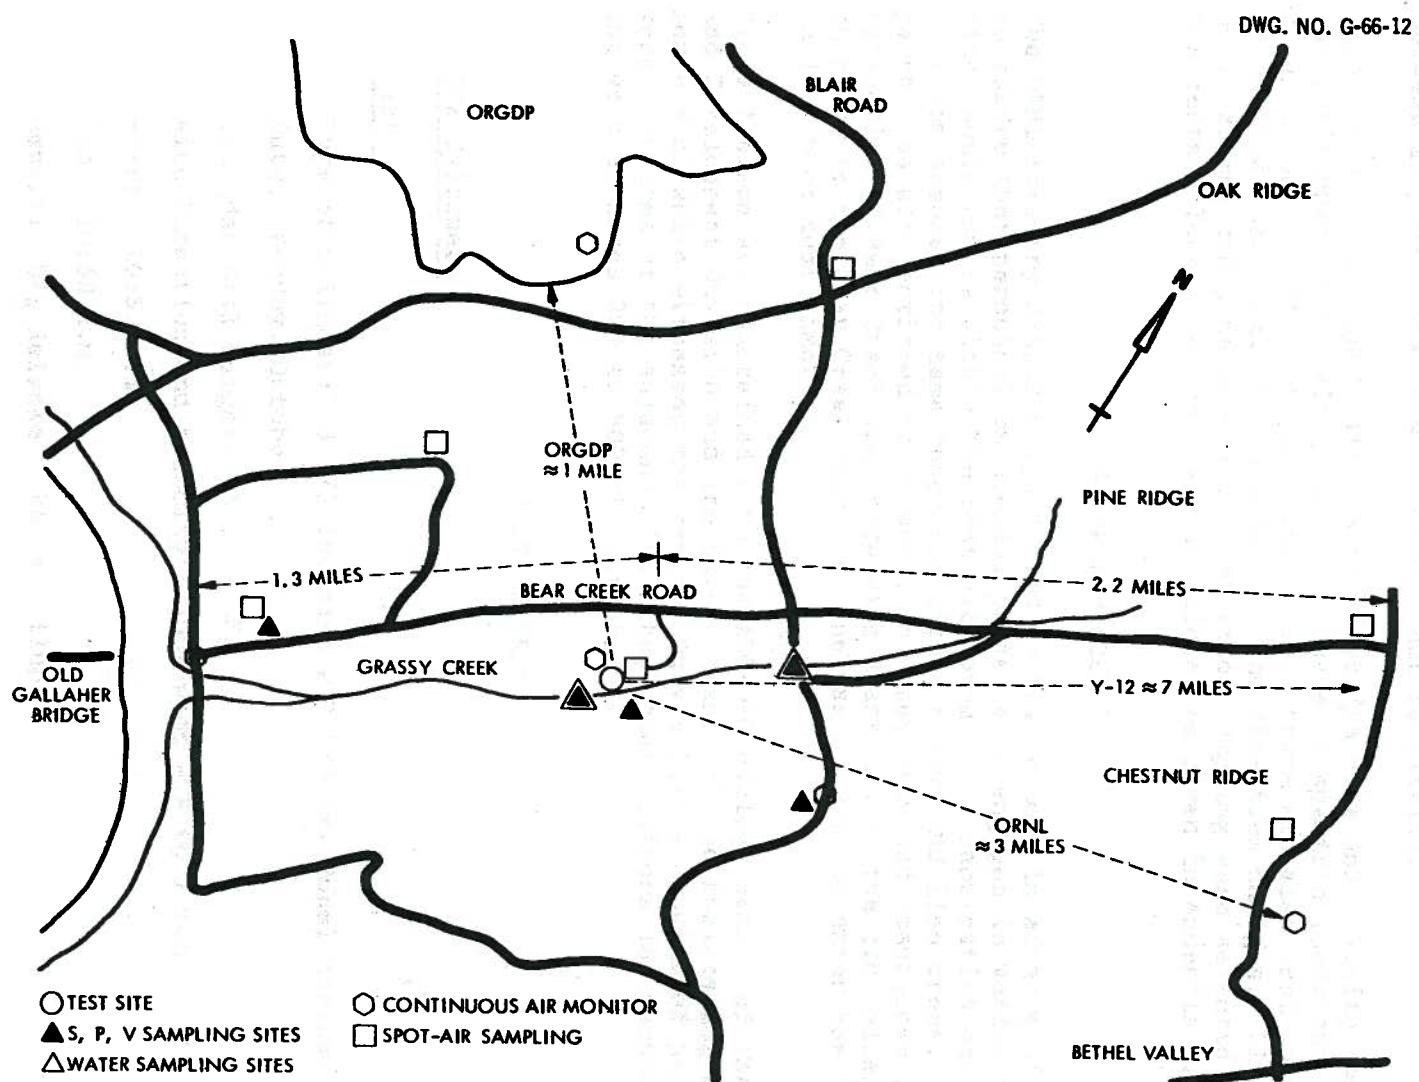
Figure 1
 UF_6 CYLINDER - FIRE TEST SITE

The ORGDP Rifle Range was selected as the most suitable test location based on the topography, normal wind direction for the fall period, distances to

various plant facilities and public roads, availability of water for fire fighting, roads for equipment movement, and viewing areas. See map of test area (Fig. 1).

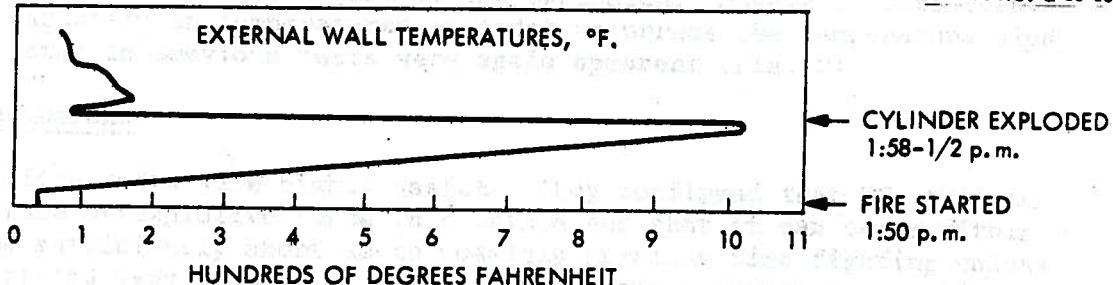
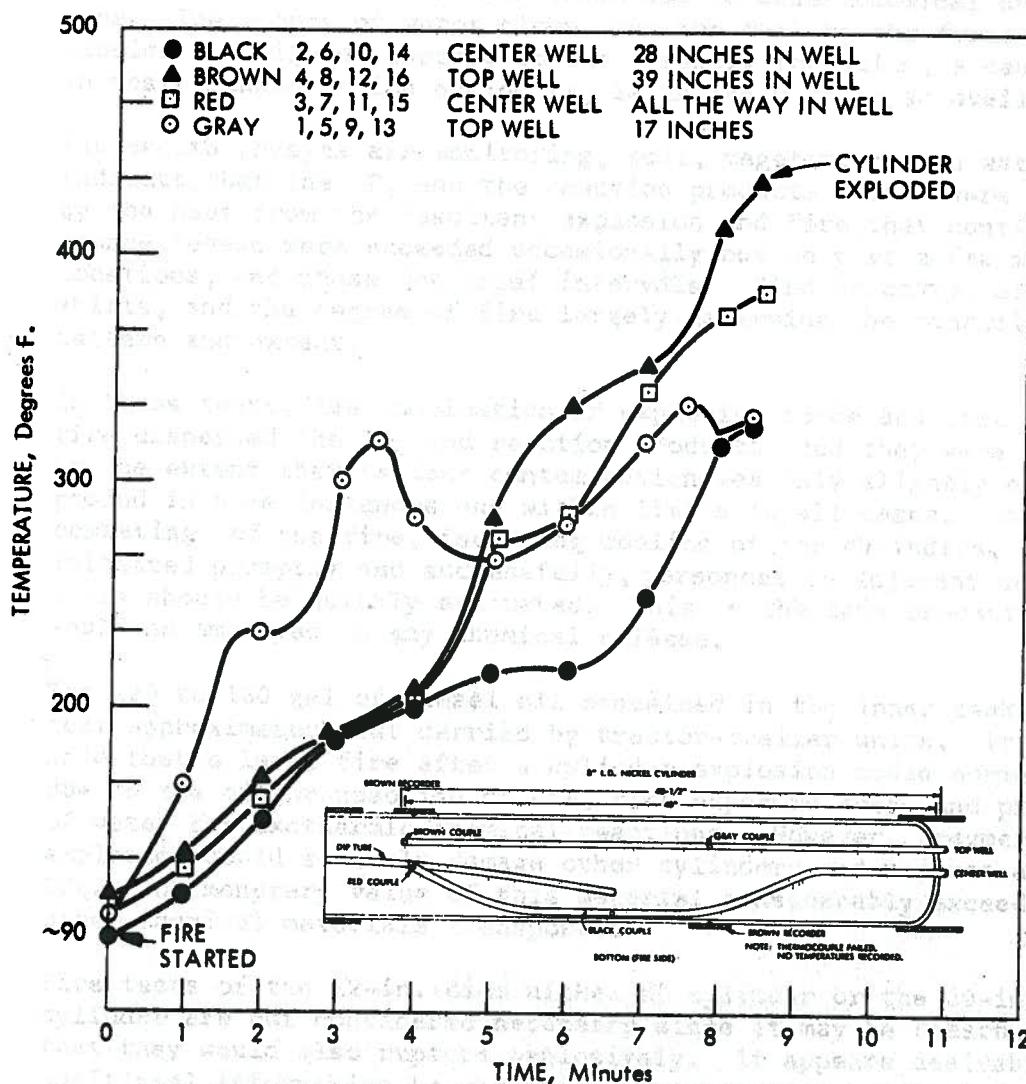
DWG. NO. G-66-13

8" DIA. NICKEL CYLINDER FIRE TEST, 10-29-65

zone and the one in the center well registered about the same temperature (330°F) at the time of the explosion. However, considerable variation in temperatures recorded occurred; the temperature dips noted in previous tests were again apparent (Fig. 2).

In an effort to secure additional cylinder internal temperature data, two 1/2-in.-I.D. x 40-in.-long Monel thermowells were installed in the base of the unit. One well was positioned slightly off center, the second was bent so that, for several inches, it was about 1/4 in. from the cylinder wall before curving back into the unfilled part of the cylinder (Fig. 2). A TE in the bent section of the thermowell was on the down side of the cylinder when in test position. A second TE was at the 40-in. limit. In the straight line well, the thermal elements were in approximately the same positions with respect to internal distances from the base. Additional TE's were clamped in position externally, near each end of the cylinder.

The cylinder ruptured explosively in 8 1/2 min without release from the valves. On the basis of previous cylinder hydrostatic tests, this result had appeared quite possible. The explosion was about the same intensity as that for the 8-in. cylinder with valve cap, but the resulting fireball did not appear to be as large. A green coloration of the flames near the center of the cylinder was observed prior to the explosion, indicating a possible UF₆ release and nickel compound formation. Both steel rails were blown from the tank; the east rail, with the lower half of the cylinder still attached, was blown about 4 ft from the outer tank. The cylinder head was found about 52 ft from the tank; the upper section of the cylinder body, altered to a flat sheet of metal, was in the inner tank. Again, most of the unburned oil and the water were blown from the inner tank. Inspection of the cylinder head indicated the valves were apparently undamaged by the fire. This was verified later when the valves were removed, bisected longitudinally, and the threaded stem and metal seat were found in good condition although the Teflon stem gasket had melted. The silver solder sealer, where the valves were threaded into the cylinder end cap, was not melted.

Some ground contamination was visible between the test site and the recorders, about 40 ft distant. This was washed away with the auxiliary hose system. Although high-speed gears were installed in the temperature recorders, the temperature readings obtained do not permit an accurate assessment of what occurred internally in the heating interval. In this instance, the maximum internal temperature, 430°F, was recorded by the top thermal element in the non-UF₆ zone. The thermal element in the thermowell within a quarter inch of the wall
