AN EVALUATION OF PROTOTYPE SURFACE MOUNT CIRCUIT BOARDS ASSEMBLED WITH THREE NON-LEAD BEARING SOLDERS

ABSTRACT

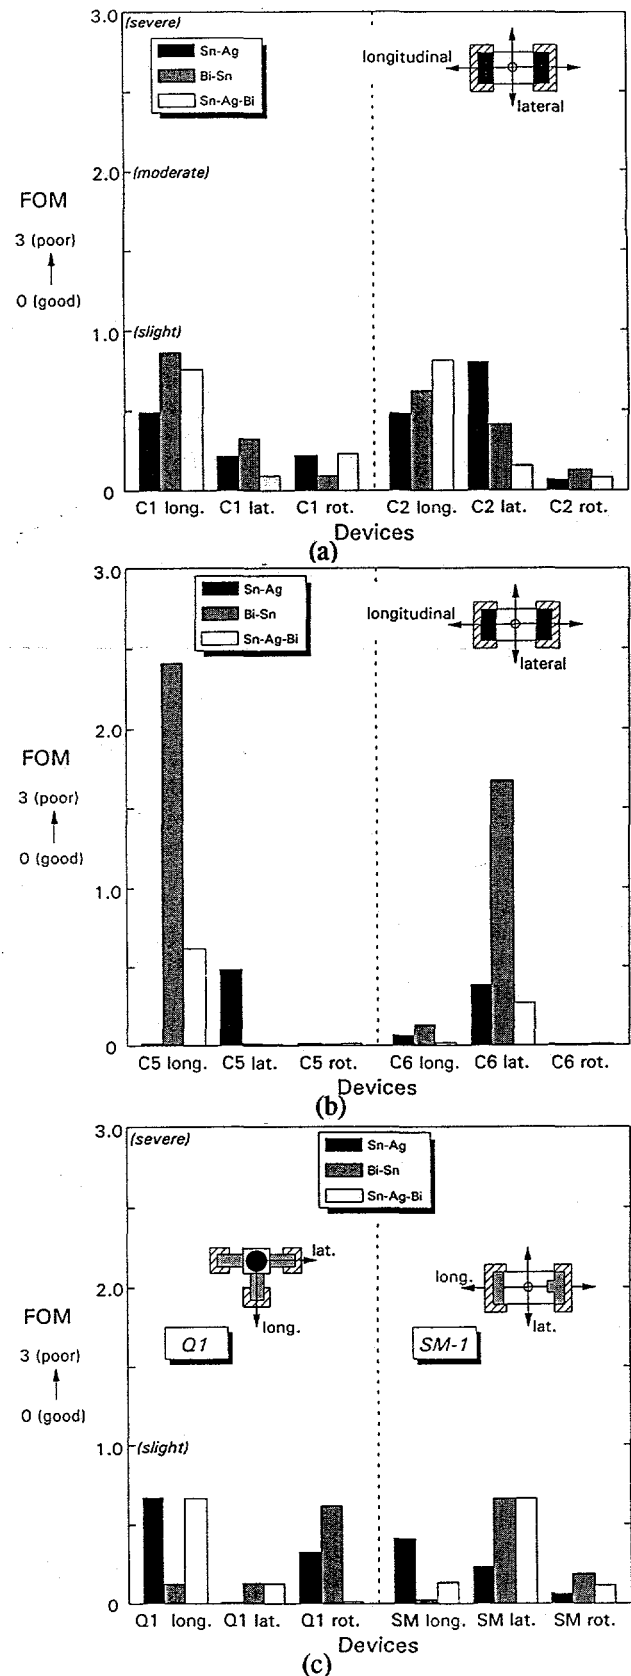
Figure 8: Misregistration figures-of-merit (FOM) for (a) the C1 and C2 chip capacitors, (b) C5 and C6 chip capacitors, and (c) the Q1 and SM-1 packages.

Device misregistration reflects the capacity for the solder to align devices which are not properly centered on the pads during the placement process. Shown in Fig. 8a is the bar diagram of the FOMs for each of the three displacement "vectors" (longitudinal and lateral cases as per the insert in the upper right-hand corner) for the C1 and C2 chip capacitor measurements. In general, for each classification of misregistration (longitudinal, lateral, or rotational), the overall magnitude was very slight. Longitudinal displacements and chip rotation were the most and least observed defects, respectively. However, lateral displacements gained prevalence on the C2 capacitor. a higher propensity for misregistration was observed with the Bi-Sn solder. This observation reflects the lower surface tension of the Bi-Sn solder (310 dynes/cm) as compared to values of the other alloys (490 dynes/cm and 418 dyne/cm for the Sn-Ag and Sn-Ag-Bi solders, respectively)[6]. The surface tension provides a mechanical force which centers the package between the pads in order to minimize system free energy; the higher the surface tension, greater is the alignment force. The C5 and C6 capacitors showed similar trends; again, most of the orientation defects were associated with the Bi-Sn solder (Fig. 8b).

The misregistration of the Q1 (SOT) and SM-1 packages produced a different situation because the wettable area of each package was non-symmetrical. Shown in Fig. 8c are the FOMs for each of the misregistrations from the Q1 and SM-1 packages. The pictorial inserts describe the bonding format of the two packages. In the case of the SOT, the solder surface tension of the joint of the non-paired lead would cause a persistent longitudinal shift to exist which was observed. The shift would expectedly increase for solders with higher surface tension which was borne out by observing that the least shift occurred with the Bi-Sn solder. The effect, however, was not sufficiently strong enough to distinguish between the Sn-Ag and Sn-Ag-Bi solders. Lateral misregistration was small; however, the amount of rotated parts was high, indicating a placement problem.

Longitudinal shifts were expected, and observed, for the SM-1 package since the bond (or wettability) area is larger on one end than the other (insert in Fig. 8c). Solder surface tension would tend to pull the package toward the end with the larger bond area. Again, the longitudinal shift was weakest for the Bi-Sn solder due to its lower surface tension. The high lateral shift was caused by the package literally "rolling" off of the solder bumps comprising the joints; this phenomenon would have no consistent solder composition dependence; this point was verified by the data in Fig. 8c.

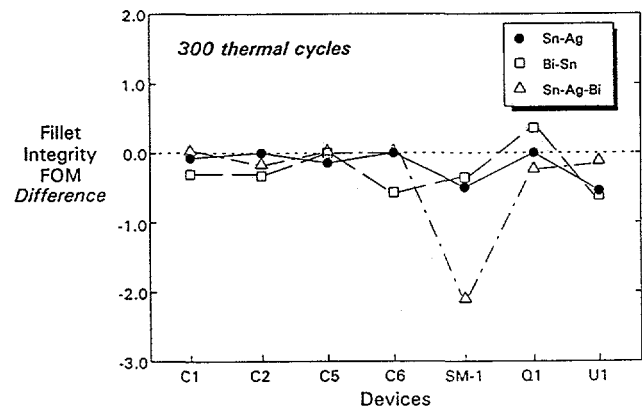
Figure 15: Fillet integrity FOM difference diagram for solder joints after exposure to 300 thermal cycles.

Exposure of the solder joints to thermal cycling environments (i.e., slower temperature ramp rates) impacted the solder microstructure. The fillet integrity FOM difference diagram for samples exposed to 300 thermal cycles is shown in Fig. 15. These results were compared

with those in Fig. 12 from the thermally shocked units. The Sn-Ag and Sn-Ag-Bi solders exhibited negligible change to the fillets of the chip capacitors. Slightly more degradation was observed with the Bi-Sn alloy; the trend showed a negligible dependence upon the package size. Deformation was in the form of phase boundary sliding, located in the gap between the pad and package. The solder fillet was not disturbed (Fig. 16). The Bi-Sn and Sn-Ag-Bi solders

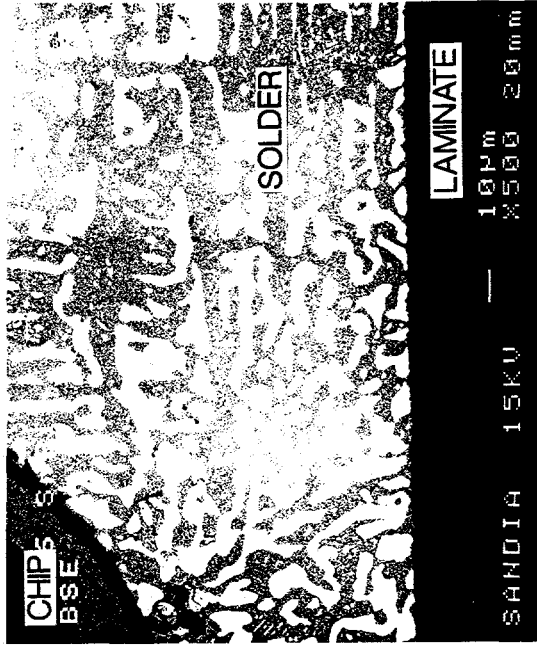
Fig. 14
P. Vance

Figure 14: SEM micrograph of crack formation in a Sn-Ag-Bi SM-1 solder joint following 400 thermal shock cycles exposure.

damage was particularly severe in the SM-1 solder joints, resulting in cracks near the solder/SM-1 package interface (Fig. 14). As can be seen in the scanning electron micrograph (SEM) micrograph, voids in the joints (which were extensive in these joints as noted in Fig. 9) appeared to influence crack propagation.
