Corrective Action Decision Document/Closure Report for Corrective Action Unit 560: Septic Systems Nevada Test Site, Nevada

Environmental Restoration
Project

U.S. Department of Energy
National Nuclear Security Administration
Nevada Site Office

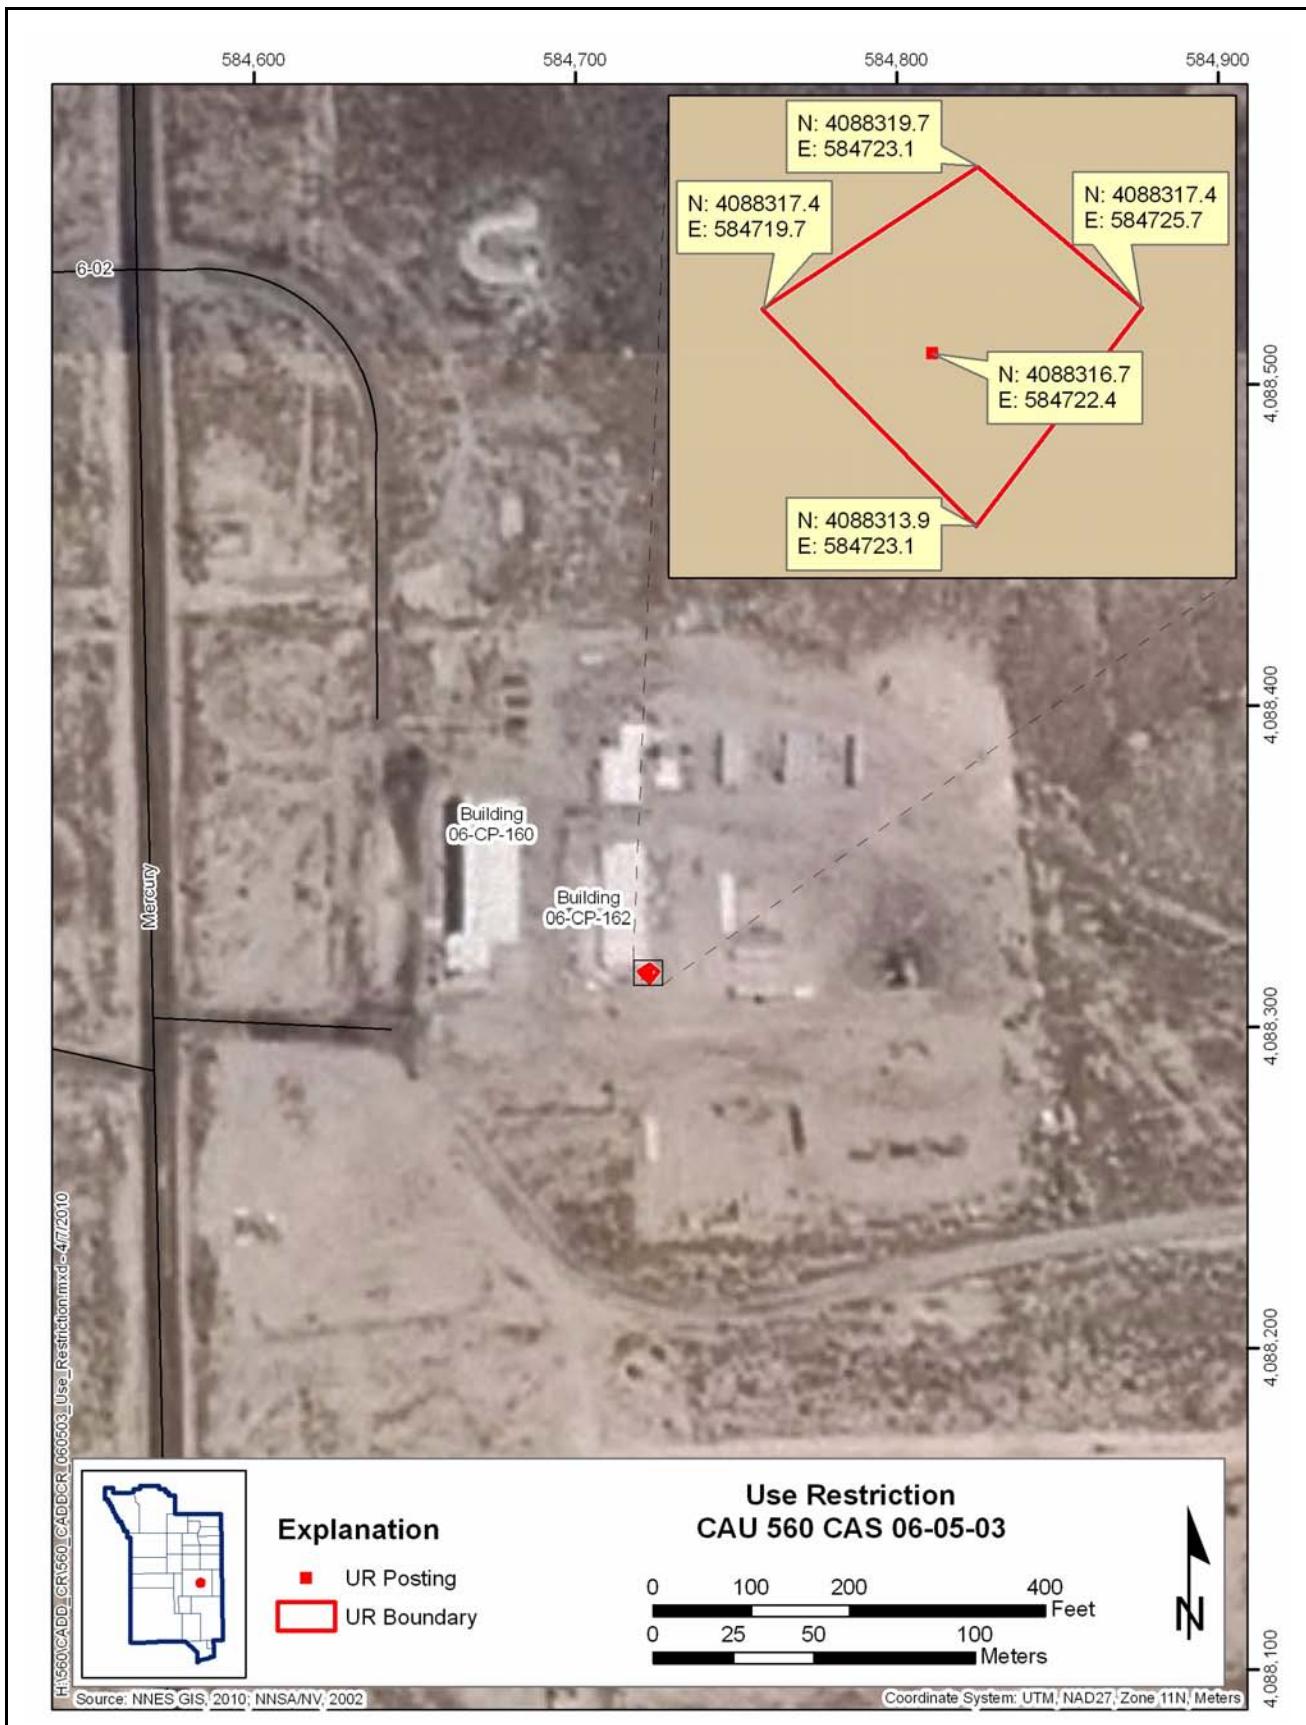
CAU 560, Septic Systems, CAS 06-05-03, UR Boundary

Comments: The contaminated Potential Source Material is located at the base of the leach pit chamber. The leach pit is a 5-foot diameter concrete chamber with approximately 2 to 3 feet of leach rock surrounding the outside wall. The removal of the leach pit chamber and the PSM contained within was not feasible due to depth of the PSM and configuration of the leach pit; the proximity of an active sewer line to the leach pit; and the proximity of the Building CP-162 foundation. To further limit potential exposure and future migration of contaminants away from the leach pit, the chamber was filled with concrete from 14.5 feet below ground surface to a depth of 5 feet below ground surface (top of chamber).
