Waste Isolation Pilot Plant
Geotechnical Analysis
Report
For
July 2007 – June 2008

Geotechnical Analysis Report for July 2007 – June 2008
DOE/WIPP-09-3177, Vol. 1

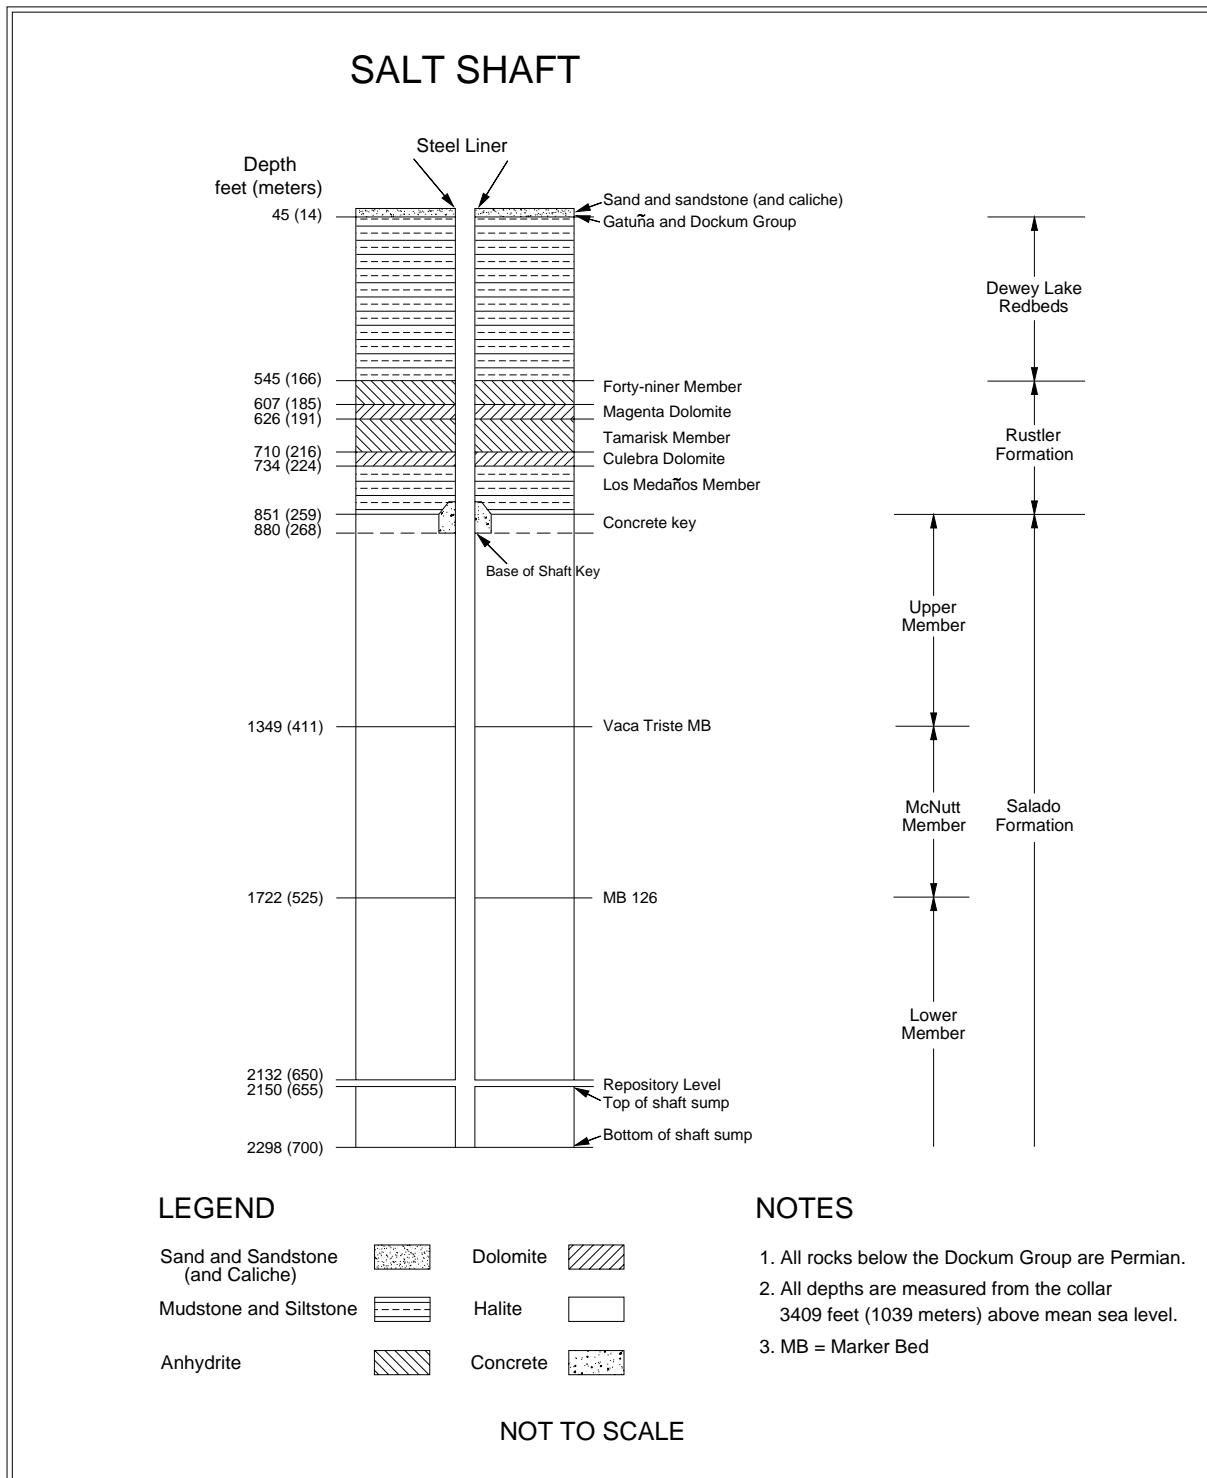
Figure 3-1 – Salt Shaft Stratigraphy

The first construction activity undertaken during the SPDV Program was the excavation of the Exploratory Shaft. This shaft was subsequently referred to as the Construction and Salt Shaft and is currently designated the Salt Shaft (see Figure 1-2). The shaft was drilled from July 4 to October 24, 1981, and geologically mapped in the spring of 1982 (DOE, 1983). Figure 3-1 presents the stratigraphy in the shaft.

The Salt Shaft is lined from the surface to 846 ft (258 m) with steel casing having an inside diameter of 10 ft (3-m). The thickness of the steel liner (including external stiffener rings) increases from 0.62 in (1.6 cm) at the top to 1.5 in (3.8 cm) at the key. Cement grout was placed between the liner and rock face. The 10-ft (3-m) diameter extends through the concrete shaft key to 880 ft (268 m). The shaft key is a 37.5 ft (11.4-m) long, reinforced-concrete structure that begins 3.5 ft (1.07 m) above the bottom of the steel liner. From the key to the bottom at 2,298 ft (700 m), the shaft has a nominal diameter of 12 ft (4 m).

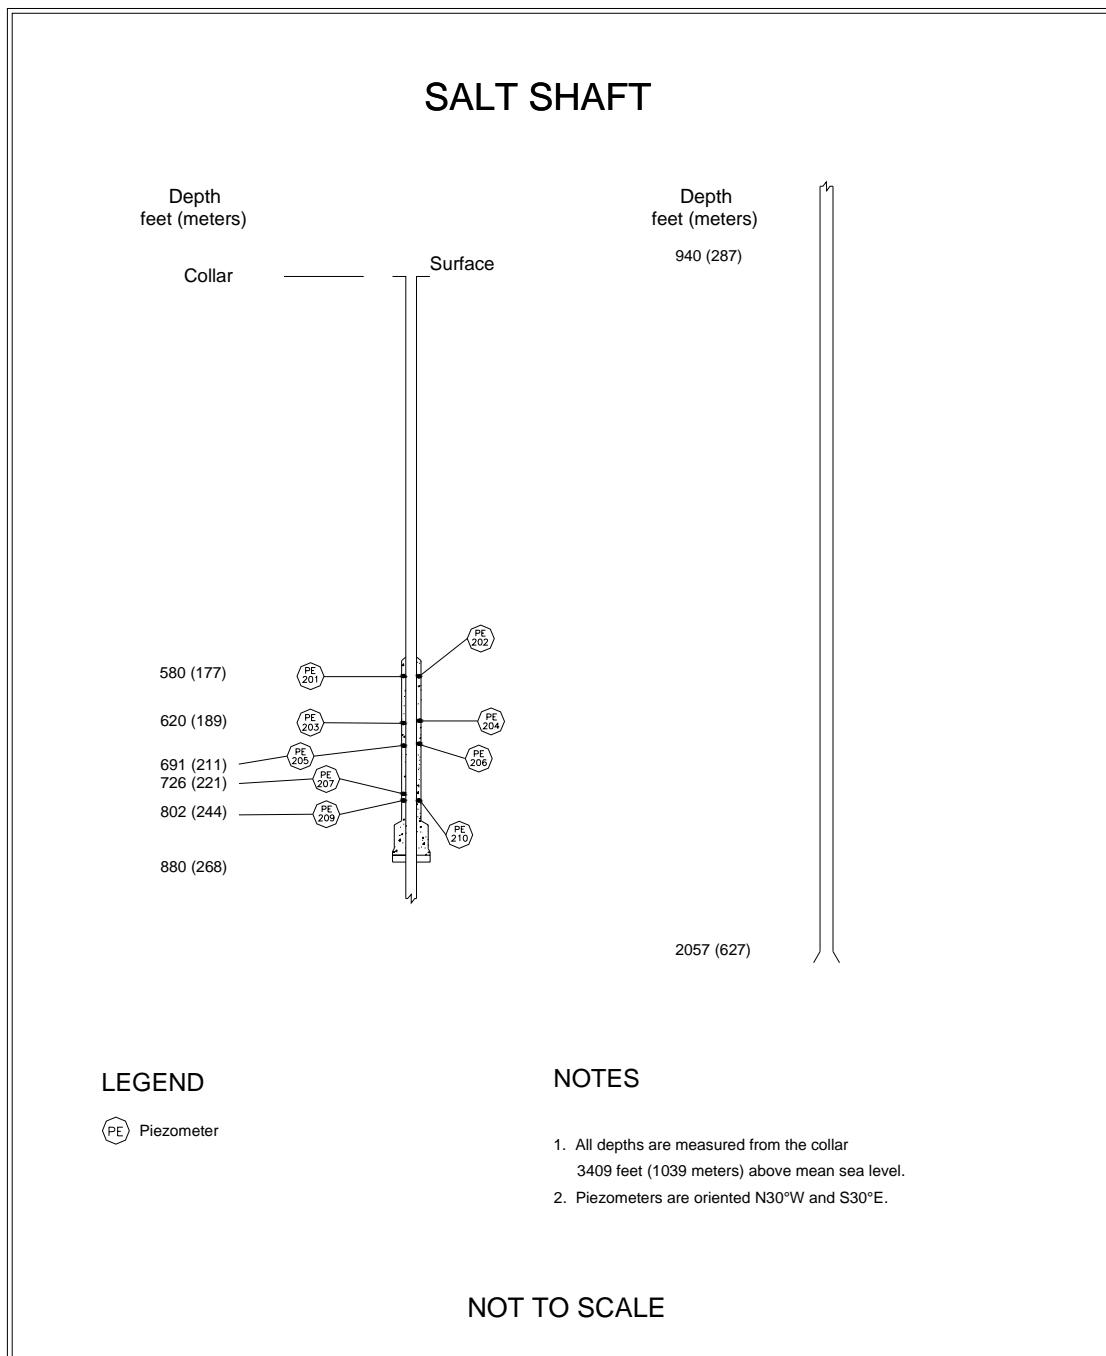
Figure 3-2 – Salt Shaft Instrumentation (Without Shaft Key)

Eleven of the 12 piezometers continue to provide data. The fluid pressures recorded at the end of this reporting period range from approximately 66 pounds per square inch (psi) (455 kilopascals [kPa]) at the 802-ft (244-m) level in the Los Medaños Member to 234 psi (1,613 kPa) at the 620-ft (189-m) level in the Magenta Dolomite Member. The recorded pressures for this reporting period are generally consistent with the readings from the previous reporting period. The fluid pressure on the shaft liner will continue to be monitored on a regular basis.

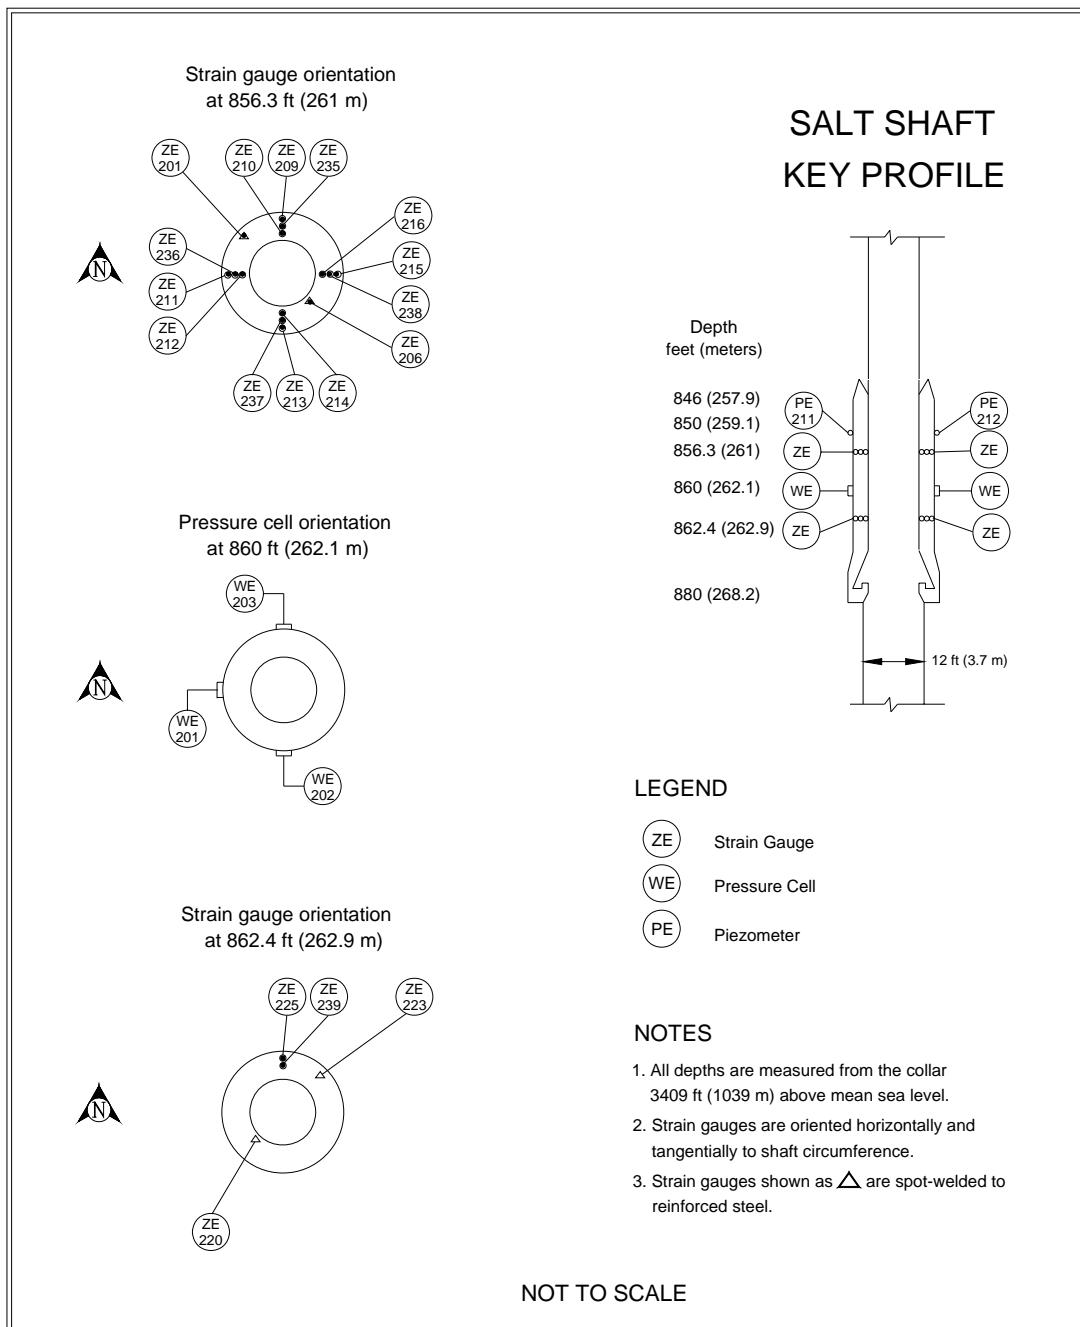
Figure 3-3 – Salt Shaft Key Instrumentation

Four earth pressure cells were installed in the key section during concrete emplacement at the 860-ft (262-m) level. These instruments measure the normal stress between the concrete key and the Salado Formation as salt creep loads up the key structure. Three of the four earth pressure cells continue to provide data. These instruments have indicated essentially no contact pressure since their installation (readings resemble instrument drift at a zero pressure). The contact pressures recorded by the instruments for this reporting period ranged from -22 to 4 psi (-152 to 28 kPa).

Sixteen spot-welded and twenty-four embedment strain gauges were installed on and in the shaft key concrete at both the 856.3-ft (261-m) level and at the 862.4-ft (263-m) level. Four spot-welded strain gauges are still functioning at these levels. Maximum strains at the 856.3-ft (261-m) level were 650 and 722 microstrain. Strains at the 862.4-ft (263-m) level were 627 and 853 microstrain. The strains from the 12 embedment strain gauges at the 856.3-ft (261-m) level ranged from -717 to 987 microstrain. The strains from the two embedment strain gauges at the 862.4-ft (263-m) level were 221 to 357 microstrain. The strains recorded by the spot-welded

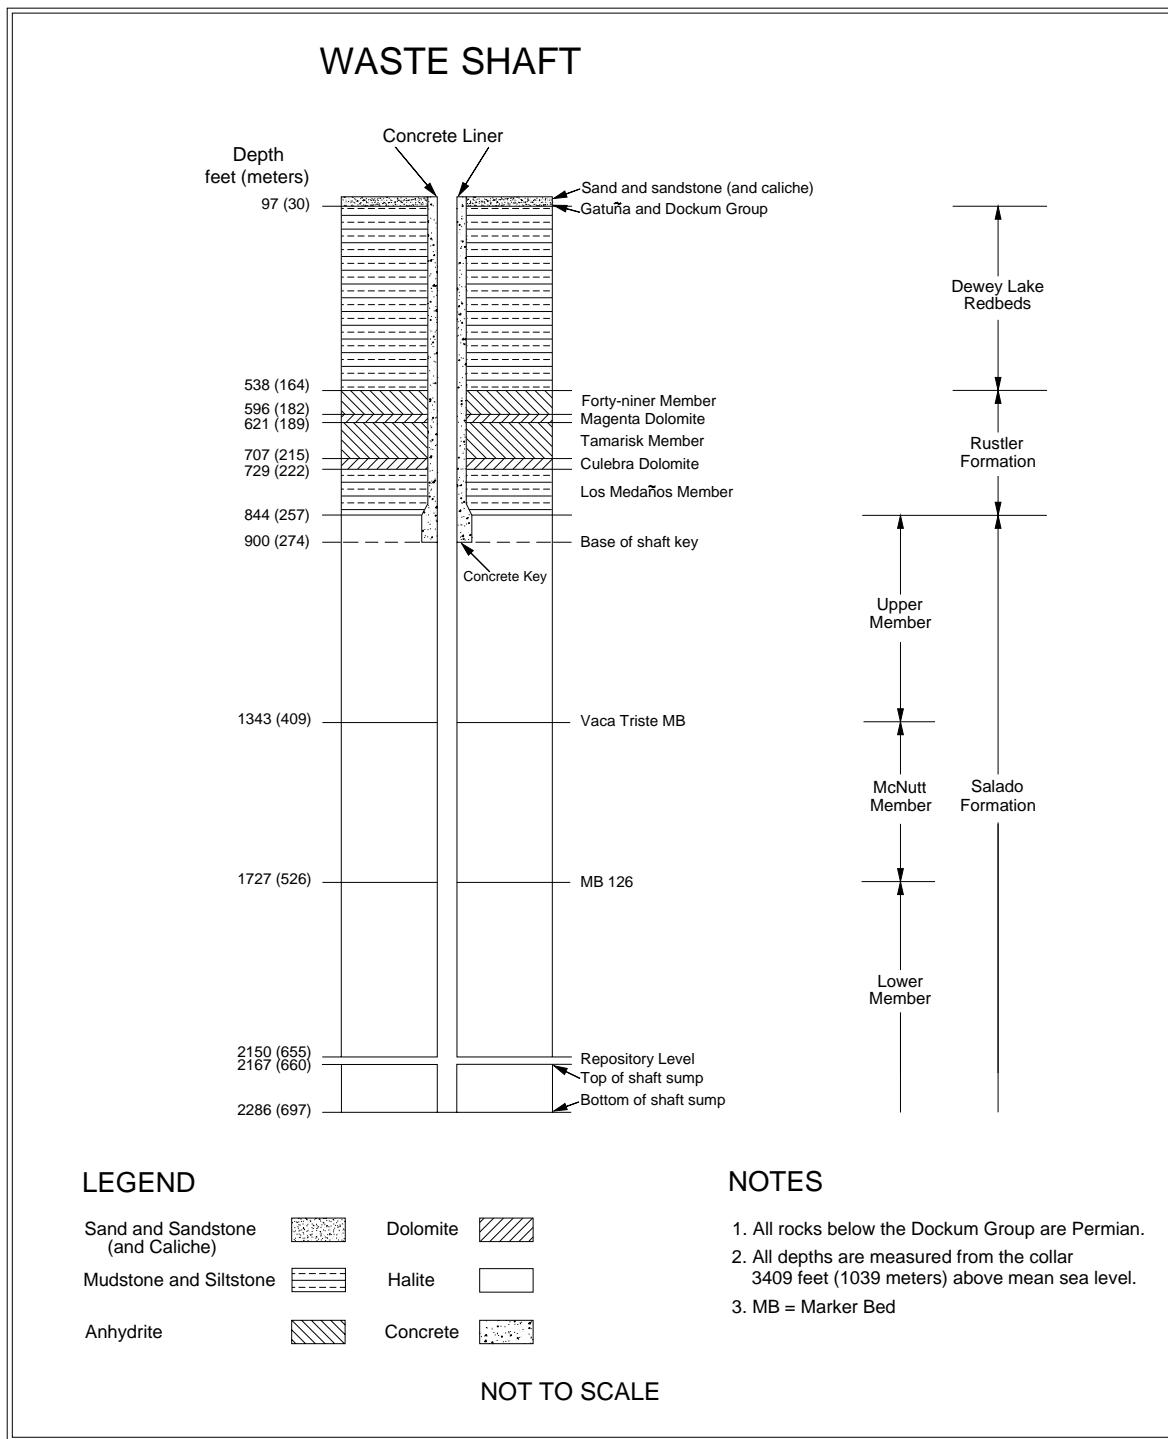
Figure 3-4 – Waste Shaft Stratigraphy

As part of the SPDV Program, a 6-ft (2-m) diameter ventilation shaft, now referred to as the Waste Shaft, was excavated from December 1981 through February 1982 (see Figure 1-2). This shaft, in combination with the Salt Shaft, provided a two-shaft underground air circulation system. From October 11, 1983, to June 11, 1984, the shaft was enlarged to a diameter of 20 to 23 ft (6 to 7 m) and lined above the key. Stratigraphic mapping (Figure 3-4) was conducted during shaft enlargement from December 9, 1983, to June 5, 1984 (Holt and Powers, 1984).

The Waste Shaft is lined with nonreinforced concrete having a 19 ft (6 m) inside diameter from the surface to the top of the key at 837 ft (255 m). Liner thickness increases from 10 in (25 cm) at the surface to 20 in (51 cm) at the key. The key is 63 ft (19 m) long and 4.25 ft (1.3 m) thick and is constructed of reinforced concrete. The bottom of the key is 900 ft (274 m) below the surface. The diameter of the shaft is 20 ft (6 m) at the bottom of the key and increases to 23 ft (7 m) just above the shaft station. The shaft below the key is lined with wire mesh anchored by rock bolts. The diameter of 23 ft (7 m) extends to a depth of approximately 2,286 ft (697 m), with the shaft sump comprising the lower 119 ft (36 m) of that interval.

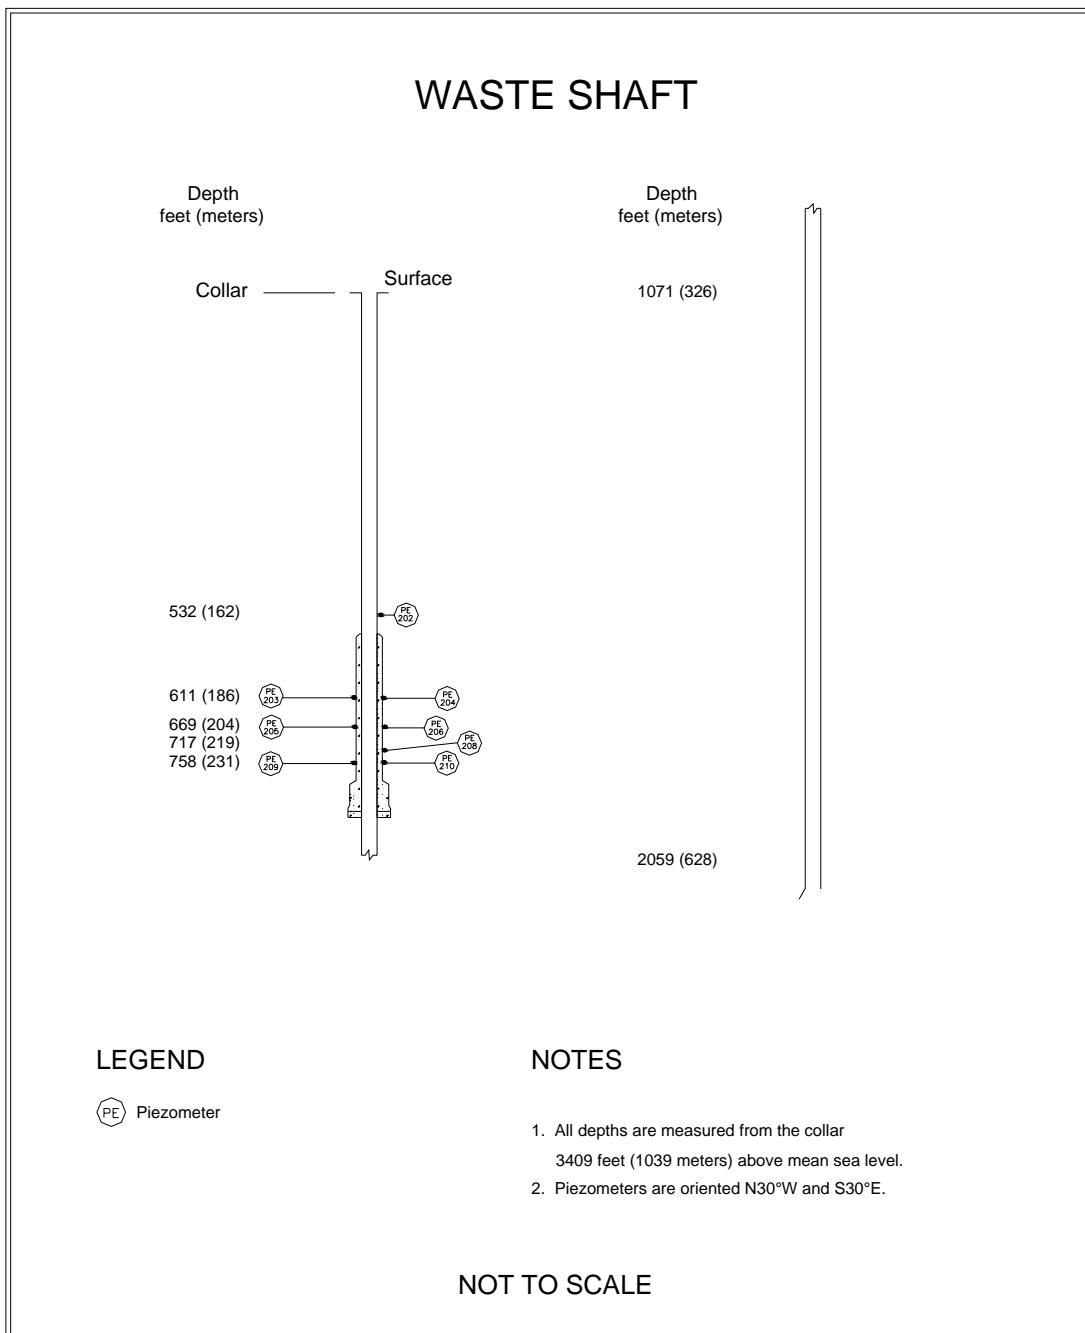
Figure 3-5 – Waste Shaft Instrumentation (Without Shaft Key)

Twelve piezometers were installed in the lined section of the Waste Shaft on September 7 and 8, 1984, to monitor fluid pressure behind the shaft liner and the key section. Data continue to be received from 10 piezometers. The maximum recorded fluid pressure during this reporting period was 143 psi (986 kPa) at the 717-ft (219-m) level. The pressure readings during this reporting period were consistent with the readings from the previous reporting period with a mean change in pressures of less than 2.5 psi (17 kPa).

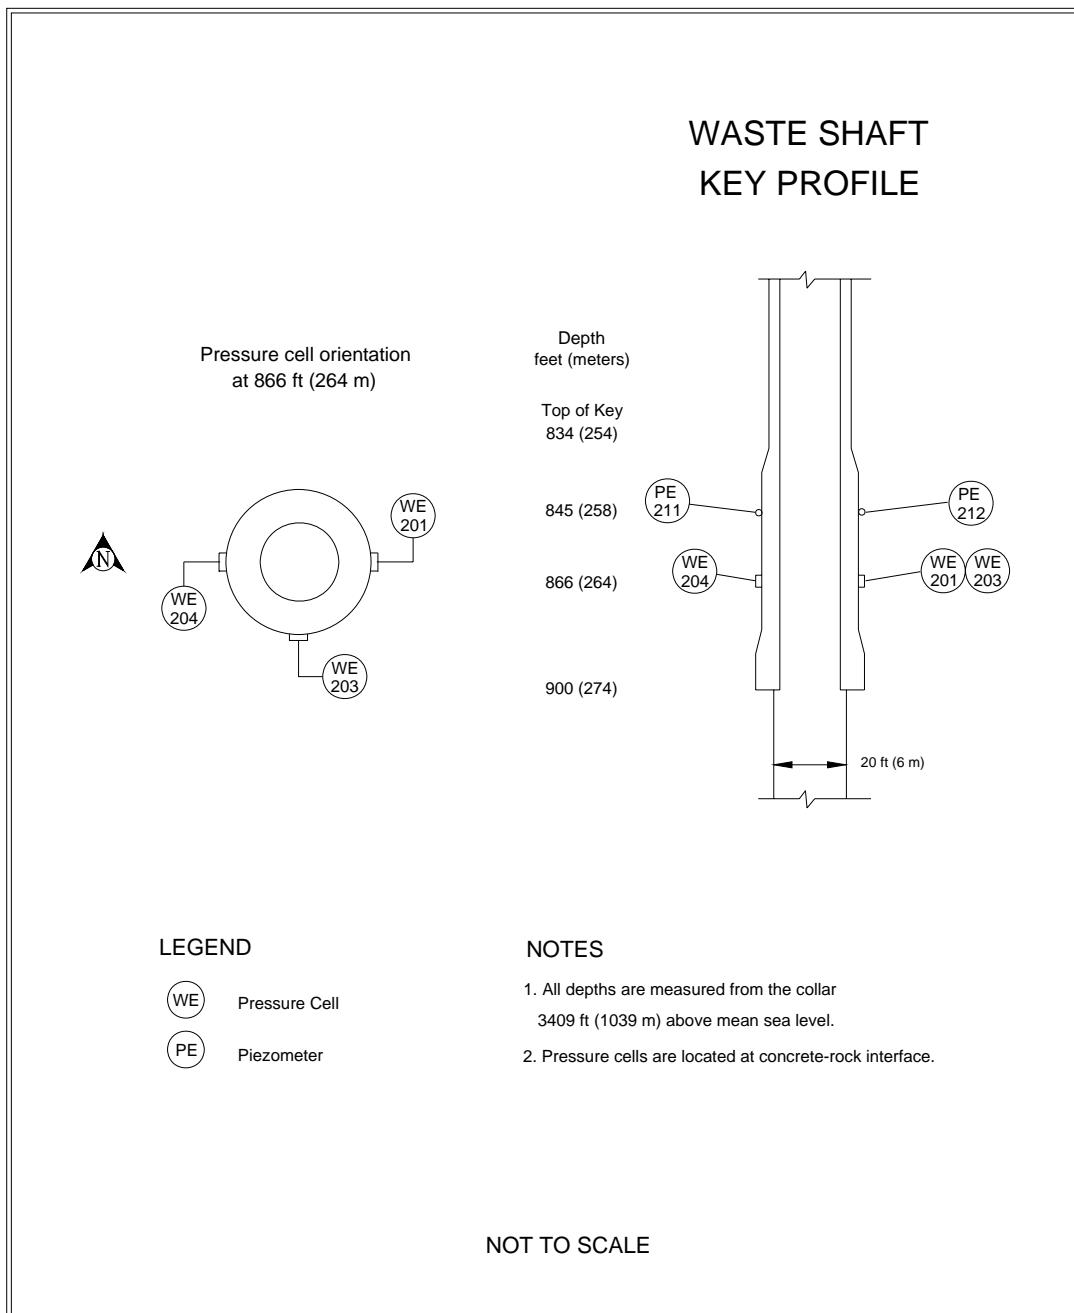
Figure 3-6 – Waste Shaft Key Instrumentation

Four earth pressure cells were installed in the key section of the Waste Shaft during concrete emplacement between March 23 and April 3, 1984. Three are still working. These instruments measure the normal stress between the concrete key and the Salado Formation as salt creep loads the key structure. The contact pressures recorded by the instruments during this reporting period ranged from 81 to 122 psi (558 to 841 kPa).

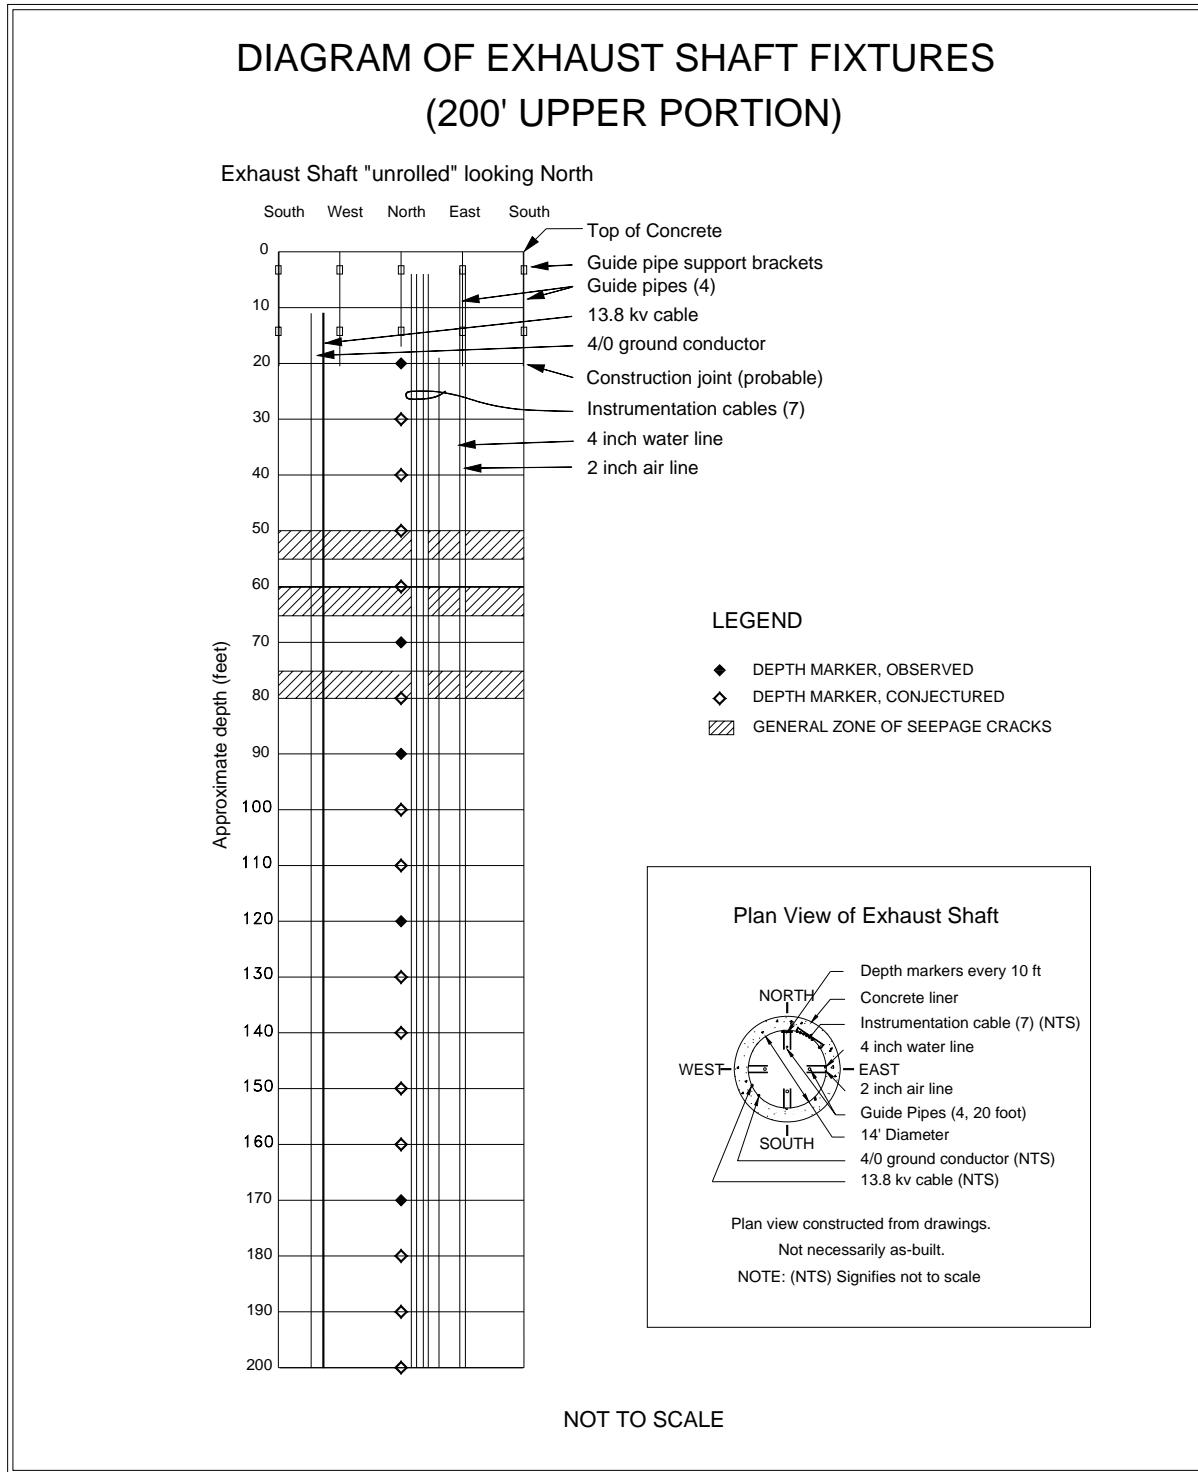
Figure 3-9 – Diagram of Exhaust Shaft Fixtures and Seepage Zones (Upper 200 ft)

The Exhaust Shaft liner is examined for cracks, seepage, and general shaft stability. Currently, there are three principal zones of seepage in the shaft. The first is about 50 to 55 ft below the shaft collar (bsc). The second is about 60 to 65 ft bsc. The third is about 75 to 80 ft bsc, as shown in Figure 3-9. Monitoring of seepage horizons started before 1995. Water entering the shaft through these cracks is believed to originate from a perched aquifer at the base of the Santa Rosa Formation that is being recharged as the result of surface modifications at the site. The fluid level in the Santa Rosa near the shaft is about 43 to 44 ft below the surface. Based on examination of inspection videos, the flow rate into the shaft during this reporting period is estimated at about 1 to 1-1/2 gallons per minute, most of which is carried out of the shaft by the exhaust air. Seepage cracks are confined primarily to the eastern side of the shaft wall.

Though the Magenta and Culebra water rings are encrusted with salt buildup, no water appears to originate from the liner or water rings. Most of the seepage was observed along the east face of the shaft wall near the instrumentation cables and the air lines and waterlines in the upper section of the shaft. Though the presence of water is an inconvenience requiring periodic disposal, at this time it does not appear to have created any hazard or affected the structural integrity of the shaft. However, brine increases the probability of corrosion and deterioration of utility hangers and brackets. There are no visible signs of dissolution of the salt below the key.

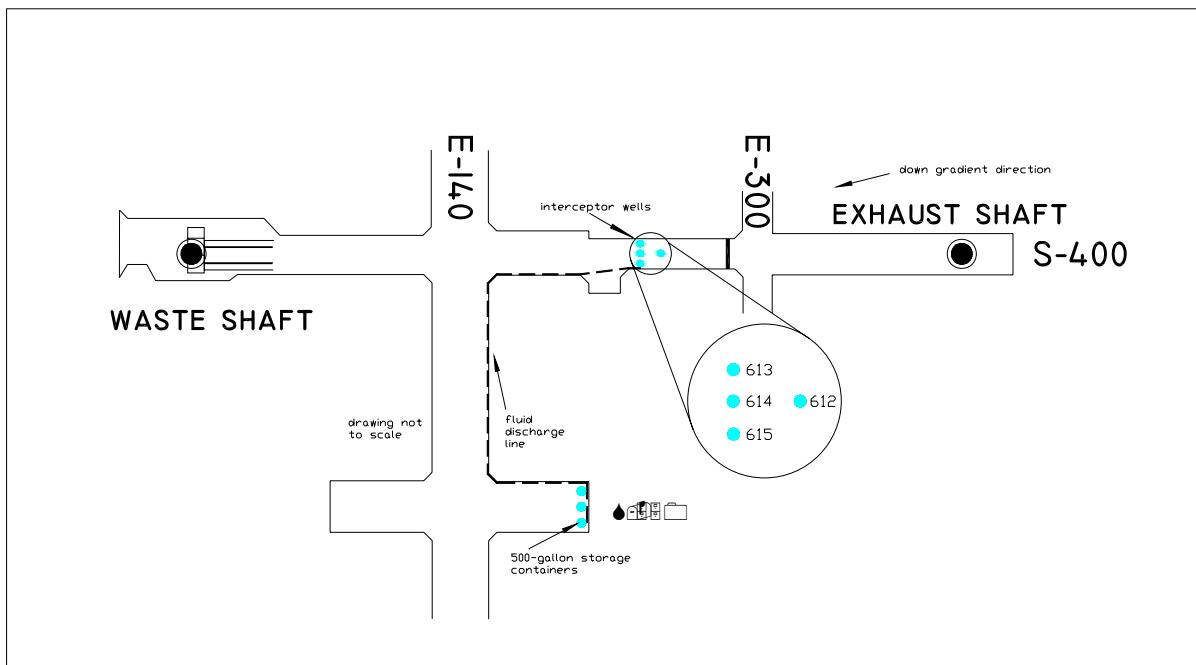
Figure 3-10 – Location of Interception Wells and Storage Containers

When fluid was detected seeping into the shaft, a catch basin was designed and installed at the base of the Exhaust Shaft to intercept water and prevent it from draining into the Waste Shaft Sump. Fluid was removed from the catch basin from March 1996 through October 2005 as needed. The catch basin was damaged in 2004 by fallen debris, either salt or instrumentation cables or both. A new catch basin was fabricated and installed in December 2004. This basin was damaged in August 2005, most likely the result of fallen debris. An interception well system was installed between November 2005 and March 2006 to replace the catch basin. Interception wells were drilled down-gradient in S-400 between E-140 and E-300 (Figure 3-10). The interception well system consists of four 30-ft deep 9-7/8-in diameter holes with a submersible pump and pressure transducer in each. Fluid is pumped from each hole to a series of storage containers in S-550. A data-acquisition system monitors the fluid level in each hole, turning the pump on and off between set limits as needed.

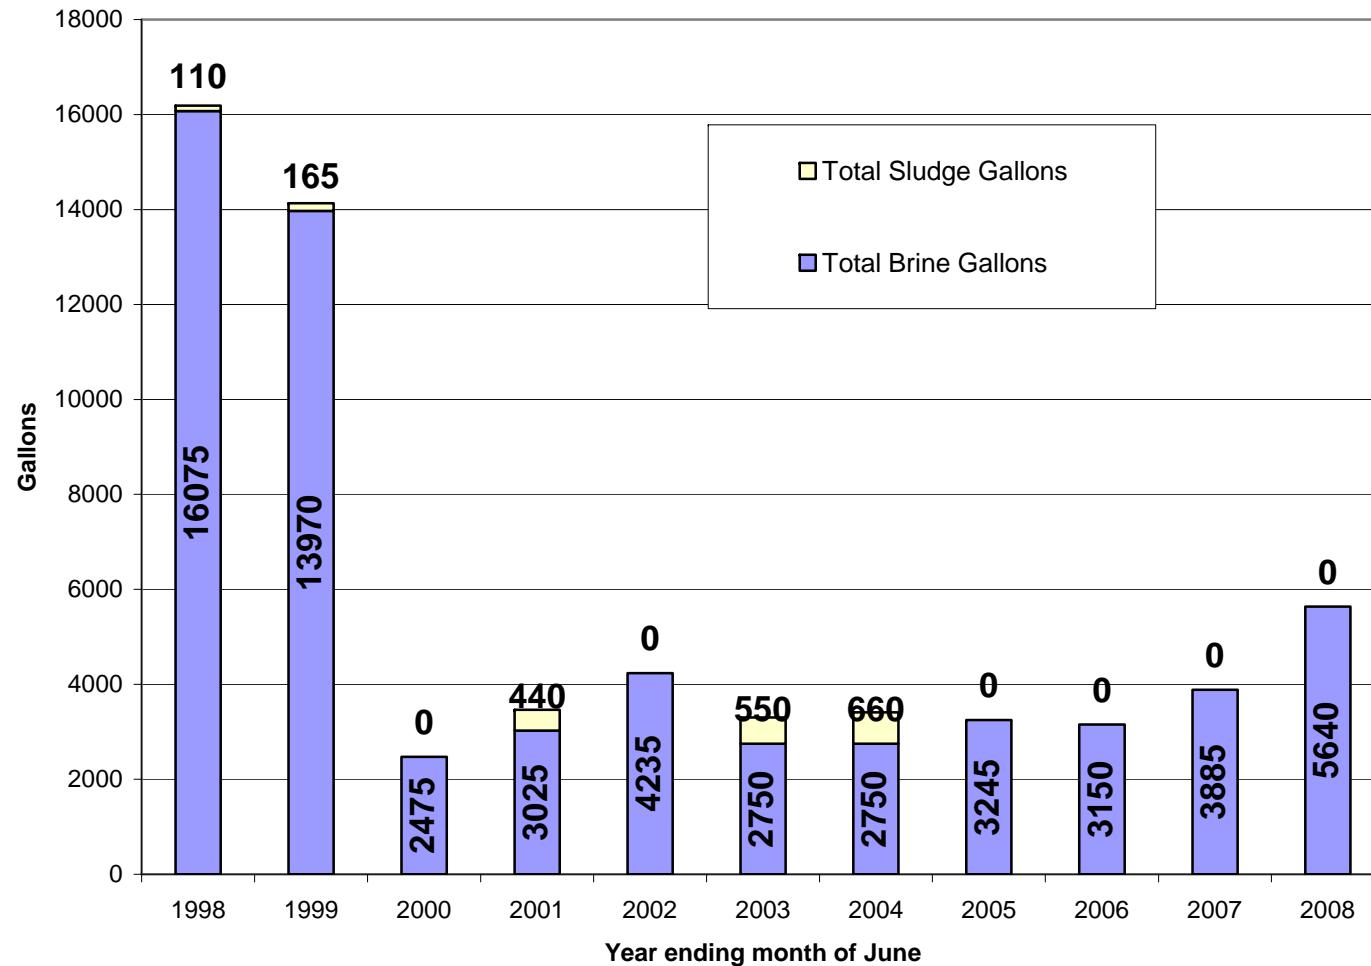
Figure 3-11 - Water Removed from the Exhaust Shaft Catch Basin
and the Interception Well System

Table 3-1 and Figure 3-11 present the volume of fluid removed from the catch basin from July 1997 through June 2006, and by the interception well system from July 2006 through June 2008. The largest reported volumes are typically associated with periods of reduced ventilation and increased humidity. For a discussion of the factors affecting the quantity of fluid produced in the Exhaust Shaft, refer to DOE/WIPP 00-2000, *Brine Generation Study*.

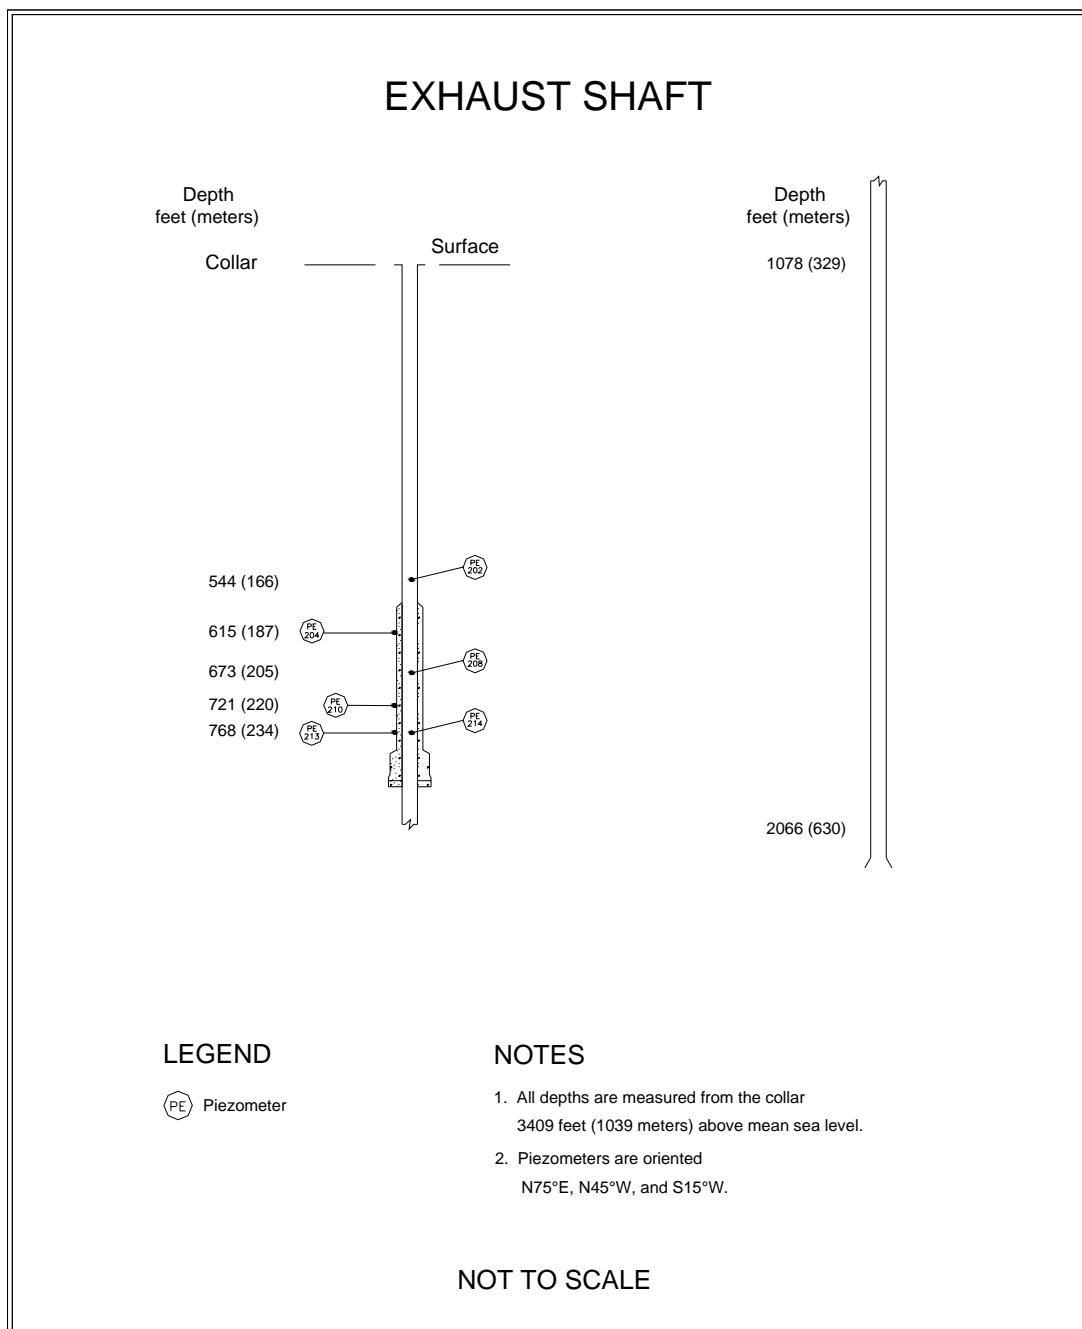
Figure 3-12 – Exhaust Shaft Instrumentation (Without Shaft Key)

The Exhaust Shaft was equipped with geomechanical instrumentation in two stages. Earth pressure cells were installed behind the liner key in November 1984. Piezometers and nine multiposition extensometers were installed during November and December 1985. Figures 3-11 and 3-12 show the instrument locations.

Nine piezometers remain in working condition. The fluid pressure readings from the working piezometers at the end of the reporting period range from -3 psi (-21 kPa) at 544 ft (166 m) to 142 psi (979 kPa) at 721 ft (220 m). Maximum pressure readings from the working piezometers during this reporting period were consistent with maximum readings from the previous reporting period.

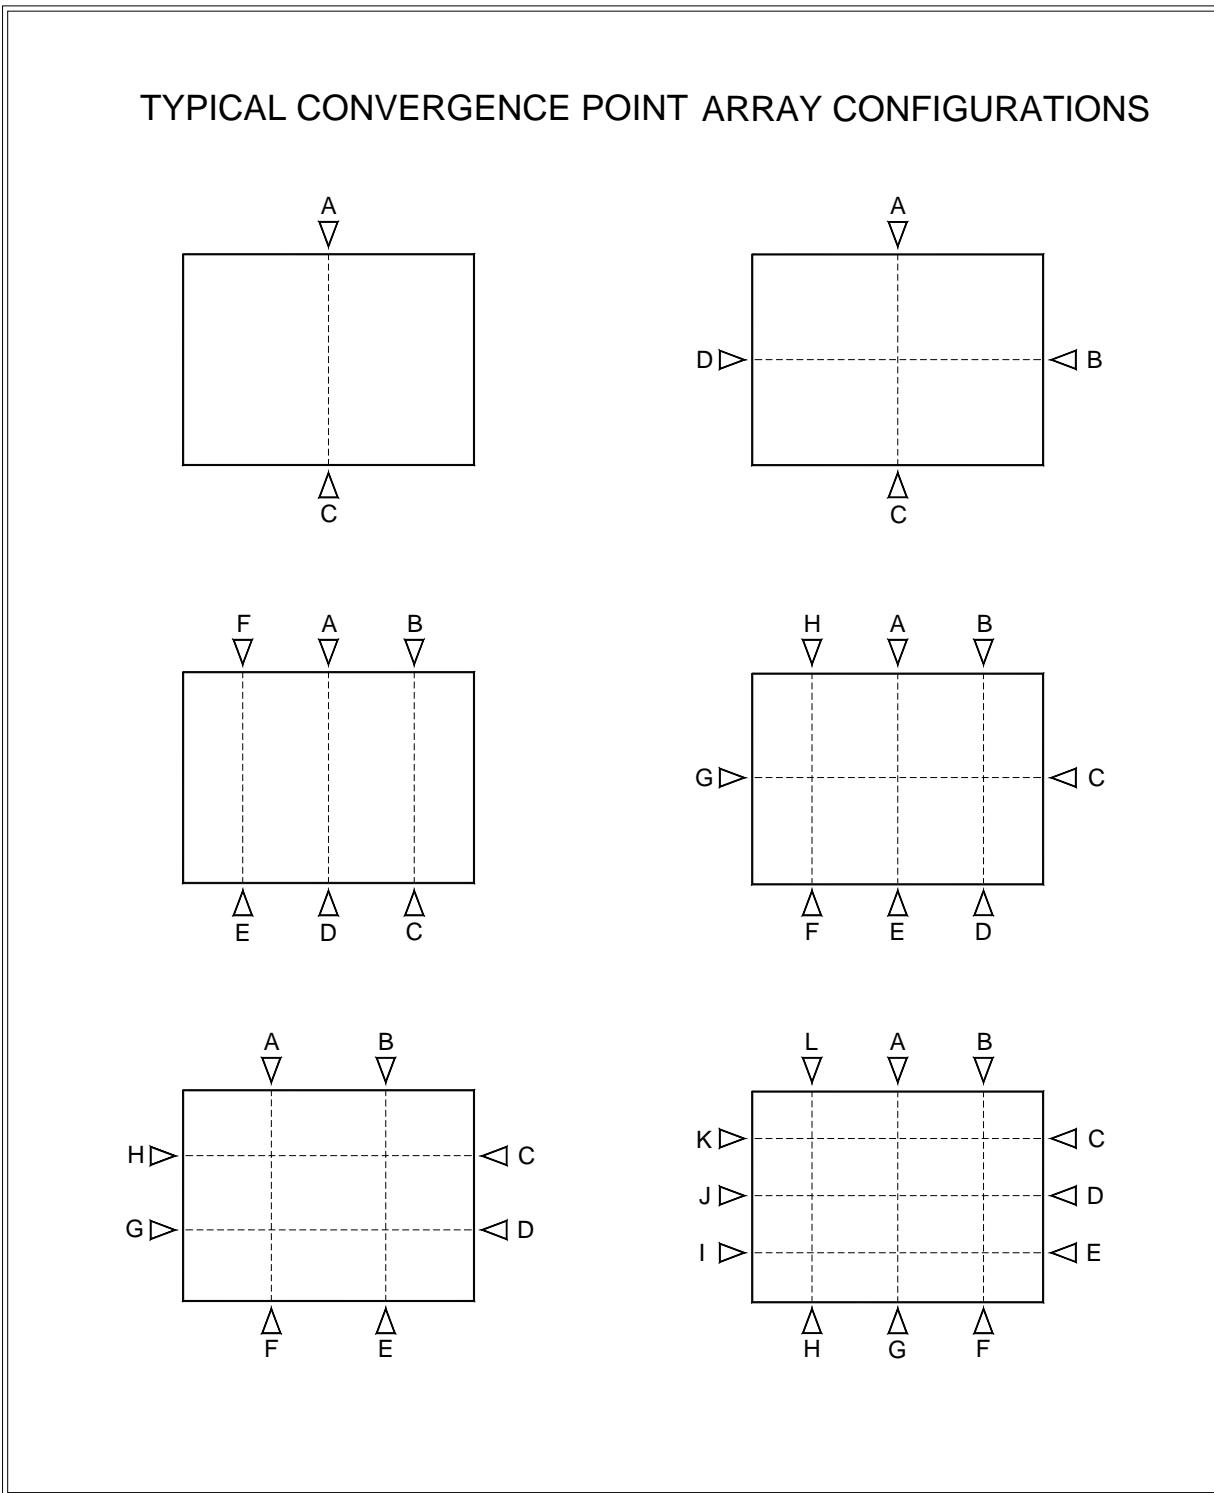
Figure 5-1 – Typical Convergence Point Array Configurations Showing Anchor Designations

Figure 5-1 shows typical convergence point array configurations. Instrumentation installed during this reporting period was limited to the replacement of convergence point arrays in previously mined areas and the installation of new monitoring arrays in the newly mined areas. New and replacement convergence points were installed in 25 locations throughout the WIPP underground access drifts because of mining and trimming activities. Horizontal and vertical convergence point arrays were installed at various locations. Most of these installations were located in the southern access drifts. Convergence points within the access drifts are read manually at least every two months, with more frequent monitoring in some areas. Table 5-2 lists the new and replacement convergence points that were installed during this reporting period.

Convergence point data are obtained by measuring the change in distance between fixed points anchored into the rock across an opening, either from rib-to-rib or from roof-to-floor. Extensometer data are obtained by measuring the displacement from the reference head anchor (collar) to each fixed anchor of the extensometer. These measurements are made, at a minimum, every two months throughout the WIPP underground, except when convergence points are not accessible. Convergence rates and extensometer displacement rates indicate how an excavation is performing; rates that decrease or are relatively constant typify stable excavations, whereas increasing rates may indicate some type of developing instability or may be the response to nearby mining.
