DOE/NV--1409

Closure Report for Corrective Action Unit 408: Bomblet Target Area Tonopah Test Range (TTR), Nevada

September 2010

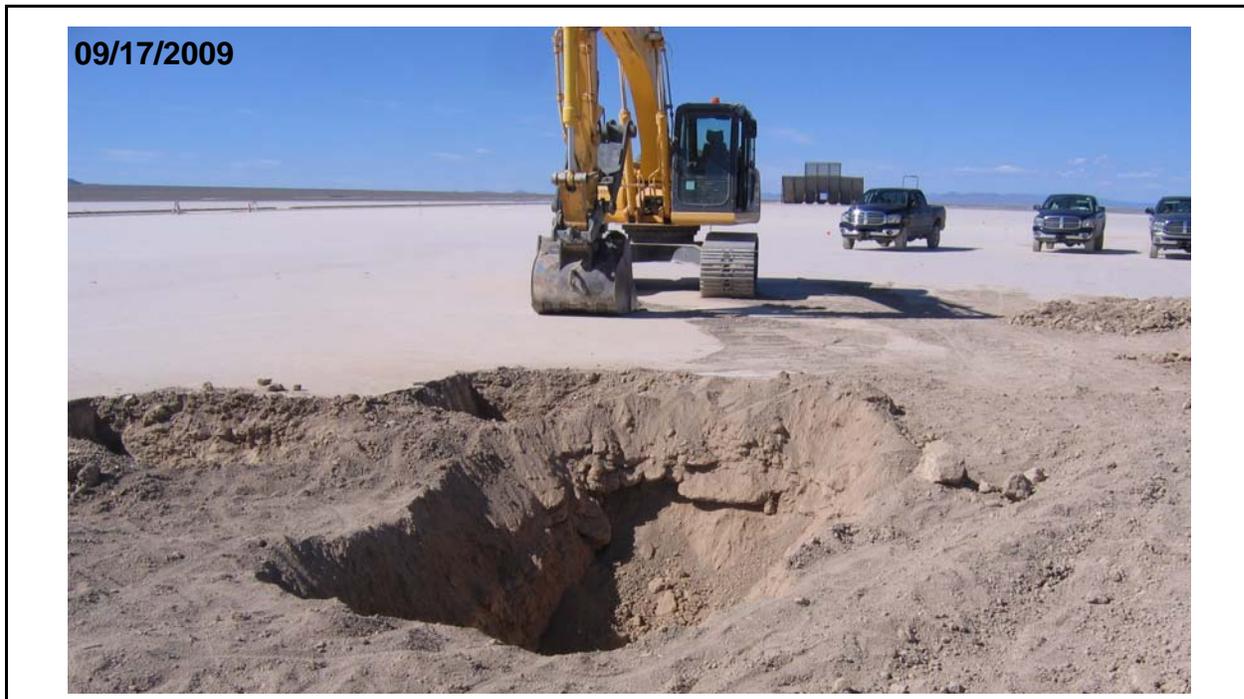
Figure 2-9
Exploratory Pit at Anomaly B114_122 on South Antelope Lake

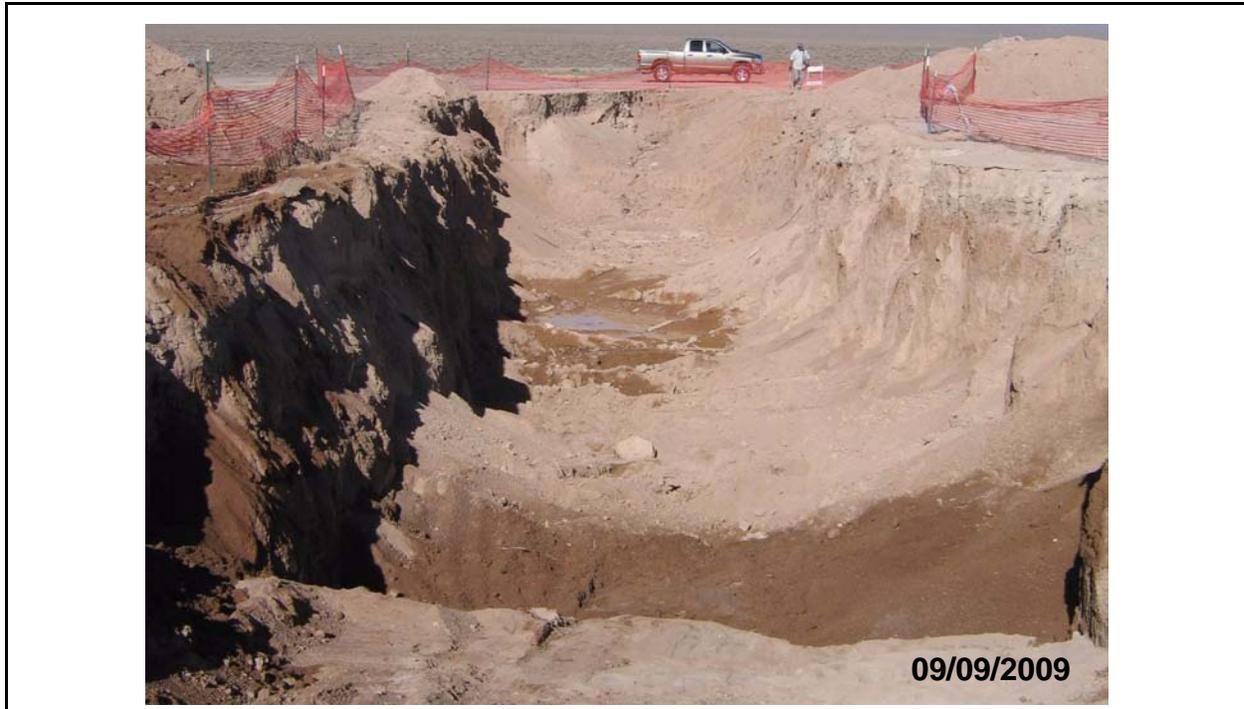
Figure 2-10
Excavation at Anomaly 156_95 on South Antelope Lake

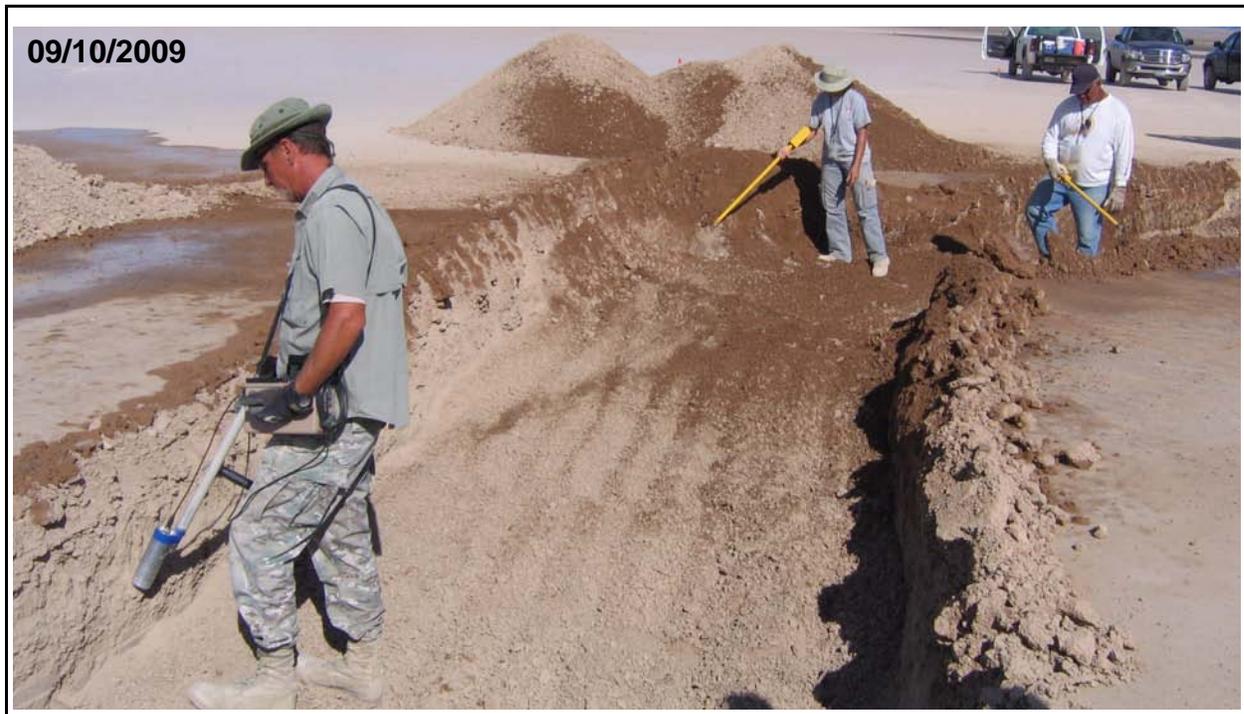
Figure 2-11
Radiological and UXO Screening of Soil in Excavation at Anomaly G104_008

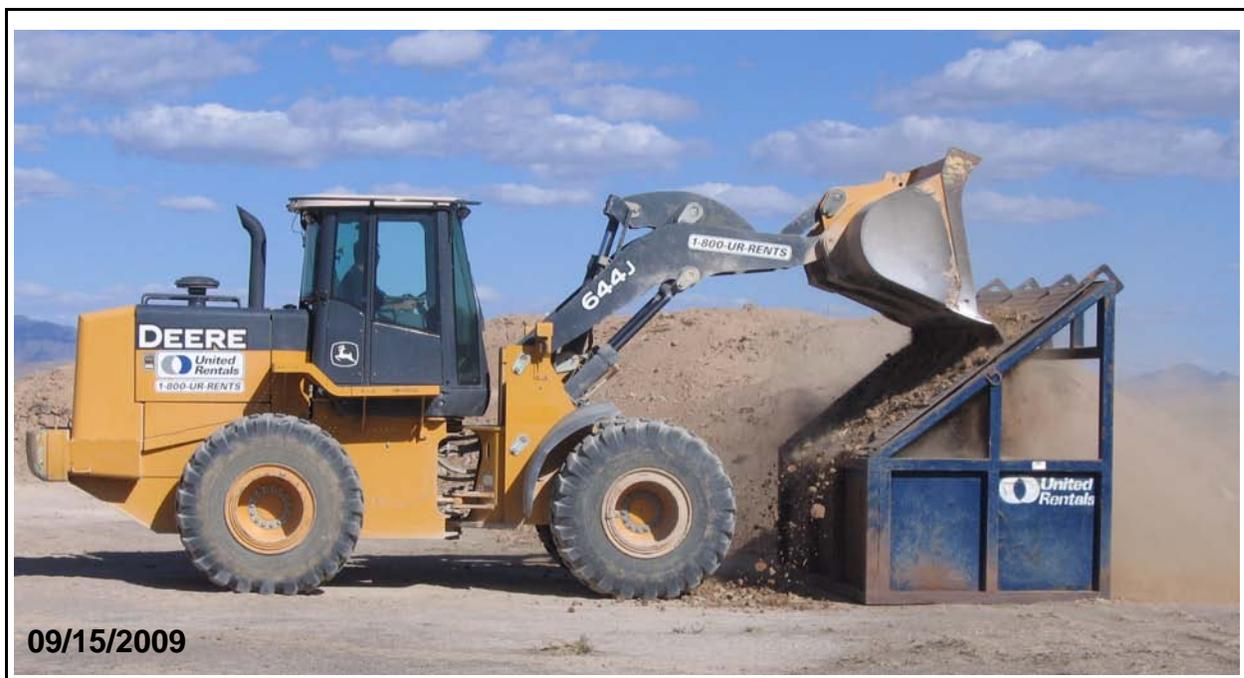
Figure 2-12
Grizzly Operation at Anomaly G156_95 on South Antelope Lake

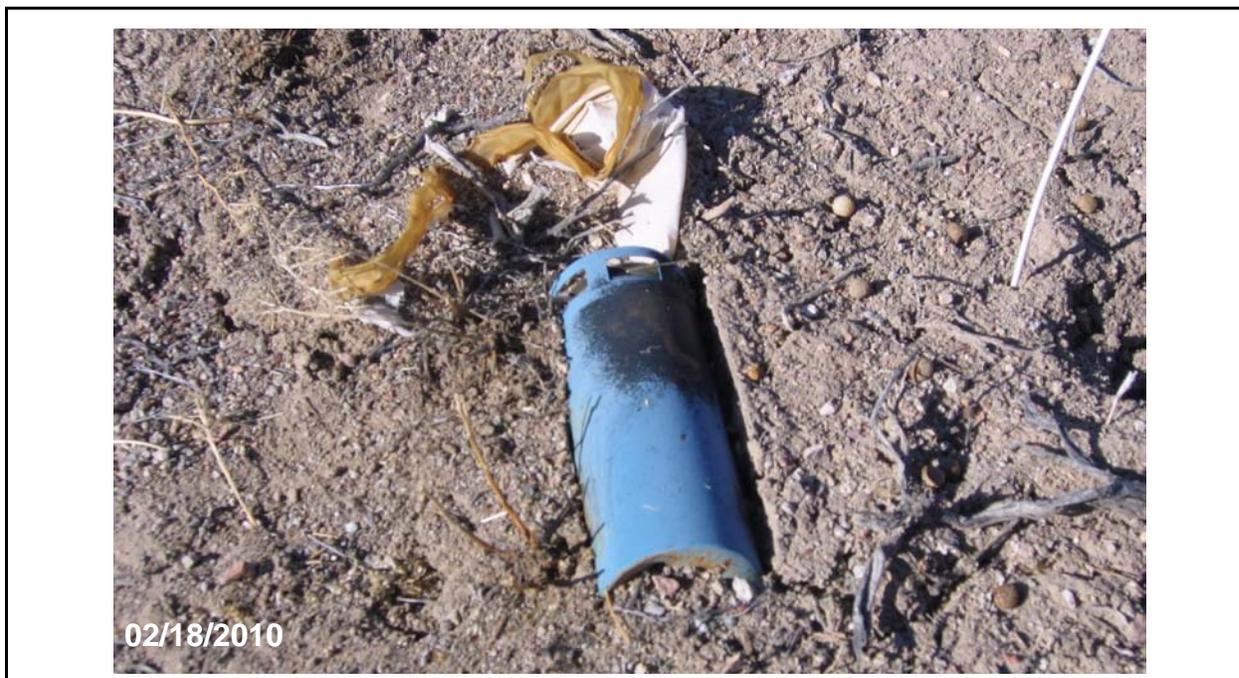
Figure 2-13
BLU-97 Submunition Located on Surface in Mid Target

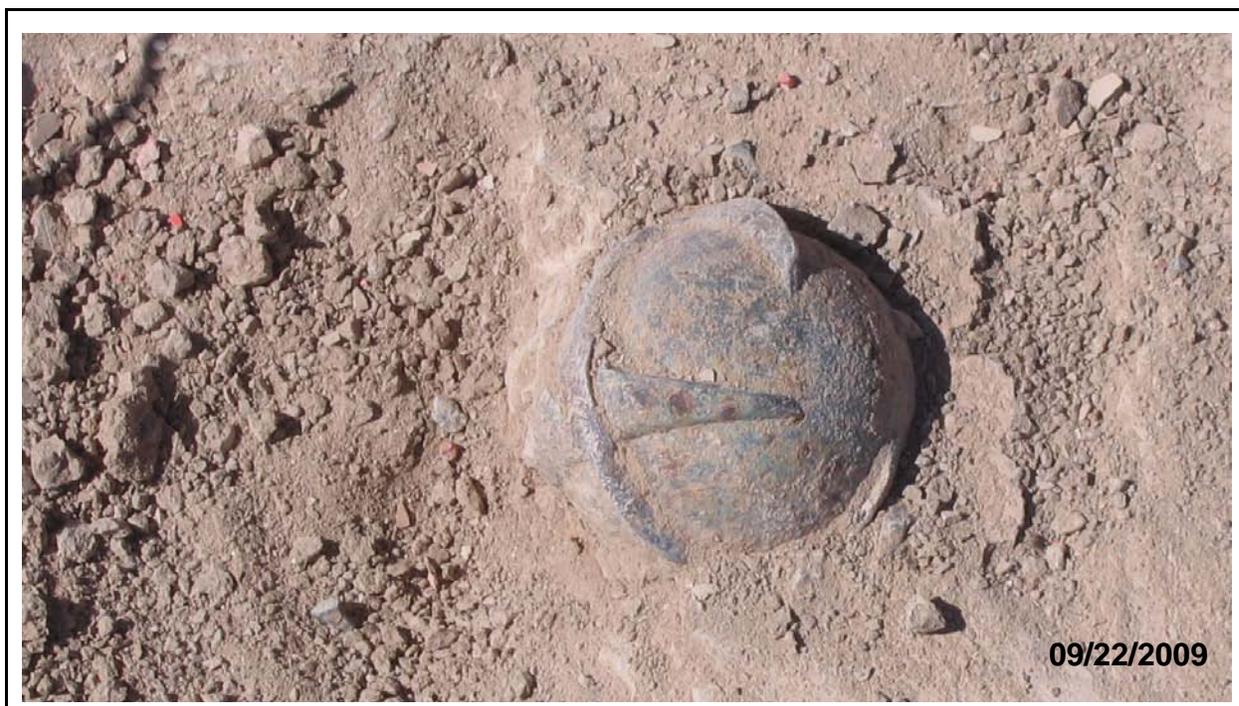
Figure 2-14
BLU-26 Submunition Found near Anomaly D058_01 on South Antelope Lake

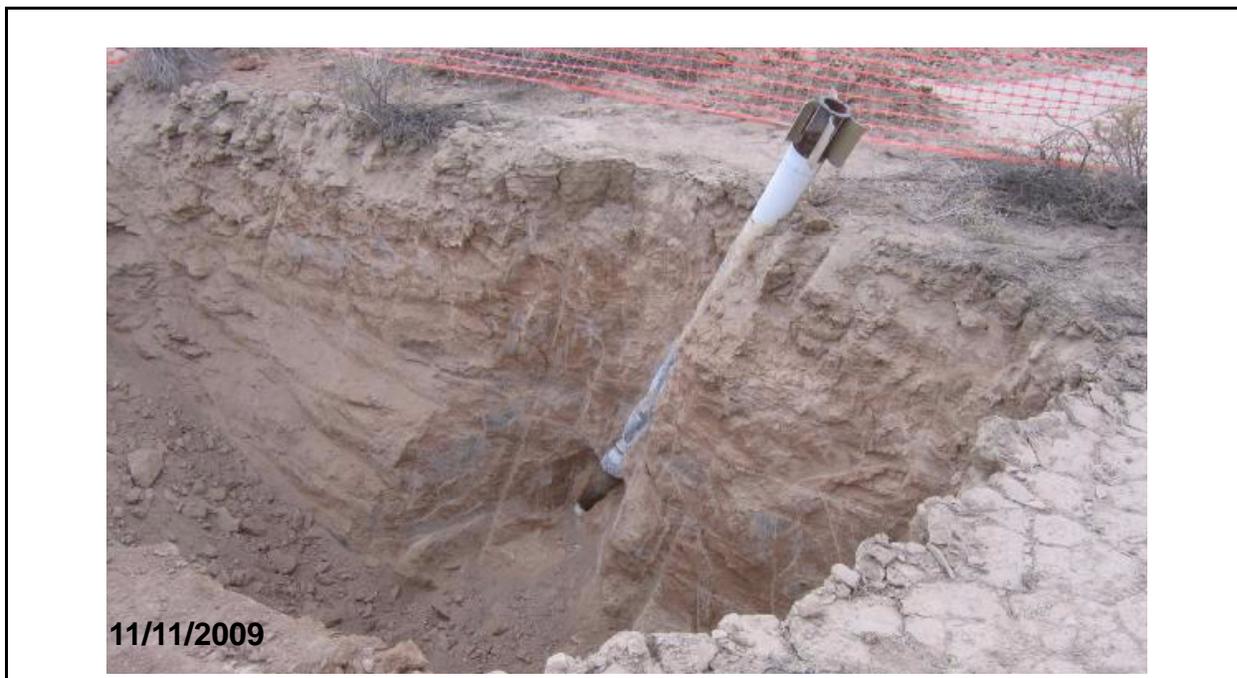
Figure 2-17
Inert Zuni Rocket in Grid 73/733 at SAC Target 1

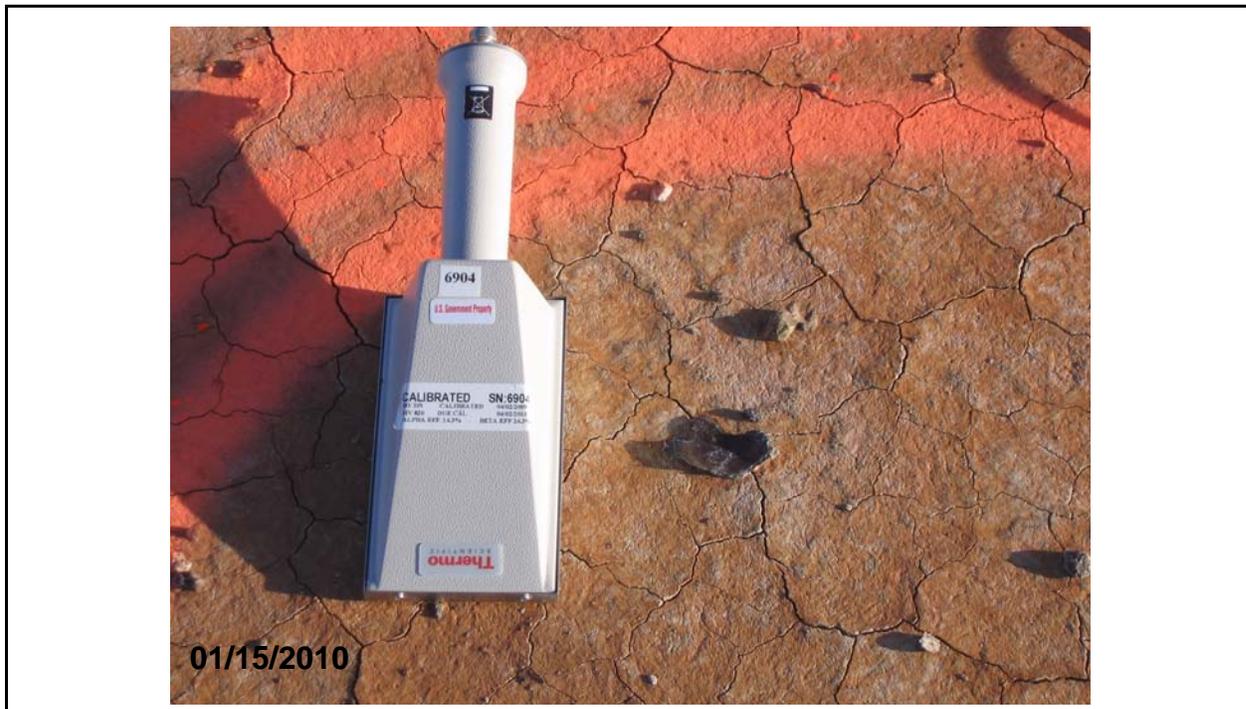
Figure 2-18
Small Fragment of DU Alloy Found in Grid 94/695 on South Antelope Lake

All pieces of DU-impacted metal and debris ([Figure 2-18](#)) discovered during CAU 408 CAI activities were discrete fragments found on the surface and are likely associated with non-DOE-related submunition testing. The walkover surveys performed as part of the CAU 408 project allowed a thorough investigation of the area and identification of additional DU-impacted metal and debris.

01/15/2010	One piece of DU alloy found on grid 94/695 exhibiting 13,000 dpm/100cm ² alpha fixed and 1,500,000 dpm/100cm ² beta/gamma fixed.	South Antelope Lake 94/695	UTM83N, UTM83E 4169544, 529558 4169544, 529458 4169644, 529458 4169644, 529558
01/19/2010	One piece of DU frag 1 by 2 in. found on grid 93/689 exhibiting 150 dpm/100cm ² alpha fixed and 8,000 dpm/100cm ² beta/gamma fixed.	South Antelope Lake 93/689	UTM83N, UTM83E 4168944, 529358 4168944, 529458 4169044, 529358 4169044, 529458

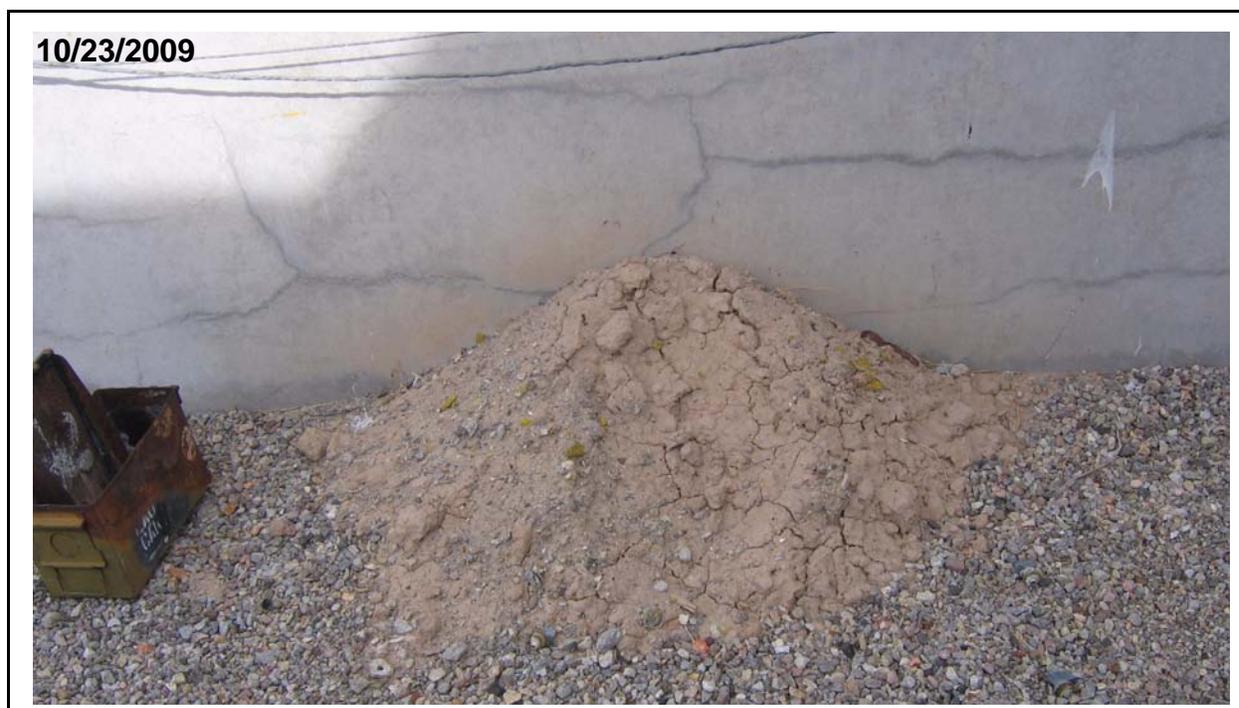
Figure 2-20
DU-Contaminated Soil Pile in Bunker near NEDS Lake

Personnel also identified a mound of soil (approximately 5 cubic feet) impacted with DU inside a concrete bunker near NEDS Lake ([Figures 2-20](#) and [2-21](#)). The origin of the DU-contaminated soil is unknown and not likely CAU 408 related; however, the soil mound was removed and containerized for disposal. Following removal of the DU-contaminated soil, the soil underneath the mound and surrounding area was surveyed using all NE Electra with DP6BD probe, and determined to be indistinguishable from background.

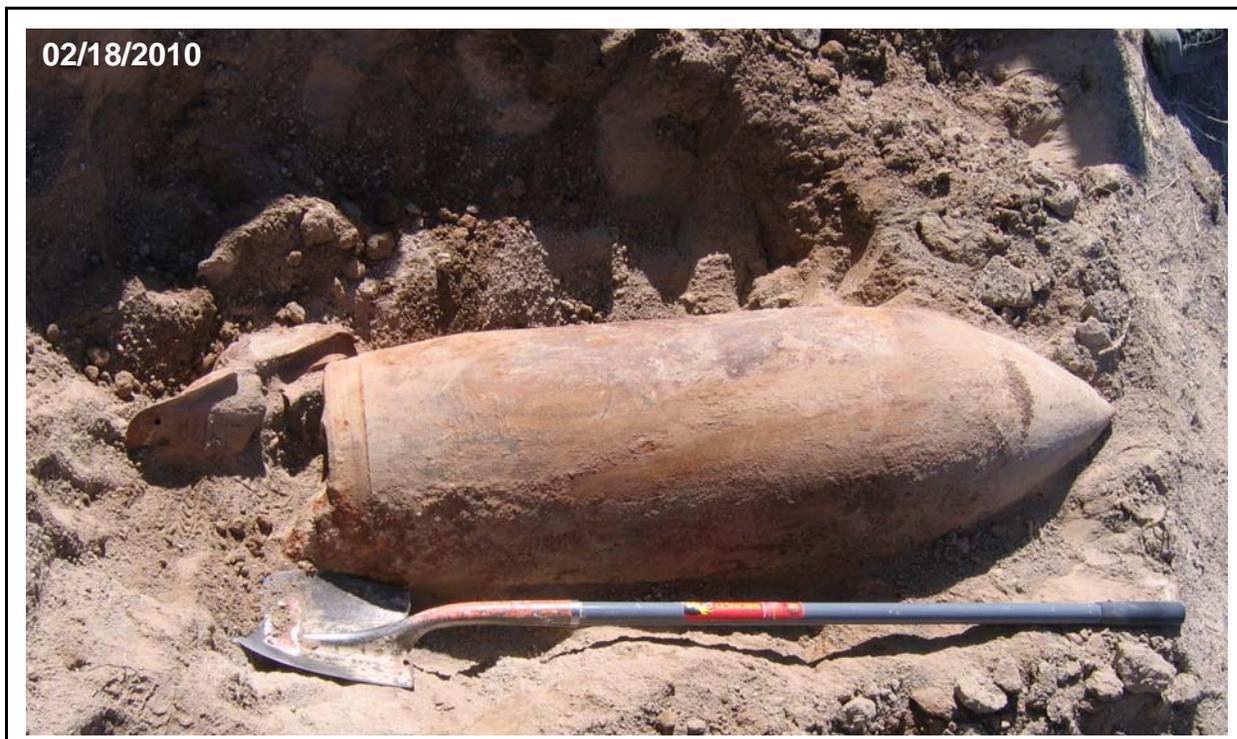
Figure 2-22
M117A1 (750-lb bomb) Uncovered in Grid 53/816 at Mid Target

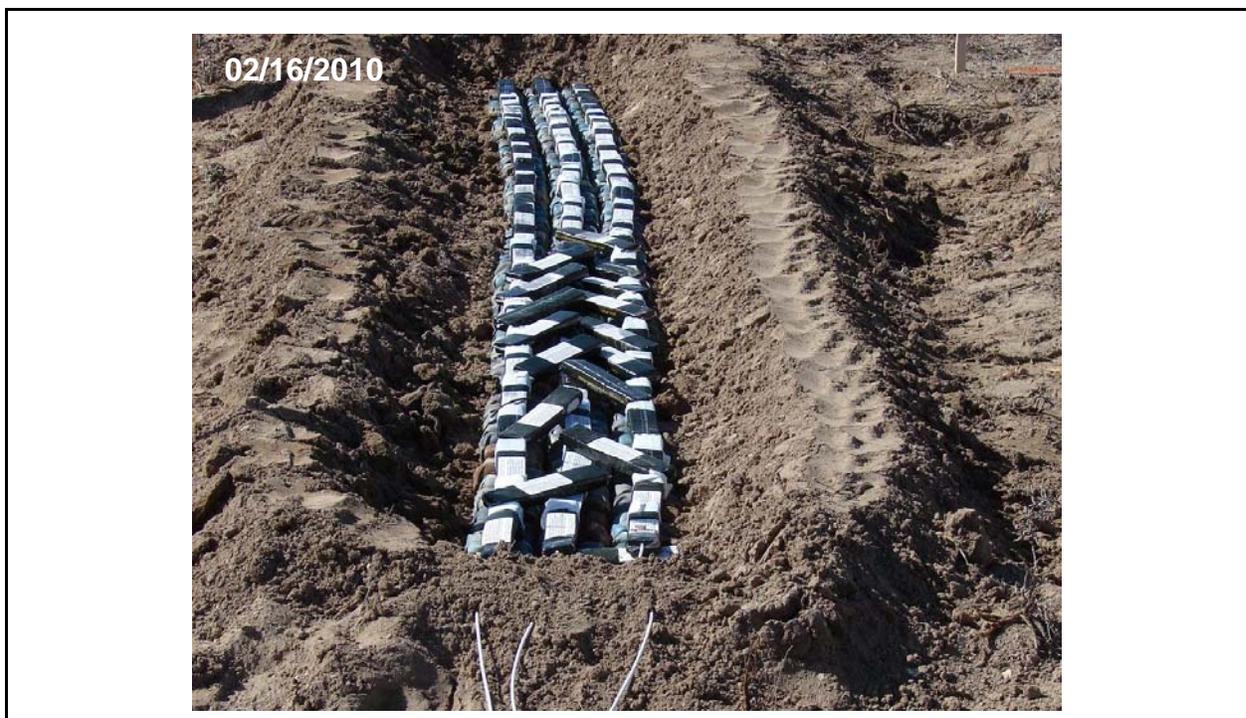
Figure 2-25
Typical Demolition Setup for BLU-63s at Mid Target
Note: C-4 donor explosive charges on top of BLU-63s.

Five demolition events ([Figure 2-25](#)) were conducted to render all MEC inert between February and August 2010. The first three events included MEC treated under the NDEP Emergency Treatment Permit (Murphy, 2009 and 2010), the last two events included remaining MEC recovered under the Military Munitions Rule (CFR, 2010). [Table 2-3](#) summarizes the demolition events, including detonation times, donor explosives, and treatment locations. Inspection of the demolition site by qualified UXO personnel was completed following each detonation. Inspection of the site included visual and magnetometer sweep of the area for removal of remaining fragments and debris. Visual inspection confirmed the absence of any remaining explosive residues.

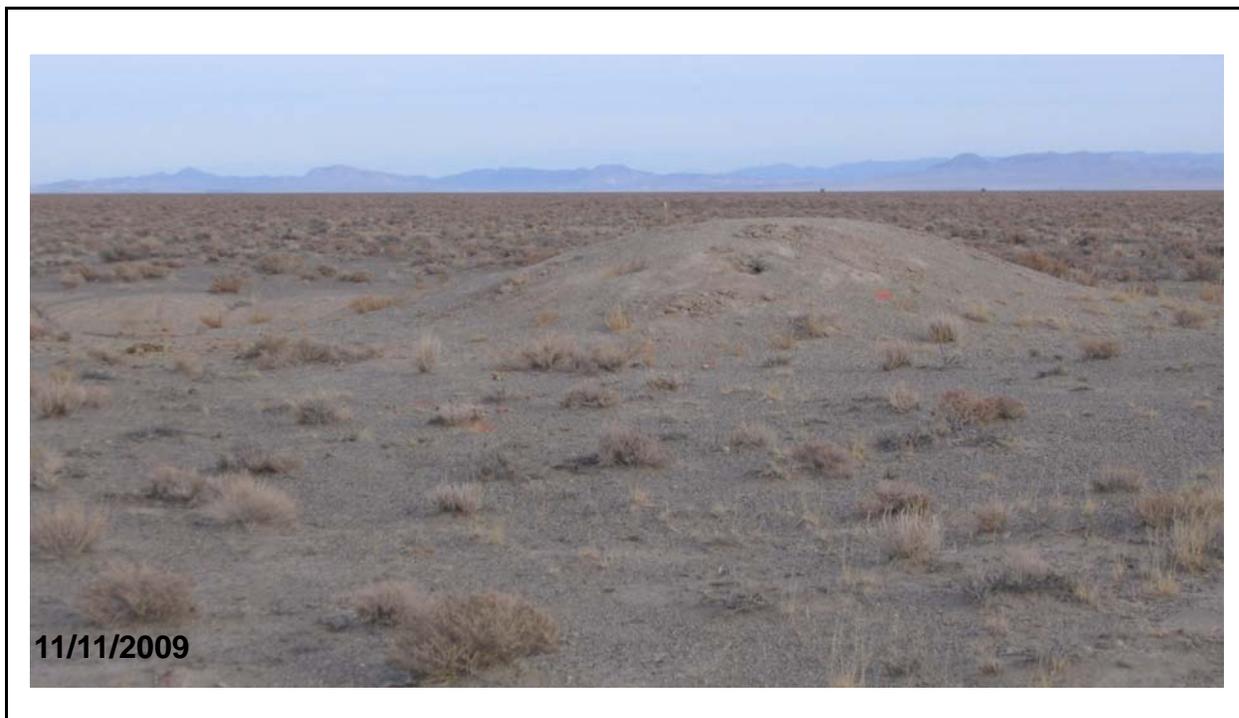
Figure 2-26
Before: Soil Mound in Grid 71/729 at SAC Target 2 before Inspection

Verification sample analytical results from the SAC Target 2 soil mound (grid 71/729) showed lead concentrations above the preliminary action level (PAL) (Figures 2-26 and 2-27), but below the FALS (see Appendix E).

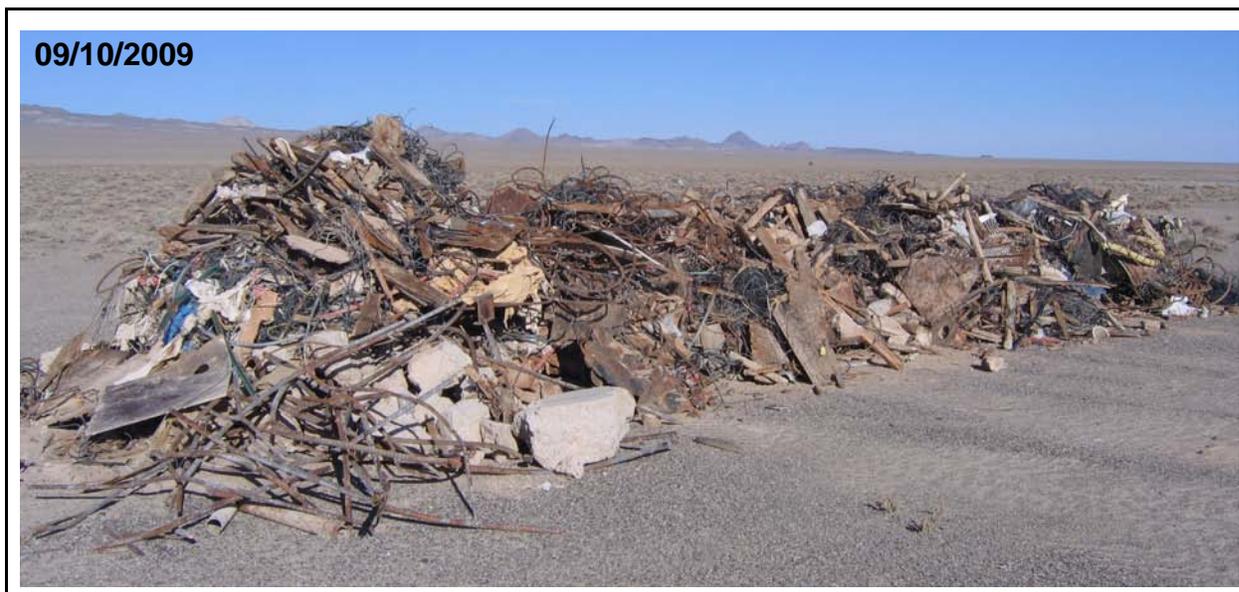
Figure 3-1
Construction Debris Pile from Anomaly G156_95

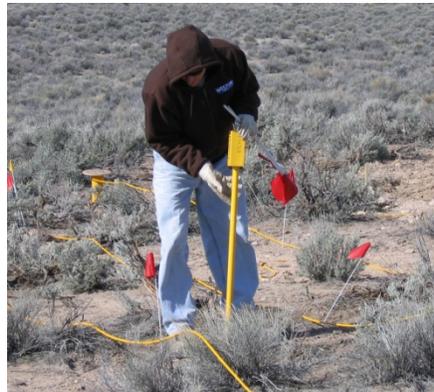
Schonstedt handheld magnetometers were used for screening soil removed from the disposal pits. The Schonstedt GA-52Cx ordnance locator identifies magnetic field variations between two sensors spaced 20 cm apart. An audible signal is used to identify any variation in the magnetic field as the sensor is passed over or near a ferromagnetic source (see Photo 3-1). The volume and frequency of the signal changes as the sensor pinpoints the center of the source body. Similar to the Schiebel, the instrument sensitivity can be adjusted to increase or decrease detection capability of small metallic material.

Photo 3-1 Technician Performing Sweep with Schonstedt

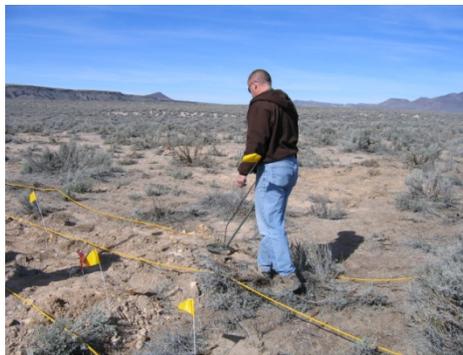
The Schiebel AN-19/2 consists of a hand-held two-coil design, which utilized the electromagnetic method to detect both ferrous and non-ferrous metals. As the UXO Technician sweeps a lane (see Photo 3-2) an audible signal will sound when the sensors are swept over conductive material. The volume and frequency of the signal changes as the sensor pinpoints the center of the source body. The instrument sensitivity can be adjusted to increase or decrease detection capability of small metallic material.

Photo 3-2 Technician Performing Sweep with Schiebel

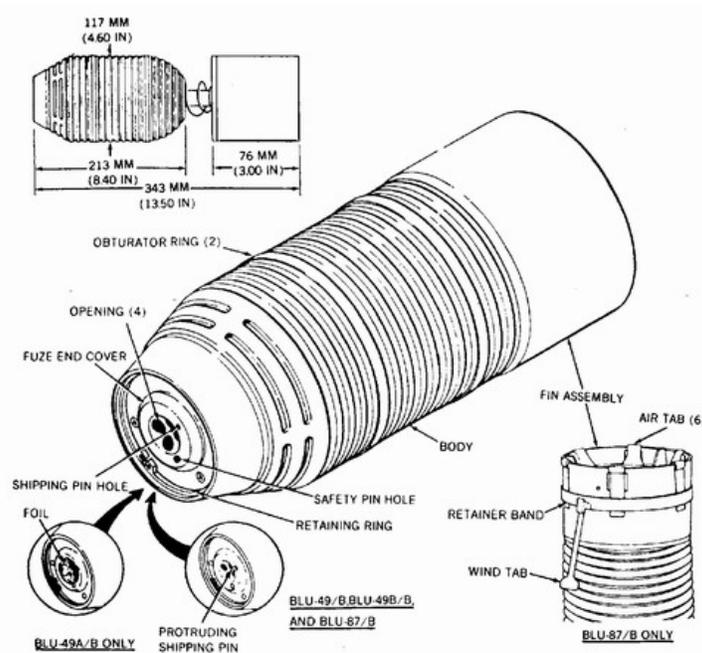
BLU-49s were recovered in the Burial Pits and at the South Antelope Lake Target. The BLU-49 is the munition with the greatest fragmentation distance (MGFD). Recent guidance from the U.S. Army Corps of Engineers (USACE) and the Department of Defense Explosive Safety Board has indicated that the Hazardous Fragment Distance (1/600 rule is the new guidance for unintentional detonation of known MEC. The hazardous fragment distance for the BLU-49 was established as 395' which is the greater of the two hazardous fragment distances listed in Tables 4-1 and 4-2 of the Department of Defense Explosive Safety Board (DDESB) Technical Publication (TP) 16. As such, the safety exclusion zone for non-EOD qualified or non-essential personnel will be set as 395' feet outside the work area during investigation activities.

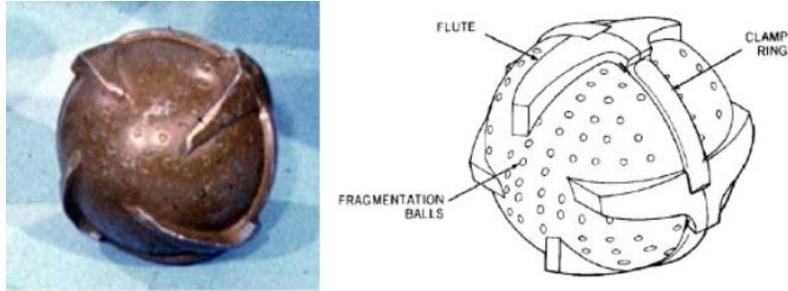
BLU-26

The BLU-26/B "Guava" was an air-dispensed APAM (anti-personnel/anti-material) fragmentation bomblet with 600 embedded steel fragments. The BLU-26/B had three different fuzing options. It could detonate immediately on impact, as an airburst 9 m (30 ft) above ground, or after a selectable but fixed time after impact. The BLU-26/B was used as payload in cluster bombs.

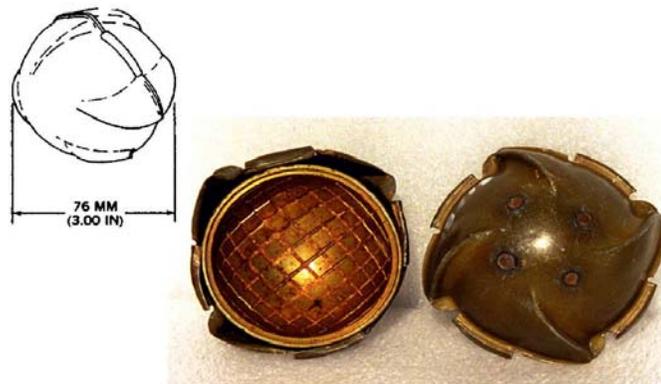
BLU-63

The BLU-63/B was an aerially dispensed, centrifugally-armed, impact-fired anti-personnel/anti-material fragmentation bomblet. It contained 113 g (0.25 lb) of Cyclotol. There was also a BLU-63A/B version, but confirmed information about the differences is not available (the 63A/B possibly had a secondary incendiary effect). The BLU-63()/B was used as payload in a cluster bombs.

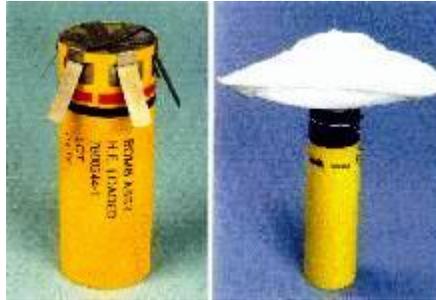
BLU-97

The BLU-97/B Combined Effects Bomb (CEB) is deployed against armor, personnel and material. It is configured as a shaped charge, scored steel casing, and zirconium ring for anti-armor, fragmentation, and incendiary effects. The case is made of scored steel designed to break into approximately 300 preformed fragments. The bright yellow body of the sub-munition is cylindrical and approximately 20 centimeters long with a 6 centimeter diameter. The original Cyclotol explosive was later replaced with PBXN-107 explosive in the improved BLU-97.

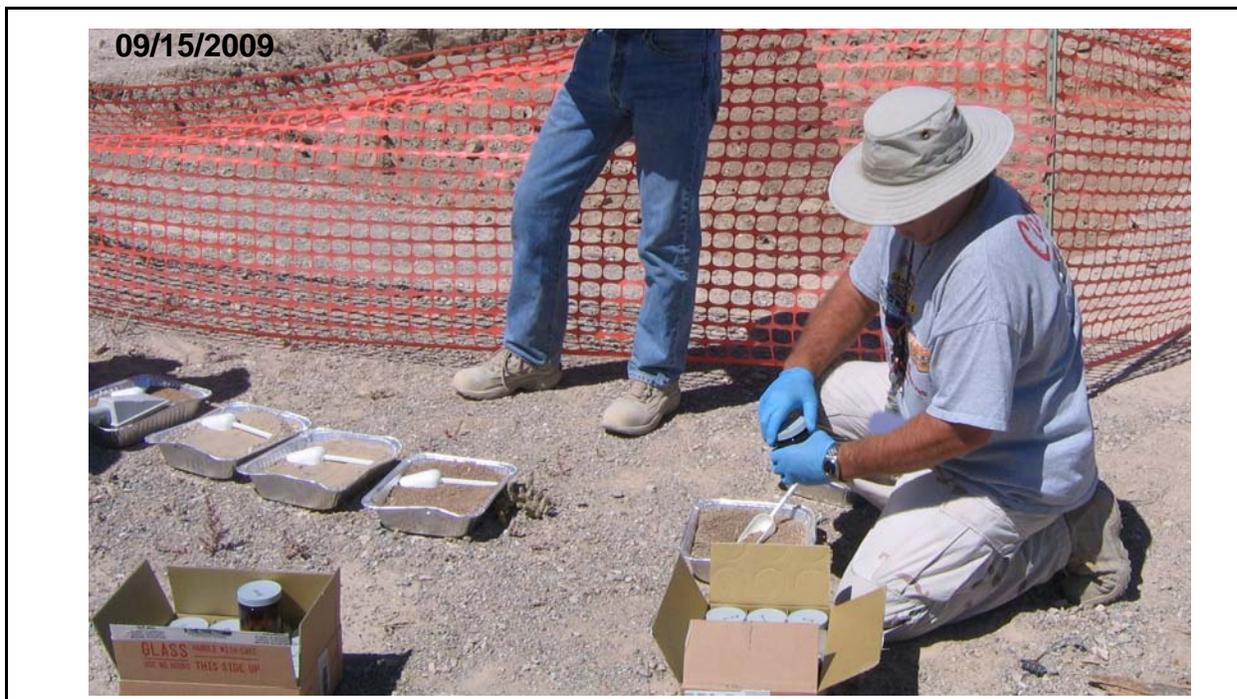
Figure C.3-2
Disposal Pit G156_95 Soil Sampling

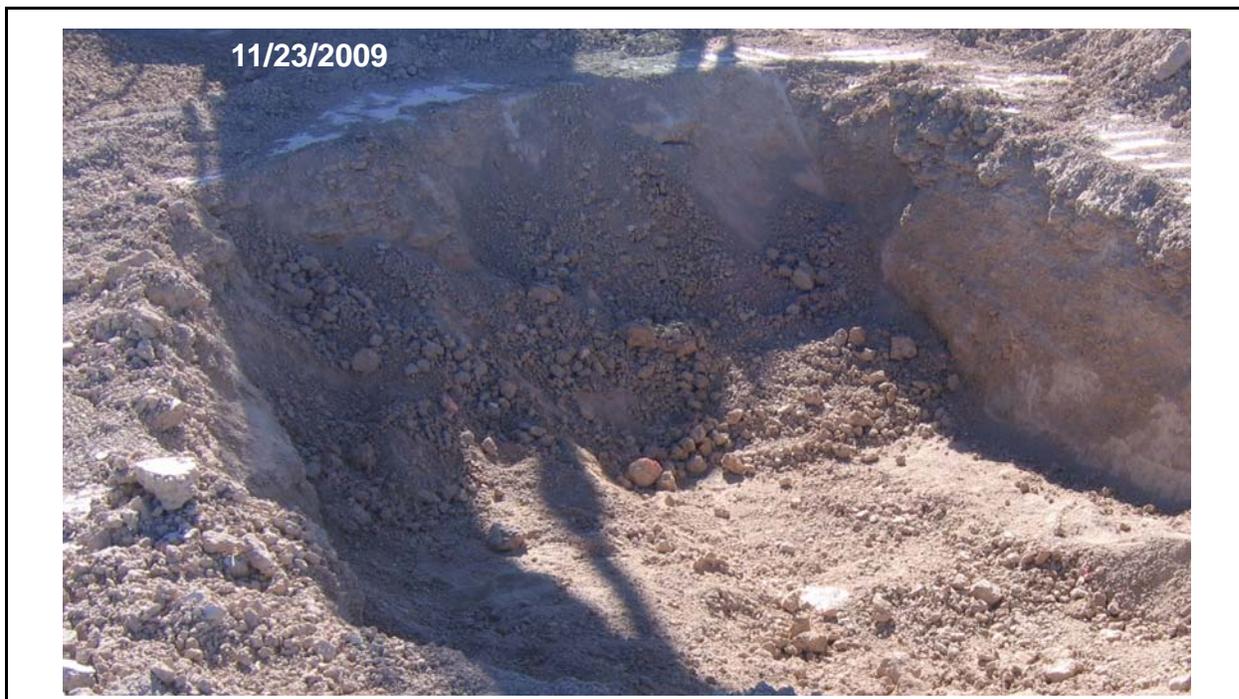
Figure C.3-4
Grid 94/701 Post-excavation and Remediation
