WHC-SA-2403-FP

308 Building Zone I Stabilization and Confinement

Date Published
August 1994

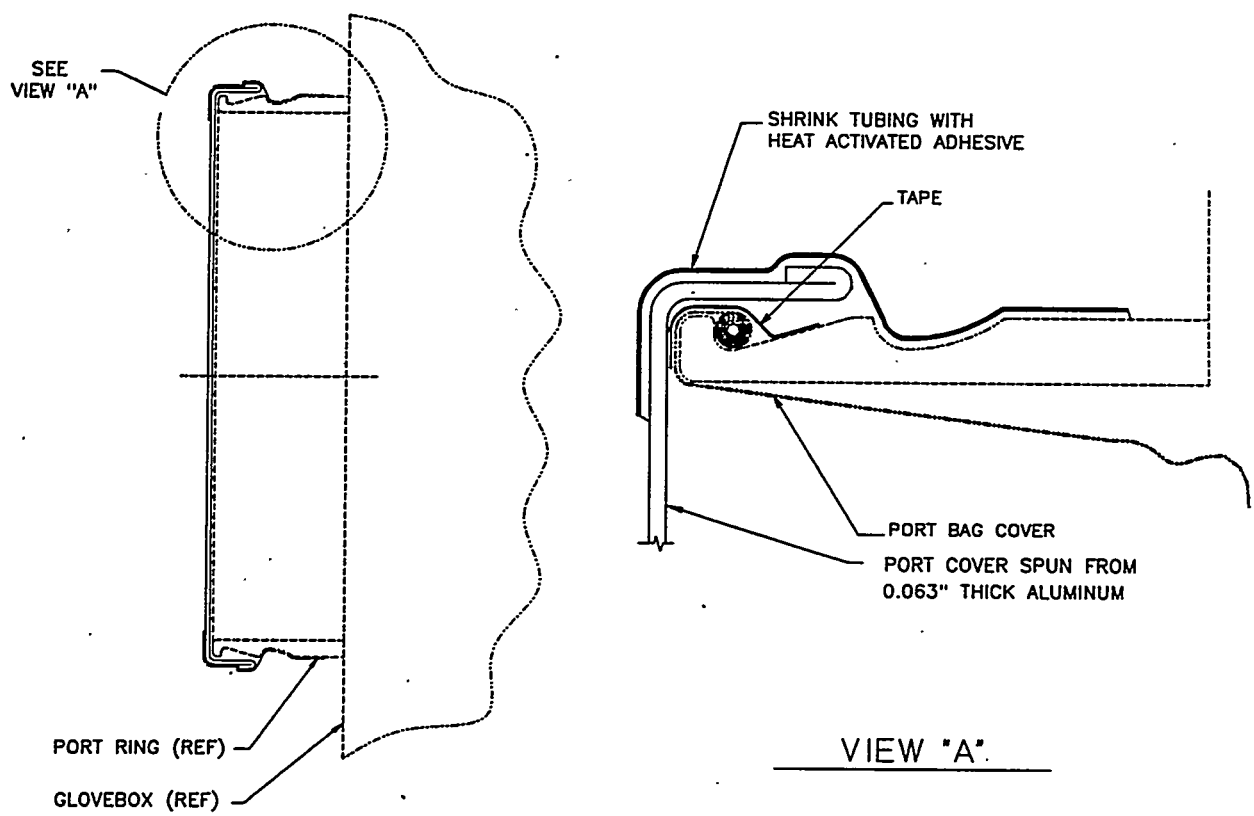
Figure 1. Glovebox Port Seal Arrangement.

Ports. After the interiors of the gloveboxes were stabilized, the existing gloves or bags were removed and port bags installed using standard techniques. To provide physical protection, aluminum port covers were installed. Next, the covers were secured with shrink material having a heat-activated adhesive lining. This material also provided a tight fit and an additional barrier. This composite of barriers is shown in Figure 1.
