Materials Performance in the Atmospheric Fluidized-bed Cogeneration Air Heater Experiment

ANL-91/4

MATERIALS PERFORMANCE IN THE ATMOSPHERIC FLUIDIZED-BED COGENERATION AIR HEATER EXPERIMENT

February 1991

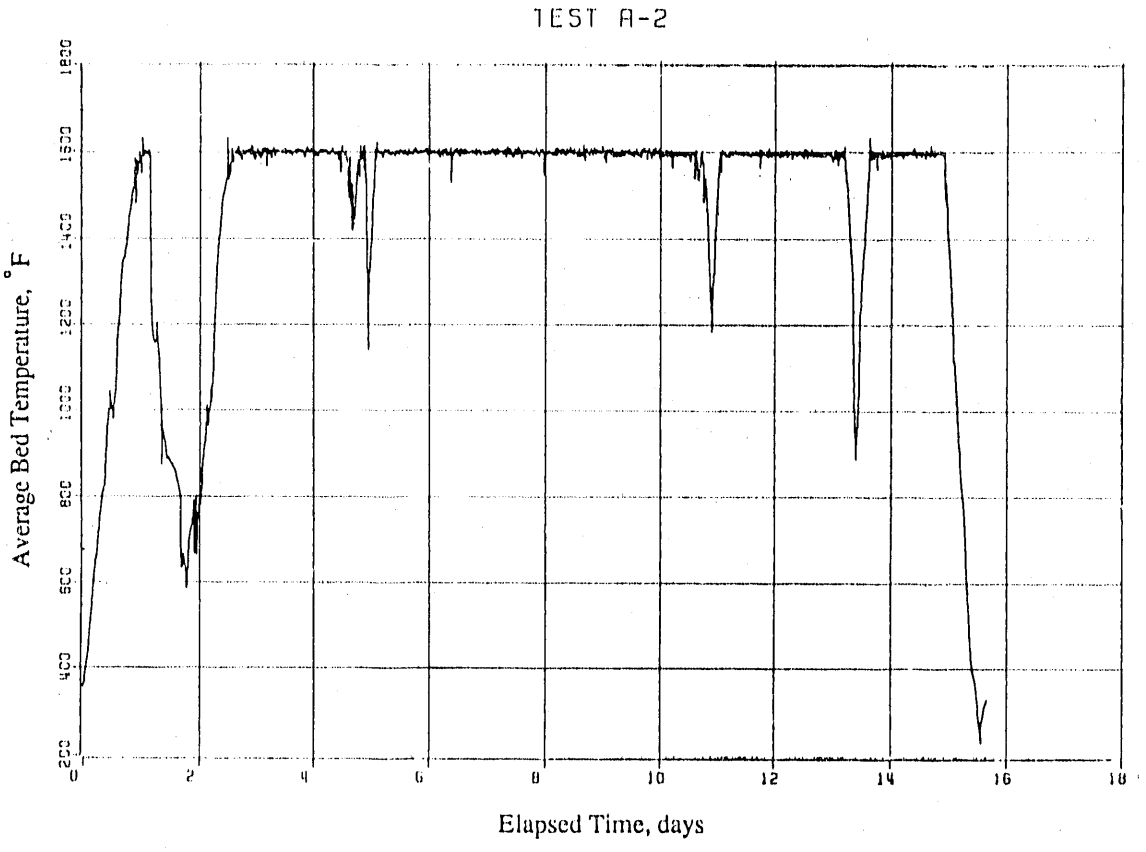
Fig. VI-1. Data Plot for Bed Temperature

Two hours into the next test period, the bed-drain line failed, requiring an immediate shutdown for repairs. This was the first of many corrosion failures of sensitized stainless steels and carbon steels because of the lack of preservation and the presence of salt air from the ocean nearby. The test was restarted and the first 250-h segment completed. However, the coal-system plugged intermittently (due to wet coal), yielding approximately a 70% availability (see Fig. VI-1).

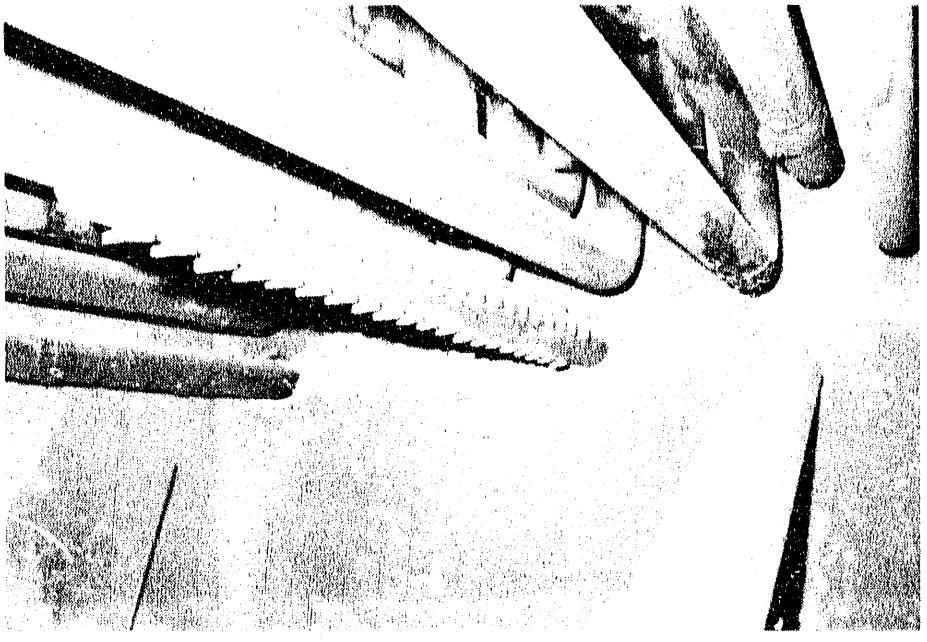
Fig. VI-3. View of Combustor below Tube Bundle

The combustor was inspected after Test segment A-3, and no anomalies were noted (Fig. VI-3). One of the ABB/CE probes was found to be approximately 1-in. (25.4-mm) short, causing the first specimen to be inside the refractory (Fig. VI-4). The external thermocouples which had been installed on the tube bundle were gone (Fig. VI-5). This was not unexpected; however, they lasted long enough to provide some external tube temperatures.

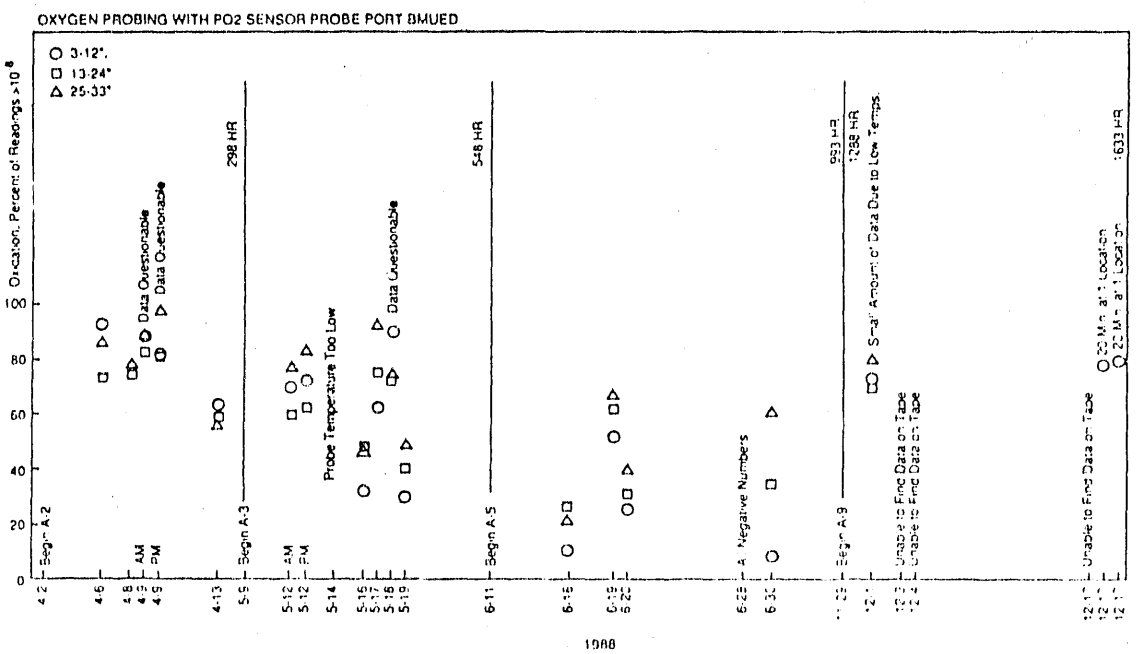
Fig. VIII-4. Oxygen Probe Results from Port BMUED

The data in Figs. VIII-4 through -7 vary substantially with exposure time and distance from the wall. The data indicate that the pO_2 values were above 10^{-8} atm at port BMUED for an exposure period between ~300 and 500 h for only 25-50% of the time. Further, the data show that the bed essentially operated under reducing conditions for the second 500 h of exposure of the corrosion probes, the time period of June 16-30, 1988 (which spans the second 500 h of exposure of corrosion probes). However, laboratory corrosion test results obtained under gas conditions cycled between oxidizing and reducing showed that exposure for as long as 100 h to a sustained low pO_2 is needed to initiate sulfidation attack of high-Cr alloys in an SO_2-containing combustion environment.[6] The flue-gas sample line developed a leak during the second 500 h of testing, which was interpreted as an insufficient fuel feed rate. During this period, the coal-feed rate was increased to reduce the flue-gas oxygen concentration; this, in effect, decreased the in-bed oxygen concentration, leading to operation under reducing conditions. It can be seen that the oxygen concentrations near the combustor walls were generally lower than in the center of the bed.

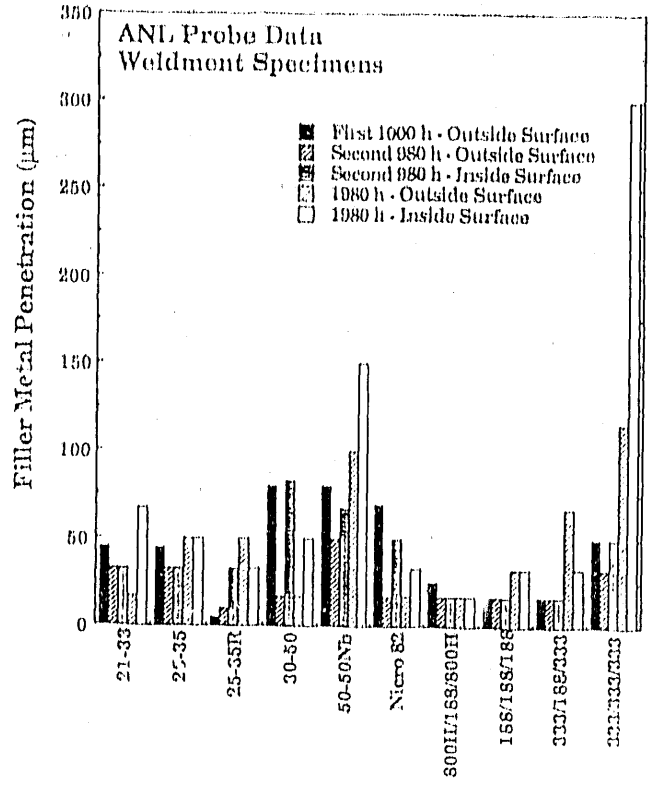
Fig. X-5. Filler Metal Penetration Data from ANL Probe BMUEB

tested materials. The results also show that the filler metal selected for application in FBC atmosphere should be impervious to not only the gas atmosphere but also the bed-deposit material. On that basis, filler metals 25-35R, 25-35, and 188 alloys are the most desirable.

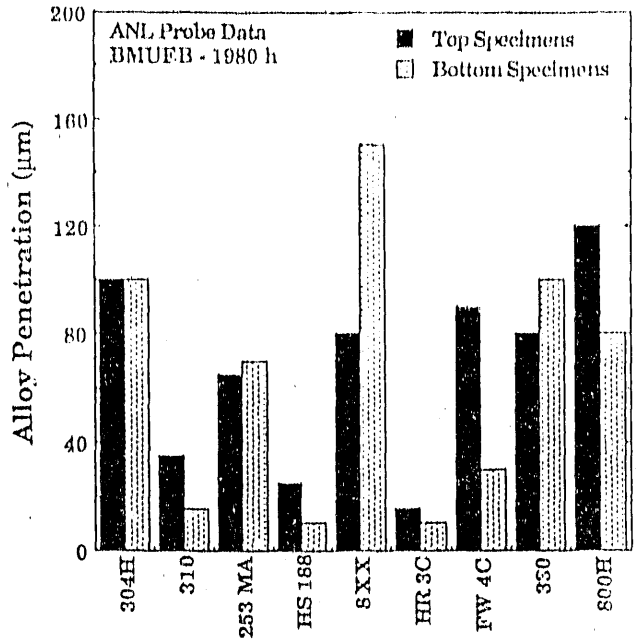
Fig. X-6. Alloy Penetration Data from ANL Probe BMUEB

The base metal specimens in the ANL probe were all exposed for 1980 h. Detailed microstructural evaluation of various base-metal alloys was conducted, and the SEM photographs of the cross sections of different alloys are given in Appendix B. The specimens on the top of the support rod (identified as "Top Specimens") would have had some accumulation of bed material on them, while those on the bottom of the support rod would have been exposed to particle/gas impingement and essentially would have had no accumulation of bed material. Figure X-6 shows the alloy penetration data for all the base-metal specimens exposed in ANL probe BMUEB. The penetration rates for the alloys ranged between 10 and 160 μm (which translates to 0.02 - 0.34 mm/yr, based on parabolic kinetics) after 1980-h exposure. Alloys such as Type 310 stainless steel, HS 188, and HR 3C exhibited better corrosion resistance than the others. The internal penetration in most of these alloys was predominantly due to oxidation attack, and virtually no sulfur was detected.

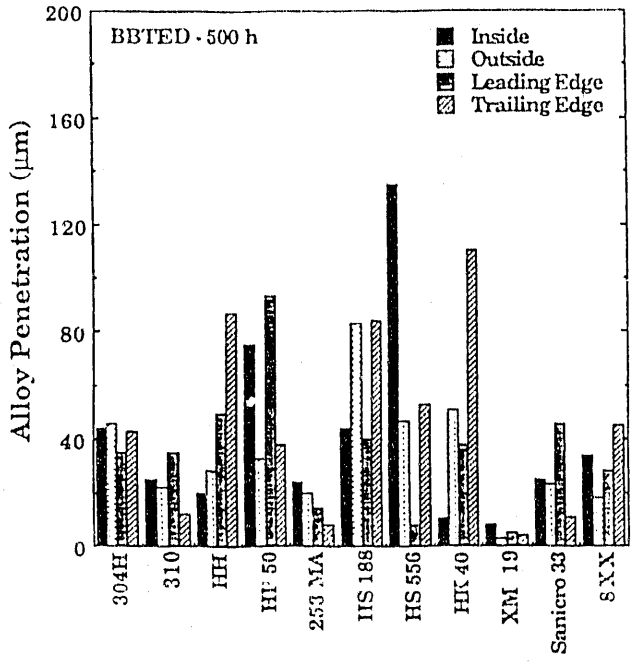
Fig. X-7.

Figures X-7 to -9 show the penetration depth data for different surfaces on alloys exposed in B&W probes for 500, 1000, and 1980 h. In general, the data show that the penetration was much less on the outer surfaces of the alloy specimens when compared with those on the inside surfaces, which were exposed to deposits of bed material. This is especially true for the specimens exposed for 1980 h. The penetration on the outer surfaces for all the alloys was in a range of 3-110 µm. The penetration depths for the leading- and trailing-edge surfaces were essentially in the same range. On the other hand, penetrations on the inside surfaces of all the specimens (except Types 304 and 310 stainless steel) ranged between 630 and 3000 µm (which translates to 1.3 and 6.3 mm/yr, based on parabolic kinetics). The inside surfaces of stainless steels exhibited a maximum of 90 µm (equivalent to 0.02 mm/yr).

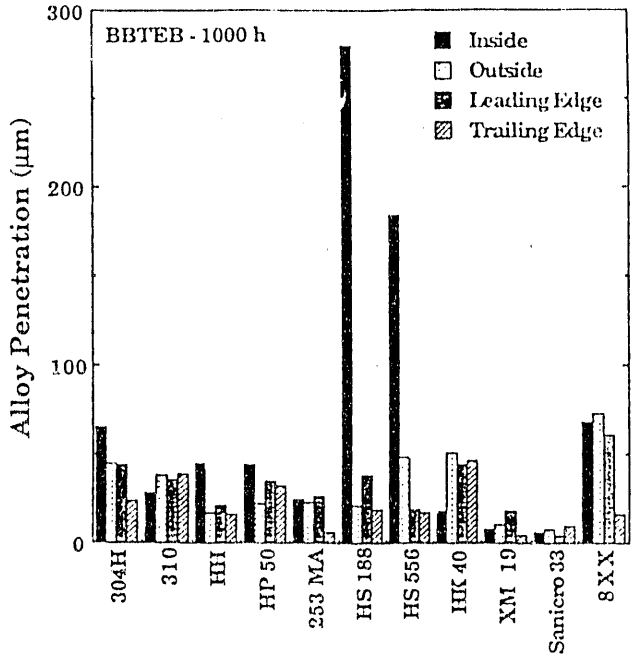
Fig. X-8.

Penetration Data for Alloy Surfaces Exposed for 1000 Hours in B&W Probe BBTEB

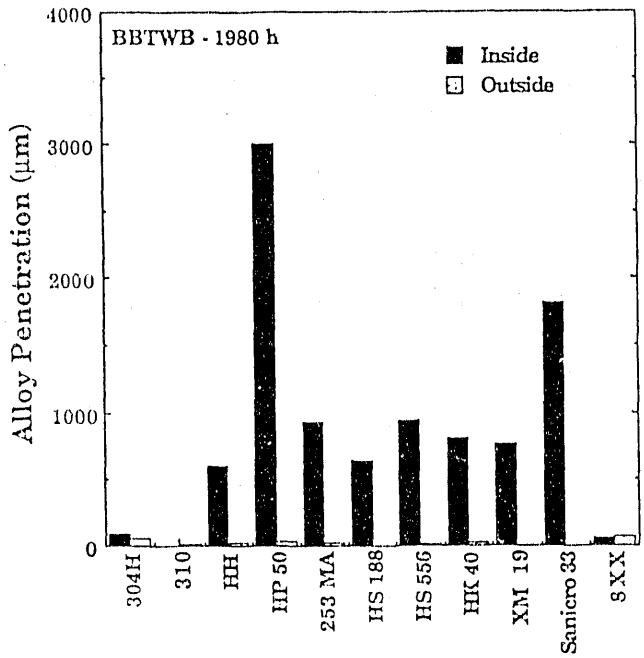
Fig. X-9.

Penetration Data for Alloy Surfaces Exposed for 1980 Hours in B&W Probe BBTWB

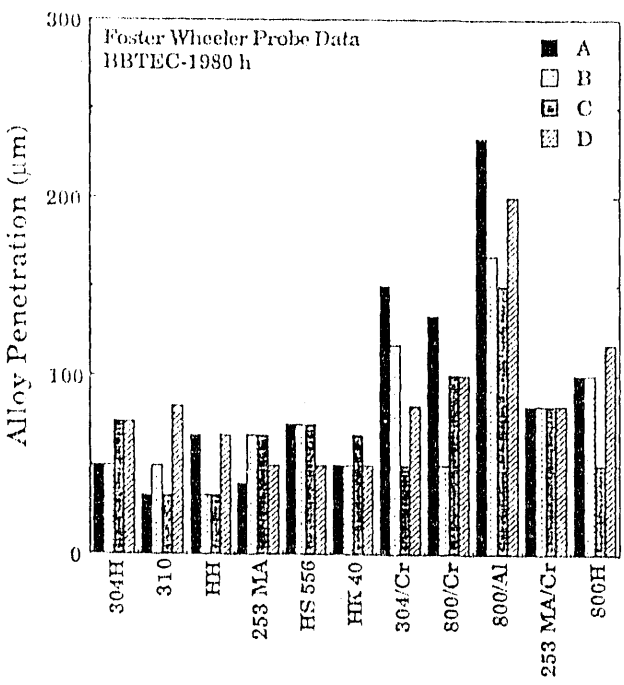
Fig. X-13.

Figure X-13 shows the penetration depth data for alloys and coatings exposed in the FW probe BBTEC for 1980 h. The results indicate that the coated specimens exhibited less corrosion resistance than the corresponding base metals. The penetration in all of the samples was dominated by oxidation and very little, if any, sulfur was detected. Figure X-14 shows a comparison of data for alloys (exposed under similar conditions) common to the probes exposed by the three organizations. The penetration rates for the alloys ranged between 5 and 10 μm (0.01- and 0.21-mm/yr, based on parabolic kinetics) after 1980-h exposure to the FBC environment. Figure X-15 shows a comparison of penetration data for common alloys exposed in location A of FW probe and the top row of specimens in the ANL probe.

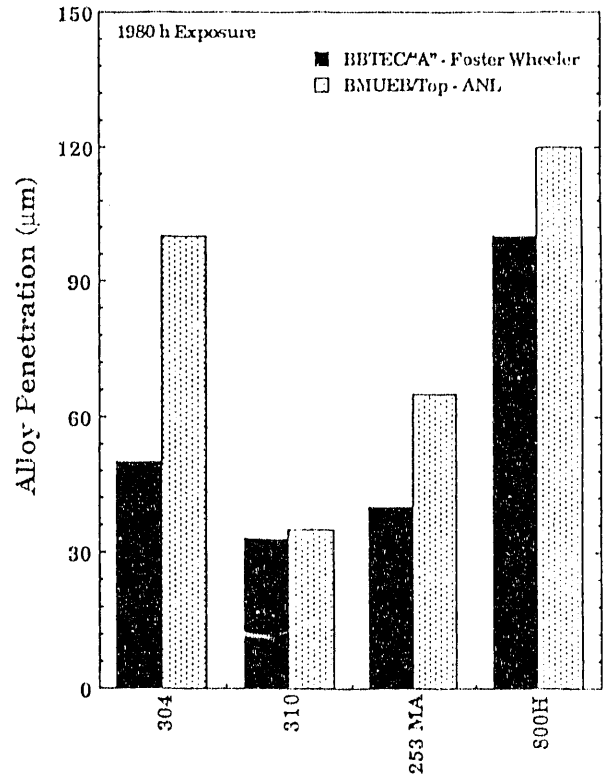
Fig. X-15.

Comparison of FW and ANL Penetration Data for Top Specimens

The specimens obtained from B&W probes were exposed in the 9 o'clock position, and data from these could not be included in this comparison. The similarity of penetration depths in Fig. X-15 indicates that the probe exposure elevation [18.3 in. (46.5 cm) for FW probe vs. 50.7 in. (129 cm) for ANL probe] had negligible effect on the corrosion process.

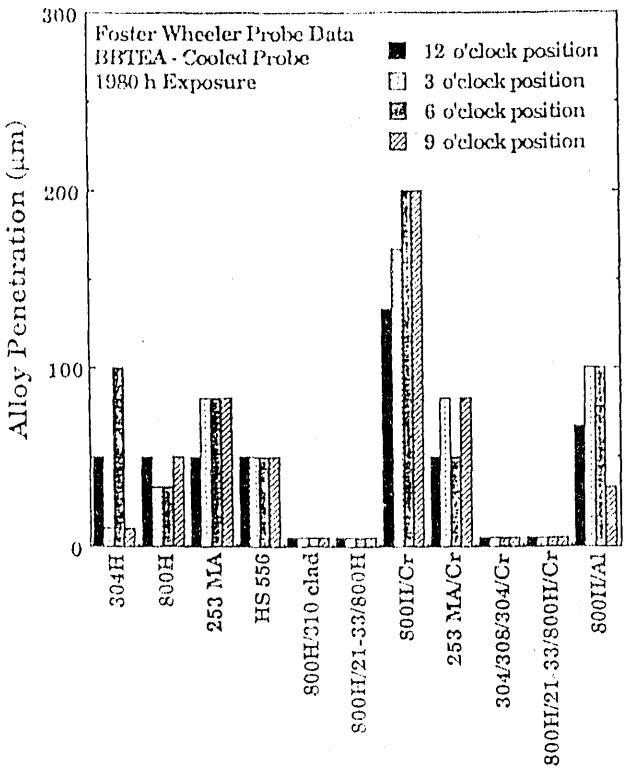
Fig. X-16.

Specimens from one FW cooled probe, identified as BBTEA, were analyzed. The exposure temperatures ranged between 774 and 843°C (1425 and 1550°F) for the specimens in this probe. The specimens were exposed for 1980 h at an elevation of 18.3 in. (46.5 cm) from the air distributor plate (see Fig. X-13). Among the specimens, the uncoated specimens were exposed at the lower end of the temperature range, while the coated specimens experienced higher temperatures. The clad and weldment specimens were exposed in the middle of the temperature range. Details on the microstructural analyses of these specimens are presented in Appendix G. Figure X-16 shows the alloy penetration depth data for the alloys, claddings, coatings, and weldments exposed in BBTEA probe. The higher penetration depth for some of the chromized and aluminized specimens is due to internal penetration of coating layer, primarily via oxidation mode, and no sulfur being present. The data also show that a number of alloys, claddings, and weldments performed with adequate corrosion resistance for 1980 h.

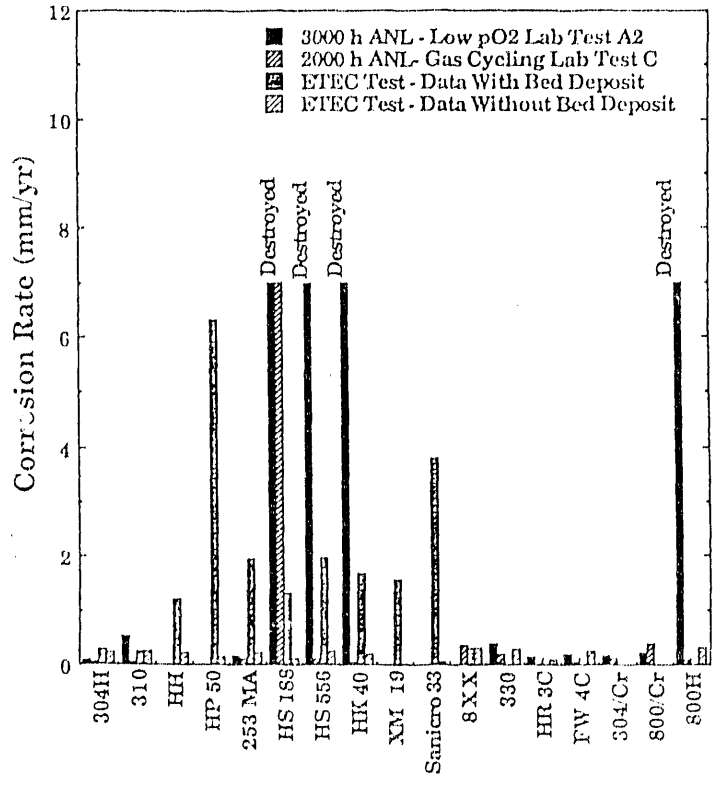
Fig. XI-1. Corrosion Rates for ANL Tests A-2 and C and ETEC Tests

Figure XI-1 shows the corrosion rates calculated for several candidate alloys exposed in Tests A2 and C, as well as in the ETEC AFBC tests. The data included in this figure incorporate information developed at ANL from all the specimens (from ANL, B&W, and FW probes) analyzed. The ETEC test data in this figure are differentiated as to whether or not the specimens were covered with the bed material. The data show that some of the alloys (such as 800H, HK 40, HS 188, and HS 556) are susceptible to catastrophic corrosion when subjected to a sustained low-pO_2 and relatively high-pS_2 environment (dictated by the boundary between CaO and $CaSO_4$ phases). The next worst environment from the materials corrosion point of view is one in which bed deposit material is present. Of the alloys exposed to a bed deposit in the ETEC exposure, HP 50 and Sanicro 33 exhibited 4- to 6-mm/yr corrosion,

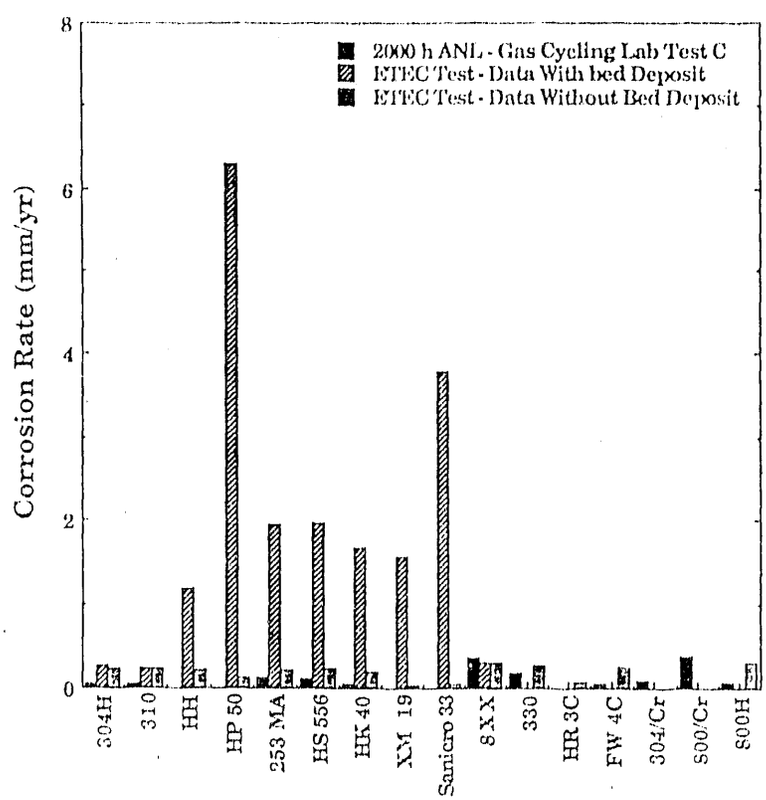
Fig. XI-2. Corrosion Rates for ANL Test C and ETEC Tests

Figure XI-2 shows the results plotted without the data from Test A2. The gas-cycling data showed that the alloys, in general, can tolerate the oxidizing/reducing environments as long as the alloys are exposed to oxidizing condition in the startup cycle. Only Alloy HS 188 exhibited high corrosion, which manifested as internal oxidation of the alloy. The results also show that a number of structural alloys (such as Types 304 and 310 stainless steel, HR 3C, FW 4C, 8XX, and 330) and some of the chromized coatings performed well under all the environmental conditions used in different tests. The corrosion rates for these materials were in the range of 0.25 to 0.4 mm/yr (0.25 to 4 mm/yr) for temperatures in the range of 775 to 871°C (1425 to 1600°F). In the case of air tubes with 5 to 6 mm wall thickness, the above corrosion rates will lead to a thickness loss of 0.8 to 1.25 mm after 10 years of service in the FBC environment. Since abnormal conditions (e.g., the low-pO_2 condition during the second 500 h of the present test at ETEC) are anticipated during the operation of an FBC system, the material selected for the air tubes should possess adequate corrosion resistance, even under the perceived abnormal conditions. Another aspect of importance in materials selection, which this report does not address, is the adequacy of mechanical properties of materials at elevated temperatures. However, based on this study, corrosion resistant materials can be applied as a cladding onto structurally acceptable alloy (e.g., Type 310 stainless steel clad on Type 304 stainless steel, Alloy 800, or HR 3C) to achieve adequate corrosion resistance and other mechanical properties for the air-heater tubes.

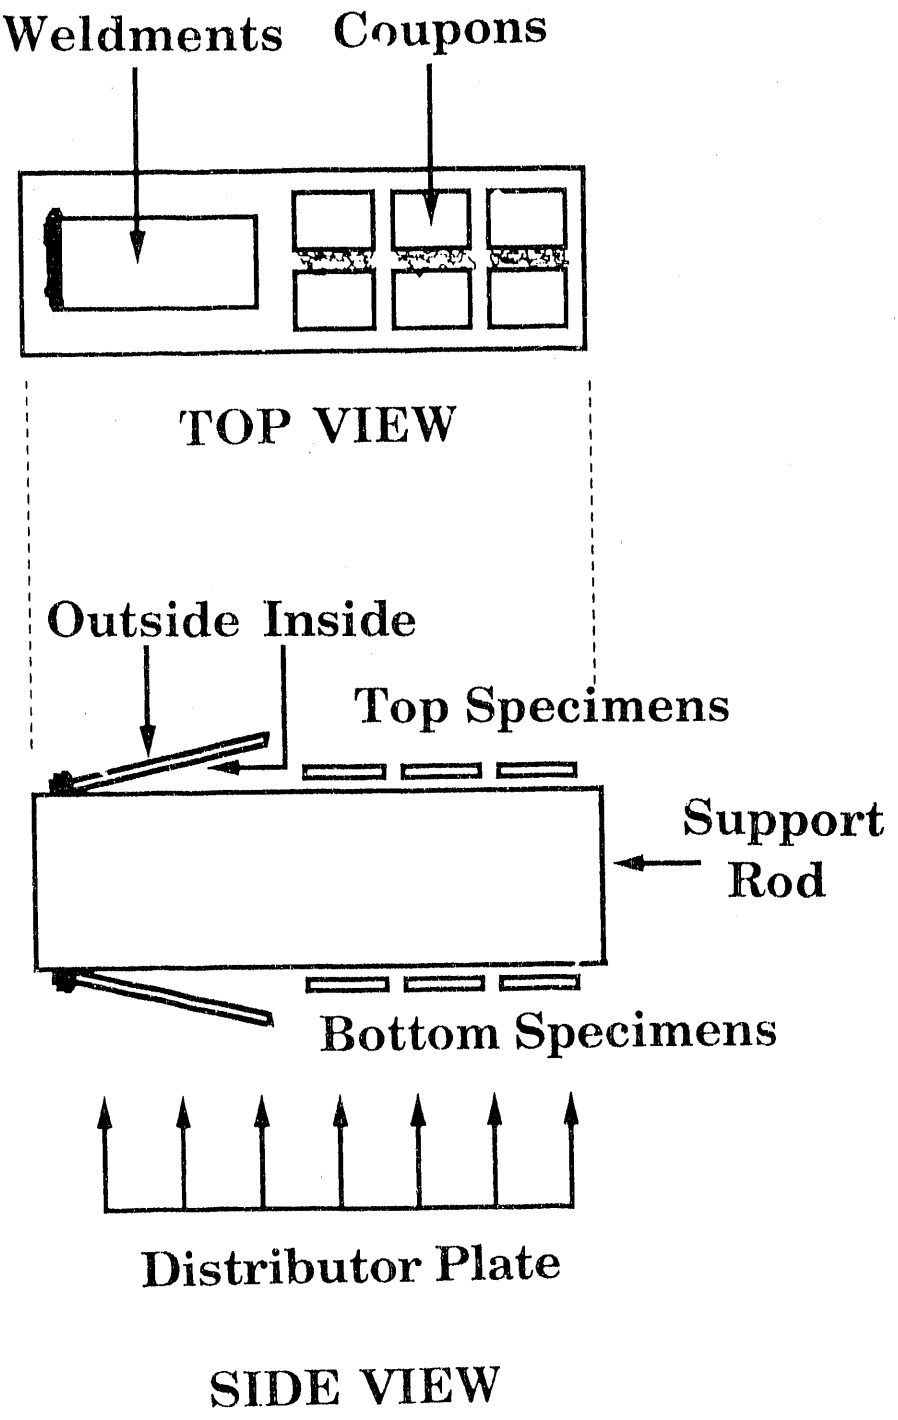
ANL Uncooled Probe BMUEB

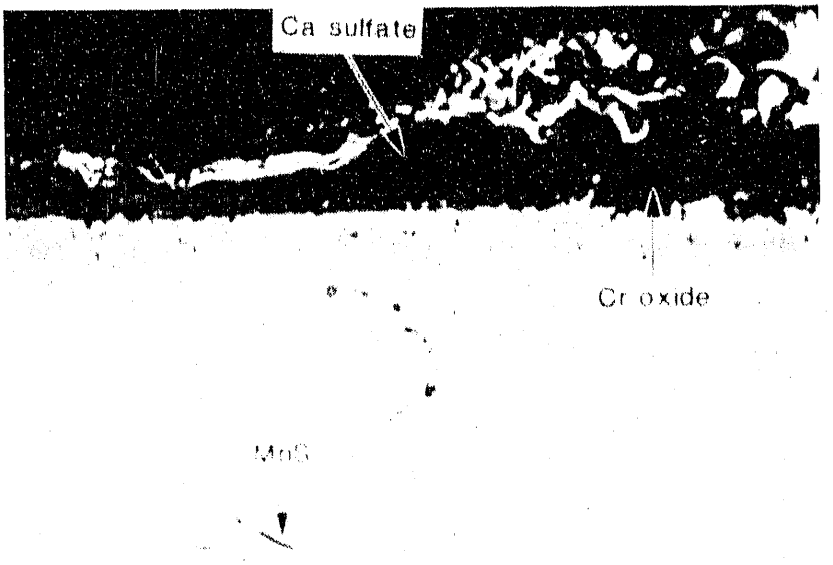
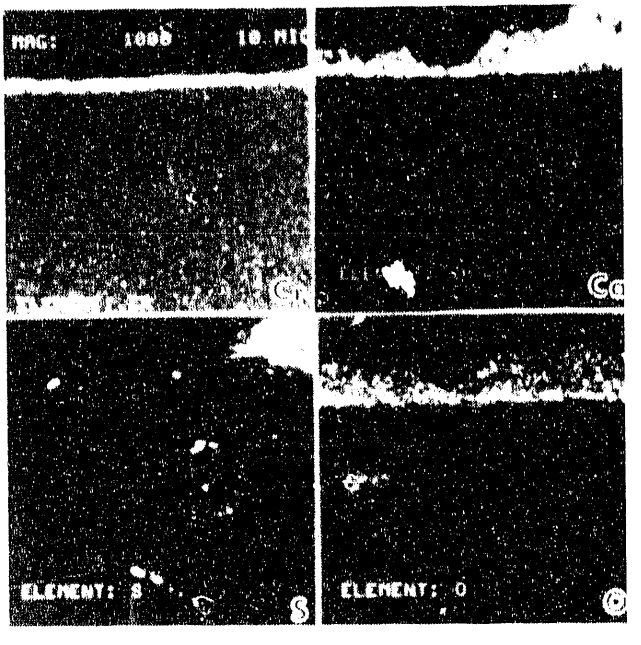
SEM Micrograph and X-ray Mapping of Alloy 800 Exposed for 1000 h

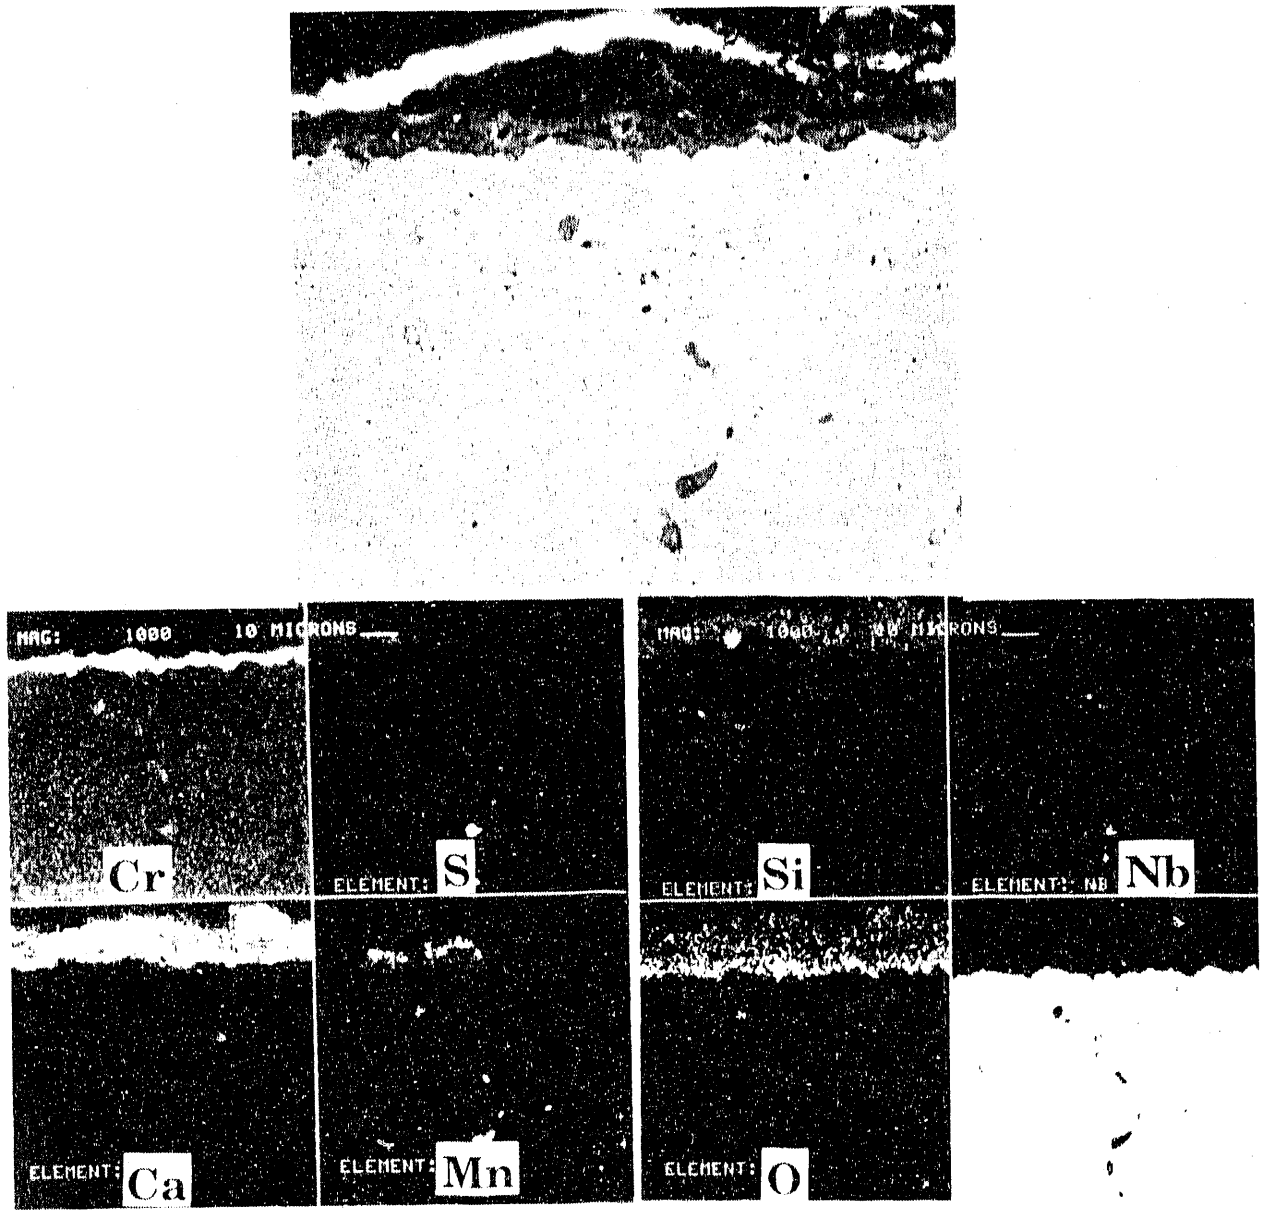
SEM Micrograph and X-ray Mapping of 800H/Nicro 82/800H
Weldment after 1000 h Exposure

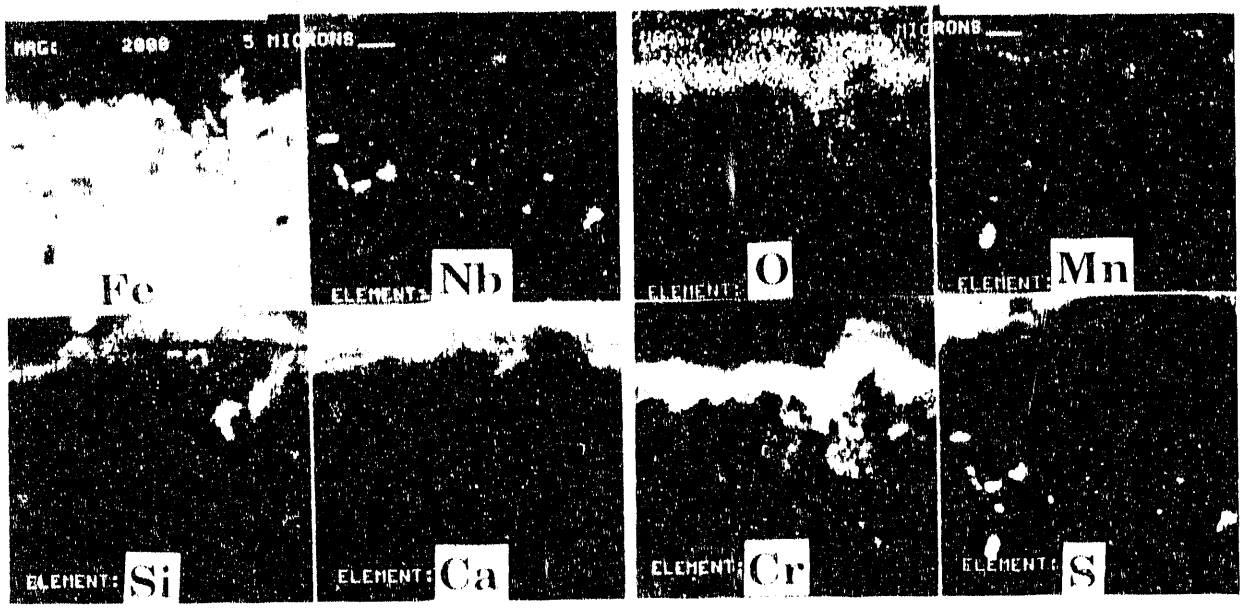
800H/21–33/800H

SEM Micrograph and X-ray Mapping of 21-33 Weldment after 1000 h Exposure

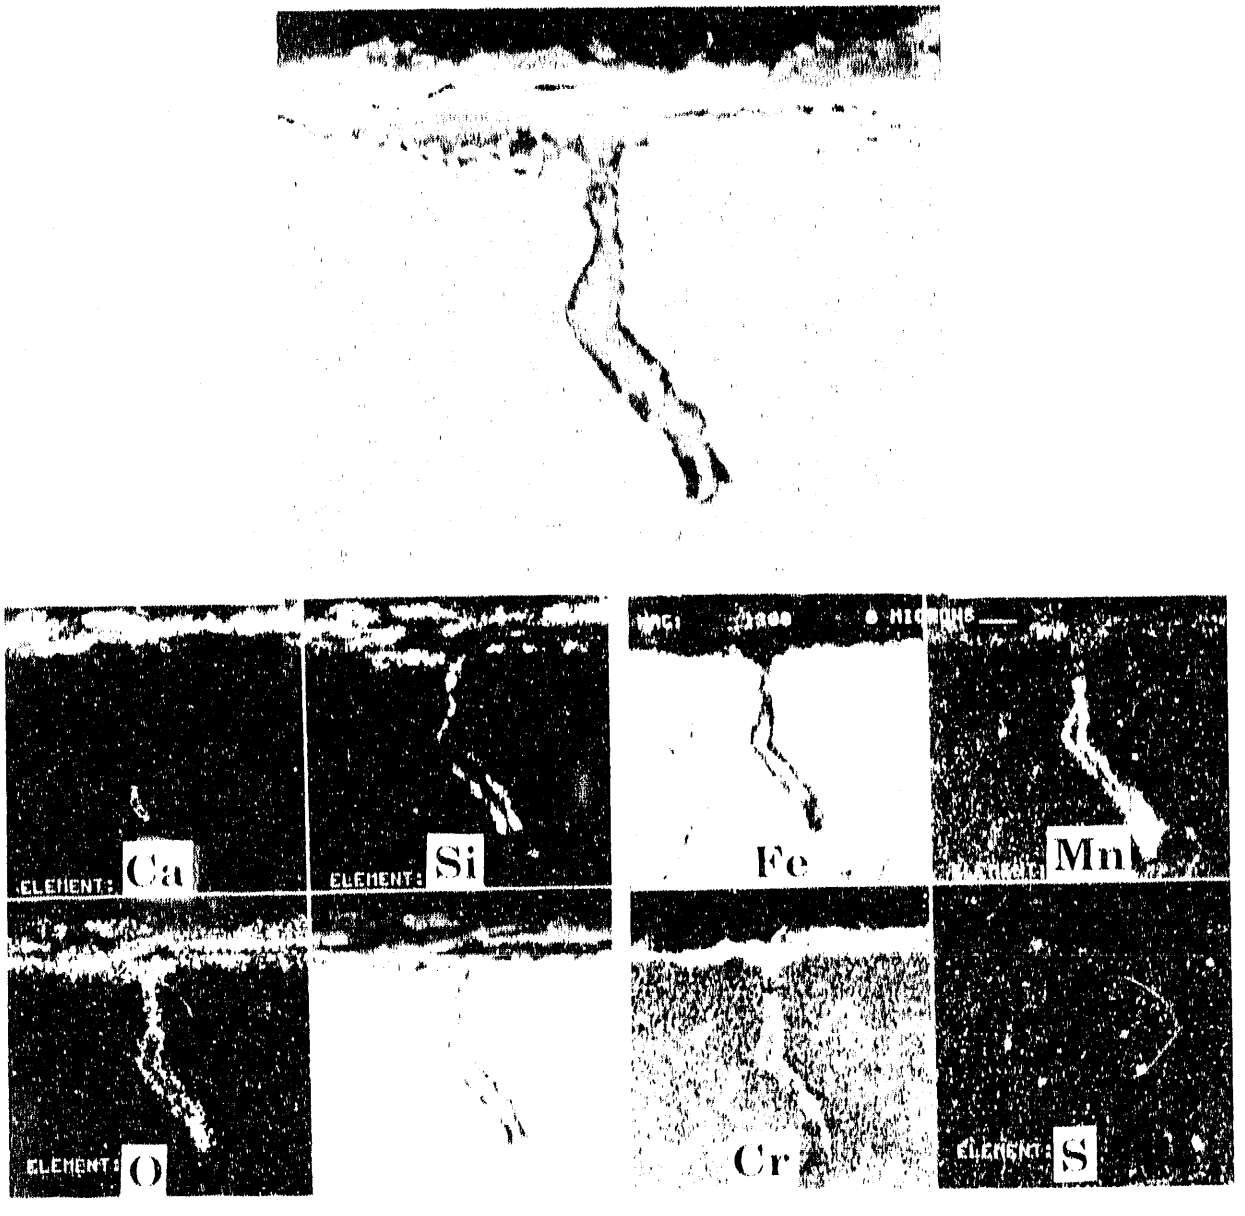
800H/25–35/800H

SEM Micrograph and X-ray Mapping of 25-35 Weldment after 1000 h Exposure

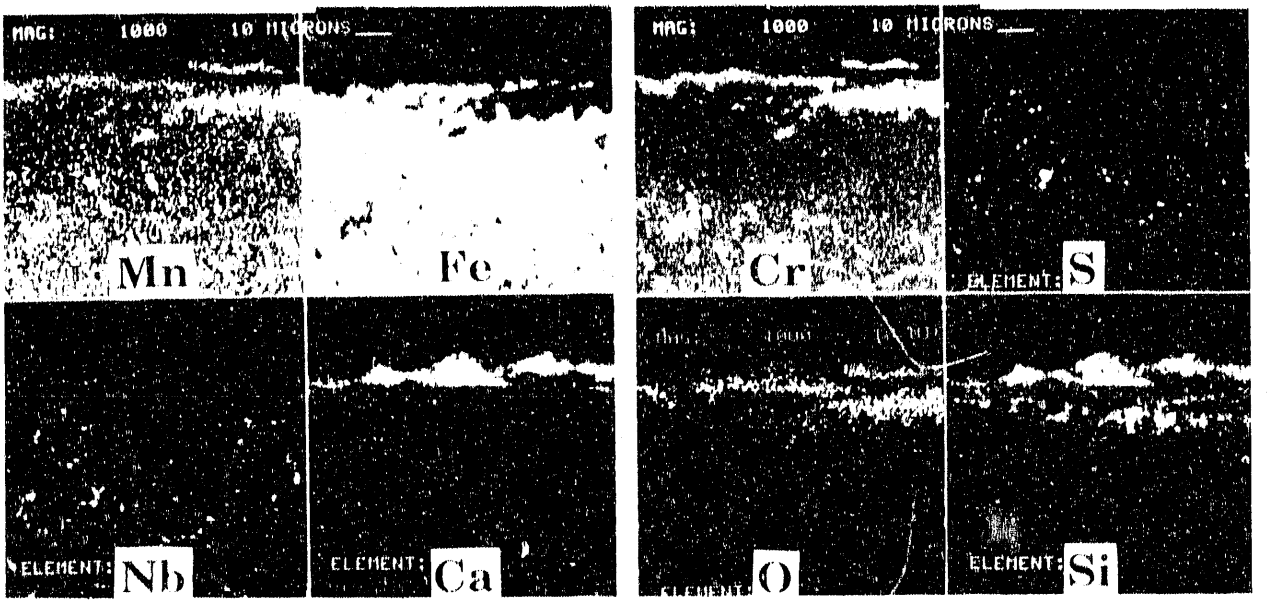
800H/25-35R/800H

SEM Micrograph and X-ray Mapping of 25-35R Weldment after 1000 h Exposure

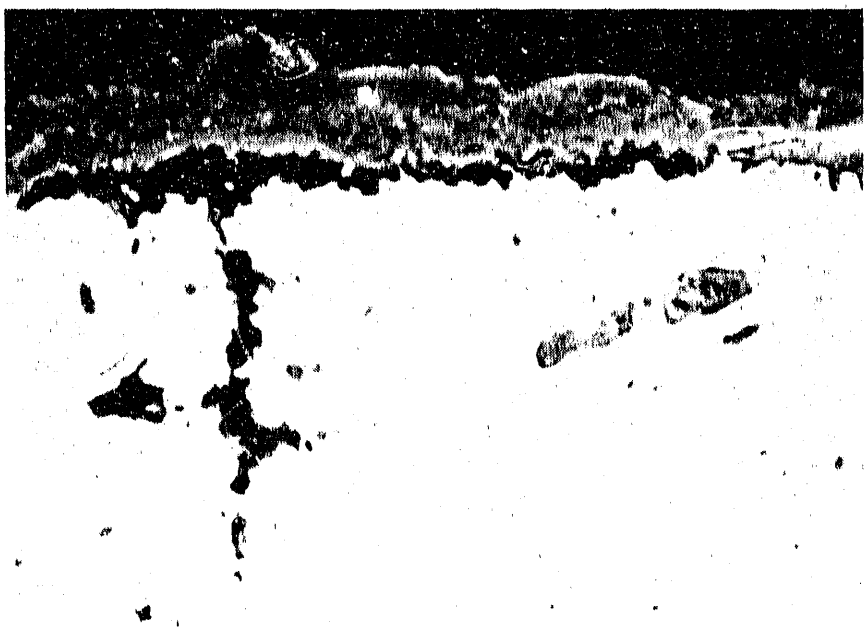
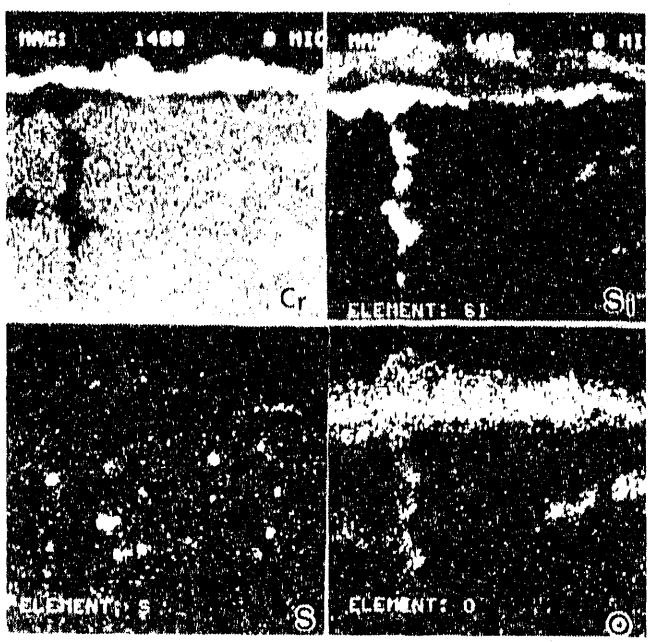
800H/30–50/800H

SEM Micrograph and X-ray Mapping of 30-50 Weldment after 1000 h Exposure

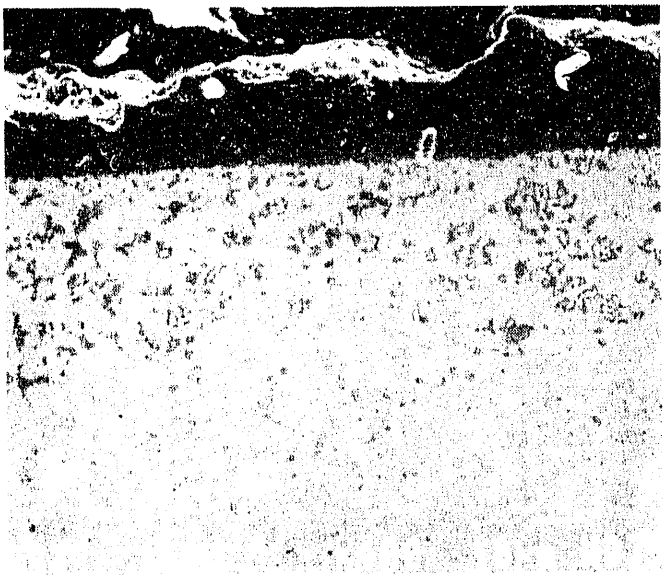
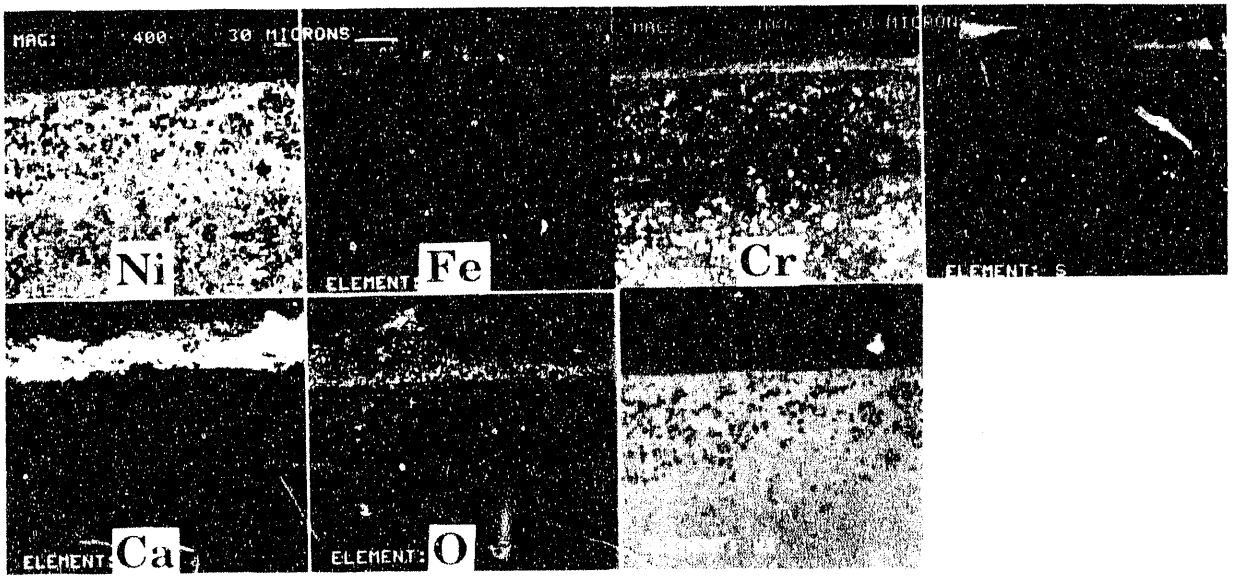
800H/50–50 Nb/800H

SEM Micrograph and X-ray Mapping of 50-50 Nb after 1000 h Exposure

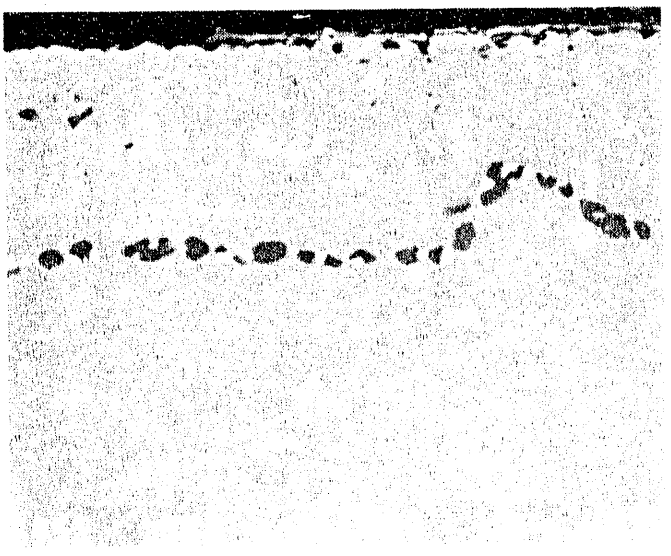
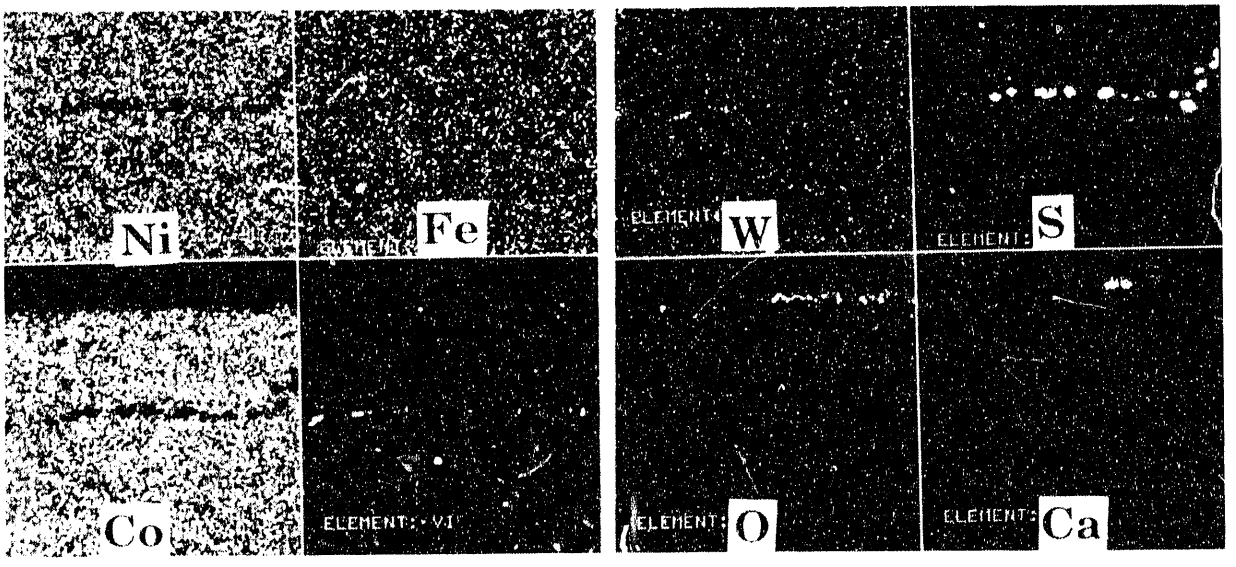
800H/188/800H

SEM Micrograph and X-ray Mapping of 188 Weldment after 1000 h Exposure

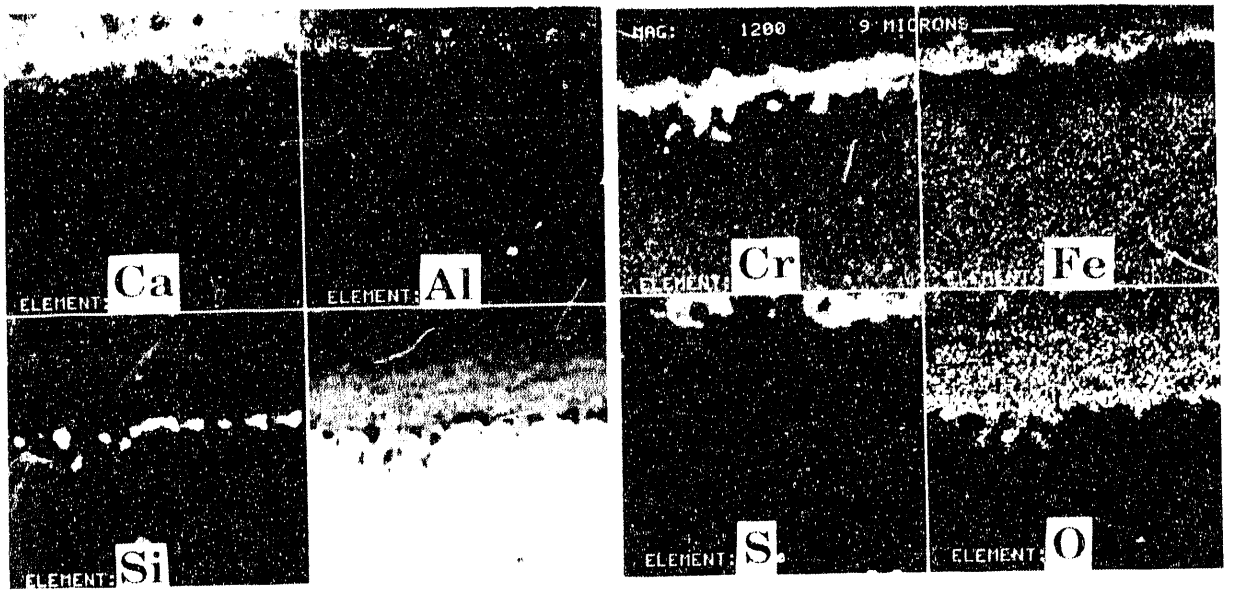
RA 333/RA 333/RA 333

SEM Micrograph and X-ray Mapping of RA 333 Weldment after 1000 h Exposure

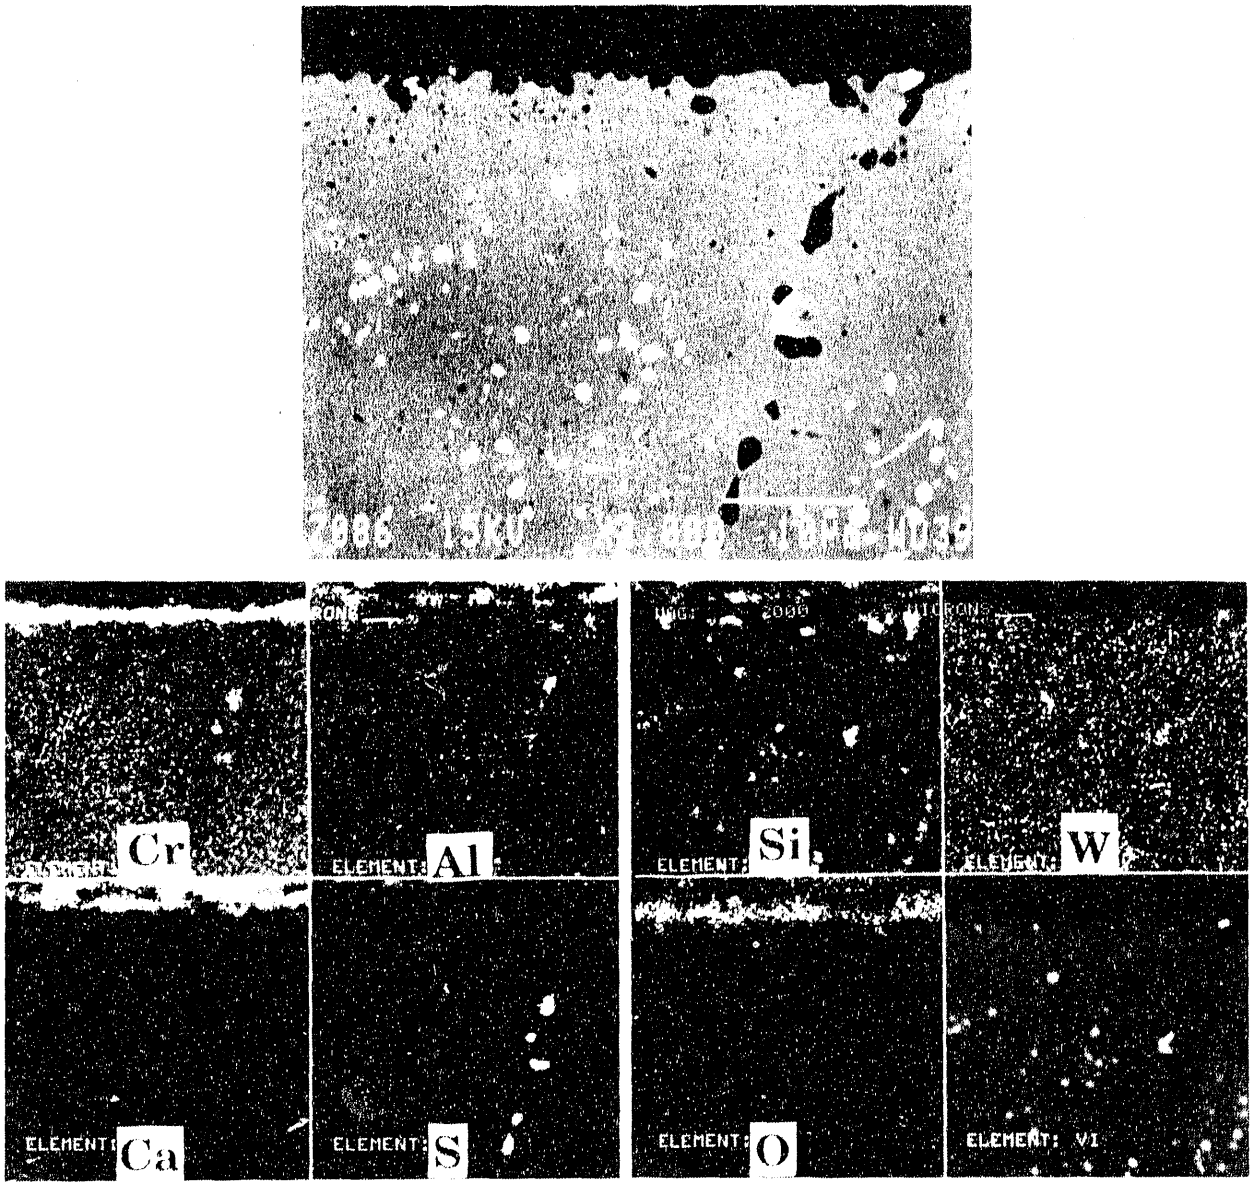
SEM Micrograph and X-ray Mapping of RA 333/188/RA 333
Weldment after 1000 h Exposure
