Materials Performance in the Atmospheric Fluidized-bed Cogeneration Air Heater Experiment

ANL-91/4

MATERIALS PERFORMANCE IN THE ATMOSPHERIC FLUIDIZED-BED COGENERATION AIR HEATER EXPERIMENT

February 1991

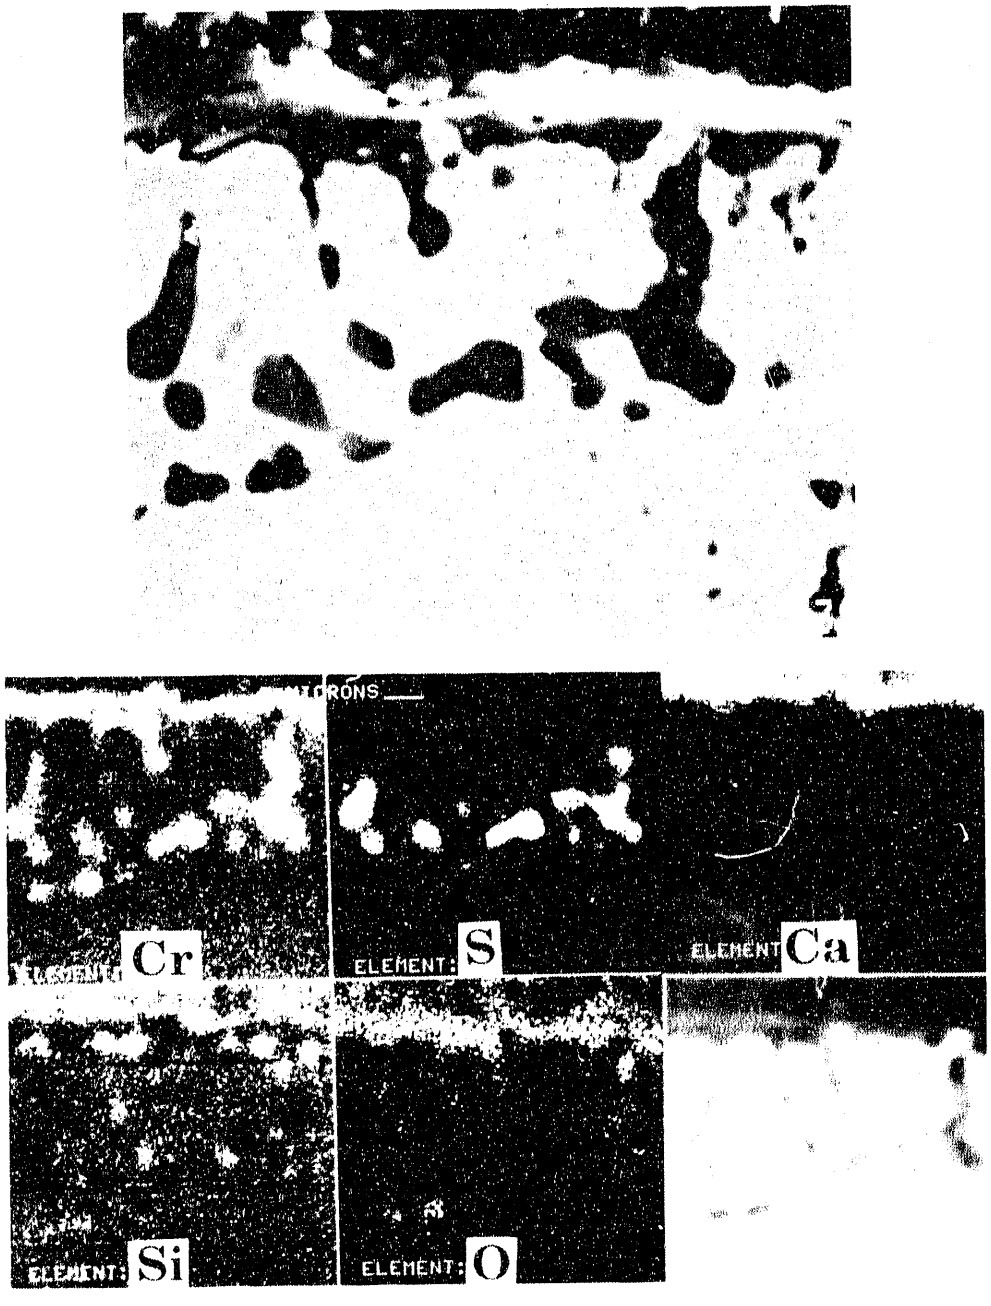
188/188/188

SEM Micrograph and X-ray Mapping of 188 Weldment after 1000 h Exposure

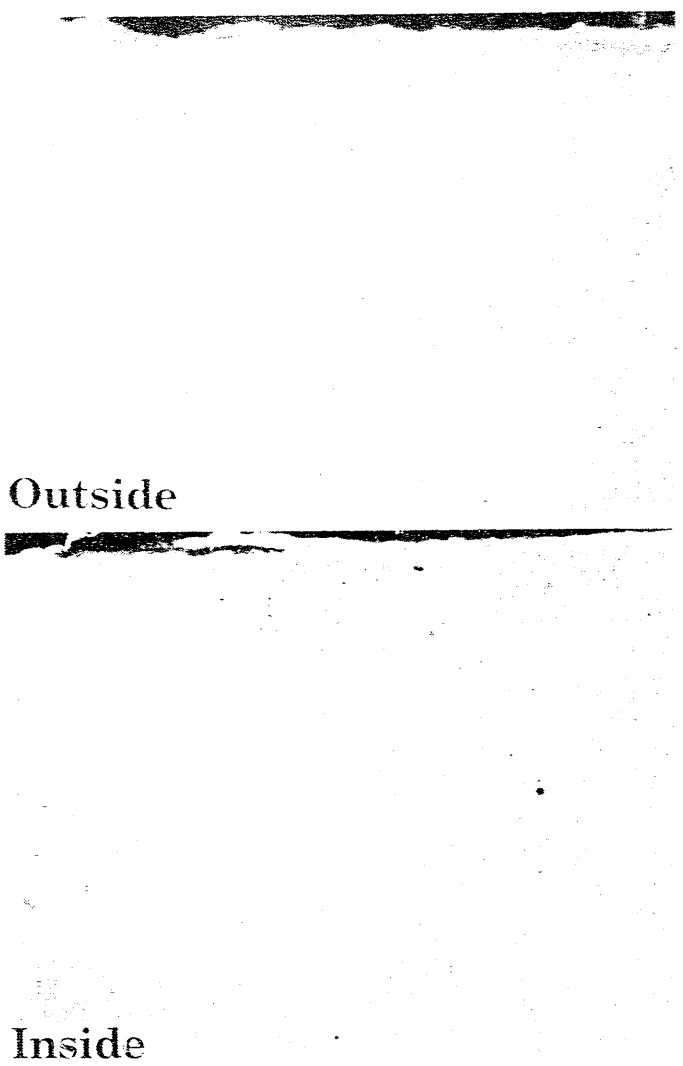
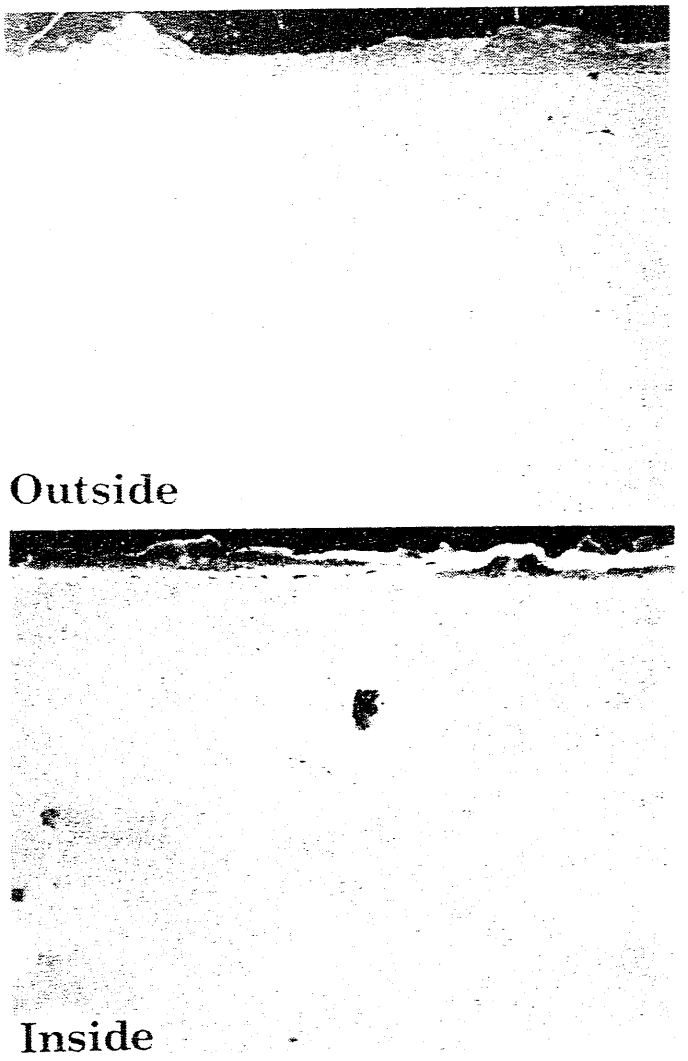
SEM Micrographs of Cross Sections of Nicro 82 and 21-33 Weldments after the Last 980 h Exposure

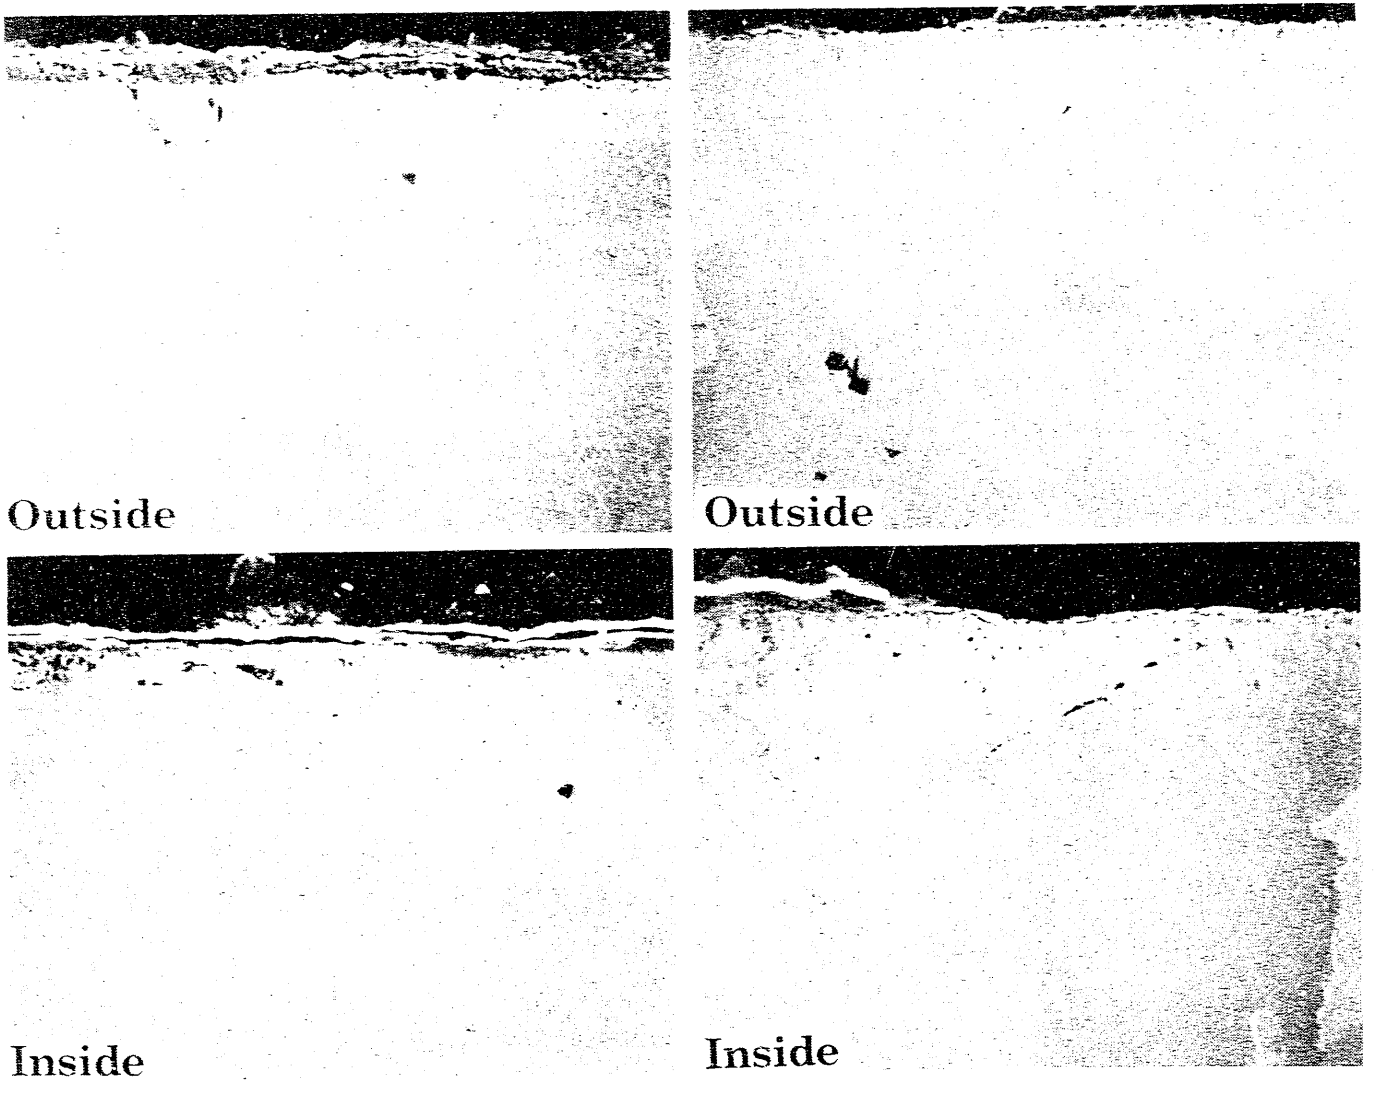
SEM Micrographs of Cross Sections of 25-35 and 25-35R Weldments after the Last 980 h Exposure

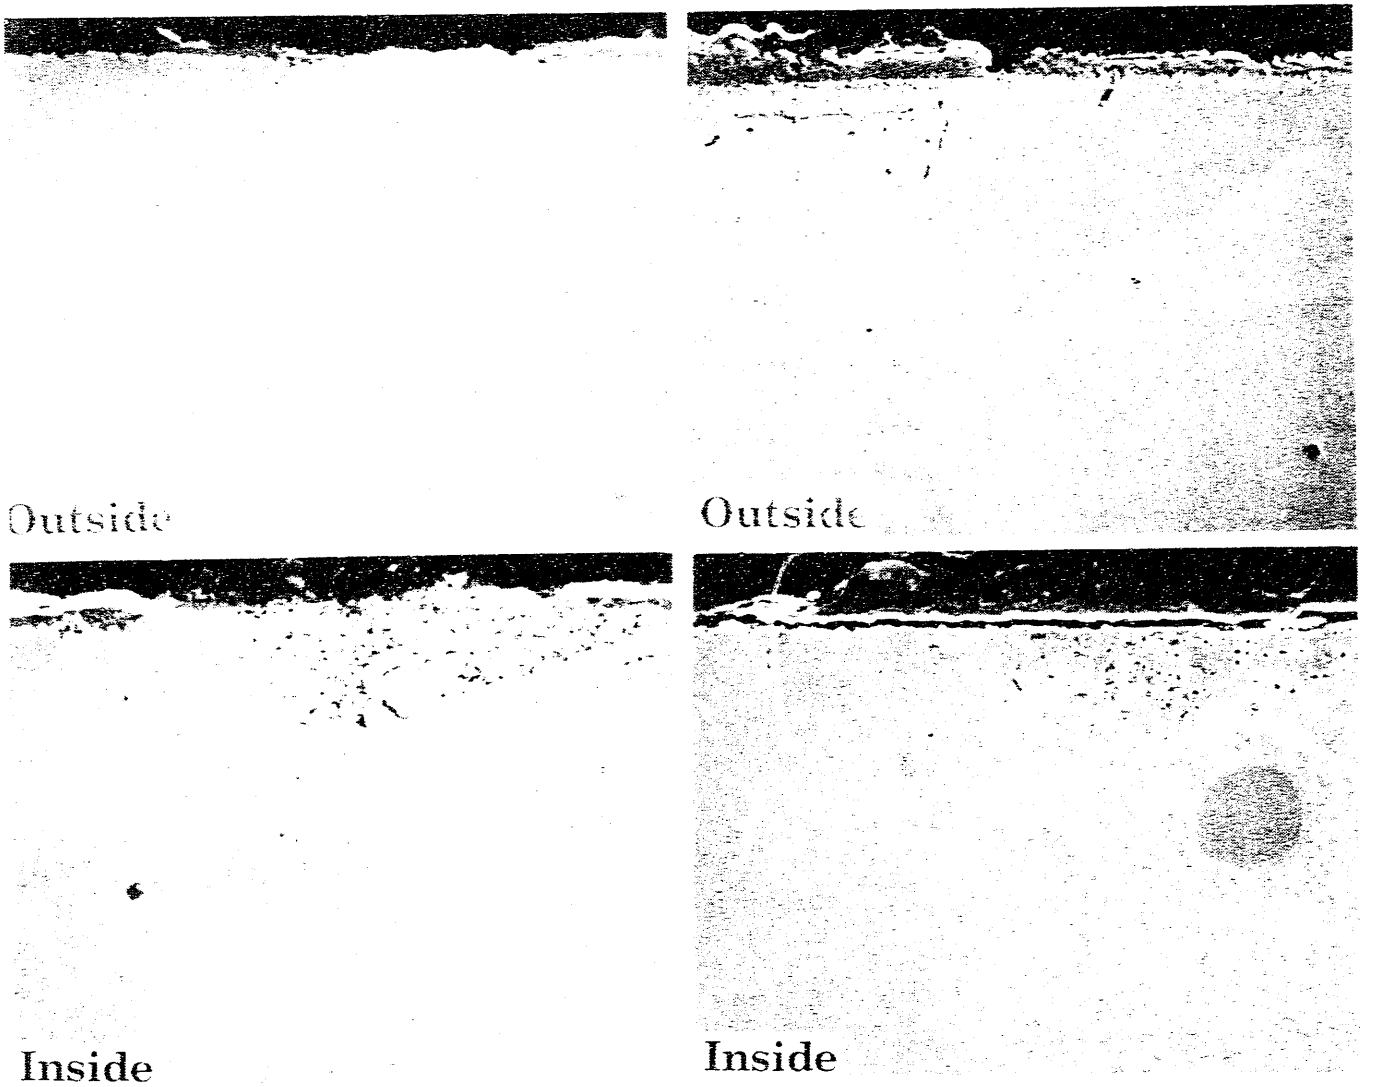
800H/30–50/800H **800H/50–50 Nb/800H**

SEM Micrographs of Cross Sections of 30-50 and 50-50 Nb Weldments after the Last 980 h Exposure

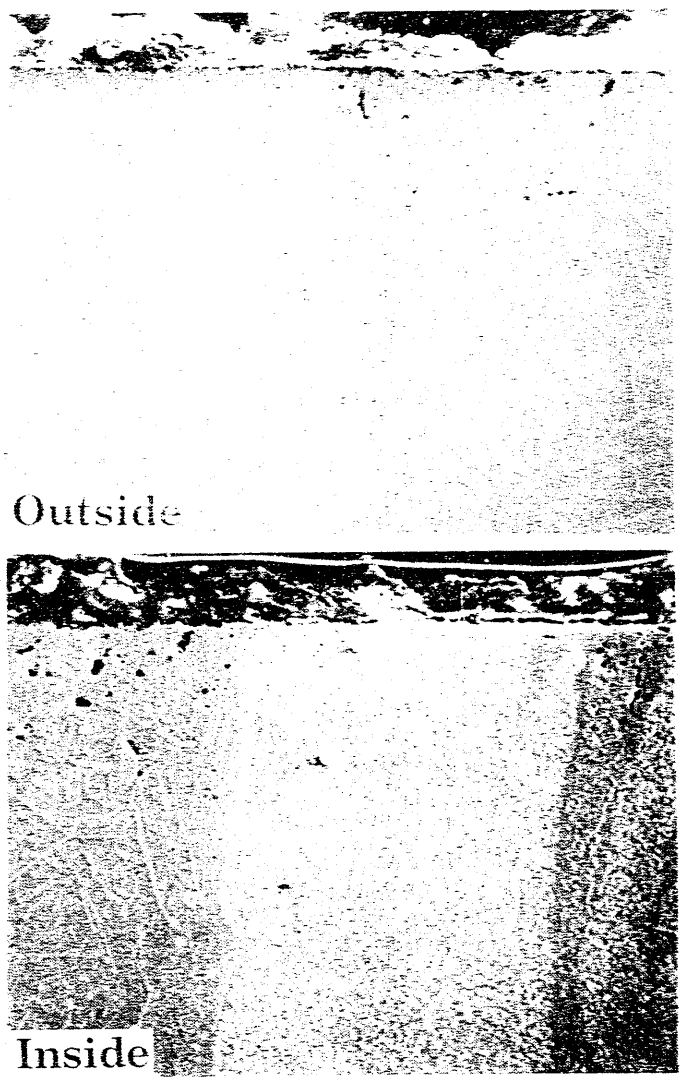
SEM Micrographs of Cross Sections of RA 333 and 188 Weldments after the Last 980 h Exposure

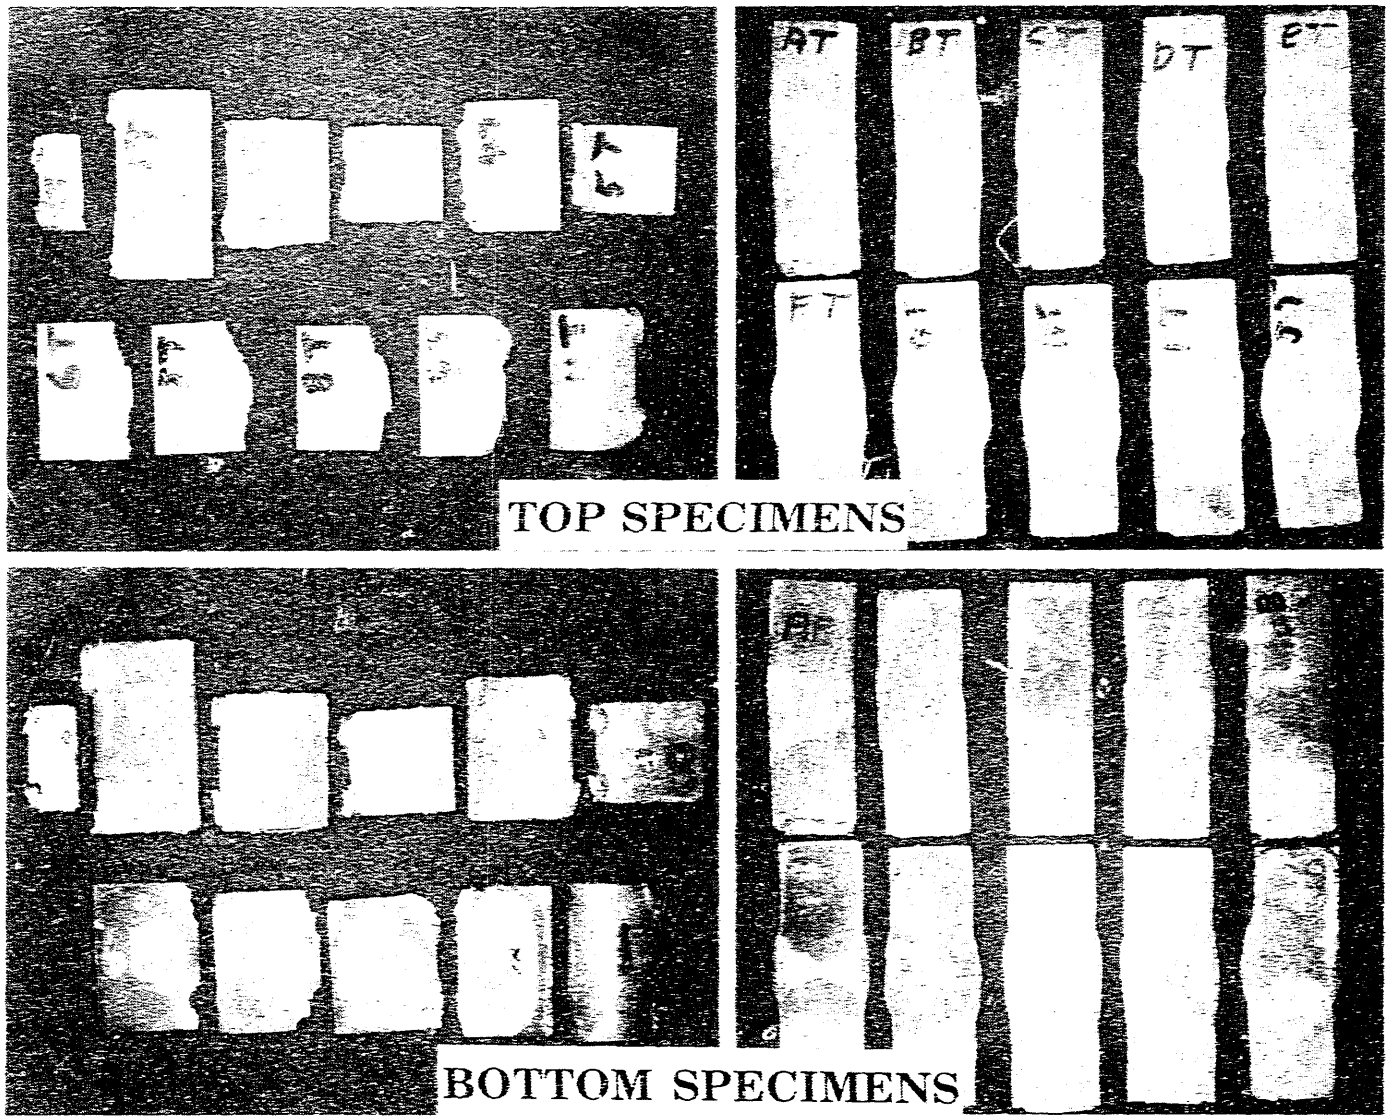
Microphotographs of Base Metal and Weldment Specimens after 1980 h Exposure in ANL Probe

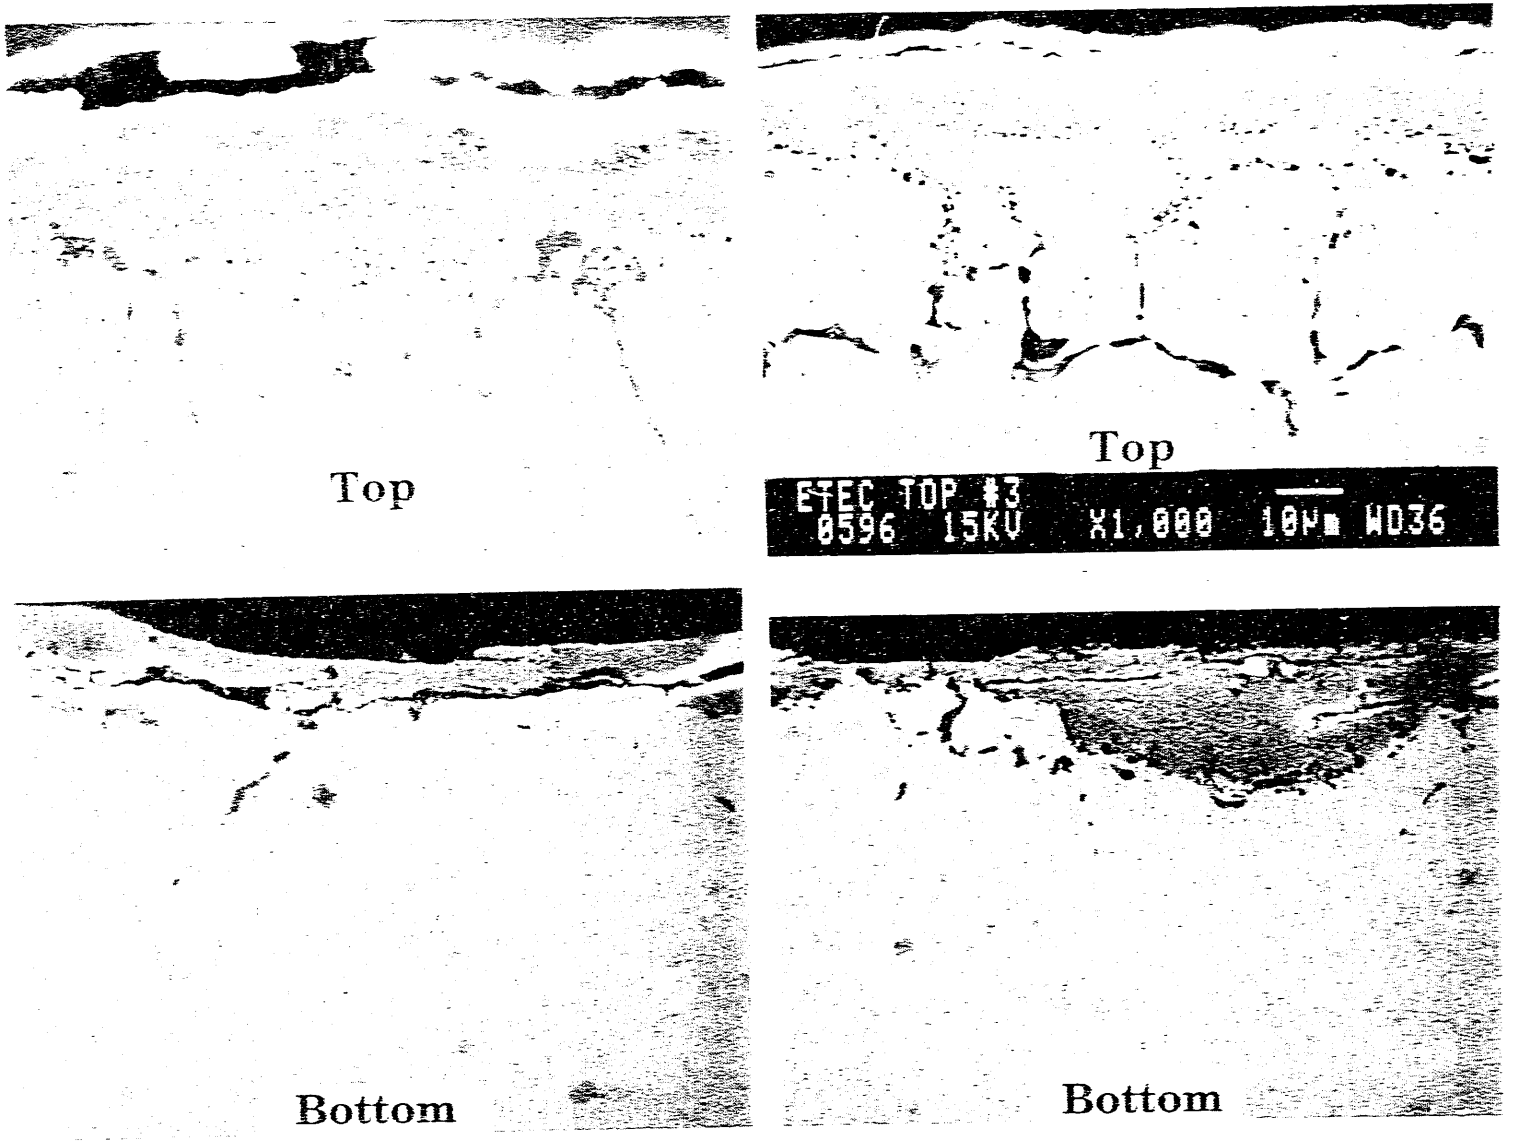
SEM Photographs of Cross Sections of Alloy 800 and 304 SS after 1980 h Exposure

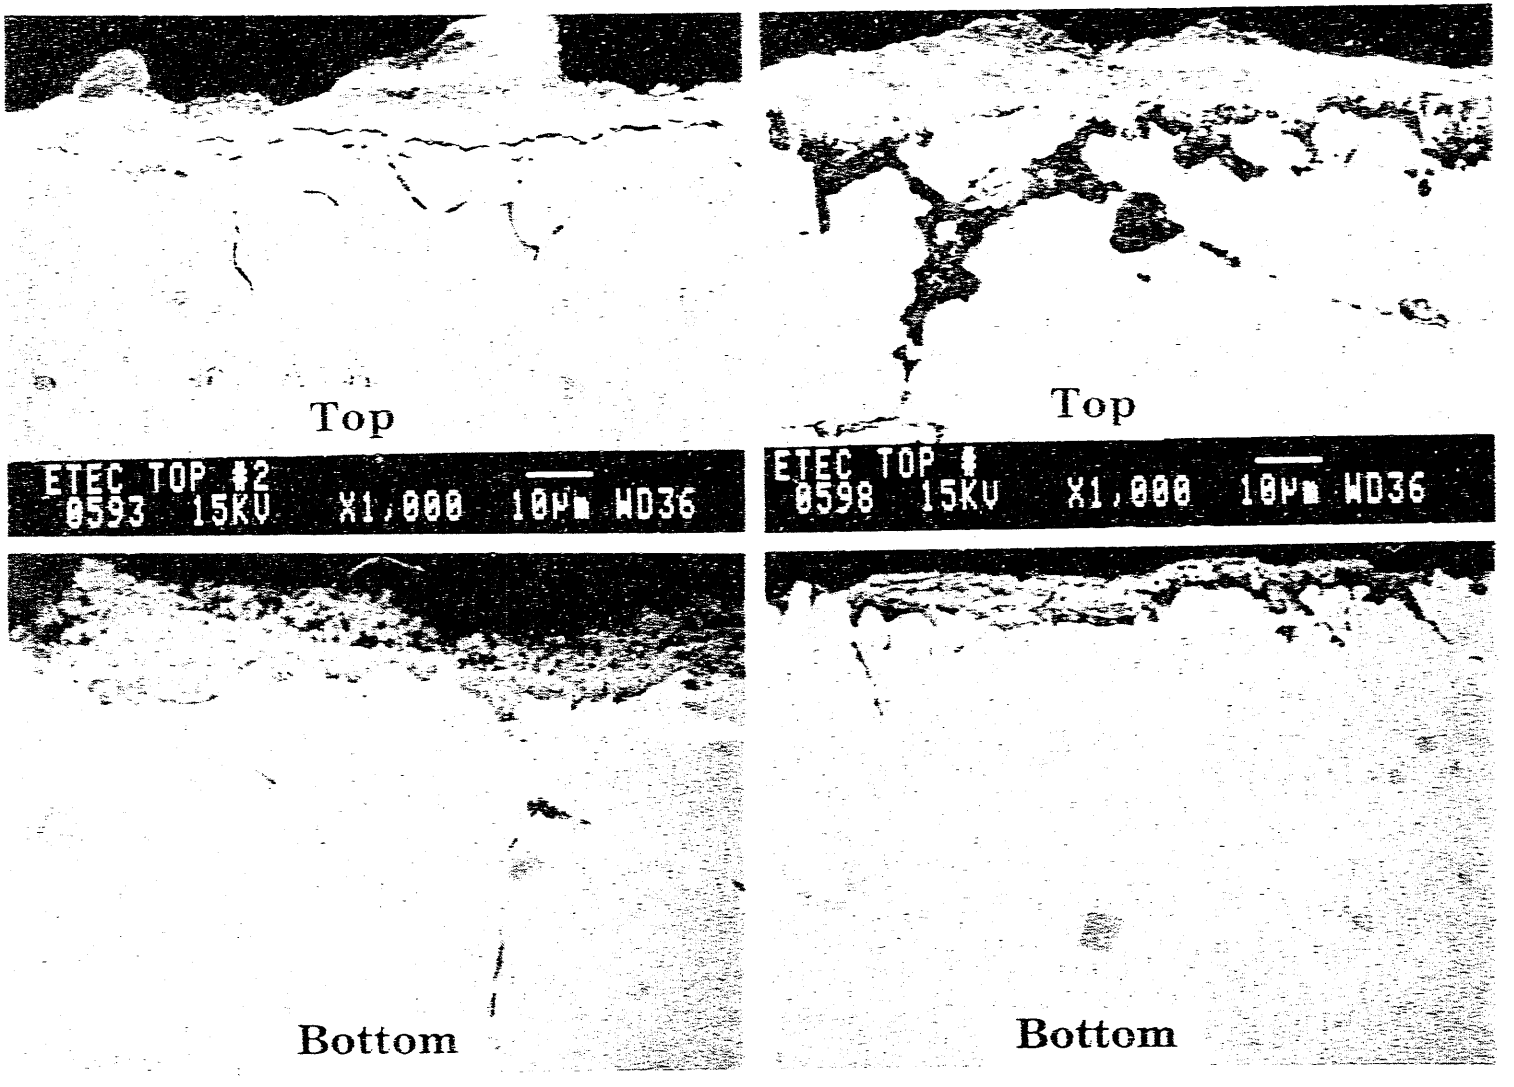
SEM Photographs of Cross Sections of Alloys 310 and 330 after 1980 h Exposure

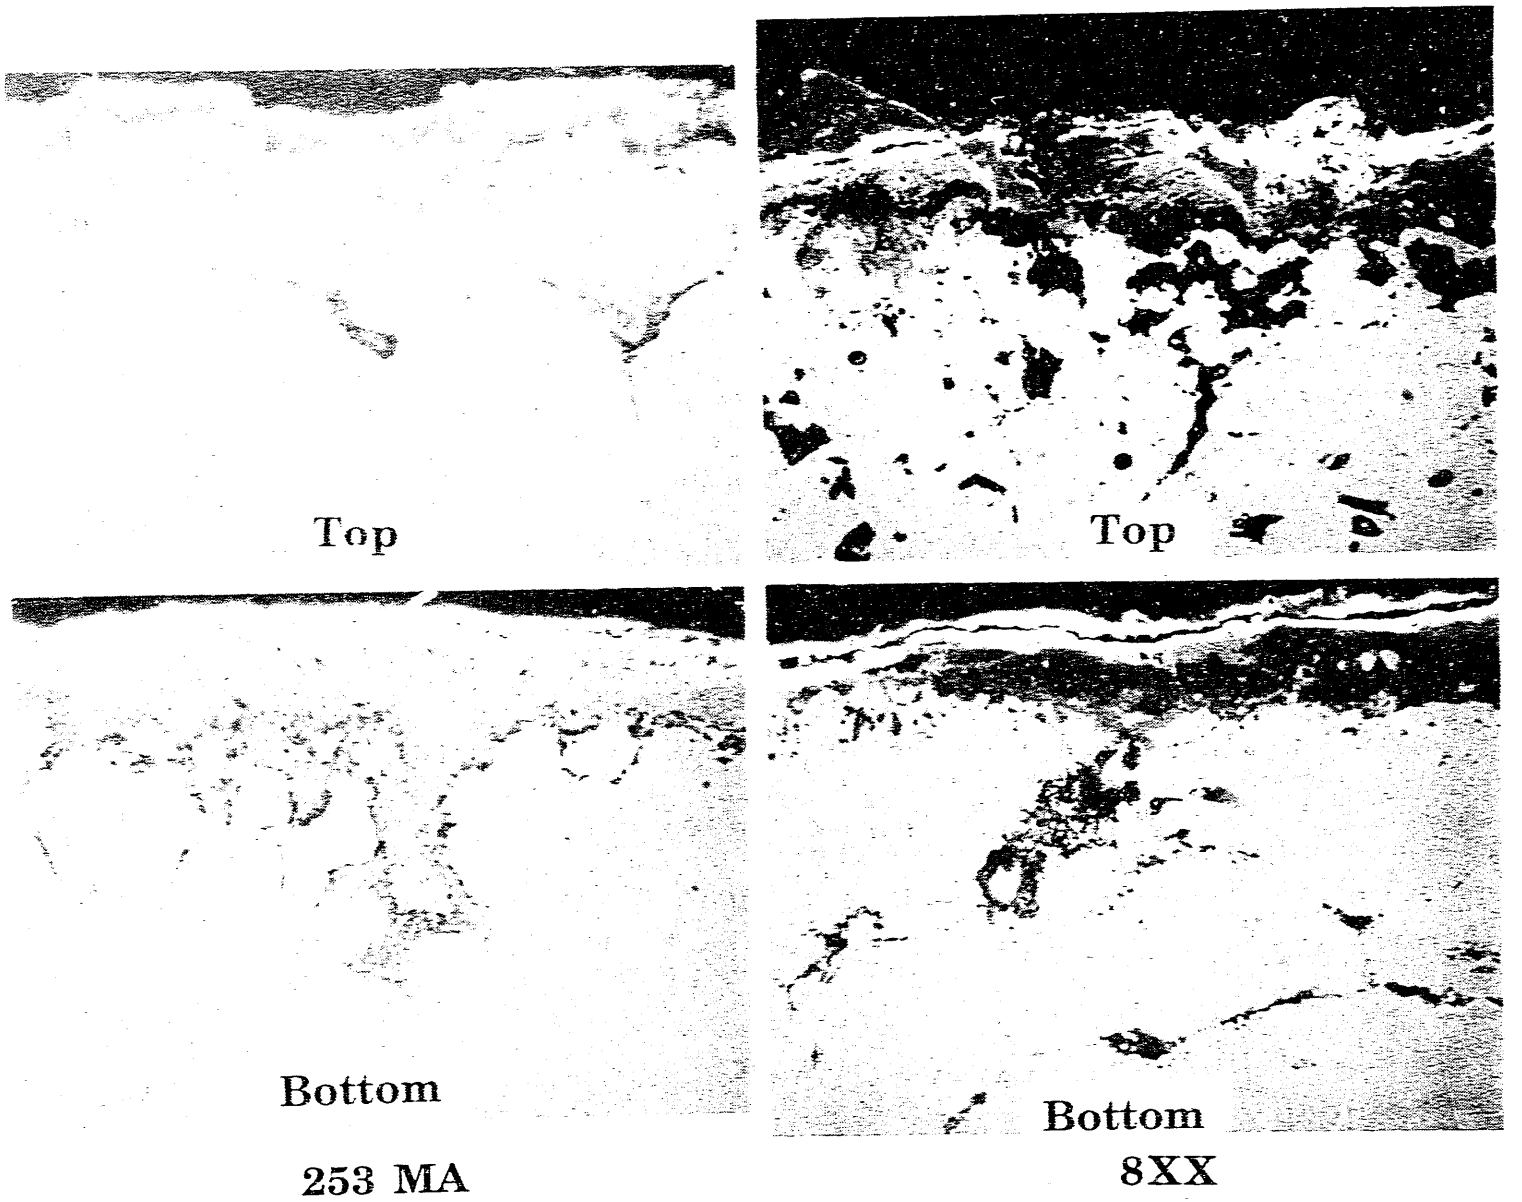
SEM Photographs of Cross Sections of Alloys 253 MA and 8XX after 1980 h Exposure

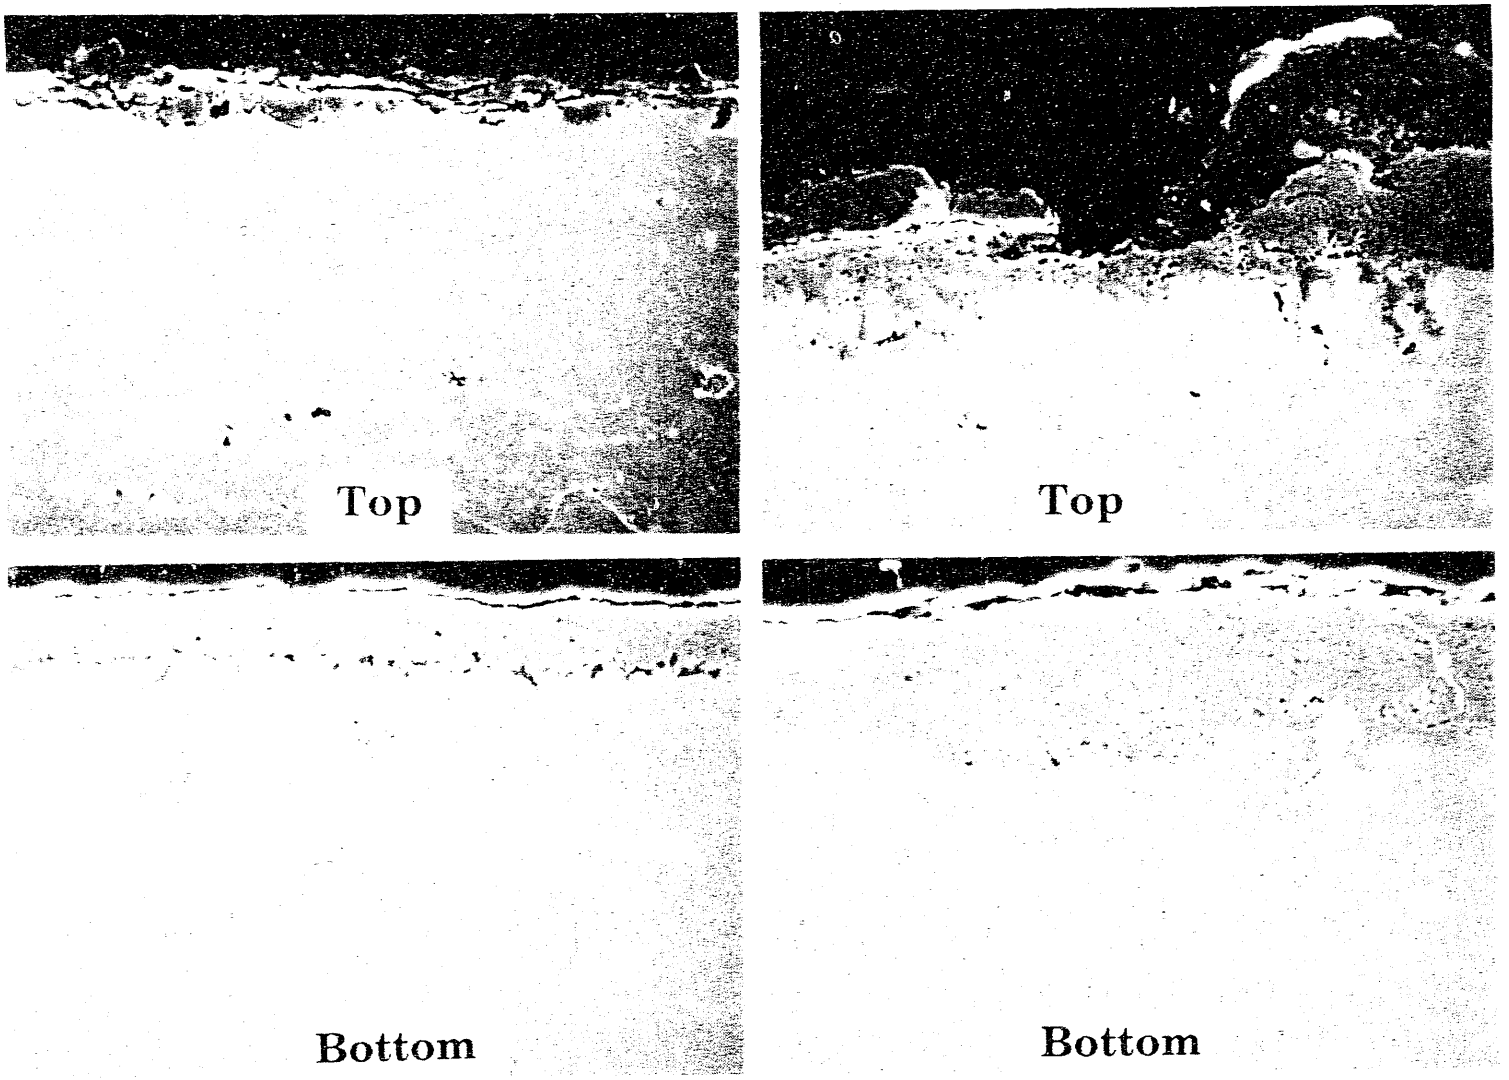
Fe–25Cr–20Ni–3Nb **Fe–25Cr–20Ni–3Zr**

SEM Photographs of Cross Sections of Alloys Fe-25Cr-20Ni-3Nb and Fe-25Cr-20Ni-3Zr after 1980 h Exposure

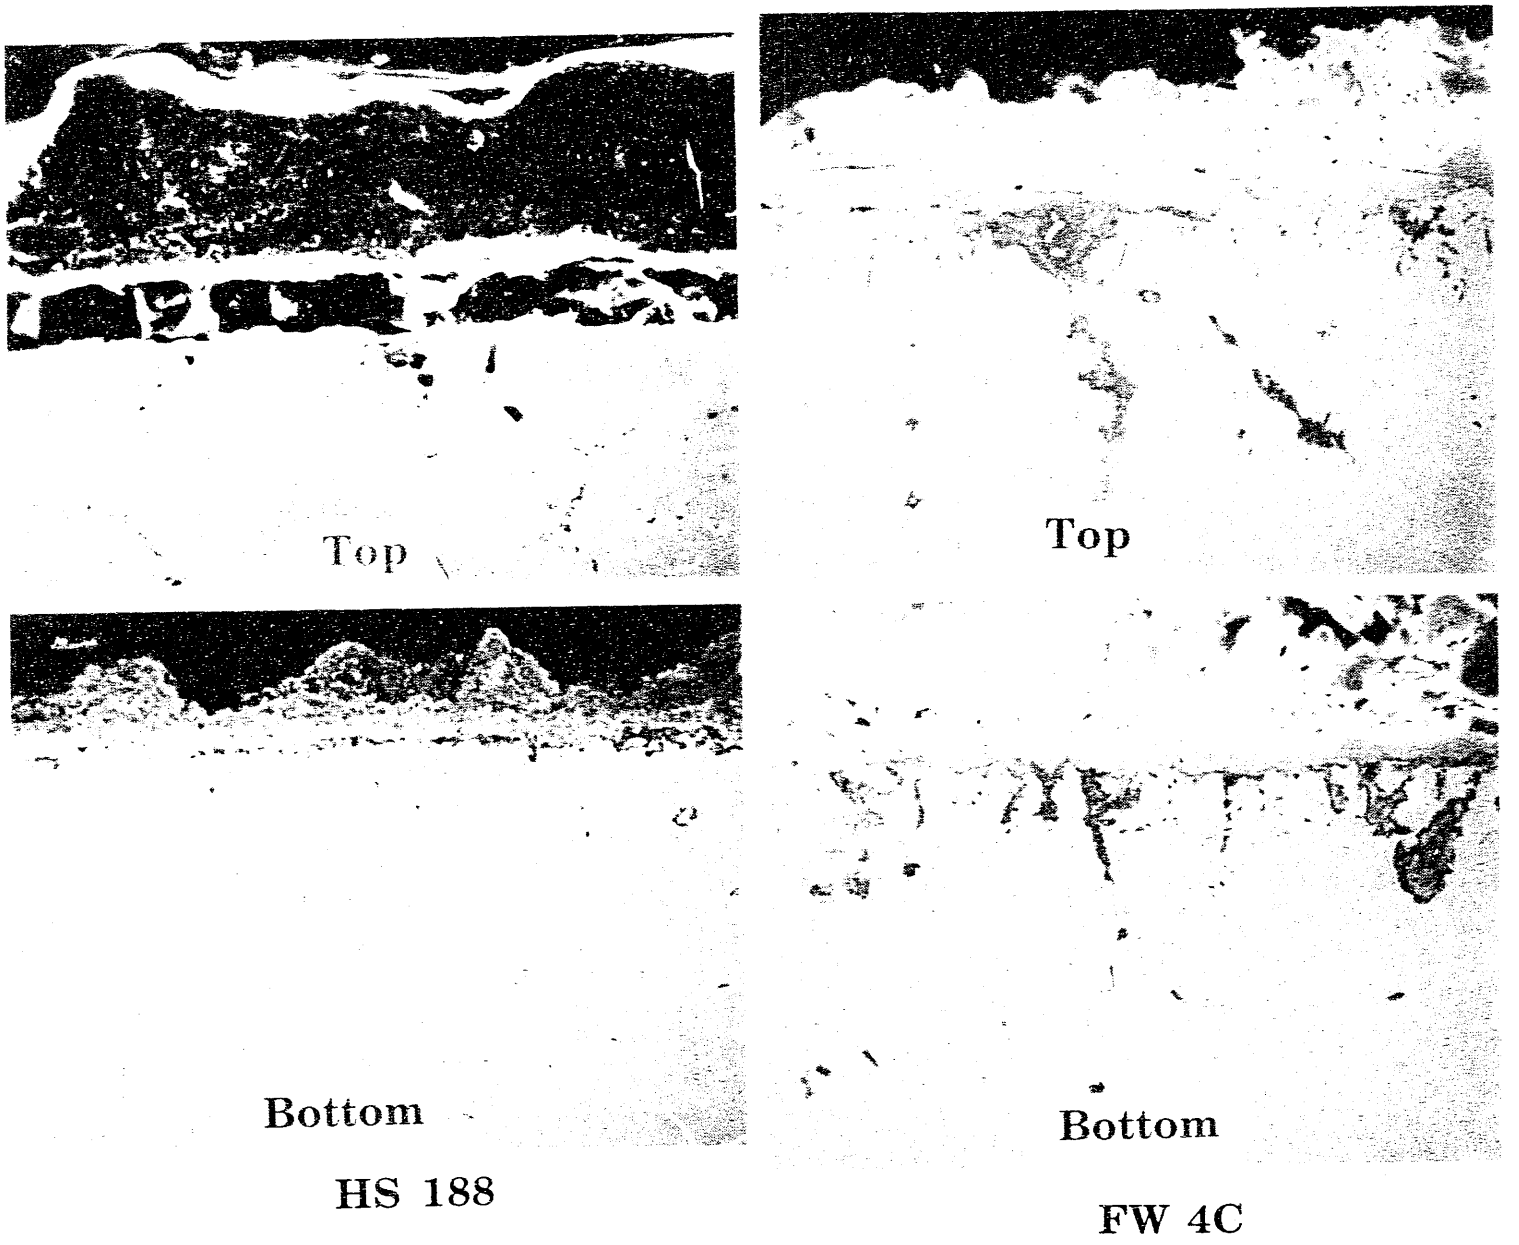
SEM Photographs of Cross Sections of Alloys 188 and FW 4C after 1980 h Exposure

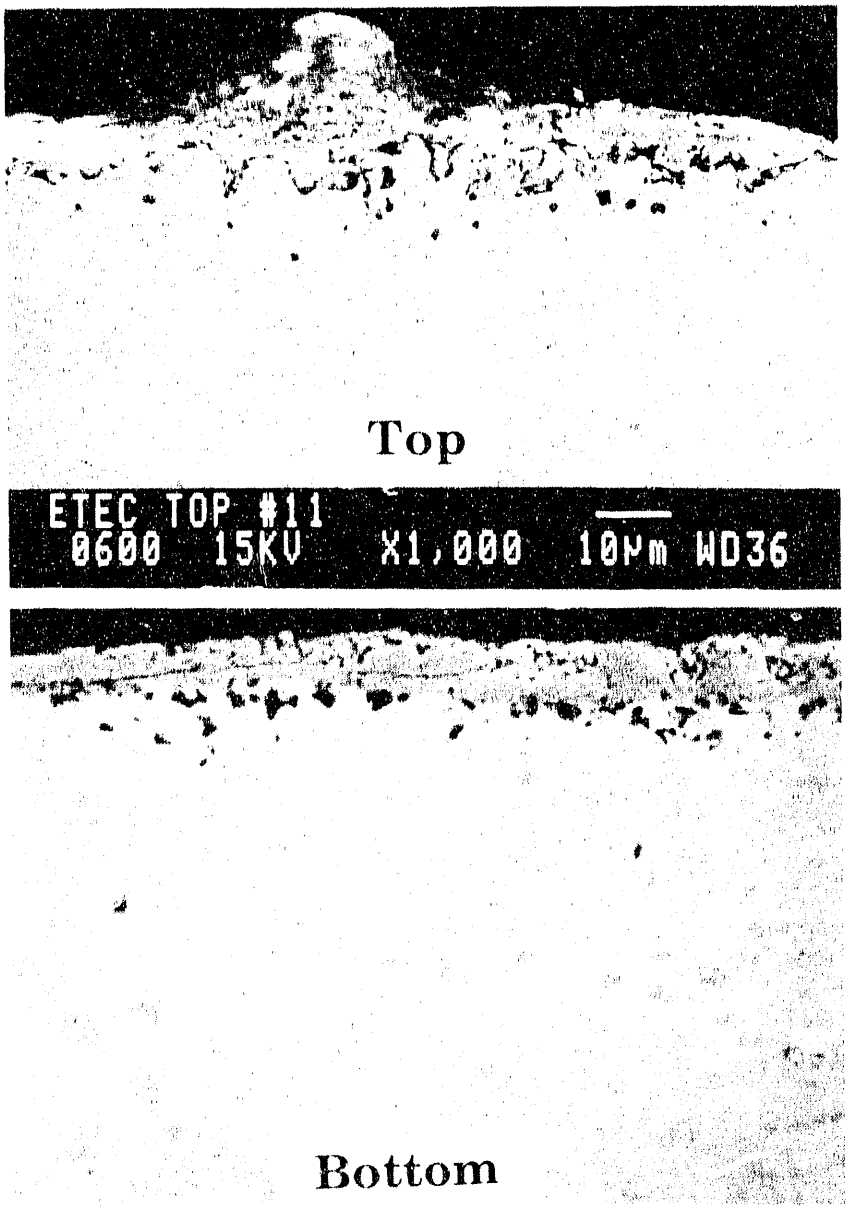
SEM Photographs of Cross Sections of Alloy HR 3C after 1980 h Exposure

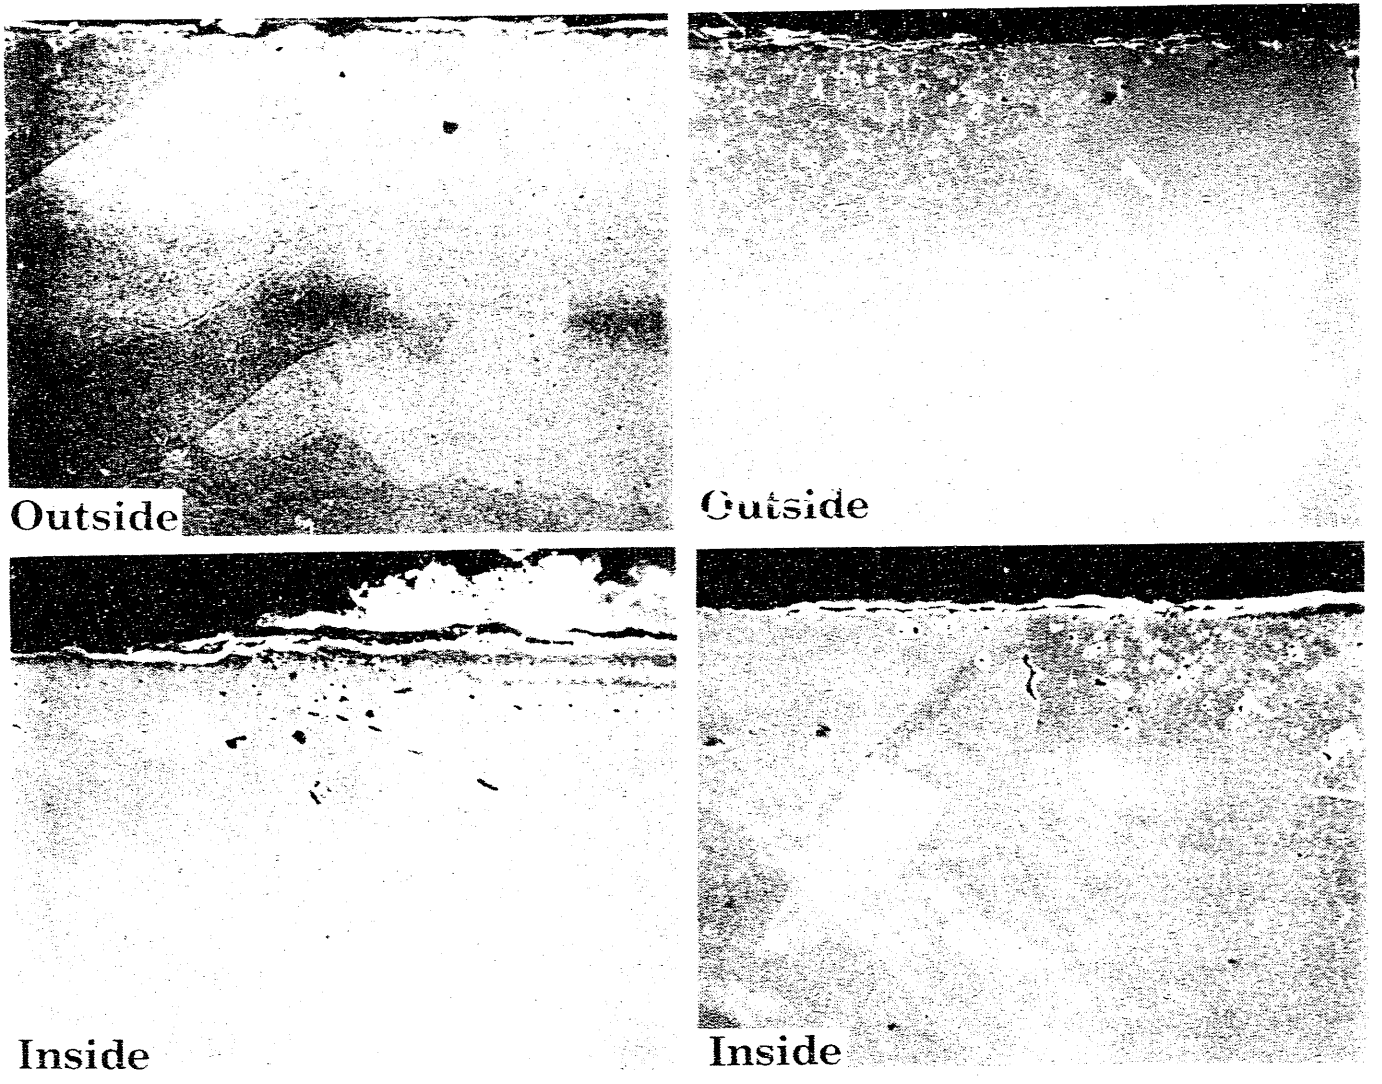
800H/Nicro 82/800H **800H/21–33/800H**

SEM Photographs of Cross Sections of Nicro 82 and 21-33 Weldments after 1980 h Exposure

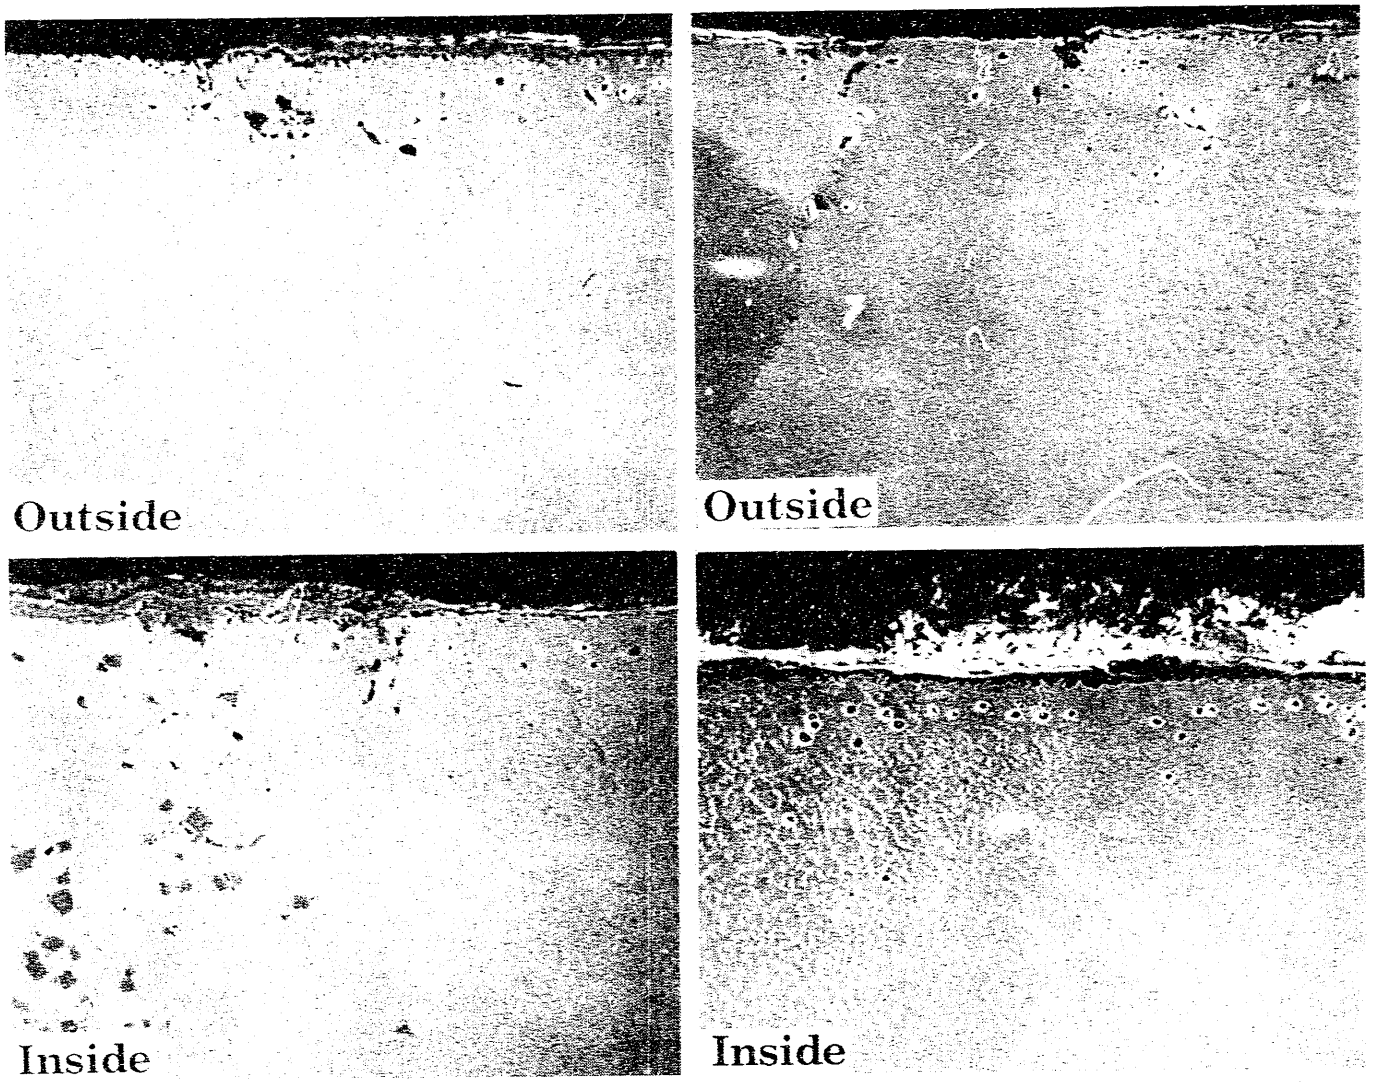
800H/25–35/800H **800H/25–35R/800H**

SEM Photographs of Cross Sections of 25-35 and 25-35R after 1980 h Exposure

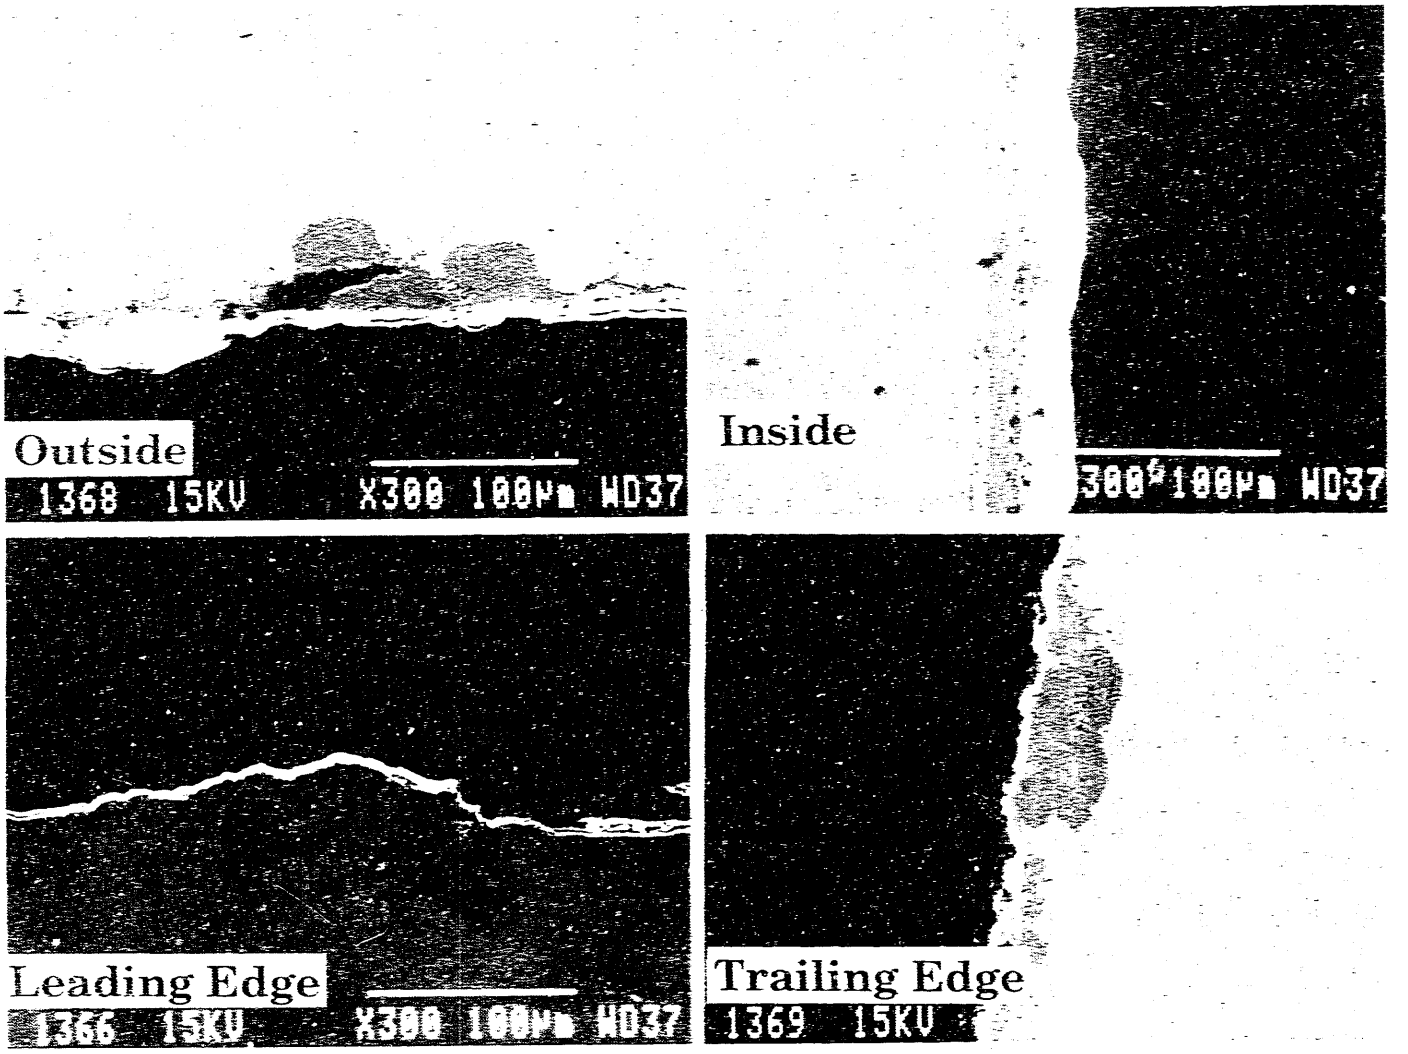
304H SS

SEM Micrographs of 304 Stainless Steel after 500 h Exposure
