Materials Performance in the Atmospheric Fluidized-bed Cogeneration Air Heater Experiment

ANL-91/4

MATERIALS PERFORMANCE IN THE ATMOSPHERIC FLUIDIZED-BED COGENERATION AIR HEATER EXPERIMENT

February 1991

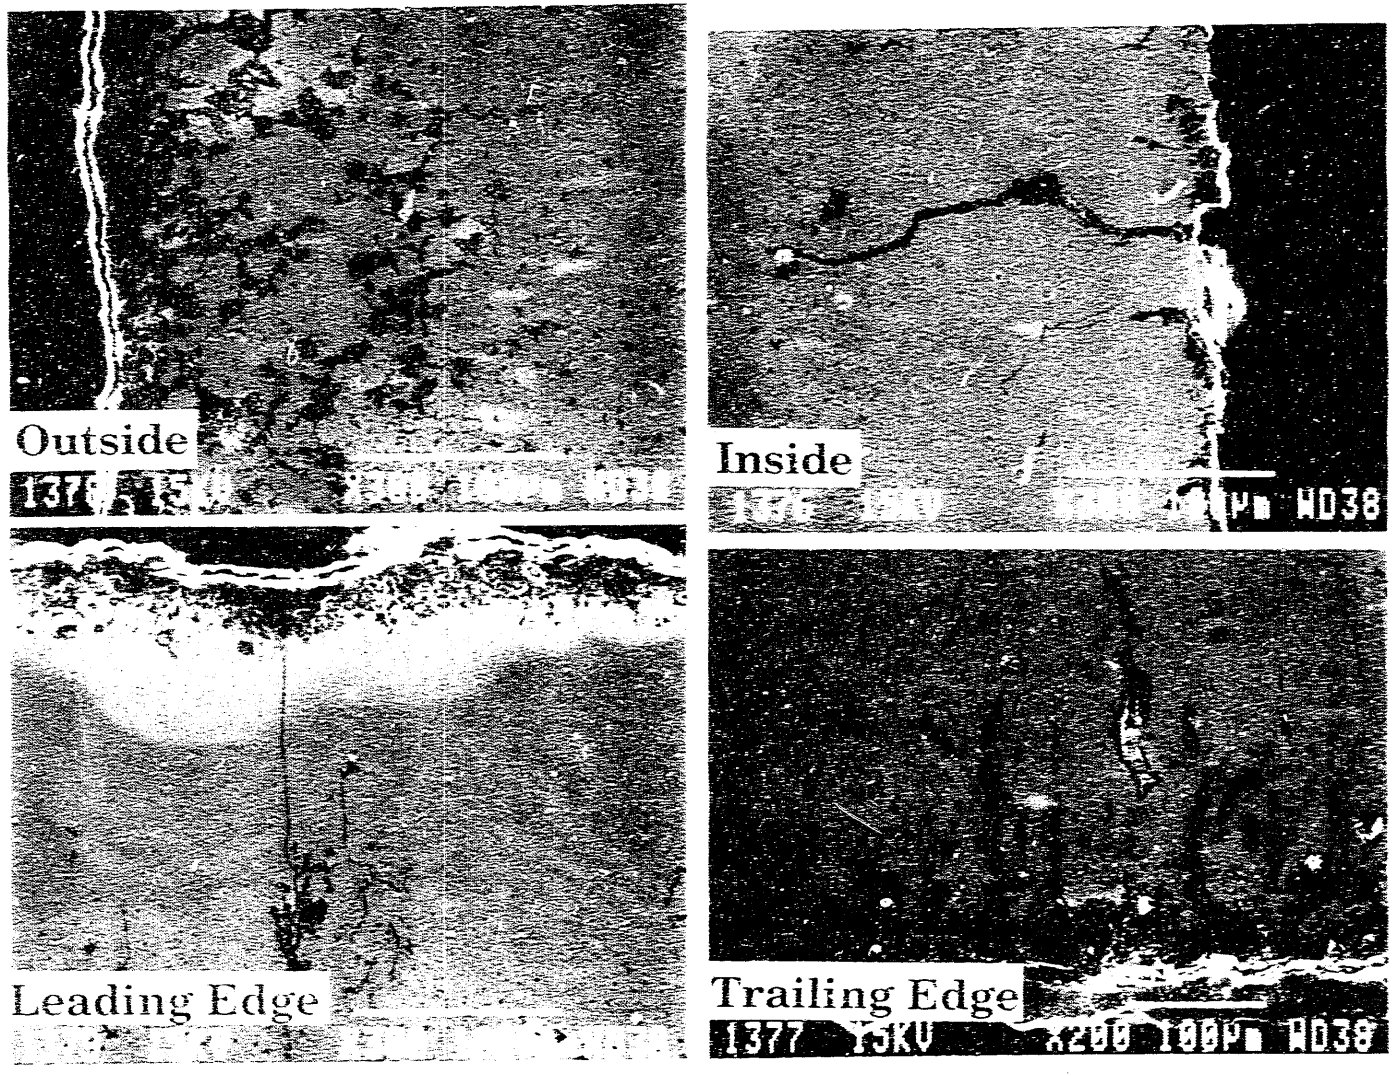
304H/Al

SEM Micrographs of Aluminized 304 Stainless Steel after 500 h Exposure

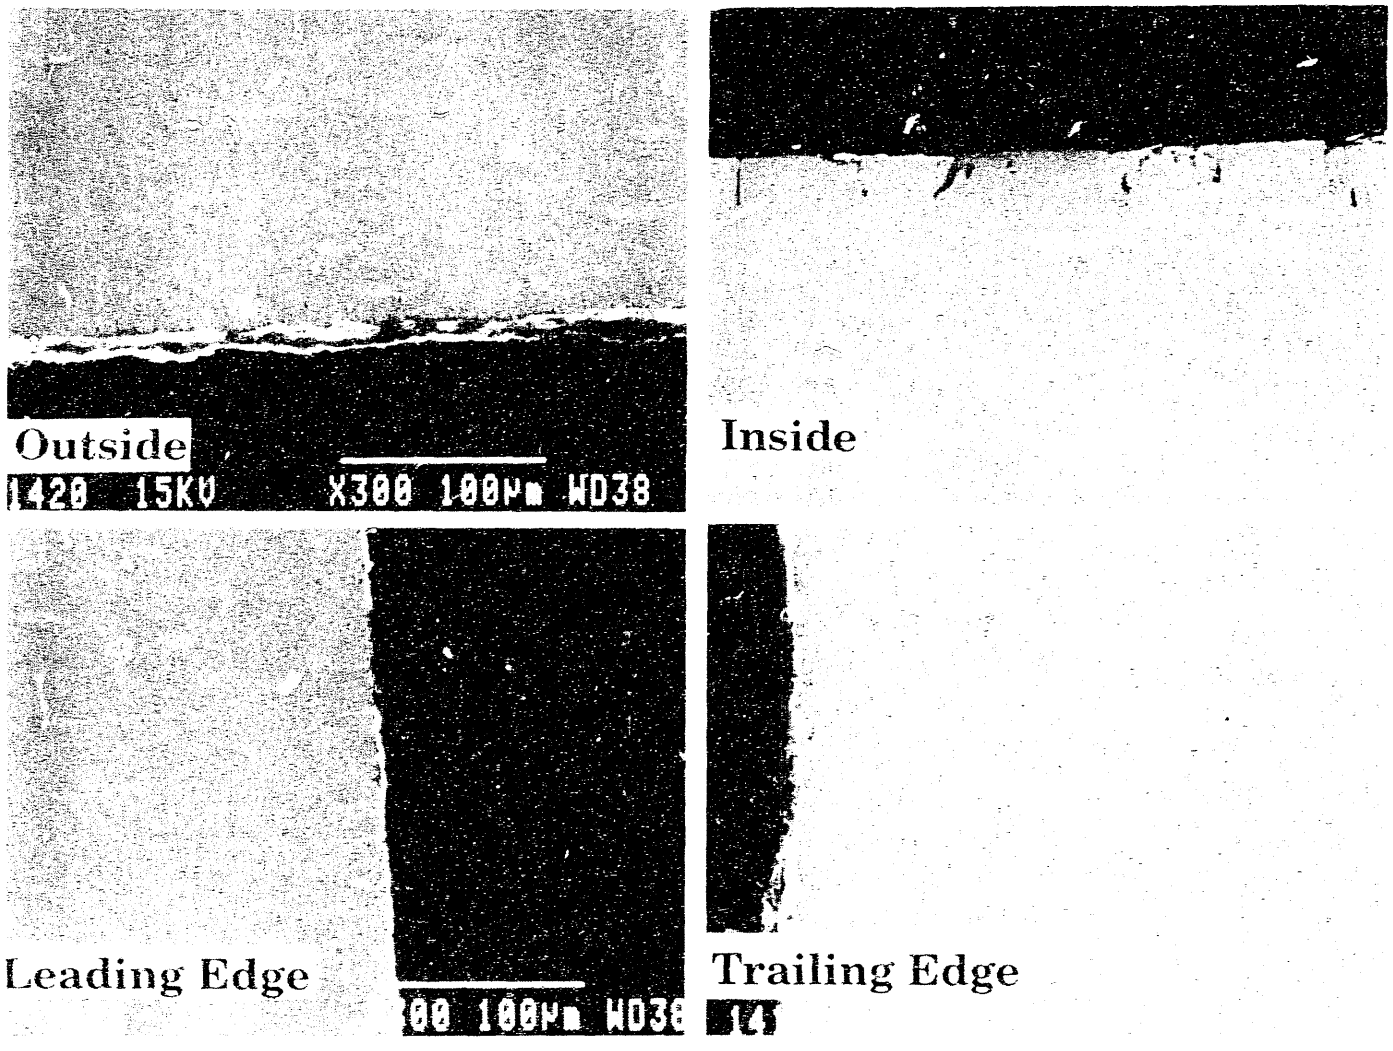
310 SS

SEM Micrographs of 310 Stainless Steel after 500 h Exposure

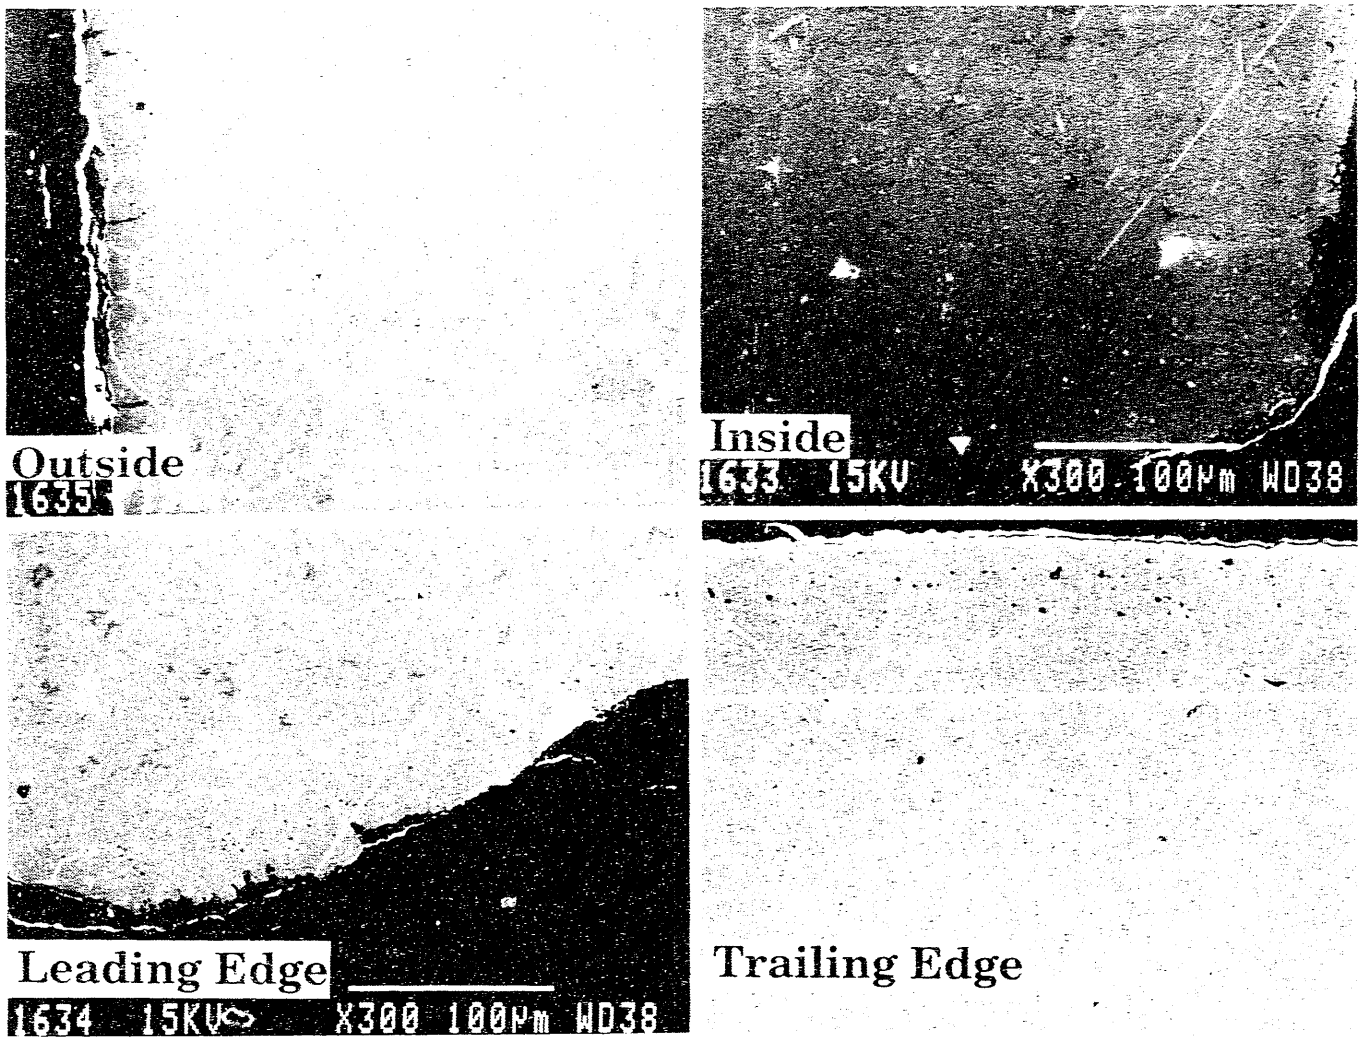
3. Alloys such as HH, HP 50, 253 MA, XM 19, Sanicro 33, HS 556, and HS 188 were found susceptible to unacceptable corrosion when in contact with the bed material.

SEM Micrographs of 253 MA after 500 h Exposure

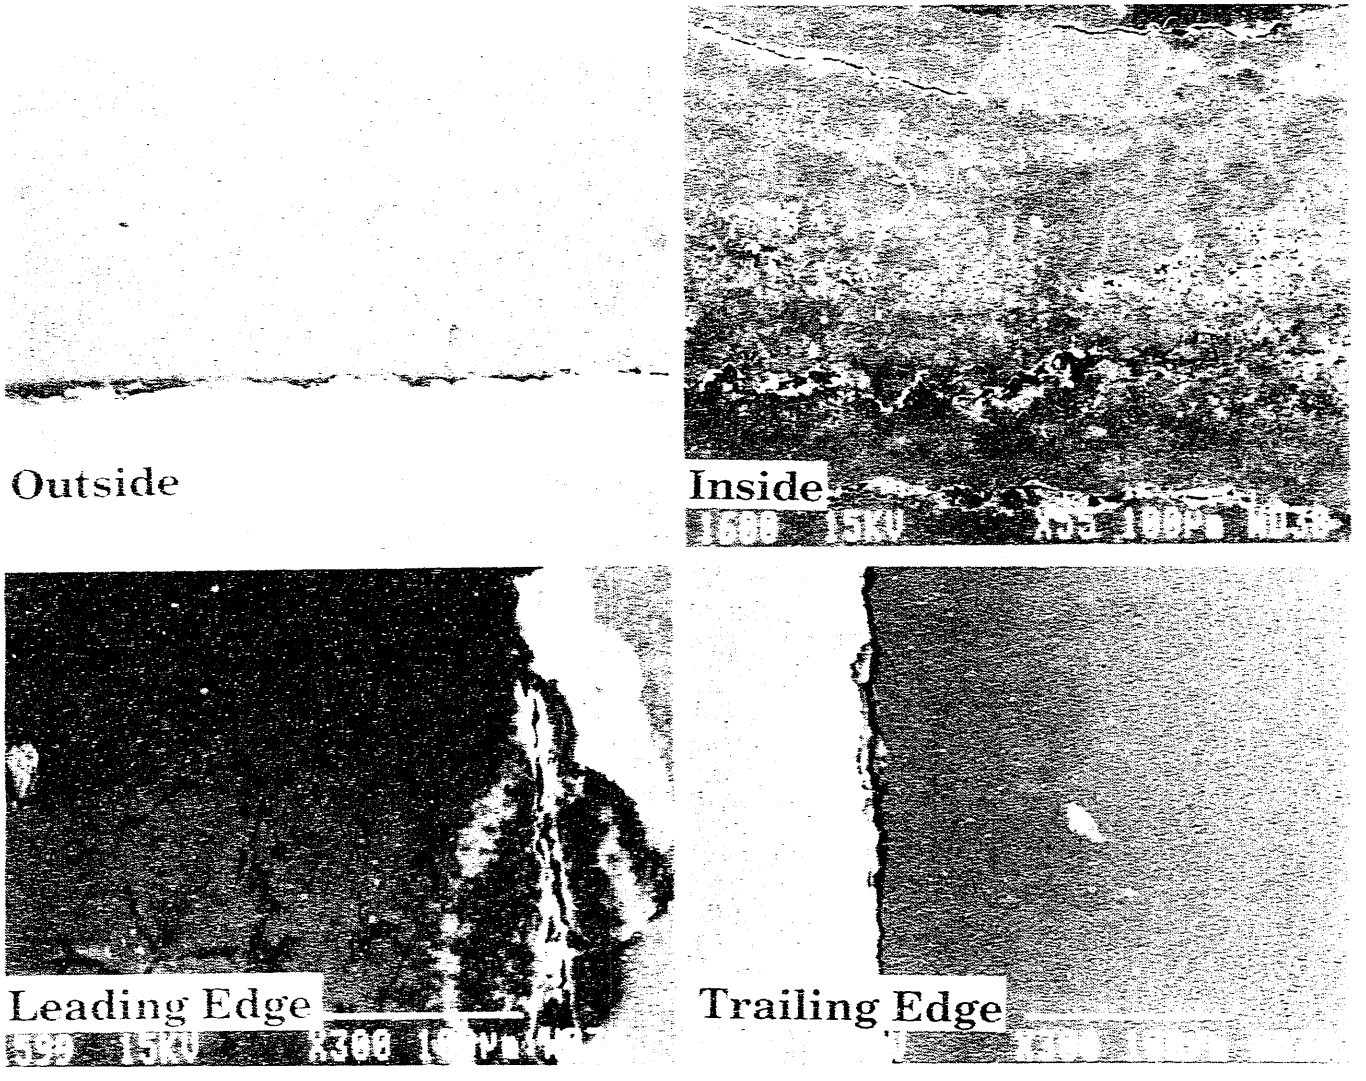
SEM Micrographs of RA 330 after 500 h Exposure

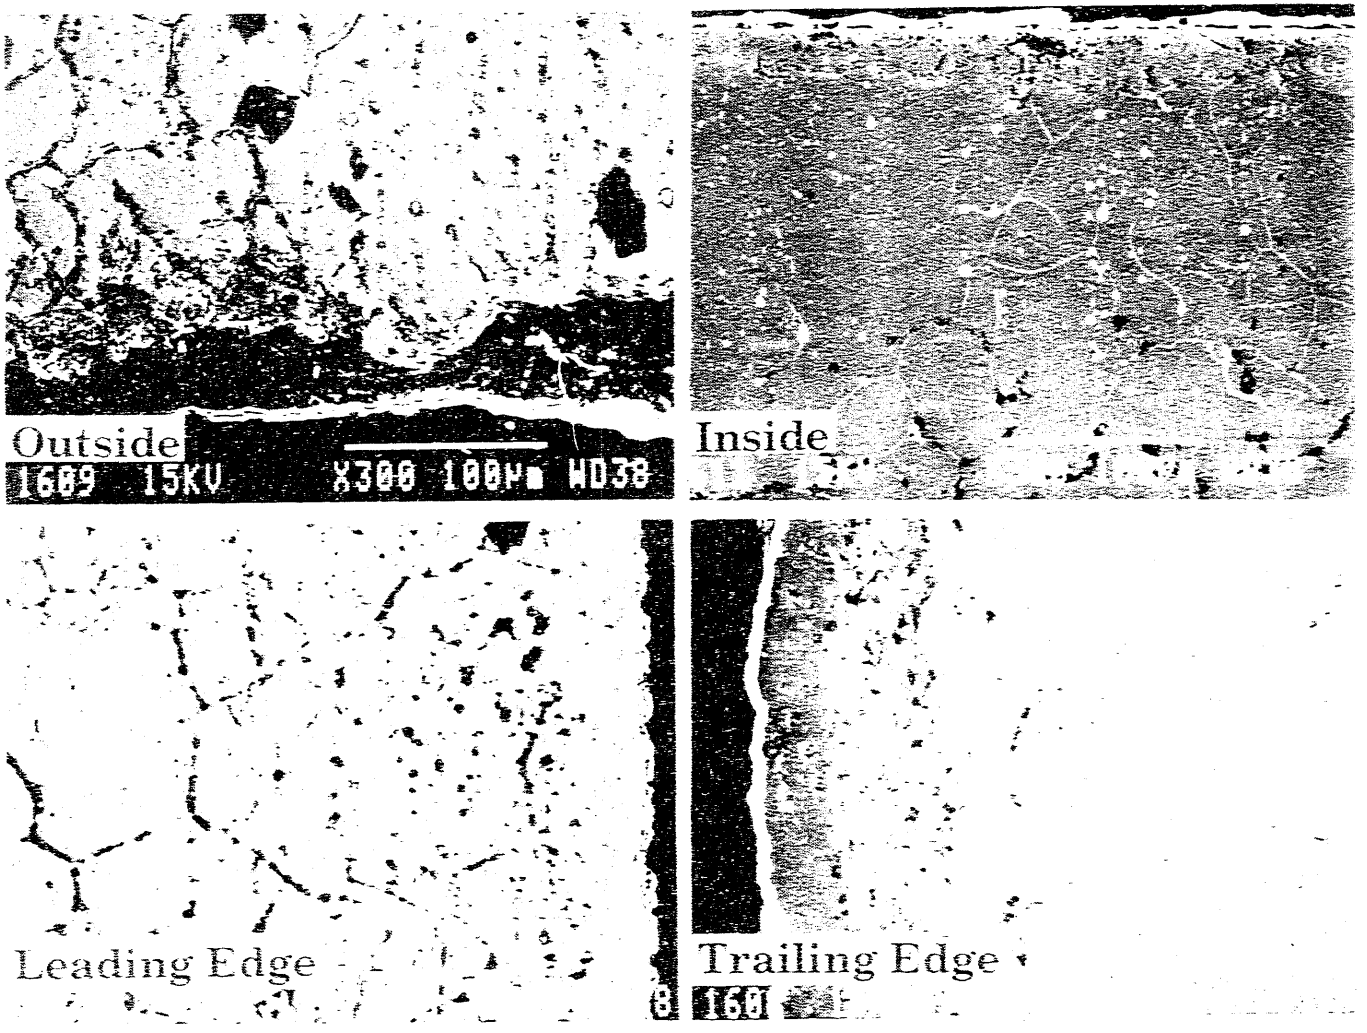
SEM Micrographs of HS 188 after 500 h Exposure

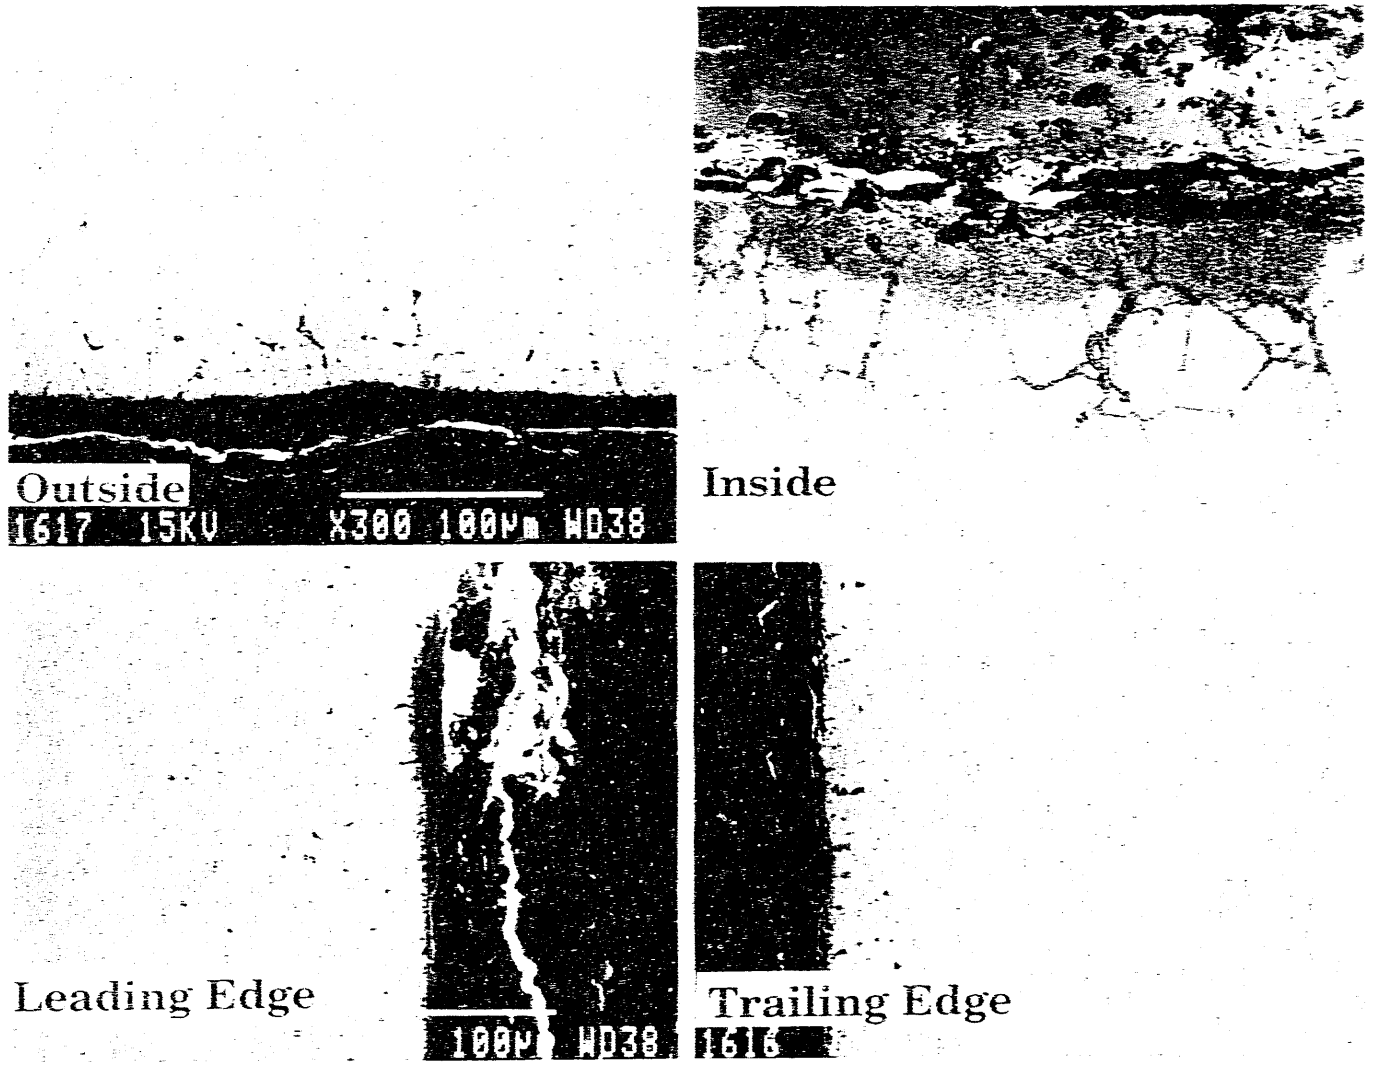
SEM Micrographs of HS 556 after 500 h Exposure

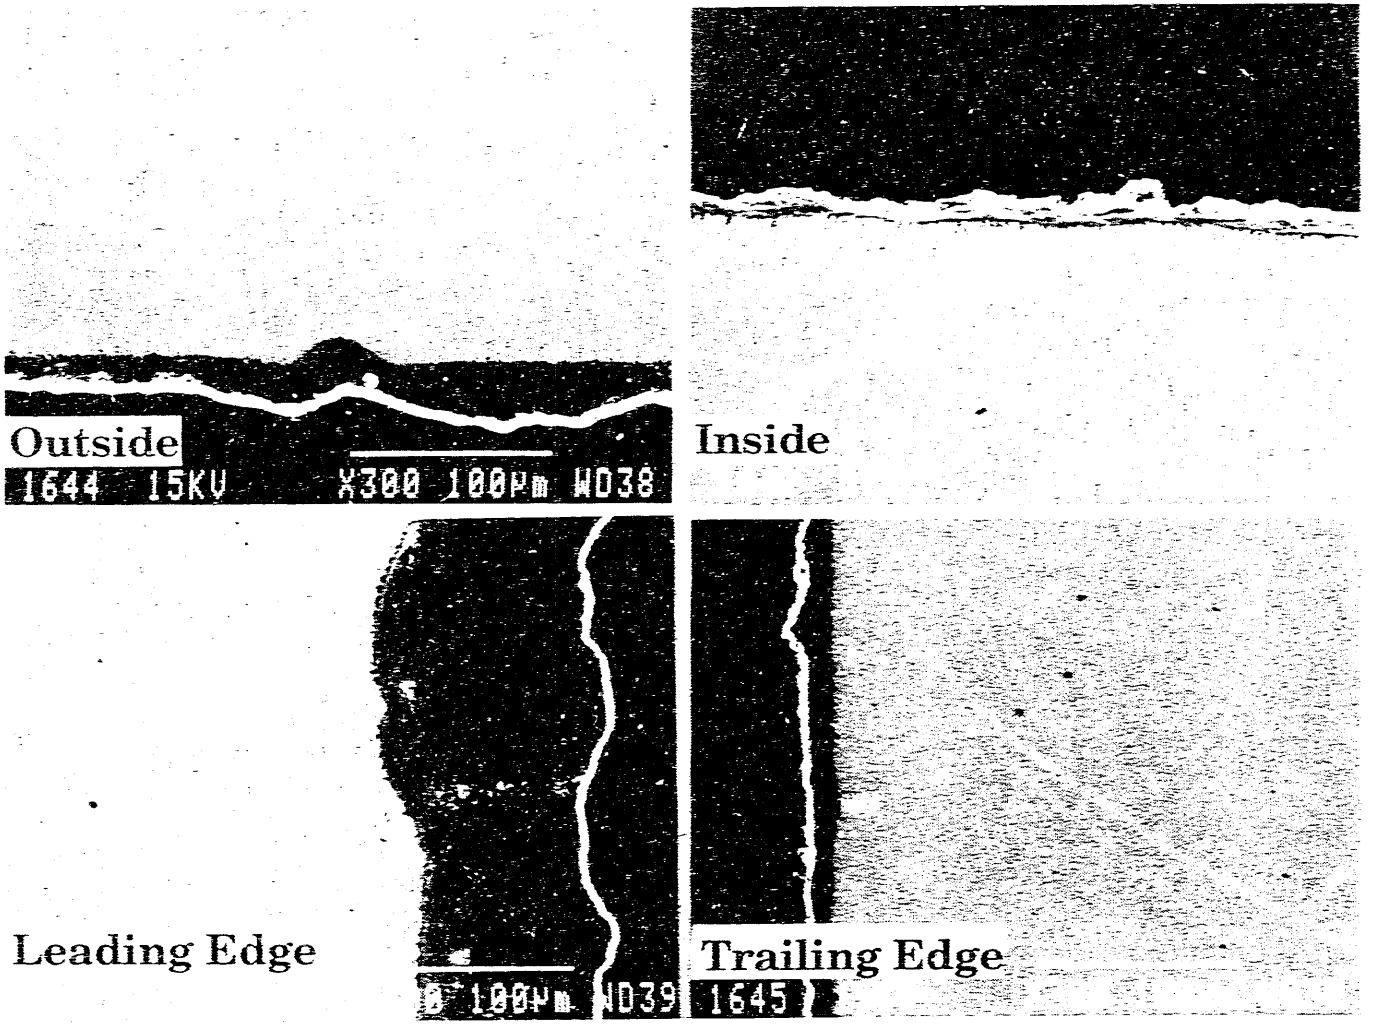
SEM Micrographs of HK 40 after 500 h Exposure

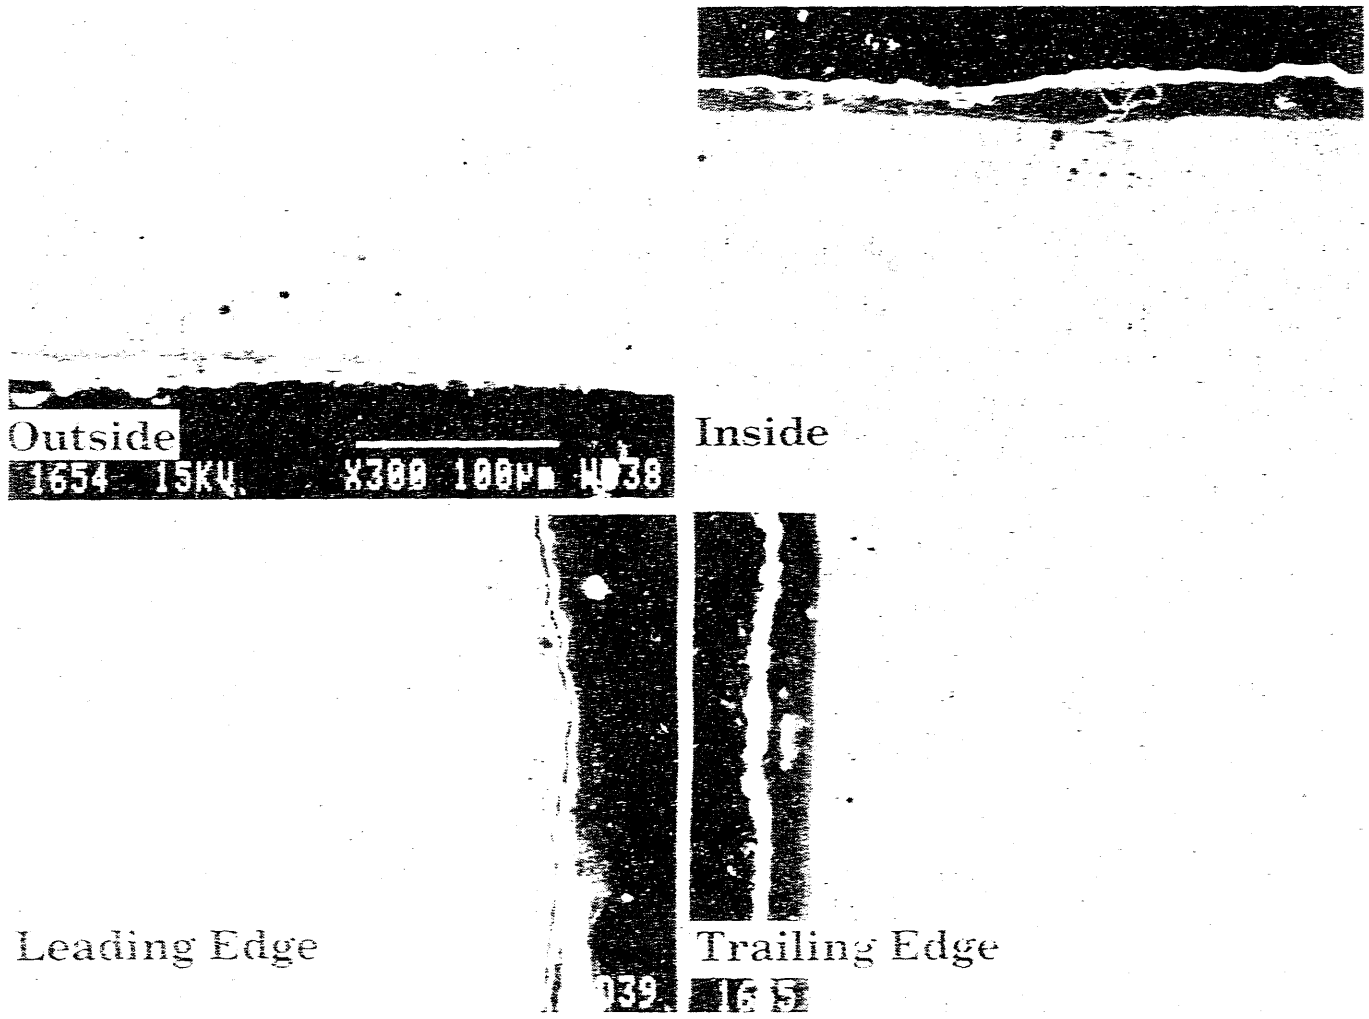
SEM Micrographs of XM 19 after 500 h Exposure

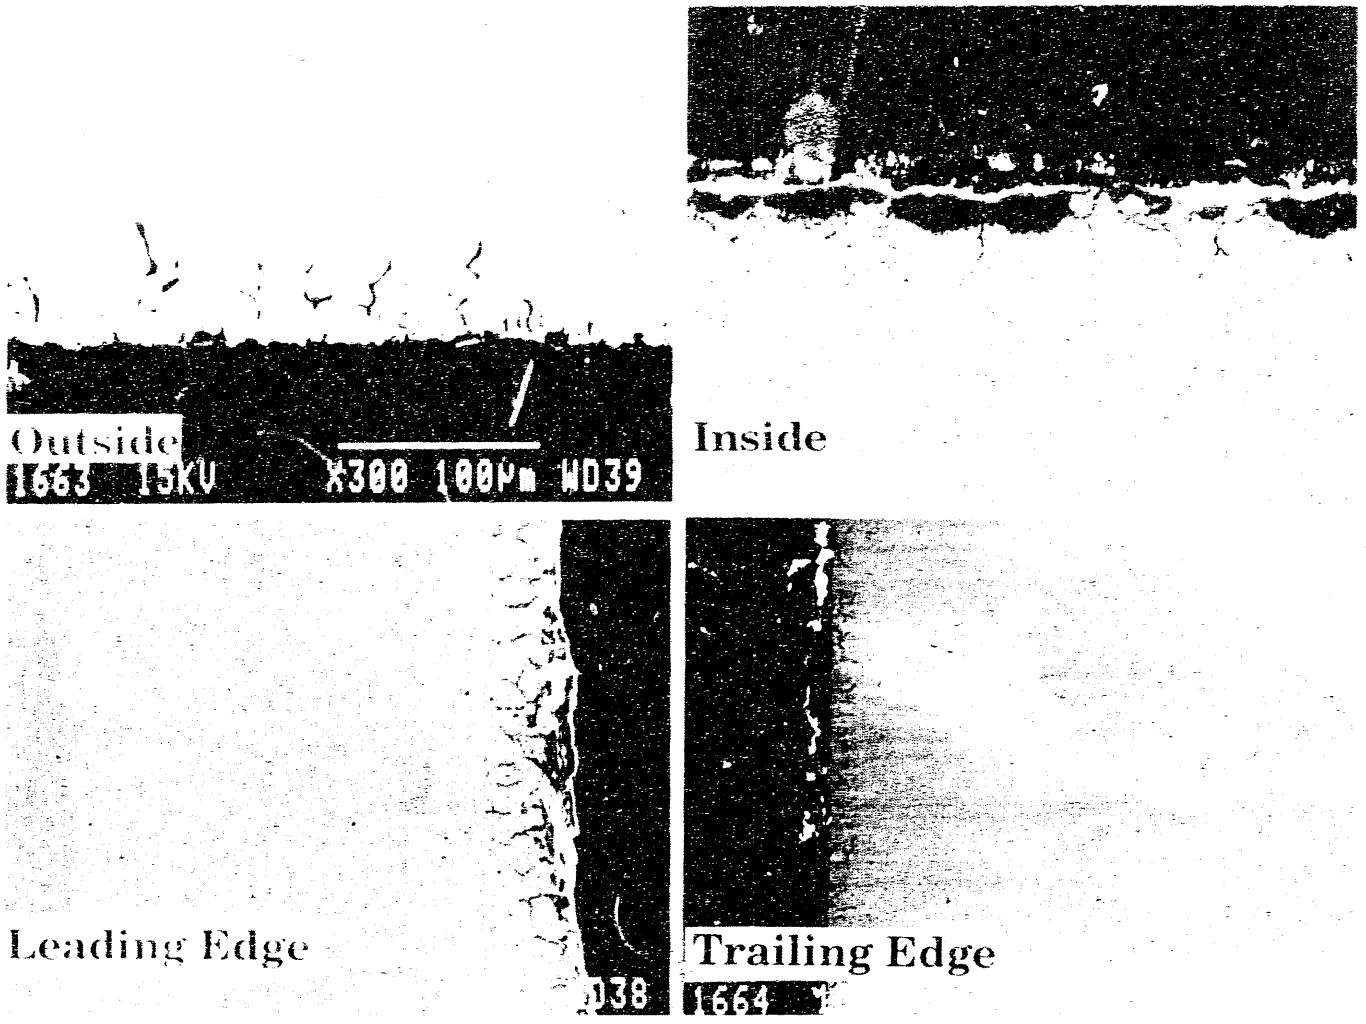
SANICRO 33

SEM Micrographs of Sanicro 33 after 500 h Exposure

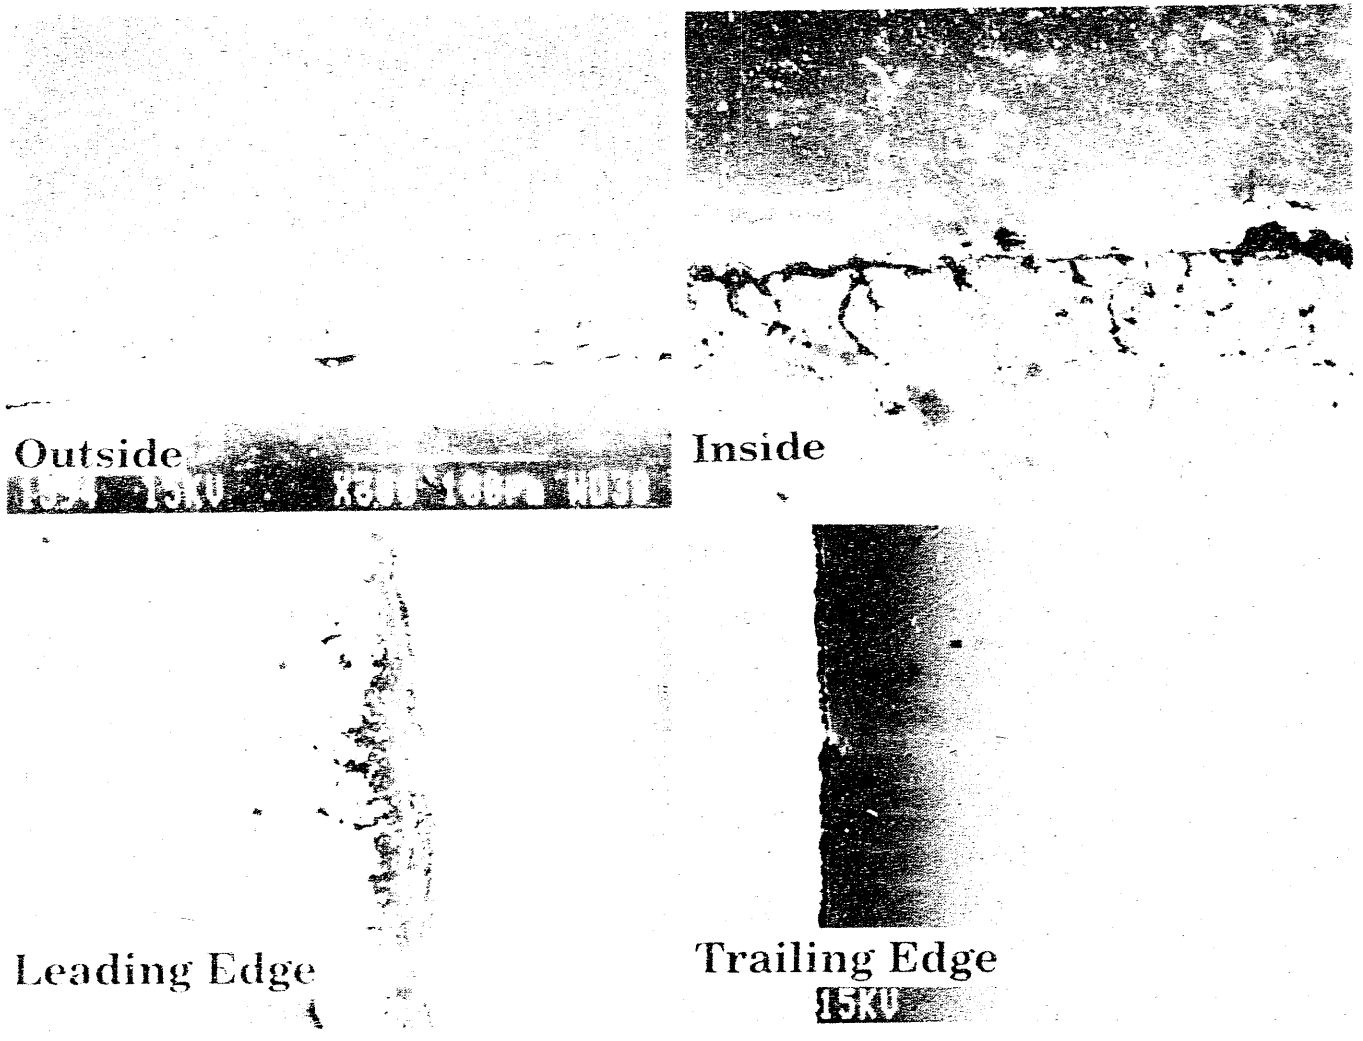
304/310

SEM Micrographs of 310-Clad 304 Stainless Steel after
500 h Exposure Near the Center of the Bed

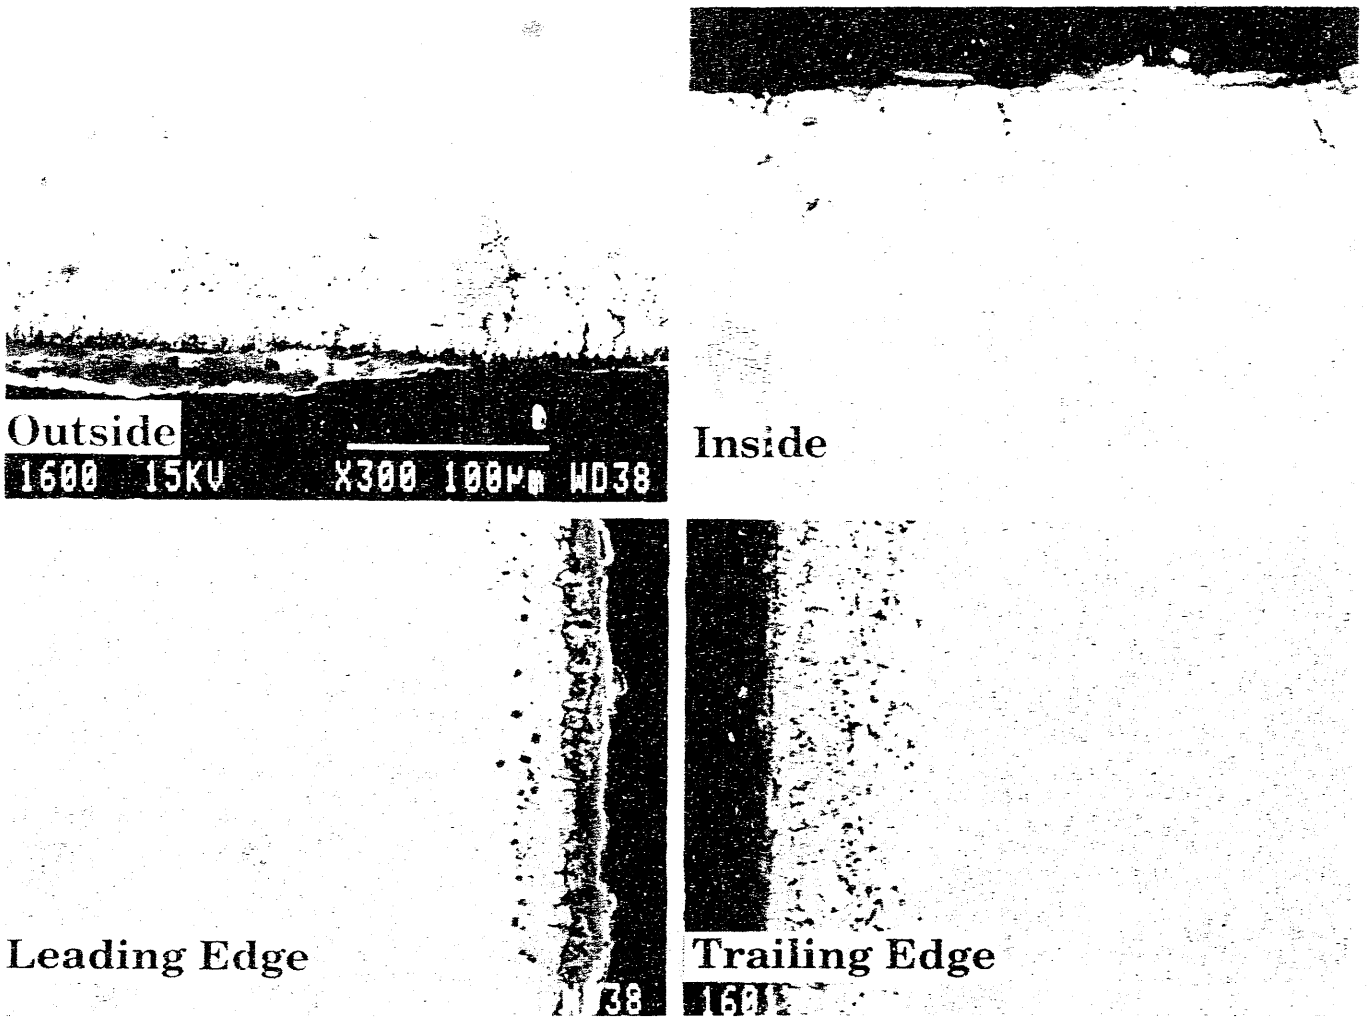
800H/310

SEM Micrographs of 310-Clad 800H Alloy after
500 h Exposure Near the Center of the Bed

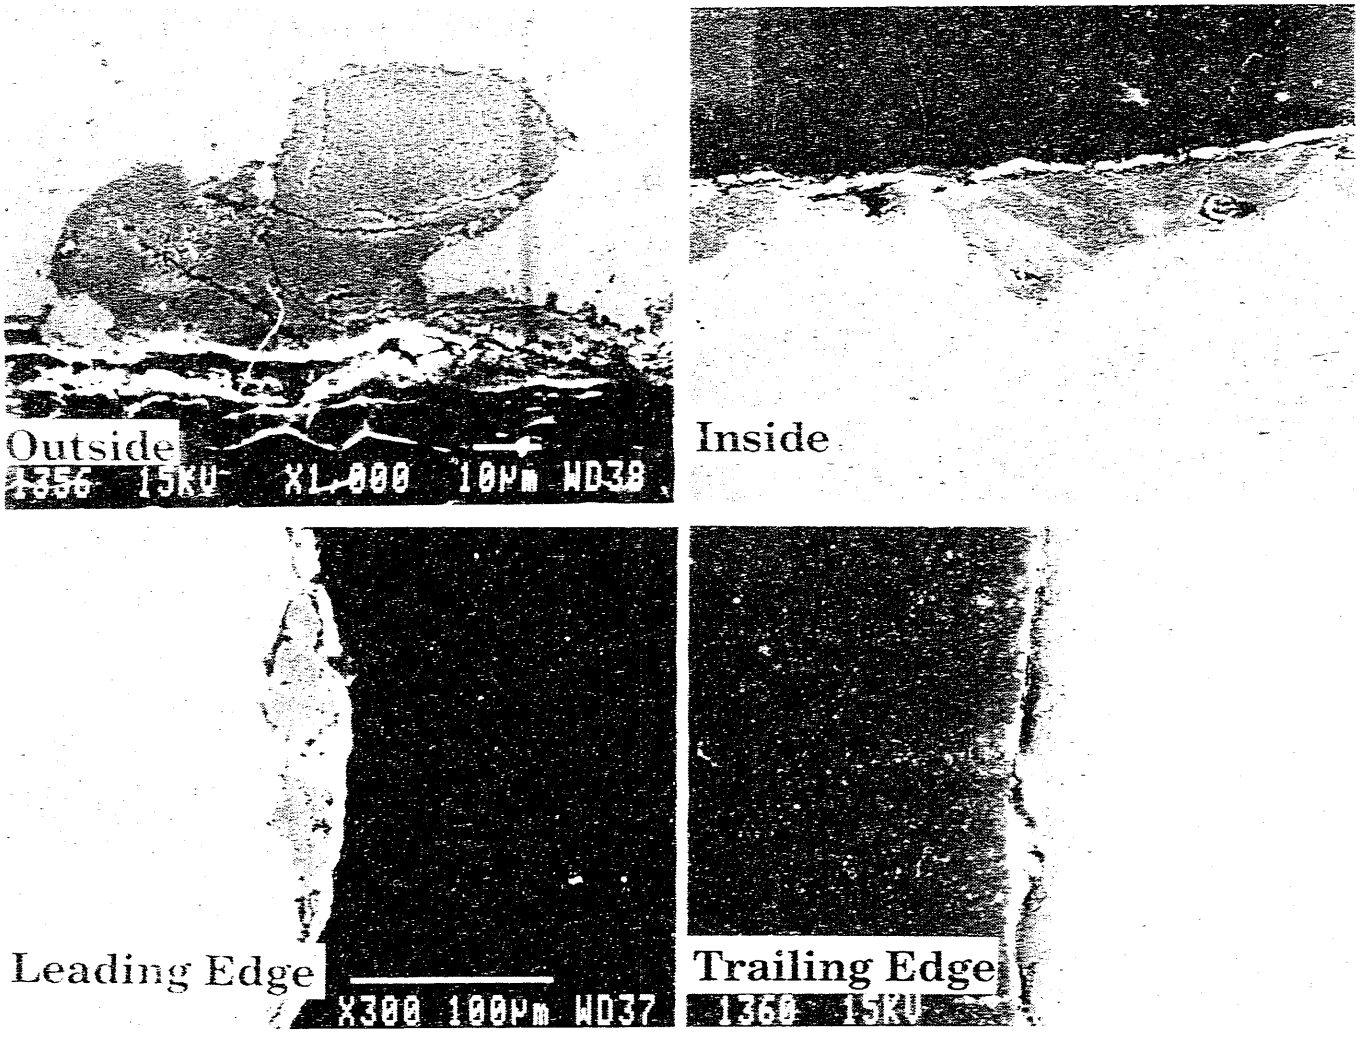
304H SS

SEM Micrographs of 304 Stainless Steel after 1000 h Exposure

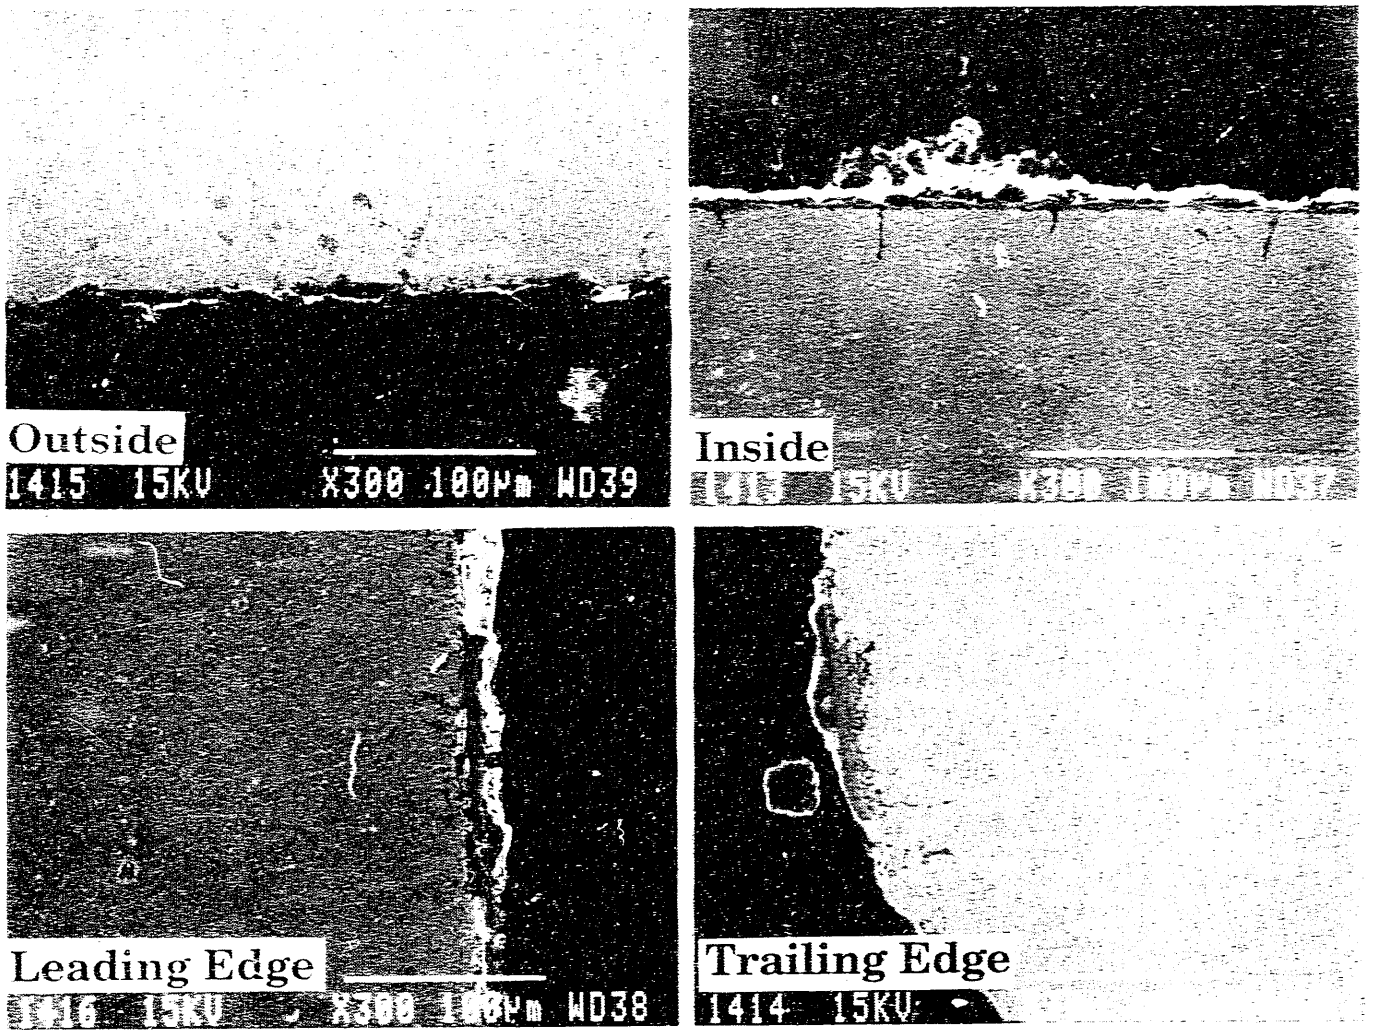
310 SS

SEM Micrographs of 310 Stainless Steel after 1000 h Exposure

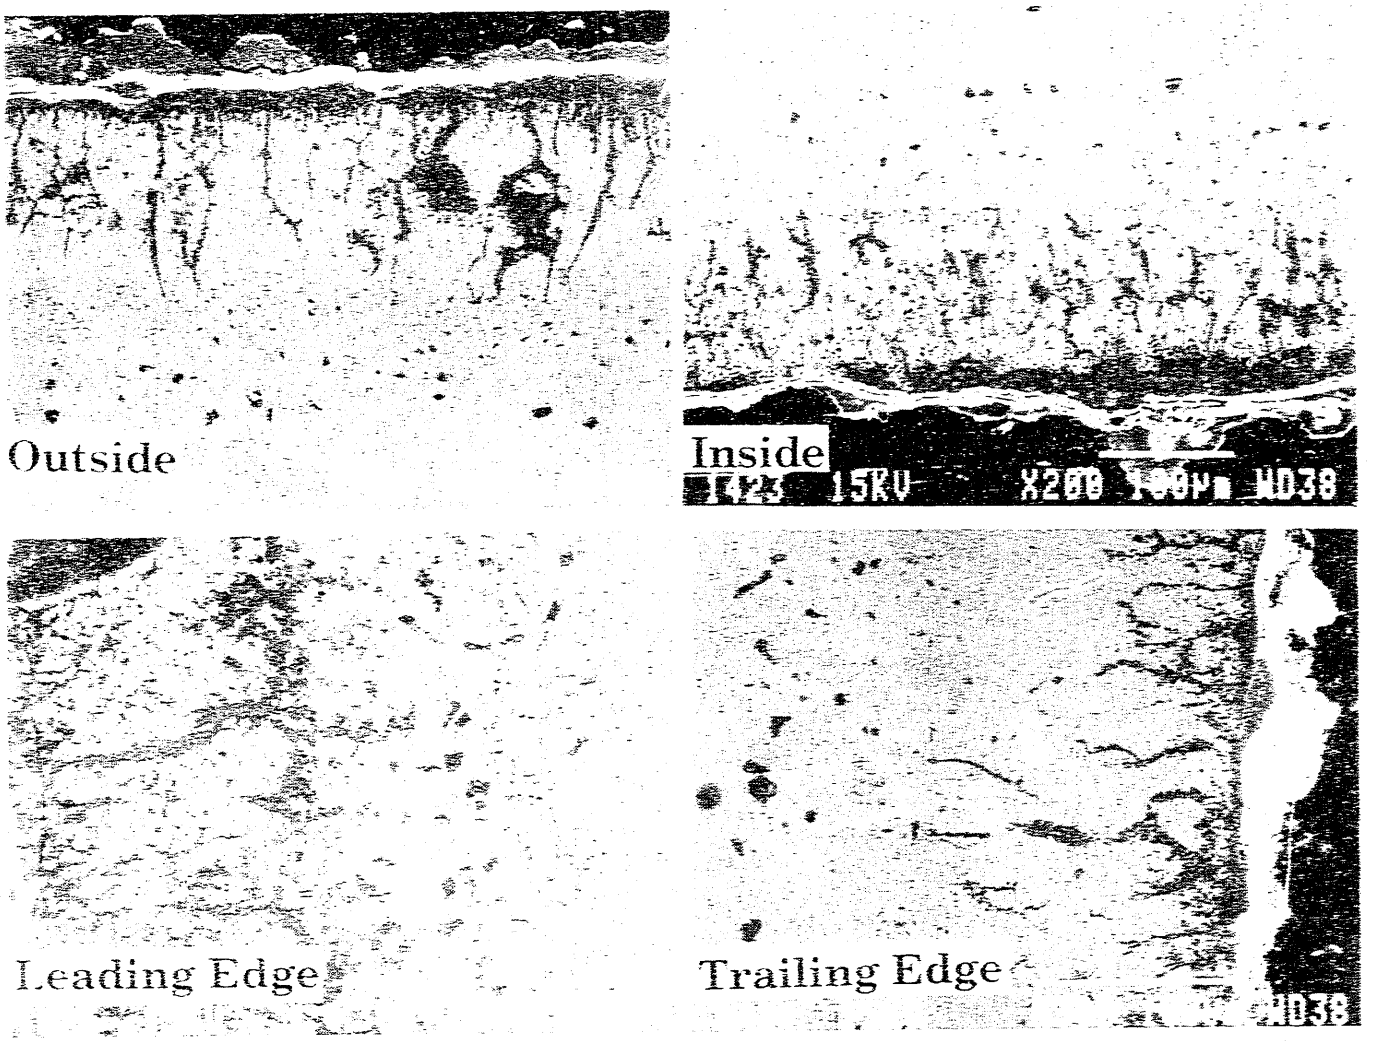
310/Al

SEM Micrographs of Aluminized 310 Stainless Steel after 1000 h Exposure

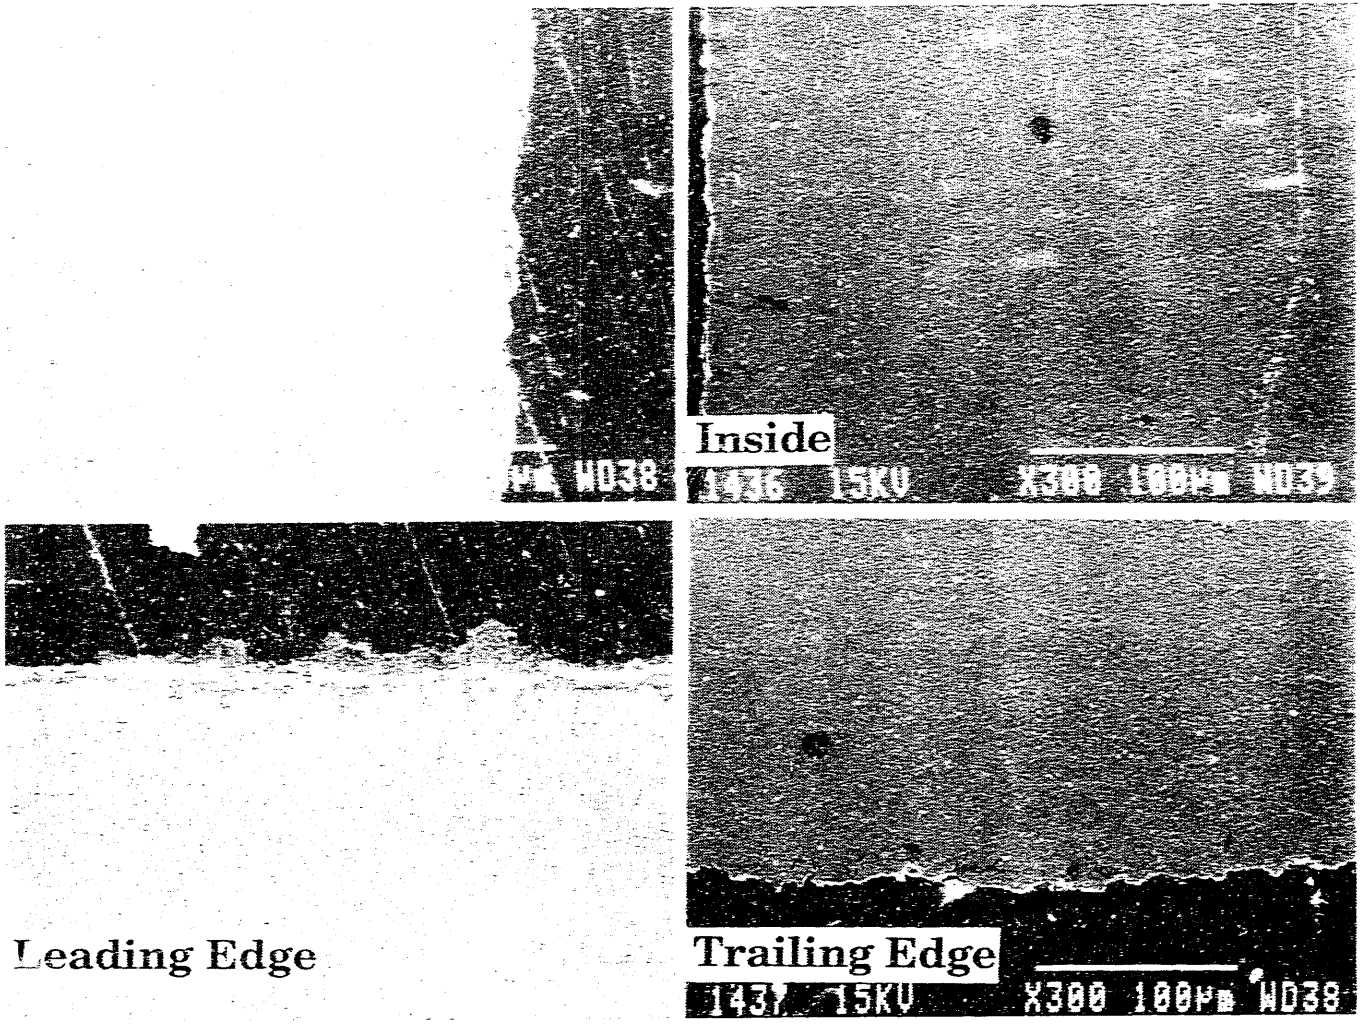
SEM Micrographs of HH after 1000 h Exposure

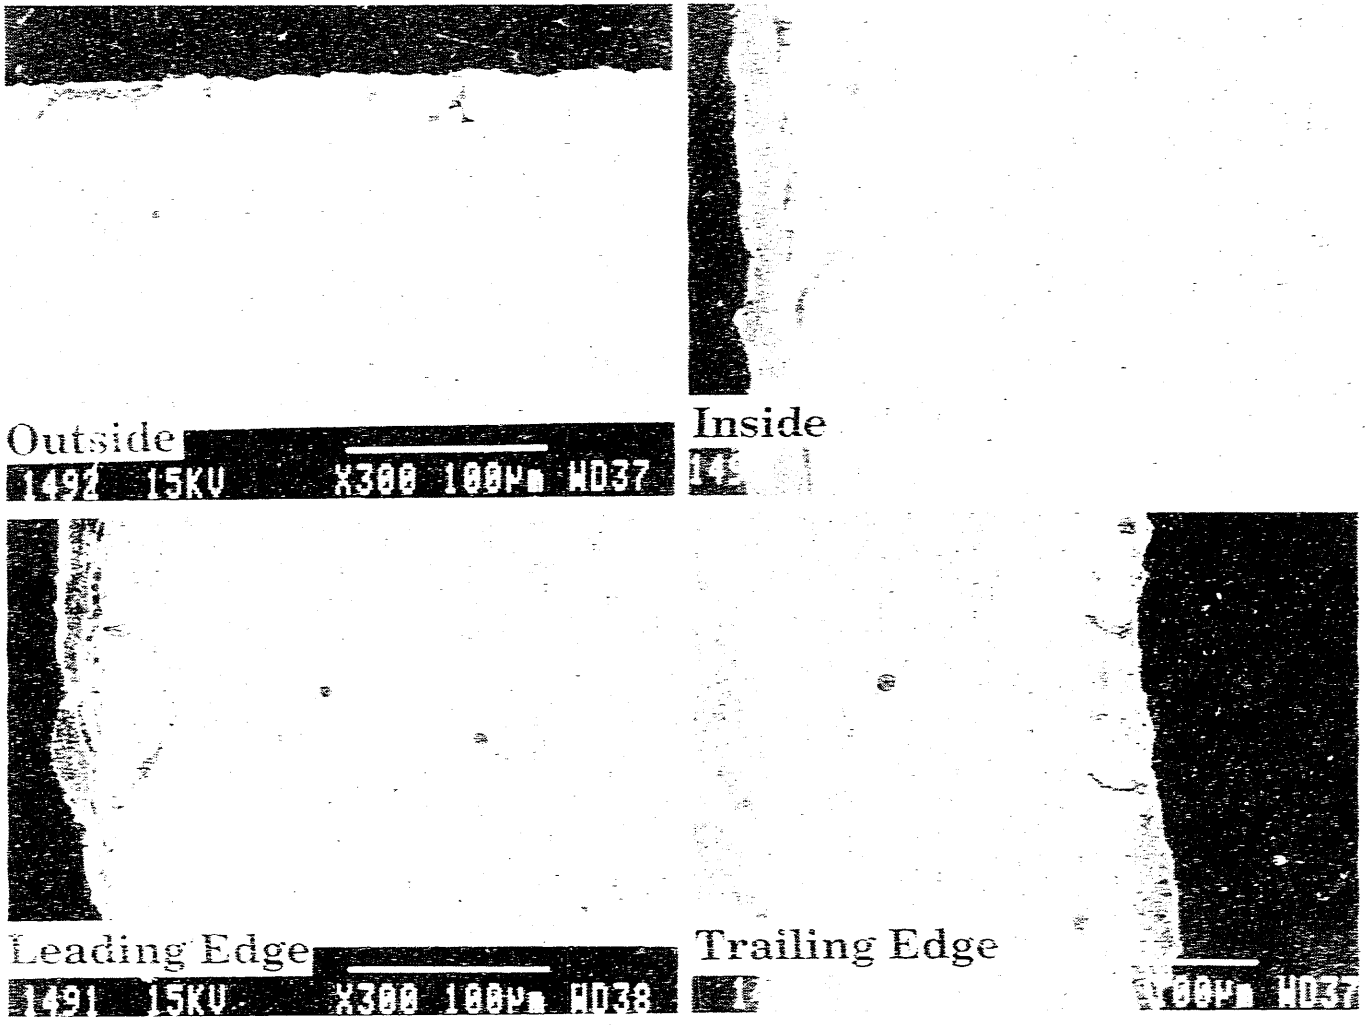
SEM Micrographs of HP 50 after 1000 h Exposure
