Materials Performance in the Atmospheric Fluidized-bed Cogeneration Air Heater Experiment

ANL-91/4

MATERIALS PERFORMANCE IN THE ATMOSPHERIC FLUIDIZED-BED COGENERATION AIR HEATER EXPERIMENT

February 1991

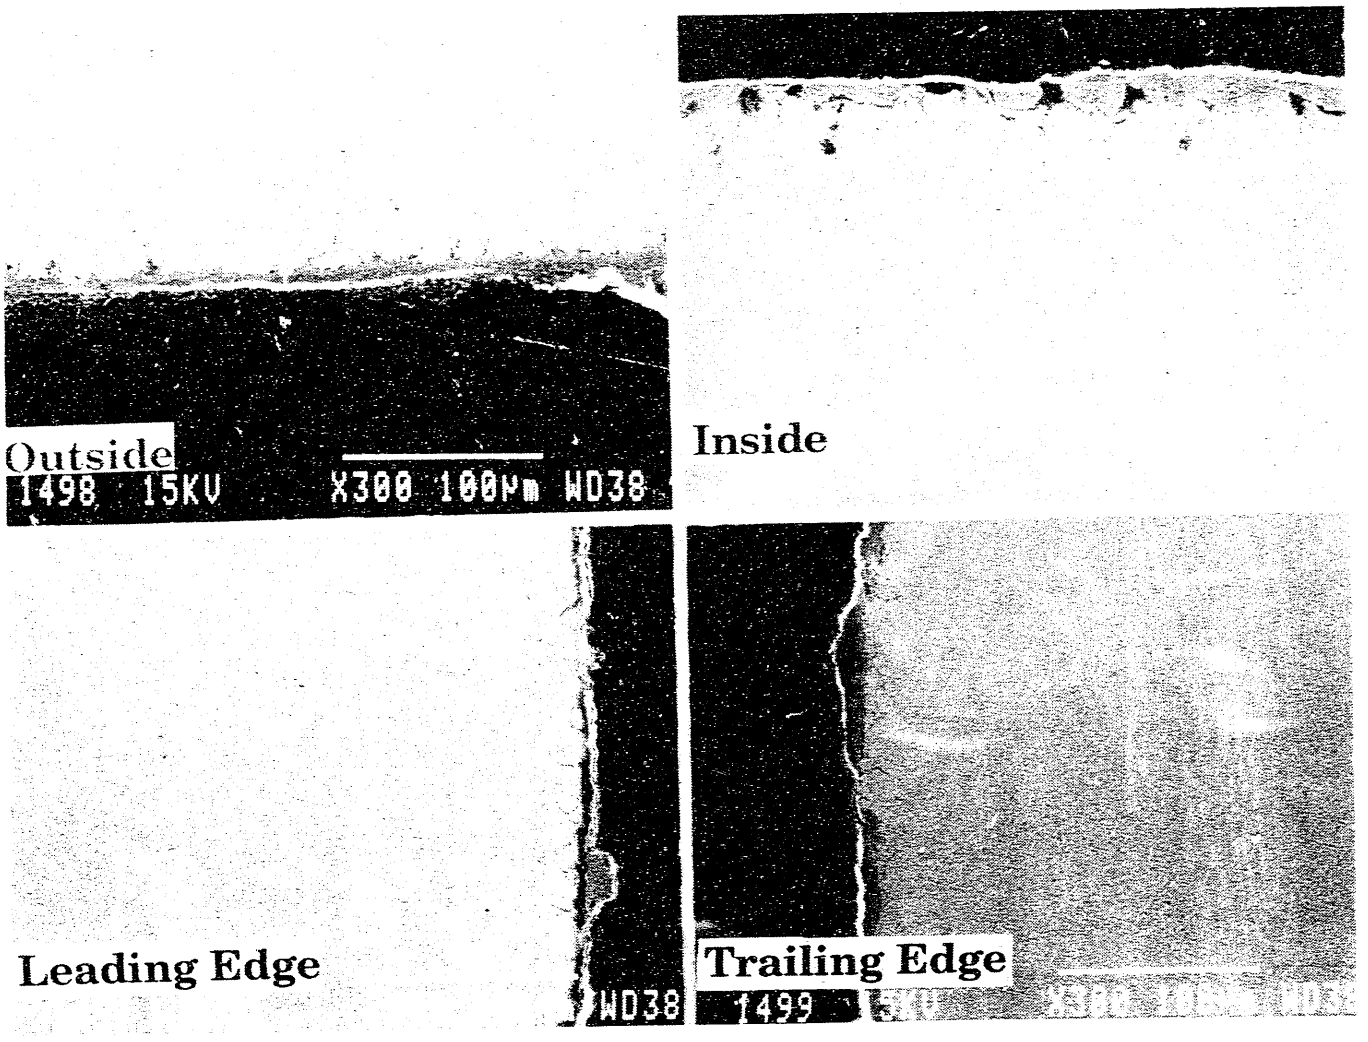
304/310

SEM Micrographs of 310-Clad 304 Stainless Steel after 1000 h Exposure Near the Bed Wall

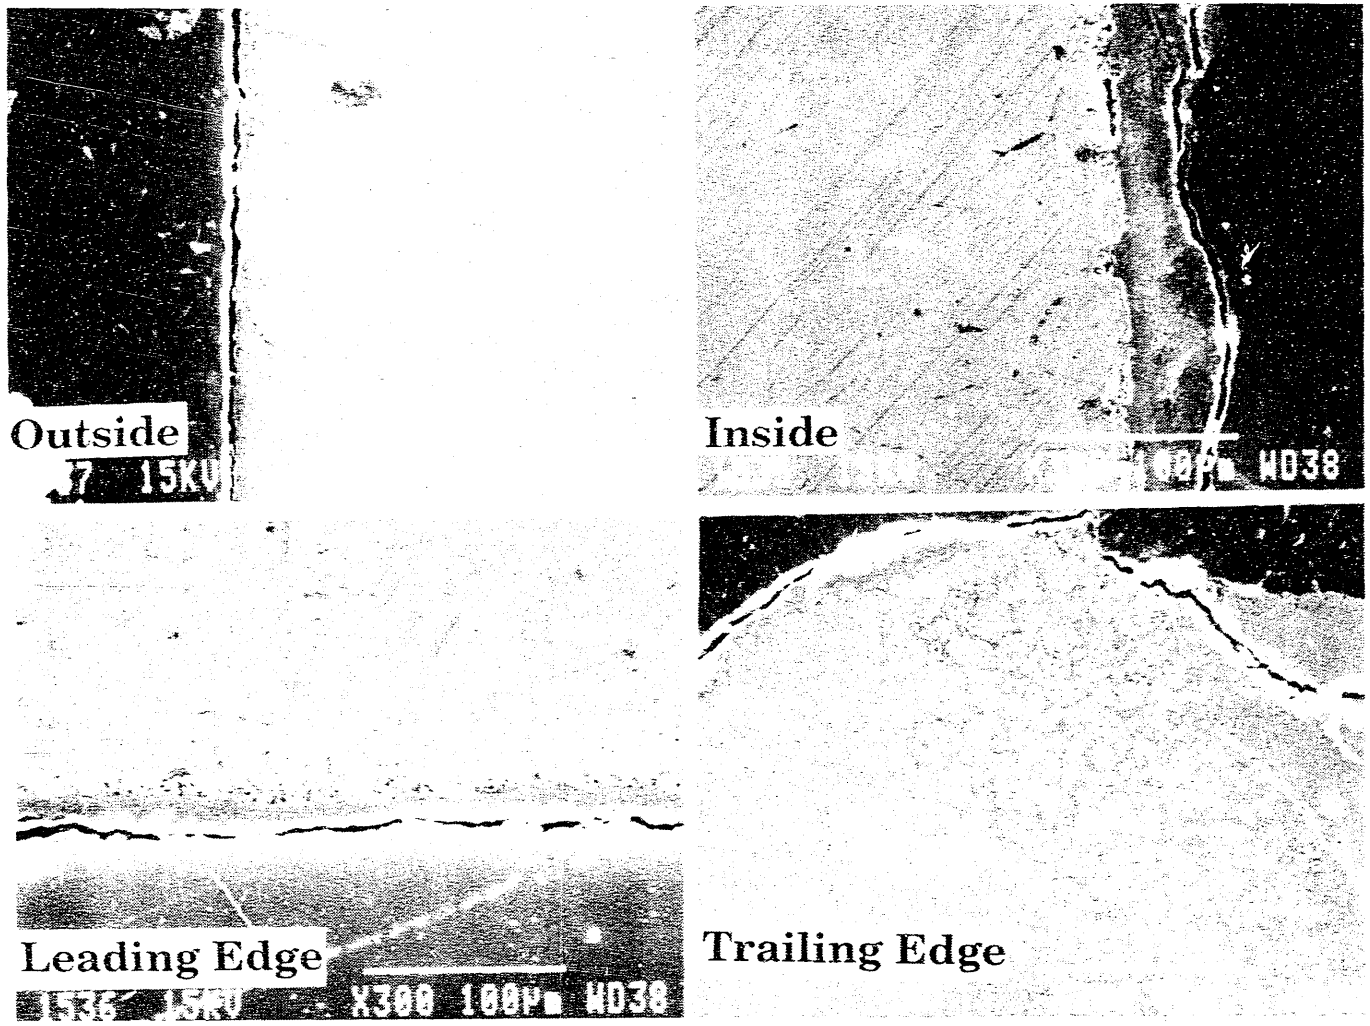
800H/310

SEM Micrographs of 310-Clad 800H after 1000 h Exposure

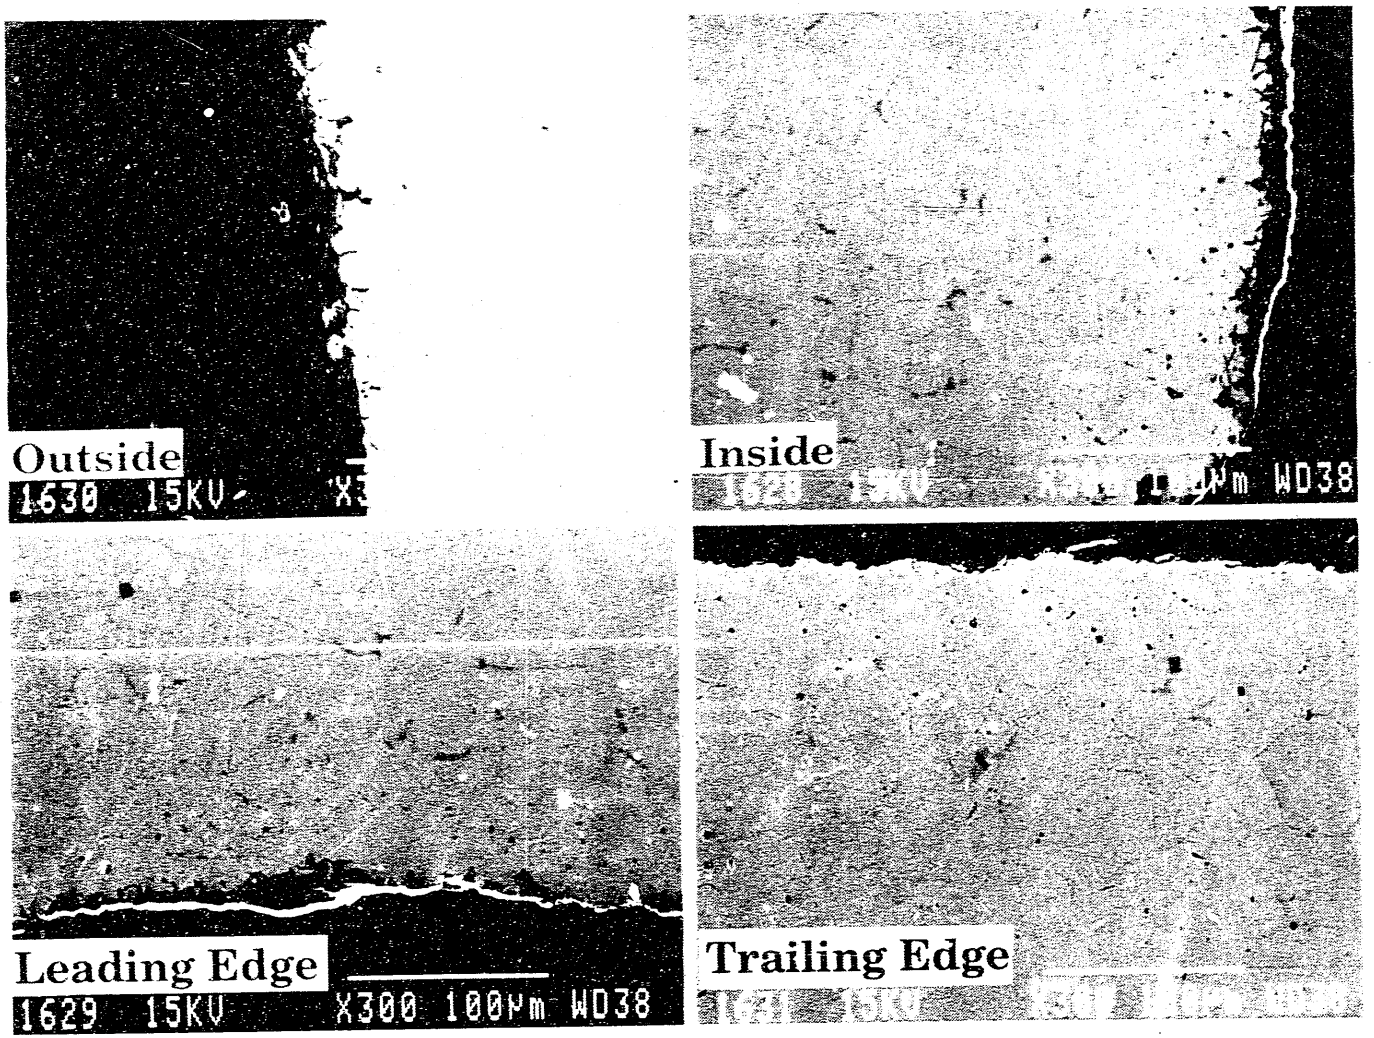
SEM Micrographs of 253 MA after 1000 h Exposure

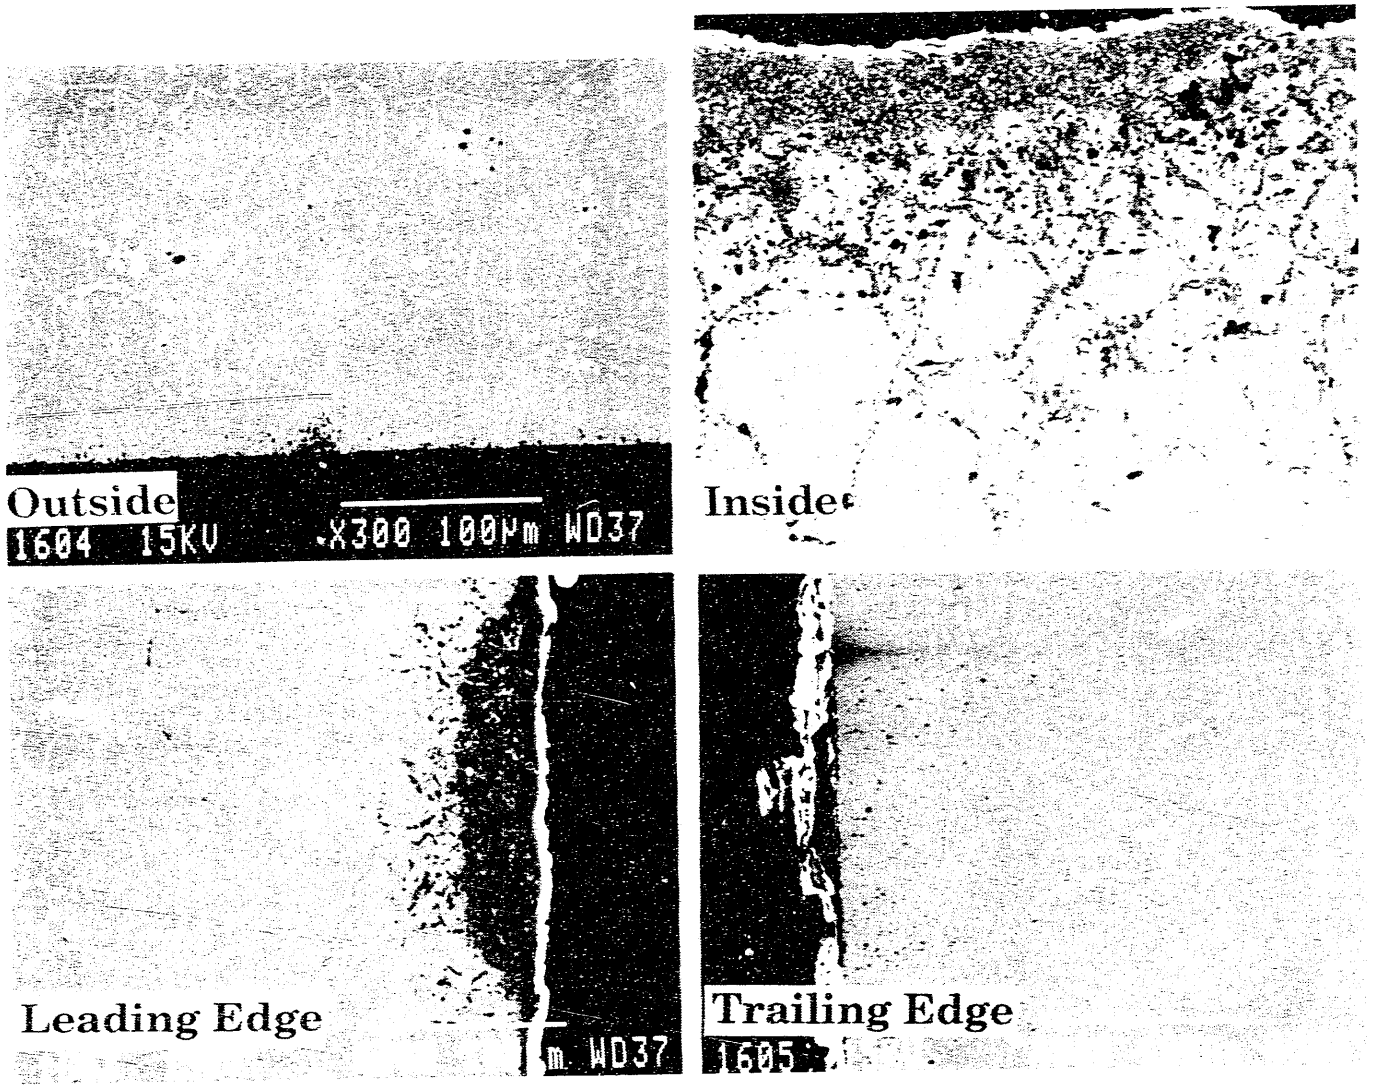
SEM Micrographs of HS 188 after 1000 h Exposure

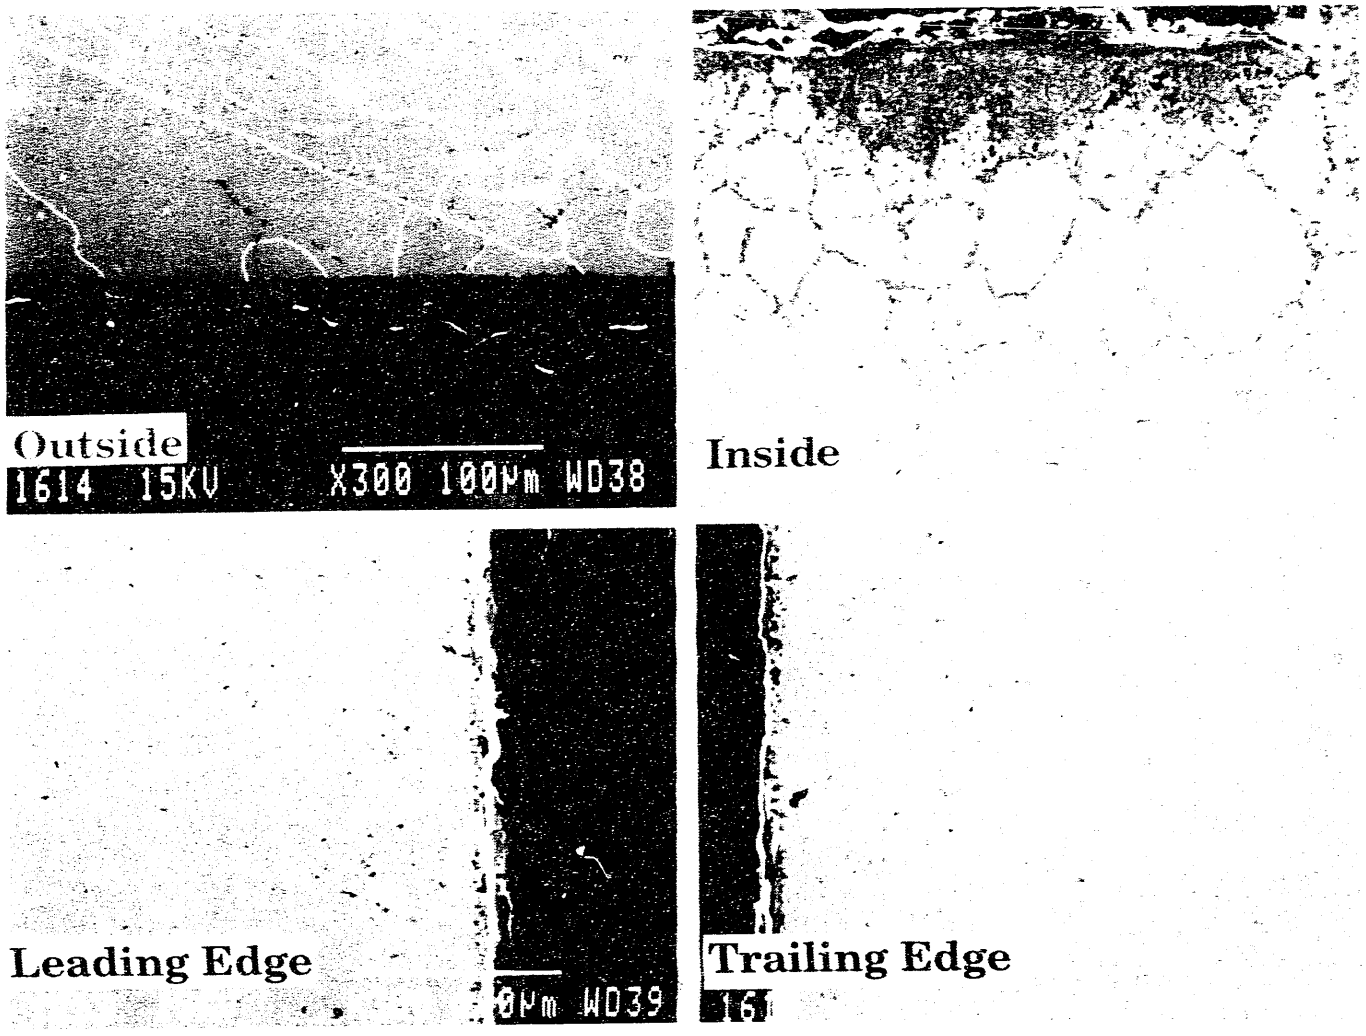
SEM Micrographs of HS 556 after 1000 h Exposure

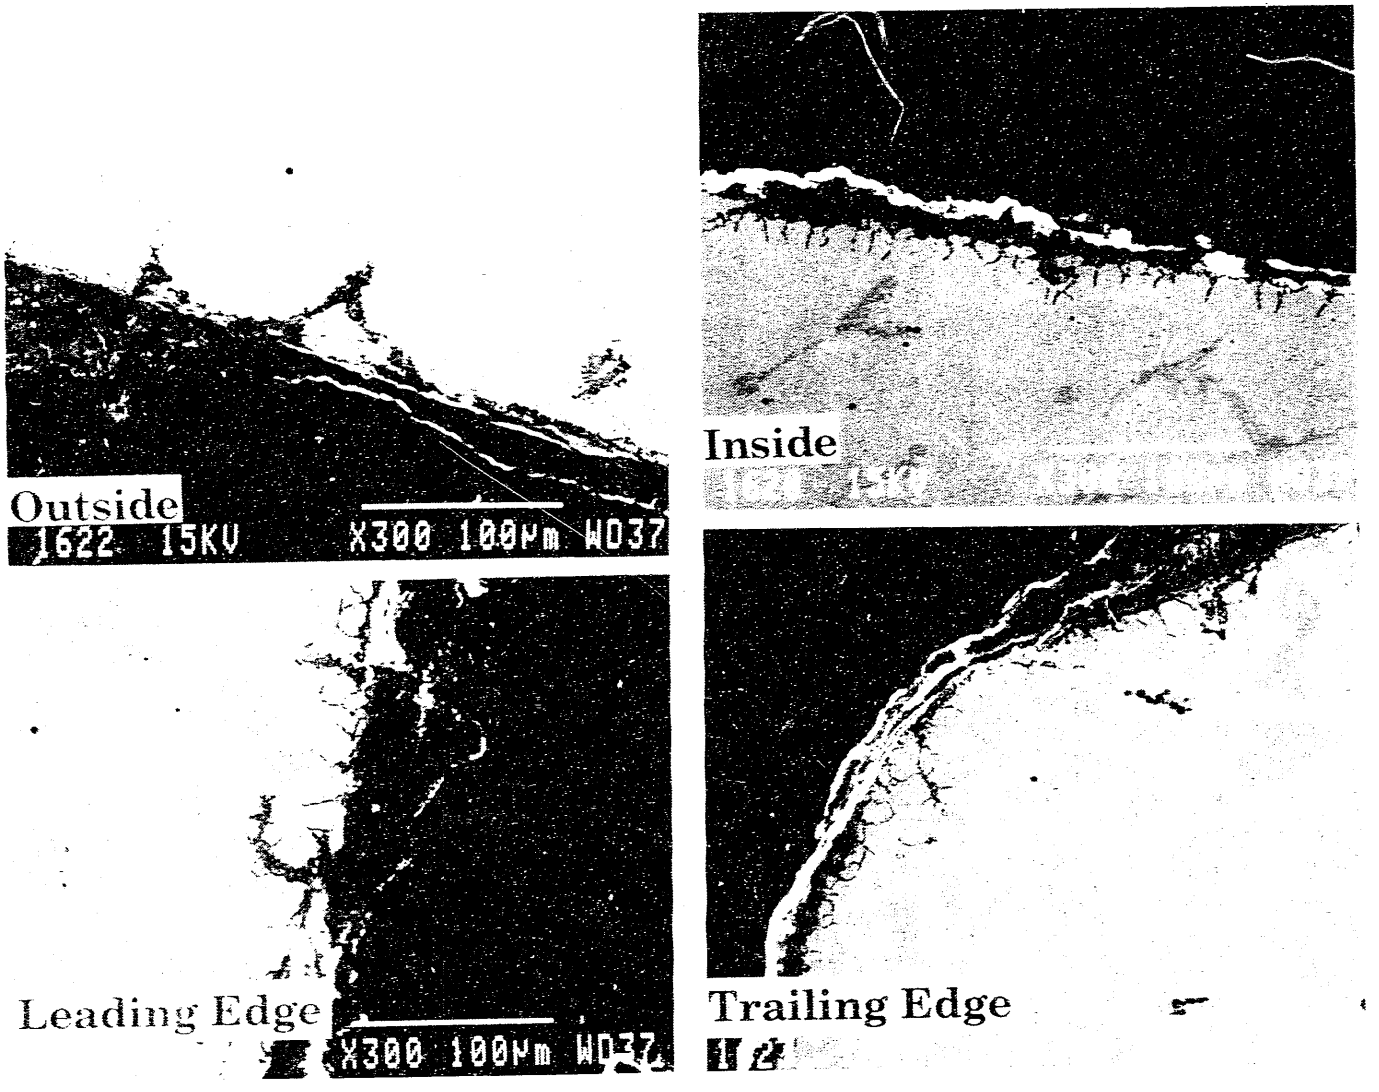
SEM Micrographs of HK 40 after 1000 h Exposure

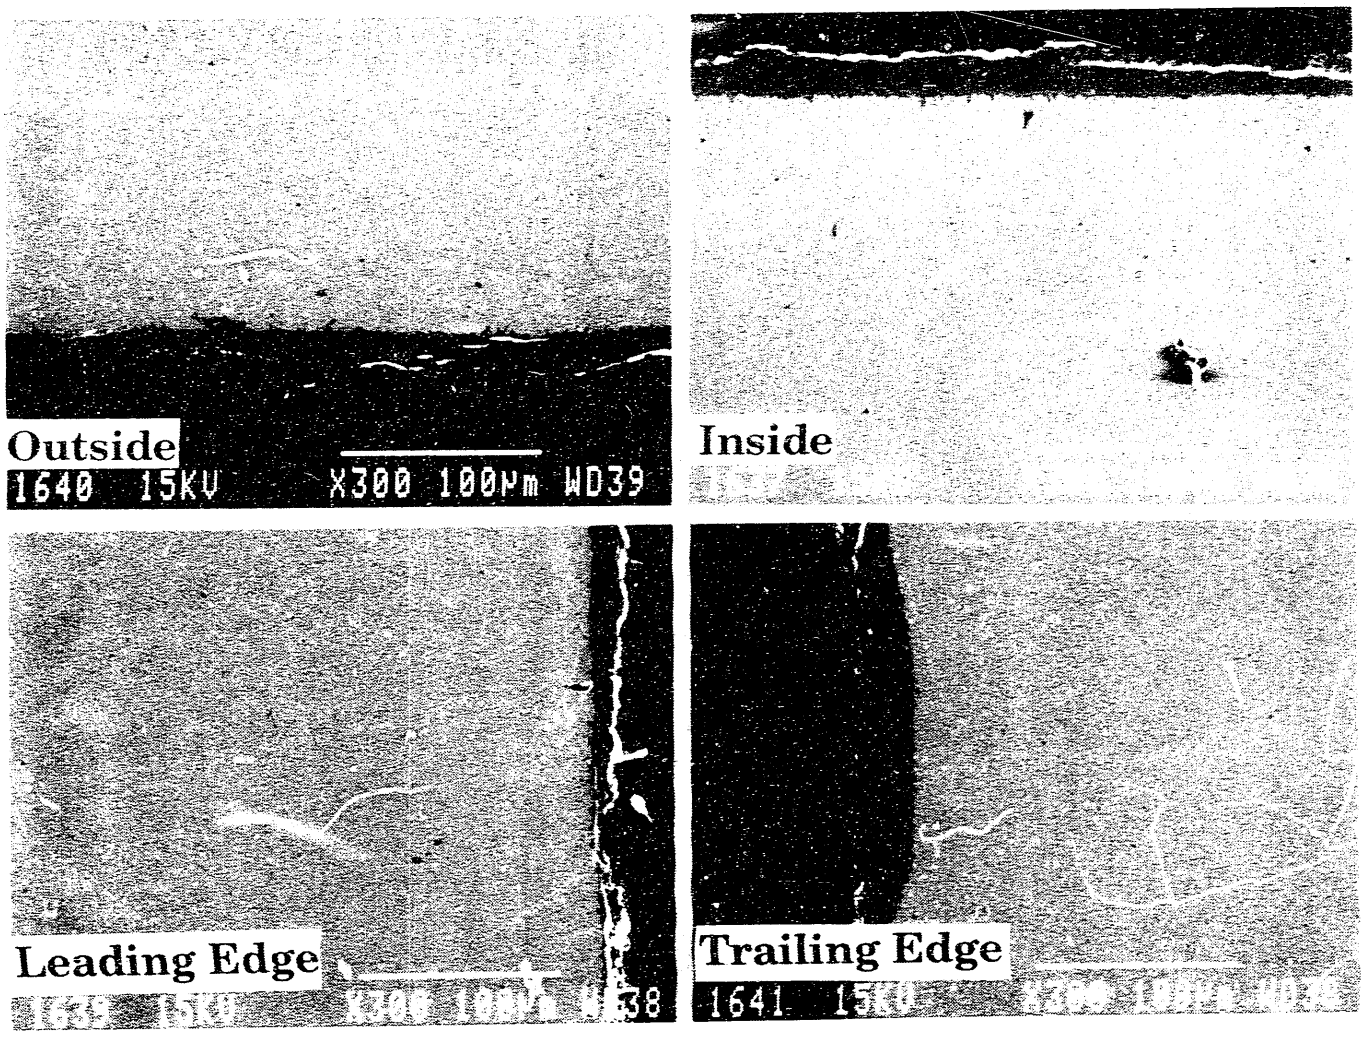
SEM Micrographs of XM 19 after 1000 h Exposure

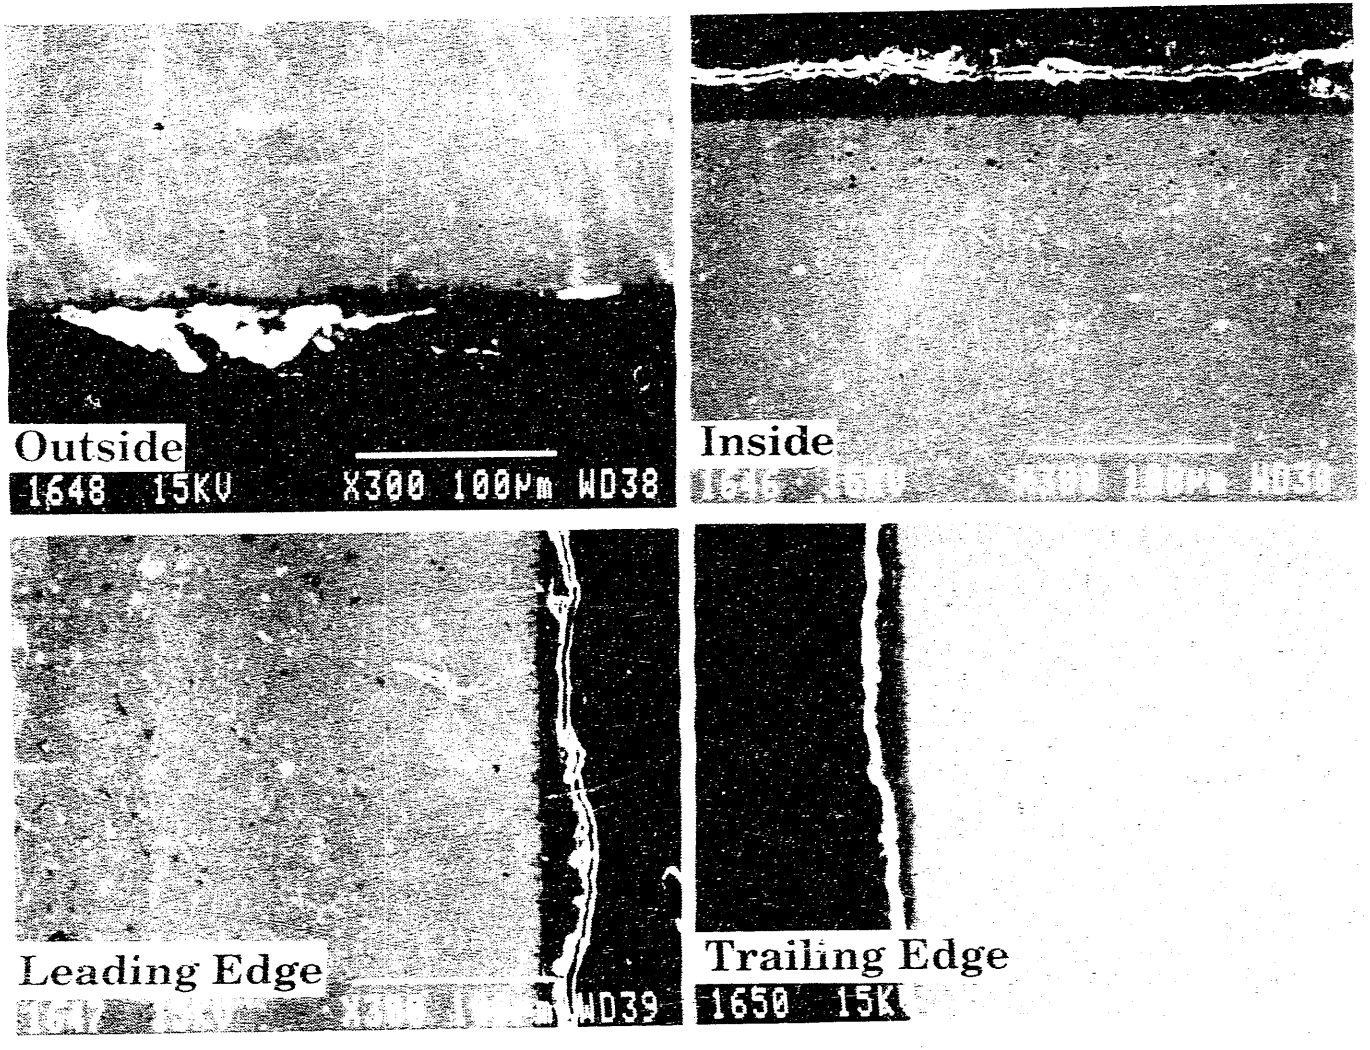
SANICRO 33

SEM Micrographs of Sanicro 33 after 1000 h Exposure

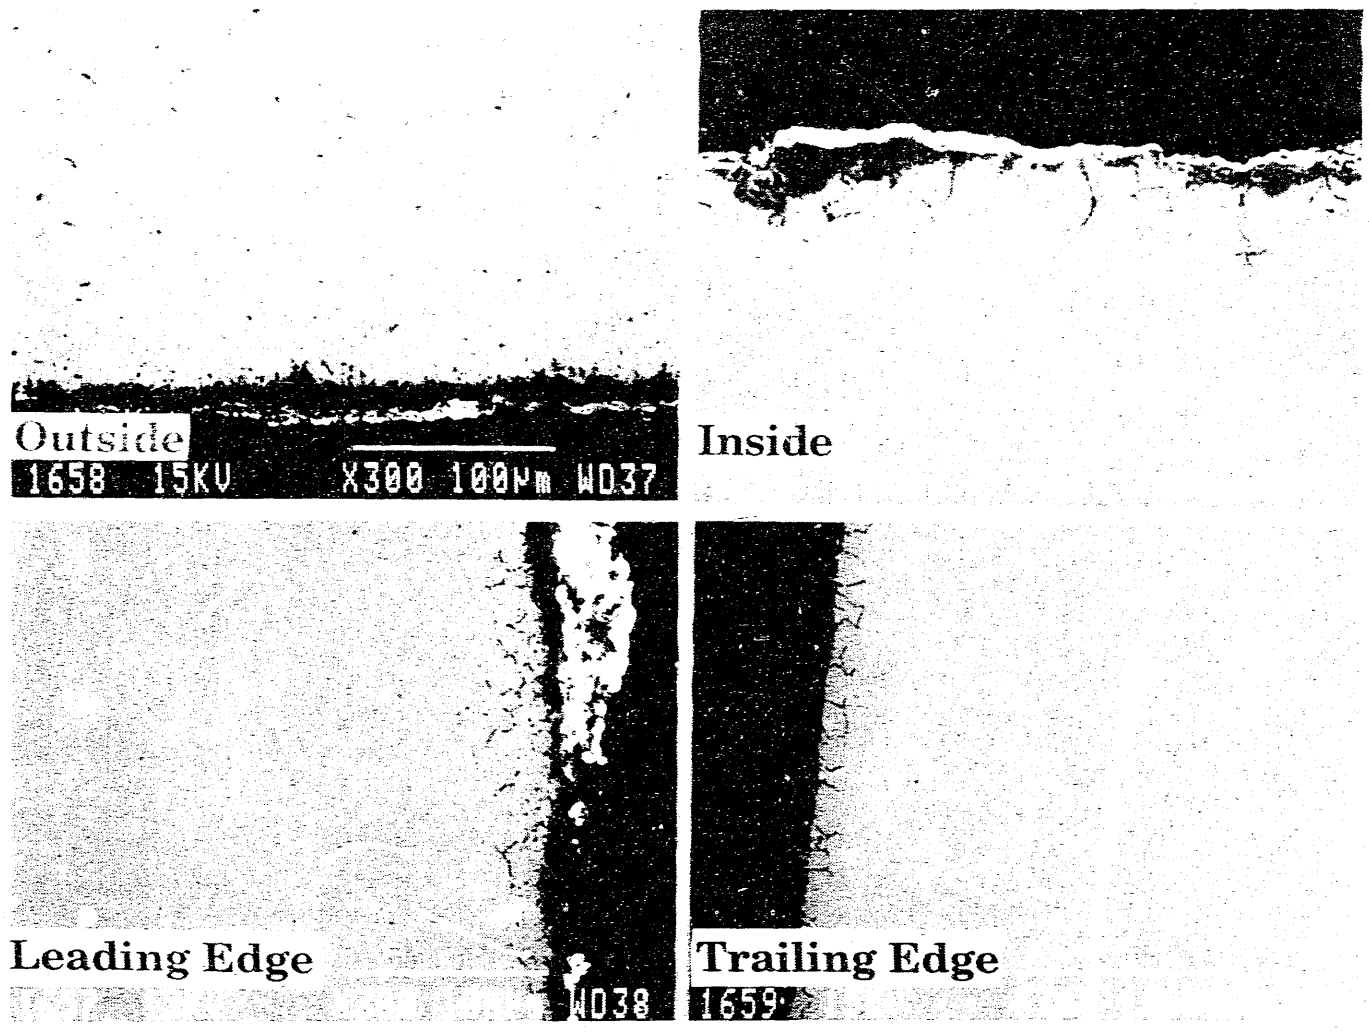
304/310

SEM Micrographs of 310-Clad 304 Stainless Steel after
1000 h Exposure Near the Center of the Bed

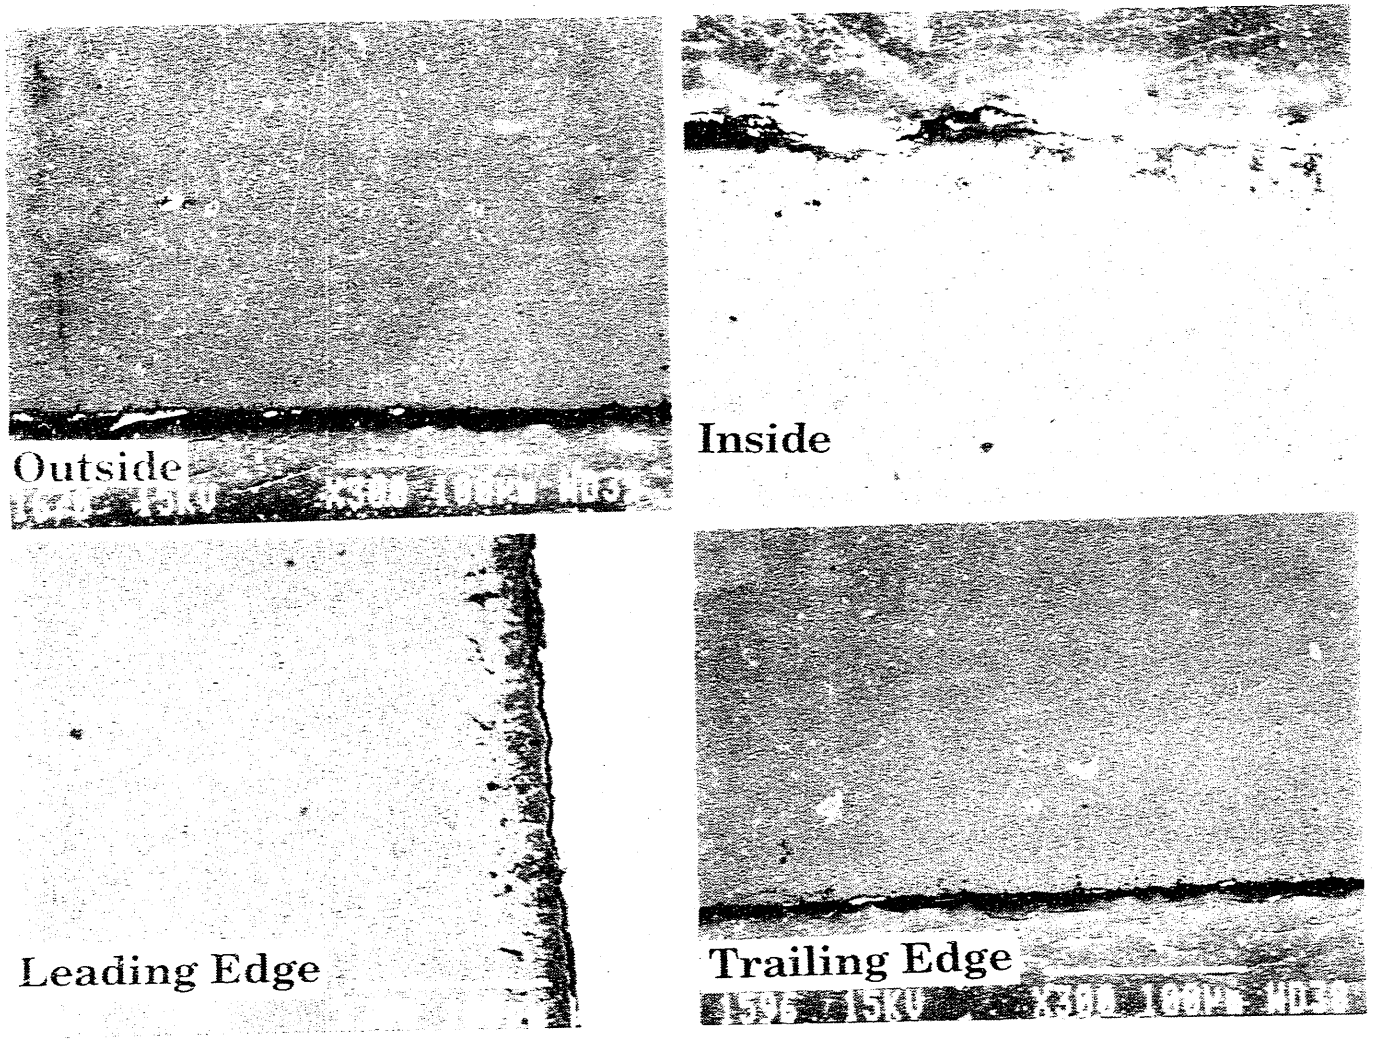
800H/310

SEM Micrographs of 310-Clad 800H after 1000 h Exposure

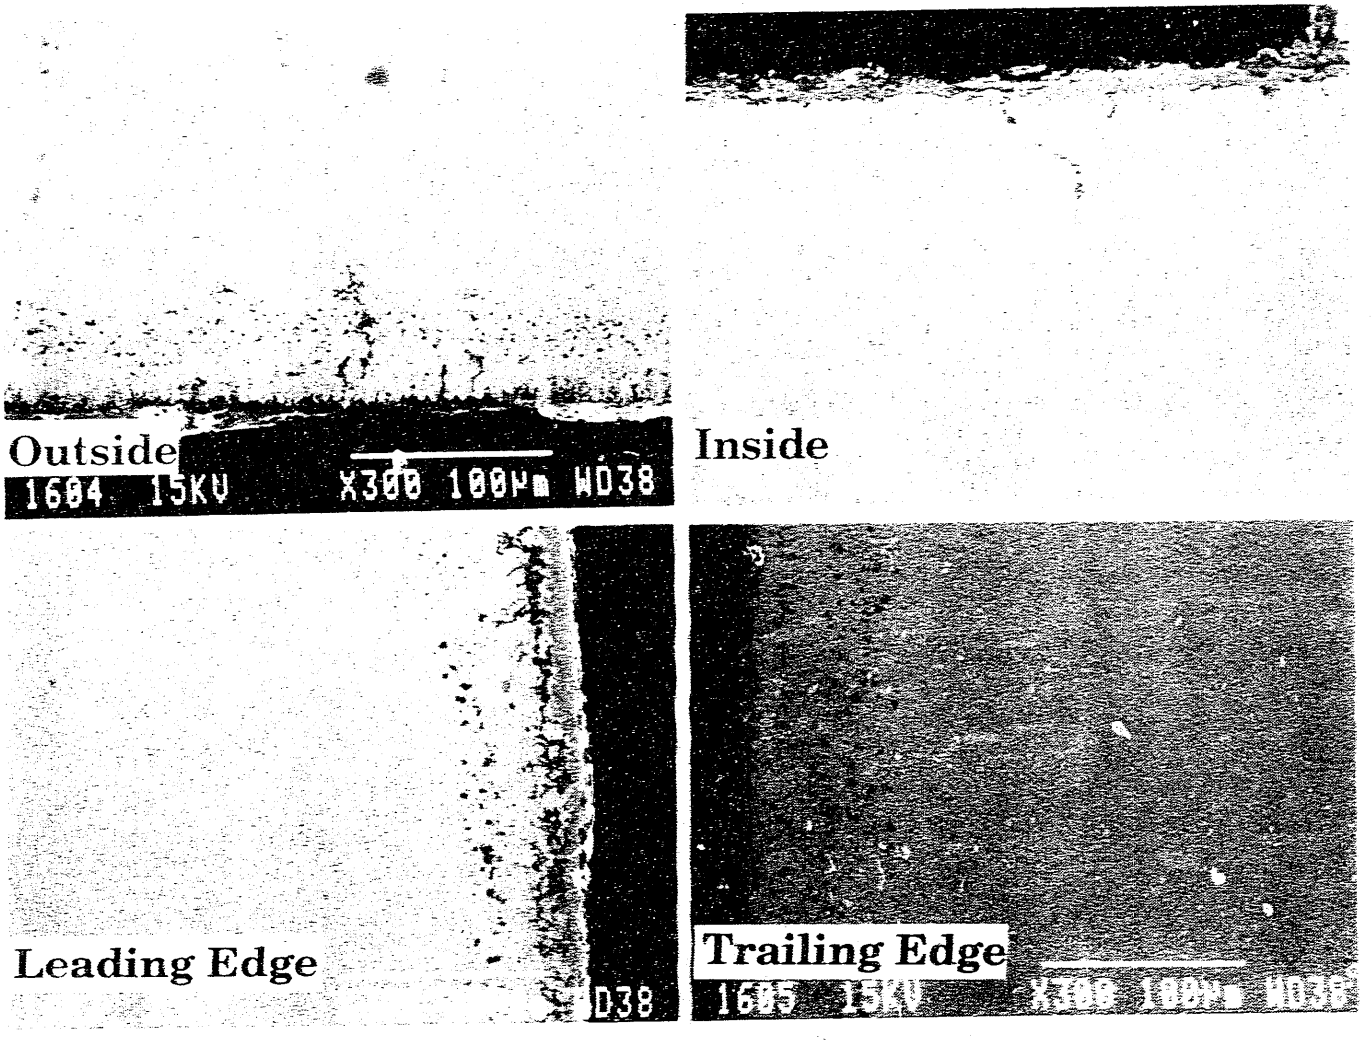
800H/8XX

SEM Micrographs of 8XX-Clad 800H after 1000 h Exposure

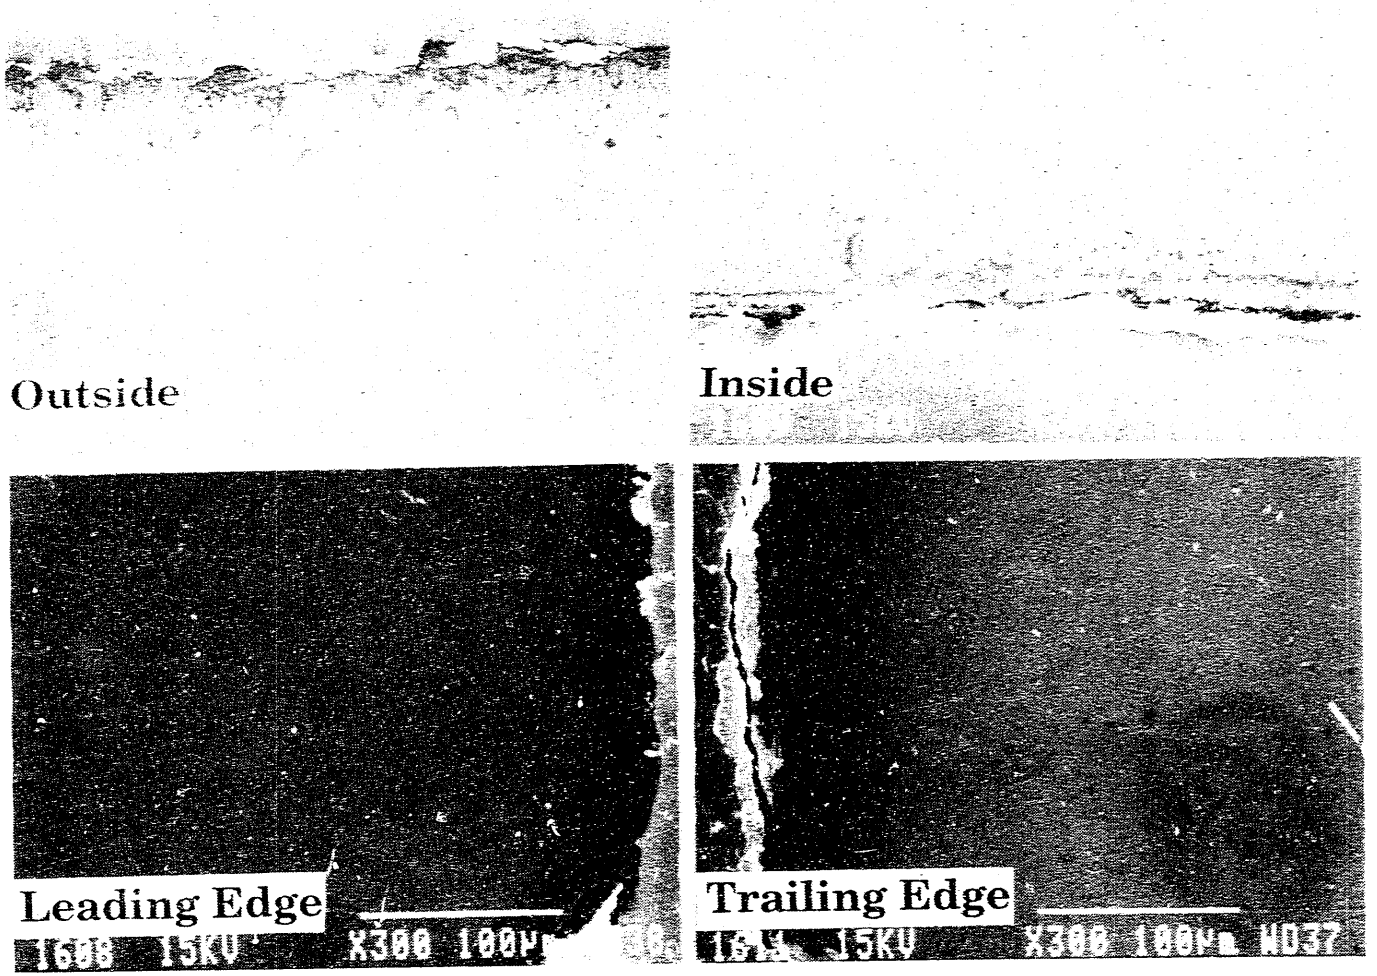
SEM Micrographs of 8XX after 1000 h Exposure

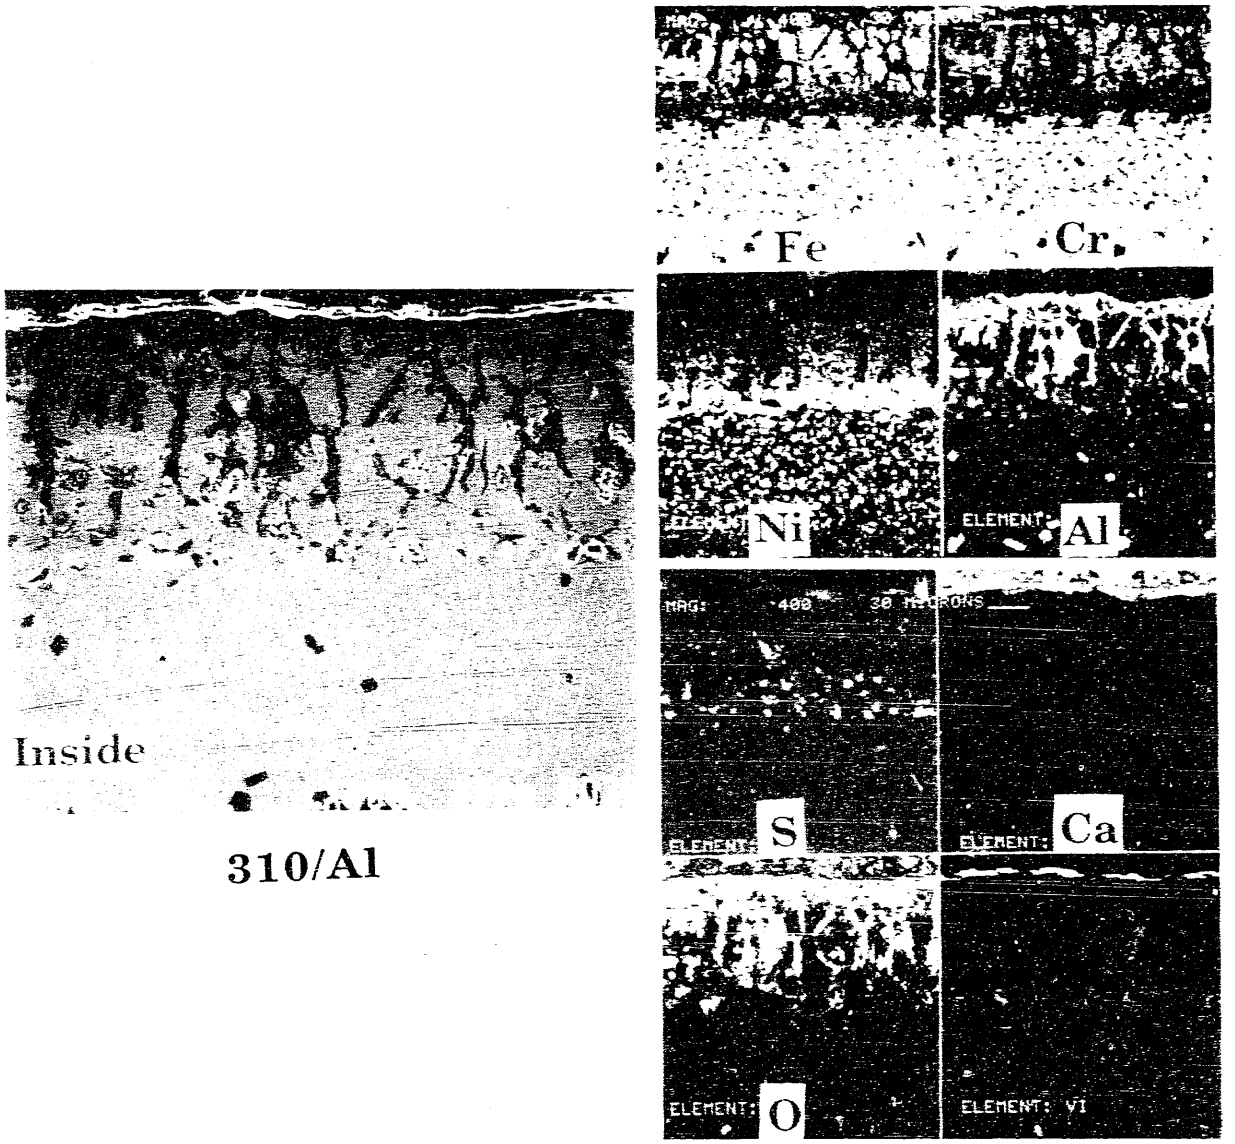
SEM Micrographs and X-ray Mapping of Aluminized 310 Stainless Steel after 1980 h Exposure

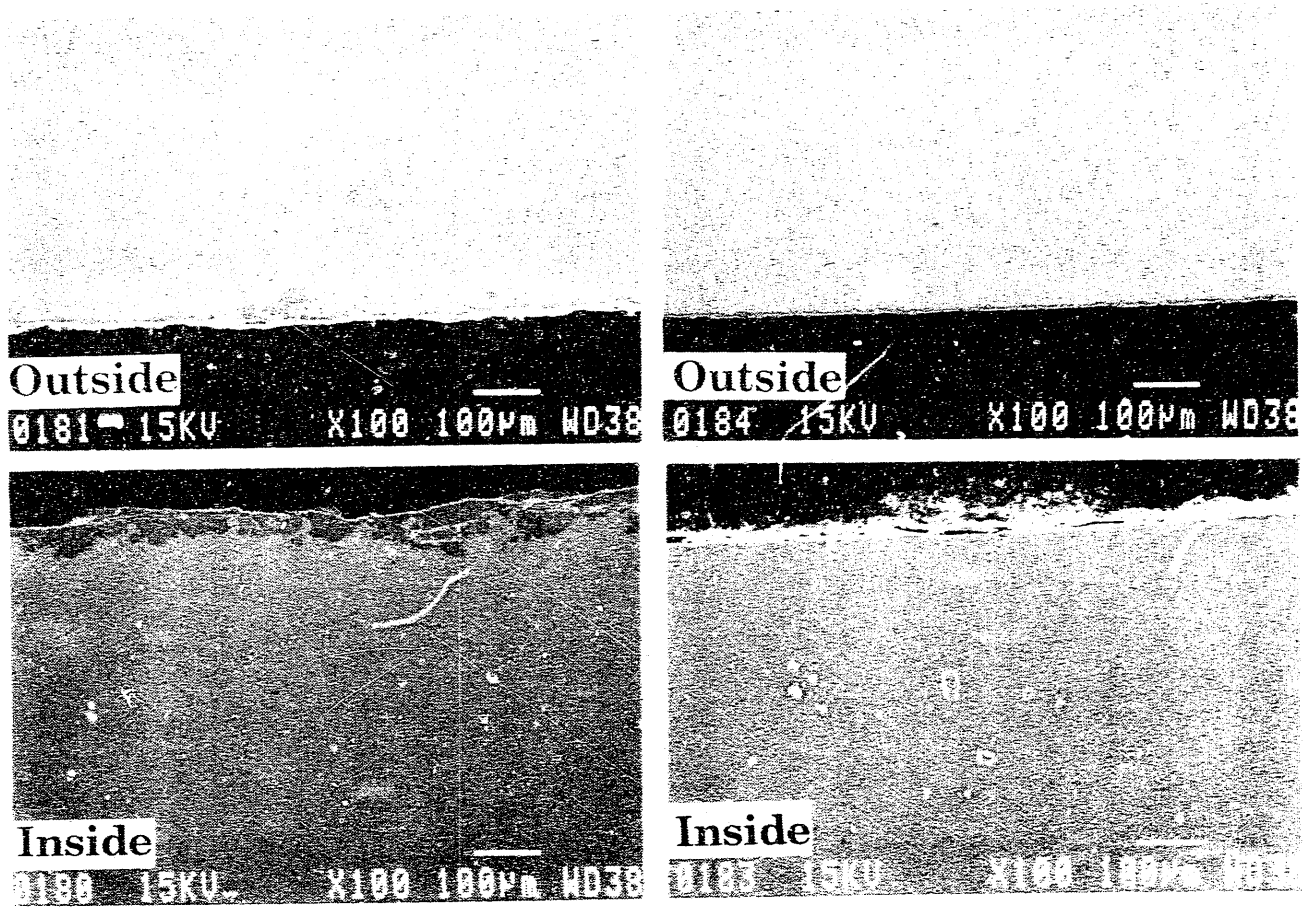
304H SS **310 SS**

SEM Micrographs of 304 and 310 Stainless Steel after 1980 h Exposure

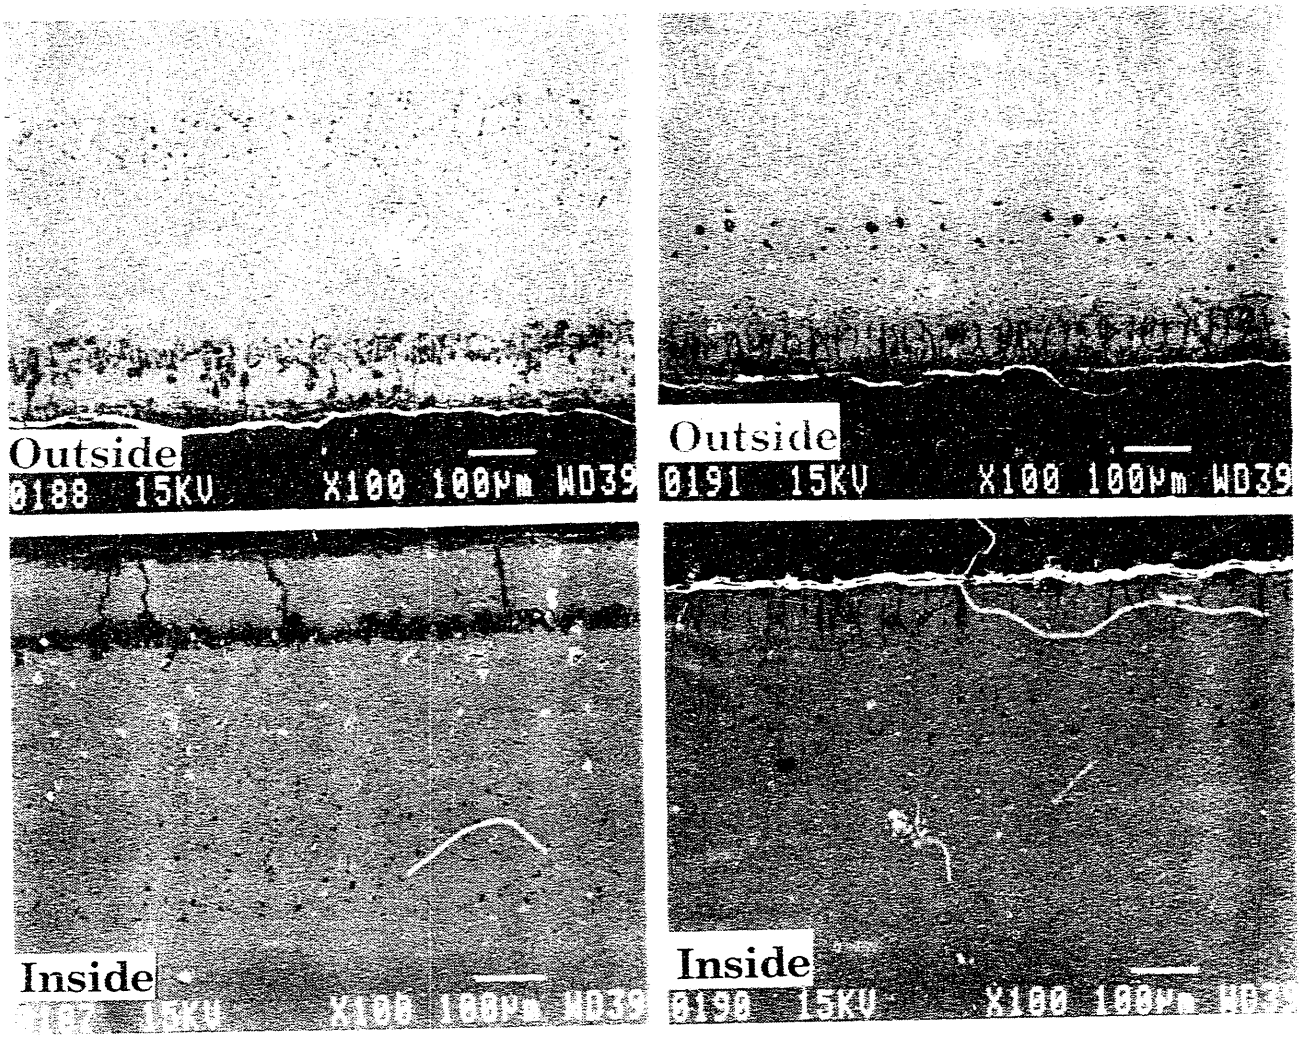
304H/Al **310/Al**

SEM Micrographs of Aluminized 304 and 310 Stainless Steels after 1980 h Exposure

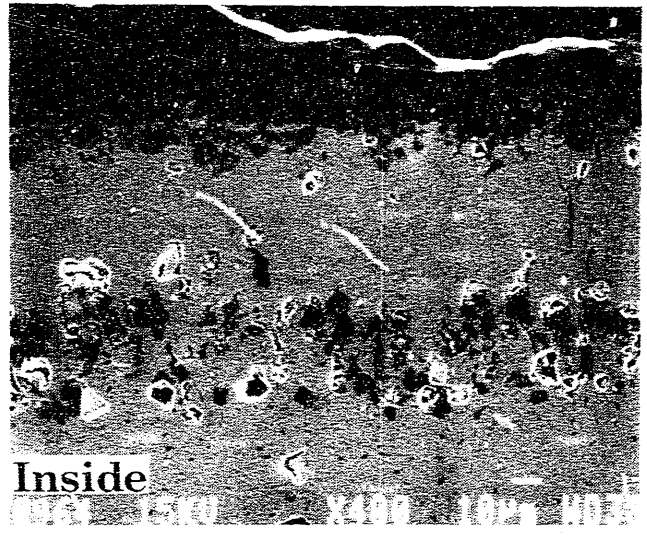
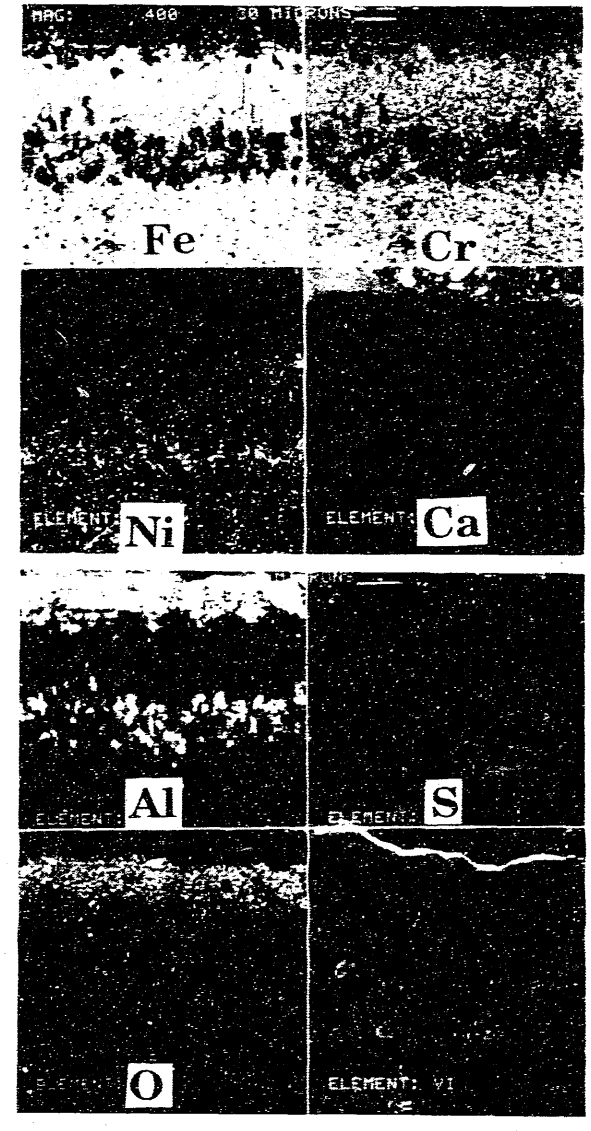
304H/Al

SEM Micrograph and X-ray Mapping of Aluminized 304 Stainless Steel after 1980 h Exposure
