Materials Performance in the Atmospheric Fluidized-bed Cogeneration Air Heater Experiment

ANL-91/4

MATERIALS PERFORMANCE IN THE ATMOSPHERIC FLUIDIZED-BED COGENERATION AIR HEATER EXPERIMENT

February 1991

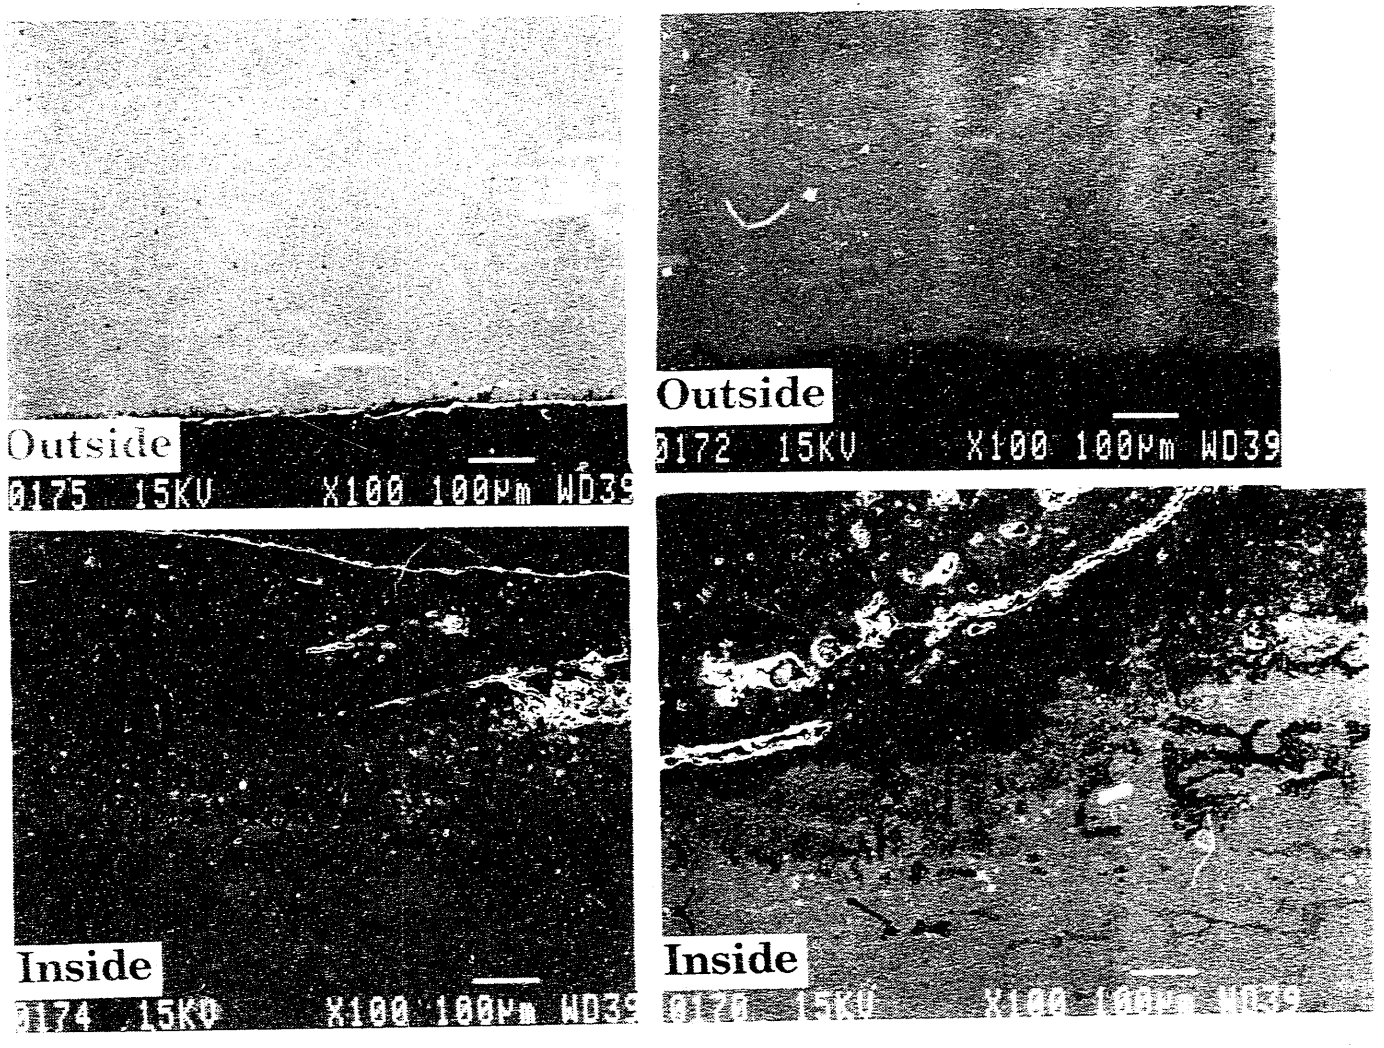
HH **HP 50**

SEM Micrographs of HH and HP 50 after 1980 h Exposure

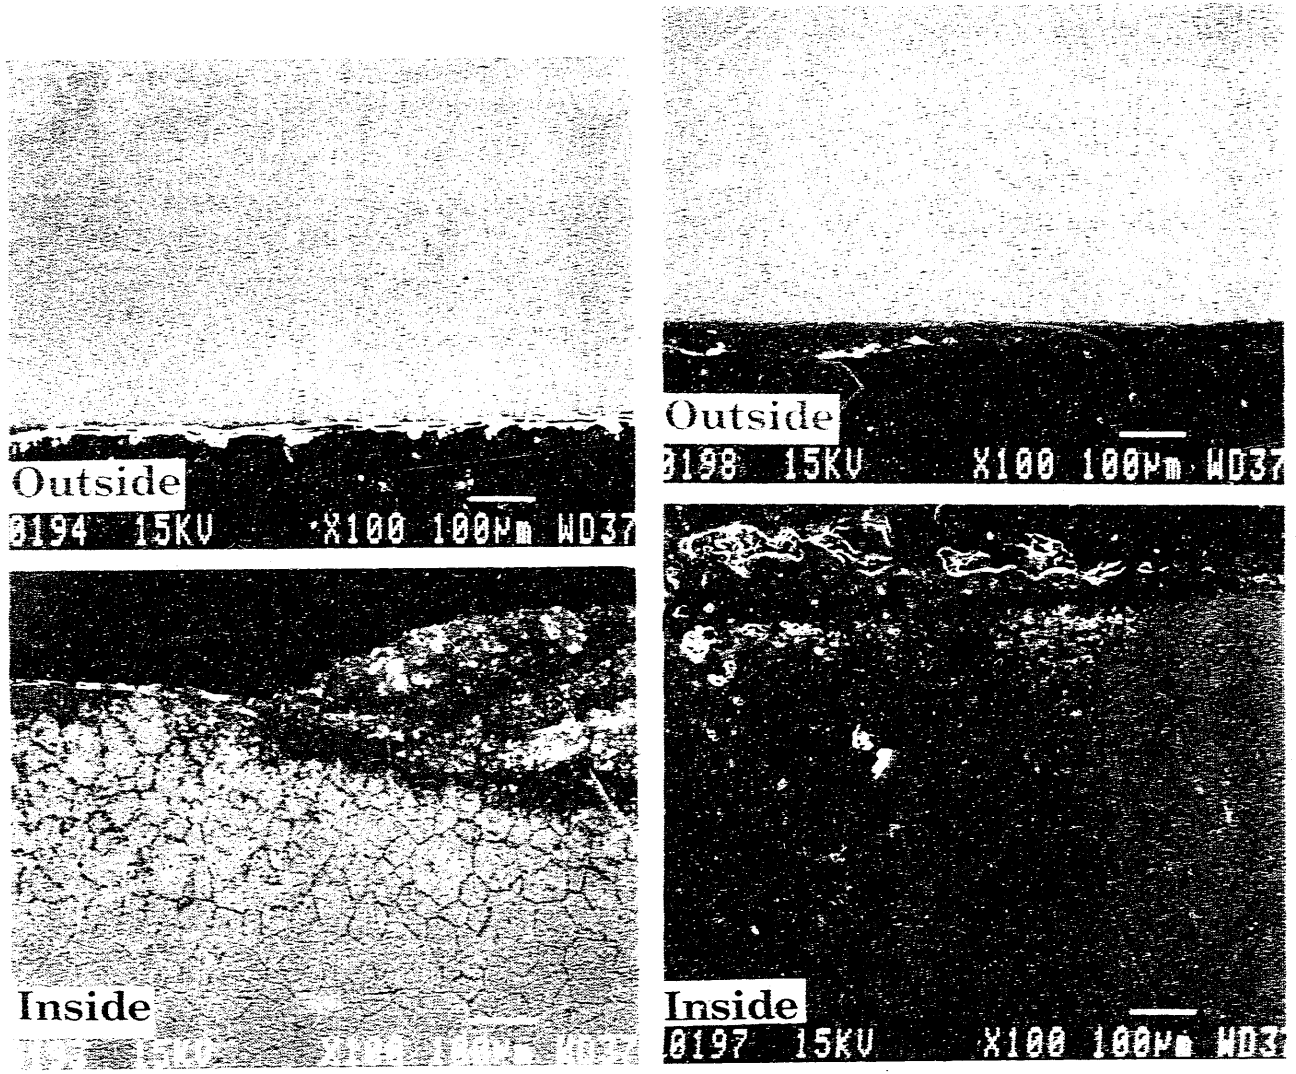
304/310 **800H/310**

SEM Micrographs of 310-Clad Alloys after 1980 h Exposure Near the Bed Walls

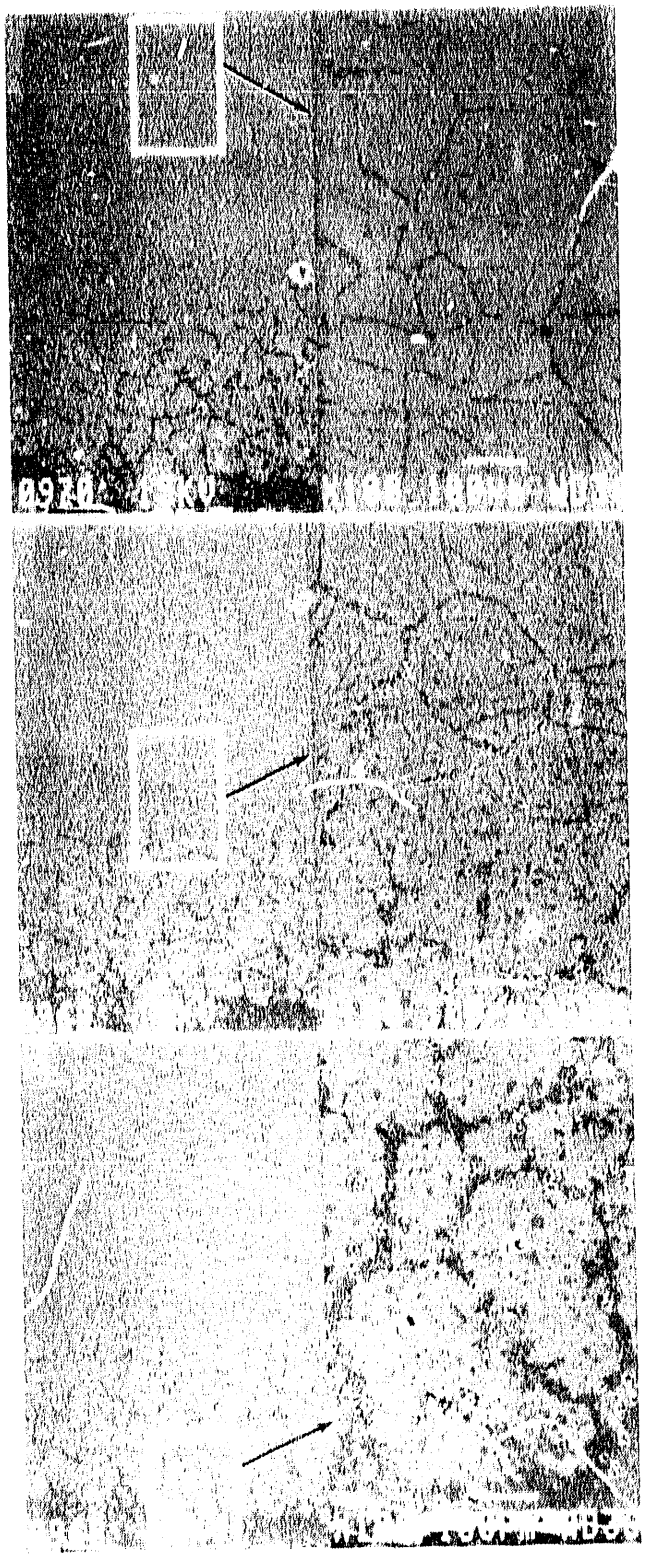
304/310

SEM Micrographs of Different Regions of 310-Clad
304 Stainless Steel after 1980 h Exposure

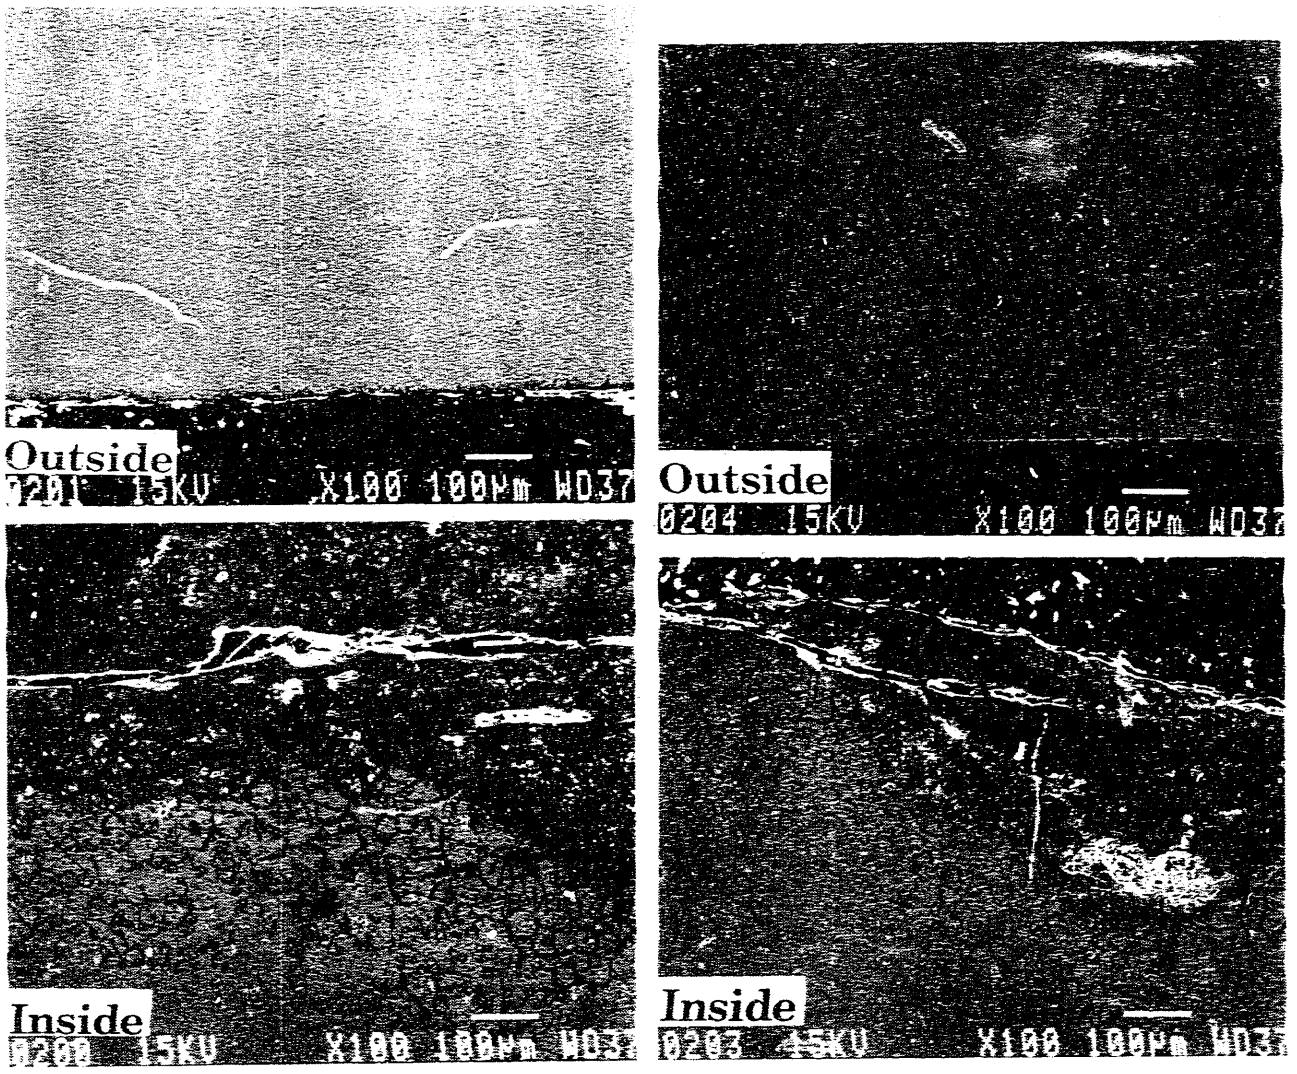
253 MA **HS 188**

SEM Micrographs of 253 MA and 188 after 1980 h Exposure

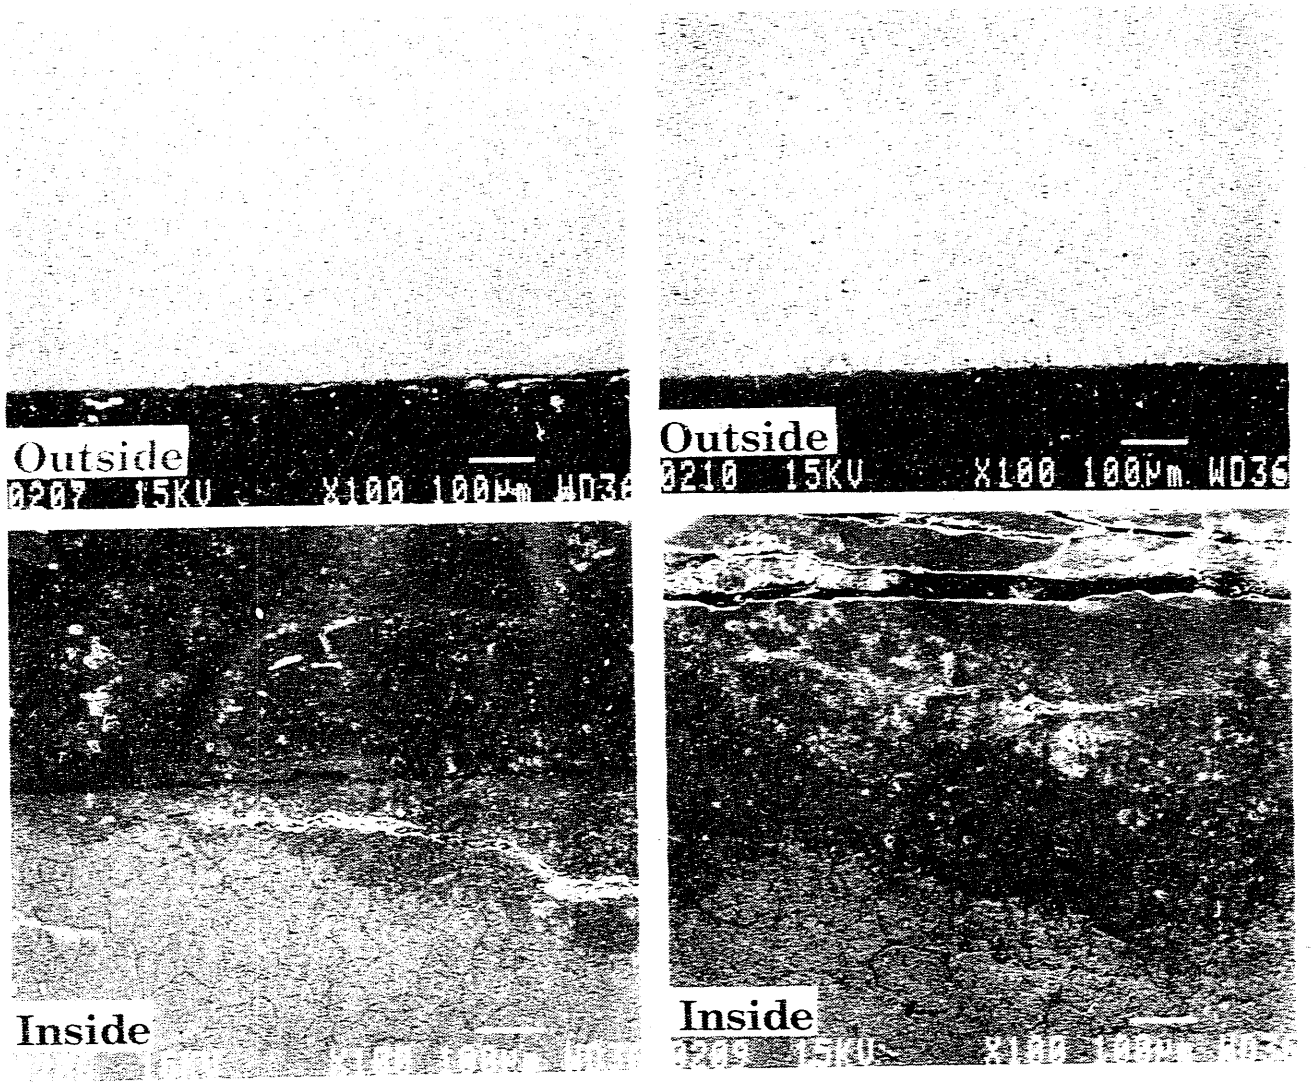
HS 556 **HK 40**

SEM Micrographs of HS 556 and HK 40 after 1980 h Exposure

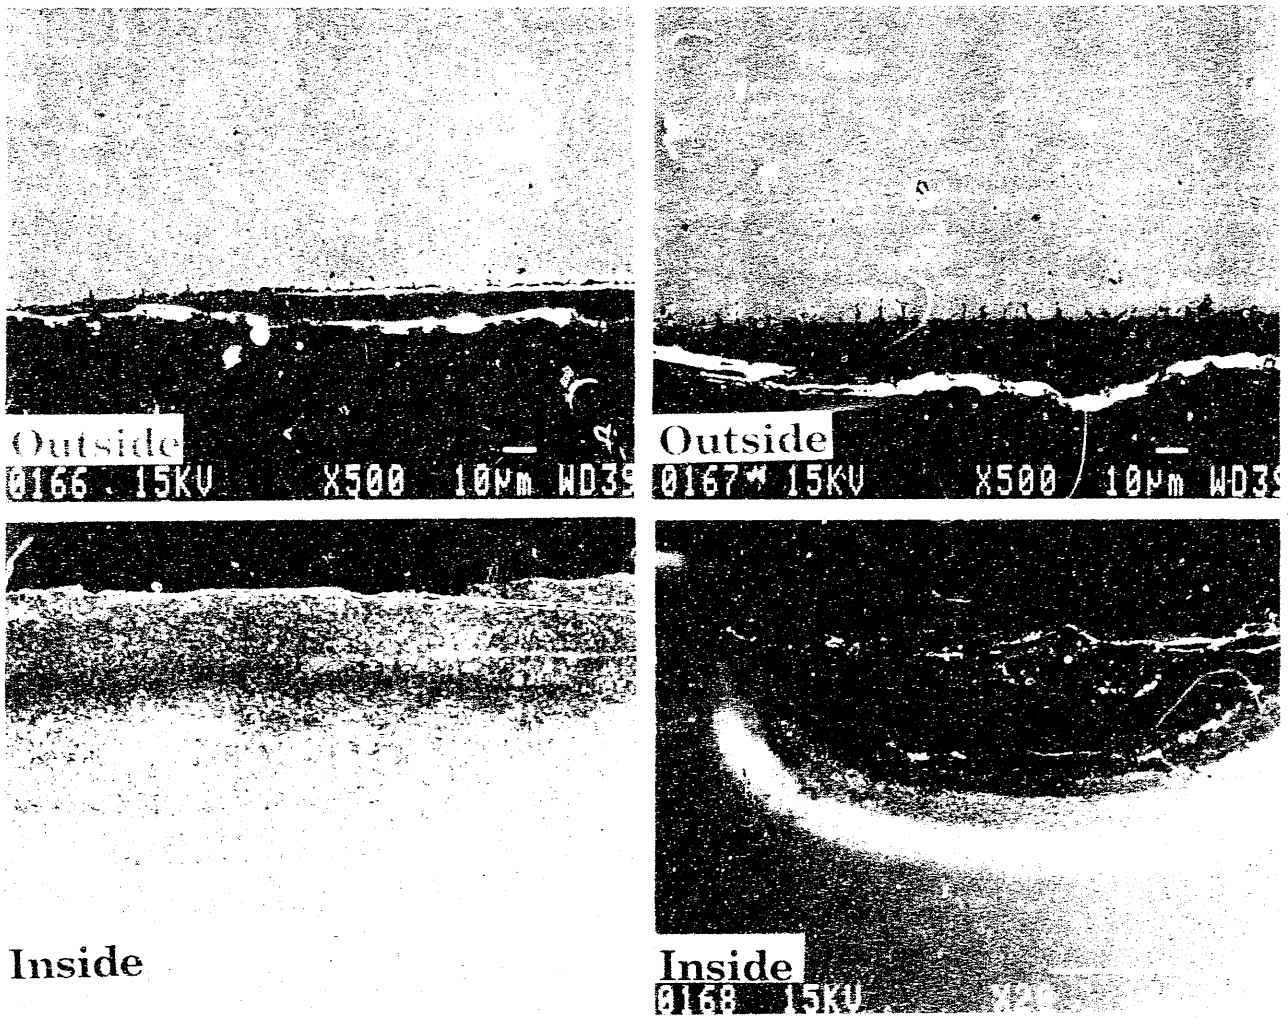
XM 19 **SANICRO 33**

SEM Micrographs of XM 19 and Sanicro 33 after 1980 h Exposure

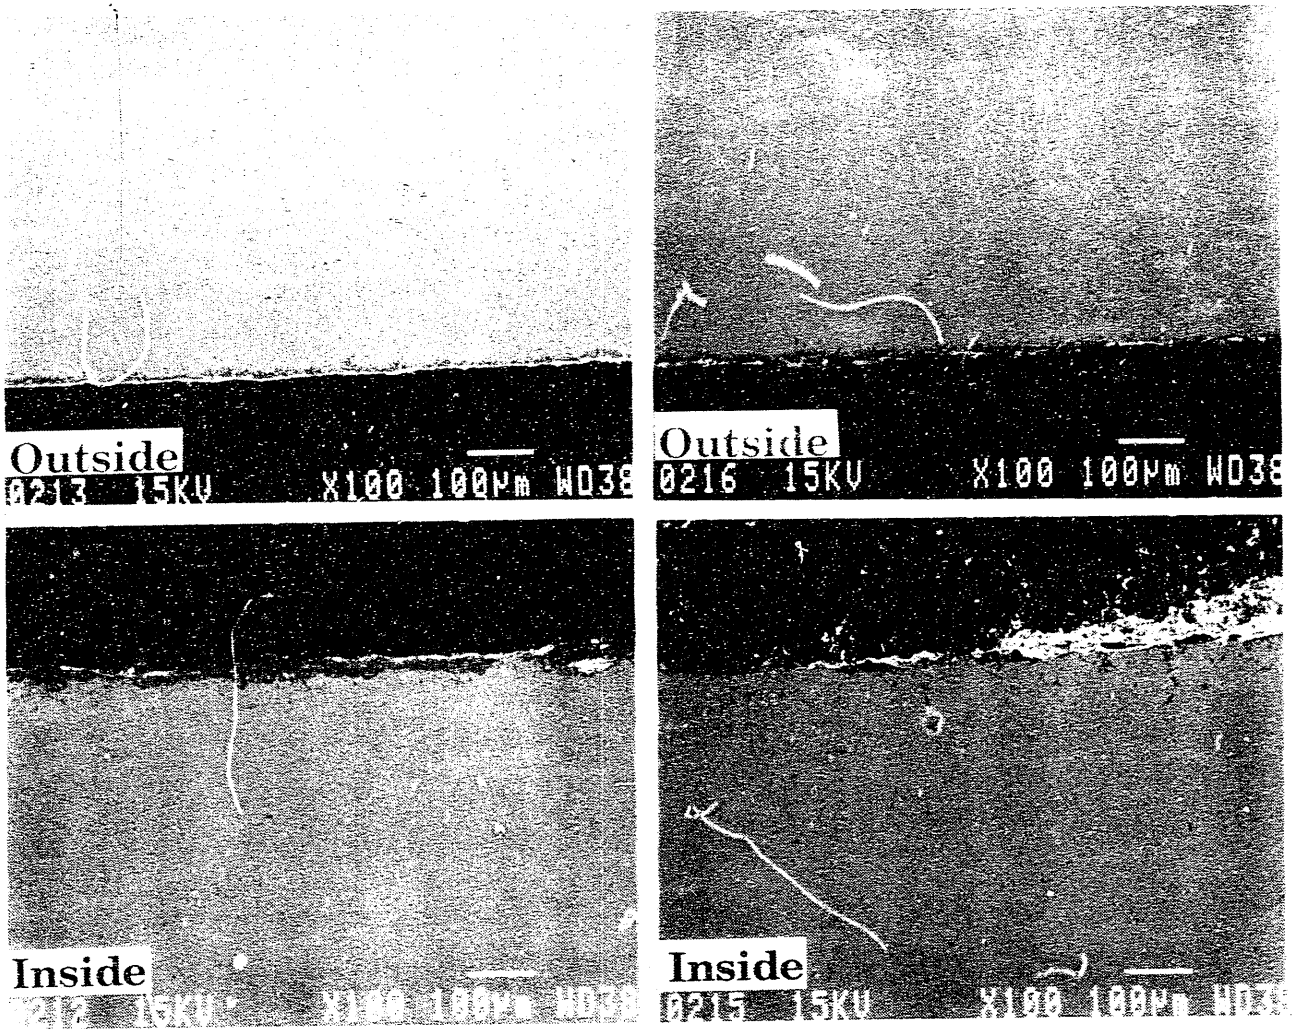
304/310 **800H/310**

SEM Micrographs of 310-Clad Alloys after 1980 h Exposure Near the Center of the Bed

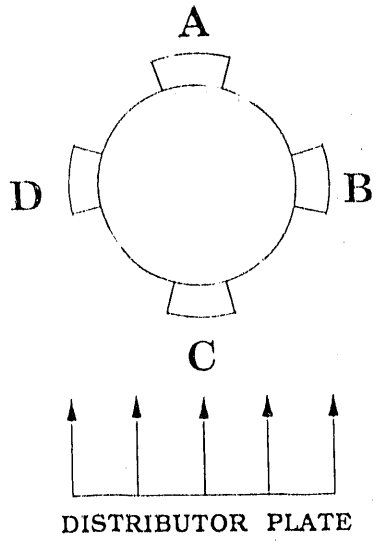
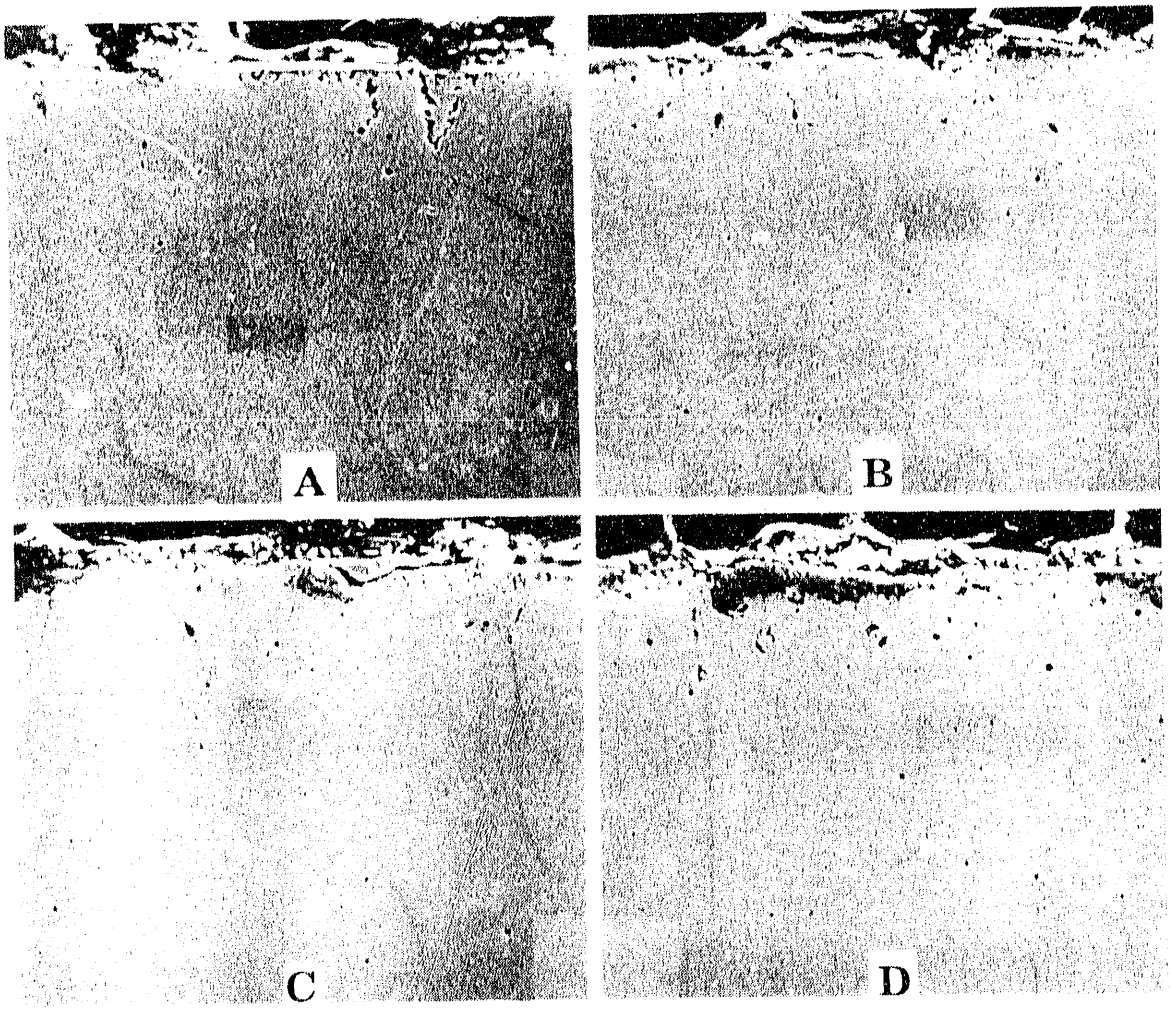
304 SS

SEM Micrographs of 304 Stainless Steel after 1980 h Exposure

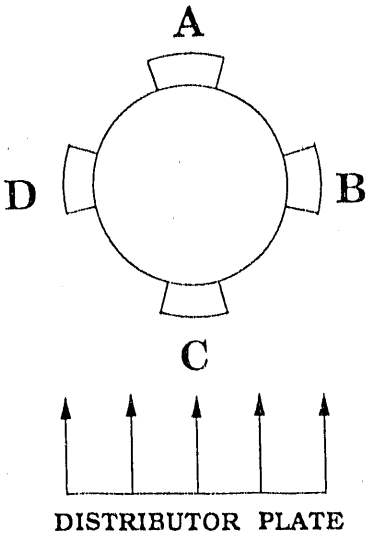
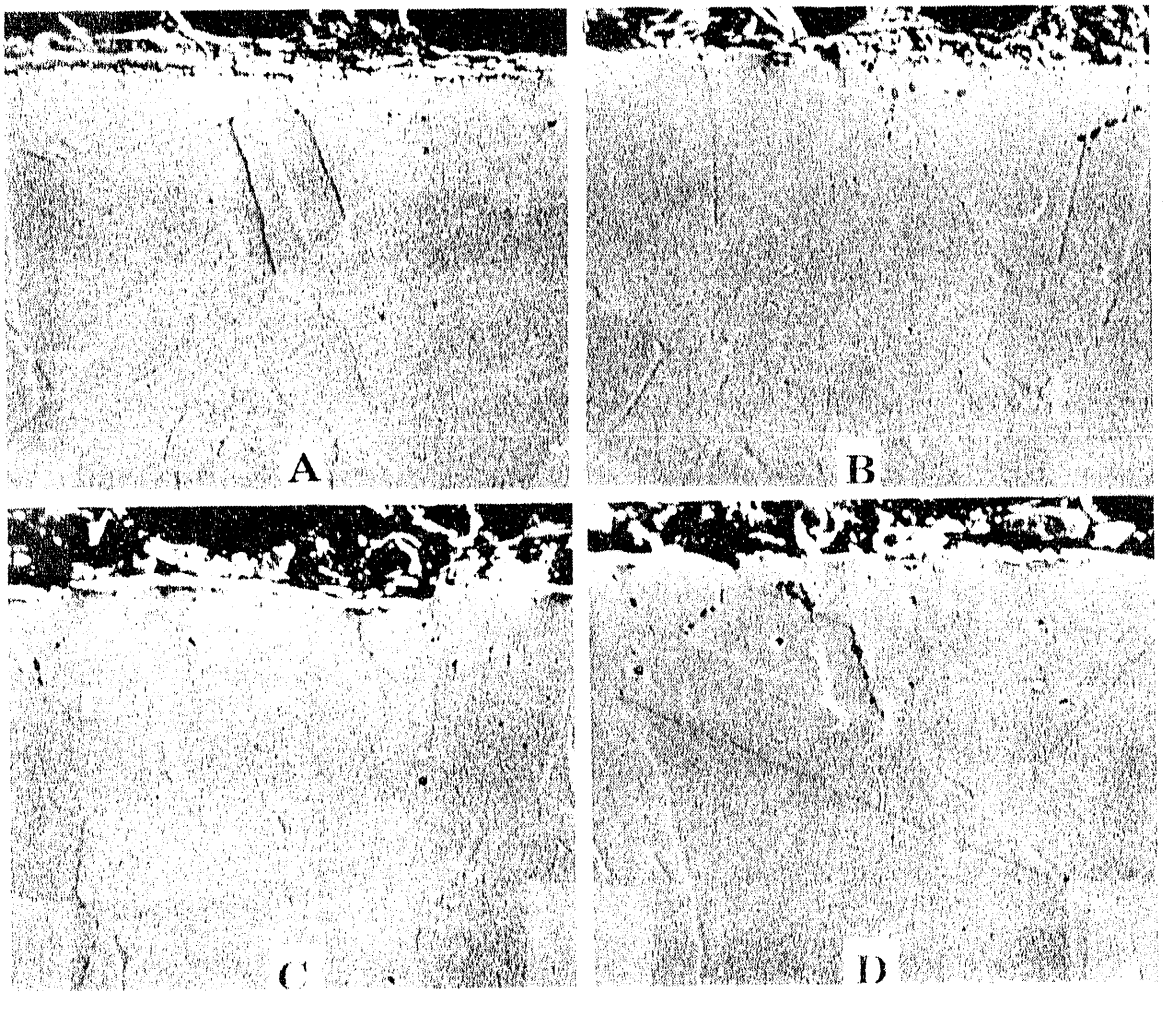
310 SS

SEM Micrographs of 310 Stainless Steel after 1980 h Exposure

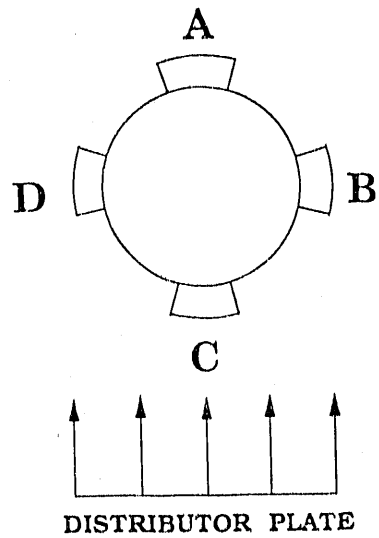
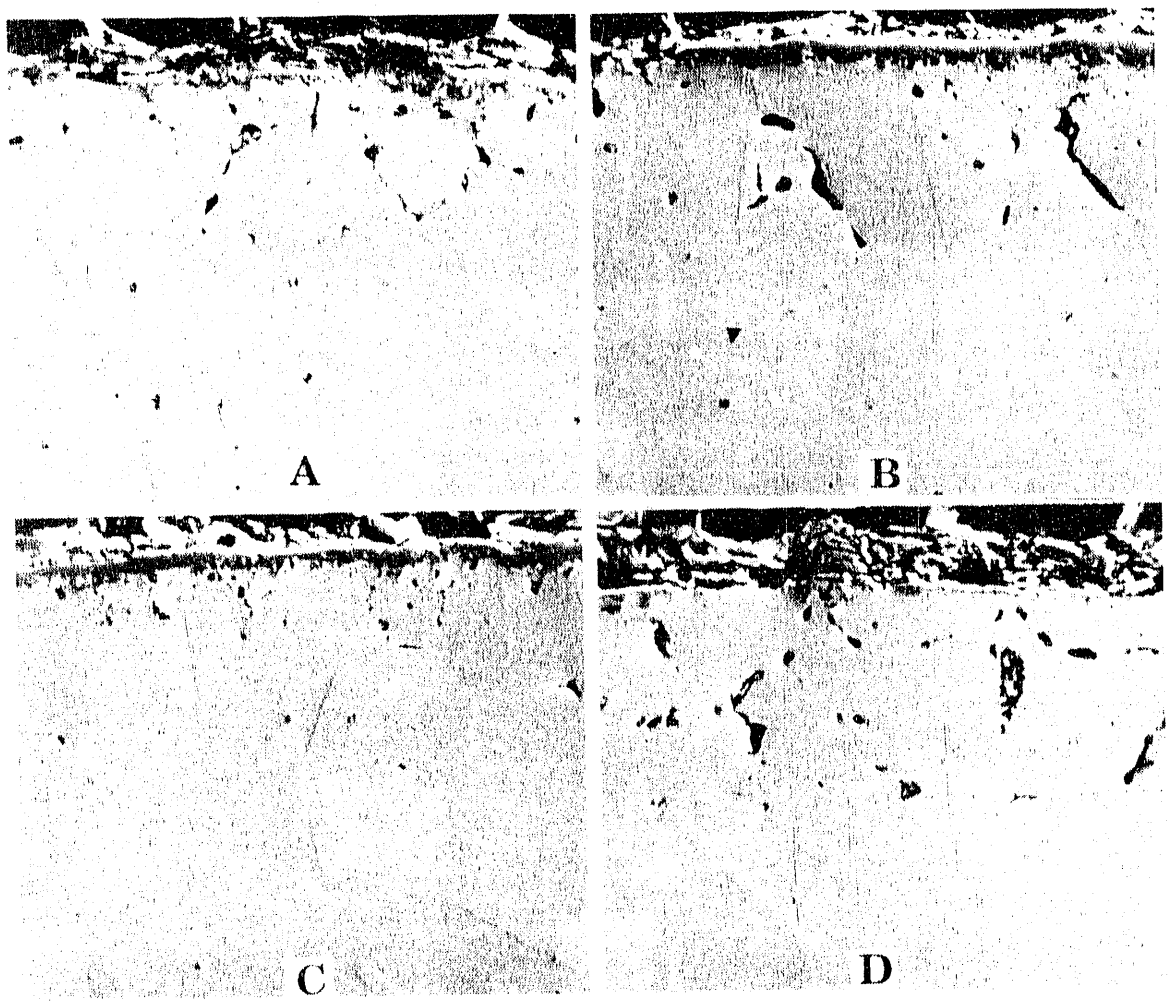
SEM Micrographs of Alloy 800 after 1980 h Exposure

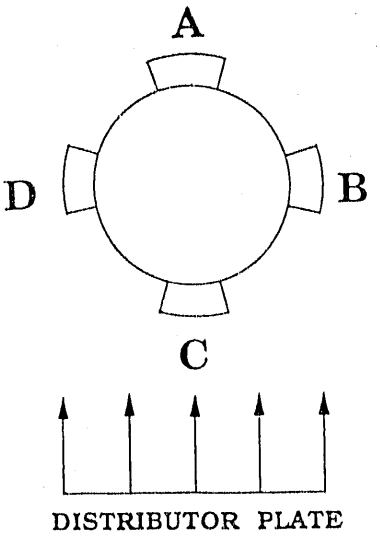
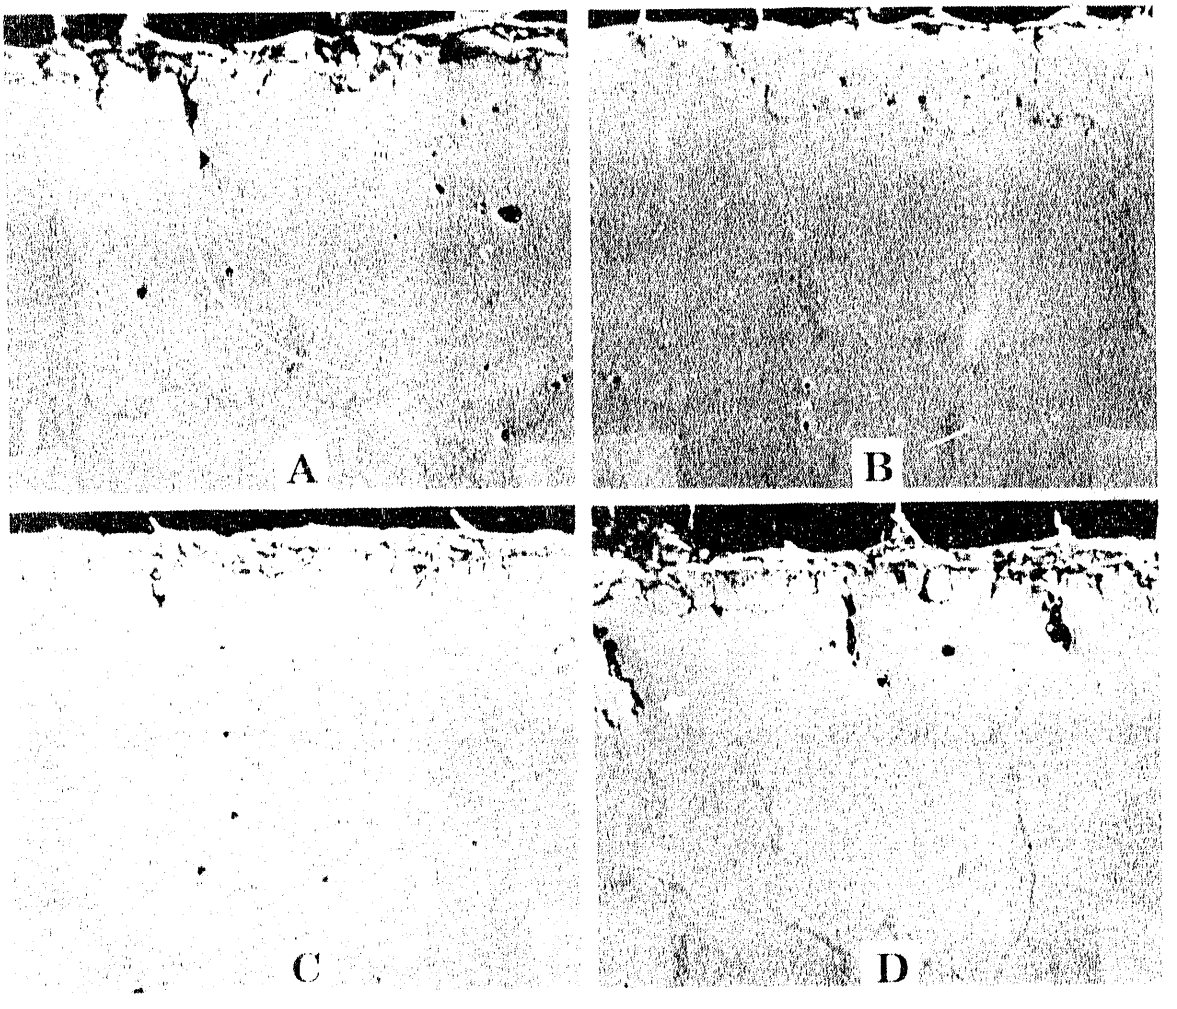
SEM Micrographs of HH after 1980 h Exposure

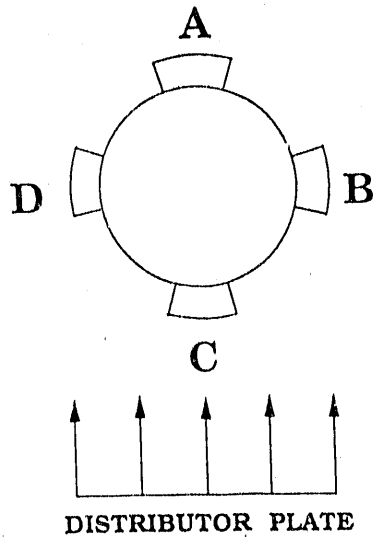
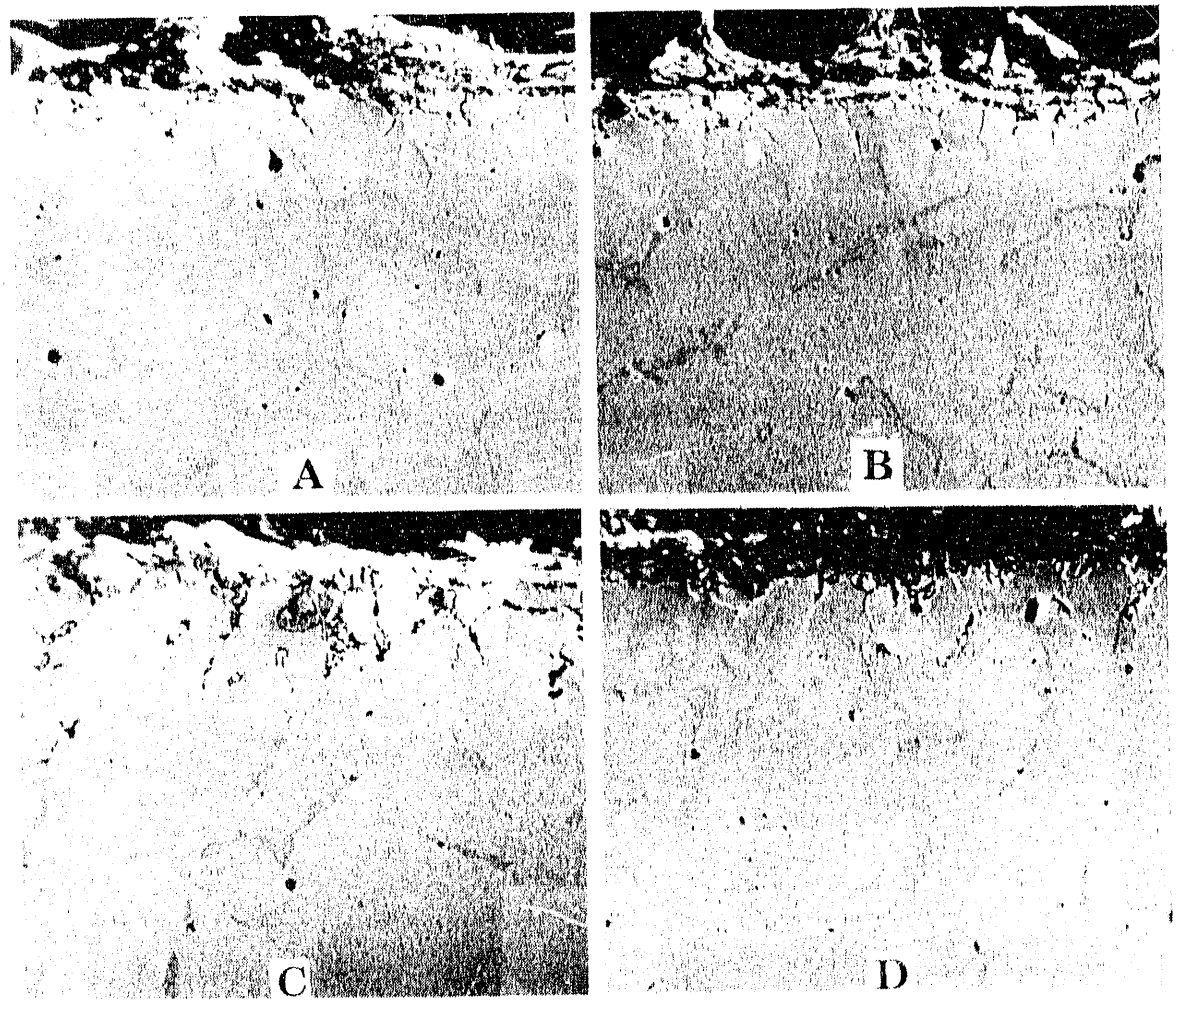
SEM Micrographs of HK 40 after 1980 h Exposure

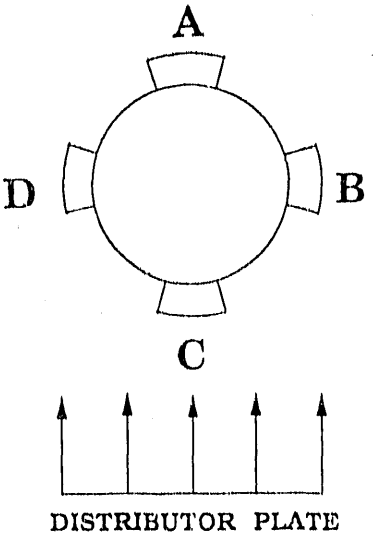
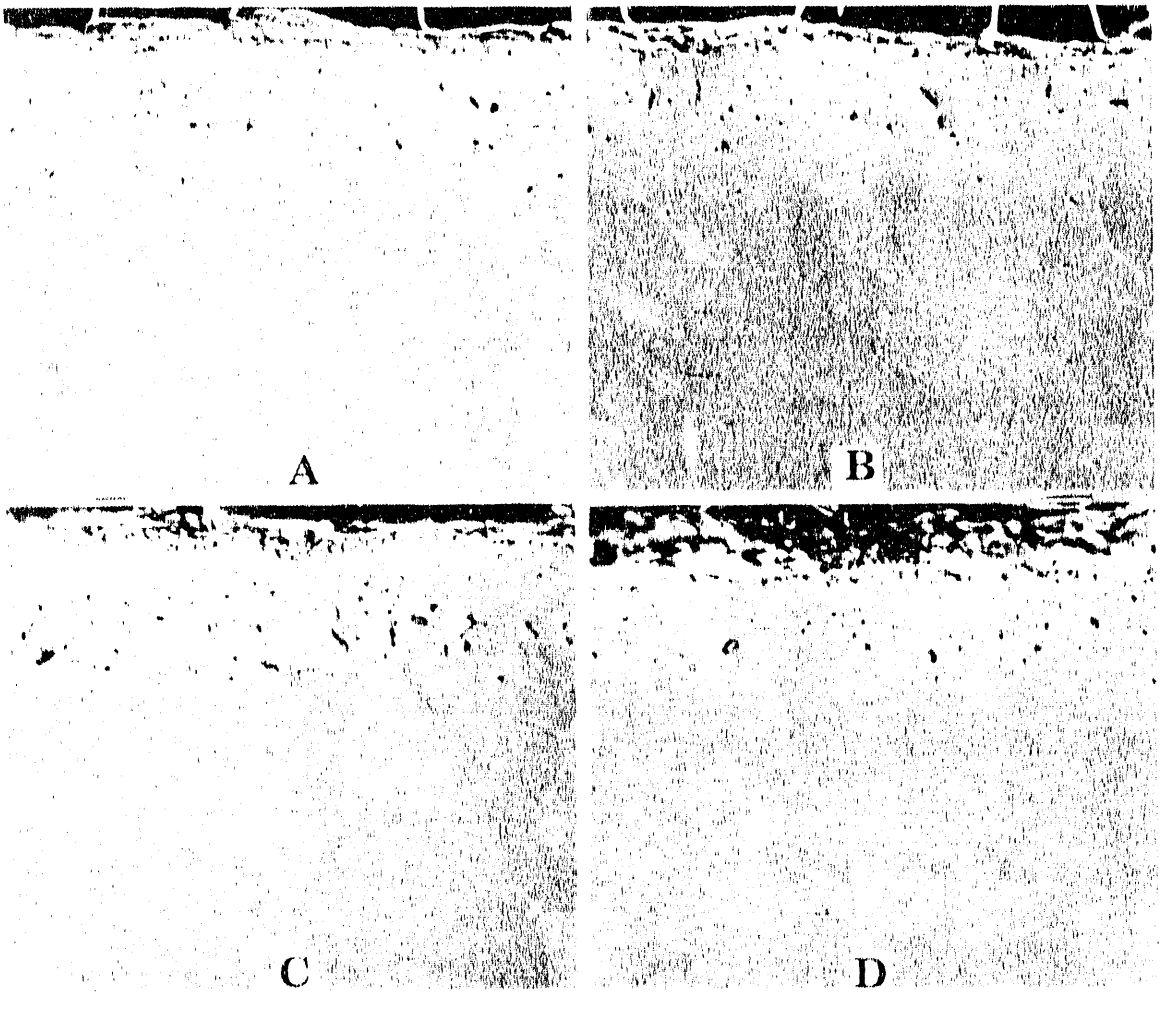
SEM Micrographs of Alloy 556 after 1980 h Exposure

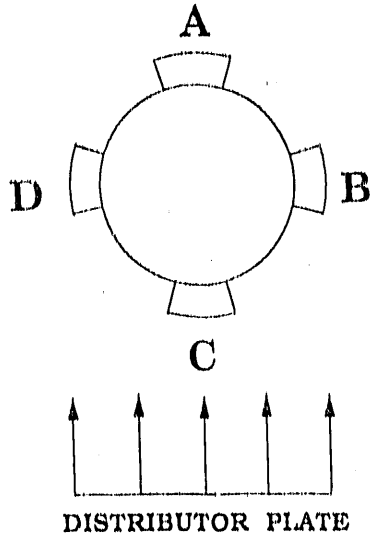
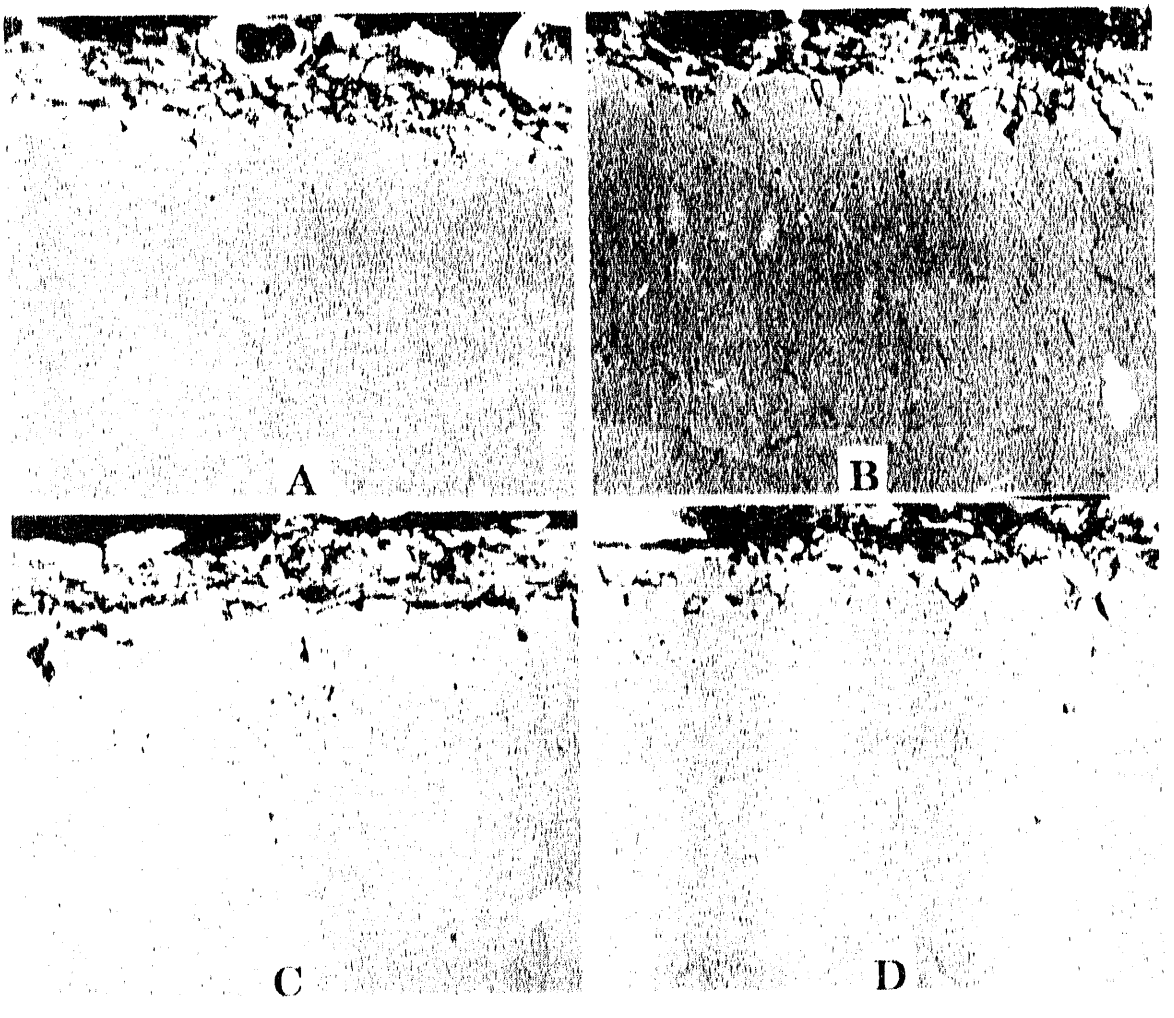
SEM Micrographs of 253 MA after 1980 h Exposure

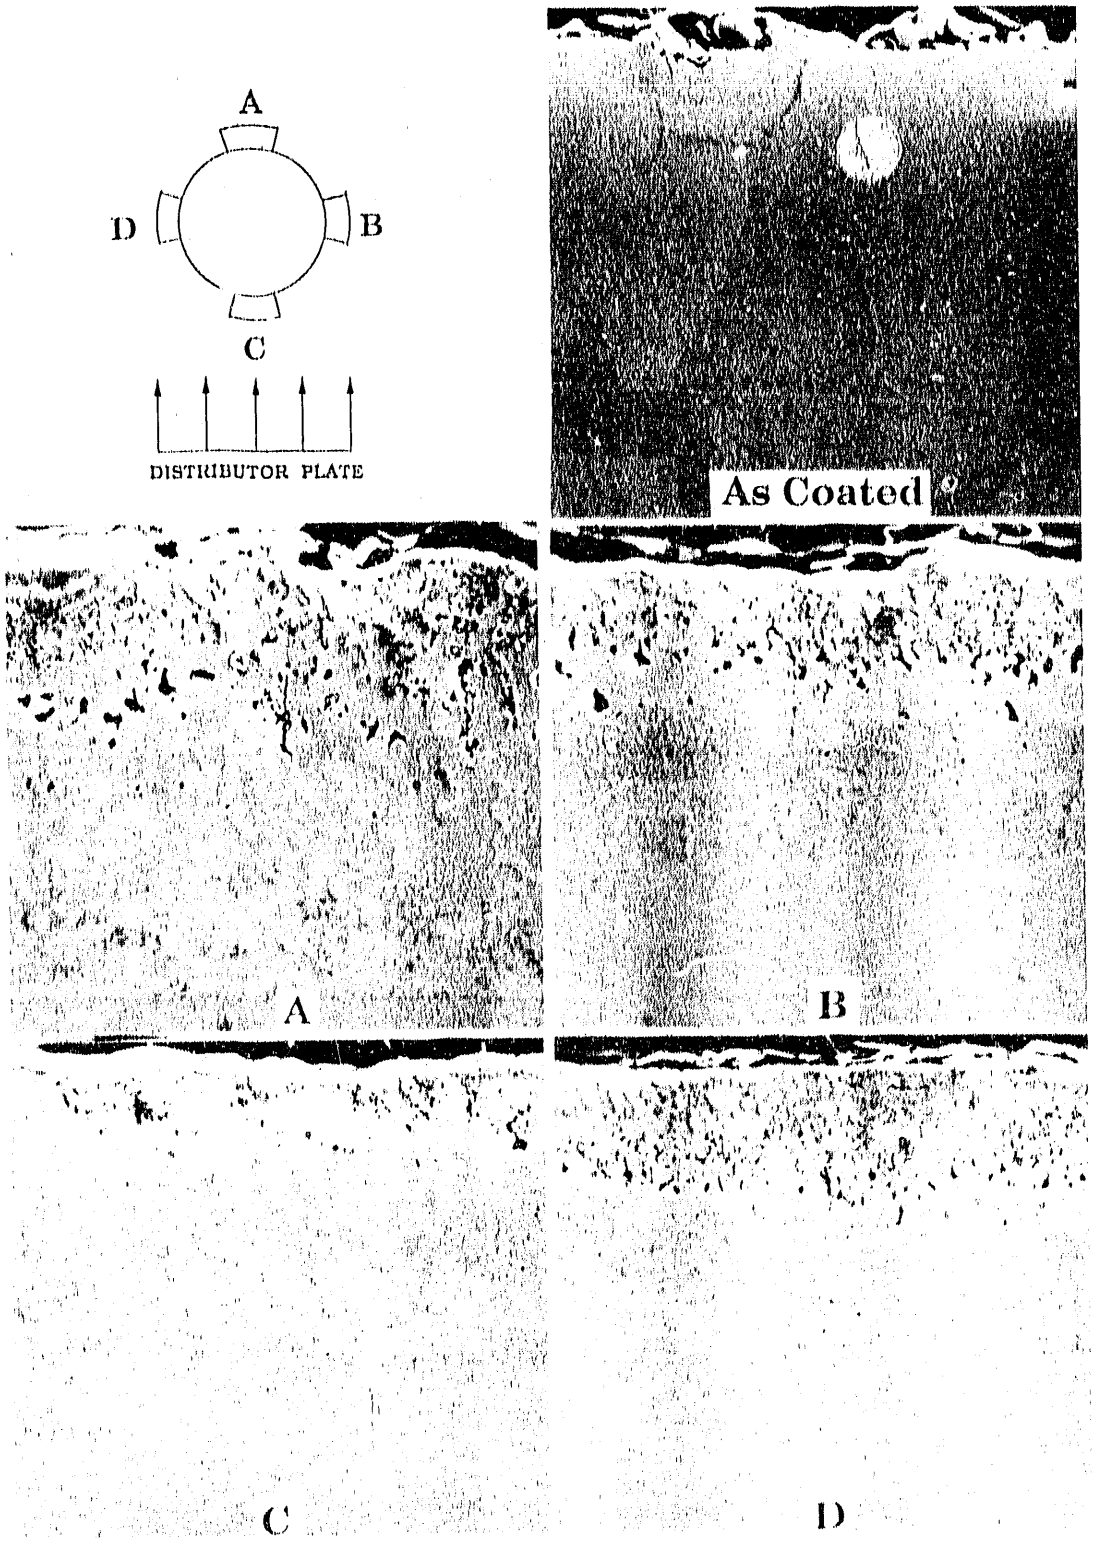
304/Cr

SEM Micrographs of Chromized 304 Stainless Steel after 1980 h Exposure

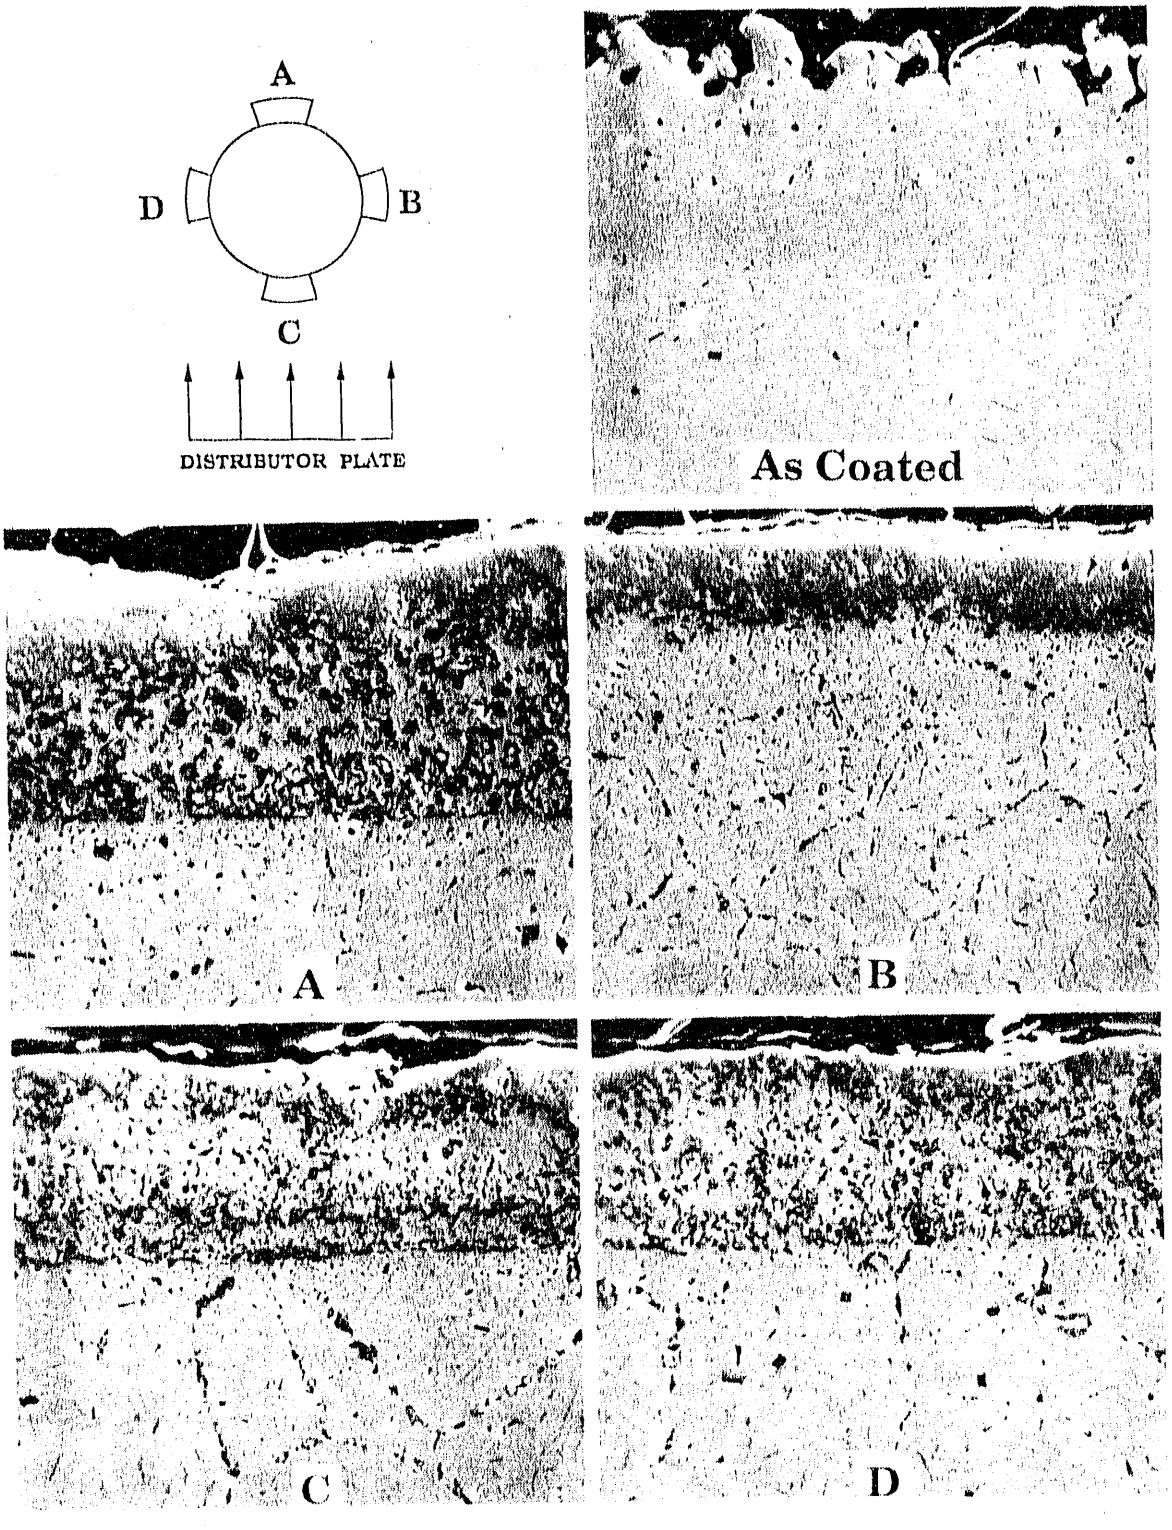
800/Cr

SEM Micrographs of Chromized 800 after 1980 h Exposure
