Materials Performance in the Atmospheric Fluidized-bed Cogeneration Air Heater Experiment

ANL-91/4

MATERIALS PERFORMANCE IN THE ATMOSPHERIC FLUIDIZED-BED COGENERATION AIR HEATER EXPERIMENT

February 1991

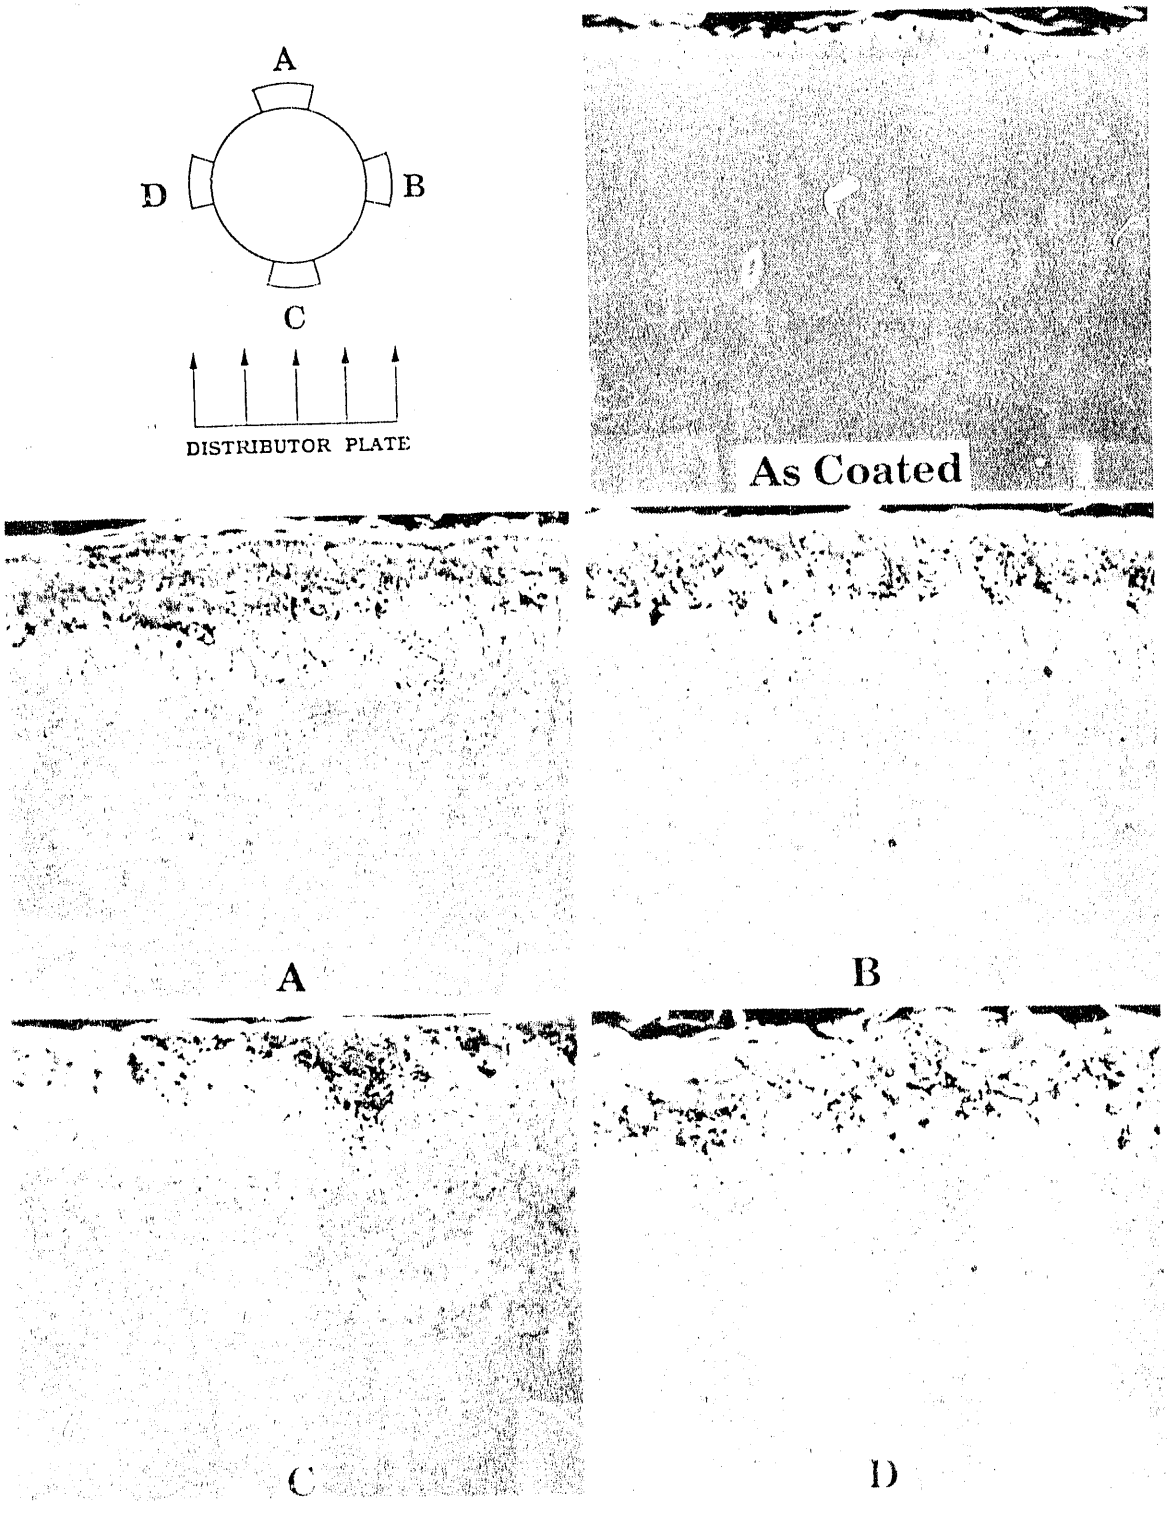
253 MA/Cr

SEM Micrographs of Chromized 253 MA after 1980 h Exposure

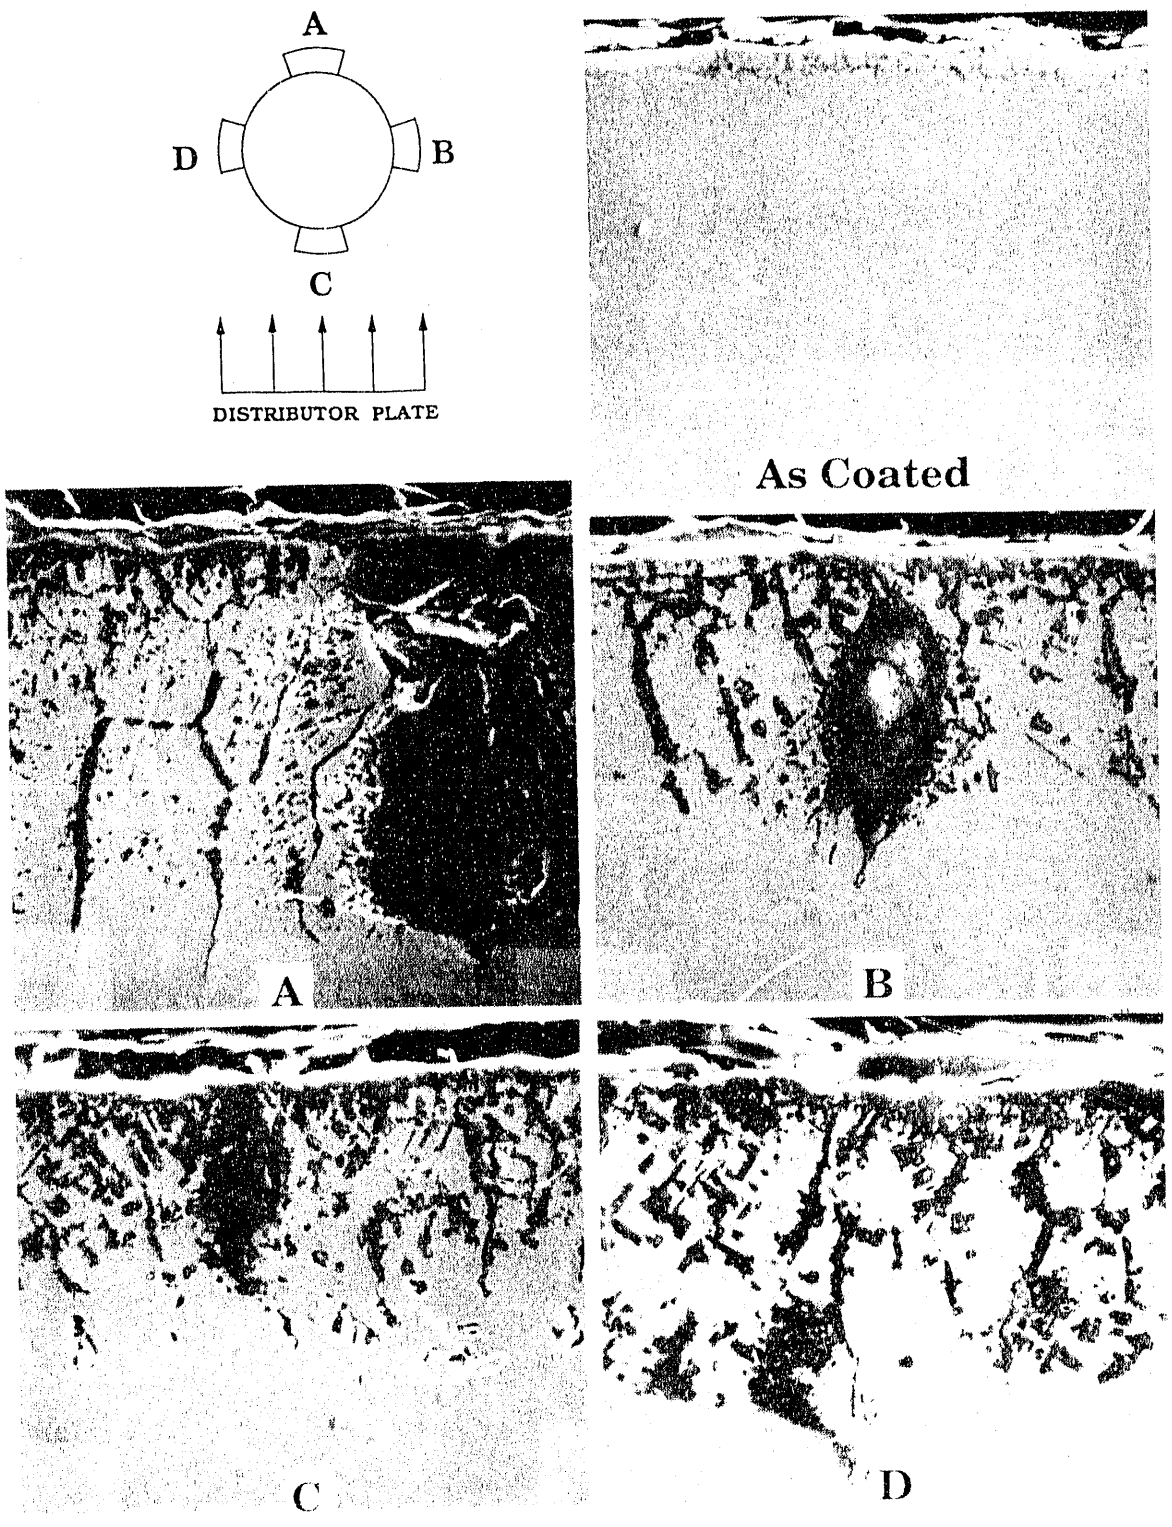
800/Al

SEM Micrographs of Aluminized 800 after 1980 h Exposure

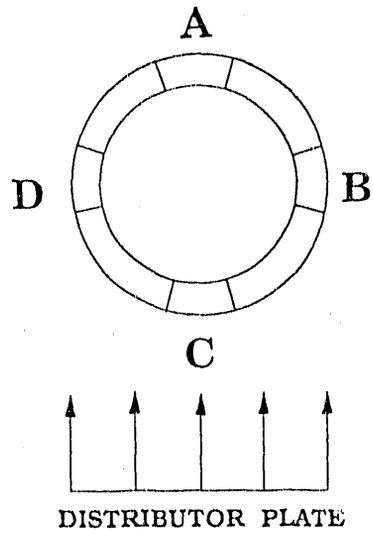
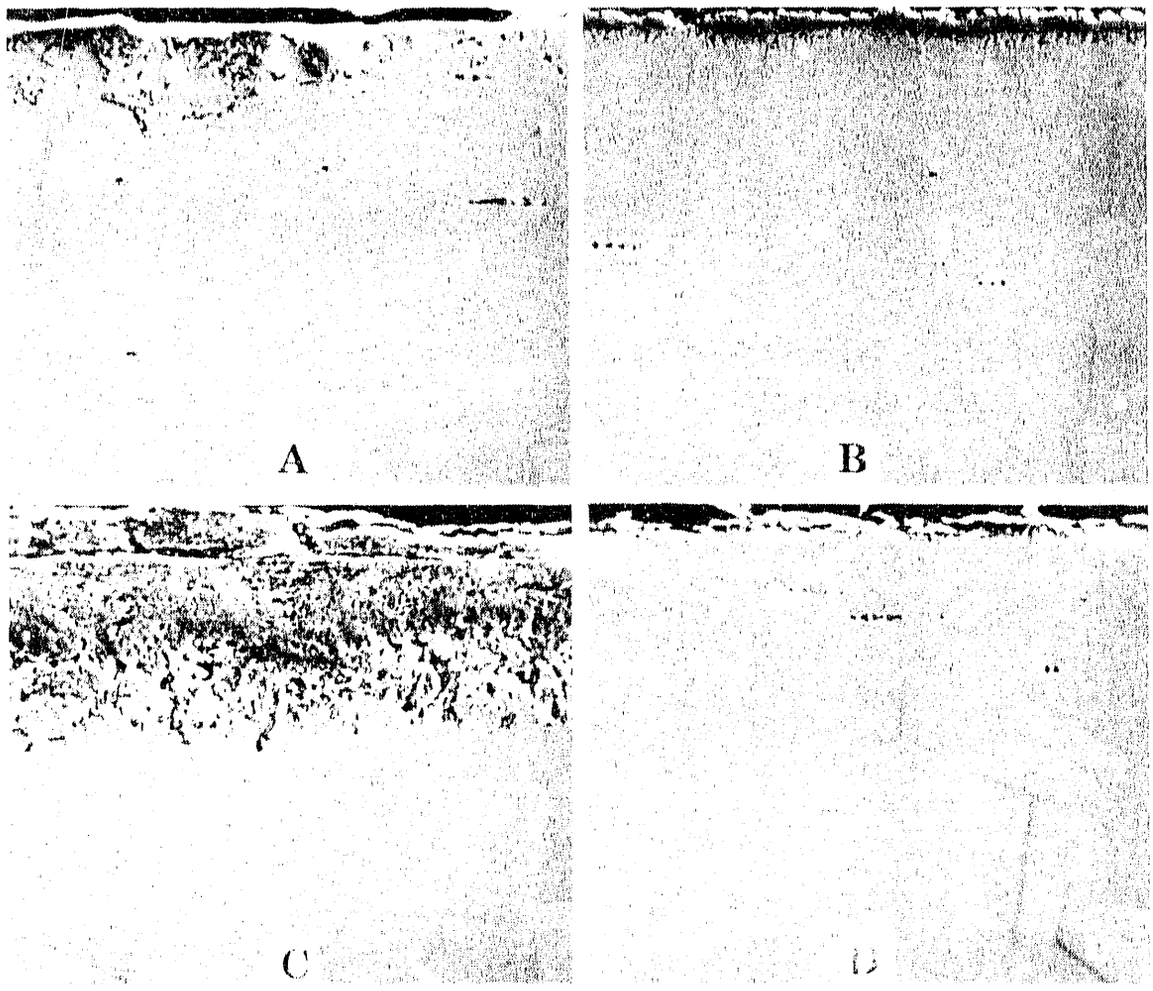
304 SS

SEM Micrographs of 304 Stainless Steel after 1980 h Exposure

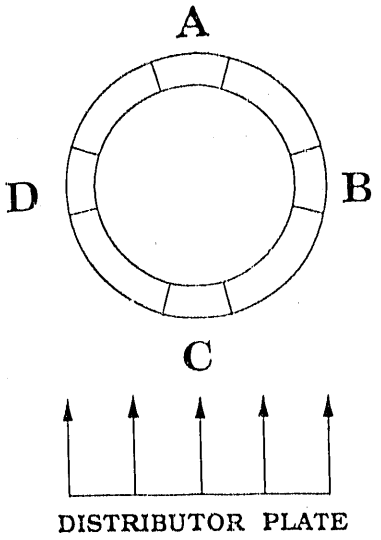
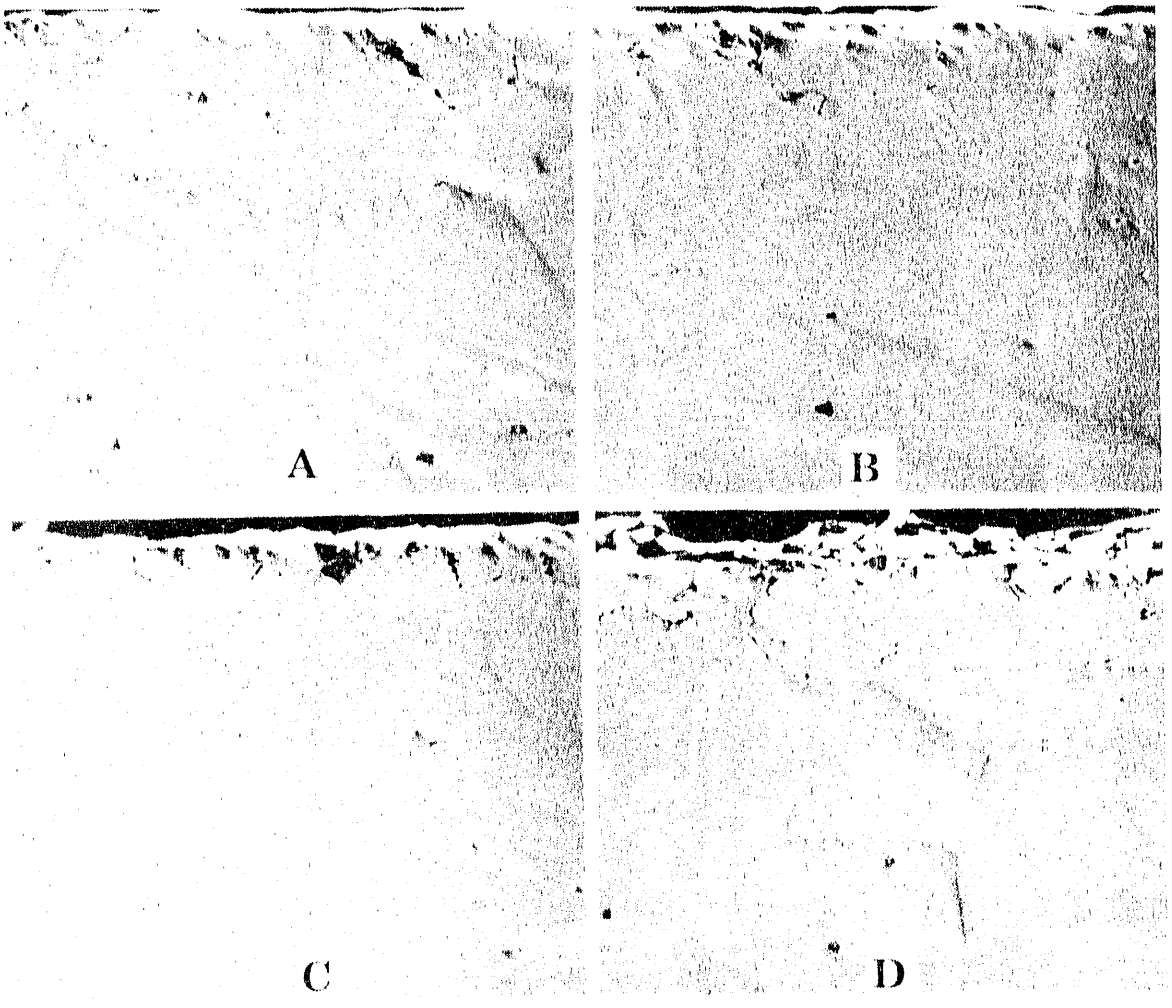
SEM Micrographs of Alloy 800 after 1980 h Exposure

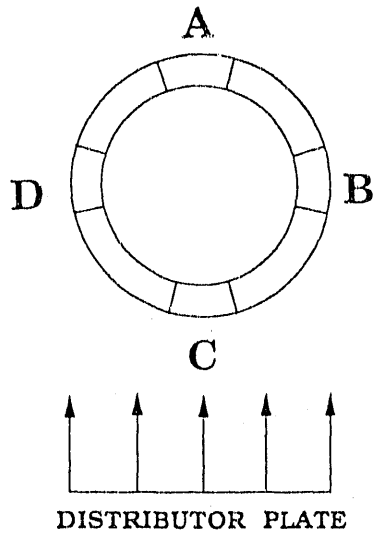
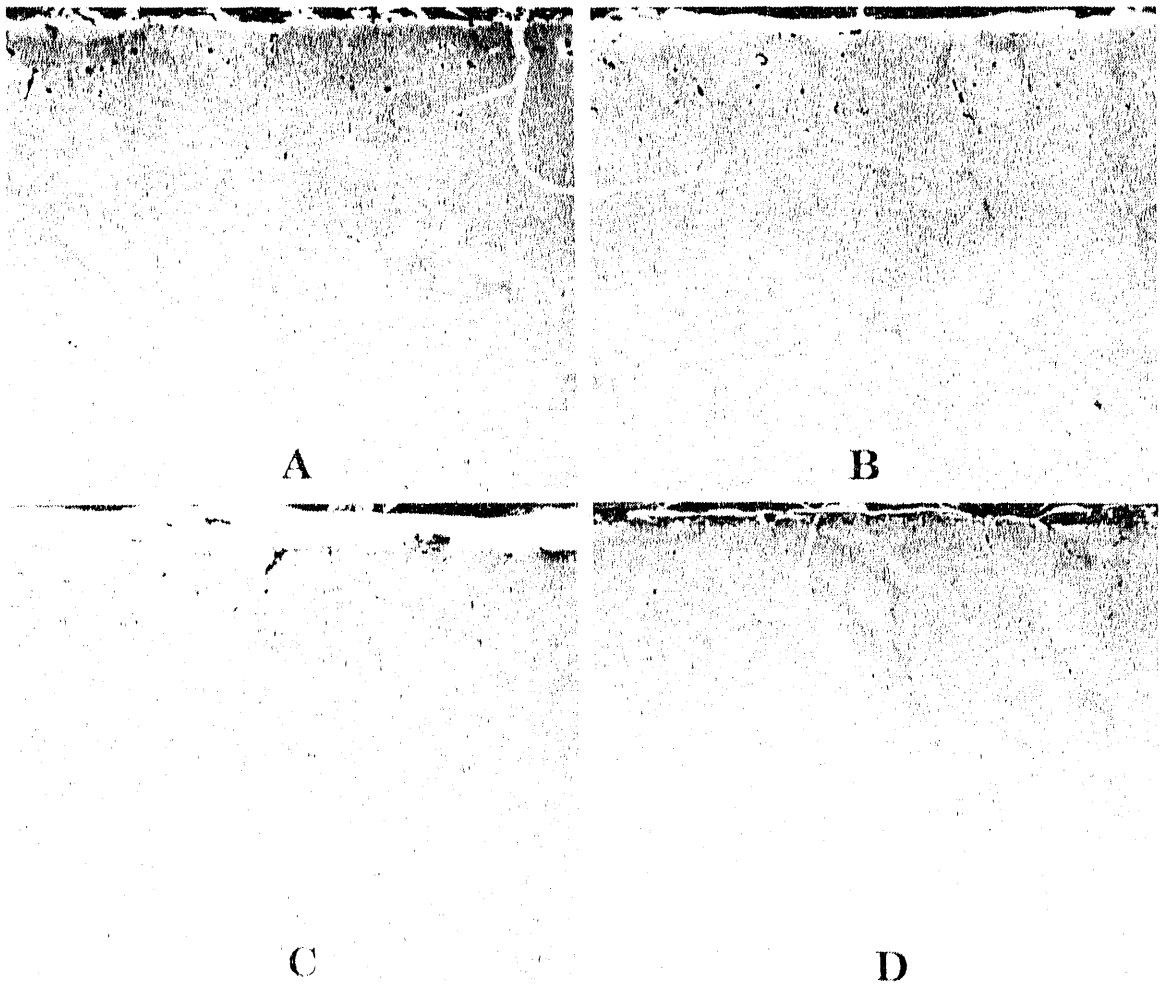
SEM Micrographs of 556 after 1980 h Exposure

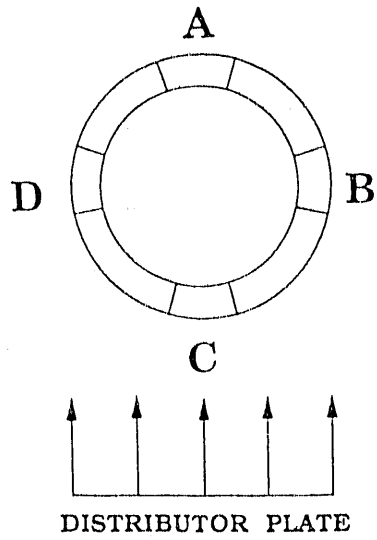
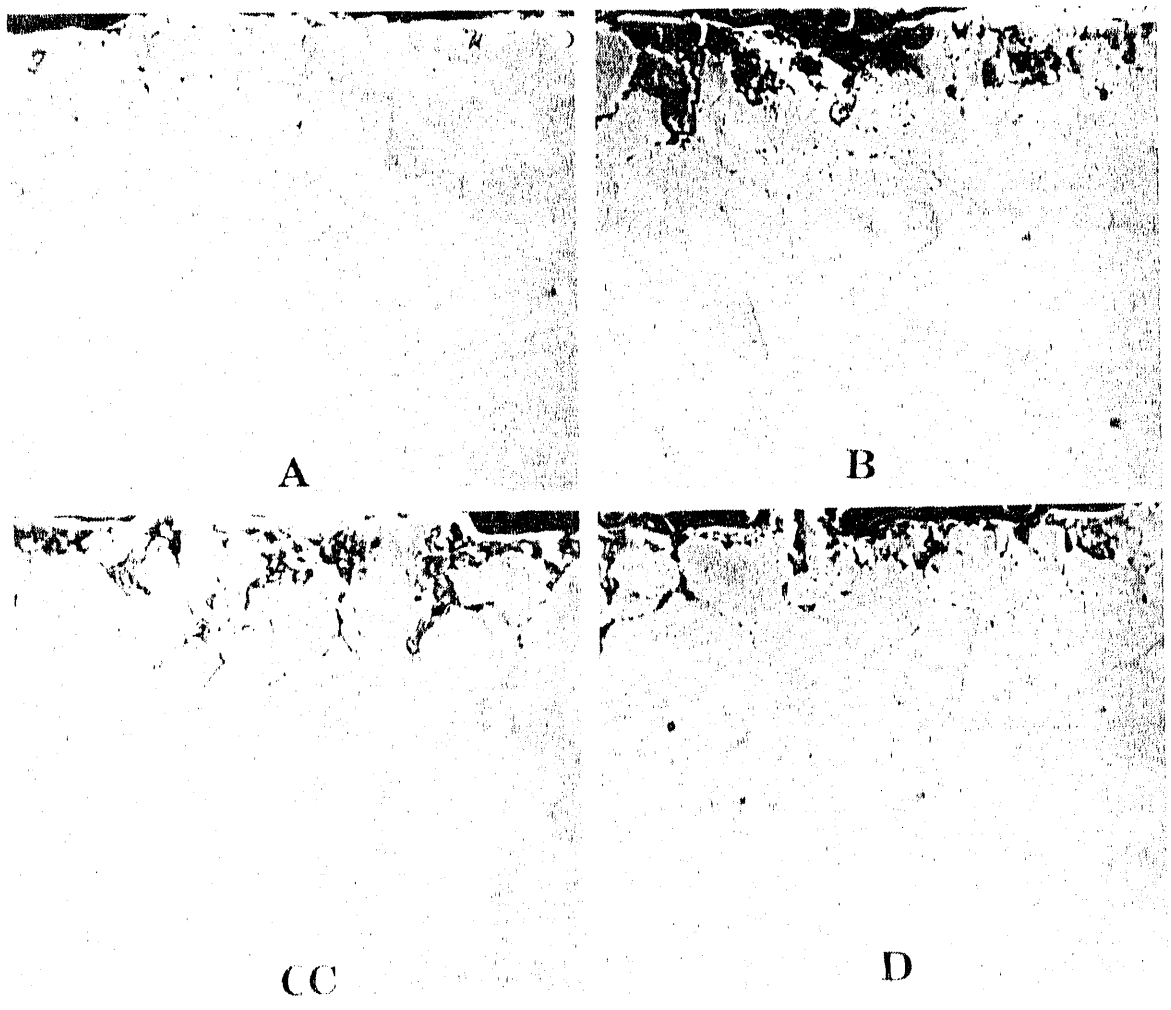
SEM Micrographs of 253 MA after 1980 h Exposure

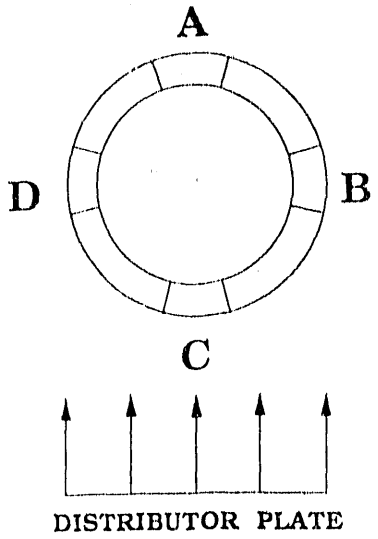
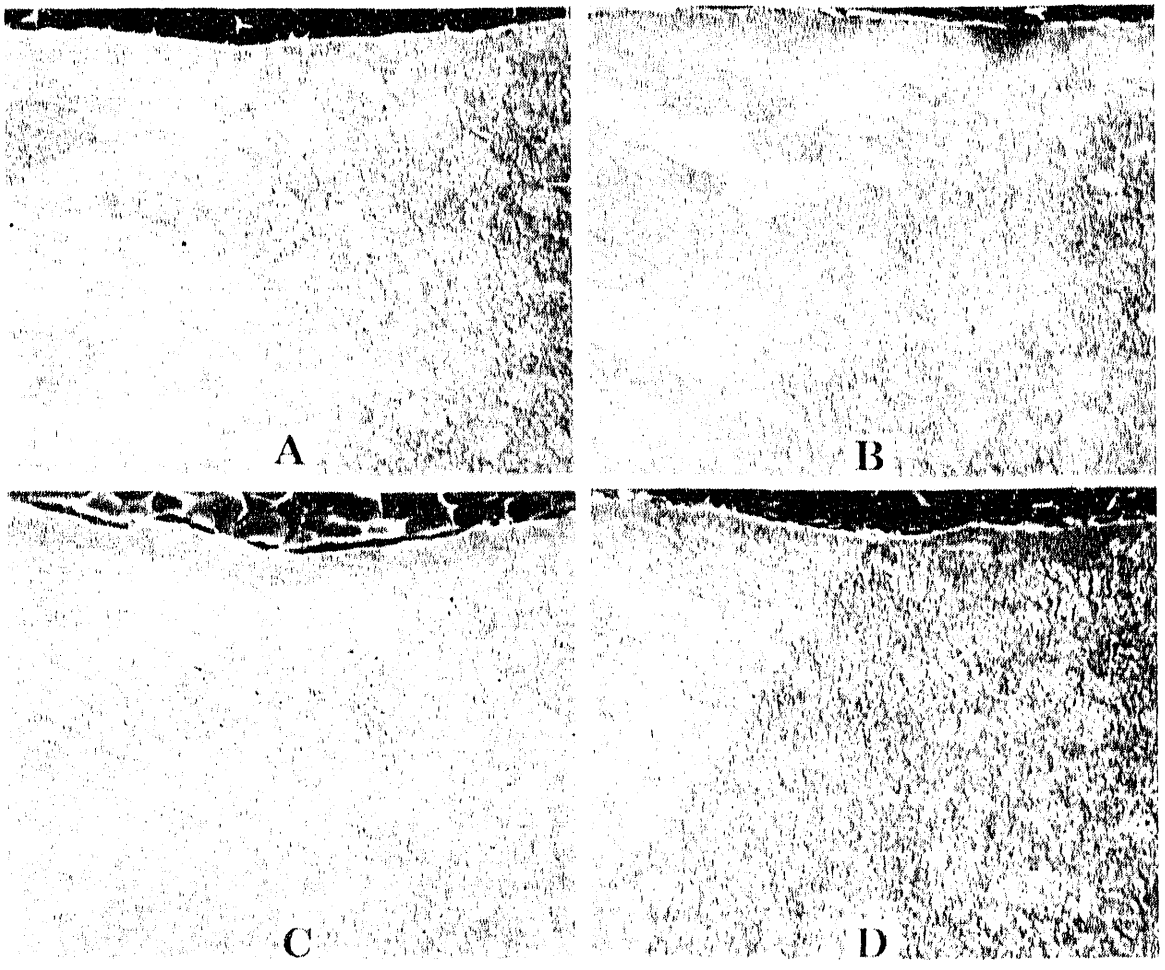
800H/310 Clad

SEM Micrographs of 310-Clad 800H after 1980 h Exposure

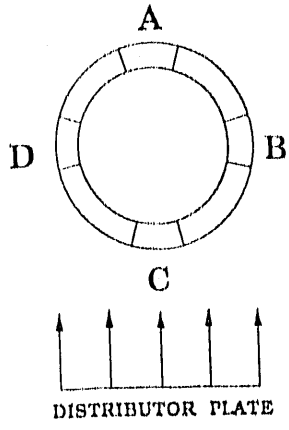
800/Cr

SEM Micrographs of Chromized 800 after 1980 h Exposure

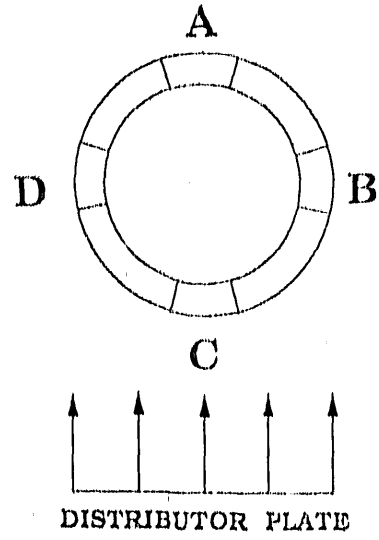
253 MA/Cr

SEM Micrographs of Chromized 253 MA after 1980 h Exposure

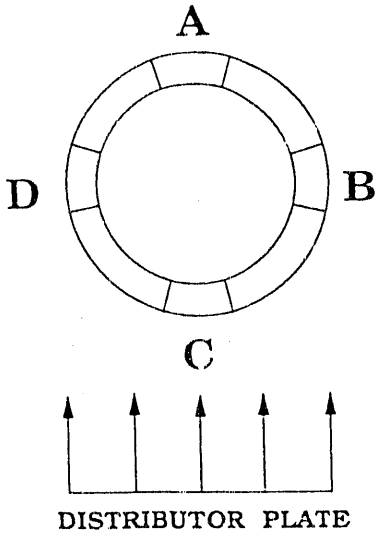
800H/21-33/800H

SEM Micrographs of 21-33 Weldments after 1980 h Exposure

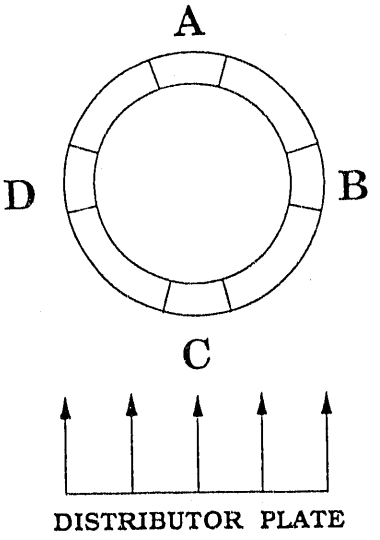
Chromized (304/308/304)

SEM Micrographs of Chromized 308 Weldment after 1980 h Exposure

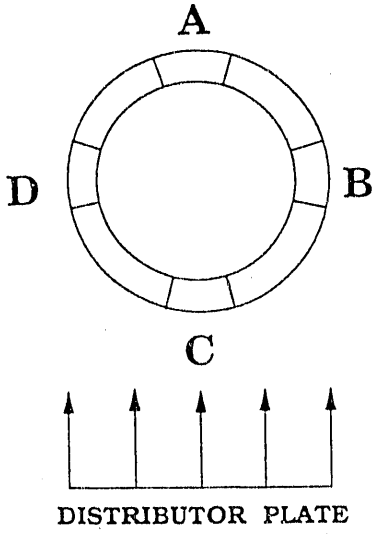
Chromized (800H/21-33/800H)

SEM Micrographs of Chromized 21 33 Weldment after 1980 h Exposure
