A SUMMARY OF ACCIDENTS AND INCIDENTS

INVOLVING RADIATION

ATOMIC ENERGY ACTIVITIES

D. F. Hayes
Safety and Fire Protection Branch
Division of Organization and Personnel
U. S. Atomic Energy Commission
Washington, D. C.

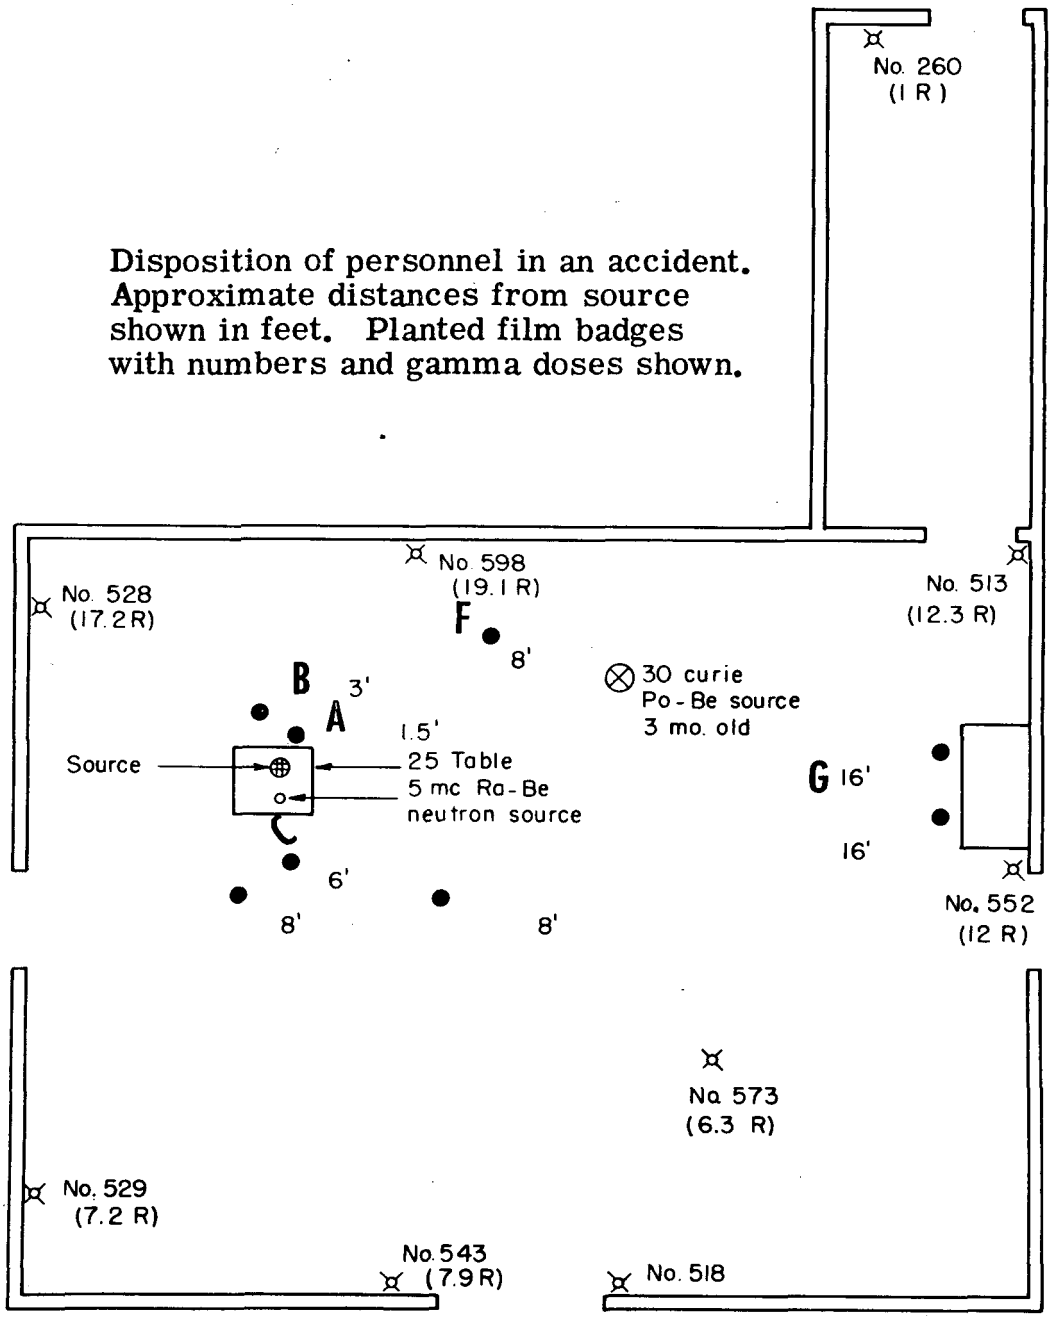
Scientist (A) who was demonstrating the experiment received radiation dosage sufficient to result in injuries from which he died 9 days later. The scientist (B) working with the deceased received radiation dosage sufficient to cause serious injuries and some permanent partial disability.

Disposition of personnel in an accident. Approximate distances from source shown in feet. Planted film badges with numbers and gamma doses shown.

While some work had been done in fabricating mechanical remote controls previous to this incident, as a result of an earlier similar critical assembly accident, such devices had not been fully developed to the point where they were considered sufficiently reliable to perform the task of critical assembly studies.

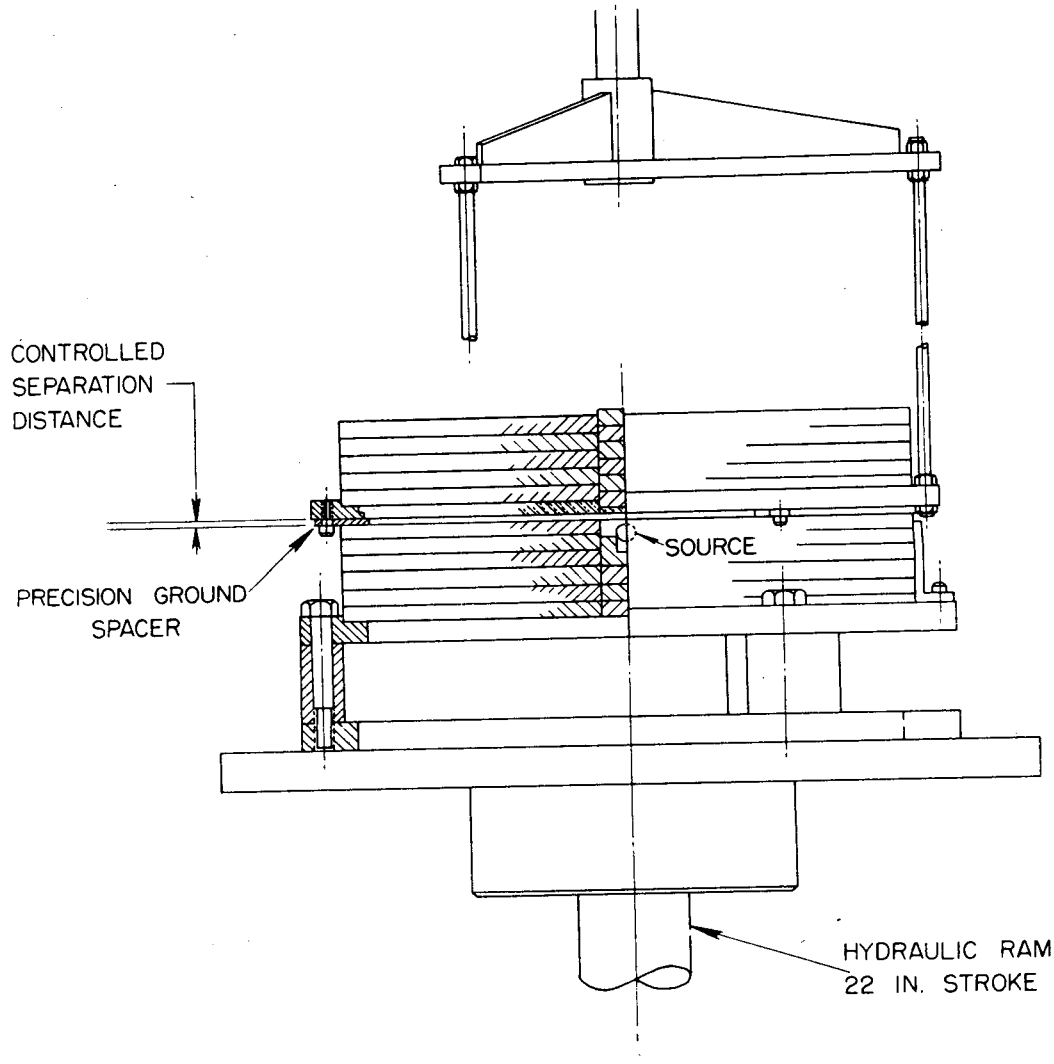
A criticality test assembly.

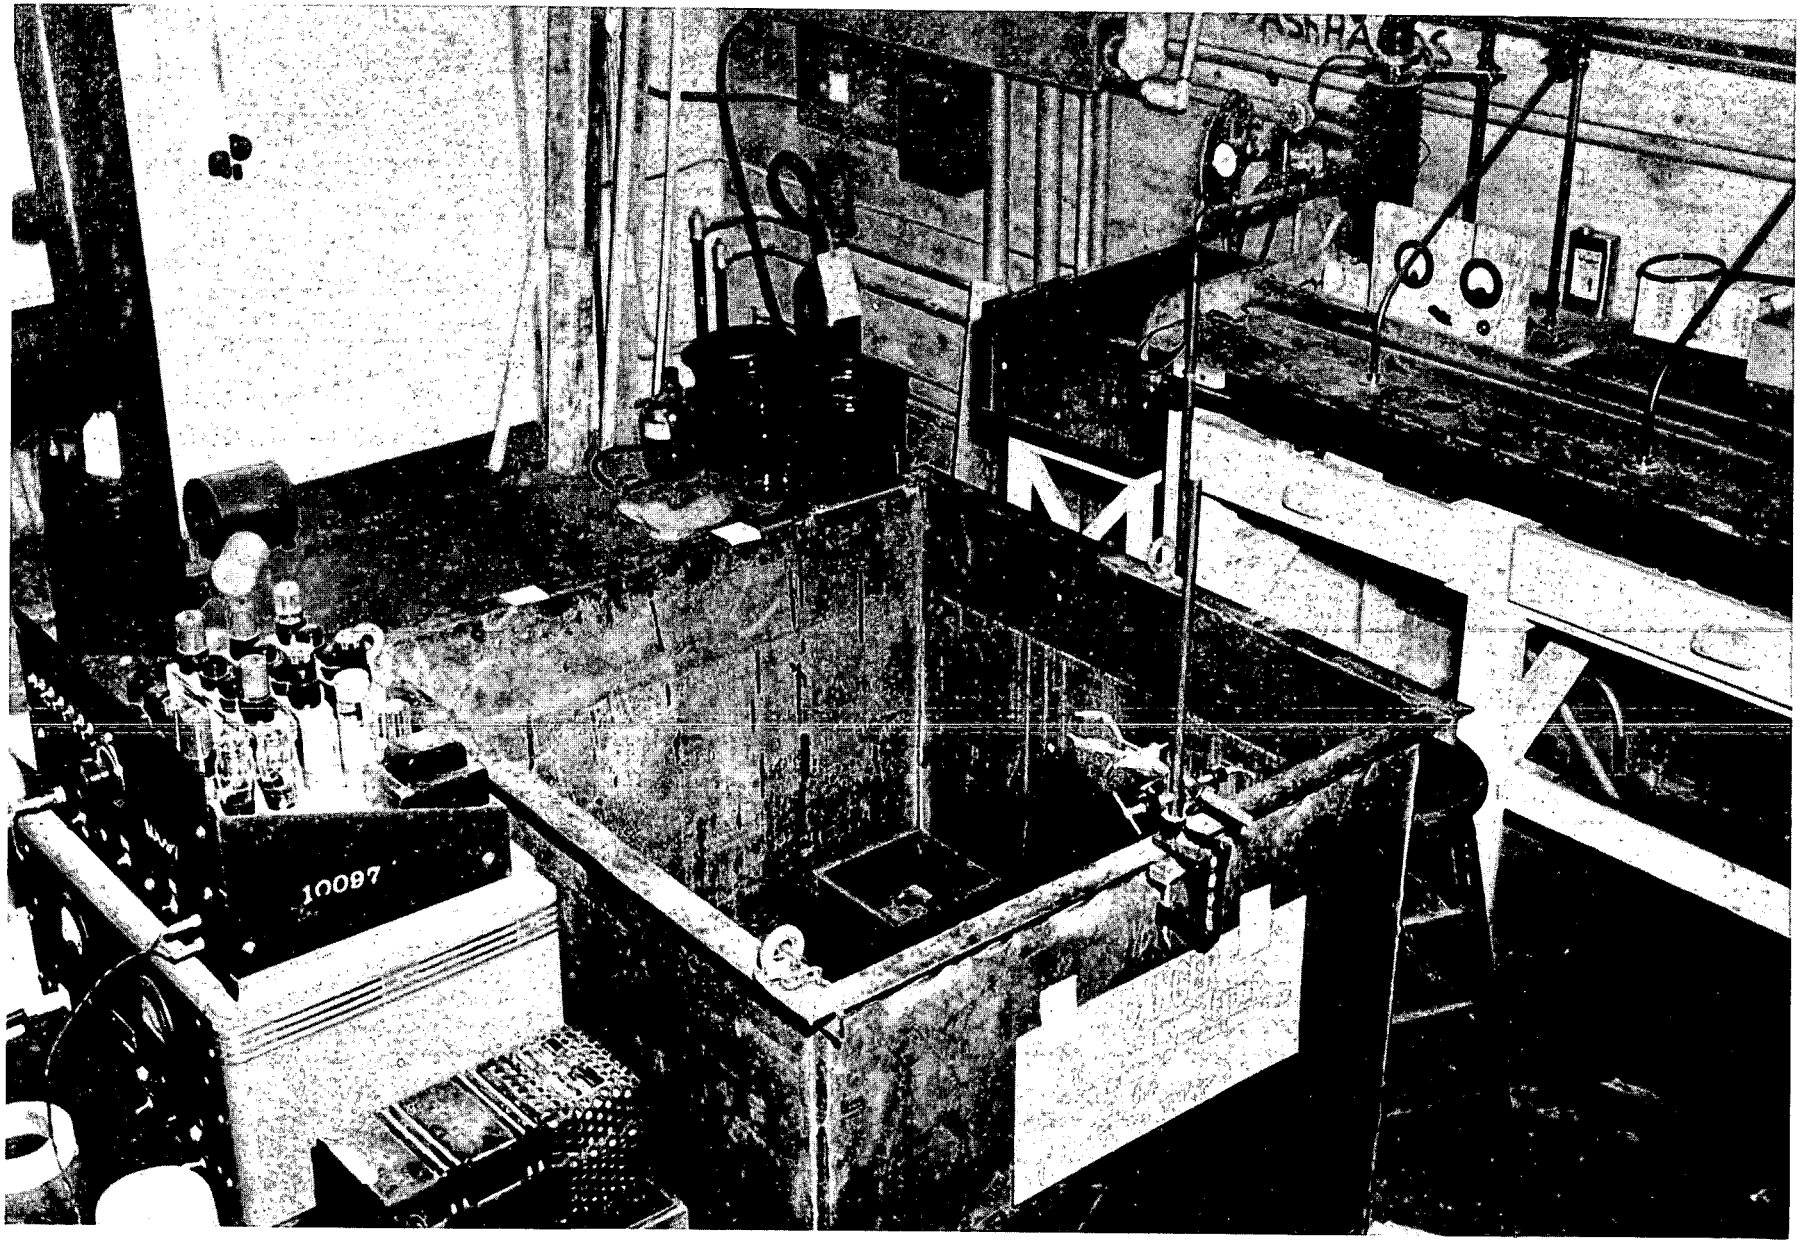
It seems most probable that the unanticipated increase in reactivity

Test equipment for water shielded assembly.

occurred because of water seeping between the blocks of active material and increasing the internal moderation of the assembly. Sufficient heating occurred to melt and deform the plastic bottom of the assembly container, and the water between the blocks must have vaporized, thus stopping the reaction. More water would then seep in and the cycle would repeat. It was estimated that three such cycles occurred before the water level in the tank fell sufficiently low to prevent further reaction.

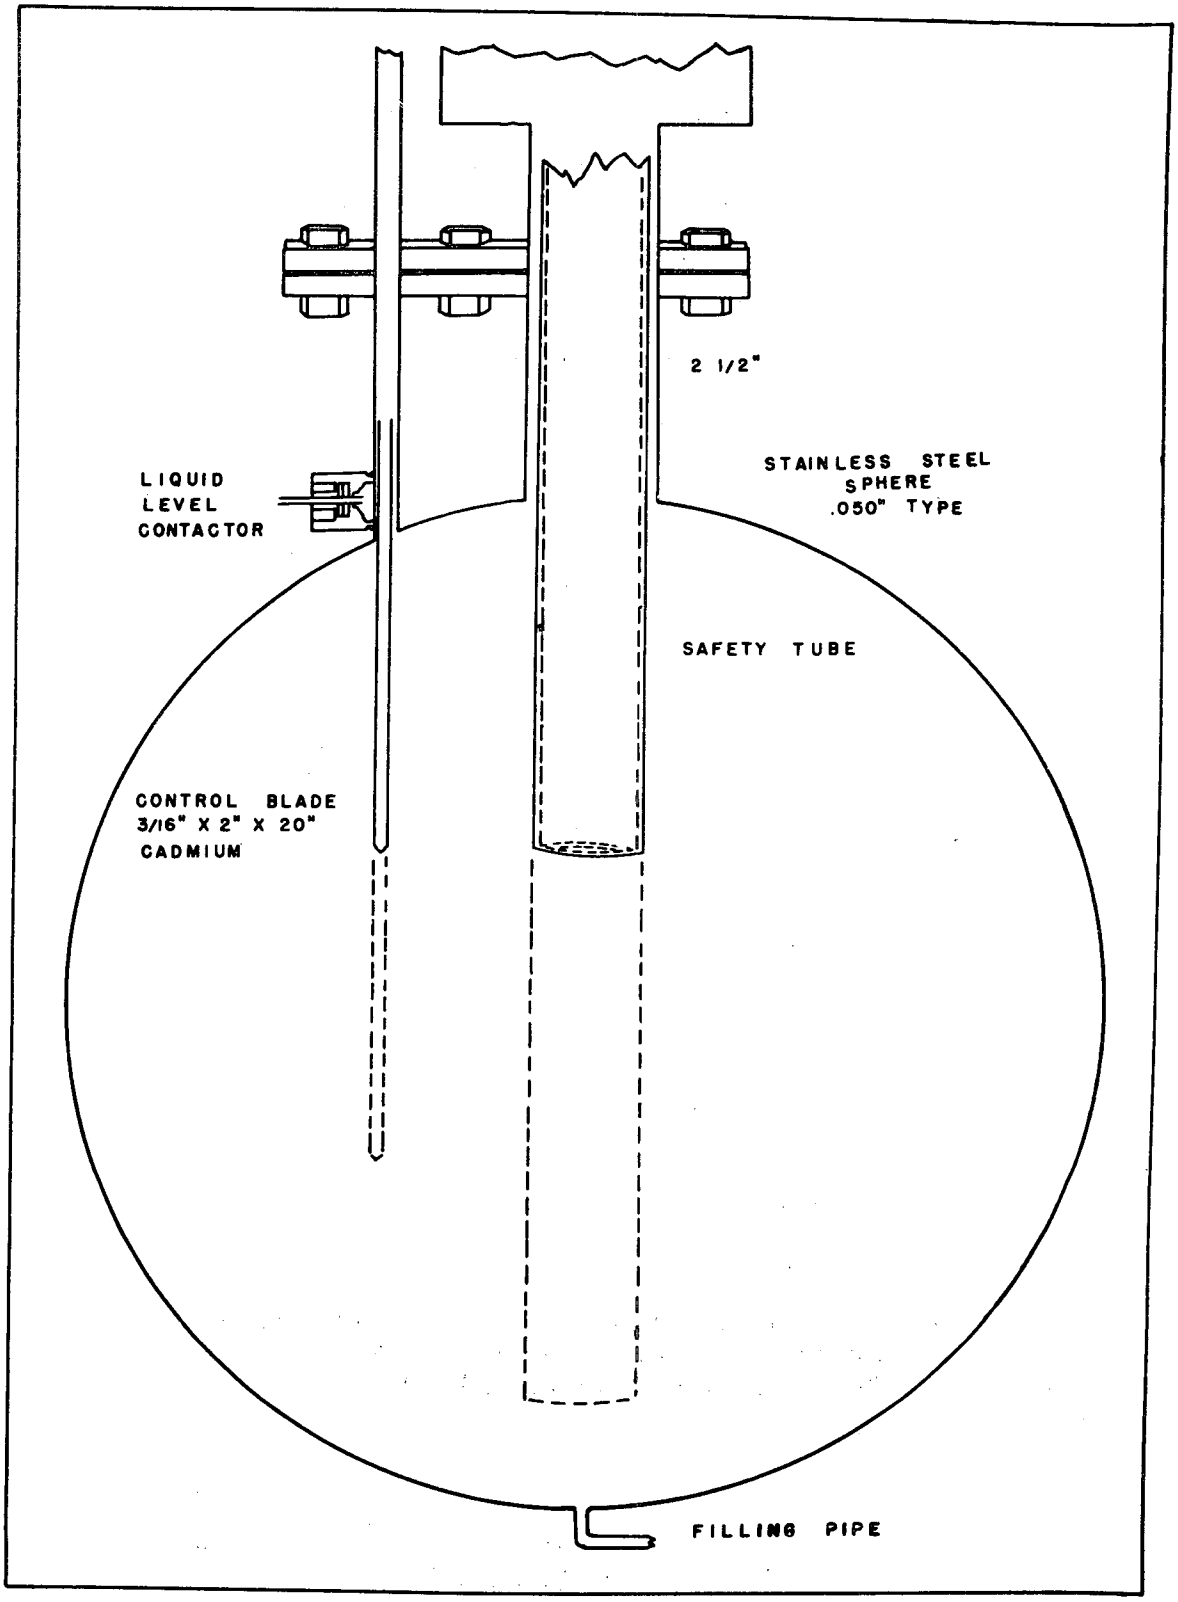
A SCHEMATIC DIAGRAM OF THE REACTOR ASSEMBLY.

(2.3 inches/second). A waiting period for the delayed neutron effect of about 15 seconds was made just prior to the incident. This was too short a time to determine whether or not the assembly was critical. The operators next heard the safety controls actuate, instrument indicators moved off scale, scalers jammed, and the most startling manifestation was that of the breakdown of "counters" playing back through the public address system. The portable "Juno" in the control room was off scale. Presumably, a further rod withdrawal had been made.

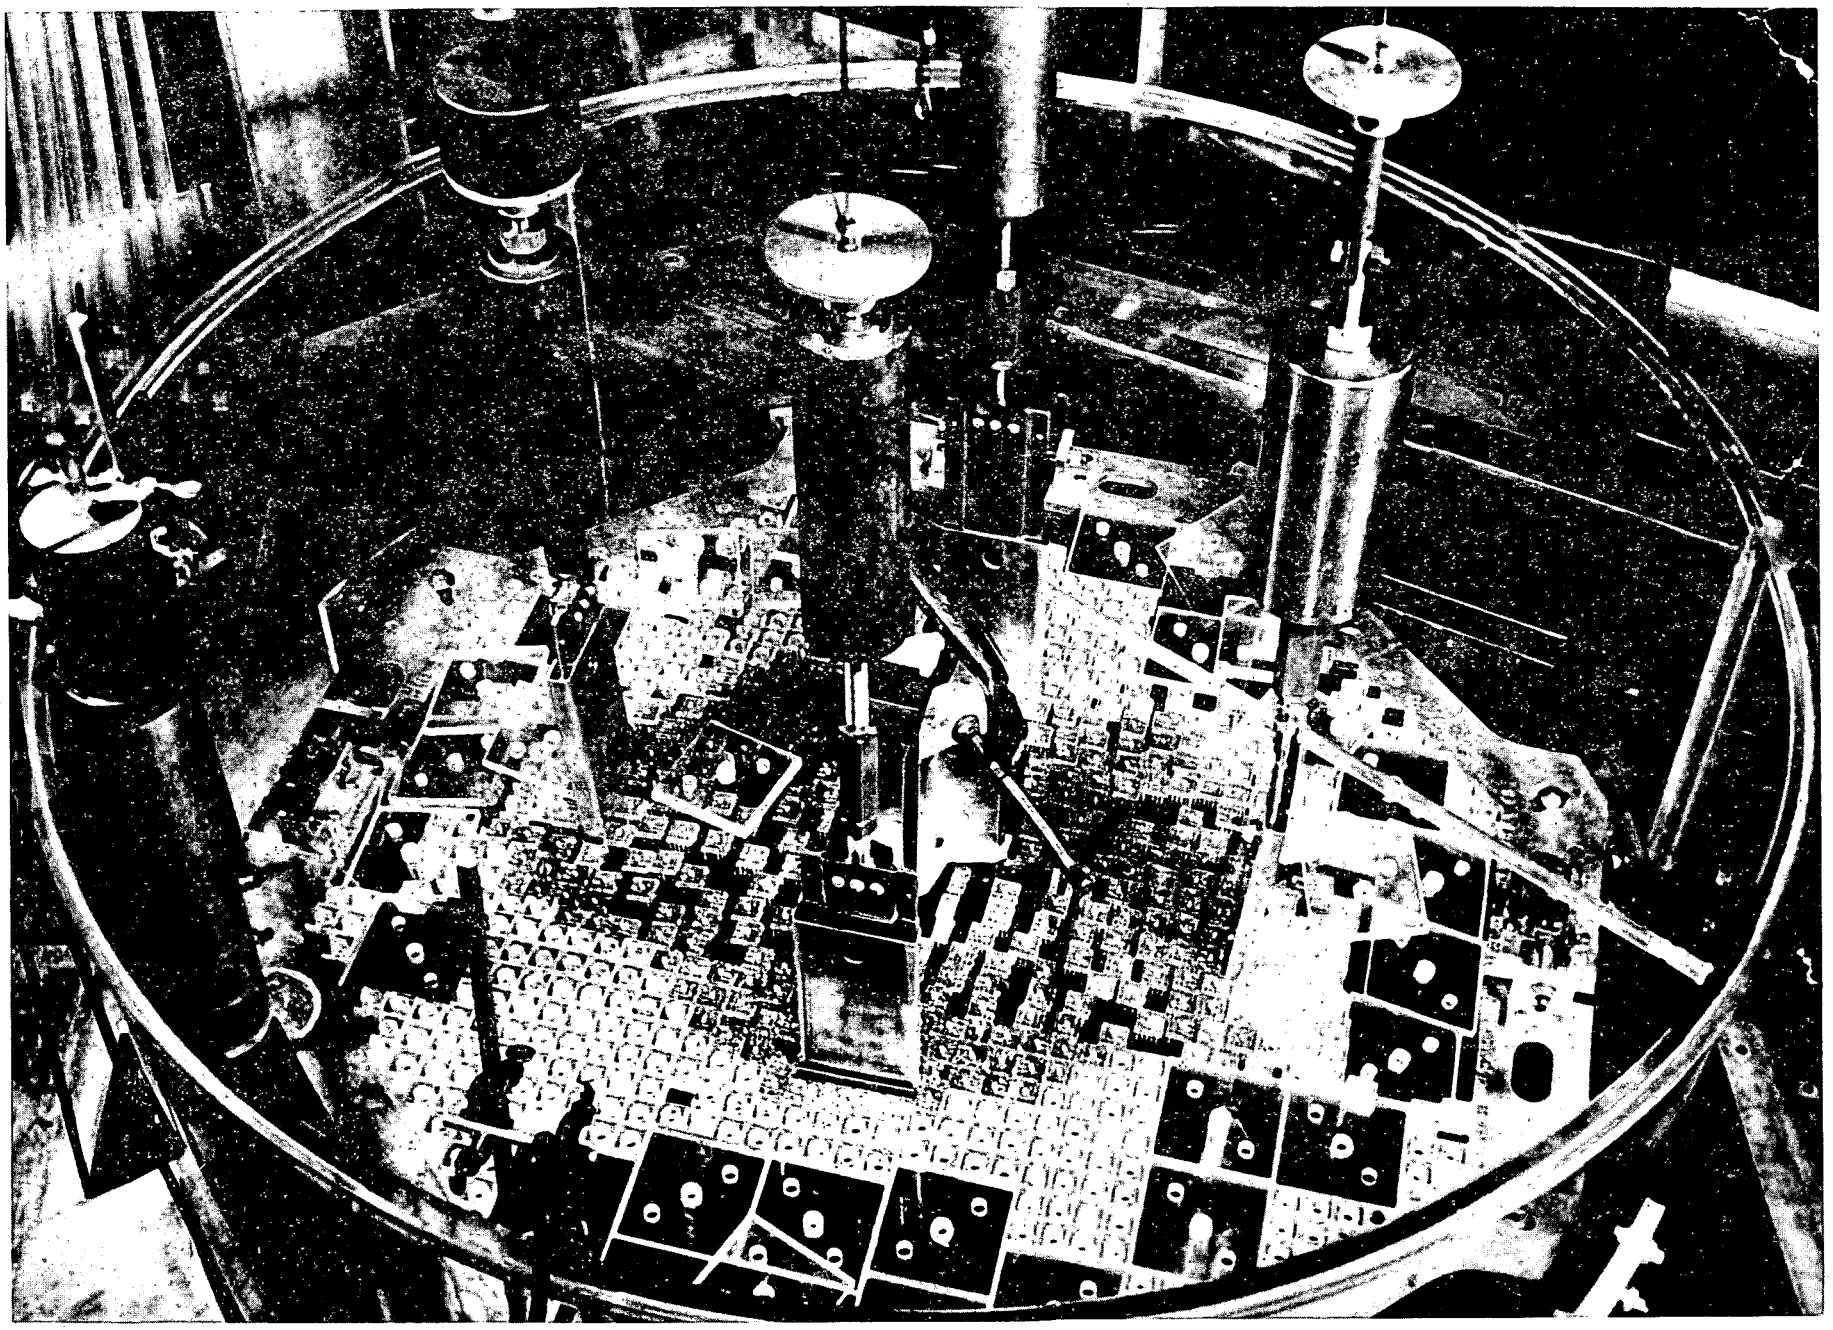
The reactor became super-critical because the test rod being removed by the leader was highly effective in suppressing the chain reaction when fully inserted. But, as it was being removed, a point was reached when the reactor was critical even with the standard type rods fully inserted. In removing this rod, the reactor passed through the critical into the prompt critical stage. This would not have occurred if water had not been in the reactor assembly, since this thermal reactor was dependent upon water to moderate the neutrons from the fast energy level to the thermal energy level and the fission process can only be supported by thermal energy neutrons.

Top view of test reactor.

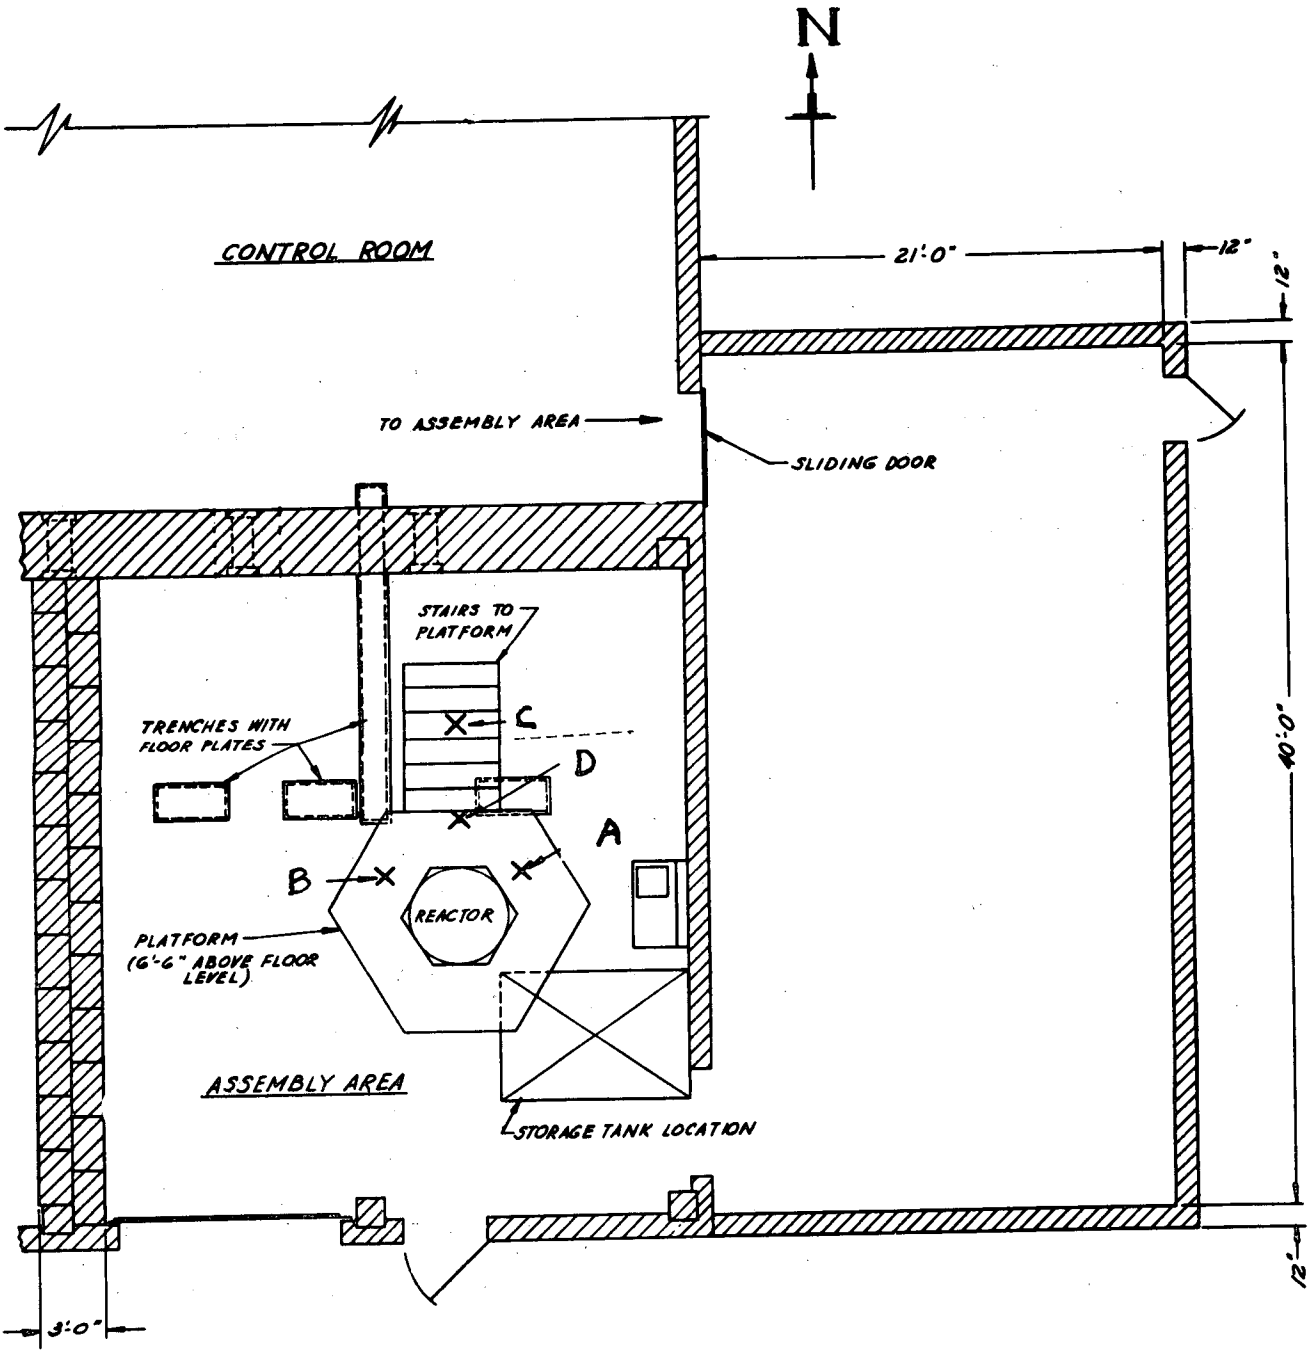
The direct cause of the nuclear reaction comprising the incident was the rapid withdrawal by hand of the control rod being tested from the water-filled assembly. This effected a large increase in reactivity and the reactor achieved super-criticality in a very short time. The following recommendations were made and have been carried out to prevent occurrence of a similar incident:

Layout of reactor showing position of crew at time of the accident.

2. Prepare and keep up to date an operating manual which would include not only standard operating procedures but operating restrictions imposed by nuclear safety considerations.

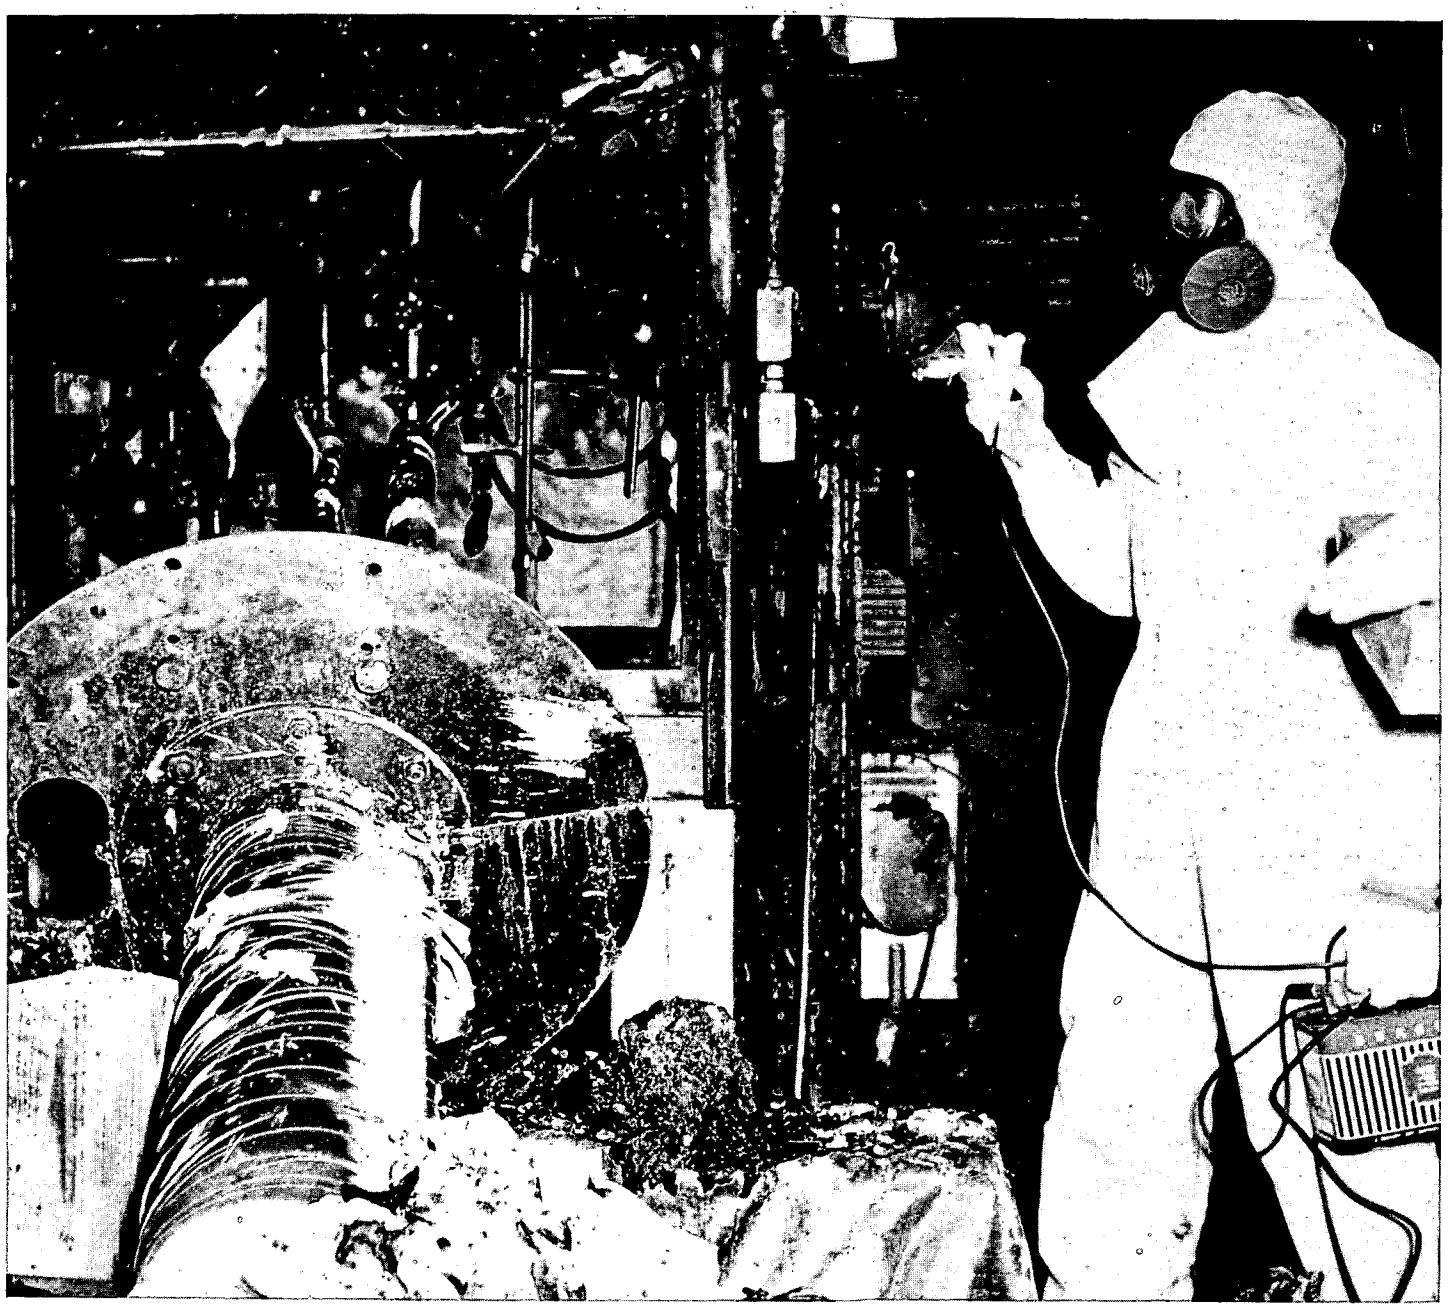
Considerable difficulty was experienced in extinguishing the blaze in the hood filters. It was necessary to break open the filter unit and remove the filter elements to put out the flames and prevent further release of plutonium to the atmosphere.

The total amount of plutonium released was estimated to be between one and four grams. Most of this came from the burned hood filter and the remainder from the previously contaminated waste material. All surveyable surfaces inside the building gave positive alpha readings. A part of the released plutonium was washed from the building by the water used to extinguish the fire, and deposited on the ground outside the building. The contaminated ground was covered with sand to prevent the pickup of active particles from the ground by winds.

Fire damage in contaminated waste fire.

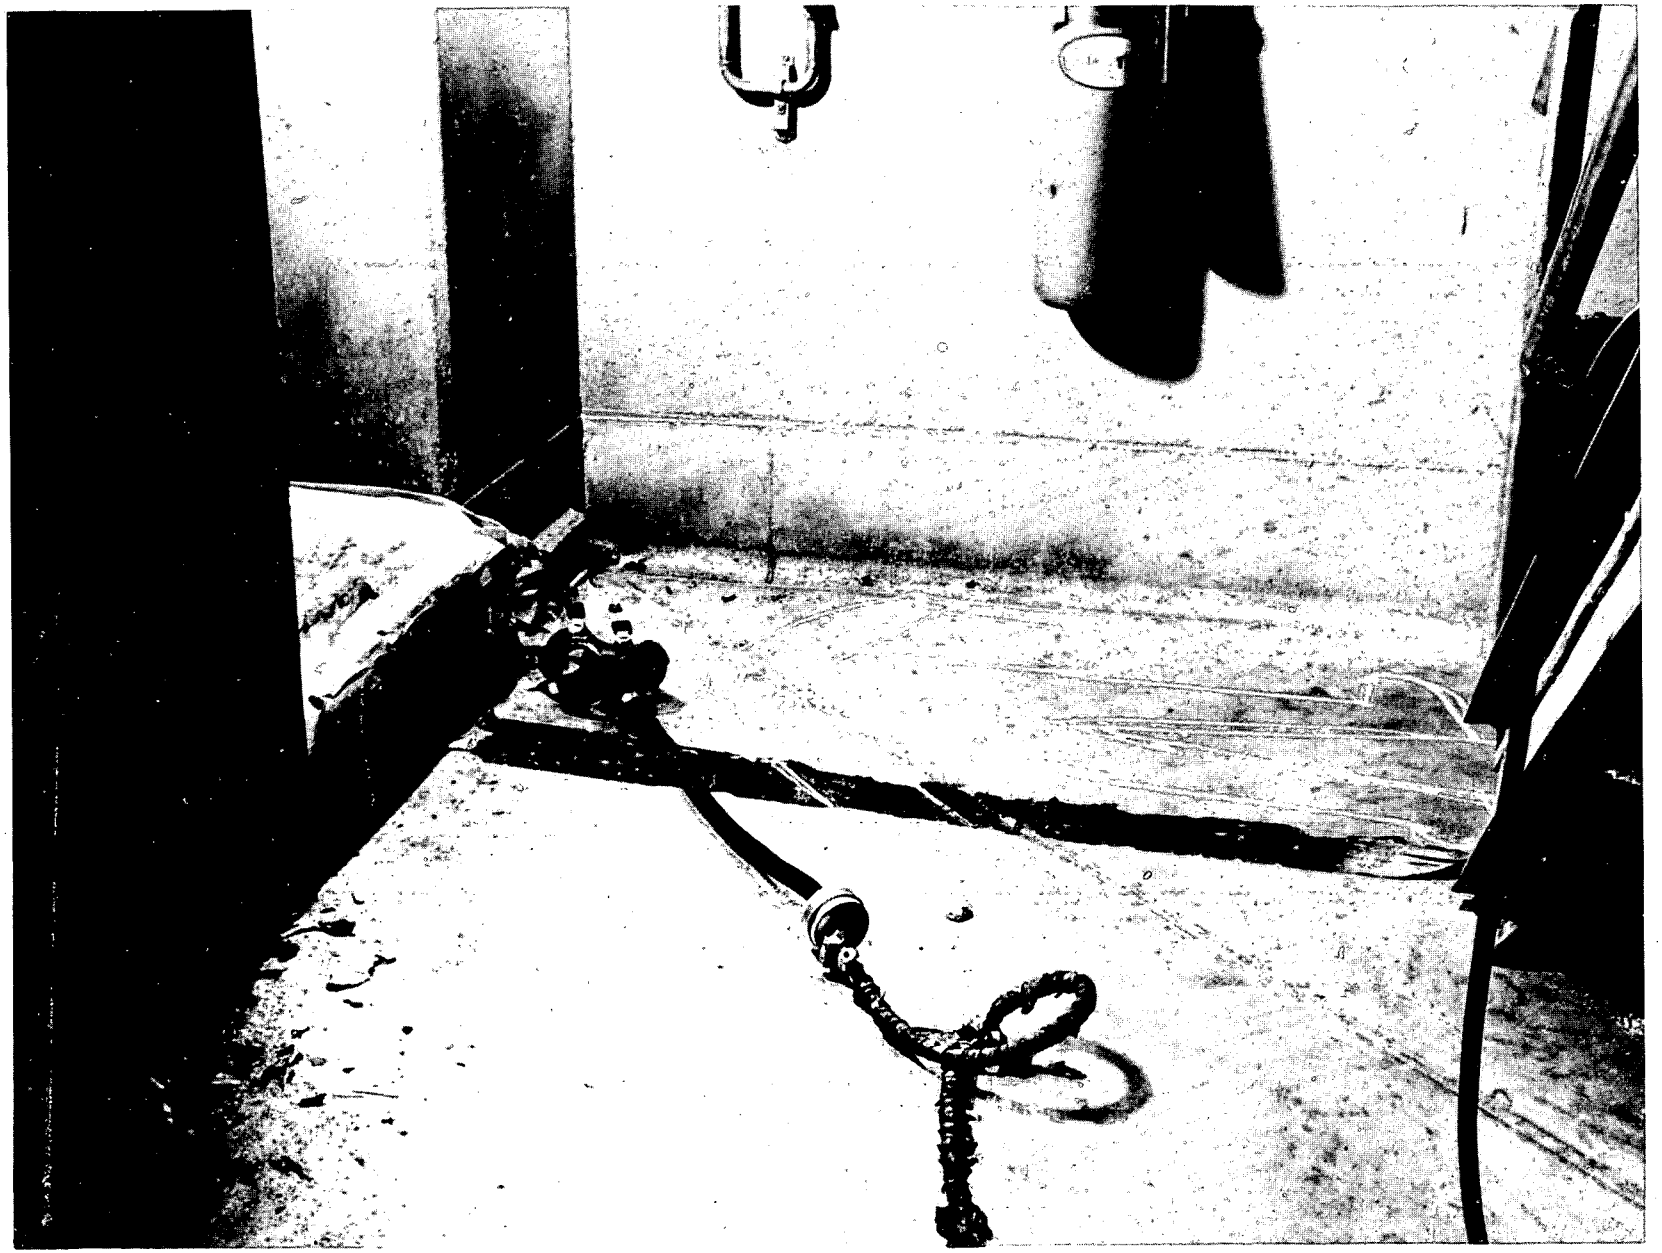
Chalk marks show position of body when found.

1. No employee should enter an area requiring such equipment unless tended from outside.
2. Breathing air systems should be used for this purpose only.
3. Air-line respirators should include a "self-rescue" air cylinder
4. Employees should be instructed in the difference between acute and chronic radiation hazard.
5. Where such equipment is used in a situation where the life hazard is not acute, employees should be instructed to remove the mask and leave the area if trouble develops with the mask.
