T-11803 7/12/66 File: P20.000

ANTENNA DEPLOYMENT OF
DIAGNOSTIC EFFECTS SIMULATOR (DES)
(U)

Organization 7300 Environmental Test Report

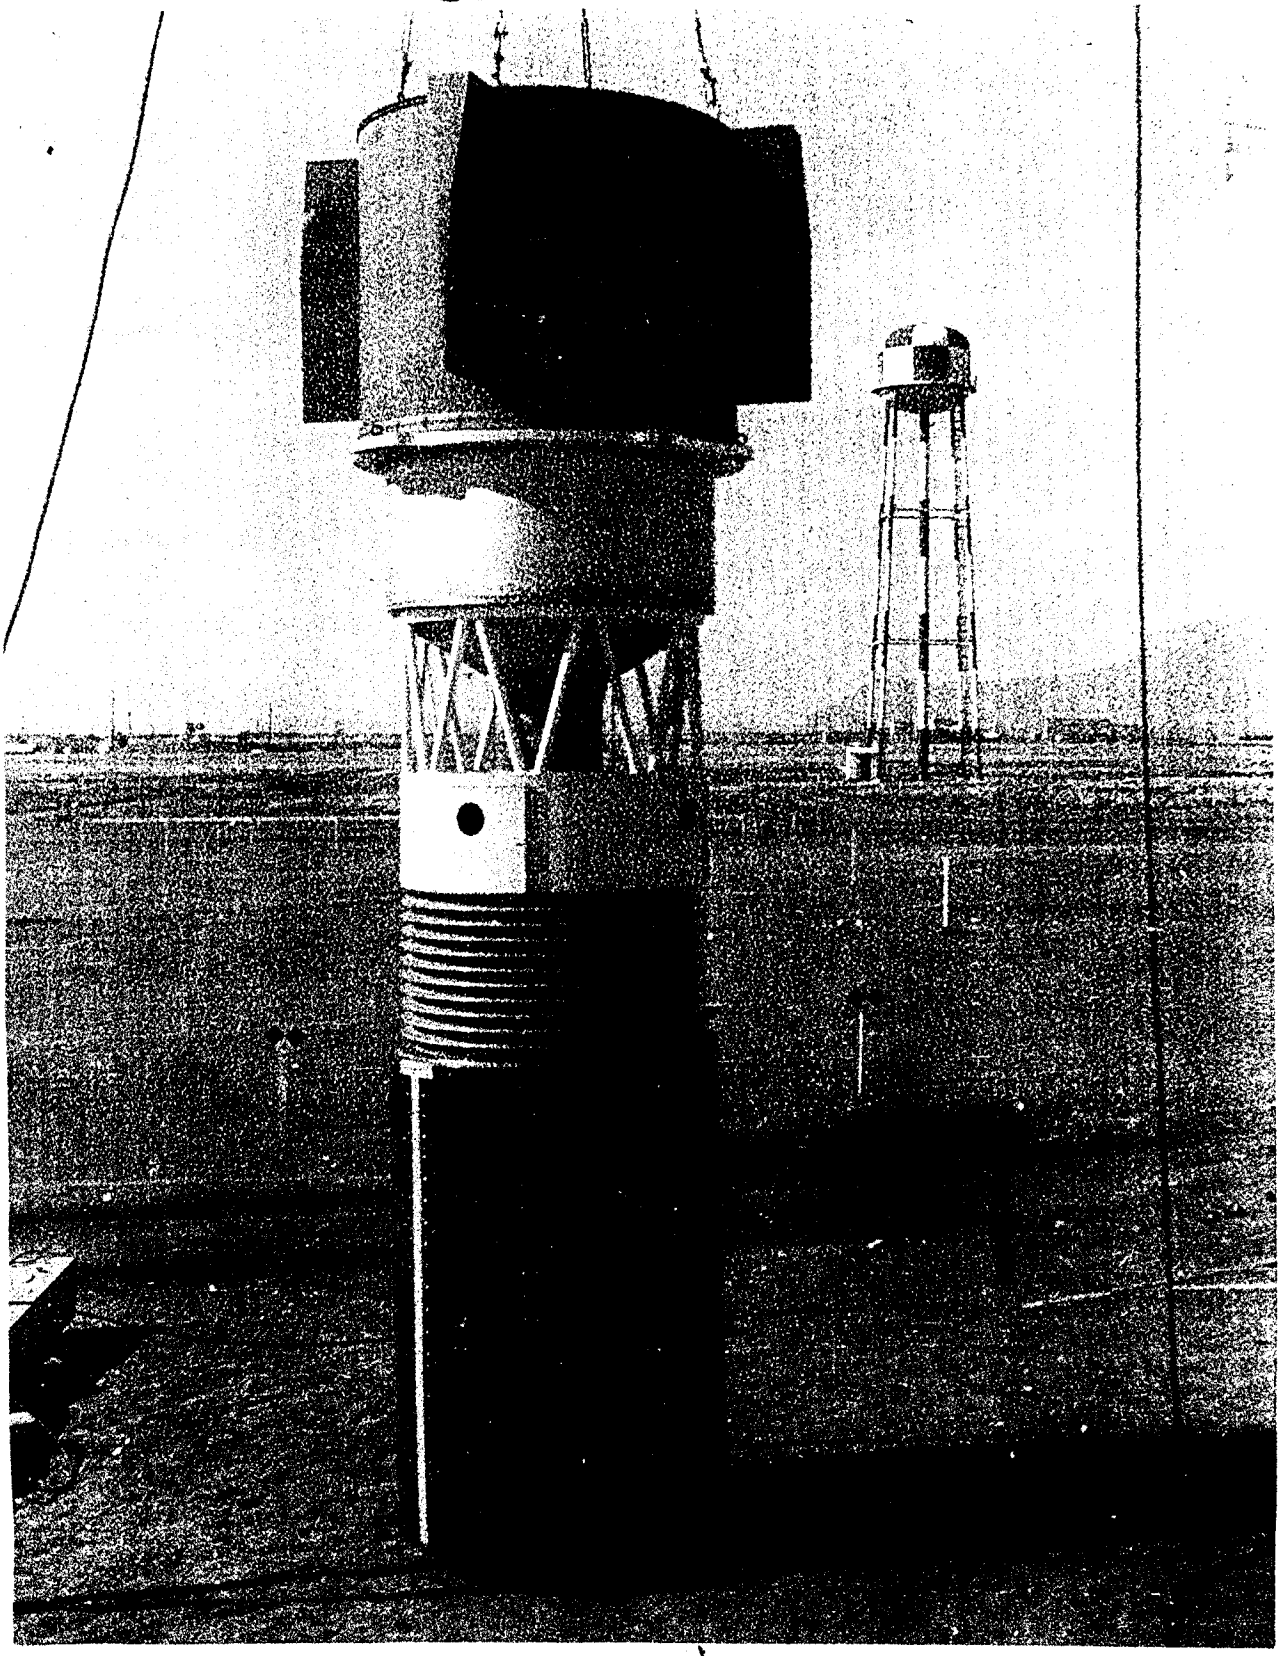
DES No. 3 was subjected to the first six tests and DES No. 5 was subjected to the last two tests (total of eight tests). Figures 7 and 8 show the unit after the first test. The load mitigator from the test was restraightened and modified by cutting notches every four inches (to decrease rigidity) and used for test No. 2. Figure 9 shows the results of the second test. A new mitigator which had been notched the same as for test No. 2 was installed for test No. 3. Figures 10 and 11 show the results of test No. 3. Following test No. 3, the mitigator was straightened and every other section removed, as shown in Figures 12 and 13 for test No. 4. The MA5 component plate stiffening rod, which attach between the MA5 plate and the Teller Light mounting cone, were removed for test No. 4. Figures 12 and 13 and 14 show the results of test No. 4. For tests No. 5, a new thin mitigator was used. Figure 15 shows the test results. The mitigator was straightened and used for test No. 6. Figures 16 and 17 show the results of test No. 6. A new mitigator (same as for test No. 5) was installed for test No. 7. Figure 18 shows the parachute lines used to suspend the unit for test Nos. 7 and 8. Figures 19 through 21 show the results of test No. 7. The mitigator was straightened and used for test No. 8. Figure 22 shows the test results for test No. 8.

FIGURE 7 DES-3 AFTER TEST NO. 1.

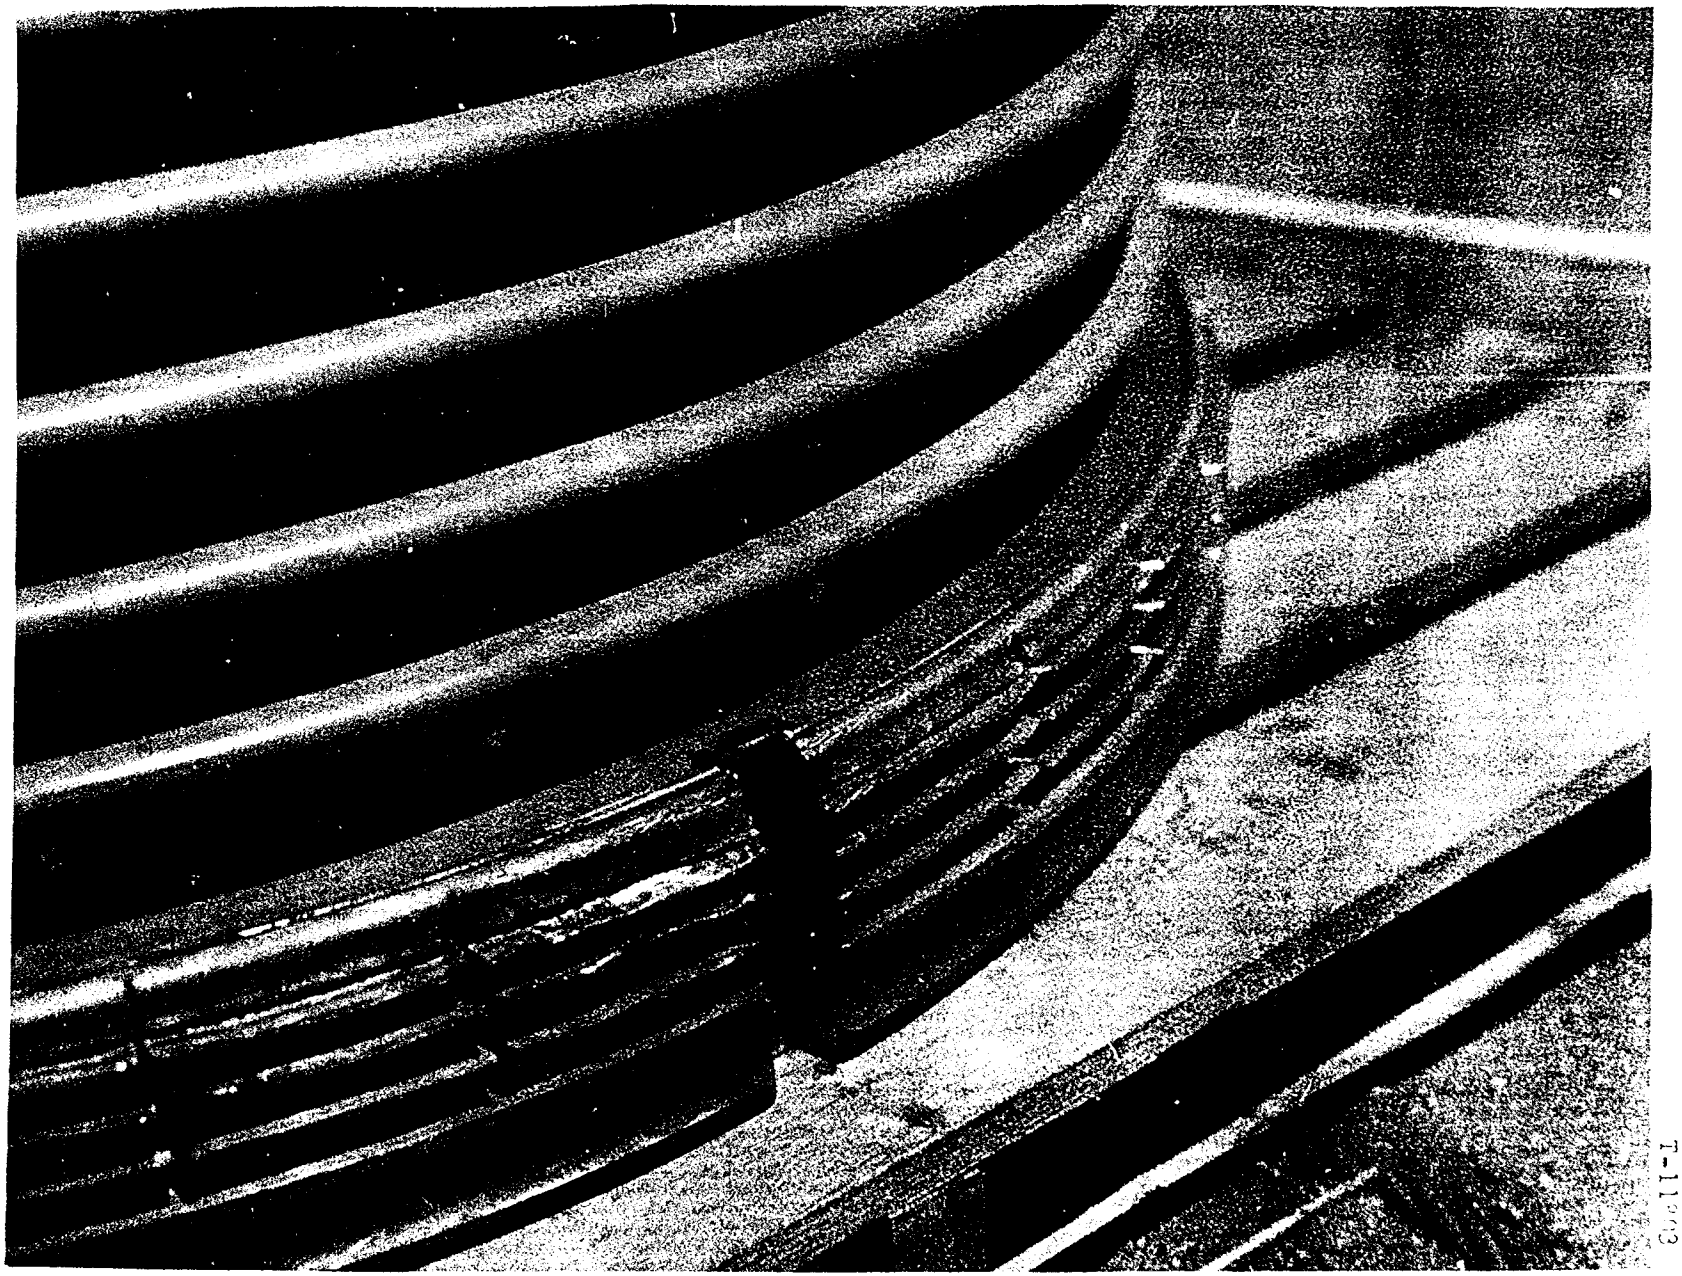
FIGURE 9 LEAD MITIGATOR AFTER TEST NO. 2.

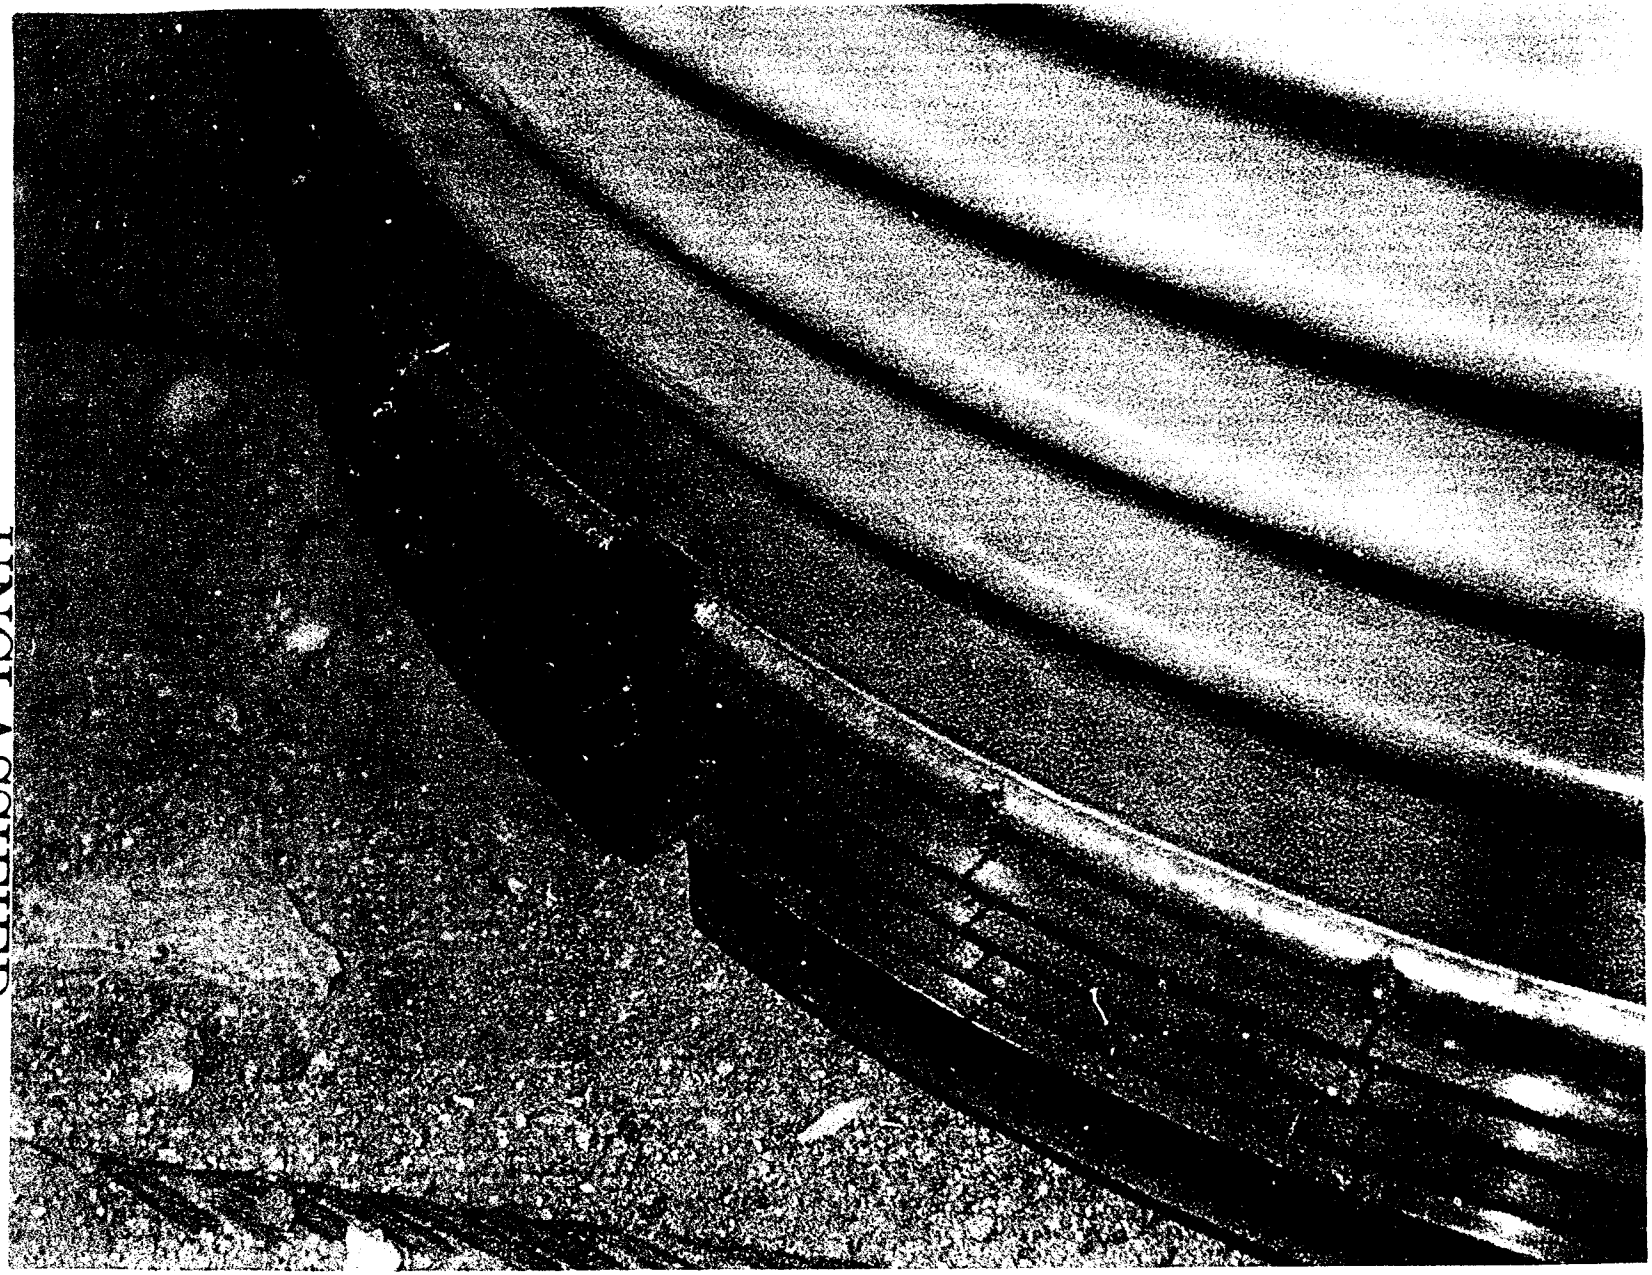
FIGURE 10 LEAD MITIGATOR AFTER TEST NO. 3.

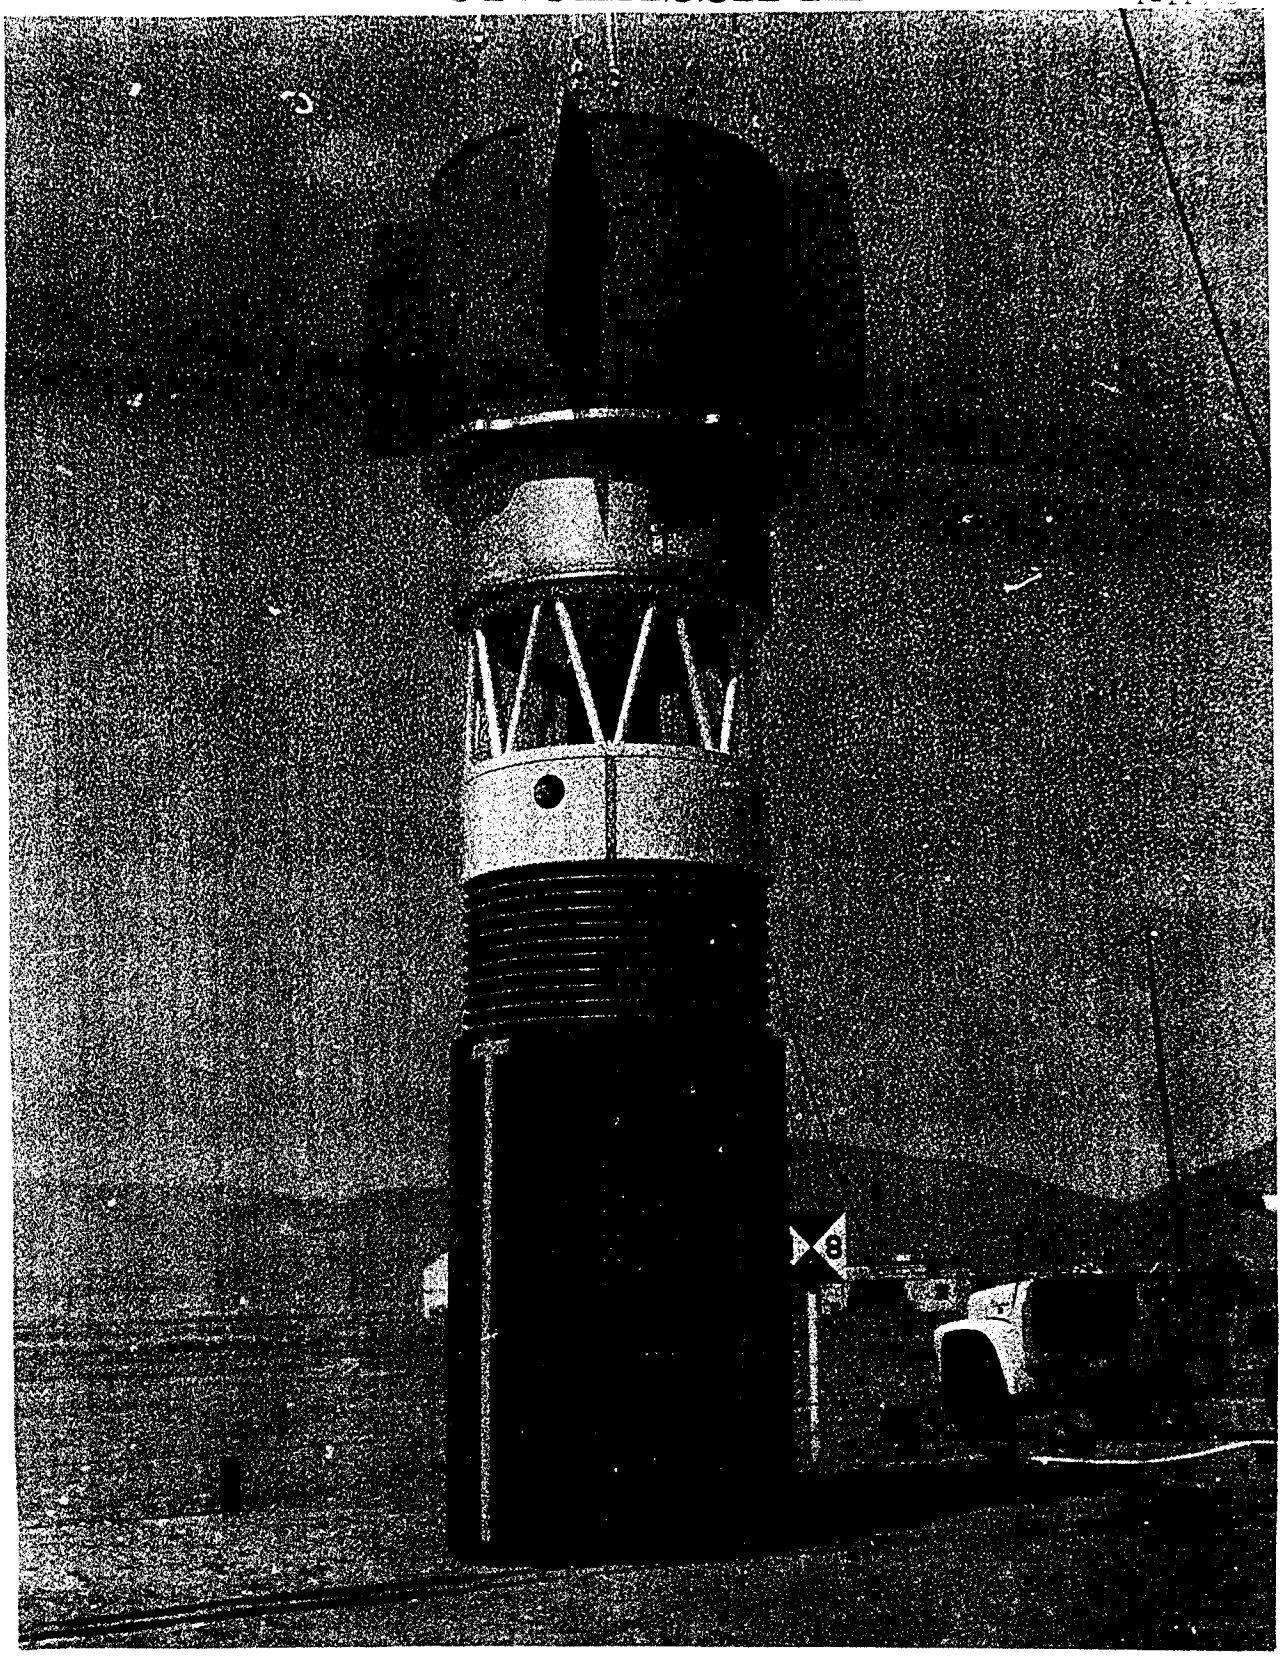
FIGURE 11 DES-3 AFTER TEST NO. 3. D#66-7208

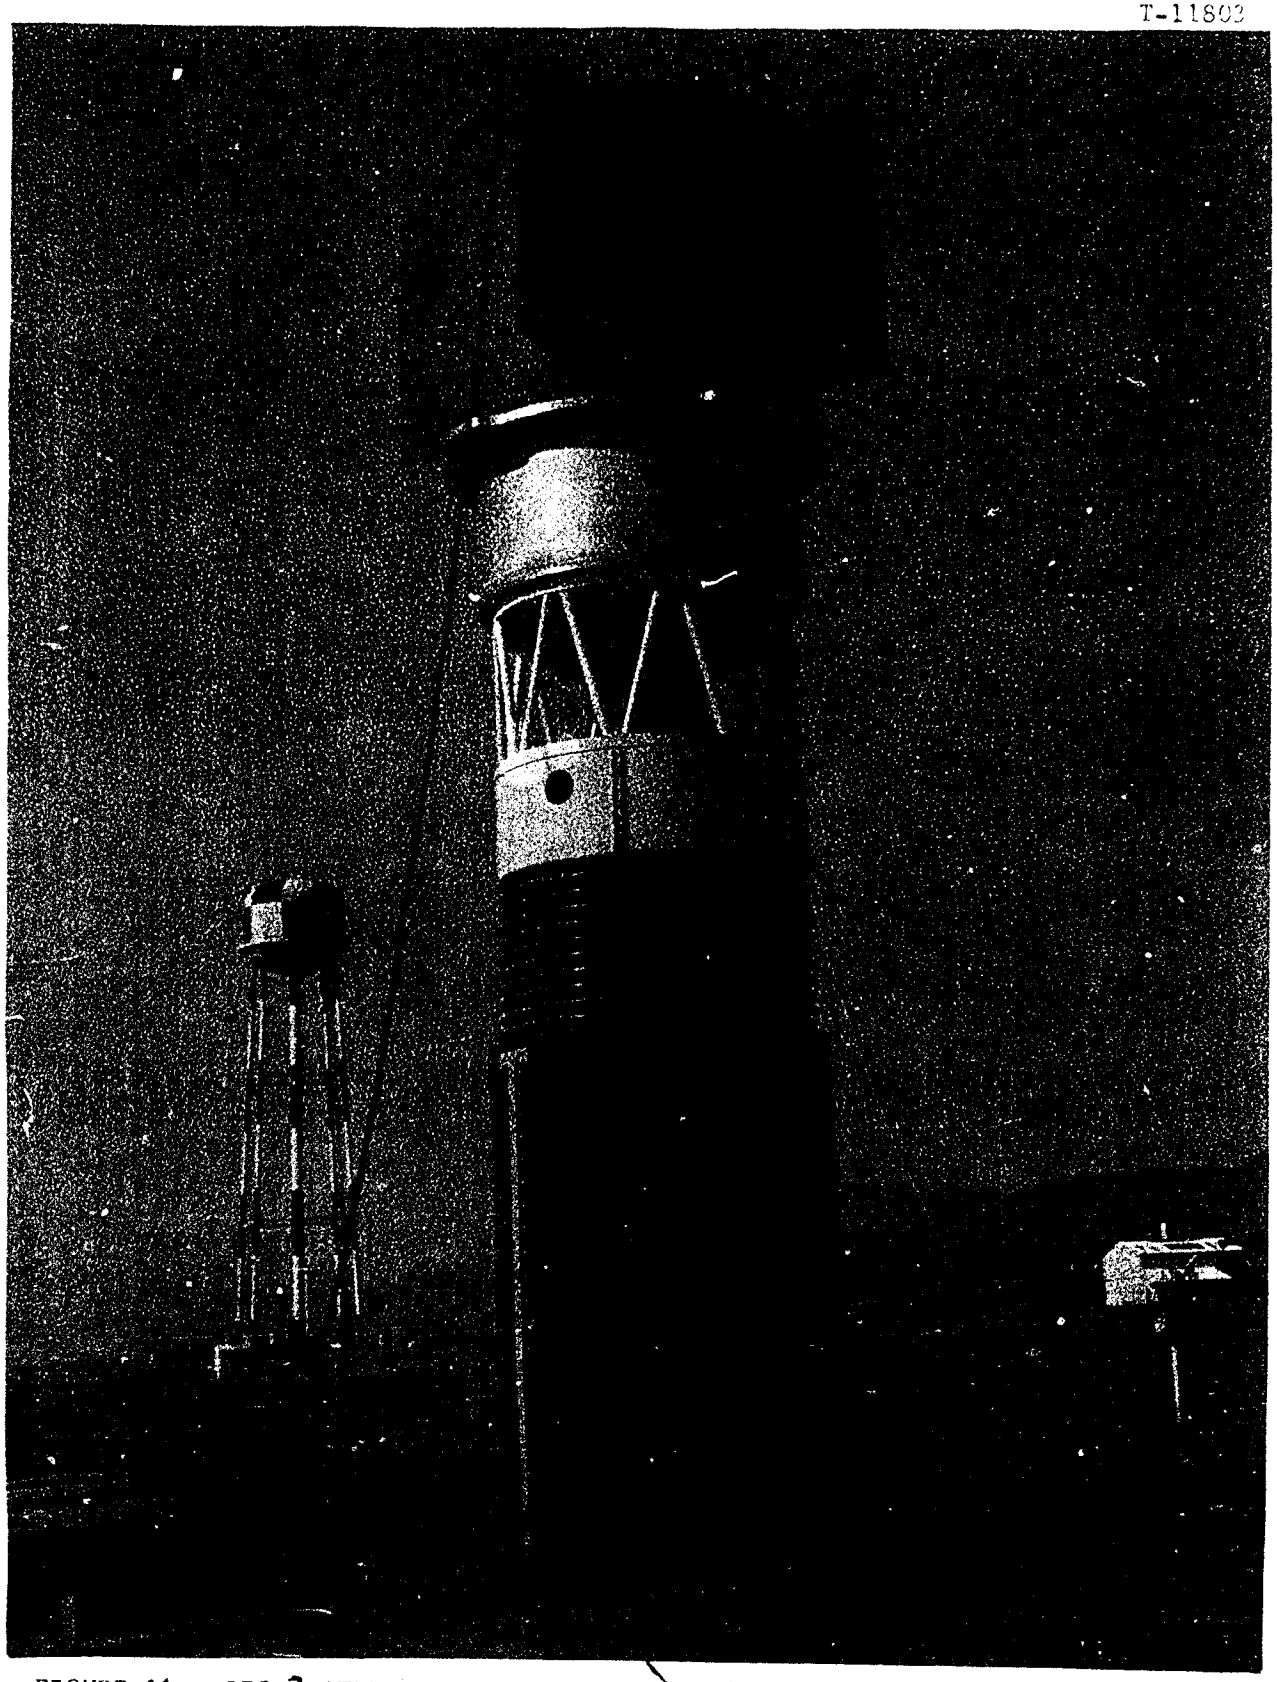
FIGURE 14 DES-3 AFTER TEST NO. 4.

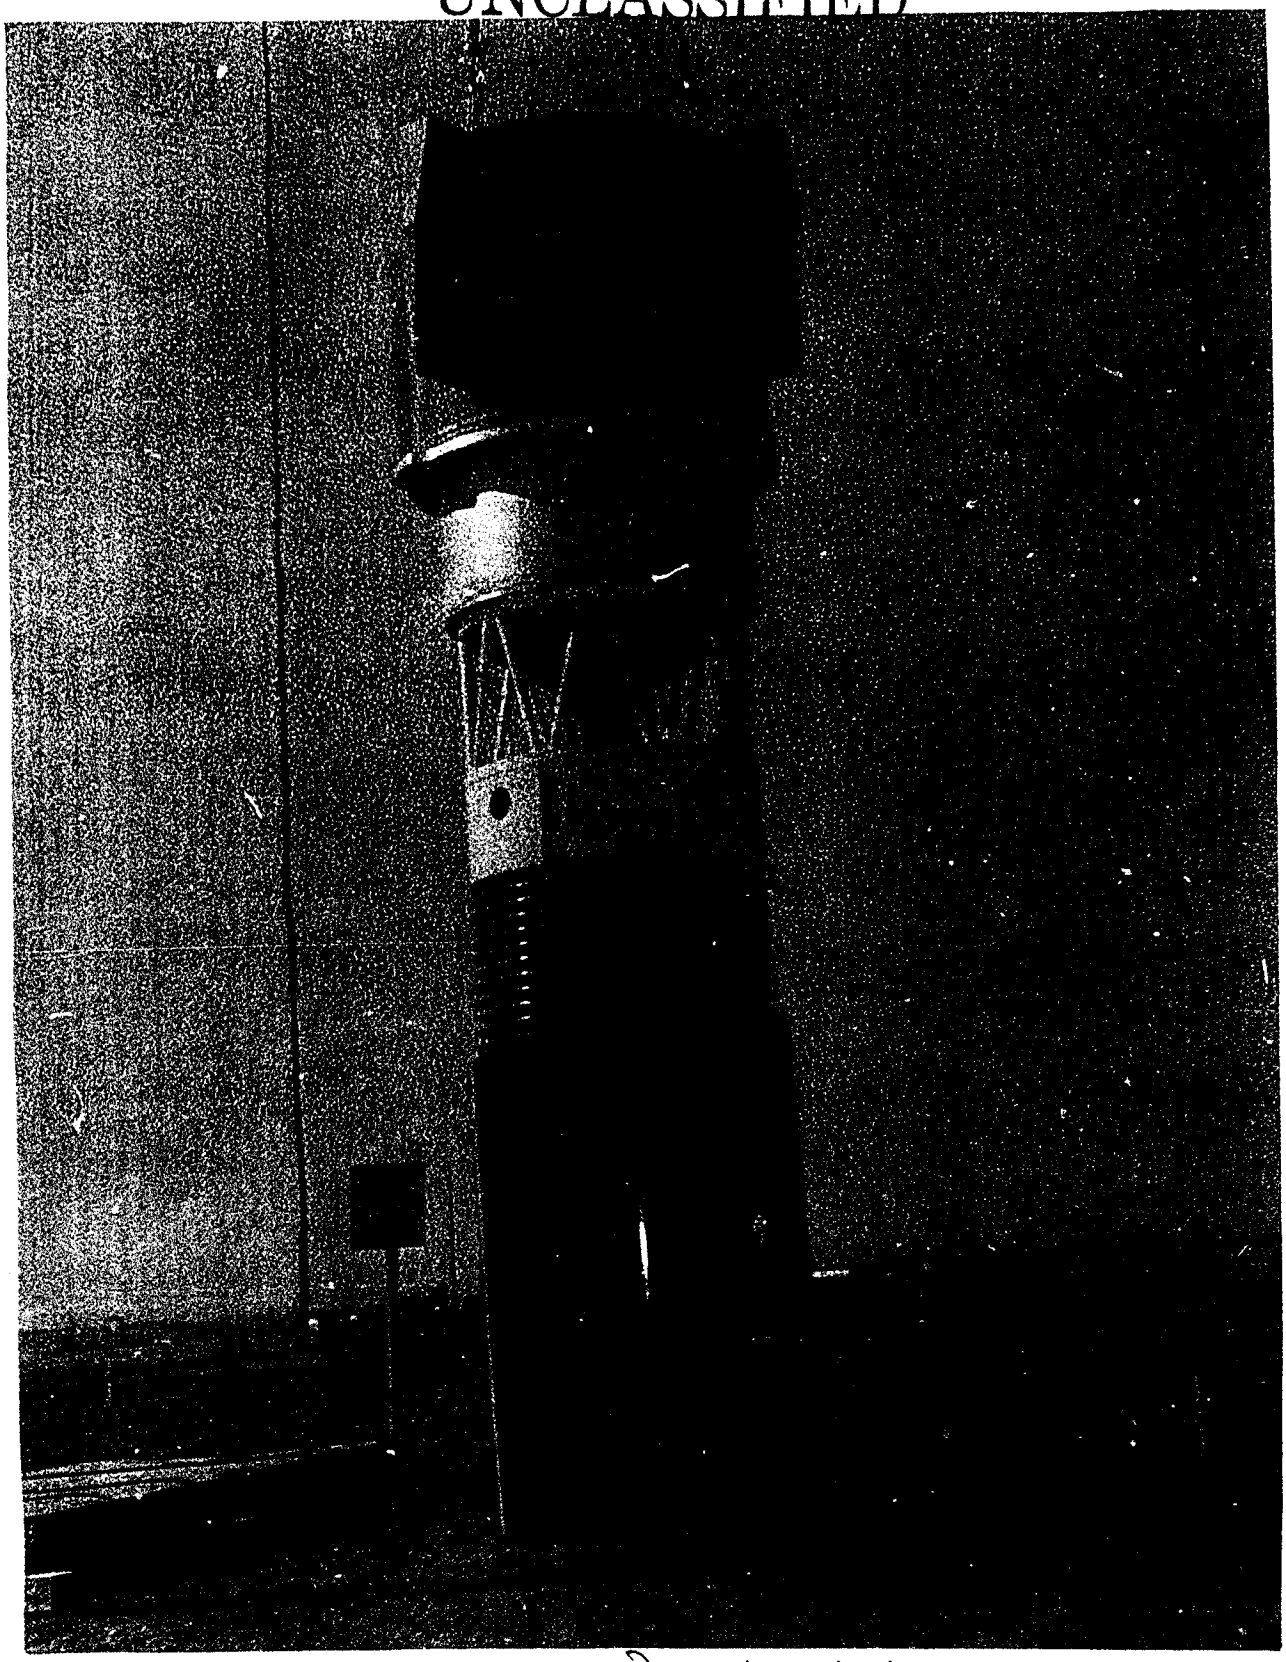
FIGURE 16 DES-3 AFTER TEST NO. 6. D#66-7147

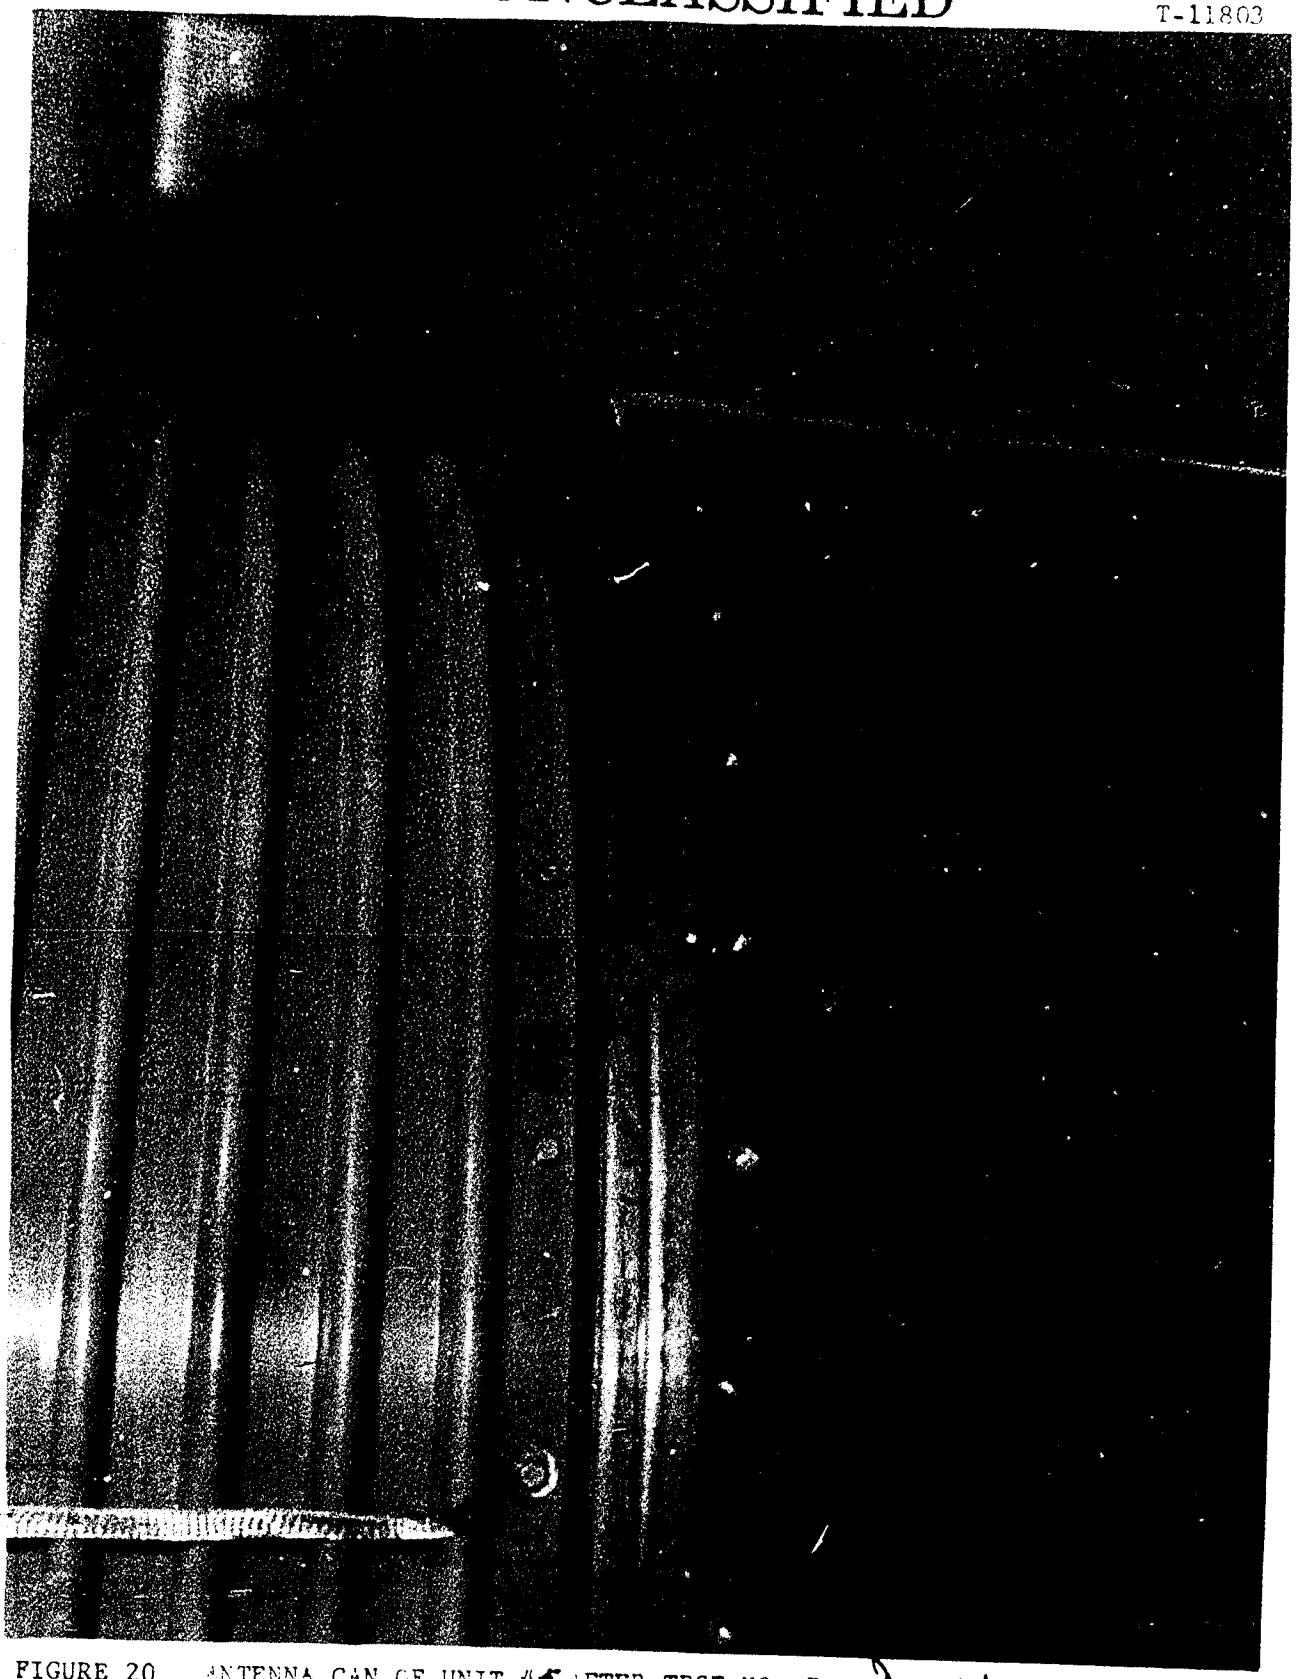
FIGURE 20 ANTENNA CAN OF UNIT #5 AFTER TEST NO. 7.

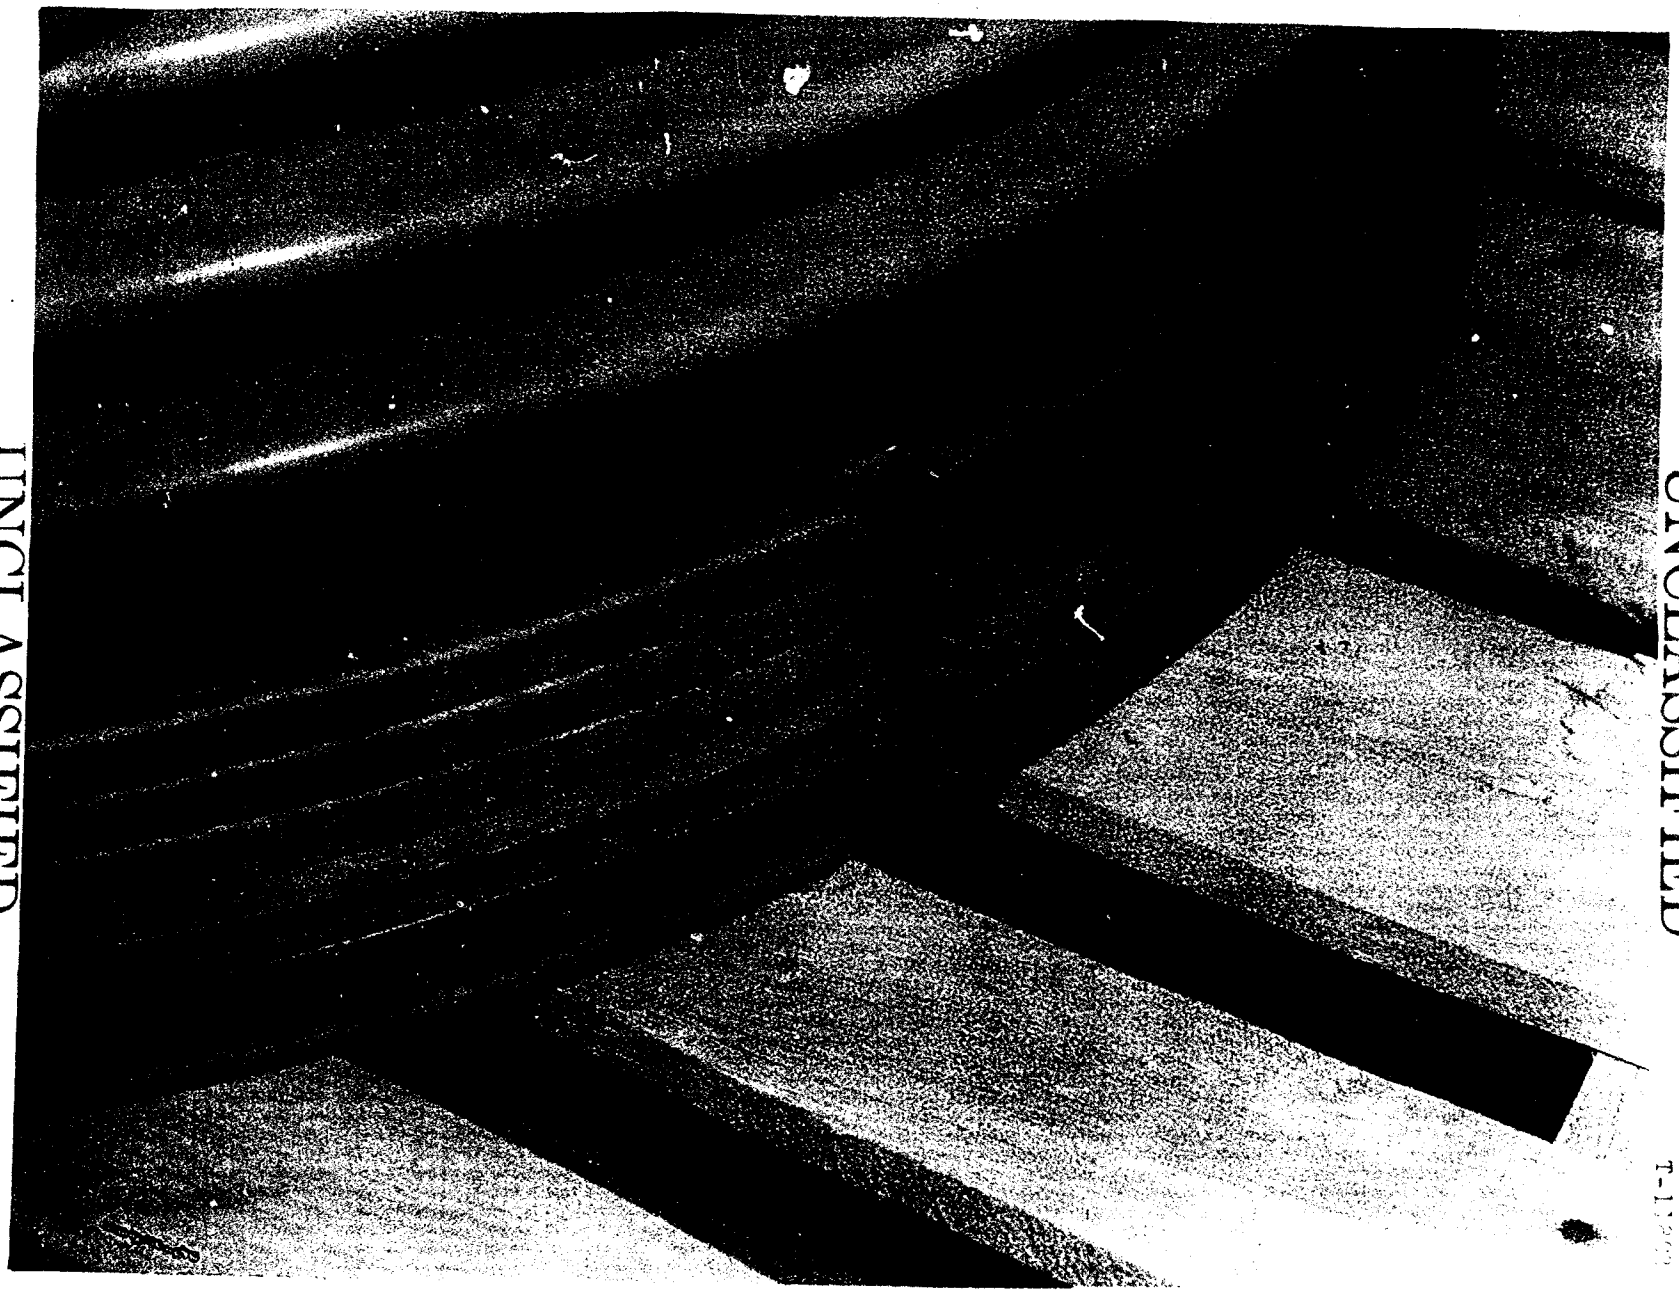
FIGURE 22 LEAD MITIGATOR AFTER TEST NO. 8. D#66-7160
