SAND94—0945 • UC—335
Unlimited Release
Printed April 1994

Evaluation of Scanners for C-Scan Imaging in Nondestructive Inspection of Aircraft

John H. Gieske

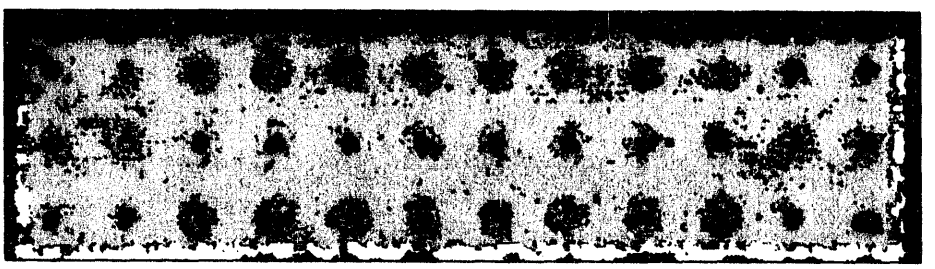
Reference Sample, 0.040 inch thickness with no corrosion

Krautkramer, Branson, Hocking manual scanner. No corrosion is shown.

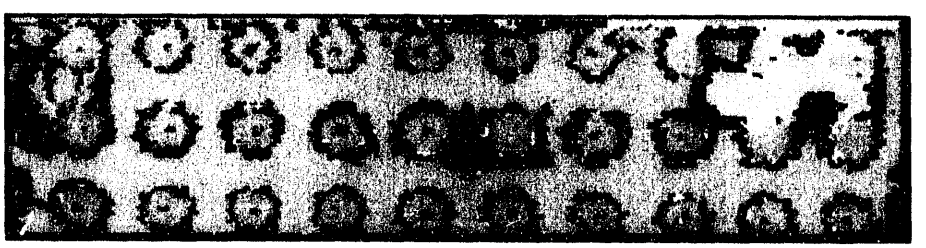
DuPont, CalData, Zetec automated scanner. Corrosion is shown in black and yellow

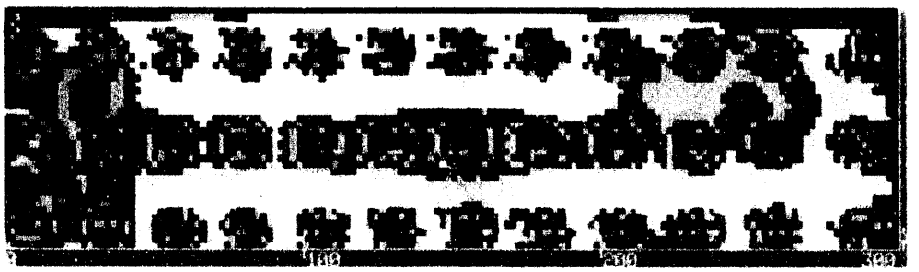
SAIC Ultra Image International manual scanner. Corrosion is shown in orange, yellow, and green.

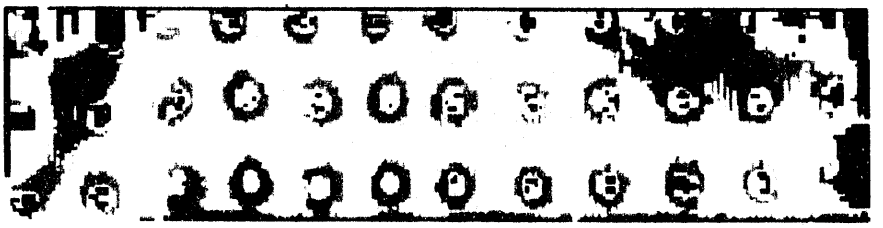
McDonnell Douglas semi-automatic scanner. Corrosion is shown in orange and red.

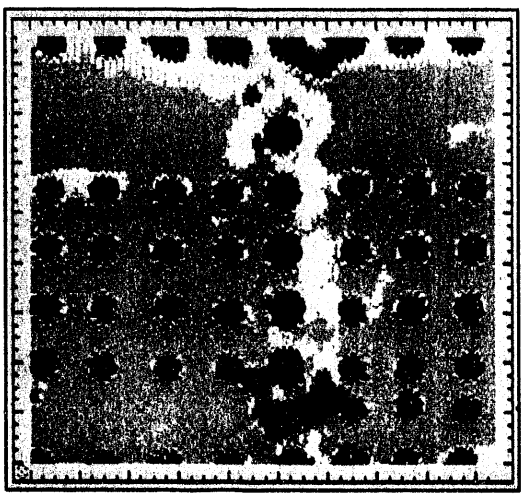
Dupont image of the corrosion shown in yellow.

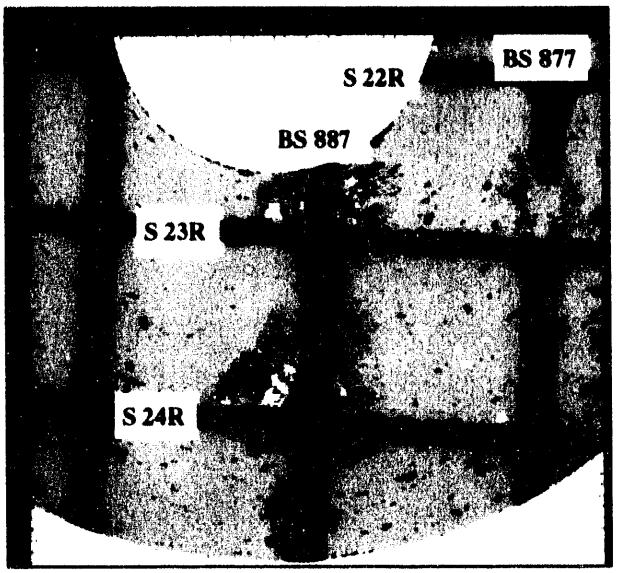
Corrosion is shown in orange arround BS 877 and BS 887.

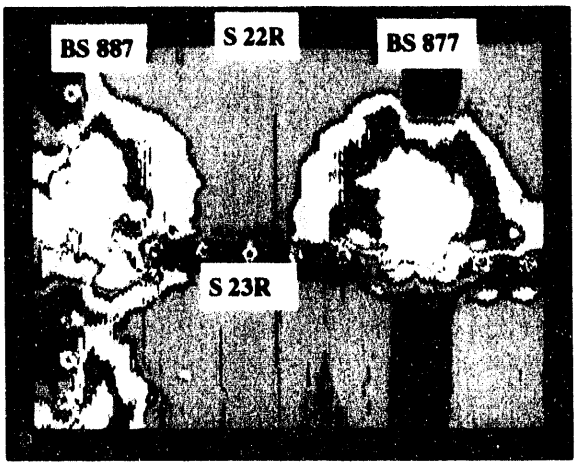
Corrosion is shown in areas around BS 877 and BS 887.

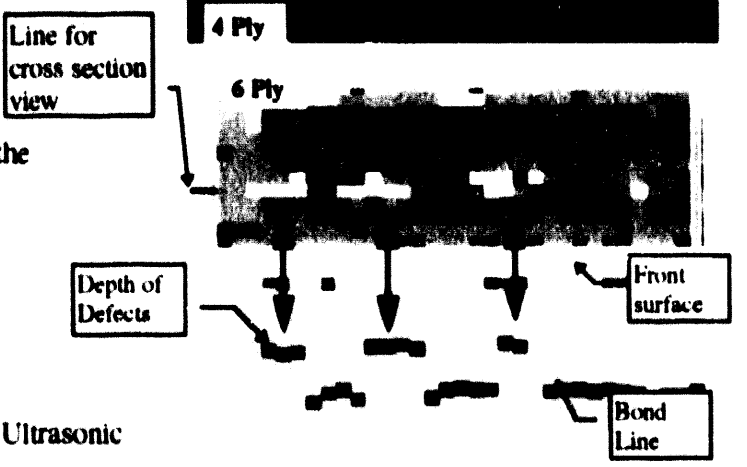
Panametrics automated scanner image of the four and six ply regions of the sample. The defects are in yellow.

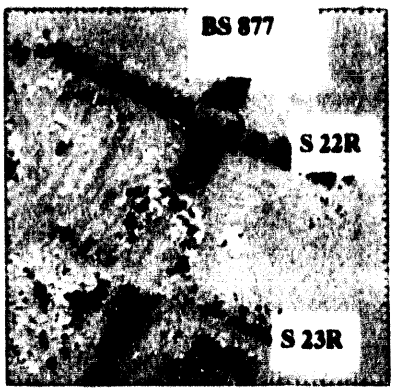
Krautkramer Branson manual ultrasonic C-scan image showing corrosion in yellow. Gray area in the image is missing data due to labor intensive manual scanning when insufficient time is taken to cover all data points.
