Forensic Analysis of Faulted NSTX-U Inner Poloidal Field Coil

Joseph R. Petrella Jr., Irving J. Zatz, Stefan Gerhardt, Clayton Myers, and Mark D. Boyer, *Princeton Plasma Physics Laboratory*

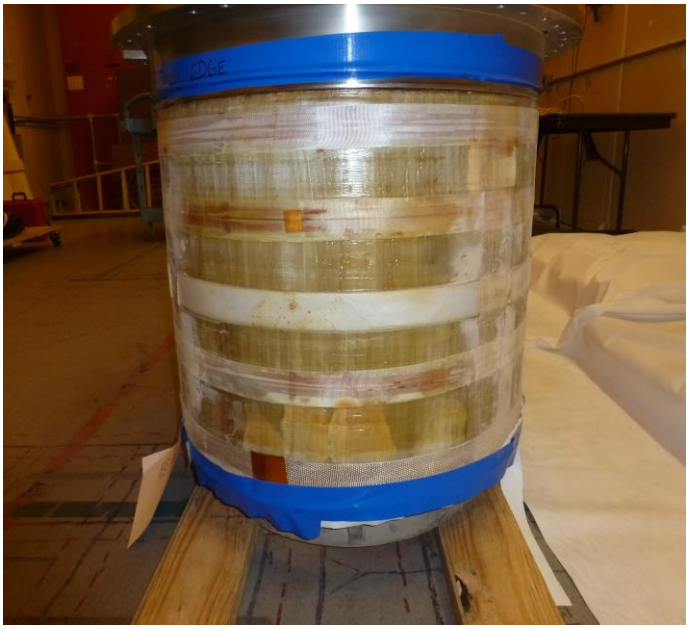
Fig. 4 – PF1A-U Exterior with shields removed

die-grinder, thereby exposing the overall circumferential surface of the coil pack (Fig. 4). High-pot electrical tests at voltages ranging from 500 to 5,000 volts were repeated on the shield-less coil on August 26, 2016 and compared to the previous tests. The comparison of the electrical tests was unremarkable. It is noteworthy that on June 6, 2016, approximately one month prior to the blockage event, the leakage current was measured to be 9uA at 5kV.

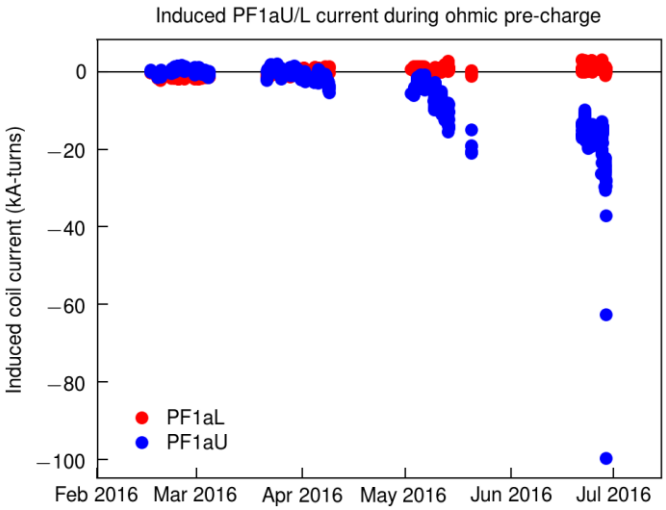
Fig. 3 – Gradual change in the inductance of PF1A-U over time

The induced PF1A-U coil currents generated during routine plasma operations can be retrospectively assessed because the ohmic coil (the central solenoid) applies a consistent loop voltage to the PF1A-U coil immediately before each plasma discharge. More specifically, the ohmic coil is ramped to a pre-charge current of +20 kA before the initiation of the plasma. This ohmic current ramp applies the same ~2 V of inductive loop voltage to the PF1A-U coil in every discharge. As such, the PF1A-U flux loop measurements could be examined over several months of operations to determine if currents were being induced in an electrical fault in the PF1A-U coil. Fig. 3 illustrates the total induced current in PF1A-U as inferred from the poloidal flux loop measurements. These data are obtained by computing the mutual inductance coupling matrix between the two flux loops and the coil and then inverting the coupling matrix to extract the coil current. The PF1A-U induced current measurements (Fig. 3, blue) show a clear degradation that begins toward the end of the March/April run period. This degradation continues through the May and June run periods and then accelerates rapidly on the final run day before operations were halted. Approximately 100 kA-turns of current were induced in PF1A-U during the ohmic pre-charge for the final plasma shot. Similar measurements for the PF1A-L coil (Fig. 3, red) show that PF1A-L did not experience any degradation over the course of the run. Effective July 22, 2016, PF1A-U operations were suspended.

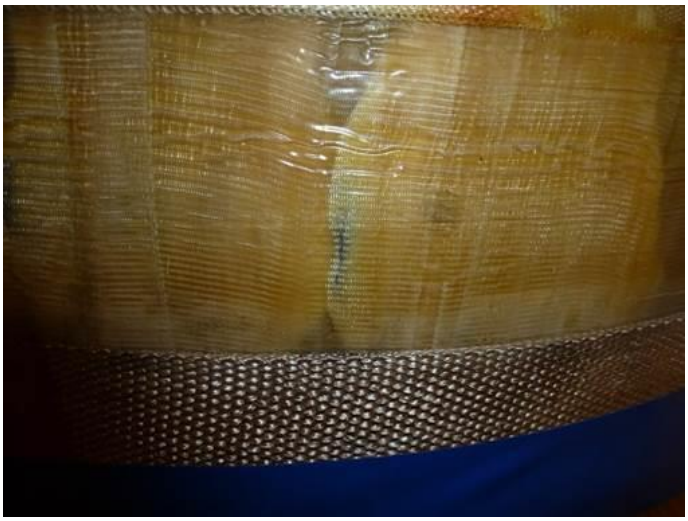
Fig. 5 – PF1A-U ground wrap delamination

Fig. 5 illustrates a focused view of the outside surface of PF1A-U coil. Short, dark vertical lines were observed that evidence separations/tears in the ground layer wrap. An internal coolant path leak in the electromagnet may communicate with these separations as potential exit points for coolant. Removal of the shields evidenced numerous ground wrap delamination areas identified by their lighter color and confirmed by lightly tapping the areas with a tool that audibly noted hollows beneath the ground layer.

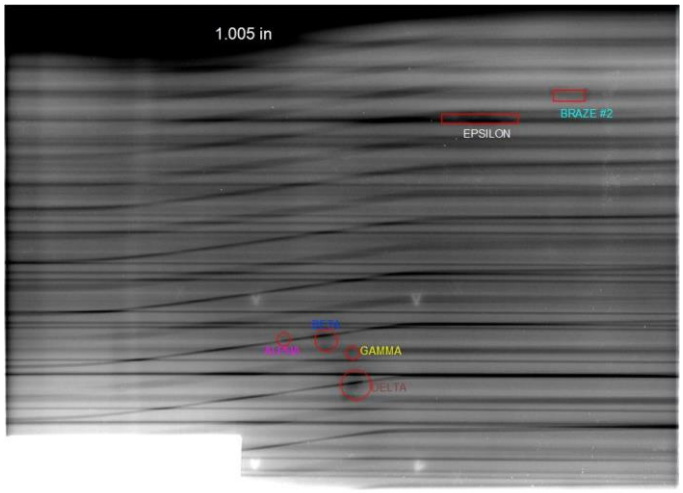
Fig. 7 – Approximate references for anomalies identified in region 0_1A

On August 30, 2016, the PF1A-U coil/mandrel was transported by PPPL truck to Mistras Group, Inc. (Mistras) in Marcus Hook, PA, and staged for gamma radiographic examination. On September 1, 2016, Petrella traveled to Mistras to observe a radiographic study of the PF1A-U. Mistras personnel employed an Iridium-192 radioisotope source to irradiate 14”x17” photostimulable phosphor plates placed in angular segments around the exterior of the PF1A-U coil. The exposed phosphor plates were digitized in a Virtual Media Integration (VMI) model 5100MS-C plate scanner. The PF1A-U exterior circumference was marked with 8 angular regions labeled “0” through “7” and a symmetric centerline was designated proximal to the mid-plane of the coil pack. Image segments located above the mid-plane area toward the lead-out flange were designated “A” and images below the mid-plane proximal to the tapered end of the mandrel were designated “B”. Correspondingly, recorded images were identified in segmental fashion, i.e., “image 0_1A”. A total of nineteen (19) images were recorded during the September 1, 2016 imaging session with scale reference. Images were surveyed for anomalies by Mistras representatives using VMI Starrview 8.0 NDT software. The September 1, 2016 survey identified (4) anomalies with signatures indicative of in-line braze joints (Fig. 6). The locations of these anomalies corresponded proximally to the locations identified in the Manufacturing Process Outline/Traveler (MPO) provided by the coil manufacturer, Everson Tesla, Inc. Additionally, the September 1, 2016 survey identified an anomalous region proximal the mid-plane of the coil pack section at the angular proximity of the lead-in/out area.

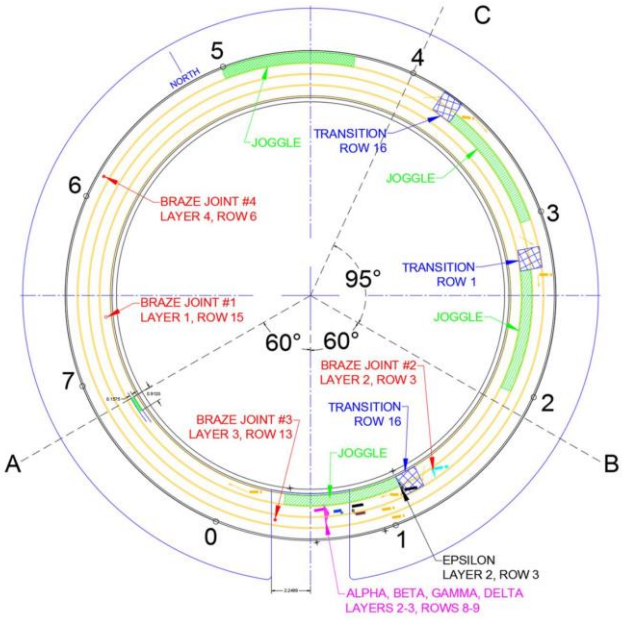
Fig. 8 – Identified sectioning cuts "A, B and C"

A Peer Review was held on September 19, 2016 to establish consensus on the proposed destructive testing plan based on the results of the radiography. Determination of the origin and extent of the internal anomalies observed in the radiographic survey necessitated visual and physical access to individual PF1A-U conductor segments. The combined observed and deduced locations of braze joints and anomalies guided the selection of three feature-free areas for segmentation of the coil pack. The three sectioning cuts were proposed and identified as cuts ‘A’, ‘B’ and ‘C’ as noted in Fig. 8. Section

A-B would be of the greatest interest because it contained the five principal anomalies, alpha thru epsilon, identified by radiography, plus the leads and two of the four braze joints.

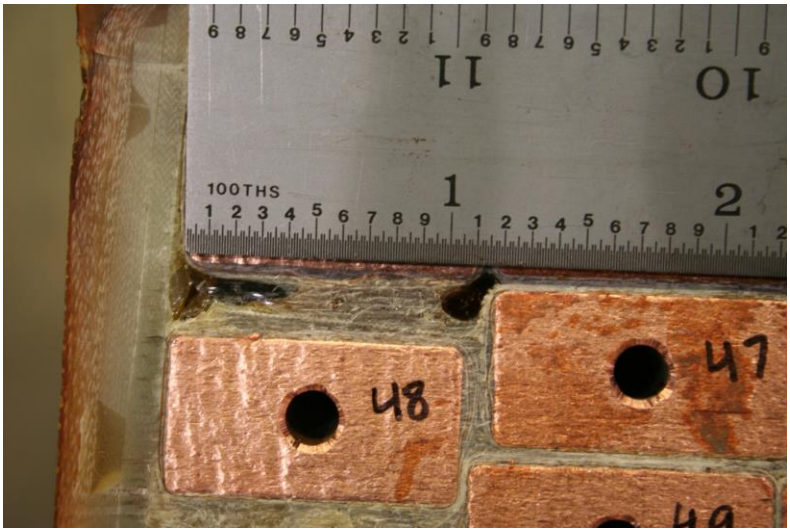
Exterior visual examination of cutting planes A and C, left and right, evidenced insulation anomalies that were also observed during the milling process (Fig. 9). Cutting plane B, left and right, evidenced a separation between conductor layers two (2) and three (3) from approximately conductor row three (3) to conductor row sixteen (16). Observed conductor spacing, insulation characteristics, and conductor keystoning were noted and photographed (Fig. 10). Examination of the insulation wrap sequence evidenced that each conductor was wrapped with a half-lap co-wound glass/Kapton layer with the glass portion laid-up against the conductor surface. A glass-only half-lap layer was observed to be wound over the co-wound glass/Kapton layer. Each layer-to-layer region evidenced an additional flat-laid glass layer.

Fig. 9 – Coil pack section plane C void

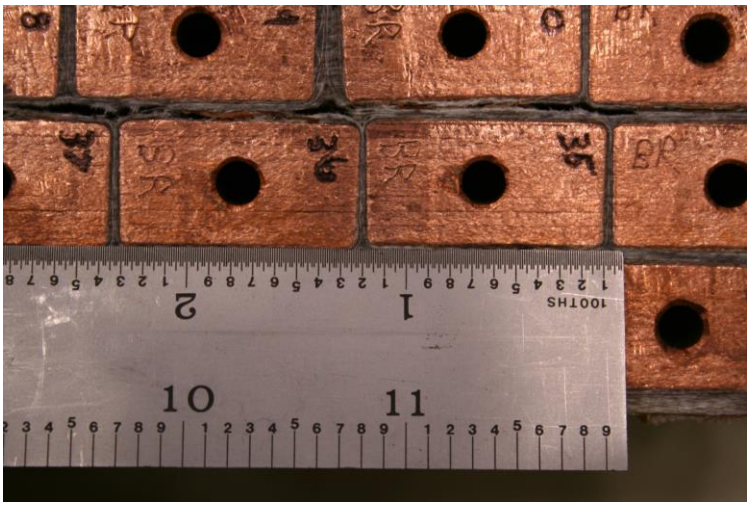
Fig. 10 – Coil pack section plane B keystoning

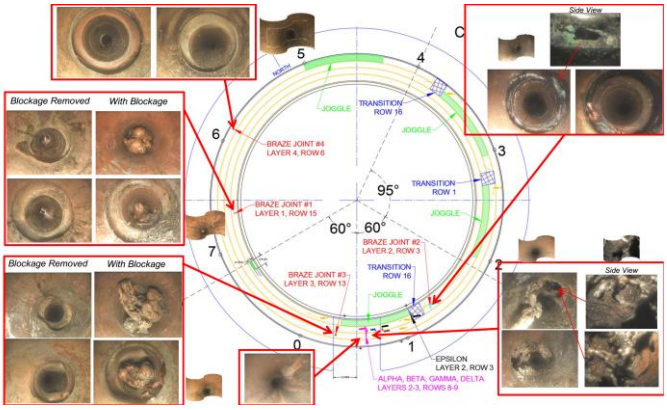
Each coil segment cooling path was surveyed for visual anomalies and photographed and videoed with the Olympus videoscope if anomalies were observed. It is noteworthy that the braze joints and anomaly "delta" (features visible from the cooling paths) radial positions predicted in the radiographic triangulation method were accurate and verified through the cooling path visual examination. A compilation of findings mapped to a plan view of the PF1A-U coil is illustrated in Fig. 11.

Fig. 11 – Borescope findings compilation

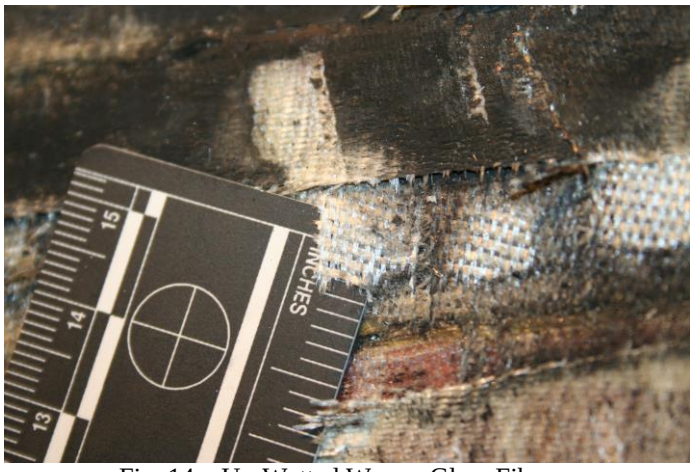
An area of damaged electrical insulation was observed that measured approximately 10 inches in height and 12 inches in length (toroidally) between layers 2 and 3 (Fig. 12 and Fig. 13). Areas of un-wetted woven glass fibers were observed proximal to the damaged region (Fig. 14).

Fig. 14 – Un-Wetted Woven Glass Fibers
