PNNL-26328

# NDE Technology Development Program for Non-Visual Volumetric Inspection Technology

## Technology Screening Report

**March 2017**

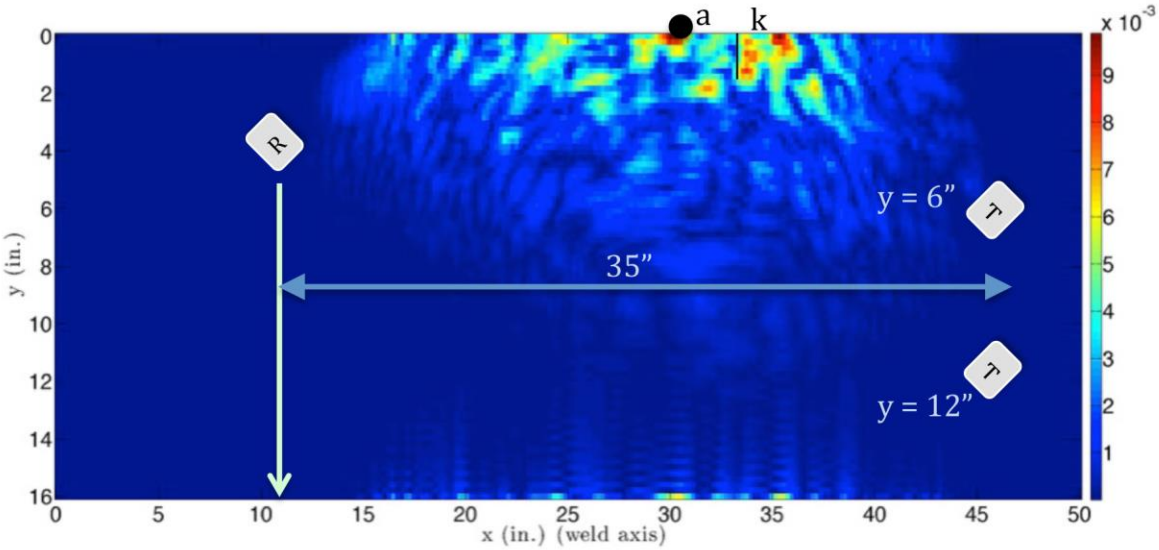
Penn State detected Pit "a" using the pitch-catch technique with the transmitter and receiver separated by 35 inches to simulate the distance between adjacent air slots in the DST. In the pitch-catch mode, Pit "a" was detected when the transmitter was closer to the defect. The transmitter ranged from 17 to 24 inches from the flaw during the three different scanning positions. The results compiled using SAFT showed a clear separation between Pit "a" and Notch "k." The SNR for Pit "a" ranged from 4 to 30 dB (Figure 7.5).

**Figure 7.5**. SAFT-Reconstructed Image Combining the Results Obtained from Three Transmit-Receive Configurations

Penn State detected Notch "k" using the pitch-catch technique with the transmitter and receiver separated by 35 inches. In the pitch-catch mode, Notch "k" was detected when the transmitter was closer to the defect. The transmitter ranged from 14 to 21 inches from the flaw at the three different scanning positions. The results compiled using SAFT show a clear separation between Notch "k" and Pit "a." The SNR for Notch "k" ranged from 2.5 to 31 dB (Figure 7.5).

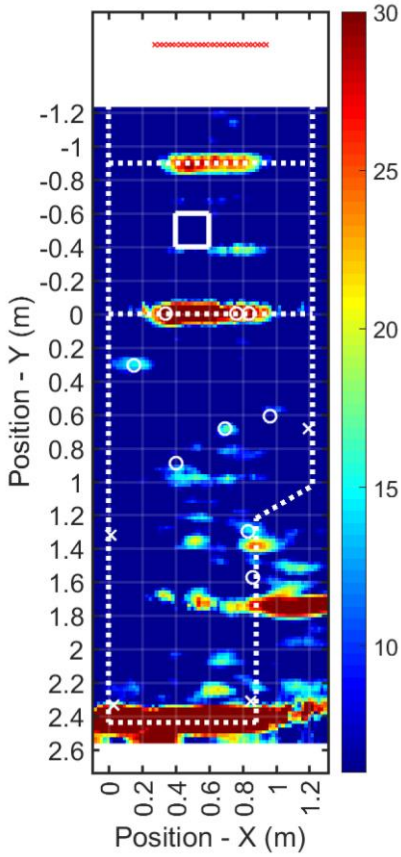
SwRI did not detect Pit “a” as this flaw was located in the transition weld. The weld produced a strong reflection from the transition from 7/8-inch to ½-inch plate and masked any response from the defects located in the weld (Figure 7.6).

**Figure 7.6**. SAFT Image Produced Using 57 kHz Data Set

SwRI did not detect Notch “g” because this flaw was located in the transition weld. A strong reflection was produced from the 7/8-inch to ½-inch plate transition weld, which masked any response from the defects located in the weld (Figure 7.6).

SwRI did not detect Notch "k" as this flaw was located in the transition weld. The 7/8 to ½-inch plate transition weld produced a large reflection and masked any response from the defects located in this region (Figure 7.6).

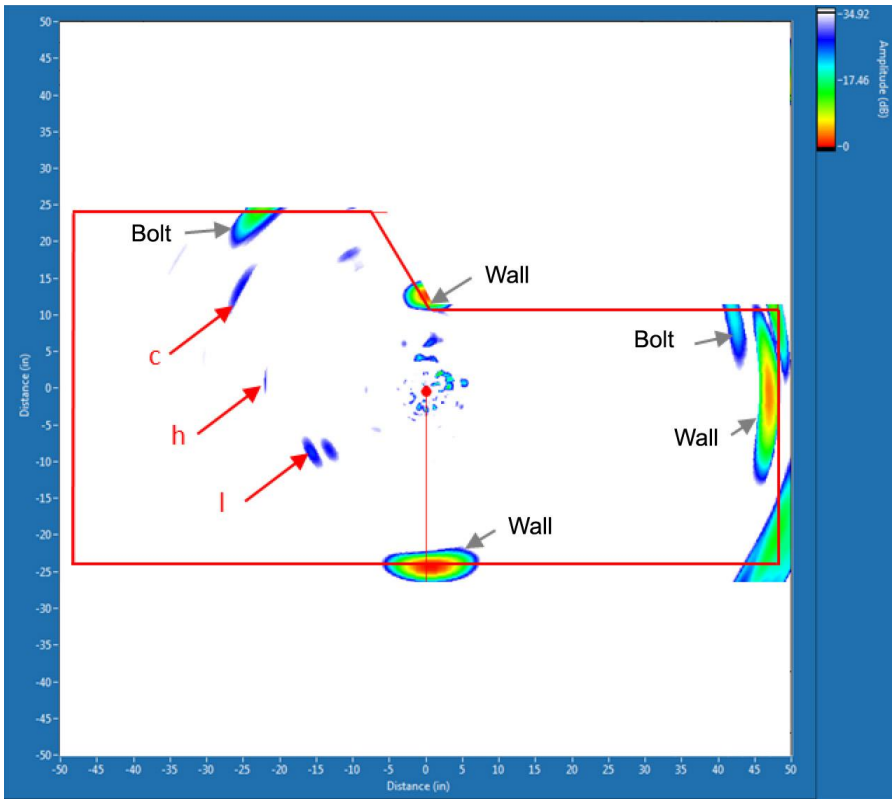
Pit “c” was detected by Guidedwave from four different transducer locations and two different excitation frequencies (150 and 165 kHz). The farthest position Pit “c” was detected from was 28 inches (Figure 7.10). Pit “c” was also detected in the composite images at both the 165 and 150 kHz excitation frequency (Figure 7.3 and Figure 25 in Appendix A, respectively). However, the composite images showed many other indications around this area that could be the result of sound bouncing between multiple defects, plate ends, and bolt holes. The SNR for Pit “c” ranged from 8.7 to 22 dB.

**Figure 7.10**. GWPA Scan on Plate 1 at Location 1 Pulsed at 150 kHz

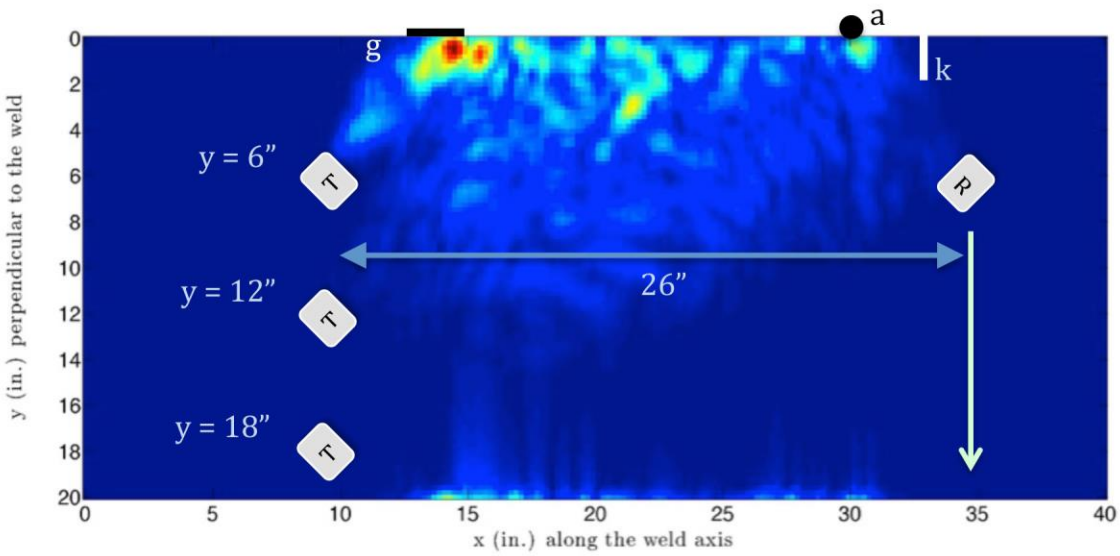
Penn State detected Notch "g" using the pitch-catch technique with the transmitter and receiver separated by 26 inches. In the pitch-catch mode, Notch "g" was detected when the transmitter was closer to the defect. The transmitter ranged from 8 to 19 inches from the flaw during the three different scanning positions. The results compiled using SAFT located Notch "g" within an inch of the true position. The SNR for Notch "g" ranged from 6 to 21 dB (Figure 7.14).

**Figure 7.14**. SAFT-Reconstructed Image Combining the Results Obtained from Three Transmit-Receive Configurations

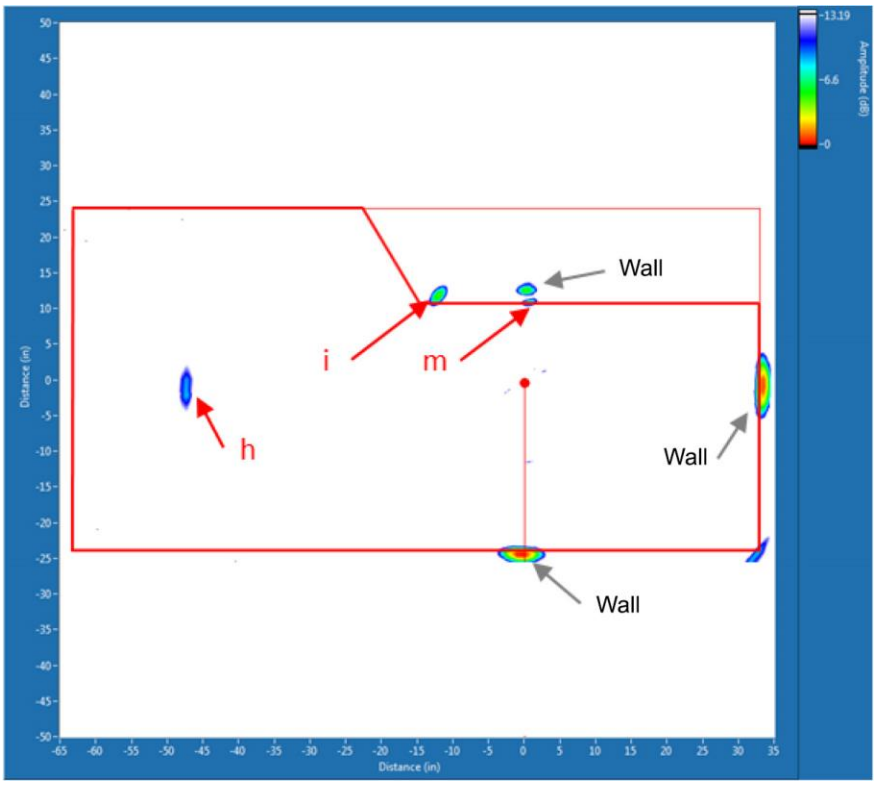
Notch “h” was detected from three different transducer locations using two different excitation frequencies (150 and 200 kHz). Transducer Location 3 was the farthest from Notch “h” at 36 inches (Figure 7.15). The SNR ranged from 6.8 to 11.7 dB. Notch “h” was also detected in the composite images at both the 165 and 150 kHz excitation frequencies (Figure 7.3 and Figure 25 in Appendix A, respectively). The composite images of this data show other indications around this area, which could be the result of sound reflecting between multiple defects, plate ends, and bolt holes.

**Figure 7.15**. GWPA Scan on Plate 1 at Location 3 Pulsed at 200 kHz

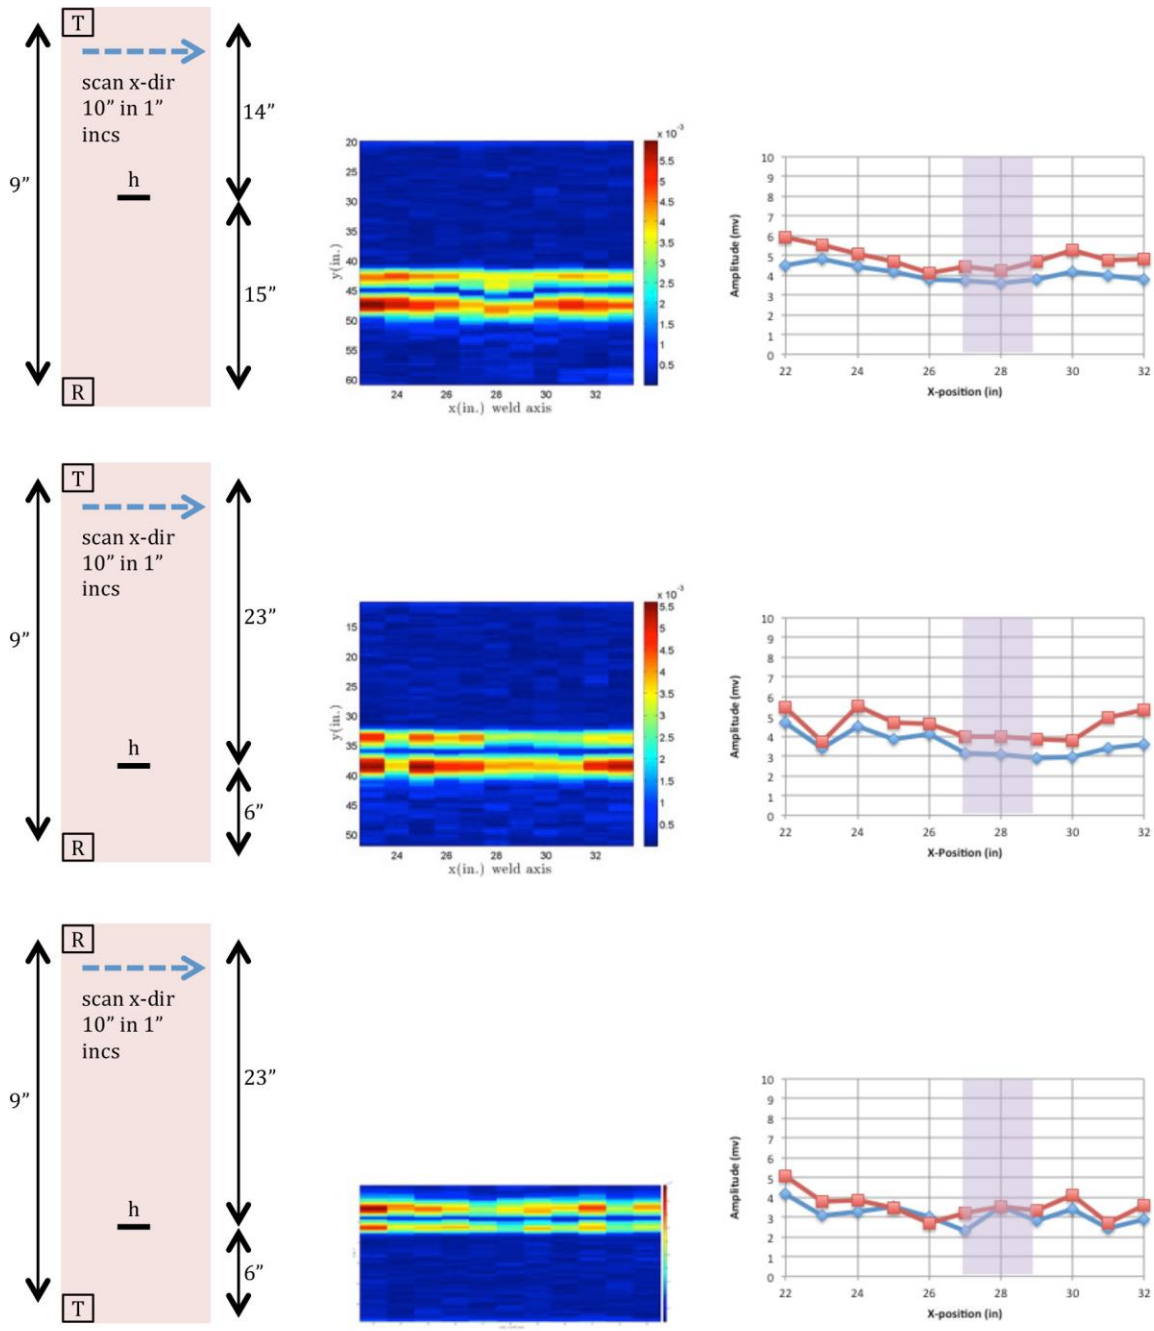
Penn State detected Notch "h" using the through-transmission mode with the transmitter and receiver separated by a fixed distance of 29 inches. In the through-transmission mode, Notch "h" was marginally detected when the transmitter and receiver were at varying distances of 23 and 6 inches or 14 and 15 inches from the flaw. The SNR for Notch "h" ranged from 17 to 20 dB. PNNL would like to note that the data provided does not have a corresponding image (Figure 7.16) to support such a high SNR value.

**Figure 7.16**. Test Schematic (*left*), B-scan (*middle*), and Summary Graph (*right*) for Notch "h"

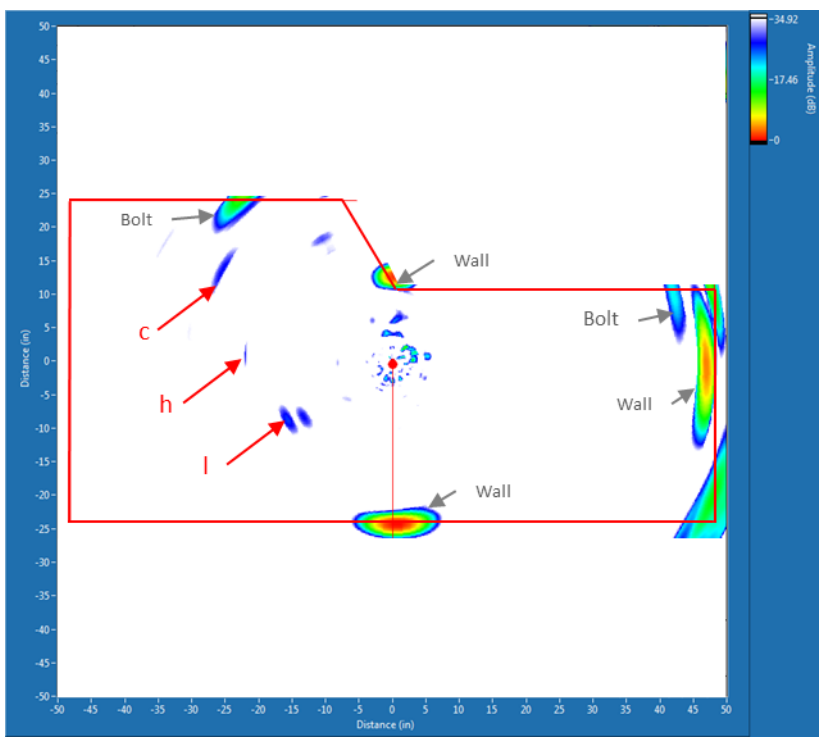
**Figure 9 GWPA scan on plate 1 at location 1. GWPA scan performed at 150 kHz.**

The center of the plate is commonly used as a starting point for GWPA inspections. At this location, location 1 (Figure 8), defects 'c', 'h', and 'l' were detectable as shown in Figure 9.

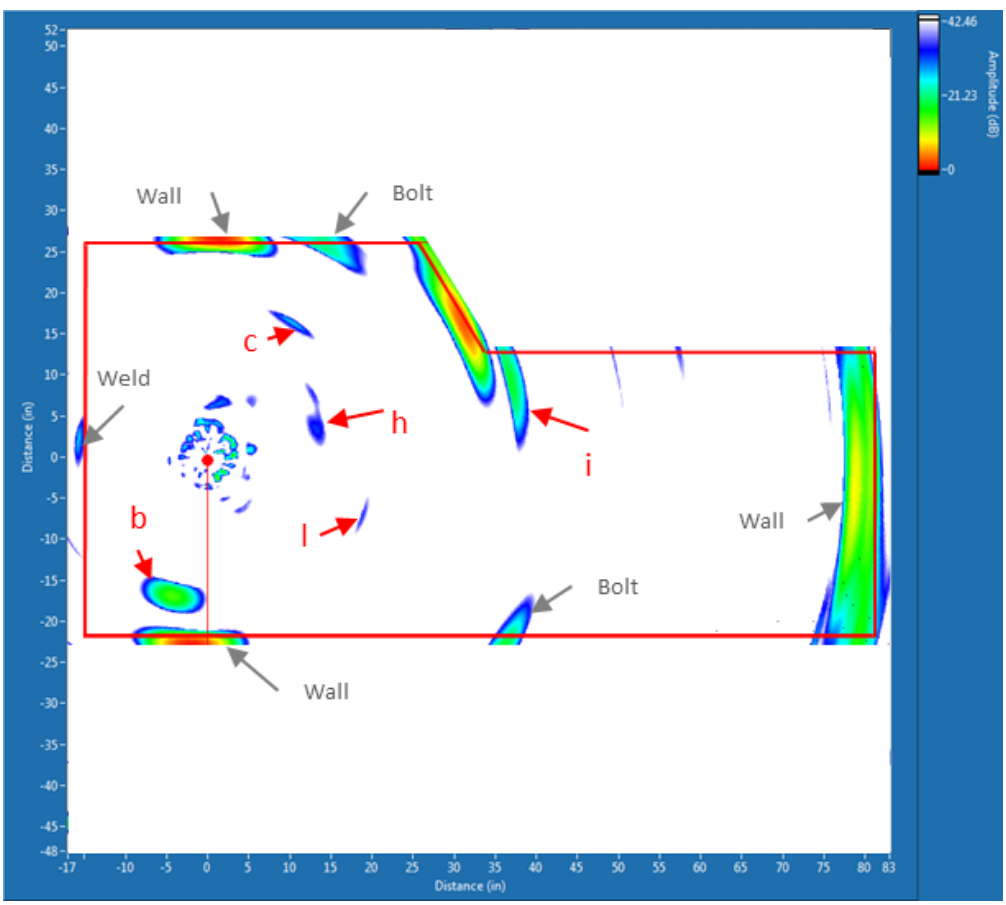
**Figure 11 GWPA scan on plate 1 at location 2. GWPA scan performed at 150 kHz.**

At the second location, location 2 (Figure 10), defects 'c', 'h', 'l', 'b', and 'I' were detectable as shown in Figure 11.

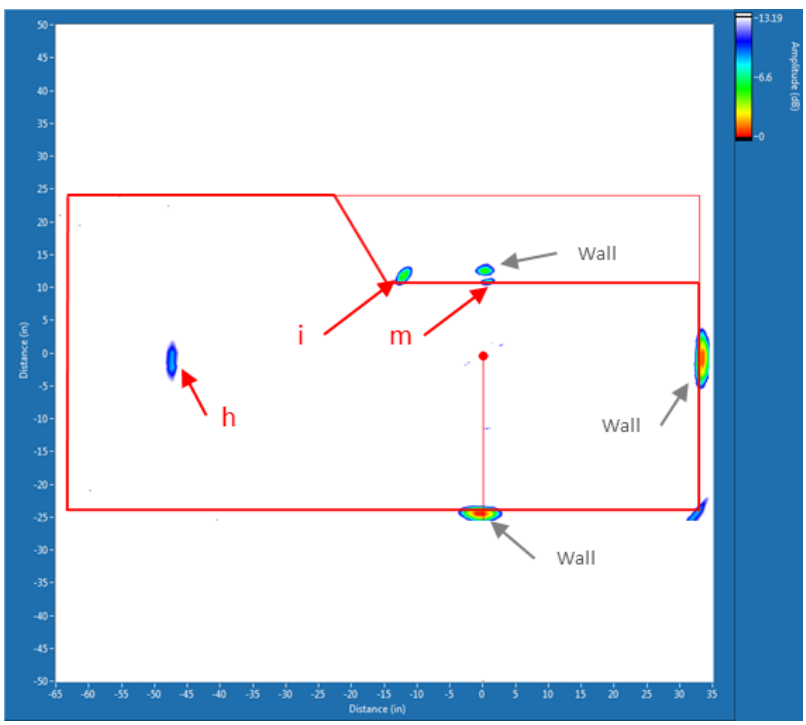
**Figure 13 GWPA scan on plate 1 at location 3. GWPA scan performed at 200 kHz.**

At location 3 (Figure 12), defects 'h', 'i', and 'm' were detectable as shown in Figure 13. To differentiate defect 'm' from the plate sidewall, the acquisition frequency was raised to 200 kHz.

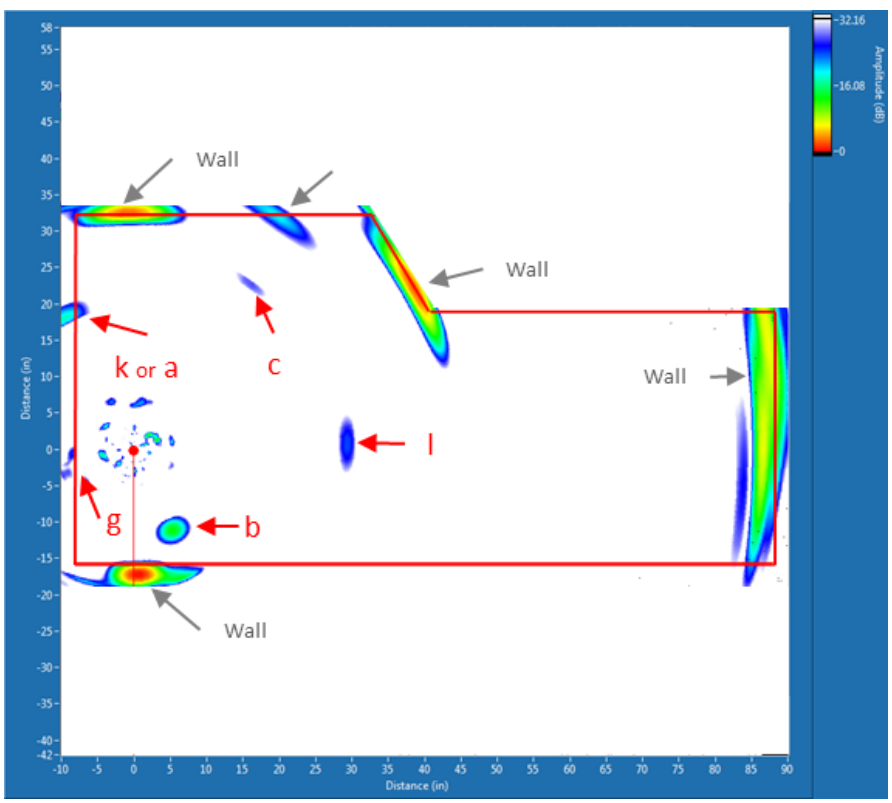
**Figure 15 GWPA scan on plate 1 at location 4. GWPA scan performed at 150 kHz.**

At location 4 (Figure 14), defects 'c', 'l', 'b', 'g', and 'k' or 'a' were detectable as shown in Figure 15. The indication is strong where defects 'a' and 'k' are. However, with the defects being very close together, it was not possible to separate the reflectors at this location. A-scans are provided for the defects in Figure 16 through Figure 19. The defect location is indicated with a red vertical cursor.

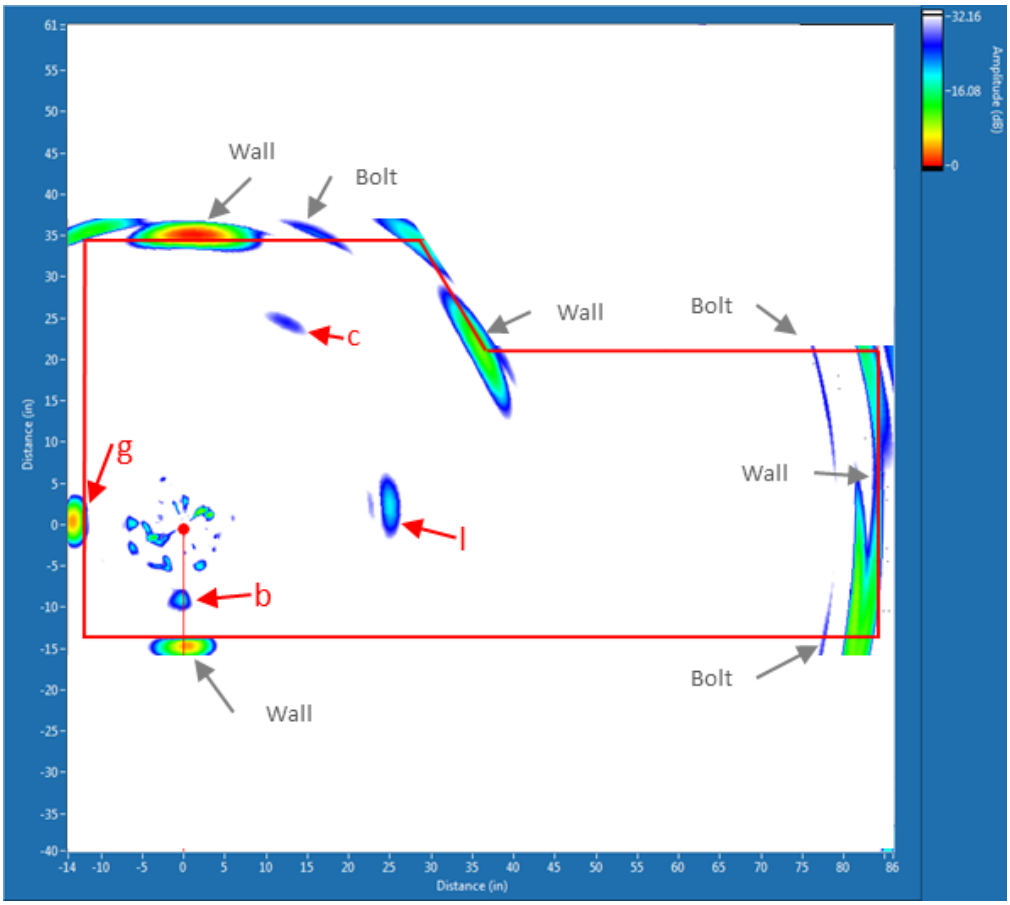
**Figure 21 GWPA scan on plate 1 at location 5. GWPA scan performed at 165 kHz.**

At location 5 (Figure 20), defects 'c', 'l', 'b', and 'g' were detectable as shown in Figure 21.

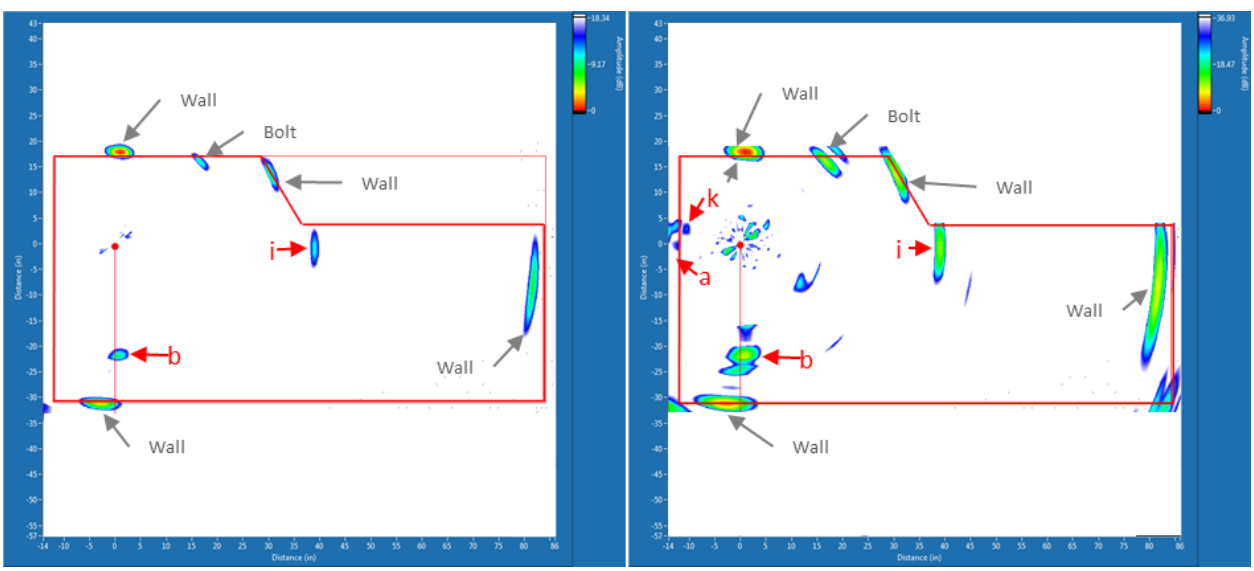
**Figure 23 GWPA scan on plate 1 at location 7. GWPA scan performed at 200 kHz. (Left) the color scale is set to clearly identify the larger defects, and (right) the color scale is set to identify the smaller defects, defects 'a' and 'k'.**

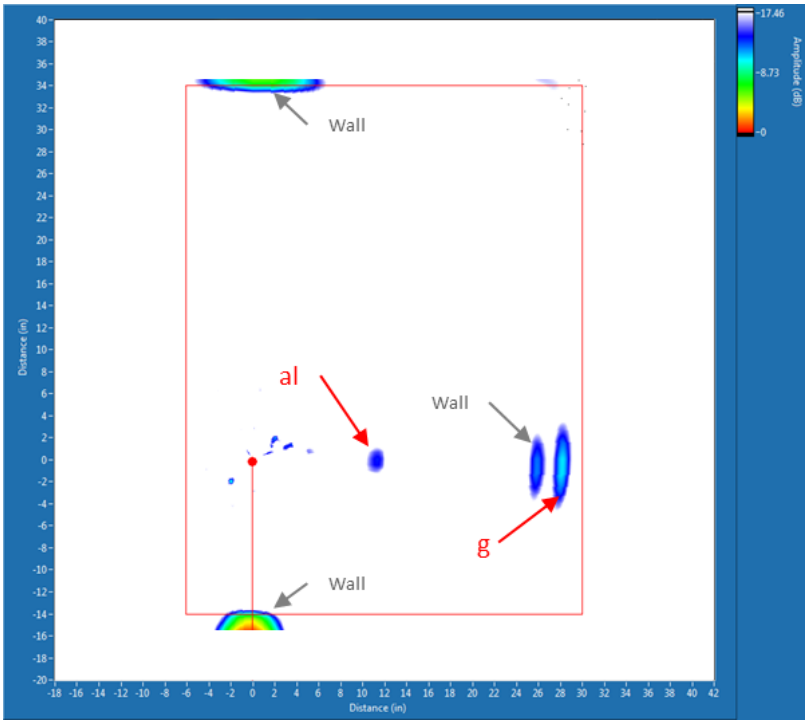
**Figure 25 GWPA scan on plate 2 at location 1. GWPA scan performed at 150 kHz.**

Data was also taken on plate 2, at location 1 (Figure 24), which is thicker than the base plate. Plate 2 is 7/8 inch thick. The GWPA sensor was placed perpendicular from the notched defect, defect 'al'. The defect was easily detectable as shown in Figure 25. Defect 'g', which is located in the weld bead between plates 1 and 2, is also clearly detectable at this location.

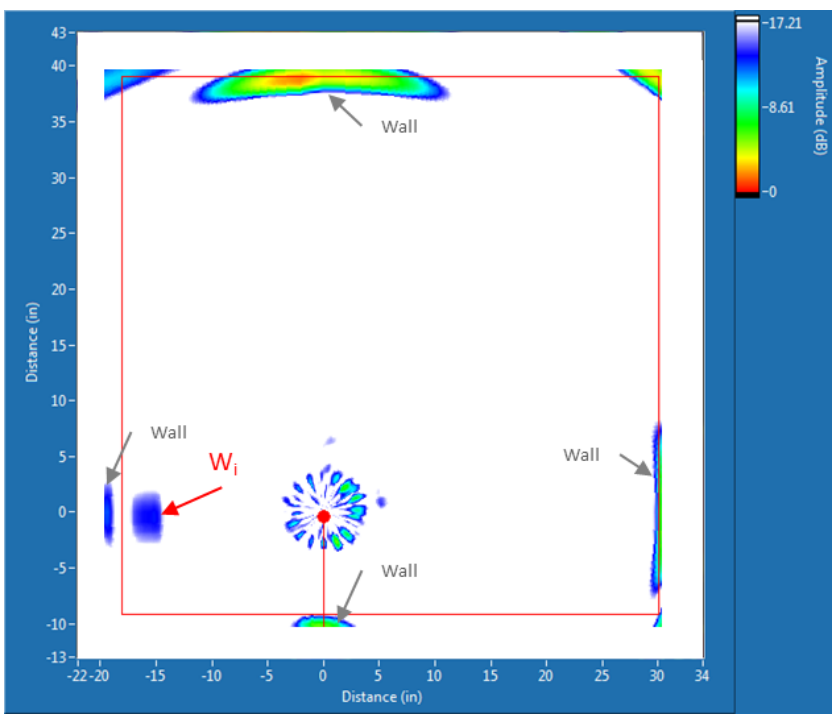
Guidedwave was able to detect Notch “al” located on the 7/8-inch bottom plate (Figure 7.13) and Notch “wi” from the tank wall (Figure 27 in Appendix A). Notch “wi” is an example of Guidedwave’s technique that can detect defects on the ID when the sensor is placed on the OD. The GWPA approach was also sensitive to the bolts that were securing the bottom plate of the mockup.

**Figure 27 GWPA scan on plate 3 at location 1. GWPA scan performed at 150 kHz.**

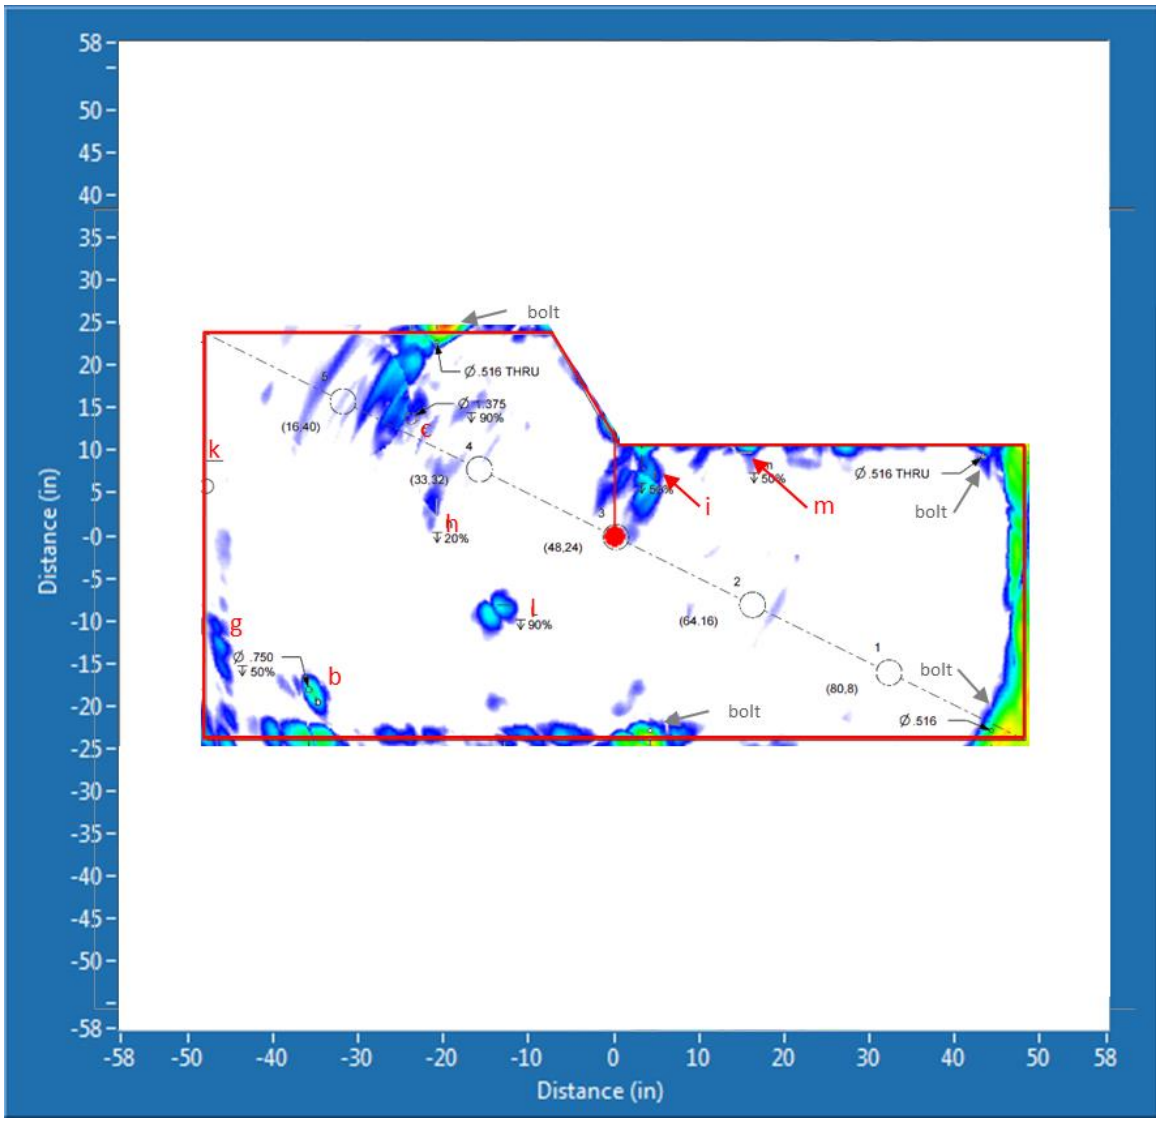
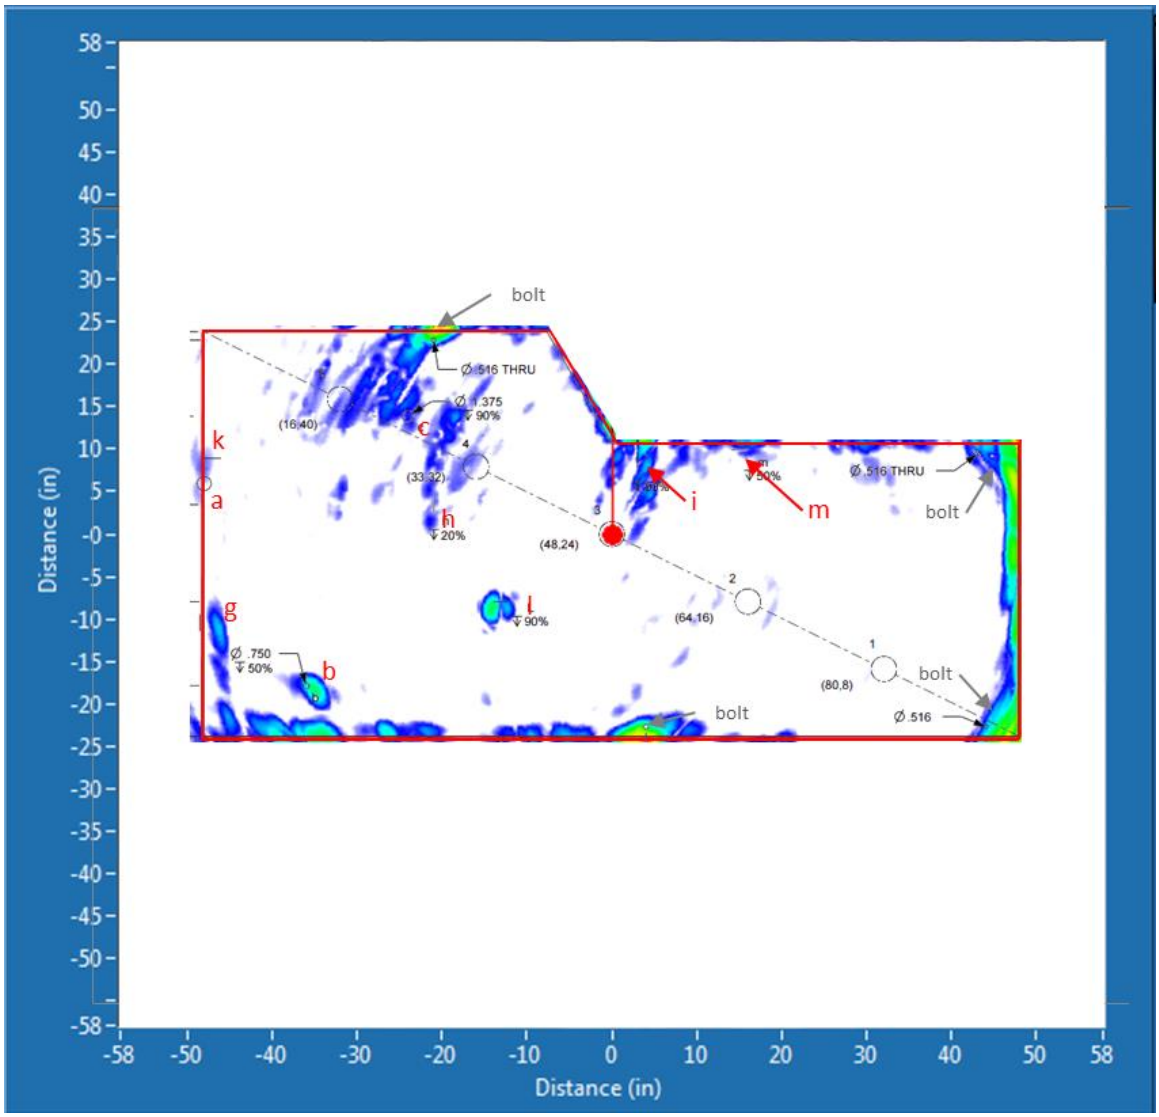
The GWPA software has the capability of generating composite images from multiple inspection locations. With composite imaging, reflections from side lobes are reduced and indications from structural features and defects are enhanced. This improves the resulting GWPA image and makes data interpretation easier. In this scenario, only five locations were used and a very detailed GWPA image was generated. From the composite images (Figure 29 and Figure 30), defects 'b', 'c', 'h', 'l', and 'i' can clearly be detected. Defects 'g', 'k', and 'a' are also clearly visible when compared to the corresponding amplitude of the weld reflections. Defect 'm' would be difficult to call due to the high amplitude reflections produced from the perfectly cut plate ends, which would not occur in real-world scenarios. Welds have much lower reflection amplitudes than plate ends (by a factor of 3-5x). Not all the side lobe reflections were eliminated, which would improve with more inspection locations and welded joints. Also, around defects 'h' and 'c', there are many indications in this area. This could be due to the ultrasound bouncing between the multiple defects, bolt hole, and plate end. Side lobes in this area may be causing distortion due to the multiple features in the plate. This may be cleared up by increasing the number of inspection

locations. However, with only five inspection locations, all but defect 'm' can be clearly identified in the composite image, which is excellent considering the locations were from a single path along the diagonal of the plate.

**Figure 29 Composite image generated with data collected at 150 kHz at the five locations along the diagonal path representing the limited access channel on the tank floor.**

**Figure 30 Composite image generated with data collected at 165 kHz at the five locations along the diagonal path representing the limited access channel on the tank floor.**

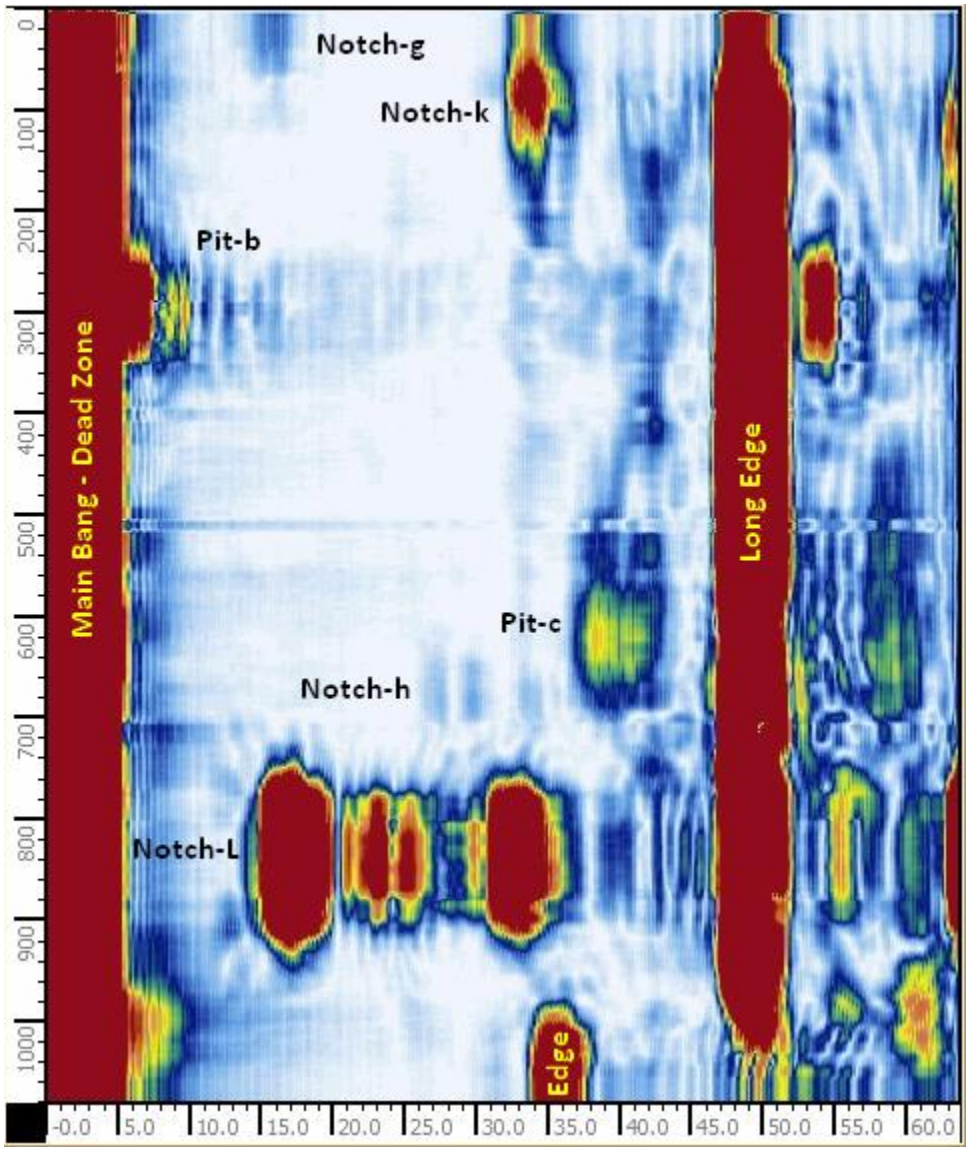
**Figure 11. Manual B-Scan of bottom from edge**

- Vertical axis is the scan axis while the horizontal axis is the distance to the defect with reference to the sensor position.
- All the defects on the first section of the base plate (48" wide) were clearly detectable placing the sensor on one edge of the mockup.
- This test was performed using SH0 wave mode at 128 kHz.

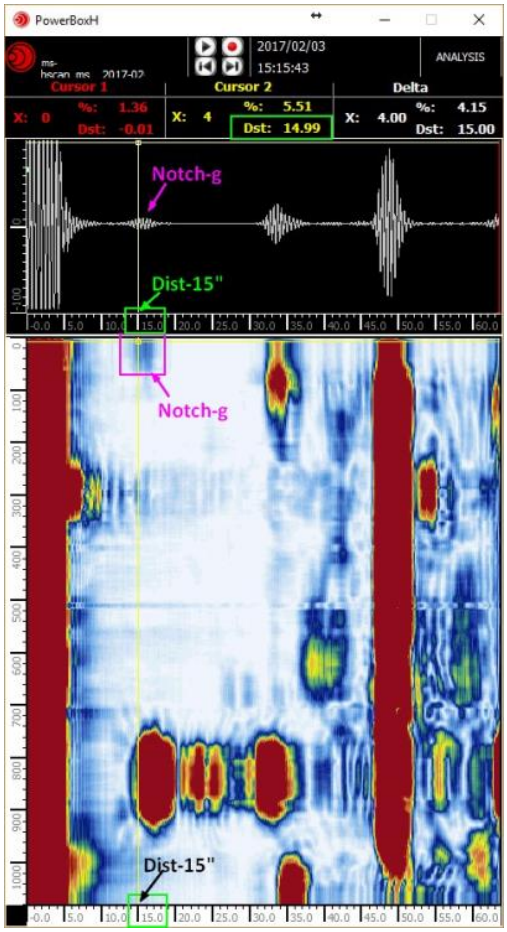
### 3.1.1. Notch-g

- “Notch-g” was 50% deep (0.25”), 2” long and 0.125” wide placed parallel to weld in 7/8 to ½ inch transition weld.
- The B-scan response from “Notch-g” is weak due to the orientation of this notch (vertical to the beam direction) and the location of the strip (the strip was offset from the weld). Angling the sensor by 15-20º provided an increase in signal to noise x3 or more (scanning in this way would require a sensor at an angle).

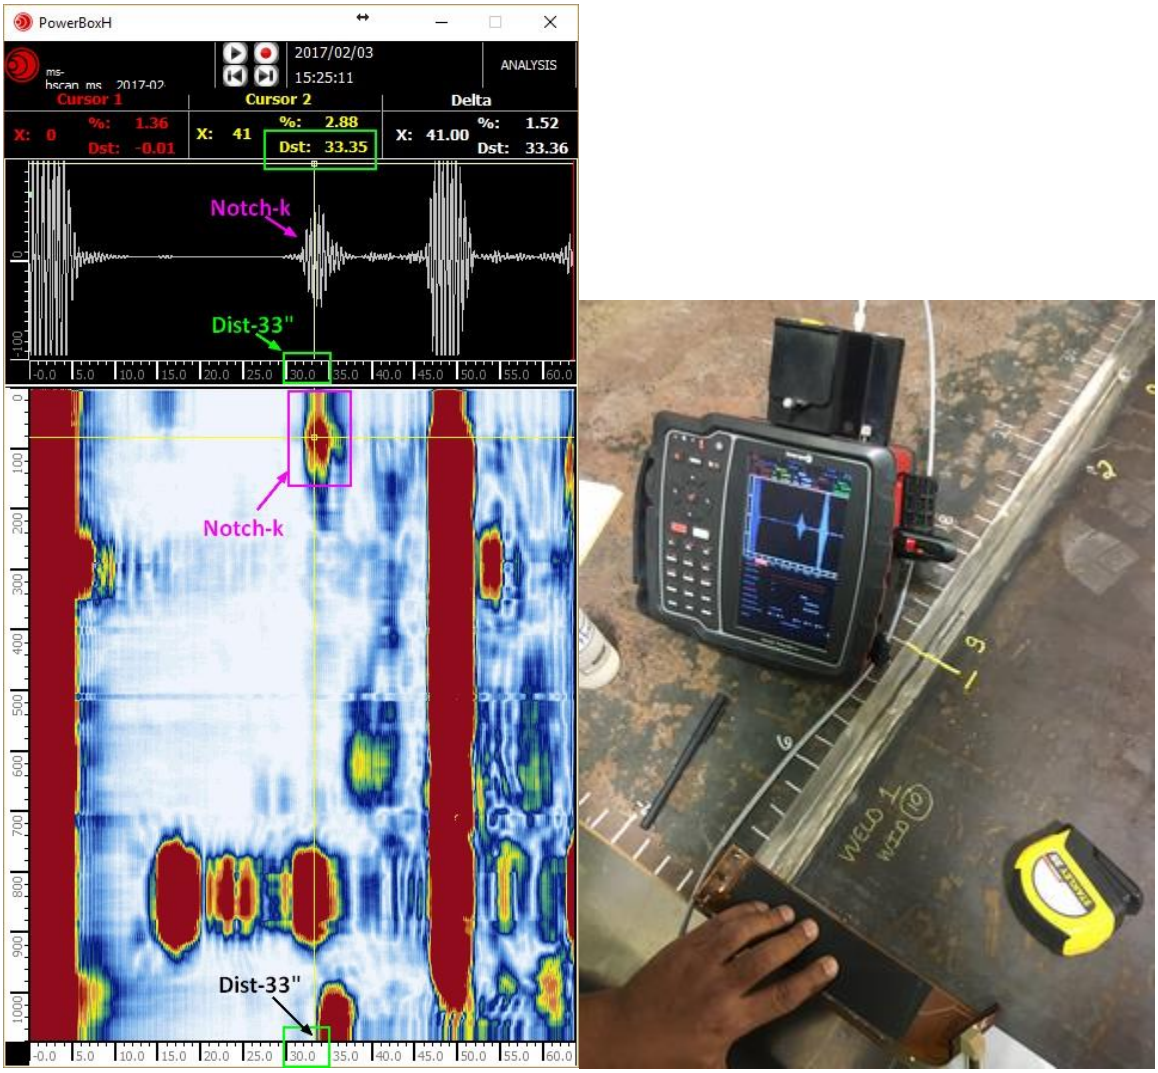
**Figure 13. Position of Sensor for Notch-k – 4 inch**

- “Pit-a” was 50% (0.25”) deep, 0.75” diameter and placed in 7/8 to ½ inch transition weld.
- “Notch-k” was 50% (0.25”) deep, 2” long and 0.125” wide placed perpendicular to weld in 7/8 to ½ inch transition weld.
- Response from “Pit-a” is not apparent on the B-scan which was scanned along the strip.
- Angling the sensor provided only a faint response on Pit-a (Figure 12. Angled Sensor) that was mostly masked by the amplitude Notch-k.
- Notch-k, being perpendicular to the weld, was easily detectable with strong reflections.

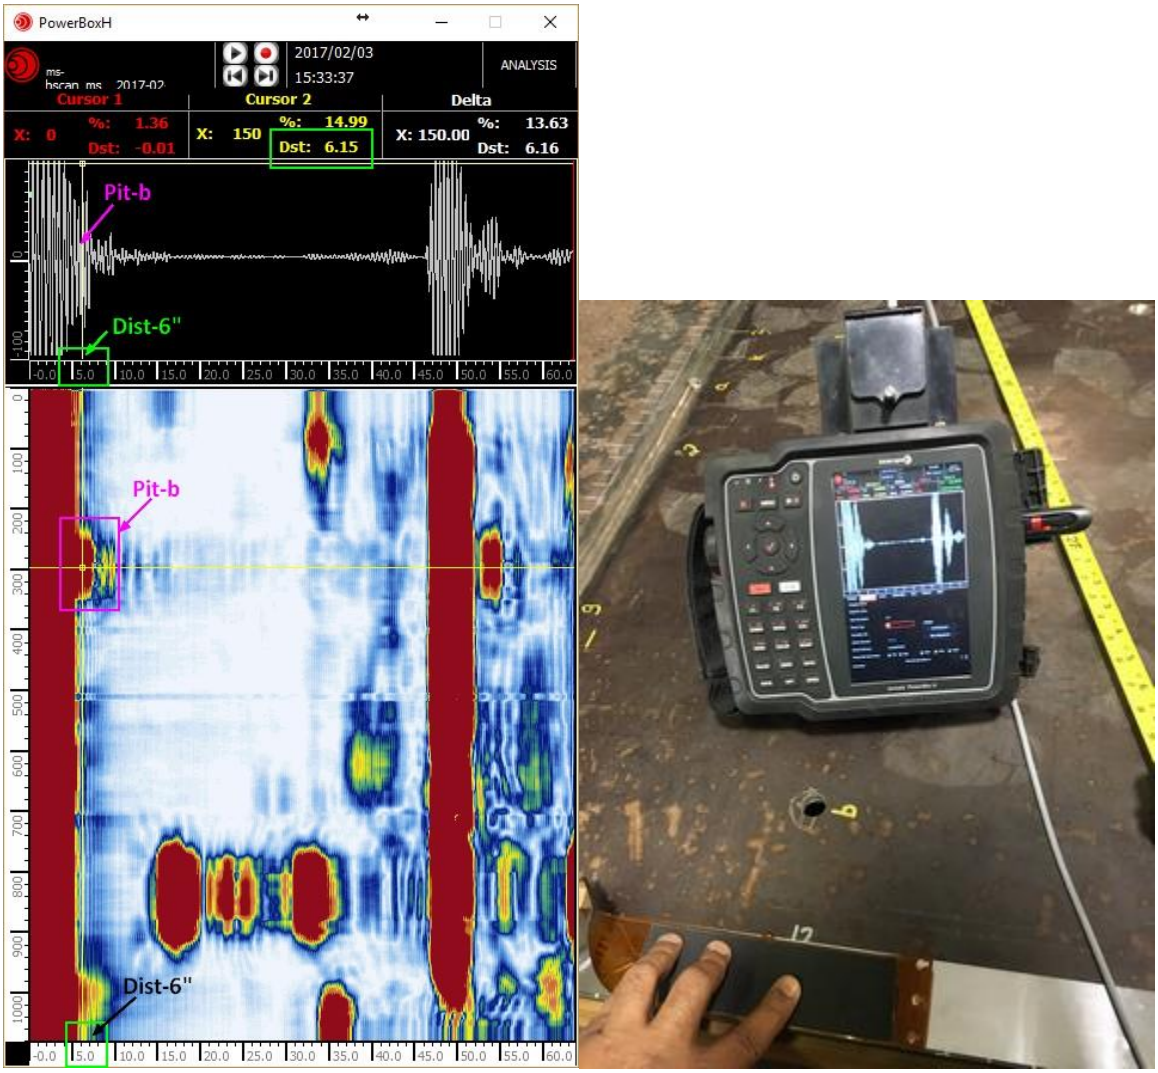
**Figure 14. Position of Sensor for Pit-b – 11 inch**

- “Pit-b” is thru wall 100% deep and 0.75” diameter placed in the base metal.
- Response from “Pit-b” was very strong, but by being closer to the edge the response is partially merged with the main-bang (dead zone).
- Inspection of the dead zone of the sensor should be performed from the other side of the mockup (adjacent channel in the tank).

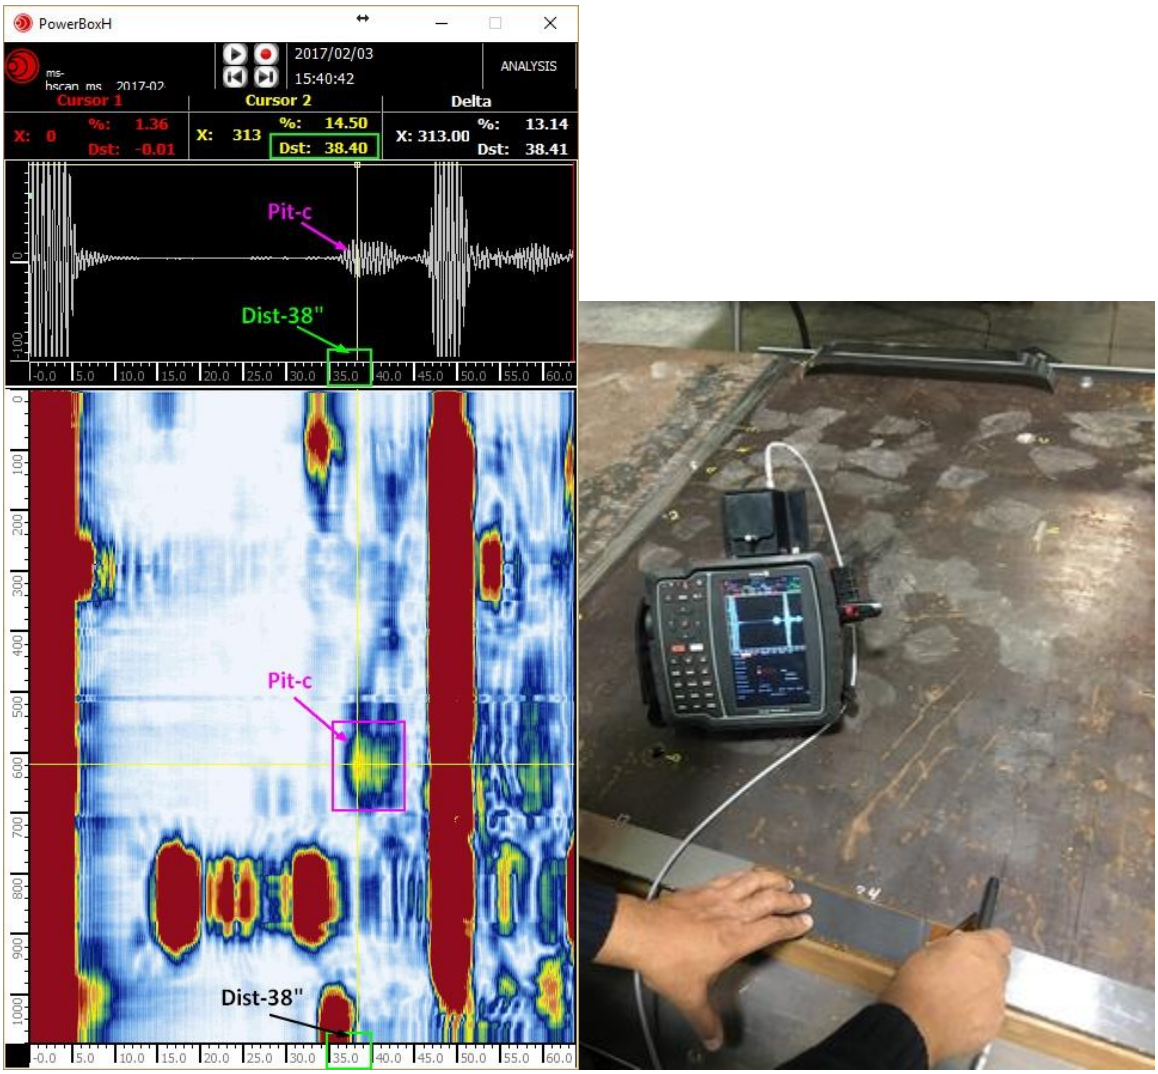
**Figure 15. Position of Sensor for Pit-c – 24”**

- “Pit-c” is 90% (0.45”) deep with a diameter of 1.375 inch and placed in the base plate.
- “Pit-c” is clearly detectable with very good signal to noise ratio.

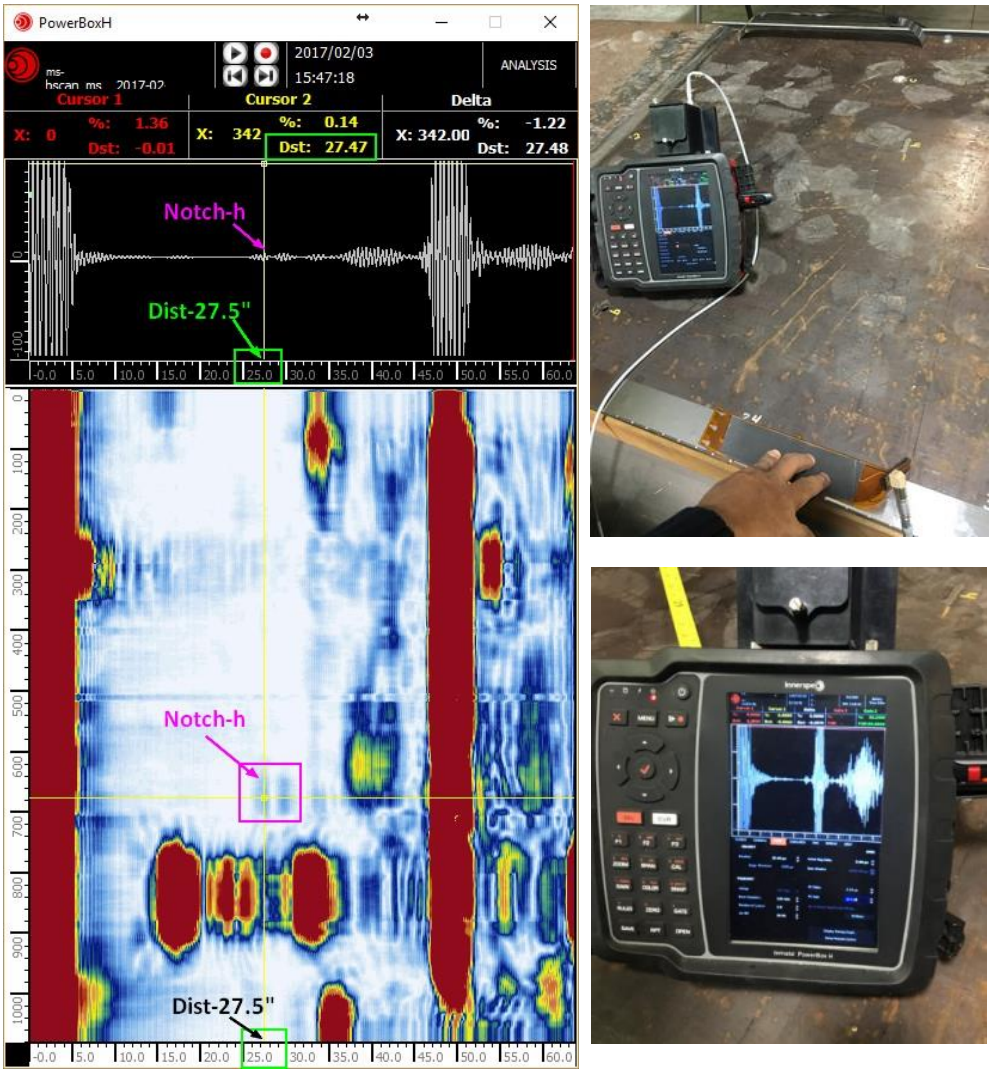
**Figure 16. Position of Sensor for Notch-h – 26 inch**

- “Notch-h” was 20% (0.10”) deep, 2” long and 0.125” wide placed parallel to weld in base plate, and vertically from the scan direction.
- “Notch-h” response is marginal (top A-scan and B-scan) due to the orientation of the notch and relative shallow depth with reference to the plate thickness.
- By increasing gain by 6dB (from 9 to 15dB), the signal to noise increased to approx. 3:1 (bottom A-scan). This could be equivalent to using Distance Amplitude Correction which was not applied to these tests (we didn’t create DAC curves).
