PNNL-26328

# NDE Technology Development Program for Non-Visual Volumetric Inspection Technology

## Technology Screening Report

**March 2017**

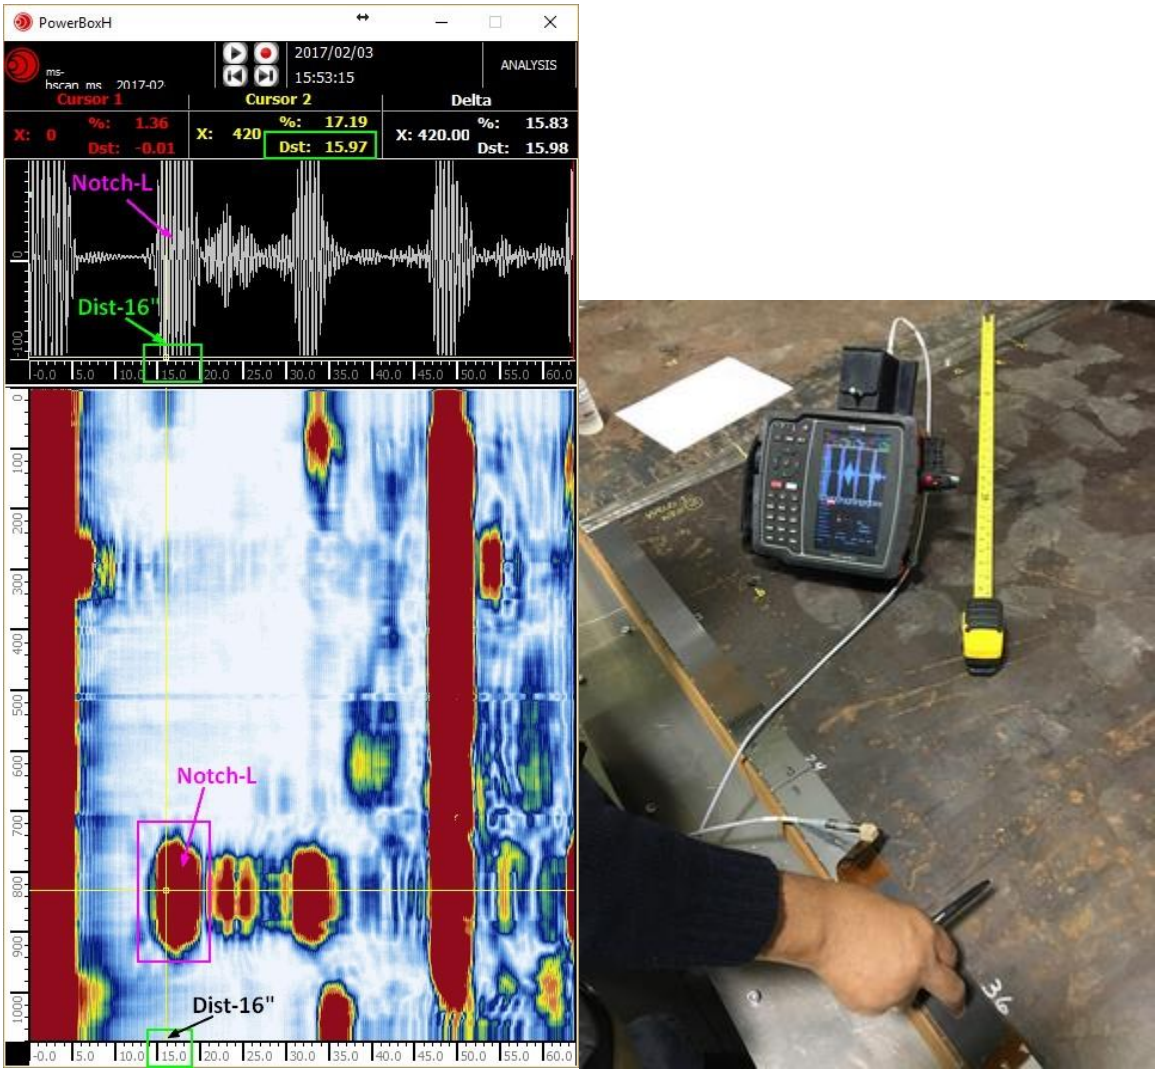
**Figure 17. Position of Sensor for Notch-L – 35 inch**

- “Notch-L” was 90% (0.45”) deep, 2” long and 0.125” wide placed perpendicular to weld in base plate.
- “Notch-L” response is very strong due to its axial orientation and depth.
- The secondary reflection is a result of the sound bouncing back from the edge, and hitting the notch again. The smaller reflections in between the two strong ones are caused by reverberations from the edge (potentially they could be eliminated using a unidirectional coil).
- The nature of the secondary reflection could have been discerned by using different angles or sensor arrays.

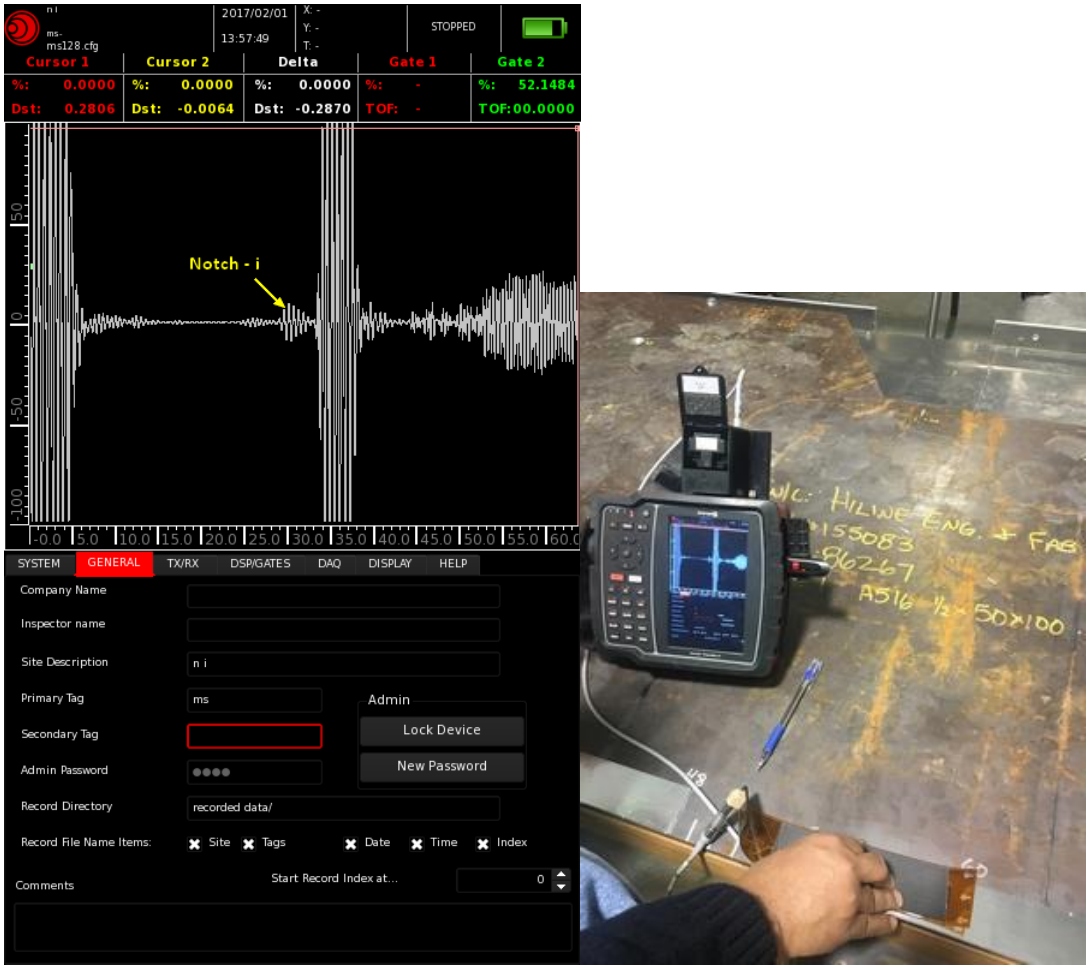
**Figure 18. Position of Sensor for Notch-I – 54 inch**

- “Notch-i” was 50% (0.25”) deep, 2” long and 0.125” wide placed parallel to weld in base plate.
- “Notch-i” was detected with good signal to noise.

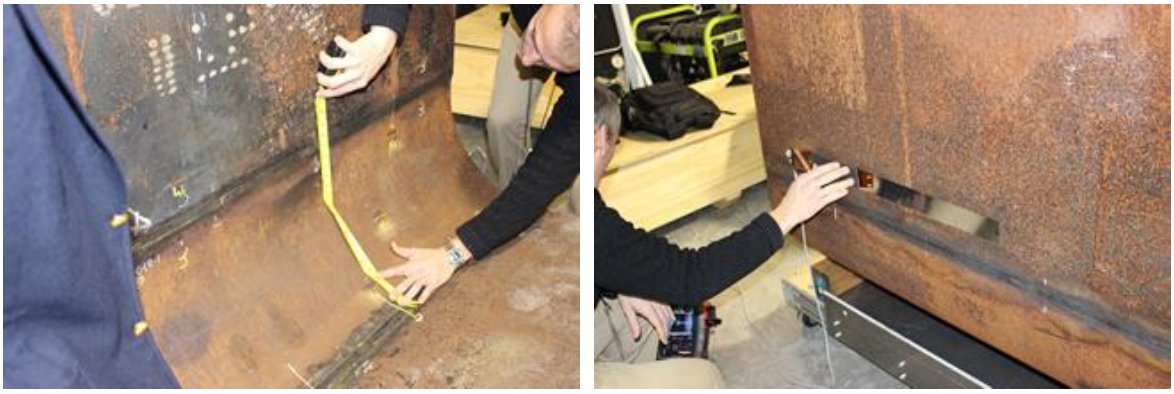
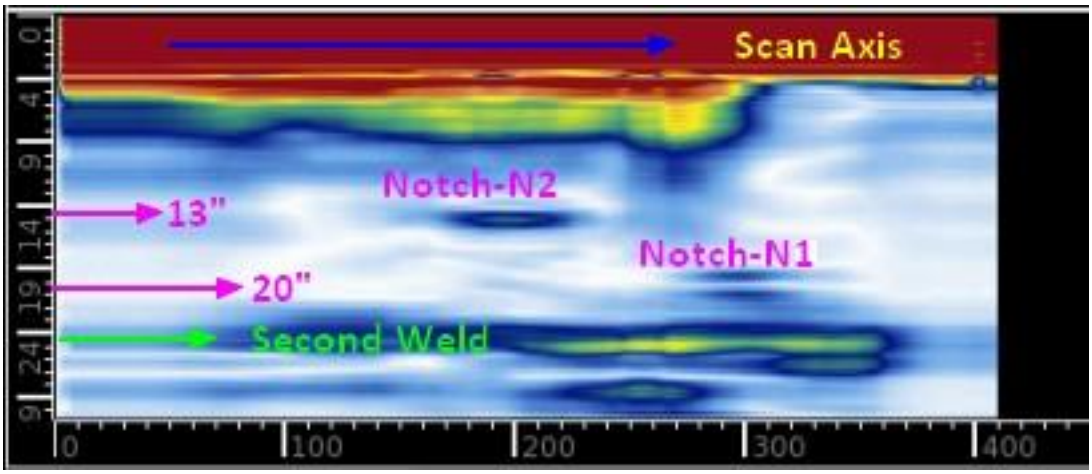
**Figure 20. Results from knuckle**

As shown in the dispersion curves (Figure 6 above) for SH waves. The 128 kHz coil available for this test is not adequate for this thickness, and there is a very high probability of generating other modes which complicate the interpretation of results by creating spurious signals which can also interfere with the signal of interest.

On this scan, the weld just in front of the notch reflects a lot of energy back, but two notches (N1 and N2) are still clearly detected between the two welds. The second weld also provides a strong response and there is a reflection later in time that could be a defect or another mode.

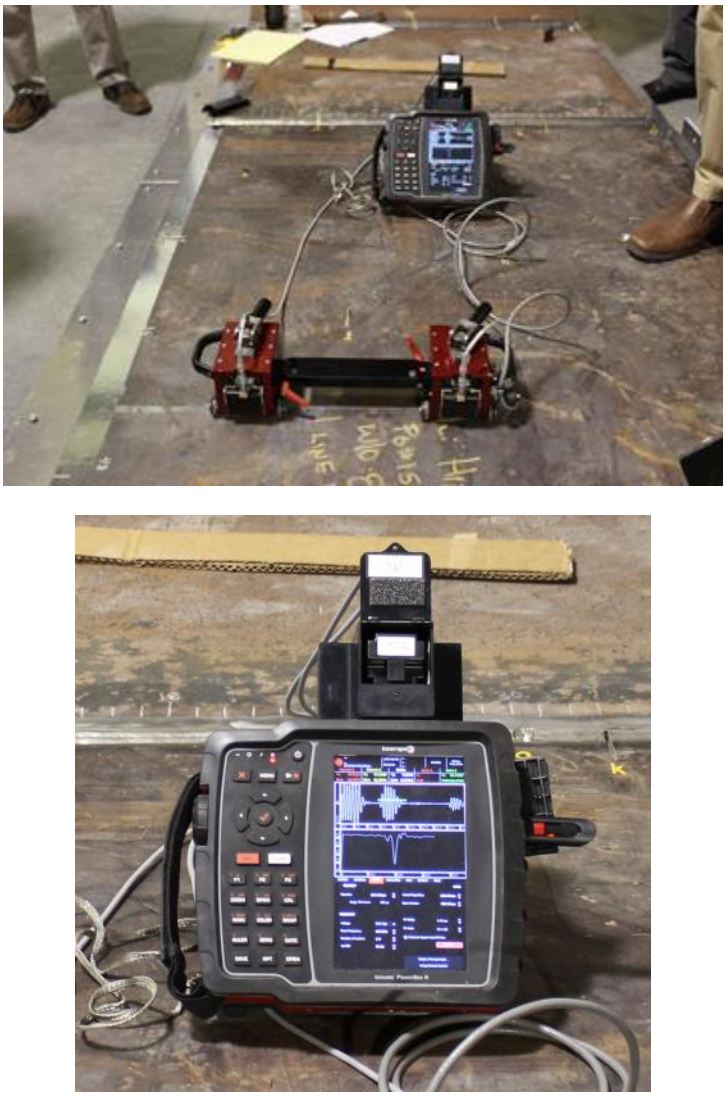
**Figure 21. Notch l Lamb wave attenuation test**

- Two Lamb wave sensors were set up to scan using a bar to hold both sensors together. The longest available bar was approx. 10”.
- Notch-L (90% deep) completely attenuated the signal and was easily detectable with this technique.

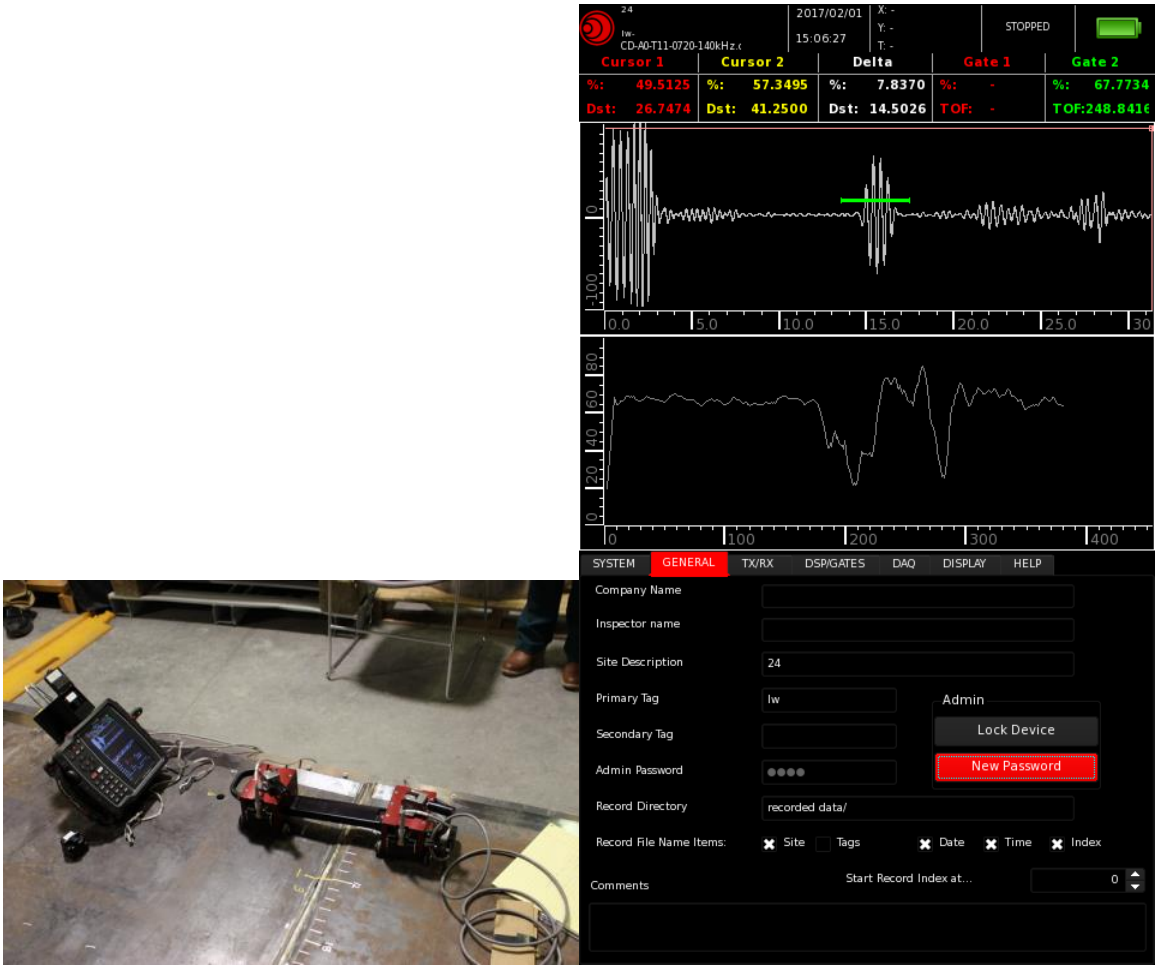
**Figure 22. Notch g and Pit c Lamb wave attenuation tests**

- Two Lamb wave sensors were set up to scan using a bar to hold both sensors together. The longest available bar was approx. 10”.
- Notch-g and Pit-c were clearly detected by this technique due to the attenuation of ultrasonic energy.

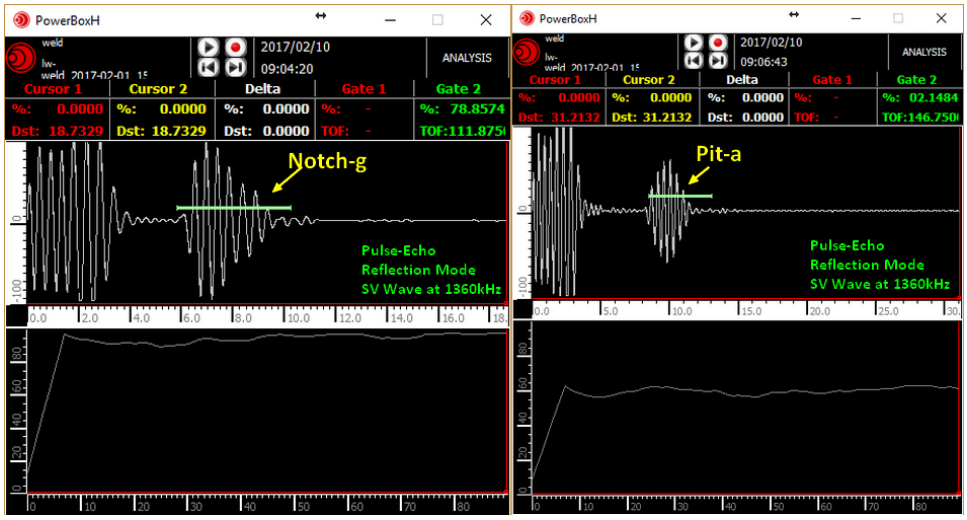
**Figure 23. A-scan snapshots in Pulse-Echo Reflection Mode**

- One of the Lamb wave sensors was positioned to across the defects in the weld in pulse-echo configuration looking for the reflections in a-scan mode from possible defects.
- Notch-g and Pit-c were clearly detected by this technique due to the reflection of ultrasonic energy.

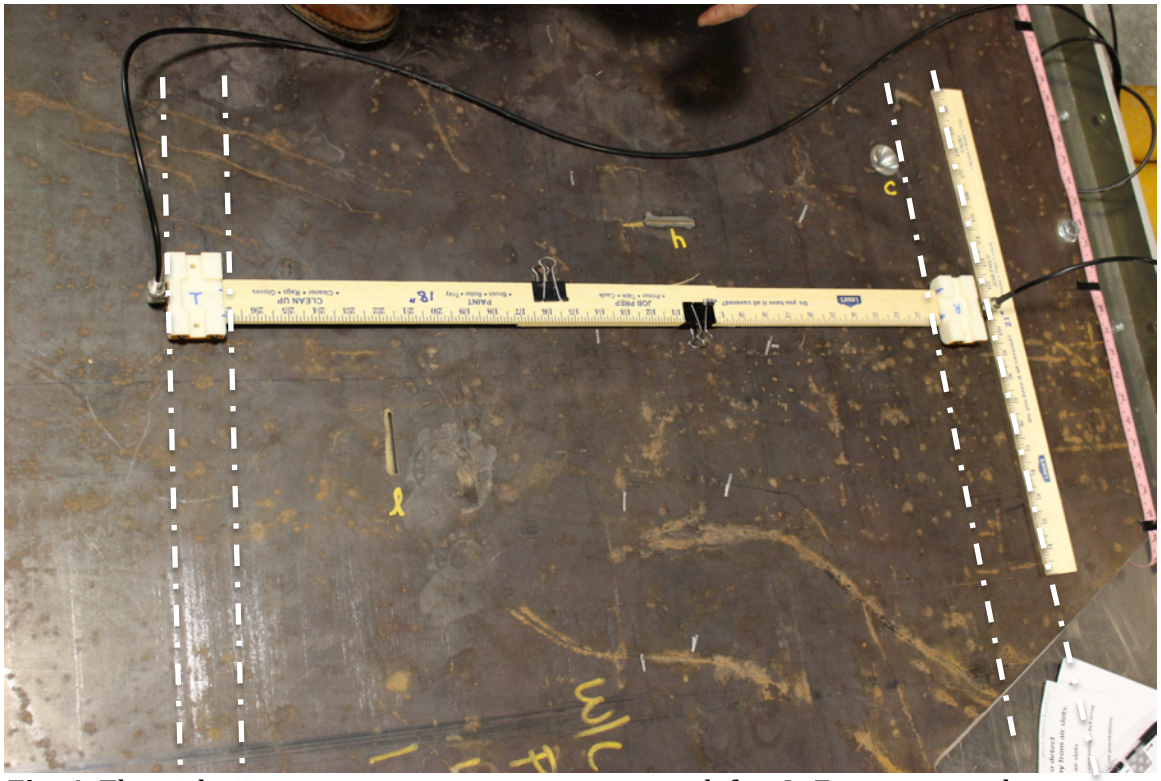
Description: 90% through-thickness 2" long notch located at (16, 33.5-35.5) based on coordinate system shown in Fig. 3.

***Fig. 4.*** *Through-transmission measurements across defect L. Fictitious air slots are marked by white dot-dash lines.*

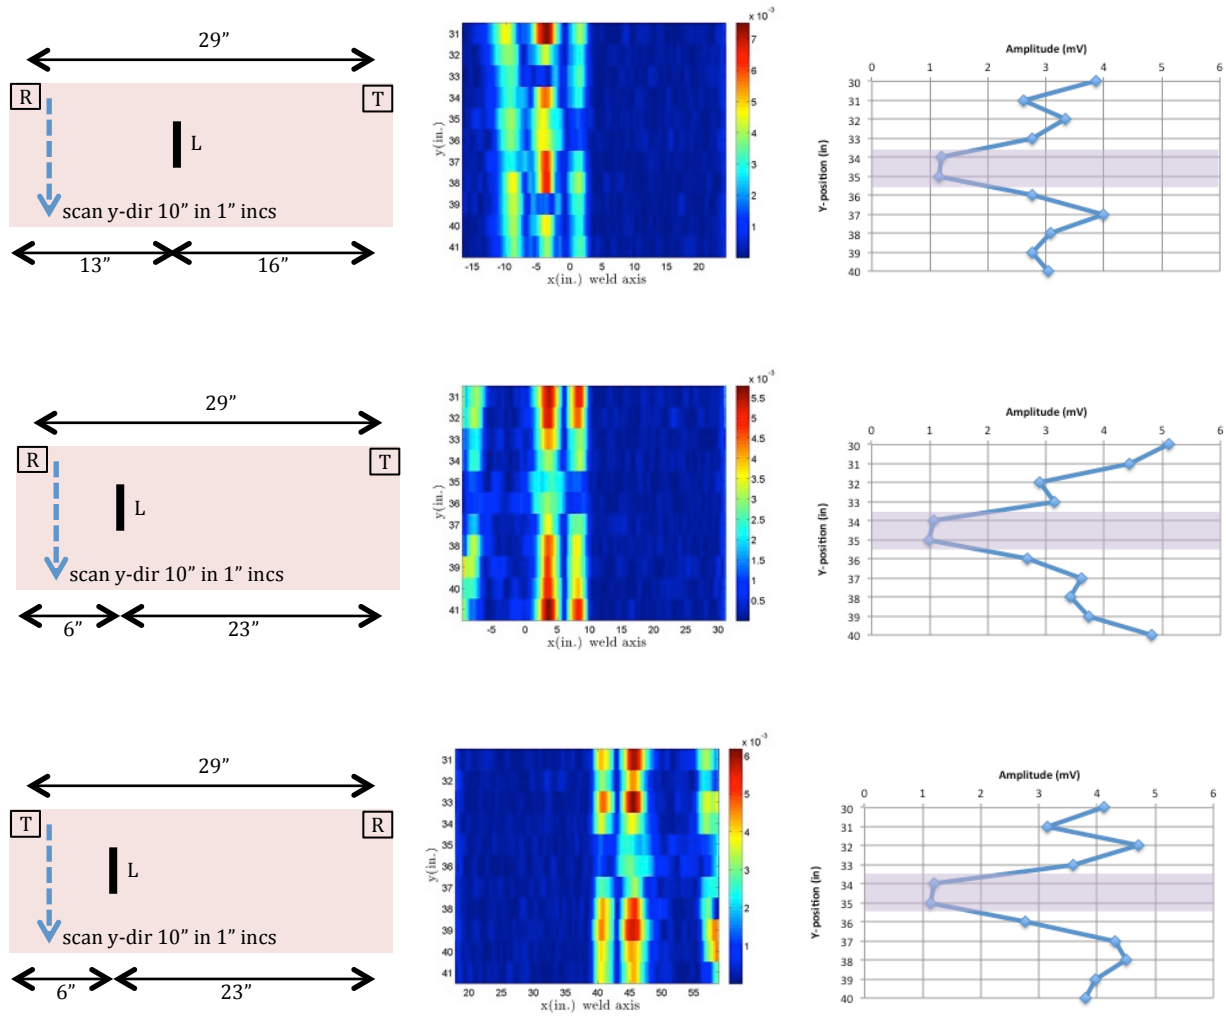
***Fig. 6.*** *Test schematic (left), B-scan (middle), and summary graph (right). Wave propagation is in the x-direction and the EMATs are scanned in the y-direction.*

amplitude as a function of position, and the position of the defect is shaded for clarity. Notch L is clearly identified in each of the three positions relative to the EMATS: middle, near the receiver, and near the transmitter. Results for through-transmission measurements of defects c, b, and h are presented in an analogous way.

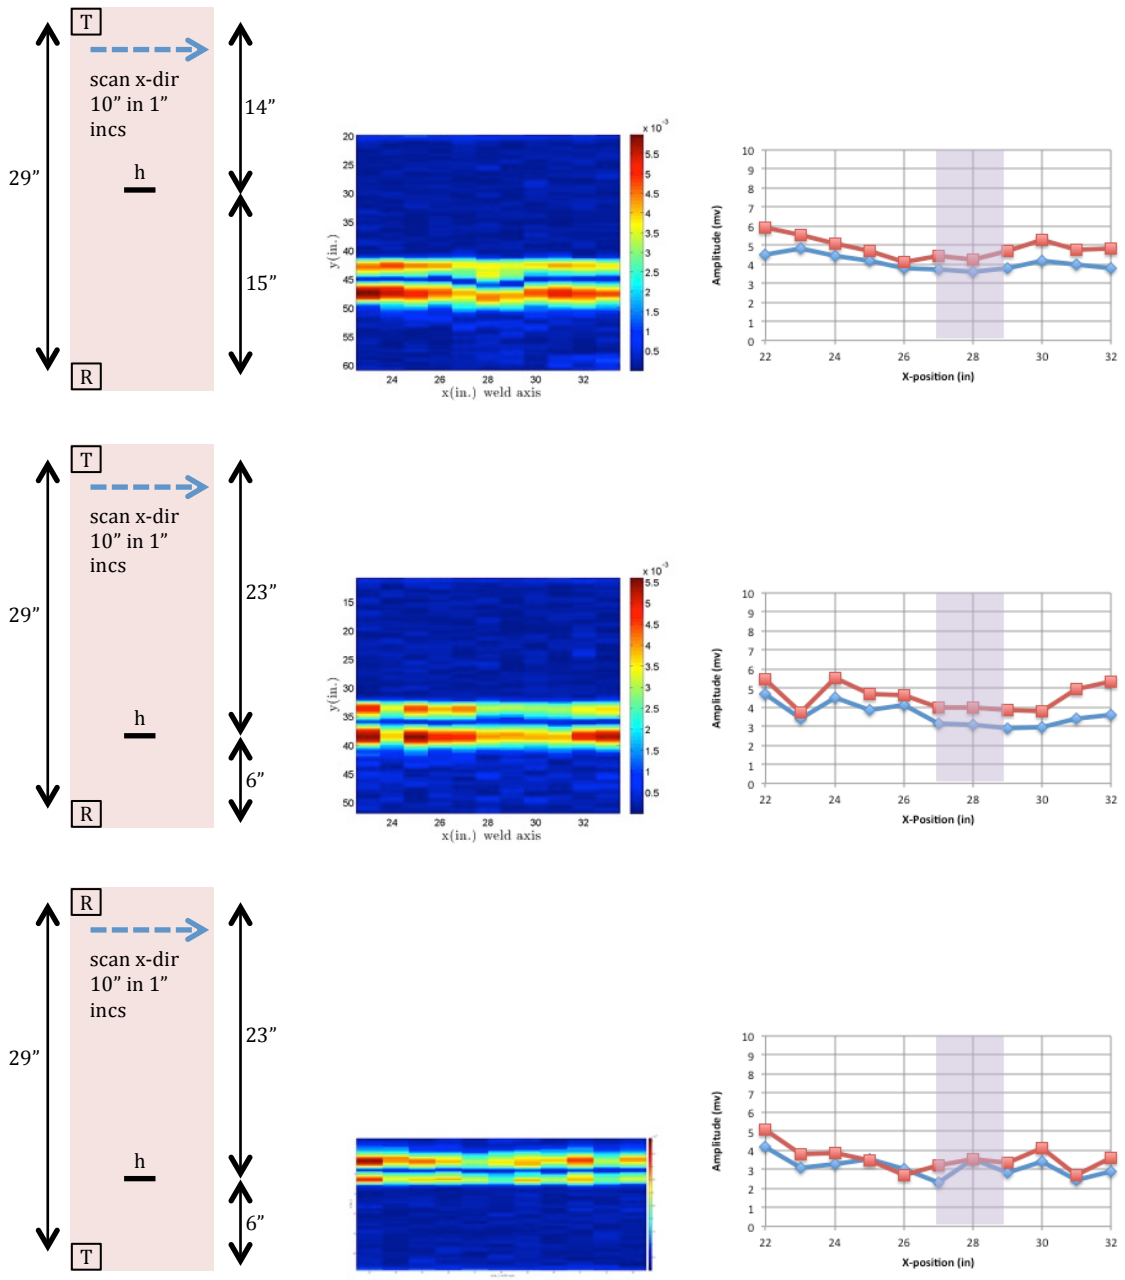
Defect h was scanned in the x-direction to avoid interference from defect c. The B-scans indicate the presence of defect h, but the indication is less clear because the notch depth is smaller than the other defects. Defect h is rather poorly apparent on the summary graphs. These results could be significantly enhanced by additional A-scans that take advantage of the beam divergence. That is, for one transmitter position the receiver is scanned (along the air slot) and then the transmitter position is moved and the process repeated. The additional data enables a tomographic reconstruction algorithm to be implemented that provides better defect sensitivity. Of course, high power instrumentation will also help.

***Fig. 11.*** *Test schematic (left), B-scan (middle), and summary graph (right). Wave propagation is in the y-direction and the EMATs are scanned in the x-direction.*

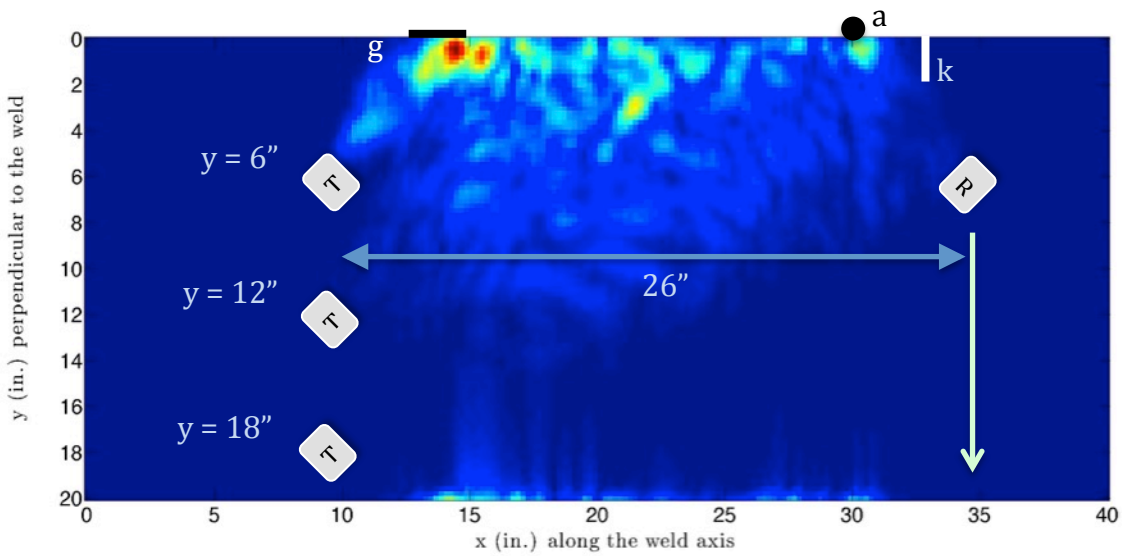
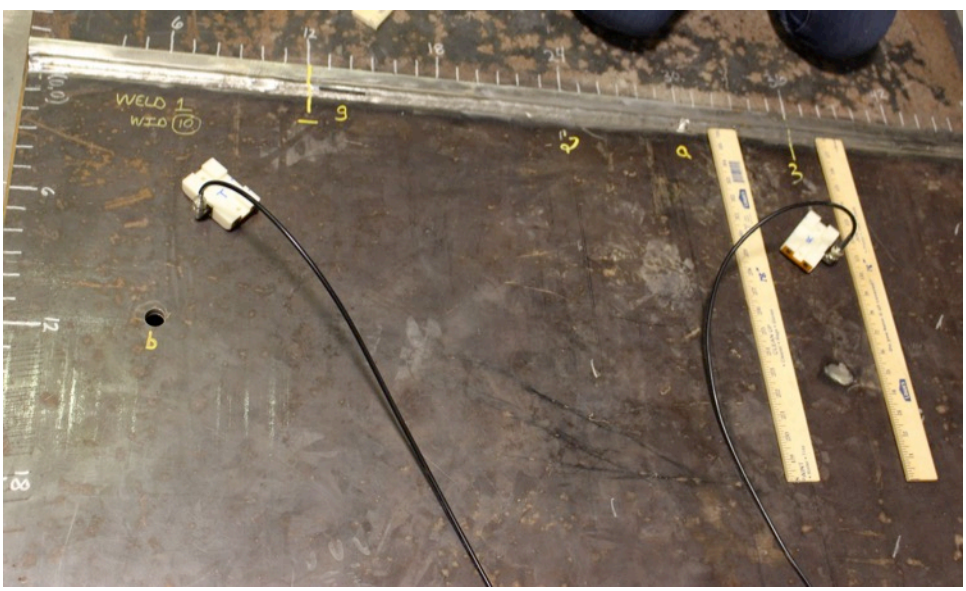
***Fig. 13.*** *SAFT-reconstructed image (above) combining the results obtained from the three T-R configurations. The approximation locations of the sought defects together with T and R positions are marked on the image (above). The photo (bottom) shows the placement of T (x = 9", y = 6") and R (x = 35", y =6") for one acquisition.*

SNR depends on the orientation of the T-R pairs relative to the defect. In the first configuration, the indication around the location of defect ‘g’ has maximum reconstructed amplitude of about 0.011 while the noise level is variable ranging from about 0.001 to 0.005 giving SNR in the range of 2-11 (6 - 21 dB). In the second configuration, the SNR is so low that the defect indication lies within the noise level.

Although appearing at about x = 28”, the strong indication on the right hand side is believed to be from the defect group ‘a & k’. The errors due to the manual movement of the transducers are the likely cause of the apparent misplacement of the indication. Diffraction from the tip of defect ‘k’ and the presence of multiple modes are other likely sources of artifacts and errors. Automated data collection and more rigorous post-processing will alleviate such errors. It seems apparent that the pitch-catch method is most effective on defects located nearer to the T than the R. This is not a serious concern because we intend for each EMAT to perform both send and receive functions sequentially. However, future tests could assess the use of a shallower angle for defects located farther away from the T.

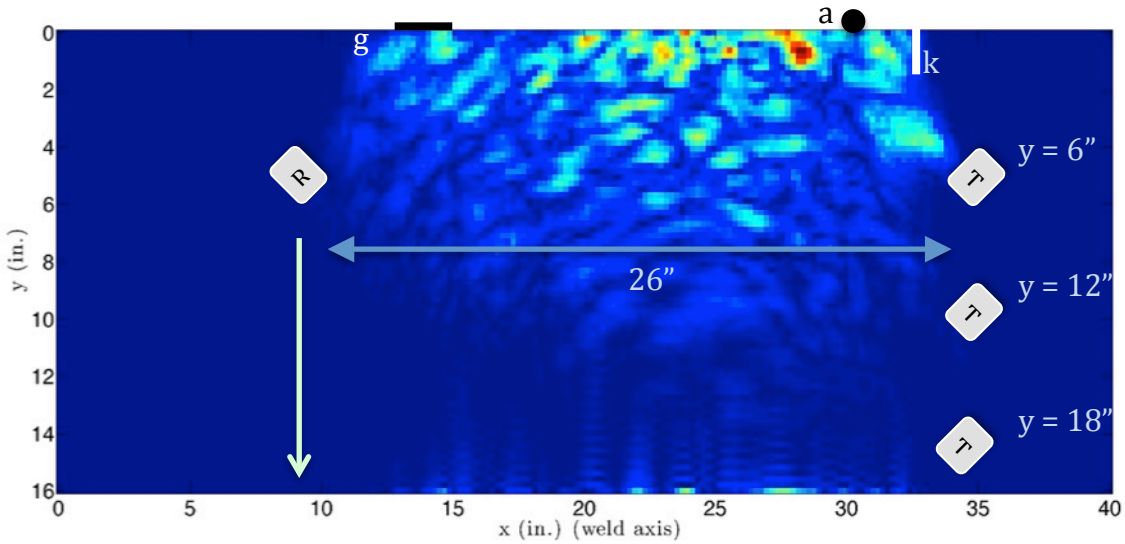
***Fig. 14.*** *SAFT-reconstructed image combining the results obtained from the three T-R configurations. The approximate locations of the sought defects together with T and R positions are marked on the image.*

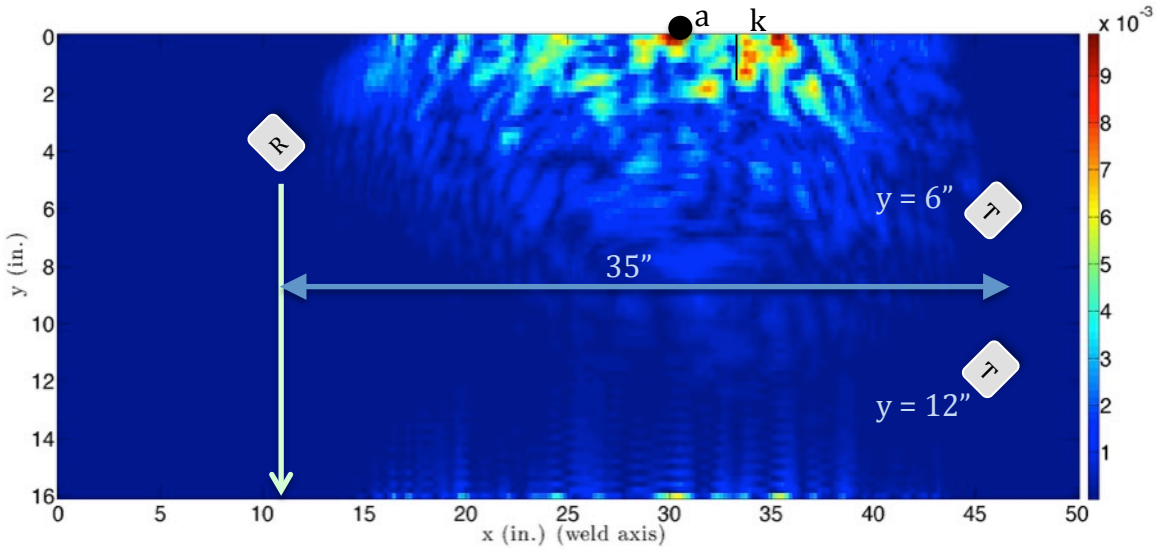
***Fig. 15.*** *SAFT-reconstructed image combing the results obtained from the three T-R configurations. The approximation locations of the sought defects together with T and R positions are marked on the image.*

In the first configuration (Fig. 15), the indication around the location of defect ‘a’ has maximum reconstructed amplitude of about 0.01 while the noise level is variable ranging from about 0.0003 to 0.006 giving SNR in the range of 1.5 - 33 (4 - 30 dB). In the case of defect ‘k’, the maximum amplitude is about 0.008 resulting in slightly lower SNRs: 1.3 – 26 (2.5 – 28 dB). In the second configuration (Fig. 16), the SNR is so low that the defect indication lies within the noise level. However, there is a strong reflection along the weld between x = 20” and 23”. Although this strong reflection does not correspond to any of the cataloged defects, it has appeared in some of the previous images. The pulse-echo measurement results (next section) clearly indicate the presence of a reflector at that location.

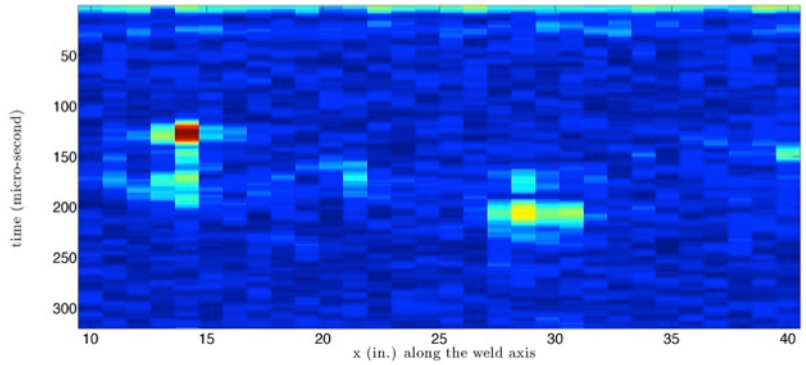
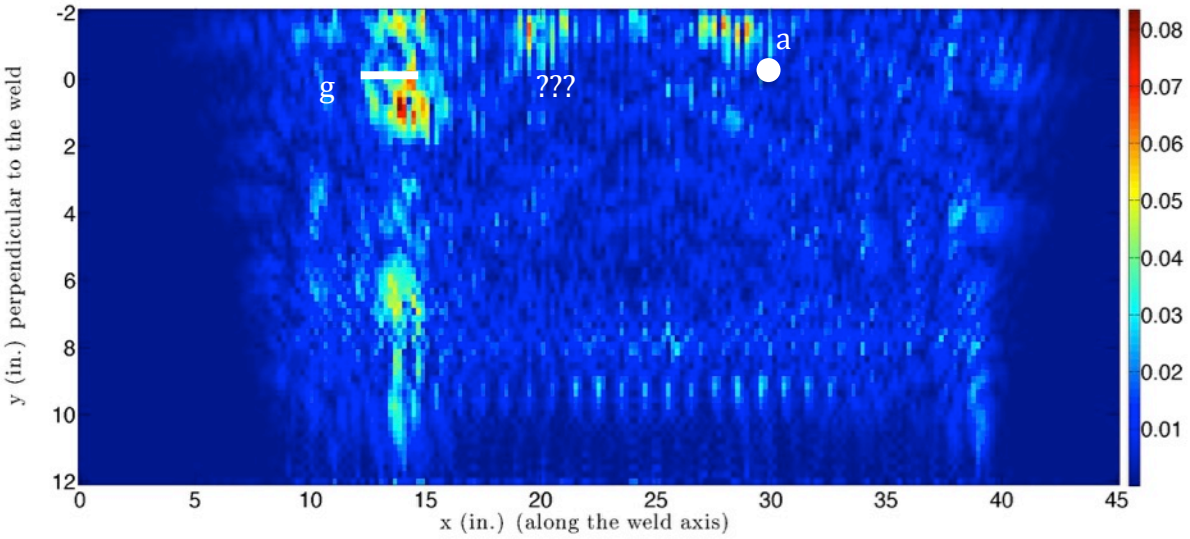
In the pulse-echo mode, the T and R are side-by-side with their active parts perfectly aligned (Fig. 17 below). An electromagnetic shield is placed directly between the EMATs. Pulse-echo experiments were conducted to provide us with more information about the weld reflections and reflections from defects 'g' and 'a' along the weld, it is not intended for application to DSTs because there is no access to allow this measurement. One B-scan was collected in the pulse-echo mode: the T/R was moved parallel to the weld axis offset by about 12". Thirty one (31) signals at 1" spacing were collected. The resulting B-scan is shown in Fig. 18a. The corresponding SAFT-image is also given in Fig. 18b. Reflections from defects 'g' and 'a' are clearly seen in both images. The multiple indications at defect 'g' are believed to be caused by the presence of multiple modes. In addition, there is an unknown indication between x = 20" and 22". This unknown indication matches anomalously strong reflections observed in Fig. 16.

***Fig. 18.*** *The test results in the pulse-echo mode: (a) B-scan; and (b) SAFT-reconstructed image.*

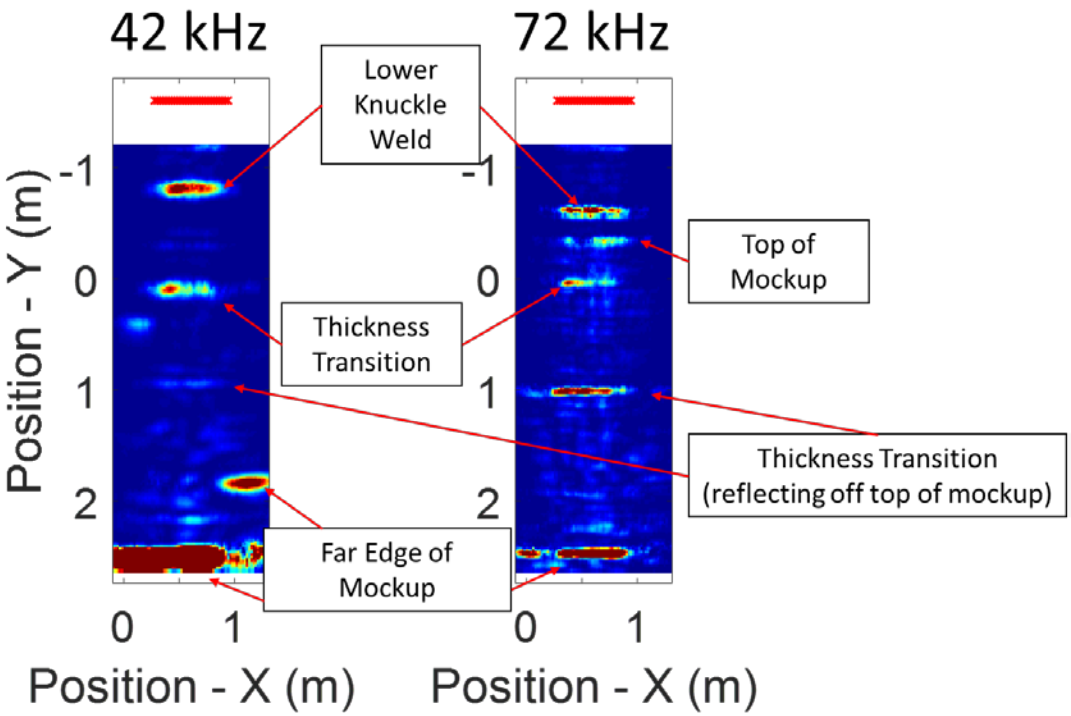
**Figure 6. SAFT results obtained using the 42 kHz (left) and 72 kHz (right) data sets. The data collection locations are denoted by the red "x" markers; because data collection density and the figure size, the "x" markers lie on top of one another. The images have been scaled so that highest amplitude in the image is equivalent to the maximum SAFT response from the thickness transition weld located at 0 m in the "Y" axis.**

Figure 6 also displays the SAFT results from the 72 kHz data. As can be seen, all welds below the sensor were visible, but there was also a strong reflection from the top edge of the mockup. Also, a second reflection from the thickness transition weld is visible from sound bouncing off the top edge of the plate and then reflecting back from this weld. The data collected at 72 kHz was the only configuration where the top edge was not suppressed properly; this is most likely because timing between two transmit signals was not correct for the meander spacing. Note that this sensor coil and associate sensor electronics software was developed specifically for this effort but testing was not possible at SwRI as material of the appropriate thickness was not available in the time available after fabrication for testing. Based on these initial test results, all remaining inspection results reported are from the 57 kHz data set. This set was chosen as it was the highest frequency data that performed as expected, so it will have the best performance.

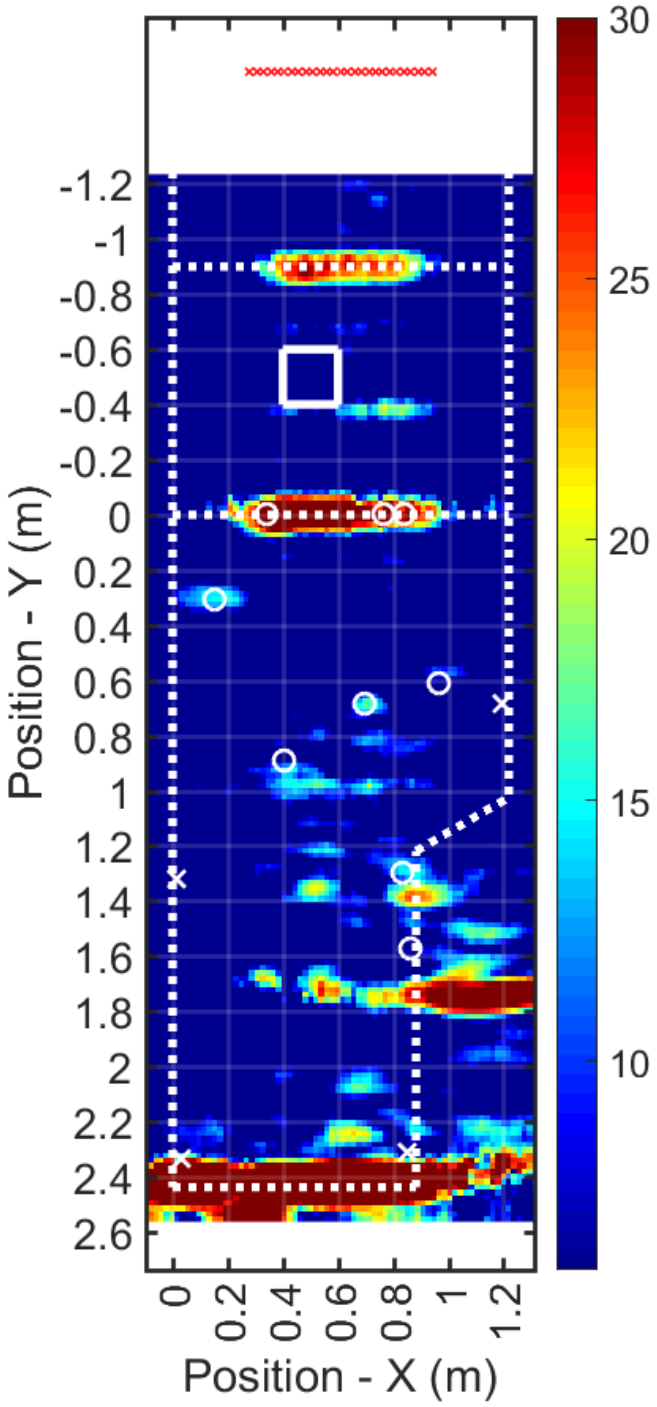
**Figure 7. SAFT image produced using 57 kHz data set. The dashed white lines denote the mockup edges and welds, the white circles denote artificial flaws, the white "x" marks denote mounting holes for the mockup, the white square denotes the noise calculation region, and the red "x" marks denote the data collection locations. The SAFT results are in units of decibels (dB) relative to the mean value calculated in the noise region. The color bar units are in dB.**

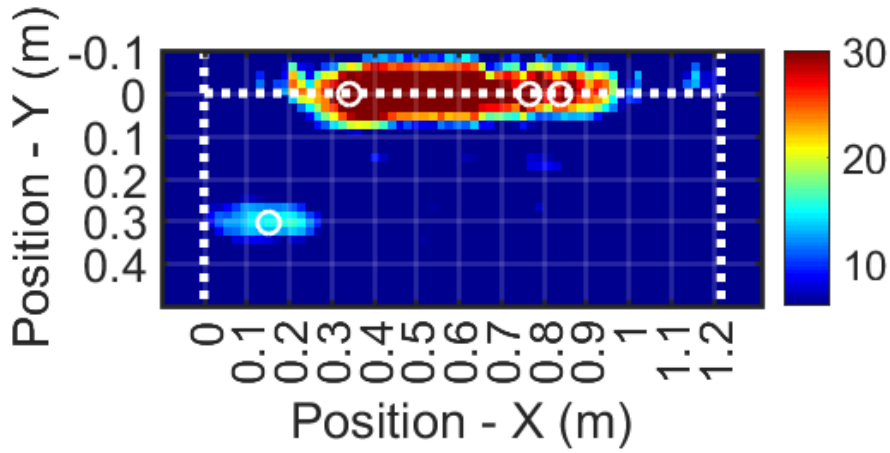
Four of the flaws were located close to the transition weld at 0 m in the Y direction. Three flaws (“a”, “g” and “k”) were in the weld itself; flaw “b” was located 300 mm from the weld. Figure 8 shows the SAFT results from the region near this weld. The image color scale is from 6 dB to 30 dB; a flaw is considered detected if it above a 6 dB threshold. The three flaws located in the weld produce no obvious indications because the transition from 22 mm to 13 mm at the weld is a strong reflector itself. Flaw “b,” which is a 19 mm diameter through hole, is clearly visible with a maximum SNR of over 15 dB. Also, the SAFT indication agrees closely with the expected location of the flaw. There also are some low SNR spurious arrivals with SNR values close to 6 dB. Since responses are isolated and low amplitude, they would not likely be considered of concern for follow-up screening.

**Figure 8. SAFT image from the 57 kHz data set. Region restricted to the portion of the mockup between -0.1 and 0.5 m from the thickness transition weld. Refer to Figure 7 for the meaning of the different markings.**

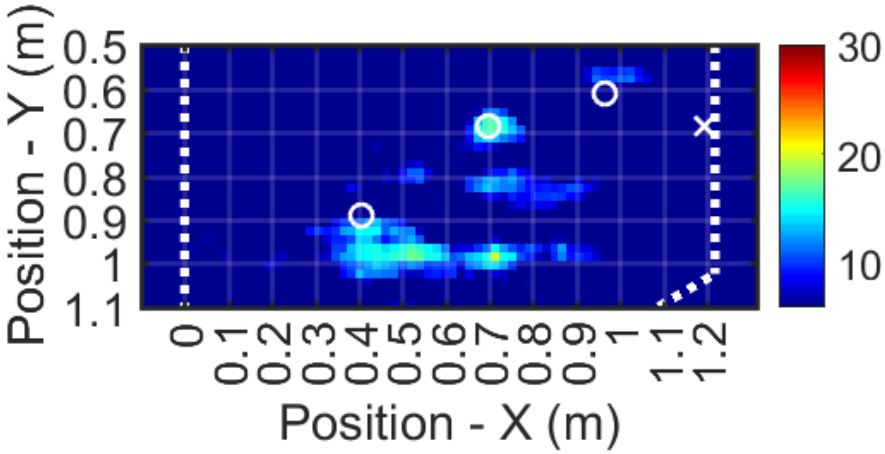
Three of the flaws were located between 0.5 m and 1.1 m from the thickness transition weld. Flaw "c" is a round and deep pit, flaw "h" is a shallow notch that is perpendicular to the beam direction and flaw "L" is a deep notch that is parallel to the beam direction. Note that a notch that is parallel to the beam direction is challenging to detect. The SAFT image from this region is shown in Figure 9. There is an indication in the SAFT image for each of these flaws:

In addition to these flaw indications, there are two other SAFT indications that require explanation. First, there is a large indication that is at the same horizontal (X) position as flaw "h" but approximately 150 mm further from the weld. The source of this arrival is not clear but it is likely due to reverberations between the closely spaced flaws. The second indication that requires explanation is the linear feature at approximately 1 m from the transition weld. This feature has

already been explained as a reflection from the transition weld from sound first propagating upwards from the EMAT and reflecting from the top edge.

**Figure 9. SAFT image from the 57 kHz data set. Region restricted to the portion of the mockup between 0.5 and 1.1 m from the thickness transition weld. Refer to Figure 7 for the meaning of the different markings.**

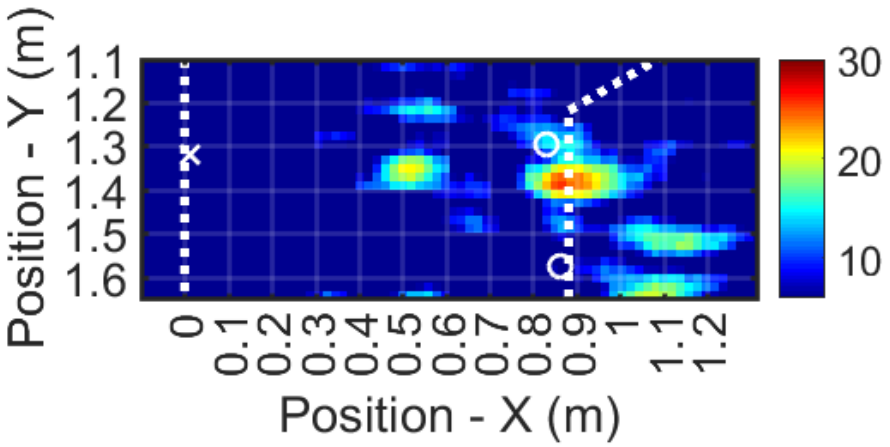
The final region of the 12.7 mm plate to consider is 1.1 m to 1.6 m from the transition weld. There are two flaws in this region; flaw “i" is a deep notch perpendicular to the propagation direction and flaw “m” is a deep notch parallel to the propagation direction. Both of these flaws are positioned close to the edge of the mockup. The SAFT response from this region is shown in Figure 10. There is a strong (>25 dB) indication in the SAFT result approximately 60 mm from the expected location of flaw “i" but there is no observable indication from flaw “m.” It is concerning that the indication associated with flaw “i" is not closer to the expected location; however, this flaw is 50% of wall thickness in depth and favorably oriented so it should produce a very strong indication. On the other hand, flaw “m” not being detected is expected given that it is poorly oriented even though it is 50% of wall thickness in depth. The similarly oriented flaw “L” was detected as discussed in Section 6.2, but this flaw was almost completely through the mockup. If notch-like flaws are expected in the DST where their long dimension is oriented along the radius of the vessel, it may be possible to angle the guided wave sensor on the sidewall so that the propagation direction is more favorable. Finally, there are significant other indications in the

SAFT results. They likely are a result of non-"direct path" arrivals (i.e., reverberations between neighboring flaws and the mockup edges).

**Figure 10. SAFT image from the 57 kHz data set. Region restricted to the portion of the mockup between 1.1 and 1.6 m from the thickness transition weld. Refer to Figure 7 for the meaning of the different markings.**

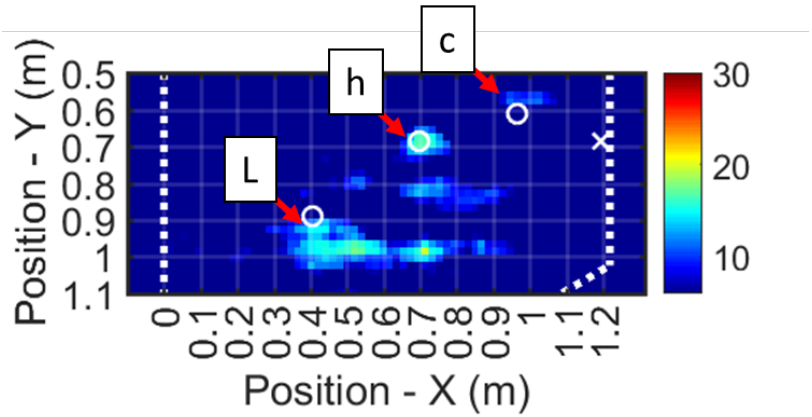
**Figure B-2 – Flaws c, h, and L**

| *Surrogate Flaw Details* | | | *Test System Response* | | | | |
|---|---|---|---|---|---|---|---|
| **Notch** | L | Base plate<br>Perpendicular to weld | Y | 15.9 dB | 50 mm | B-2 | Indication further to weld than expected |

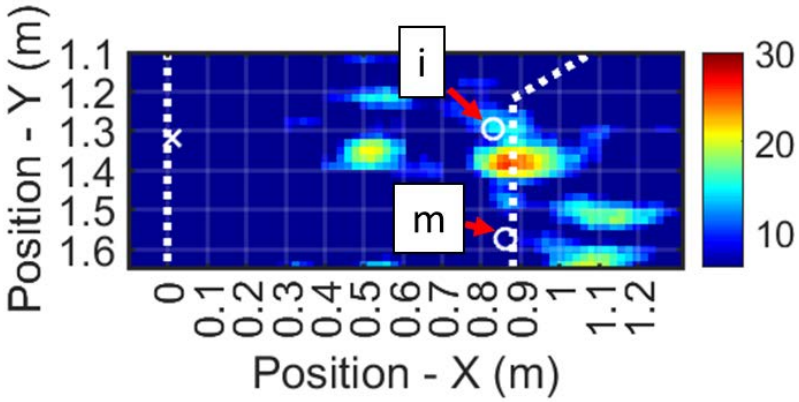
**Figure B-3 – Flaws m and i**

| *Surrogate Flaw Details* | | | *Test System Response* | | | | |
|---|---|---|---|---|---|---|---|
| **Notch** | m | Base plate<br>Perpendicular to weld | N | n/a | n/a | B-3 | Unfavorable flaw orientation |
