U.S. Department of Energy
Grand Junction Projects Office Remedial Action Project

Final Report of the Decontamination and Decommissioning of Building 44 at the Grand Junction Projects Office Facility

July 1996

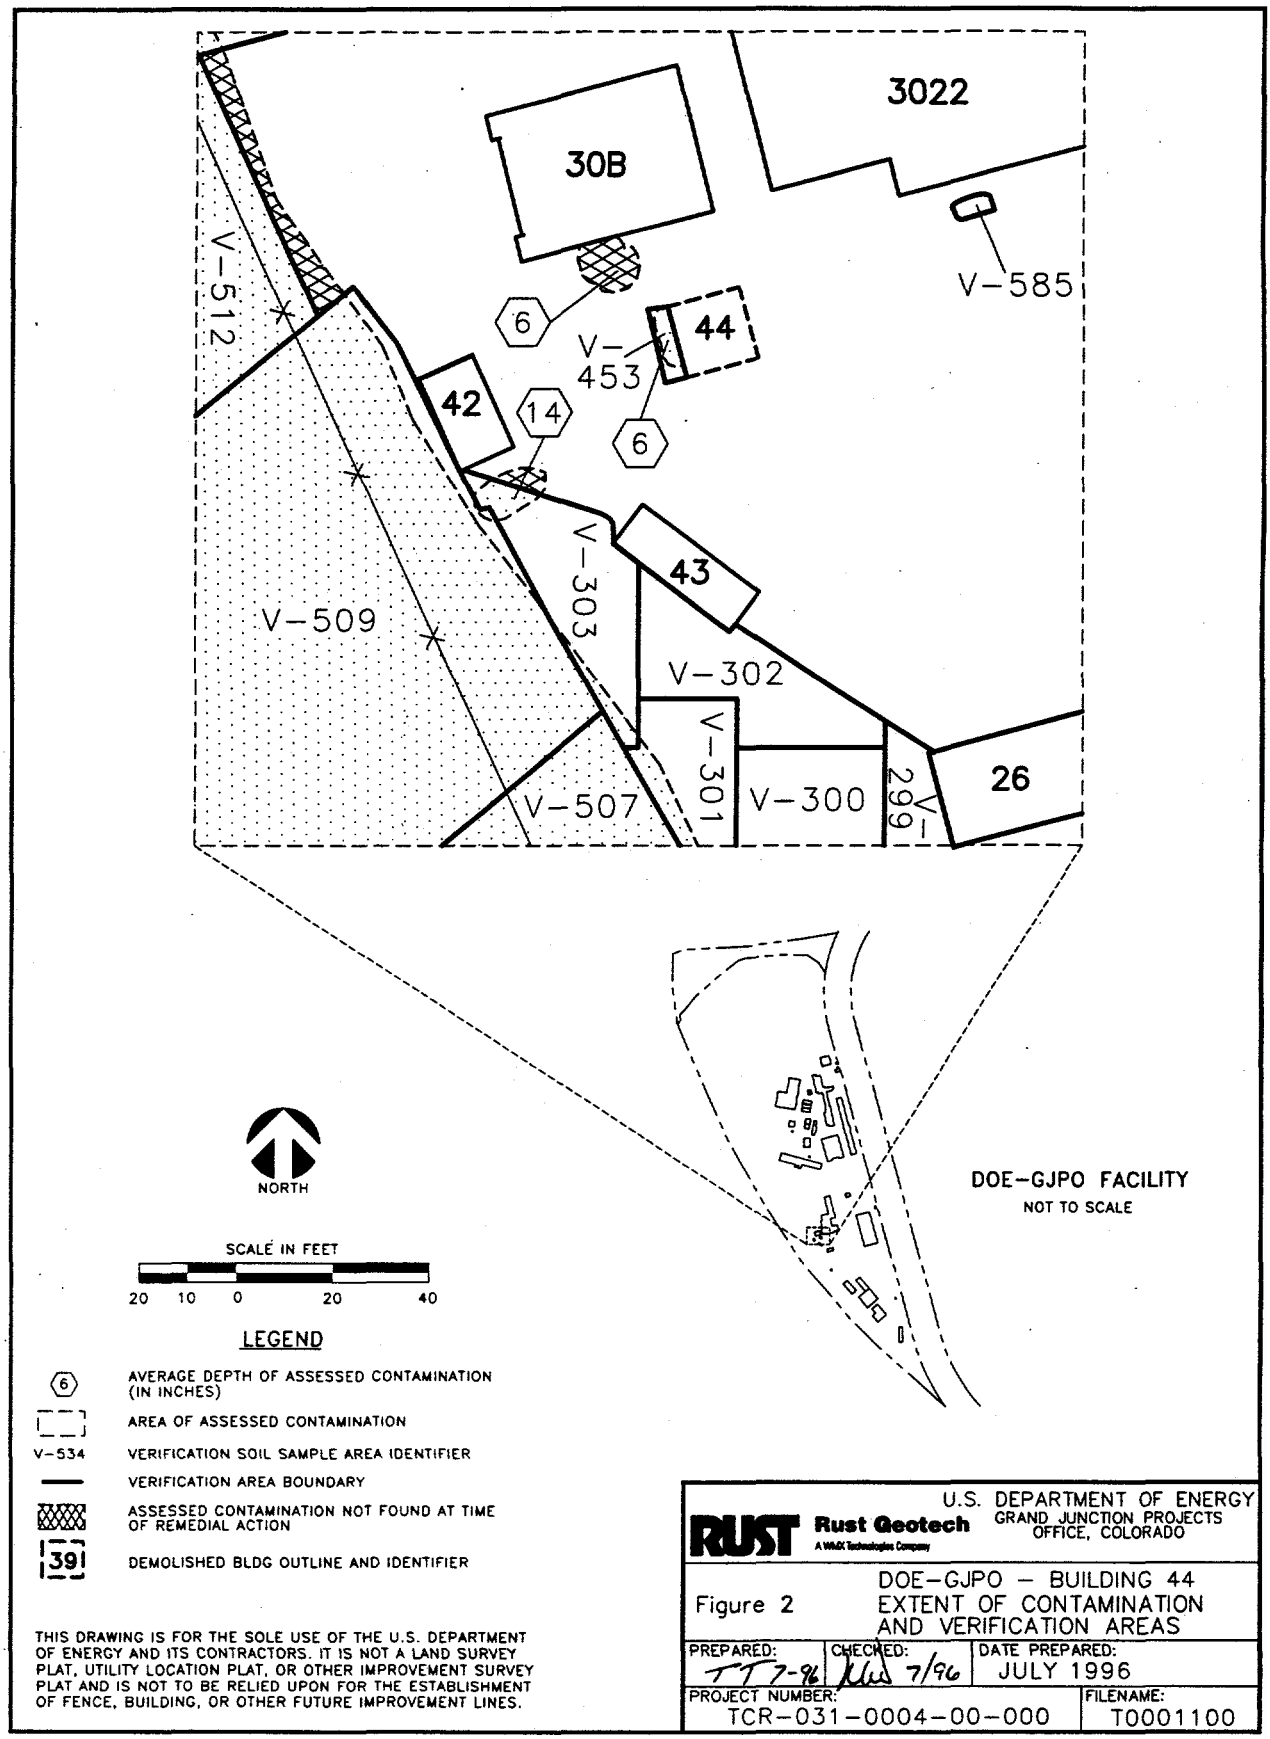
Figure 2. Extent of Contamination and Verification Areas

Summary of Remedial Action—The exterior areas adjacent to Building 44 were remediated in 1989 during Construction Phase IB (Figure 2). Building 44 was demolished in September 1994. The remediation process involved breaking up the building and floor slab using a track hoe and hauling the debris by truck to the Cheney Disposal Cell. Gamma measurements and analyses of samples of the underlying soil indicated that the soil was not contaminated (Rust 1994).
