Empirical Validation of the Conceptual Design of the LLNL 60-kg Contained-Firing Facility

February 24, 1995

Abstract

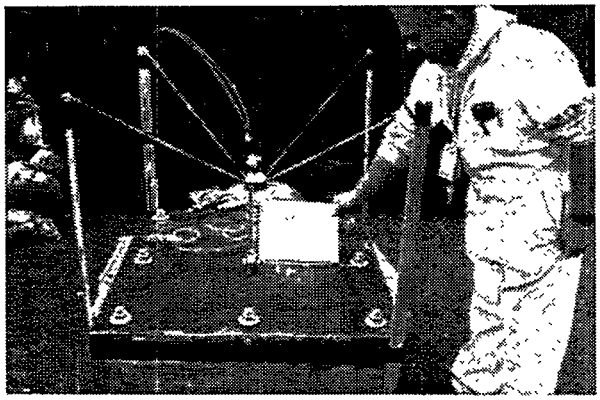
Figure 5. 1/4-scale floor section prior to testing at the 25% explosive weight level.

The highest unit shock (blast) loading that the CFF must withstand will occur on the floor just below the 60-kg explosive charge location. Currently, due to diagnostic requirements of the FXR and the desired operational optical LOSs, this distance is 1.22 m. This results in an extremely close-in ($Z = 0.66$ ft/lb$^{1/3}$) blast loading on the reinforced concrete floor of the chamber. Historically, floor damage from close-in loading has been a common problem for many blast chambers within the DOE/DoD (Department of Defense). Given this, the close-in blast loading on the chamber floor is considered to be one of the critical design issues for the proposed CFF. To investigate this concern, a series of 19 close-in blast loading experiments was conducted on a 1/4-scale section of the proposed floor design (see Fig. 5). The following conclusions were reached as a result of this testing.[6]

• Tensile strains in the concrete were 10 times the allowable dynamic tensile yield and would be likely to cause severe concrete cracking and pulverizing in the long term.

• A low-cost blast attenuation system was developed and tested that reduced the measured strains in the concrete to acceptable elastic levels to prevent severe pulverizing of the concrete.

• Measured strains in the reinforcement, the bolts, and the anvil were all within elastic limits for steel.

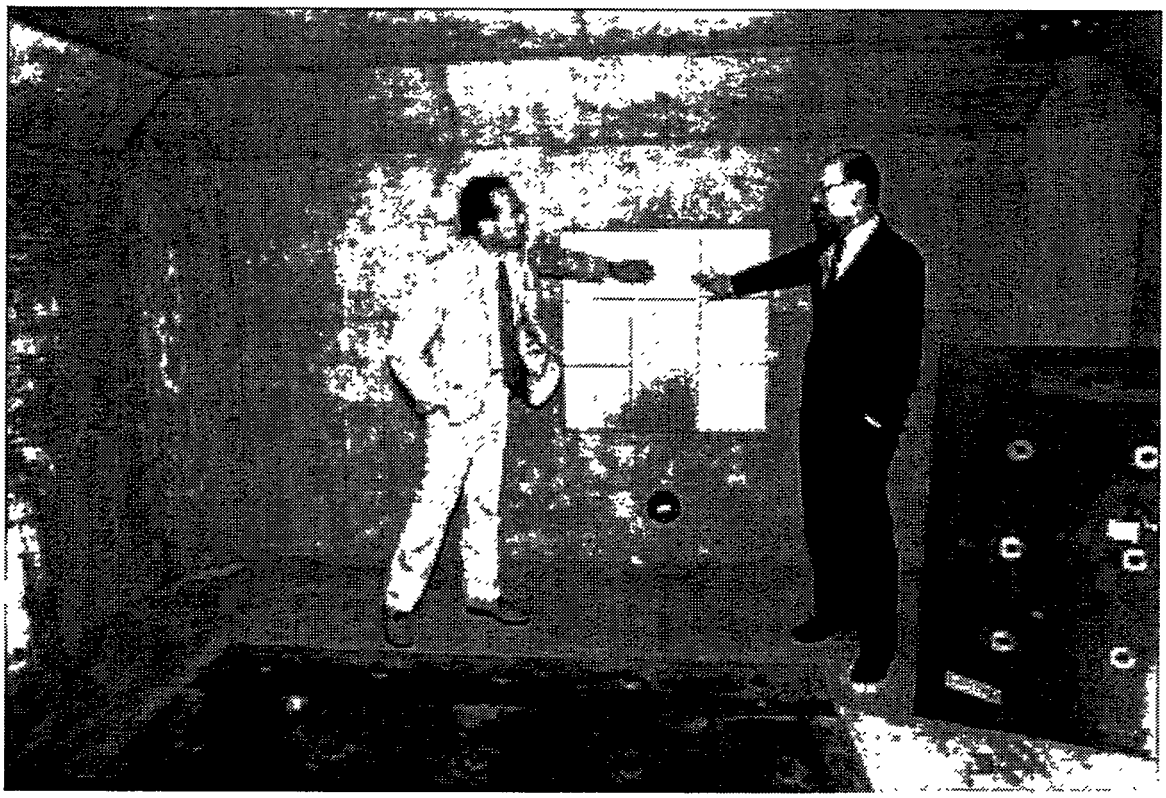
Figure 10. High-temperature coatings on shrapnel protection plates.

7. Various high-temperature coatings were applied to the nine mild-steel shrapnel-protection plates mounted within the north inside wall of the chamber. Table 6 lists these coatings by surface preparation and manufacturer's name. These coatings, which were all at a scaled distance of approximatley 4.5 ft/lb$^{1/3}$ from a charge in Zone 1, performed equally well and did not show any signs of burning from the detonation fireball.

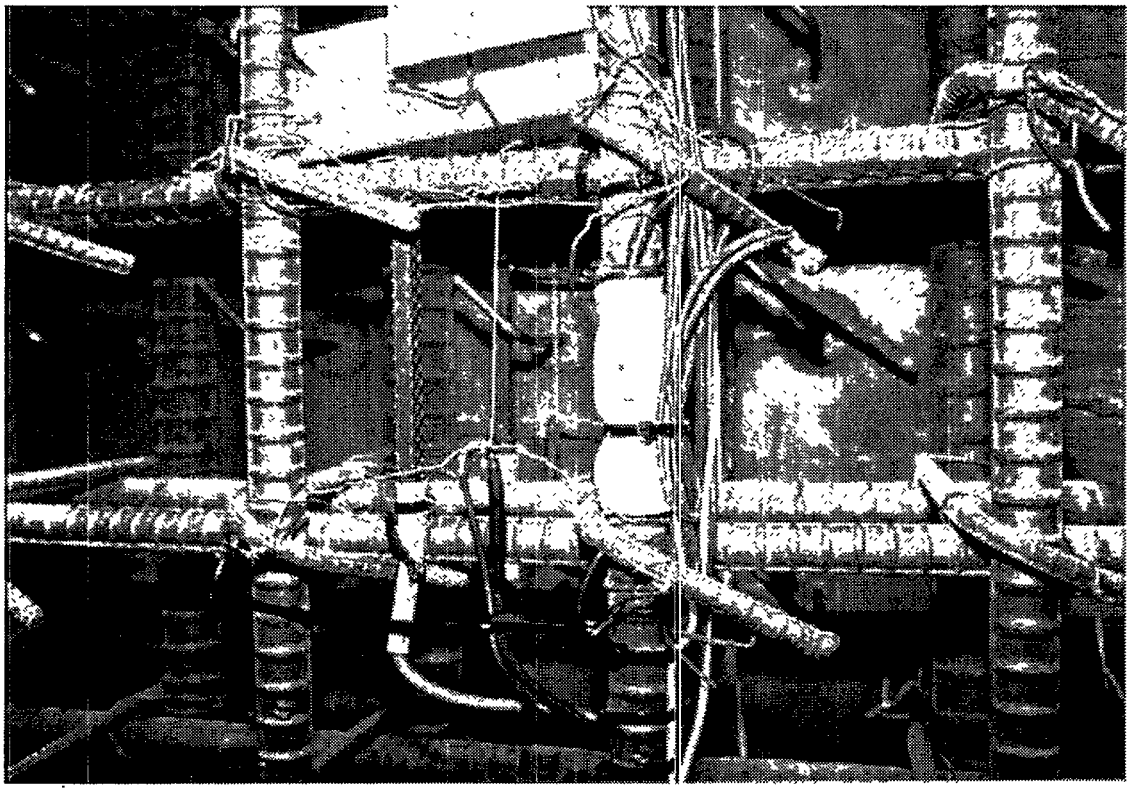
Figure 16. Concrete strain gauges C7 and C14 on the outside of the north wall. Note J hooks on the pressure liner in the background.

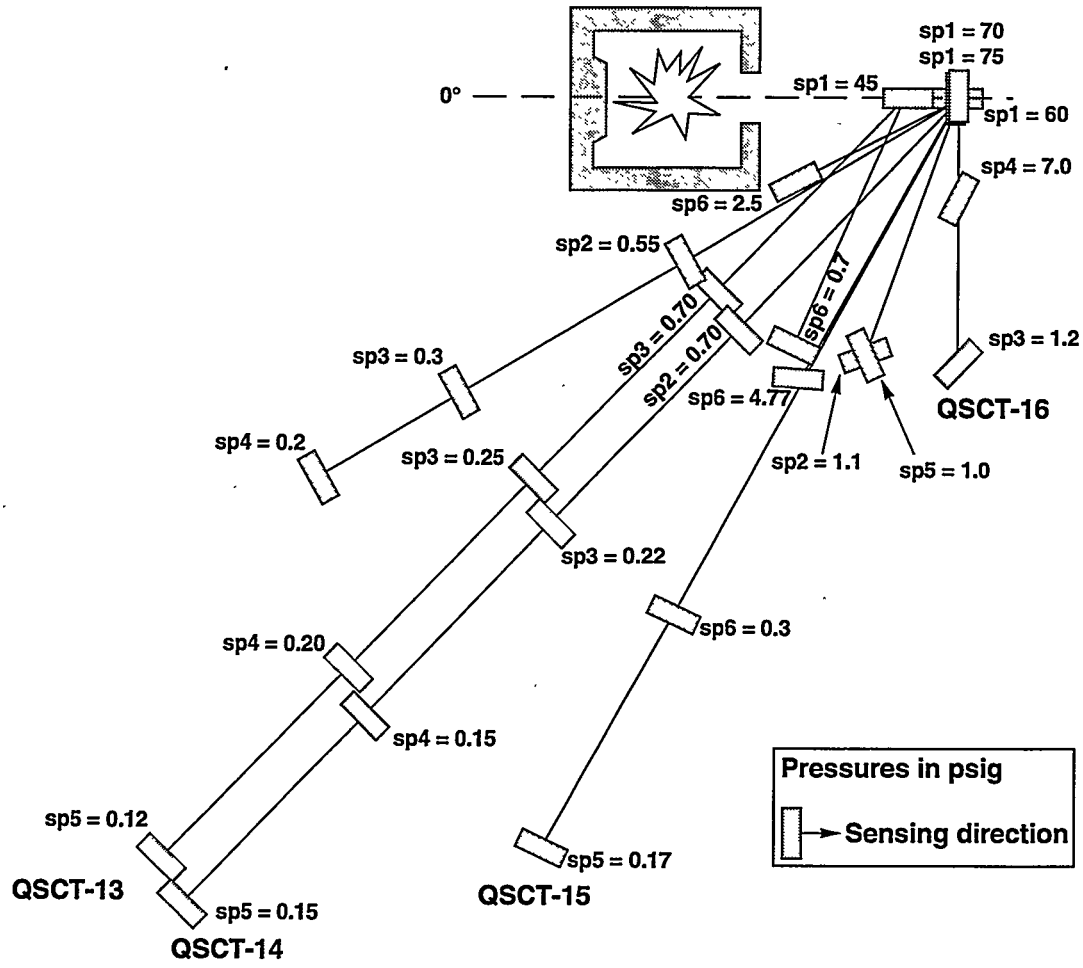
Figure 18. Open-door test pressures map.

External blast overpressures from an accidental detonation scenario ranging from 0.1 to 70 psig were measured during the open-door tests at 22 locations outside the firing chamber model.

Peak external blast pressures from the open-door tests are summarized in Fig. 18. Peak internal blast pressures from each data record are tabulated in Table 5. Typical internal blast pressure traces recorded from the 100% charge levels for the bullnose and the south wall are shown in Figs. 19 and 20, respectively.

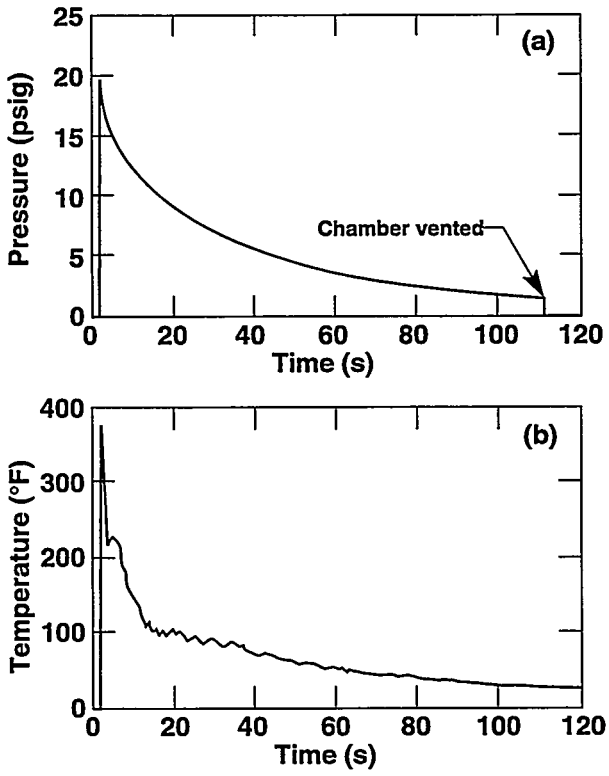
Figure 21. Typical quasistatic gas pressure and temperature records for closed door tests with 125% charges detonated in Zone 1.

Figure 21 shows quasistatic gas pressure and corresponding average air temperature from a 125% over-test in Zone 1. While it was intended to measure only the quasistatic gas pressure, the pressure transducer also was exposed to the more impulsive high-pressure shock waves. This is believed to have excited an internal resonance within the transducer that produced a false overshoot and ringing for the first 10 seconds. The trace in Fig. 21a has been filtered to remove erroneous ringing and overshoot.

10. Figure 28 shows a reasonable correlation of the peak values for measured quasistatic pressure and temperature as a function of charge weight. As expected, the quasistatic pressure is due to the hot products of combustion and it decreases at the same rate as the gases cool (see Fig. 21).

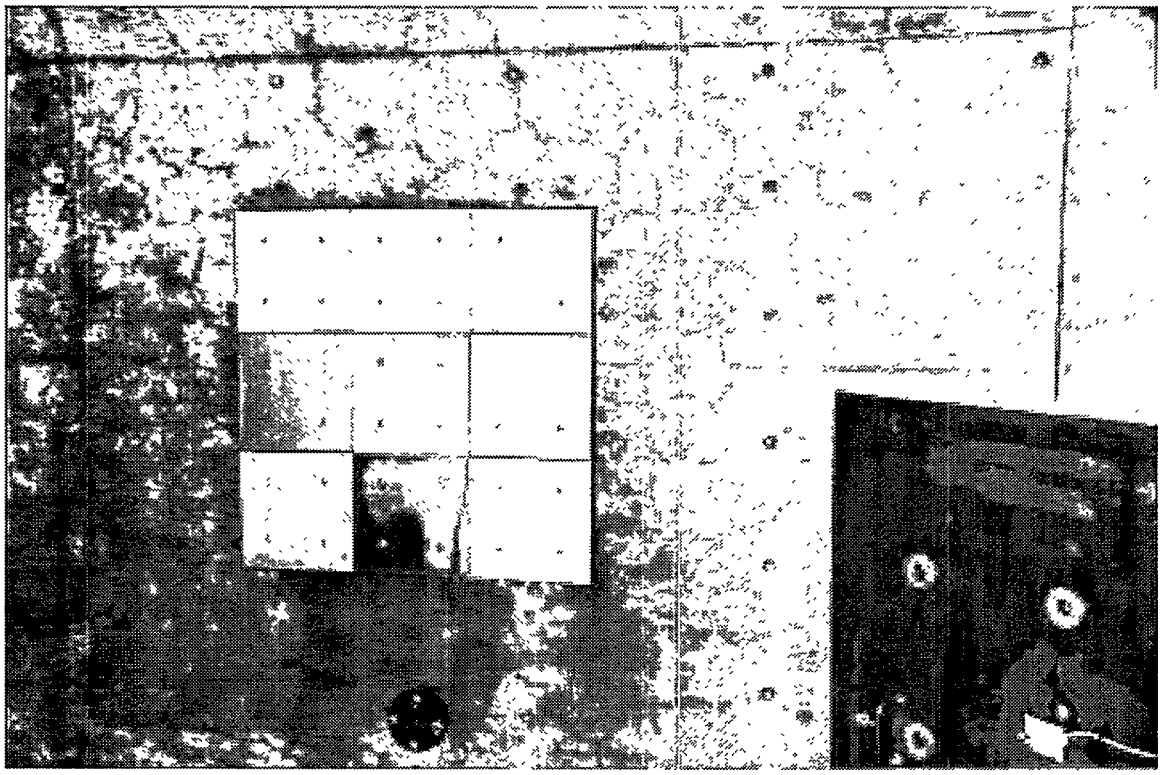
(C11) for the two 100% test levels in Zone 1. At the 125% level, the safety factors for the outer concrete had increased to 1.32 and 1.24. This appears to be at the expense of the inner concrete (C12) safety factors, which then deceased to 0.95 and 0.88. From these observations, it is assumed that cracking of the concrete in the ceiling initiated at the outer surface and eventually advanced through the ceiling to the inner surface. To enhance the visual effects of the cracks, the concrete was moistened and photographed during different stages of drying before the 125% shot level. Figures 22–24 show typical cracks from the dynamic response of the firing chamber.

Figure 24. Interior cracks in north wall after 100% charge level experiments.

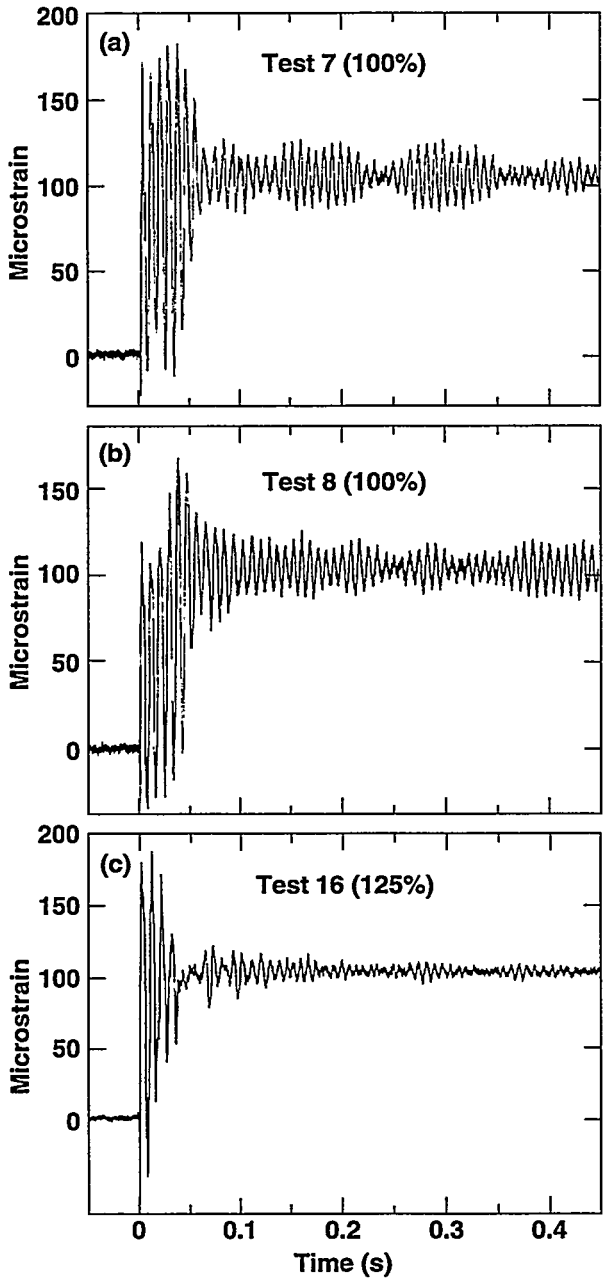
structure. This can be seen by examining Fig. 26, which gives a chronological history of the strain in the concrete of the north wall (gauge C7) prior to and during yielding. This figure also gives evidence of strain relaxation and redistribution by the reduction in the peak strain value from (a) to (b) . It is not clear that this cracked section behavior is desirable from a repeated use standpoint, in that it may not be compatible with the original design criteria of an infinite-life elastic response. Clearly, the long-term behavior after cracking has not been tested in these experiments, and further study is recommended.

Figure 26. Damping increased, possibly because of cracking in the concrete in the north wall of the chamber (gauge C7).

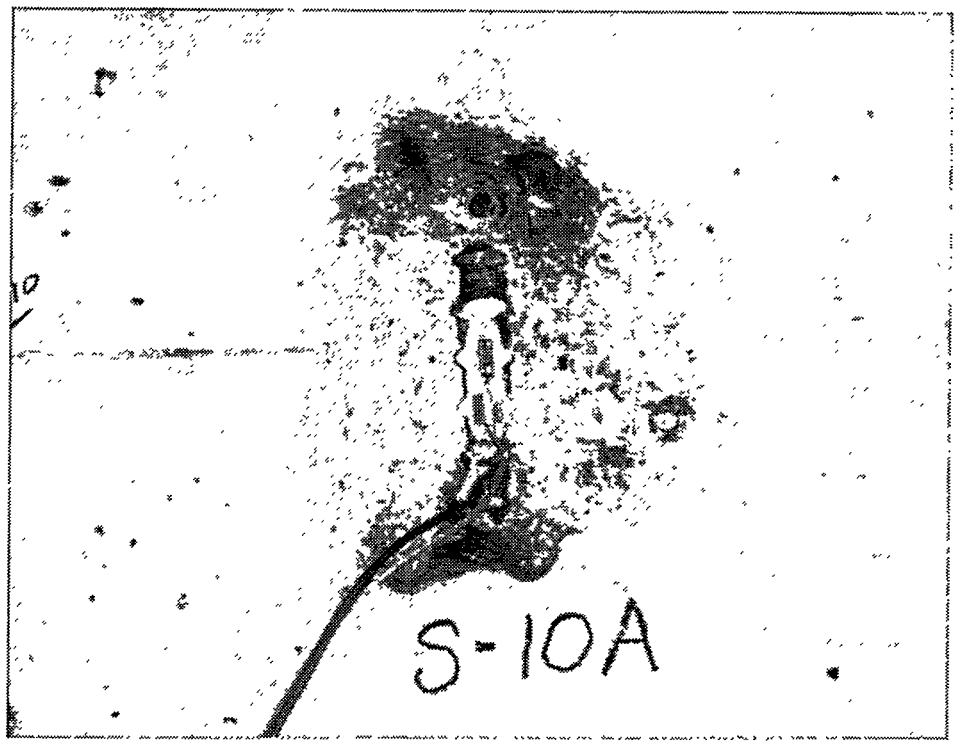
8. Unexpectedly, about half of the steel rebar strain gauges failed just before and just as testing started. Although this was unfortunate, we overcame this condition by replacing strain gauges during mid-testing and successfully obtained rebar strain at important points (see Fig. 27). Since similar strain gauges are planned to be used in the full-size chamber to monitor its dynamic response over its lifetime, it is recommended that these failures be investigated to determine the exact cause so that they may be prevented in the future.

Figure 27. Replacement strain gauge added to rebar after concrete was cured.

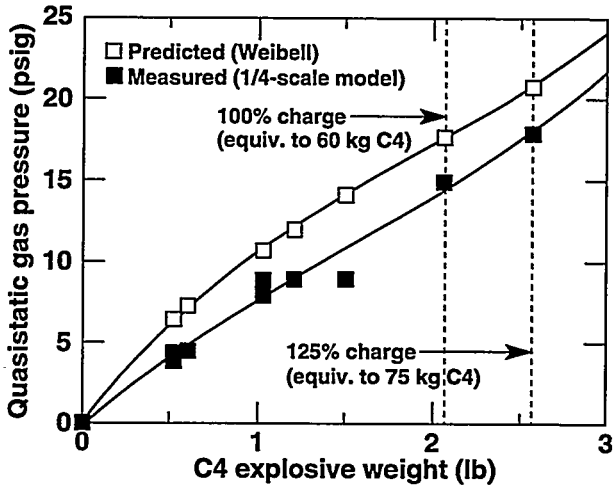
Figure 29. Comparison of predicted and measured quasistatic gas pressure for the 1/4-scale model as a function of charge weight.

Internal blast pressures averaged 2 to 3 times greater than expected. Quasistatic gas pressures peaked at 18 psig, roughly 86% of the 21 psig predicted by calculation.

11. The quasistatic gas pressure measured during the experiments tracked the predicted pressures fairly well. Figure 29 is a plot of the peak values of the quasistatic pressures as a function of the charge weights used. At the 125% shot level, the measured pressure was 18 psig vs 21 psig calculated via the Weibell formula.
