Research and
Development Report

SUMMARY REPORT OF HTRE NO. 3 NUCLEAR EXCURSION

Published by
TECHNICAL PUBLICATIONS SUB-SECTION
August 1959

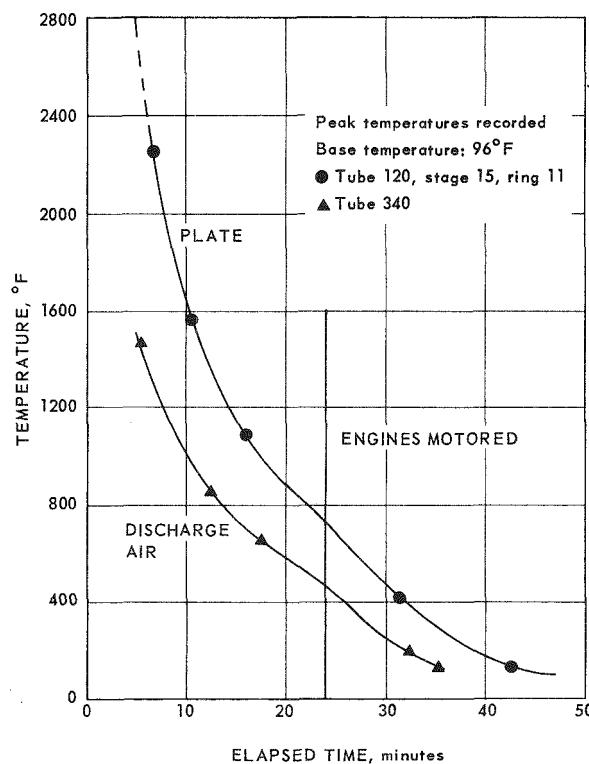
Component temperatures recorded following scram are presented in Figures 29 through 41. The highest temperatures recorded for a given component have been selected and are plotted as a function of elapsed time. In addition, circumferential, longitudinal, and radial temperature distributions are presented where data were available. Temperature information on the moderator bars, control rod discharge air, and both the front and rear tube sheets was fairly complete since thermocouple loss was slight; however, loss of instrumentation on the fuel elements was extensive, and few data were obtained. Only the peak temperatures recorded during the scan have been selected for presentation here. Instrumentation on hotter elements probably failed during the power excursion. Thermocouples in the reactor shield and core support structure indicated a temperature of approximately 60° to 100°F 5 minutes following the scram.

Fig. 29 — Fuel element plate and air temperatures during
power falloff from scram

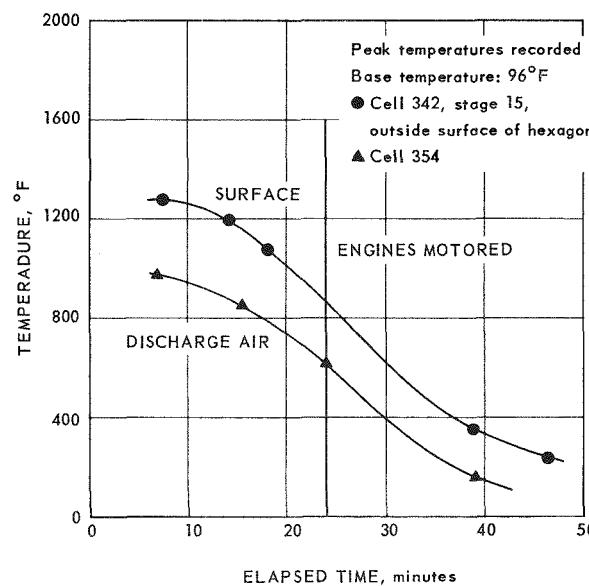
Fig. 30 — Moderator surface and air temperatures during
power falloff from scram

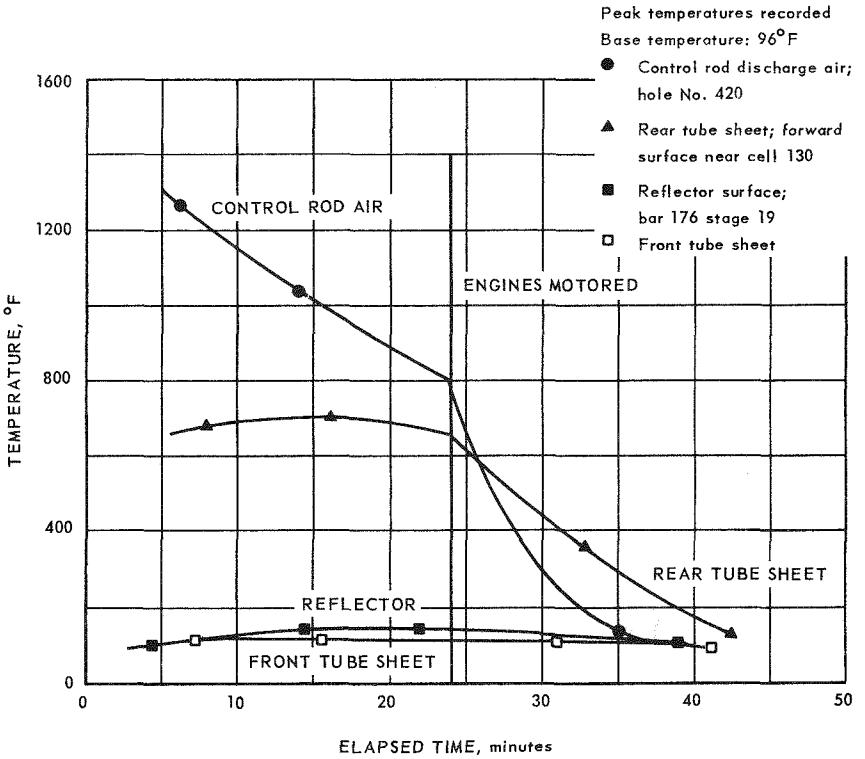
Fig. 31 – Reactor component surface temperatures during power falloff from scram

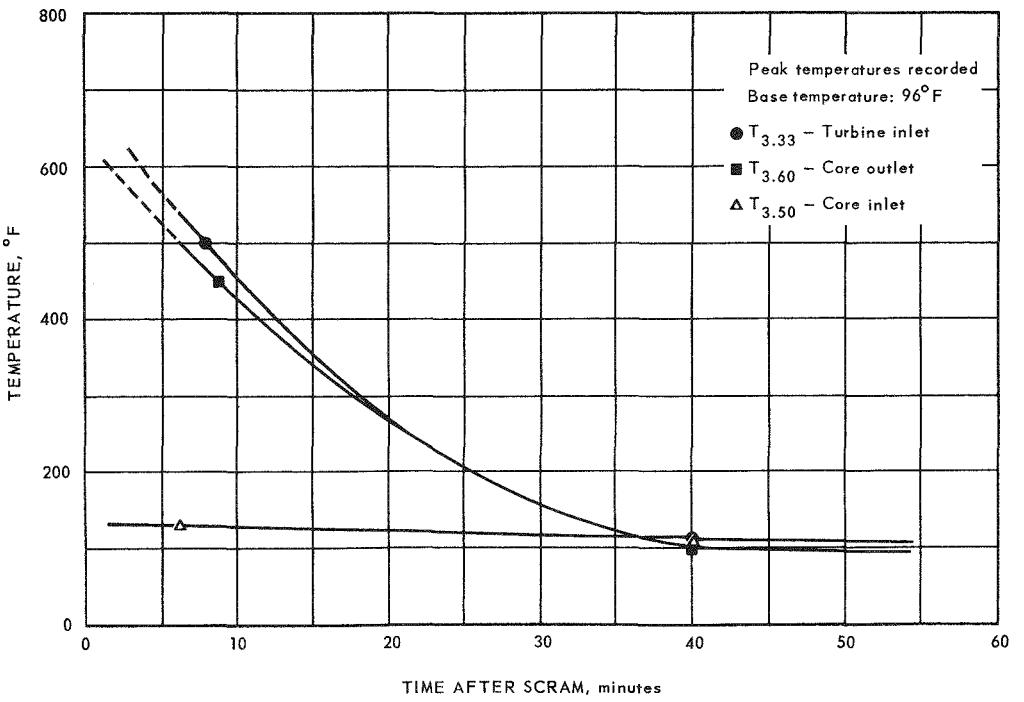
Fig. 32 – System loop temperatures during power falloff from scram

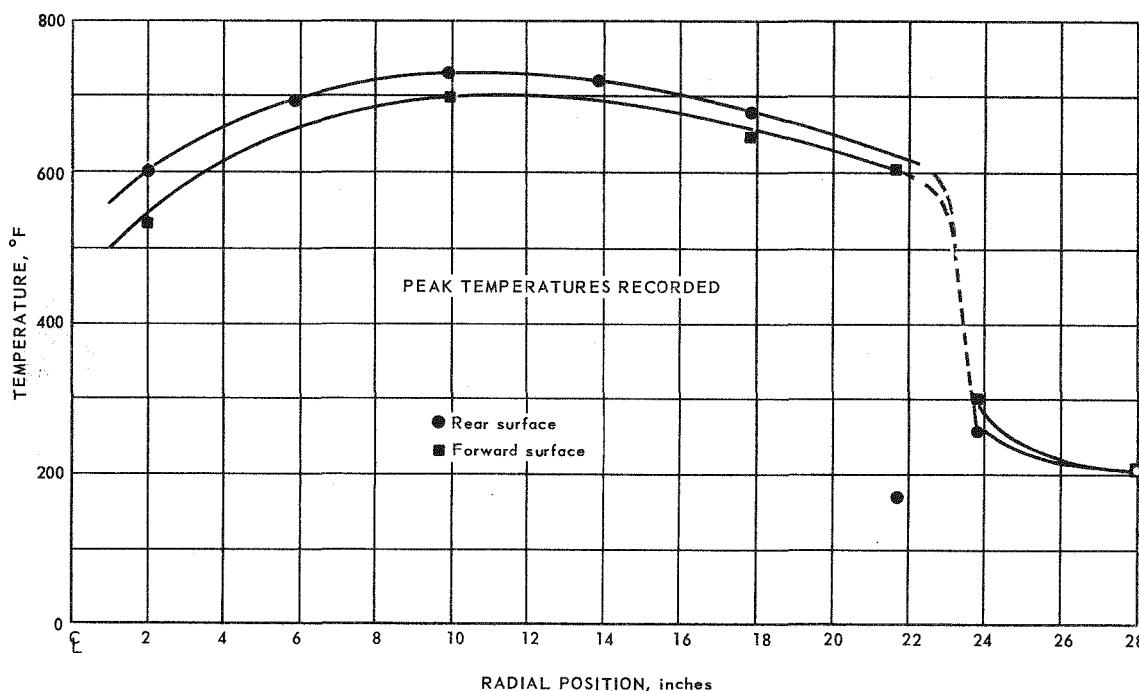
Fig. 33 — Rear tube sheet radial surface temperatures 16 minutes after scram

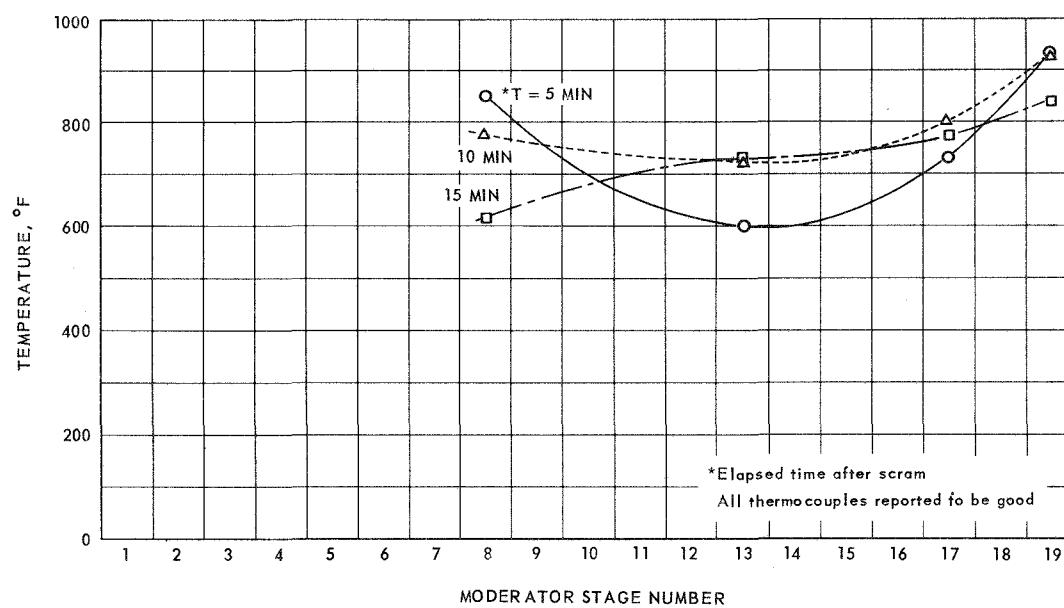
Fig. 34 — Longitudinal moderator temperatures after scram, cell 463

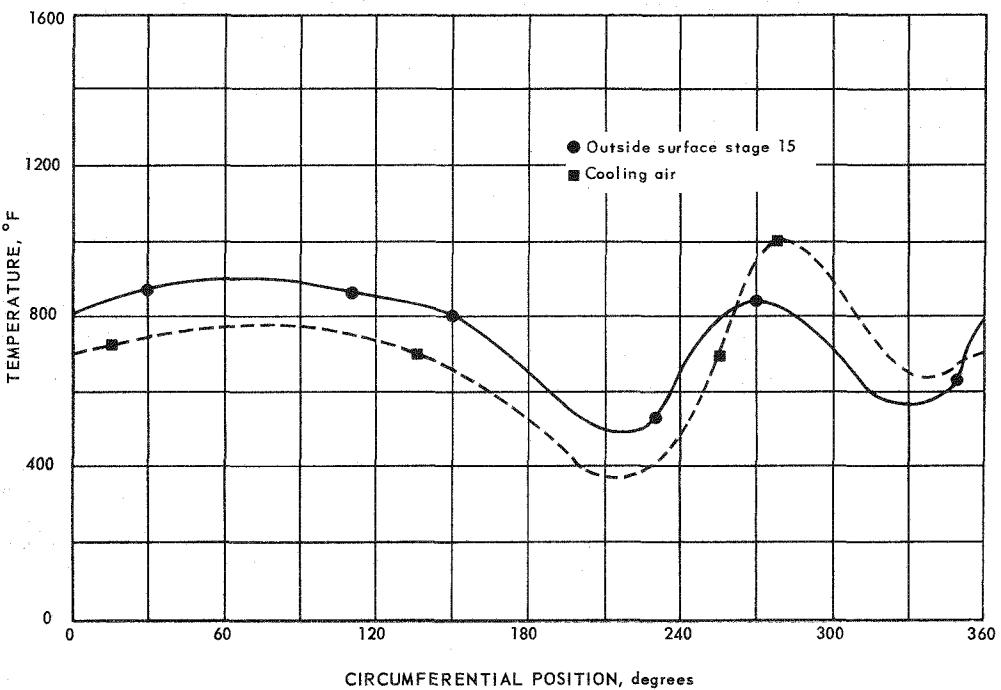
Fig. 35 – Circumferential moderator surface and air temperatures 6 minutes after
scram, cell 160

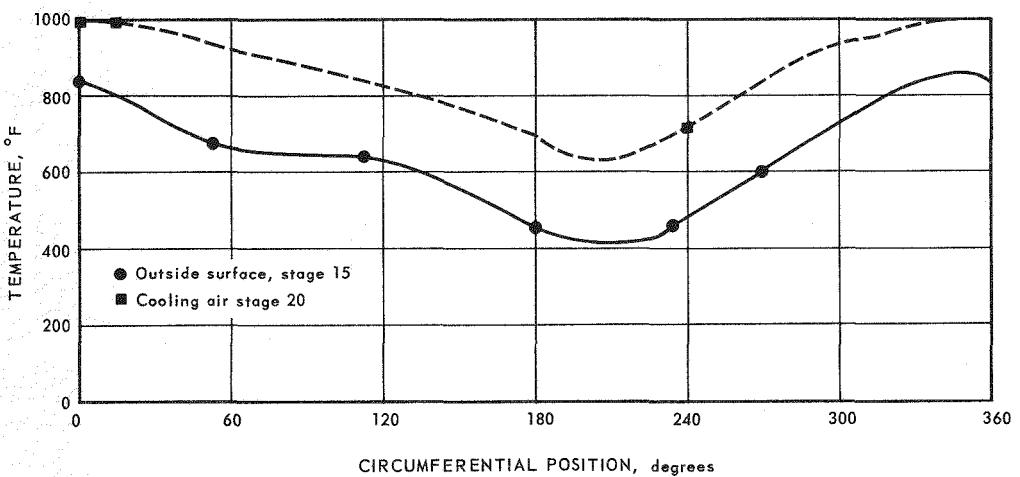
Fig. 36 – Circumferential moderator surface and air temperatures 6 minutes after
scram, cell 273

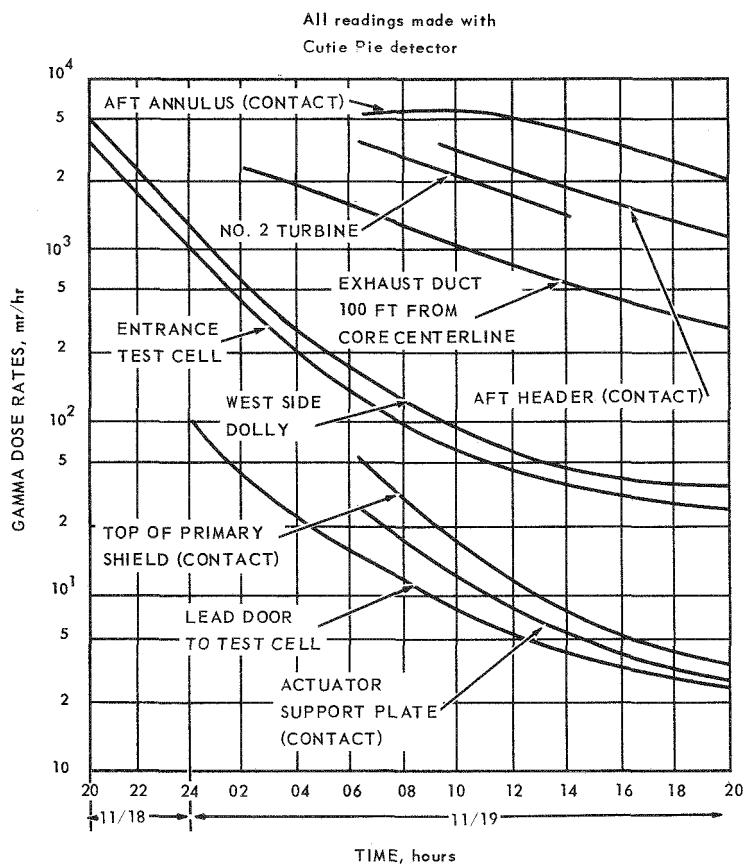
Fig. 45 – Radiation levels in test cell

Radiation levels were measured with Cutie Pie meters at various points in and around the test cell including contact readings at several points on the D102A reactor assembly and on the IET large duct (approximately 100 feet from core centerline). Readings were repeated over a period of approximately 24 hours to follow the decay of the radiation levels. The resultant curves are shown in Figure 45. The highest radiation levels indicated are about 5 roentgens per hour, which tend to substantiate the belief that large quantities of fuel did not leave the reactor core and deposit in the dolly ducting or the IET large duct.

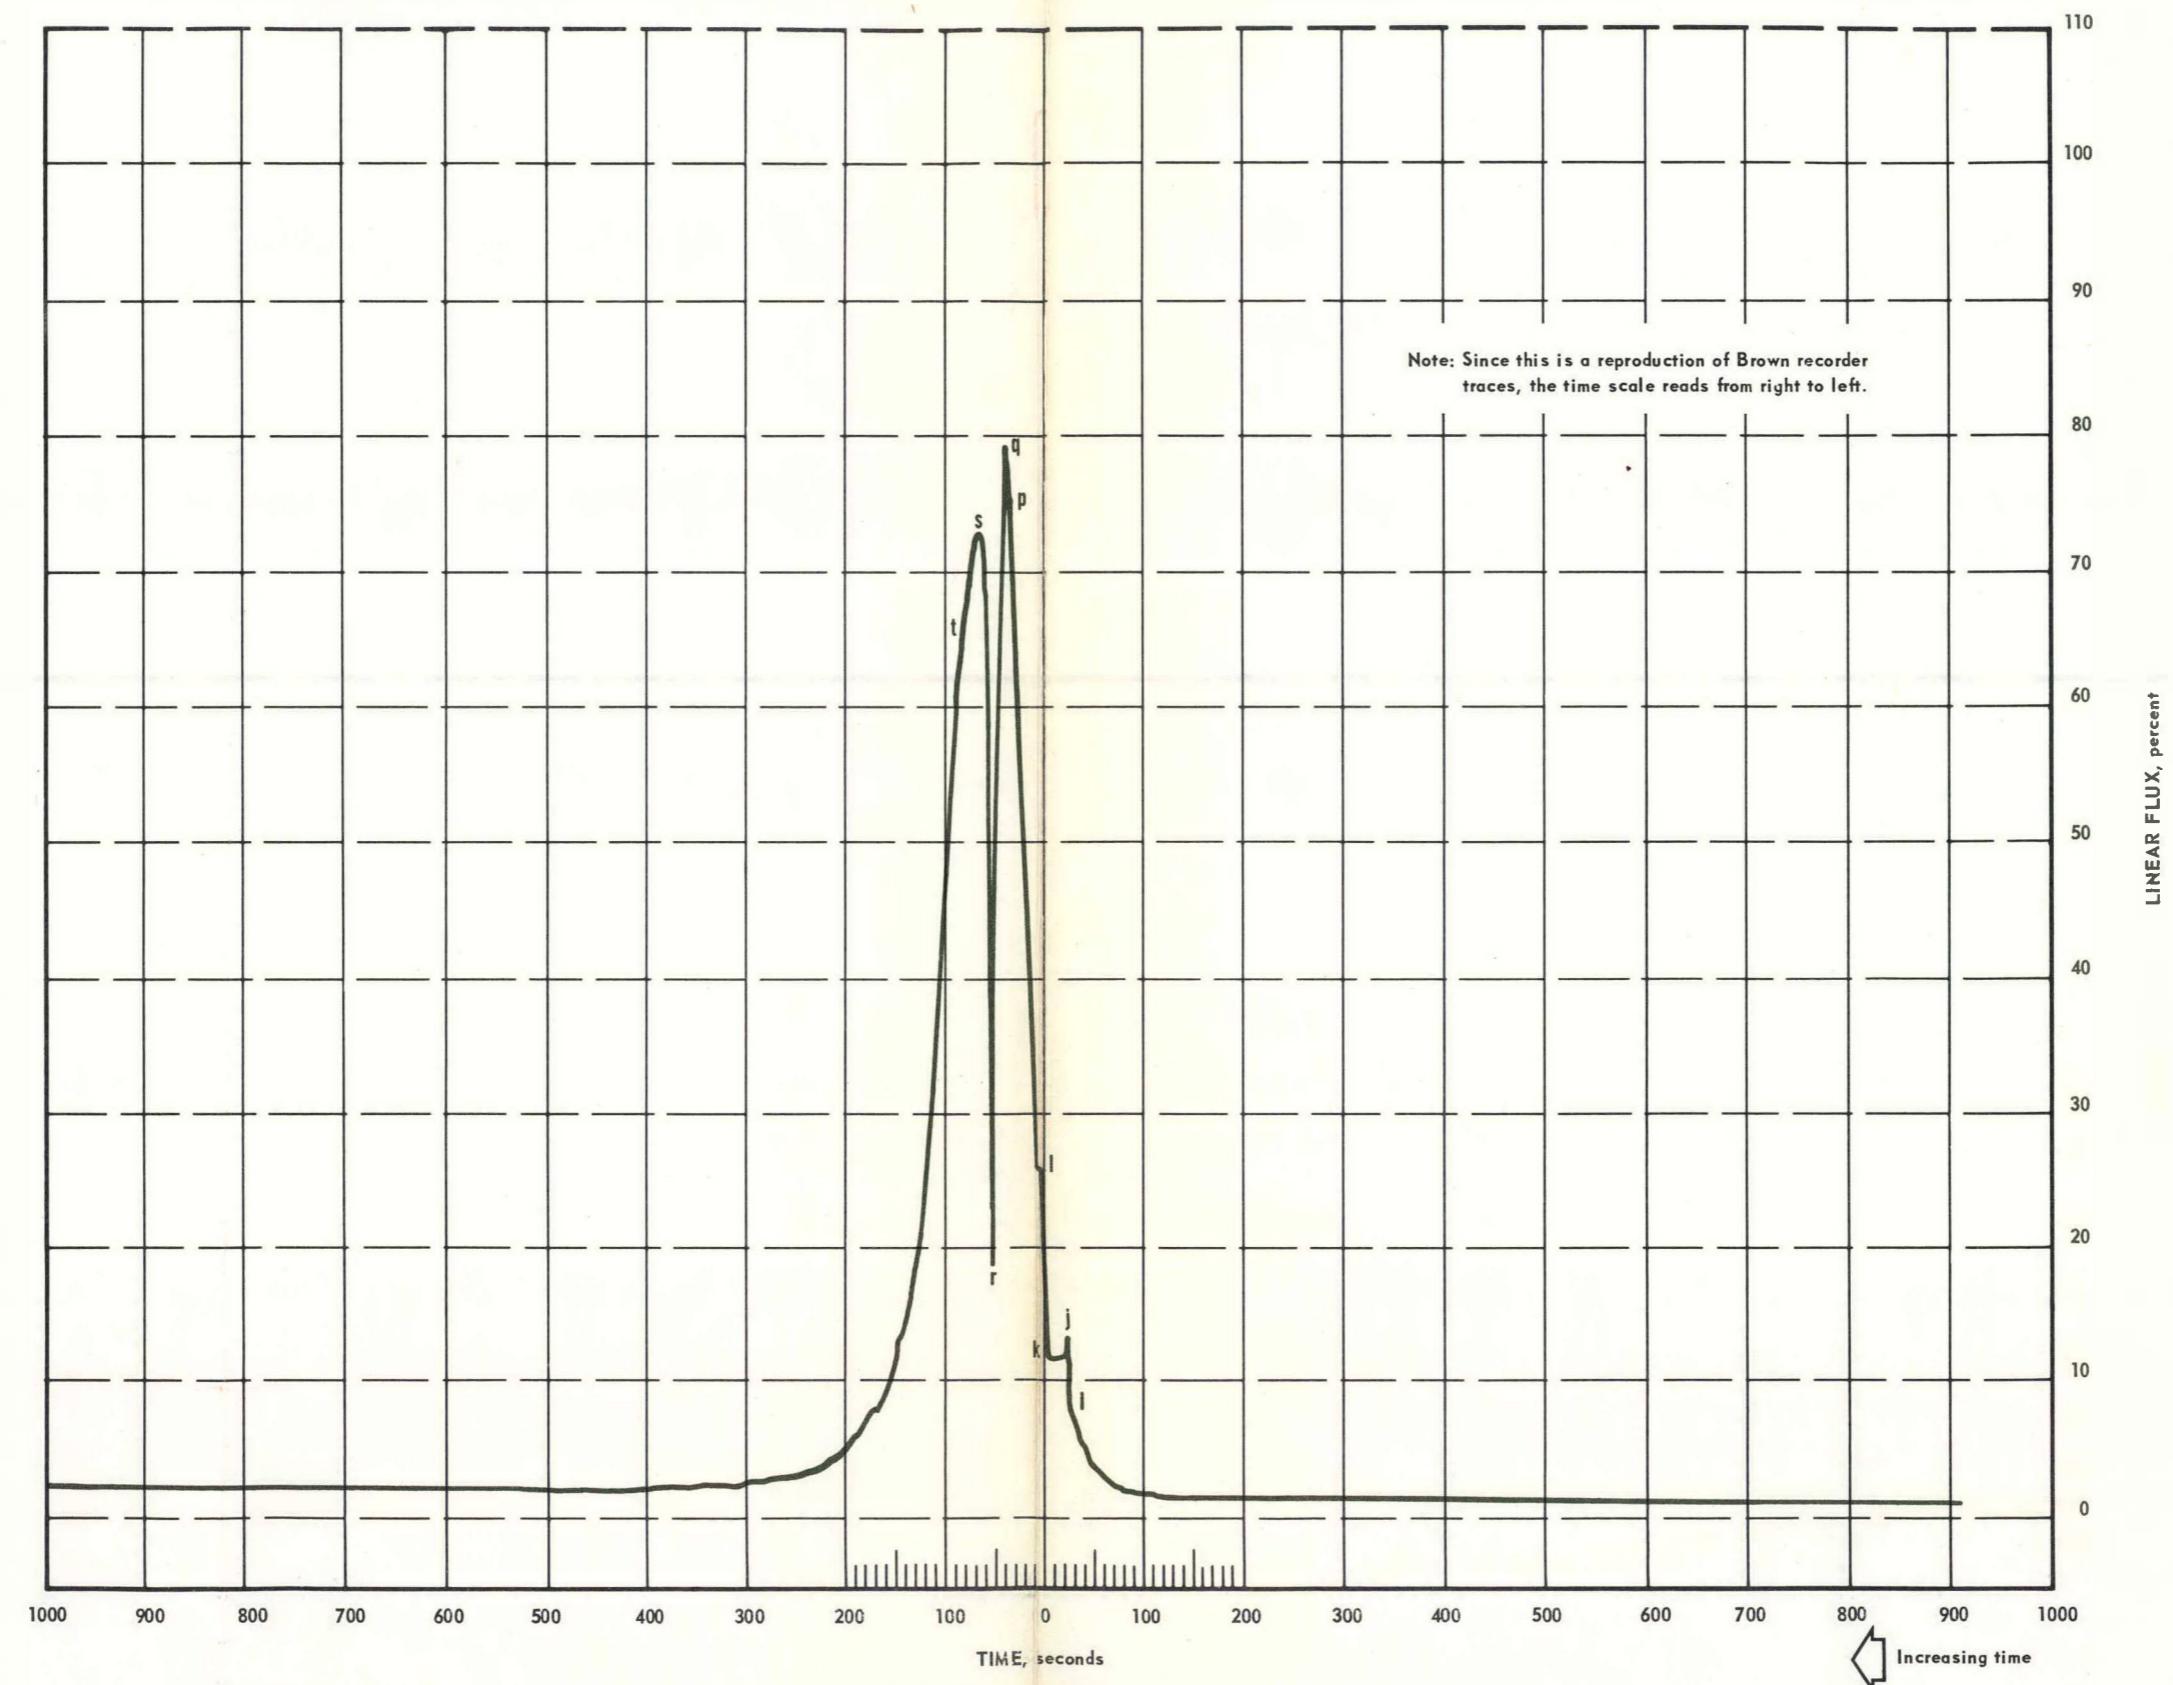
Fig. 48 — Linear-flux trace

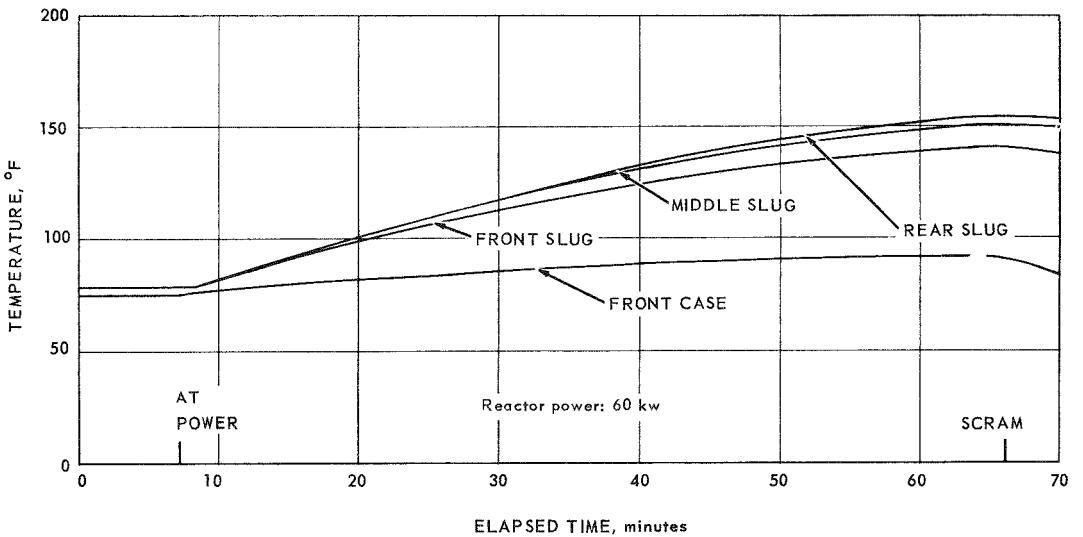
Fig. 50 — Hydrided zirconium heat sensor temperatures, control rod hole 520, run 15-2

During the previous run (run 15-2) when reactor power was at about 0.060 megawatt,
the hydrided zirconium slugs in the heat sensor in control rod hole 520 showed a tem-
perature increase of about 0.030 degree per second during the first part of the run
when heat losses from the slugs were small (see Figure 50). The sensor therefore
measures reactor energy at the rate of 2.0 megawatt-seconds per °F when losses are
low. Extrapolation of data shows that during the power excursion, this same slug was
heated from about 130°F to at least 380°F, a difference of 250°F. The energy released
during the power excursion was, therefore, at least 2.0 megawatt-seconds per °F x 250°,
or 500 megawatt-seconds.

For this calculation the temperature of the slug before the excursion was assumed
to be the same as the inlet air temperature, which was measured 6 minutes after shutdown
and found to be about 130°F. However, the inlet air temperature during previous runs
at the same flow rate was about 80°F. If this temperature were applied to the calcula-
tion, the energy release determined would be at least 600 megawatt-seconds. Therefore,

this method showed reactor energy release to be at least 500 or 600 megawatt-seconds. This calculation agrees well with the 540 megawatt-seconds calculated from the appearance of the fuel, and also fairly well with the 765 megawatt-seconds obtained by indium foil exposure during the excursion.

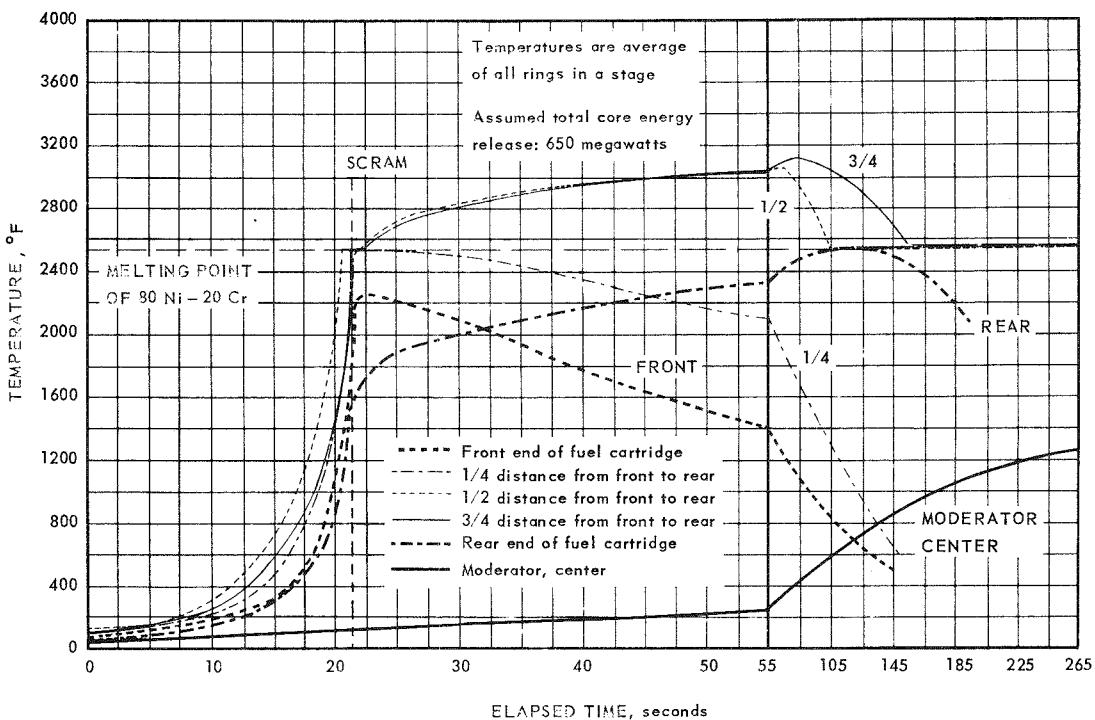
The results of this calculation are shown in Figure 51. The temperatures shown agree very well with reports of the physical damage and appearance of the core. They also agree with the temperatures observed during the event and those recorded 4 minutes after shutdown. The calculations show complete melting of fuel elements near the center of the core longitudinally, partial melting of fuel elements at the rear end of the core, and no melting at the front end. The longitudinal hottest portion of the inner moderator hexagons, about three-quarters of the distance from front to rear of the core, was calculated to reach 1200°F after 3 minutes and then to cool slowly. This calculation agrees qualita-

Fig. 51 — Calculated core temperatures caused by power excursion

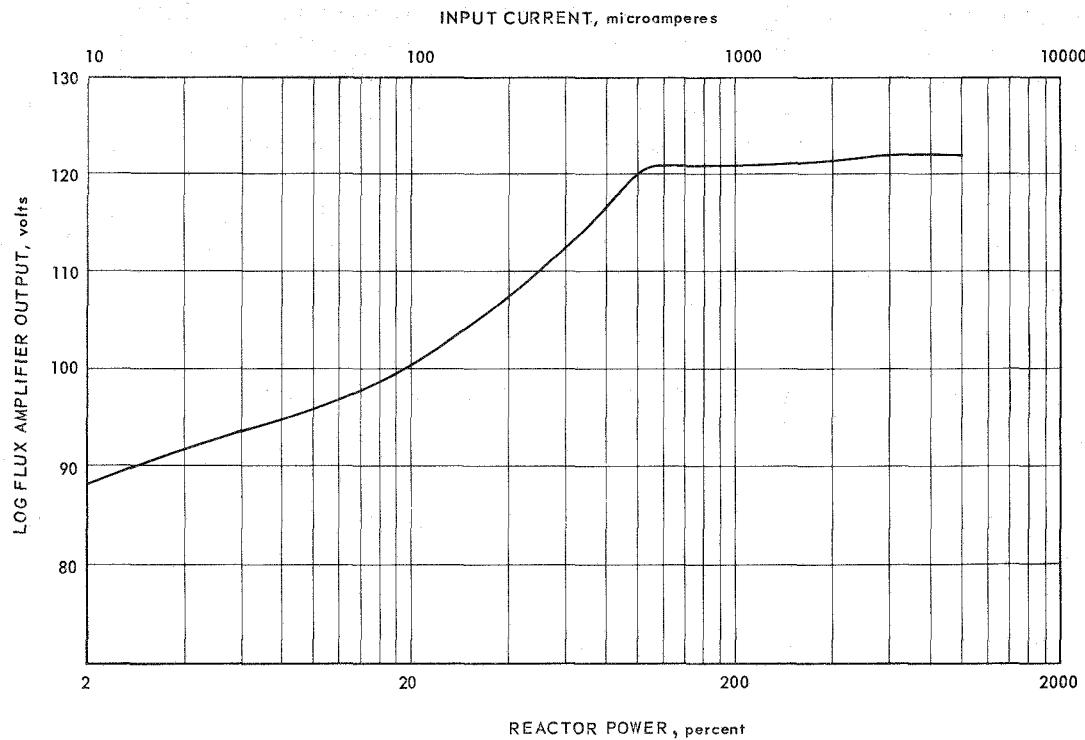
Fig. 60 — Typical log-flux response, upper portion

The log-flux amplifier is not normally used during power-range operation. The amplifier is so designed that the log diode characteristic becomes linear above 20 to 30 percent of full power, depending on the individual diode. A typical characteristic curve showing the upper portion of the log-flux amplifier response is shown in Figure 60. During the operation of this amplifier in this region of linear response, the period signal response indicates a shorter period than the actual period of the reactor. For this reason, the period-amplifier safety circuits are normally automatically bypassed during the power-range operation. Complete saturation of the log-flux amplifier occurs at an input current between 500 microamperes and 1 milliampere, depending upon the particular log-flux amplifier board checked. This represents a flux level of approximately 100 to 200 percent.

The amplifier saturation plus chamber saturation at a later time caused the inter-mediate-range safety circuits to be inoperative during the excursion, even though the operations personnel had removed the bypass action that usually exists around the intermediate-range safety contacts when operating in the power range. Saturation in the amplifier occurs in the plate circuit of the starved pentode amplifier, shown in Figure 61, because of the grid currents of the cathode-follower output tube through the plate load resistor of the pentode.

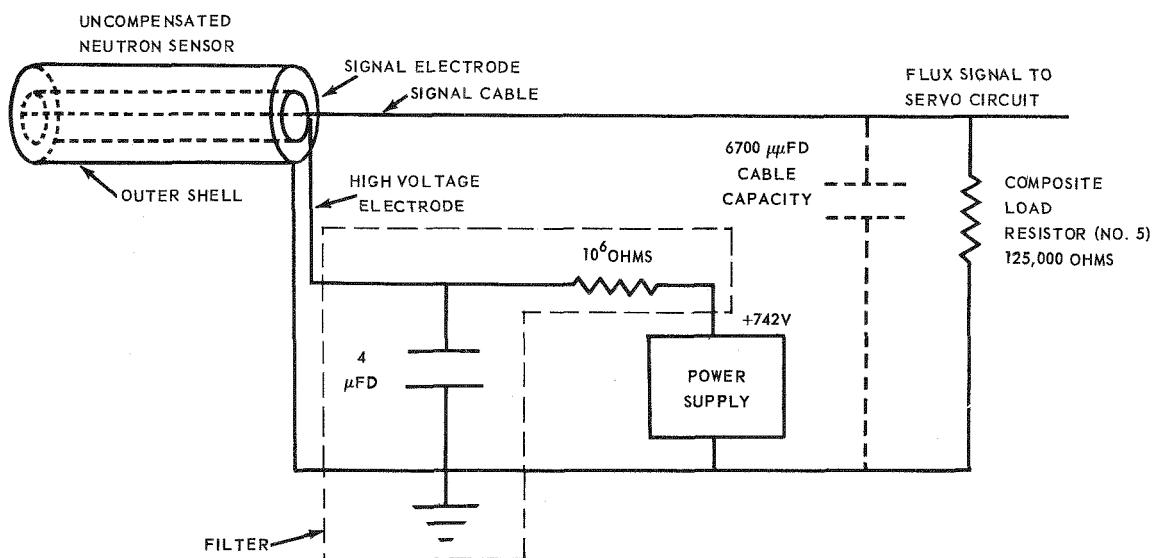
Fig. 62 — Neutron sensor and portion of linear-flux channel

Figure 62 shows the portion of the linear-flux channel that is necessary to determine the direct cause of the accident and to explain the recorded linear-flux trace. An uncom-pensated ionization chamber consisting of three concentric cylinders, each insulated from the others, is the flux-sensing element. (The inner electrode is shown as a dashed line

on Figure 62.) The outer surface of the inner electrode and the inner surface of the middle electrode are coated with boron, thus making the chamber neutron sensitive. The signal current is normally derived from the inner electrode and the chamber collecting voltage is normally applied between the middle electrode and ground. The signal electrode is connected to ground through a 125,000-ohm signal voltage developing resistor. The outer electrode or housing is connected directly to ground and prevents an electrical shock hazard, facilitates chamber mounting within the reactor, and provides extrinsic electrostatic shielding of the signal electrode. There was approximately 0.0007 microfarad of cable capacity across the signal-developing resistor; the chamber collecting voltage was obtained through an RC filter from a variable voltage power supply that was set for an output voltage of 800 volts. (The design setting for the power supply was 1500 volts.) The actual voltage out of the power supply however, was 742 volts. The power-supply filter, which was not a part of the circuit as designed, consisted of a 1-megohm resistor electrically connected between the power supply and the high-voltage electrode in the ionization chamber and a 4-microfarad condenser, which is electrically connected across the chamber high-voltage electrode and ground. Figure 63 shows a photograph of the RC filter and its location with respect to the linear-flux and log-flux power supplies in the IET control console. This filter was originally used with the HTRE No. 1 (compensated ion chamber) linear flux circuits to eliminate difficulties due to power-supply noise being coupled from the high-voltage electrode to the signal electrode by means of the chamber interelectrode capacity. The filters were permanently mounted in a separate drawer in the IET secondary relay panels and were connected into the circuit by means of coaxial cables. Figure 64 shows the characteristic curves of a prototype ionization chamber.

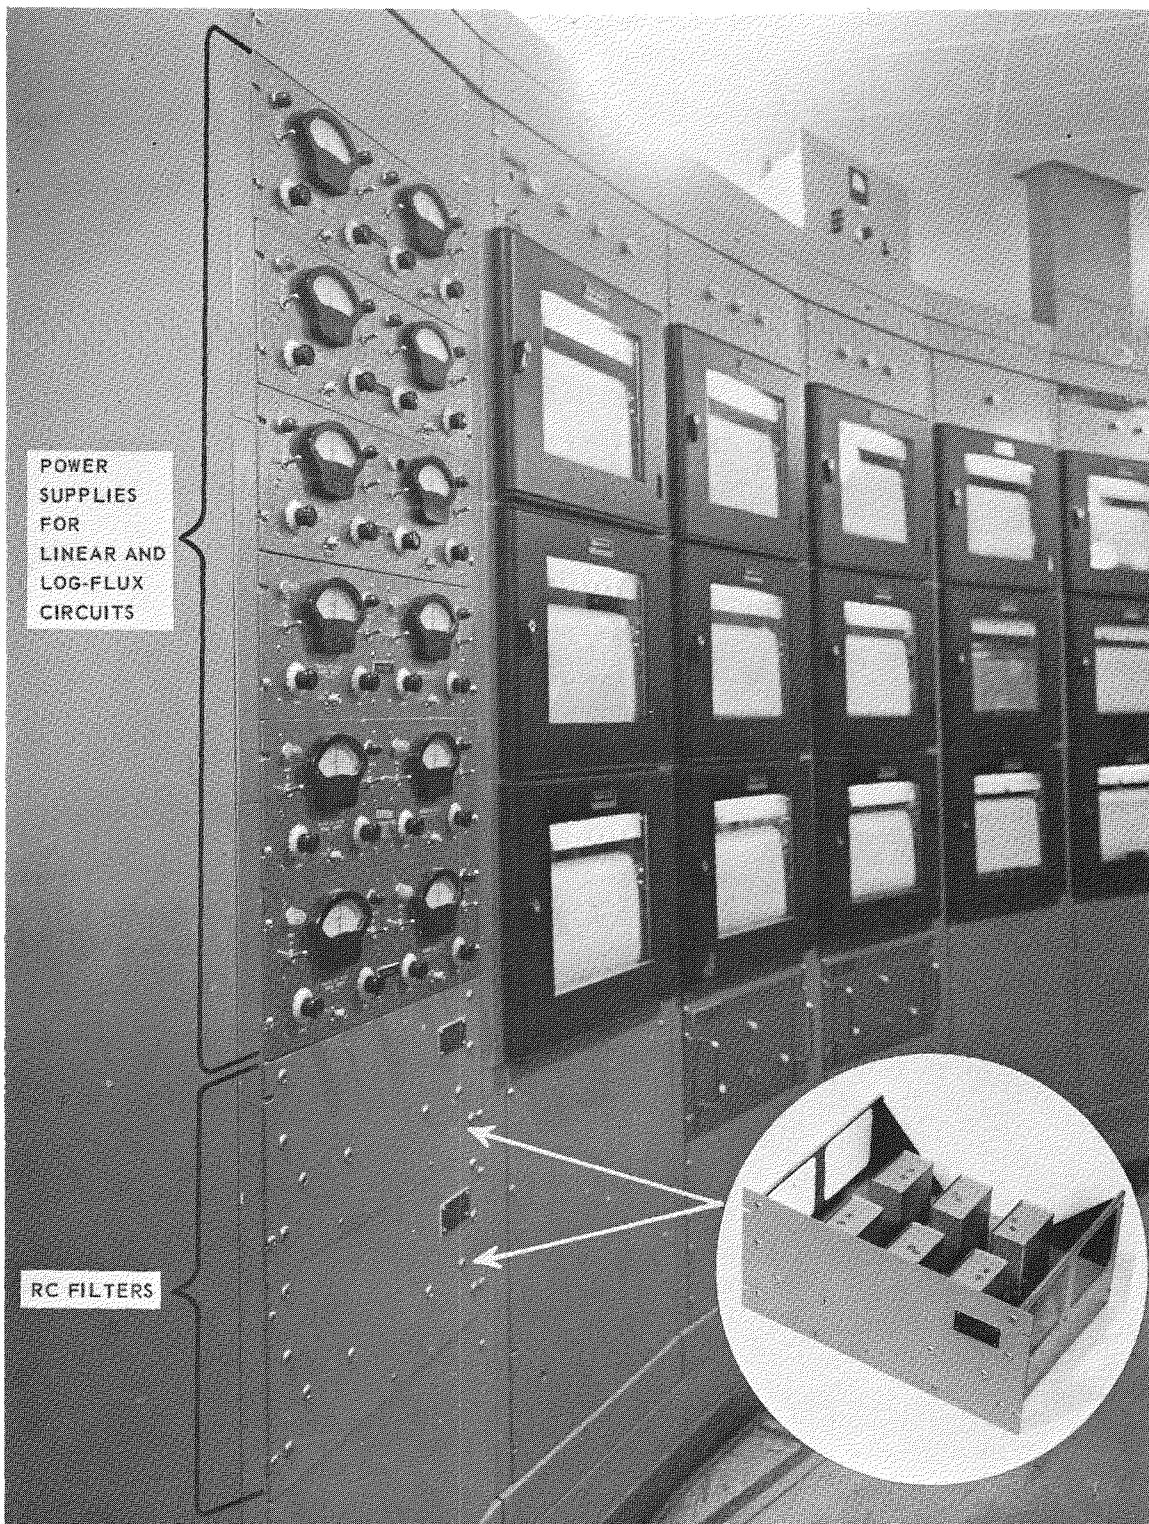
It can be concluded that the primary cause of the incident was that the linear-flux circuitry was unable to indicate true reactor power because of the presence of electrical noise filters in the circuitry. In addition the power supply was set at 800 volts. The recommended setting for these power supplies when the circuitry was designed was 1500 volts. Had the power supply been set at 1500 volts the flux level at which saturation occurred would have been increased. For this particular run this increase might have been sufficient to permit the indicated flux signal to satisfy the demand. Thus it is seen that the physical cause of the incident was the presence of two conditions, the removal of either of which might have prevented the incident. These two conditions can be attributed to human factors and not to basic design of the reactor or of the instrumentation.

Fig. 63—IET control console showing location of RC filter

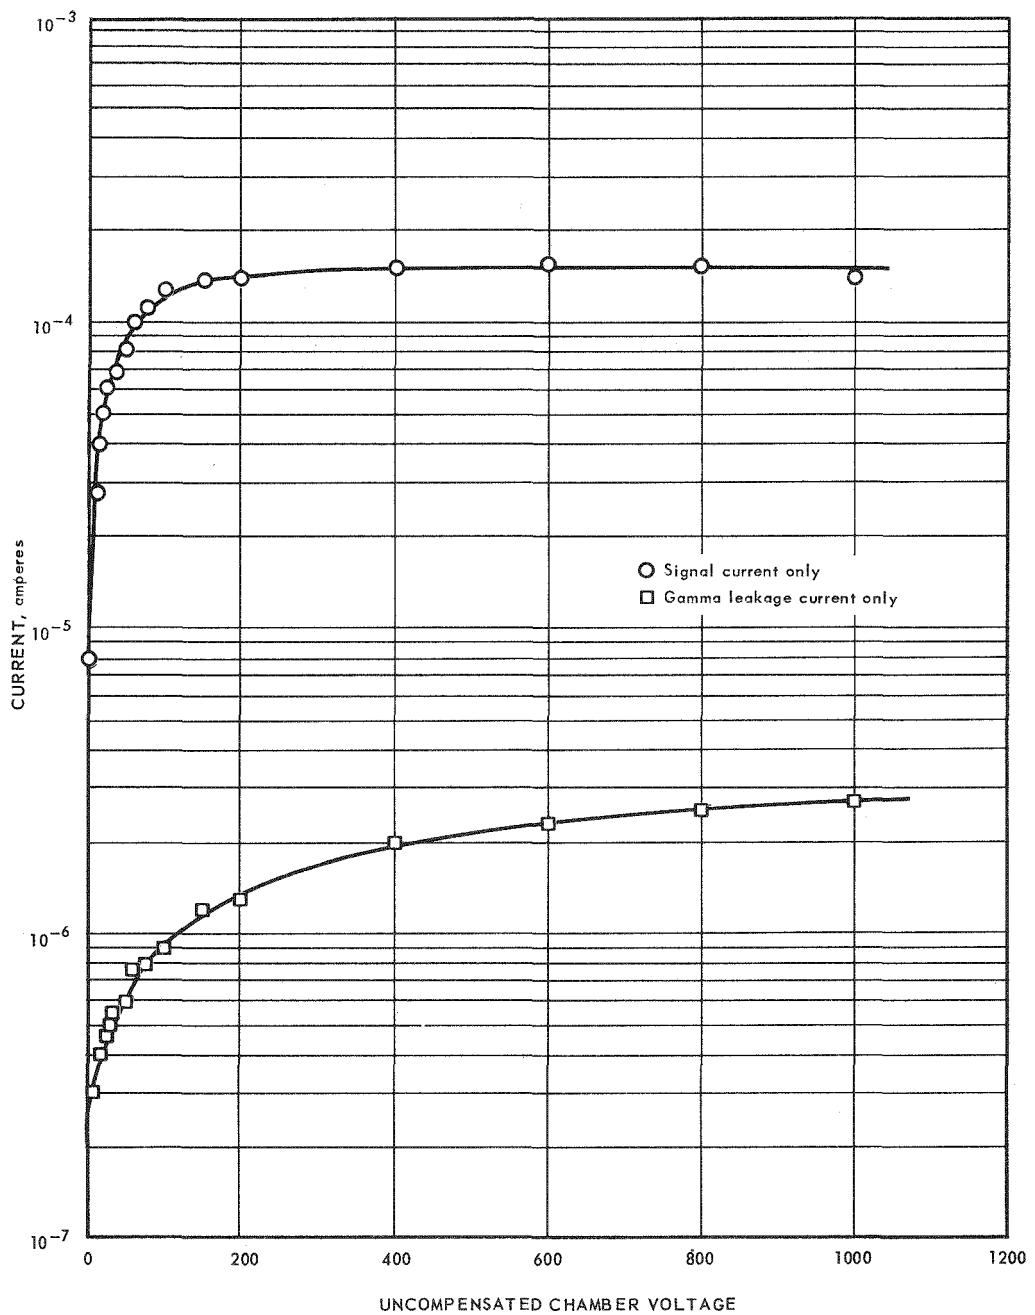
Fig. 66 — Uncompensated ion chamber characteristics derived from MTR test, reactor at 40 kilowatts (2.88×10^9 nv)

One of the uncompensated ion chambers in use during the excursion was tested in the MTR to determine the amount of gamma leakage current and to reaffirm the chamber characteristics. The curves thus obtained are shown in Figure 66. The curve of current versus collection voltage shows that the chamber behavior was very close to that of the prototype, the characteristics of which were used to construct the hypothesis regarding behavior of the chamber. The gamma leakage current is about as expected and is such that the current bypass produced by the gamma leakage can be expected to begin driving the circuit downscale at fluxes or power levels roughly 100 times greater than those at which the circuit becomes current limited. Based on the characteristics of signal current

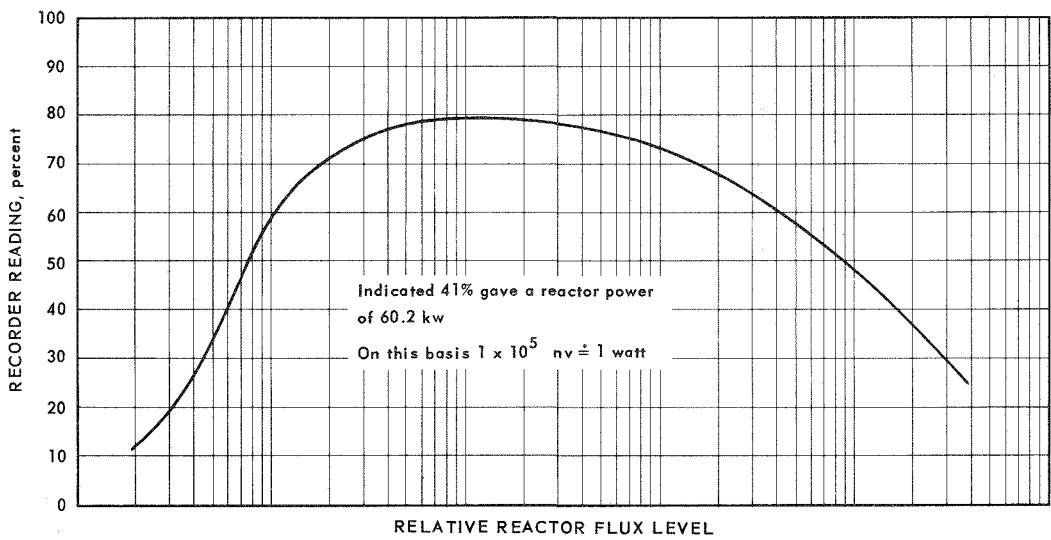
Fig. 67 — Calculated linear-flux circuit characteristics based on MTR test

and gamma current shown in Figure 66, a circuit characteristic curve has been derived and is shown in Figure 67. This curve is calculated from the characteristics obtained in the MTR test and shows the expected linear-flux-circuit indication as a function of relative flux level.

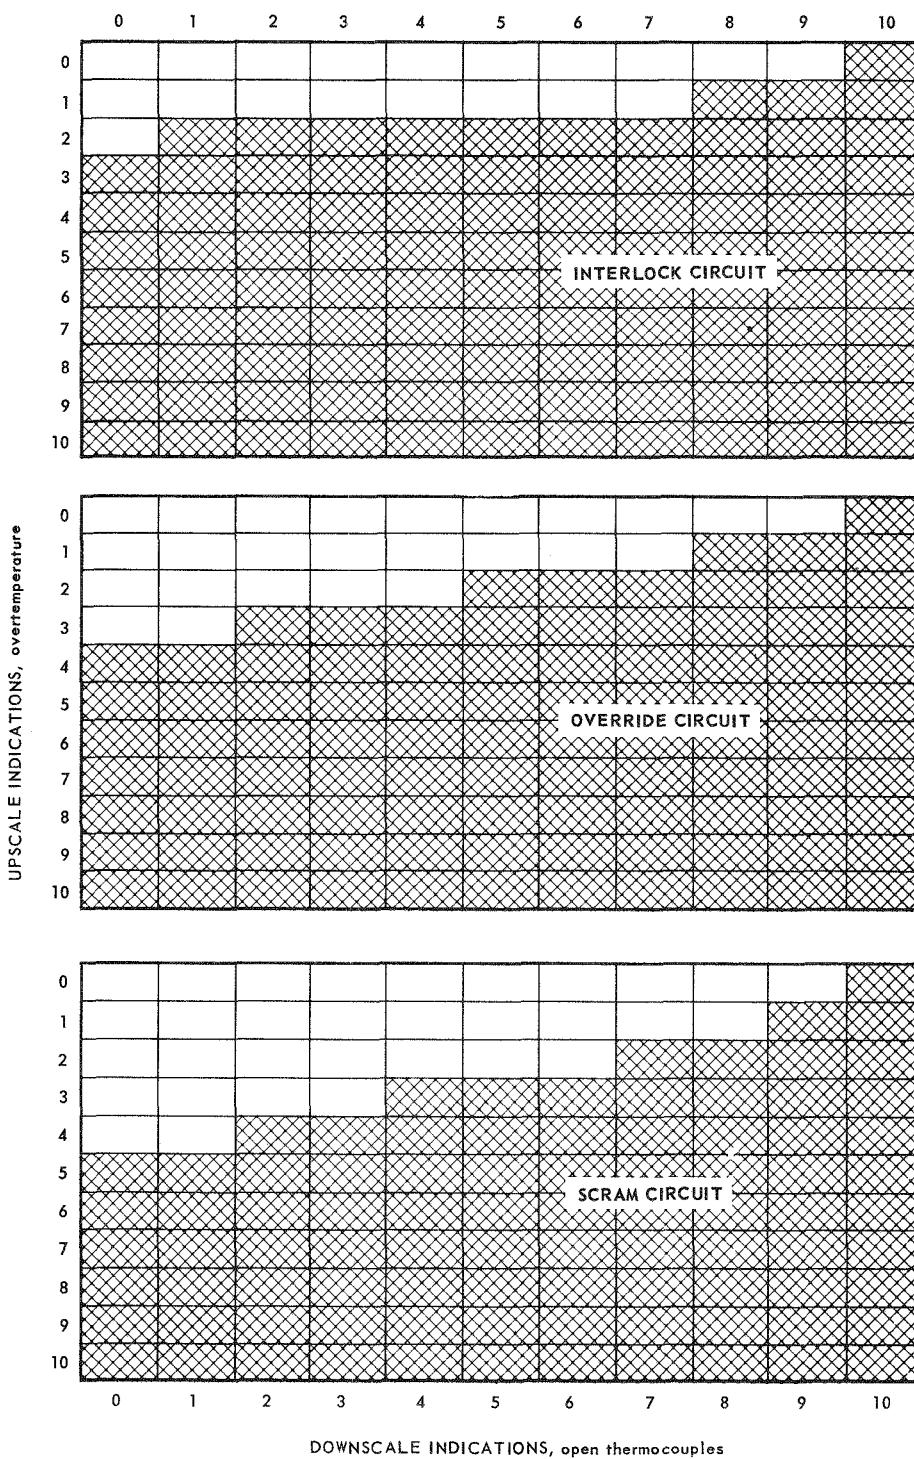
Fig. 69 — Fuel element temperature bridge

The fuel element temperature bridge was checked in Idaho after the excursion. Three upscale readings were found to be required for an interlock response, four for override, and five for scram. Potentiometers in series with each safety-level relay will change the number of thermocouples required to give a safety response by one or two thermocouples. The chart in Figure 69 shows the number of upscale readings (overtemperature) versus the number of thermocouples that are open (causing a downscale reading) required to give the various safety responses. The potentiometers of the bridge were adjusted to correspond to the number of upscale indications required at Idaho. This test was then carried out up to 10 open-couple responses in tests made at Evendale. Because of the settings of the recorders for normal power-range operation, the low airflow in the system, and the initial low-temperature operation, the fuel element temperature

circuit was slow to respond. The fuel element temperature circuit was credited with giving the initial scram action as observed by the operators. Ten thermocouple open circuits are required for a scram response in the absence of any upscale reading. Table 6 (page 70) shows the postexcursion condition of the ten thermocouples that were connected into the scram circuit.

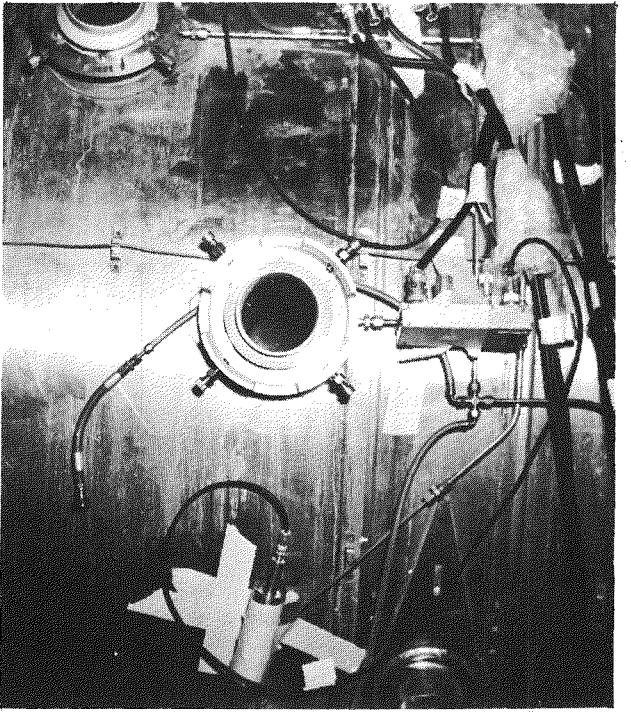
Fig. 70 – D102A primary shield showing placement of BF_3 counters

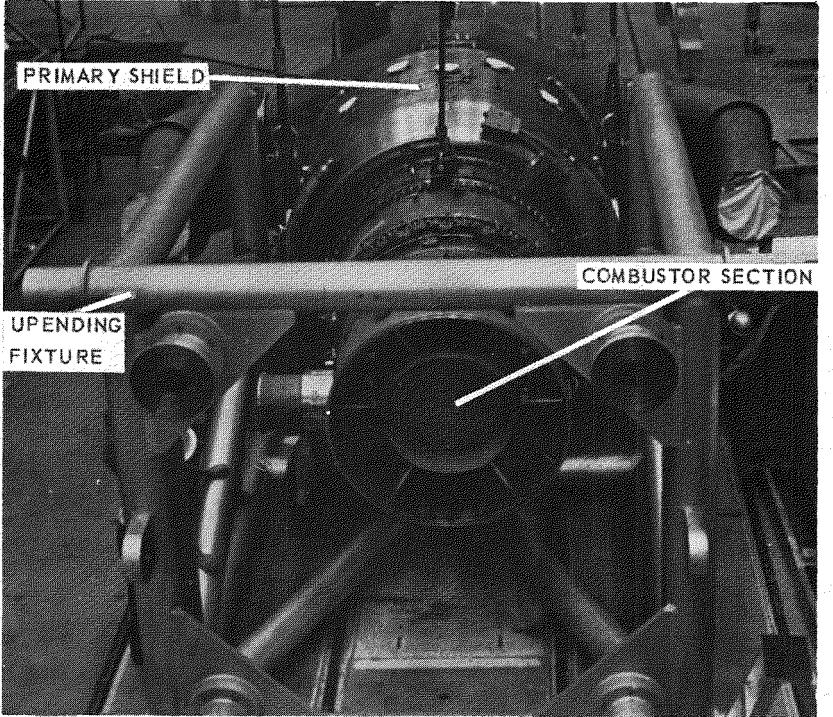
Fig. 71 – Reactor-shield assembly in upending fixture

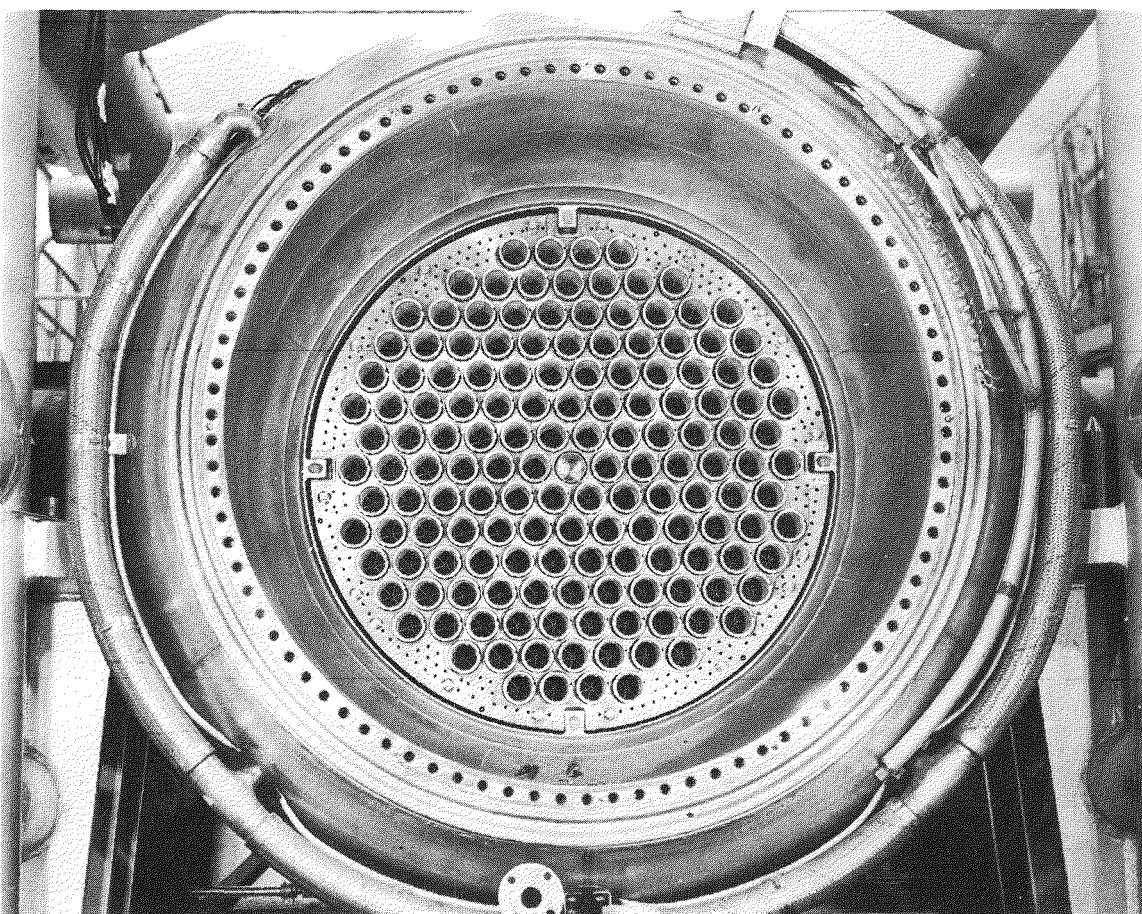
Fig. 72 — Rear tube sheet exposed after removal of combustor and rear plug
