Research and
Development Report

SUMMARY REPORT OF HTRE NO. 3 NUCLEAR EXCURSION

Published by
TECHNICAL PUBLICATIONS SUB-SECTION
August 1959

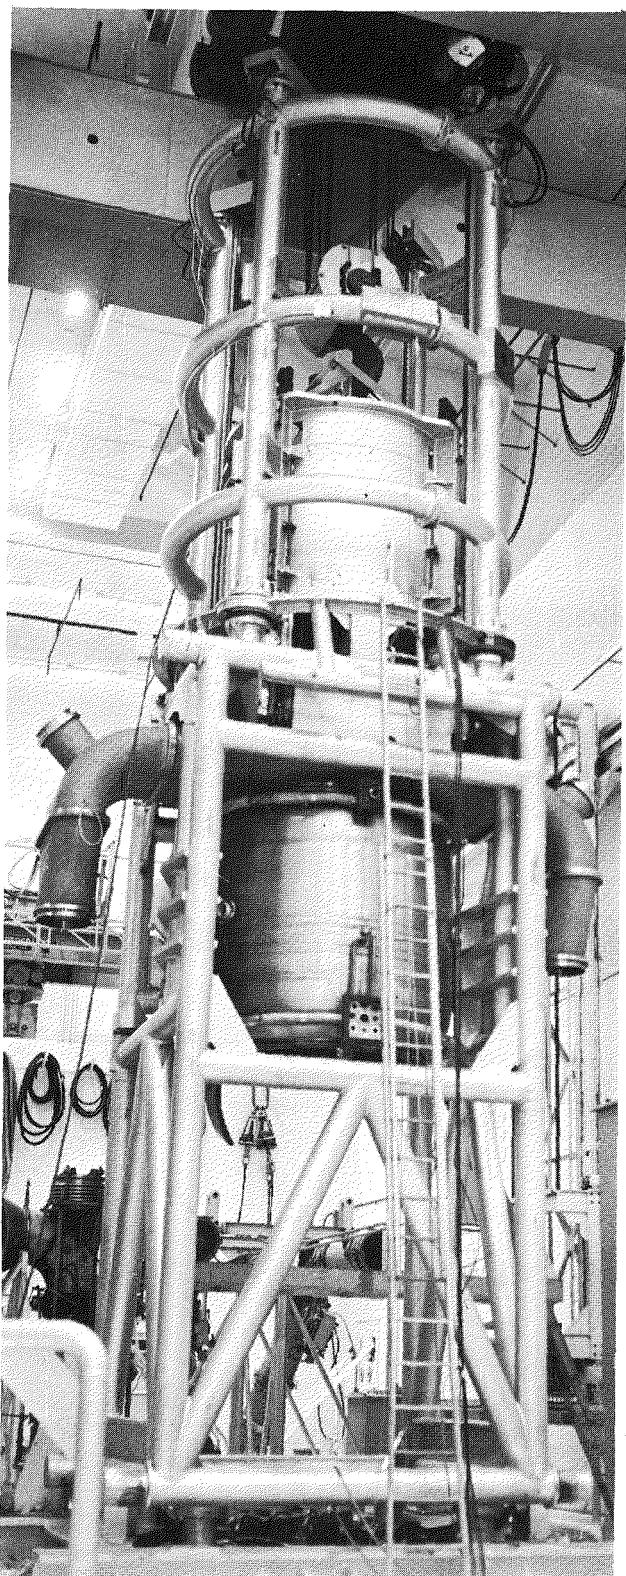
Fig. 73 – Upending fixture in vertical position with core-removal fixture on top

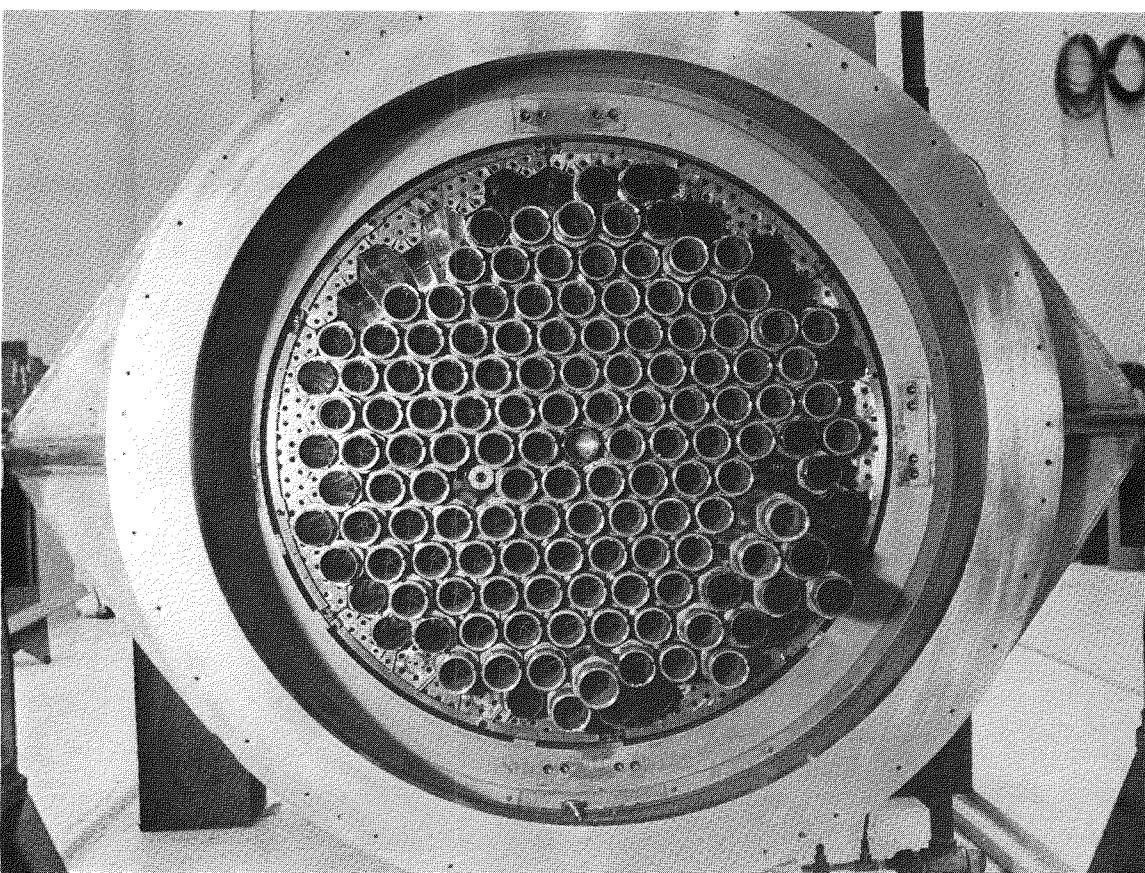
Fig. 74—Moderators exposed after removal of rear tube sheet

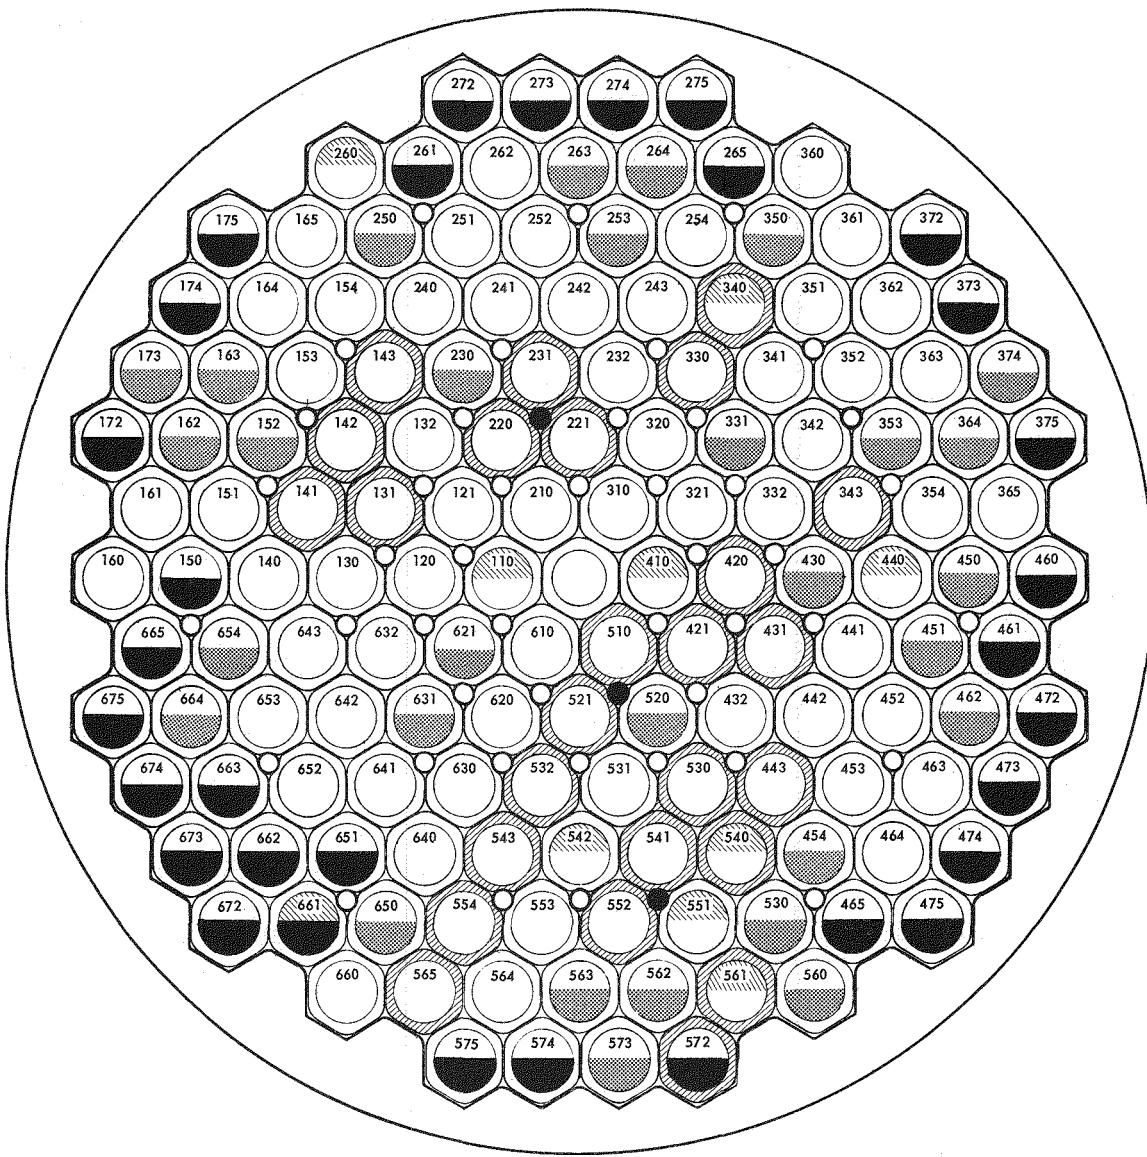
Fig. 75 – Core damage survey

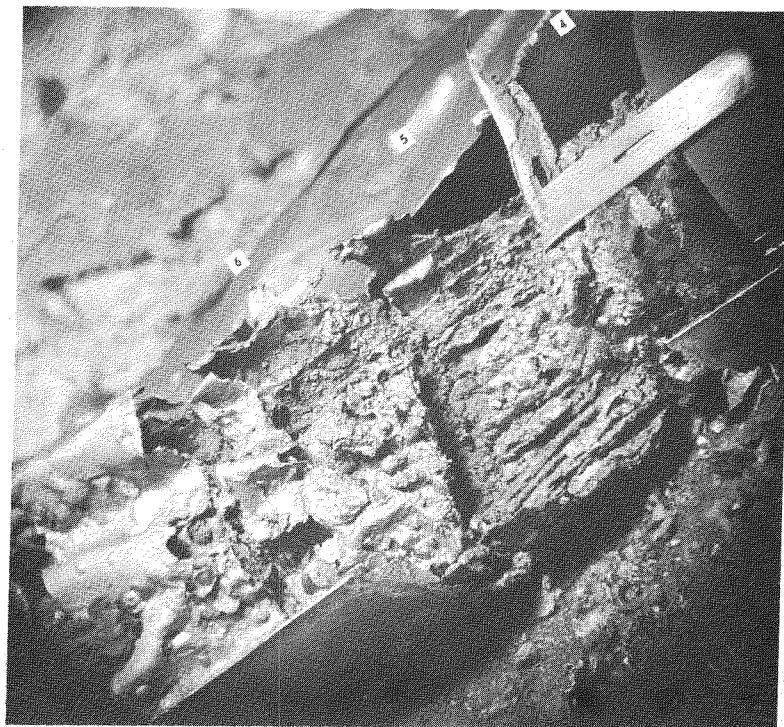
Inspection of the fuel cartridges that were removed from the moderator cells shows that melting and collapsing of the fuel elements was confined to stages 4 through 16. Fuel cartridge SN 1060 was removed from cell 273, which is in the outside circle of moderator cells. These cells produce about 7 percent less than the average total tube power and are representative of the lowest-power cells. The radial orientation (in degrees) indicated on the photographs is clockwise rotation from the "0" point (vertical centerline), looking downstream through the cartridge. Figure 76 shows the over-all fuel cartridge damage. The meltdown and chemical oxidation damage to stages 4, 5, and 6 of the fuel cartridge is clearly shown in Figure 77. The almost complete meltdown and oxidation of stage 5 is shown in Figure 78. Meltdown damage to stages 7, 8, and 9 is shown in Figure 79. Damage to stages 10 through 16 is shown in Figures 80 and 81. The meltdown

Fig. 77 – Damage to stages 4, 5, and 6, cartridge 1060, cell 273

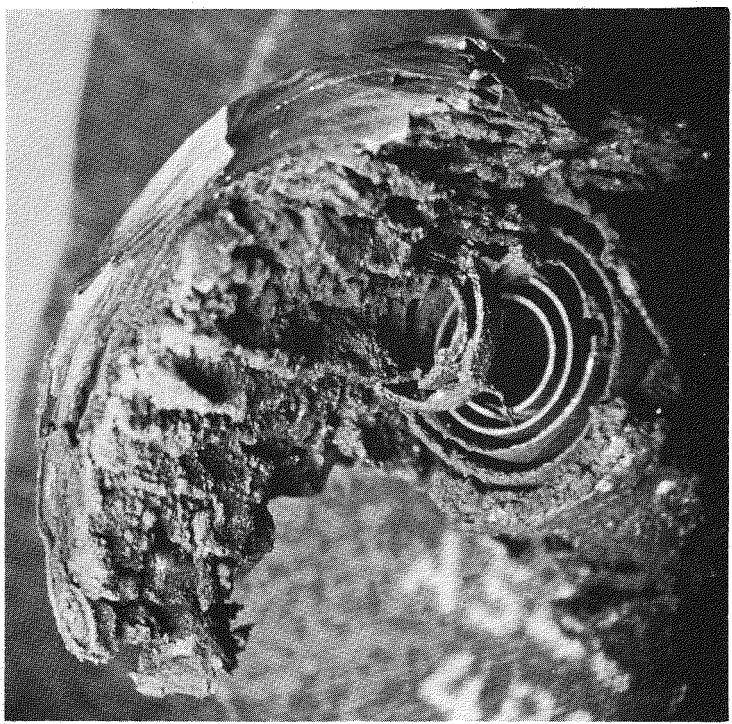
Fig. 78 – Meltdown and oxidation of stage 5, cartridge 1060, cell 273

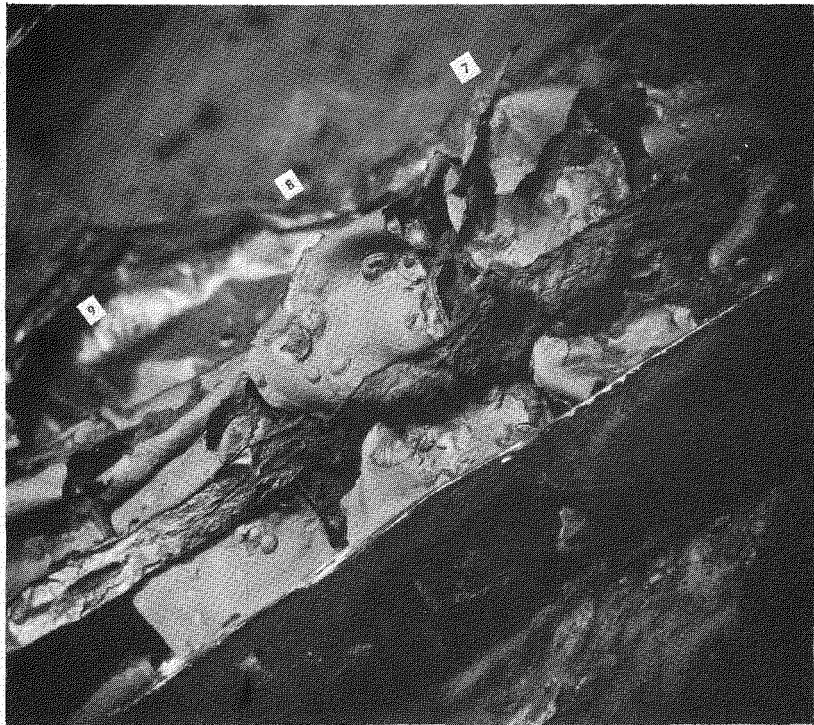
Fig. 79 – Damage to stages 7, 8, and 9, cartridge 1060, cell 273

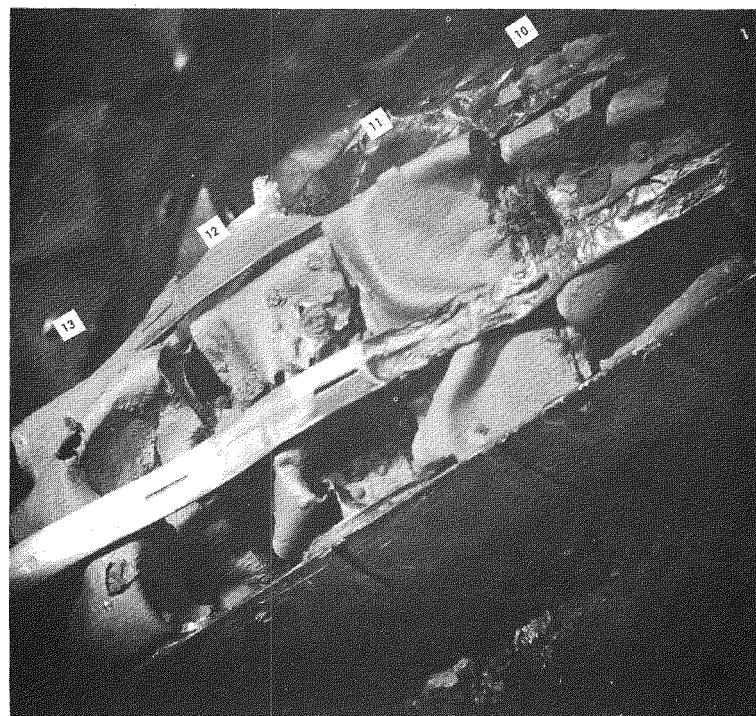
Fig. 80 — Damage to stages 10, 11, 12, and 13, cartridge 1060, cell 273

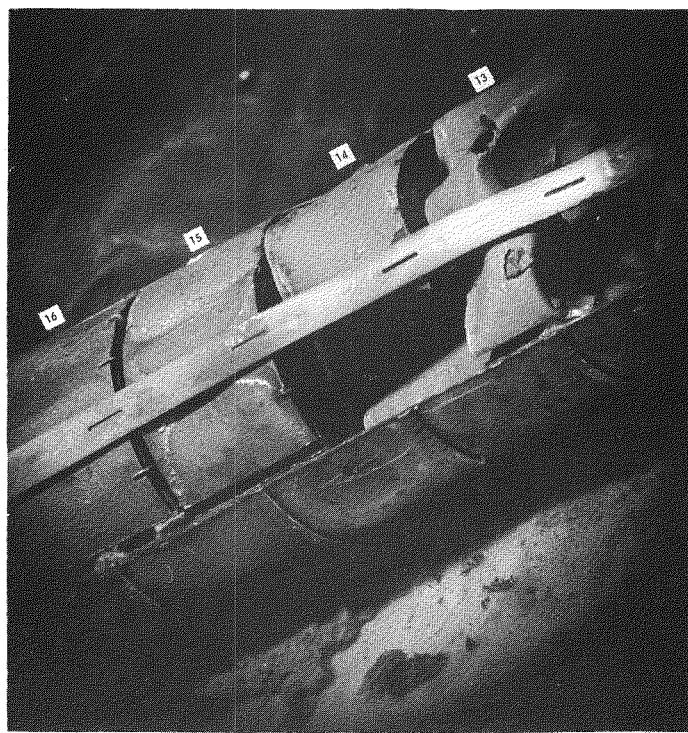
Fig. 81 — Damage to stages 13, 14, 15, and 16, cartridge 1060, cell 273

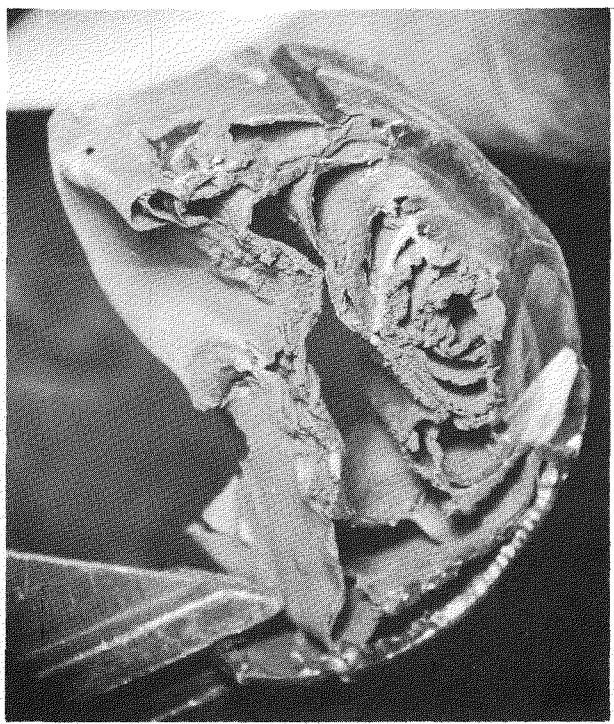
Fig. 82 — Upstream face of stage 12, cartridge 1060, cell 273

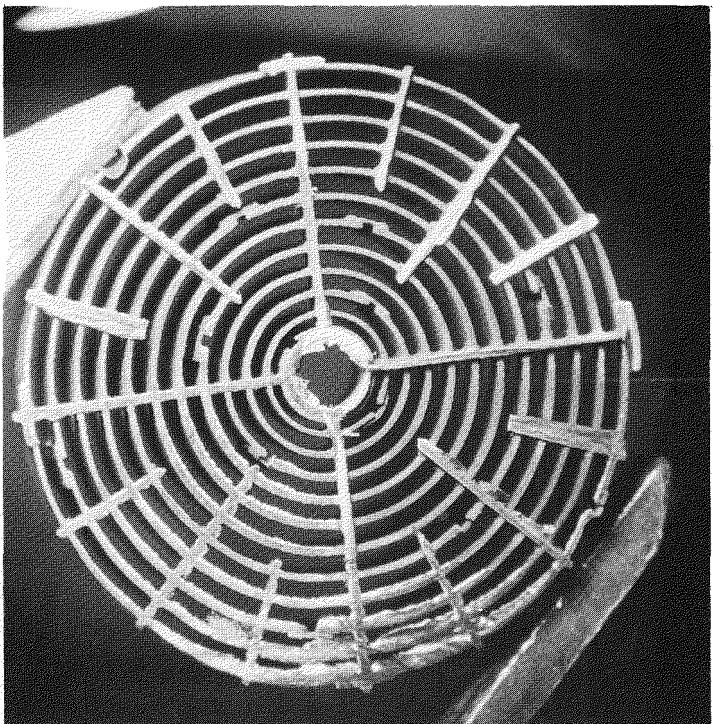
of stage 12 is shown in Figure 82. The 19th stage, which did not reach a temperature level as high as stages 4 through 16, is shown in Figures 83 and 84 to have sustained relatively little damage.

Fig. 83 — Upstream face of stage 19, cartridge 1060, cell 273

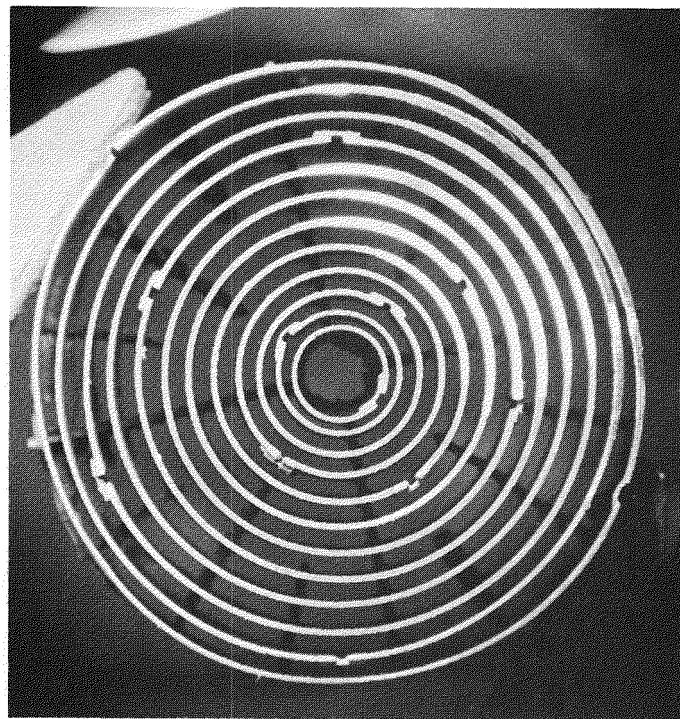
Fig. 84 – Downstream face of stage 19, cartridge 1060, cell 273

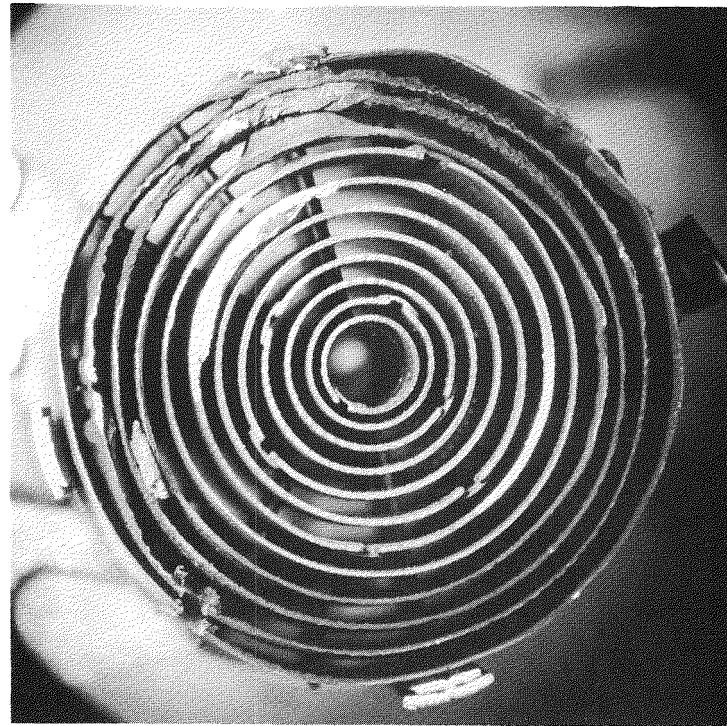
Fig. 85 – Downstream face of stage 3, cartridge 1060, cell 273

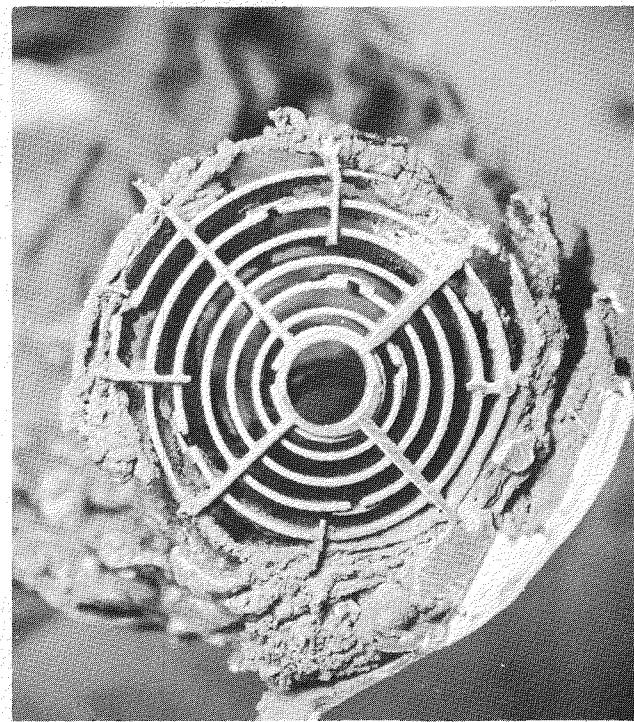
This series of photographs shows that the greatest damage is in stages 4, 5, and 6. An explanation for this is that more chemical oxidation occurred in these stages than in stages 7 through 16. Chemical analysis of the molten material obtained from stages 4 and 5 verifies that chemical oxidation did occur in these stages. Figure 85 shows the downstream face of stage 3 and indicates some damage to this stage. Stage 4, shown in Figure 86, shows the meltdown of the outer ring and the 180-degree position (the lower side of the fuel cartridge when installed in the core). Another view of stage 4 at the 0-degree position is shown in Figure 87.

Fig. 86 – Upstream face of stage 4, cartridge 1060, cell 273

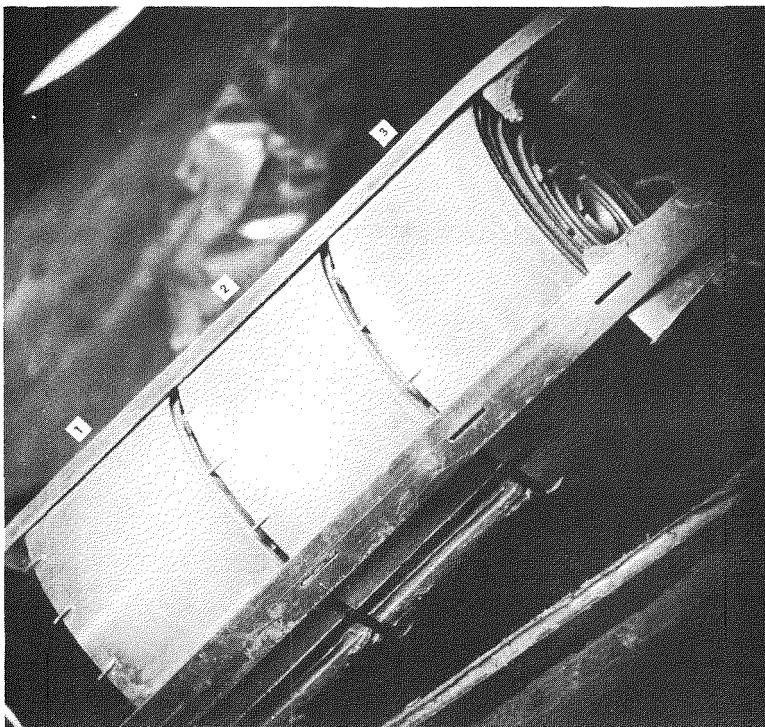
Another example of cartridge damage was obtained from cell 510, which is located in the innermost circle of moderator cells. These cells produce 7 percent above average total tube power and are representative of the highest-power cells. The total damage to this fuel cartridge is shown in Figure 88. Stages 1, 2, and 3, shown in Figure 89, appear to have sustained little or no damage. Figure 90 shows the meltdown and chemical oxidation damage in stages 4, 5, and 6. Figures 91, 92, and 93 show the damage that occurred to stages 7 through 15. The meltdown and possible chemical oxidation damage appear to be greater than the damage to the same stages in Cell 273 (Figures 79, 80, and 81). The The damage sustained in stages 16 through 19 is shown in Figures 94 and 95.

Fig. 89 – Stages 1, 2, and 3, cartridge 1129, cell 510

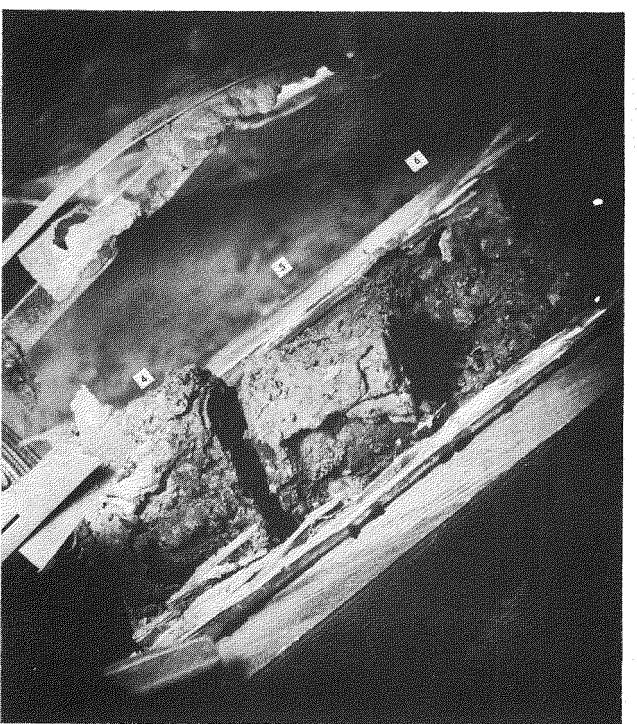
Fig. 90 – Stages 4, 5, and 6, cartridge 1129, cell 510

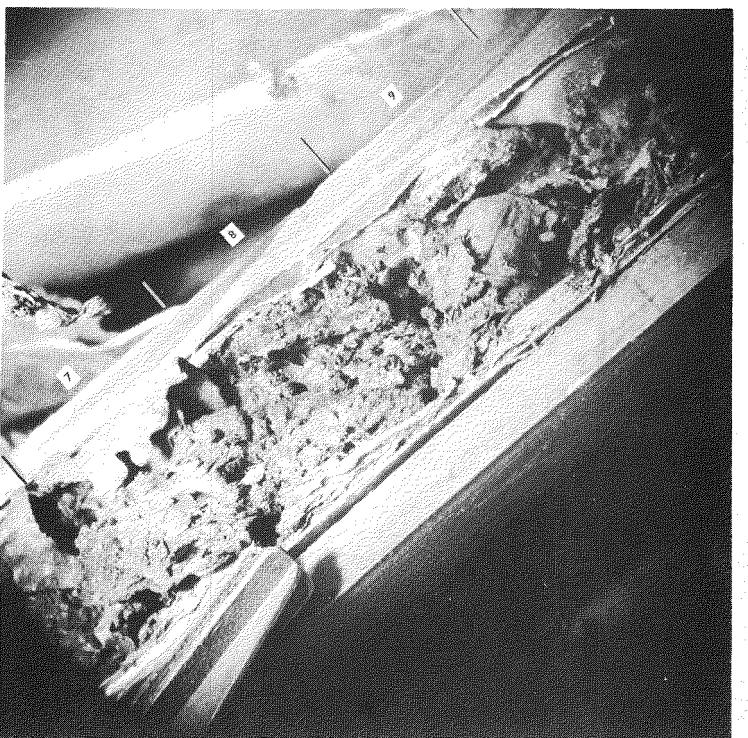
Fig. 91 – Stages 7, 8, and 9, cartridge 1129, cell 510

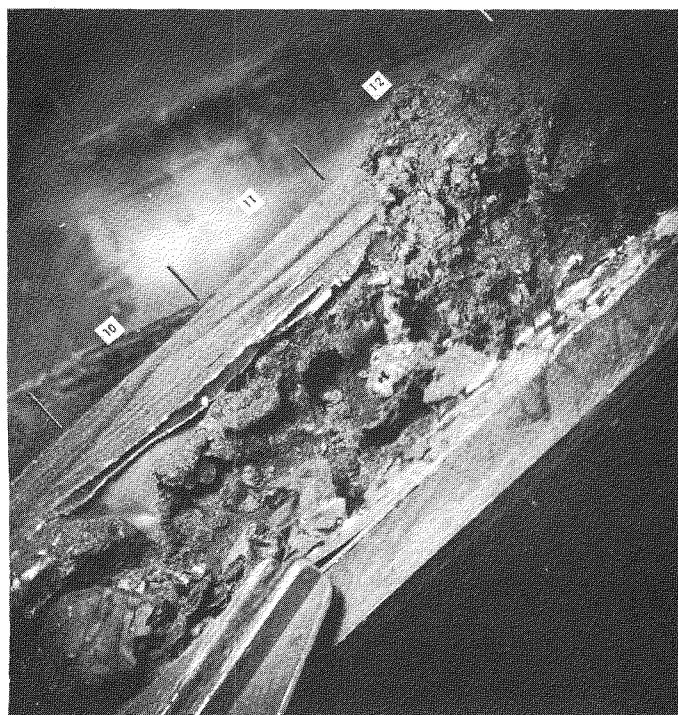
Fig. 92 — Stages 10, 11, and 12, cartridge 1129, cell 510

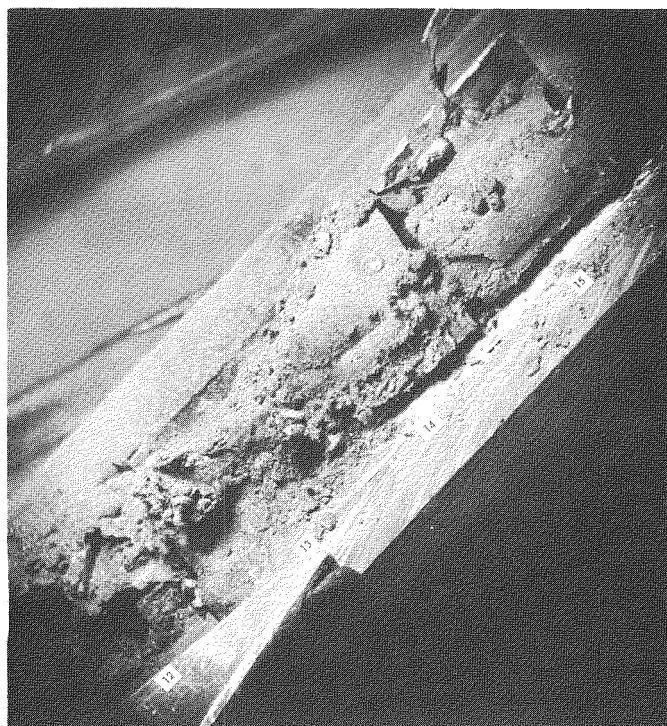
Fig. 93 — Stages 13, 14, and 15, cartridge 1129, cell 510

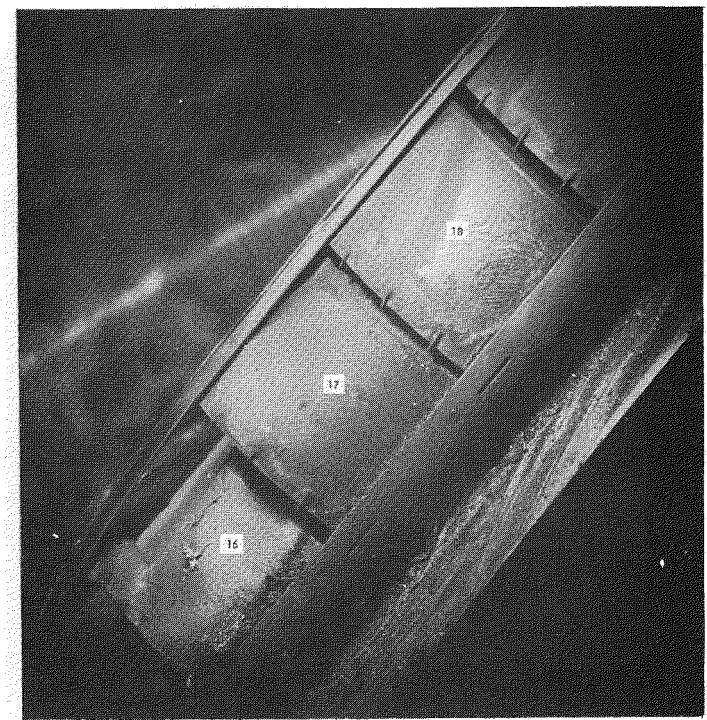
Fig. 94 — Stages 16, 17, and 18, cartridge 1127, cell 510

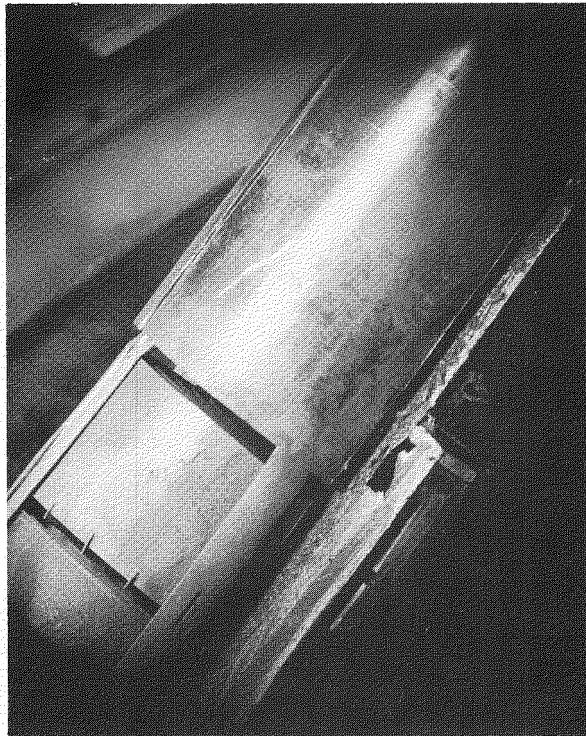
Fig. 95 — Stage 19 and tail cone, cartridge 1129, cell 510

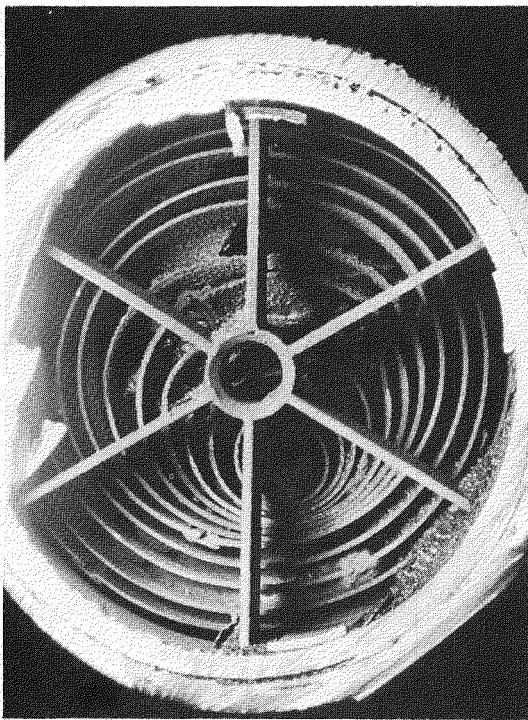
Fig. 96 – Typical ring deformation at 19th stage, downstream face

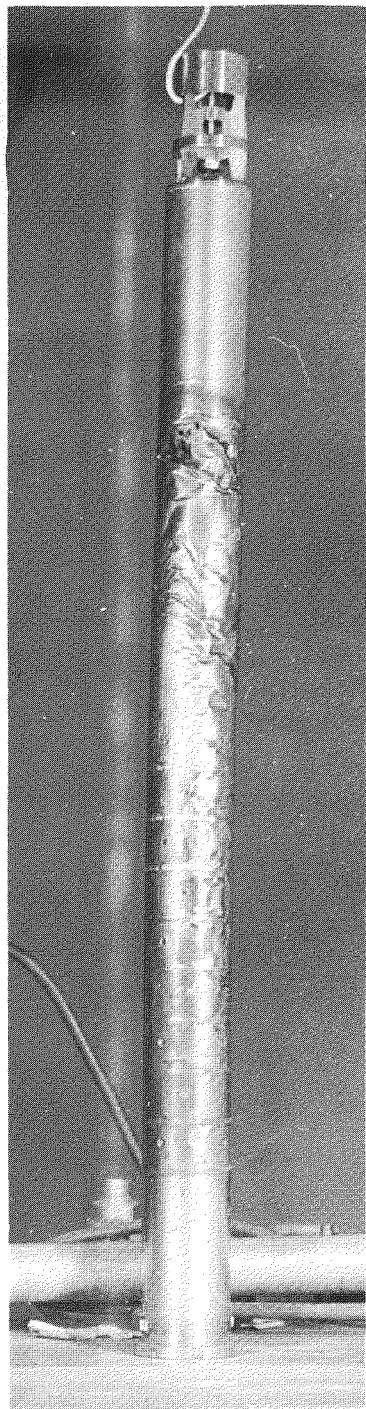
Fig. 97 – Example of burning, wrinkling, and bowing of fuel cartridges and liners

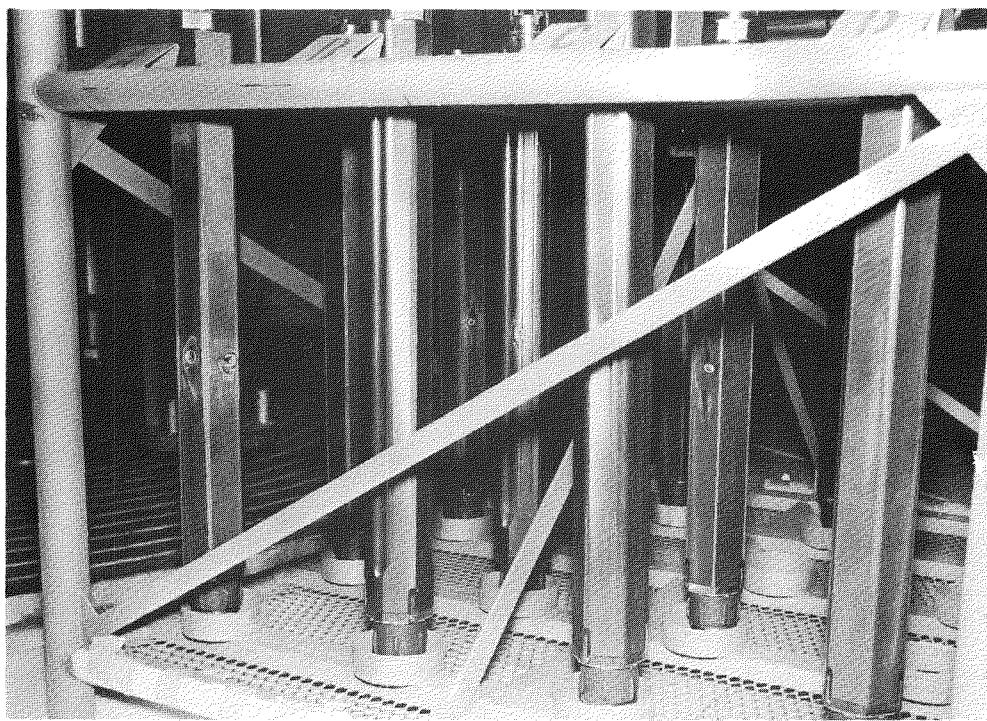
Fig. 99 — Moderators in storage rack showing burn spots

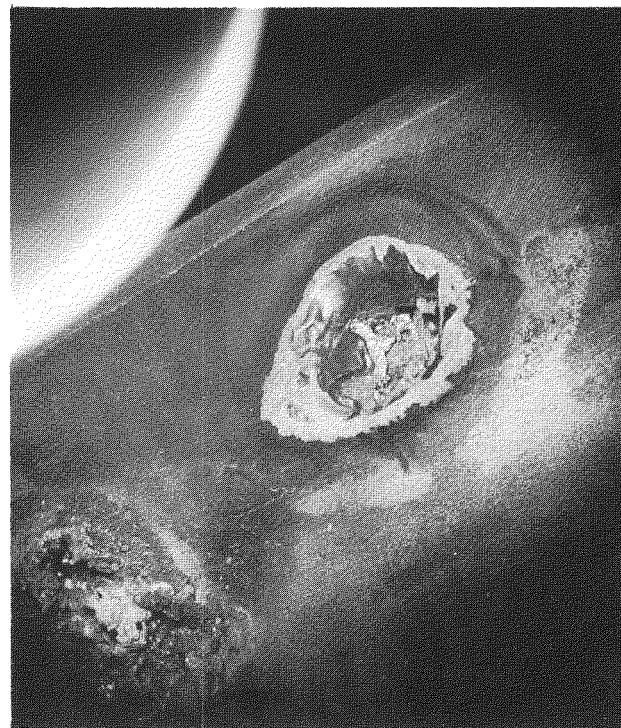
Fig. 100 — Moderator from cell 421 showing burn hole approximately
14 inches from downstream end

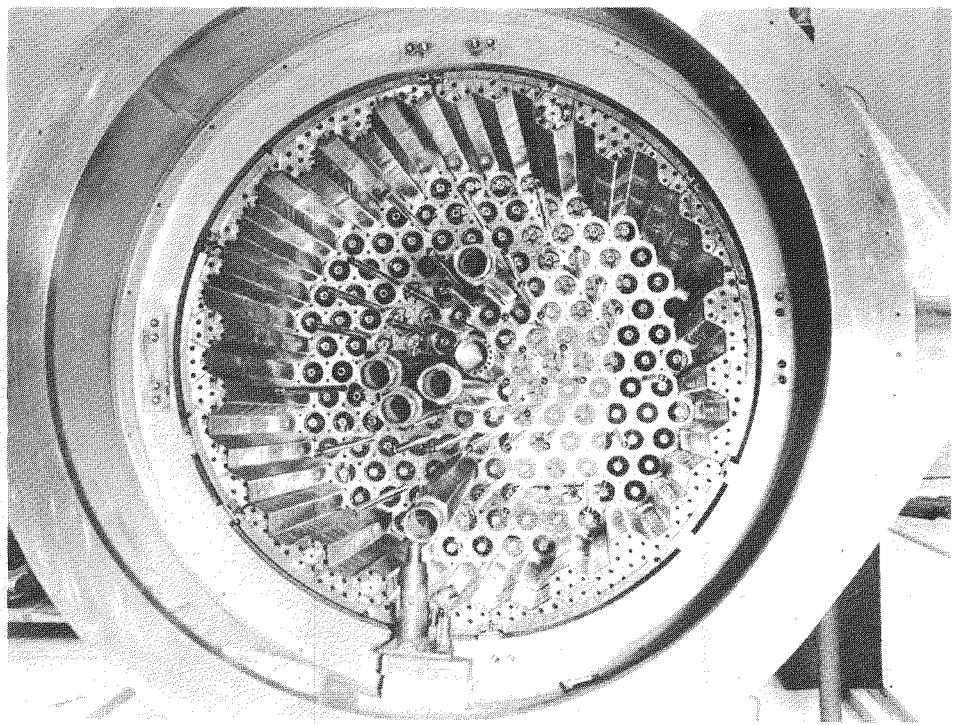
Many of the hydrided zirconium hexagonal moderator blocks were intact and will be reusable. In a few isolated cases molten slag had burned through the moderator block and welded the moderator block to the adjacent control rod guide tubes. A typical moderator block with melt-through is shown in section 5.1, Figure 101. It has been determined that 74 moderator blocks will be reusable. The control rod guide tubes, in general, will be reusable after replating.

Fig. 102 – Reactor core showing five moderator blocks welded to control rod
guide tubes, View A

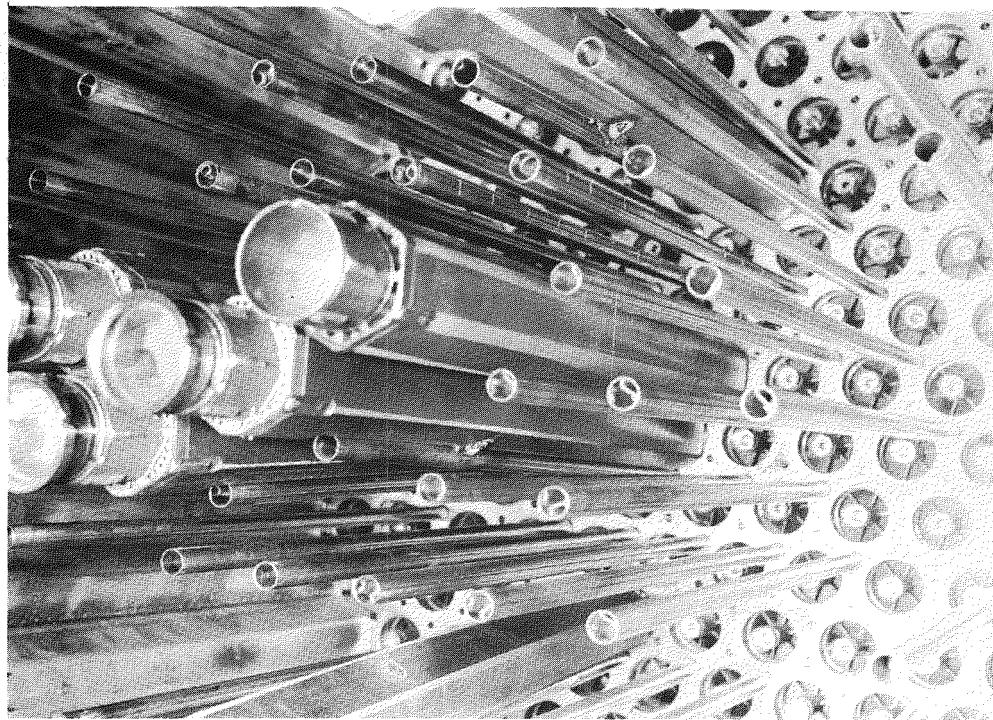
Fig. 103 – Reactor core showing five moderator blocks welded to control rod
guide tubes, View B

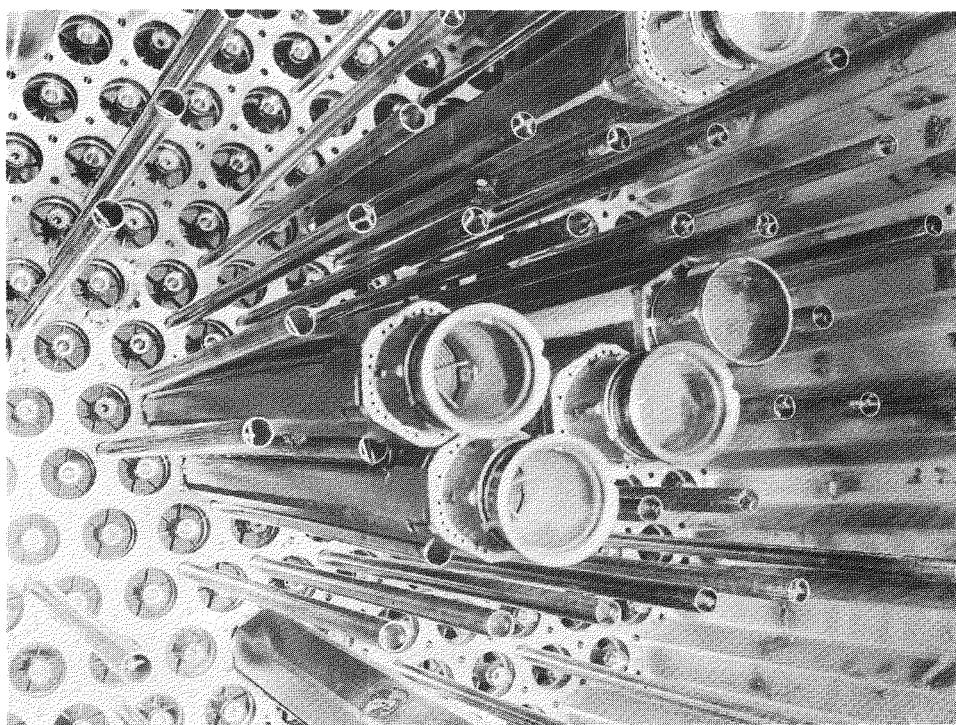
Fig. 104 – Reactor core showing five moderator blocks welded to control rod
guide tubes, View C

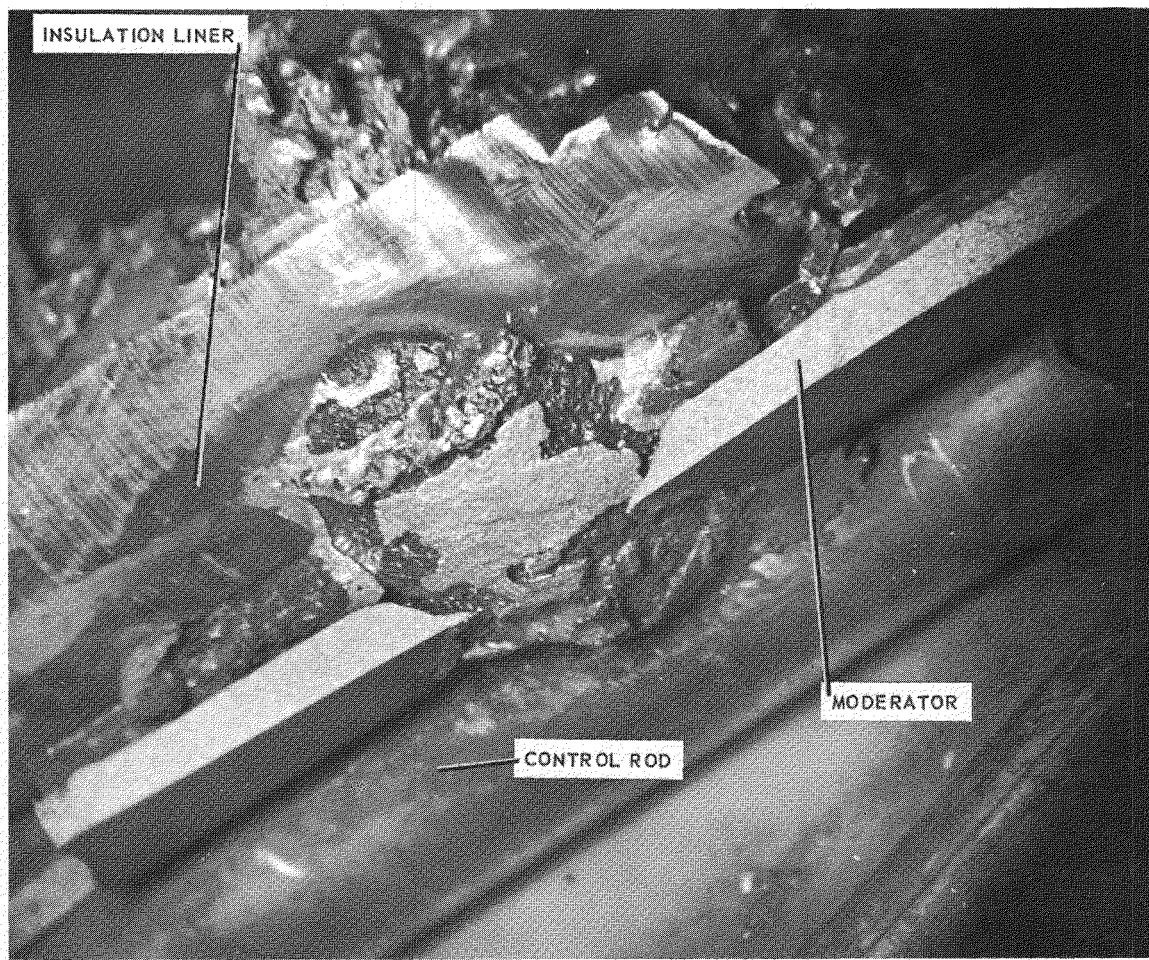
Fig. 105 — Fused control rod and fuel cartridge, cell 510, with moderator removed

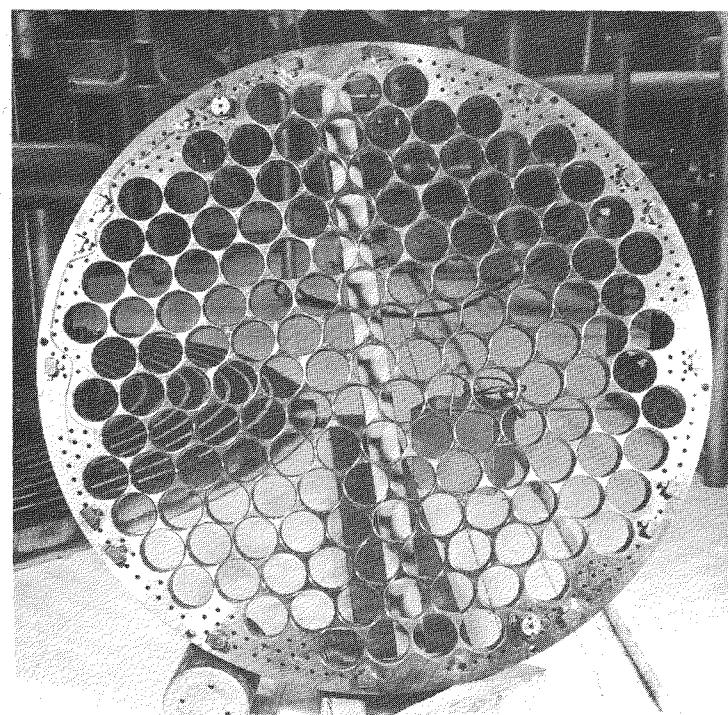
Fig. 106 – Rear tube sheet, upstream face

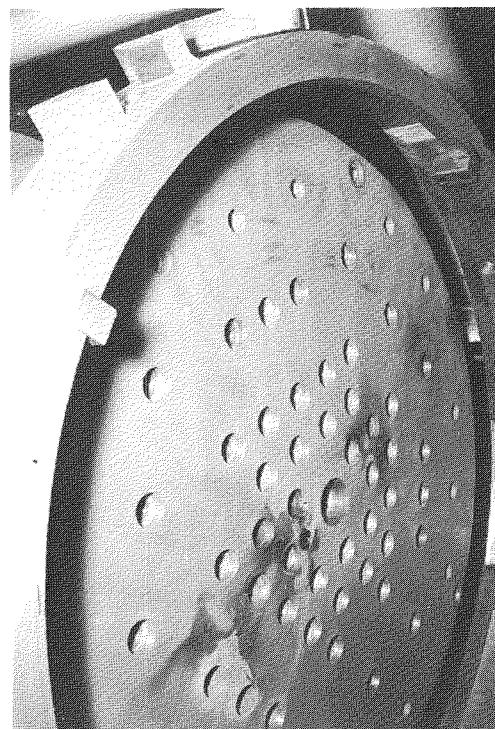
No visible damage was sustained during the event by the front and rear plug shields, primary shield, combustor, and aft header. Figure 107 shows the aft face of the front

Fig. 107 – Aft face of front plug shield

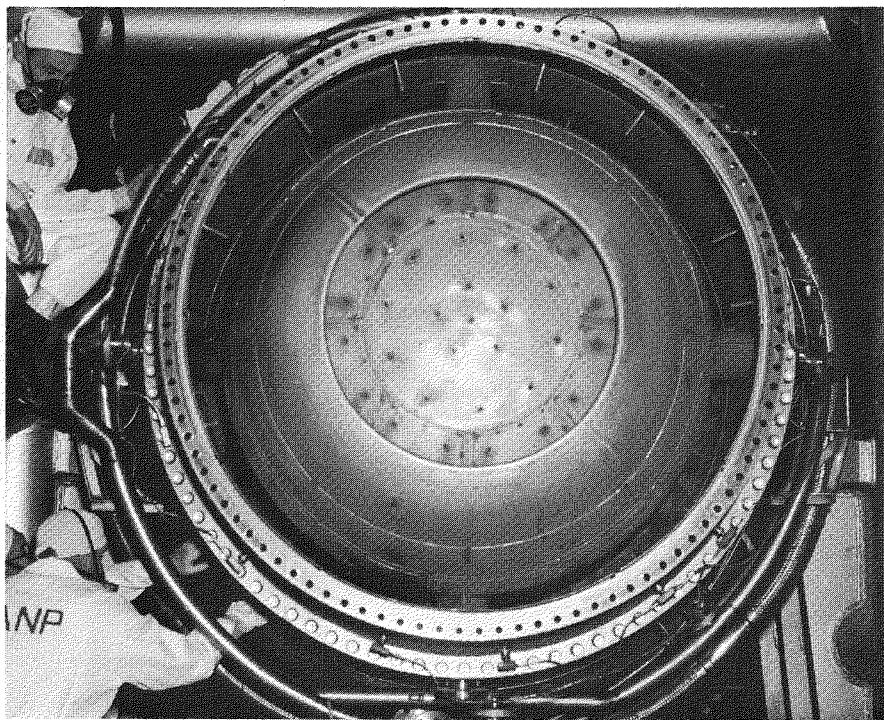
plug shield. Figure 108 shows the rear plug shield. Some foreign material was noted in the plenum aft of the core and can be noted in Figure 109. Figure 110 shows a view of the combustor. Figure 111 shows the aft header. The foreign material noted in the combustor and aft header was determined to be the remains of the aft-plug shielding measurement devices; that is, copper foils, aluminum and cadmium cover, and sulfur pills. One section of insulation material in the rear-plug shield will be replaced because of damage caused by the melted aft-plug measurement devices.

Fig. 108 – View of rear plug looking upstream

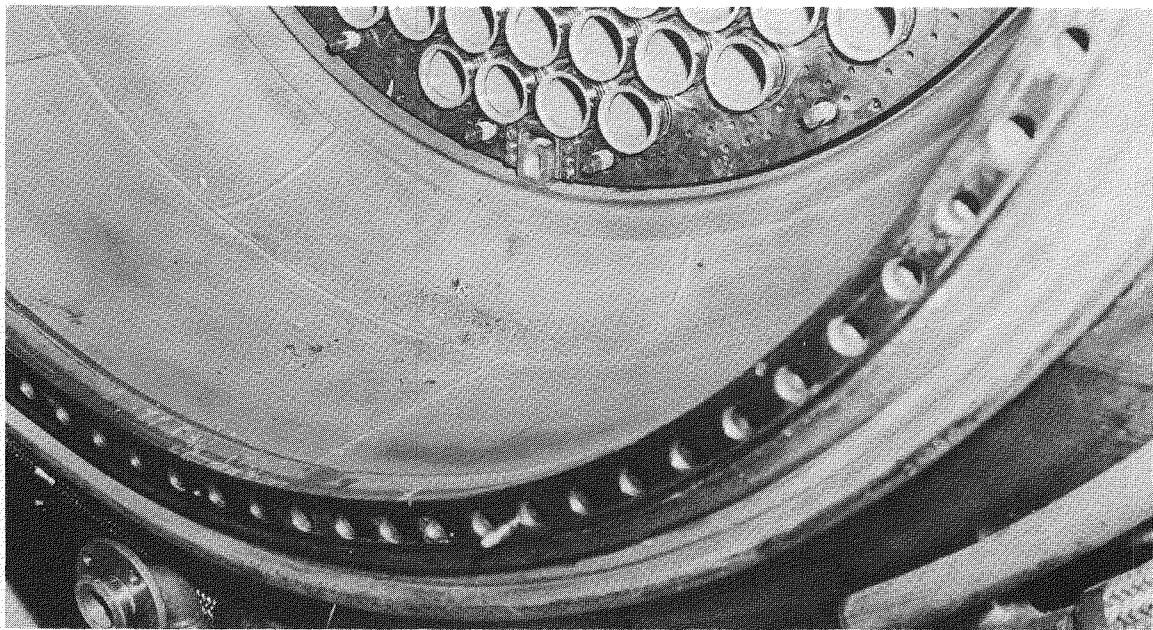
Fig. 109 – Deposits at bottom of primary shield

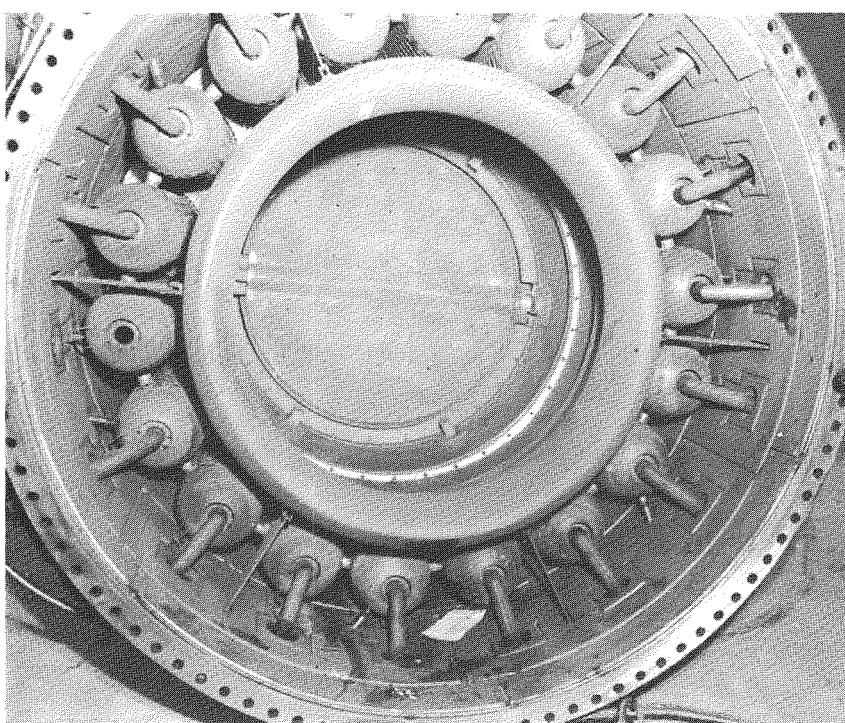
Fig. 110 — Unit combustor

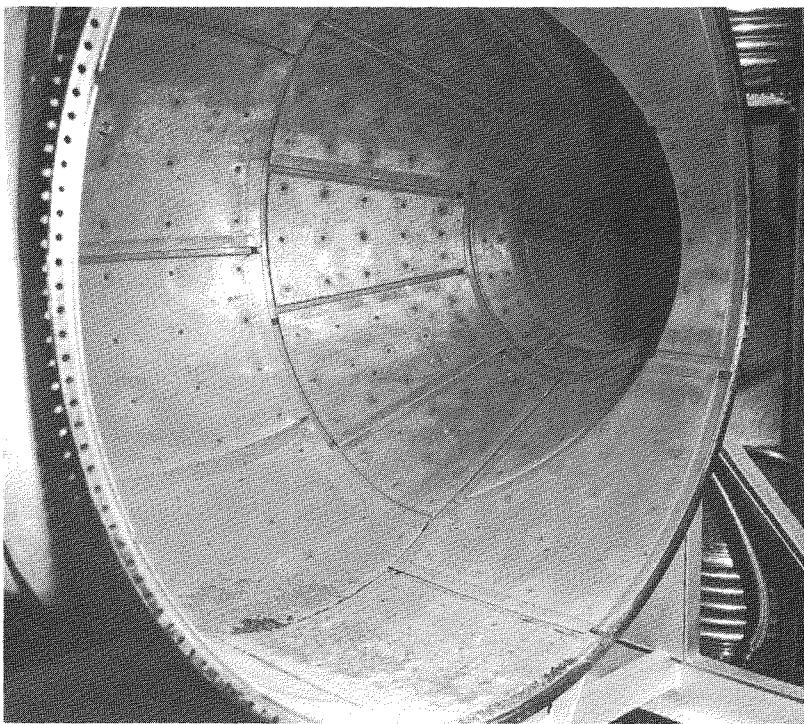
Fig. 111 — Aft header
