Research and
Development Report

SUMMARY REPORT OF HTRE NO. 3 NUCLEAR EXCURSION

Published by
TECHNICAL PUBLICATIONS SUB-SECTION
August 1959

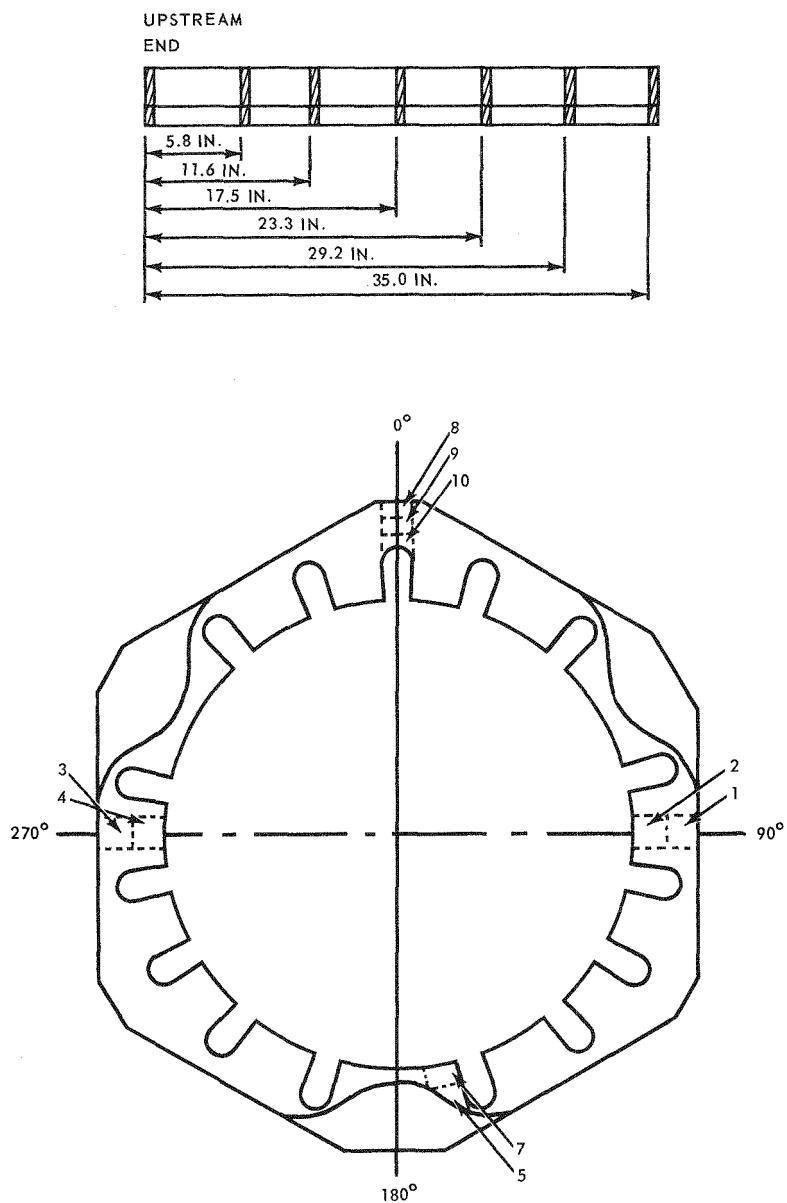
Hydrogen migration samples have been obtained on cell 421. The moderator cell was sectioned into seven equally spaced transverse slices, each 0.5 inch thick. Figure 112 shows the sectioning of moderator cells. A slice (0.5 inch) was taken from each end,

Fig. 112 — Sectioning of moderator block for hydrogen migration sampling

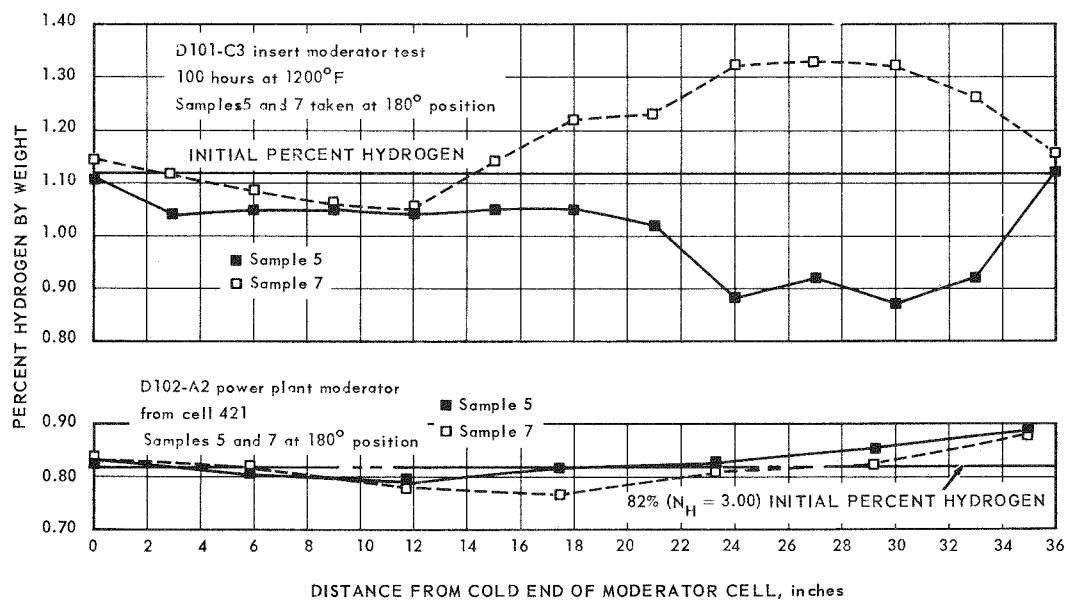
Fig. 113 — Comparison of hydrogen migration in D102A core with D101C-3 insert samples

There is no general redistribution of hydrogen. Since the moderator reached peak temperatures at 10 minutes after the event and was at temperatures above 1000°F for only a matter of minutes, the data appear consistent, as 100 hours at 1200°F does not produce more than 5 percent loss. Therefore, it is believed that no general loss or redistribution of hydrogen occurred because of the event.

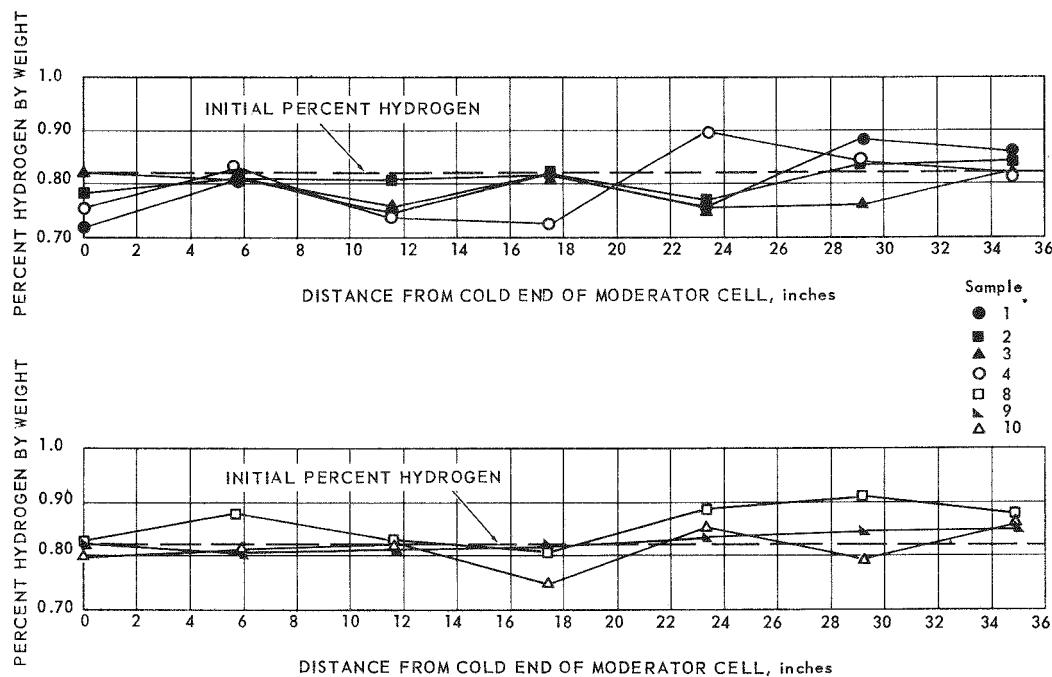
Fig. 114 — Hydrogen migration samples from cell 421, D102A

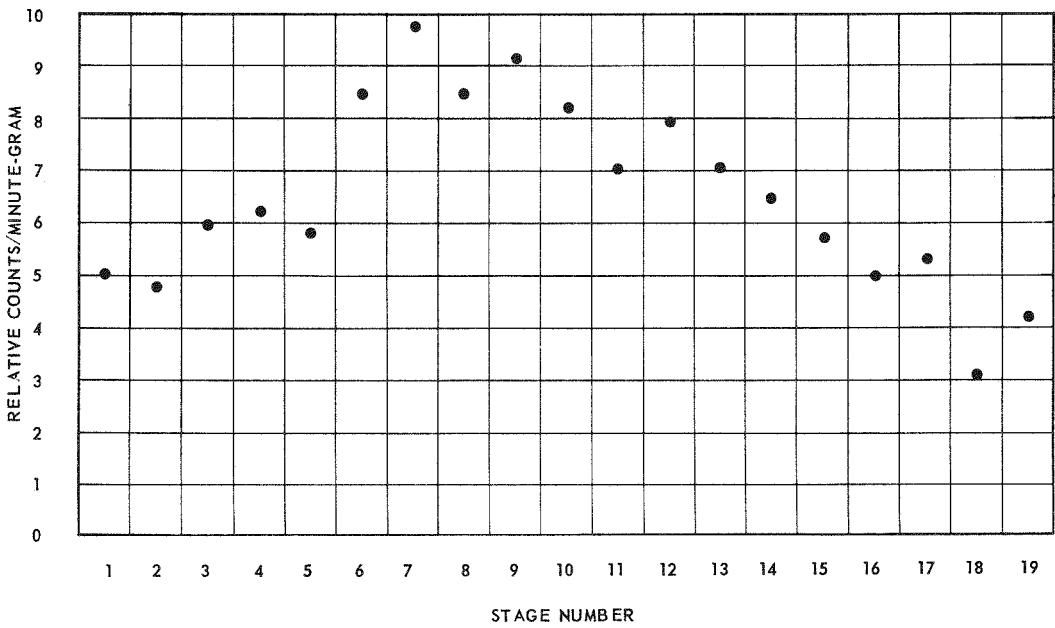
All stages of the fuel cartridge from cell 620 were gamma-scanned to determine the relative concentration of Zr^{95} in each segment. A gamma spectrum of each stage was obtained on the 256-channel gamma ray spectrometer connected to a scintillation head, and the Zr^{95} peak height was determined from the gamma spectrum. The data are presented in Figure 115. From these data an approximation to the longitudinal power profile of the fuel cartridge can be obtained. The data scatter noted on this graph can be attributed to the following:

Fig. 115 — Gamma-scan data from cell 620

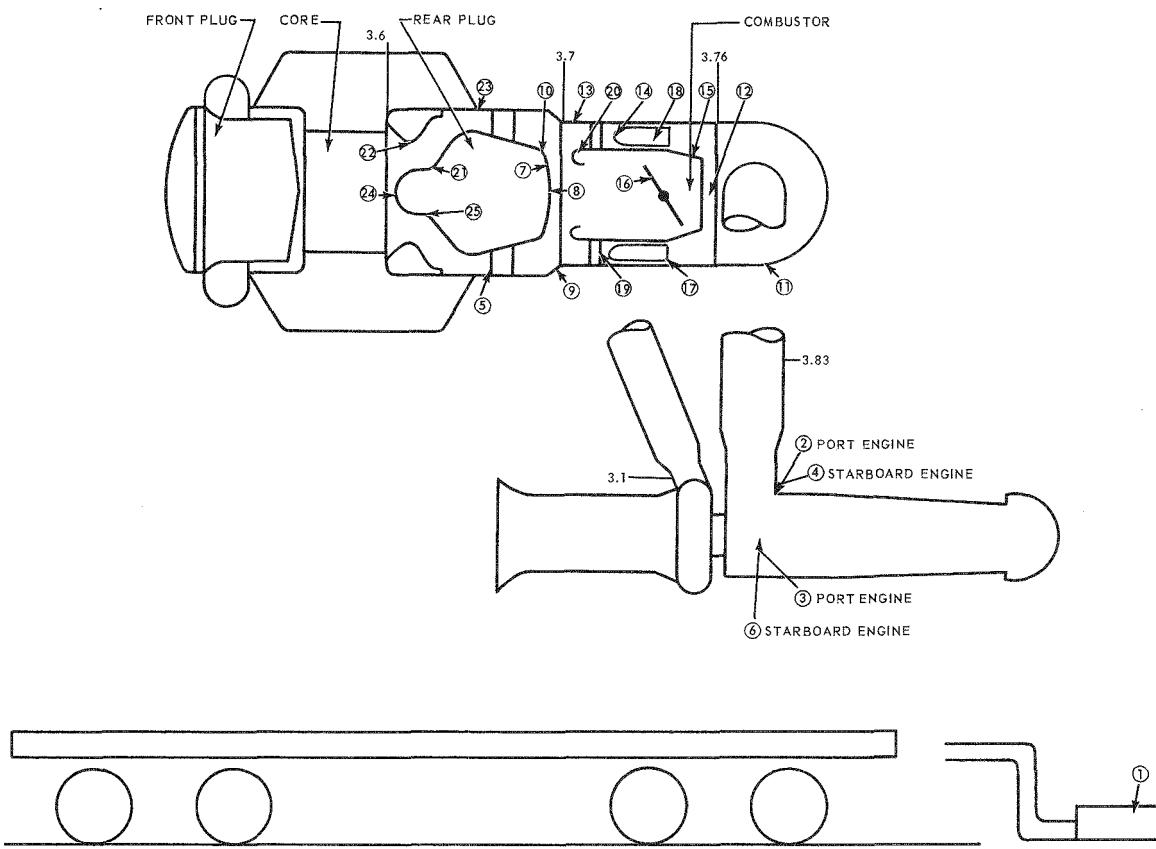
The smears were counted in a 2π alpha counter to determine the alpha activity. All smears were counted in the same geometry and the results reduced to counts per minute per square centimeter as shown in Table 12, column 2. The location of each smear is shown in Figure 116.

Fig. 116 — Smear locations on D102A power plant

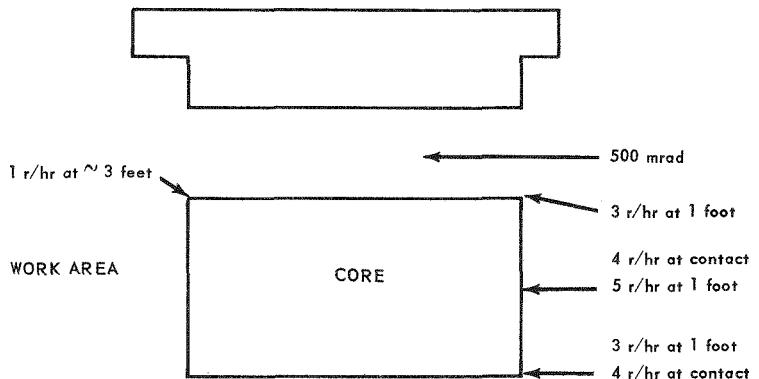
Fig. 117 – Radiation survey of core, December 2, 1958
