Blast Tests of Expedient Shelters in the DICE THROW Event

BLAST TESTS OF EXPEDIENT SHELTERS IN THE DICE THROW EVENT

Date Published: March 1978

OAK RIDGE NATIONAL LABORATORY
Oak Ridge, Tennessee 37830
operated by
UNION CARBIDE CORPORATION
for the
DEPARTMENT OF ENERGY

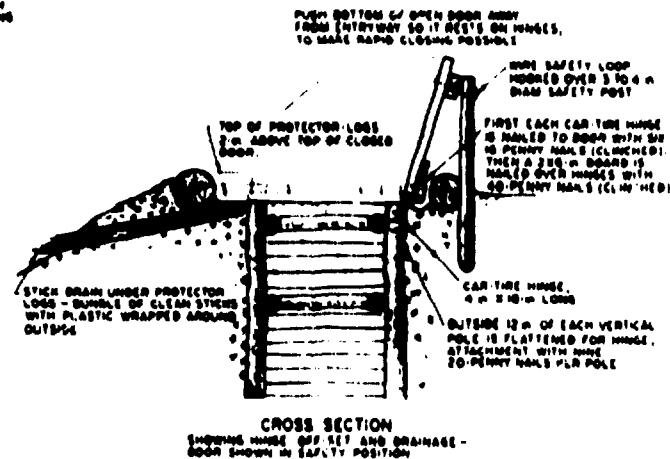
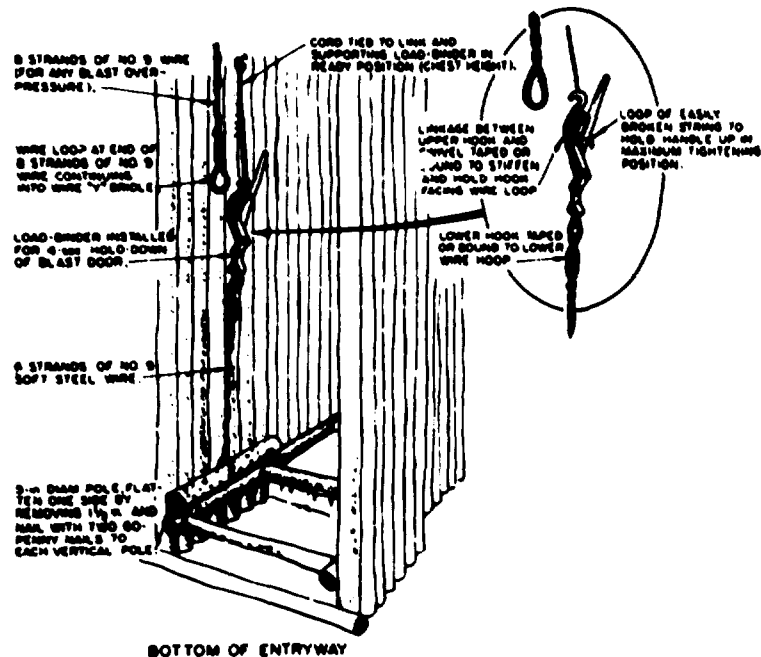
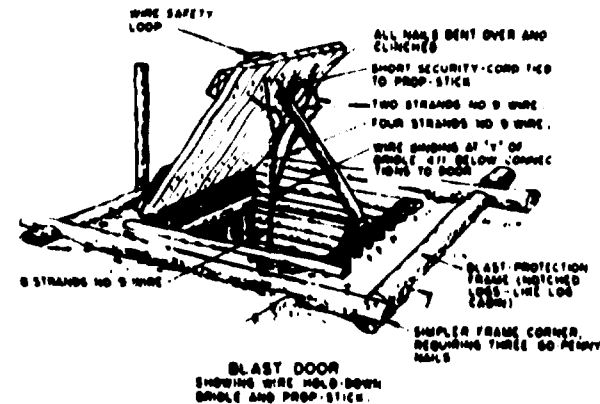
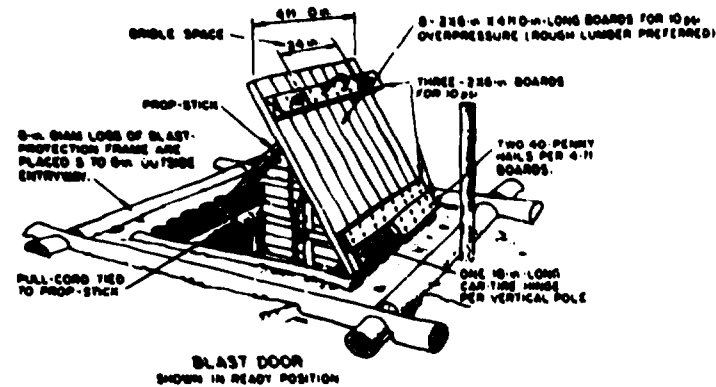
Fig. 4.4.   Expedient blast door that can be closed and secured in 4 sec.   The expedient blast doors tested at DICE THROW were all of stronger construction than this door made of boards. This door was damaged but still intact after being subjected to about 17 psi in the main explosion of DNA's MIXED COMPANY Event.

Each blast door was surrounded with blast-protector logs which had
been notched and spiked together and were evenly spaced around the door
(see Fig. 4.4). These logs (about 8 in. in diameter and 8 ft long) had
been placed with their upper sides about 2 in. higher than the top of
the closed blast door. Without blast-protector logs, the reflected
shock overpressure against a vertical side edge of this type of door
could be several times as great as the free-field peak overpressure.[11]
At the 53-psi overpressure range, this reflected peak overpressure, that
would move the closed door horizontally, could be as much as 77,000 lb.
We believe that the door hinges and hold-down attachments of an expedient
door could not withstand this great a horizontal force. Furthermore,
stout blast-protector logs give an aboveground blast door some protec ion
against the heavy objects that in most areas would be hurled by a large

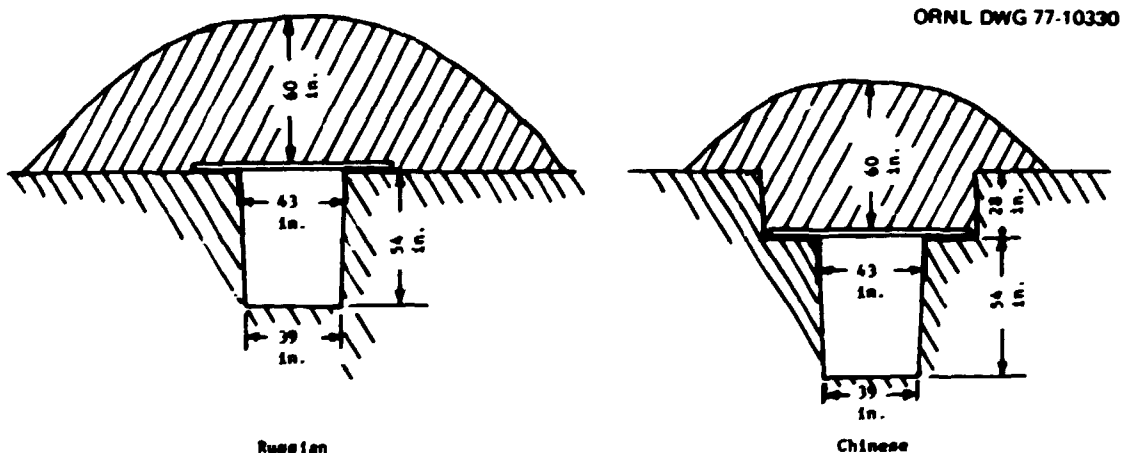
ORNL DWG 77-10330

Fig. 6.1. Comparison of Russian way and Chinese way of positioning poles to roof a trench shelter. Note that the Chinese way requires about 35% less earth to be moved in order to make a 5-ft-thick covering — about the thickness specified in a Chinese handbook for shielding against initial nuclear radiation.

As shown in Fig. 6.1, the Chinese half was built with its roof poles resting on earth shelves 28 in. below ground level, cut into the hard caliche. All roof poles (logs) were ponderosa pine. The poles averaged about 5 in. in diameter, not including their bark; all were cut 7 ft long. Earth was mounded about 5 ft above ground level over this whole shelter. This resulted in about 4-1/2 ft of earth covering the roof logs of the Russian half and about 6 ft covering the roof logs of the Chinese half. Blast-wind scouring removed a foot of this mounded dry, loose earth. If blast-wind scouring by a very large explosion had blown away almost all the dry earth mounded above ground level, the Chinese shelter would still have had adequate cover to provide good fallout protection.

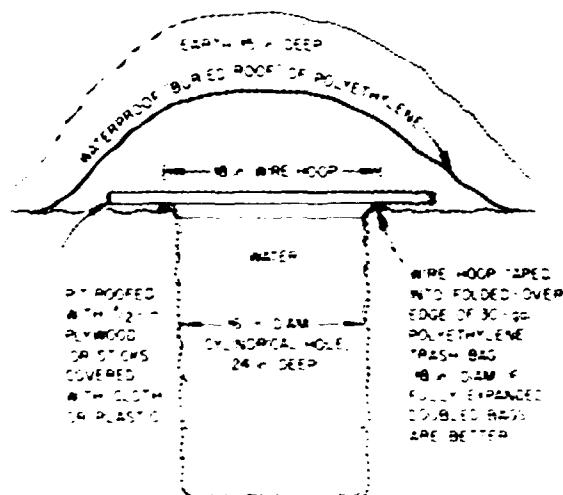
ORNL DWG 77-10423

16.2.1 Water stored in plastic bags lining cylindrical pits in the earth.[12] As anticipated, lined cylindrical pits proved to be the most blast-resistant way to store water outside of blast shelters (see Fig. 16.1). Ordinary 30-gal polyethylene trash bags were used for waterproof liners. One bag was placed inside another, since a very small fraction of polyethylene bags not made for water storage have pinhole leaks. Each cylindrical pit was dug so as to have a diameter about 2 in. smaller than the diameter of its waterproof liner bag, when its liner bag was inflated.

Fig. 16.1. Vertical section of cylindrical water storage pit lined with waterproof plastic bag, or two bags.

16.3.1. If blast is expected in a shelter area, plastic-lined cylindrical pits, filled almost full and protected from blast and contamination as illustrated in Fig. 16.1, would usually be the most practical method of expedient water storage.
