IRRADIATION EMBRITTLEMENT OF THE SHIPPINGPORT NEUTRON SHIELD TANK*

O. K. Chopra and W. J. Shack

Materials and Components Technology Division
ARGONNE NATIONAL LABORATORY
9700 South Cass Avenue
Argonne, Illinois 60439

August 1989

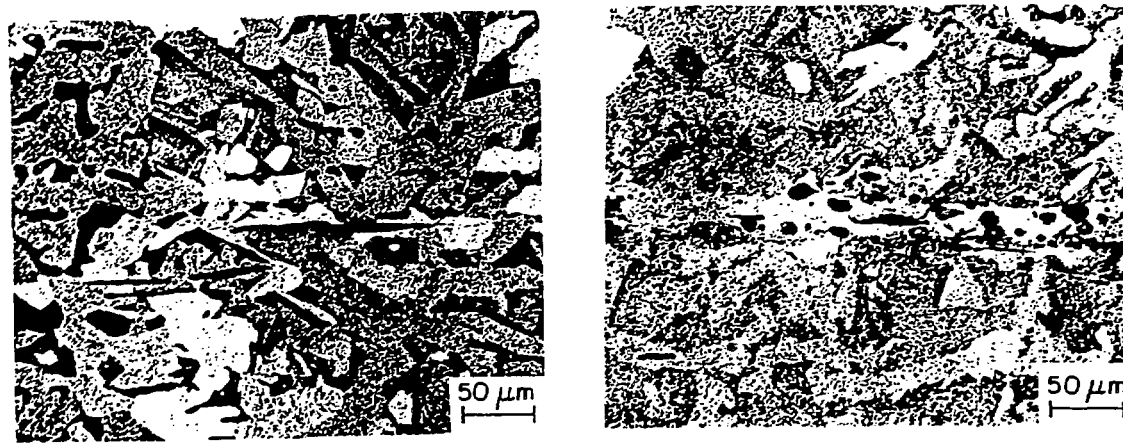
Metallographic examination of the NST material indicates that the rolling direction is in the horizontal direction. Micrographs of the grain structure along the rolling and transverse directions are shown in Fig. 2. The surfaces shown in the micrographs are designated by the direction normal to that surface. The transverse section shows some elongated grains and all the inclusions are elongated in the rolling direction. The inclusions in the rolling section are globular or flat.

Figure 2. Micrographs of the NST Material Along the (a) Transverse and (b) Rolling Sections.

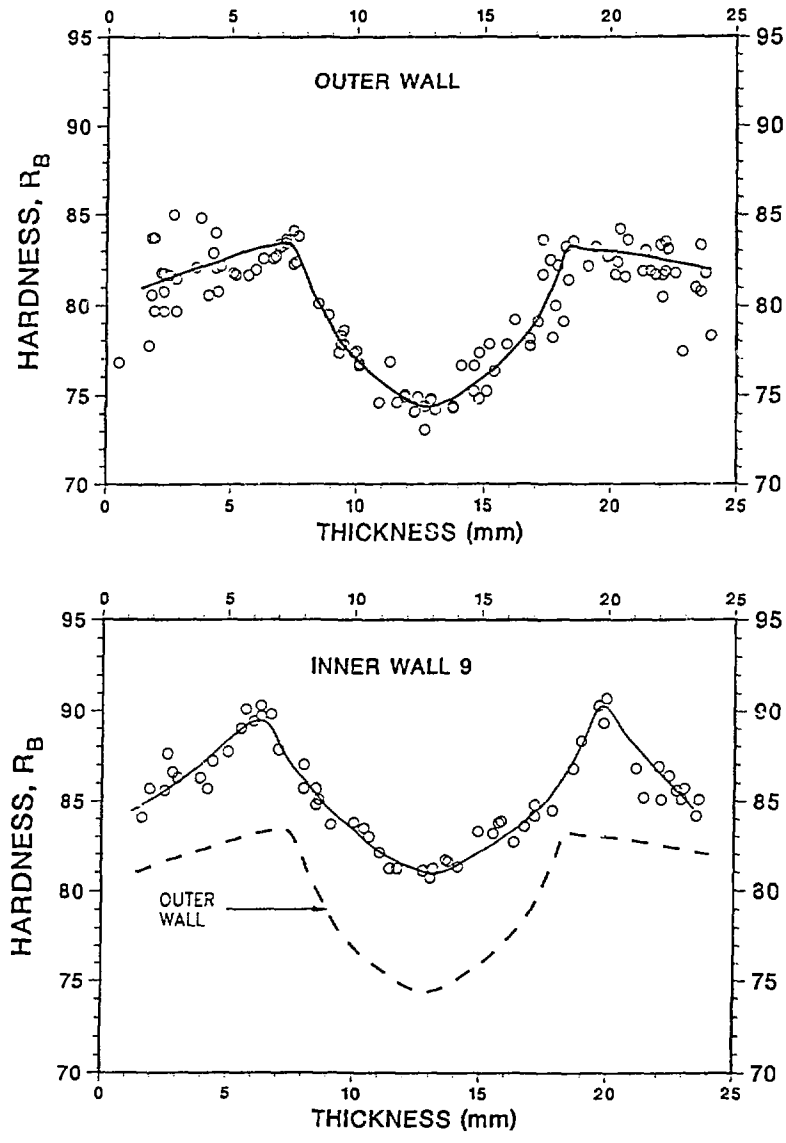
There are significant variations in hardness across the thickness of the wall. A typical hardness profile (Rockwell B) for the outer wall is shown in Fig. 3a. (The depth is measured from the inner surface of the plate, i. e., the surface towards the reactor core.) The hardness values of the inner and outer regions of the plate are ~10% higher than the plate center. However, no measurable change in grain size was observed across the thickness of the wall; the average through-wall grain size was ~12 μm. Irradiation increases

the hardness of the material, however, the V-shape profile is maintained at most locations, Fig. 3b.

Figure 3. Hardness Profile across the Thickness of the (a) NST Outer Wall and (b) Locations 9 of the NST Inner Wall.

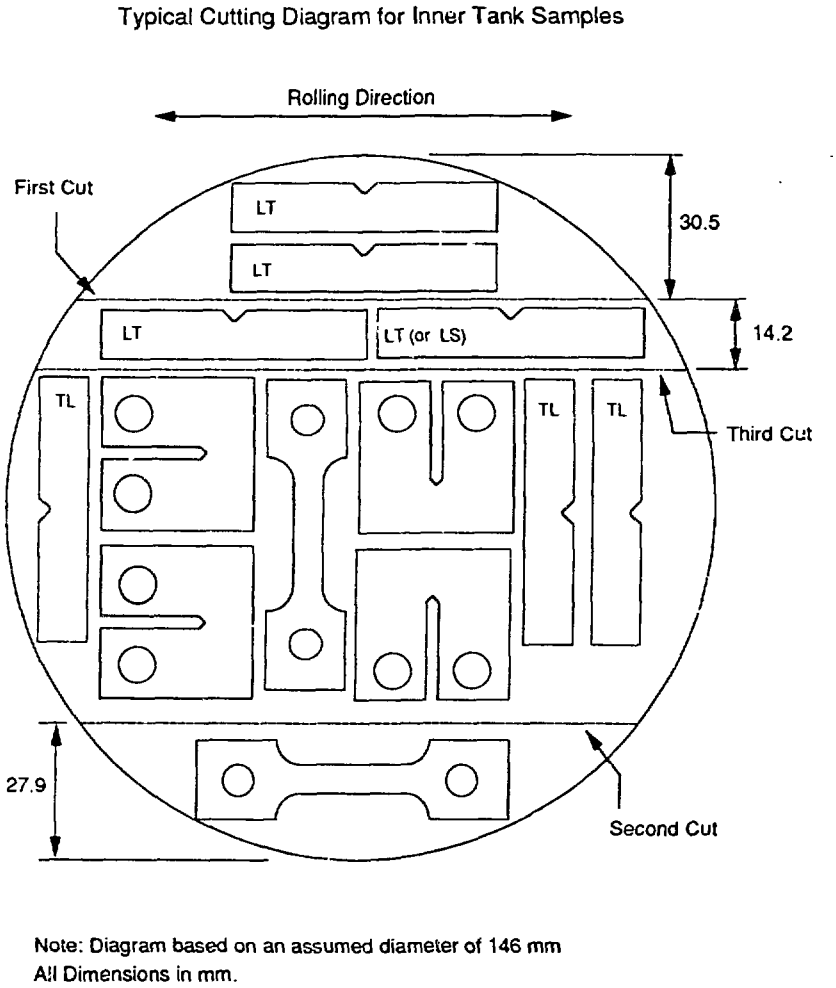
Figure 4. Cutting Diagram for Base Metal Samples from the NST inner and outer walls.

The irradiation embrittlement has been characterized by Charpy-impact and tensile tests. Specimens were obtained in the LT and TL orientations* from three regions, i.e., inner, center, and outer 10-mm wide regions, across the thickness of the NST wall. A typical layout for the base metal specimens from the inner and outer walls is shown in Fig. 4. Material from the outer wall, which was protected by ~0.9 m (~3 ft.) of water and hence had a six orders of magnitude lower fluence than the inner wall, was used to obtain baseline data for unirradiated material.

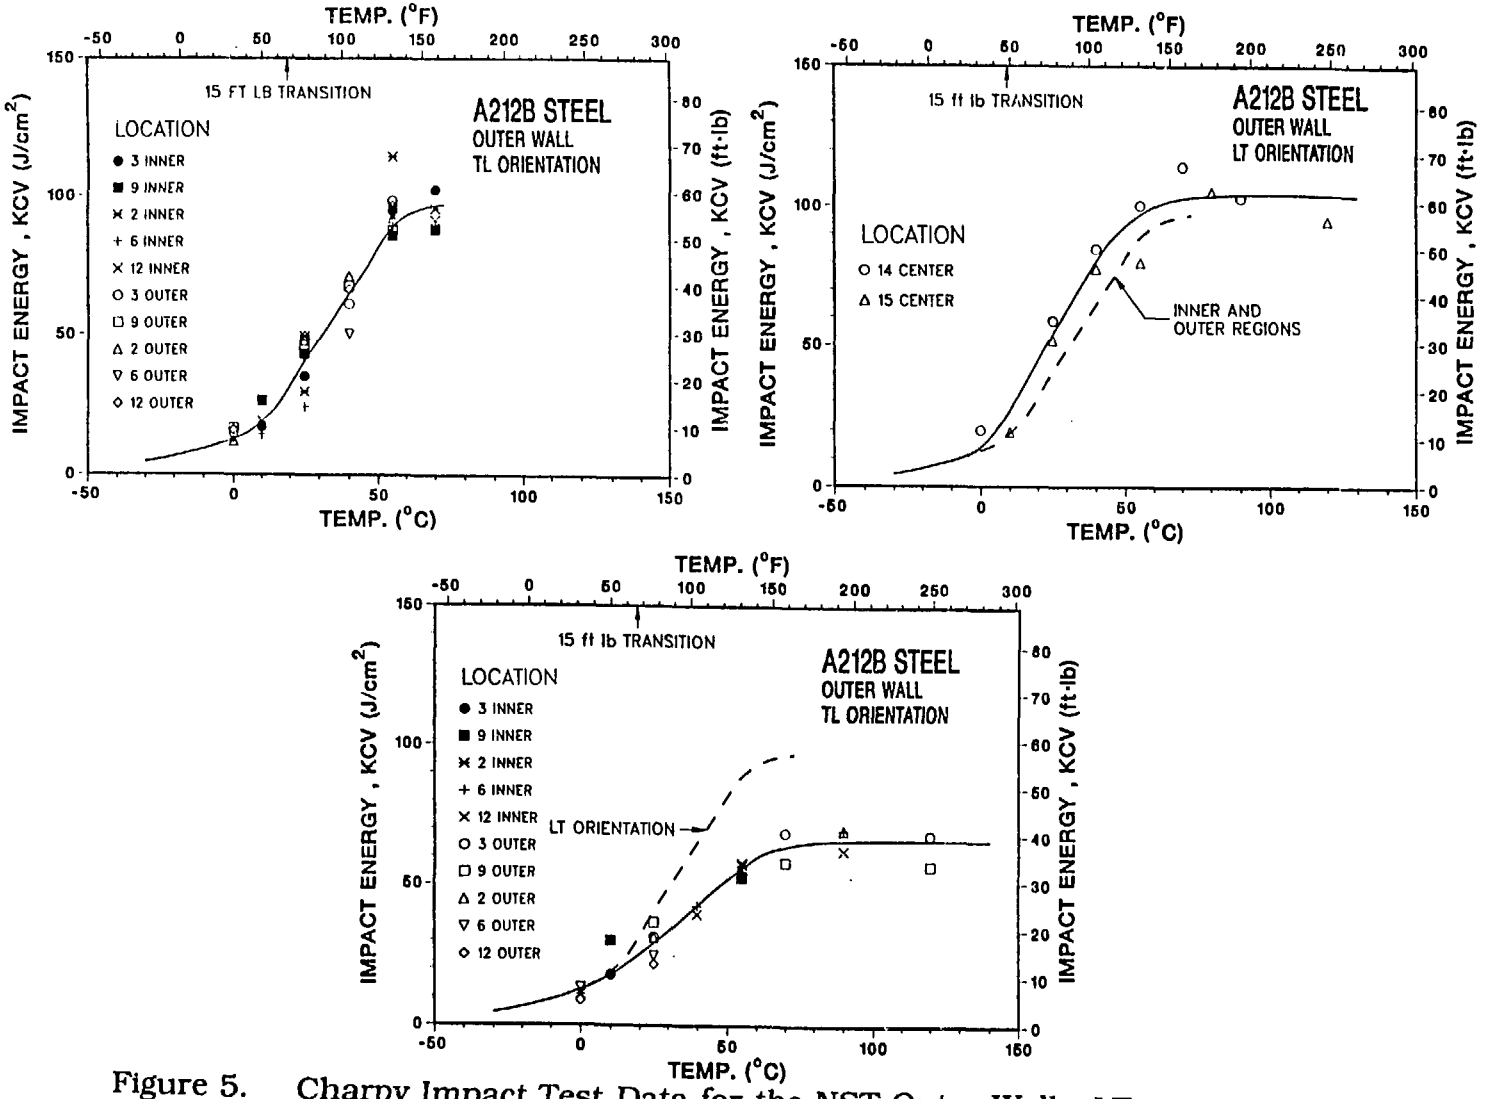
Charpy transition curves for the LT and TL specimens from different regions of the NST outer wall are shown in Fig. 5. The results indicate that the variation in the transition curves with vertical and azimuthal position is very slight. However, the TL orientation is weaker than the LT orientation. The Charpy transition temperature (CTT) at the 20.7 J (15 ft·lb) level is higher and the upper shelf energy (USE) is lower for the TL specimens. The CTT and USE, respectively, are 16°C (61°F) and 98 J/cm^2 (58 ft·lb) for LT specimens and 19°C (66°F) and 56 J/cm^2 (33 ft·lb) for TL specimens. The differences in impact strength are primarily attributed to differences in the structure of the material. The plane of the crack for TL orientation, i.e., transverse section shown in Fig. 2, contains elongated inclusions which facilitate cleavage by particle cracking.

The results also indicate some effect of position through the thickness of the wall; impact energies for specimens from the inner and outer regions of the wall are comparable while those for the center specimens are slightly higher, Fig. 5b. The CTT and USE for the center specimens are 9°C (48°F)

Figure 5. Charpy Impact Test Data for the NST Outer Wall. LT specimens from (a) inner and outer regions and (b) center region. TL specimens from (c) inner and outer regions.

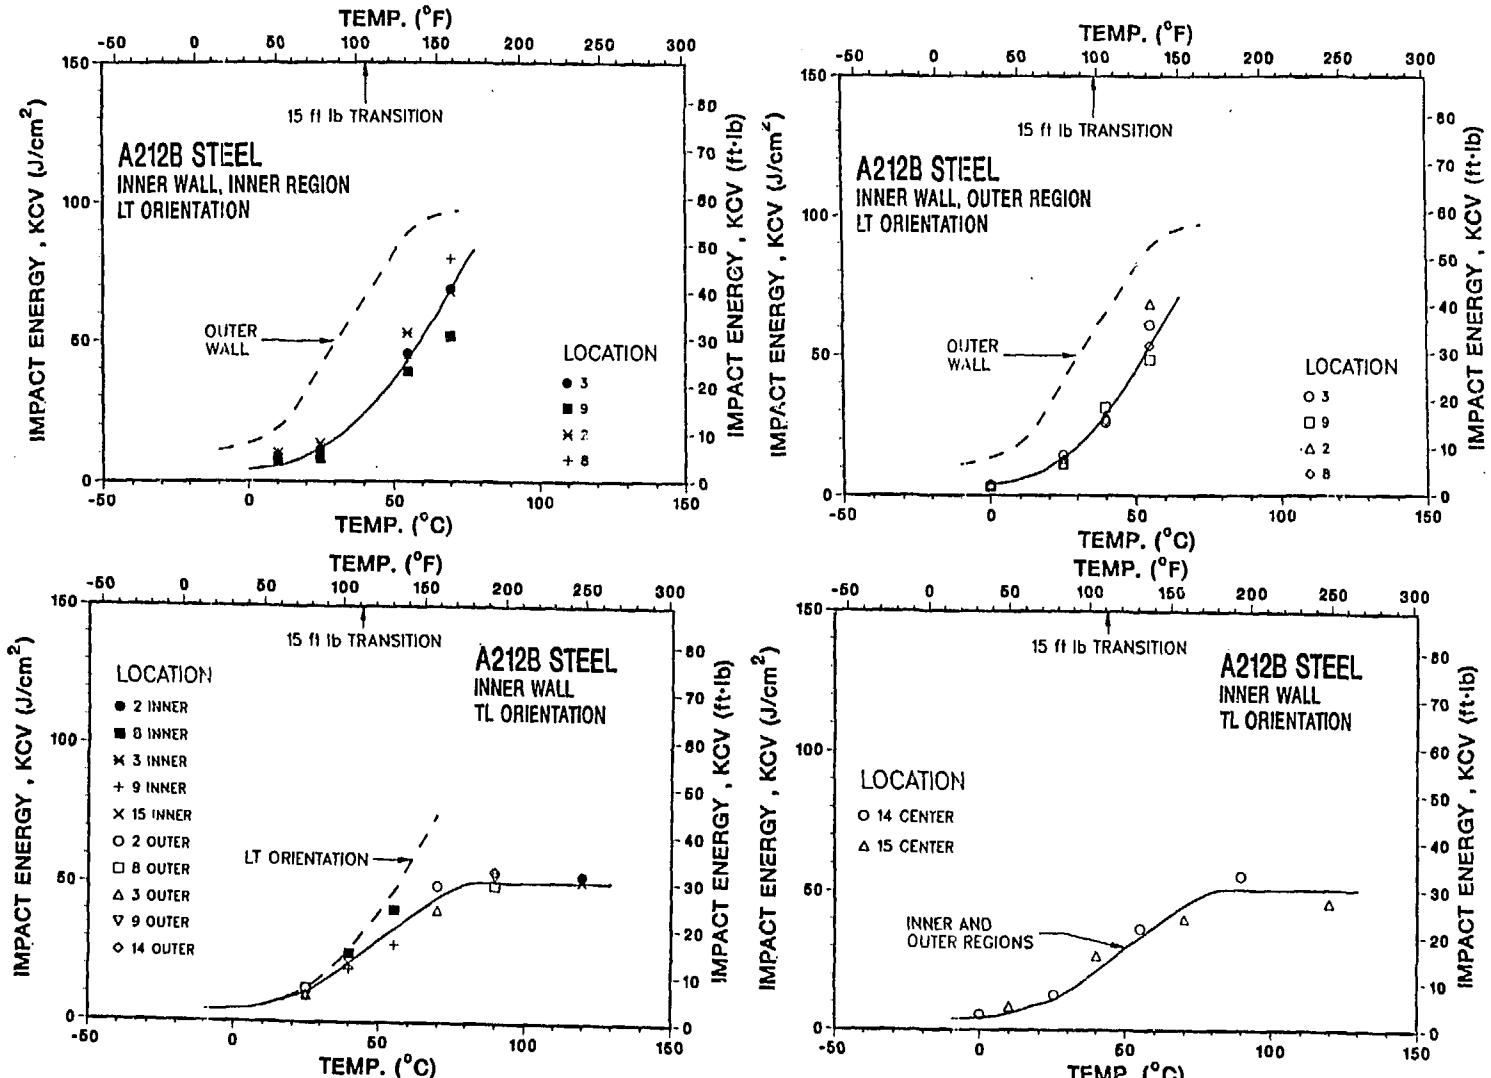
The transition curves for the LT and TL specimens from different positions on the NST inner wall, are shown in Fig. 6. The irradiated inner wall specimens show a higher CTT and lower USE relative to those from the unirradiated outer wall. The transition curves are almost independent of vertical position, which suggests that a factor of 2 to 3 variation in fluence has relatively little effect. For example, the impact energies for specimens from locations 2 and 8 (~4x10^{17} n/cm^2 fluence) are comparable to those for specimens from locations 3 and 9, (~6x10^{17} n/cm^2 fluence). For LT specimens, some differences are observed for specimens from the inner and outer regions of the wall; the shift in CTT is slightly greater for the inner region. The values of CTT are 37°C (99°F) for the outer region and 41°C (106°F) for the inner region; a shift of ~21 and 25°C (~38 and 45°F) for the outer and inner regions, respectively. The USE can not be established from the data in Figs. 6a and 6b. However, the specimens tested at 55°C show 100% shear fracture and, thus, the impact energies for these specimens are representative of USE.

The shift in CTT for the inner wall TL specimens is also 25°C (45°F), similar to that for the LT specimens. However, the actual value of CTT is higher, 44°C (111°F). The effects of material hardness are minimal for the TL specimens. The impact energies for the center specimens are comparable to specimens from the inner and outer region, although the hardness is significantly different, e.g.,R_B ~82 and 88 (156 and 176 DPH) for the center and inner or outer regions, respectively.

Figure 6. Charpy Impact Test Data for the NST Inner Wall. LT specimens from (a) inner and (b) outer region. TL Specimens from (c) inner and outer regions and (d) center region.

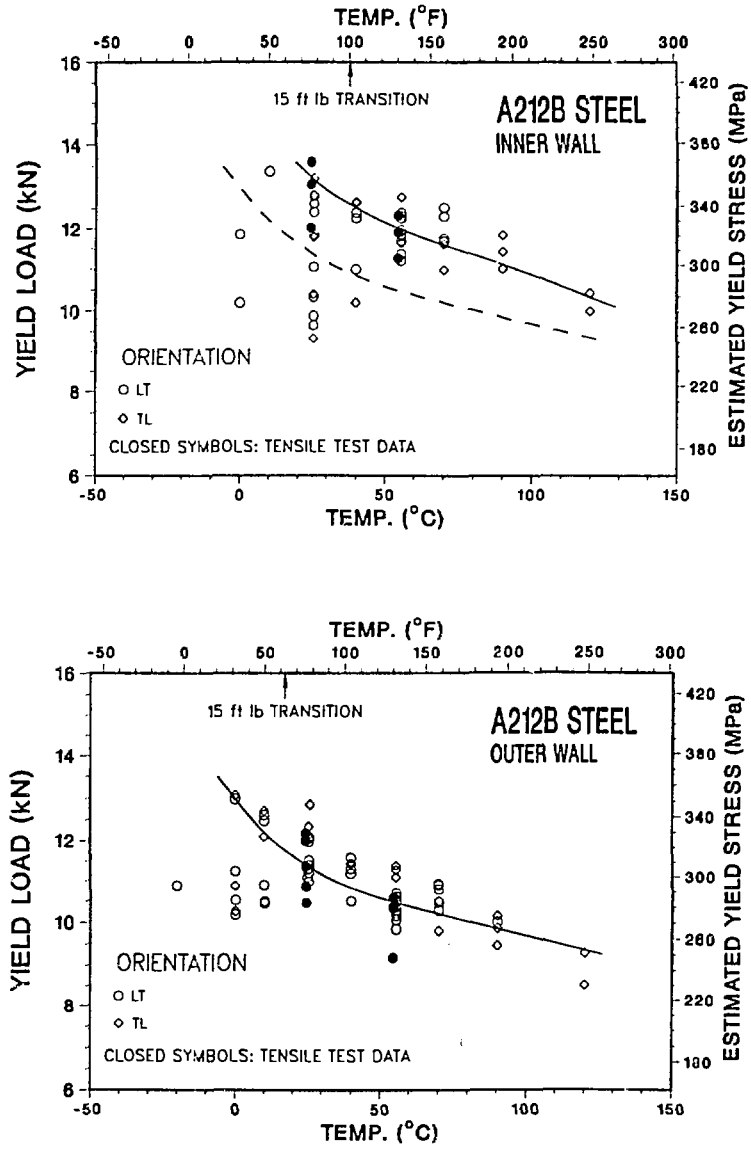
Figure 7. Yield Stress Estimated from the Charpy Impact Data for the NST (a) Outer and (b) Inner Walls.

taken from Ref. 7, where P_y is the yield load obtained from the load-time traces of the instrumented Charpy tests, W is the specimen width, B is the specimen thickness, b is the uncracked ligament, and A is a constant. The constant A was obtained by comparing the tensile and Charpy data for LT specimens tested at room temperature and at 55°C. The best value of the constant was 1.73. The yield loads and the estimated yield stresses for the outer and inner walls are shown in Fig. 7. The measured yield stresses are compared with the estimated values. The results show the expected decrease in yield stress with an increase in test temperature. In the lower shelf temperature regime, cleavage occurs before general yielding and, therefore, the yield loads are very low. For the Charpy impact tests, cleavage fracture occurs when the yield loads are ~13 kN (~1.9 kip). Irradiation increases the yield stress at all test temperatures and, therefore, the CTT shifts to higher temperatures. Irradiation hardening is greater at room temperature than at higher temperatures.

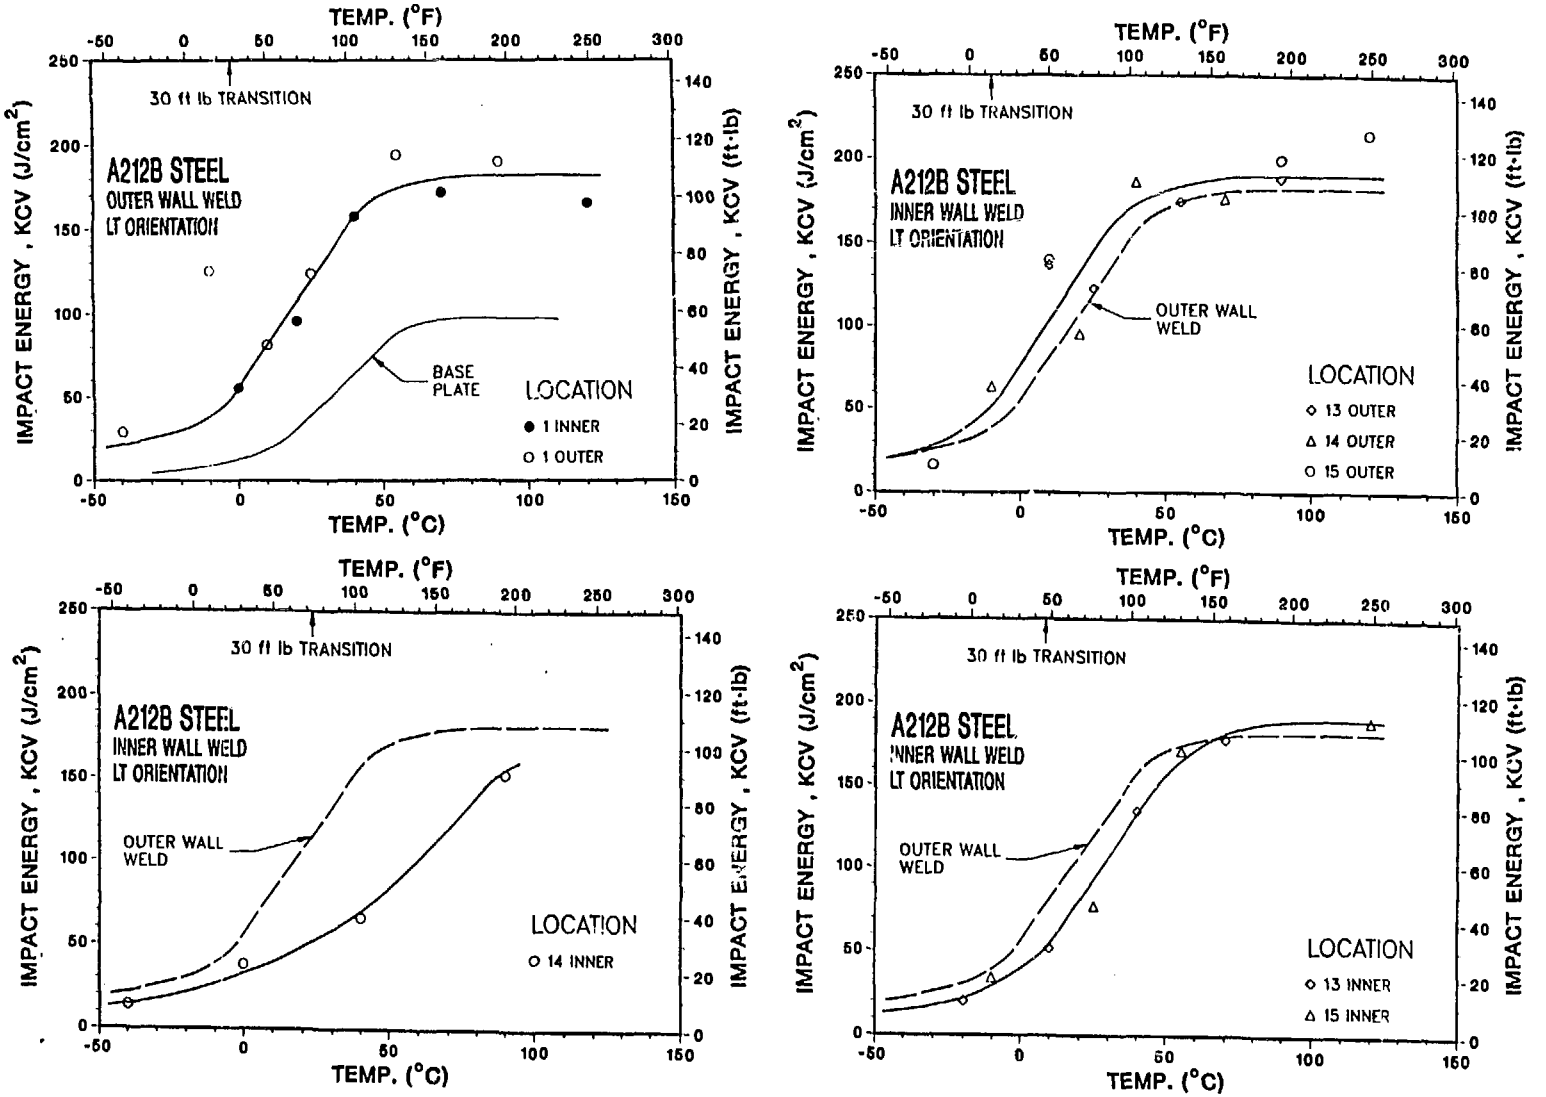
Weld samples were obtained at one position on the outer wall and three positions on the inner wall, i.e., locations 14 and 15 with ~$6x10^{17}$ n/cm^2 fluence and location 13 with ~$4x10^{17}$ n/cm^2 fluence. All the welds were transverse to the plate rolling direction. Charpy impact test specimens were machined perpendicular to the weld and from the inner and outer regions across the thickness of the plate. The impact strength of the outer wall weld is significantly higher than that of the base metal, Fig. 8a. The 41 J (30 ft·lb) CTT and USE for the weld are -2°C (28°F) and 182 J/cm^2 (107 ft·lb), respectively. Location through the thickness of the weld has little or no effect on the transition curve.

The inner wall specimens show significant effect of position around the wall as well as through the thickness of the wall. The impact energies for weld specimens from the outer region of positions 13, 14, and 15 are comparable but slightly higher than those for the outer wall weld specimens, Fig. 8b. The transition curves for the inner region of the inner wall welds are shown in Figs. 8c and 8d. The 40 J CTT is 8°C (46°F) for location 13

and 15 welds and 23°C (73°F) for location 14 weld, i.e., a shift of 10 and 25°C, respectively, for the two data sets. The results for the outer weld may not be representative of the unirradiated inner wall welds. The chemical compositions of weld metal from different locations indicate only minor variations in silicon and copper contents, Table 1. Additional tests and metallographic characterization of the welds are being performed to better establish the transition curves. Annealing studies are also planned to obtain the baseline data and determine the embrittlement behavior of the welds.

Figure 8. Charpy Impact Test Data for Weld Metal Specimens from (a) NST Outer Wall, (b) Inner Wall Outer Region, and (c) and (d) Inner Wall Inner Region.

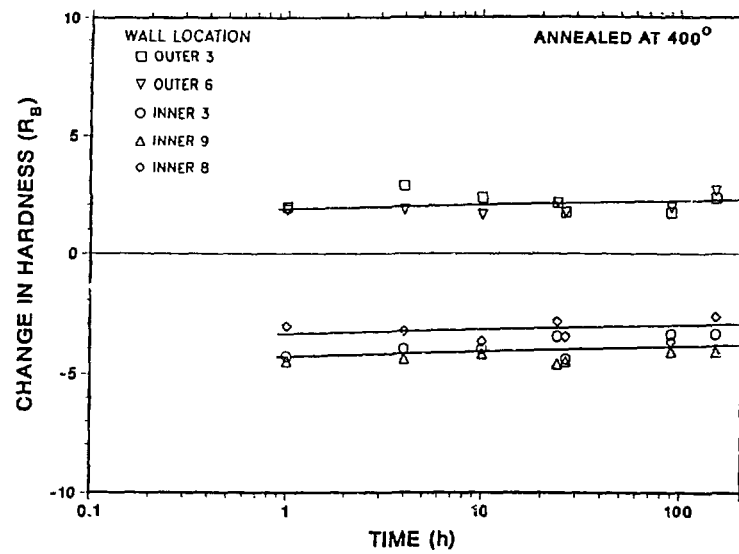
Annealing studies were conducted on material from the NST inner and outer walls to study the recovery behavior of the embrittled material. Specimens were annealed at 400°C (752°F) for up to 154 h and the annealing behavior characterized by hardness measurements. The results indicate that the hardness of irradiated material from the inner shell decreases after annealing, while the outer shell material shows an increase in hardness. Annealing for 1 h at 400°C is sufficient for recovery; there is a very slight increase in hardness of both the inner and outer shell materials after annealing for longer times. The changes in hardness for material from inner and outer shells are shown in Fig. 9. The hardness changes reflect the differences in the fluence and flux levels for the different locations, i.e., the decrease for locations 3 and 9 is greater than for location 8.

Figure 9. Change in Hardness of the Neutron Shield Material from Inner and Outer Walls after Annealing at 400°C.

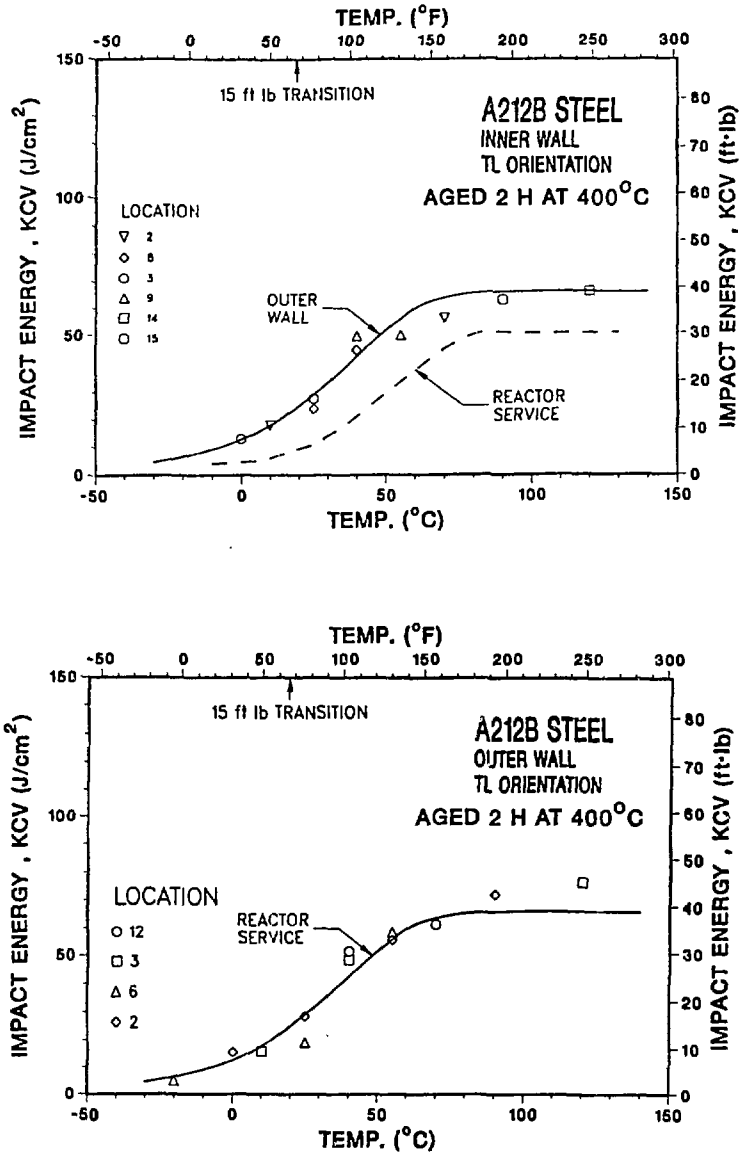
Charpy impact data for TL specimens from the NST inner and outer walls, annealed for 2 h at 400°C, are shown in Fig. 10. The results indicate a complete recovery of irradiation embrittlement, i.e., the transition curve for the annealed specimens from the inner wall is identical to that for the outer wall. Annealing has little or no effect on the transition curve for the outer wall, Fig. 10b.

Figure 10. Charpy Impact Test Data for Annealed TL Specimens from (a) Inner Wall and (b) Outer Wall.

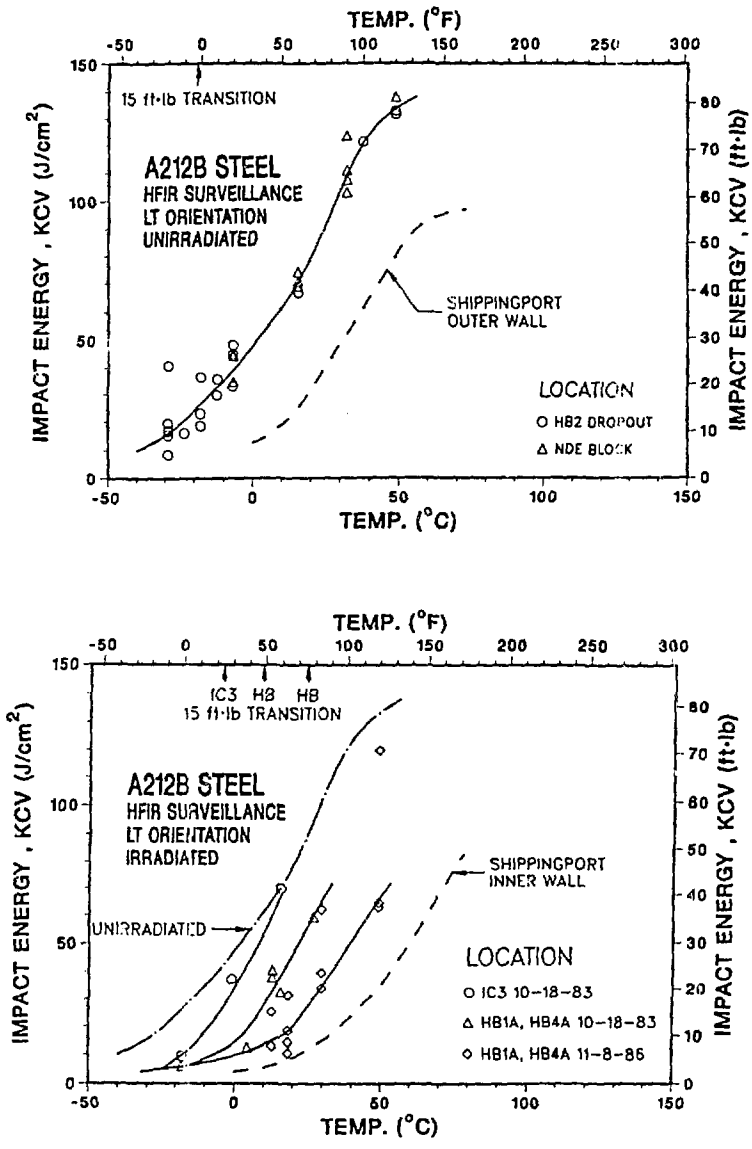
Charpy-impact and tensile data for the Shippingport NST indicate that the shift in CTT is not as severe as would be expected on the basis of the changes seen in HFIR surveillance samples. Charpy transition curves for the NST outer and inner walls are compared with the results for unirradiated and irradiated HFIR surveillance samples in Fig. 11. Although the shift is smaller the actual CTT for the NST material is significantly higher than that for the HFIR material. The impact energy for the NST inner wall is very low,~40 J/cm^2 (24 ft·lb), at the service temperature of 55°C (130°F).

Figure 11. Comparison of Charpy Impact Data for (a) Unirradiated and (b) Irradiated Shippingport NST and HFIR Surveillance Samples.

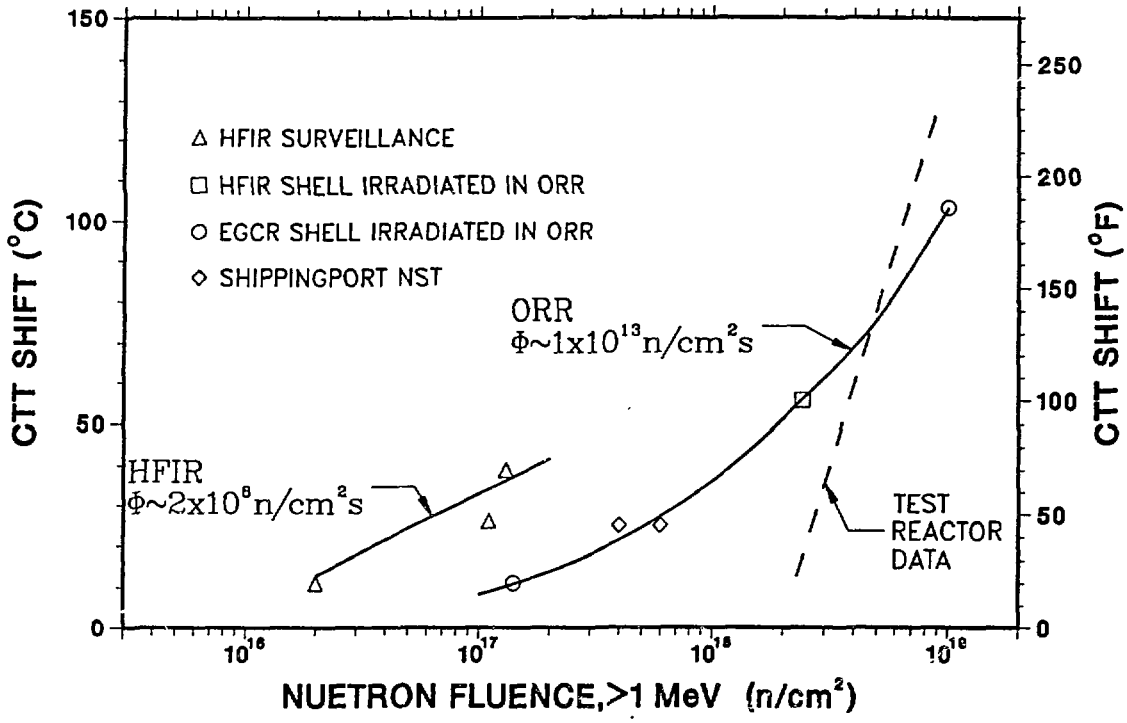
When the shifts in CTT for the NST material are compared with the results for the HFIR material irradiated in the ORR and other A212B steels irradiated in high flux test reactors, Fig. 12, the results for Shippingport NST are consistent with the test reactor data. The results for the NST material also agree very well with correlations for the shift in CTT, increase in tensile yield stress, and the increse in hardness, developed for pressure vessel steels [8-10]. The shift in transition temperature, ΔT, with an increase in tensile yield stress, $\Delta\sigma_y$, is expressed as

Figure 12. Comparison of Transition Temperature Shifts for Shippingport NST with HFIR Surveillance Results and A212B data from High Flux Test Reactors.
