NUREG/CR–5118
SAND88–7155

Leak and Structural Test of Personnel Airlock for LWR Containments Subjected to Pressures and Temperatures Beyond Design Limits

CBI Research Corporation

Sandia National Laboratories

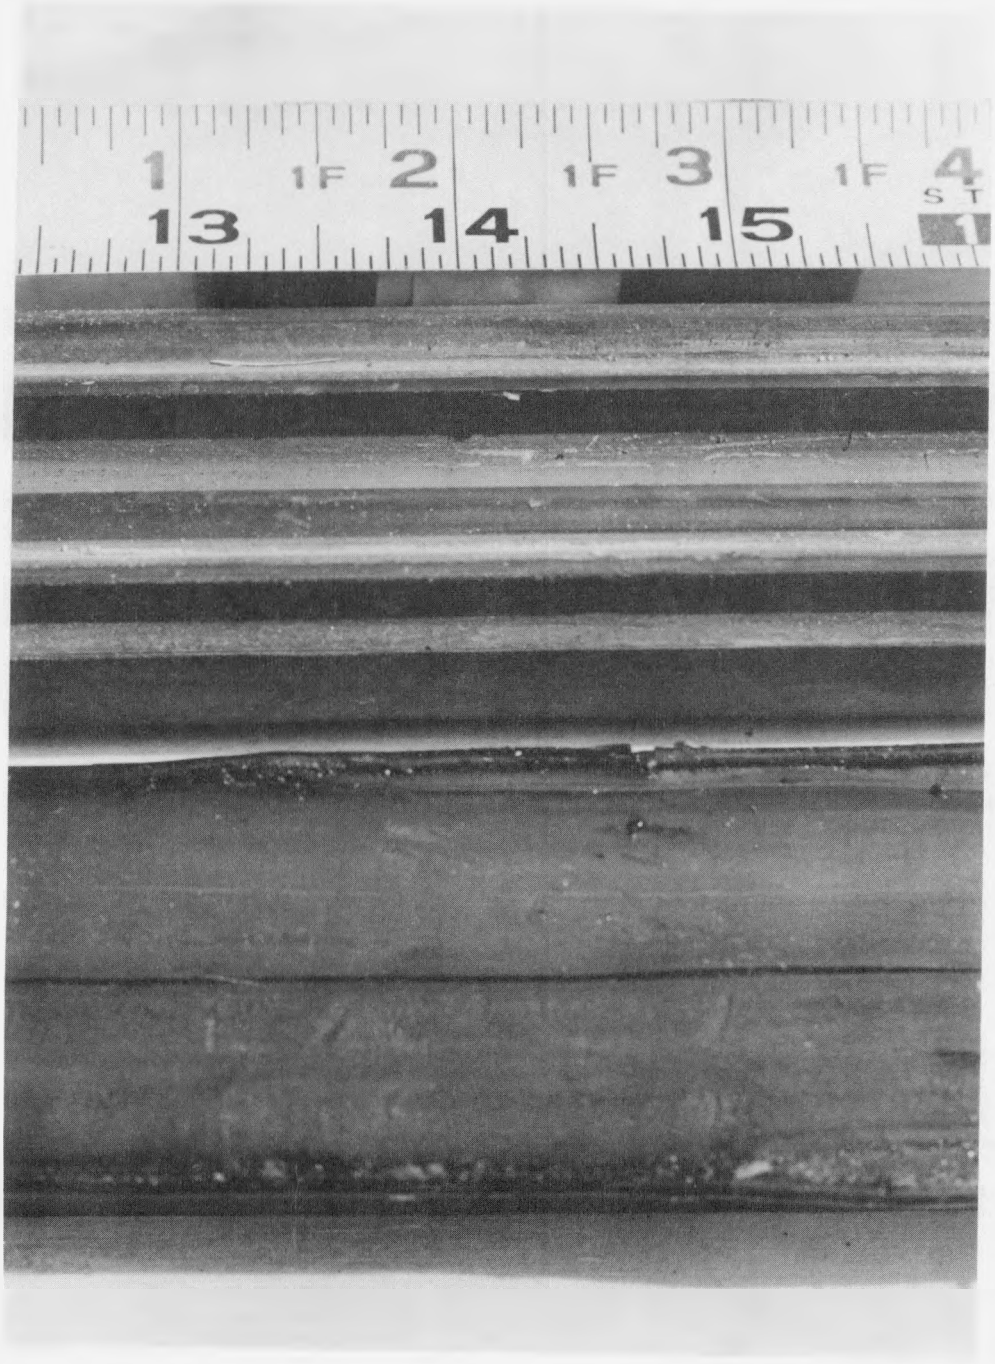
Figure 5.5 Gasket Seal Before and After Accelerated Aging

There was concern about the sealing capability of the aged gaskets. CBIRC and SNL considered replacing the aged gasket seals with the spare set of new gaskets. However, it was agreed that damage to the gaskets as a result of thermal aging should be expected, regardless of the circumstances. Therefore, two additional tests were added to the test plan, known as Tests 1AA and 1BB. The objective of these tests was to observe the sealing capability of each of the aged gaskets at ambient temperatures. The gasket seals were installed in the door, and the appropriate chamber was pressurized to 69 psig (475 kPa). Leak rates for each door were measured. Since no leakage for either door was observed, the thermally aged gaskets were used for the remaining tests.

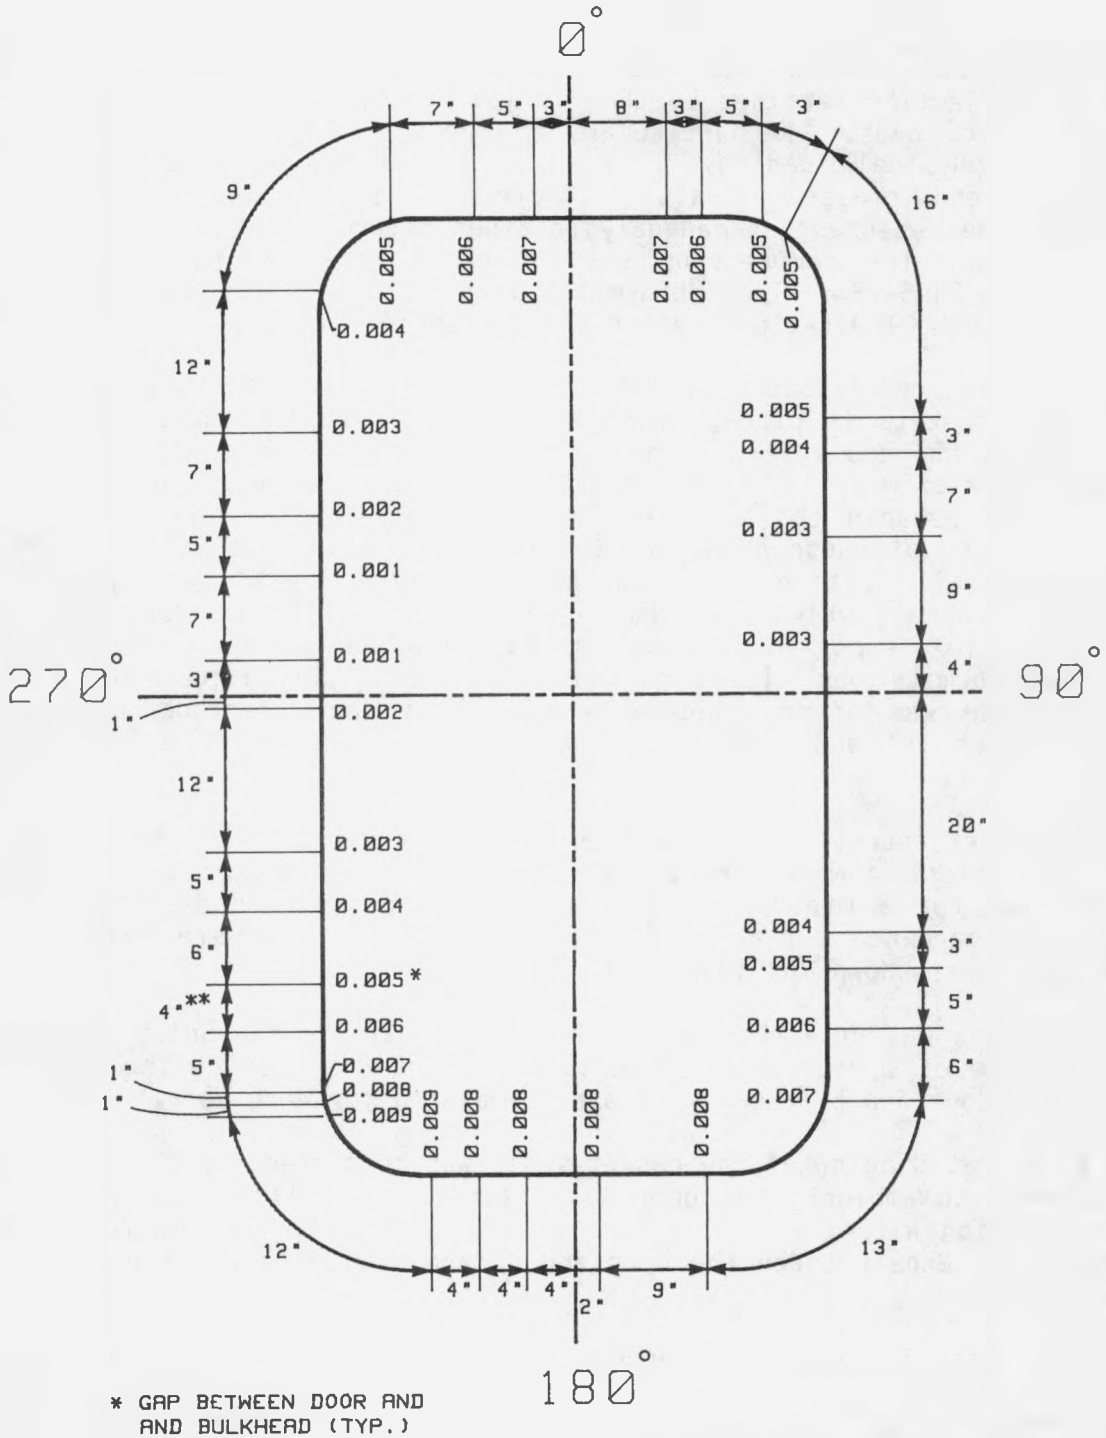
Figure 6.1 Gap Between Inner Door and Bulkhead When in Metal-to-Metal Contact

(5) The condition of the gasket due to accelerated aging did not appear to affect sealing ability at high temperatures and pressures. However, extrusion of the gasket material between the inner door and bulkhead during accelerated aging and high temperature heating, as in Item (3) above, prevented metal-to-metal contact between the door and bulkhead.

Results of these measurements are shown in Tables 6.1 and 6.2. Those measurements missing for the inner door in Table 6.1 are a result of the seal extruding into the gap and not leaving any room to take the measurement. Additionally, the depth of gasket seal gland for both doors is also presented in Tables 6.1 and 6.2.

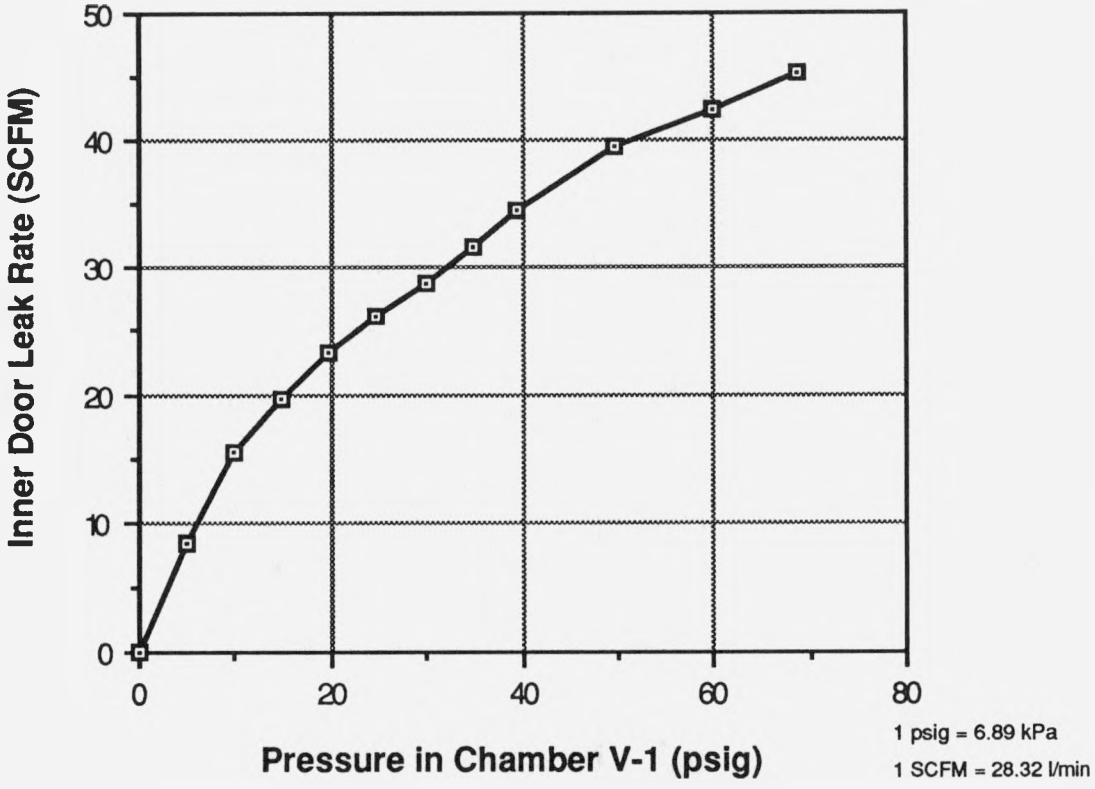
Figure 8.1 Leak Rate versus Pressure for Test 1A

Locations of these transducers are shown in the process and instrument diagram of Figure 3.2. Results for Test 1A are shown in Figure 8.1 and are also tabulated in Table 8.1. Maximum leak rate measured past the inner door was

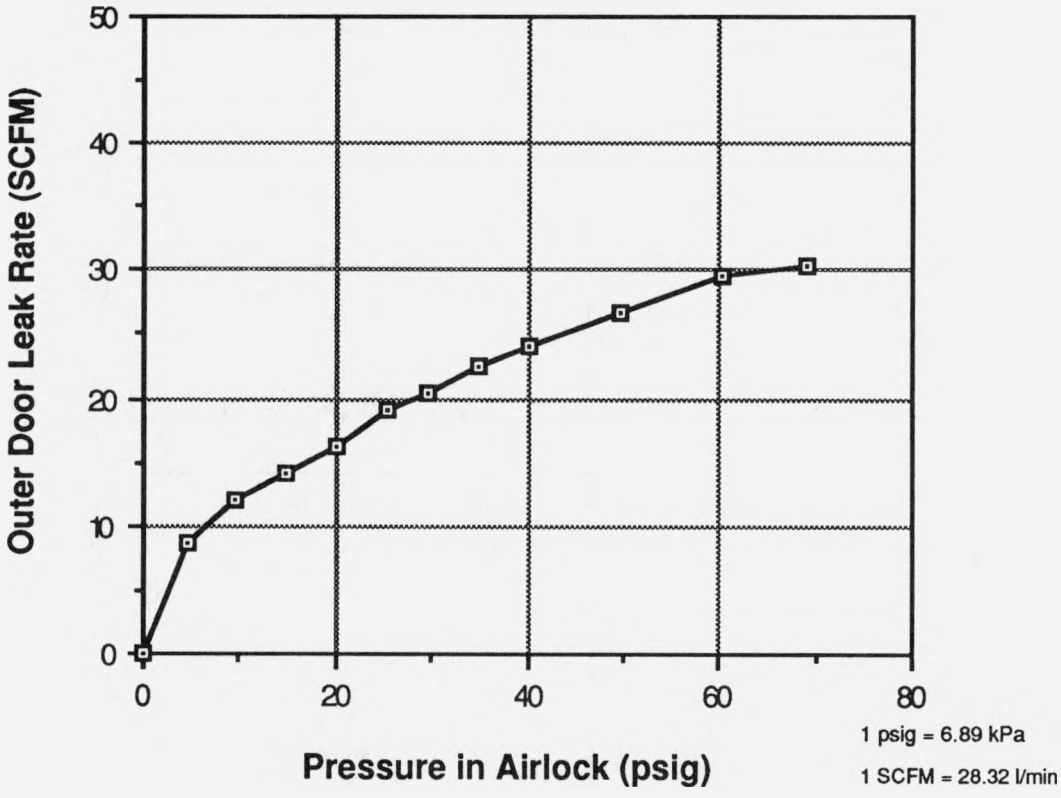
Figure 8.2 Leak Rate versus Pressure for Test 1B

Locations of these transducers are shown in the process and instrument diagram of Figure 3.2. Results for Test 1B are shown in Figure 8.2 and are tabulated in Table 8.2. Maximum leak rate measured past the outer door was 30.4 SCFM (861 l/min), or 4.4% volume/day, at a pressure in Chamber V-1 and the airlock of 69.2 psig (477 kPa).

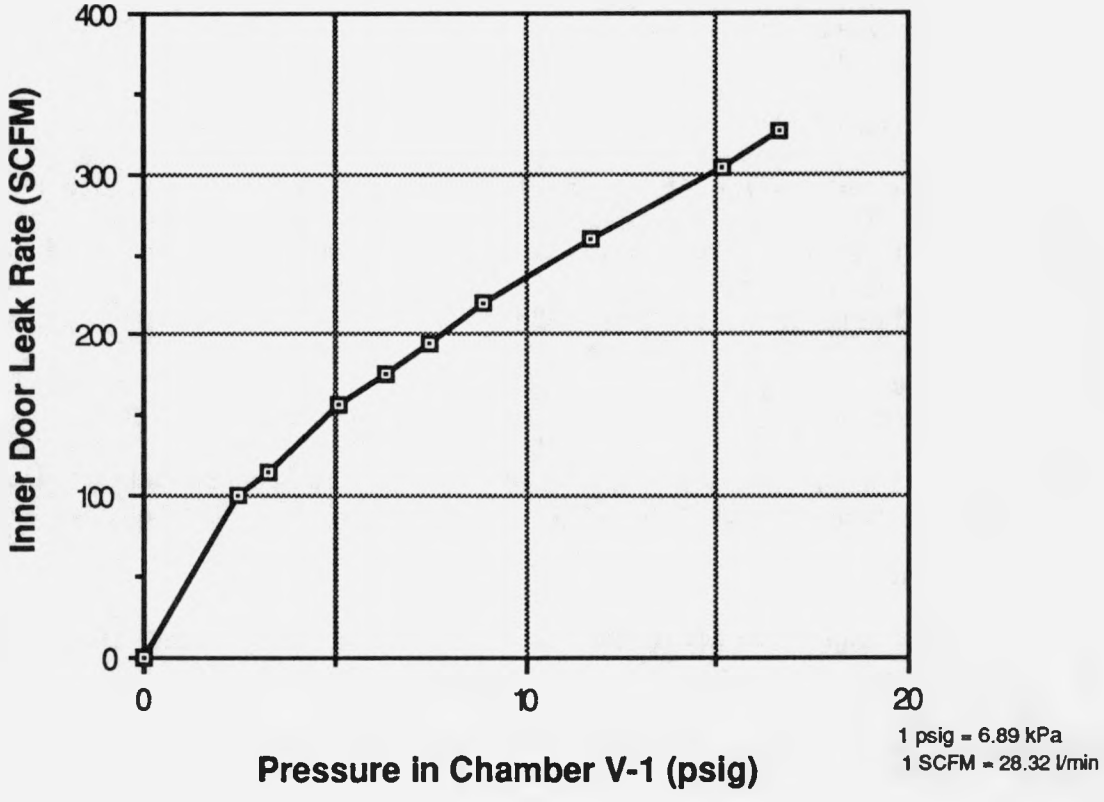
Figure 8.3 Leak Rate versus Pressure for Test 3A

The maximum pressure achieved in Chamber V-1 was 16.4 psig (113 kPa). The inner door leak rate at this pressure was 326.6 SCFM (9248 l/min), or 47% volume/day. Leak rate as a function of pressure is shown in Figure 8.3. Strains were very small at this pressure. Deflections at active transducers were near zero for gap and rotation transducers and for out-of-plane transducers across the inner door. Out-of-plane transducers measuring movement of the bulkhead indicated deflections no greater than -0.007 in. (-0.178 mm).

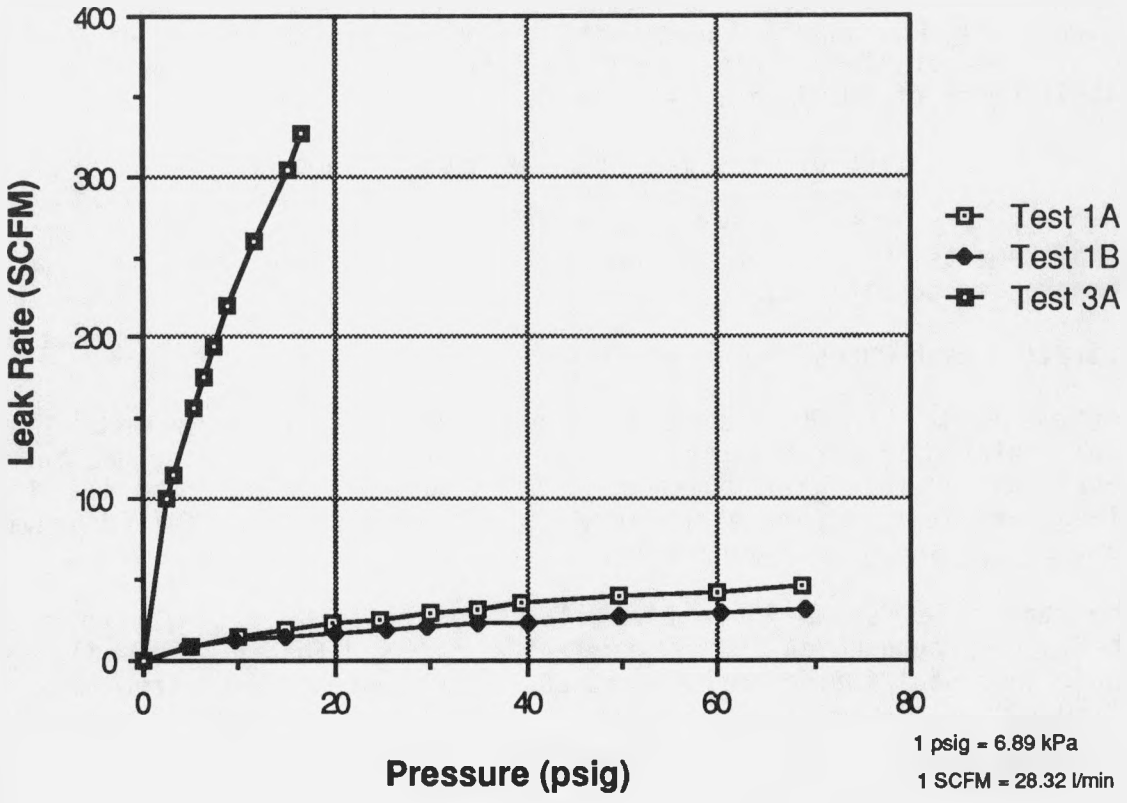
Figure 8.4 Comparison of Leak Rates for Tests 1A, 1B, and 3A

No measurable leakage was recorded past the inner door in Tests 1AA and 2A. The resulting leak rates recorded for Test 1A, where the door was in metal-to-metal contact with the bulkhead and the gasket absent from the inner door gland, and Test 3A, where the inner door gasket seal had failed previously in Test 2C, is shown in Figure 8.4.

The leak rates shown in Figure 8.4 do not reflect the relative size of the openings through which the pressurized air passed through the seal. After the inner door seal failed during Test 2C, the apparent flow area was 1.85 $in.^2$ (1190 mm^2). Based on the results of the gap measurements between the inner doors and bulkhead, the total open area for Test 1A before pressurization was approximately 1.18 $in.^2$ (760 mm^2). Although the measured leak rates are not proportional to the estimated opening through which the pressurized air bypassed the inner door, it is possible the actual opening in Test 1A became considerably smaller during pressurization. It is also possible that the failed seal opening for Test 3A was larger than the area measured where the seal failed after all tests were completed. Although there was no visible evidence, other areas of the seal may have leaked, to a much lesser degree, during Test 3A. Leak rate for Test 1B is also shown in Figure 8.4. The leak rates for Tests 1A and 1B are similar in magnitude, however, there is no apparent correlation of leak rate and open flow area between the doors and bulkheads.

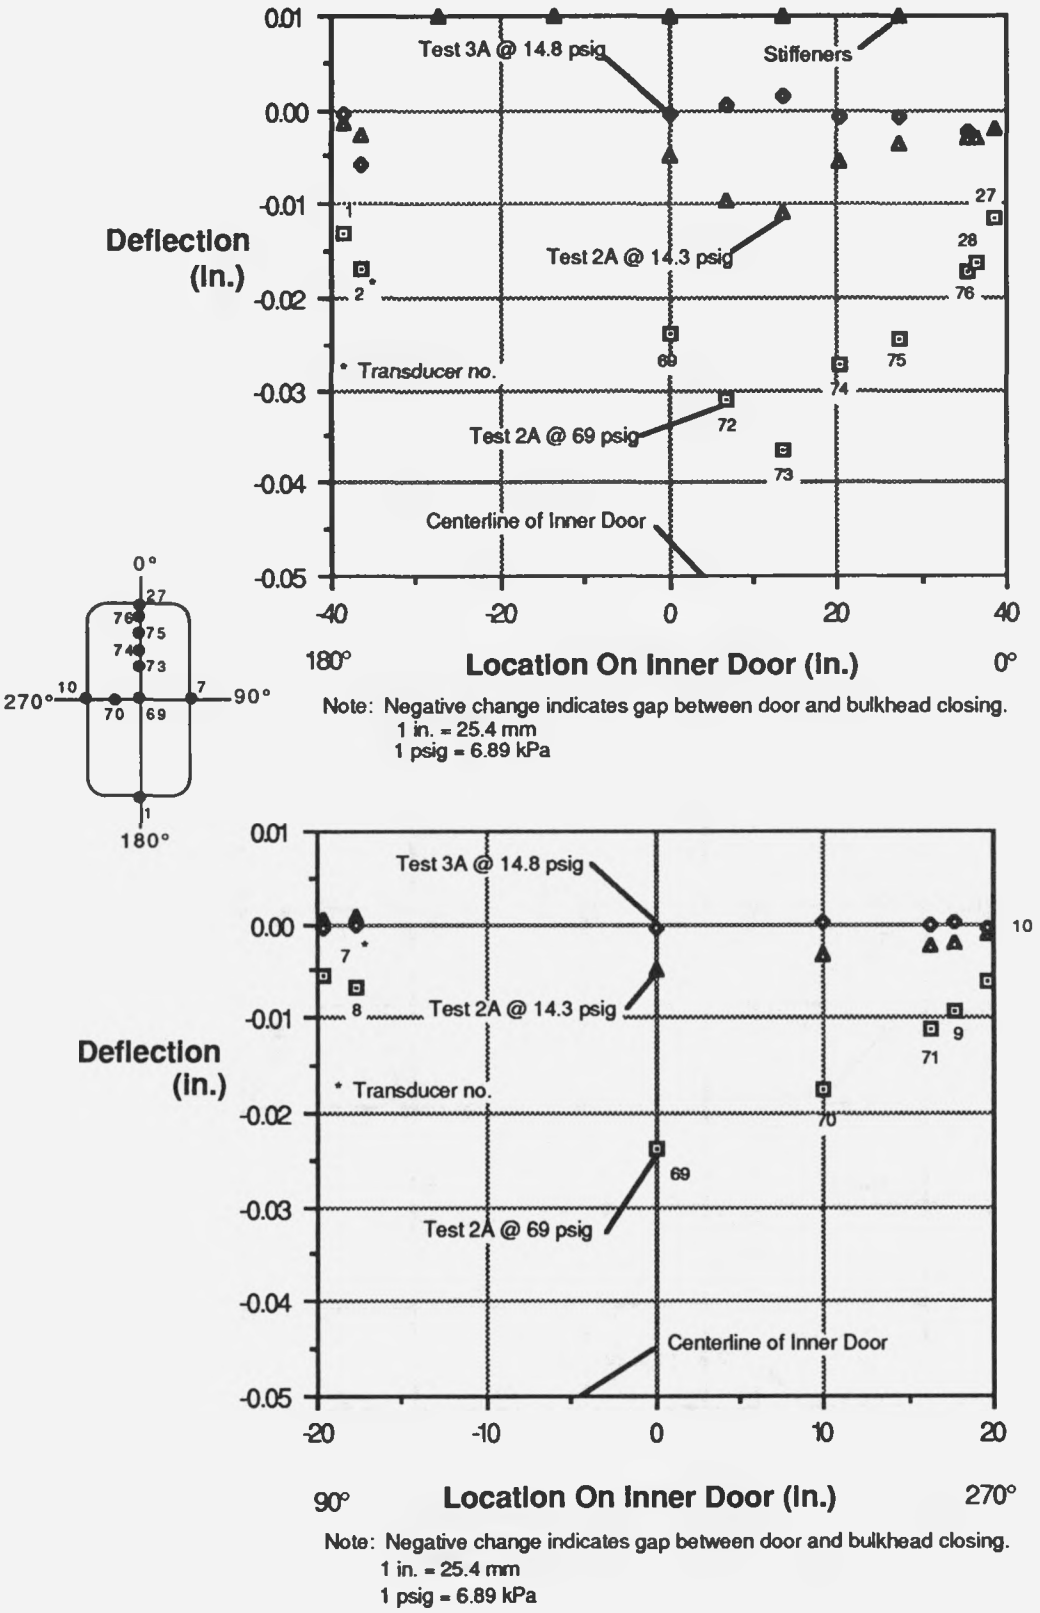
Figure 8.5 Deflection of Inner Door Centerline Along the 0°-180° and 90°-270° Axis for Tests 2A and 3A

The profile of the inner door during Tests 2A and 3A is shown in Figures 8.5 through 8.7. In general, the gap between the inner door and bulkhead closed during pressurization. Results are presented in each figure for Test 2A at maximum pressure in Chamber V-1. In addition, these changes in gap results are also presented for Test 2A at a pressure of 14.3 psig (98.6 kPa) for comparison of results for Test 3A. The maximum pressure reached during Test 3A was 16.4 psig (113 kPa), however, results for Test 3A are shown for a pressure in Chamber V-1 of 14.8 psig (102 kPa) for comparison purposes.

Deflections of the inner door along the long and short centerline directions are shown in Figure 8.5.

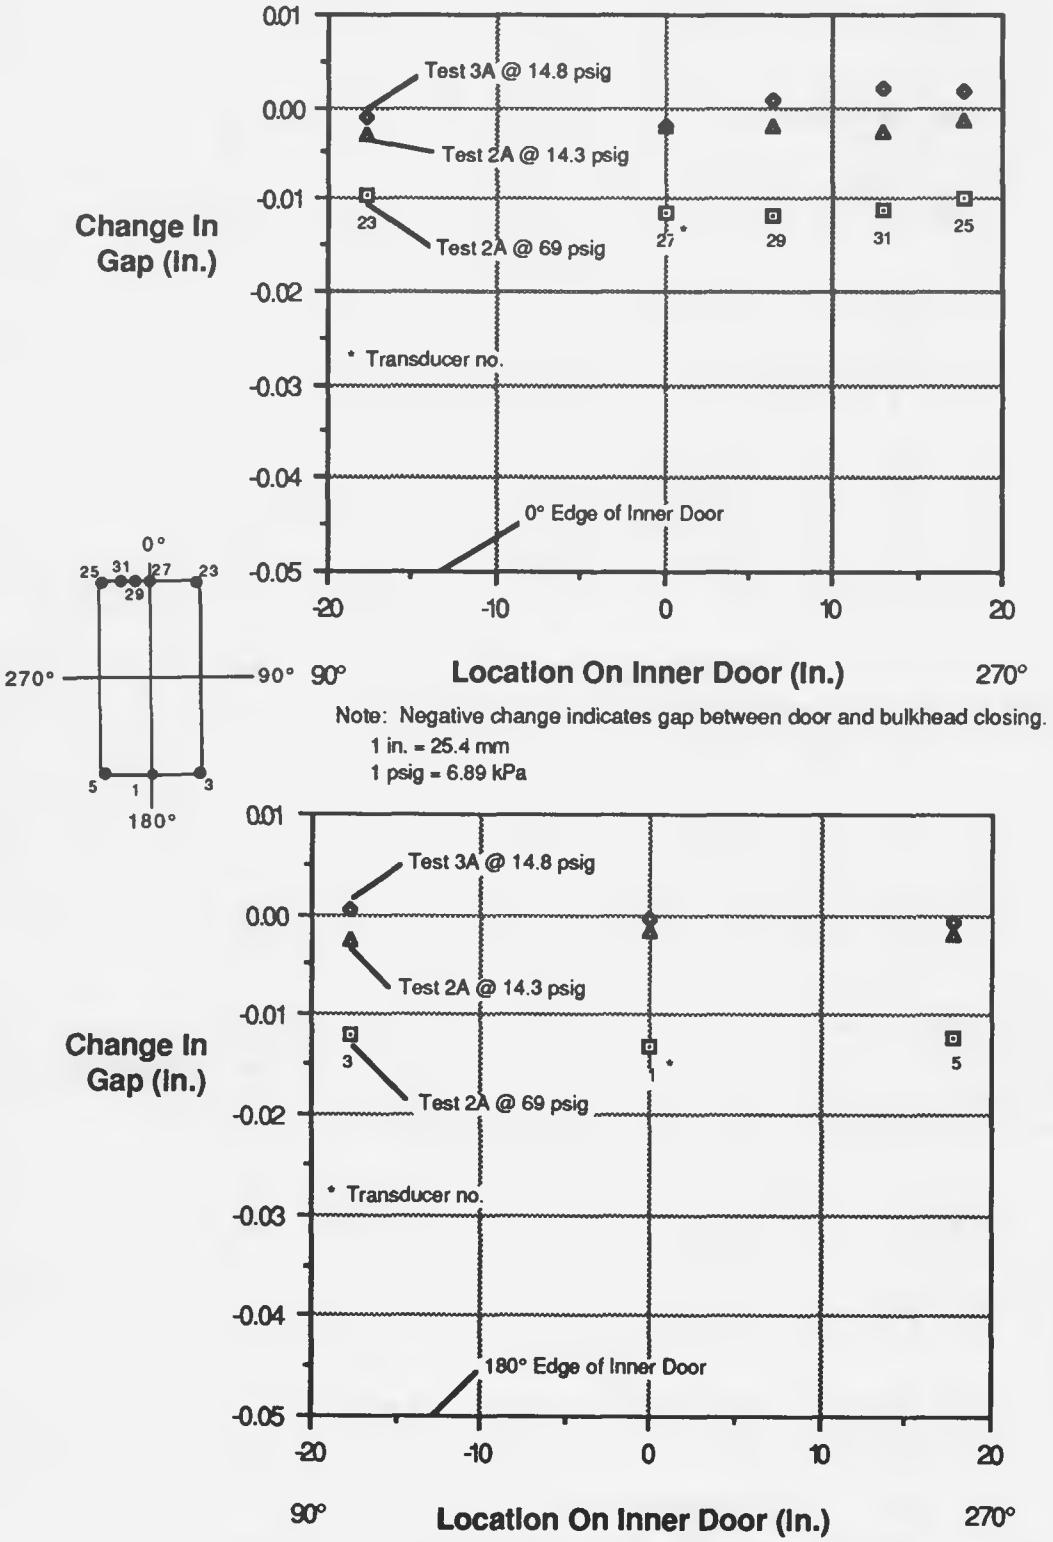
Figure 8.6 Gap Change on the Inner Door Along the 0° and 180° Edges of the Door

Change in gap along the edge of the inner door is shown in Figures 8.6 and 8.7. In general, in the long direction of the door, the corners of the door compressed more during pressurization than the center of the door along the edge. Along the short direction of the door on the edge, the gap became smaller in the center of the door than at the corners.

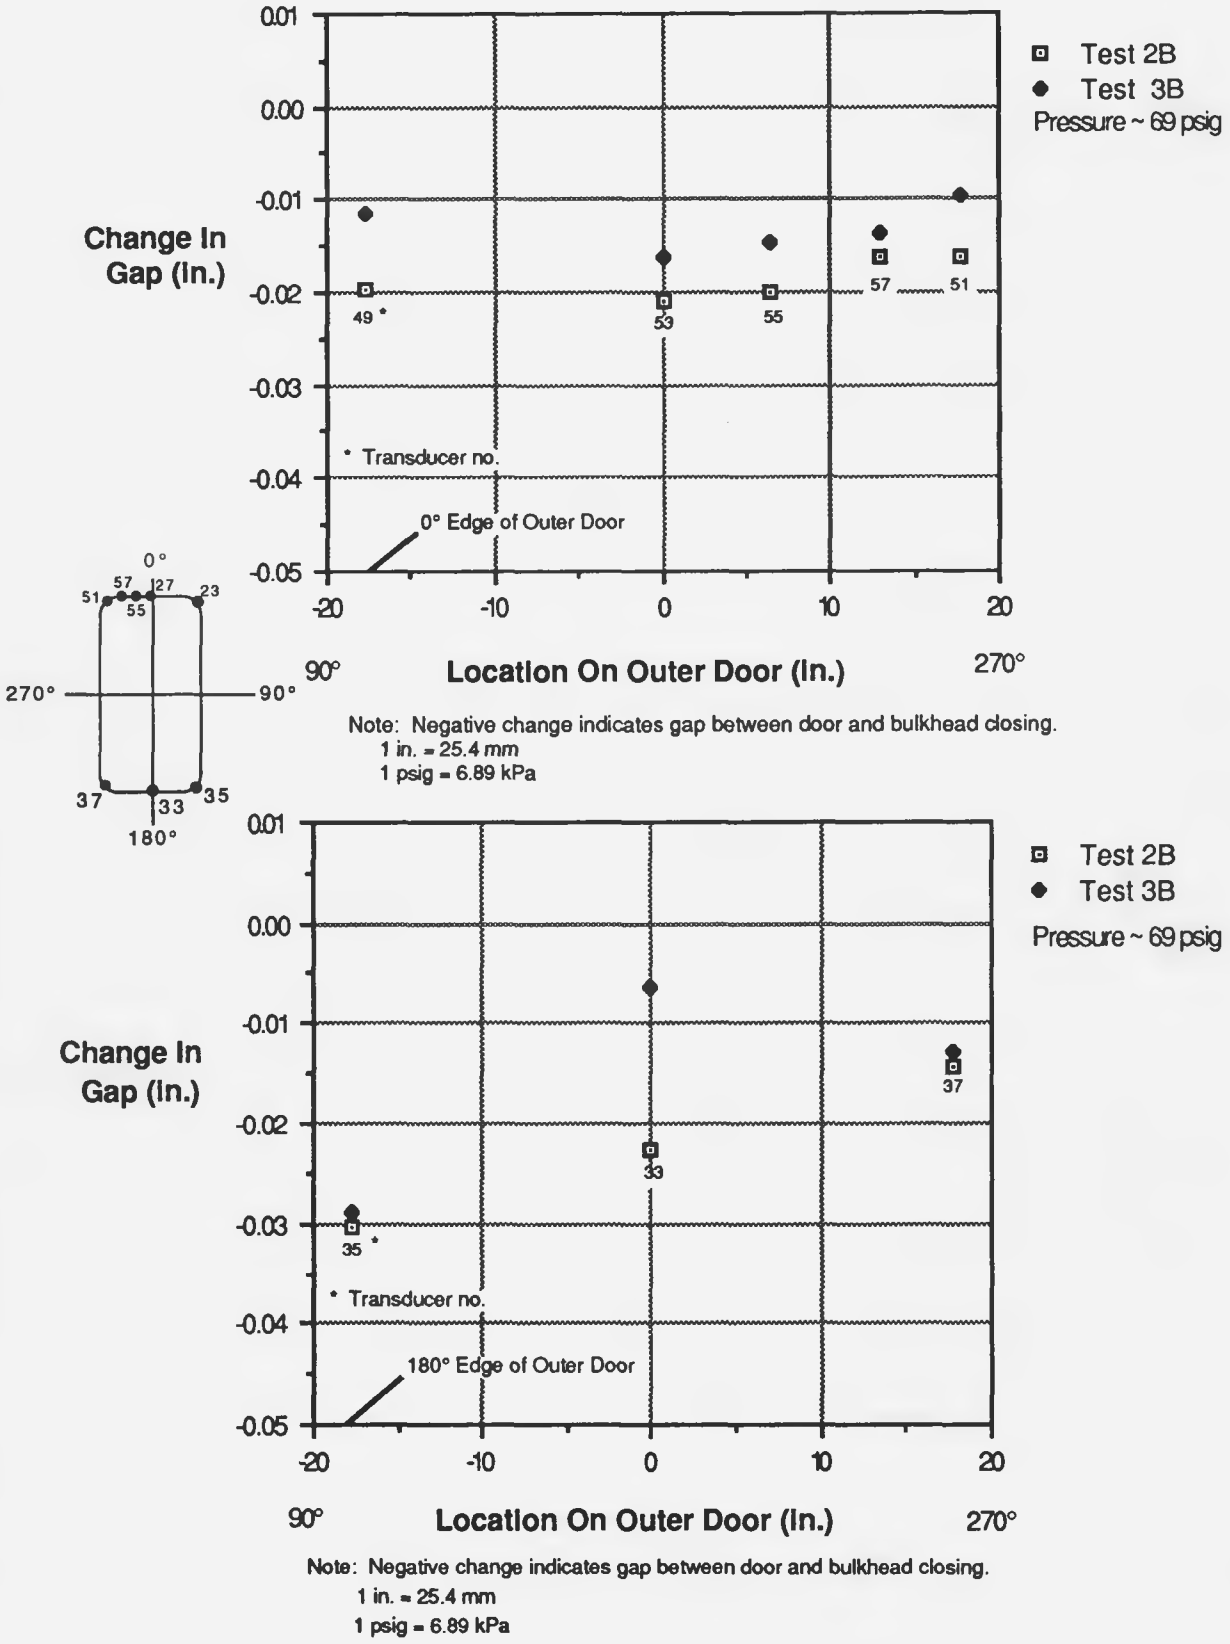
Figure 8.8 Gap Change on the Outer Door Along the 0° and 180° Edges of the Door

Change in gap for the outer door in Tests 2B and 3B are shown in Figures 8.8 and 8.9. The change in gap did not show any pattern, although the gap between the outer door and bulkhead closed more during Test 2B than in Test 3B.

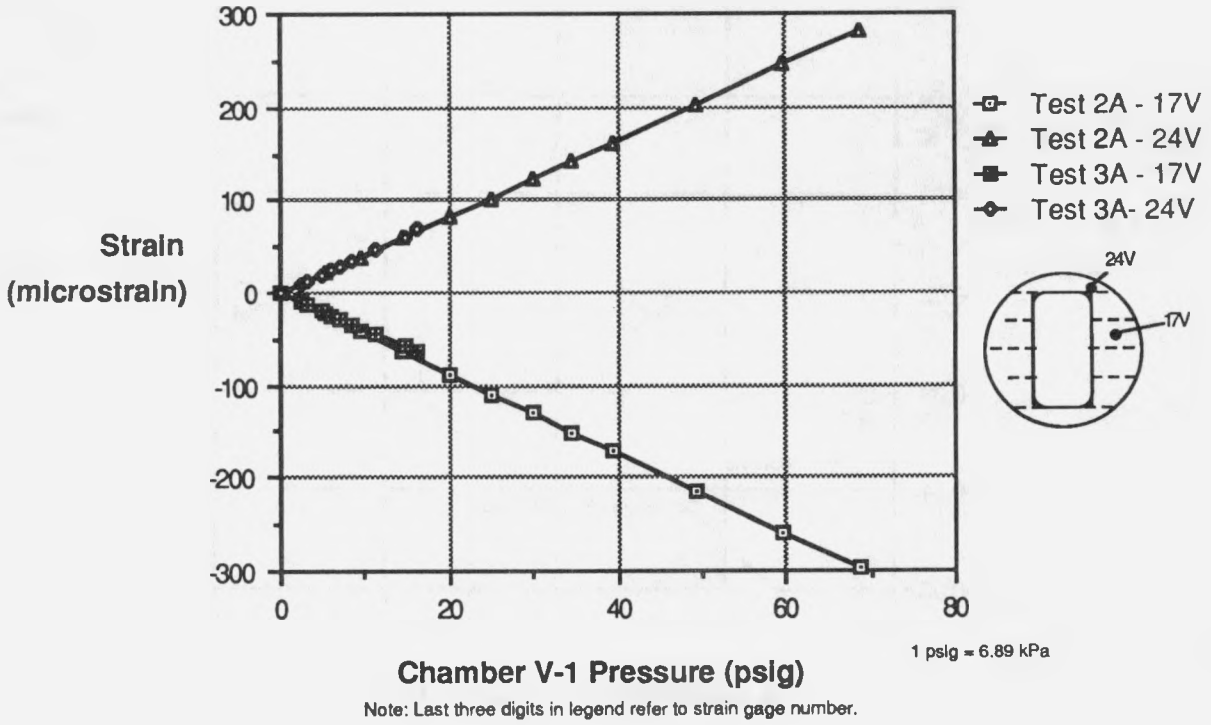
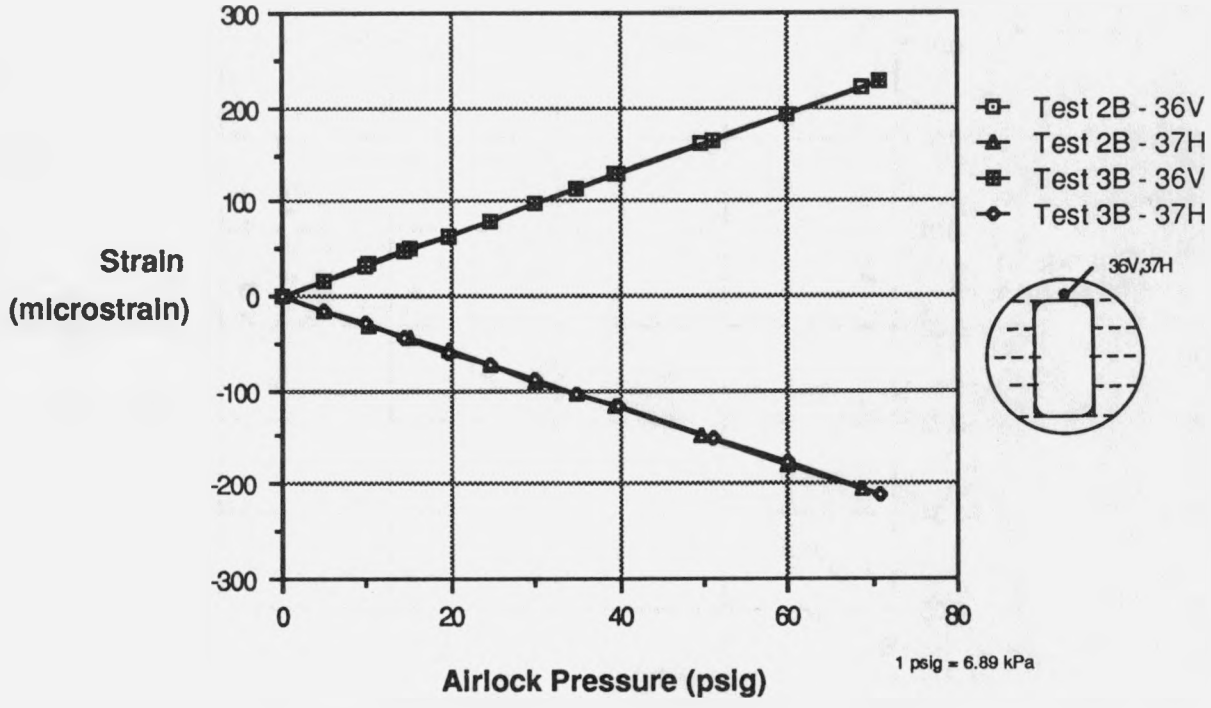
Figure 8.10 Strain versus Pressure for Measured Strains on Inner and Outer Door Bulkheads During Tests 2A, 2B, 3A, and 3B

During Tests 2A, 2B, 3A, and 3B, the strain gages indicated purely linear elastic behavior. Maximum strains were small for Test 3A as a result of the low maximum pressures. Strains were repeatable for Tests 2B and 3B, with small variations in magnitude of the resultant strains between tests. Strain gage readings at all locations did not indicate yielding during Tests 2A, 2B, 3A, and 3B. Comparison of selected strain gages before and after Test 2C are shown in Figure 8.10. These strain gages are representative of the largest tensile and compressive strains recorded during Tests 2A, 2B, 3A, and 3B.

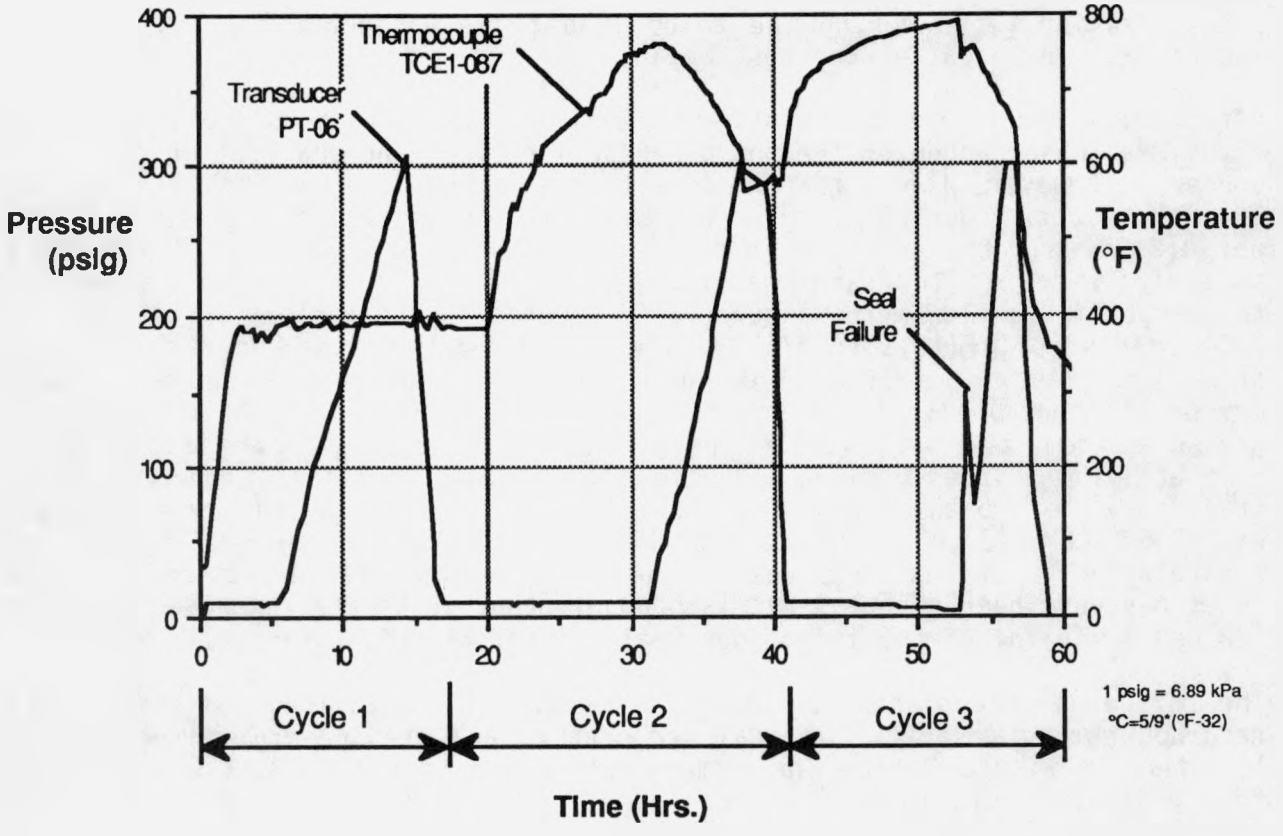
Figure 8.11 Pressure and Temperature Versus Time Relationship for Test 2C

The following is a discussion of the temperature, deflection, and strain data recorded during Test 2C. Typical temperature and pressure curve versus time is shown in Figure 8.11. The temperature shown in Figure 8.11 was recorded from a thermocouple located in Chamber V-1 18 in. (460 mm) from the cylinder wall and 19.75 in. (500 mm) above the inner door bulkhead.

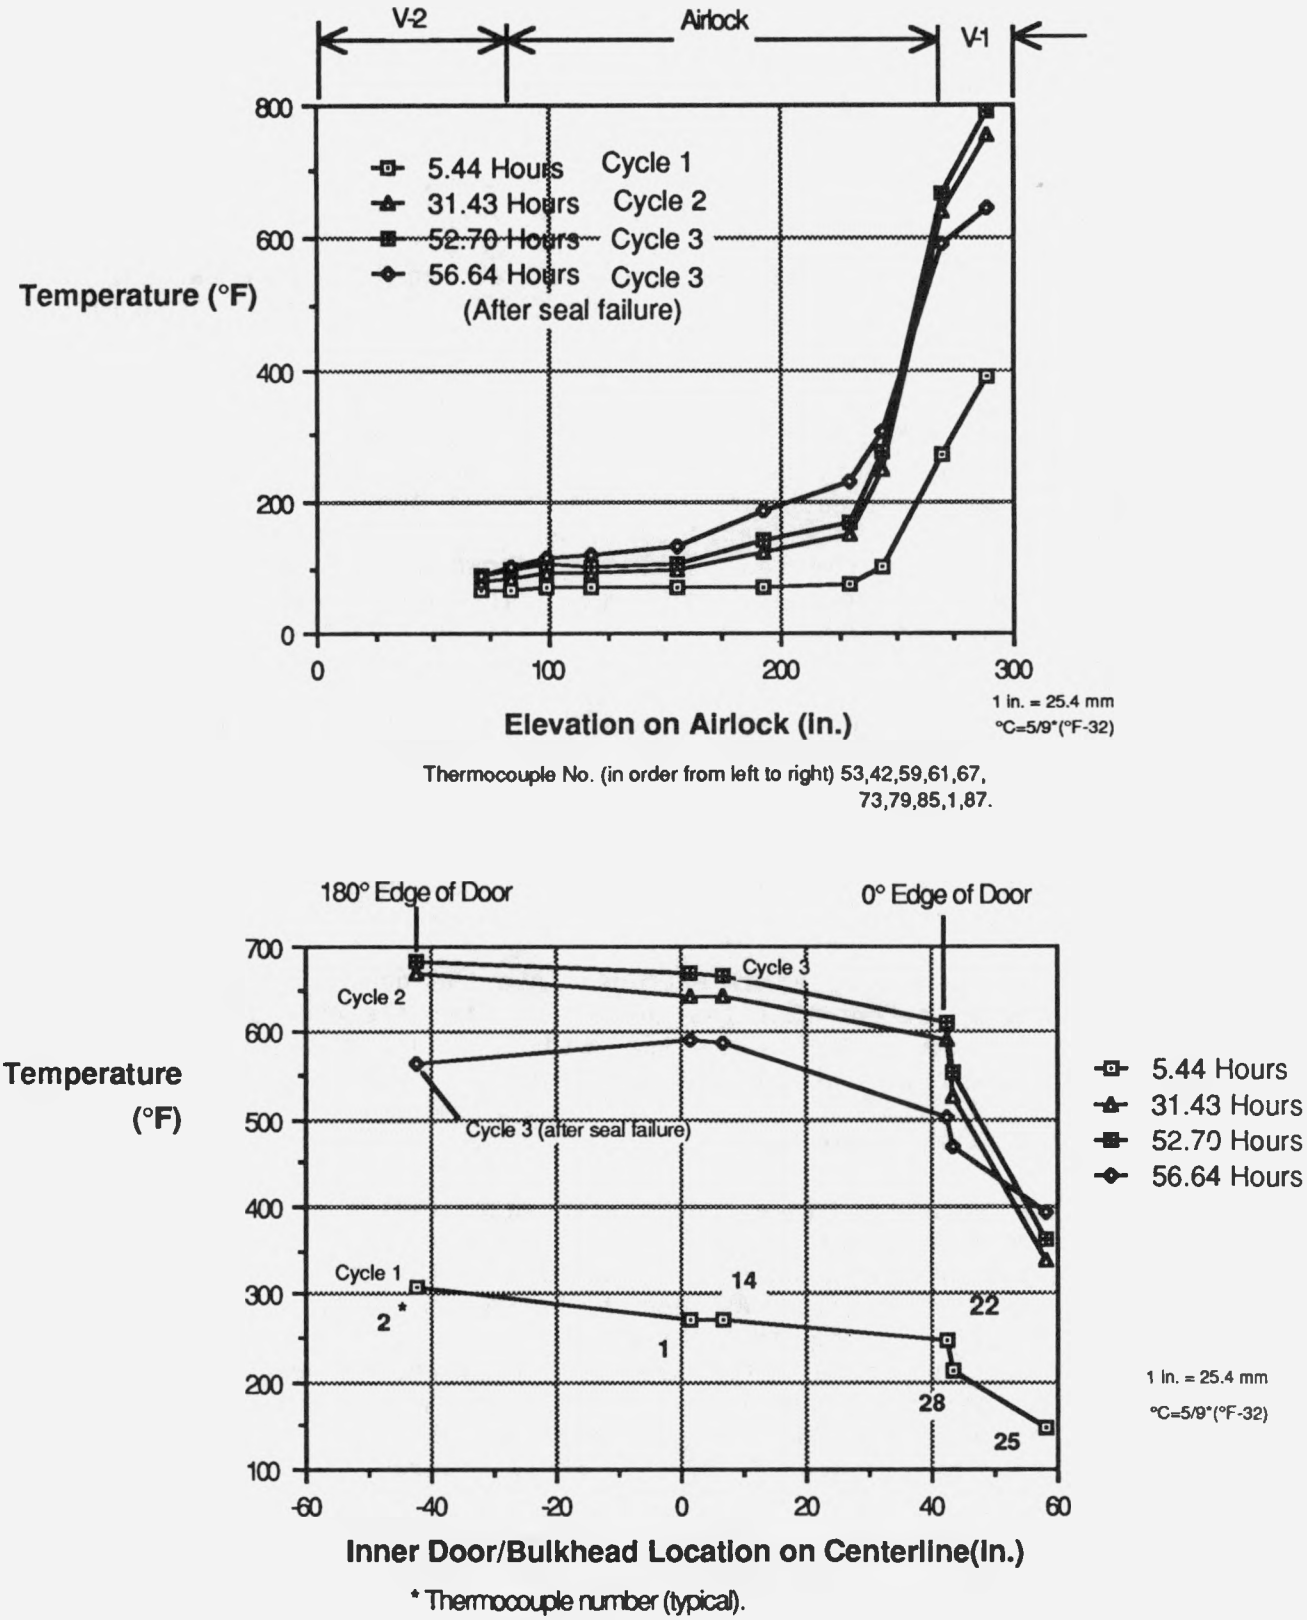
Figure 8.12 Temperature Profiles Along Length of Airlock and Across Inner Door Bulkhead

The temperature profile along the length of the airlock and across the inner door and bulkhead for several different times in the test is shown in Figure 8.12. The most significant effect that elevated temperatures had was on the inner door gasket seal. Not only did the seal fail due to exposure to temperatures at which the gasket material becomes unstable, the gasket material exhibited expansion characteristics far in excess of any anticipated.

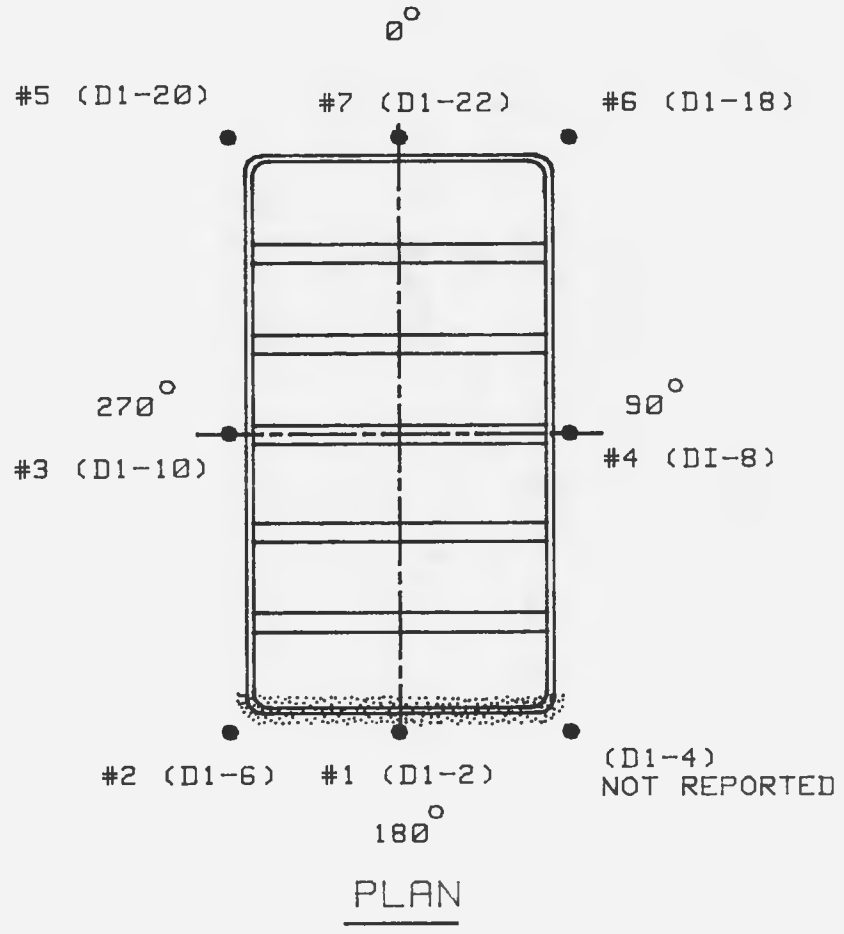
Figure 8.13 Temperature Profile Around Inner Door

In tests performed by SNL on Presray's EPDM E603 seal material, it was determined that the temperature at which the material deteriorates is approximately 620°F (327°C)[5]. As shown in Figure 8.13, the temperature profile measured on the door was fairly uniform except at 0 and 180° which had

the lowest and highest temperatures, respectively. It is clear that, prior to pressurization of the third cycle, the temperatures on the door measured in Chamber V-1 were all near the temperature at which the seal material degrades. Pressure was increased from 4.6 psig (32 kPa) to 149 psig (1.03 MPa) and the elapsed time was 34 minutes. The temperature increased at 180° orientation but decreased in every other location. The temperature increase discussed was not gradual but was represented by a spike in the temperature time relationship for the thermocouple element at the 180° orientation. The seal failed at 180° orientation and is indicated by the shaded area in Figure 8.13.

NOTE: SHADED AREA DENOTES LOCATION WHERE SEAL FAILED.

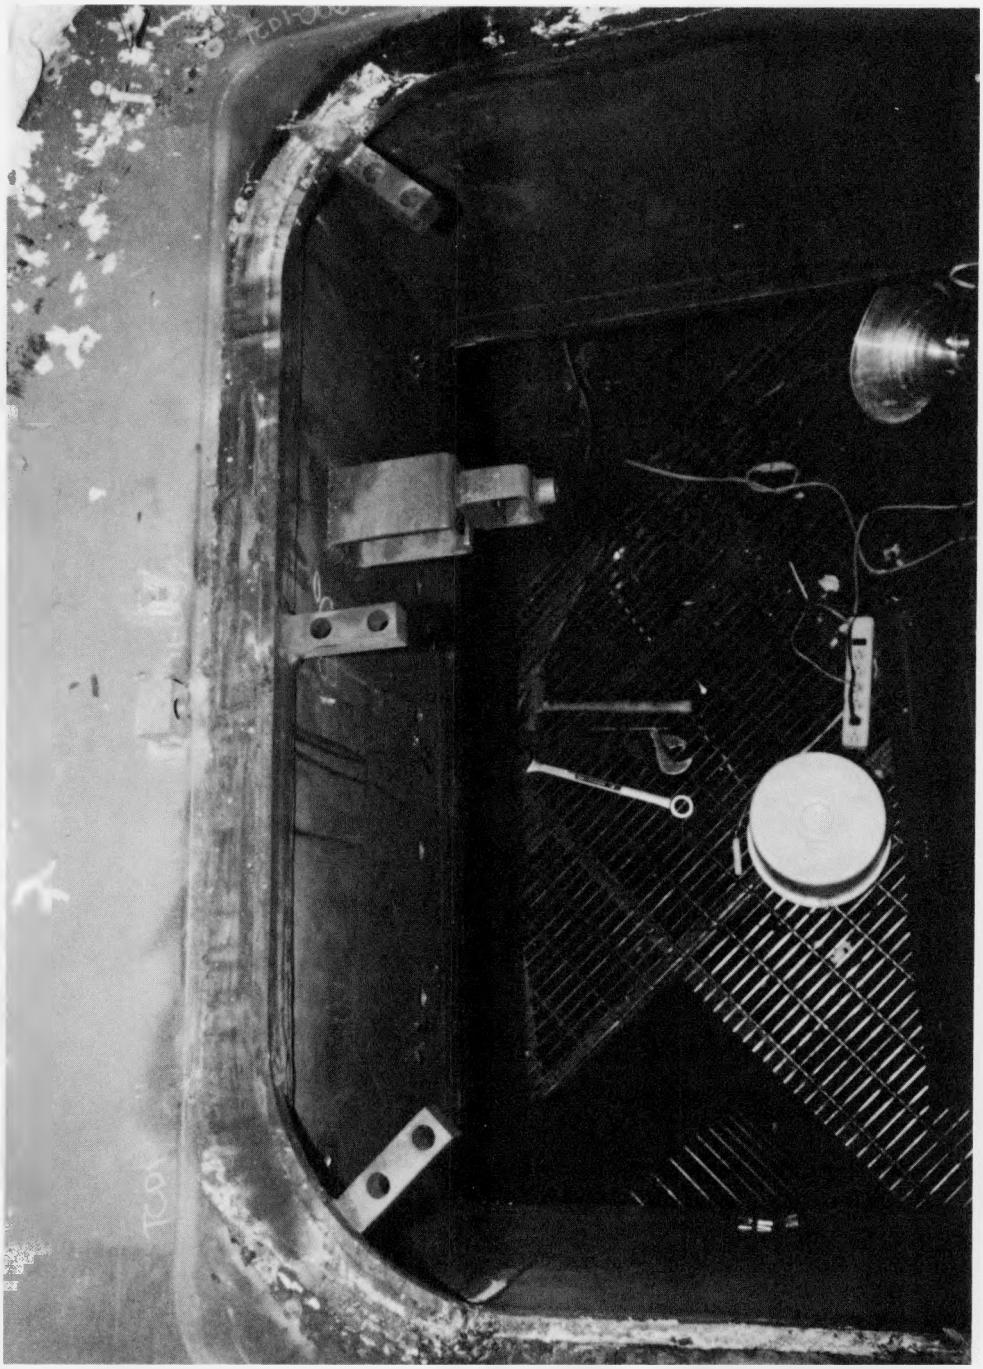
Figure 8.14 Inner Door Gasket Seal Failure Location

During the first and second loading cycles the seals remained intact and there was no measurable leakage. During the third load cycle, the inner door gasket material became unstable, and at 151 psig (1.04 MPa) the inner door seal failed. The failure occurred suddenly and the gasket eroded quickly as the hot air rushed past. Upon further examination of the data, there was evidence the inner door seal was leaking very slowly prior to full failure. During the third pressurization cycle, at a pressure of 51.0 psig (352 kPa), the pressure in the airlock (between the inner and outer doors) began to increase. Pressures in the airlock cylinder increased from 2.3 to 6.5 psig (16.1 to 44.7 kPa) while the pressure on the inner door was increased from 51 to 149 psig (352 kPa to 1.02 MPa). There was a small increase in flow rate measured past the inner door, but it was not considered to be accurate in this low range. While increasing pressure from 149 psig (1.02 MPa) to 175 psig (1.21 MPa), the seal failed completely at a pressure of 151 psig (1.04 MPa). The gasket eroded quickly in the area of the failure, creating a larger leak opening. The gasket material remaining adjacent to the eroded gasket area was either powdery or charred and brittle, indicating that the gasket may have smoldered or ignited as outgassing of combustibles occurred during the third load cycle. When the seal failed, the maximum leak rate recorded was 706 SCFM (20,000 l/min), or 102% volume/day of a 1 million ft^3 (28,300 m^3) containment building. However, since leak rate was not recorded continuously during pressurization, it is possible that the instantaneous leak rates exceeded 706 SCFM (20,000 l/min) after the inner door seal failed.

The temperature profile measured on the door was fairly uniform except along the 0 and 180° axis, which had the lowest and highest temperatures, respectively. The test temperatures measured on the door were all near the temperature at which the seal material degrades and thus these elevated test temperatures are considered the major cause of the seal failure.

(2) Degradation and subsequent failure of the gasket seal was related to temperatures in excess of the temperatures at which EPDM E603 elastomer is stable. When the gasket failed it was quickly eroded by an onrush of hot air. The gasket was reduced to a powdery consistency in the area that the seal was breached.
