NUREG/CR–5118
SAND88–7155

Leak and Structural Test of Personnel Airlock for LWR Containments Subjected to Pressures and Temperatures Beyond Design Limits

CBI Research Corporation

Sandia National Laboratories

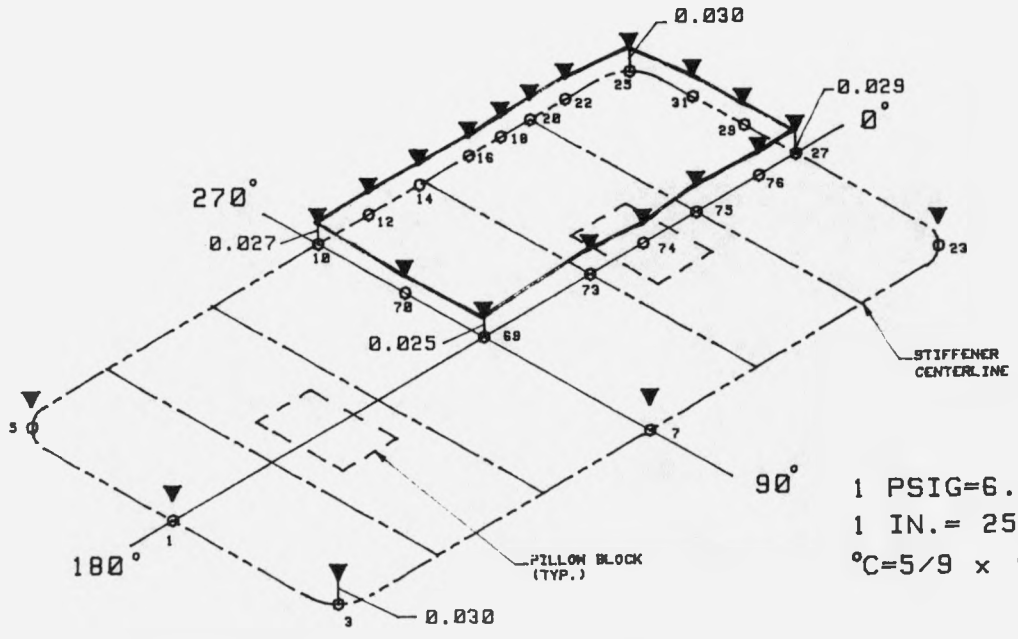
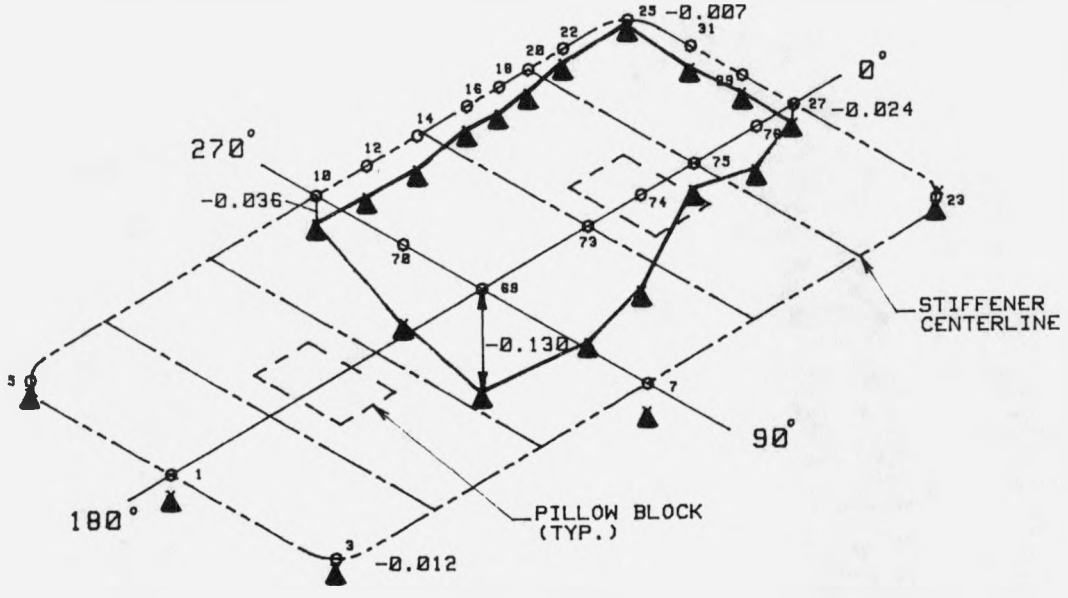
Figure 8.18 Profiles of Inner Door Displacement During the First Load Cycle

Displacements of both the inner and outer door relative to the bulkhead stiffener were measured during the test. Figures 8.18 through 8.20 are isometric views of the door showing displacement of the inner door relative to the original zero position. As can be seen in these glimpses of the displacement geometry during the three test cycles, there are two major driving forces causing these displacements: elevated temperatures and high surface pressure on the inner door. The load cycle, time, pressure and average temperature around the door perimeter are documented. Displacements have been magnified by a factor of 100 for these figures.

These glimpses of the inner door profile provide some insight into the structural interaction of the door, the latching mechanism, the effect of high surface pressures on the inner door, and the expanding gasket. To fully separate the effect of the driving forces of elevated temperatures and high surface pressures on the inner door, selected displacement transducers around the perimeter of the door were compared with the surface temperature of the door, which are shown in Figures 8.21 and 8.22. As can be seen in these figures, the most dramatic effect of increasing temperature on the gasket seal occurred during the second load cycle. As shown in Figure 8.21, the increase in gap between the door and bulkhead reached an upper limit of 0.130 in (3.3 mm), and then suddenly dropped off in magnitude. Displacement transducers for Figure 8.22 show no sudden drop off during heating. It can be surmised that, with the apparent sudden loss of structural stability of the gasket and a closing of the gap, the gasket material had reached the point at which the material became unstable. Although the gasket material may have initiated a phase change, there was no measurable loss of the seal across the pressure boundary. Both transducers along the 180° edge show this phenomena. Based on earlier discussions, the gasket seal failed along the 180° edge of the door, which is consistent with the drop off in load carrying capability shown in Figure 8.21.

The increase in gap indicated for the first load cycle is continued in the second load cycle. The offset is due to compression caused by high pressures exerted on the door. The gap increase during the third load cycle was negligible in comparison. At this point, the entire gasket had been exposed to temperatures beyond the original design and sufficient volume of the gasket reached material instability.

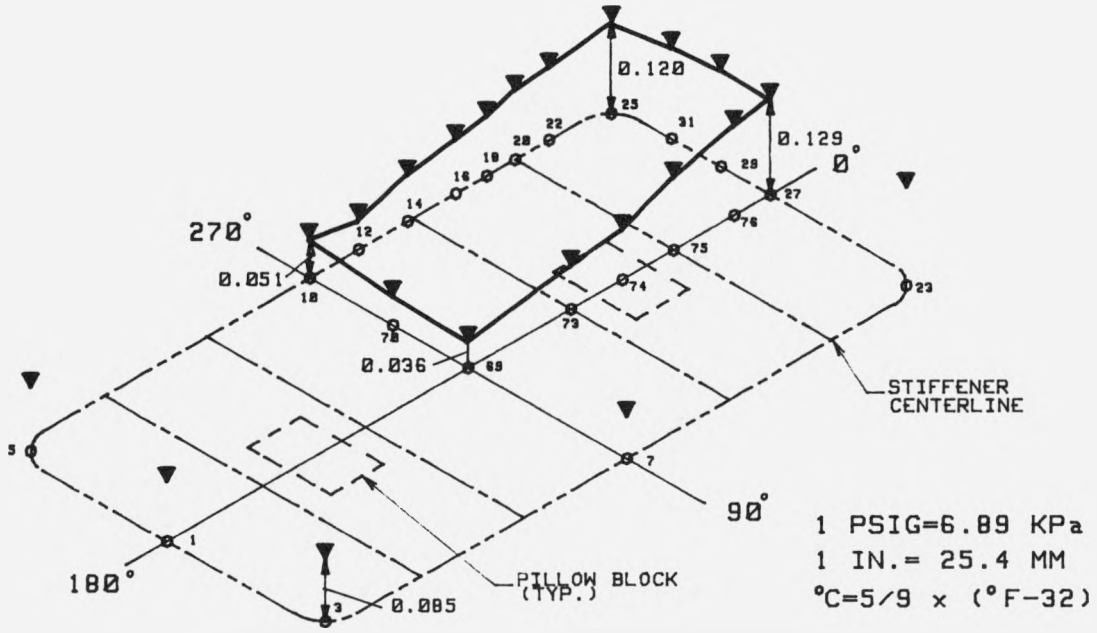
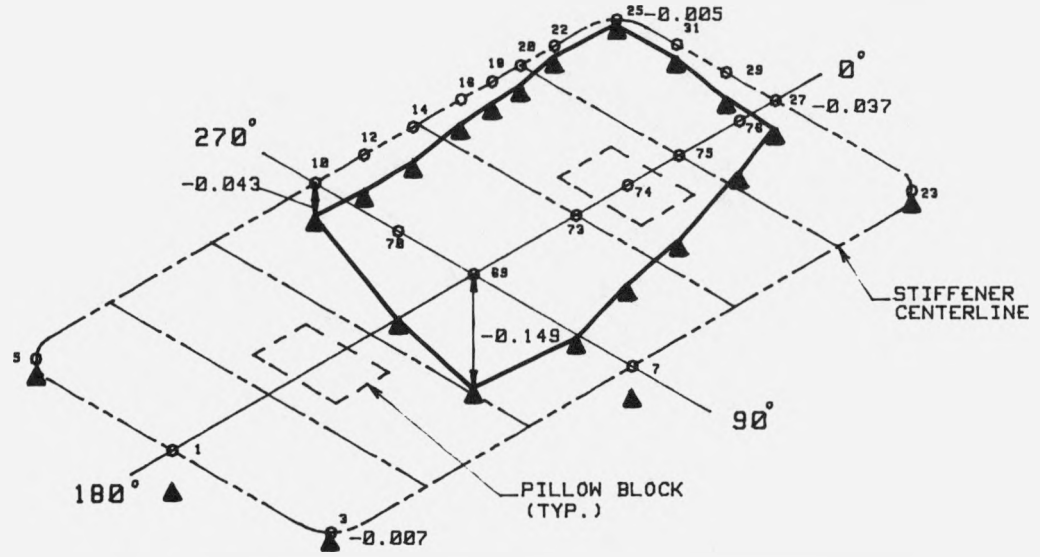
Figure 8.19 Profiles of Inner Door Displacement During the Second Load Cycle

As shown in Figure 8.19, during the second load cycle at 31.43 hours after the test began and prior to pressurization, the inner door had moved away from the bulkhead, opening the gap between the inner door and bulkhead. The center of the door moved 0.036 in. (0.91 mm) away from the bulkhead. Displacements that

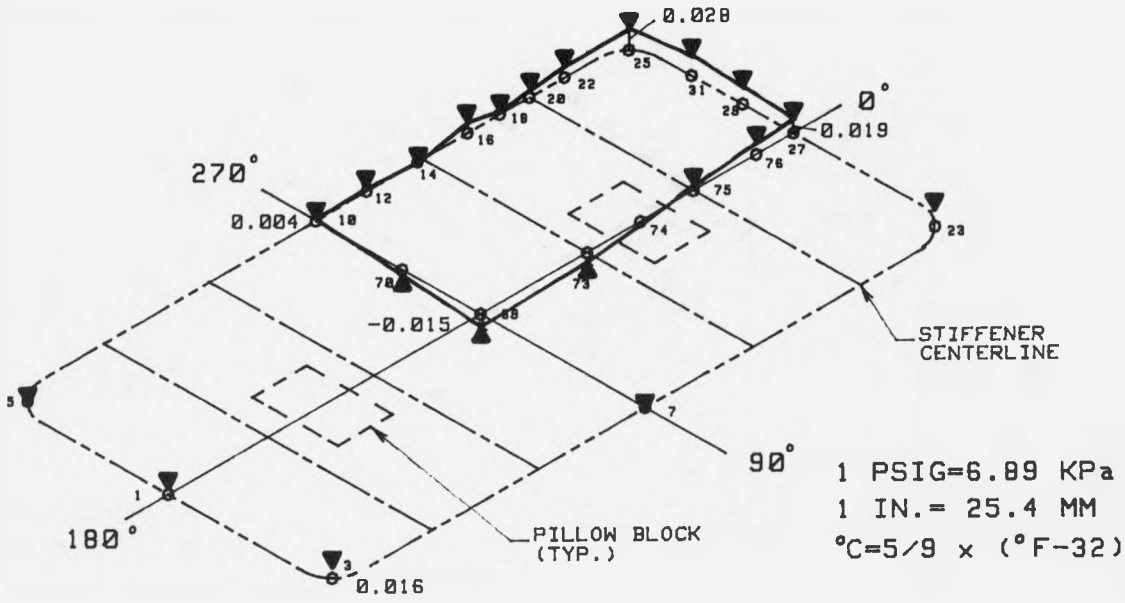
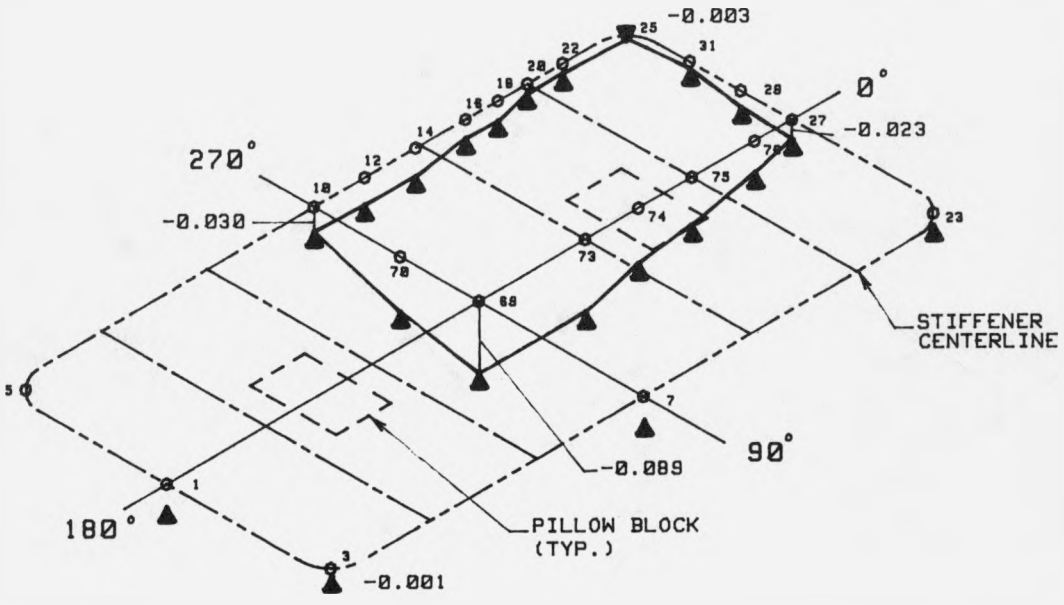
Figure 8.20 Profiles of Inner Door Displacement During the Third Load Cycle

The effect of pressure on the gap between the door is shown in Figures 8.23, 8.24, and 8.25. As can be seen in Figures 8.18, 8.19, and 8.20, profiles of the deformed inner door indicate classical plate bending due to high pressure exposures. Figure 8.25 shows the deflection of the center of the inner door at transducer location TOD2-069. The center of the door showed maximum deflection while exposed to the high pressures. From the beginning of the pressurization cycle until 300 psig (2.07 MPa) was reached during the second load cycle, the center of the inner door moved from 0.036 in (0.91 mm) to -0.149 in (3.8 mm), yielding a total movement of 0.185 in (4.7 mm). This deflection of the inner door was in part due to compression of the gasket seal, and part due to flexural deformations of the door.

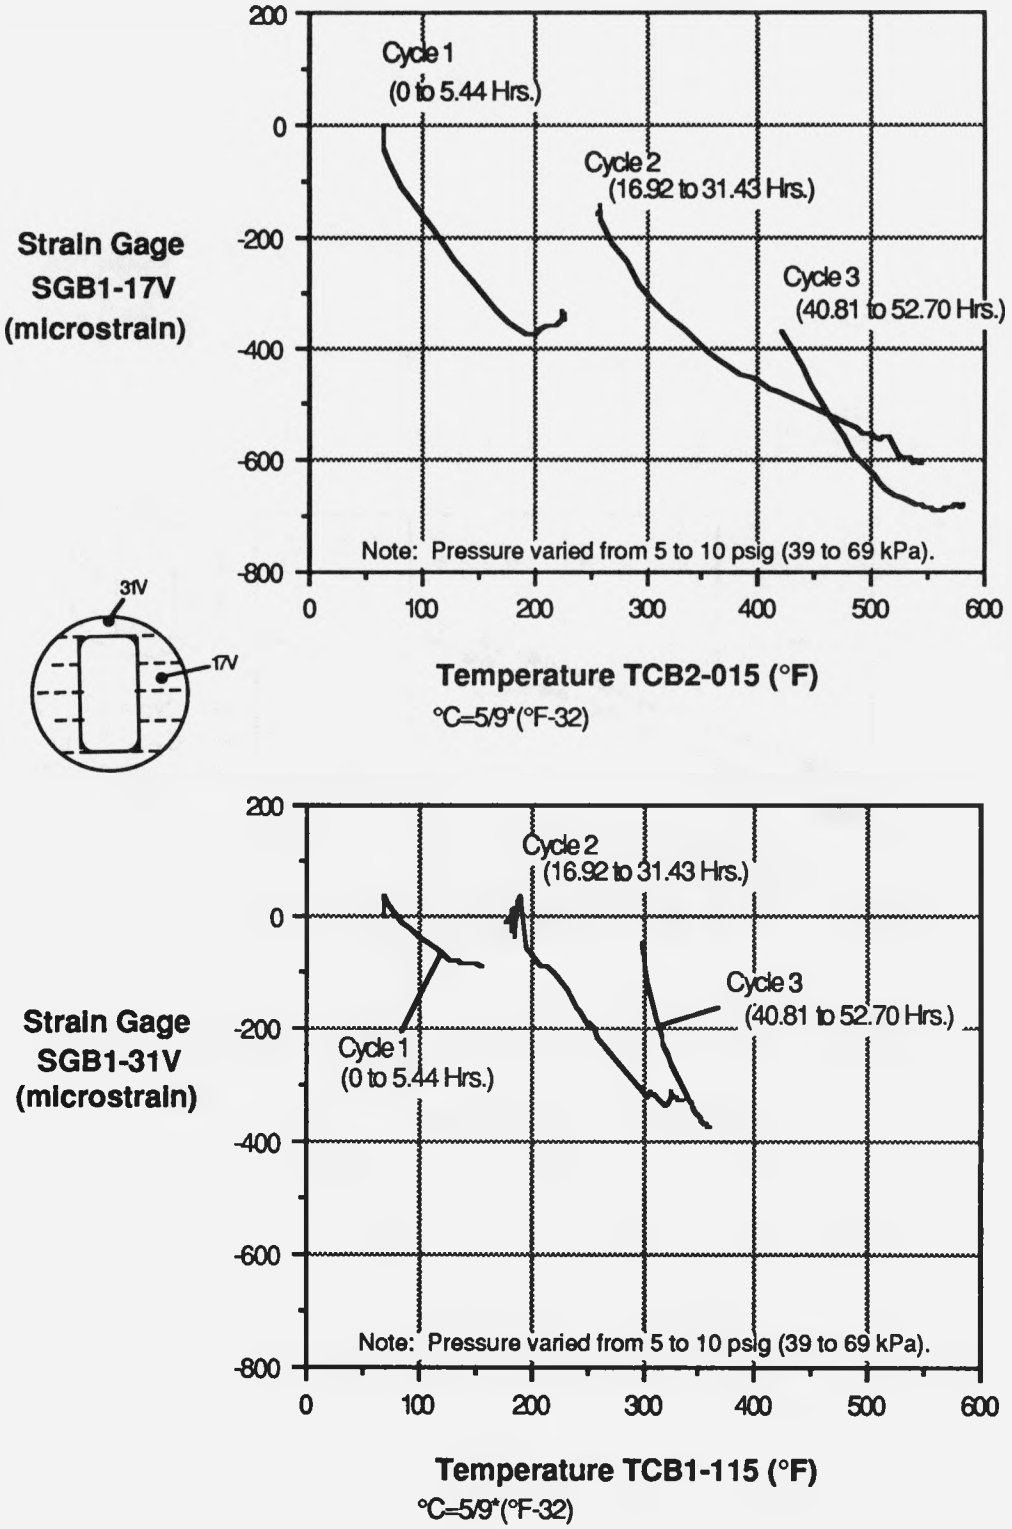
Figure 8.26 Strain versus Temperature for Measured Strains on Inner Door Bulkhead During Test 2C

Measured strains had two components which contributed to the resultant recorded strains. The first component resulted from temperature differential in the airlock and resultant internal restraints. Two strain gages, SGB1-31V and SGB1-17V are plotted against their respective thermocouple temperature output used for temperature compensation, as shown in Figure 8.26. Each curve is representative of the time period in each load cycle prior to pressurization. Duration of heating period is shown in each figure. The magnitude of these strains due to differential temperatures was dependent on temperature and restraint conditions. If the airlock was allowed to achieve uniform temperatures throughout the airlock, the strains due to internal restraint would go to zero. Maximum offset due to thermally induced strains for strain gage SGB1-17V was -681 microstrain near the end of the third cycle. Maximum offset due to thermally induced strains for strain gage SGB1-31V was -375 microstrain at the end of the third cycle, as shown in Figure 8.26.

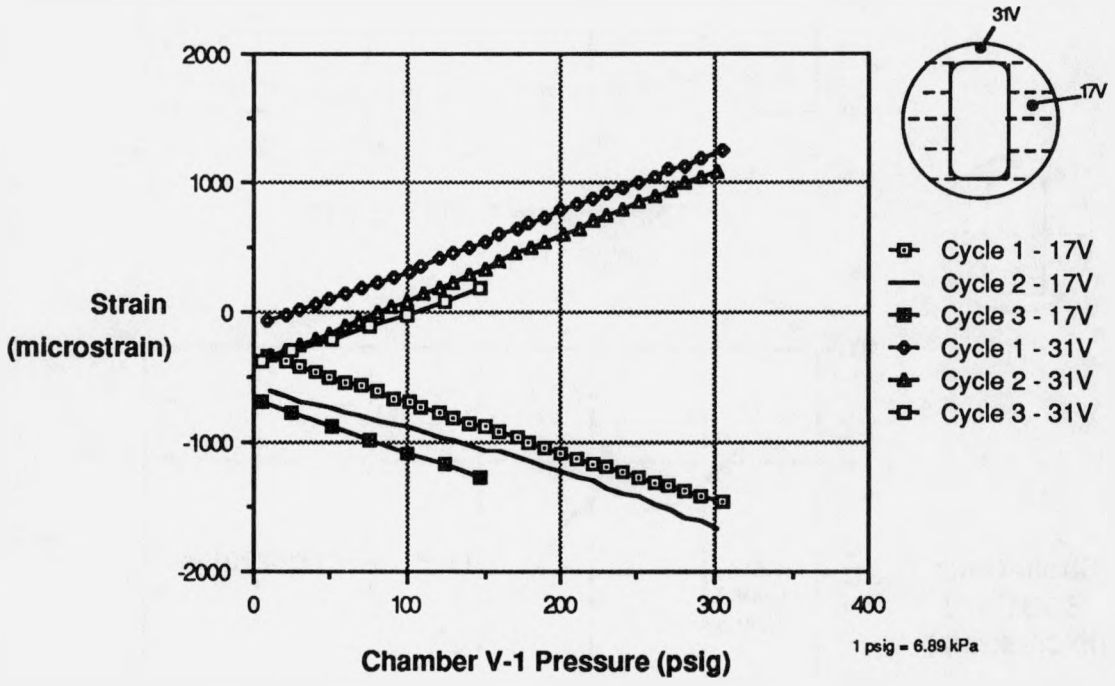
Figure 8.27 Strain versus Pressure for Measured Strains on Inner Door Bulkhead During Test 2C

The second component that contributed to the resultant strain recorded strains was due to pressurization of Chamber V-1 and the airlock. The results of strain plotted against pressure is shown in Figure 8.27. Two items are immediately apparent:

(2) The strain gage output shows an offset, i.e., they do not start at zero strain.

Although the slope is virtually the same, the curves do not fall right on top of each other for the same strain gage. The offset is a result of the thermally induced strains and internal restraint. Maximum compressive strain recorded was -1659 microstrain, which is very close to the yield point, and the maximum tensile strain recorded was 1242 microstrain.
