RAFT RIVER WELL STIMULATION EXPERIMENTS

Geothermal Reservoir Well Stimulation Program

August 1980

Republic Geothermal, Inc.
Santa Fe Springs, California

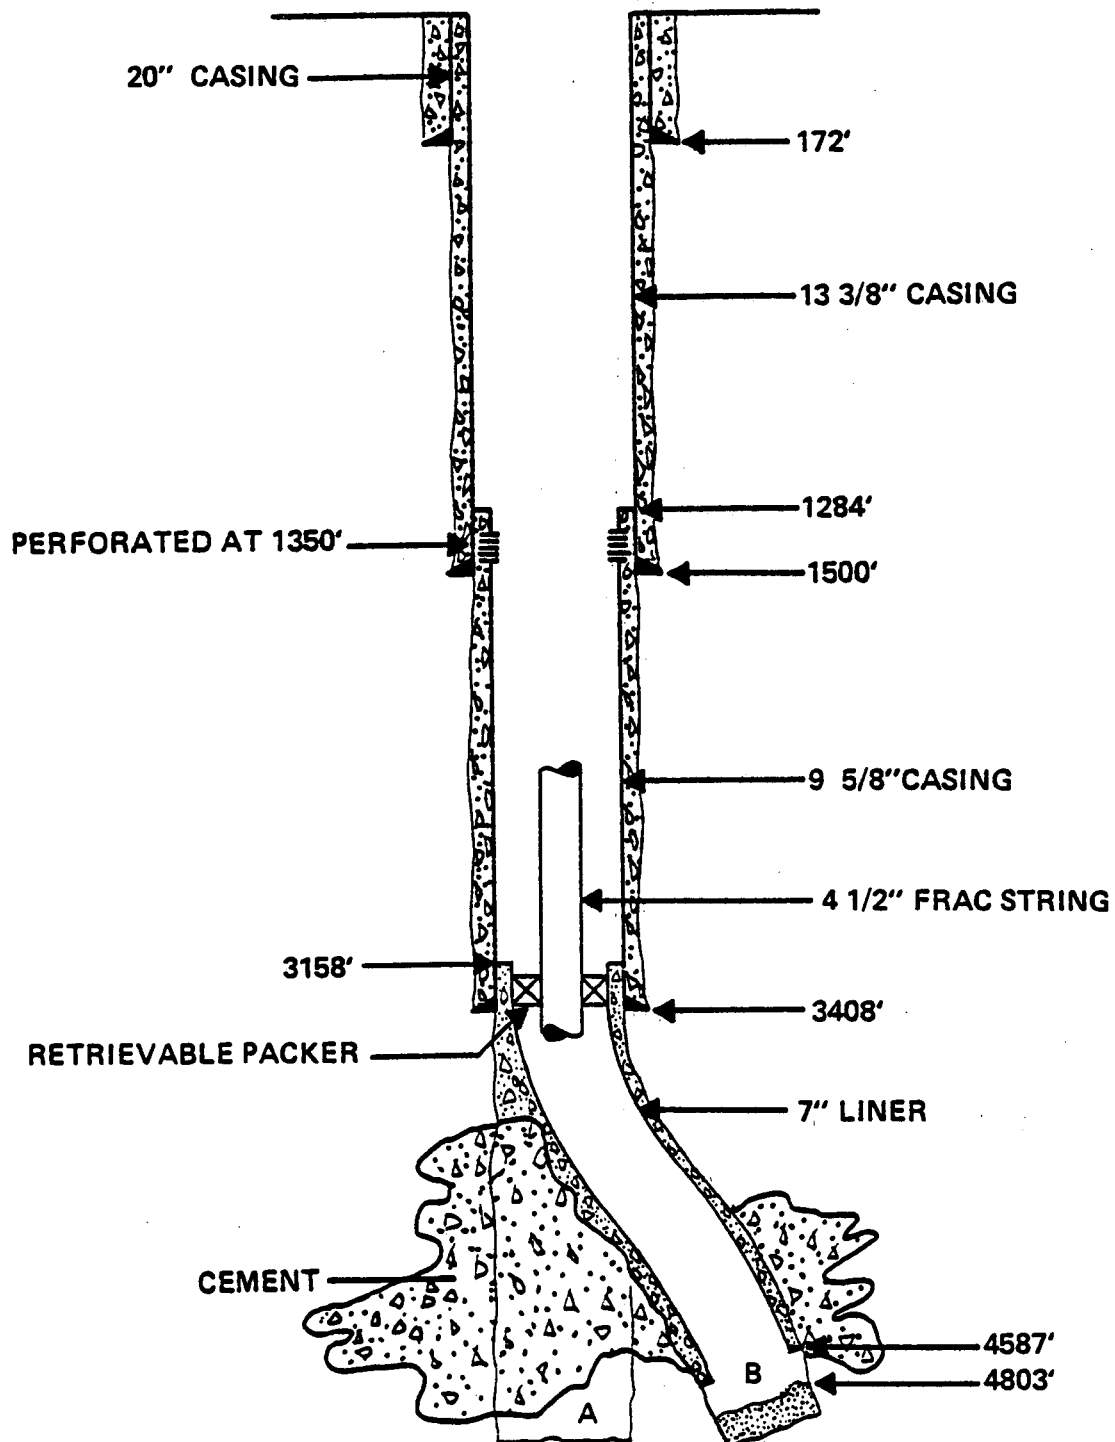
FIGURE 10

Figure 10 is a diagram of the well with the frac string in place. As in the case of RRGP-4, a 7" liner was installed to exclude all but the lower portion of the original completion interval. The interval below the liner, from 4,587 feet to 4,803 feet, was open at the time of the fracture treatment. A 4-1/2" frac string with a packer in the 7" liner was also used for this job. The surface equipment layout for this job was very similar to that for RRGP-4. B-J Hughes provided all surface fracturing equipment and all treatment materials except for the resin-coated proppant sand. The selection of B-J Hughes was based on competitive bid. Because of the large volume of the treatment, the frac fluid was mixed and pumped in a continuous process. A Model 608 120-bbl/min blender located at the pit added polymer, a small quantity of acid, and ammonium nitrate as a chemical tracer. The fluid was then pumped through a 10" steel line to four 500 bbl frac tanks which provided gelation time for the polymers. A Model 611 120-bbl/min blender fed by a Sand King drew frac fluid from the tanks and pumped to the frac units. The Sand King is a four-compartment field storage unit which stores up to 475,000 lb of proppant sand. It incorporates a conveyor belt delivery system to the blender. These units are especially useful where large volumes of sand and high delivery rates
