NUREG/CR–5117
PNL–6446

Steam Generator Tube Integrity Program/Steam Generator Group Project

Final Project Summary Report

Pacific Northwest Laboratory
Operated by
Battelle Memorial Institute

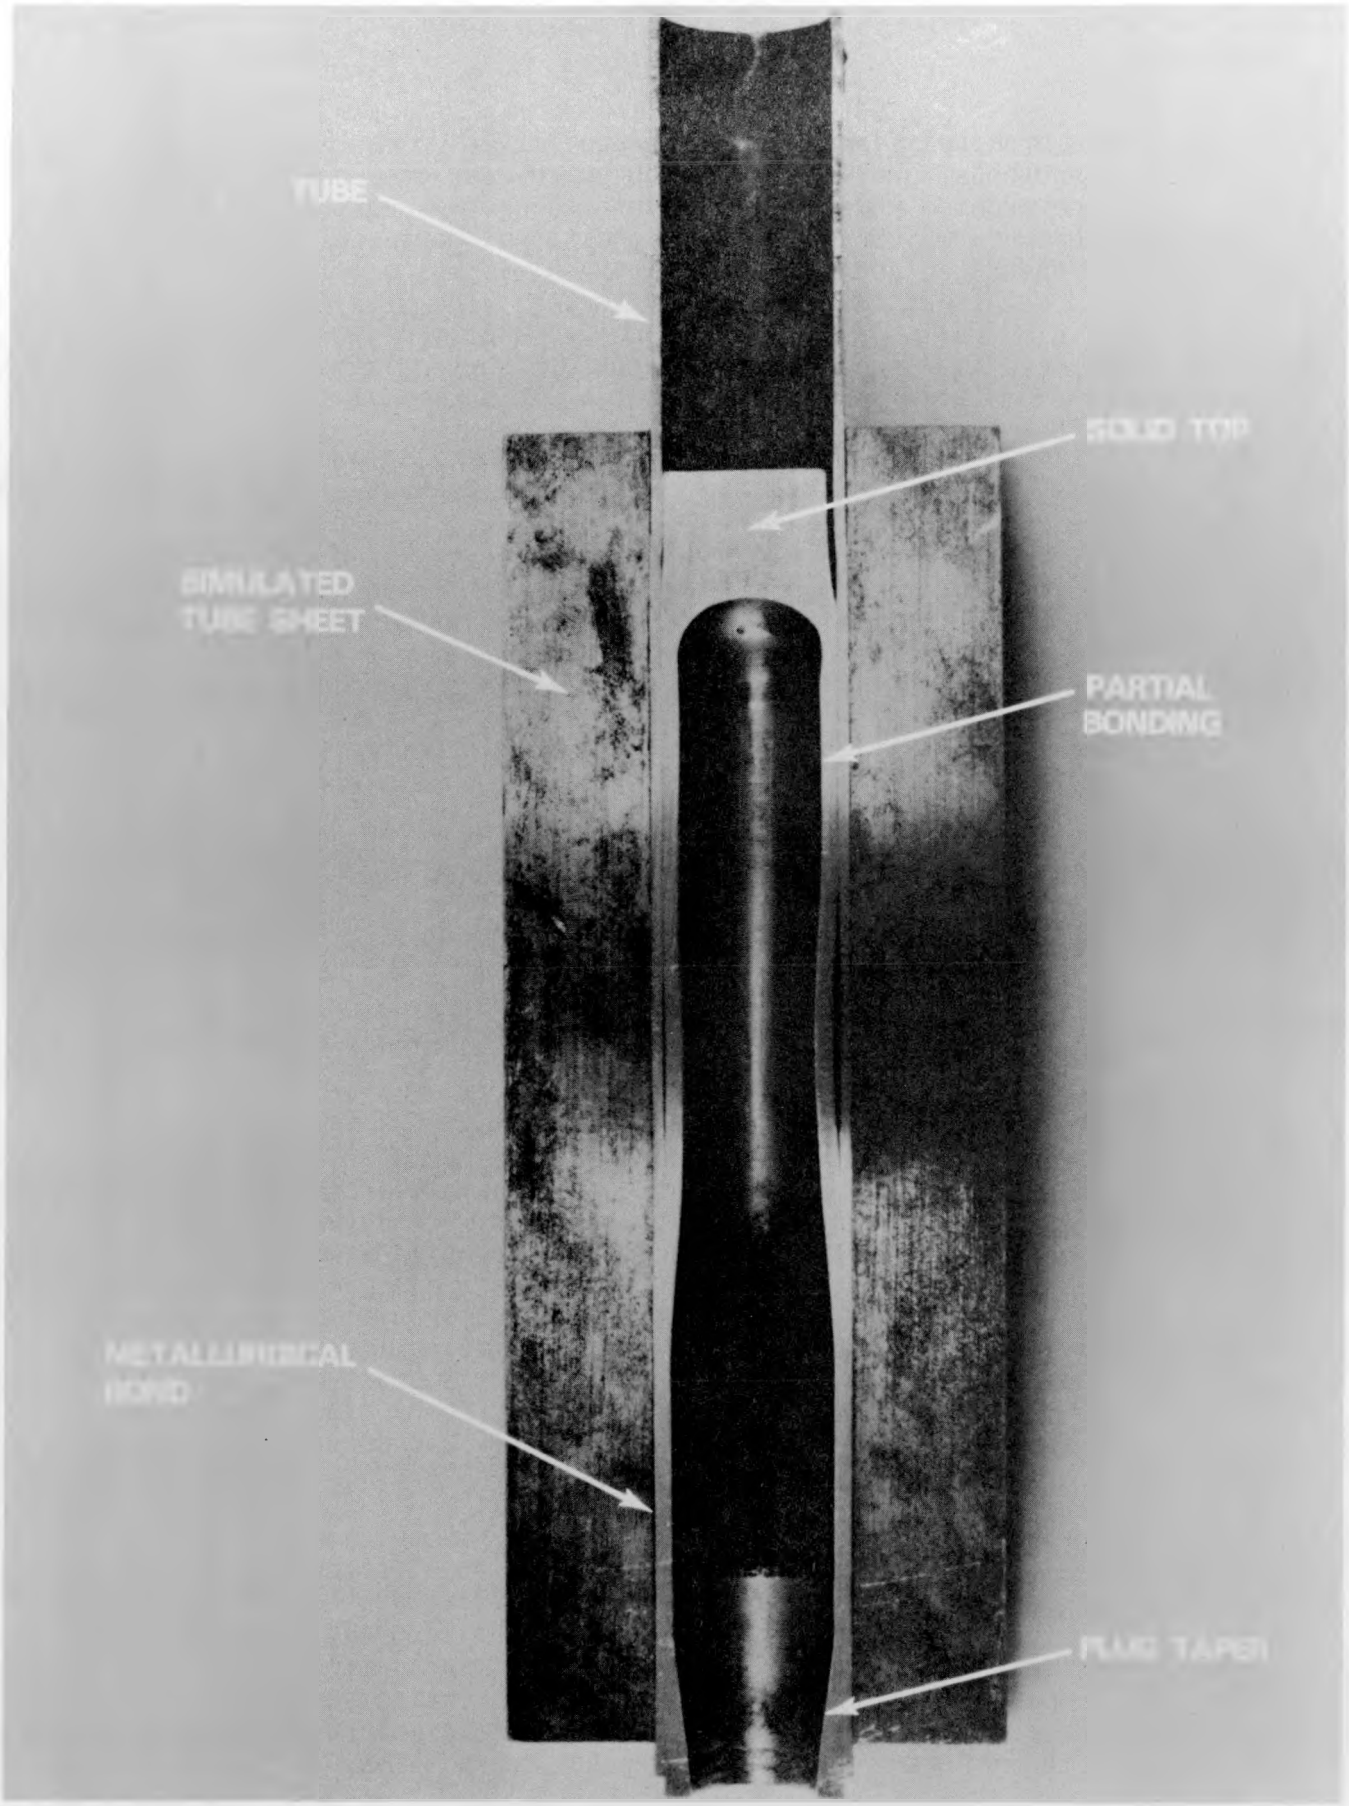
FIGURE 3.8. Sectioned Explosive Plug in Simulated Tube Sheet

Removal of the plugs shown in Figure 3.8 involved a three step process. First, a small hole was drilled through the solid end of the plug. This hole released any trapped fluid above the plug and provided a gripping orifice for later stub removal. Next, the plug body was drilled out using a drill bit that matched the tubing inner diameter. Drilling proceeded until the solid top became free-moving. Finally, a special tool was inserted through the now loose plug end, and the end removed. The majority of removals utilized equipment diagrammed in Figure 3.10. The plug to be removed was indexed by a fixture attached to the tube sheet. To this fixture was attached a reversible air-powered drill motor with an electric feed. Channel-head workers, "jumpers," would attach the drilling equipment and change bits as needed. The trained drill operators used the equipment from a remote location with visual and audio inputs from the drilling operation. Using this technique along with two simultaneously operating drills, one on either side of the channel-head, plug removals in excess of 50 per day were routinely accomplished.

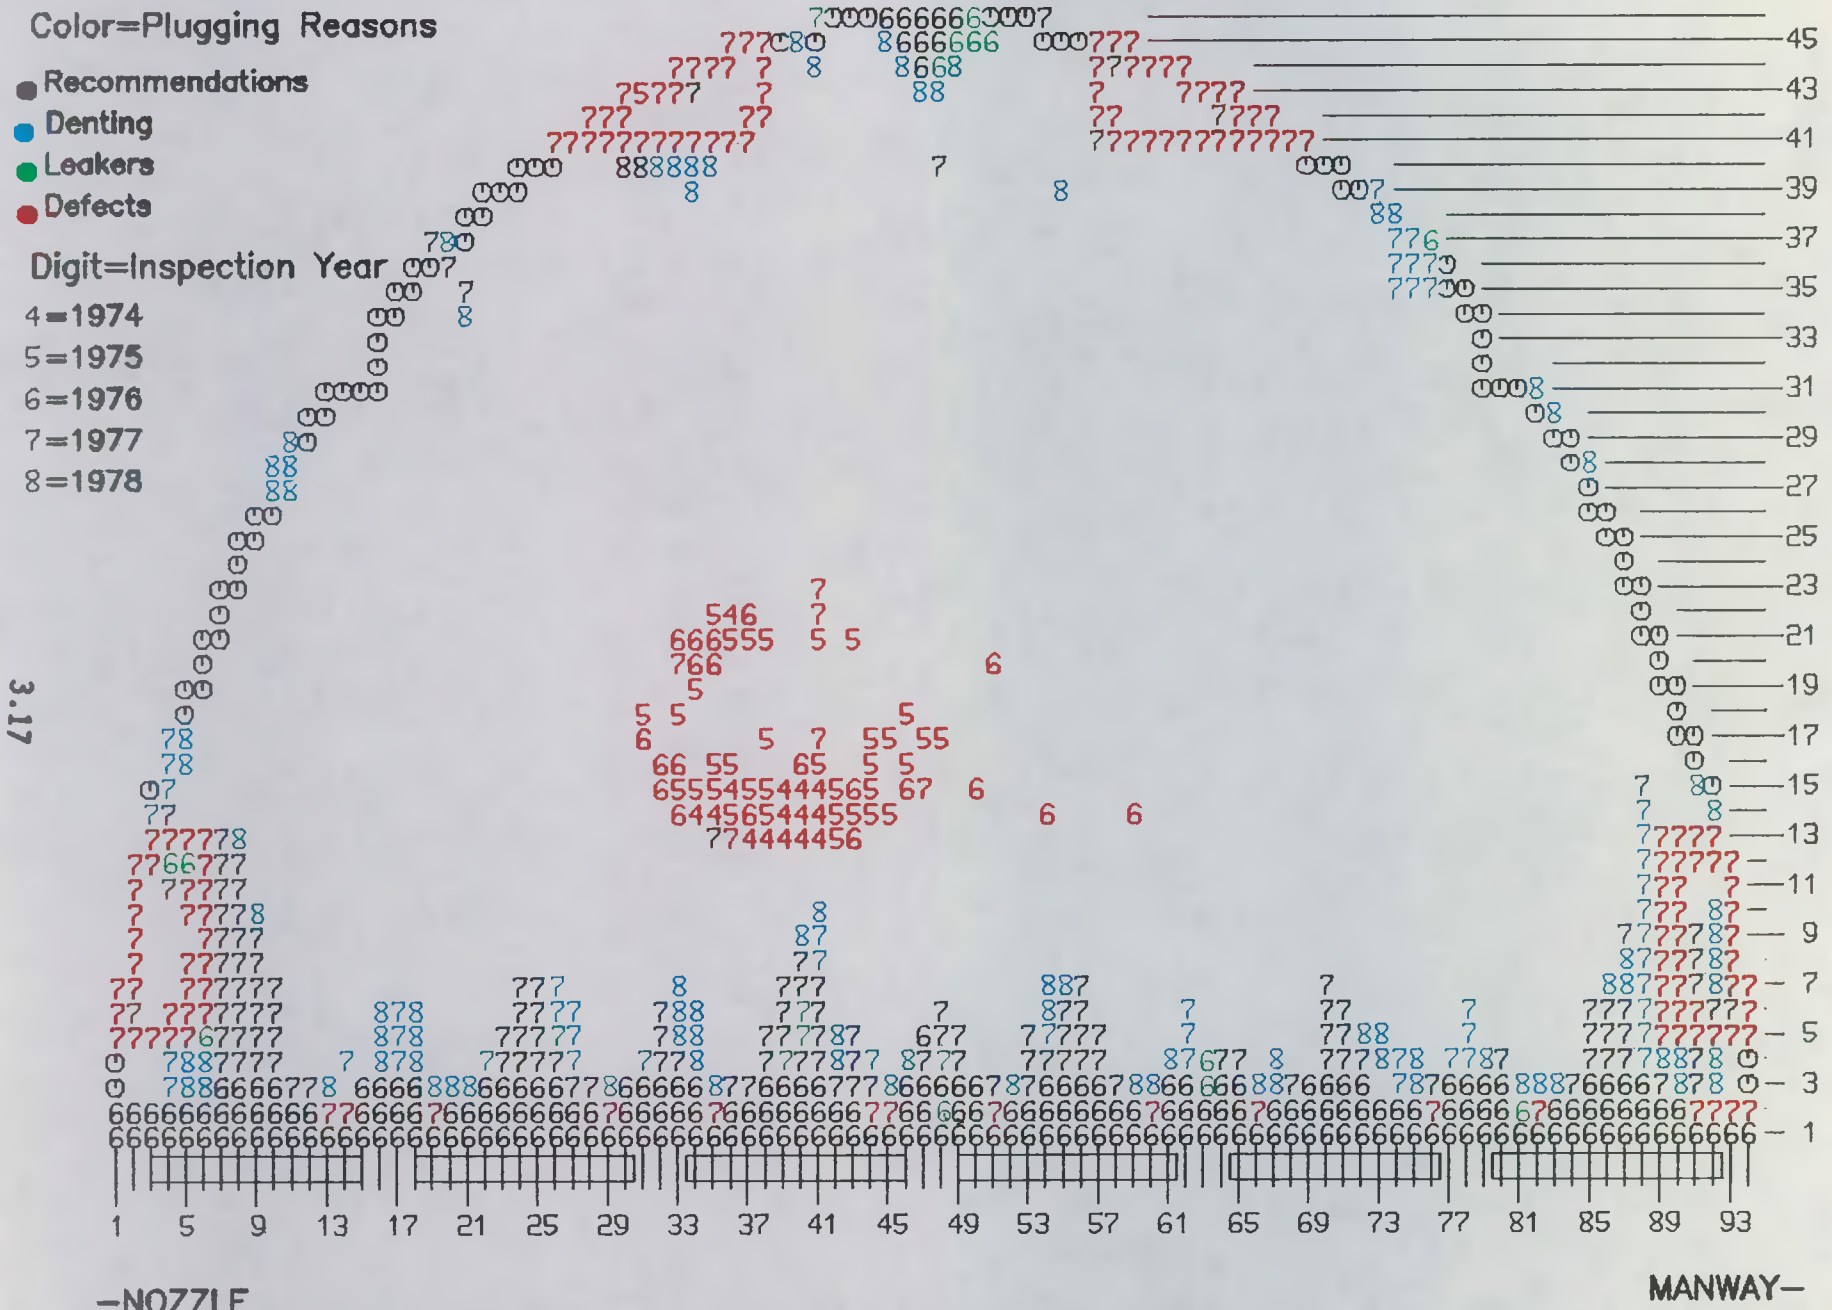
FIGURE 3.9. Surry 2A Steam Generator Tube-Plugging Map as of 8/8/78

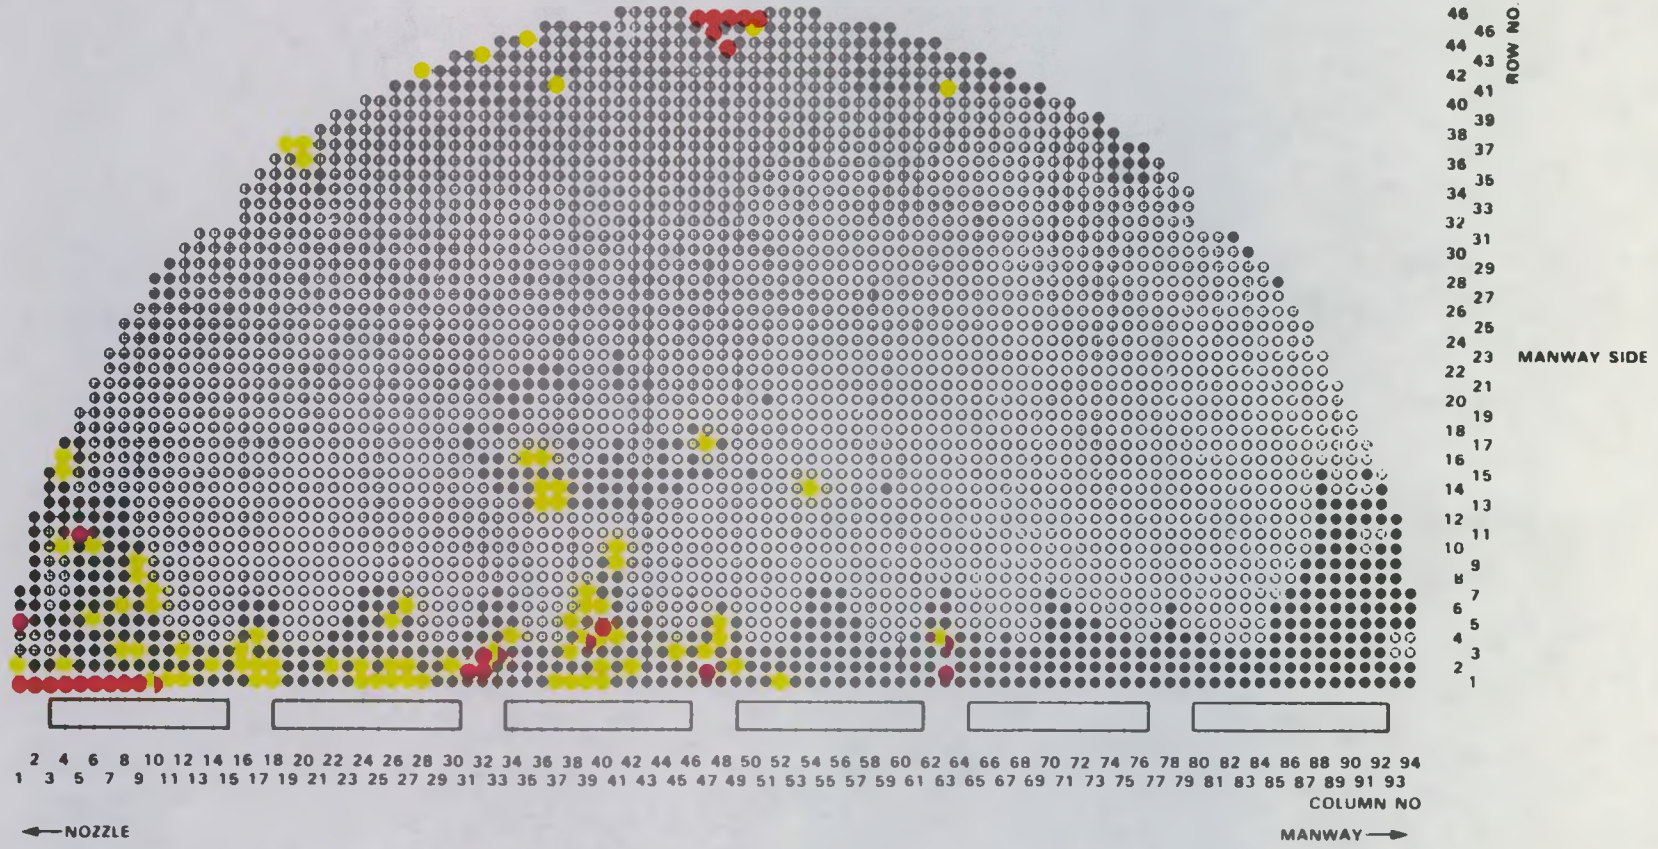
Several tubes which had been preventively plugged, and other tubes which were not leakers at the time of plugging, i.e., had no through-wall defect, were found to contain water and/or sludge deposits. Figure 3.11 shows the distribution of the water and sludge found while unplugging tubes. Water samples were obtained from 71 of the 102 plugs visually observed to leak during unplugging. Analysis of these samples indicated that most of them contained water typical of secondary-side chemistry, while a few indicated primary water. Water origin was identified mainly through high lithium and boron levels for primary water, and high copper, sodium and phosphorus for secondary water.

FIGURE 3.11. Location of Water and Sludge Samples

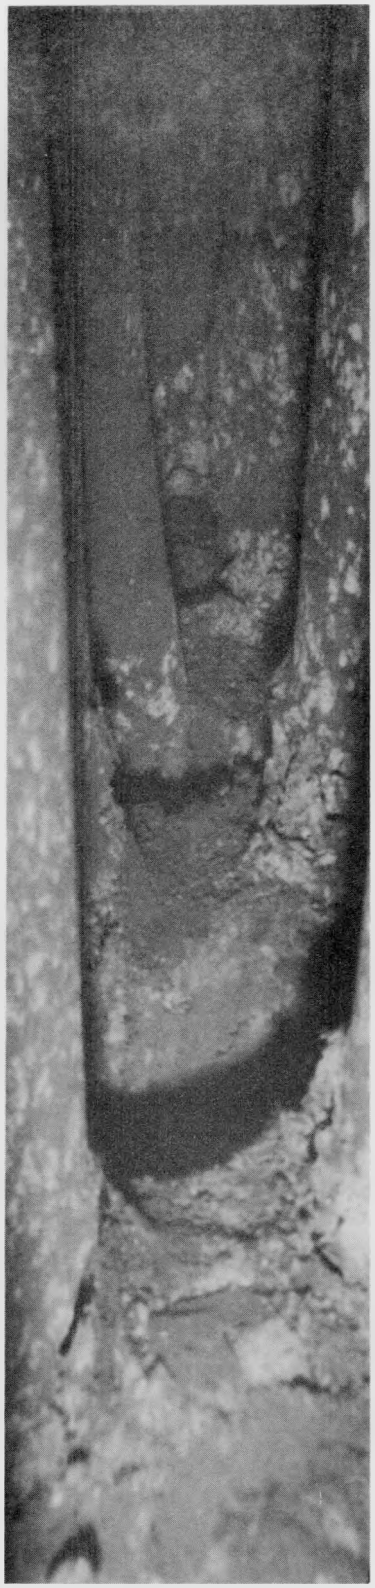
FIGURE 3.13. Side Movement (Parallel to Lane) of Tubes Relative to the First Support Plate, Column 39-40

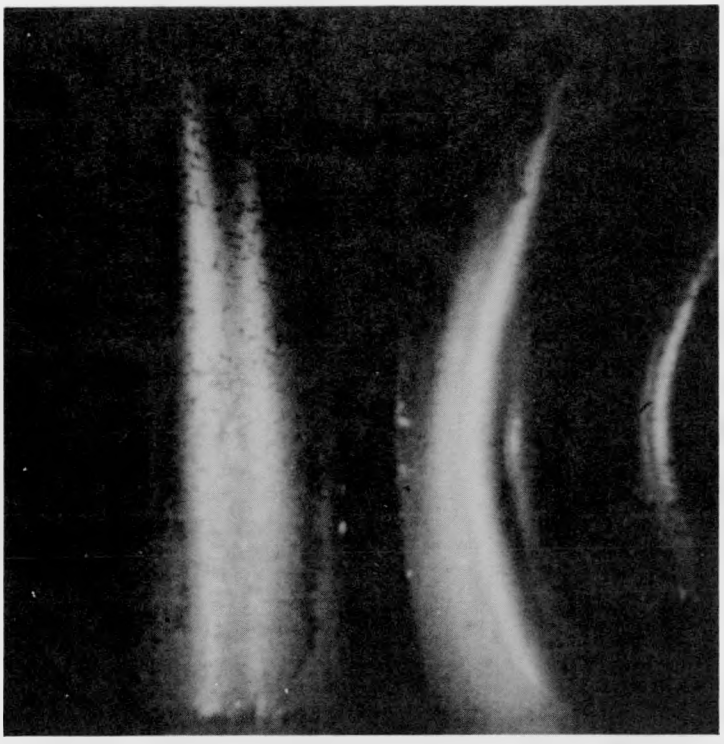
U-bends showed burst type cracks. In addition, 50 to 66 other Row 1 U-bends were probably cracked either on the extrados side of the U-bend or showed axial creases on the intrados side, probably indicative of primary-side initiated cracks that had penetrated part way through the wall. Figure 3.14 shows a creased tube.

FIGURE 3.14. Probable ID (Primary) Side Initiated Crack Which Appears as an Axial Crease in the Apex of Column 87

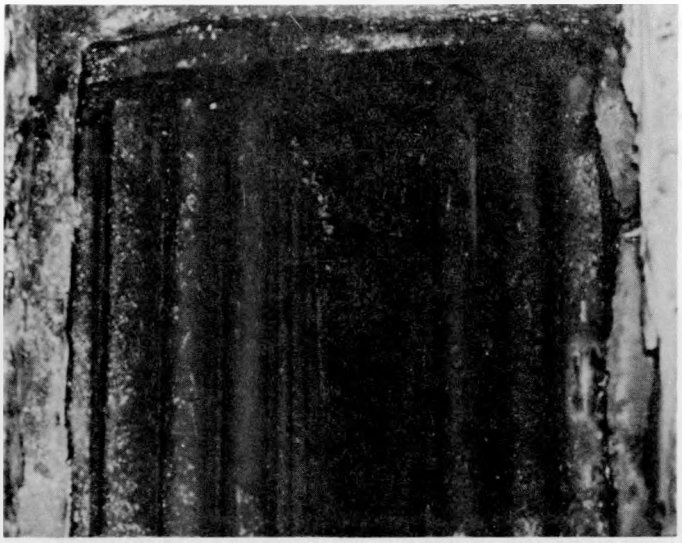
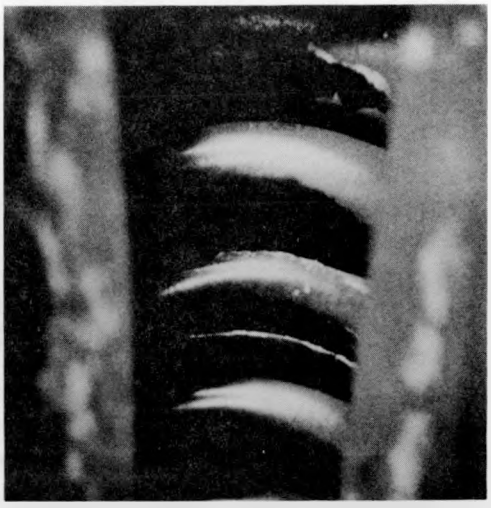
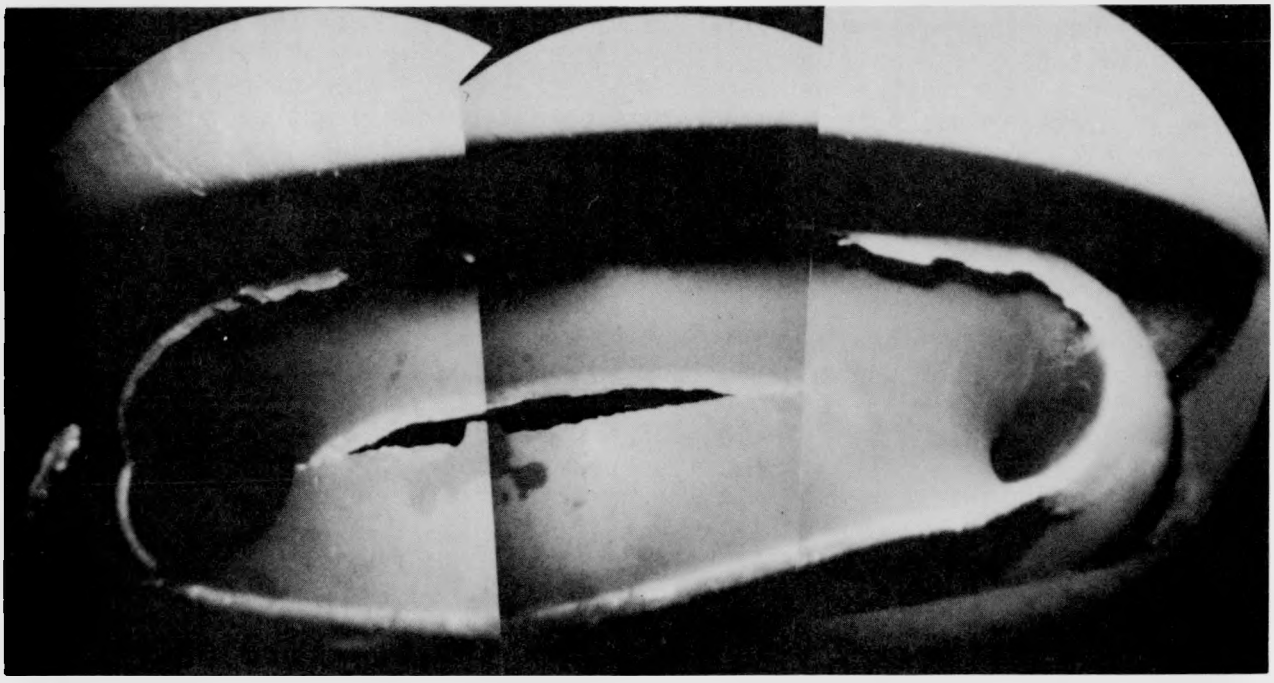
In general, visual and photographic inspection did not reveal cracks or shallow defects beneath the thin, brown-black outer scale found on most tubes. Instances of missing U-bend sections, such as shown in Figure 3.16c, were revealed. Since the inner two rows of U-bends were plugged after an initial U-bend failure, the numerous through-wall defects, and the missing tube sections, occurred after plugging. The cracking could, in part, be attributable to the increasing applied stresses as the support plates continued to corrode. No other U-bend damage was observed via the in situ secondary-side inspections.

FIGURE 3.16. Probable Burst-Type Fracture, U-Bend R1C85; a) Penetration Below Seventh TSP, b) Looking Up (Intrados Region), c) Looking Down (Extrados Region)

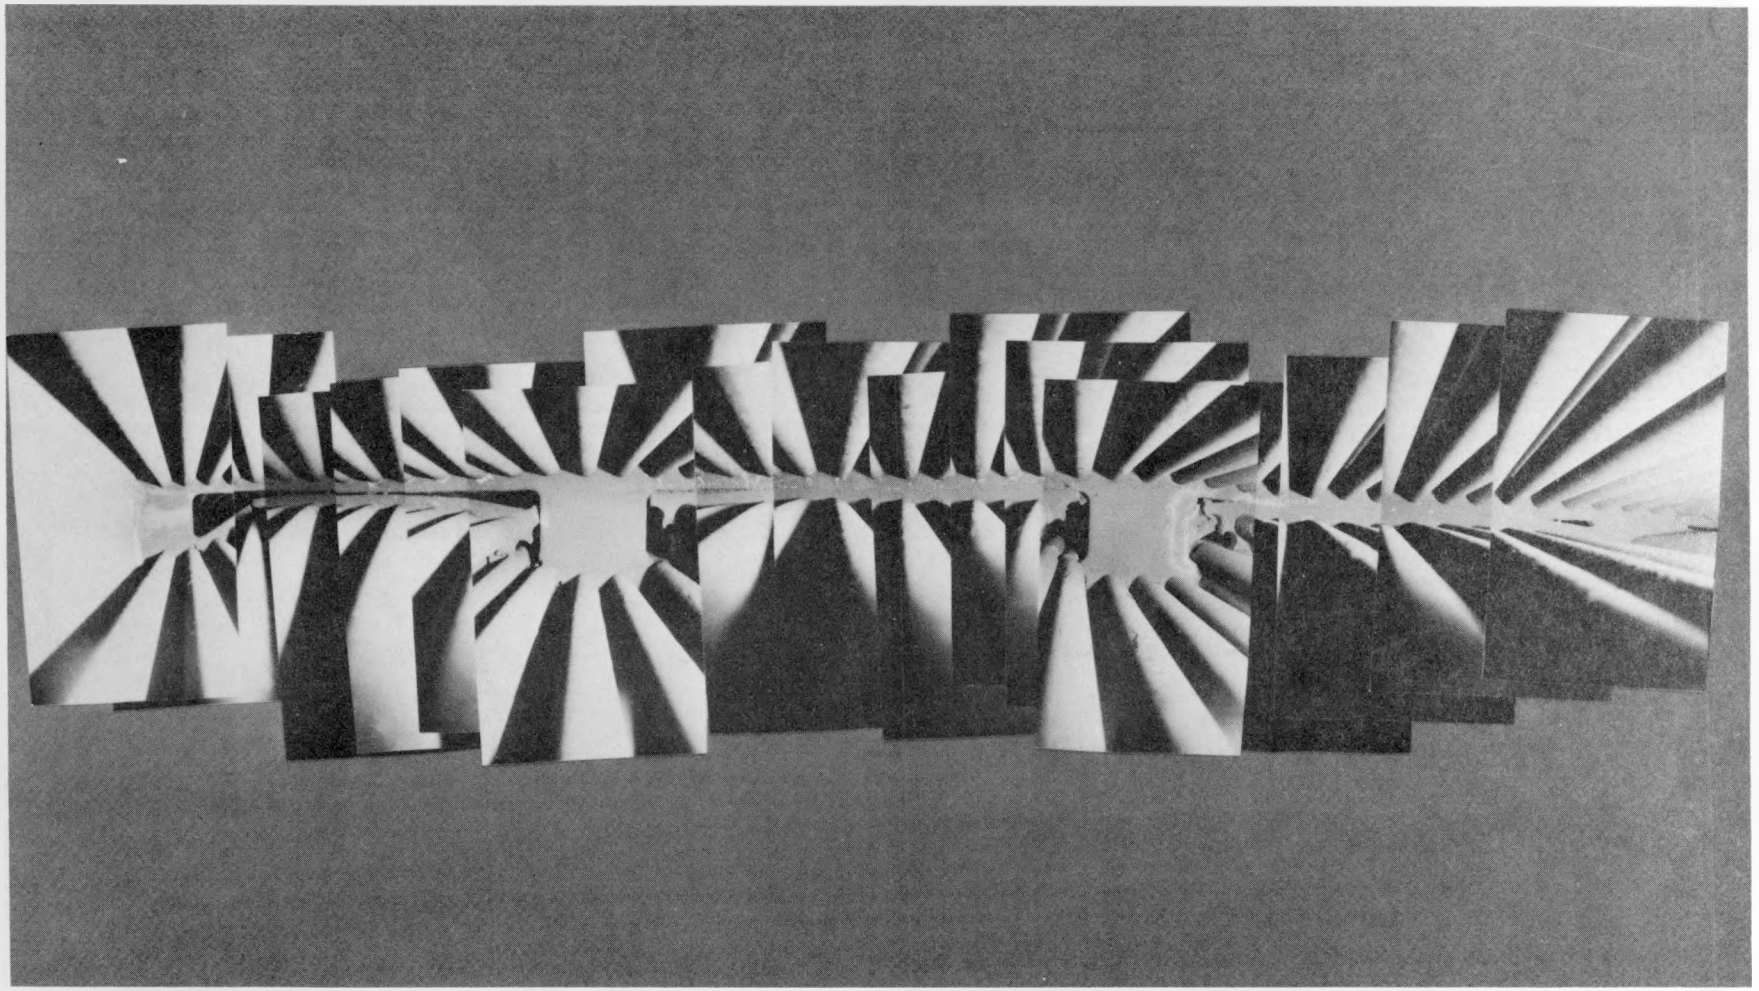
FIGURE 3.17. Bottom Side of First Support Plate, from 0° Handhole

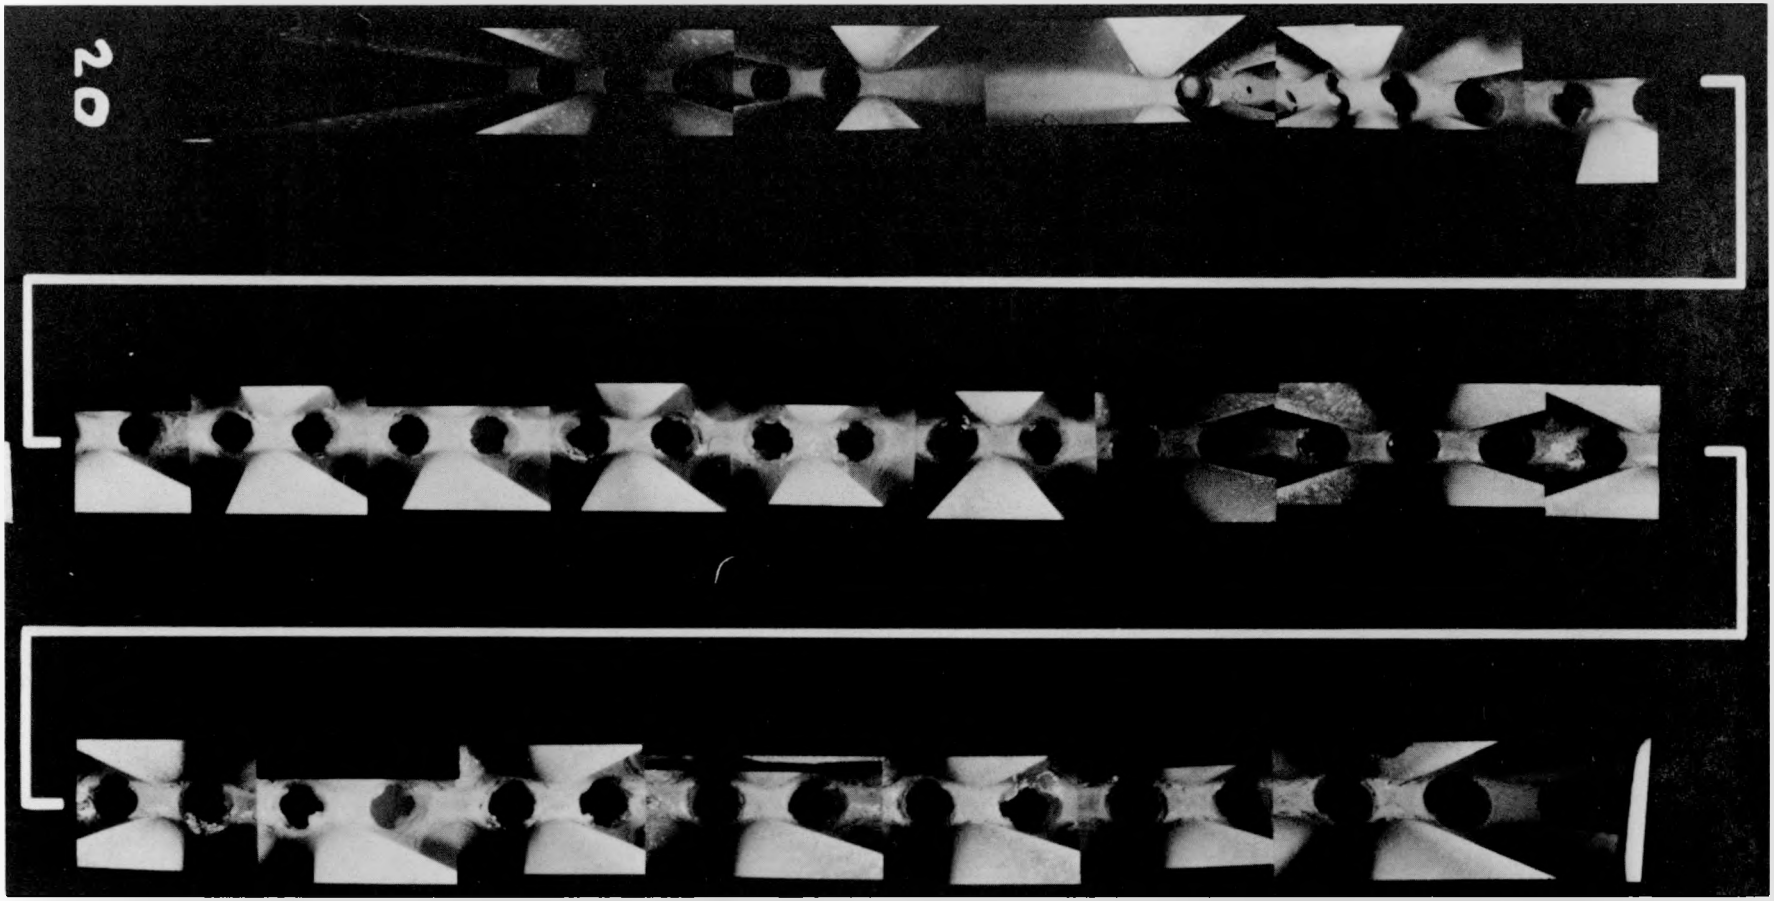
FIGURE 3.18. Montage Photo Looking Up at the Second Support Plate from Shell Wall (Hot Leg Side) to the Cold Leg Side at Column 62-63

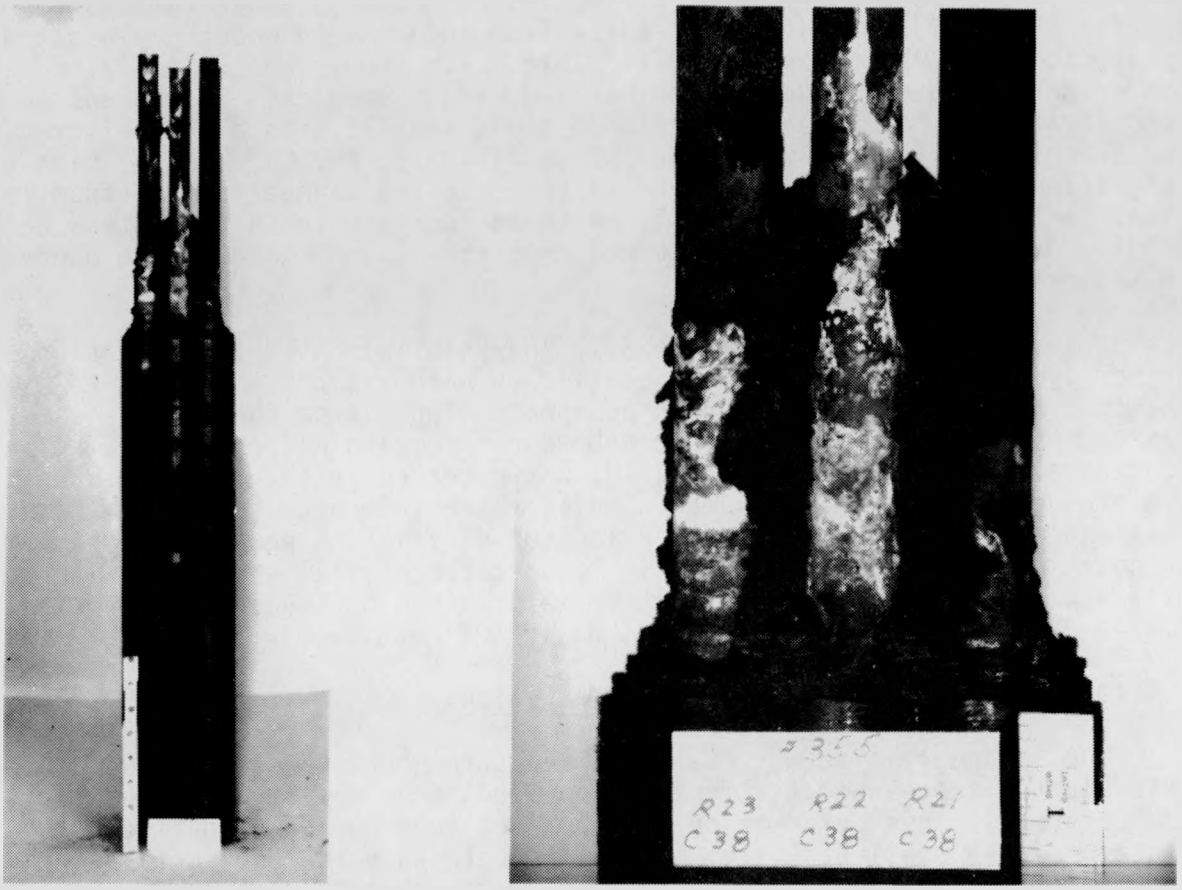
FIGURE 3.19. Overview and Sludge Pile Closeup of Hot Leg Tube Sheet Section #355

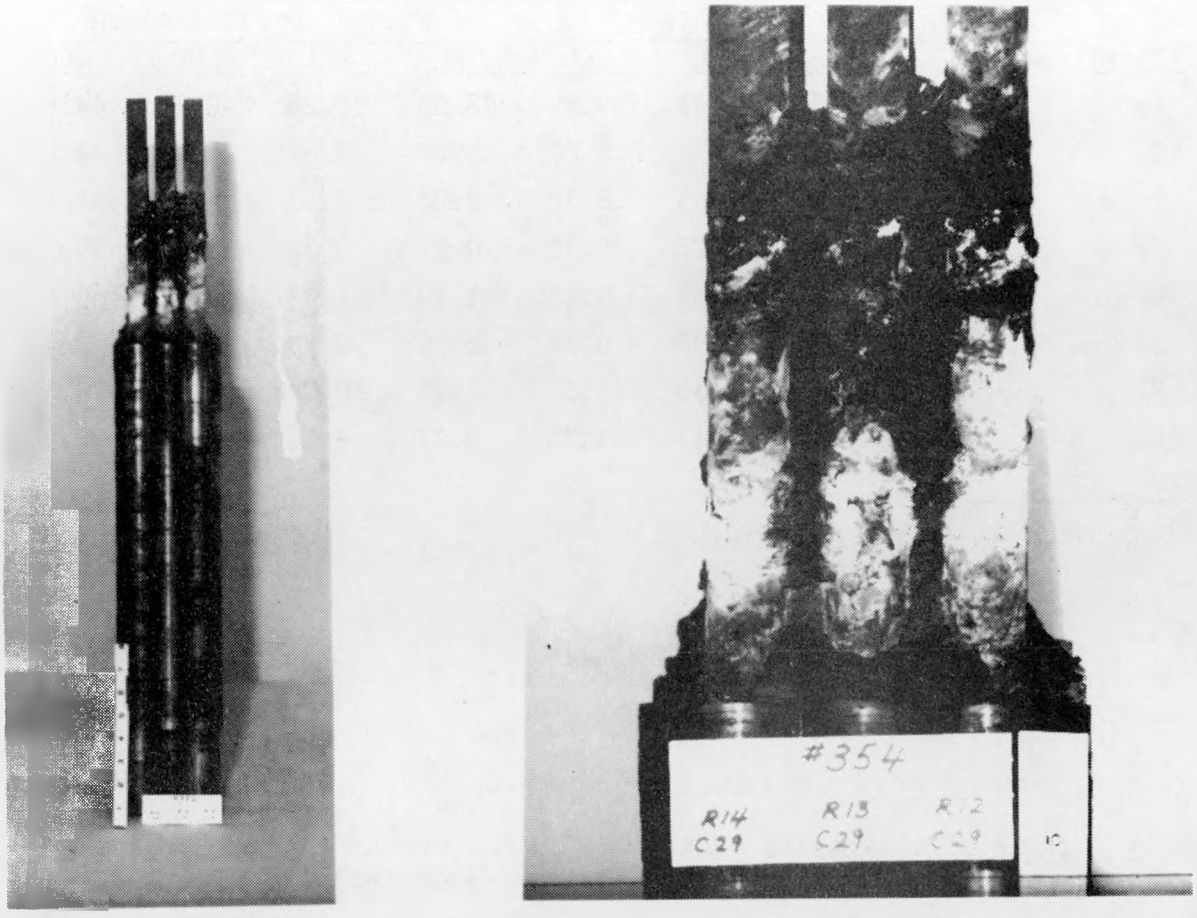
section removals, as shown in Figures 3.19 and 3.20. Sludge composition varied considerably with height above the top of tube sheet (TTS) and from the hot-leg to the cold-leg side of the generator. There were also compositional variations from point to point in a local region. Tables 3.1 and 3.2 provide a summary of sludge analysis as a function of location above the TTS for hot-leg and cold-leg regions. Results from inductively-coupled plasma spectroscopy (ICP) are presented in Table 3.1. Iron, copper, and zinc were the primary elements found in the hot-leg sludge samples. The Cu and Zn concentrations increased with distance above the TTS with a sharp increase in copper observed in the AVT sludge. In addition to Fe, Cu, and Zn, high concentrations of Na and P were found in the cold-leg sludge samples from locations up to 1.5 in. above the TTS. A sharp increase in Cu and Zn and corresponding decrease in Na and P occurred when the sludge changed from phosphate to AVT origin.

FIGURE 3.20. Overview and Sludge Pile Closeup of Cold Leg Tube Sheet Section #354

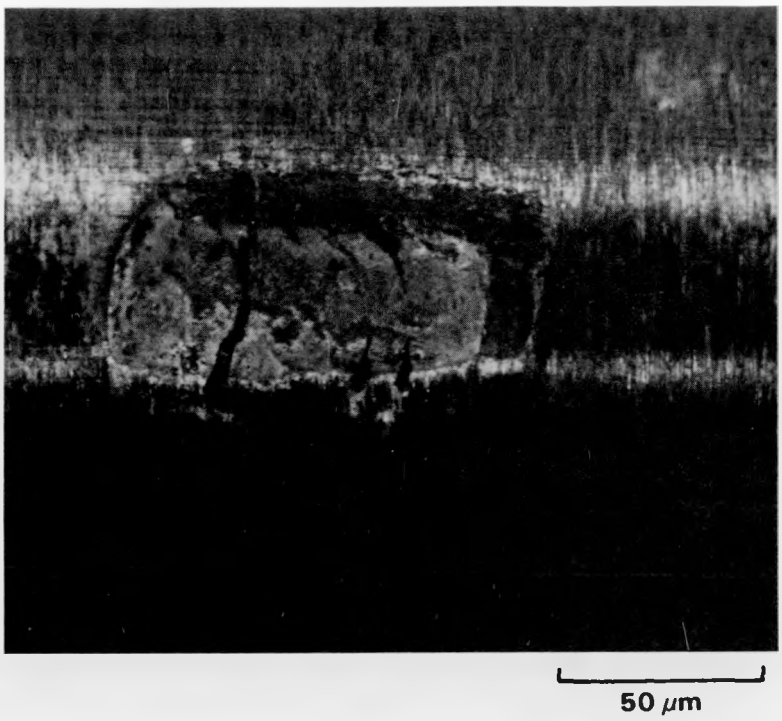
FIGURE 3.27. Wear and Corrosion at AVB Contact Areas on U-Bend Specimens 416A and 416B (R31 C58)

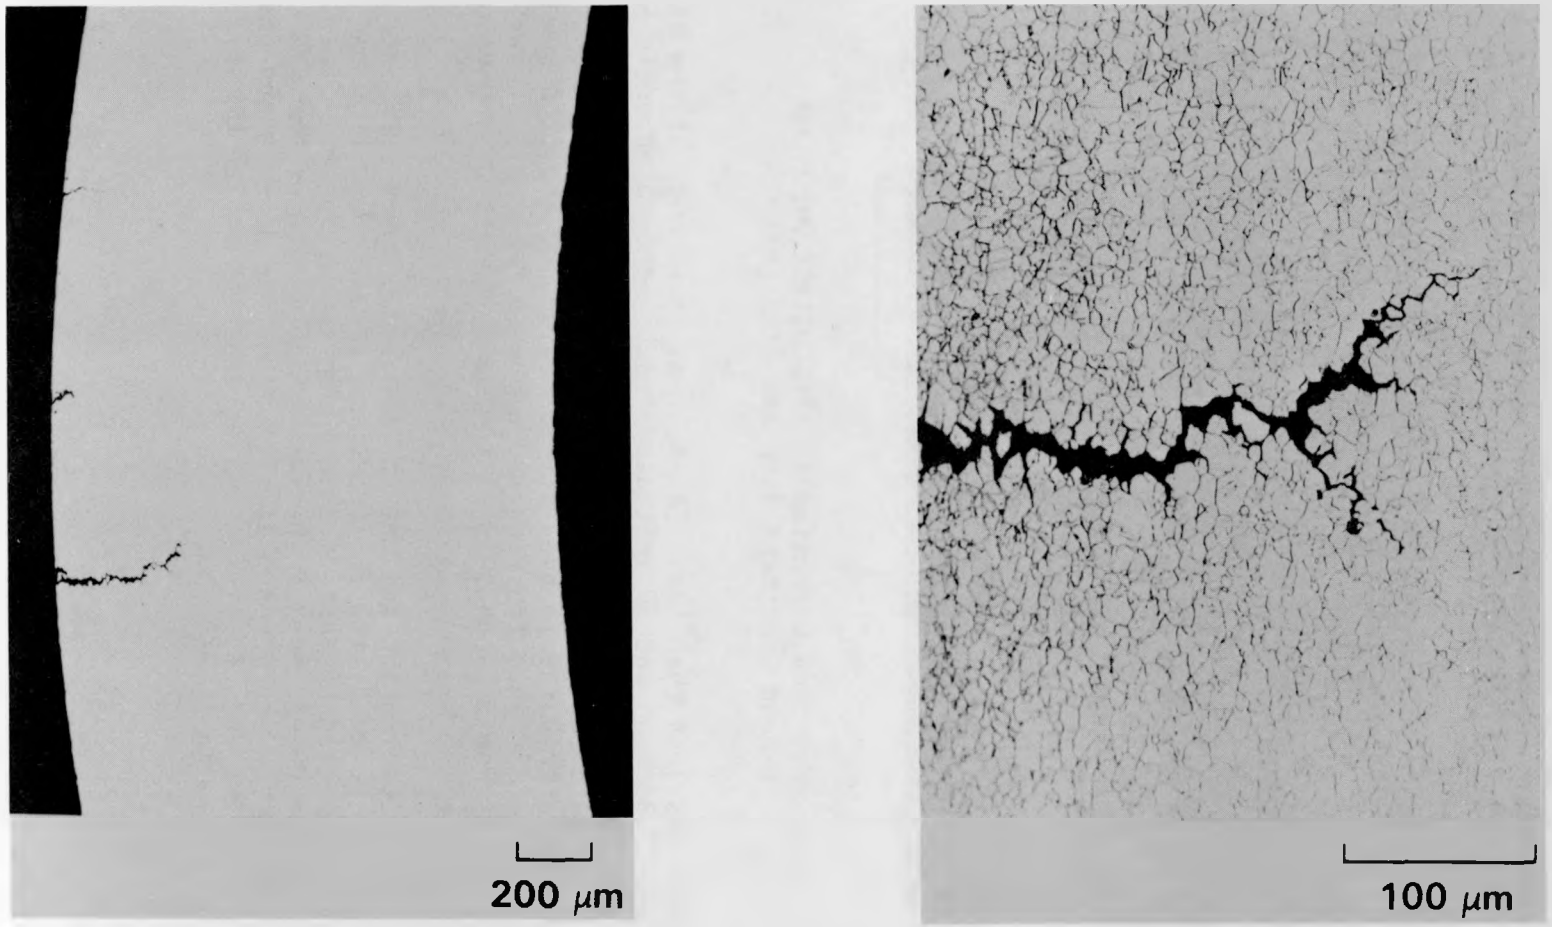
Intergranular stress corrosion cracking was also identified by visual and metallurgical examinations at specific locations within the generator. Cracking was observed at the apex of Row 1 and Row 2 U-bends which was attributed to stresses produced by inward movement of the U-bend legs from corrosion of the seventh (uppermost) TSP. Denting at the TSP intersections also produced cracking in tubes removed from the hot-leg side of the generator. Axial cracks initiated on the inner surface were found in specimens with calculated strains as low as 10%. Calculated strains greater than 60% were required to produce cracking from the outer surface.

FIGURE 3.28. Optical Micrographs Showing Axial IGSCC at the Apex of U-Bend Specimen 1049 (R2 C27)

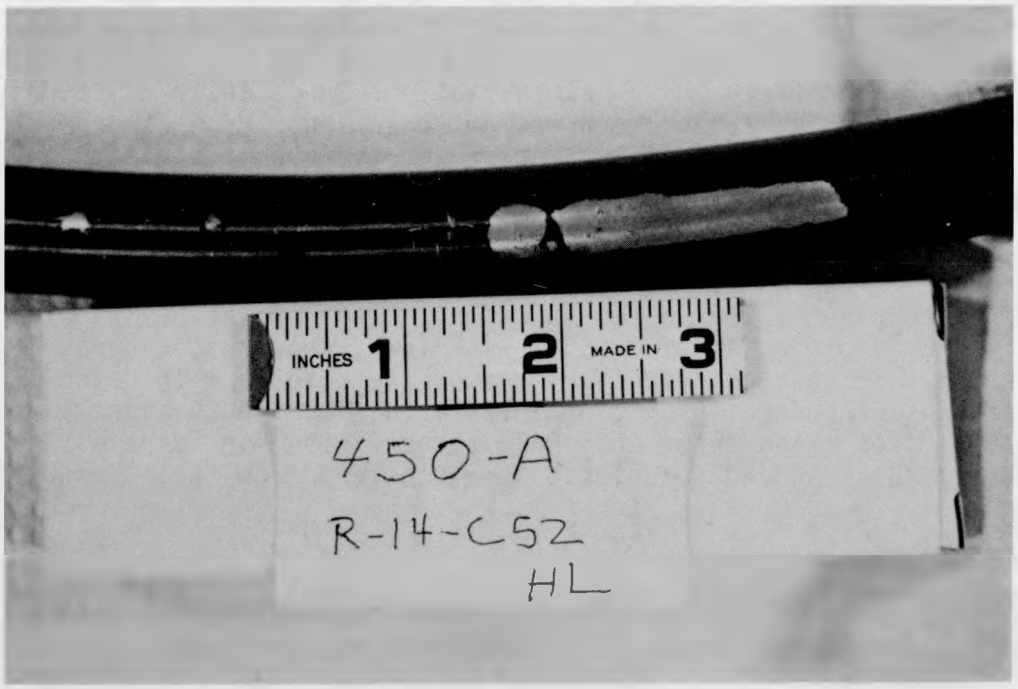
FIGURE 3.29. U-Bend Specimen 450A (R14 C52 HL) Showing Discontinuities in the Copper-Rich OD Surface Deposit

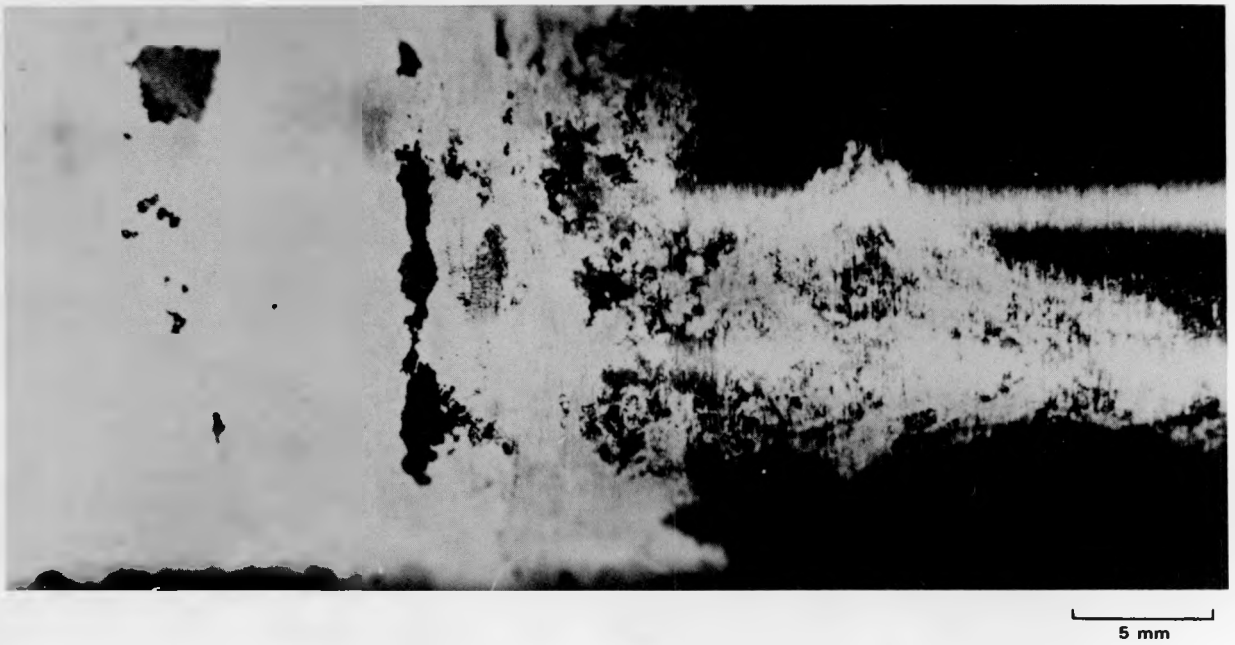
3.5.3.1.2 Support-Plate Region. Almost all of the tube degradation observed in specimens from the support-plate region of the generator was associated with the dented TSP intersections. Corrosion in the form of shallow pitting, wastage, and IGA occurred in the crevice region between the tube and support plate in most of the 117 TSP intersections examined. Figure 3.30 shows a photograph of a typical TSP intersection. The severity of the OD corrosion attack appeared greater in the more heavily dented tubes although the visual estimate of wall-loss was generally less than 20% for all specimens. Metallographic examination of 10 specimens with calculated strain values ranging up to 39% confirmed the shallow nature of the OD corrosion as evidenced by the data in Table 3.15. Various combinations of pitting (P), wastage (W), and IGA were observed in the metallographic cross sections with the maximum wall-loss ranging from 2 to 12%. Axial cracks were also visually observed on the OD surface at regions of high tensile hoop stress in specimens with calculated strains greater than 60%.

FIGURE 3.30. Typical TSP Intersection; Specimen 665 (R7 C57 HL)

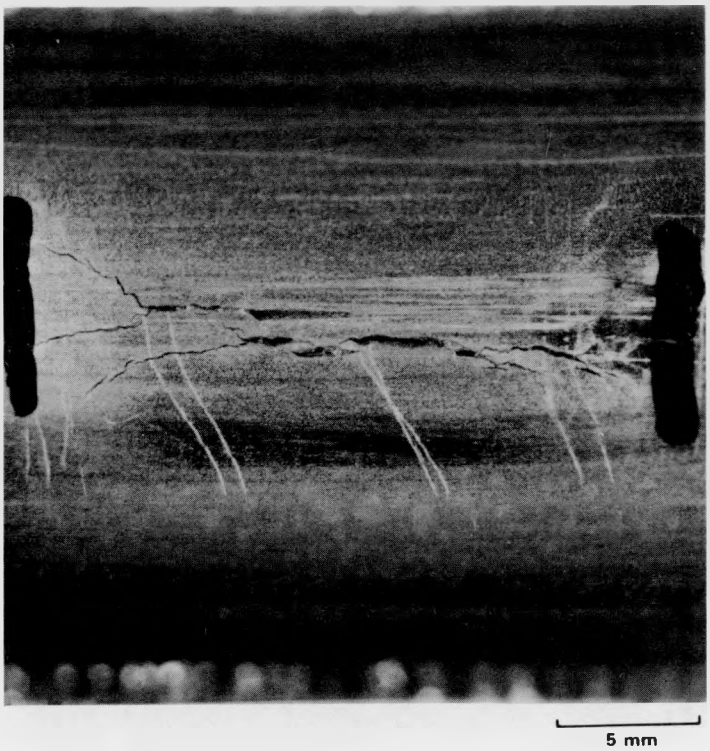
FIGURE 3.31. First TSP Specimen 1041 (R4 C51 HL) Showing ID Cracking (26.9% strain)

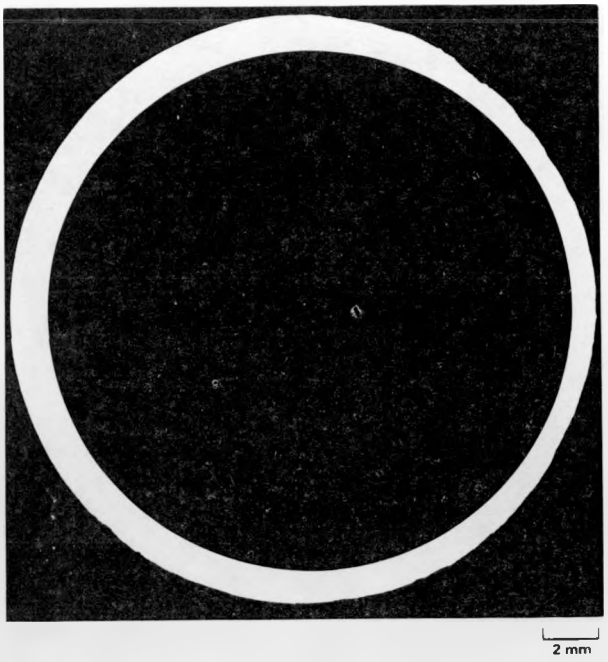
FIGURE 3.32. Optical Micrograph Showing Ring Type Wastage on Hot-Leg TTS Specimen 632 (R13 C37 HL)

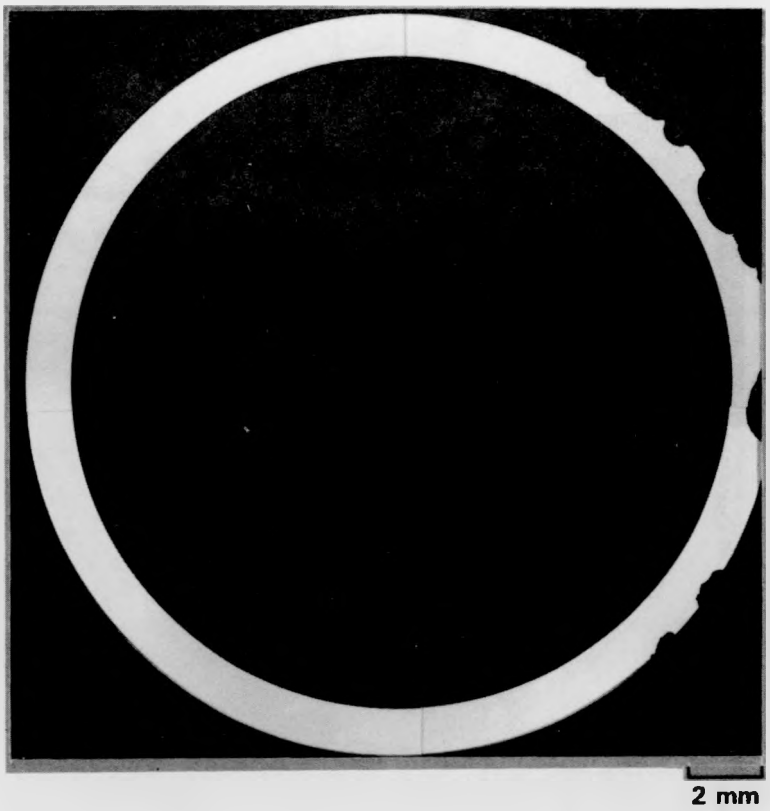
Pitting and wastage were the predominant tube defects found in the specimens examined. This type of tube degradation was identified in the sludge pile region above the top of the tube sheet (TTS), within the tube-to-tube support-plate (TSP) crevice, and to a lesser extent at antivibration bar (AVB) contact areas. The most severe pitting/wastage degradation was located in the region 0 to 2 in. above the hot-leg TTS where wall-losses ranged up to 87%. Wide variations in the distribution and depth of local degraded areas were observed both axially and circumferentially within the corroded region of the hot-leg TTS specimens. These variations in defect distributions appear to be a major factor in the variability of the EC depth estimates. In general, wall-loss from pitting/wastage type degradation in specimens from other regions of the generator was less than 20%.

FIGURE 3.33. Pitting/Wastage Type Degradation of a Hot Leg TTS Specimen

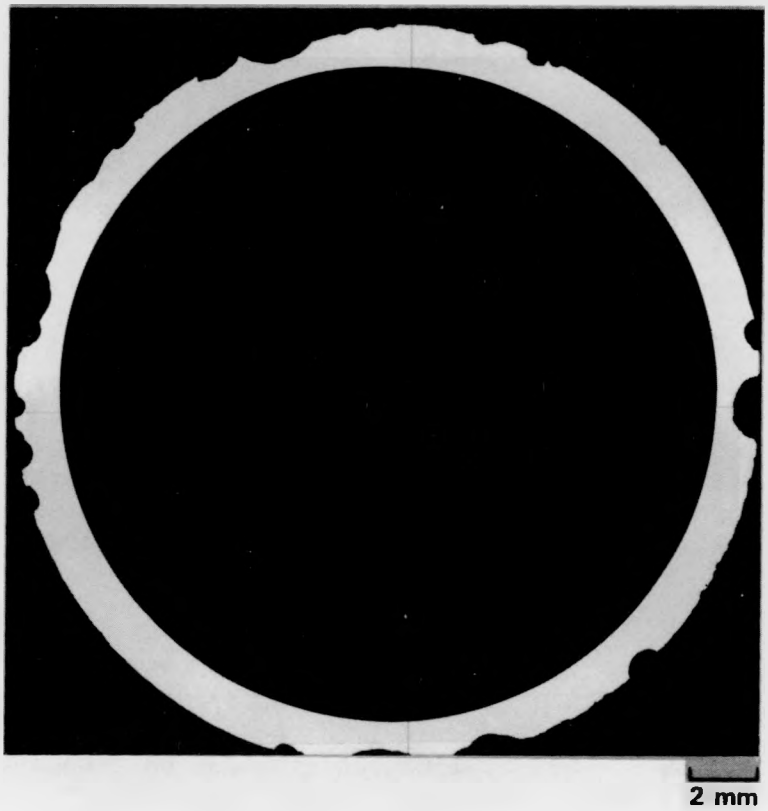
FIGURE 3.34. Pitting/Wastage Type Degradation of a Hot Leg TTS Specimen
