NUREG/CR–5117
PNL–6446

Steam Generator Tube Integrity Program/Steam Generator Group Project

Final Project Summary Report

Pacific Northwest Laboratory
Operated by
Battelle Memorial Institute

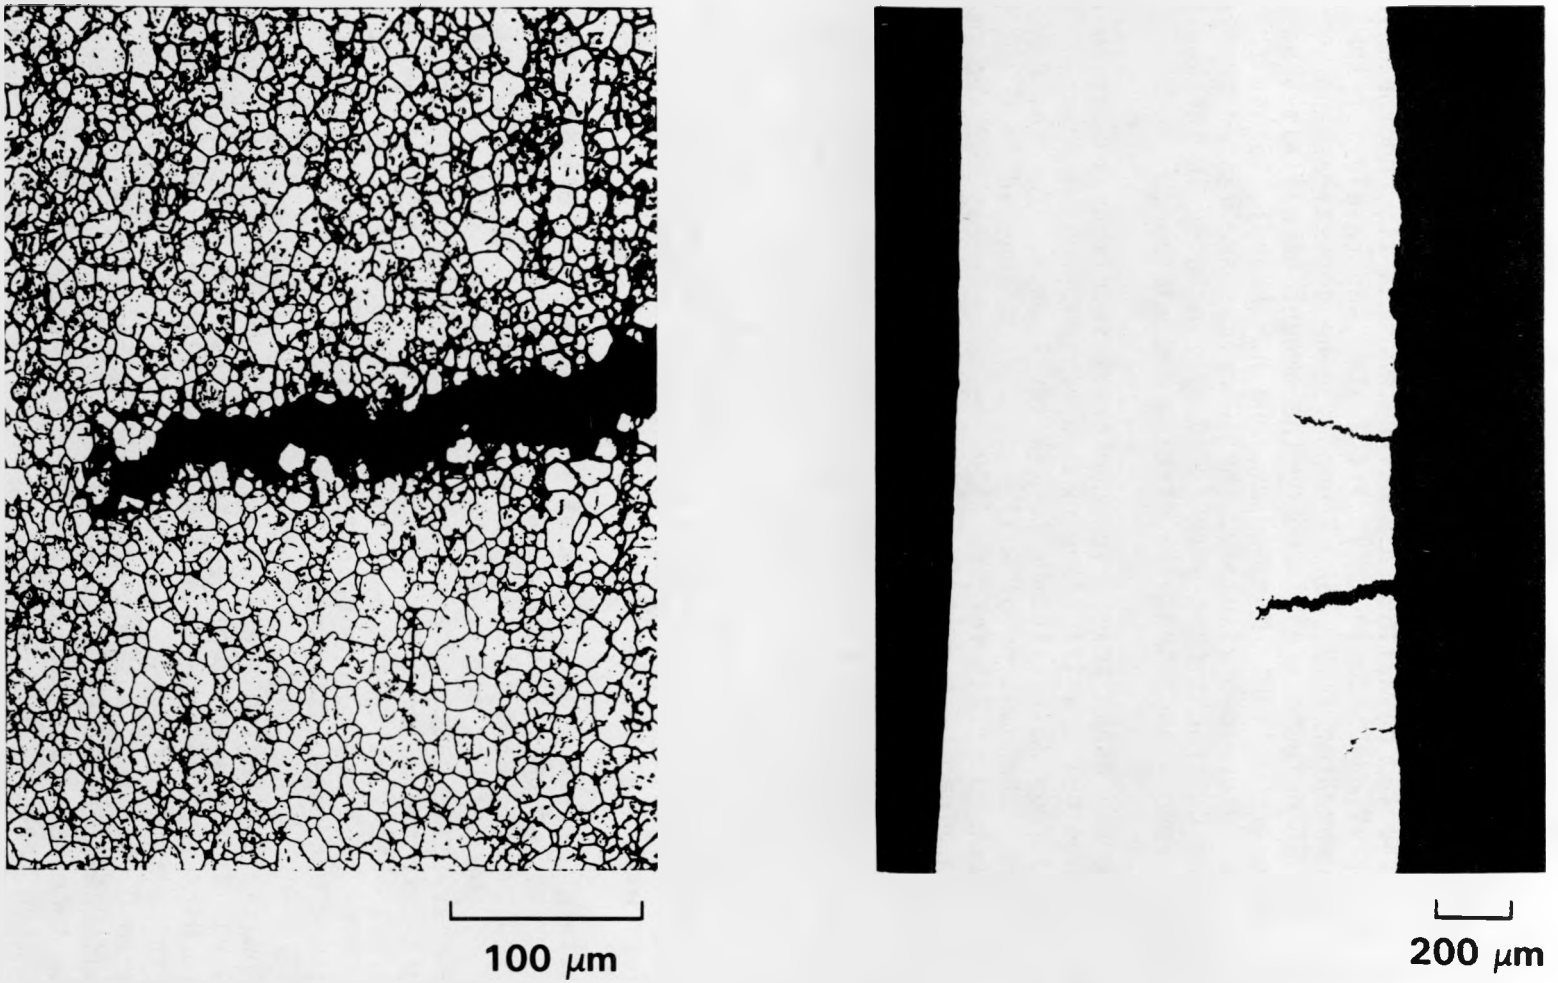
FIGURE 3.35. Optical Micrographs from a Longitudinal Section Showing OD Circumferential Cracking of TTS Specimen 633C (R13 C44 HL at TTS + 0.2 in.)

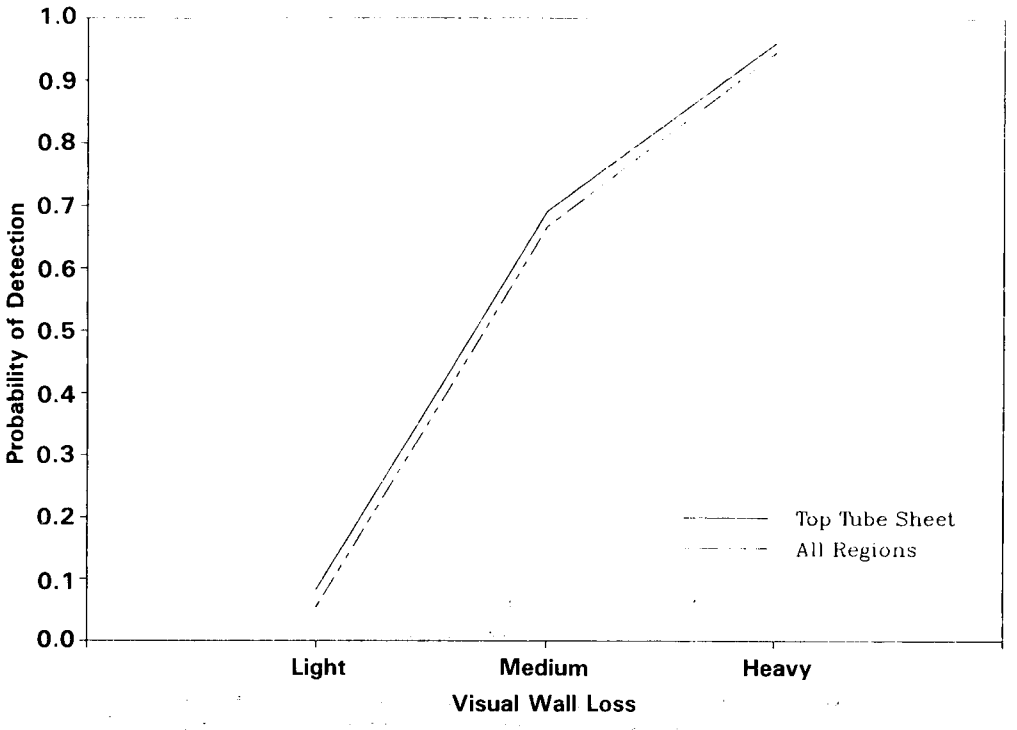
As expected, the median POD for TTS specimens increased with wall-loss and was 0.94 for specimens in the heavy category, which corresponds to estimated wall-losses greater than 40%. The POD from the seven teams ranged from 0.88 to 0.98 for this specimen category, while somewhat greater variations were observed for the light and medium categories. A slight decrease in POD was observed when specimens from all regions of the generator were included in the calculations. However, the magnitude of the decrease may be misleading since the vast majority of defects in the medium and heavy categories were found at the TTS. It should also be noted that almost all of the data pertain to pitting or wastage type defects and the PODs may not be appropriate for other defect types such as SCC or IGA.

FIGURE 3.36. Median Probability of Detection of DAARR and Base-Line Inspection Teams Based on Visual Determination of Wall-Loss

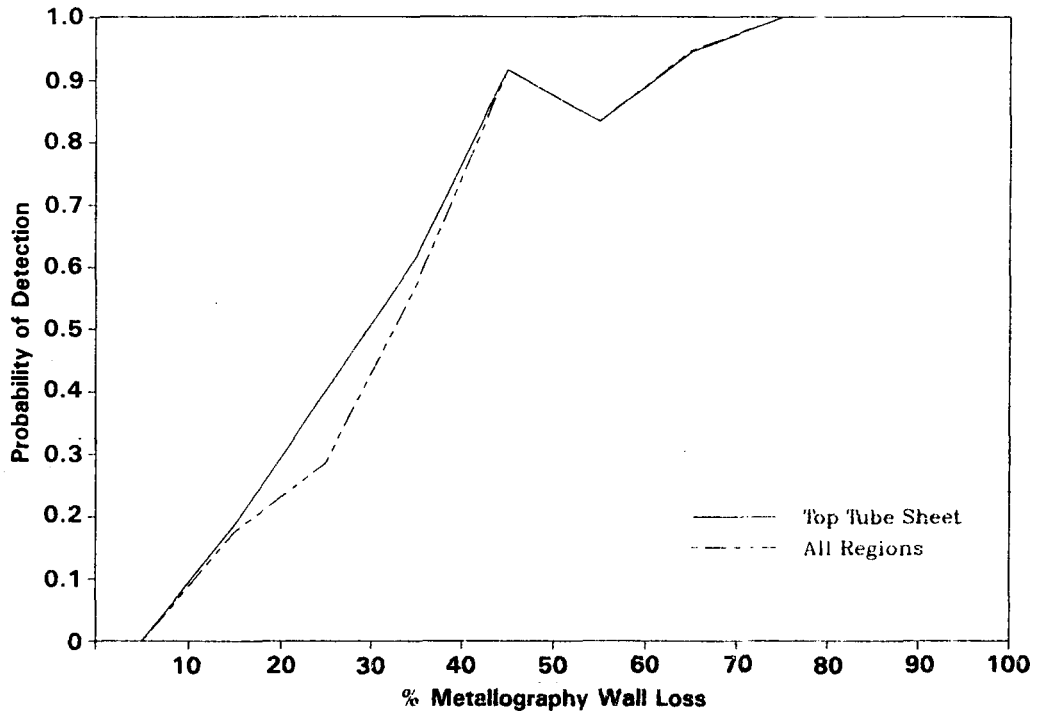
The PODs calculated from the metallography data show similar trends to those from the visual estimates of wall-loss. Figure 3.37 shows the median POD from the Base-Line and DAARR inspection teams; the metallography data are grouped into increments of 10% wall-loss. As before, the POD increased with wall-loss and the average POD for wall-loss more than 40% was greater than 0.9. Below 40% wall-loss, definite team-to-team variations in the POD curves were observed. However, there are inadequate data in each size category to

FIGURE 3.37. Median Probability of Detection of DAARR and Base-Line Inspection Teams Based on Metallographic Determination of Wall Loss

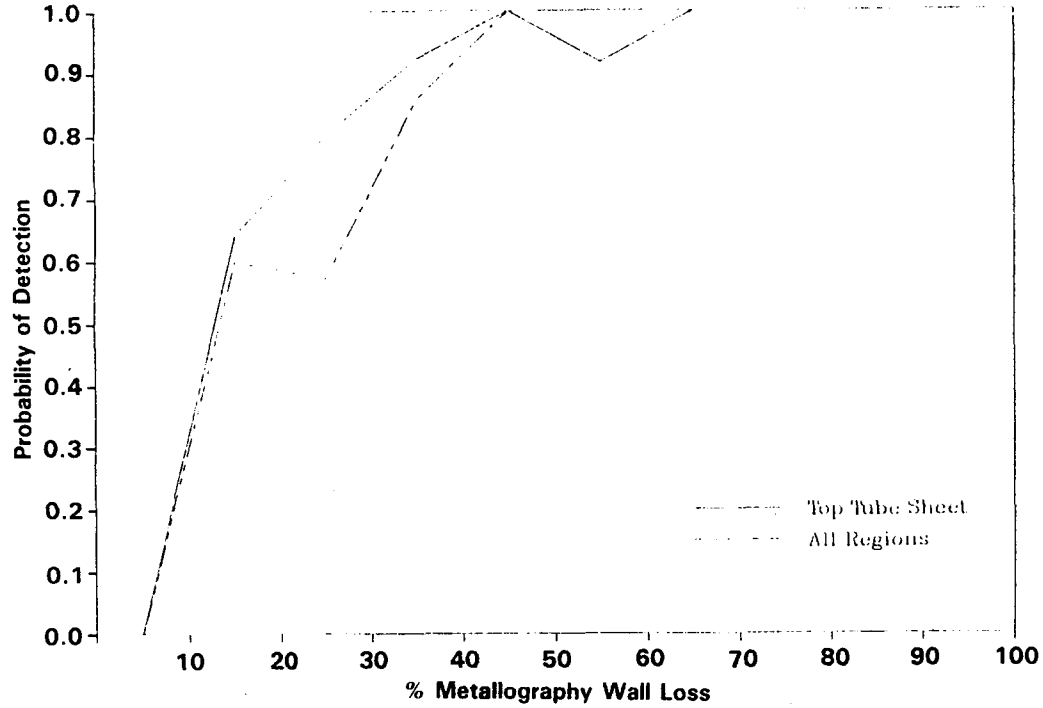
assess the statistical significance of these variations. An apparent improvement in the POD curve of one AATRR inspection team was observed, as shown in Figure 3.38. The POD curve increased more rapidly than the typical Base-Line or DAARR team and the average POD was higher above 40% wall-loss. This team utilized an automated data screening system to sort through their data prior to analysis by a human. This was probably, in part, responsible for the better POD performance.

FIGURE 3.38. Probability of Detection of an AATRR Inspection Team Based on Metallographic Determination of Wall Loss

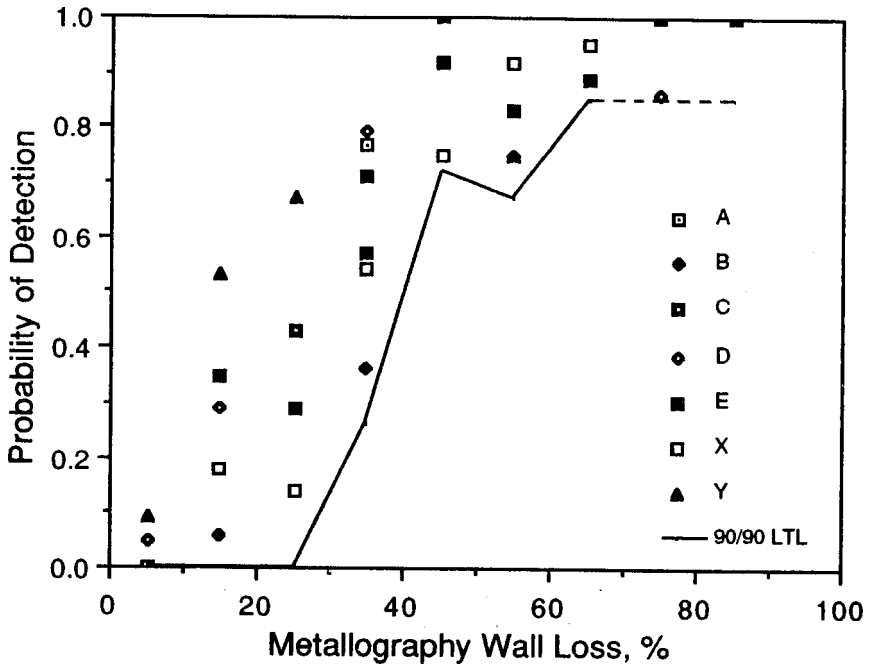
Figure 3.39 gives a plot of the individual POD performance for the DAARR and Base-Line teams for each 10% wall-loss increment. To estimate the lower bound POD, an approximate 90/90 lower tolerance limit (LTL) was computed (curve in Figure 3.39) from the teams participating in the DAARR and Base-Line inspections. These teams are assumed to be typical of the total population of teams performing ISI; therefore, if each team in this population had inspected the same set of tubes, we can be about 90% confident that about 90% of the individual team POD values would be above this LTL. The dashed segment of the curve indicates that the number of specimens with deep through-wall degradation was inadequate to provide a meaningful estimate of the LTL. Thus, the LTL at 65% wall loss is extended as a conservative approximation of the LTL (i.e., the POD is assumed to either increase or stay the same as wall-loss increases). This information was developed as an appropriate lower bound estimate of POD for field EC inspection and was used to validate the selection POD curves used in the evaluation of various sampling/inspection schemes described in Section 3.6.

FIGURE 3.39. Individual POD Performance for the DAARR and Base-Line Teams for Each 10% Wall-Loss Increment

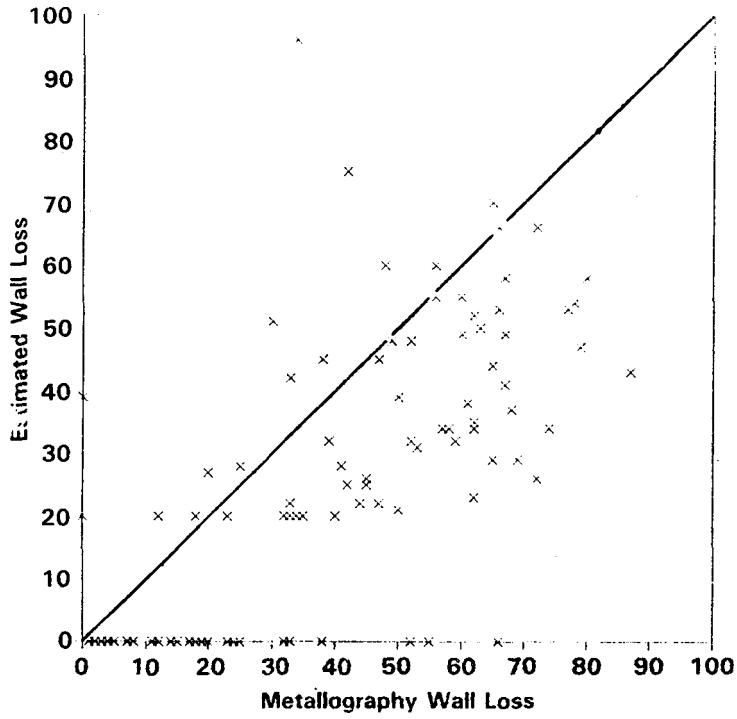
Comparing the EC and metallography data shows that EC generally tended to underestimate the defect depth as measured by metallography, especially for the more severely-degraded specimens. Figure 3.40 shows the relationship between the EC and metallographic results for a typical inspection team using standard bobbin-coil techniques. Points plotted along the horizontal axis are nondetections and points shown on the vertical axis are false calls. Team-to-team variations were observed, but the general tendencies shown in Figure 3.40 were apparent for all of the Base-Line and DAARR inspections. Wide variations in the EC depth estimates were reported for specimens with similar wall-loss and also for the same specimen but from different teams. A better correlation between the EC and metallography wall-loss was observed for one of the AATRR teams, as shown in Figure 3.41.

FIGURE 3.40. Typical Plot of EC Estimated Flaw Depth Versus Actual Depth from Metallographic Analysis

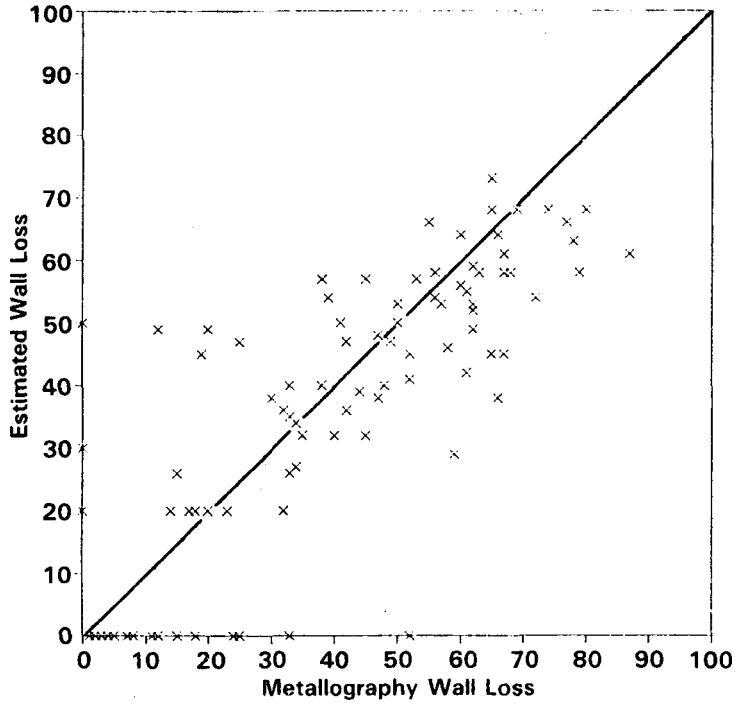
FIGURE 3.41. Plot of Best Observed EC Estimated Flaw Depth Versus Actual Depth from Metallographic Analysis

Table 3.19 shows little consistency in the estimates of the intercept. For the Base-Line and DAARR teams, it varies from 6% to 24%, which represents a significant sizing bias. The slopes, varying from 0.38 to 0.61, are reasonably consistent. The sizing errors are also consistent, 14.67% to 16.69%, with the exception of Team Y at 21.11%. These errors are large; a one standard deviation (error estimate) range about a defect size estimate is at minimum 30% of wall thickness. Although Team V's fitted intercept and slope were not significantly different from some of the other teams, their dispersion was the lowest (except for Team U with only 13 defects >20%) and their R^2 value was the highest of any team. Team V employed two inspection techniques that probably explain, in part, their improved sizing performance. First, special frequency mixes were developed specifically for the Surry generator and used to enhance the signal-to-noise ratio by suppressing the effects of dents, support plates, and copper deposits. Second, rotating EC and focused ultrasonic probes were used to reinspect 22 of the tubes previously inspected by conventional bobbin-coil EC. The wall-loss determined from the supplemental inspection was then compared to the bobbin-coil results and a correction factor computed. In this case the bobbin-coil data was adjusted by +15% to correct for an apparent underestimate of defect depth. Both of these factors, namely, special frequency mixes and augmentation of the EC/bobbin-coil data, apparently were responsible for the improved sizing accuracy.

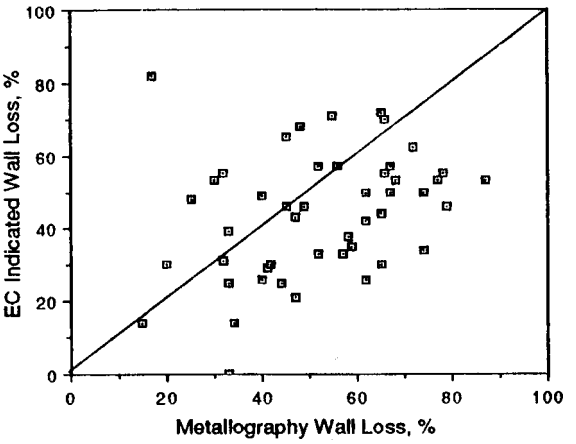
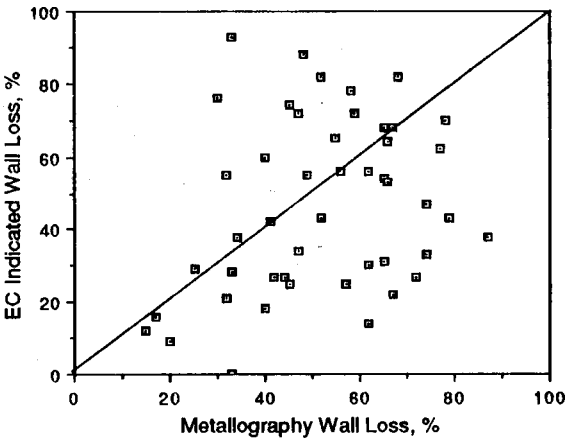
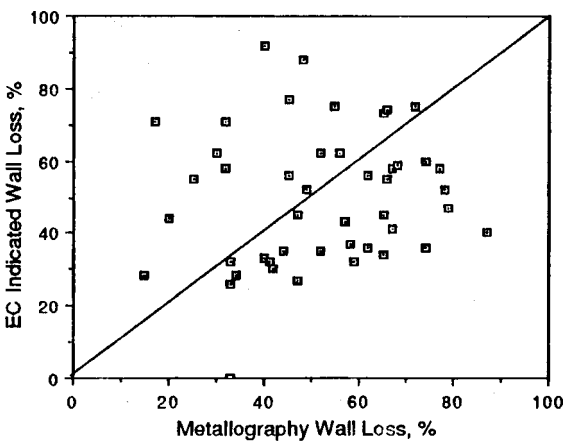
The EC data from TTS specimens with metallographic data available were reanalyzed to determine if a consistent analysis method and or frequency would improve the correlation between EC and metallography wall-loss. The EC data tapes from one of the DAARR inspection teams were analyzed at 400 kHz, 100 kHz, and a 400/100 kHz mix. The defect signals were measured at all three channels by always taking the location within the signal which produced the deepest wall-loss. This location usually was a tangent point of a deflection on the vertical channel of each output. A comparison of the resulting EC depth estimates with the metallographic data is shown in Figure 3.42. No definite improvement in the variability of the EC depth estimates is seen in the three sets of data, although a consistent analysis method was employed.

FIGURE 3.42. Comparison EC Data Reanalyzed at Various Frequencies With Metallography

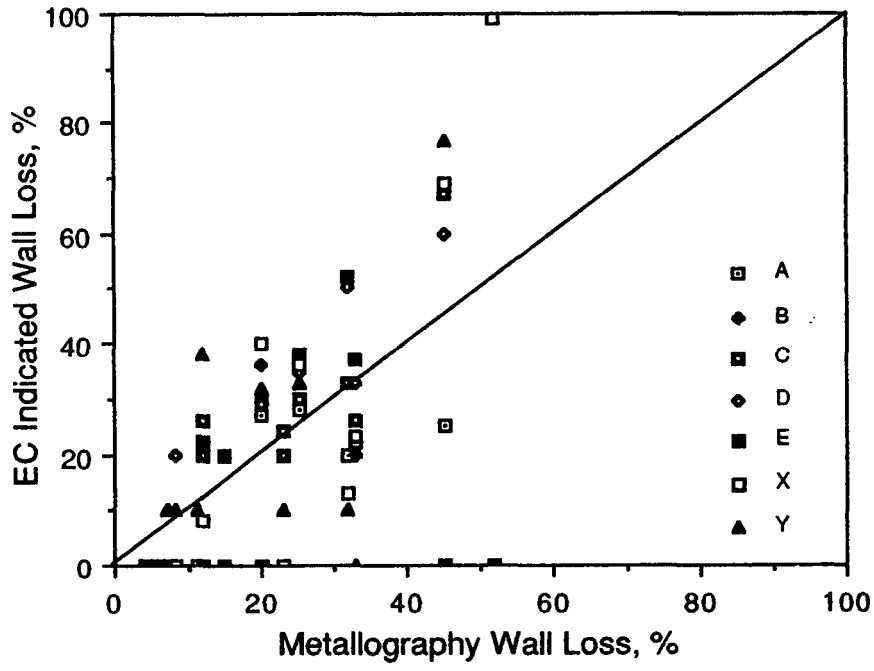
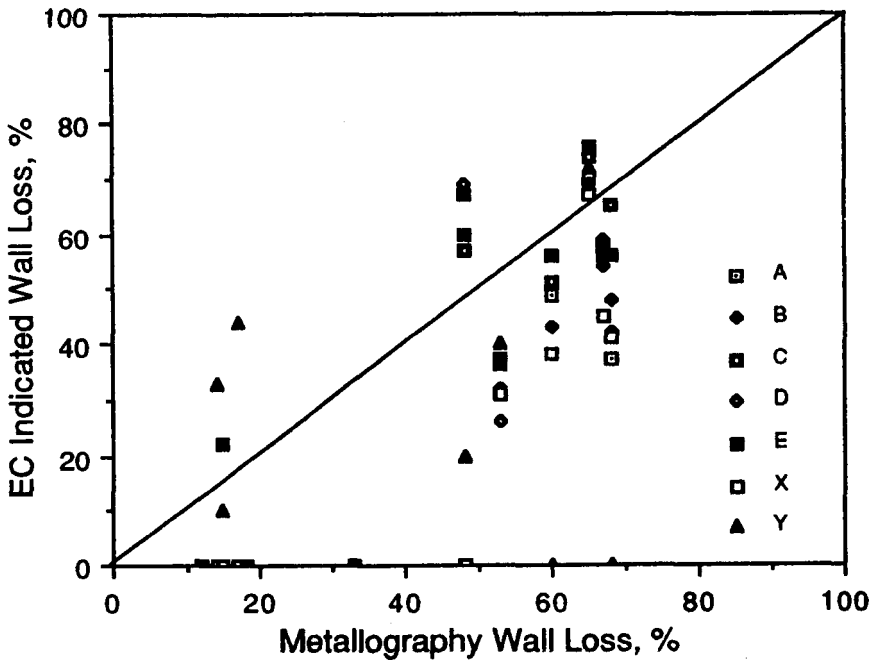
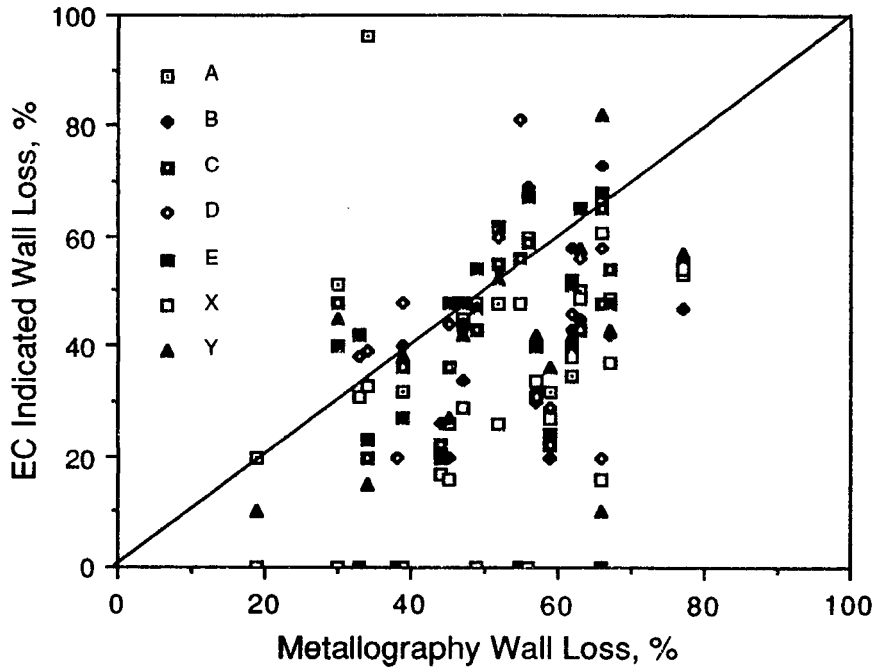
The effect of defect type and distribution on the EC sizing variability was evaluated by dividing the TTS specimens into defect categories consisting of wastage, pitting and wastage, and isolated pitting. The pitting and wastage specimens were subdivided into two categories depending on the circumferential extent of the defects in the transverse sections. Degraded regions (not necessarily continuous) were distributed around more than one-half of the tube circumference for Category 1 and less than one-half of the tube circumference for Category 2. The resulting correlations between the reported EC wall-loss from the Base-Line and DAARR inspections and the metallographic data are shown in Figures 3.43 and 3.44. As can be seen, definite improvements in the correlations were not obtained. The simple defect types, wastage and isolated pitting, appear to provide a slightly improved EC estimate of wall-loss. However, the number of specimens in these categories is limited and the differences may not be significant.

FIGURE 3.43. Correlation of EC Estimated Wall-Loss (Base-Line and DAARR Teams) With Metallography

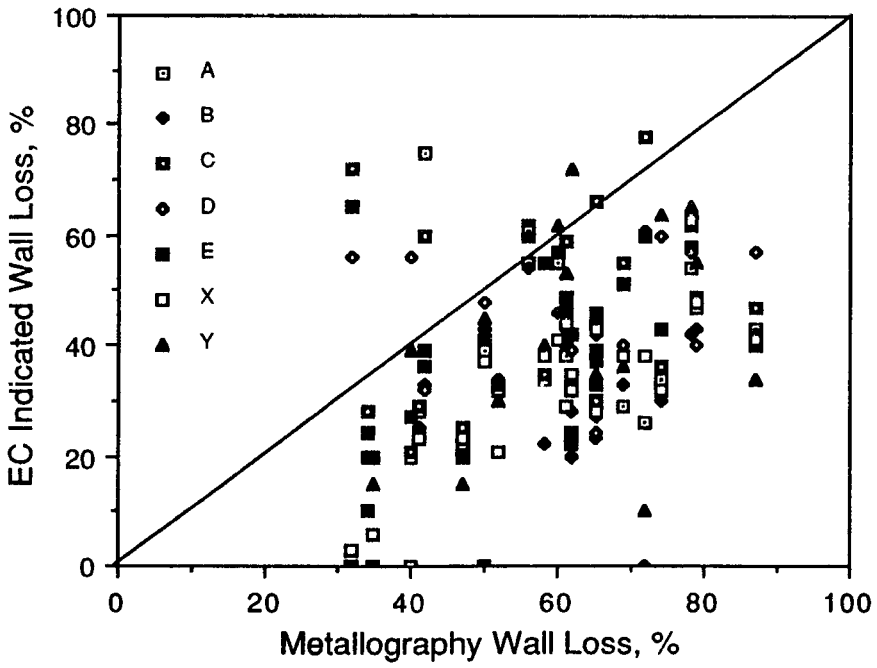
b) Pitting/Wastage More Than Half Circumference

FIGURE 3.44. Correlation of EC Estimated Wall-Loss (Base-Line and DAARR Teams) With Metallography

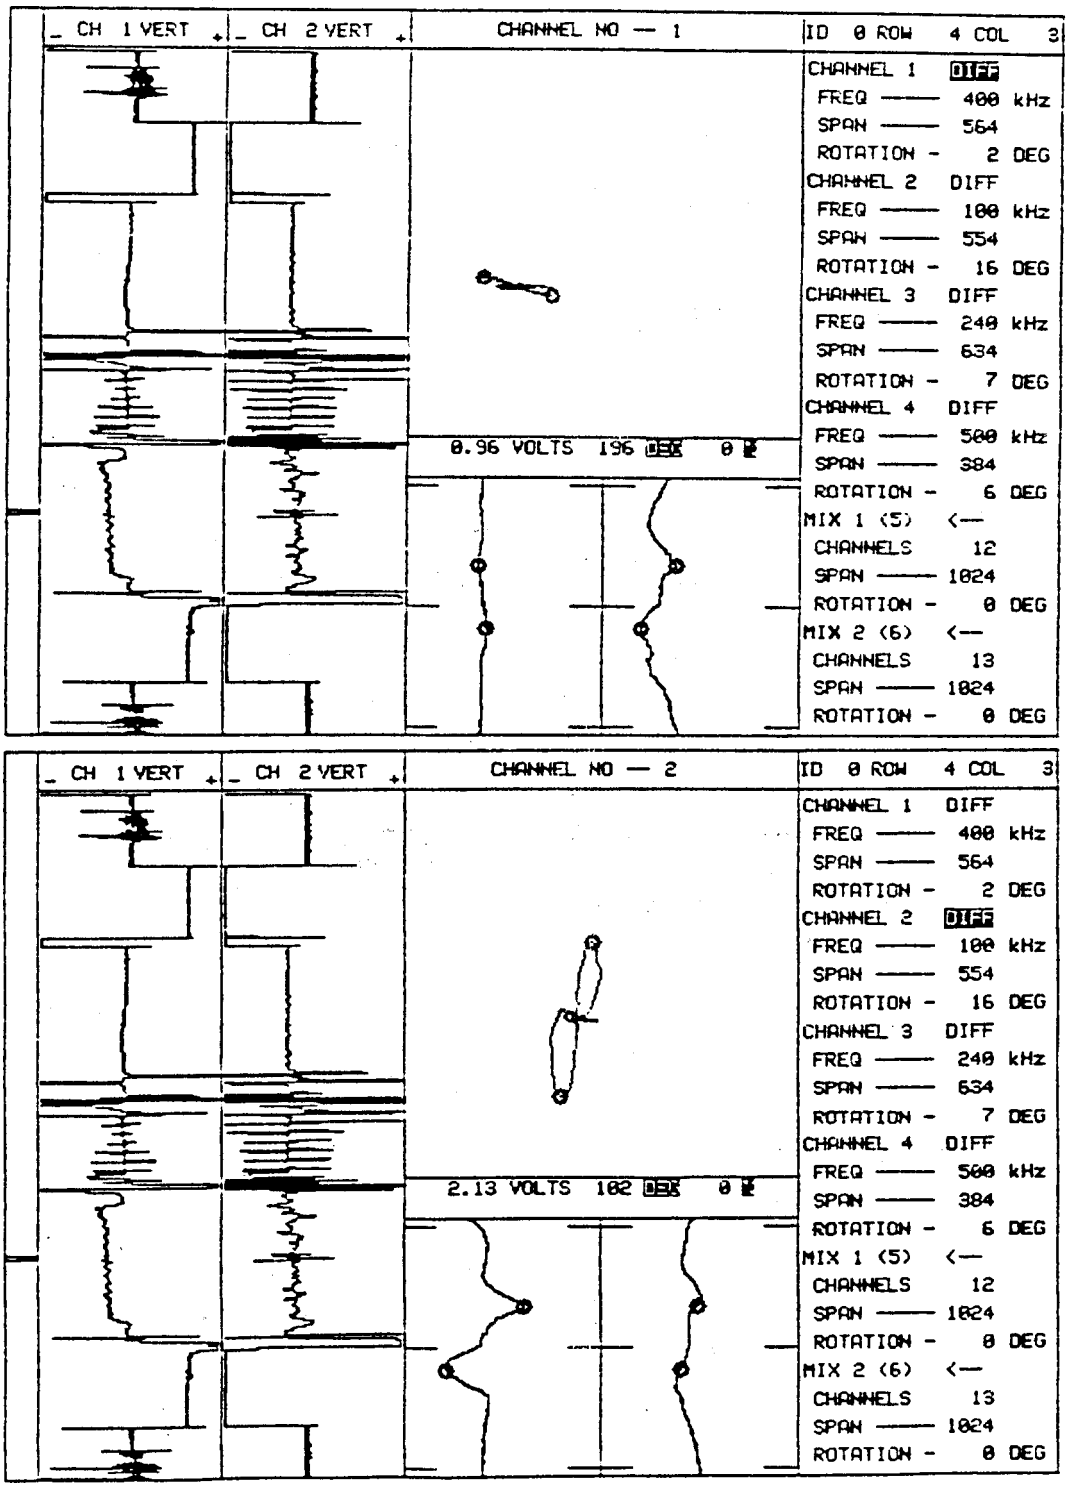
FIGURE 3.45 U-Bend Specimen 568 (R4 C3) Showing a Defect-Called Signal in U-Bend Area Which Turned Out to be an Interruption in the Copper-Rich Surface Deposits

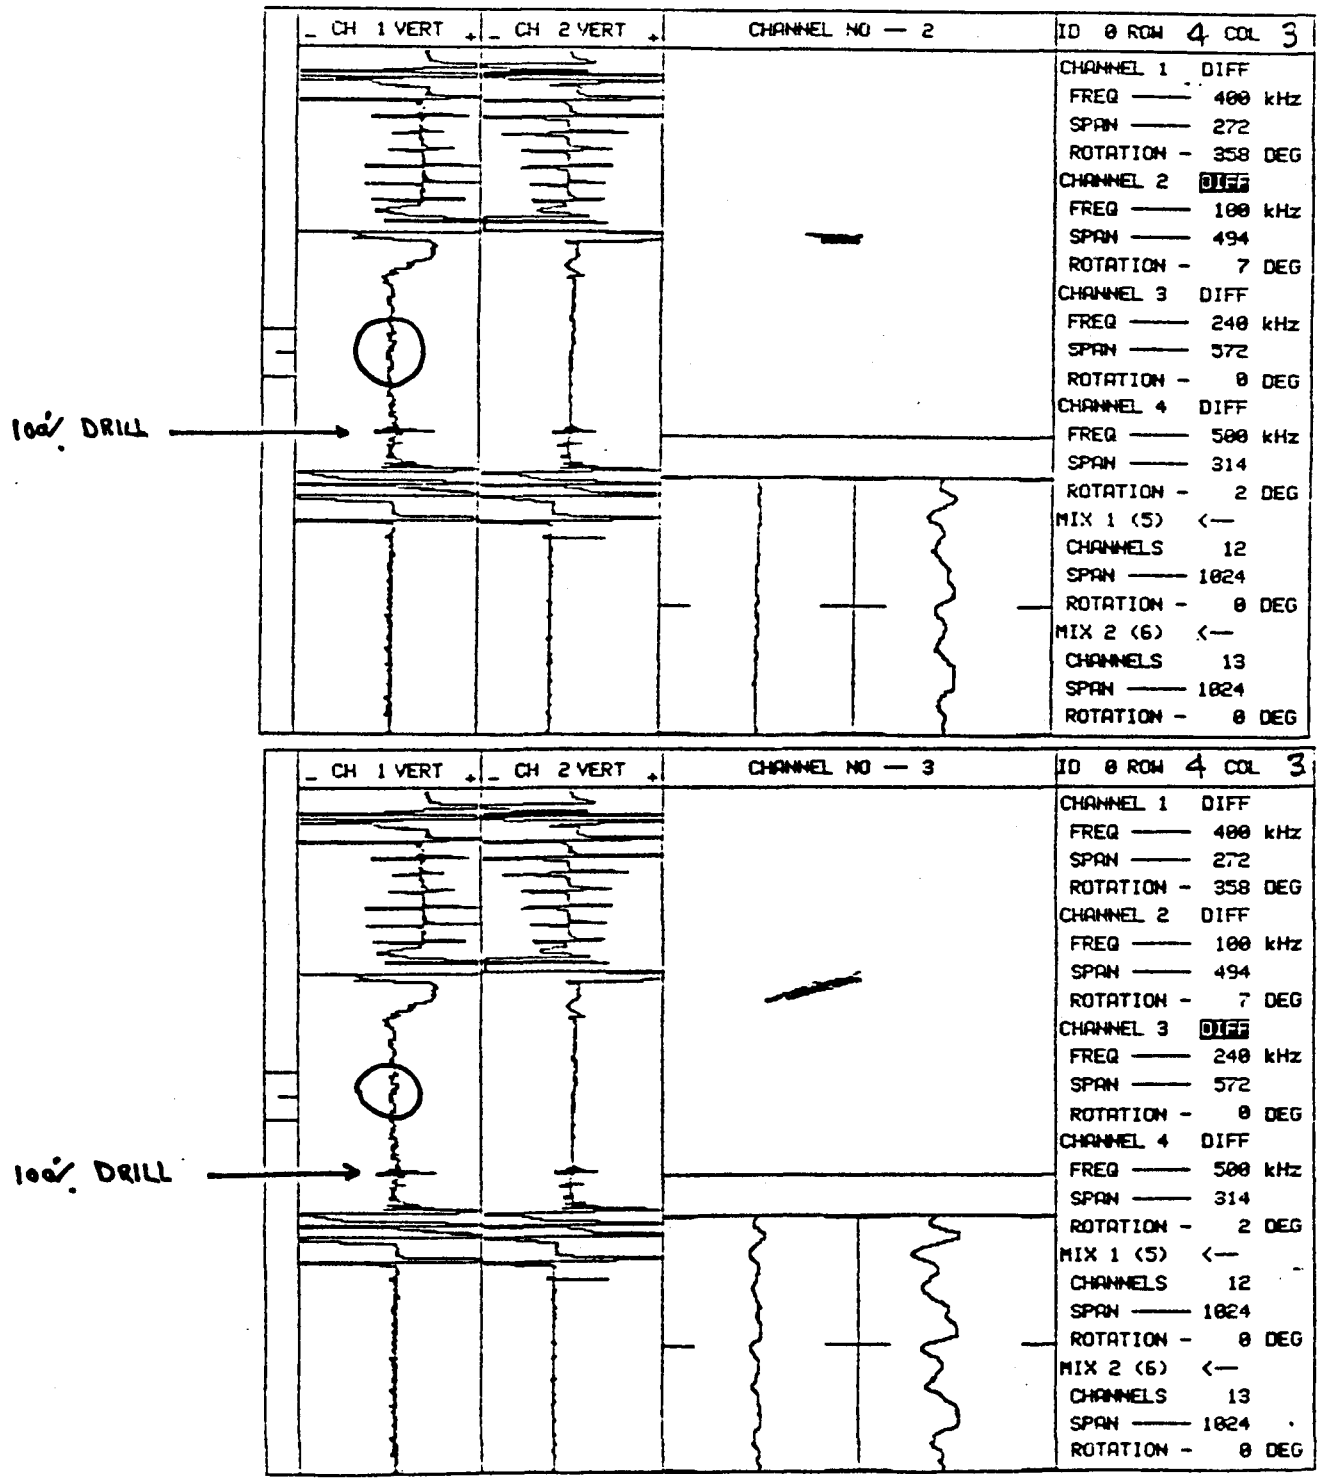
FIGURE 3.46. Specimen 568 (R4 C3) After Cleaning

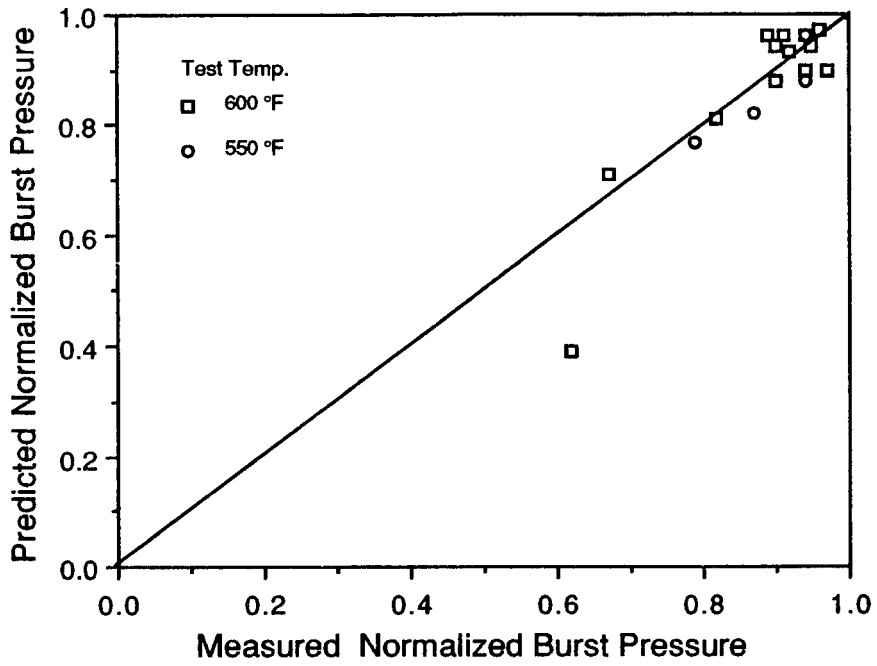
Figure 3.47 shows a plot of the calculated normalized burst pressure against measured values. Excellent agreement was obtained between calculated and measured values for the Phase I EDM notch empirical model. Similar results were obtained for the uniform-thinning model, but the elliptical-wastage model predicted burst pressures substantially below actual values. This model tended to overpredict burst pressure because it was developed from burst-test results on tubes with long axial elliptical wastage. All data points, except one, were within ±10% of perfect agreement. The one data point outside the ±10% range was from a tube in which failure was caused by an OD initiated SCC. The actual burst pressure of this tube was about 20% greater than the predicted value. This result was partially due to the method employed for characterizing the crack dimensions. The cracked portion of the tube was, in fact, composed of several small closely spaced cracks. To conservatively characterize the flawed area, an overall crack length consisting of the sum of the smaller cracks was used. The crack depth was estimated from post-test fracture surface measurements and a metallographic section taken through the center point where the crack had penetrated the tube wall. It is clear that the EDM notch empirical equation gave conservative results for the axial SCC when bounding dimensions were used to characterize its size.

FIGURE 3.47. Calculated Normalized Burst Pressure From EDM Slot Equation vs Measured Normalized Burst Pressure for Tubes Removed From the HLTTS Region With P/W Defects

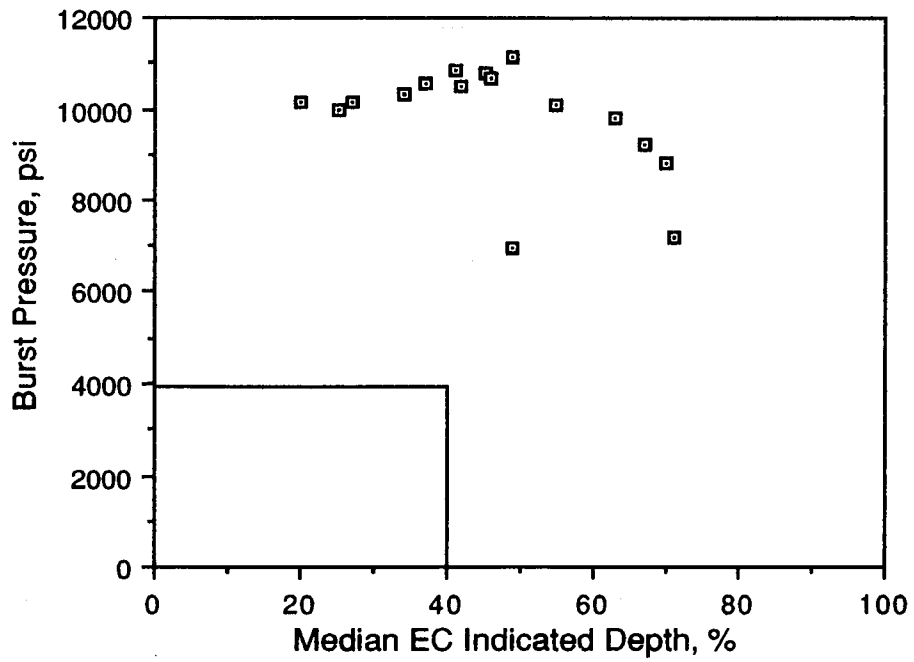
The burst-test results illustrate how bobbin-coil EC depth measurements provided a conservative estimate of remaining tube integrity even with significant undersizing. Figure 3.48 gives a plot of burst pressure versus median EC estimated defect depth for the Base-Line and DAARR teams. The boxed area in the lower left-hand corner of Figure 3.48 defines a zone bounded by the present 40% plugging limit and three (the present factor of safety specified in Regulatory Guide 1.121) times normal operating pressure differential. Note that none of the data fall within the nonconservative zone. This was because of the short axial extent of the pitting/wastage. Large uncertainty in the EC depth estimate can be tolerated when the true defect length is short (<0.25 in.). Thus, the 40% plugging limit is conservative for these defect types. Accurate measurement of defect depth becomes much more important when the defect length is greater than about one tube diameter.

FIGURE 3.48. Burst Pressure vs Median Eddy-Current Depth for Tube Segments From the Surry Steam Generator
