EPA-520/5-77-001

RADIOLOGICAL SURVEY OF PUGET SOUND NAVAL SHIPYARD BREMERTON, WASHINGTON, AND ENVIRONS

February 1977

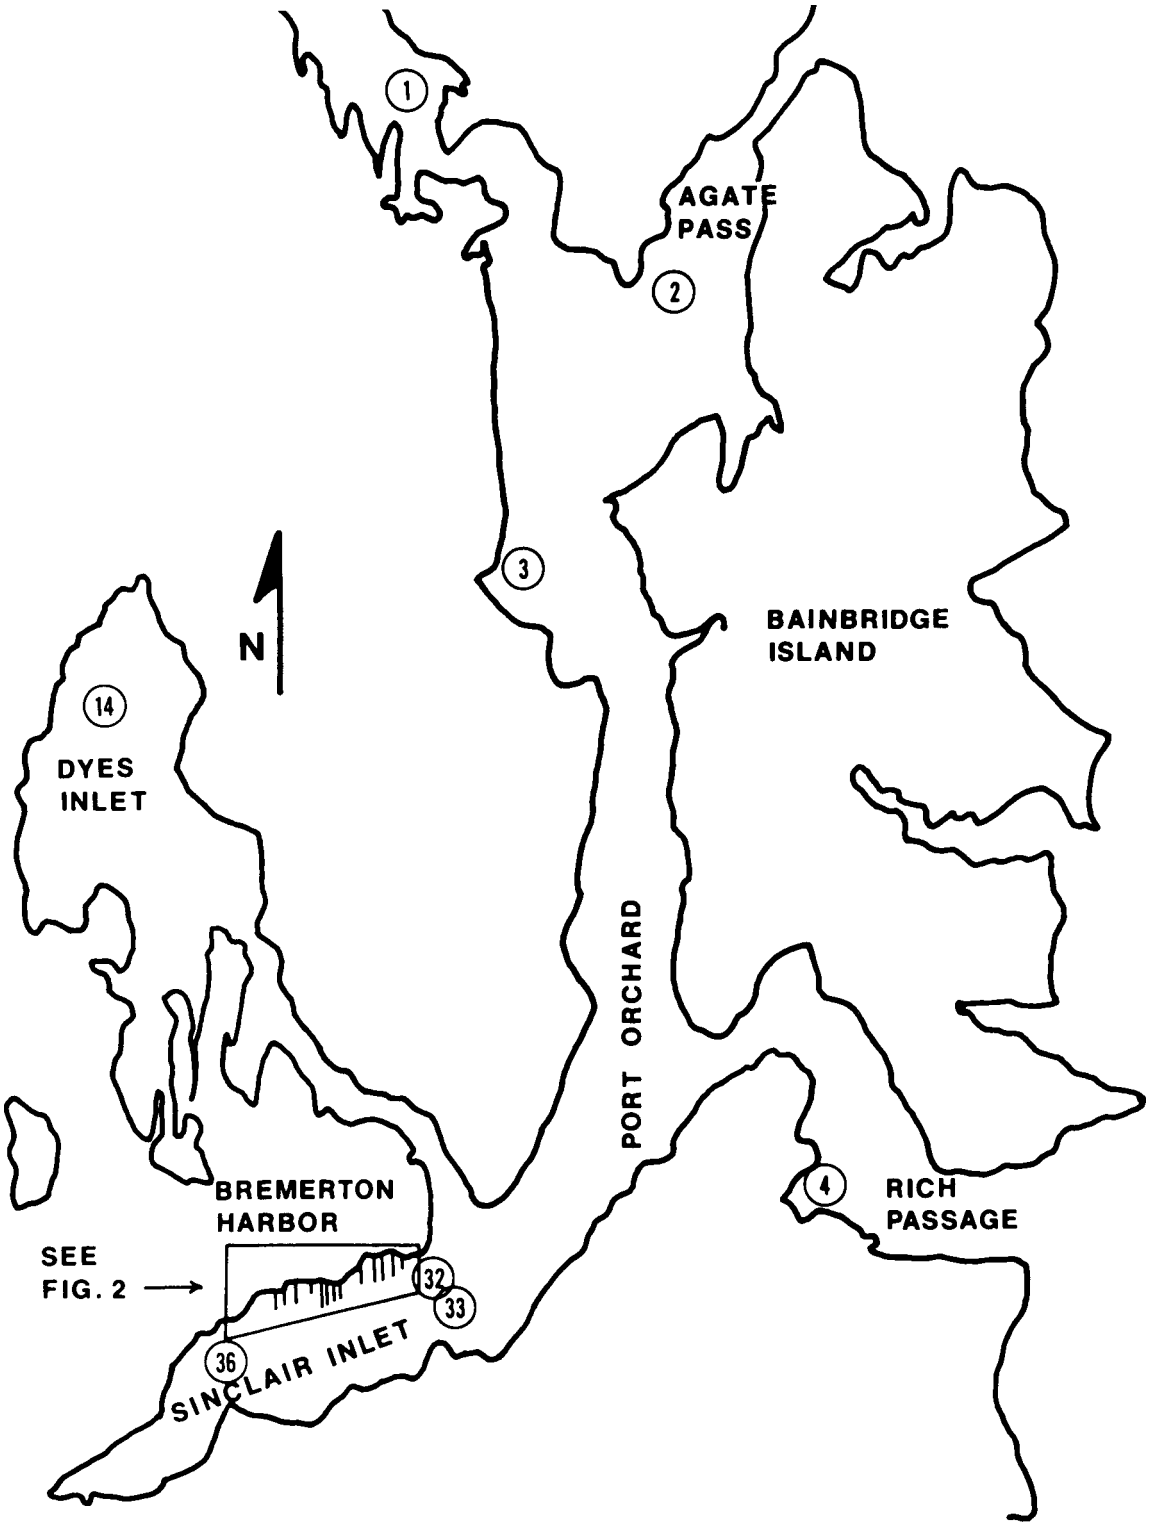
Figure 1. Sampling locations in the area

The sampling locations covered a large area with concentrated sampling in close proximity of the PSNS. These locations are shown in figures 1 and 2.

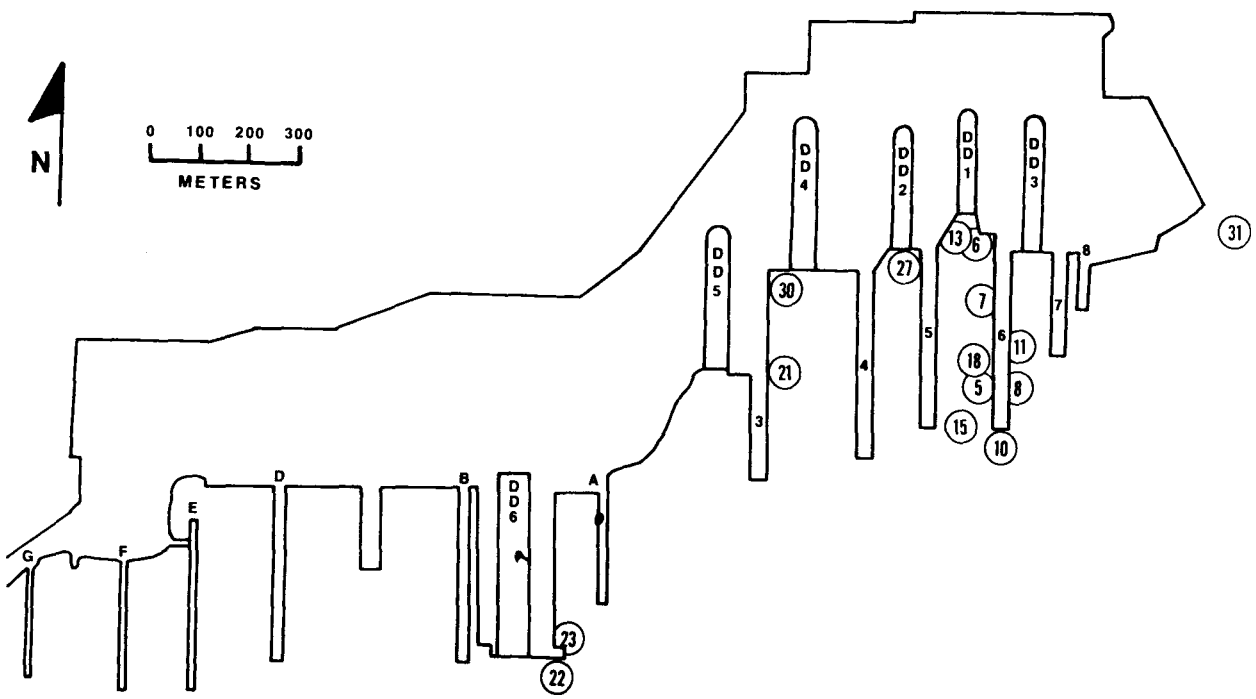
Figure 3. Locations of probe counts taken

Twenty-minute counts were taken and a background spectrum from location 1 (Liberty Bay) subtracted from each spectrum. Locations of probe counts taken in the vicinity of the shipyard are indicated in figure 3.

The underwater scintillation probe has proved useful in previous surveys (2) to quantitatively delineate general areas of radioactivity. The levels of activity encountered in this survey were below the detection limits for the underwater probe. Dredge samples were taken at locations where radioactivity seemed most probable based on the location of various operations within the shipyard.

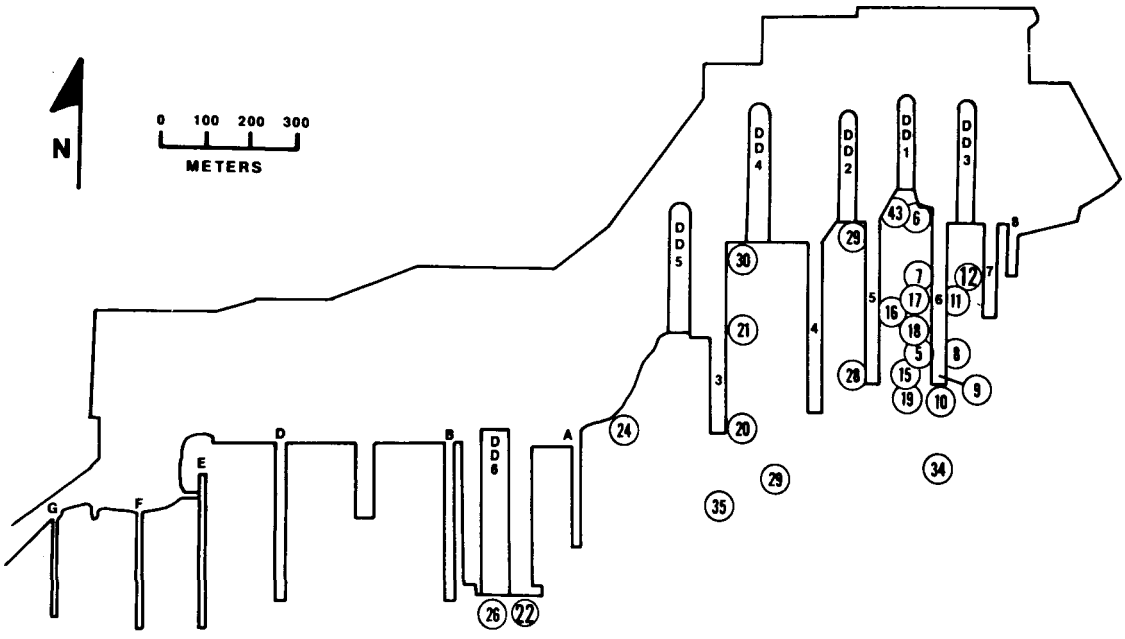
Figure 4. Silt sampling locations

Silt samples were taken at 34 locations and trace quantities of cobalt-60 were found in 9 (table 4). These results indicated that releases have taken place in the past. The levels determined are close to the limit of detectability (0.02 pCi/gm) indicating no significant releases have taken place for several years. The locations of the cobalt-60 activity in the shipyard area were expected due to past releases. However, the activity found at site 14 (Dyes Inlet) was unexpected. This activity was probably due to tidal action or possibly a release from another type of facility. The Navy Environmental Impact Statement for the TRIDENT support site on the Hood Canal stated that low levels of radioactivity from the AEC Reactors on the Columbia River could be detected in the Hood Canal marine life (5). The silt sampling locations in the vicinity of the shipyard are shown in figure 4.

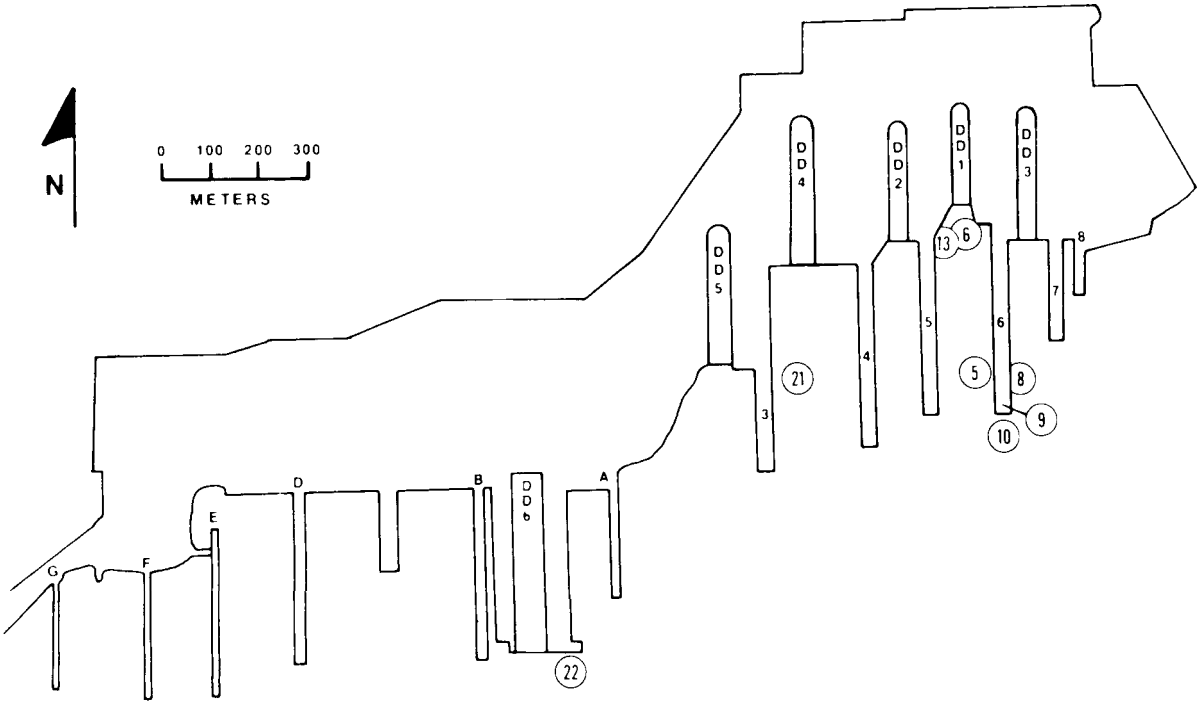
Figure 5. Core sampling locations

Core samples were collected at eight locations (see figure 5) to determine the vertical distribution of radioactivity in the sediment. The predominant activity found was from naturally occurring and typical fallout radionuclides. Only two samples collected at the south end of dry dock 6 had detectable amounts of

cobalt-60. A comparison of the silt and core samples is difficult because the levels observed were close to the limits of detectability. The analytical results from the core samples are shown in table 5.

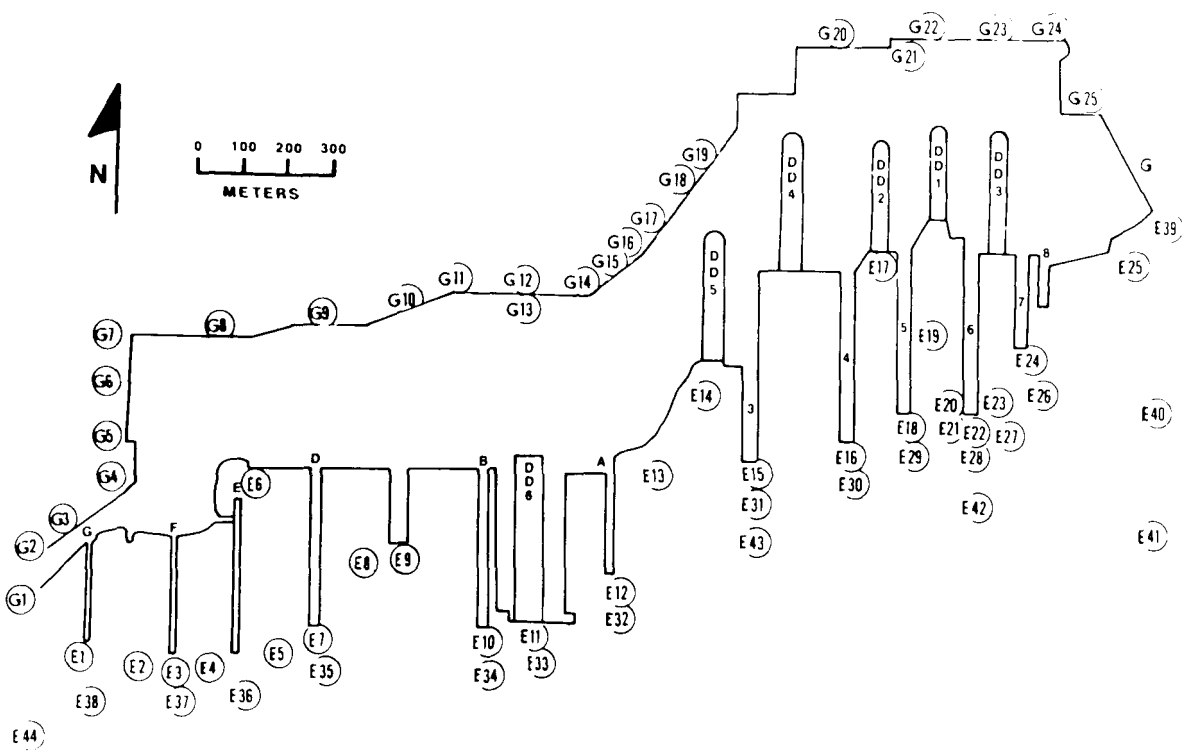
Figure 6. Locations of external gamma radiation measurements

Measurements of the external gamma radiation exposure were made at several locations using a PIC (figure 6). A series of measurements was taken along the industrial security fence on the north edge of PSNS. A series of measurements was also made over water along an imaginary line approximating the shipyard boundary in Sinclair Inlet running approximately 185 meters from the ends of the piers. These locations were chosen because they represented the nearest sites that were accessible to the general public.

Along the industrial fence at the northern and western perimeters of PSNS only one location had a gamma-radiation level which was higher than the gamma background for the area (see table 6). Measurements indicated the average background from cosmic and terrestrial radiation for the area to be 6.6 ± 1.2 micro-roentgens per hour (μR/hr). At the western end of the shipyard, location G1 on figure 6, the gamma radiation level was 8.5 μR/hr. At this location fill material had been used to stabilize the shoreline against erosion, and this material was noted to be a possible source of the elevated exposure.

The series of PIC measurements taken on the inlet off the ends of the piers (E39 through E44) produced gamma-radiation levels which were no different than background levels over water in that area (Table 7).

Measurements E1 through E38 were made between and adjacent to the piers and dry docks of the shipyard (figure 6). At locations E20 through E23 and locations E27 and E28, elevated gamma radiations were evident. The source of these elevated readings appeared to be the Radiological Support Building.
