AN ANALYSIS OF THE CAUSES OF FAILURE IN HIGH CHROME OXIDE REFRACTORY MATERIALS FROM SLAGGING GASIFIERS

James Bennett, Kyei-Sing Kwong, Cindy Powell, Hugh Thomas, and Rick Krabbe
USDOE, Albany Research Center, Albany, OR, USA 97321

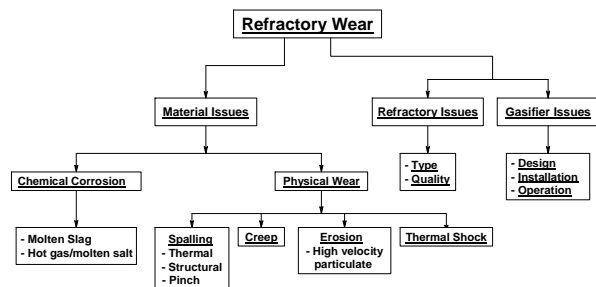
Fig. 2: Causes of refractory wear.

A general evaluation of the causes of refractory wear based on studies of samples removed from slagging gasifiers is shown in figure 2. Other issues not listed may cause refractory wear. Gasifier issues impacting wear include temperature, slag chemistry, slag viscosity, carbon feedstock throughput, and gasifier cycling. Of the causes listed, chemical corrosion (dissolution of the slag) and spalling have been found to be the predominant cause of wear that can be controlled through engineered refractory composition. Wear related to thermal cycling is typically caused by maintenance or repair of the gasifier or downstream components of the gasification system.

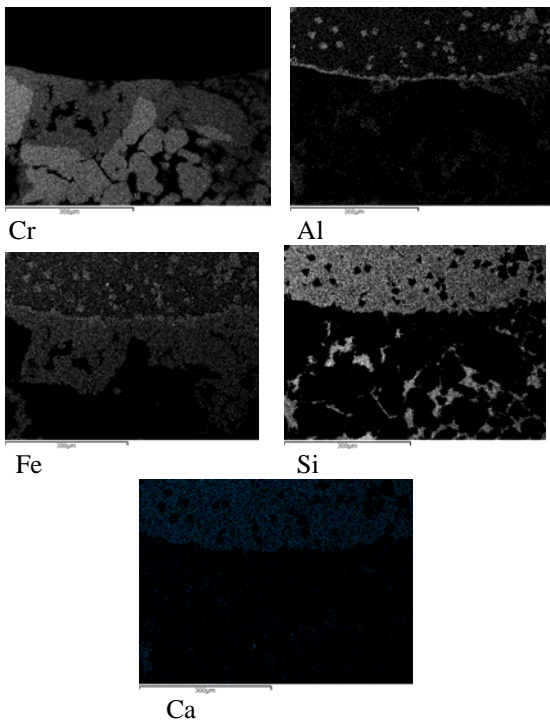
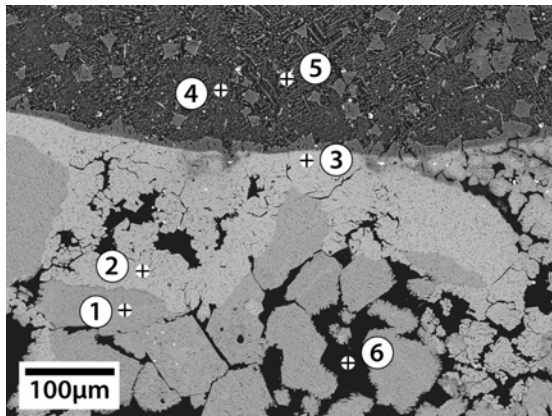
Fig. 8: SEM backscatter imaging and elemental mapping of a cross section of spent refractory.

The SEM backscatter image and elemental maps in figure 8 indicate that chrome and iron interact at the refractory surface; that alumina builds up a concentrated layer at the slag/refractory interface; and that the slag that penetrates into the refractory contains silicon, aluminum, and calcium. The reason for the buildup of alumina on the slag/refractory interface is being studied. It is of interest to note that where the slag interacts with the high chromia/alumina refractory, a fractured surface appears to form. The compound

formed is probably a solid solution of Cr_2O_3 and FeO. The impact of this on slag wear is being evaluated.

Point	Element (wt pct)				
	Cr	Al	Fe	Si	Ca
1 – ref. grain	63.8	5.7	-	-	-
2 – ref. grain	37.8	5.6	25.2	-	-
3 – ref. grain	39.9	3.5	24.0	-	-
4 - slag	-	7.2	21.1	23.2	3.5
5 – crystal slag	-	27.0	31.1	-	-
6 – interior slag	1.3	8.0	1.4	32.7	1.6
