Date Submitted: 11/14/07 Originator: L. M. Dittmer Phone: 372-9227	**WASTE SITE RECLASSIFICATION FORM** Operable Unit(s): 100-BC-1 Waste Site Code: 100-B-18 Type of Reclassification Action: Closed Out ☐ Interim Closed Out ☒ No Action ☐ RCRA Postclosure ☐ Rejected ☐ Consolidated ☐	Control Number: 2007-020

REMAINING SITES VERIFICATION PACKAGE FOR THE 100-B-18, 184-B POWERHOUSE DEBRIS PILE

Attachment to Waste Site Reclassification Form 2007-020

December 2007

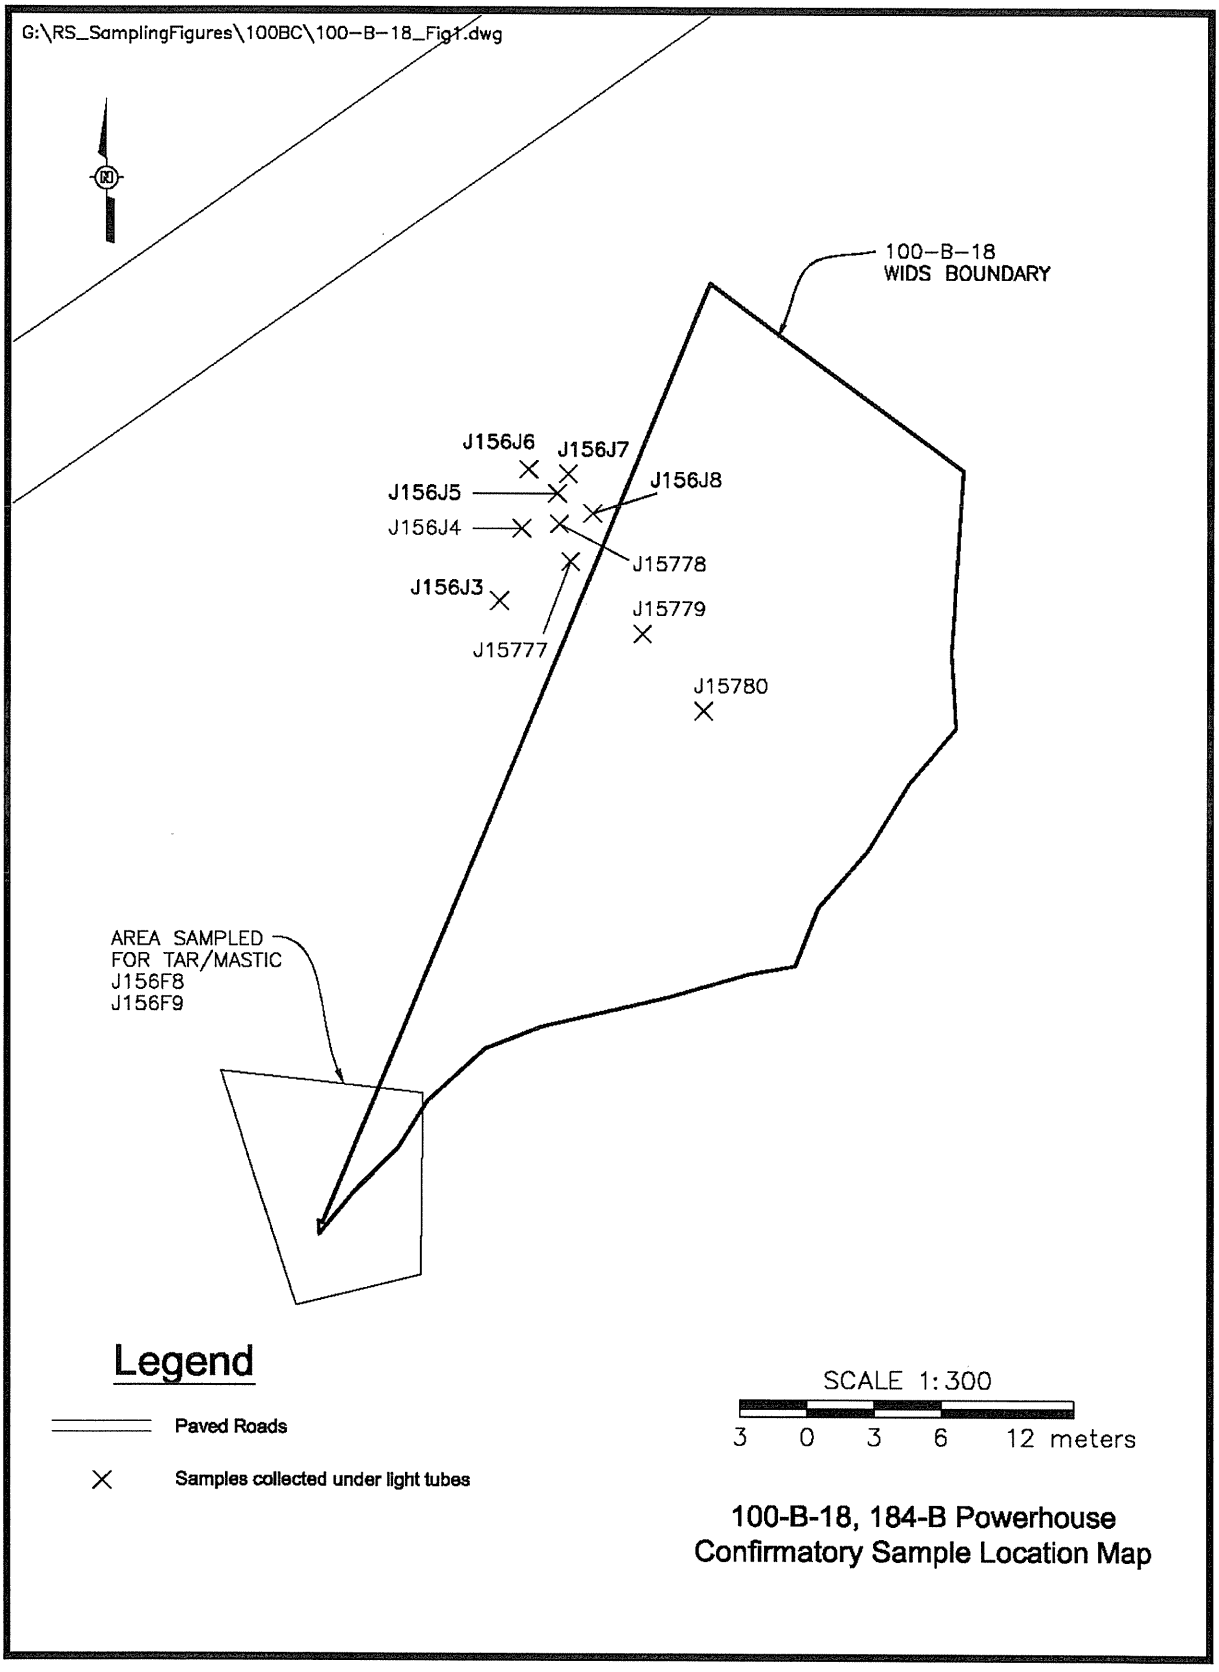
Figure 3. Sample Locations at the 100-B-18 Waste Site.

Verification sampling at the 100-B-18 site was performed on June 27, 2007, of the soils underlying the locations where the tar/mastic debris had been removed. One focused sample, composed of 25 random aliquots, was collected and analyzed for GEA, gross alpha, gross beta, inductively coupled plasma (ICP) metals, mercury, PCBs, PAHs, and VOA. The sampling area for the soil underlying the tar/mastic debris is shown in Figure 3.

A summary of the samples collected and the laboratory analyses performed are provided in Table 1. Figure 3 identifies the verification sample locations.

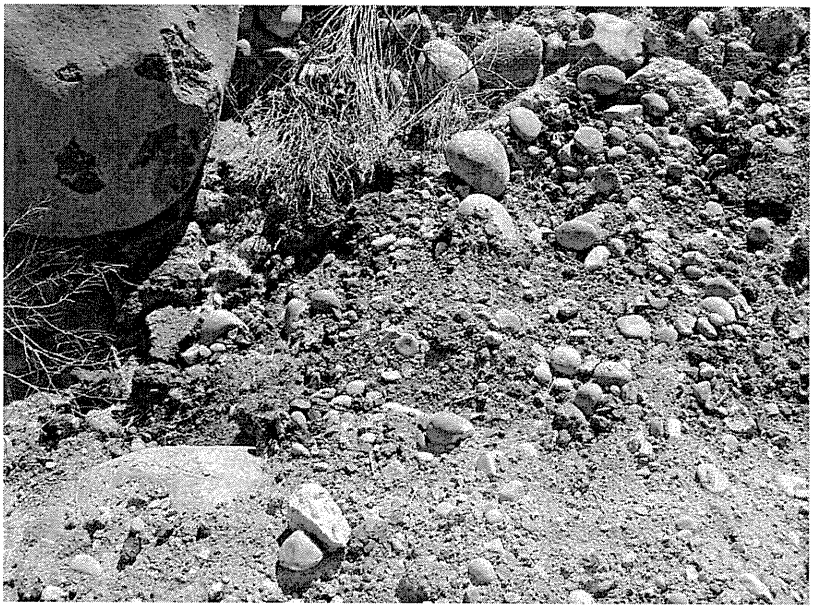
Figure 4. Visible Residual Asphalt Material Present in the Remediation Footprint at the 100-B-18 Site.

Asphalt that has been used for structural and construction purposes is excluded from consideration as a dangerous waste in *Washington Administrative Code* (WAC) 173-303-071(3)(e), is listed as an inert waste in WAC 173-350-990(2)(b), and does not present a significant risk to human health or the environment; therefore, asphalt debris present at the site was not removed.

Several PAHs were detected in the verification samples for the 100-B-18 site, above the direct exposure, groundwater, and river protection RAGs presented in the RDR/RAWP (Table 2). These samples were collected of soils underlying areas that had been remediated for potentially hazardous tar/mastic material. The detections of PAHs in the samples were determined to be the result of asphalt cross-contamination in the samples. The 100-B-18 site contains high amounts of asphalt roofing and residual fragments of asphalt material in the soils where the remediation occurred. Figure 4 is a photograph of the residual asphalt material present in the remediation footprint. Residual fragments of asphalt roofing within the verification samples collected after remediation would result in the observed elevated detections of PAHs. A comparison of the detected PAHs in the verification data set to a known asphalt sample (Table 3) shows a reasonable correlation, as indicated by the "ratio" column. Asphalt that has been used for structural and construction purposes is excluded from consideration as a dangerous waste in WAC 173-303-071 (3)(e), and is listed as an inert waste in WAC 173-350-990(2)(b). As such, the
