DOE/WIPP-08-3177
Volume 1

Waste Isolation Pilot Plant

Geotechnical Analysis Report For July 2006 – June 2007

U.S. Department of Energy

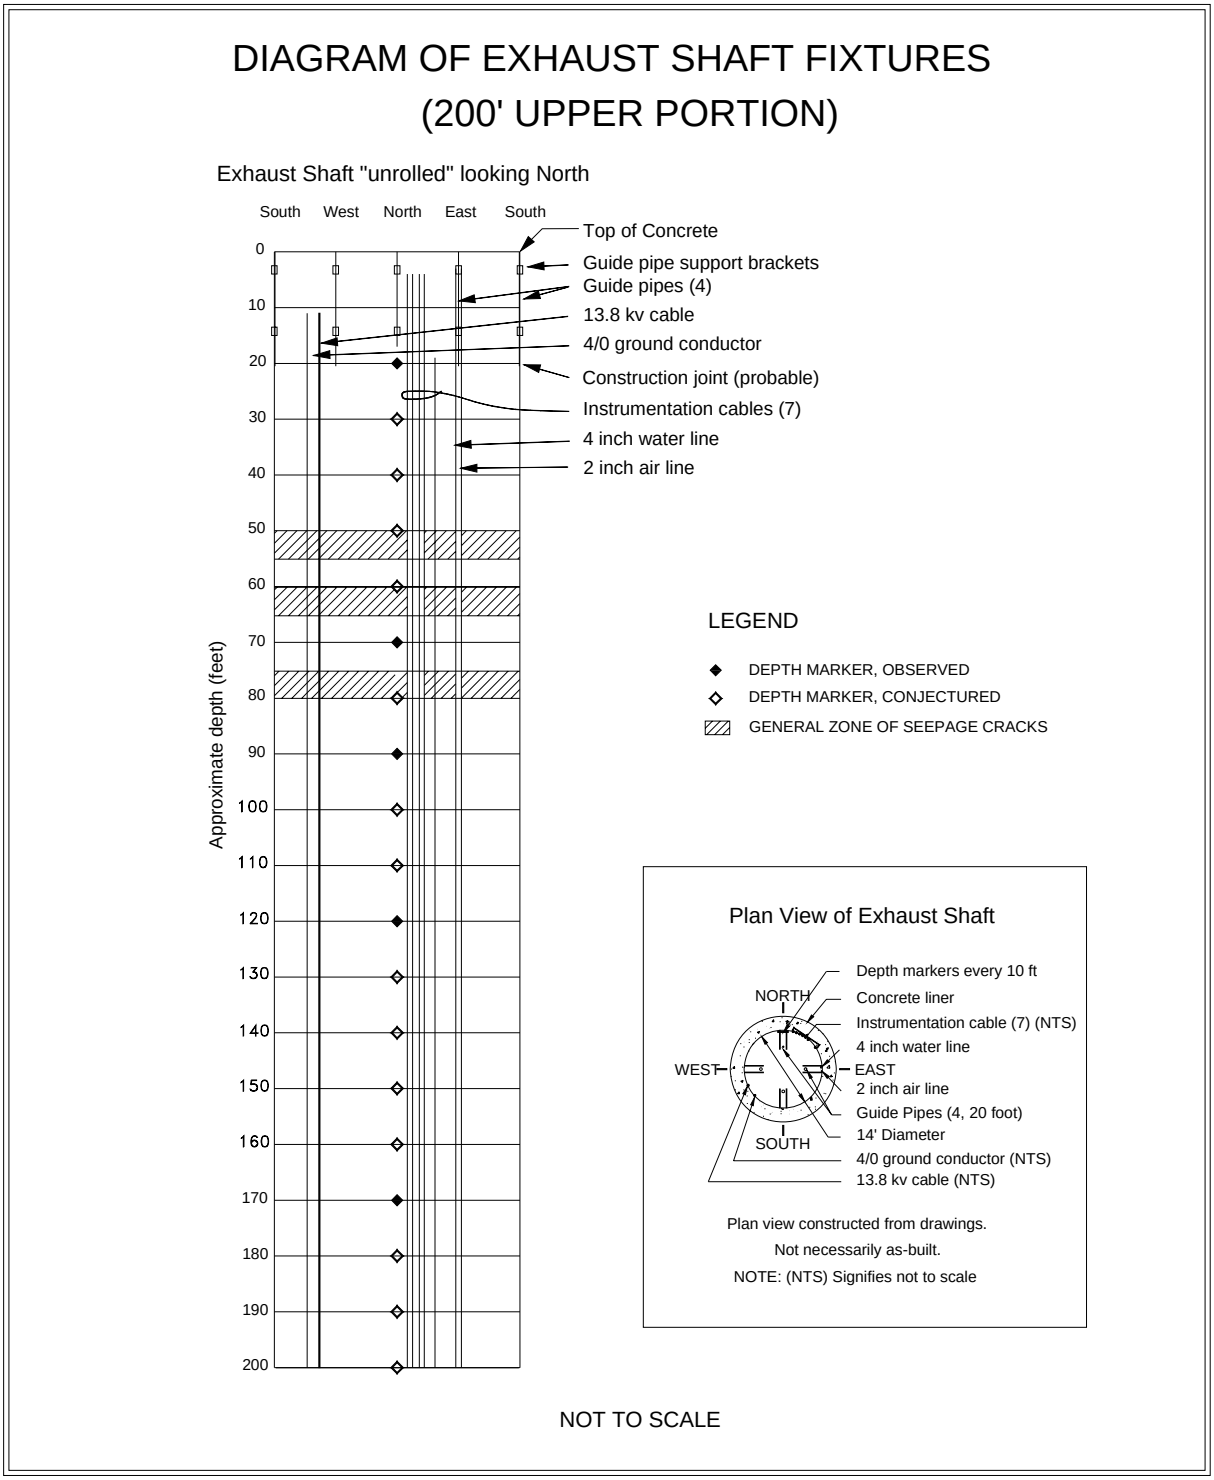
Figure 3-9 – Diagram of Exhaust Shaft Fixtures and Seepage Zones (Upper 200 ft)

The Exhaust Shaft liner is examined for cracks, seepage, and general shaft stability. Currently, there are three principal zones of seepage in the shaft. The first is about 50 to 55 ft below the shaft collar (bsc). The second is about 60 to 65 ft bsc. The third is about 75 to 80 ft bsc, as shown in Figure 3-9. Monitoring of seepage horizons started before 1995. Water entering the shaft through these cracks is believed to originate from a perched aquifer at the base of the Santa Rosa Formation that is being recharged as the result of surface modifications at the site. The fluid level in the Santa Rosa near the shaft is about 43 to 44 ft below the surface. Based on examination of inspection videos, the flow rate into the shaft during this reporting period is estimated at about 1 to 1-1/2 gallons per minute, most of which is carried out of the shaft with the exhaust air. Seepage cracks are confined primarily to the eastern side of the shaft wall.

Though the Magenta and Culebra water rings are encrusted with salt buildup, no water appears to emanate from the liner or water rings. Most of the seepage was observed along the east face of the shaft wall near the instrumentation cables and the air lines and waterlines in the upper section of the shaft. Though the presence of water is an inconvenience requiring periodic disposal, at this time it does not appear to have created any hazard or affected the structural integrity of the shaft. However, brine increases the probability of corrosion and deterioration of utility hangers and brackets. There are no visible signs of dissolution of the salt below the key.

When fluid was detected seeping into the Exhaust Shaft, a catch basin was designed and installed at the base of the shaft to intercept water and prevent it from draining into the Waste Shaft Sump. Fluid was removed from the catch basin from March 1996 through October 2005 as needed. The catch basin was damaged in 2004 by fallen debris, either salt or instrumentation cables or both. A new catch basin was fabricated and installed in December 2004. This basin was damaged in August 2005, most likely the result of fallen debris. An interception well system was installed between November 2005 and March 2006 to replace the catch basin. Interception wells were drilled down-gradient in S-400 between E-140 and E-300 (Figure 3-10). The interception well system consists of four 30-ft deep 9-7/8-in diameter holes with a submersible pump and pressure transmitter in each. Fluid is pumped from each borehole to a series of storage containers in S-550. A data-acquisition system monitors the fluid level in each hole, turning the pump on or off between set limits as needed.

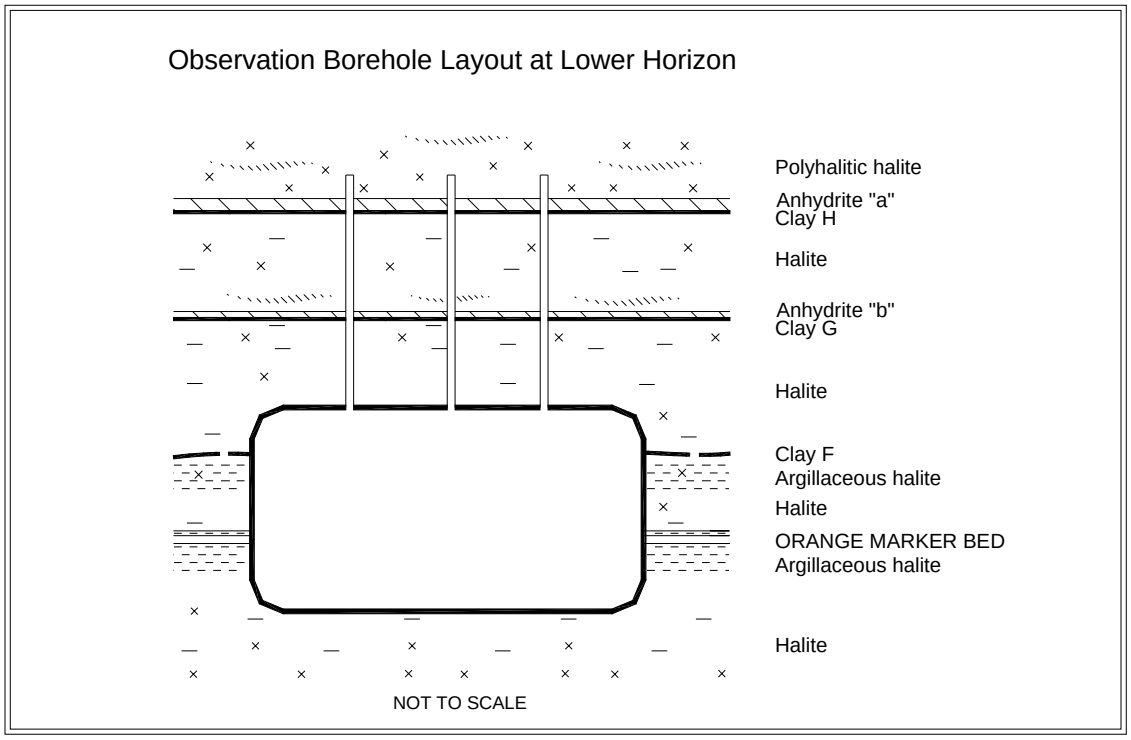
Figure 7-1 – Example of Observation Borehole Layout at Lower Horizon

Geotechnical observation boreholes are drilled at various locations throughout the underground facility. A location may contain one or more boreholes arranged in an array. These holes are drilled to depths that allow the monitoring of fracture development and offsetting and are inspected for the development of those features. Roof observation holes usually extend up past clays "G" and "H" (Figures 7-1 and 7-2).

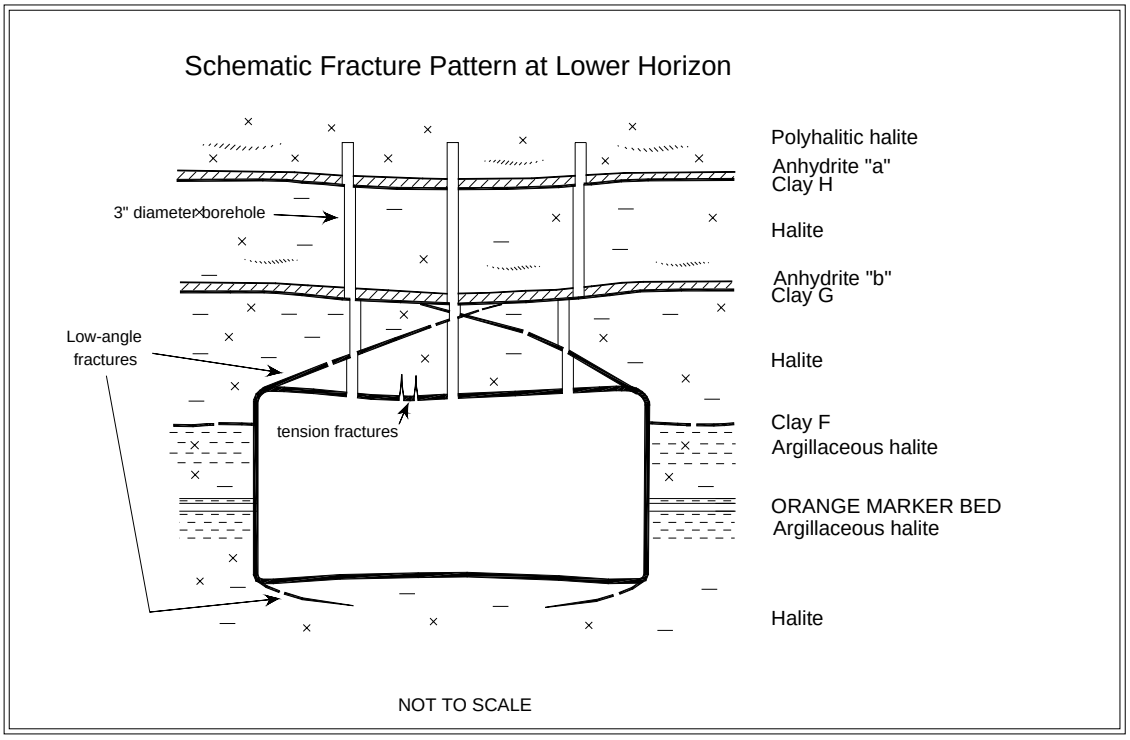
Figure 7-3 – Typical Fracture Patterns at Lower Horizon

Fracture development in the roof is primarily caused by the concentration of compressive stresses in the roof beam and is influenced by the size and shape of the excavation and the stratigraphy in the immediate vicinity of the opening. In a thick roof beam, pillar deformations induce lateral compressive stresses into the immediate roof and floor. With time, the buildup of stress causes differential movement along stratigraphic boundaries. This differential movement is identified as offsets in observation boreholes and by the bends in failed rock bolts. Large strains associated with lateral movements can induce fracturing in the roof, which is frequently seen near the ribs; however, this process may take a long time (years) to develop.

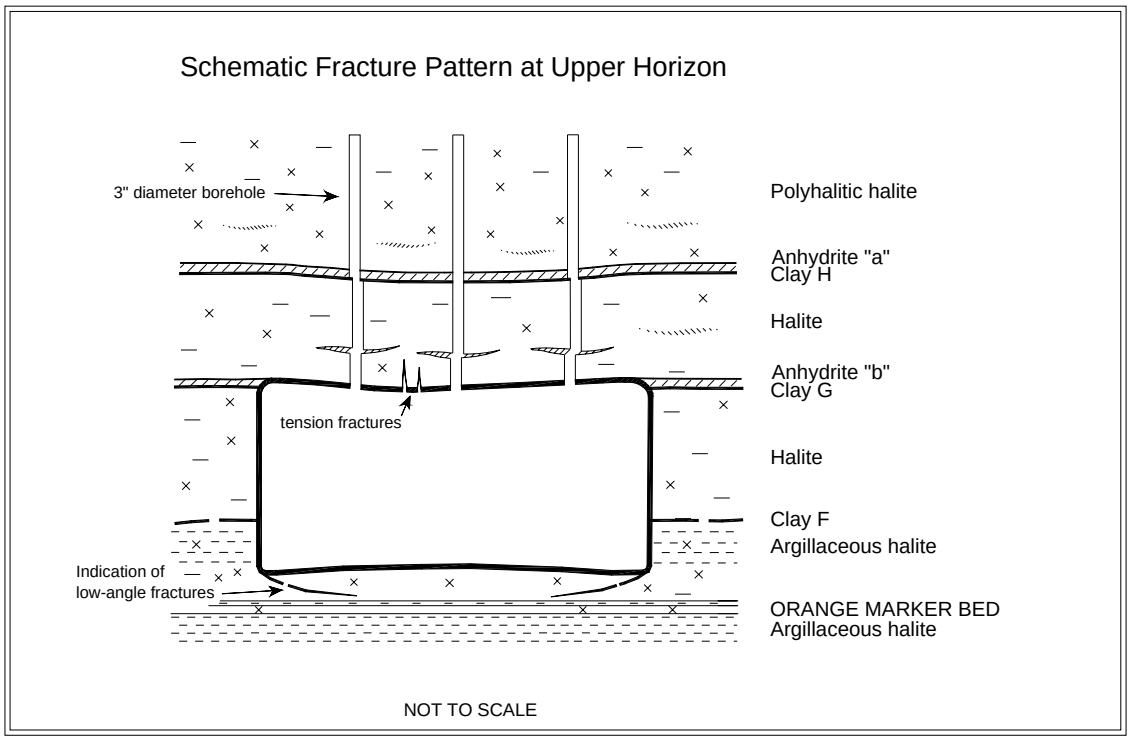
Figure 7-4 – Typical Fracture Patterns at Upper Horizon

At the upper repository horizon, clay or anhydrite stringers exert significant influence over the effective thickness of the roof beam. The presence of these stringers causes the roof beam to behave as a series of thin independent beams. Little or no tensile support is provided across the stringer interface. As horizontal end-loading continues, each beam can deflect downward causing a tensile fracture to develop along the bottom of the beam. These tensile fractures can develop in relatively new excavations soon after separation occurs along the stringer interface.
