**CORROSION ANALYSIS OF DECOMMISSIONED CARBON STEEL
WASTE WATER TANKS AT BROOKHAVEN NATIONAL LABORATORY**

P. SOO and T.C. ROBERTS

JULY, 1995

**ENGINEERING RESEARCH AND APPLICATIONS DIVISION
DEPARTMENT OF ADVANCED TECHNOLOGY
BROOKHAVEN NATION LABORATORY
UPTON, NY 11973-5000**

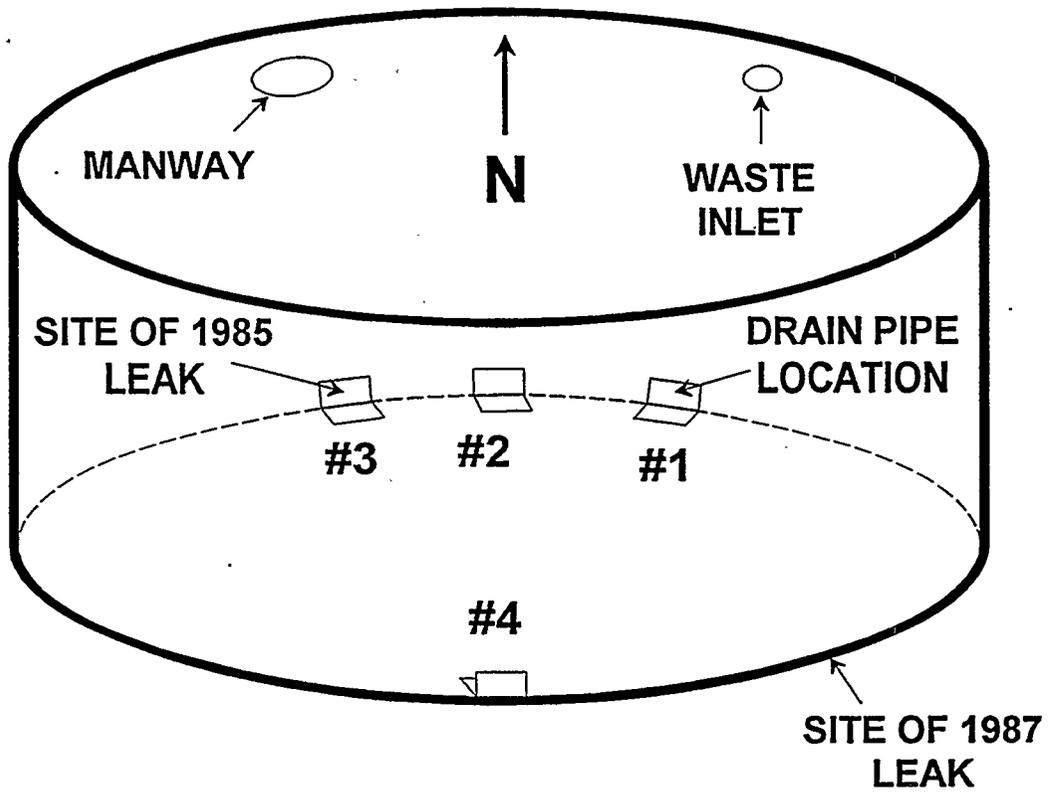
Piece #1 from Tank D3 was selected since it contained a flange and section of 6 in. pipe that was part of the tank drain line that led to the evaporator. The intent was to examine the welds in this region to determine if they were potential sources of leakage because of the relatively complex geometry and extra welds which could cause high residual stresses. The other two pieces from Tank D3 (#s 2,4) were chosen as controls. Since, as noted above, the tank samples had their internal surfaces cleaned with high-pressure water to remove loose scale, some information on the nature of the corrosion processes within the tanks was unavoidably lost.

Figure 3. Schematic Showing Sample Locations Cut From Tank D3.

Figure 6 shows a photograph of Piece #3 (see Fig. 3). The base section was heavily rusted. The wall still shows the presence of the white Amercoat paint. A large slightly elongated hole about one inch in diameter is indicated by an arrow. This is the site of the original pinhole leak. Two additional holes were detected in the adjacent base section about two inches apart adjacent to a weld seam. One was about one inch in diameter and the other about half this size. The larger hole is also marked by an arrow in Figure 6, but the smaller base hole is not easily seen. Figure 7 shows the welded patch over the original leak. The 1.5 inch air gap between the patch and tank wall is clearly visible. Figure 8 is a schematic of Piece #3. As discussed, above, the holes in the tank floor probably increased in size after the tank had been drained.
