Creep damage development in welded X20 and P91

M08-803

VÄRMEFORSK Service AB
101 53 STOCKHOLM · Tel 08-677 25 80
Mars, 2011
ISSN 1653-1248

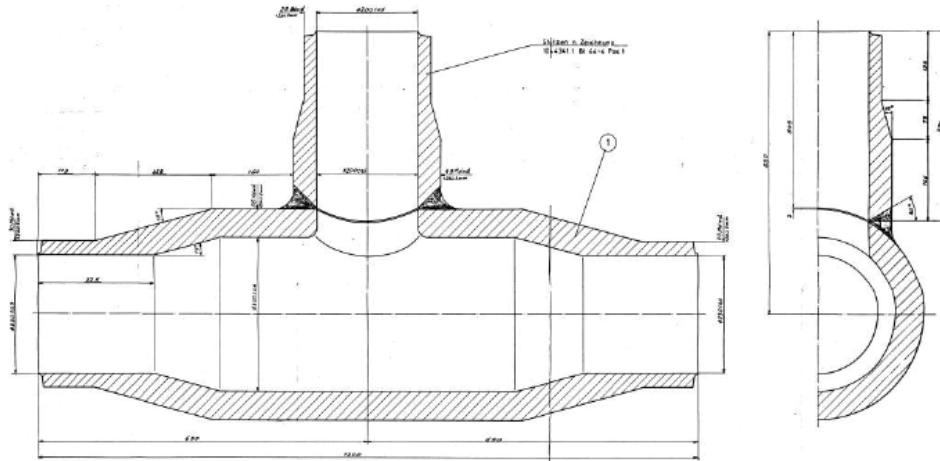
Welded HP bypass branch connection.

First inspection of the HP-bypass branch connections was in 2002 after 136.500 service hours with inspection of RA11 and RA12. At the inspection of RA11 a small amount of microcracks as well as a small amount of oriented cavities were observed; located at both upper and lower flank position in the branch body HAZ and at one occurrence in weld metal.

Re-inspection of RA11 branch weld in 2004 after total 146.000 service hours showed a 40 mm crack indication with magnetic particle testing close to the upper flank position. No indication was observed after 0,2 mm grinding. In the standard upper flank replica position an extensive amount of microcracks and extensive amount of orientated cavities was observed in branch body HAZ. Further grinding showed decreasing creep damage class with extensive amount of isolated cavities in approximately 3mm depth. Lower flank position showed extensive amount of oriented cavities in branch body HAZ.

RA11 followed by RA14 showed the highest level of creep damage in branch weld; mainly in the upper flank position but also with damage development in lower flank position. RA12 and RA13 showed various amounts of isolated cavities in a few positions. Only very few observations with small amounts of isolated cavities were observed for circumferential welds.

All four HP-bypass branch connections were replaced in 2005. RA11 branch connection was stored for further investigations, which is reported separately in this Värmegeforsk project.

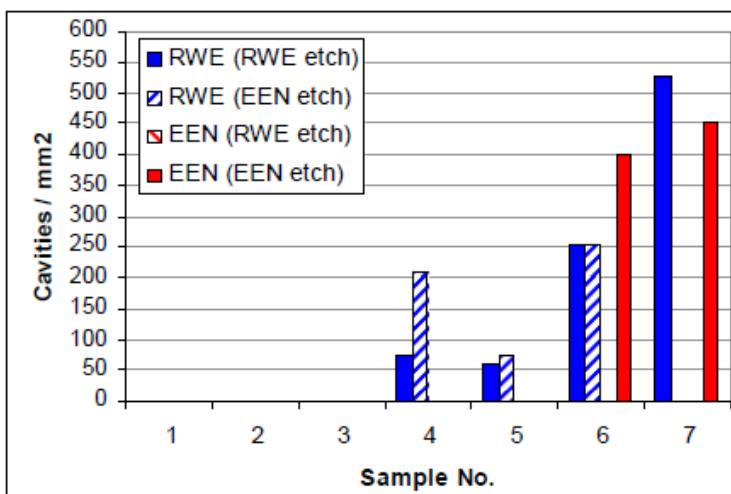
Graph comparing cavitation levels measured by EEN and RWE the Type in IV region of the investigated specimens. Note: no values were provided by EEN for RWE etch.

This exercise has highlighted potential sources of errors during the assessment of creep cavitation in Grade 91, particularly from the sample preparation stage, i.e. errors might be induced on further grinding (repreparation) which might reveal/conceal cavities, and from the assessment stage, i.e. errors from counting cavities/features from the manufacturing process (voids associated with globular inclusions, etc.).

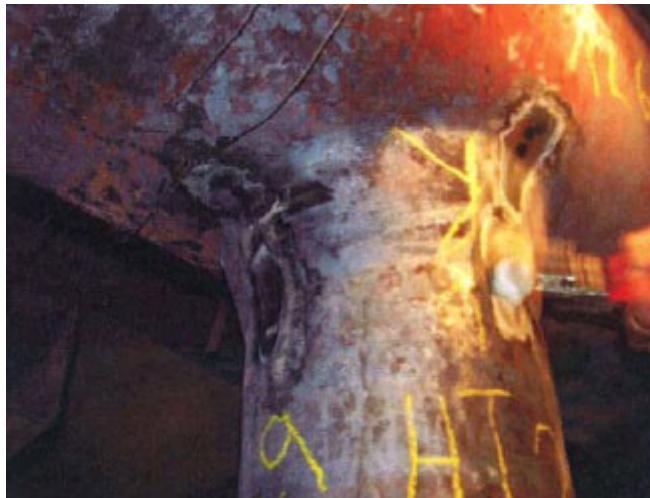
Because of this it was decided to carry out a non-destructive testing programme at Nordjyllandsværket in the summer of 2008. The two components with the shortest lives were selected for this NDT work performed by FORCE Technology. The investigation showed that no creep damage whatsoever was found. A total of 50 replicas were made of three welds and all microstructures were given a damage level of “Class 1”, which corresponds to no creep damage.

Replication in progress of the collector
