**PROCESS SYSTEMS OF PHWR  
INDIAN EXPERIENCE**

TECHNICAL COMMITTEE MEETING  
ON  
EXCHANGE OF OPERATIONAL SAFETY EXPERIENCE  
OF PRESSURISED HEAVY WATER REACTORS  
EMBALSE, CORDOBA, ARGENTINA  
3-5 APRIL 1991

T.S.V. RAMANAN  
DY. CHIEF SUPDT.,  
MAPS, INDIA.

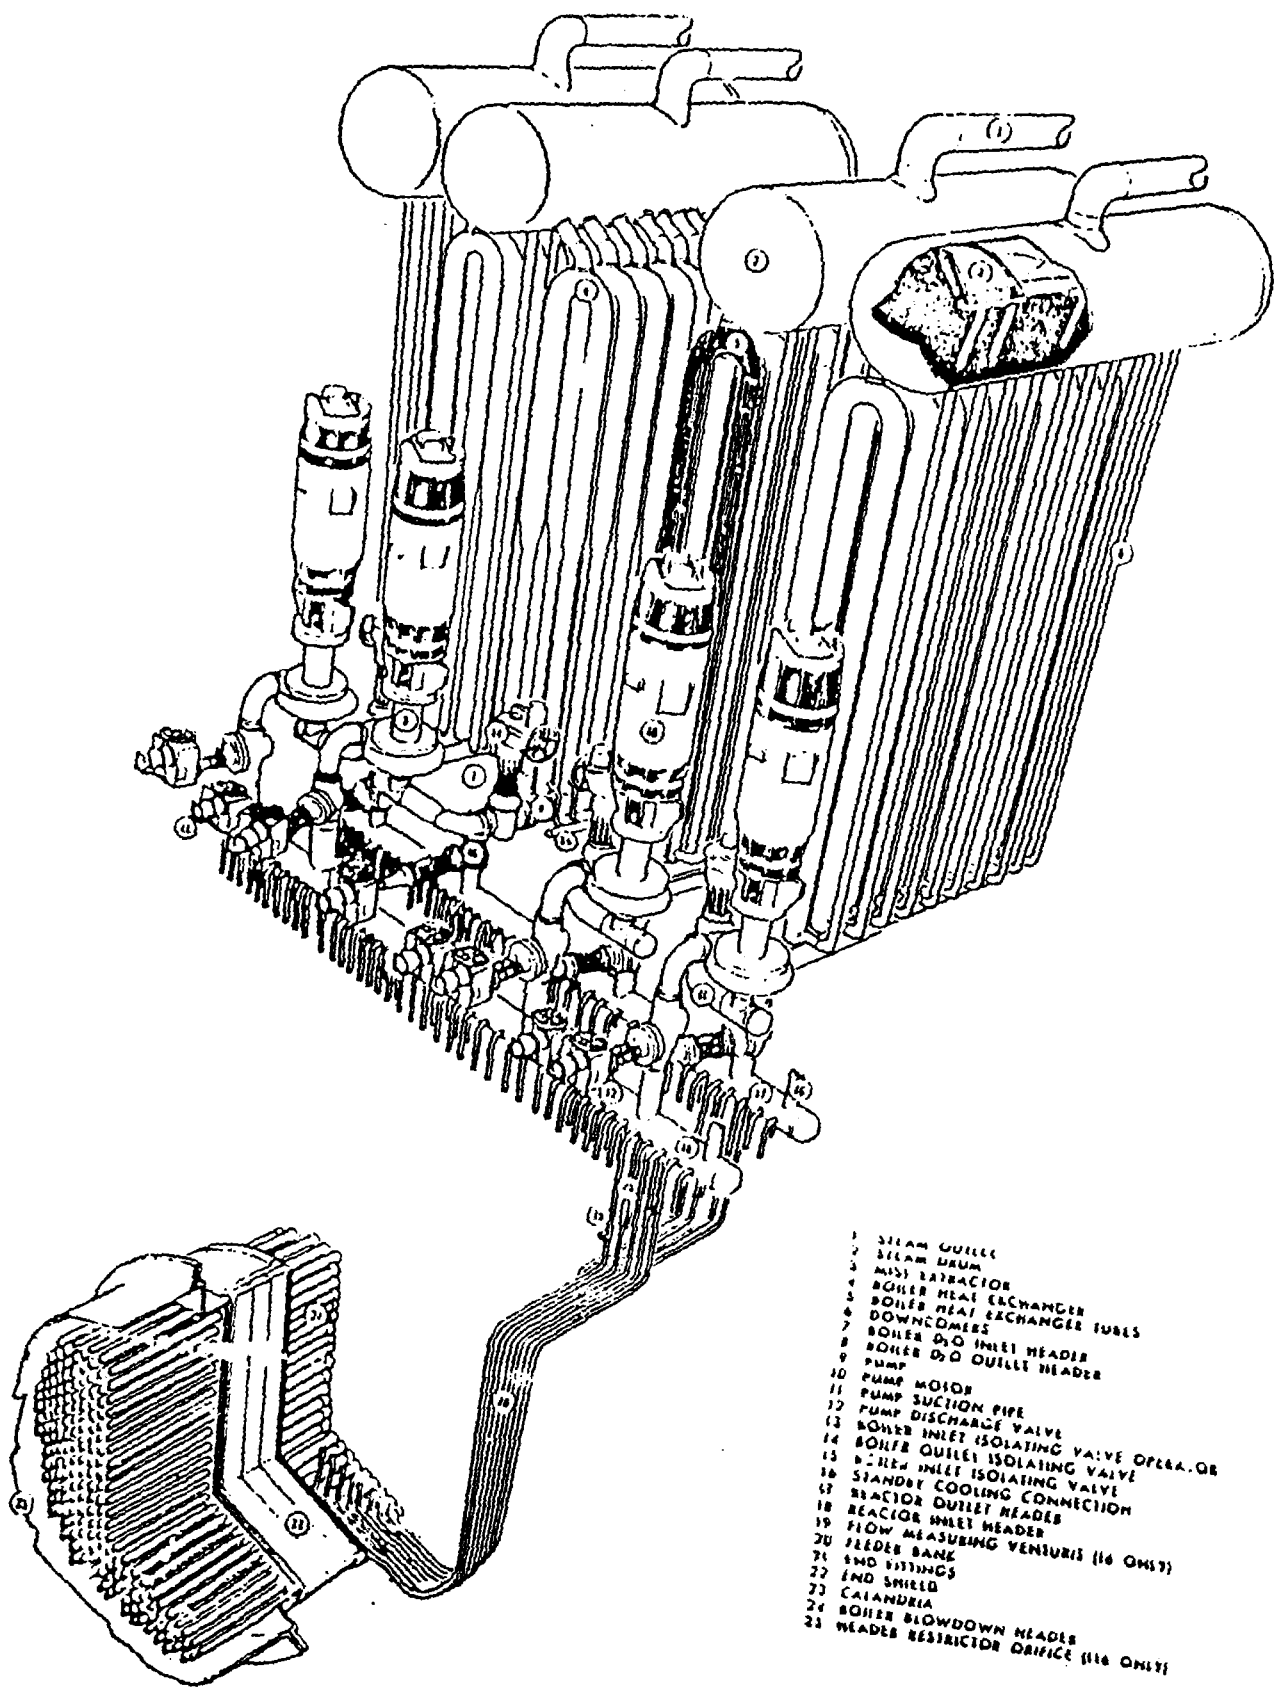
FIG. 5

The layout of the coolant circuit is shown in Figure-5. The arrangement of the feeder connections are such that fuel channels in one quadrant of the reactor are connected to a location in the inlet and outlet headers nearest to the tap off for a particular steam generator pump circuit. Out of the 306 fuel channels, flow is monitored in 16 channels distributed in each zone i.e. four in each quadrant. Out of these four, two each are provided to measure flow in channels with flow in opposite directions. The flows are graduated in percentage of design values and low flow alarm is set at 80% of the design value. Low flow trip of the reactor set at 60% of design flow is provided in six of the above flow monitored channels.

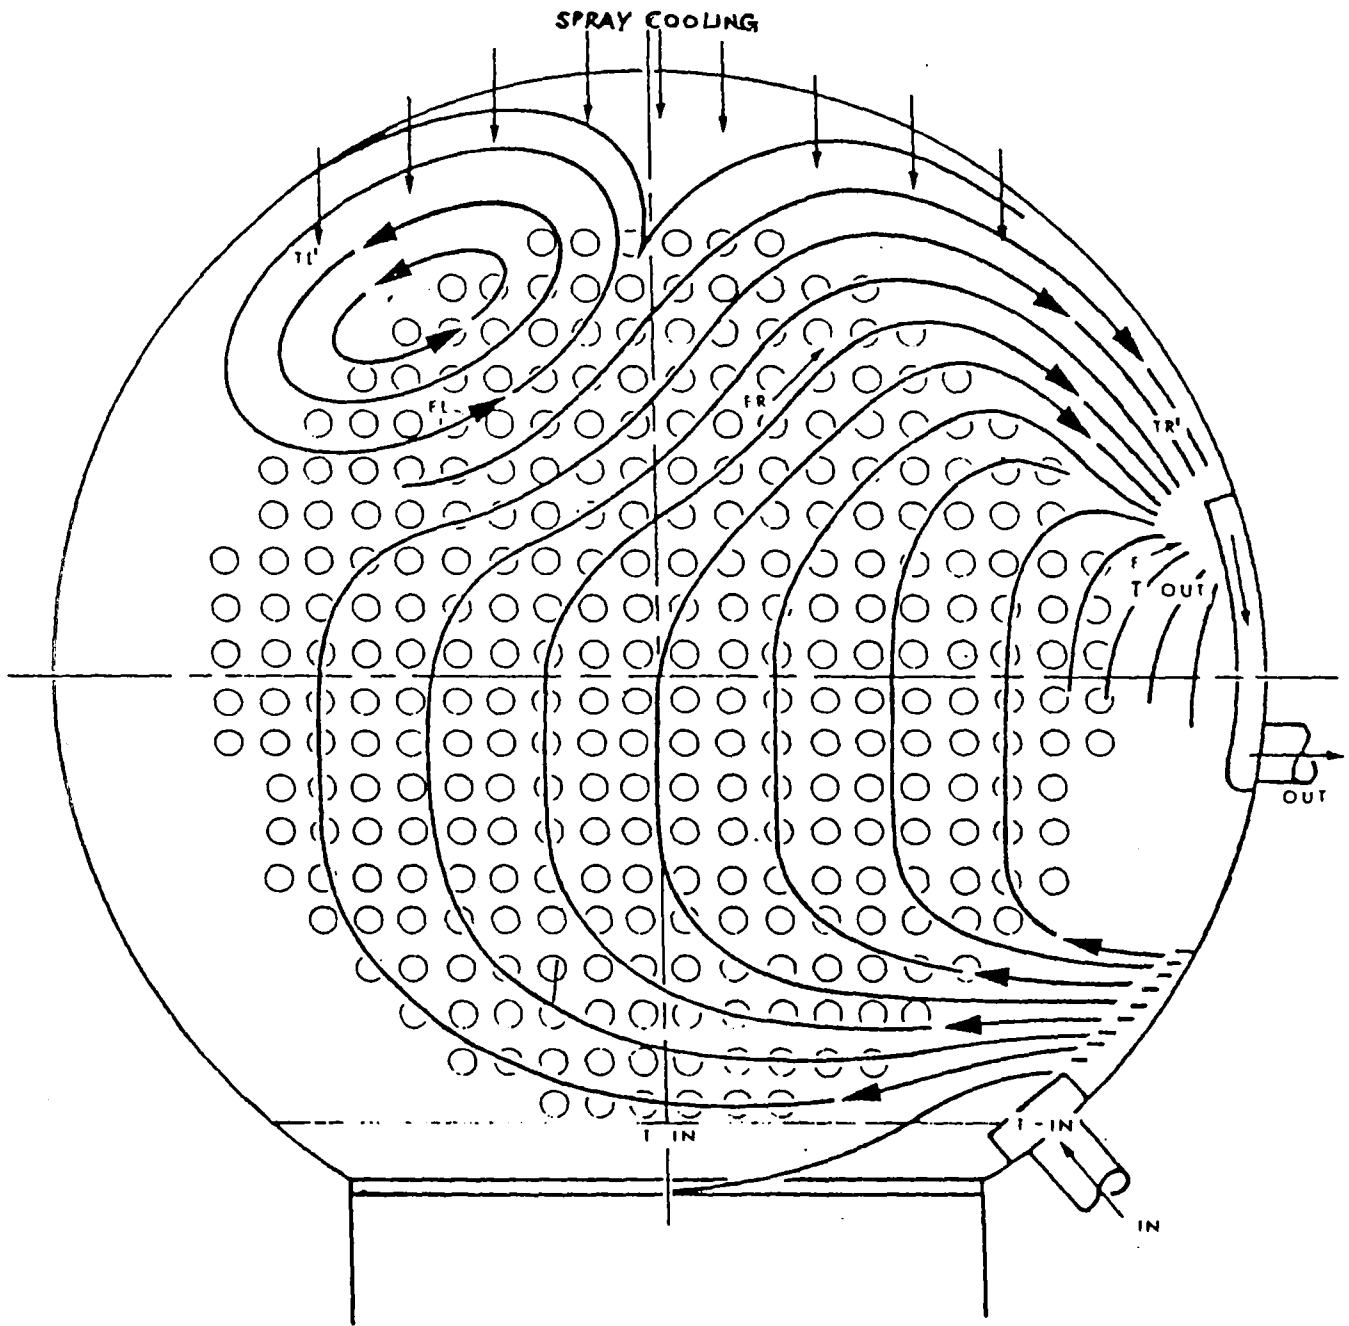
FIG-8

In early 1989, following a leak detected in a calandria tube in Unit-2, inspection of the calandria internals revealed that a portion of the inlet manifold located just in front of the inlet nozzle had sheared off and fallen on the dump ports. Surprisingly similar incident was also found to have occurred in the other MAPS Unit when it was later inspected. As an interim measure, alternate routing of moderator piping was done externally directing heavy water into the calandria through the original outlet manifold. The calandria spray flow (for cooling internal structures of calandria) was increased in order to enhance total flow into calandria. The heavy water in calandria was allowed to spill over the dump ports continuously and to return from dump tank to suction of the pumps. Since the total inflow into the calandria is less than the design, the reactors are being operated at 75% of capacity.

arrangement is shown in Figure-8. The inlet manifold can be seen in Figures 1 and 3.

THE SCHEMATIC FLOW PATTERN IN CALANDRIA  
 SHOWING INLET AND OUTLET MANIFOLDS  
 AS ORIGINALLY DESIGNED.

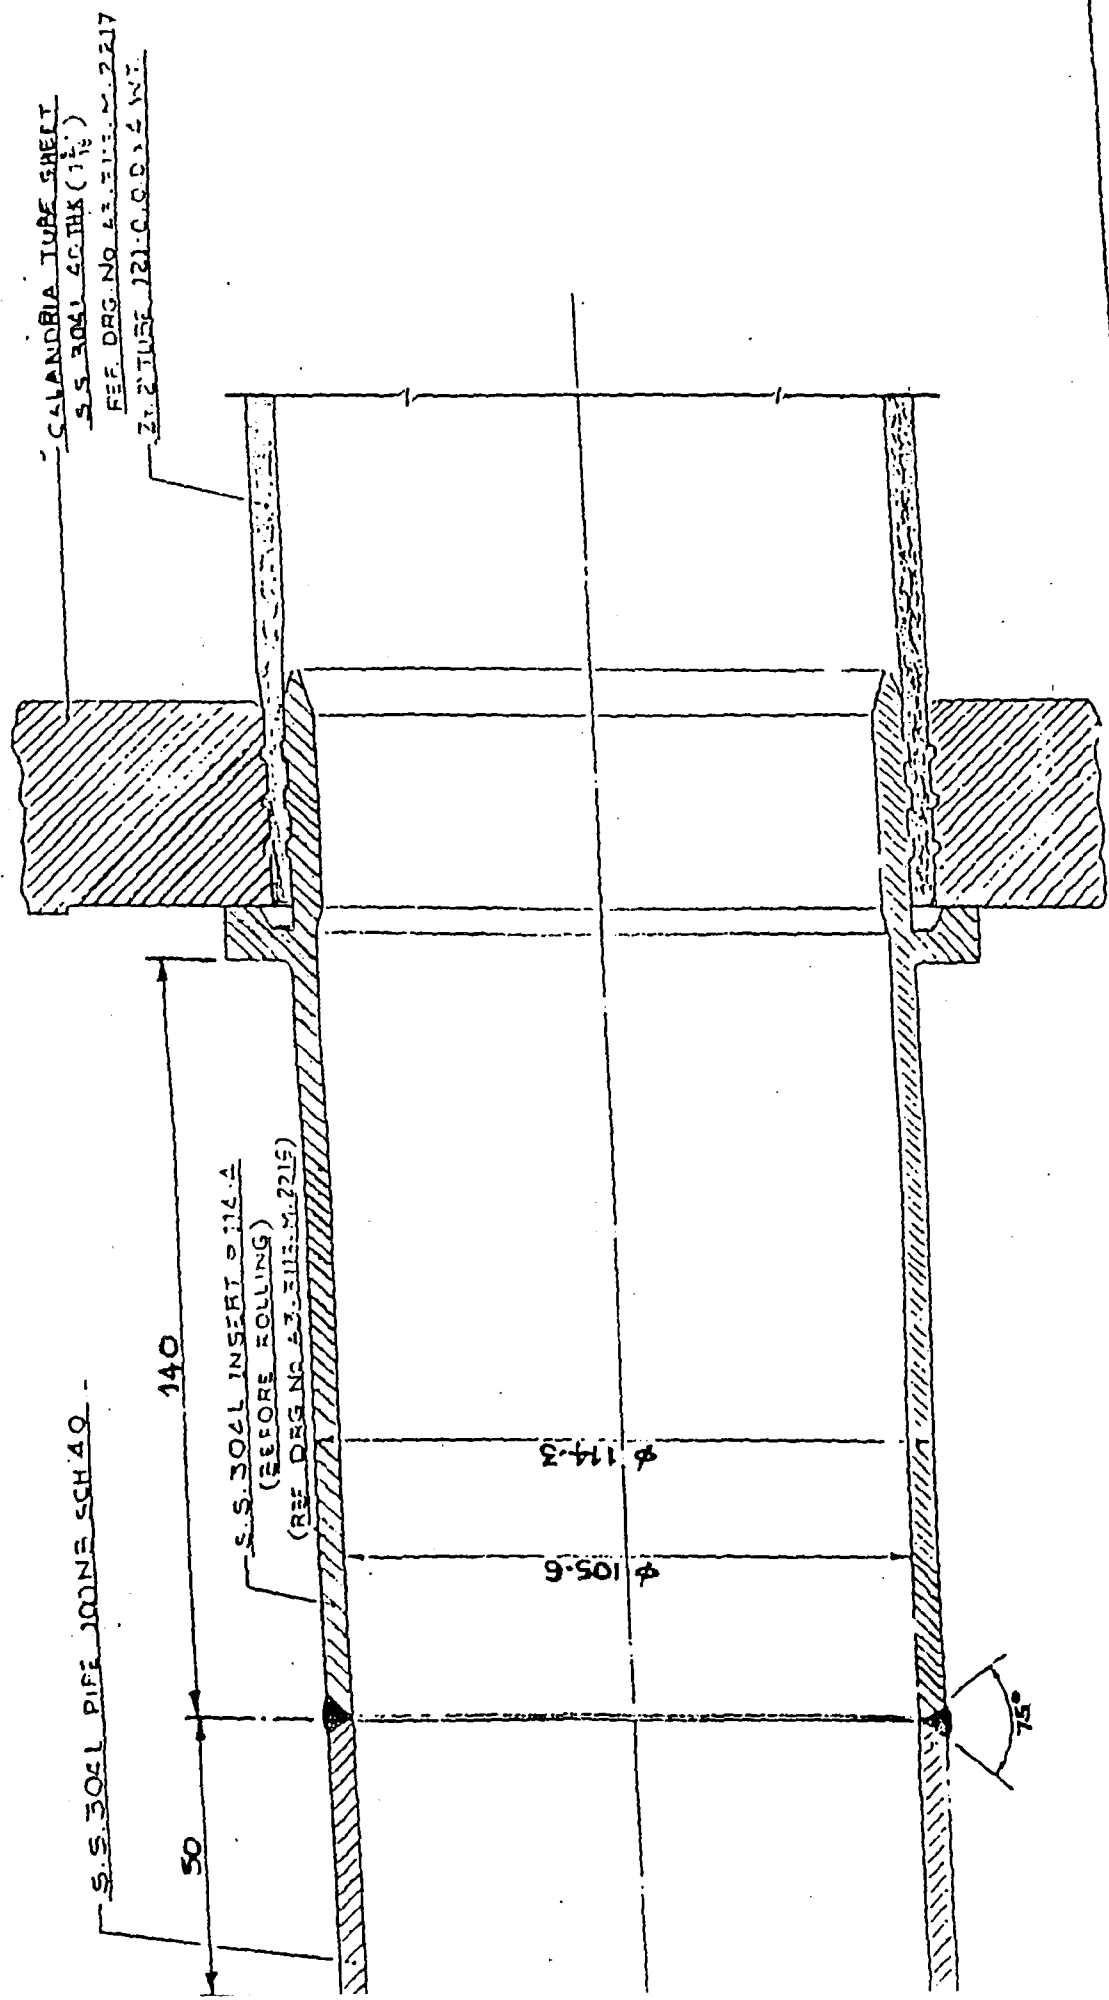
FIG-11

TITLE MAPS SPARGER CHANNEL  
 CALANDRIA TUBE SHEET TO TUBE ROLLED JOINT ASSLY.

In order to restore the moderator flow to original configuration and achieve full power, development work was undertaken and it is proposed to cut pressure tubes and calandria tubes at three lattice locations near the bottom of the calandria and install sparger tubes made of Zircalloy. These will be rolled into the calandria tube sheet. Another stainless steel insert extending upto the fuelling machine vaults through the end shield lattice bore openings will be rolled into the calandria tube sheet thus sandwiching the sparger tube between the tube sheet and the insert. Moderator piping which is routed into the fuelling machine vaults will connect to these extended inserts and the layout ensures that this arrangement will not hinder movement of fuelling machine to do refuelling in adjacent channels. Hydraulic studies were made on models and suitable provisions based on these studies have been incorporated to achieve required flow distribution through these spargers. The proposed sparger and the rolled joint are given in Figures 10 and 11. As a parallel measure, provision of a third moderator heat exchanger to bring down the moderator inlet temperature and operate the reactors at higher power in this mode itself are being studied.
